Goose & MLA Project Sites – 2024 Annual Geotechnical Inspection

Back River Project, Nunavut, Canada
B2Gold Corp.

SRK Consulting (Canada) Inc. ■ CAPR003105 ■ April 2025

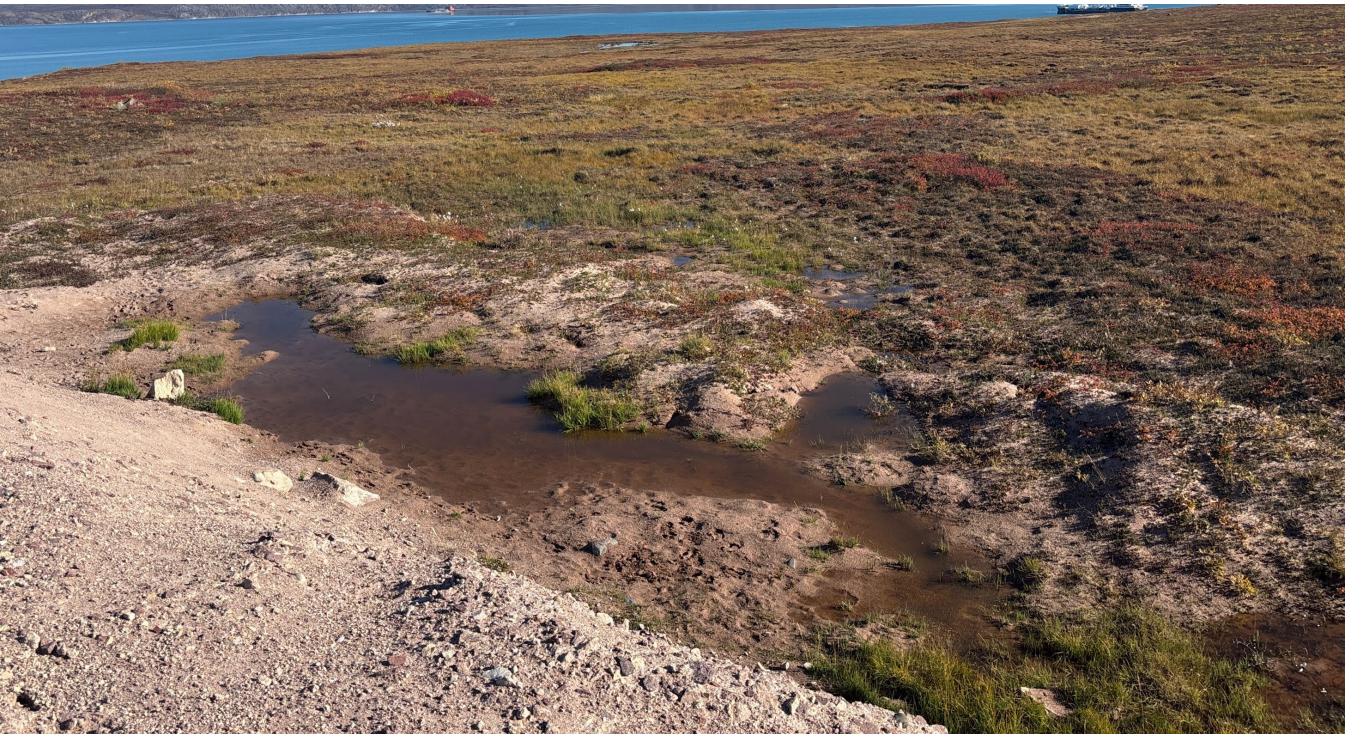
M-27: South end – Note ponding water at the toe of the embankment

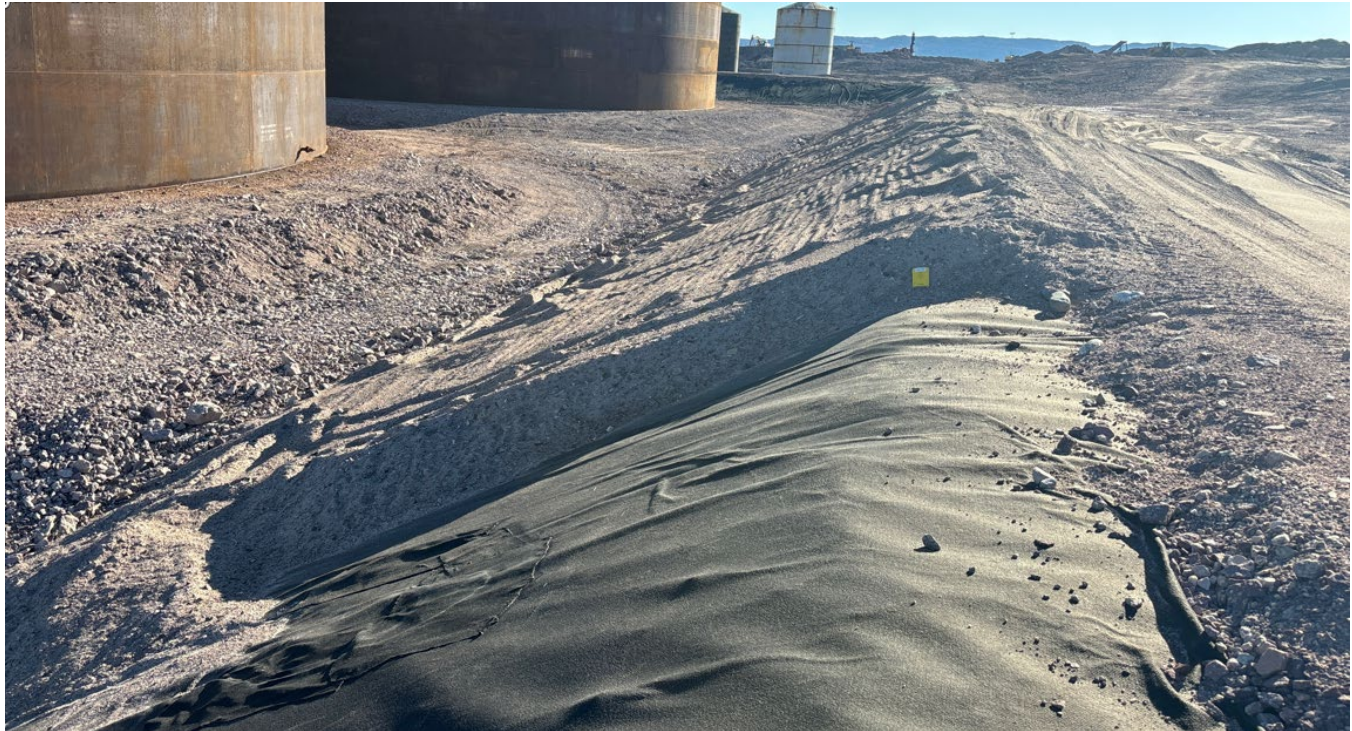
M-28: Liner fill is too thin, to allow equipment on the berm min 0.6 m of fill is required

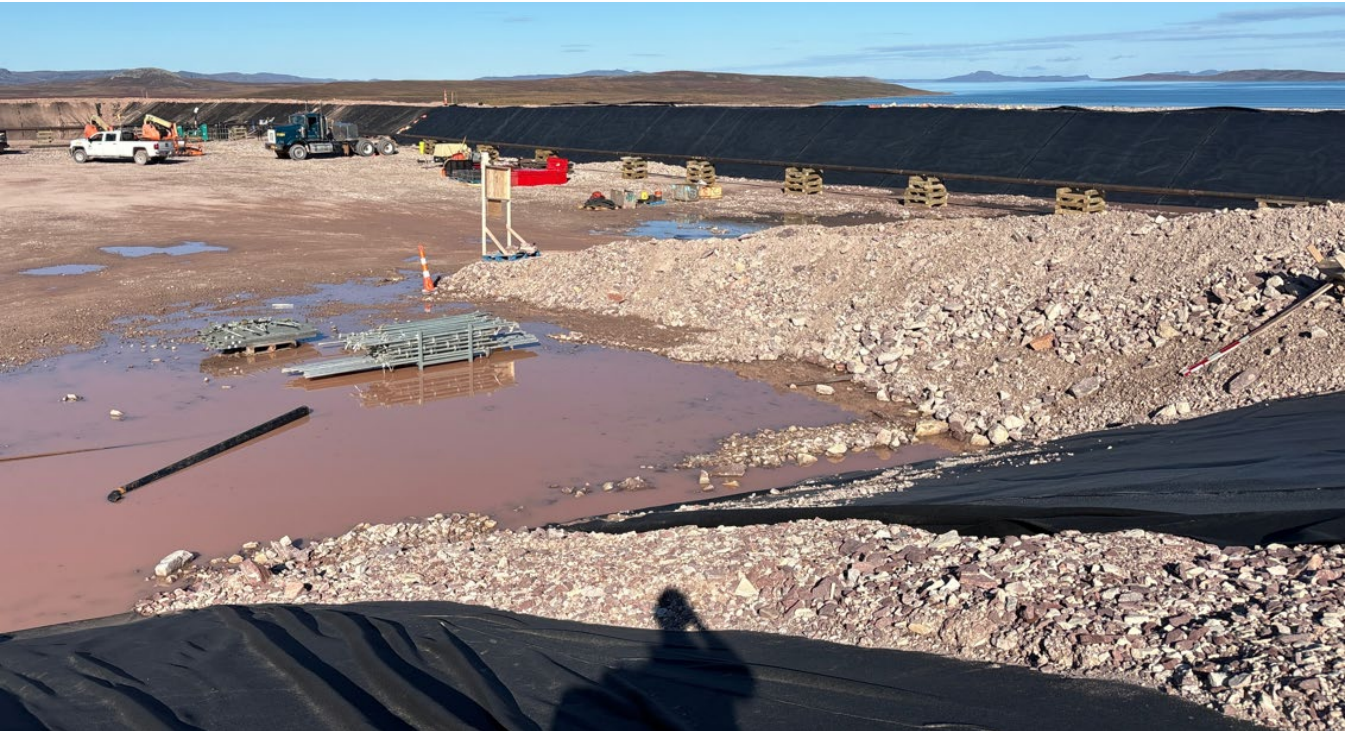
M-29: Ponding water due to the ramp access

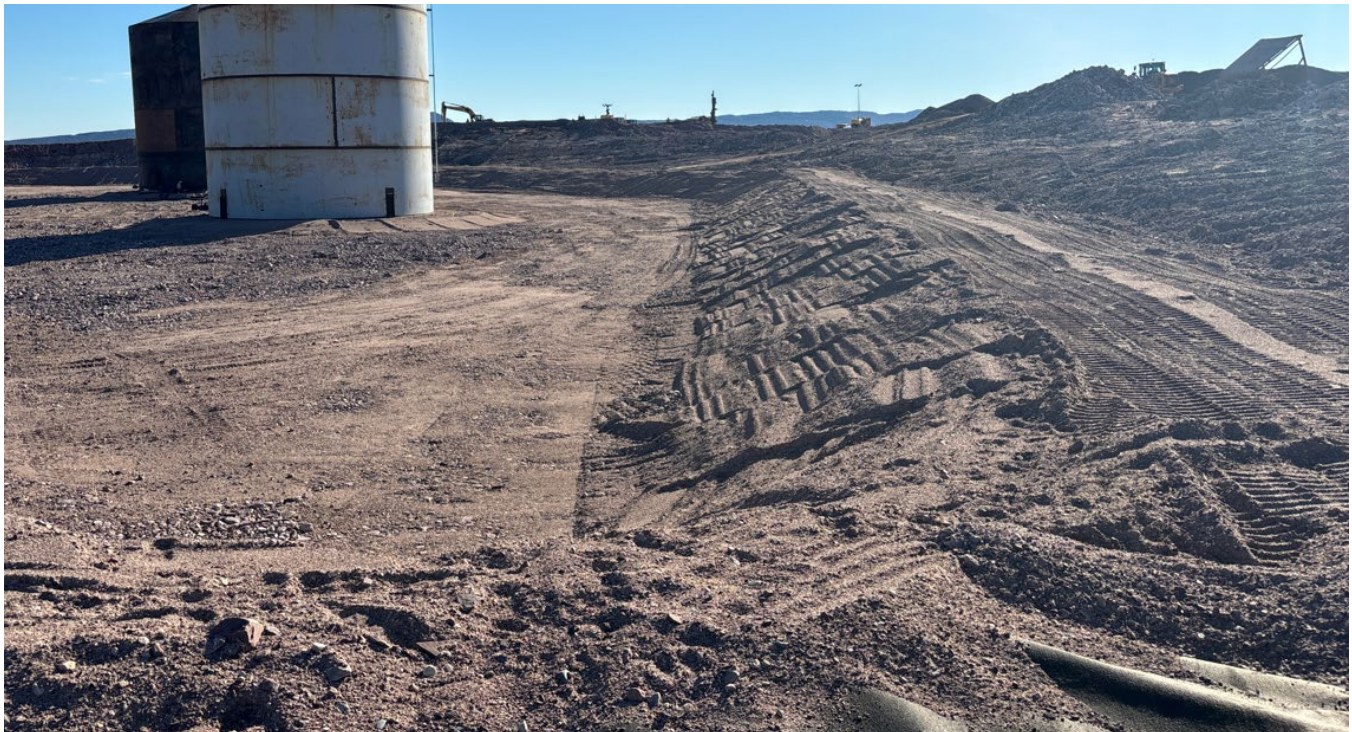
M-30: Liner fill is presented by sand, that is prone to the erosion – need to be buttressed with courser material

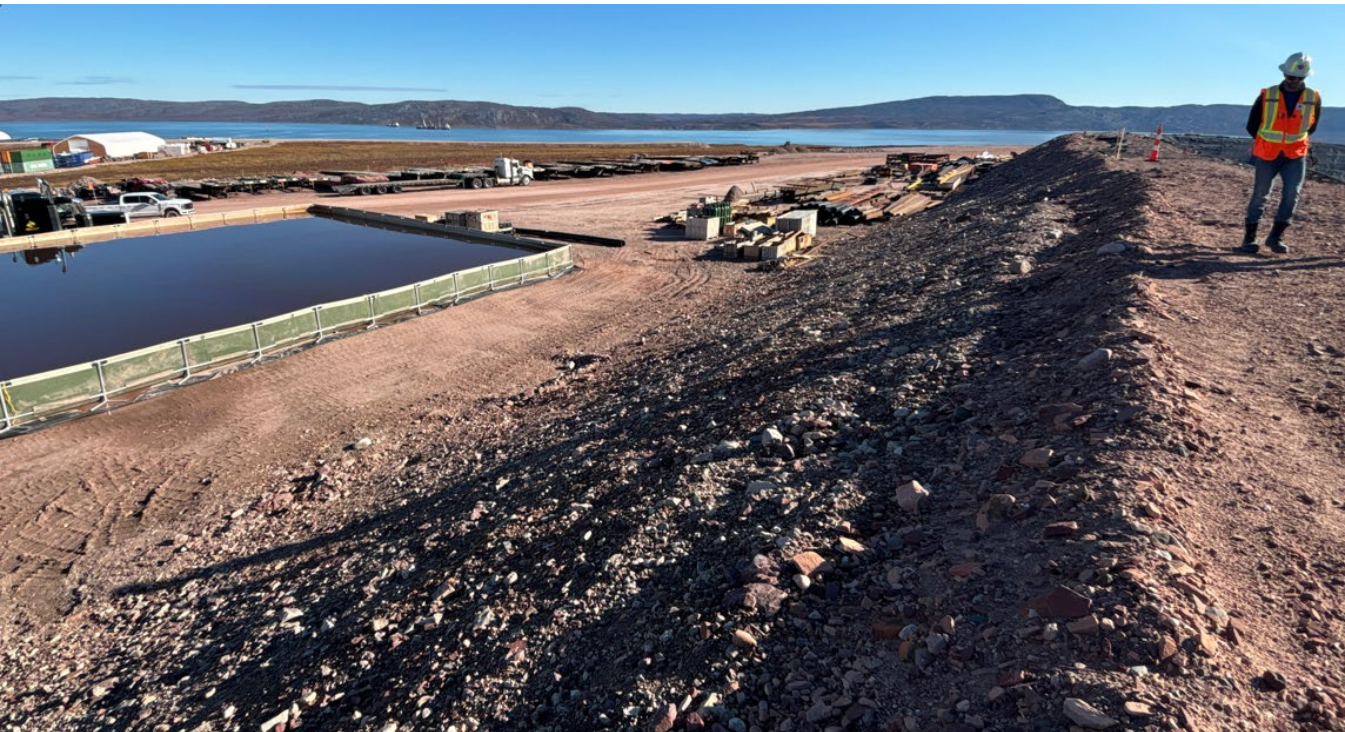
M-31: Berm slopes are too steep

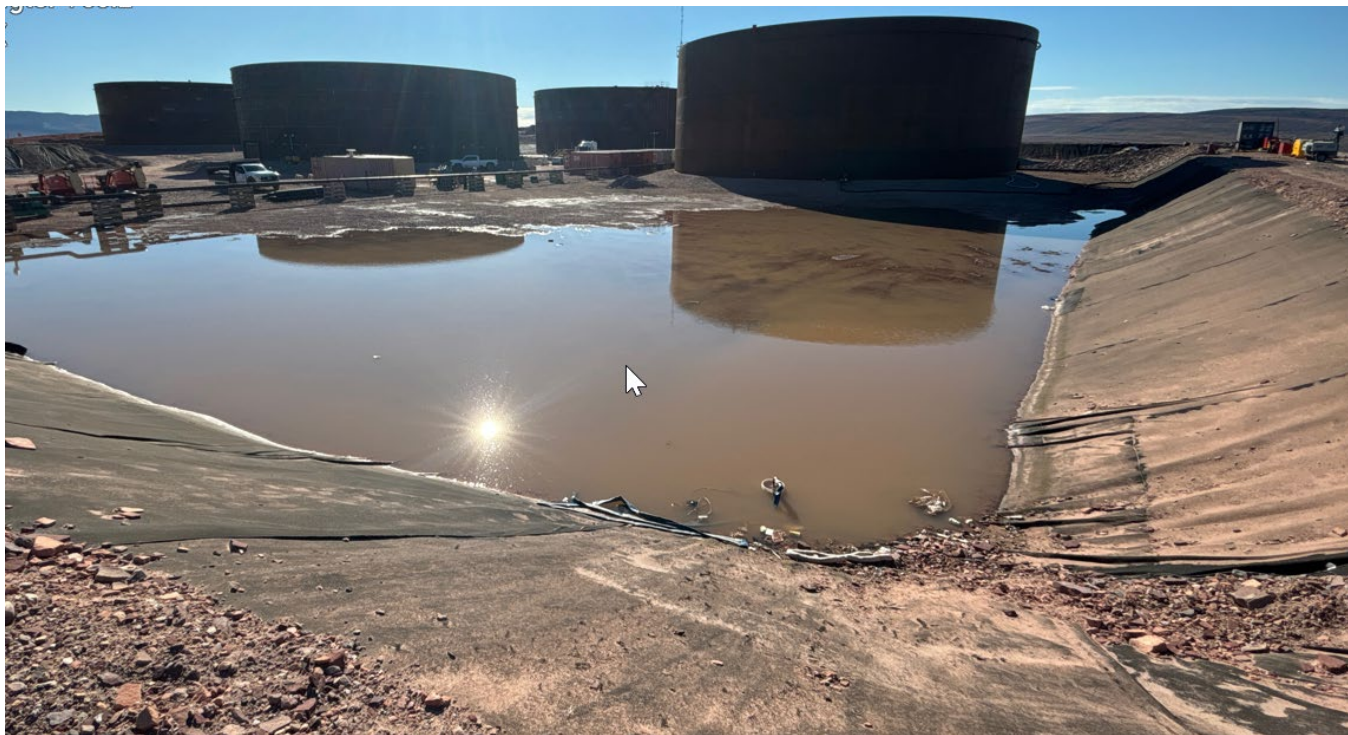
M-32: Ponding water

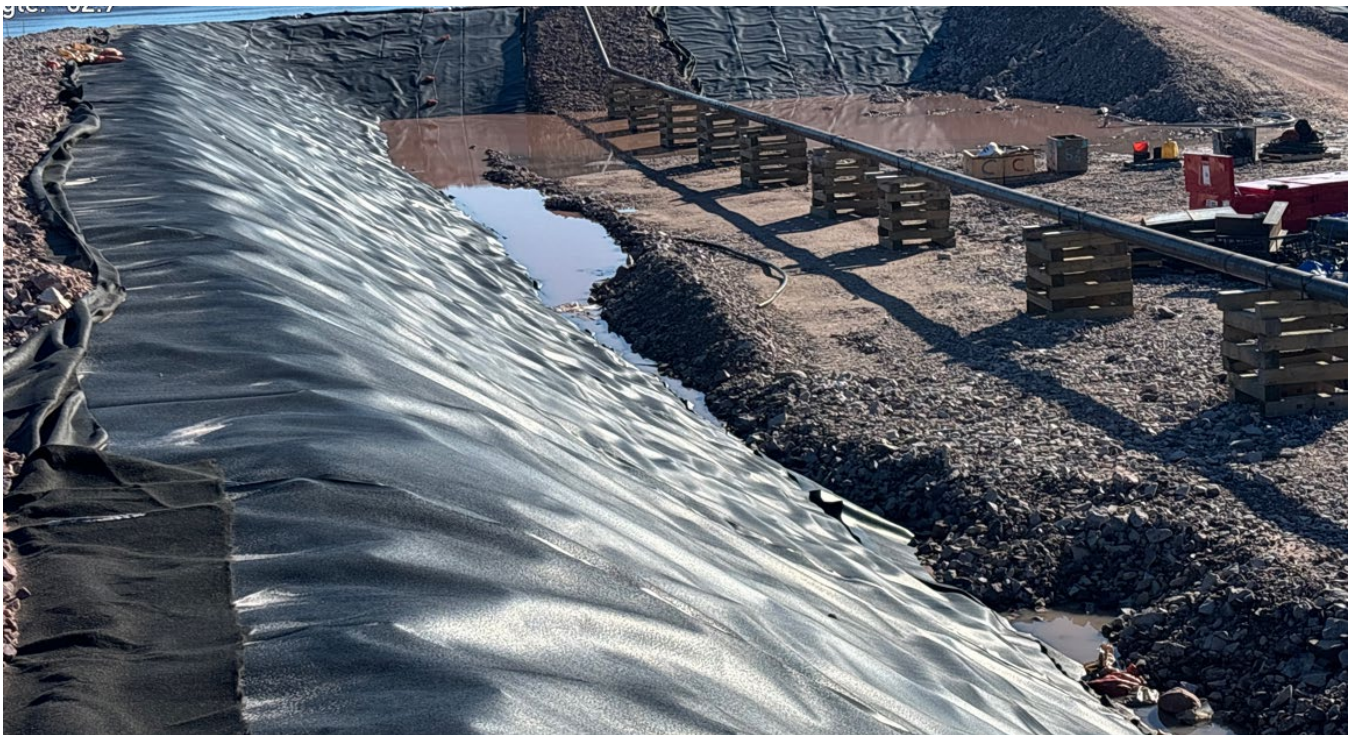
M-33: Ponding water

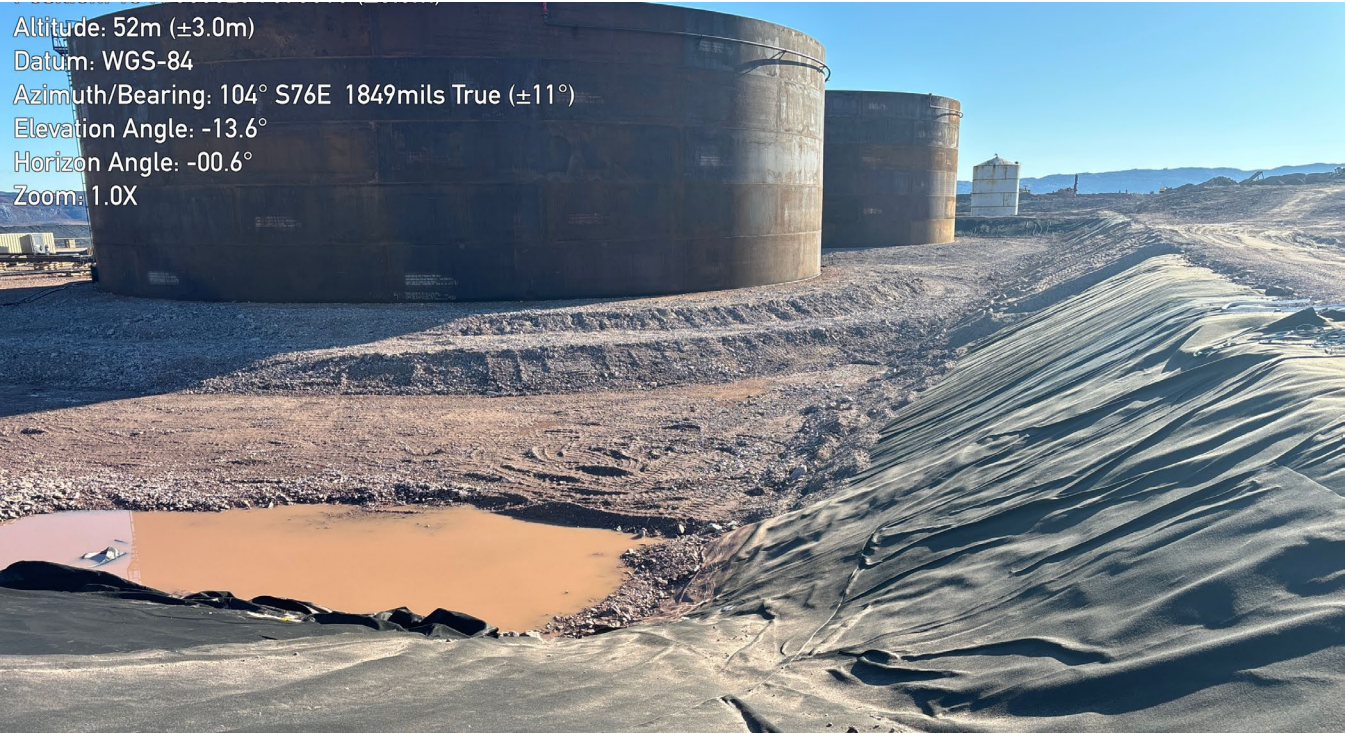
M-37: SW end of tank farm, facing west – Note ponding water

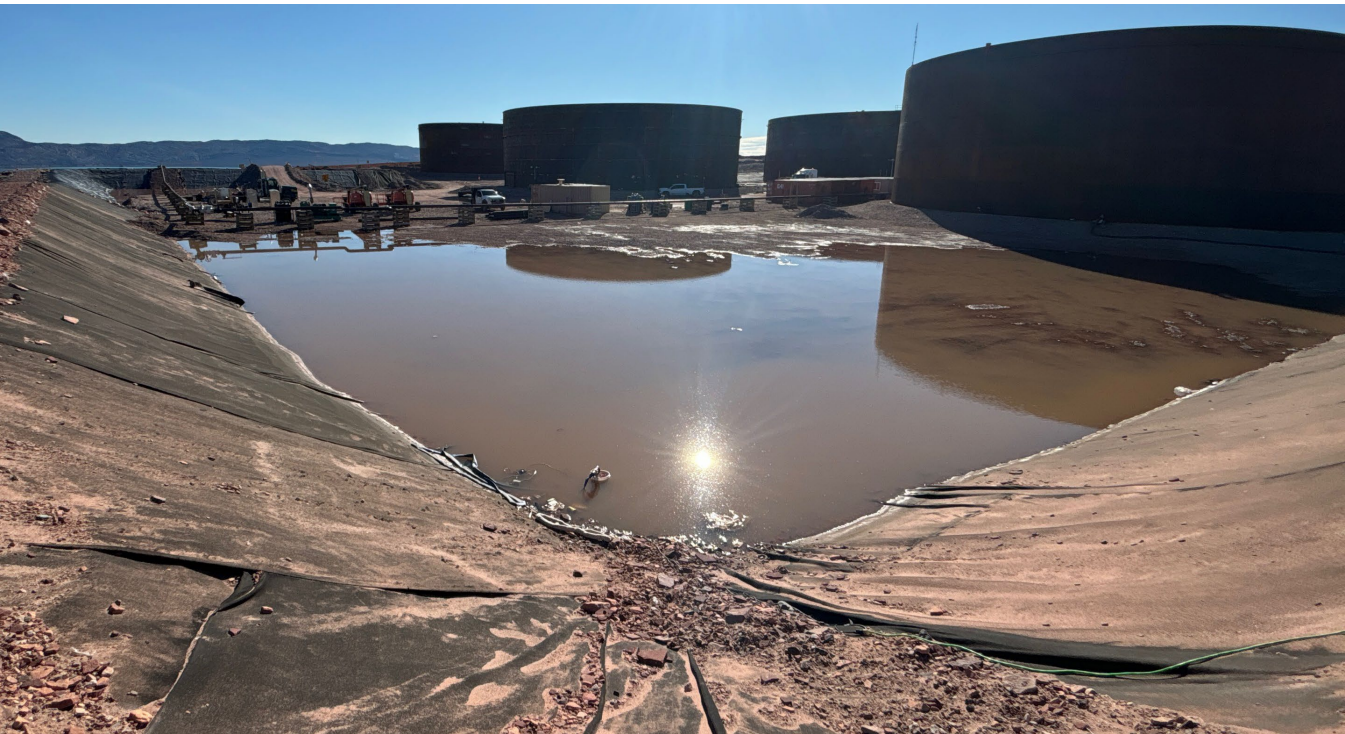
M-39: NW end of tank farm, facing south – Note ponding water

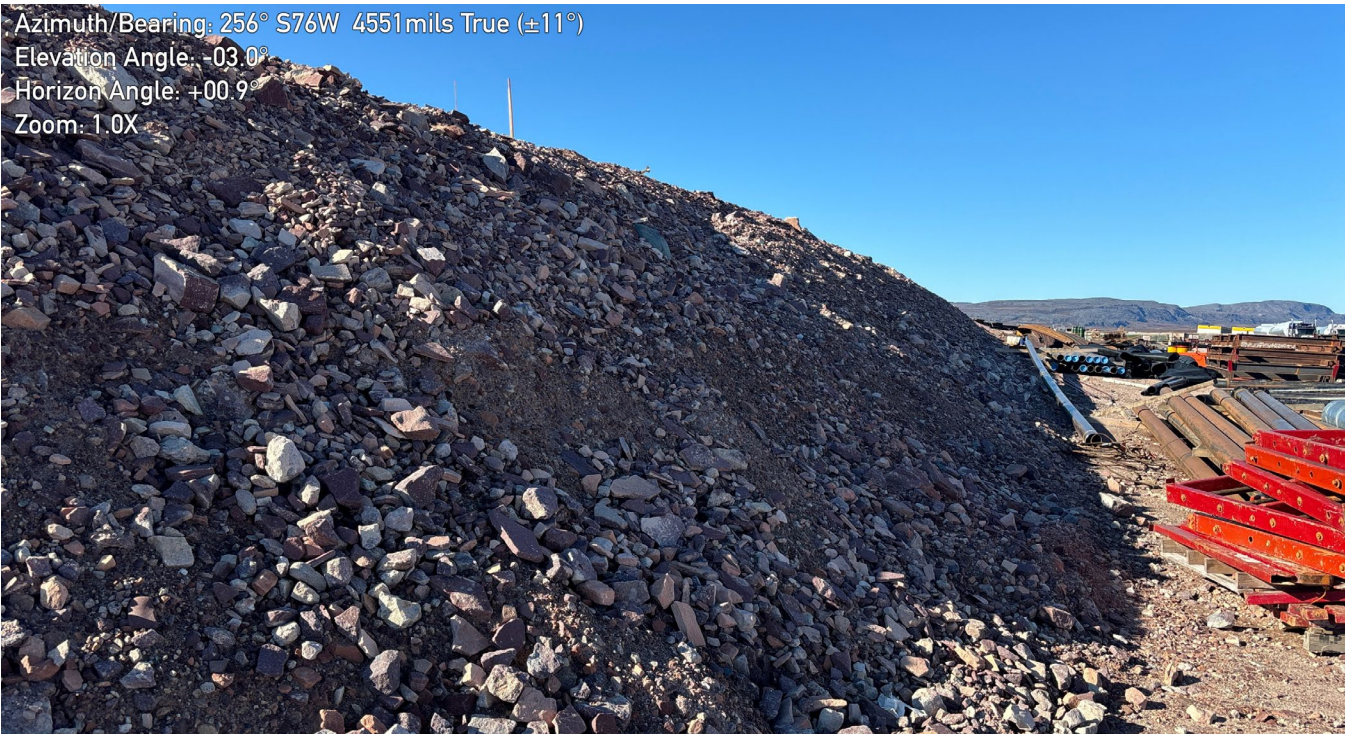
M-46: Tank farm laydown area – Note slopes oversteepened

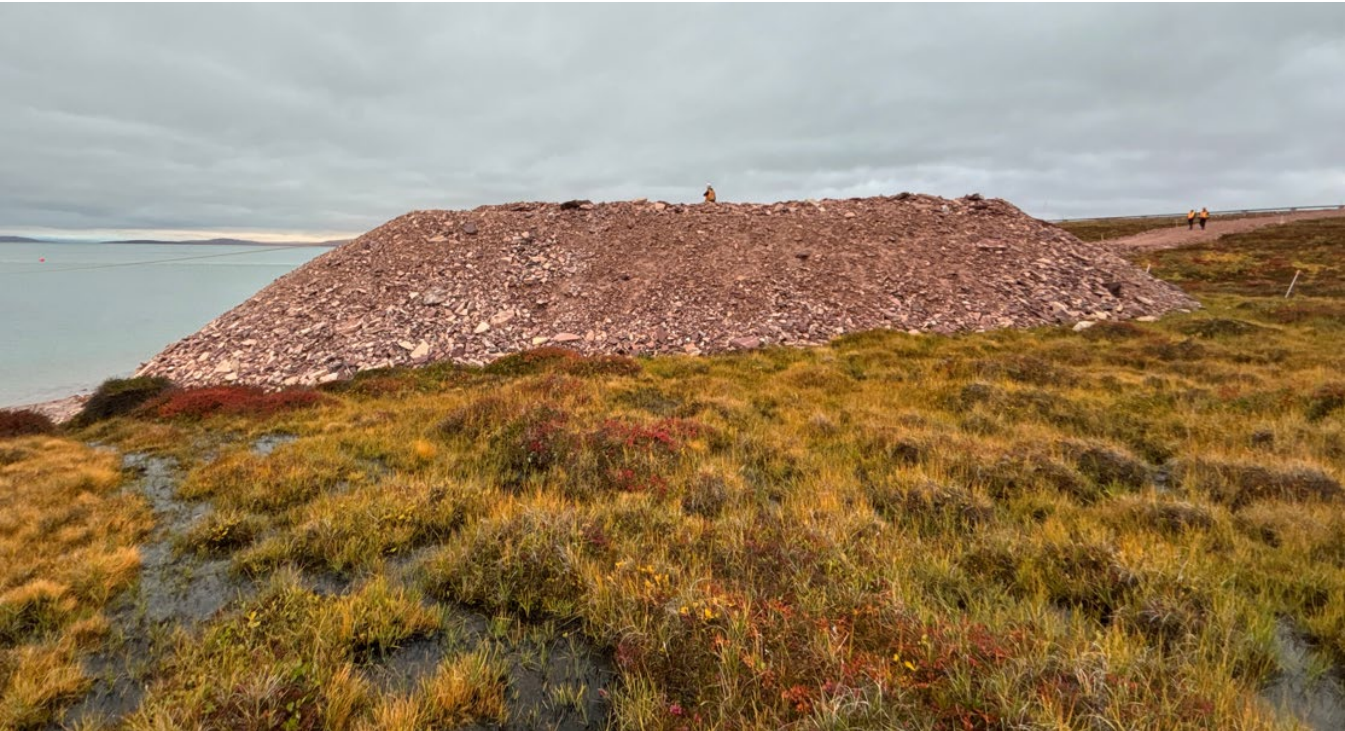
M-49: North pad, facing south – Note corner flow paths

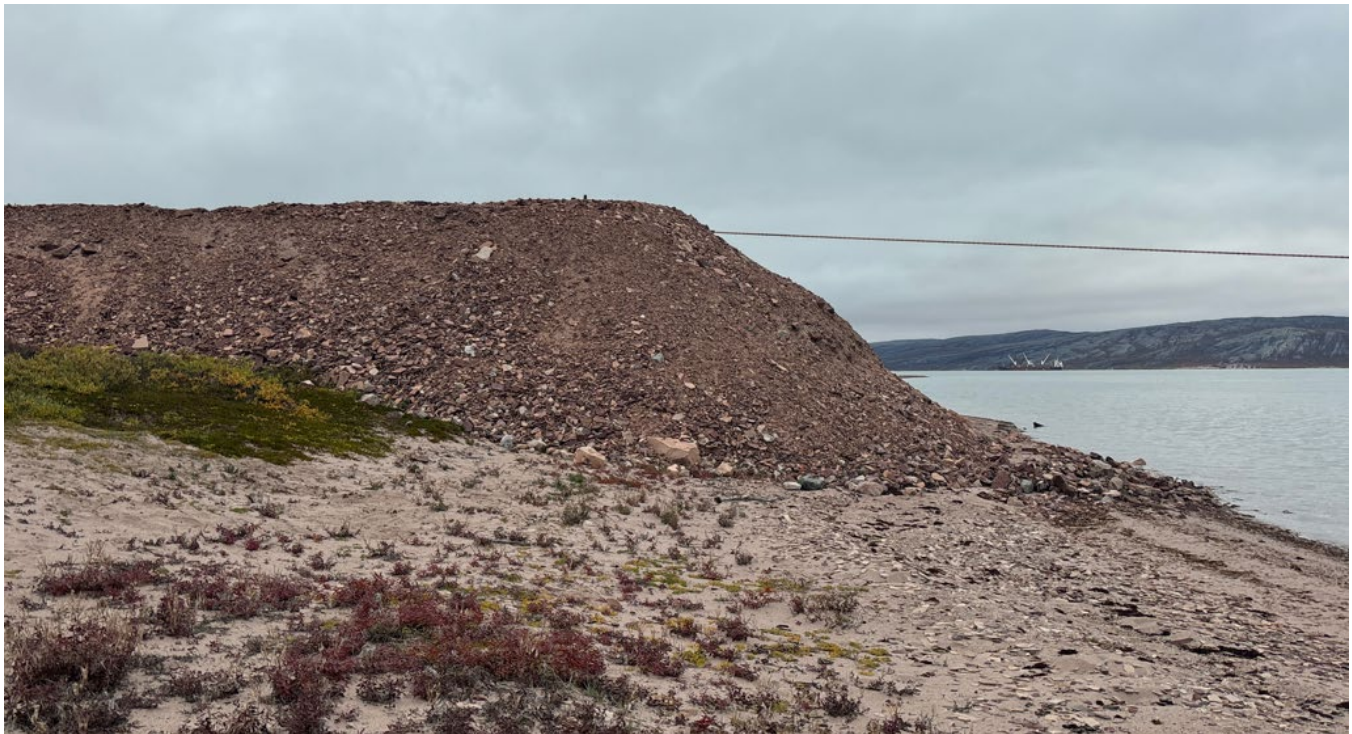
M-50: North pad, facing north – Note erosion at shore

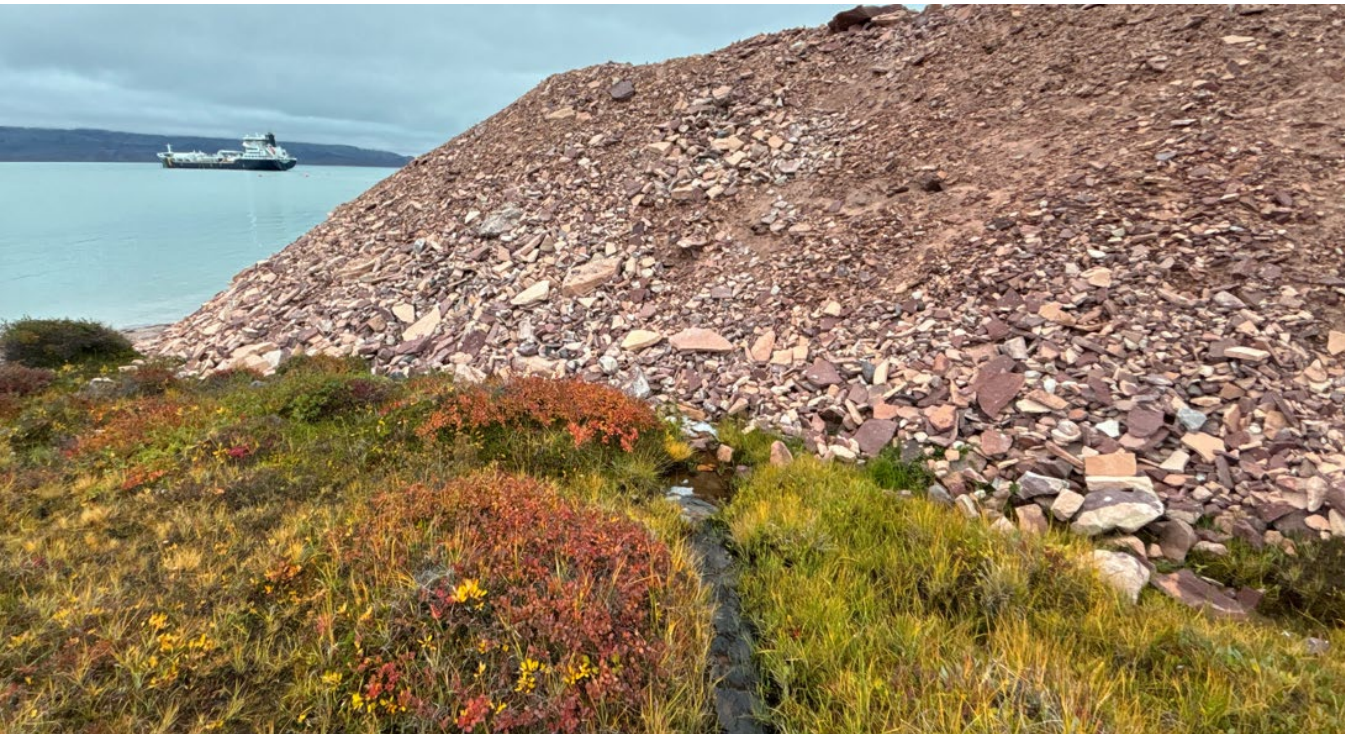
M-51: North pad, facing SE – note corner flow paths

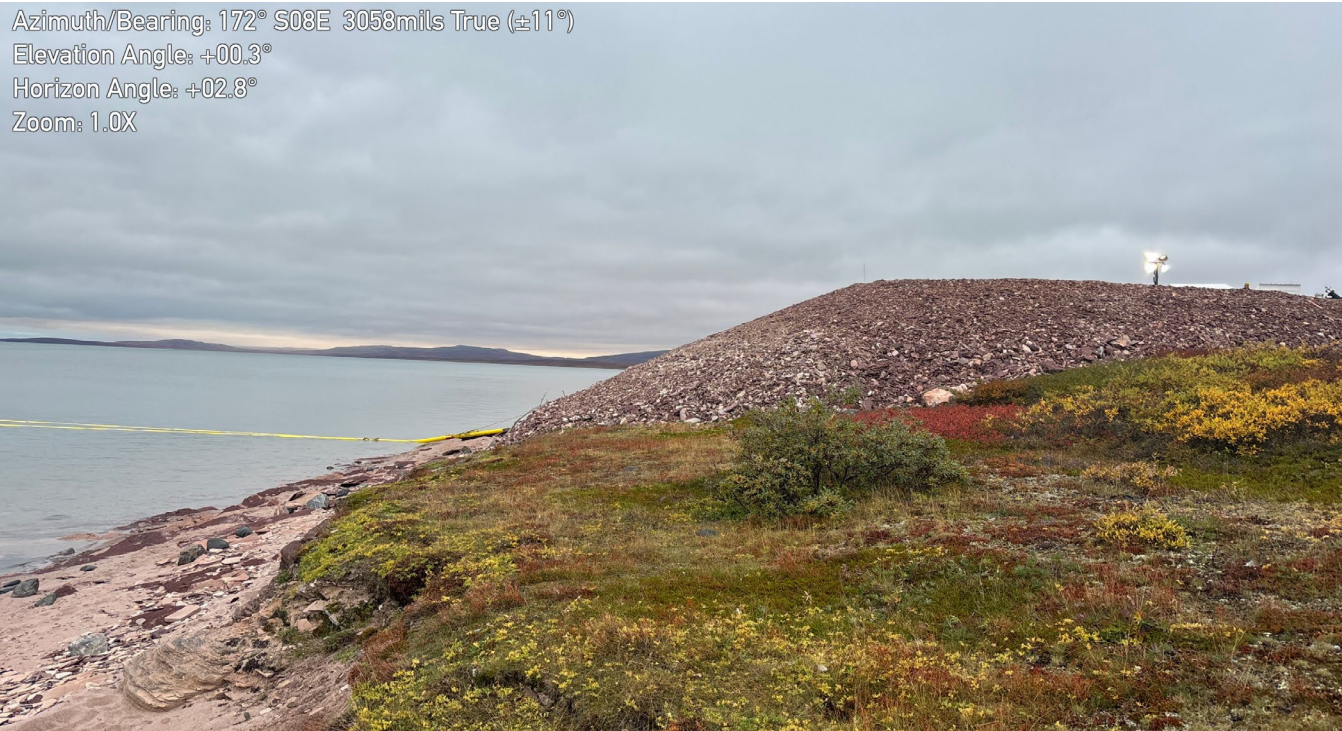
M-52: Middle anchor pad, facing south – Note shore erosion

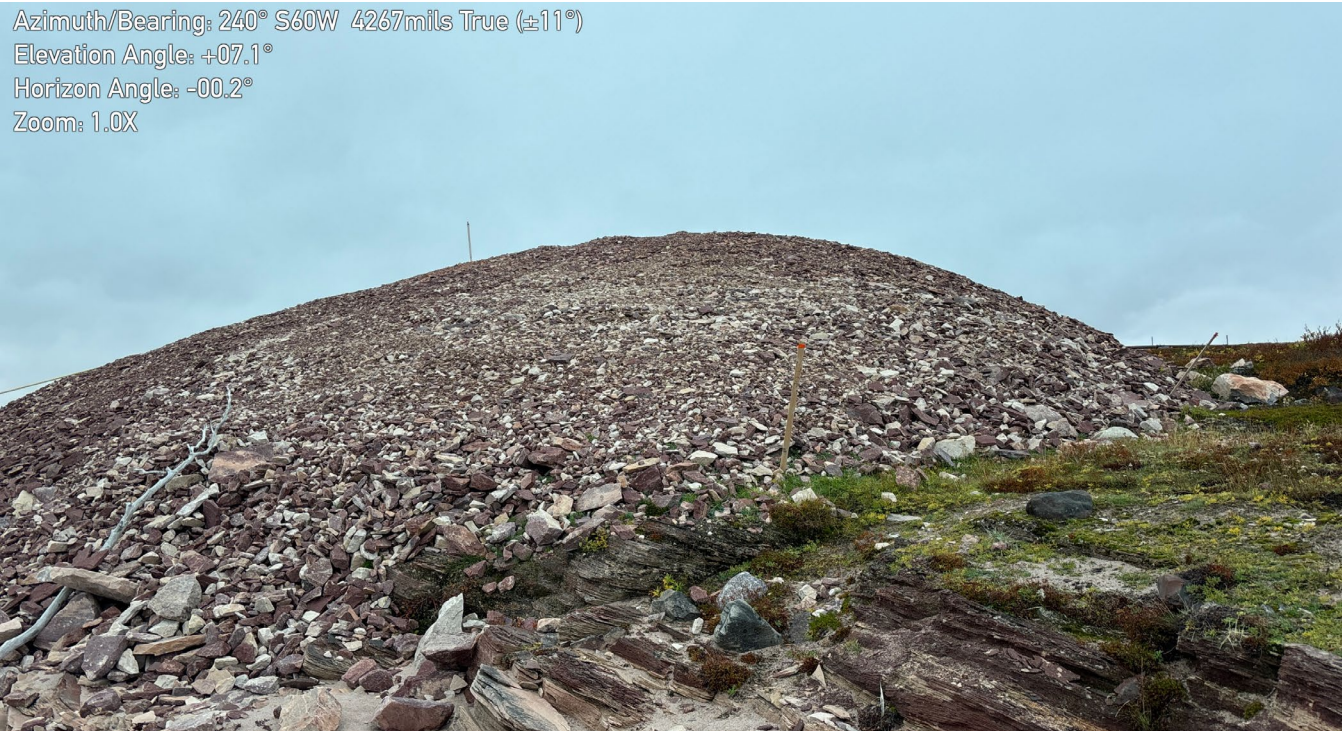
M-53: Middle anchor pad, facing west – note erosion

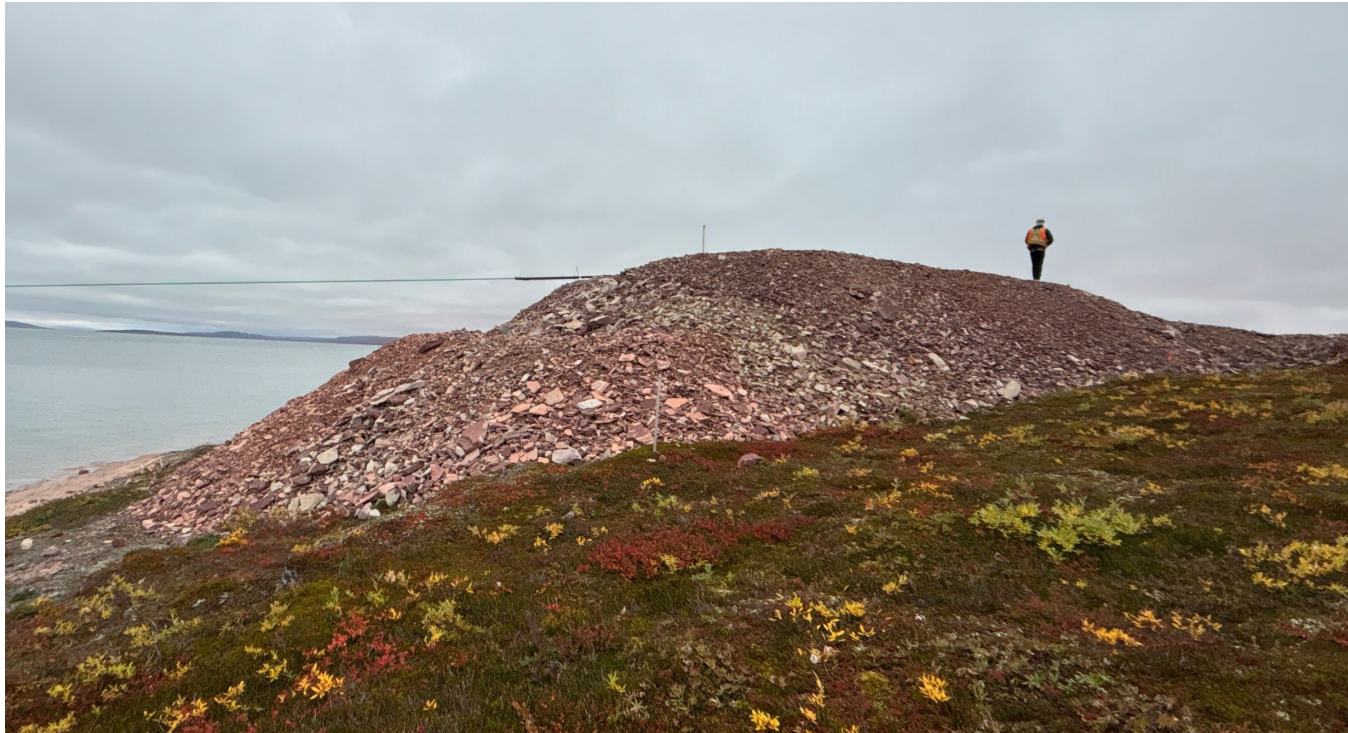
M-56: South anchor pad, facing south – Note shore erosion

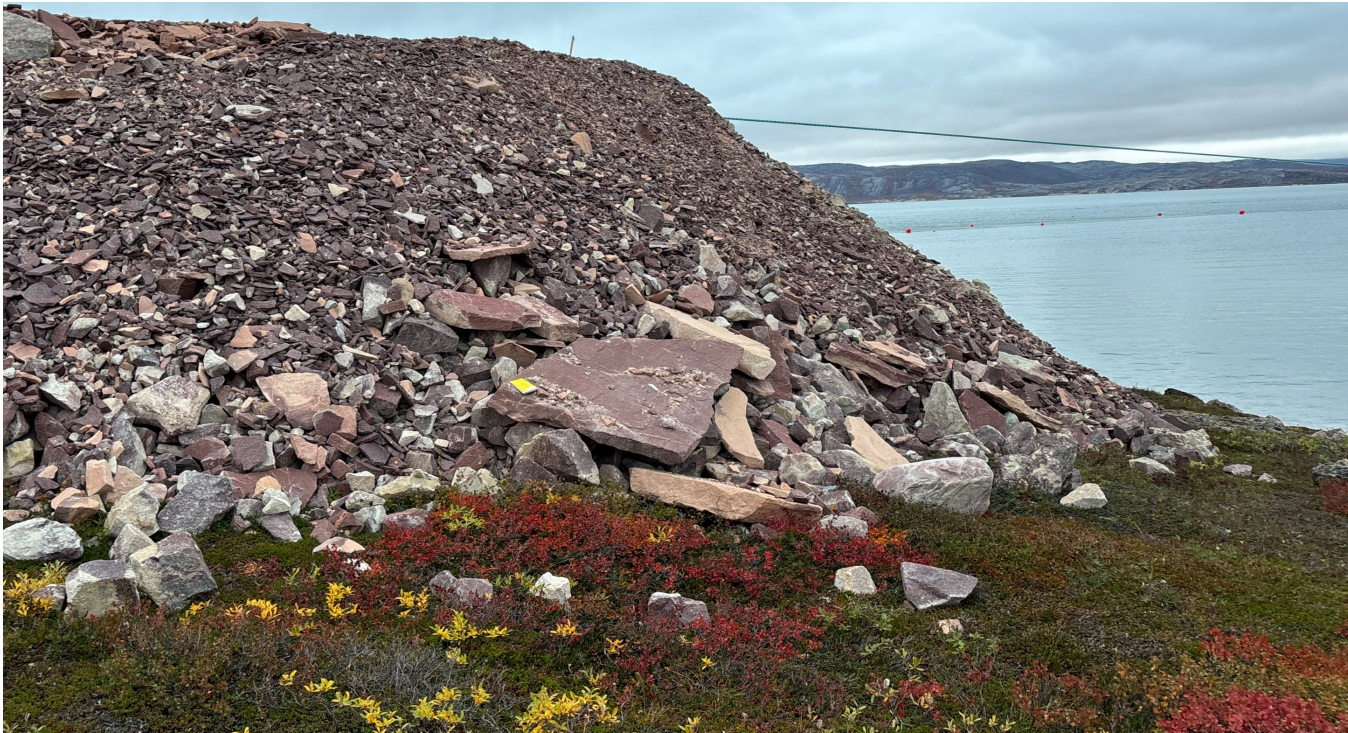
M-57: South pad, facing north – Note steep slope

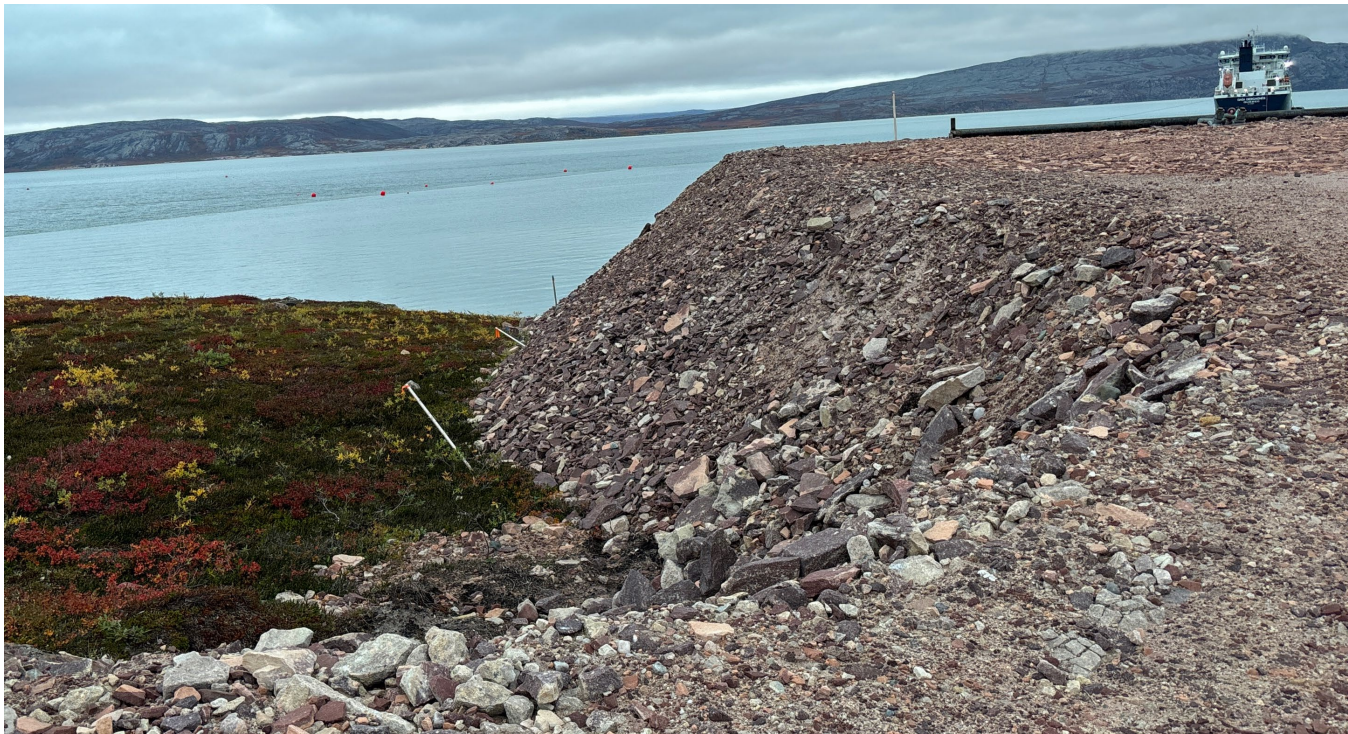
M-58: South pad facing east – Note steep slope

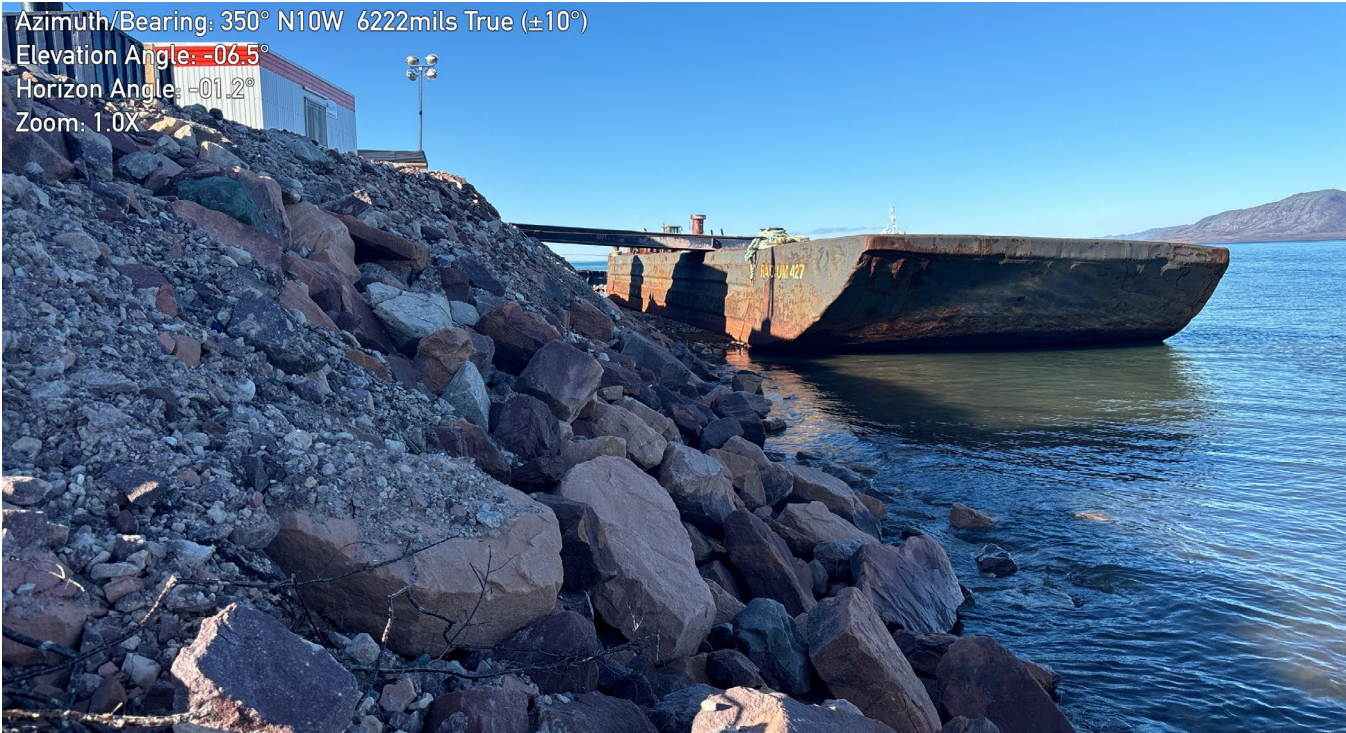
M-60: Shoreline Pad, facing NW

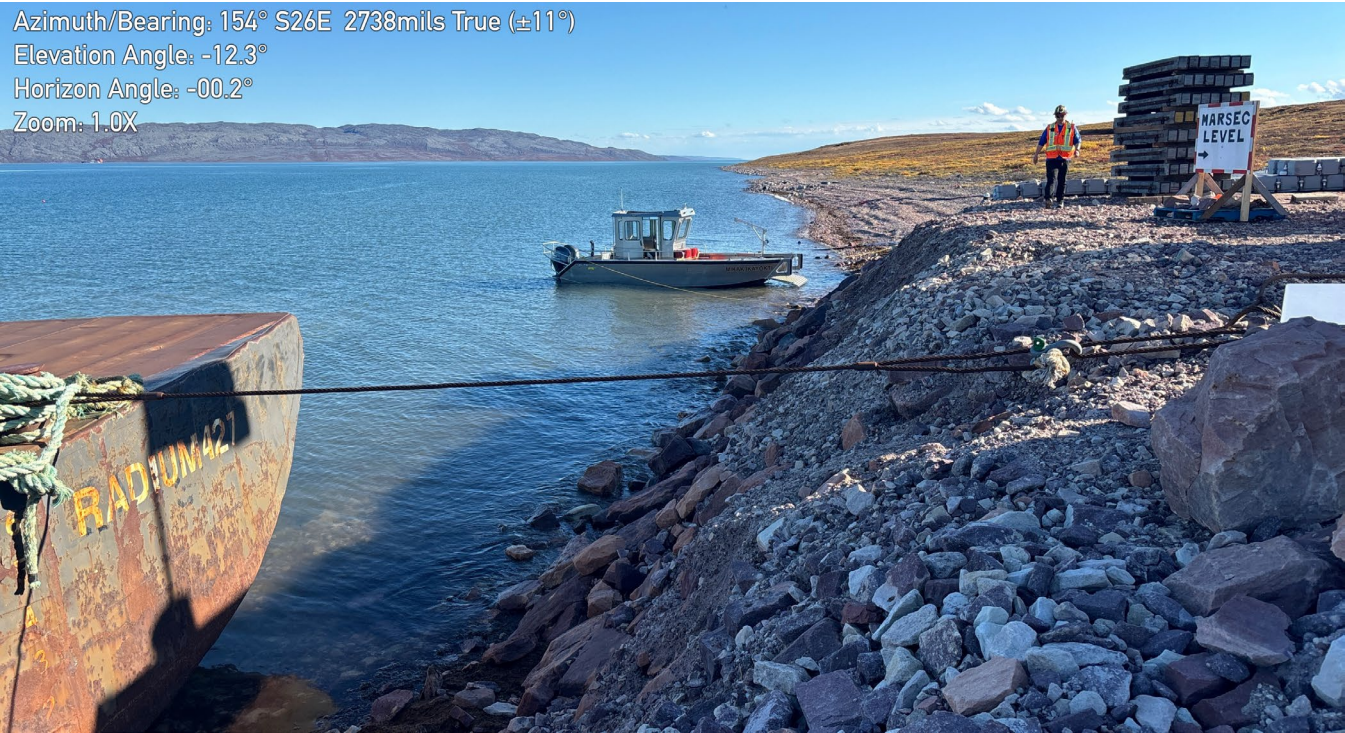
M-61: Shoreline Pad, facing SE

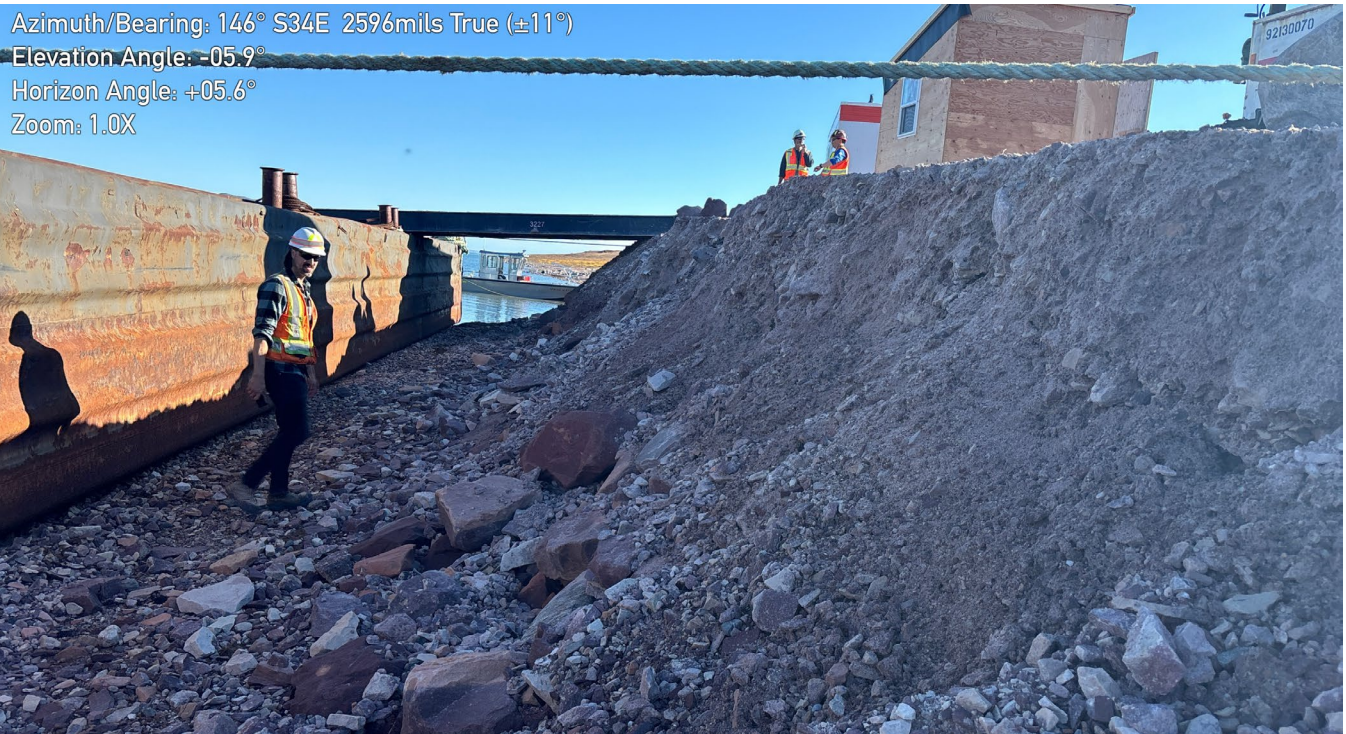
M-62: Embankment face - Note oversteepened slope

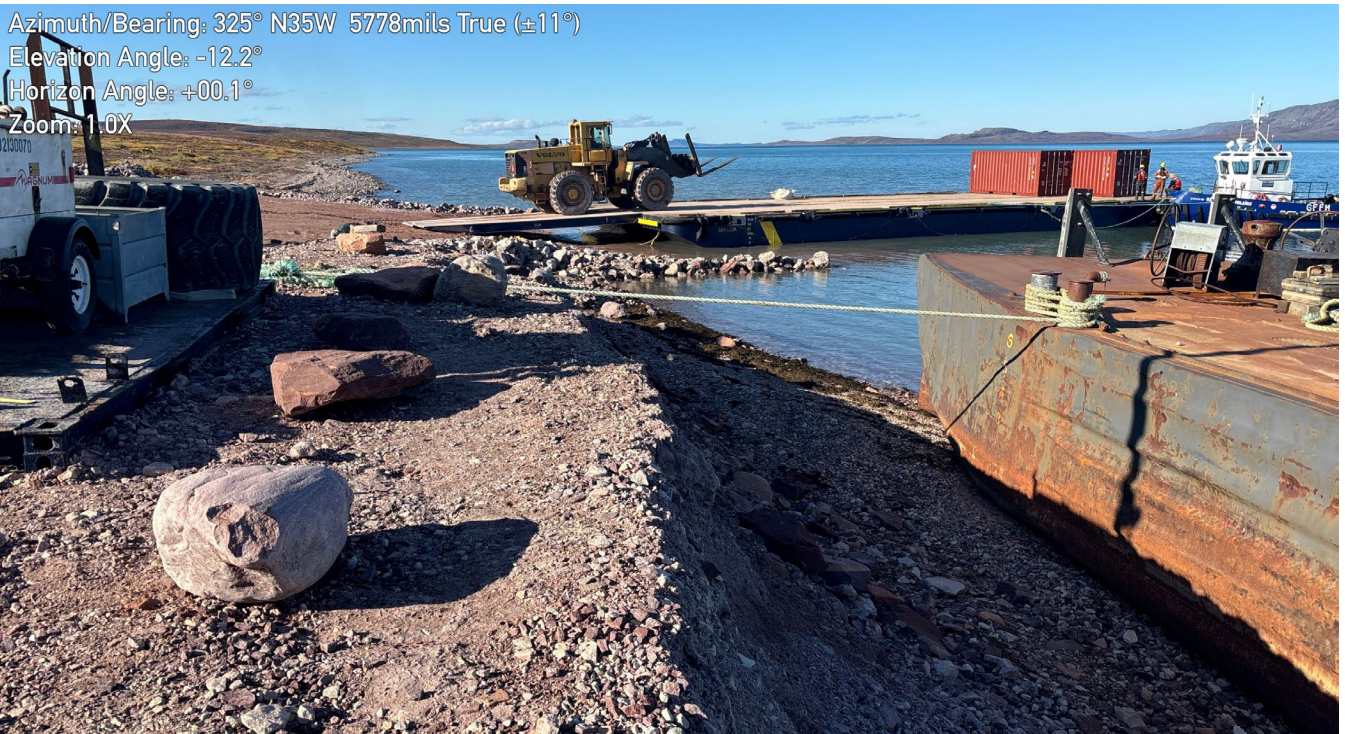
M-63: Top of slope, facing NW

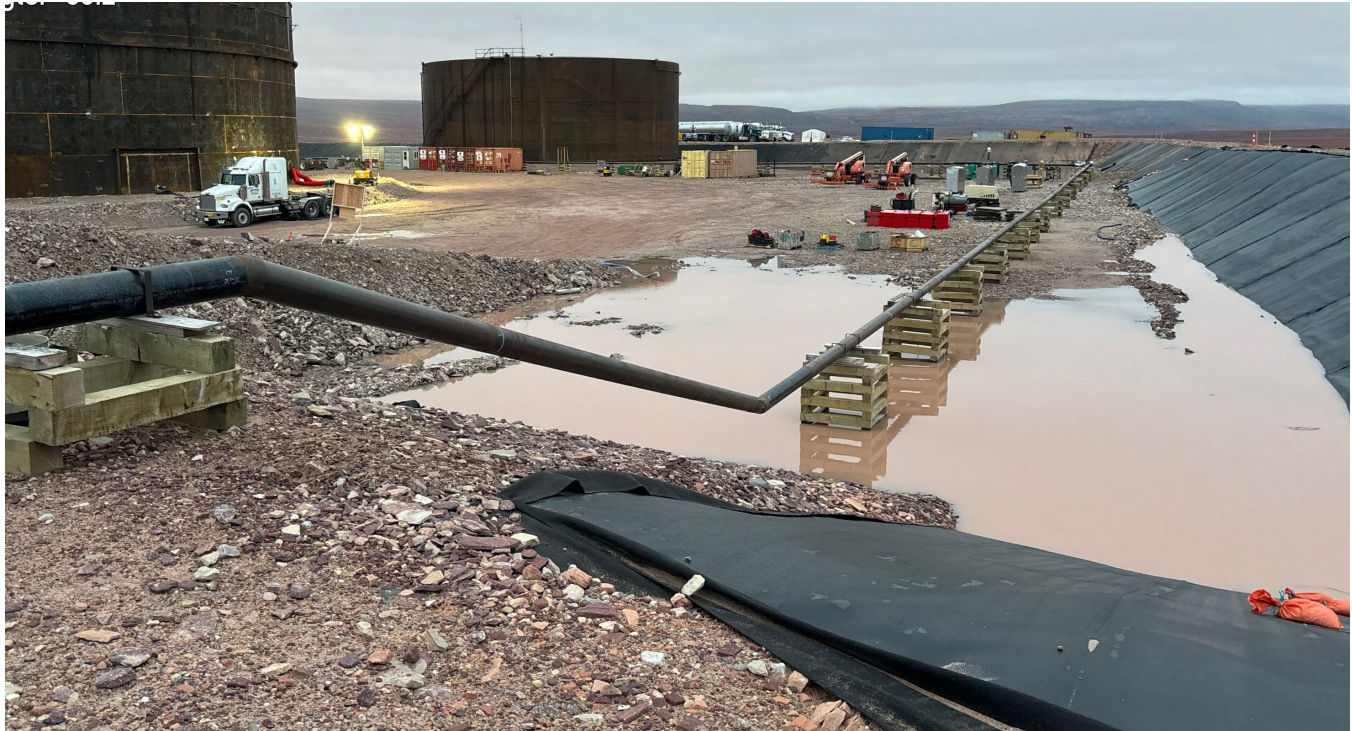
M-64: Pipeline/Tank Farm - Ponded Water.
