Goose & MLA Project Sites – 2024 Annual Geotechnical Inspection

Back River Project, Nunavut, Canada
B2Gold Corp.

SRK Consulting (Canada) Inc. ■ CAPR003105 ■ April 2025

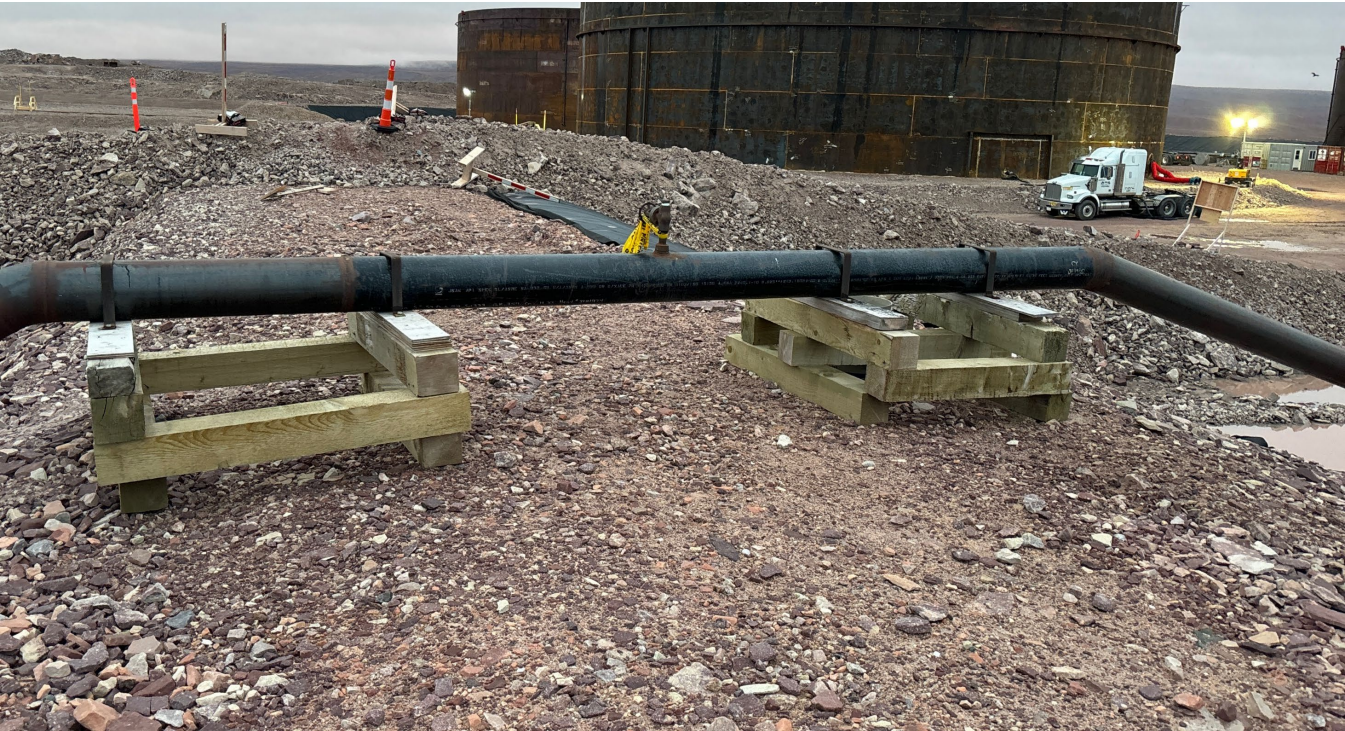
M-65: Pipeline Access to Tank Farm.

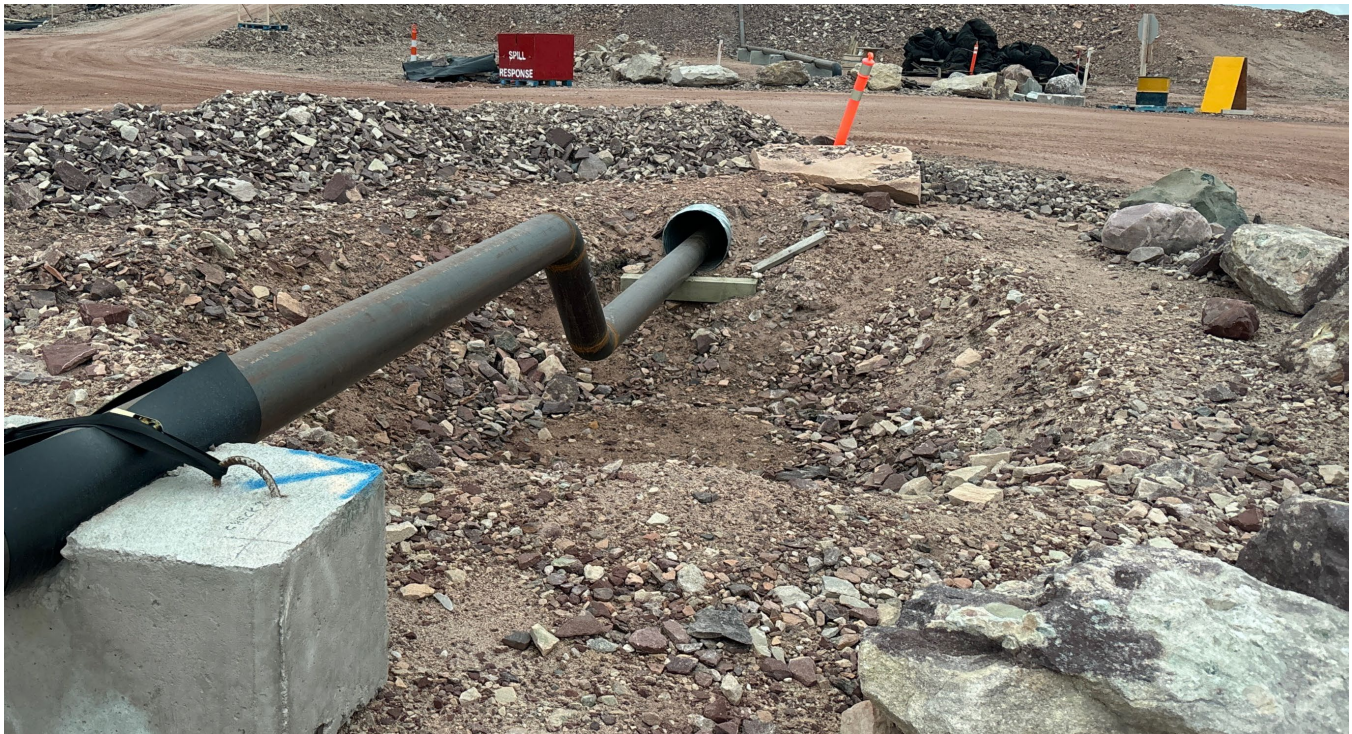
M-66: Pipeline culvert, facing west

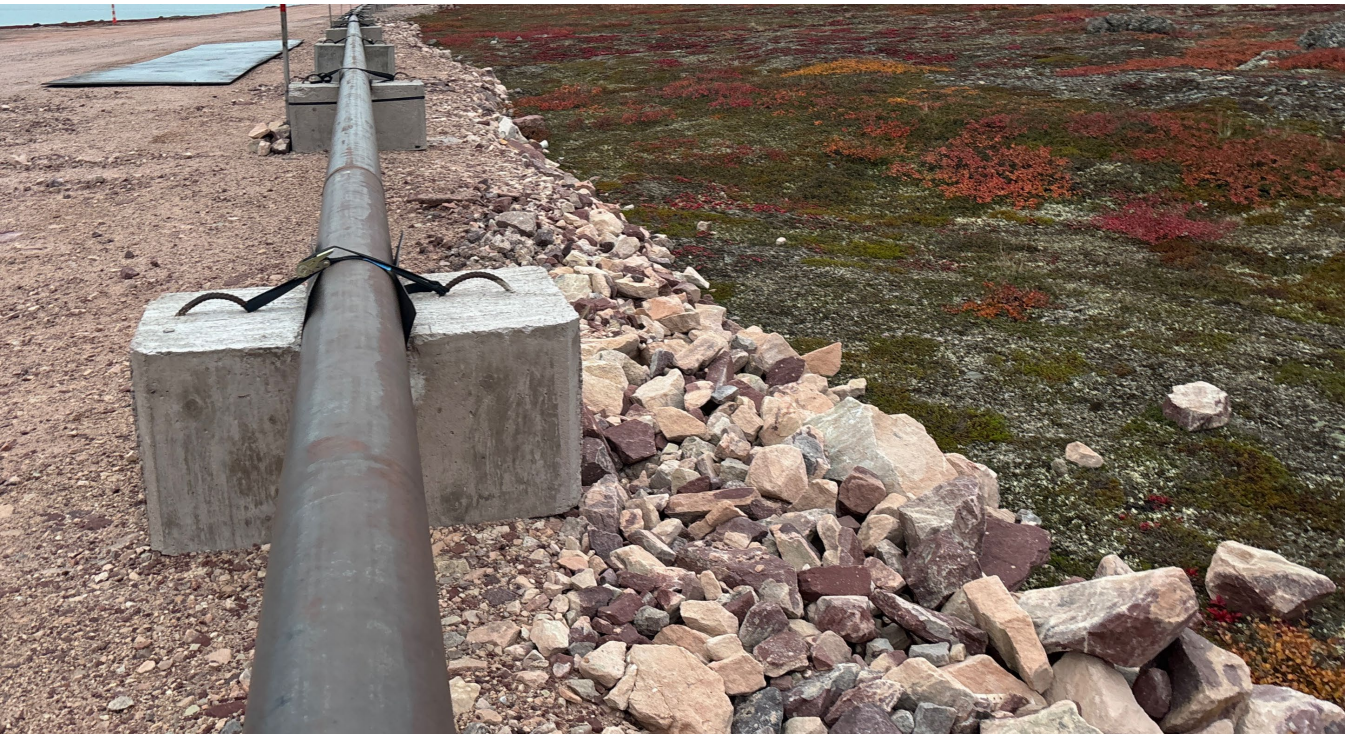
M-67: Note short distance between concrete block and edge and slope edge.

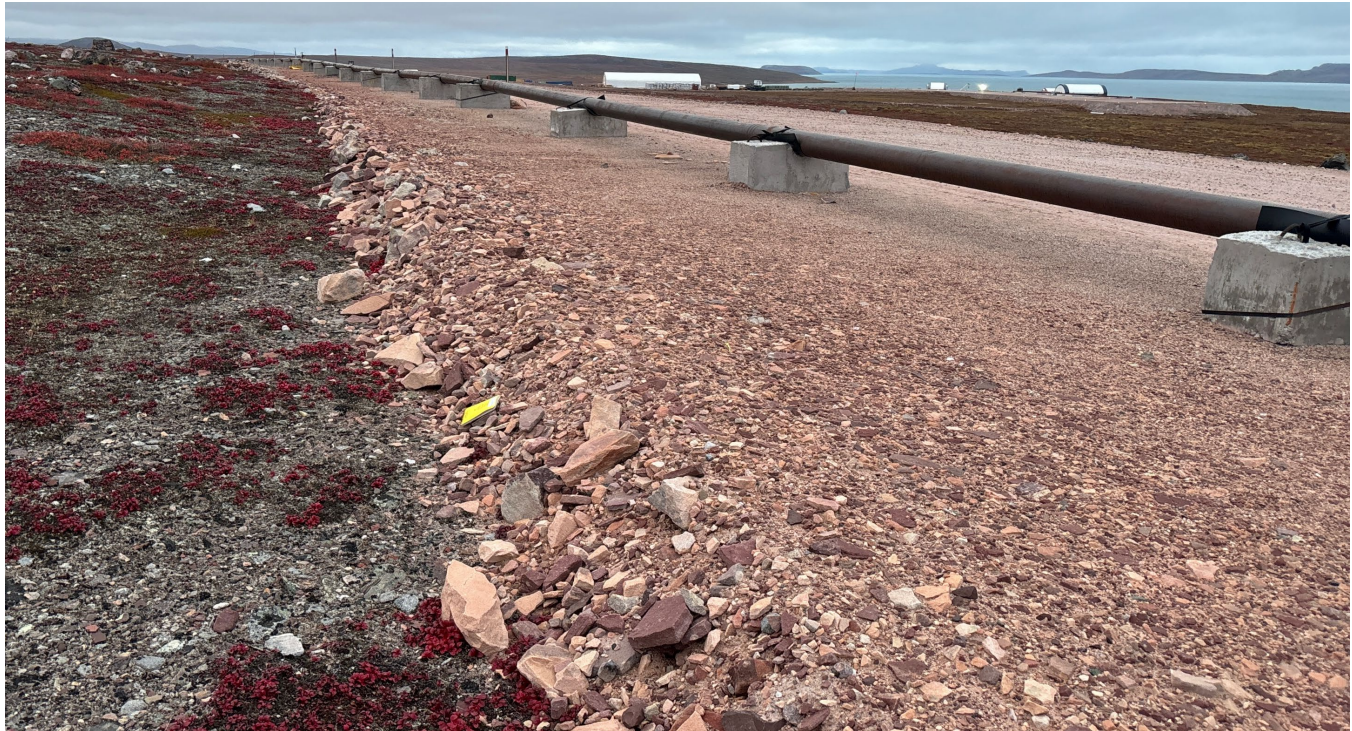
M-68: Typical road thickness

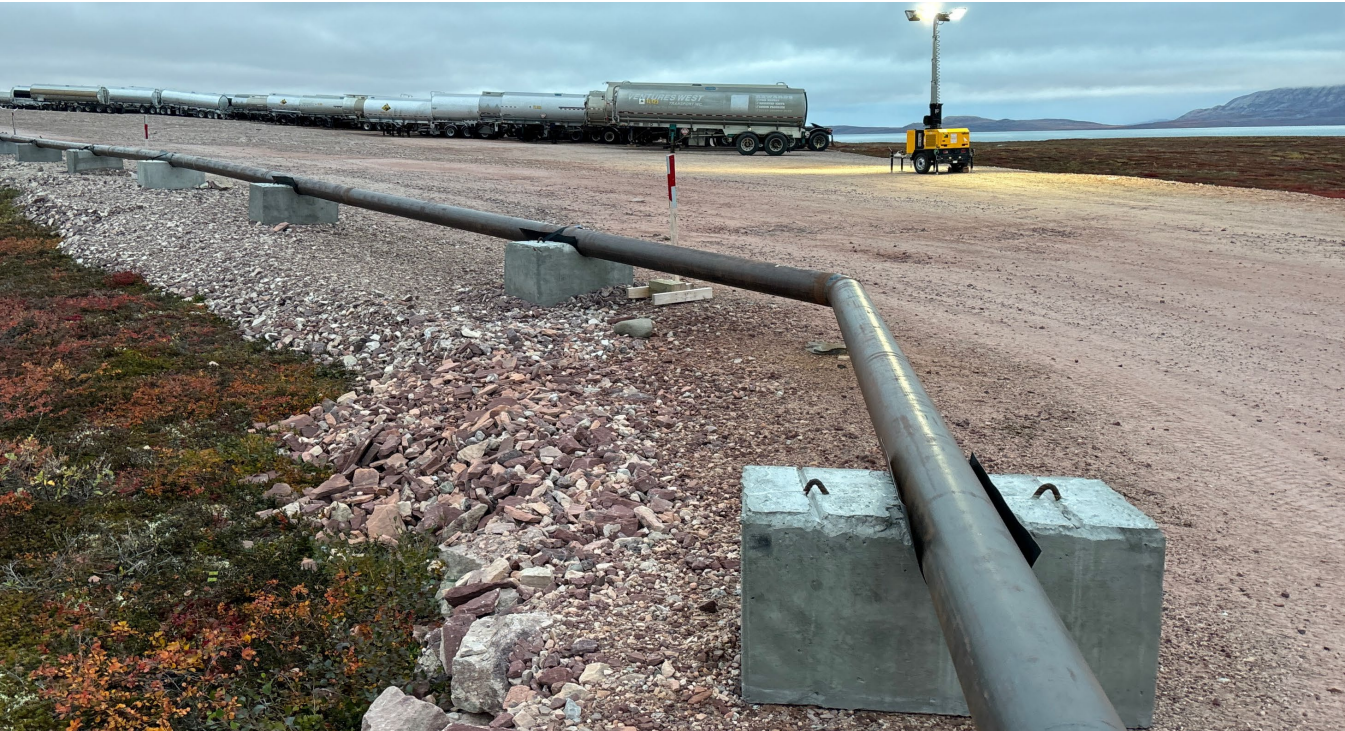
M-69: Pipeline opposite laydown area

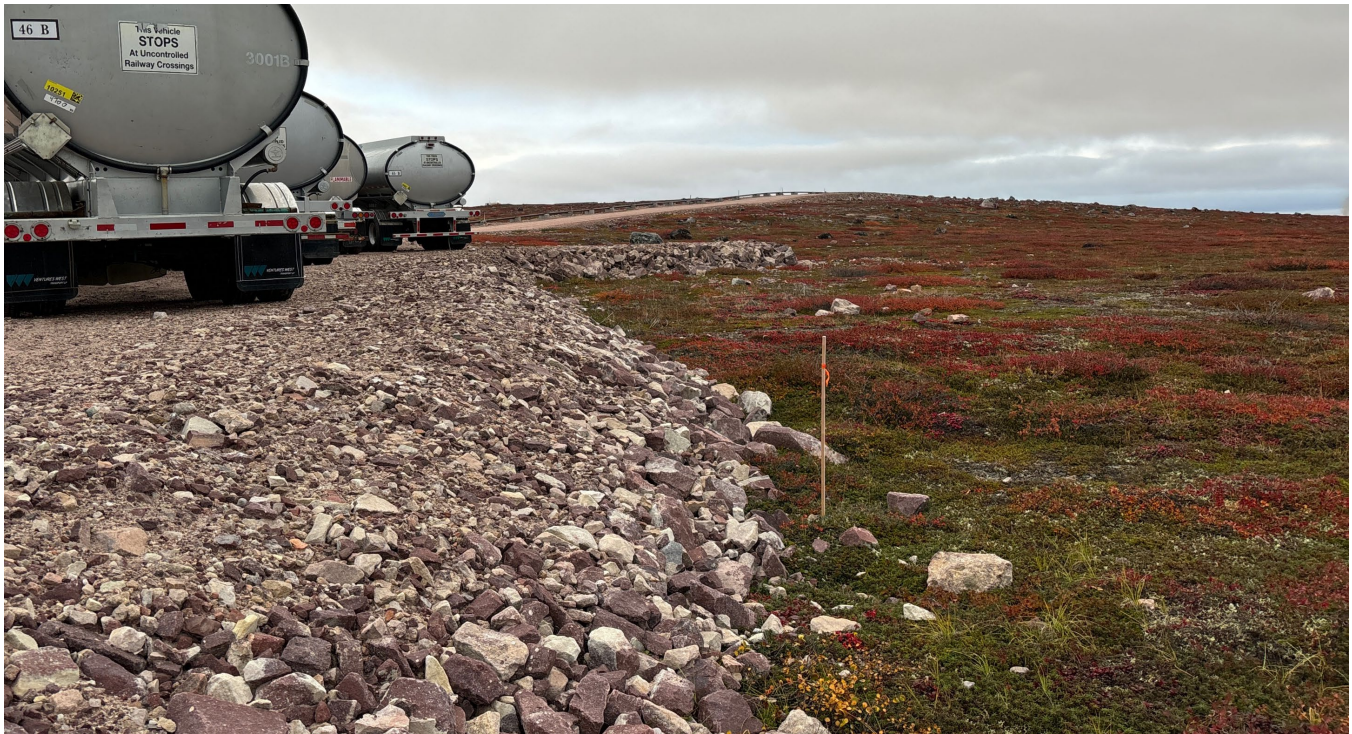
M-70: Laydown area, facing west

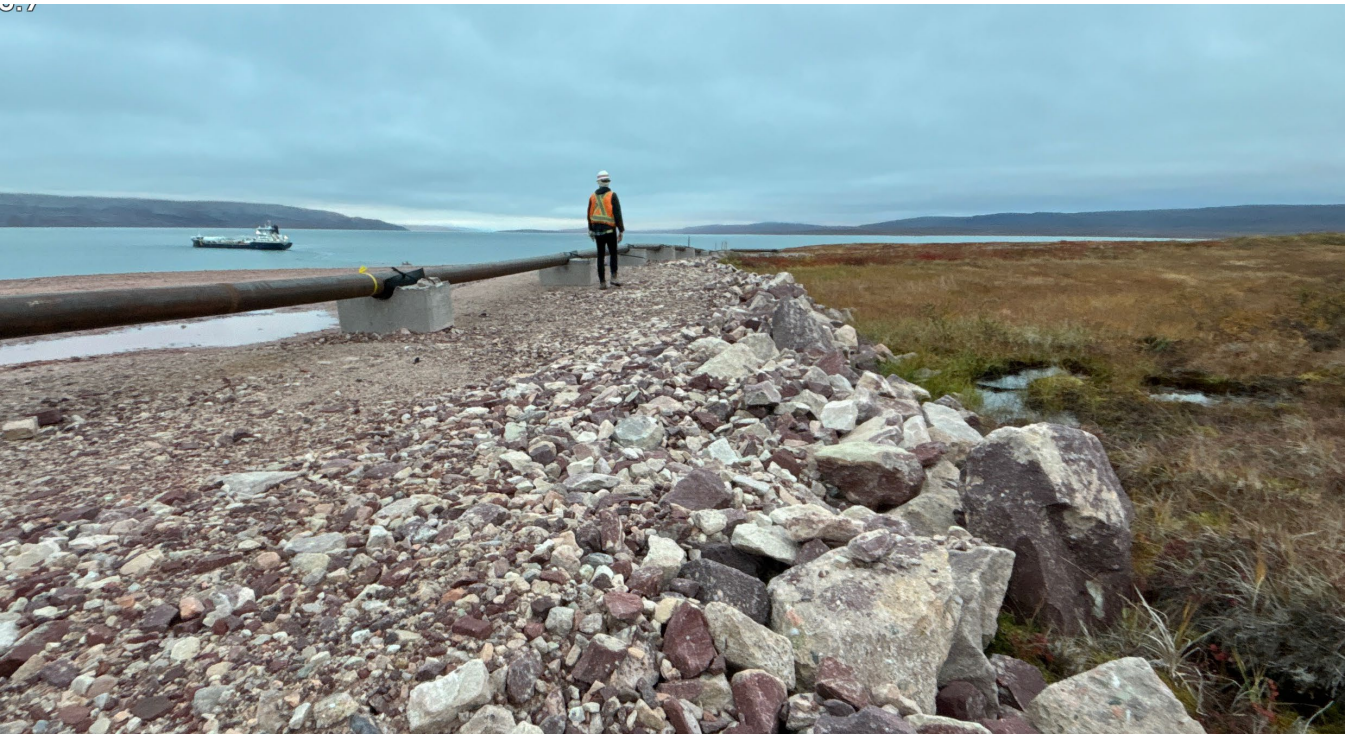
M-71: Pipeline, facing south – Note ponding water

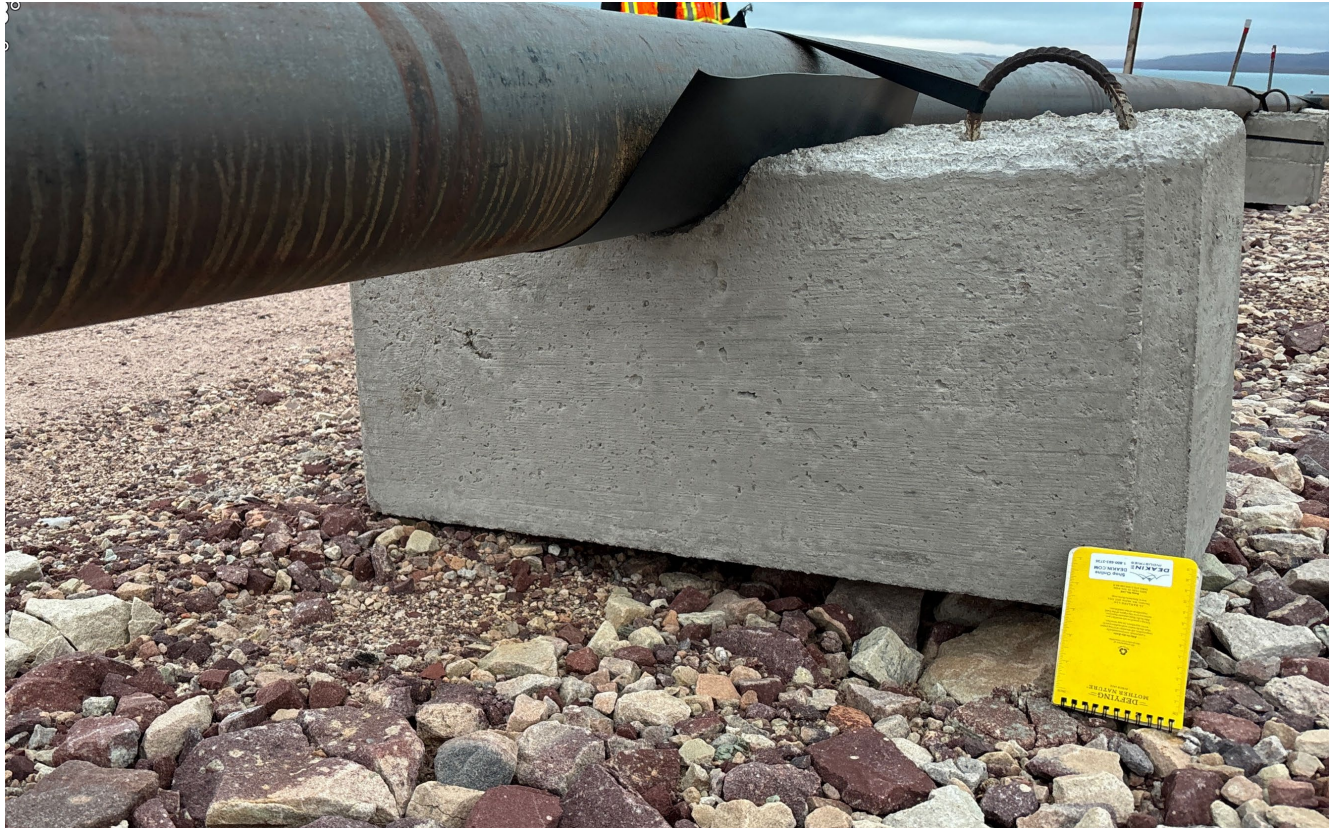
M-72: Typical bracing

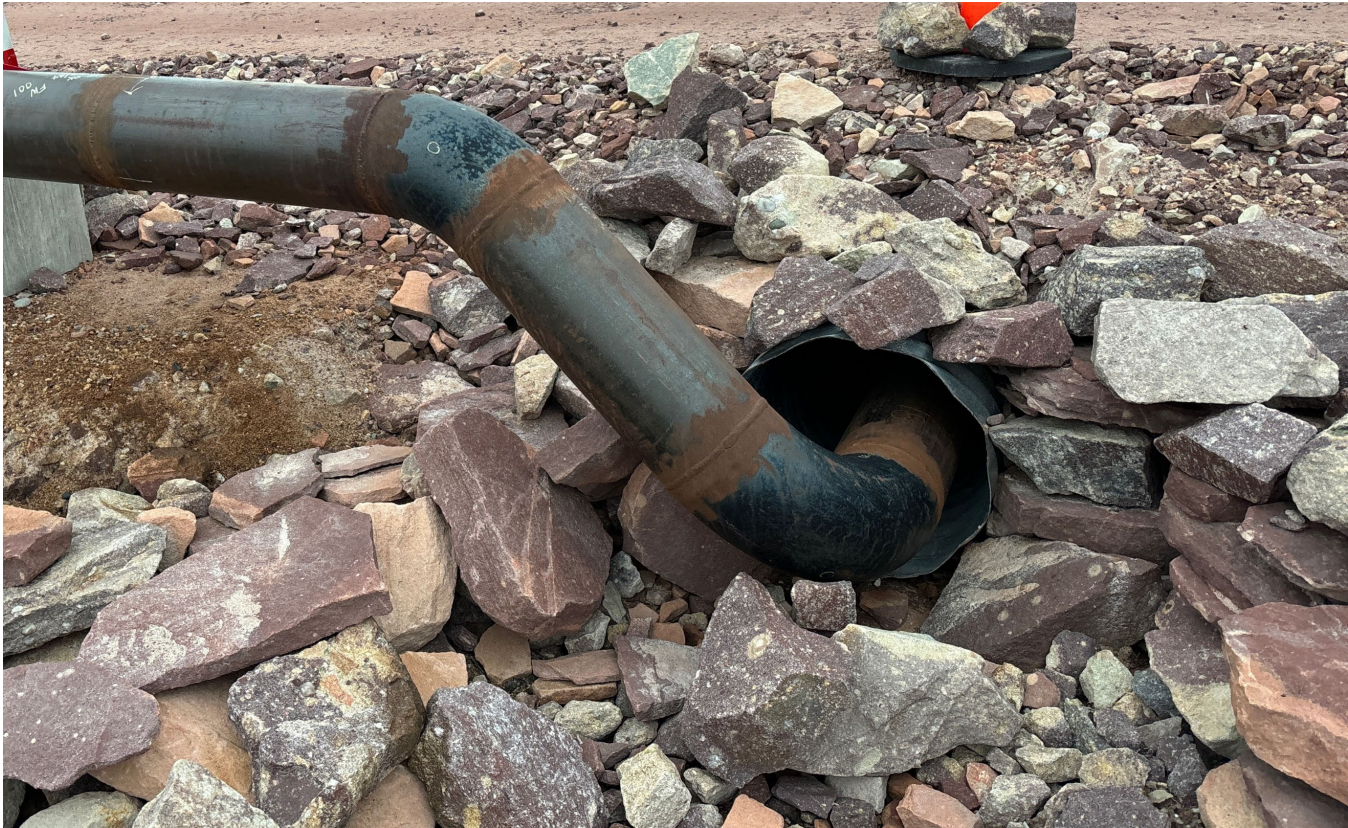
M-73: Pipeline culvert

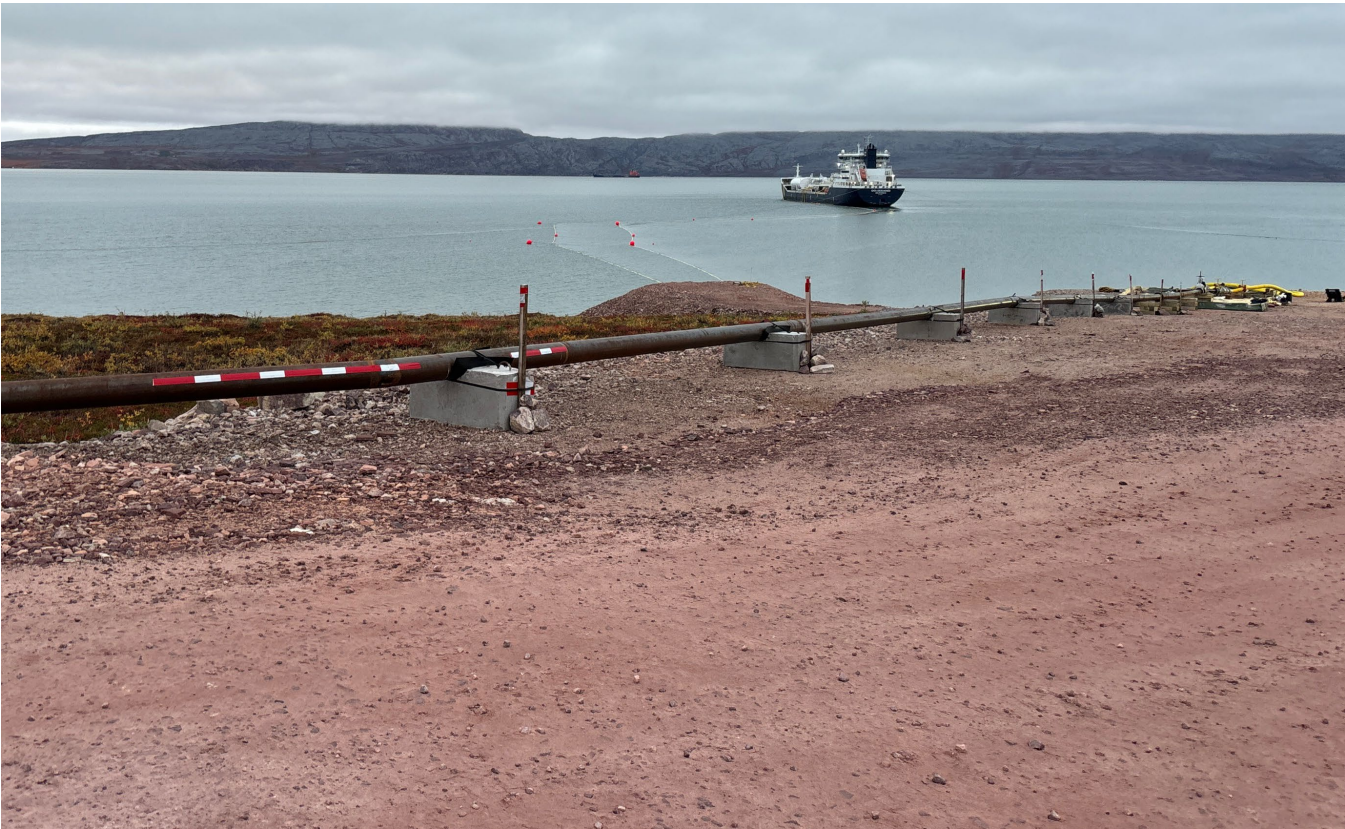
M-74: Southern end of pipeline road

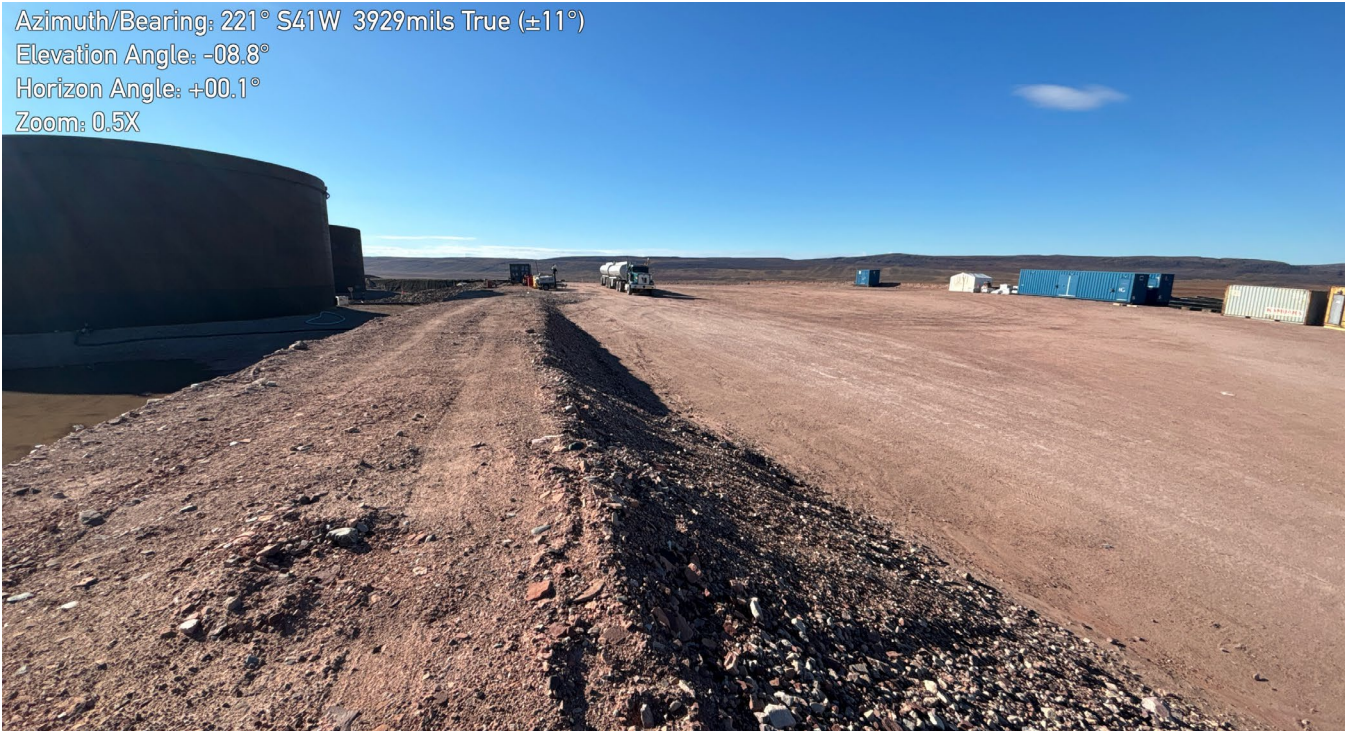
M-75: Overlooking fireball pad, facing S

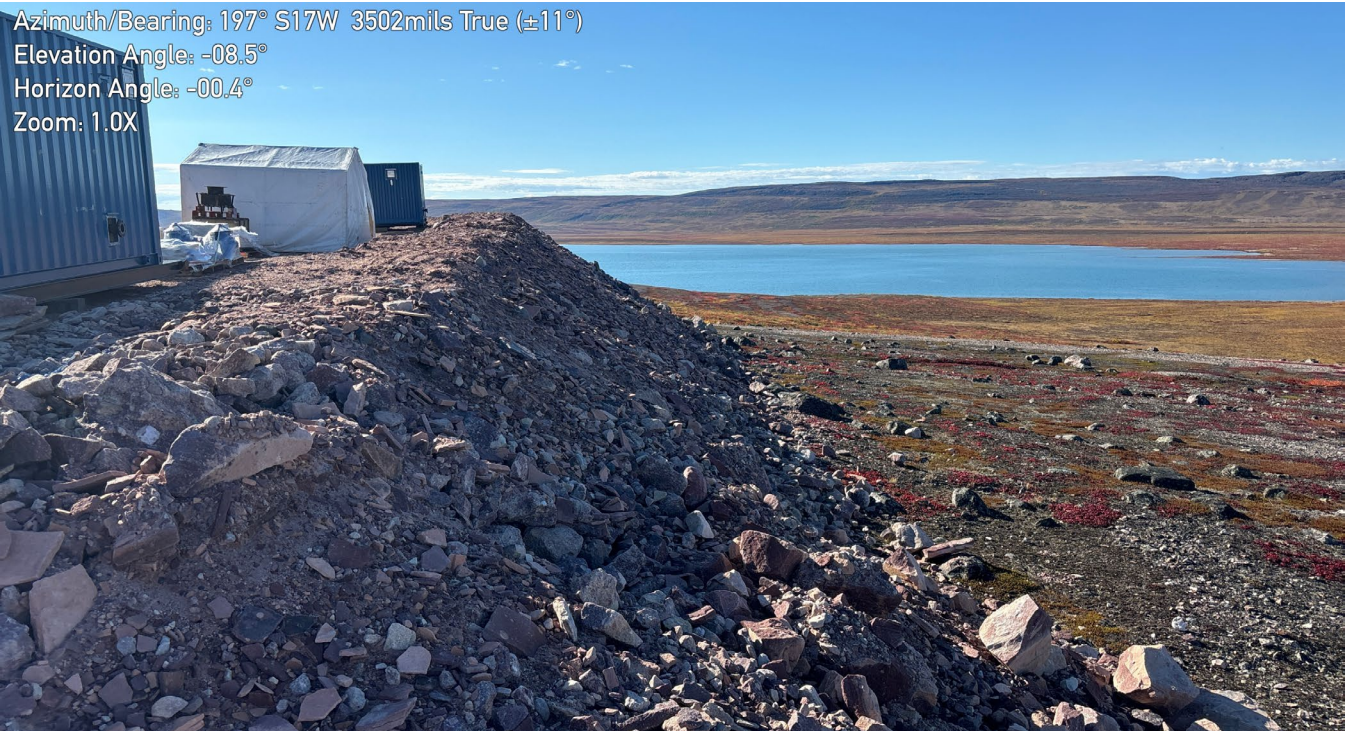
M-76: Western side of fireball pad, facing S

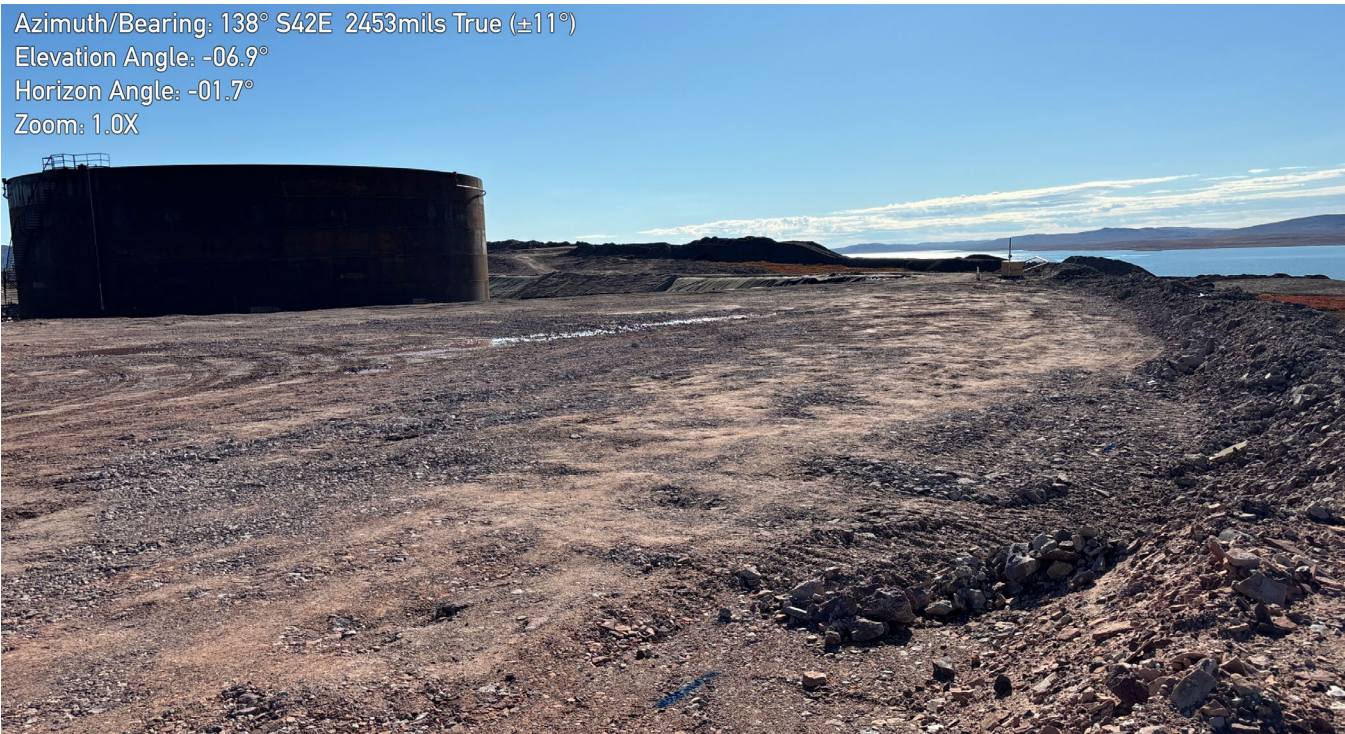
M-77: Overlooking fireball pad, facing S

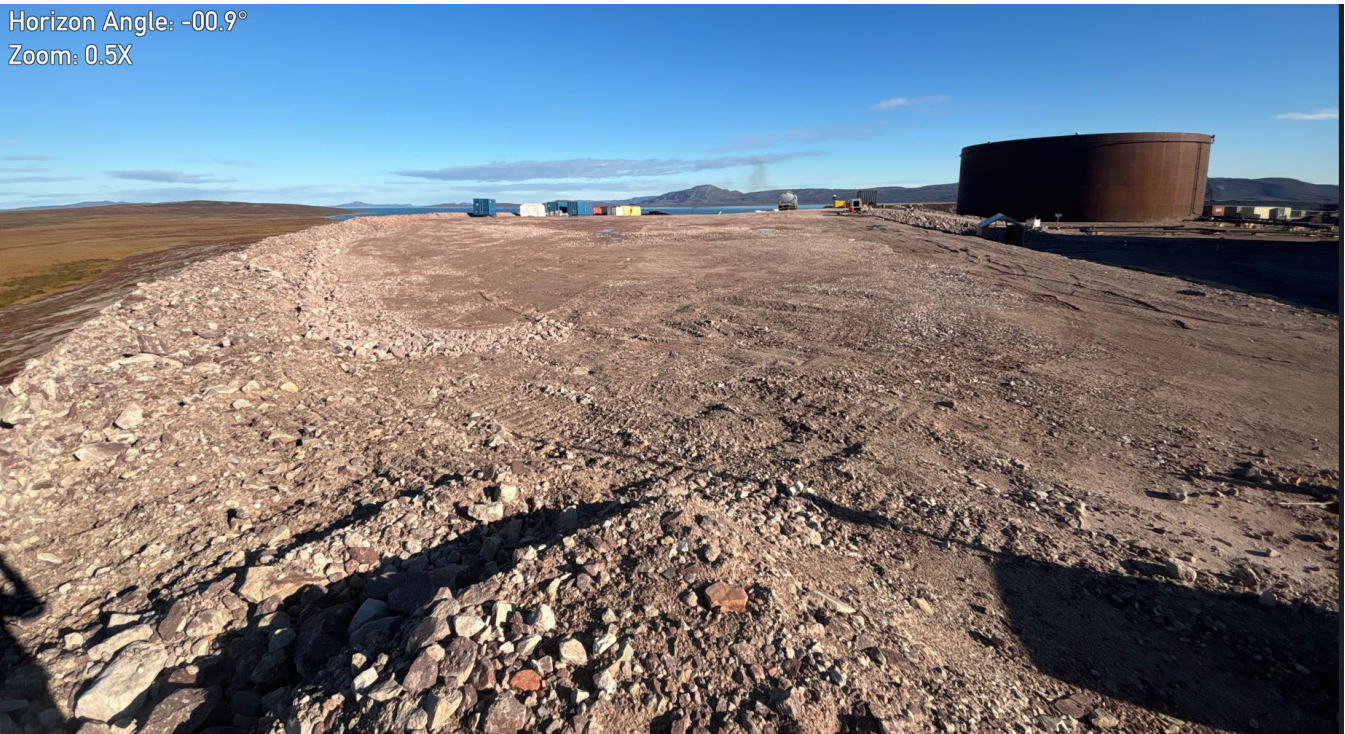
M-78: Overlooking fireball pad, facing N

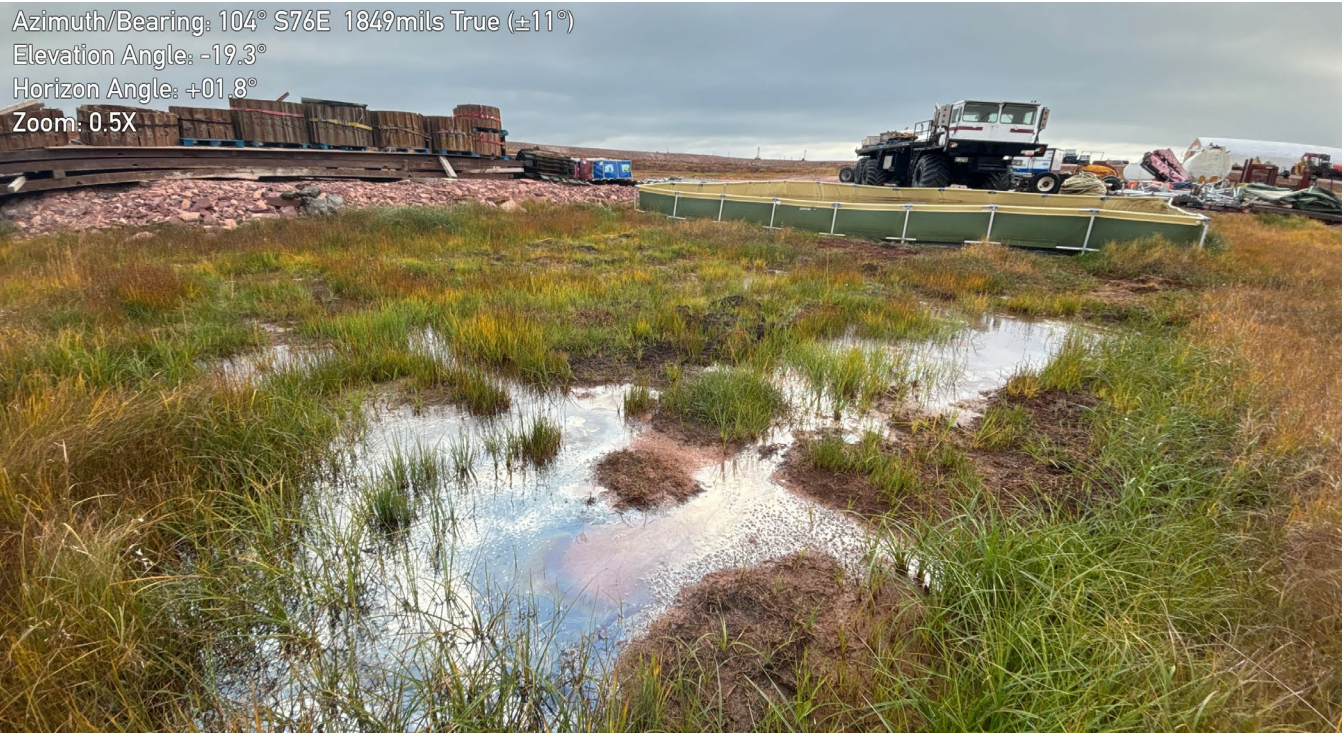
M-79: Overlooking former temporary fuel storage depot area , facing SE

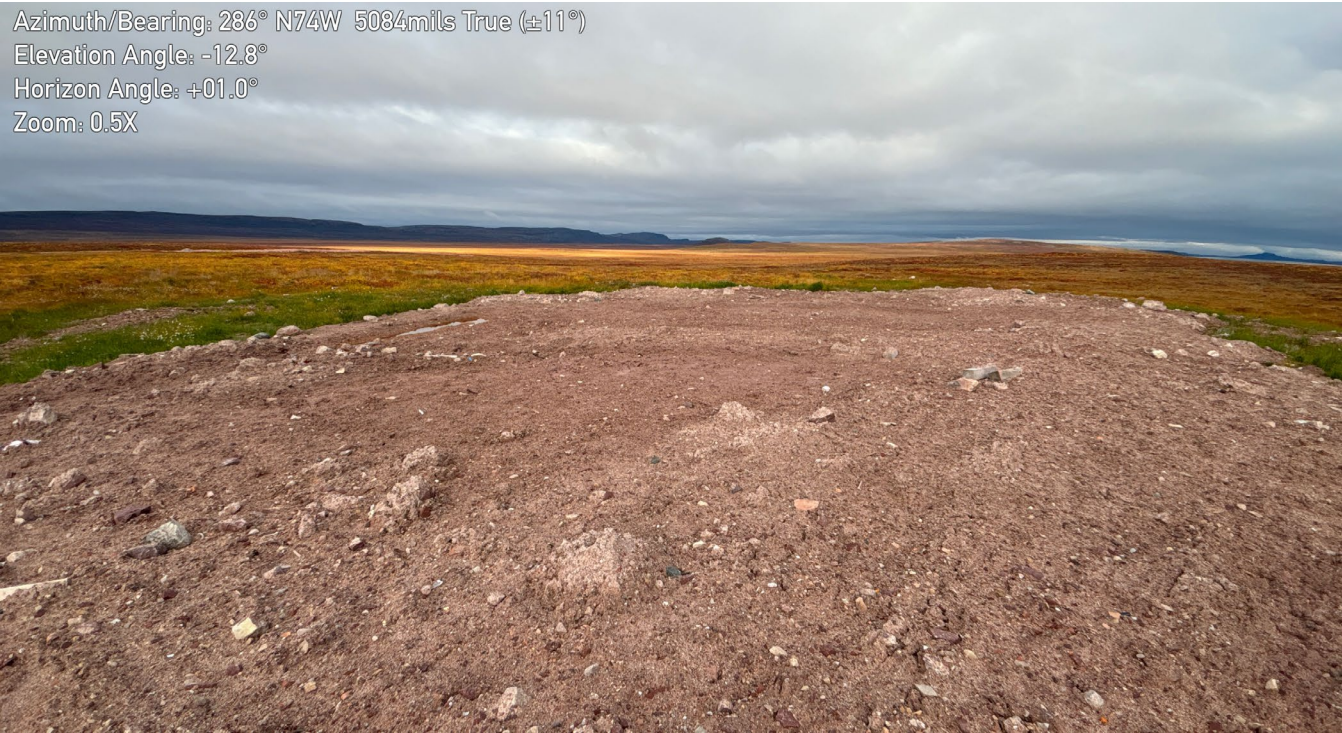
M-80: Overlooking NW end of the pad, facing N

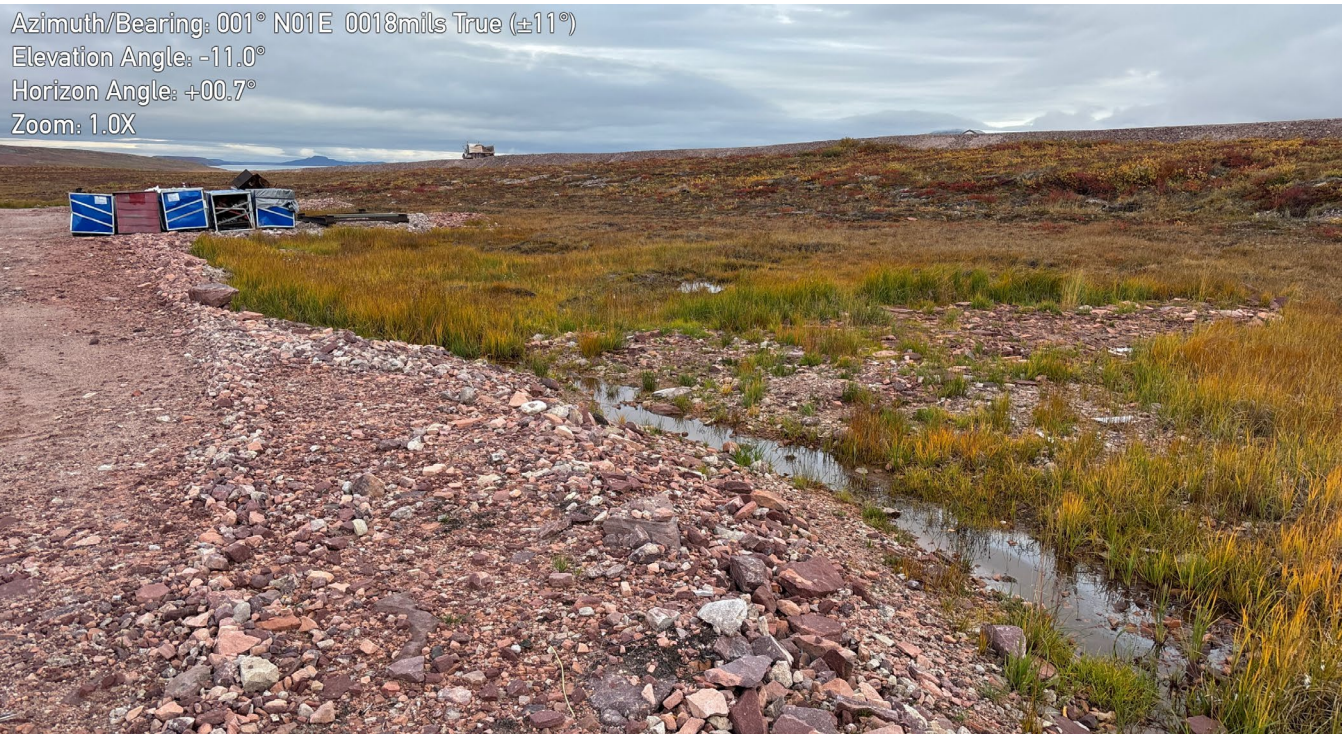
M-81: Southern side of the access road, facing S

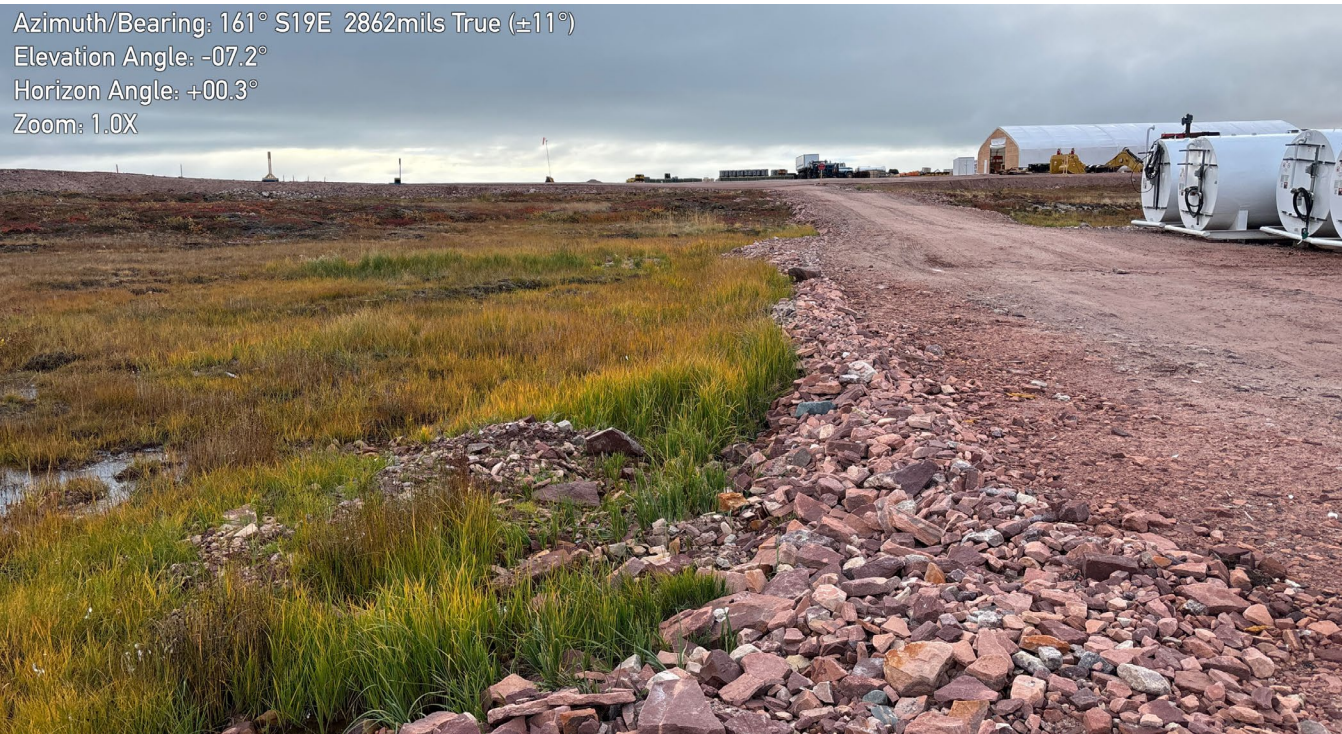
M-82: Northern side of the access road, facing SE

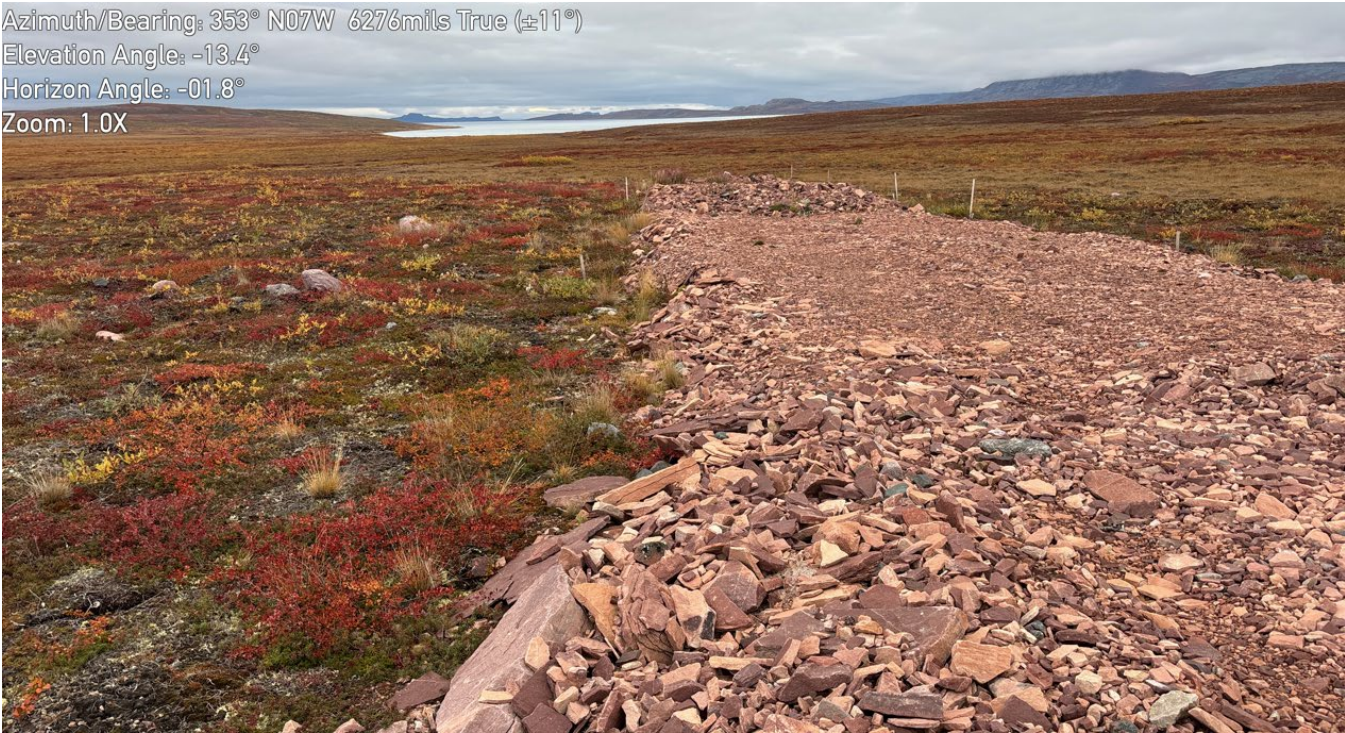
M-83: NW end of the former explosives storage access road – Note fill is too thin

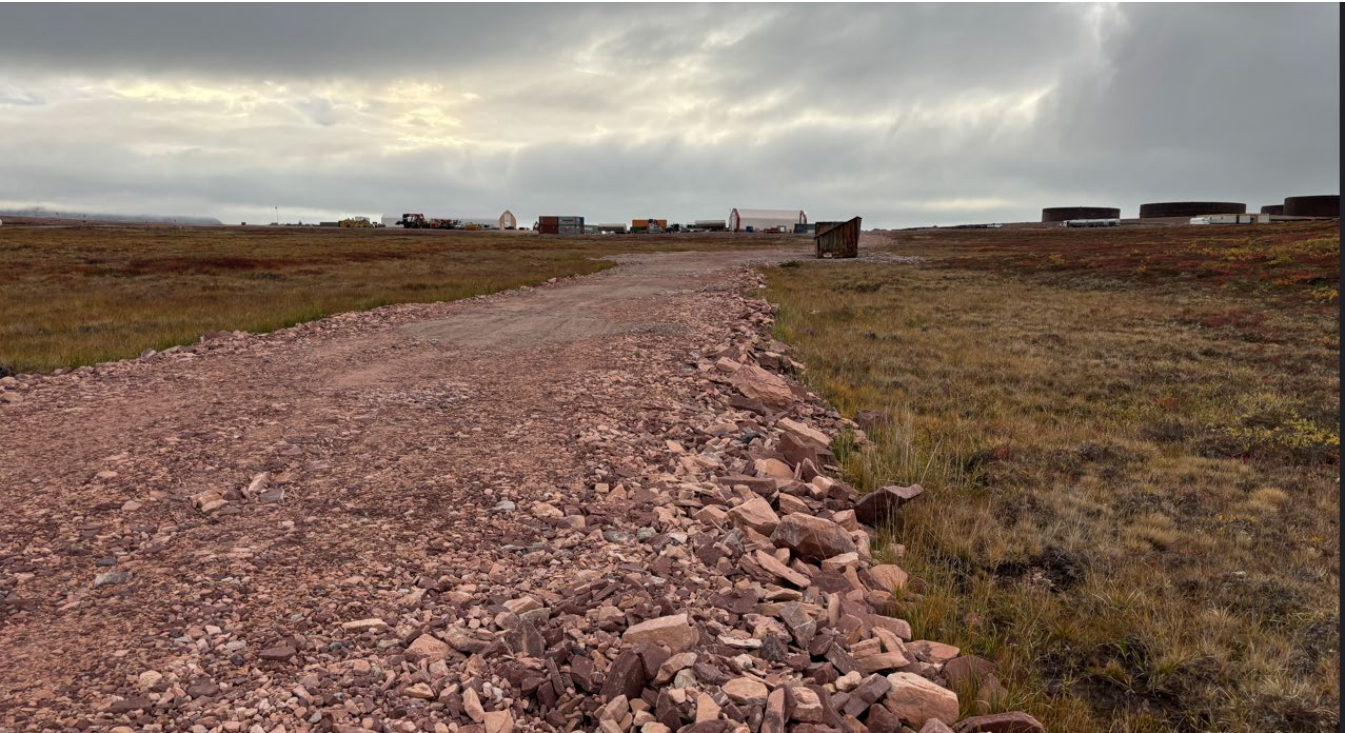
M-84: Embankment of the former explosives storage access road, facing SE

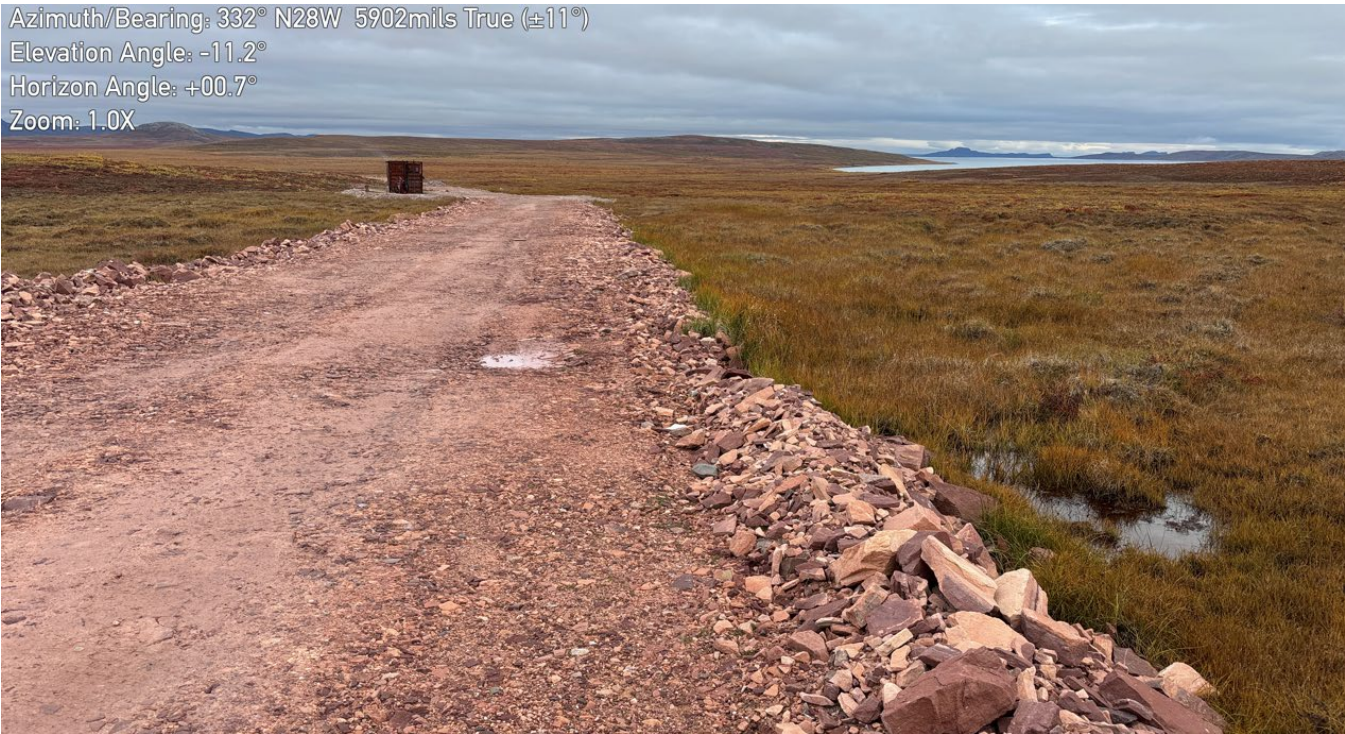
M-85: Embankment of the former explosives storage access road, facing NW

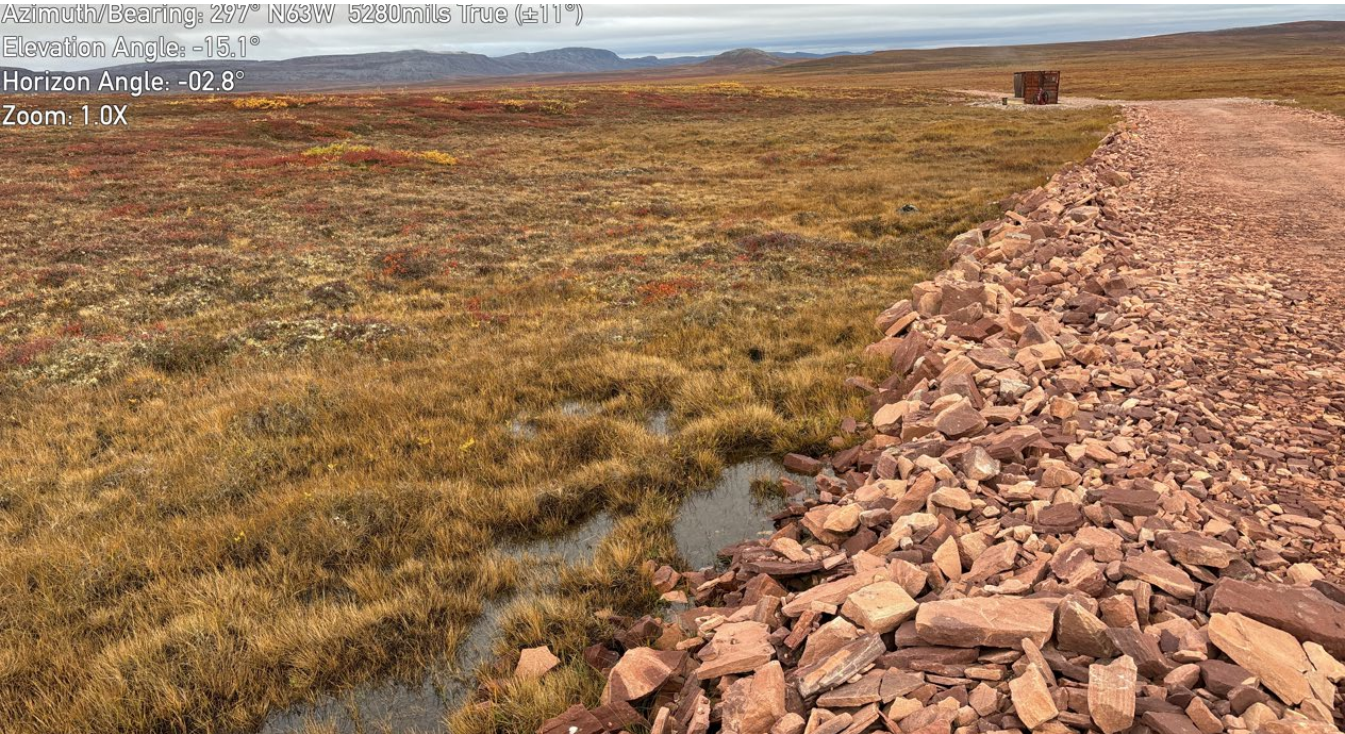
M-86: Embankment of the former explosives storage access road, facing W – Note ponding water at the western toe

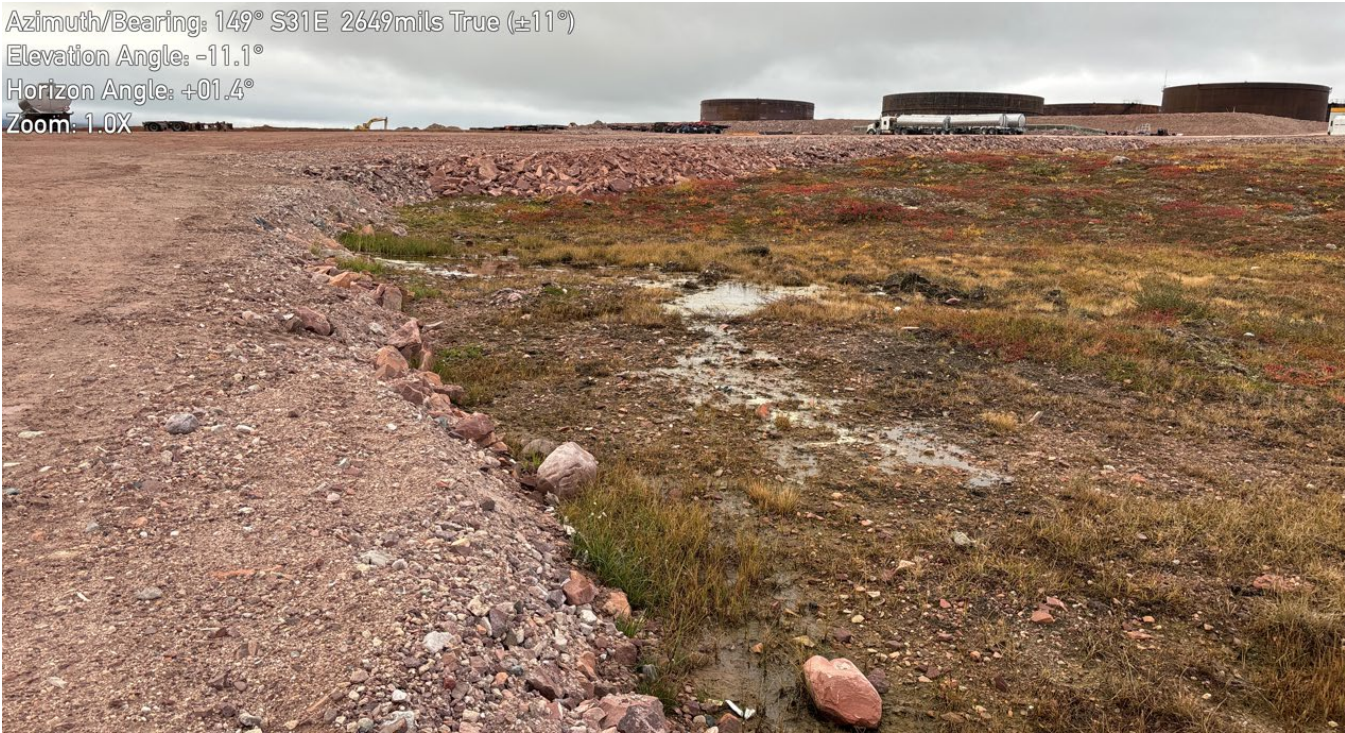
M-87: Example of the MLA roadways facing SE
