Goose & MLA Project Sites – 2024 Annual Geotechnical Inspection

Back River Project, Nunavut, Canada
B2Gold Corp.

SRK Consulting (Canada) Inc. ■ CAPR003105 ■ April 2025

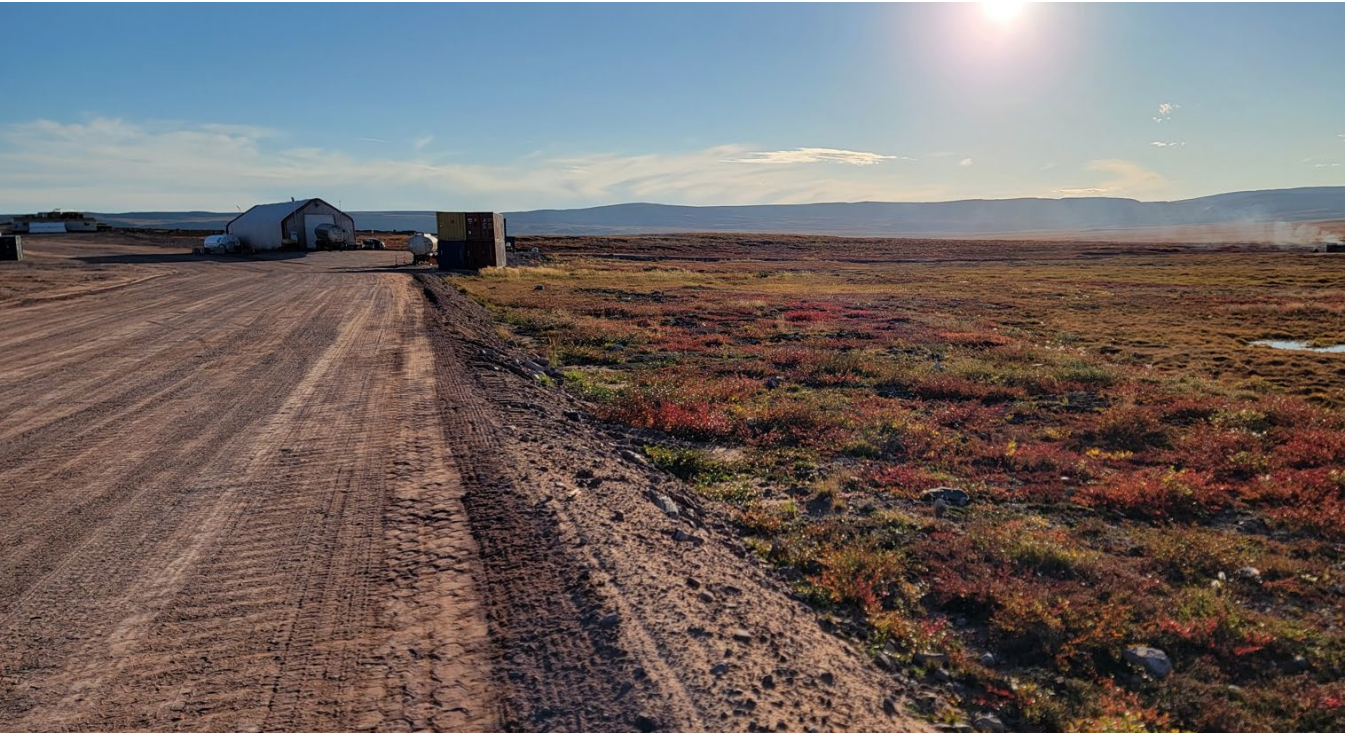
M-88: Example of the MLA roadways facing SW

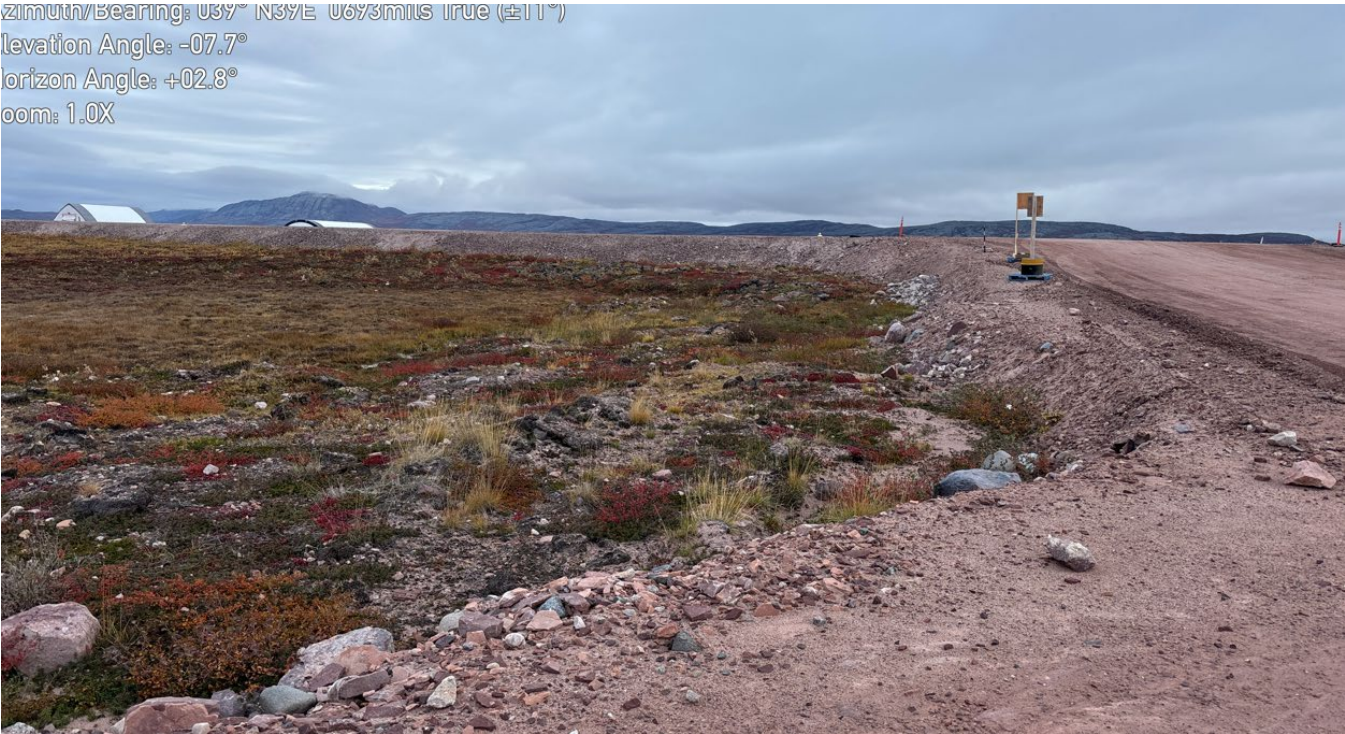
M-89: Example of the MLA roadways facing NE
