Rascal Stream West Crossing Construction Summary Report

Back River Project (B2Gold Back River Corp.)

22567626-163-R-Rev0-8000

10 July 2024

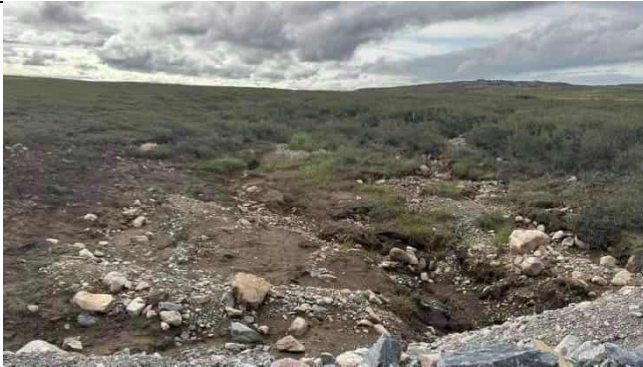
Photo 1: Natural Channel Upstream of The Culvert Location at 09:00

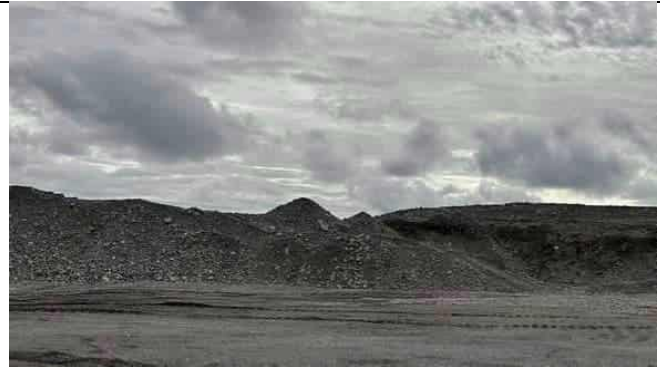
Photo 2: Proposed Substitute Material for Channel Substrate 09:30.

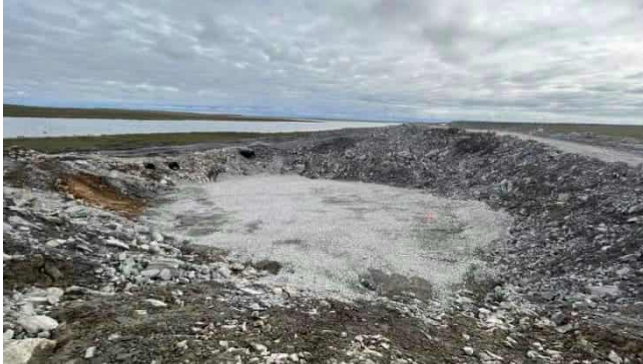
Photo 3: Prepared Segment of The Culvert Bedding at 08:40.

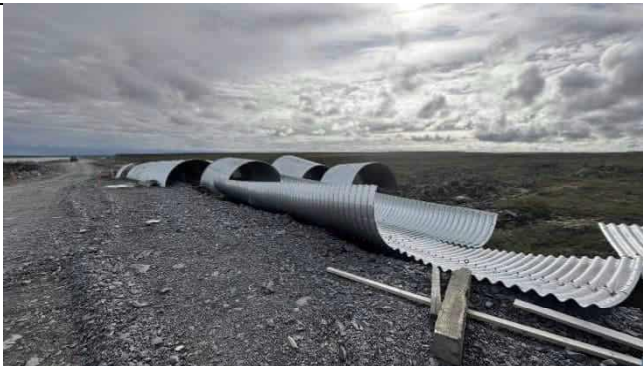
Photo 5: Partially Assembled Culvert Plates

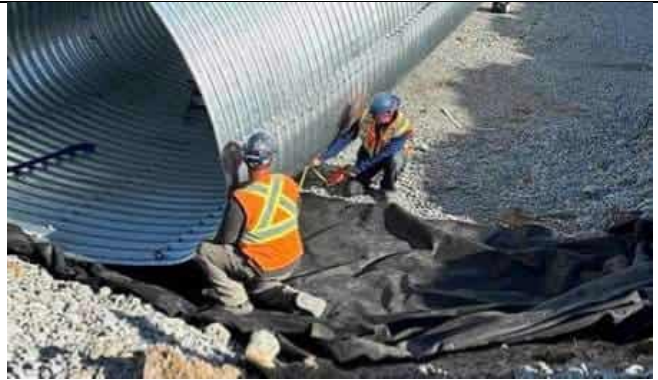
Photo 2: Non-woven geotextile extends 2 m beneath culvert

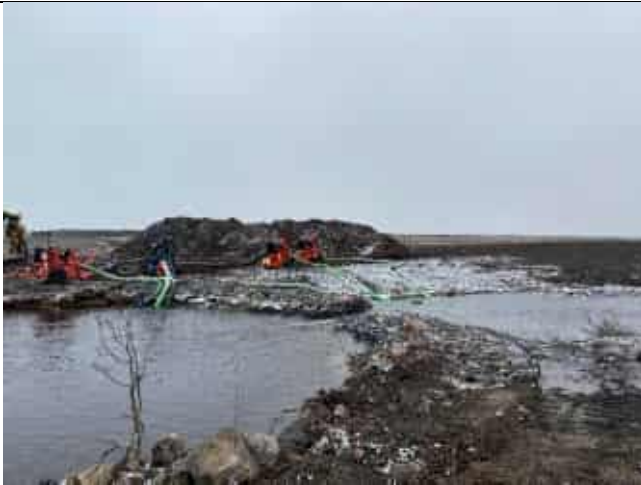
Photo 1: Dewatering pumps in upper pond and lower pond upstream of twin multiplate culvert excavation.

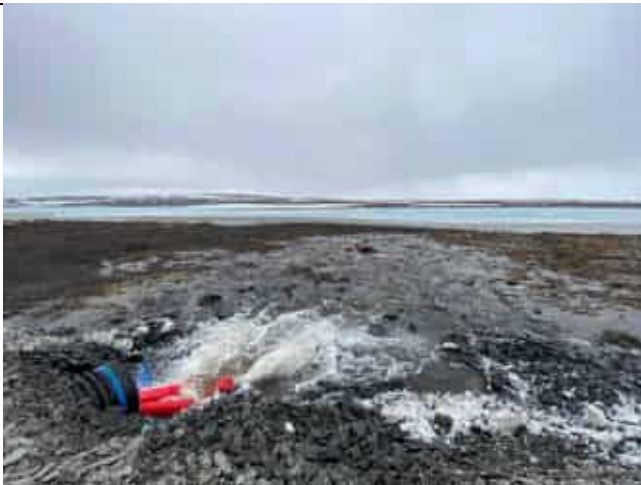
Photo 3: Dewatering pump discharge downstream of secondary culvert excavation

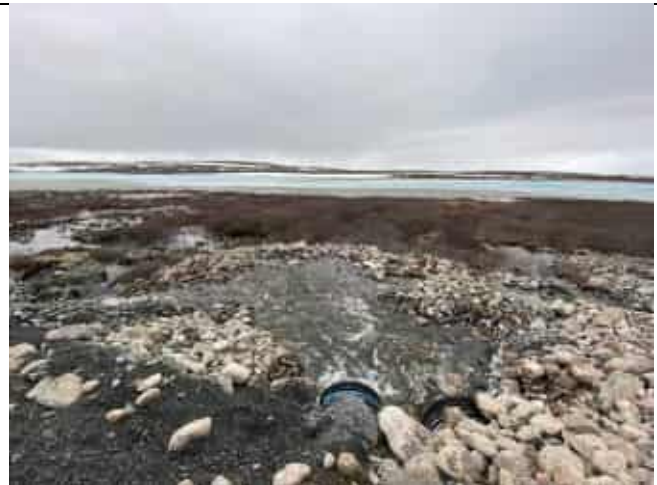
Photo 4: Temporary culverts discharging twin multiplate culvert excavation

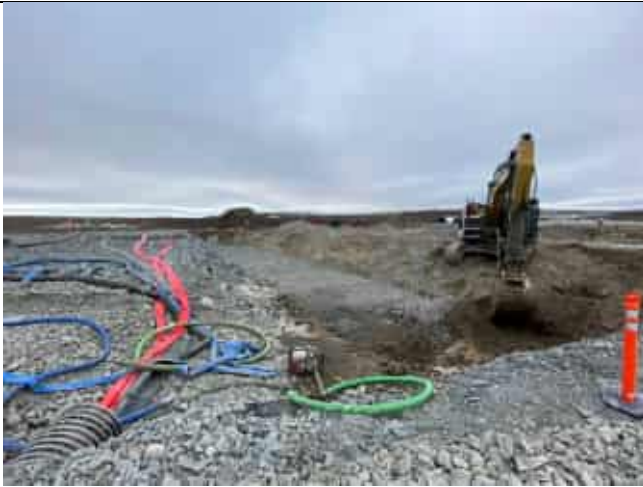
Photo 1: Secondary culvert excavation with bedding placed looking upstream at 8:23.

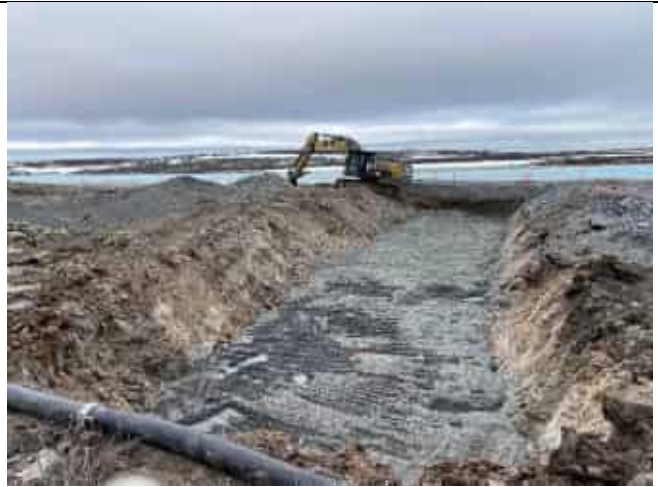
Photo 2: Secondary culvert excavation with bedding placed looking downstream at 8:24.

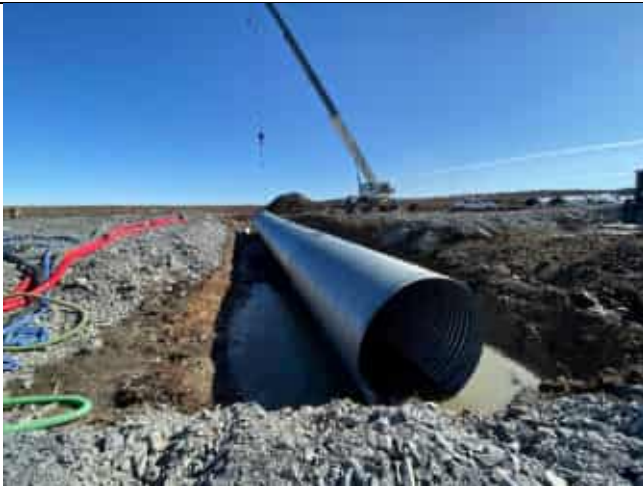
Photo 3: Secondary culvert placement with 4 sections looking upstream at 16:09.

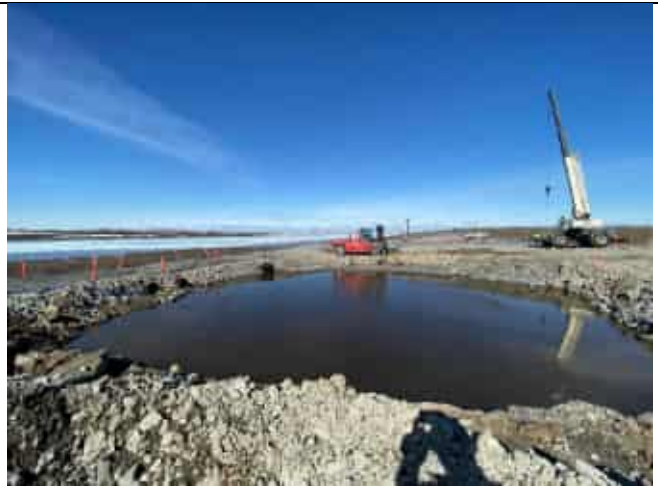
Photo 4: Twin multiplate culvert excavation at 16:10.

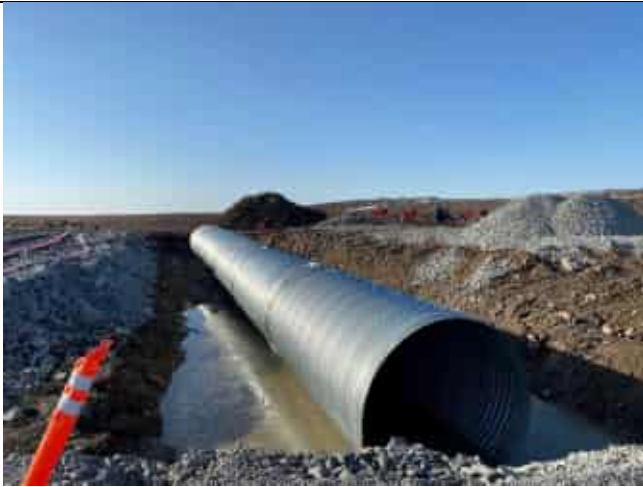
Photo 1: Secondary culvert placement with 6 sections looking upstream at 7:32.

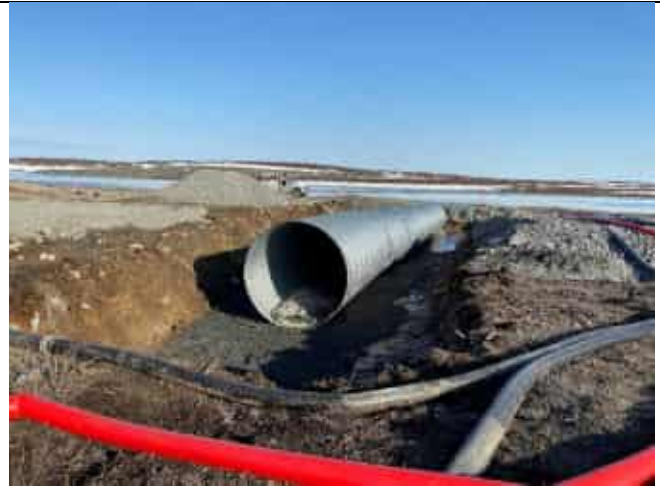
Photo 2: Secondary culvert placement with 6 sections looking downstream at 7:28.

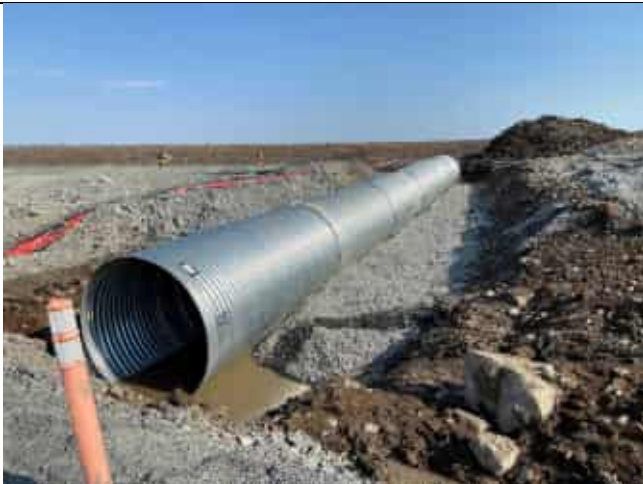
Photo 3: Secondary culvert backfill placement on left downstream bank looking upstream at 16:40.

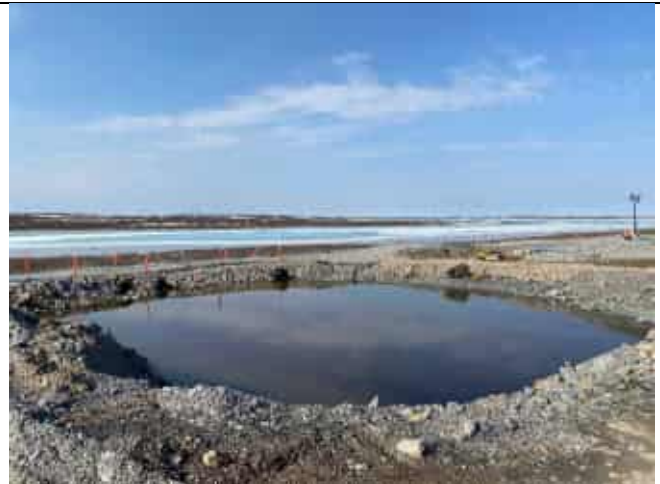
Photo 4: Twin multiplate culvert excavation at 16:38.

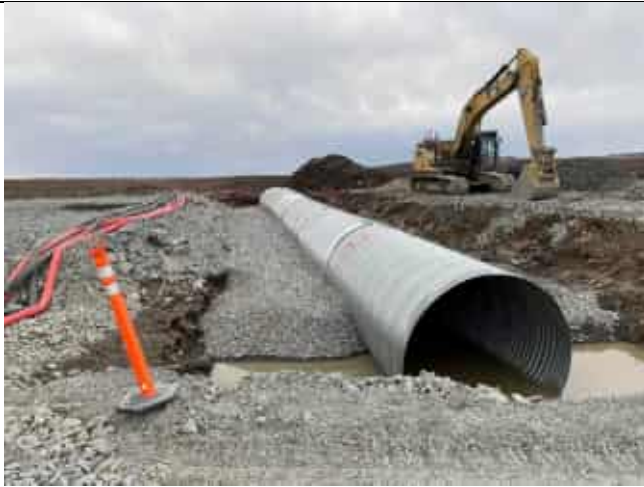
Photo 1: Secondary culvert placement with 6 sections looking upstream at 7:56.

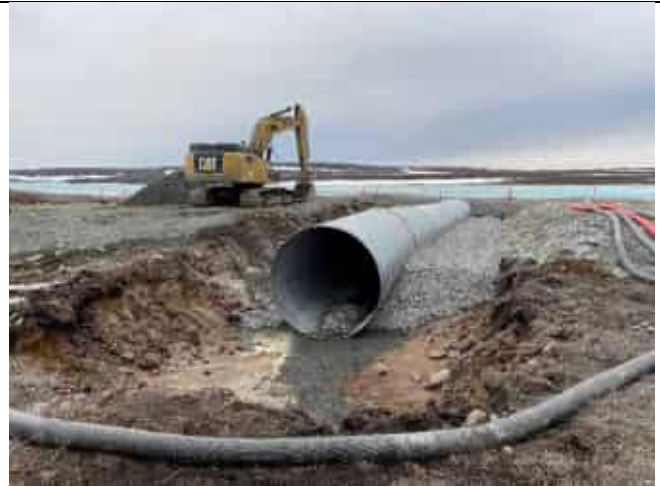
Photo 2: Secondary culvert placement with 6 sections looking downstream at 7:58.

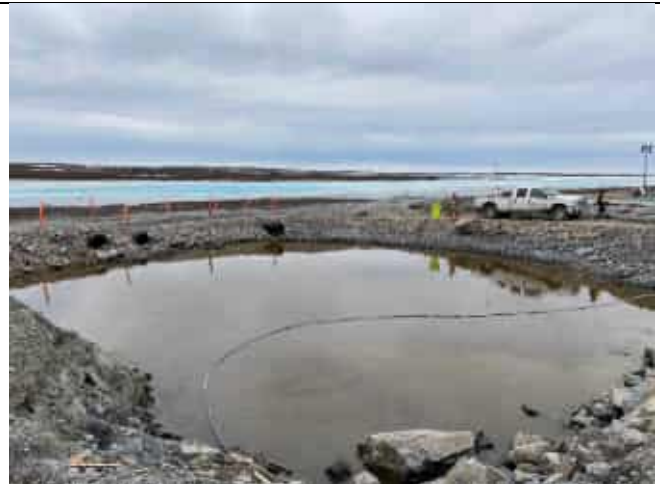
Photo 4: Twin multiplate culvert excavation at 16:40.

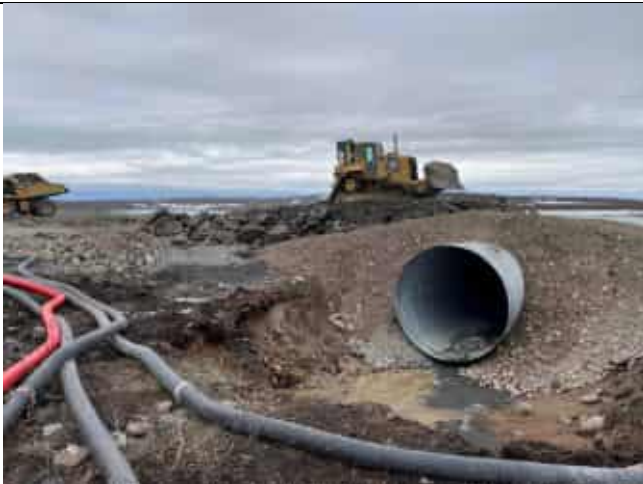
Photo 3: RoQ placement above raw esker backfill looking downstream at 16:52.

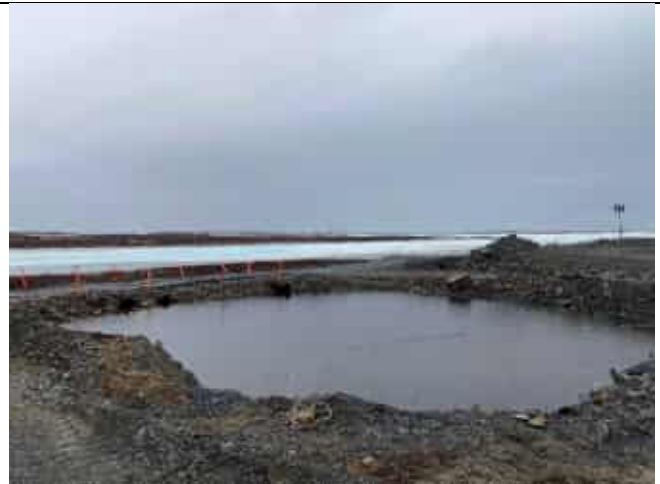
Photo 4: Twin multiplate culvert excavation at 16:15.

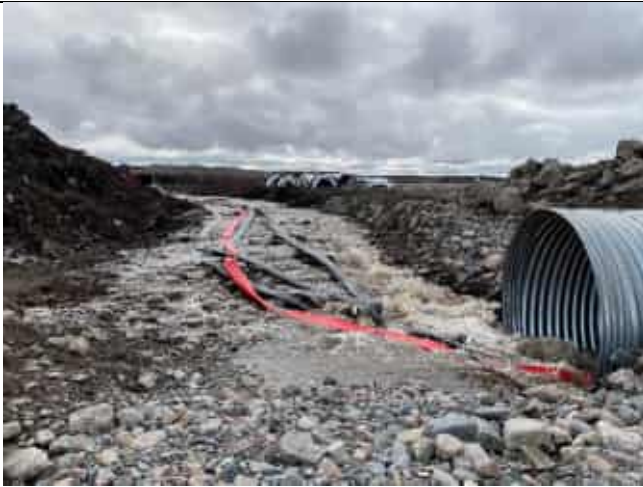
Photo 1: Secondary culvert receiving diverted flow from RSW main channel looking from RDB to LDB at 15:58.

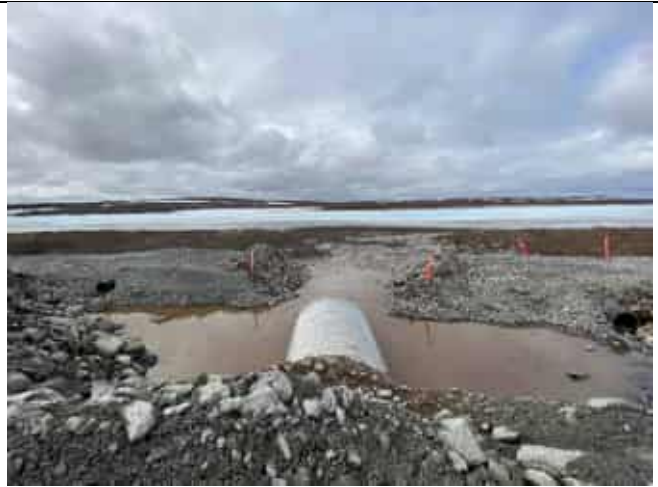
Photo 2: Secondary culvert discharging RSW over temporary riprap apron looking downstream at 14:11.

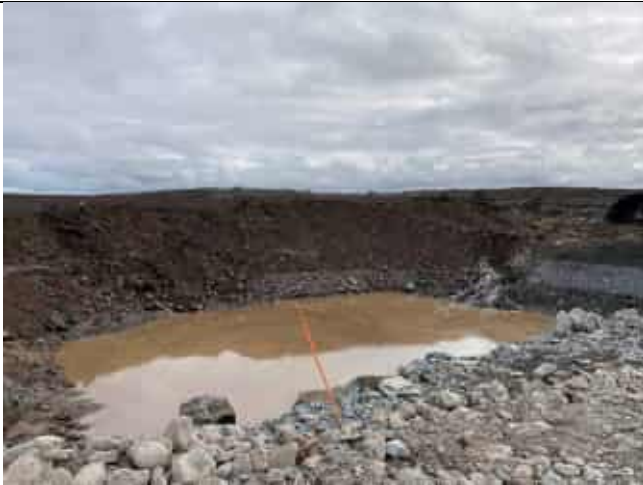
Photo 3: Temporary diversion dam isolating twin multiplate excavation looking upstream at 16:13.

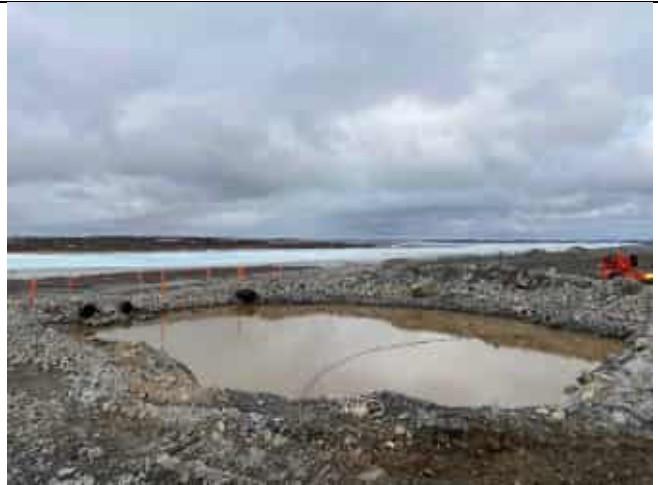
Photo 4: Twin multiplate culvert excavation at 15:49.

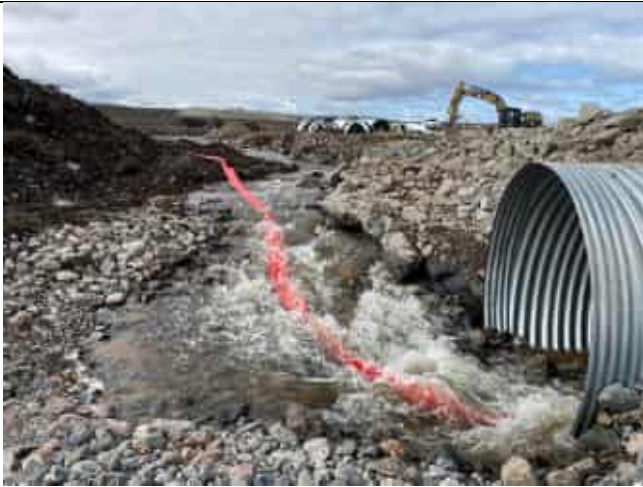
Photo 1: Secondary culvert receiving diverted flow from RSW main channel looking from RDB to LDB at 10:50.

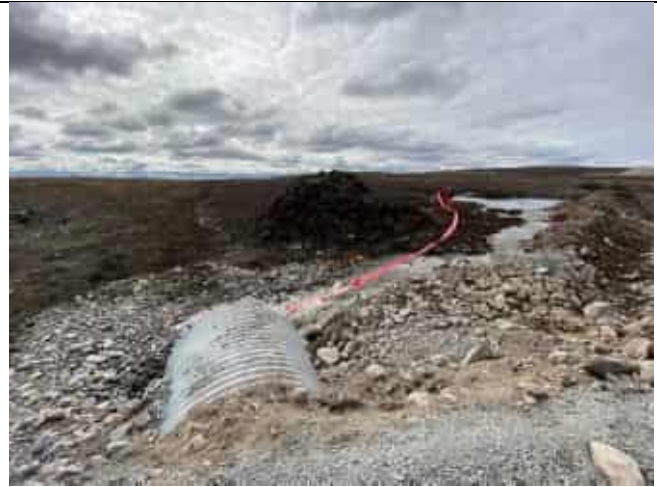
Photo 2: Secondary culvert receiving diverted flow from RSW main channel looking upstream at 10:49.

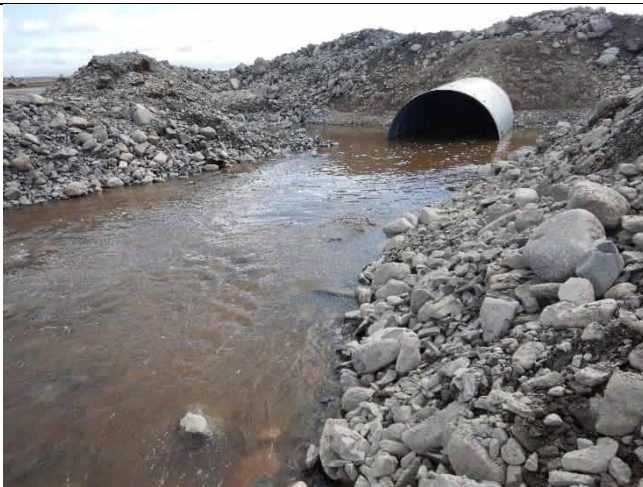
Photo 3: Secondary culvert discharging diverted RSW main channel over temporary outlet riprap apron looking upstream at 12:05.

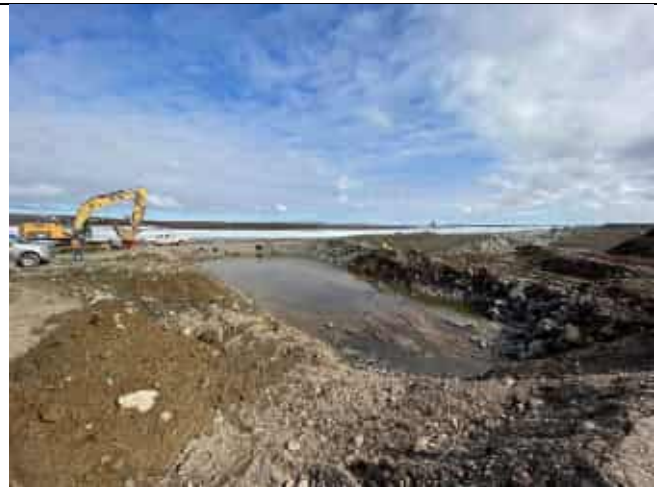
Photo 4: Twin multiplate culvert excavation at 9:53.

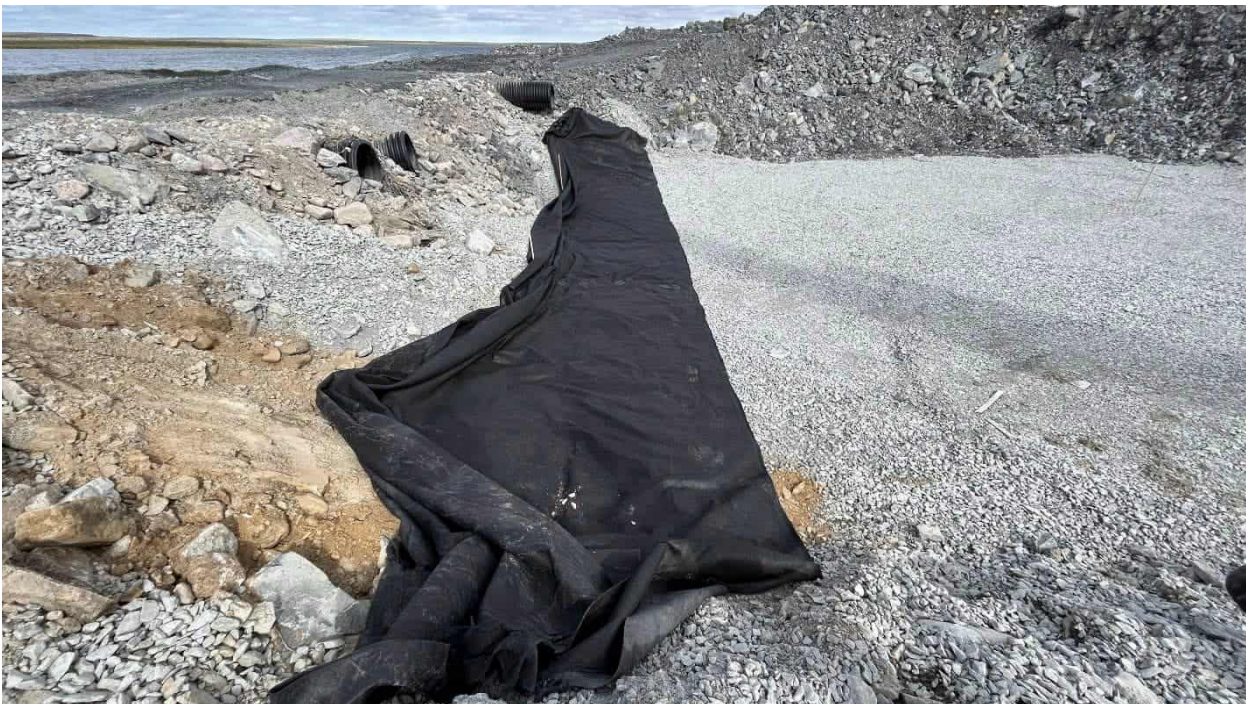
Photograph 2: Main Channel Geotextile Placement at Downstream End and Bedding Layer. Taken August 6, 2023

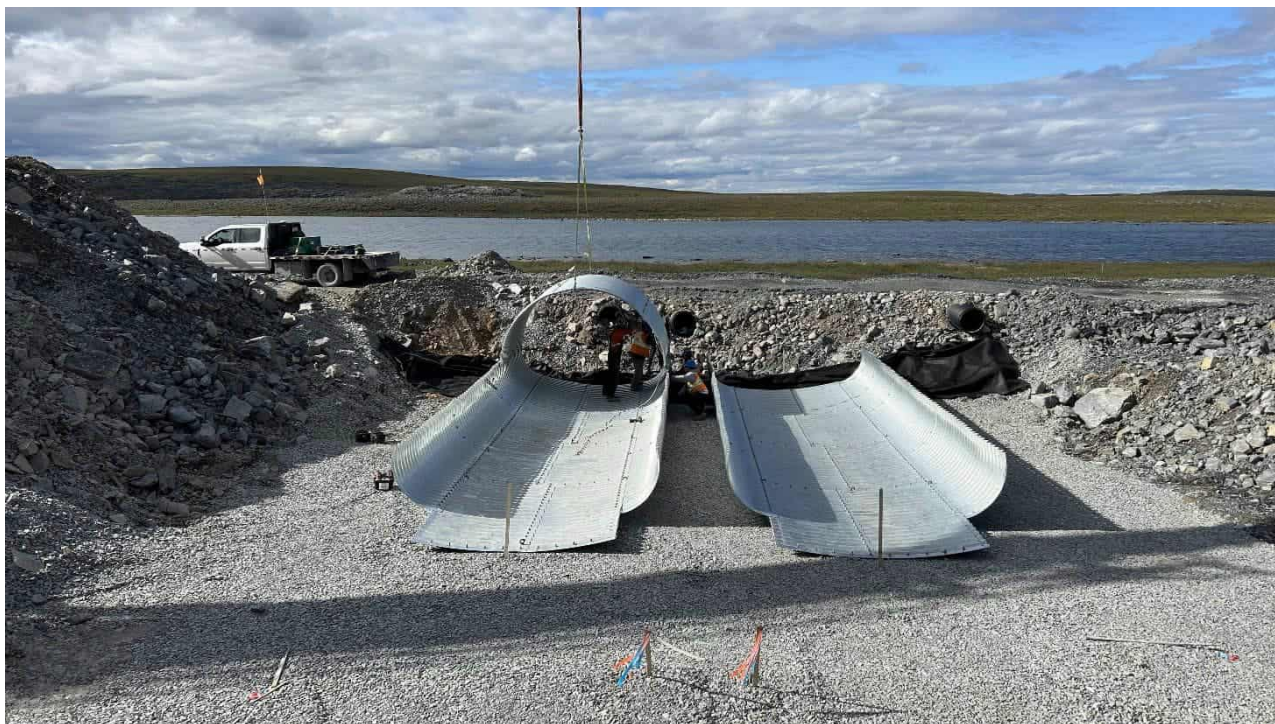
Photograph 3: Main Channel Culverts Assembly on Bedding Layer Looking Downstream. Taken August 6, 2023

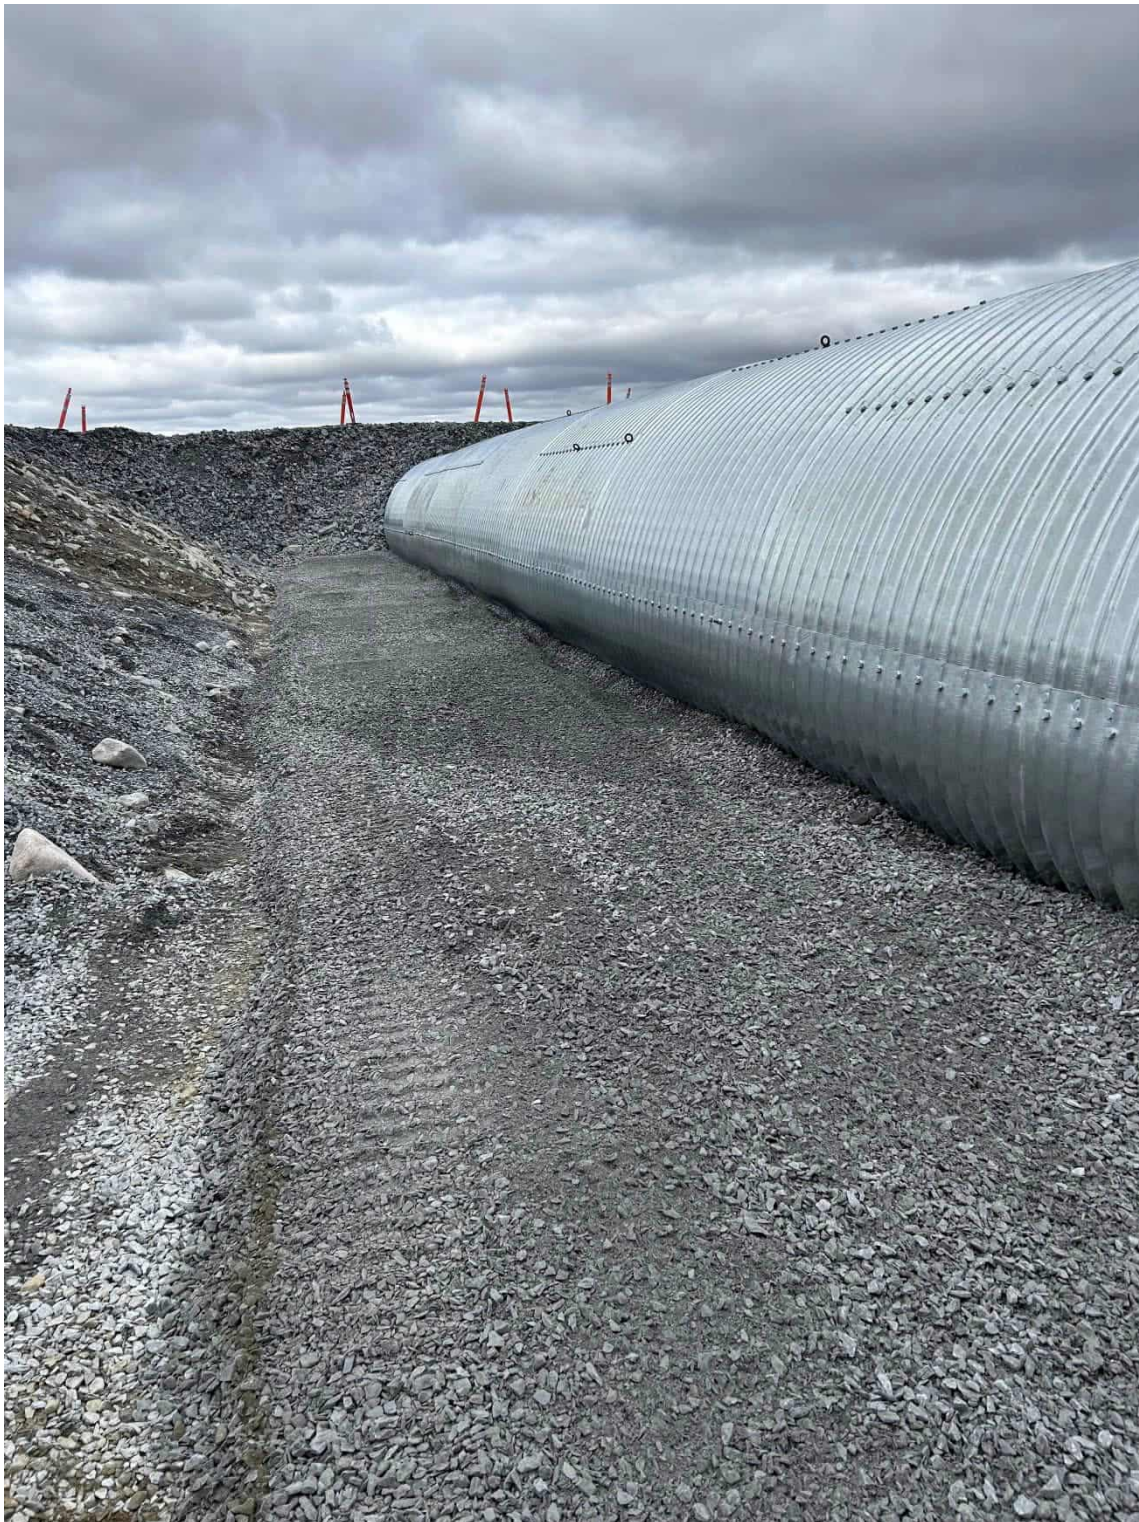
The specifications for the backfill material used for the main channel culvert construction were not provided to WSP. Based on photographs provided by B2Gold Nunavut, the material appears to be 1-inch crushed aggregate, however, based on information received from B2Gold Nunavut (Richards 2023), the material used was 2-inch clear crush, which is a modification from the design specifications. The modification from the design specification may result in unsatisfactory material compaction and load bearing. WSP recommends notification to Armtec and monitoring for culvert deformation and road subsidence.

Photograph 5: Start of Backfill Placement for Main Channel Culverts. Taken August 21, 2023 (Provided by B2Gold)

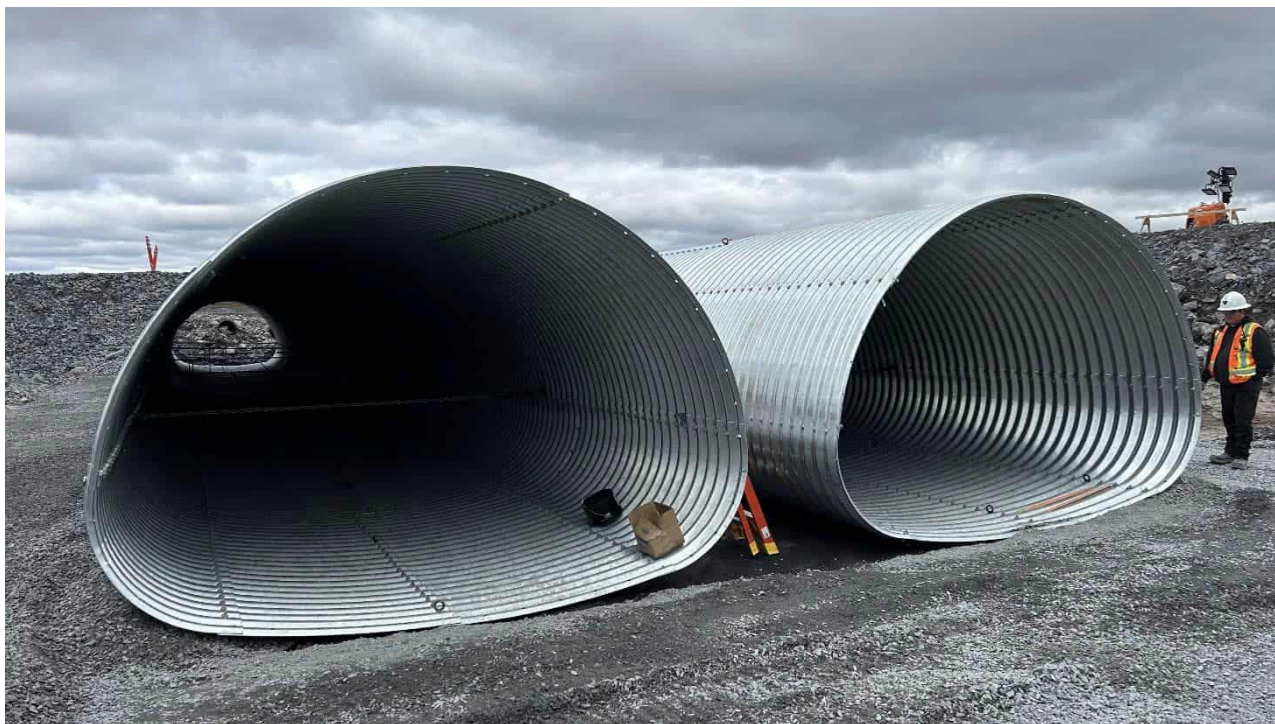
Photograph 6: Geotextile Placed Below Main Channel Cuvlerts and Backfill at Culvert Inlets. Taken August 21, 2023 (Provided by B2Gold)

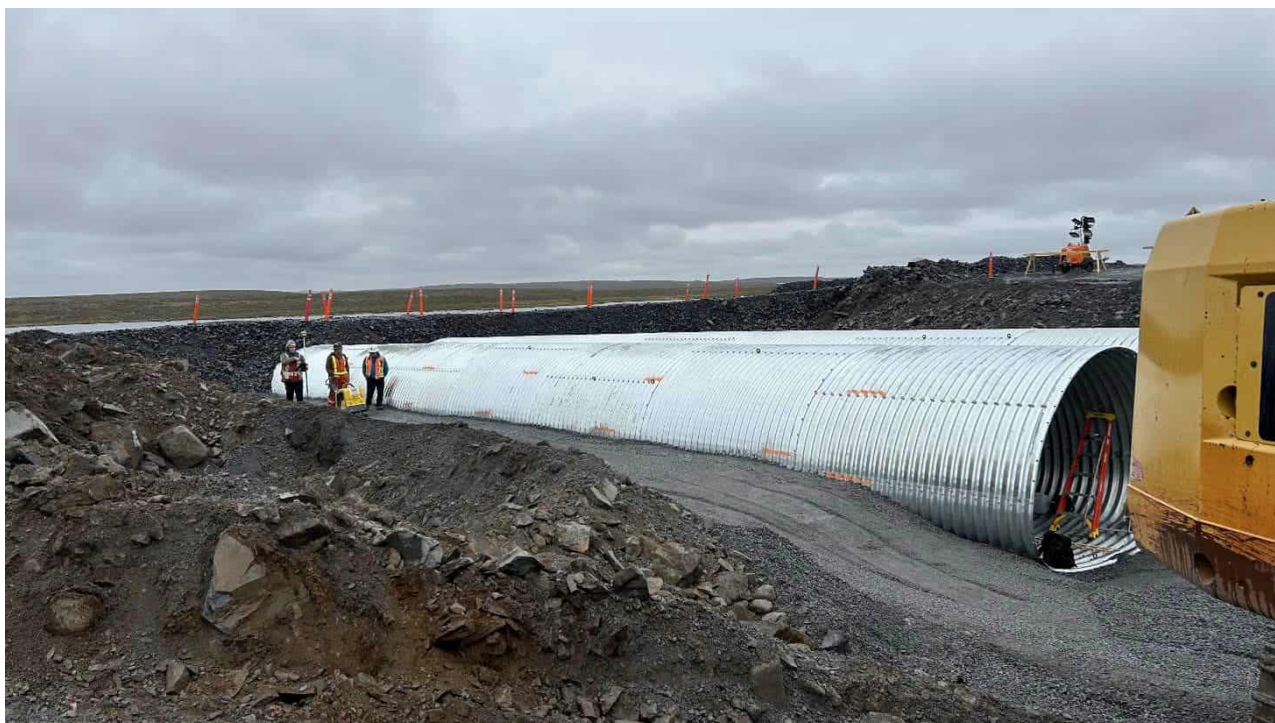
Photograph 7: Main Channel Culverts Backfill Placement and Compaction to Approximately 900 mm Above Culvert Invert. Taken August 22, 2023 (Provided by B2Gold)

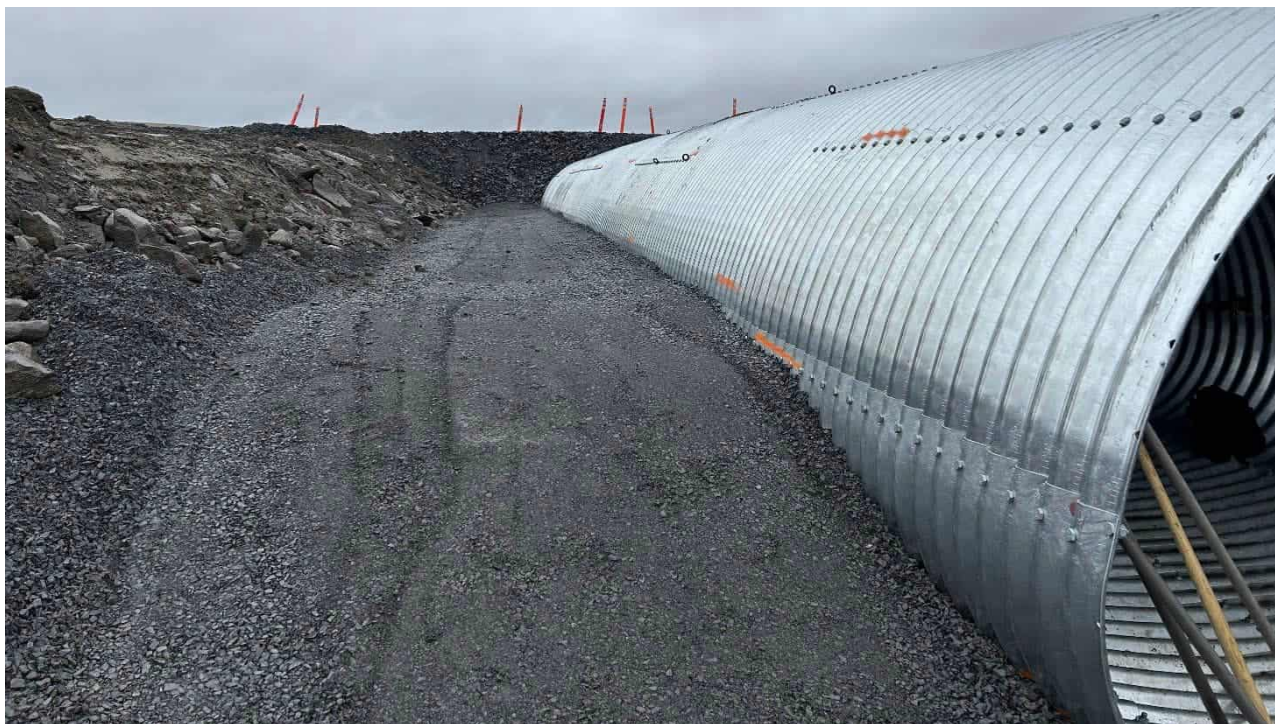
Photograph 9: Main Channel Culvert Left Barrel Backfill Placement and Compaction to Approximately 900 mm. Taken August 22, 2023 (Provided by B2Gold).

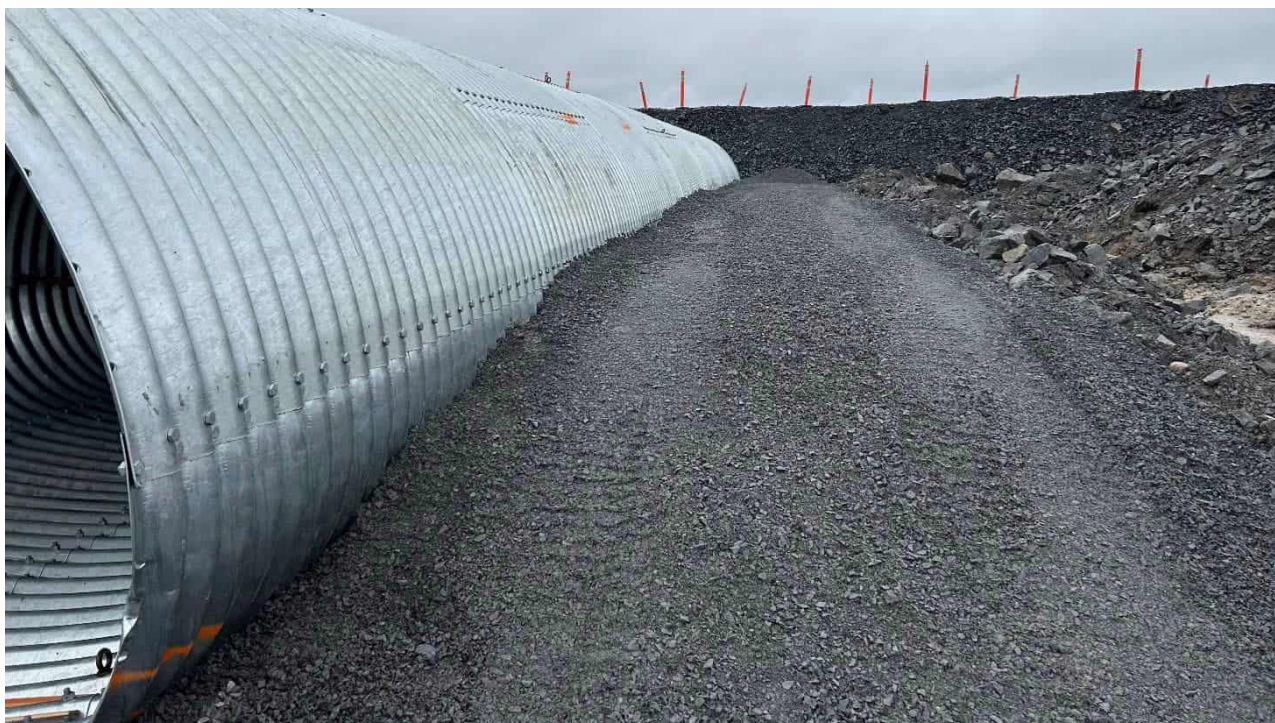
Photograph 10: Main Channel Culvert Right Barrel Backfill Placement and Compaction to Approximately 900 mm. Taken August 22, 2023 (Provided by B2Gold).

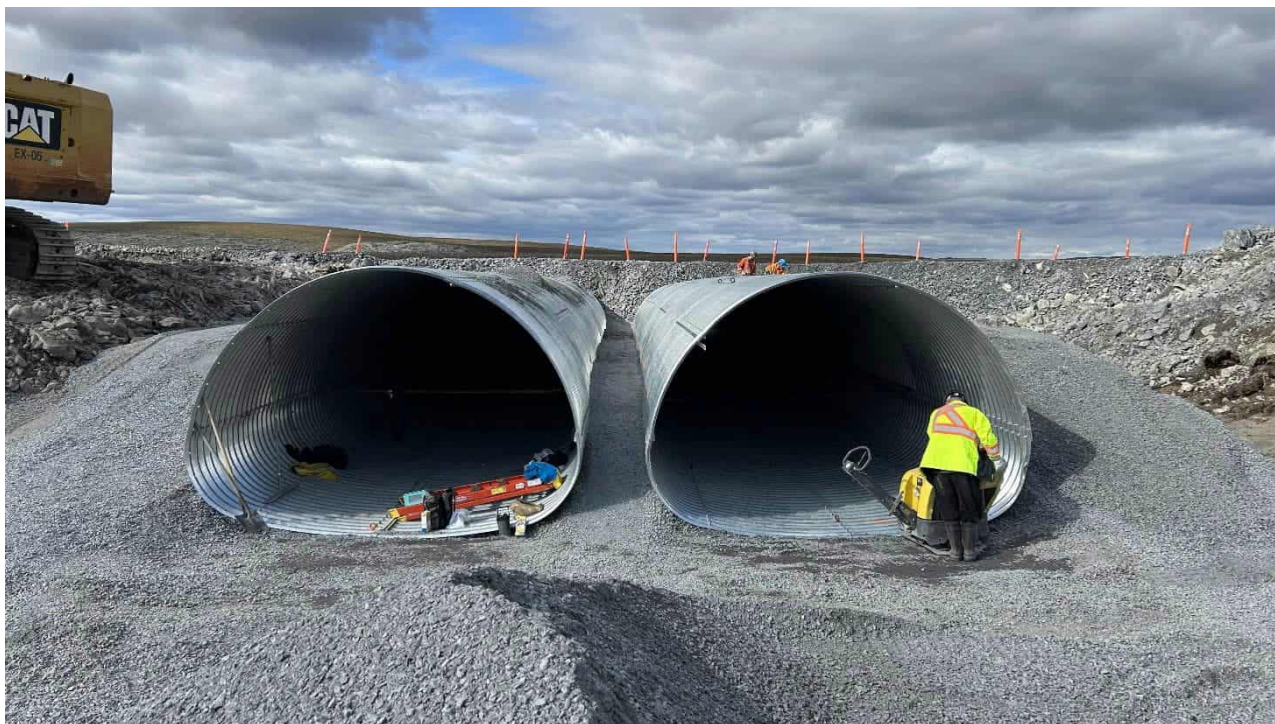
Photograph 11: Main Channel Culverts Inlets and Backfill Placement and Compaction. Taken August 23, 2023 (Provided by B2Gold).

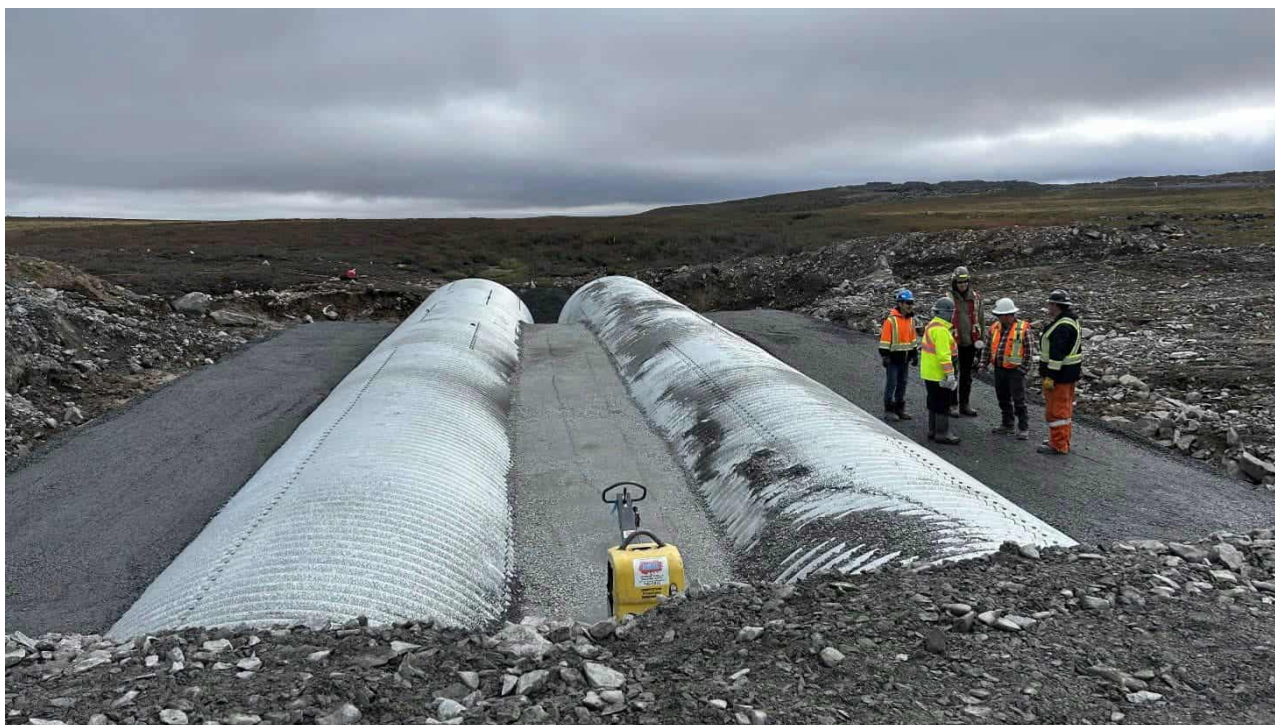
Photograph 12: Main Channel Culverts Backfill Placement and Compaction to Approximately 2400 mm Looking Upstream. Taken August 24, 2023 (Provided by B2Gold).

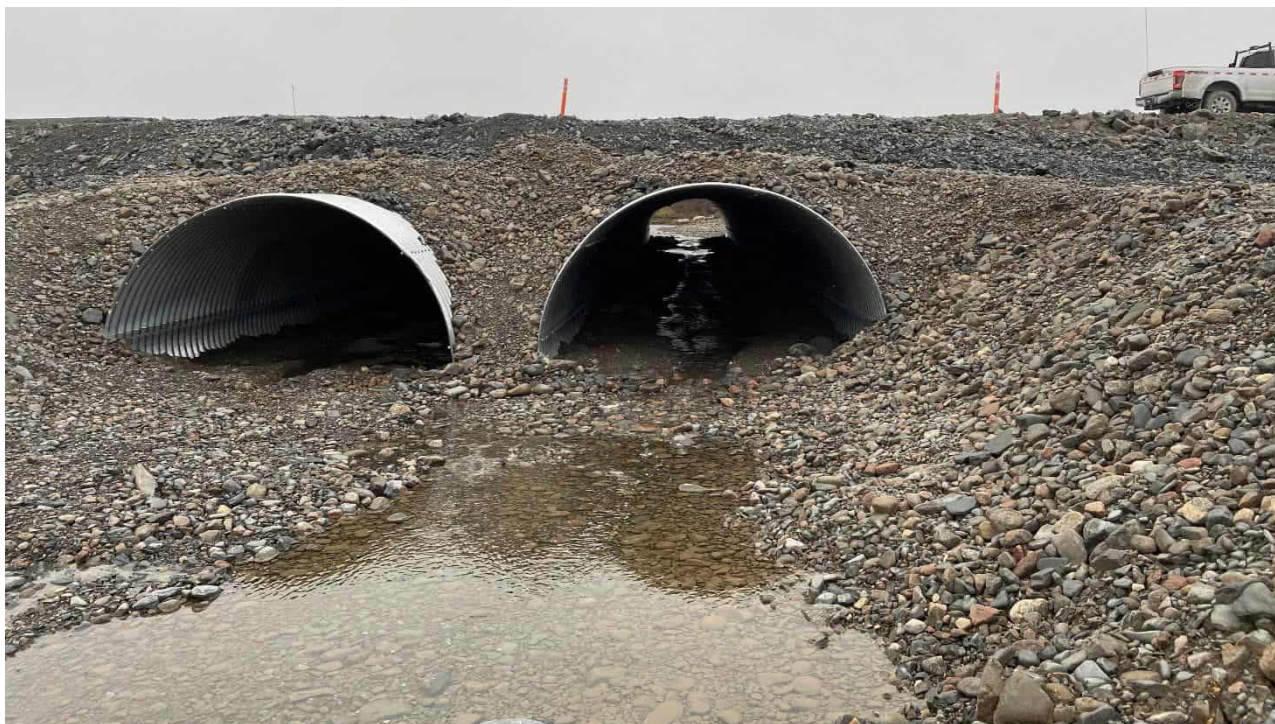
Photograph 13: Main Channel Culverts Looking Upstream from Downstream Apron, Taken September 17, 2023

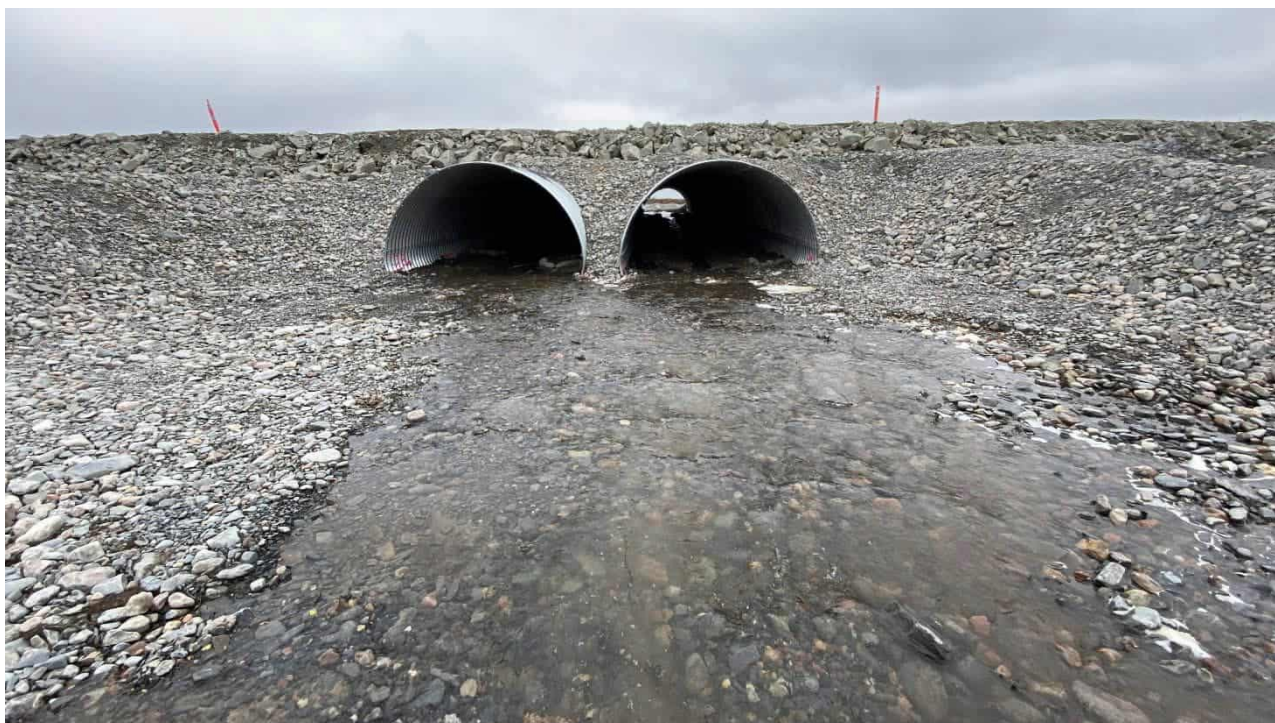
Photograph 14: Main Channel Culverts Looking Downstream from Upstream Apron, Taken September 17, 2023

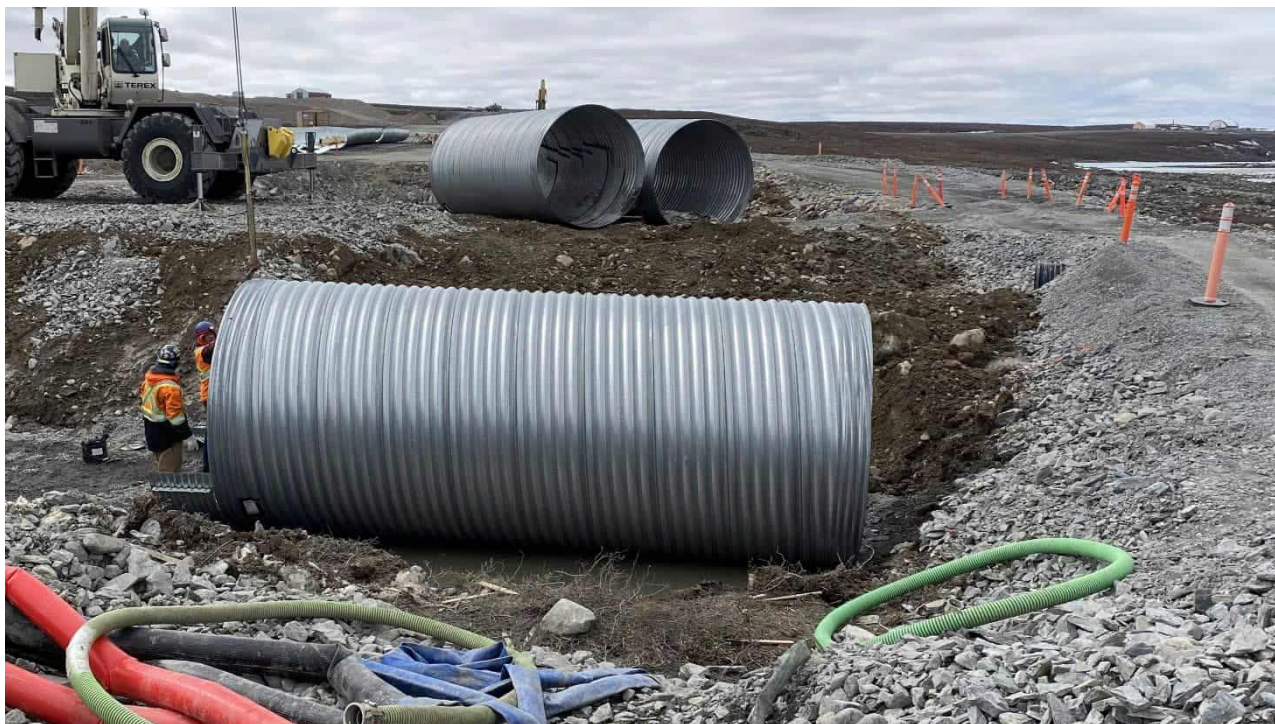
Photograph 19: Secondary Channel Culvert Outlet Placement on Bedding Material, Taken May 11, 2023

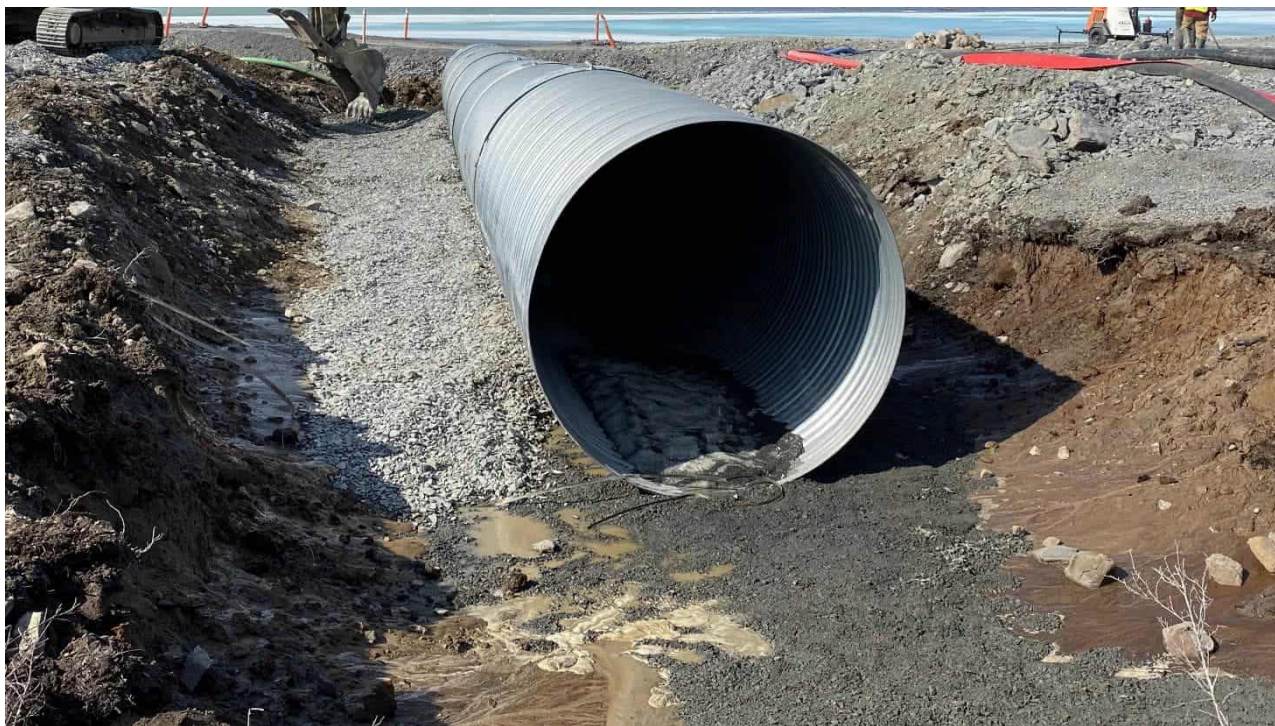
Photograph 20: Secondary Channel Culvert Inlet Placement on Bedding Material, Taken May 11, 2023
