Rascal Stream West Crossing Construction Summary Report

Back River Project (B2Gold Back River Corp.)

22567626-163-R-Rev0-8000

10 July 2024

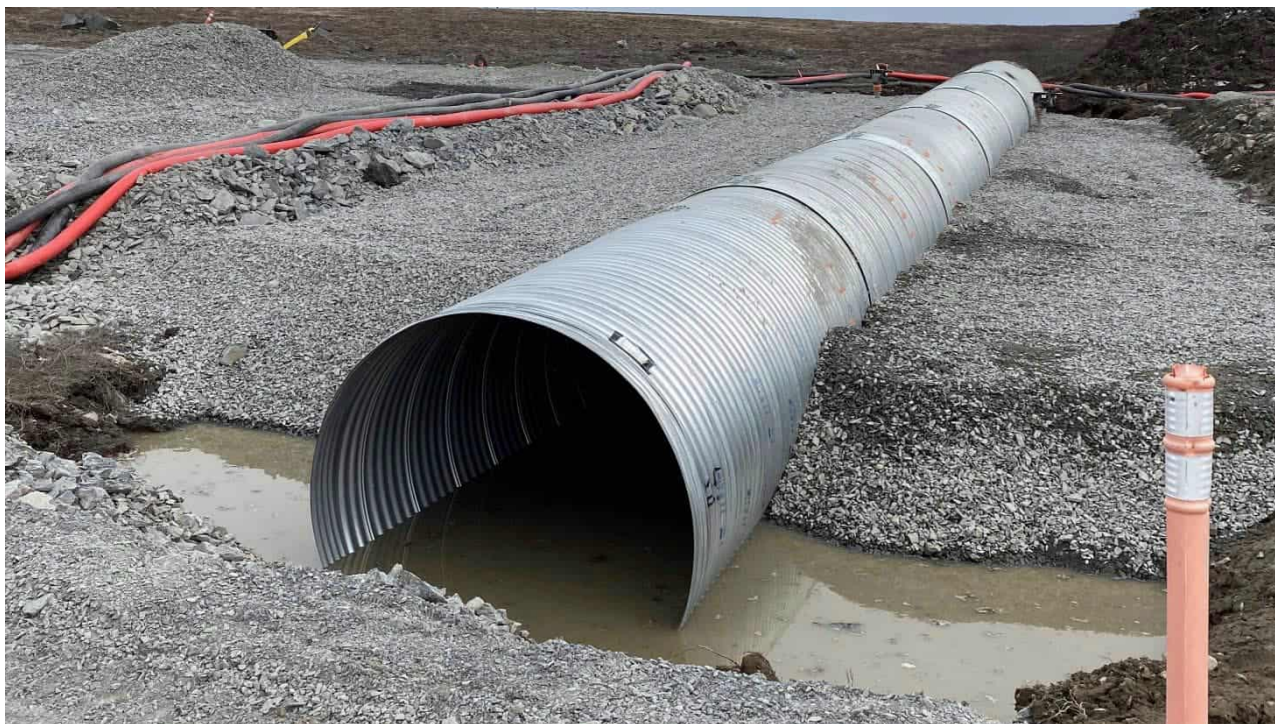
Photograph 21: Secondary Channel Culvert Backfill Placement with Approximately 900 mm on Left Downstream Wall From Outlet at Left Downstream Bank, Taken May 13, 2023

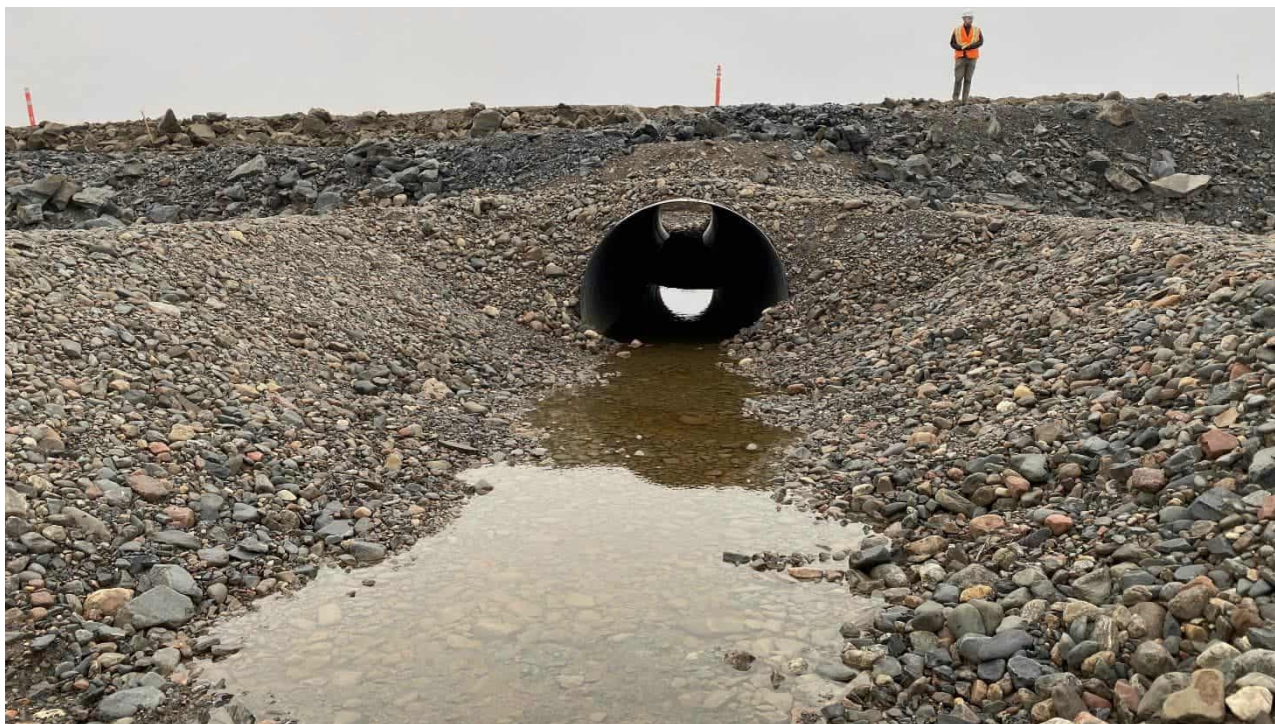
Photograph 23: Secondary Channel Culvert Looking Upstream from Downstream Apron, Taken September 17, 2023

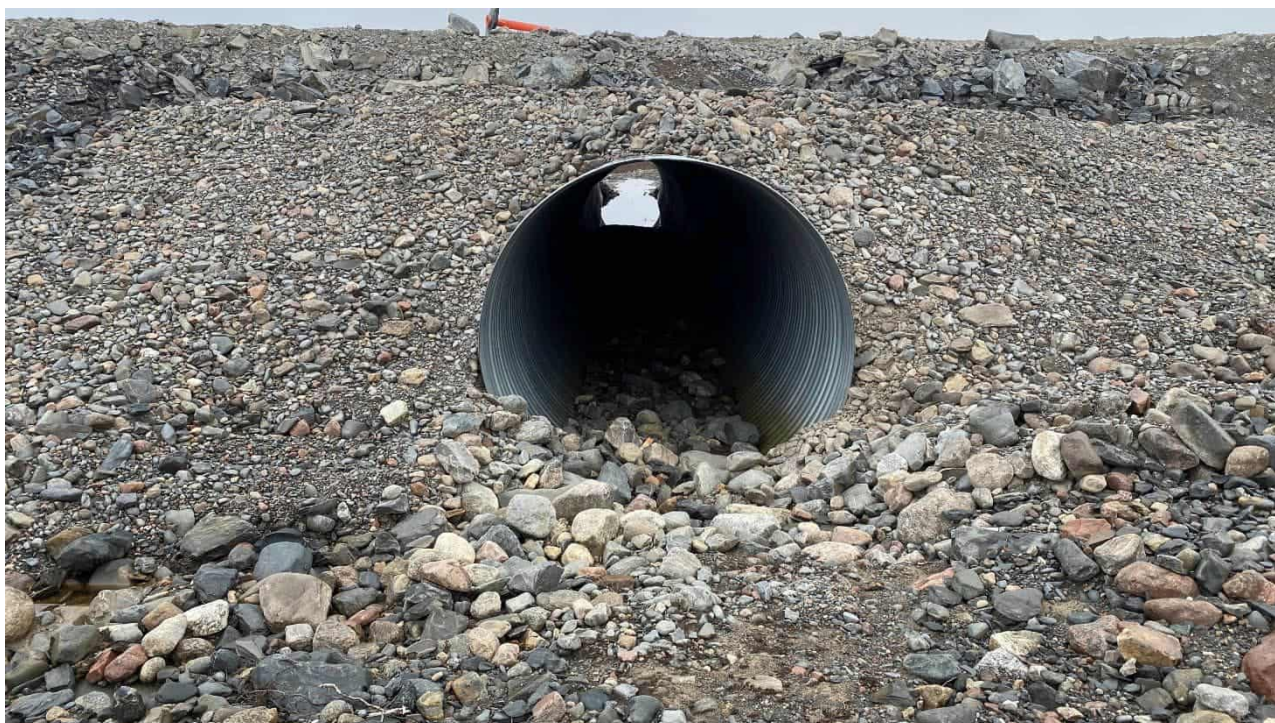
Photograph 24: Secondary Channel Culvert Looking Downstream from Upstream Apron, Taken September 17, 2023
