Rascal Stream West Crossing Construction Summary Report

Back River Project (B2Gold Back River Corp.)

22567626-163-R-Rev0-8000

10 July 2024

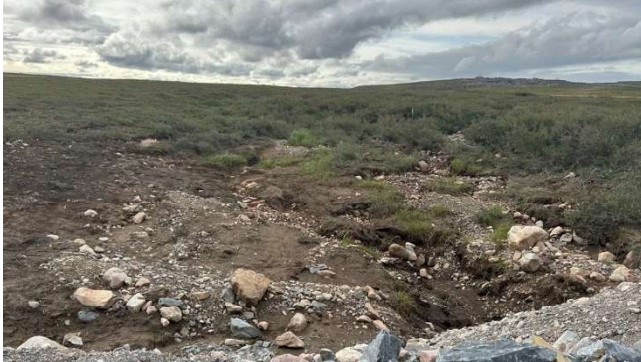
Photo 1: Natural Channel Upstream of The Culvert Location at 09:00

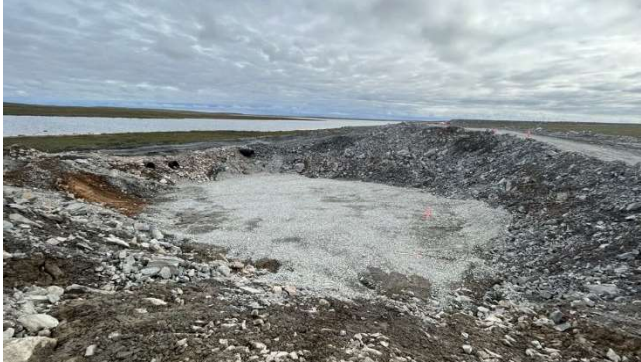
Photo 3: Prepared Segment of The Culvert Bedding at 08:40.

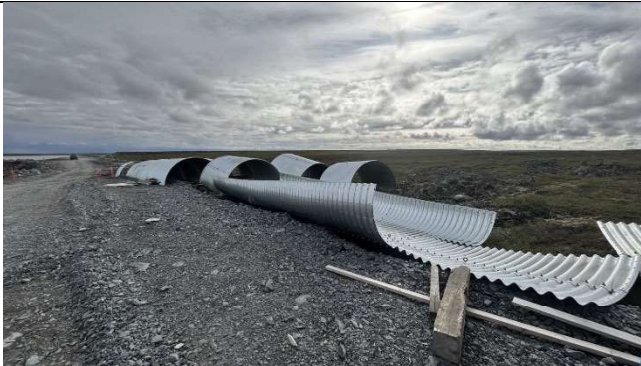
Photo 5: Partially Assembled Culvert Plates

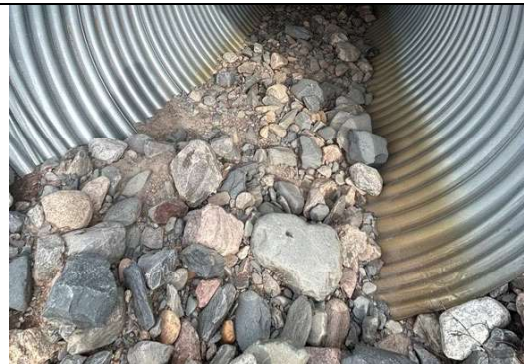
The channel embedment depth for the secondary channel culvert was specified to be 960 mm. The constructed embedment depth was observed to be approximately 310 mm on September 17, 2023 and is a modification from the design specifications. This is not anticipated to adversely affect the conveyance capacity of the secondary channel culvert. However, WSP recommends including the secondary channel culvert in future fish monitoring programs.

Photo 6: Minimal channel substrate was identified inside the secondary culvert

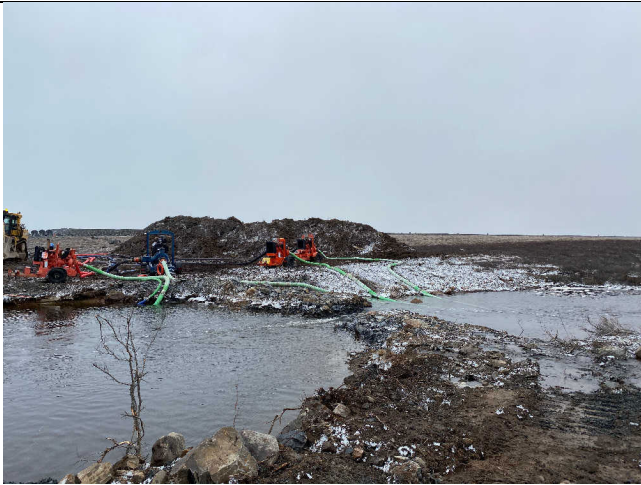
Photo 1: Dewatering pumps in upper pond and lower pond upstream of twin multiplate culvert excavation.

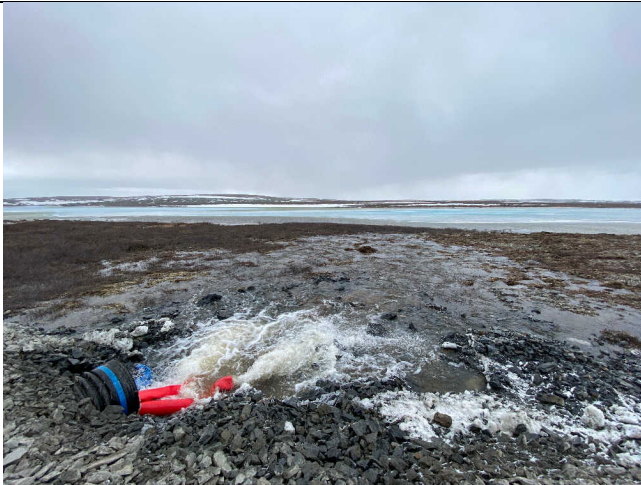
Photo 3: Dewatering pump discharge downstream of secondary culvert excavation

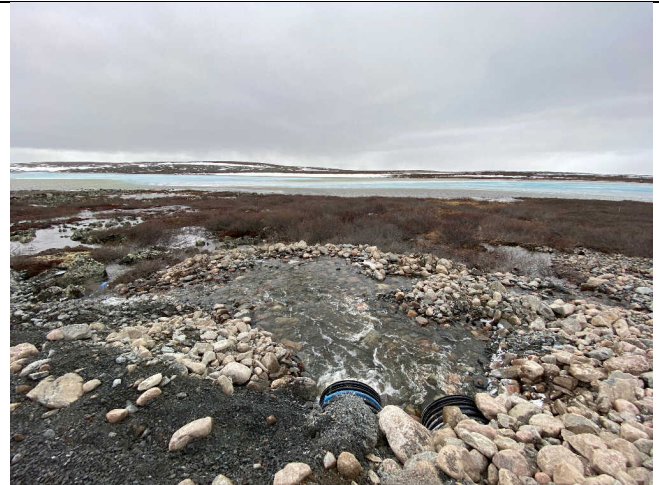
Photo 4: Temporary culverts discharging twin multiplate culvert excavation

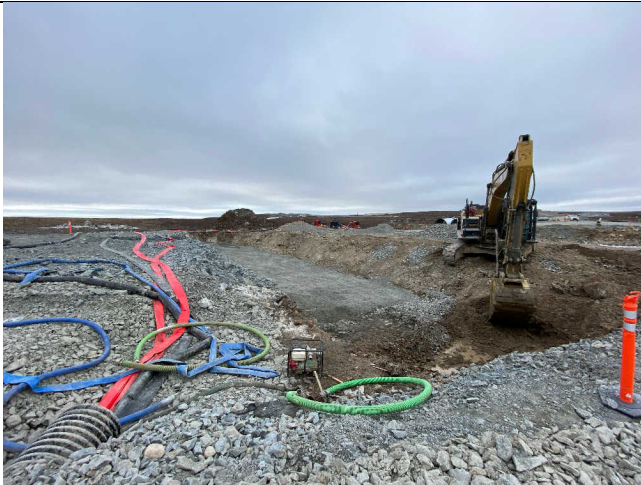
Photo 1: Secondary culvert excavation with bedding placed looking upstream at 8:23.

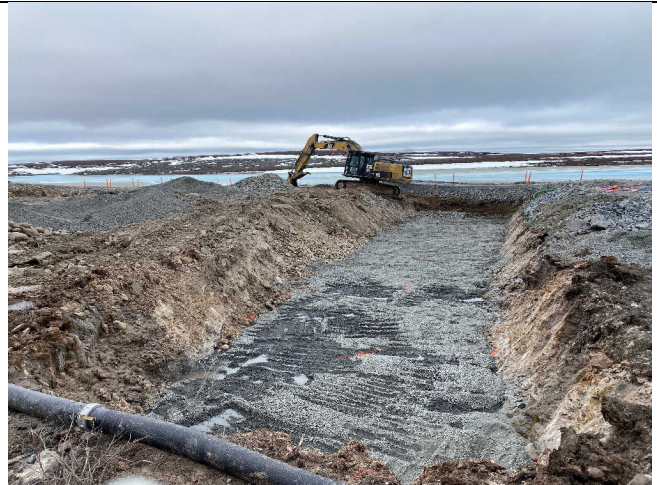
Photo 2: Secondary culvert excavation with bedding placed looking downstream at 8:24.

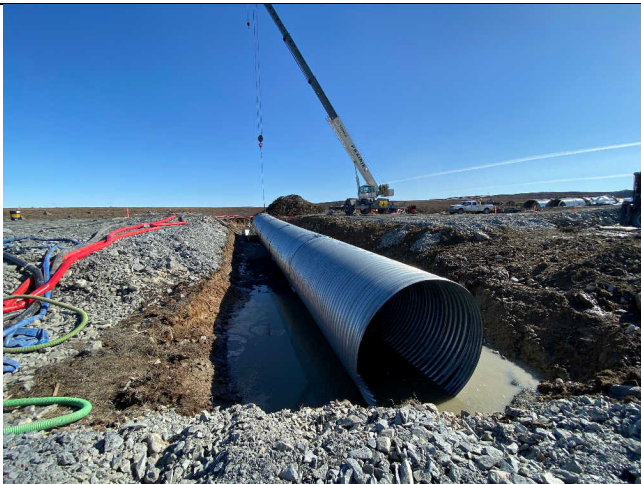
Photo 3: Secondary culvert placement with 4 sections looking upstream at 16:09.

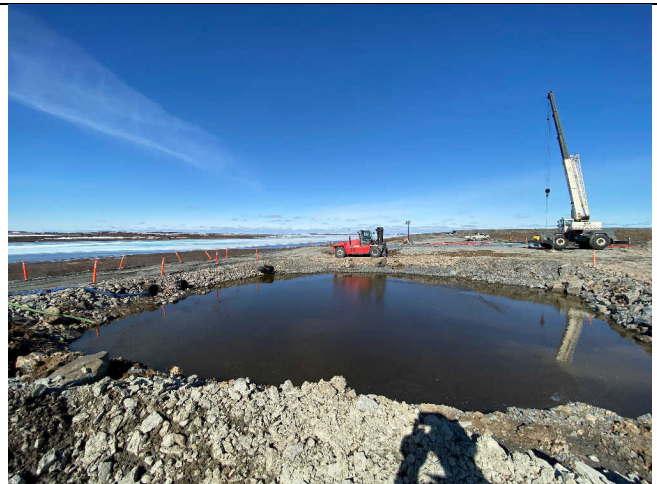
Photo 4: Twin multiplate culvert excavation at 16:10.

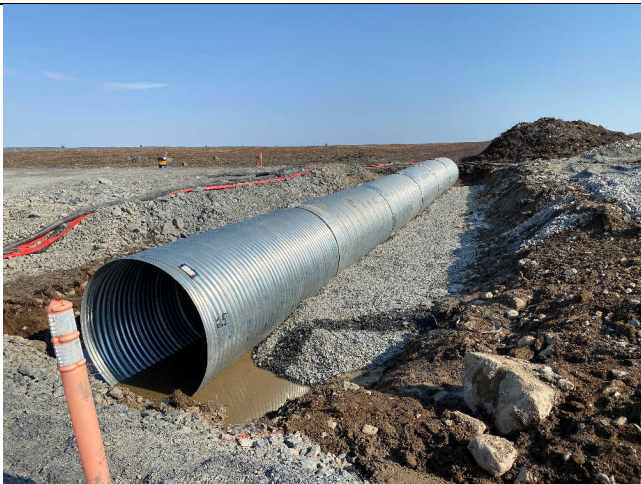
Photo 3: Secondary culvert backfill placement on left downstream bank looking upstream at 16:40.

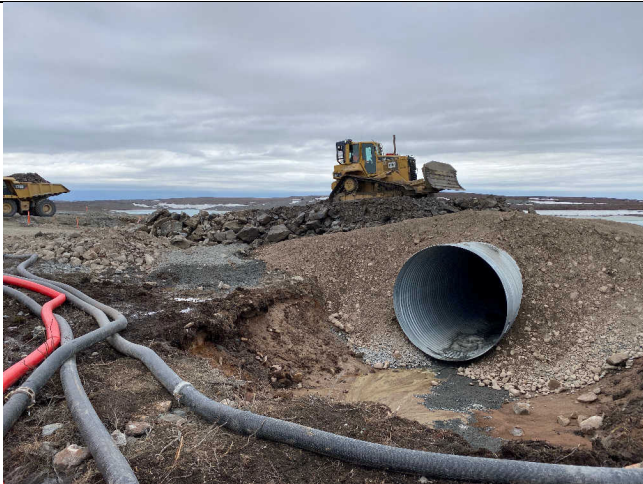
Photo 3: RoQ placement above raw esker backfill looking downstream at 16:52.

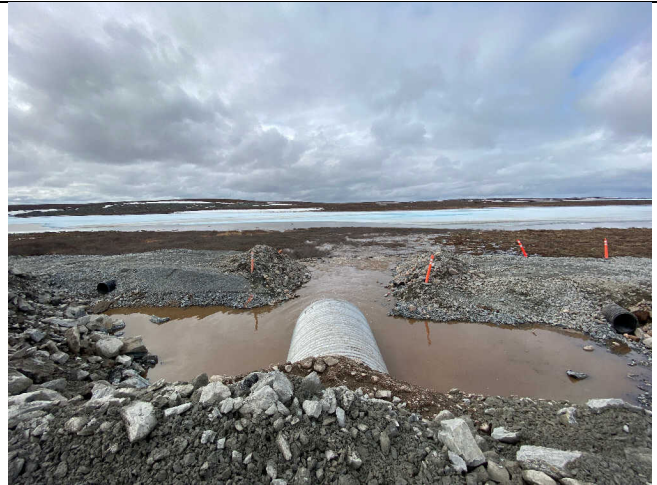
Photo 2: Secondary culvert discharging RSW over temporary riprap apron looking downstream at 14:11.

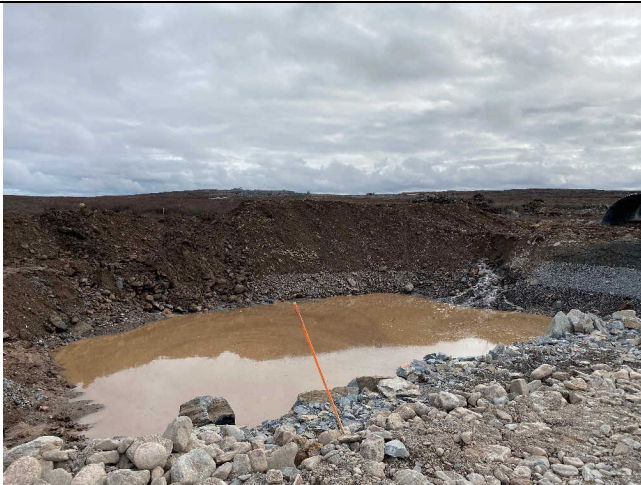
Photo 3: Temporary diversion dam isolating twin multiplate excavation looking upstream at 16:13.

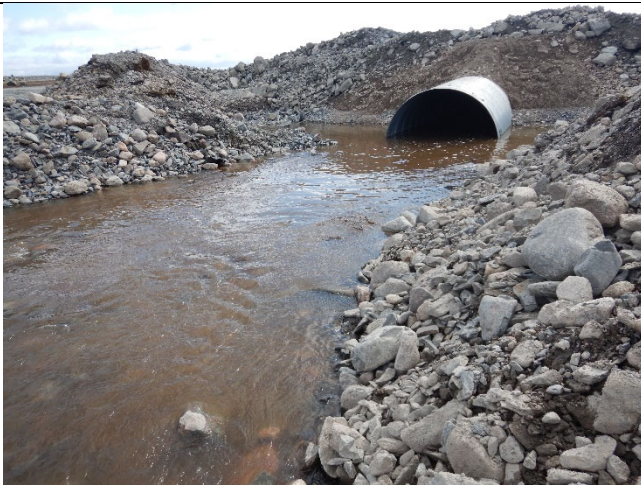
Photo 3: Secondary culvert discharging diverted RSW main channel over temporary outlet riprap apron looking upstream at 12:05.

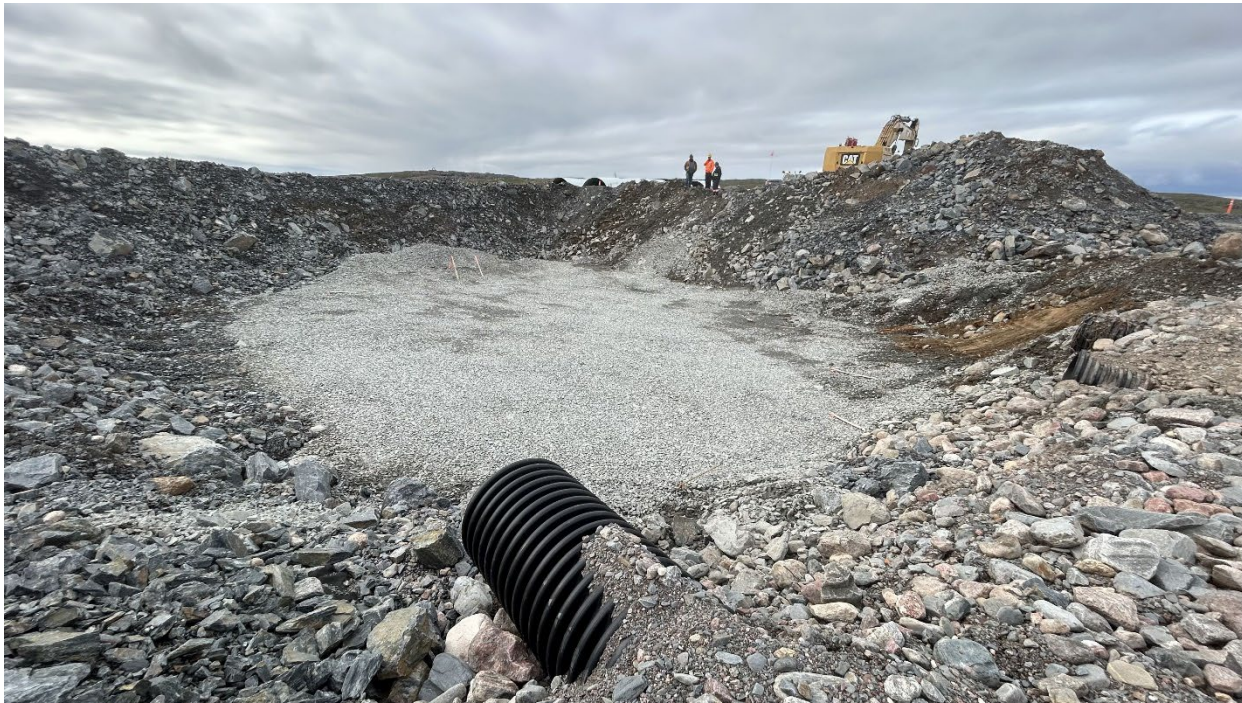
Photograph 1: Main Channel Excavation Extents and Bedding Layer Looking Upstream. Taken August 5, 2023

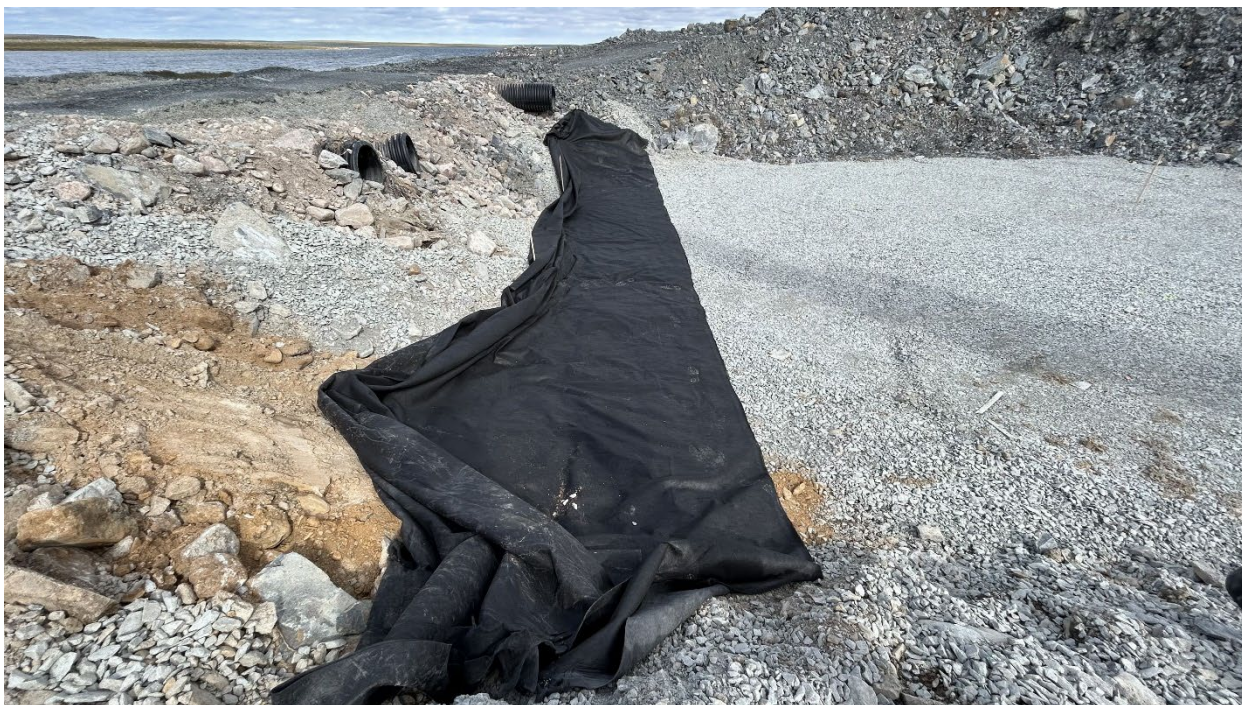
Photograph 2: Main Channel Geotextile Placement at Downstream End and Bedding Layer. Taken August 6, 2023

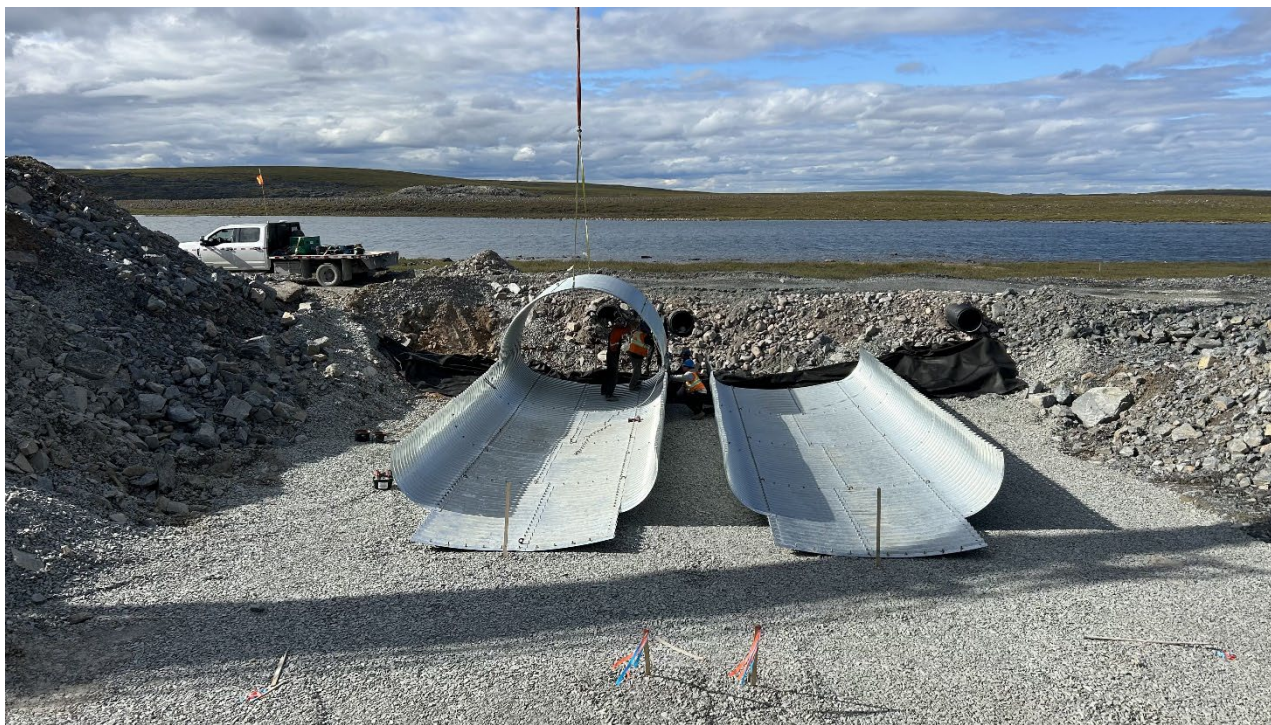
Photograph 3: Main Channel Culverts Assembly on Bedding Layer Looking Downstream. Taken August 6, 2023

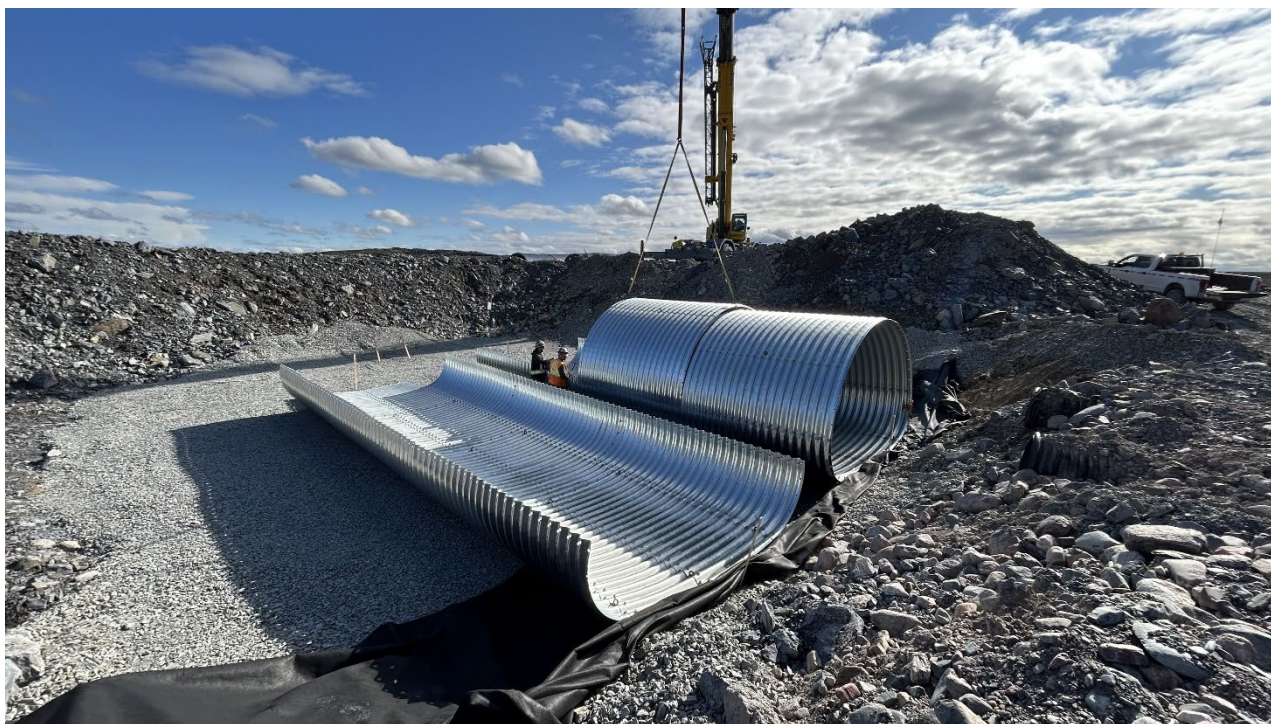
Photograph 4: Main Channel Culverts Assembly on Bedding Layer Looking Upstream. Taken August 6, 2023

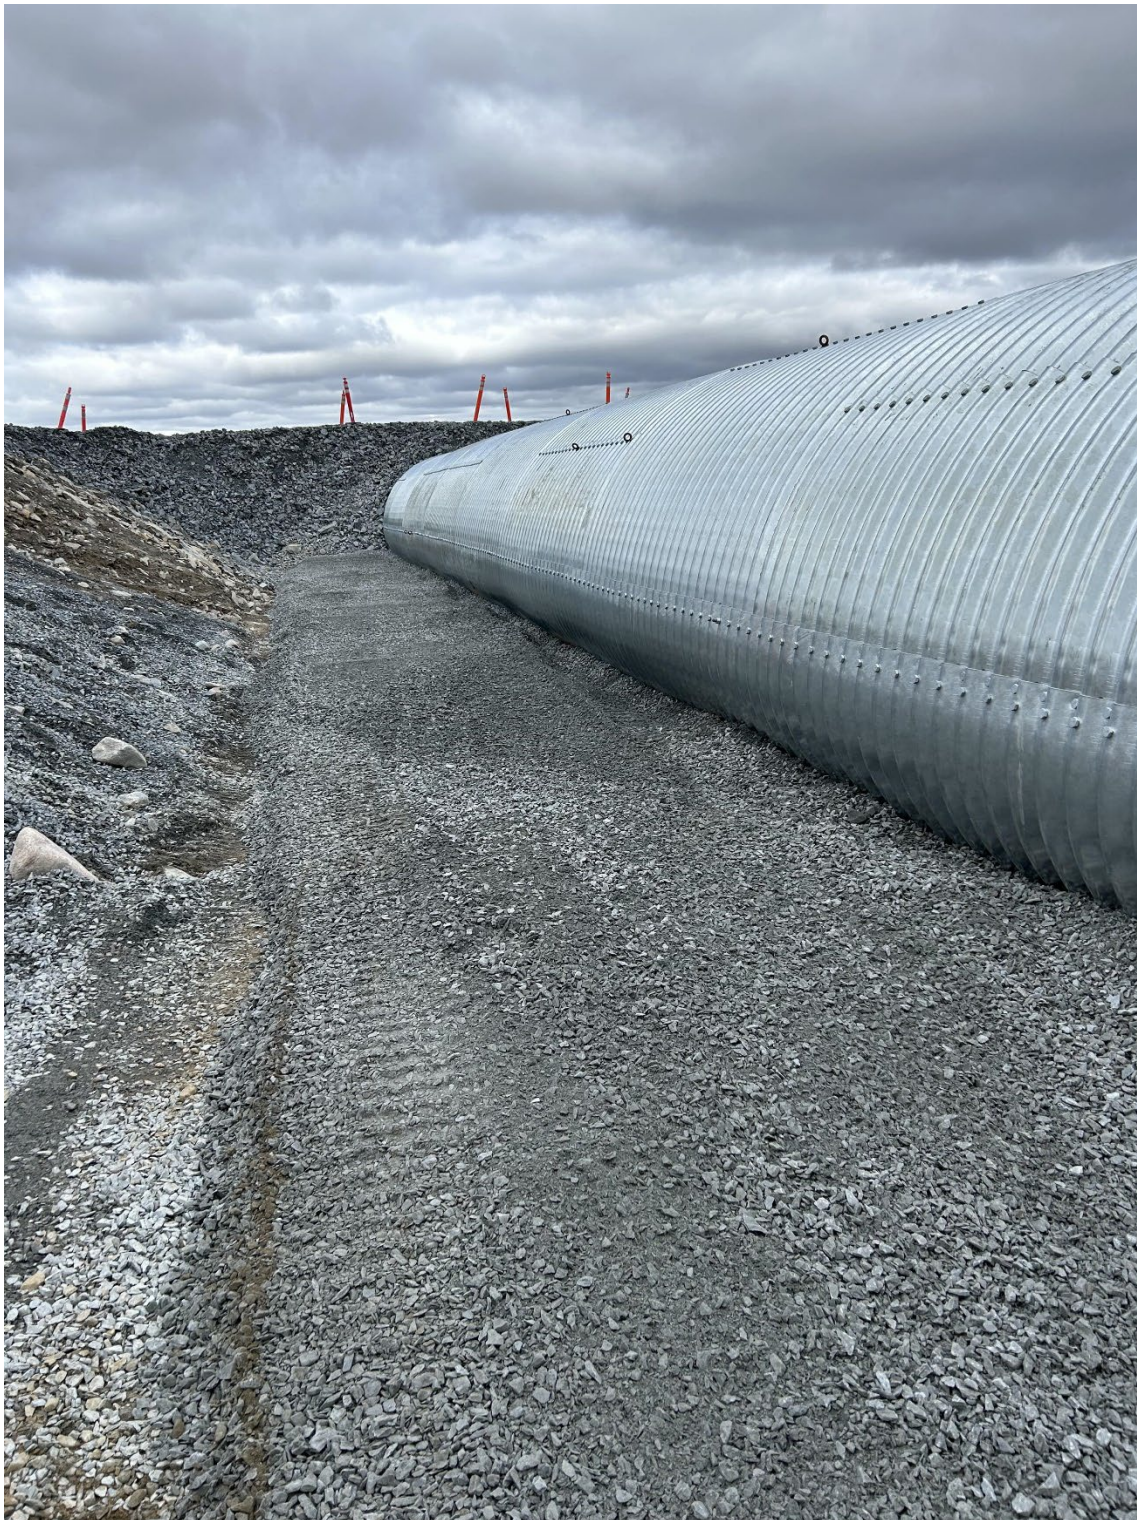
Photograph 5: Start of Backfill Placement for Main Channel Culverts. Taken August 21, 2023 (Provided by B2Gold)

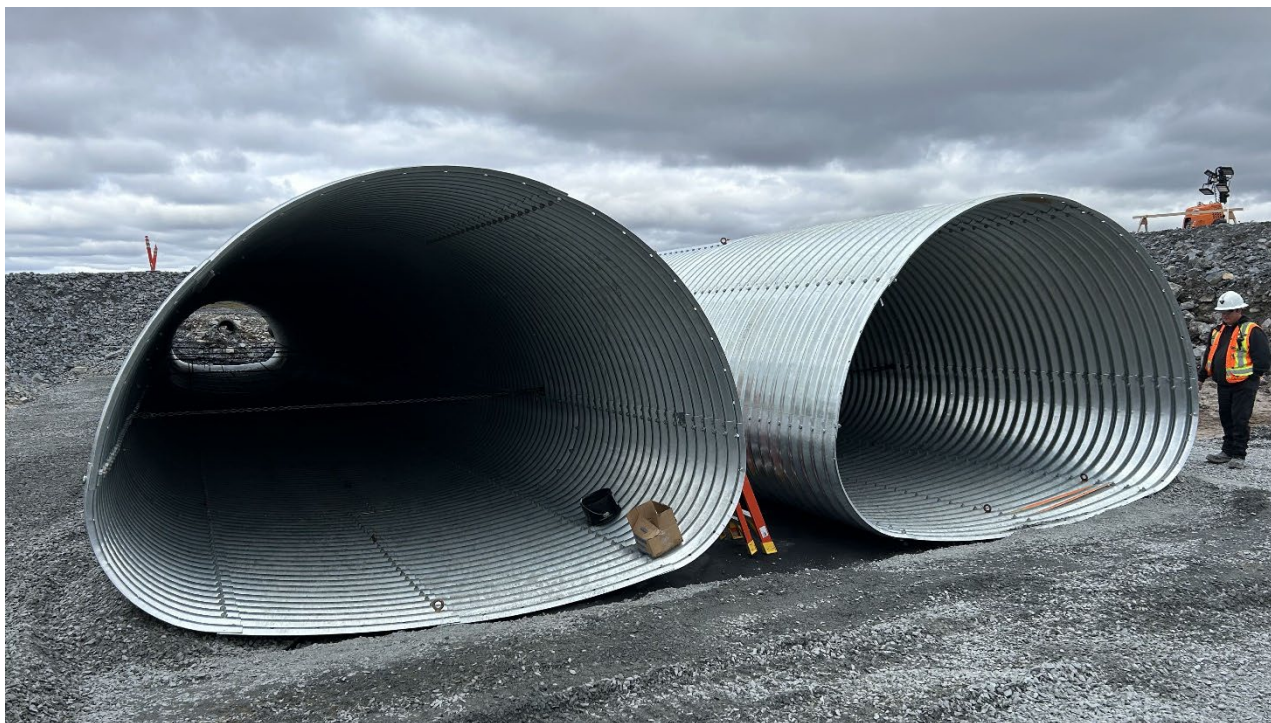
Photograph 7: Main Channel Culverts Backfill Placement and Compaction to Approximately 900 mm Above Culvert Invert. Taken August 22, 2023 (Provided by B2Gold)

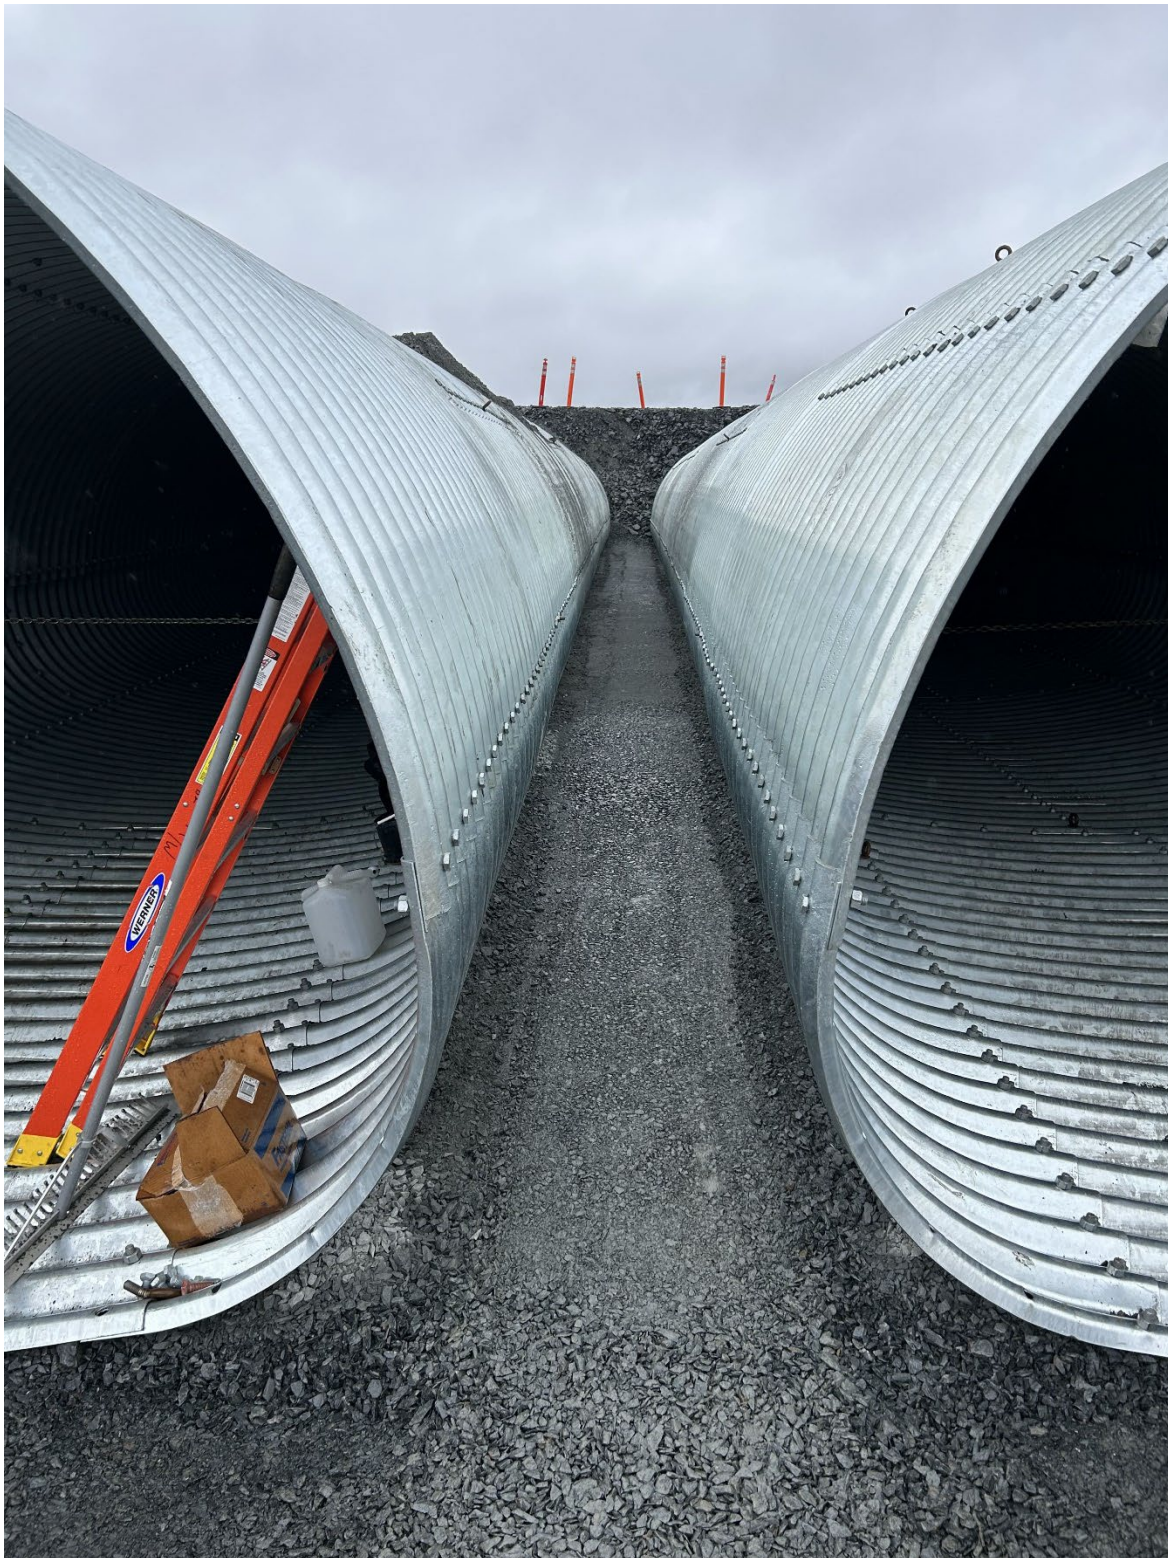
Photograph 9: Main Channel Culvert Left Barrel Backfill Placement and Compaction to Approximately 900 mm. Taken August 22, 2023 (Provided by B2Gold).

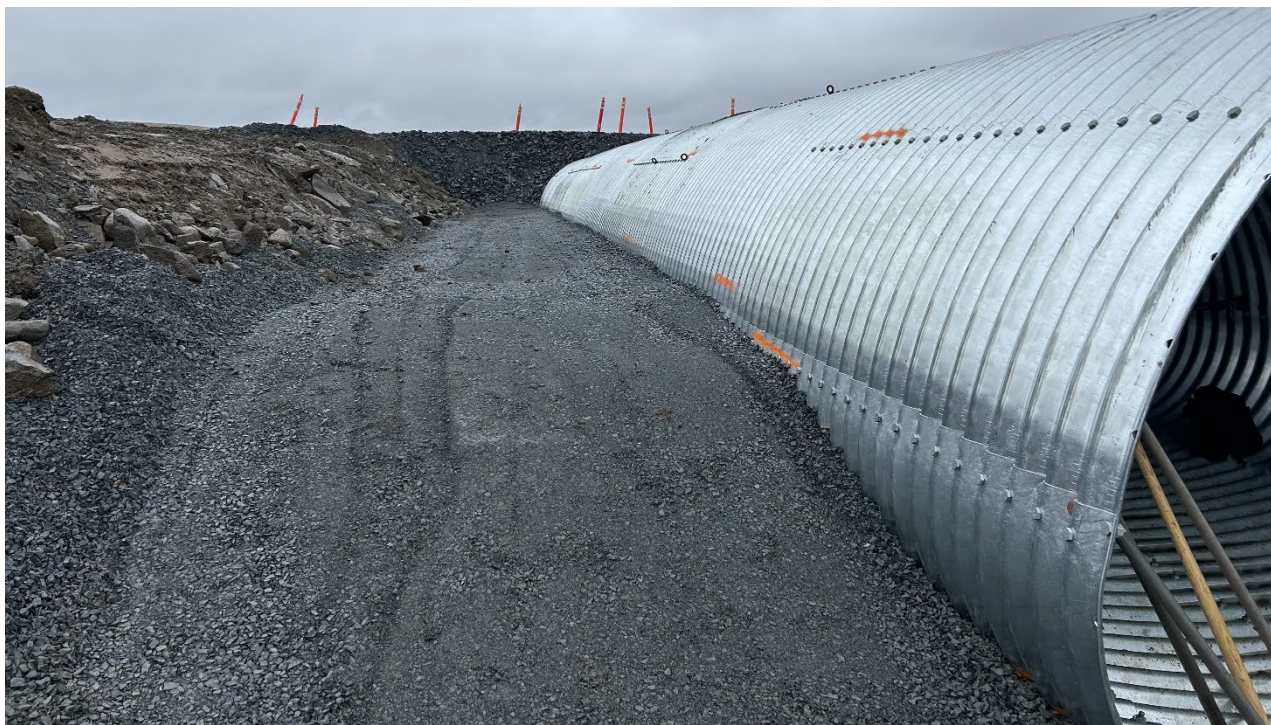
Photograph 10: Main Channel Culvert Right Barrel Backfill Placement and Compaction to Approximately 900 mm. Taken August 22, 2023 (Provided by B2Gold).

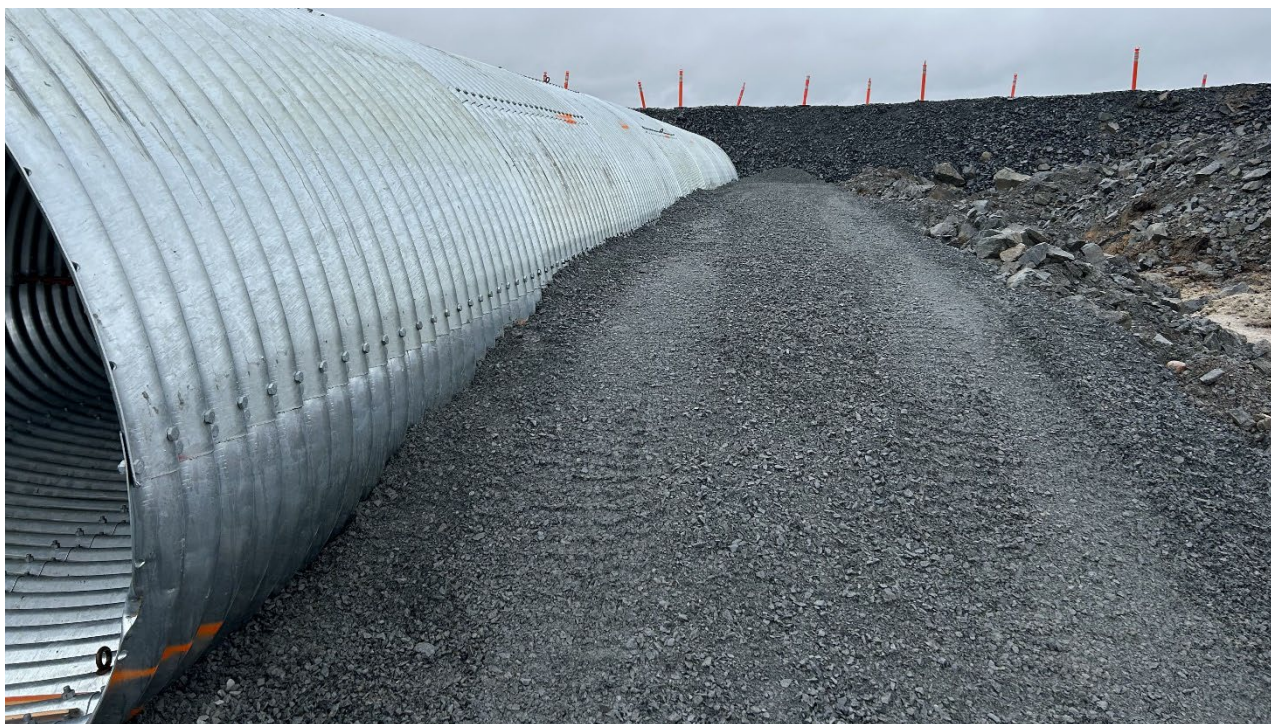
Photograph 11: Main Channel Culverts Inlets and Backfill Placement and Compaction. Taken August 23, 2023 (Provided by B2Gold).

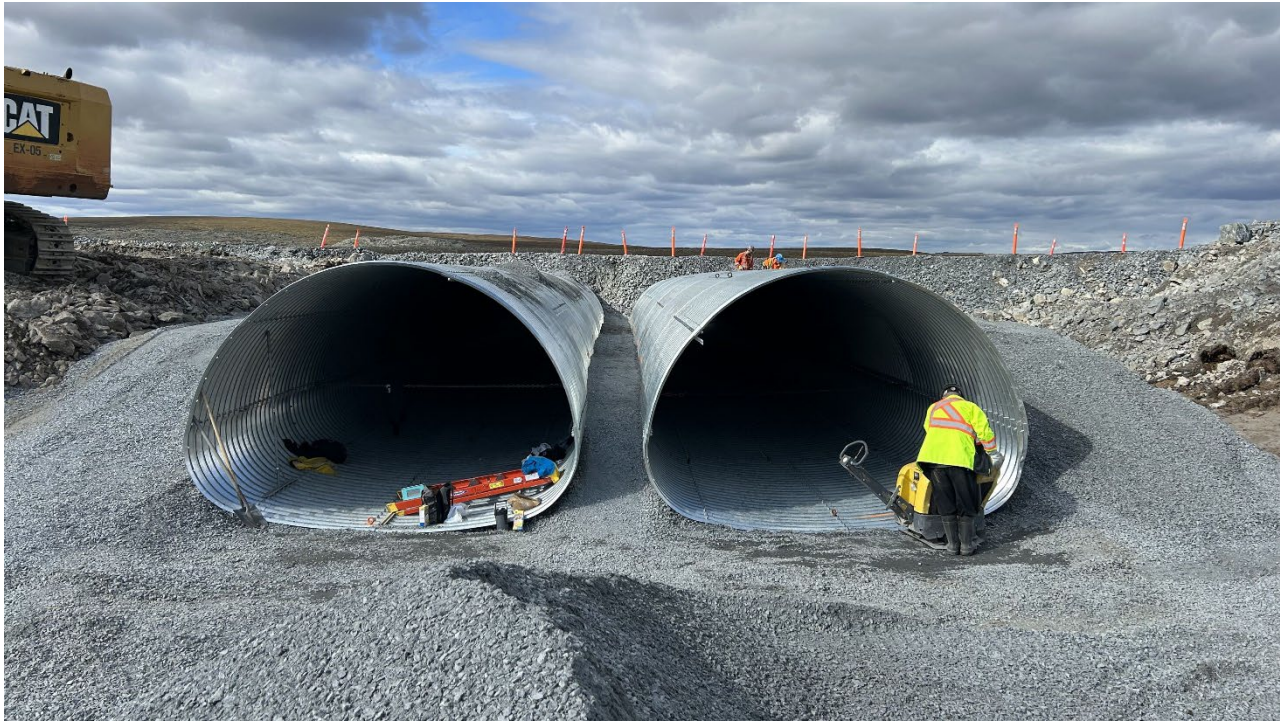
Photograph 12: Main Channel Culverts Backfill Placement and Compaction to Approximately 2400 mm Looking Upstream. Taken August 24, 2023 (Provided by B2Gold).

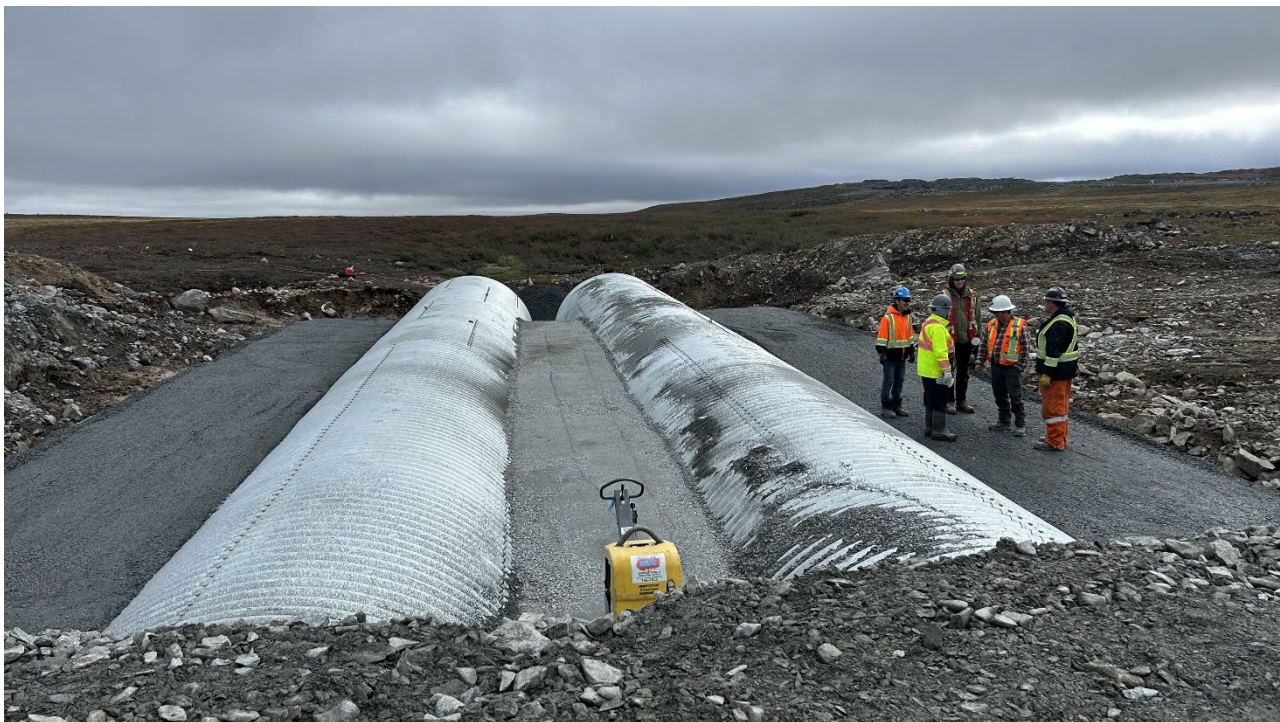
Photograph 13: Main Channel Culverts Looking Upstream from Downstream Apron, Taken September 17, 2023

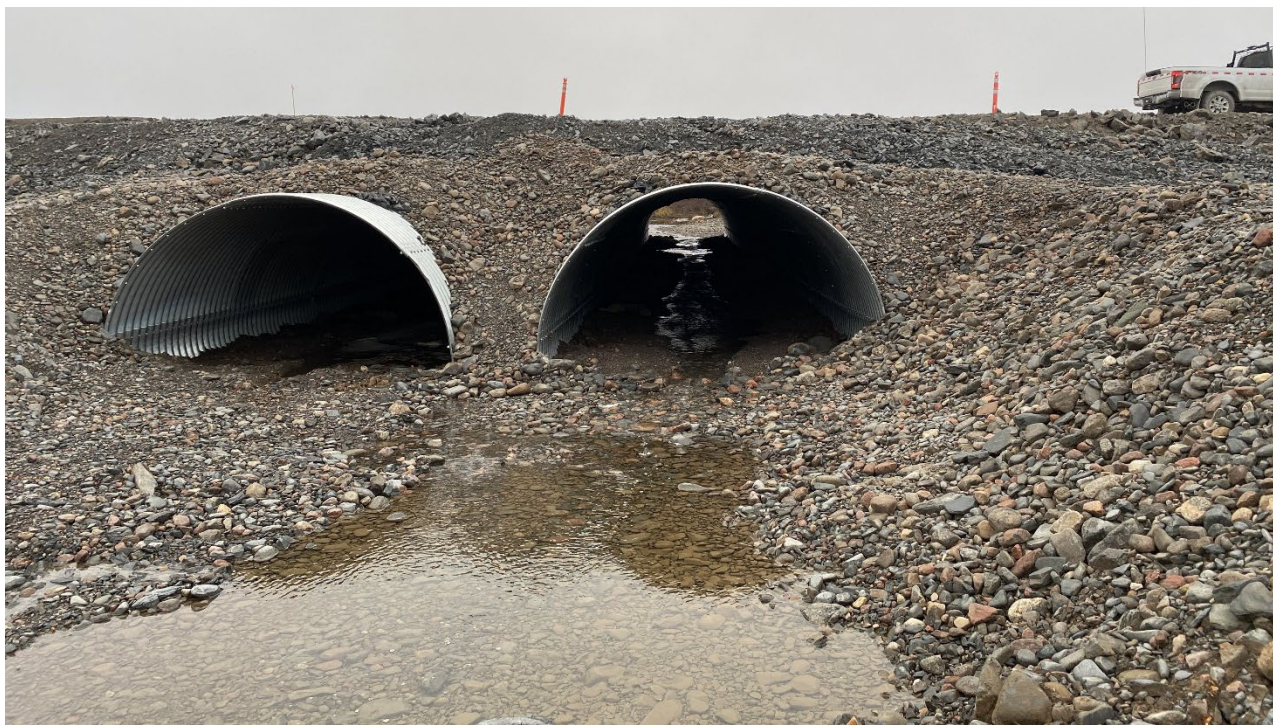
Photograph 14: Main Channel Culverts Looking Downstream from Upstream Apron, Taken September 17, 2023

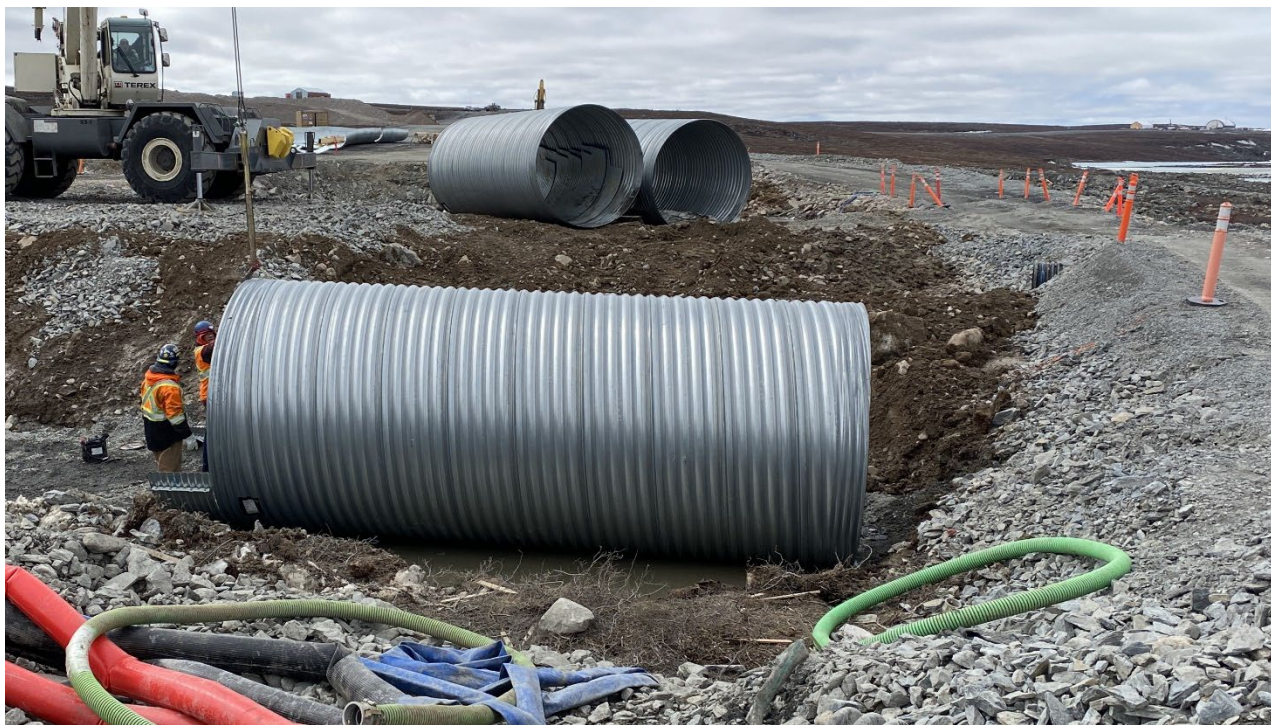
Photograph 20: Secondary Channel Culvert Inlet Placement on Bedding Material, Taken May 11, 2023

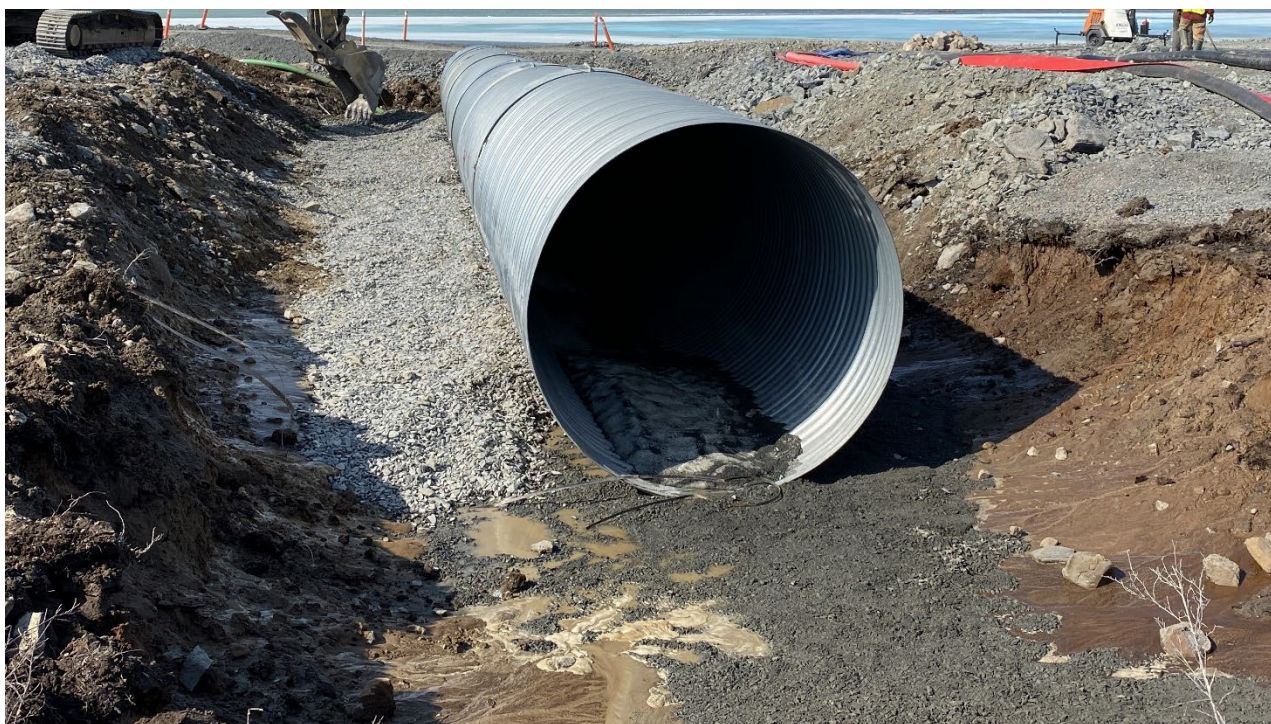
Photograph 21: Secondary Channel Culvert Backfill Placement with Approximately 900 mm on Left Downstream Wall From Outlet at Left Downstream Bank, Taken May 13, 2023

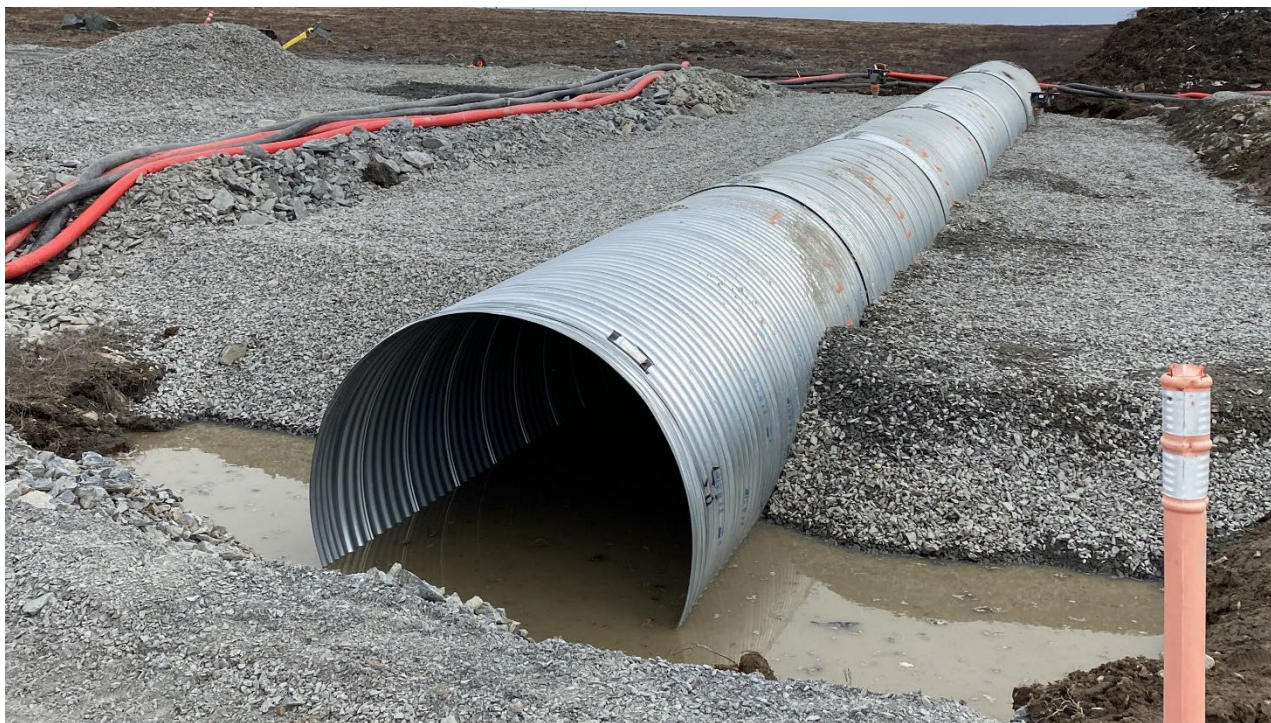
Photograph 22: Secondary Channel Culvert Backfill Placement with Approximately 1500 mm on Right Downstream Wall From Outlet at Right Downstream Bank, Taken May 13, 2023

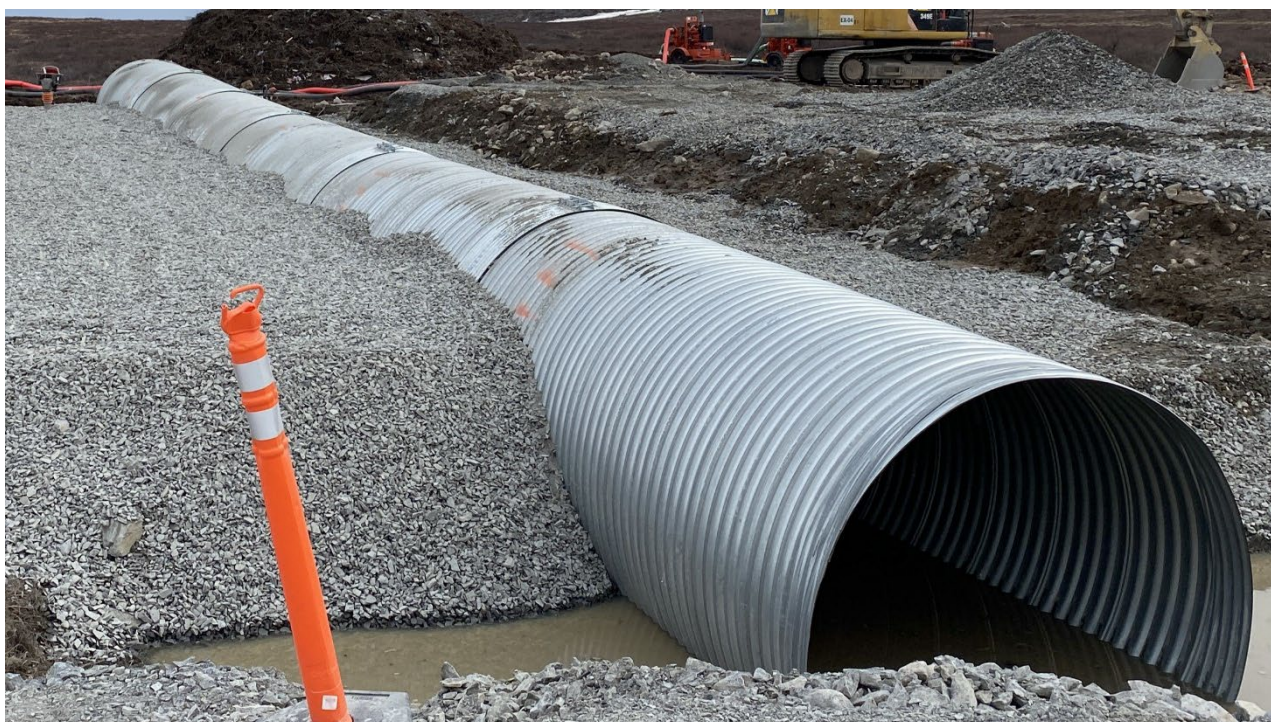
Photograph 23: Secondary Channel Culvert Looking Upstream from Downstream Apron, Taken September 17, 2023

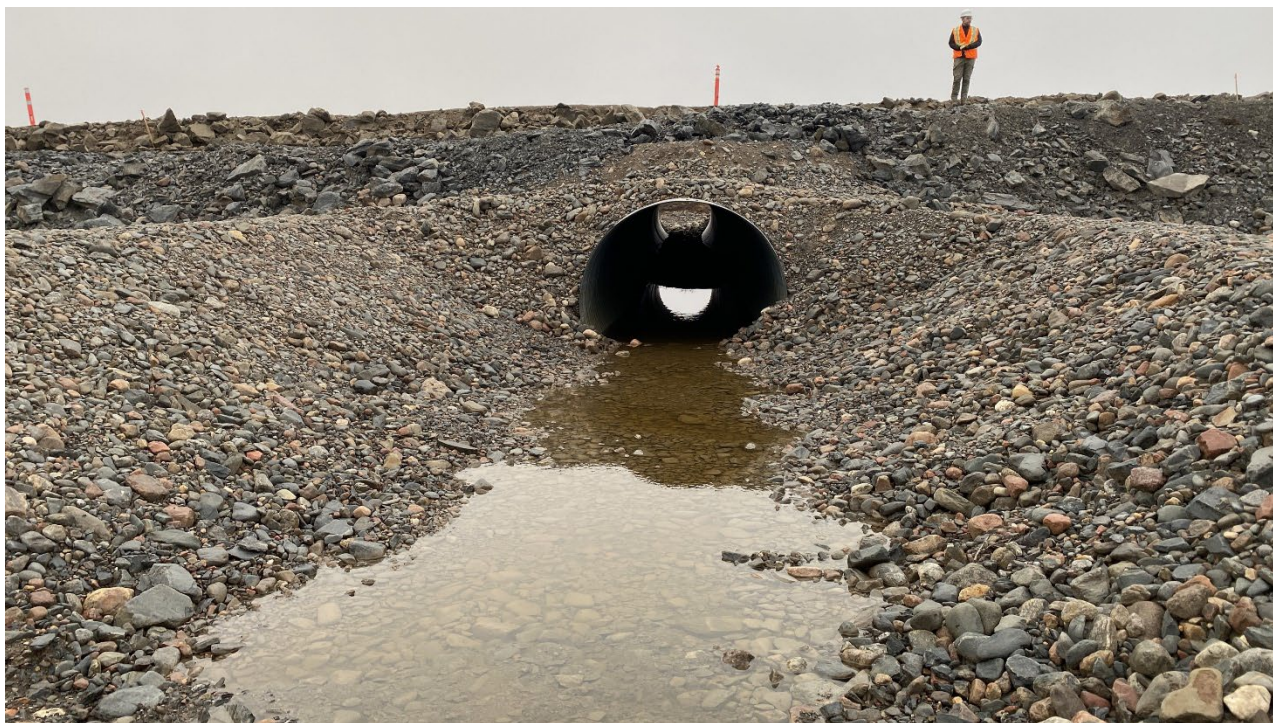
Photograph 24: Secondary Channel Culvert Looking Downstream from Upstream Apron, Taken September 17, 2023
