Attention **Merle Keefe, Environmental Permitting Manager for Sabina Gold and Silver**
Subject **Goose Project Site – 2021 Annual Geotechnical Inspection**
Project 1CS020.021

The 2021 AGI for the Goose site is the subject of this memorandum.

Attachment 3 Photolog from July 2021 Site Visit

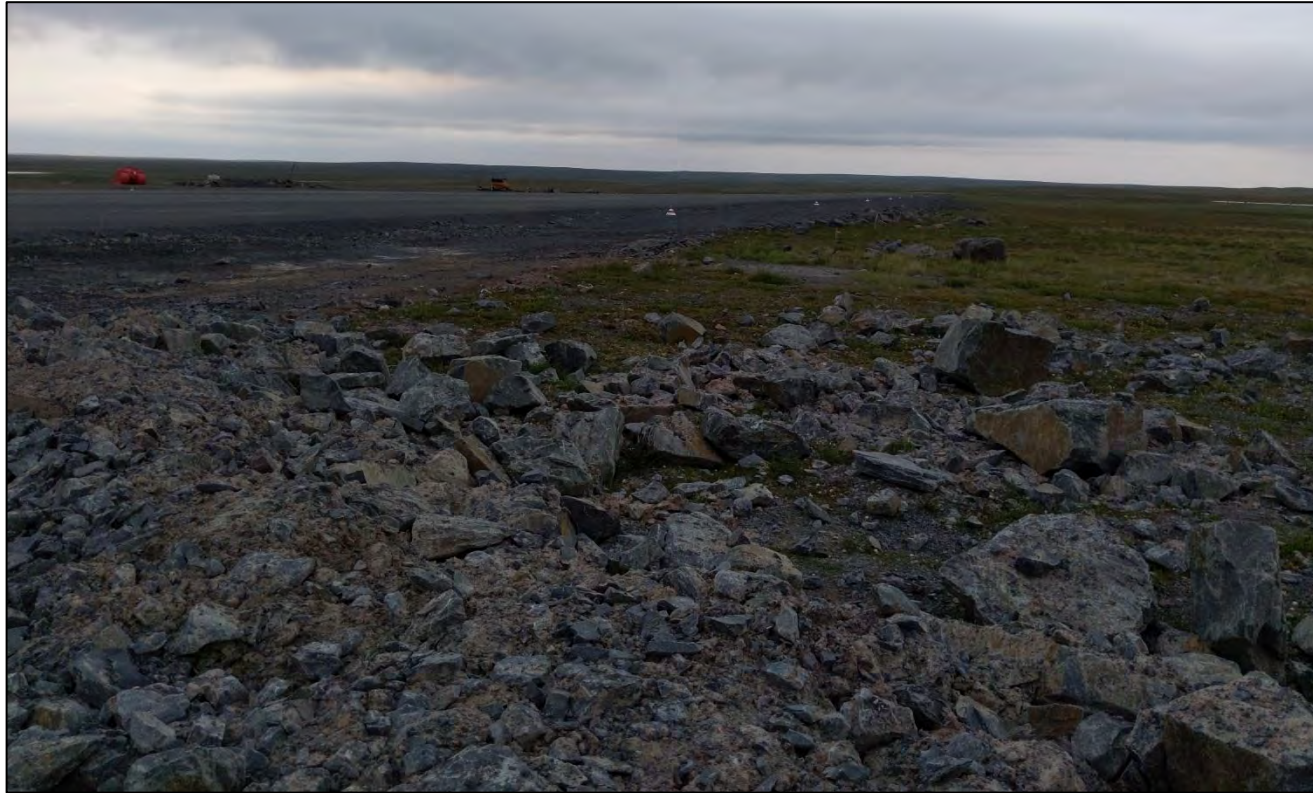
Photo 1 – view looking in southerly direction along airstrip

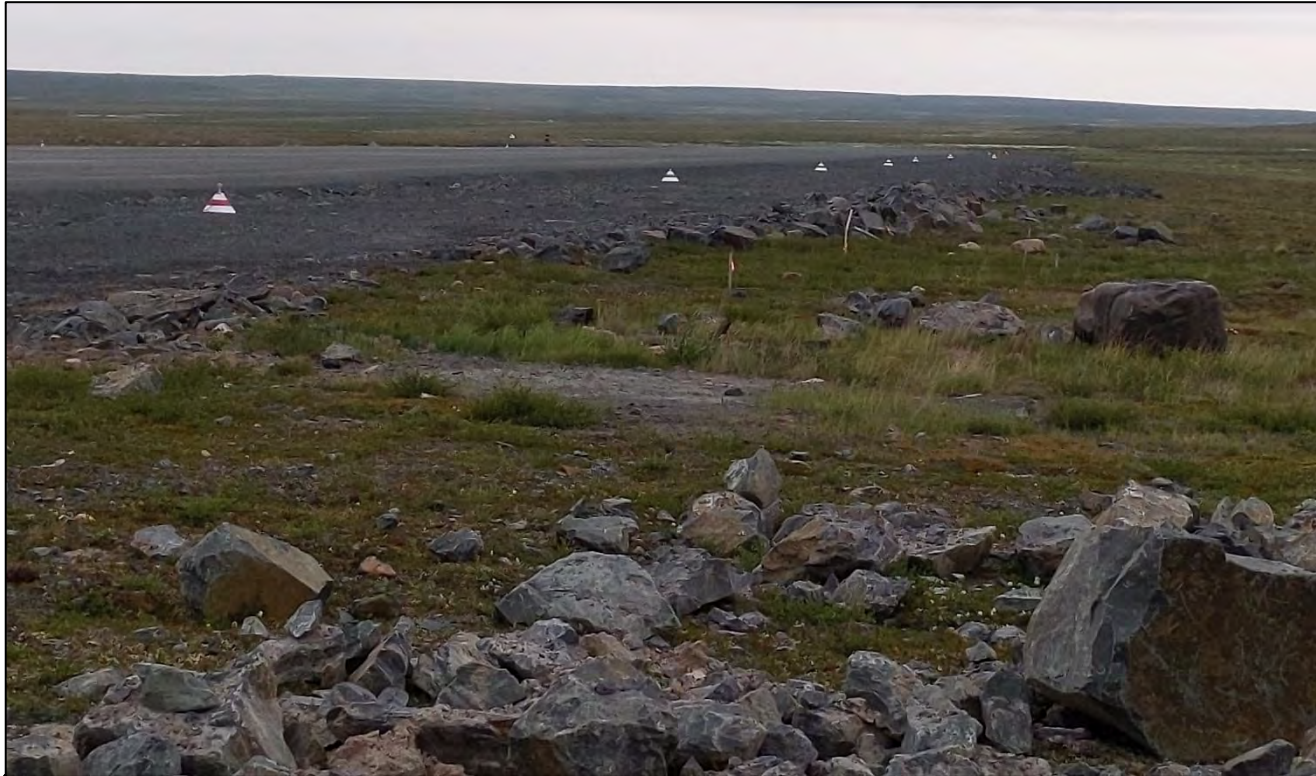
Photo 3 – View looking in southerly direction along airstrip

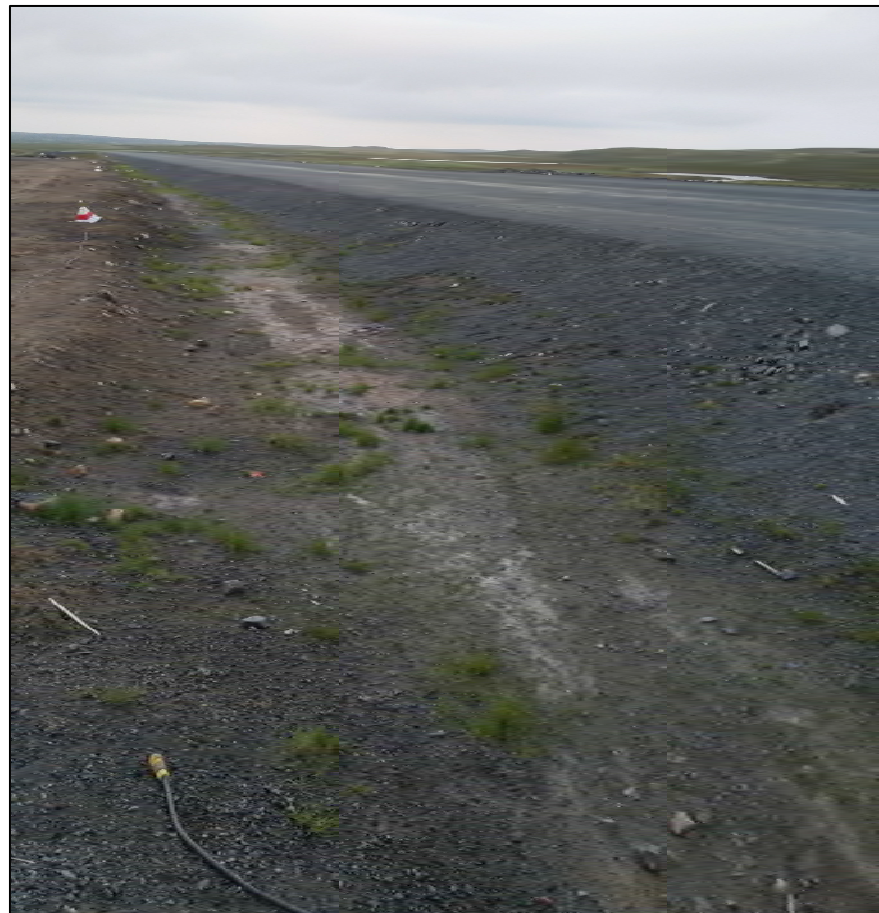
Photo 2 – View looking in southerly direction along airstrip, water management channel in place.

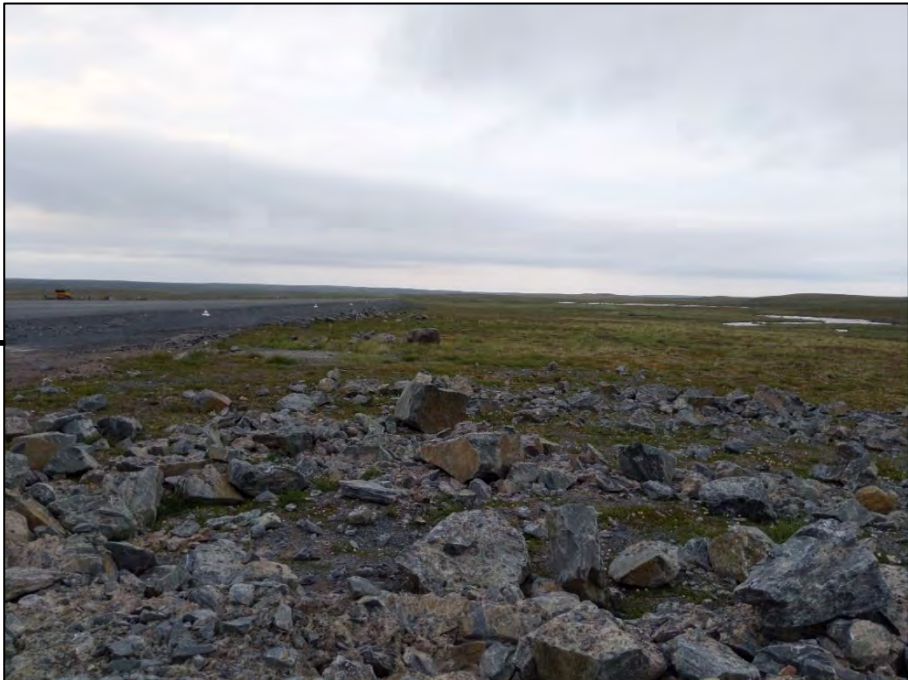
Photo 4 – view looking in southerly direction along airstrip. Note larger natural water bodies on right of photo. Water then flows towards airstrip

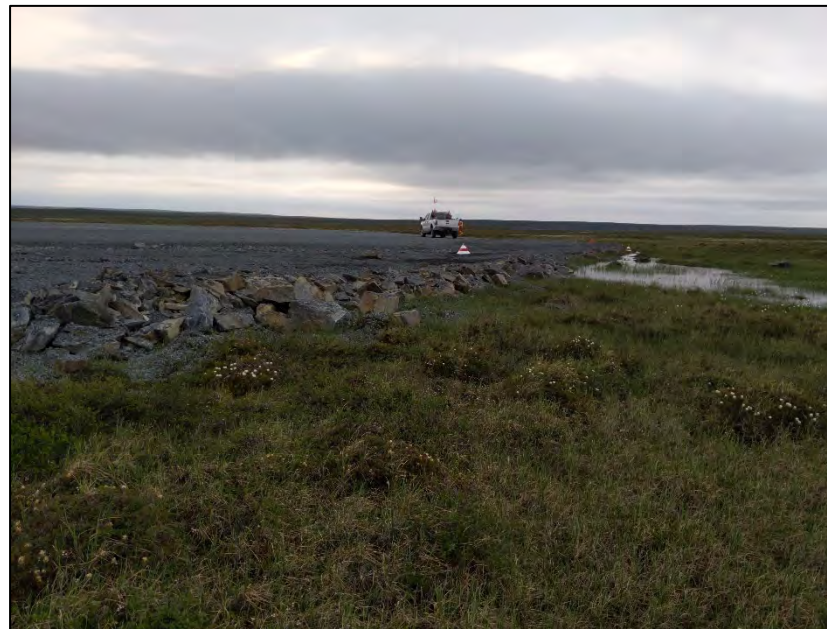
Photo 7 – view southeast of ponded water

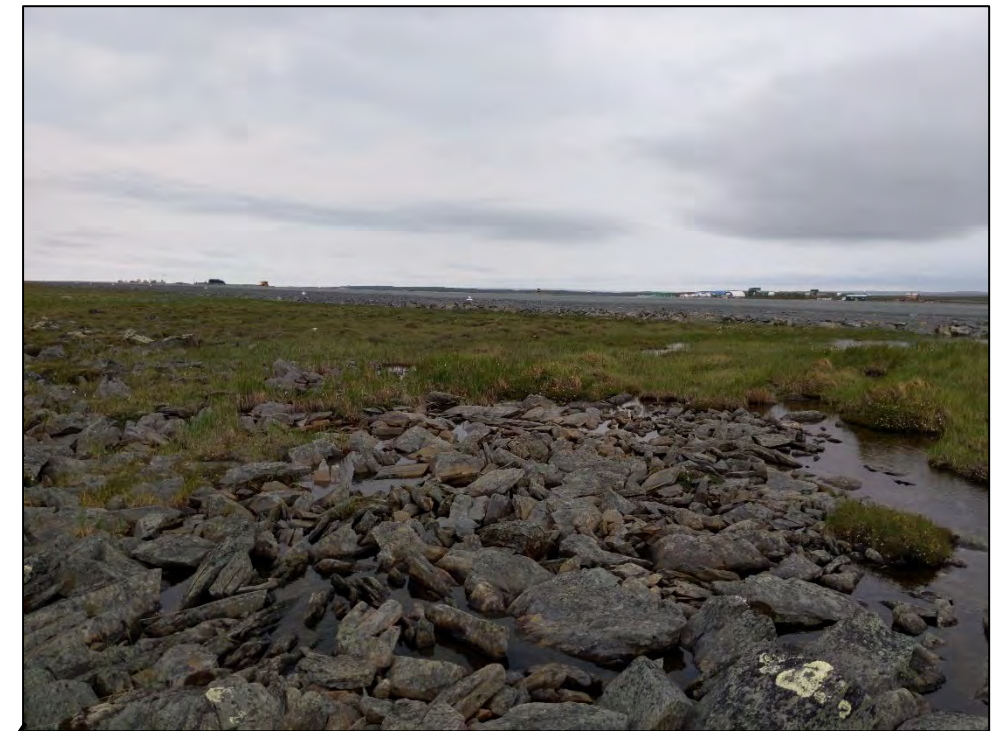
Photo 8 – water flow looking north, water travels towards airstrip and diverted to the southwest.

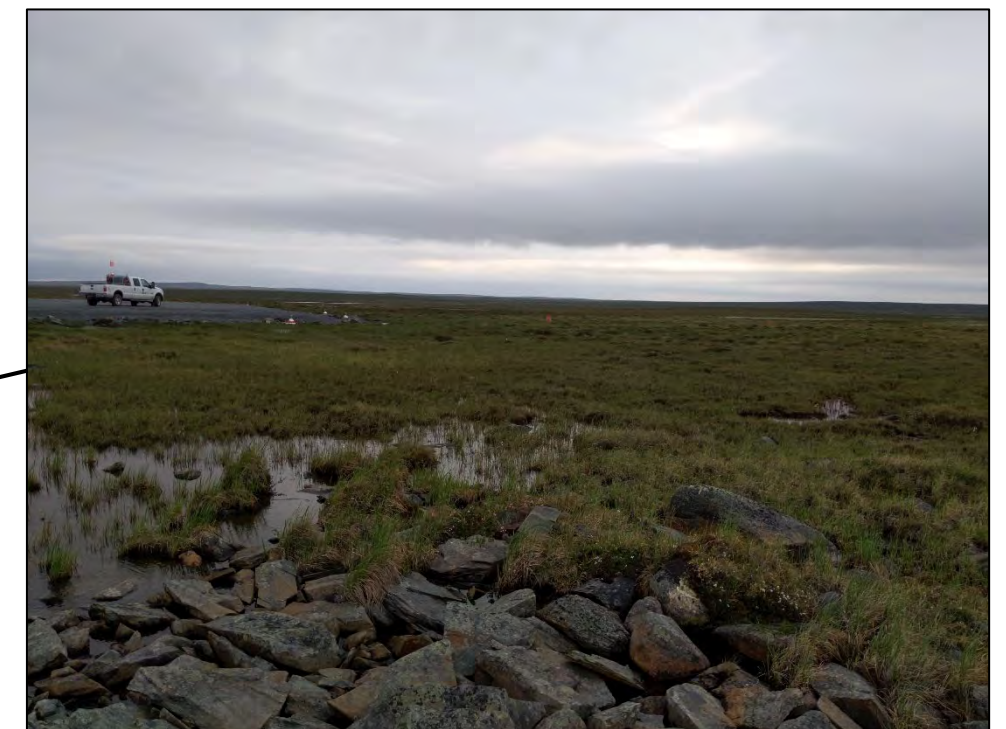
Photo 9 – Water ponded and flowing towards southeast

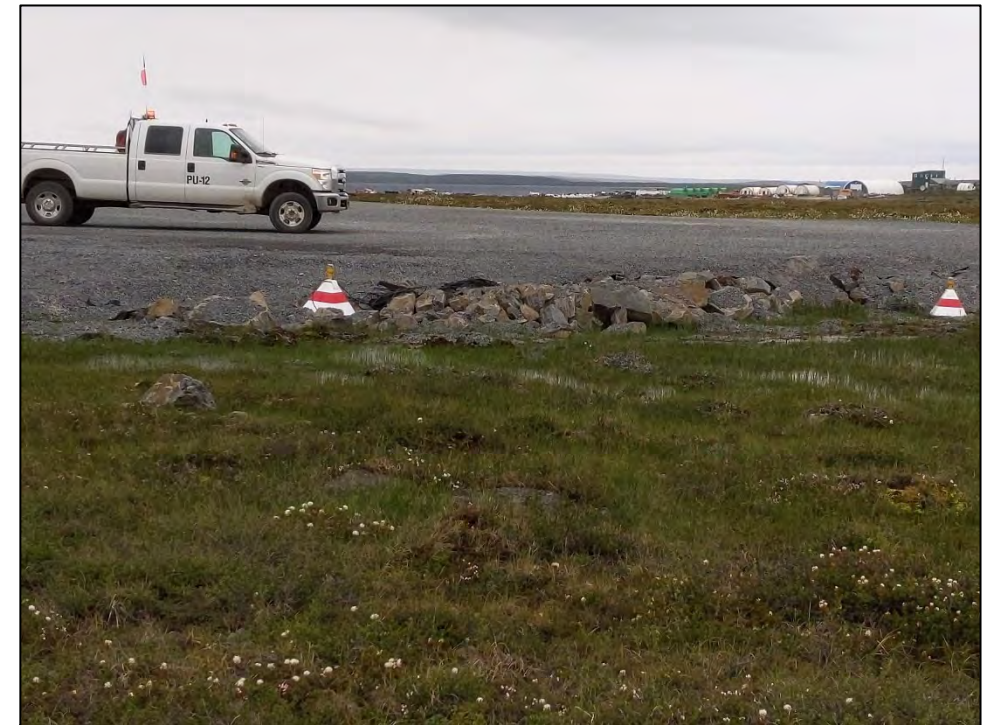
Photo 13 – Southern end of airstrip, note thin fill thickness

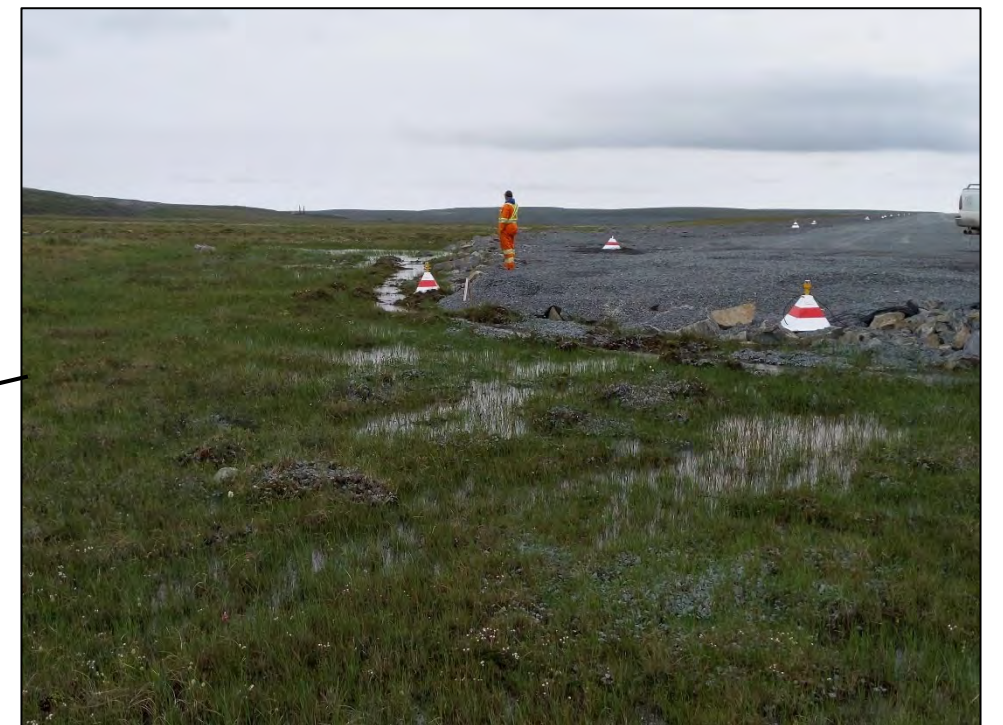
Photo 14 – Water ponding at southern point of airstrip, flow continues southeast

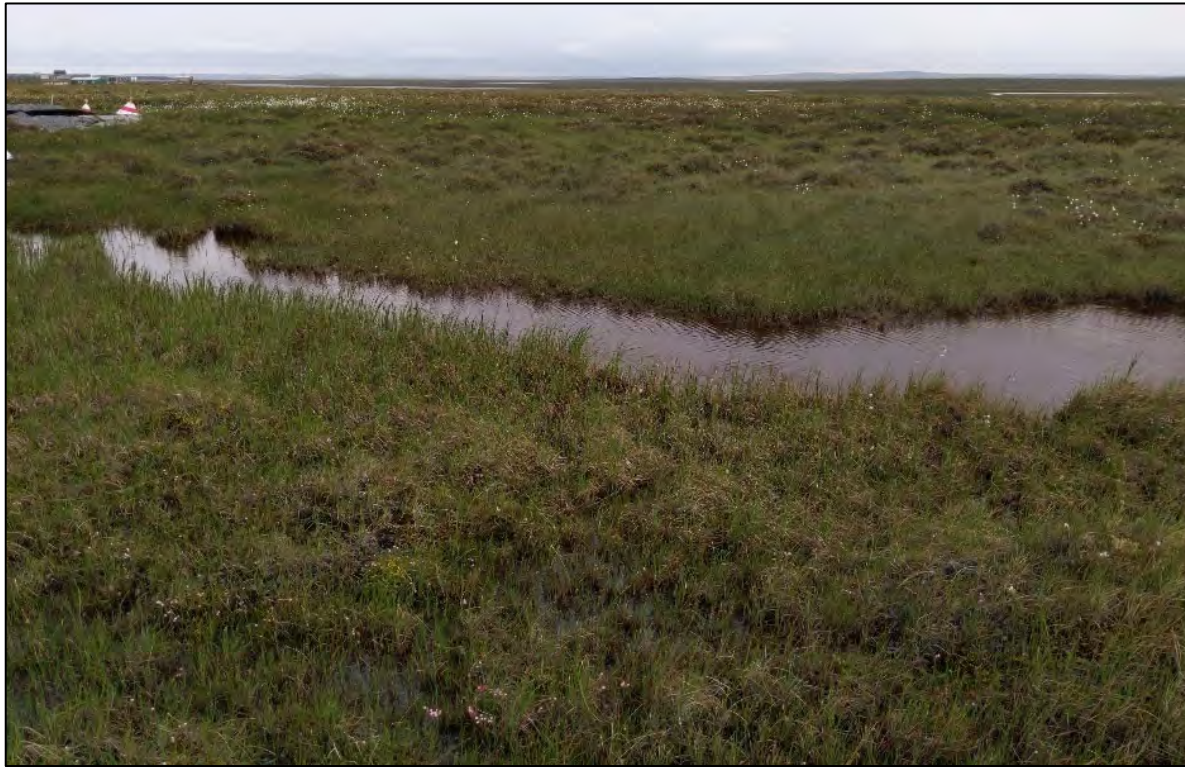
Photo 15 - Water flow away from the airstrip towards the southeast

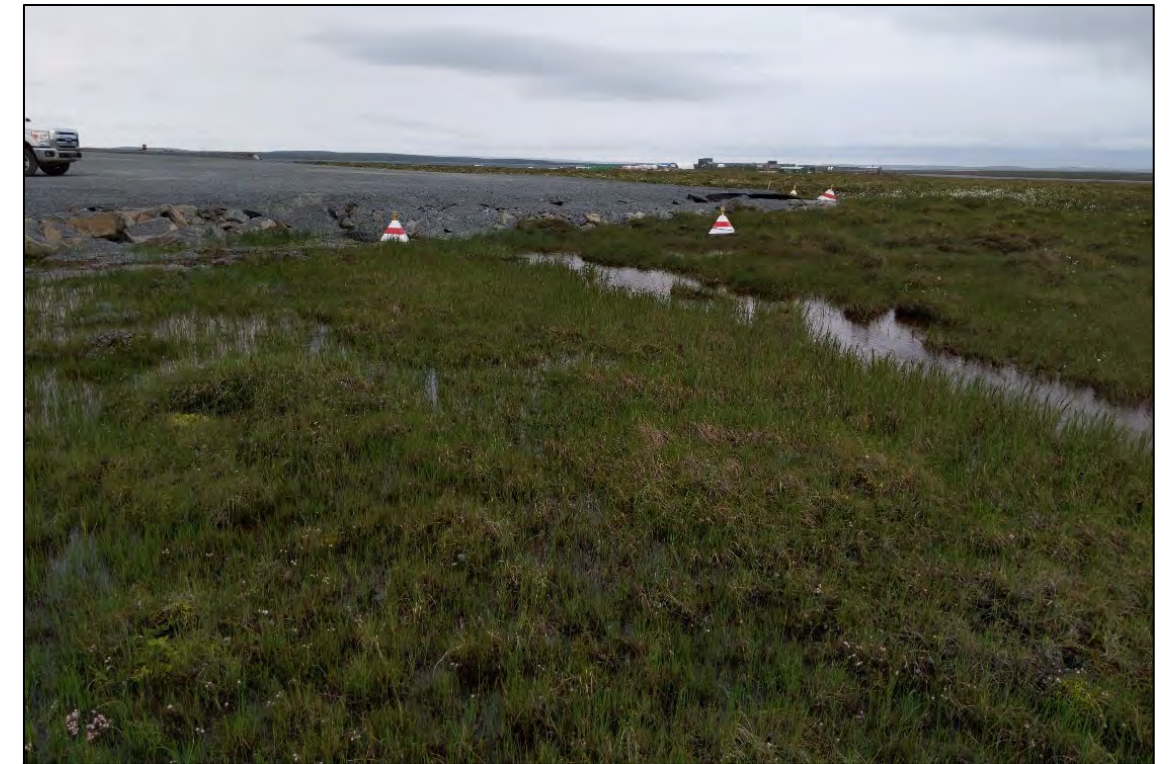
Photo 17 - Water flow away from the airstrip towards the southeast

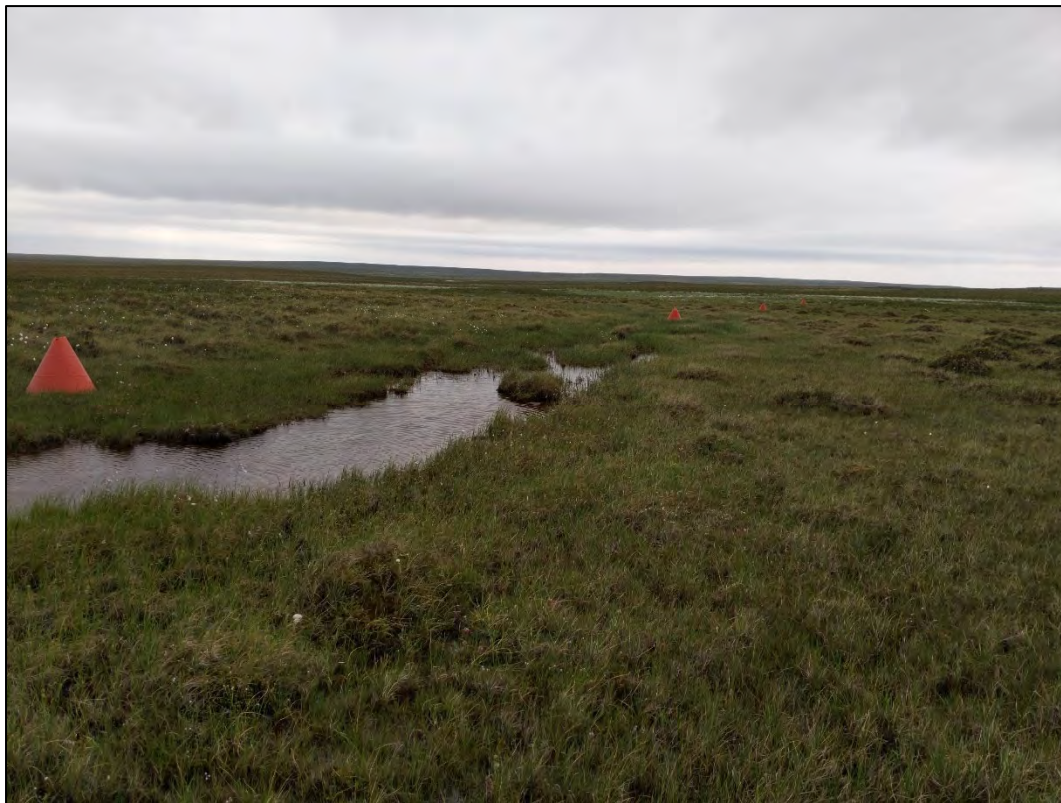
Photo 16 – Water flow away from the airstrip towards the southeast

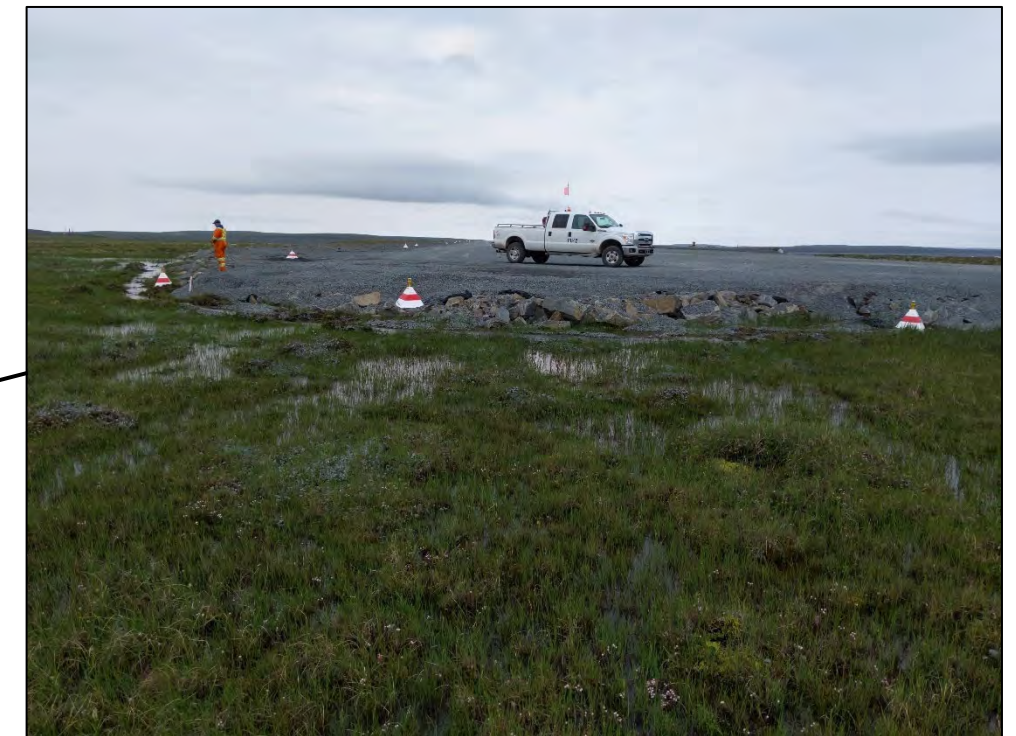
Photo 18 – water ponding at southern end of airstrip, also note think airstrip fill.

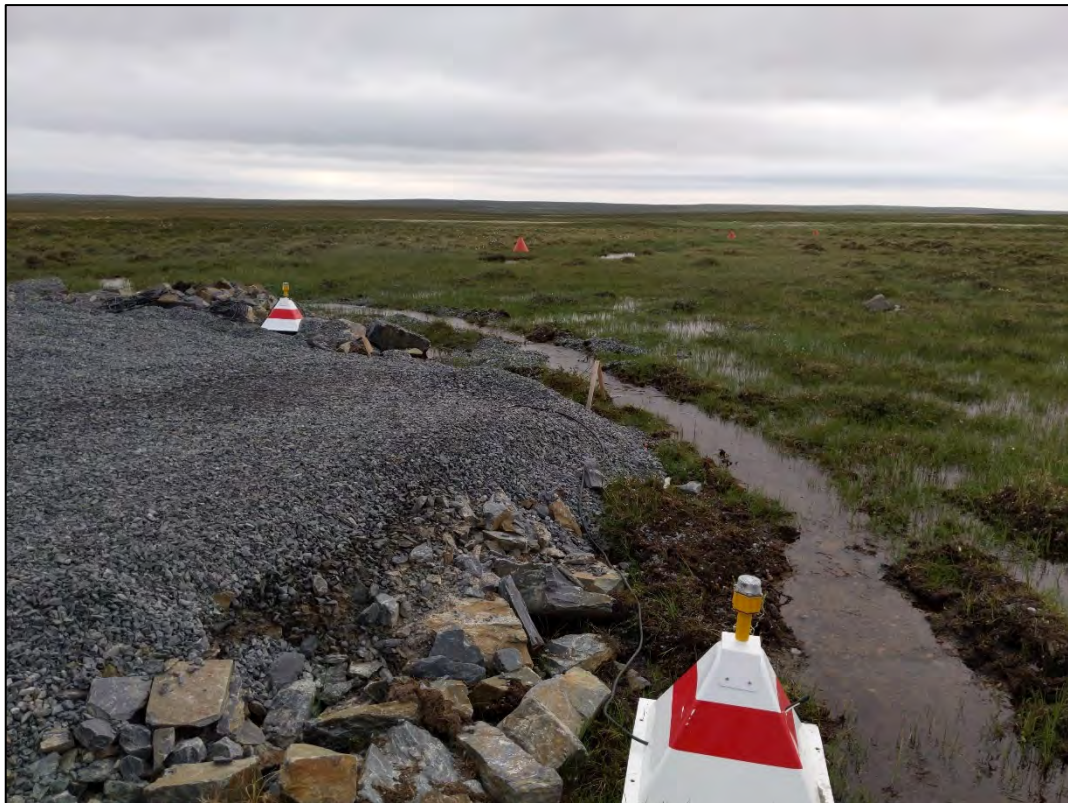
Photo 19 – water flow around airstrip towards southeast

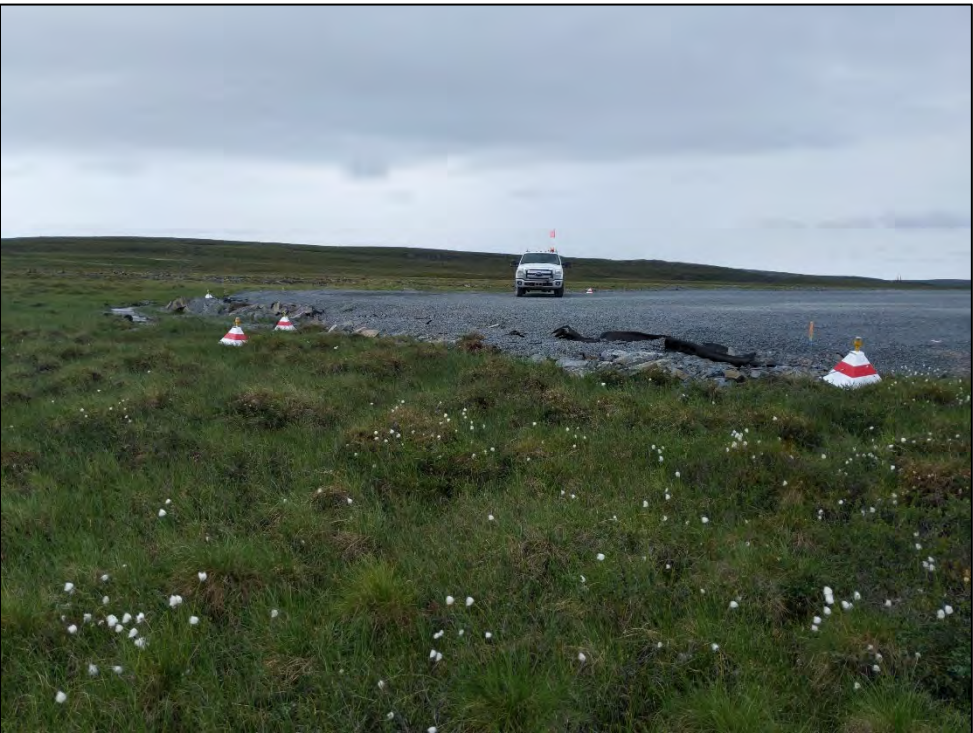
Photo 22 – southern end of airstrip, note thick airstrip fill thickness; geotextile exposed.

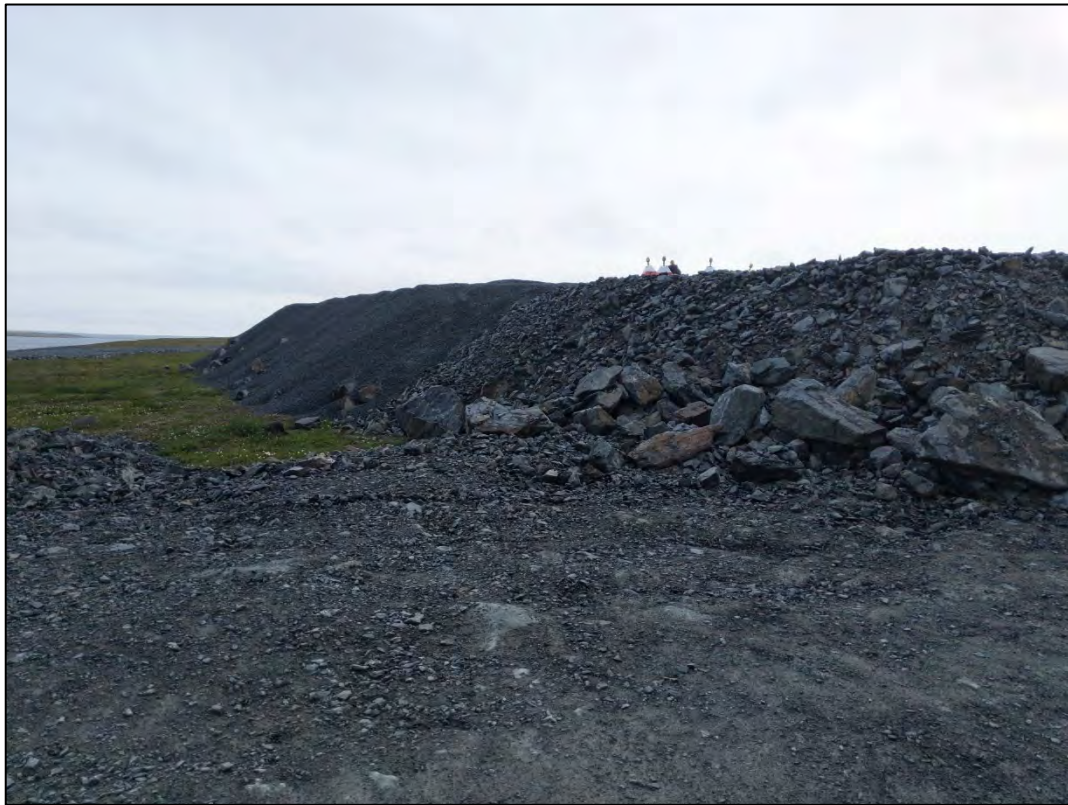
Photo 28 – Northern end of airstrip

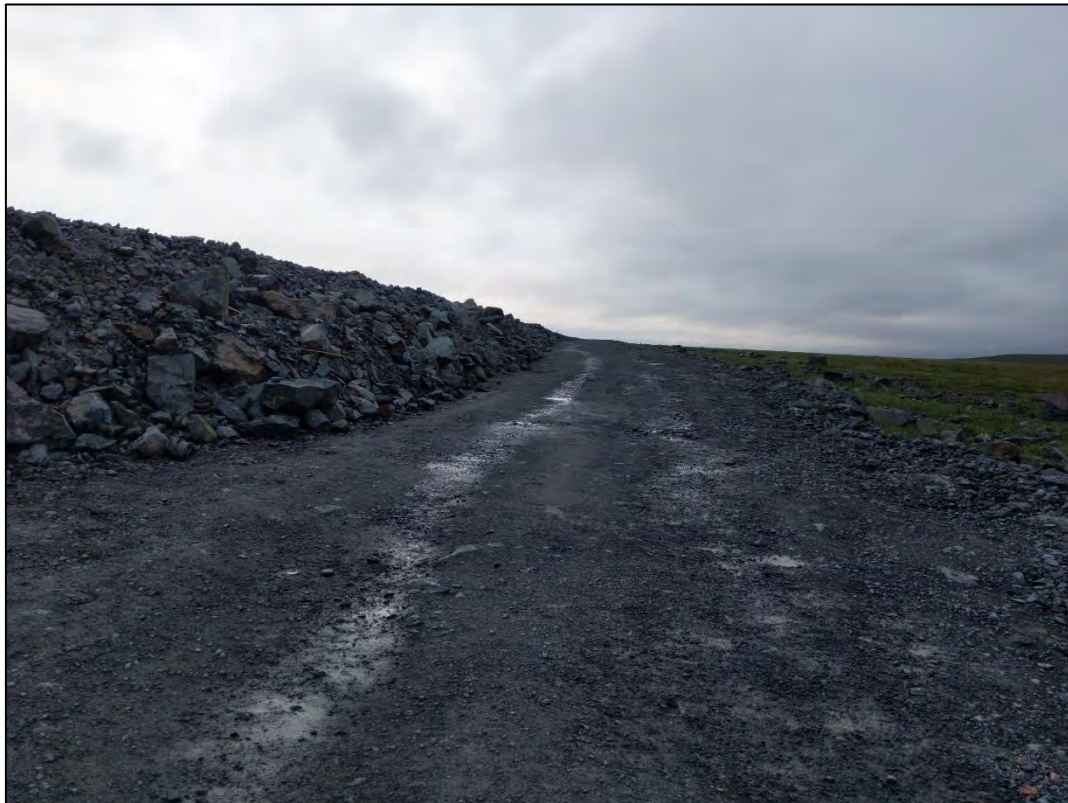
Photo 29 - Northern end of airstrip

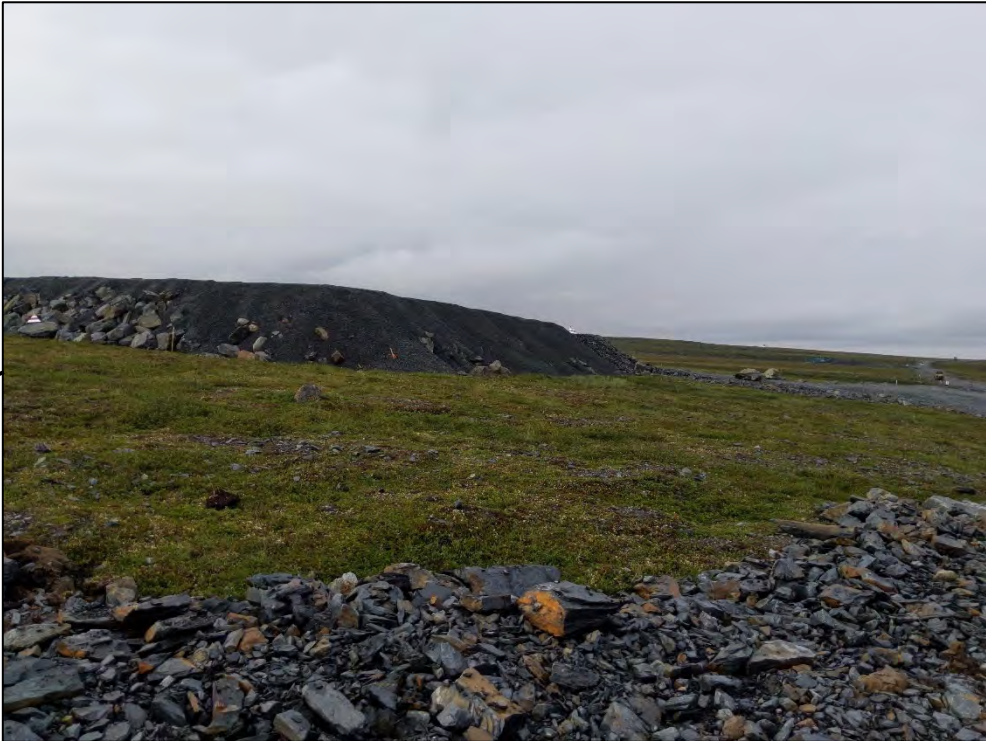
Photo 30 - Northern end of airstrip

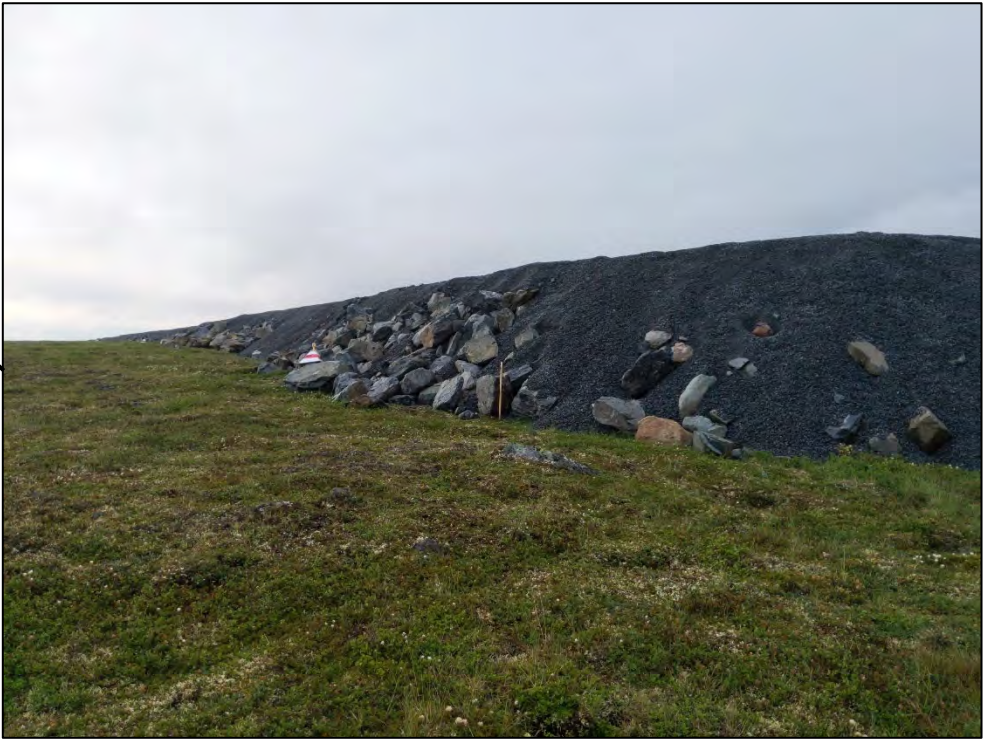
Photo 40 - Northern end of airstrip

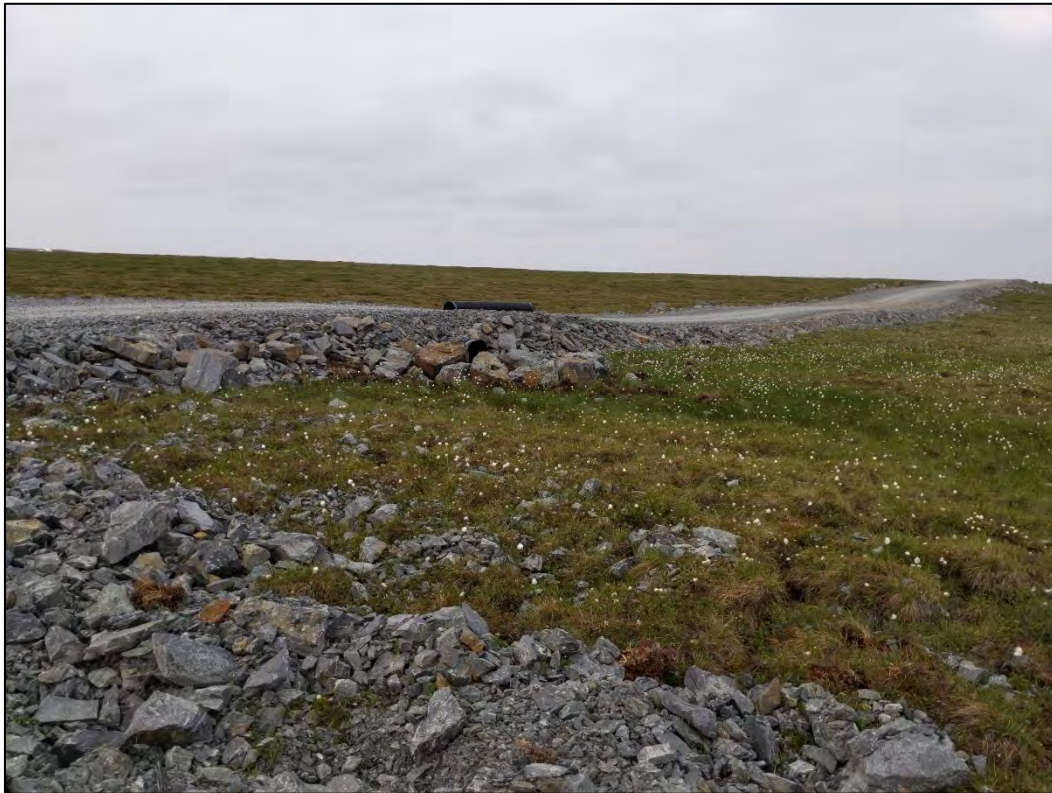
Photo 1 – Outlet, note rocks placed to dissipate water energy at culvert outlet.

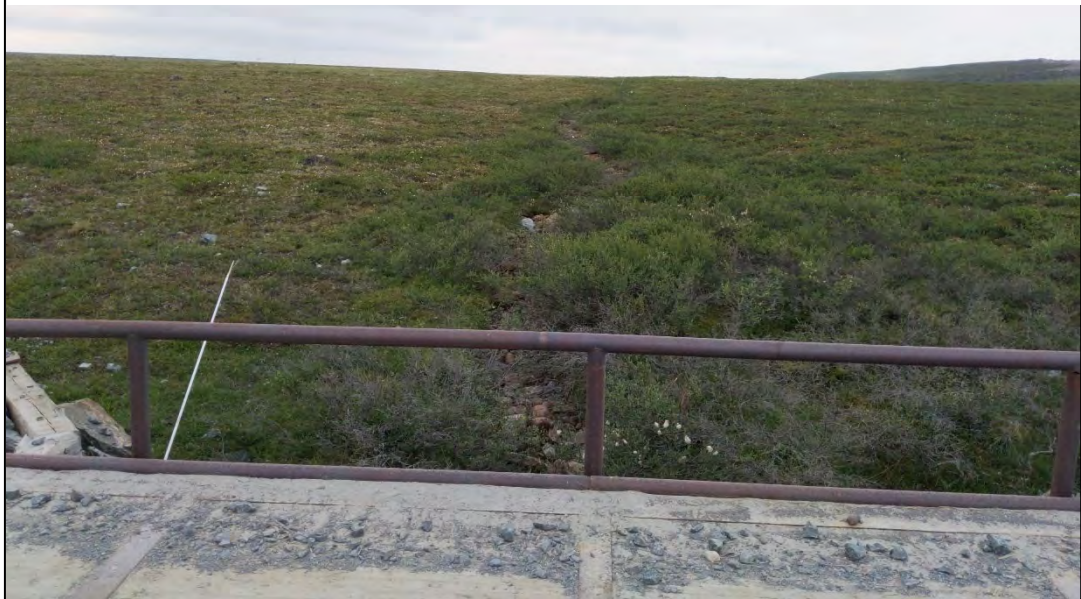
Photo 5 - Inlet

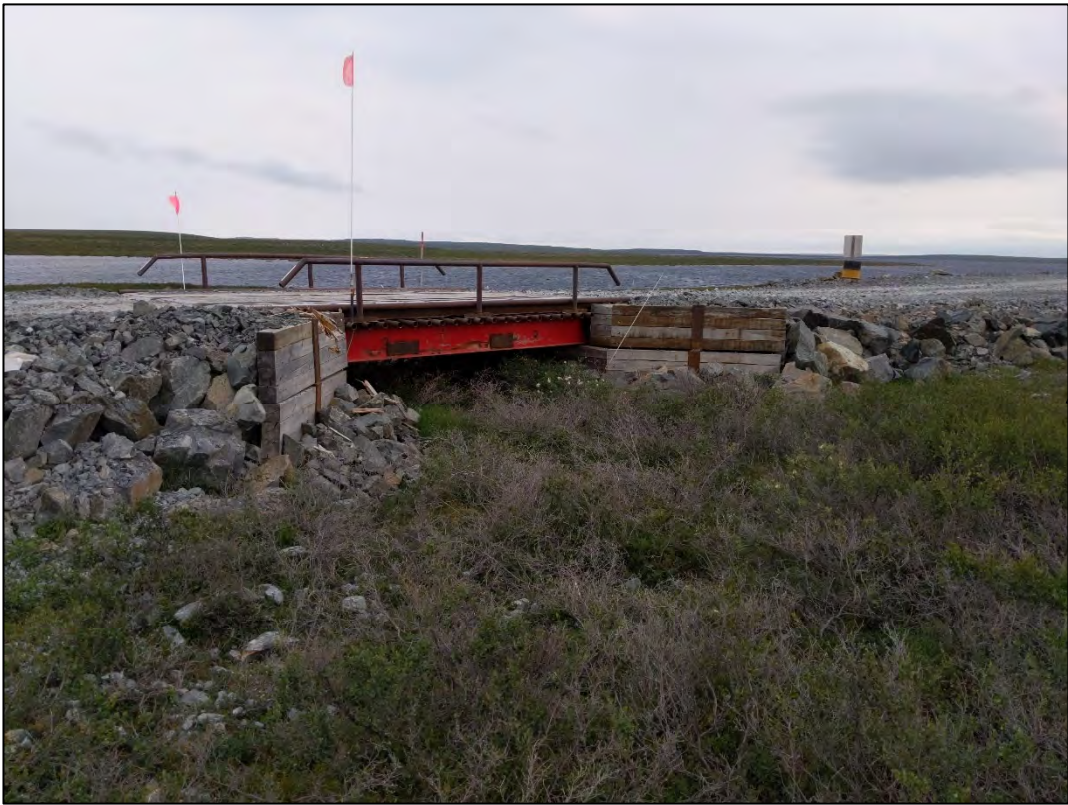
Photo 6 - Outlet

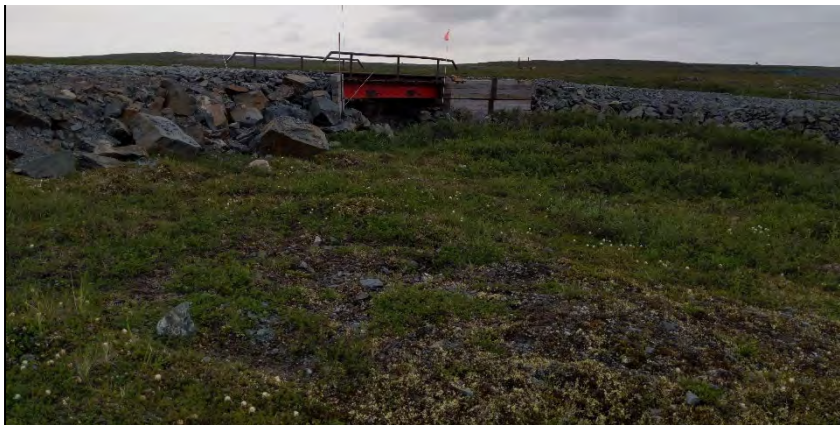
Photo 7 - Outlet

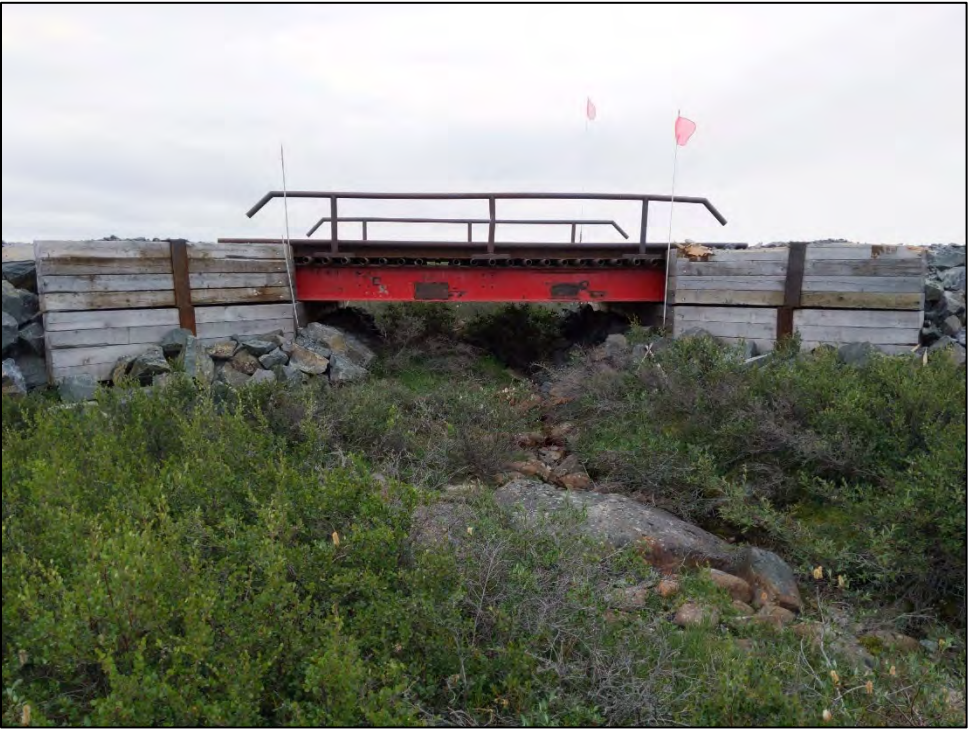
Photo 9 - Outlet

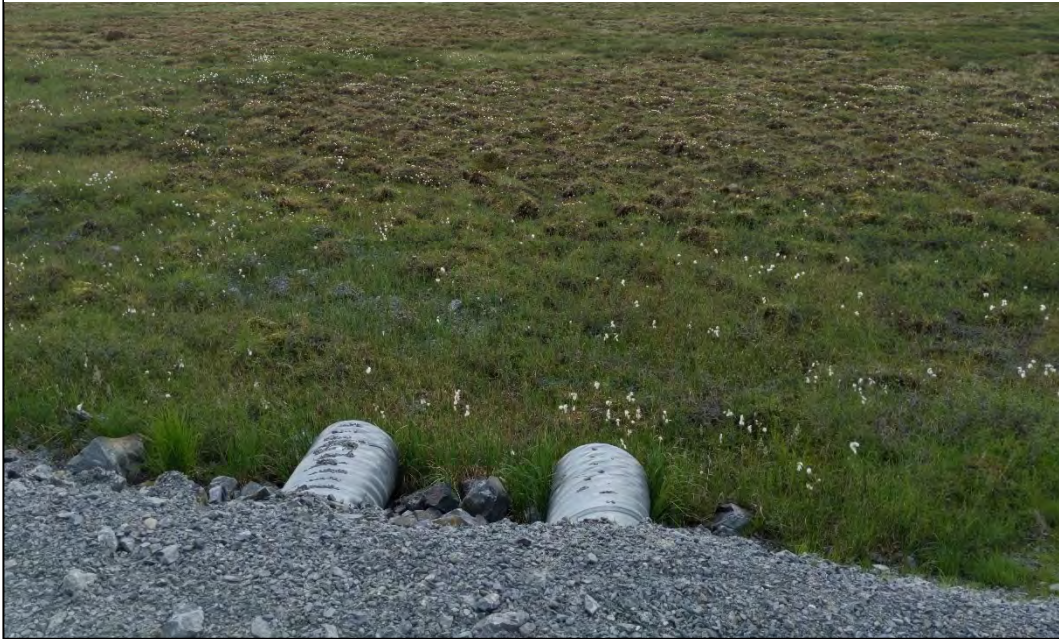
Photo 18 – Culvert invert at outlet below tundra surface

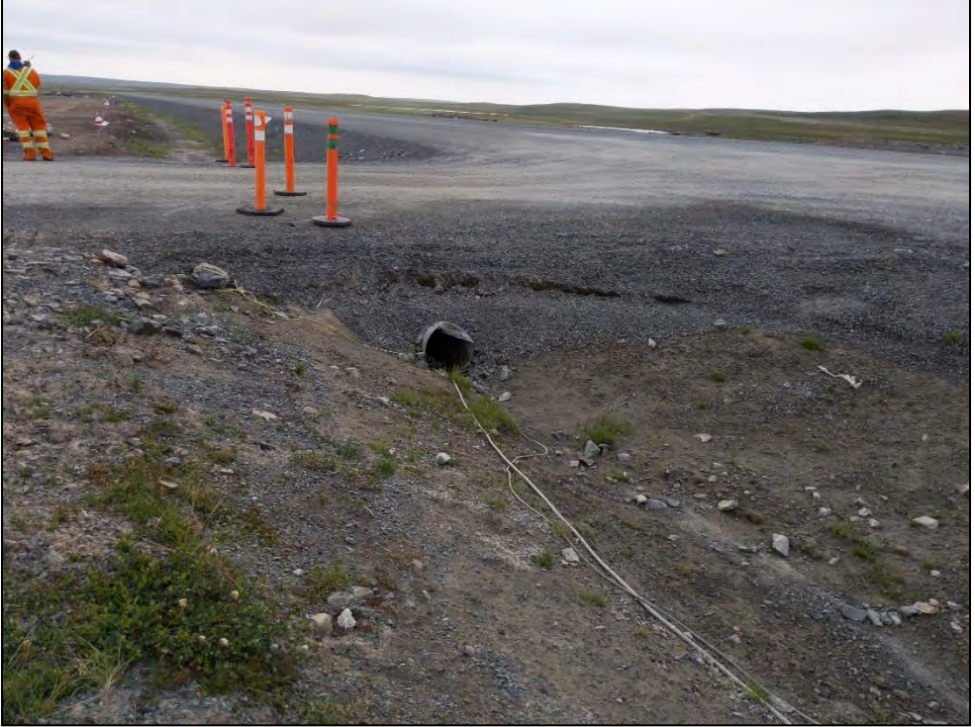
Photo 21 – Culvert along airstrip channel along northern edge

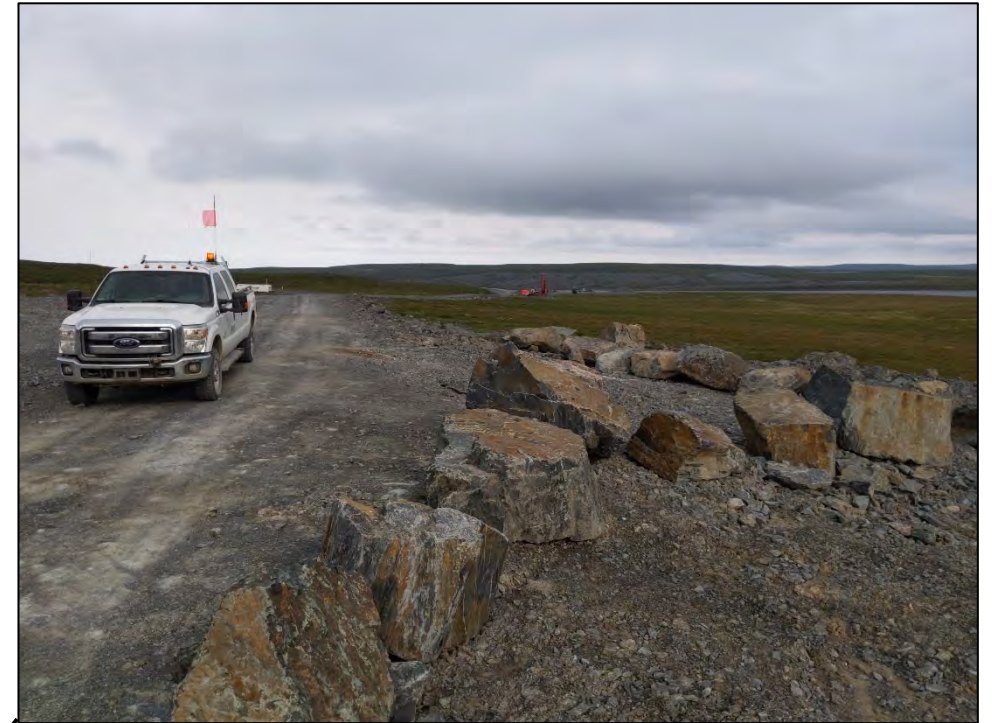
Photo 4 – Boulders blocking vehicle access

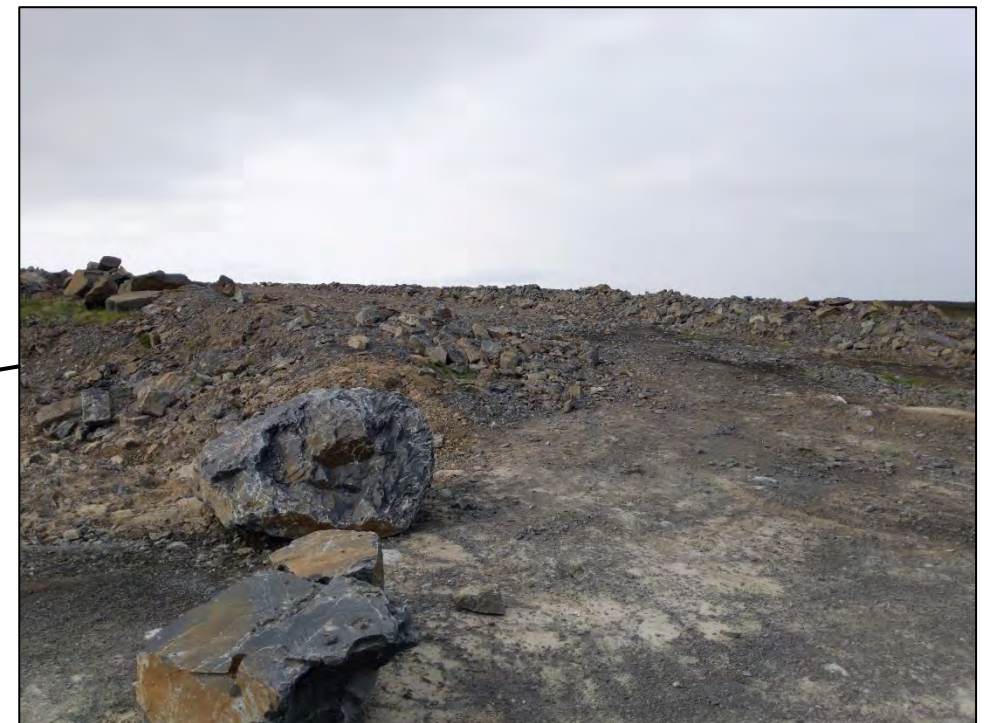
Photo 5 – no signage prohibiting access by foot

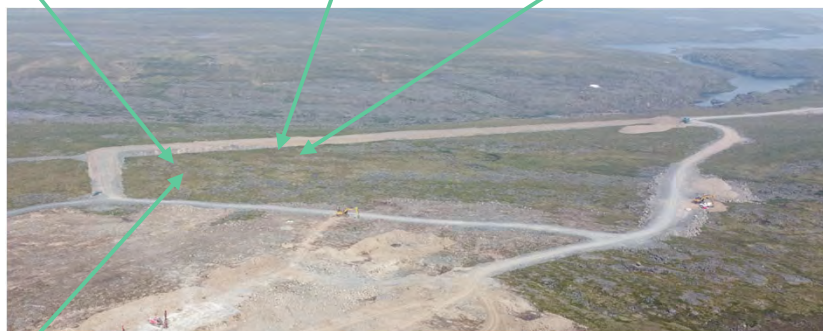
Photo 9 – Some ponded water observed within footprint

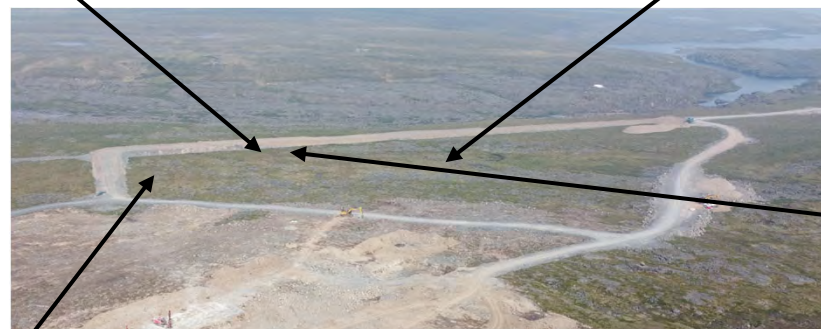
Photo 12 – Some ponded water observed within footprint

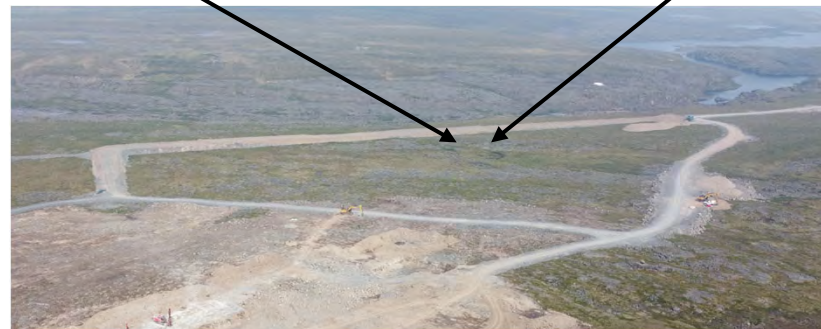
Photo 27 – Highly fractured rock outcrop extending through planned embankment area
