Attention **Merle Keefe, Environmental Permitting Manager for Sabina Gold and Silver**
Subject **Goose Project Site – 2021 Annual Geotechnical Inspection**
Project 1CS020.021

The 2021 AGI for the Goose site is the subject of this memorandum.

Attachment 3 Photolog from July 2021 Site Visit

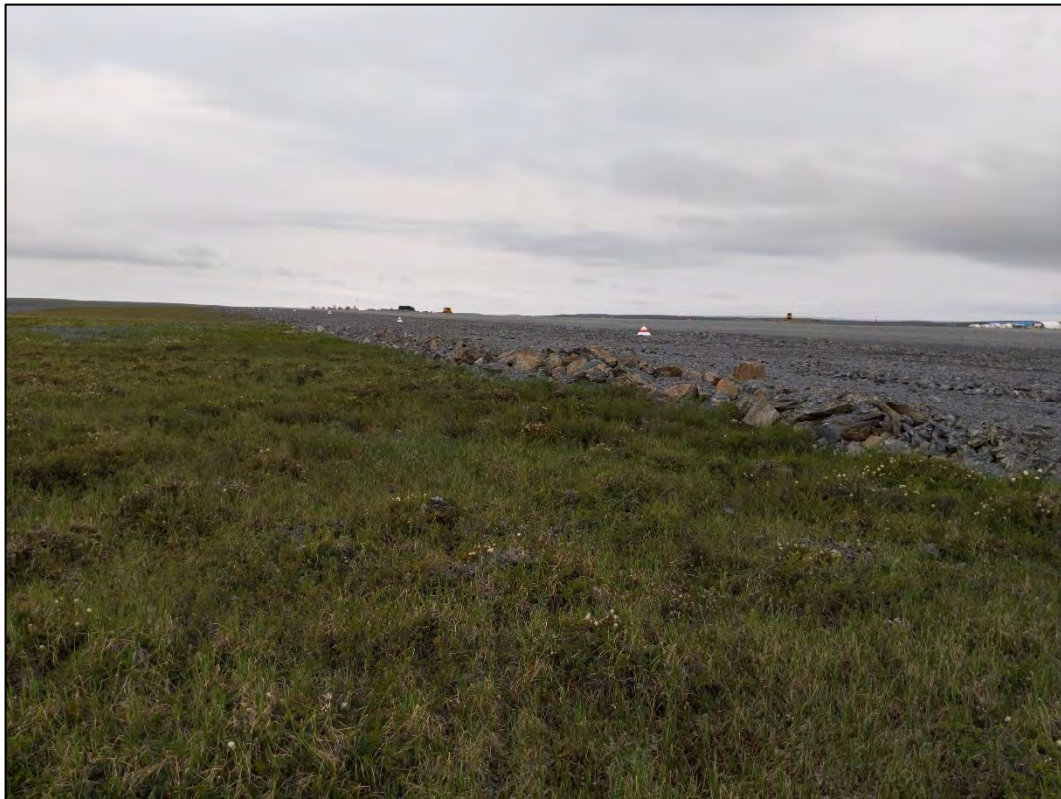
Photo 4 – view looking in southerly direction along airstrip. Note larger natural water bodies on right of photo. Water then flows towards airstrip

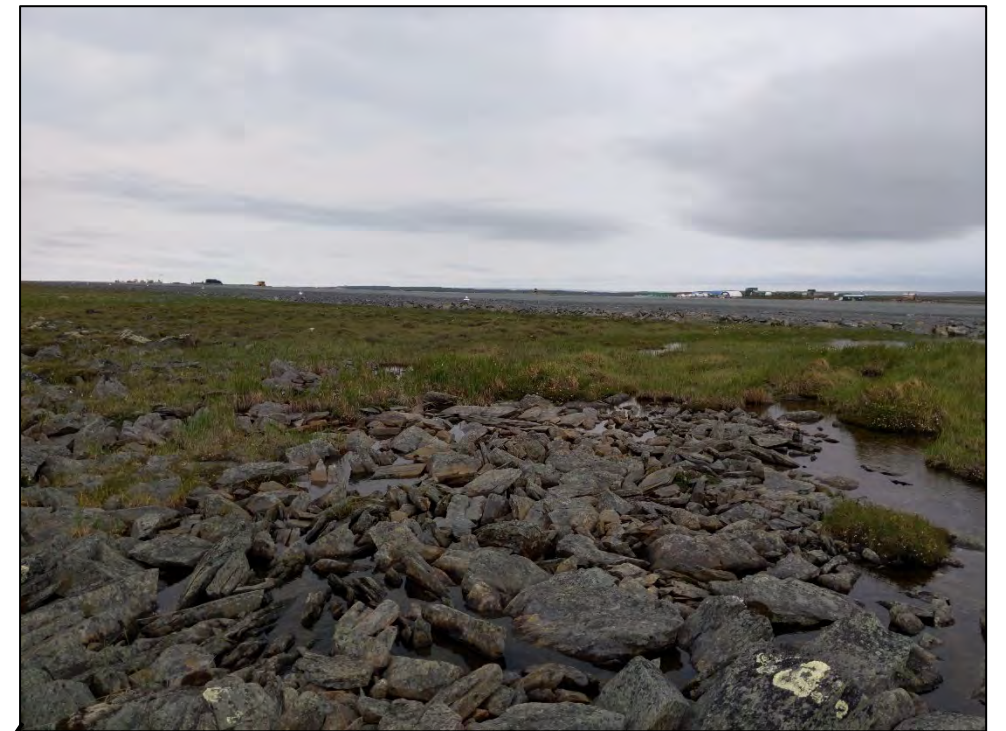
Photo 7 – view southeast of ponded water

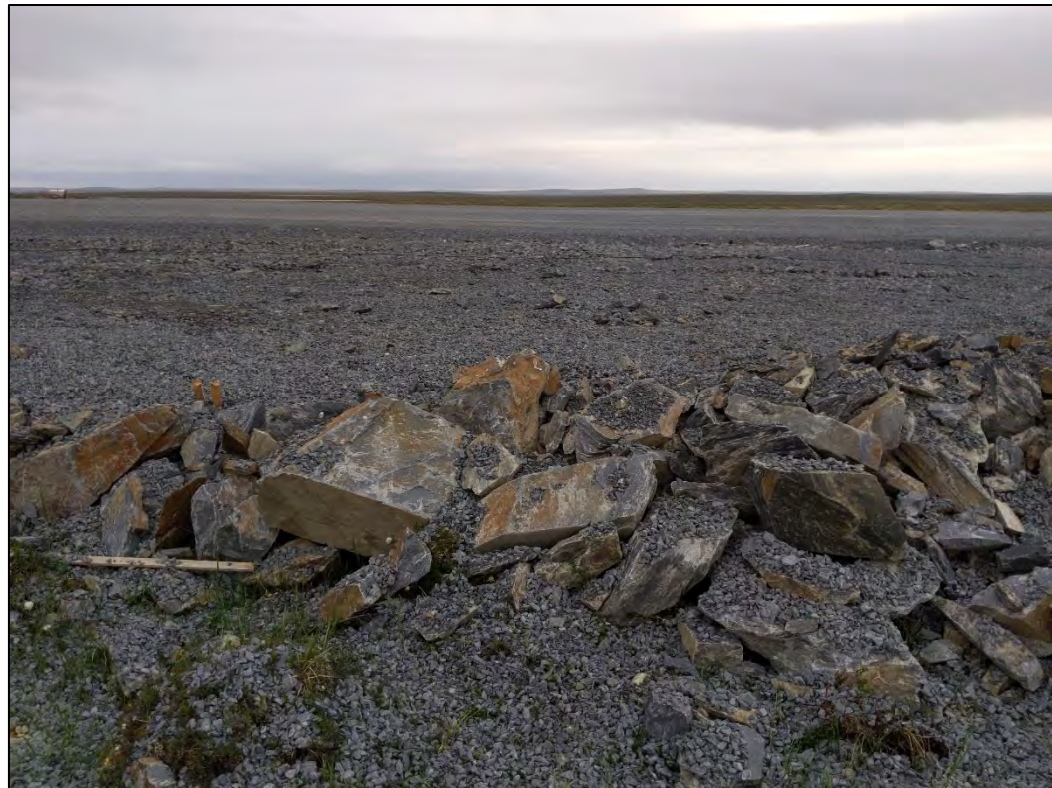
Photo 8 – water flow looking north, water travels towards airstrip and diverted to the southwest.

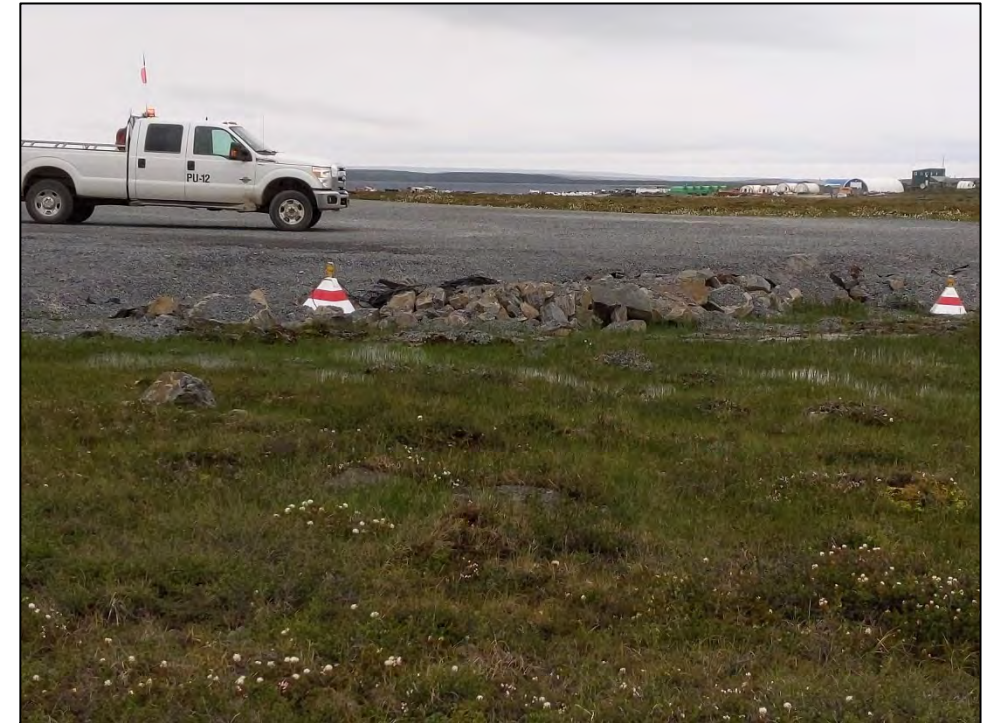
Photo 13 – Southern end of airstrip, note thin fill thickness

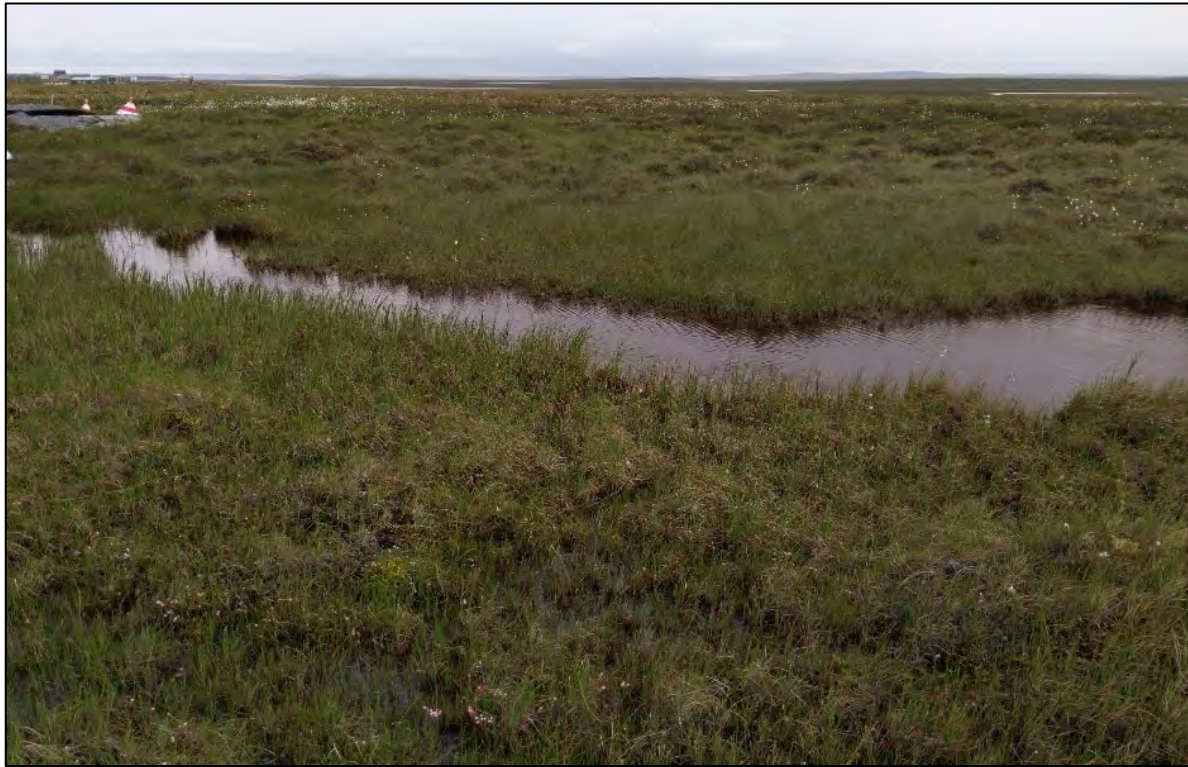
Photo 15 - Water flow away from the airstrip towards the southeast

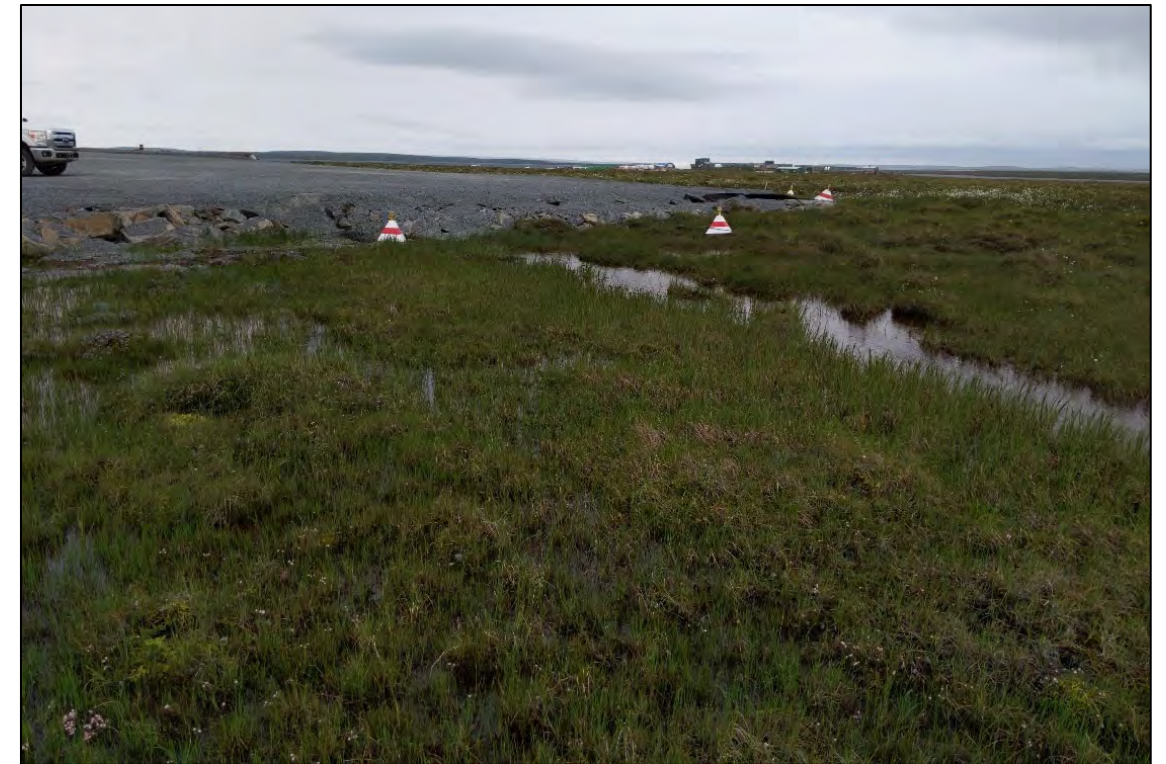
Photo 17 - Water flow away from the airstrip towards the southeast

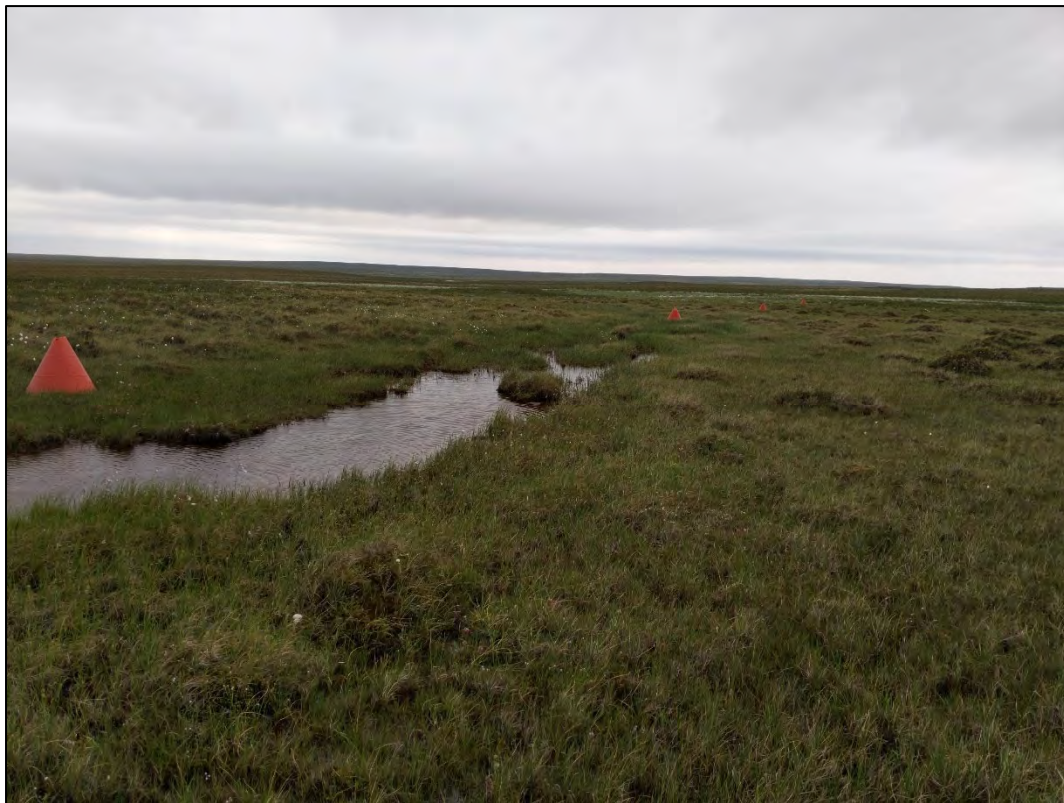
Photo 16 – Water flow away from the airstrip towards the southeast

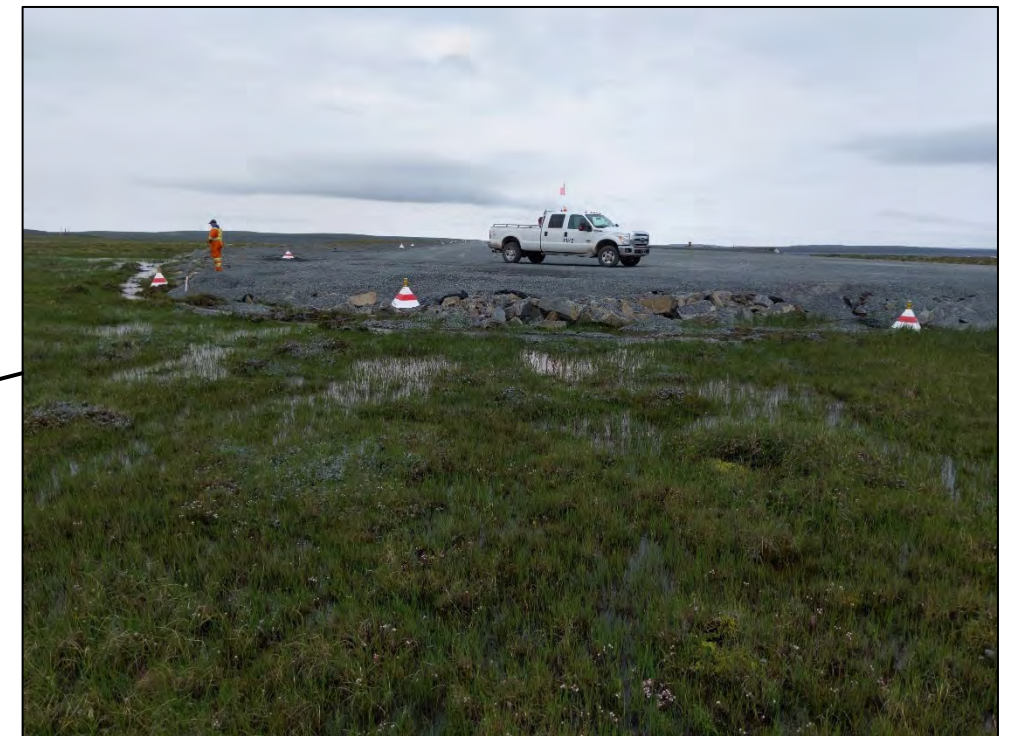
Photo 18 – water ponding at southern end of airstrip, also note think airstrip fill.

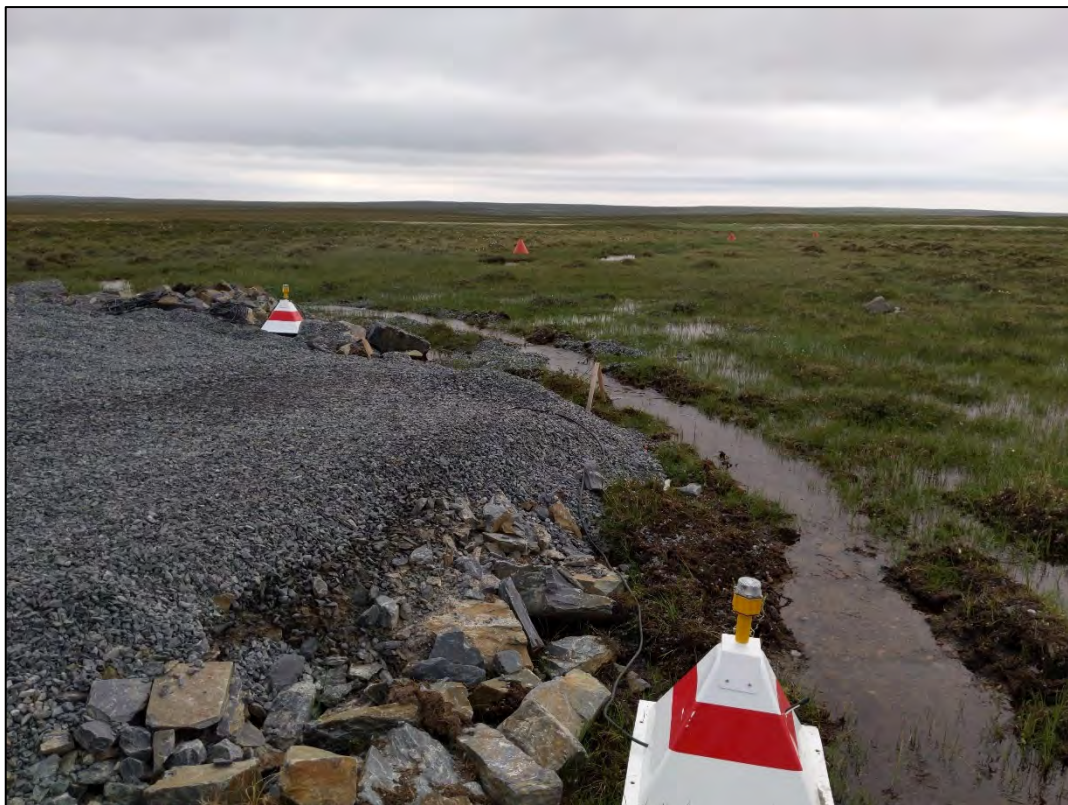
Photo 19 – water flow around airstrip towards southeast

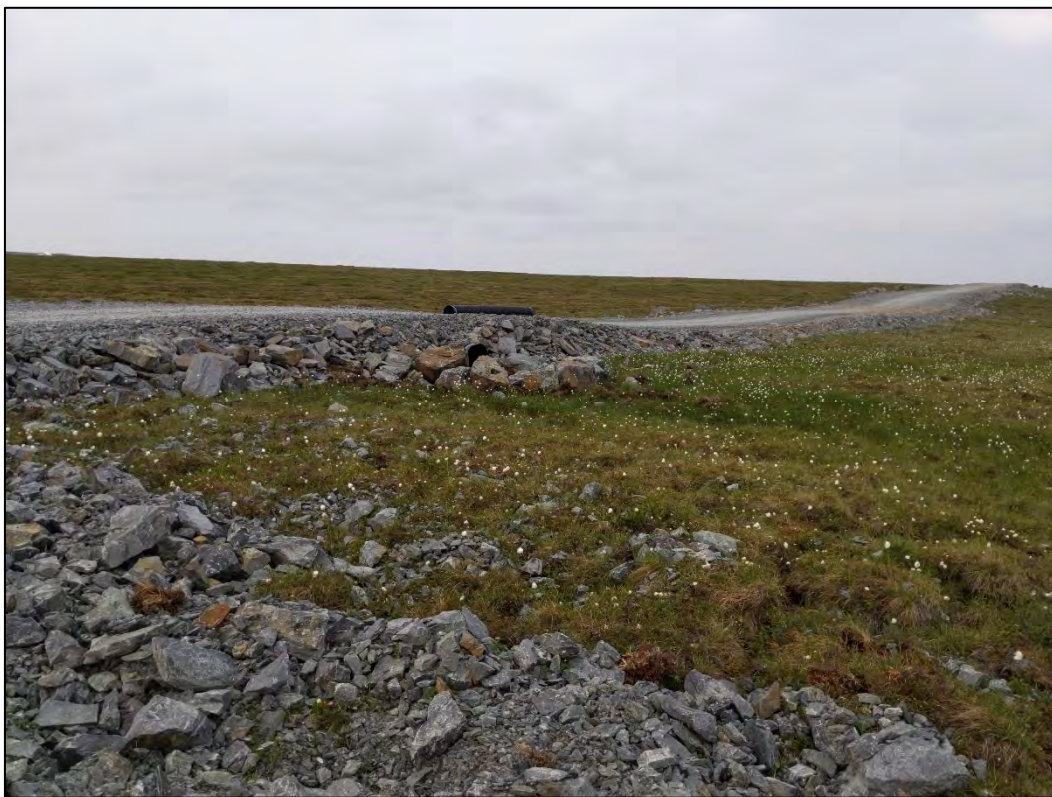
Photo 1 – Outlet, note rocks placed to dissipate water energy at culvert outlet.

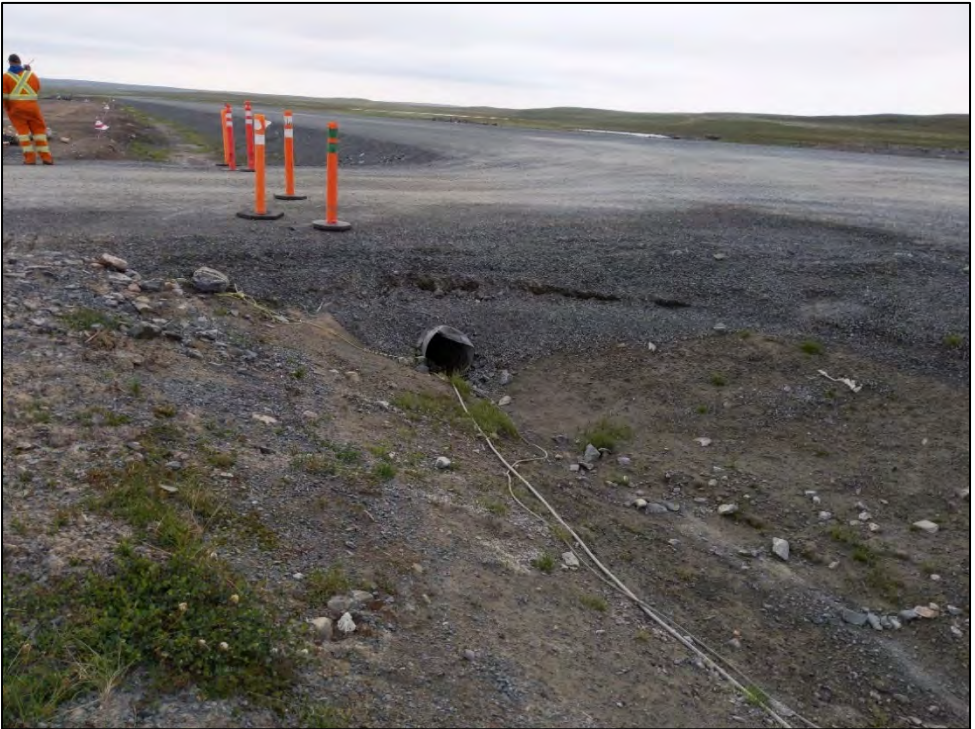
Photo 21 – Culvert along airstrip channel along northern edge

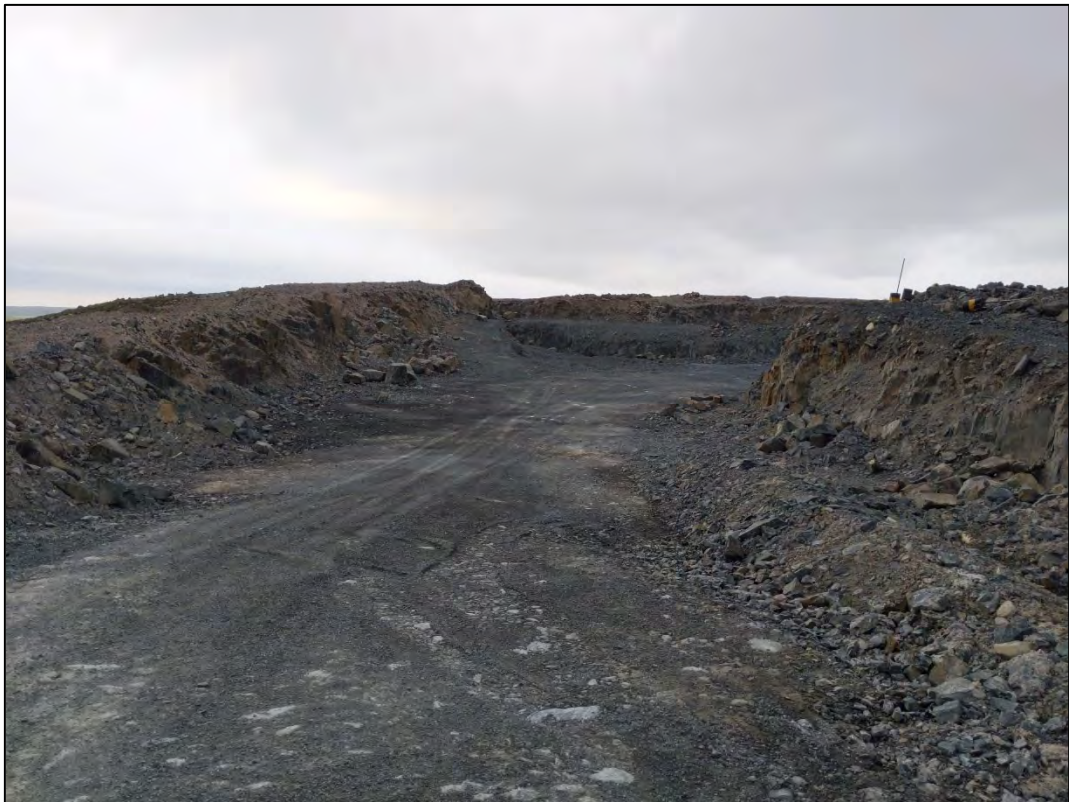
Photo 4 – Boulders blocking vehicle access

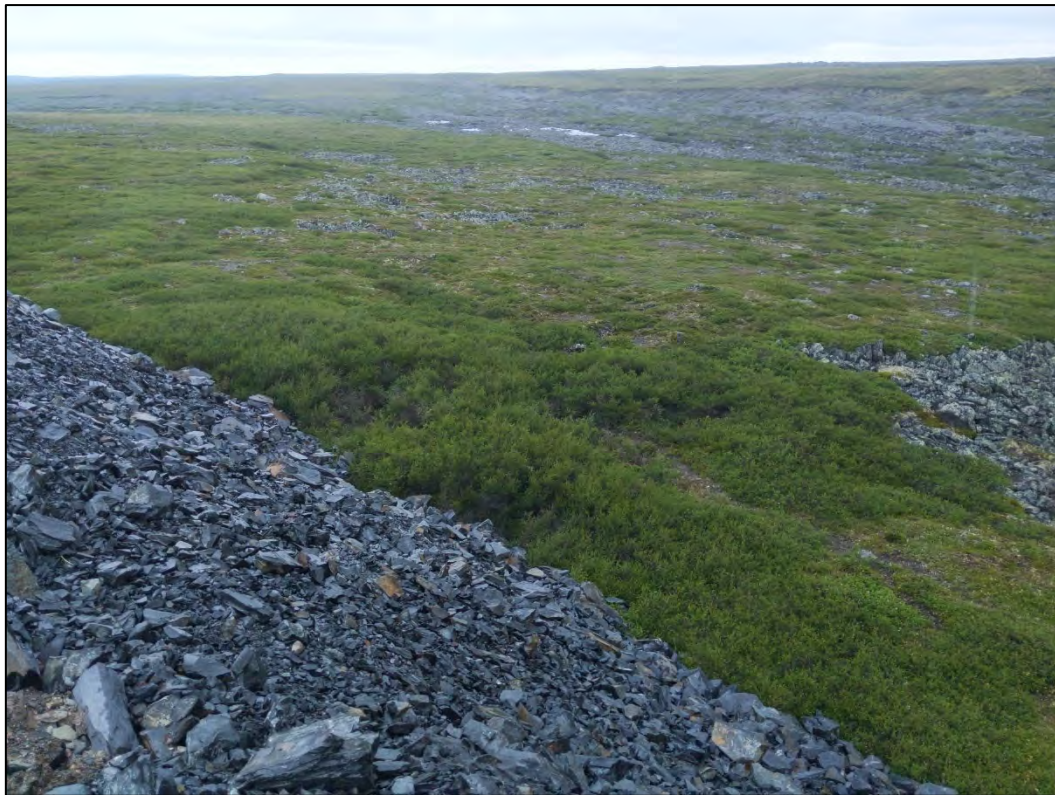
Photo 17 – View downstream from road
