Appendix G: Photo Record

North Dam As-Built Report		
		Overview of Dam Construction Activities		
Job No: 1CH008.058.430 Filename: Figure 1_Overview_1CH008.058.pptx	Hope Bay Mining Limited	Date: May 2012	Approved: JBK	Figure: 1

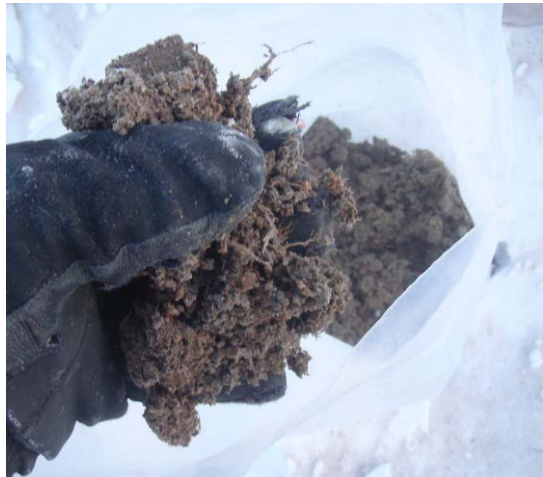
Example of organic rich soil (peat) encountered at ~1.5 m depth in percolation hole P04 January 24, 2011

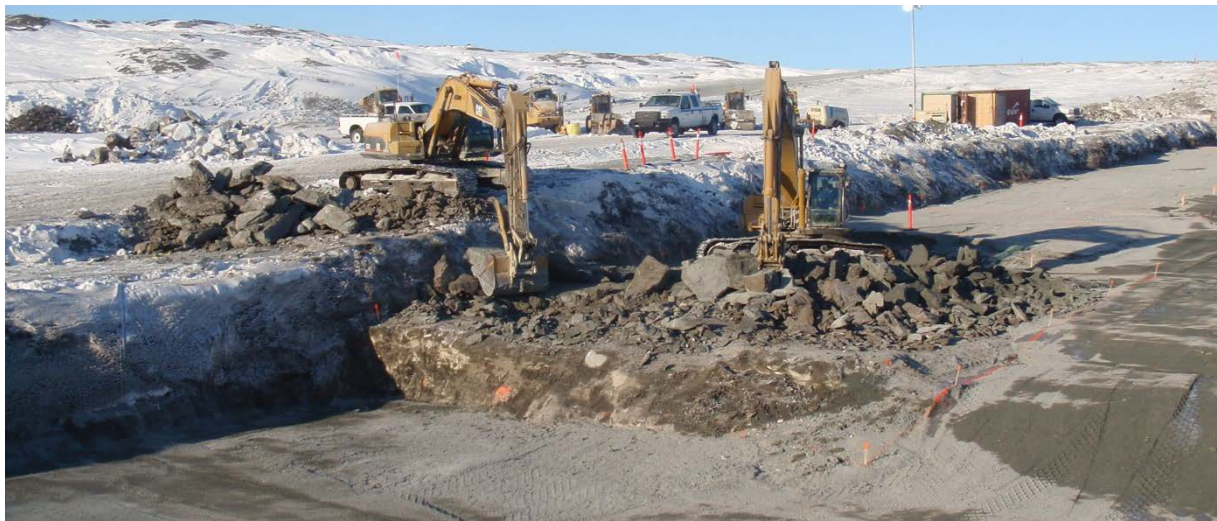
Excavating hyper-saline overburden in Soft Spot, March 22, 2011

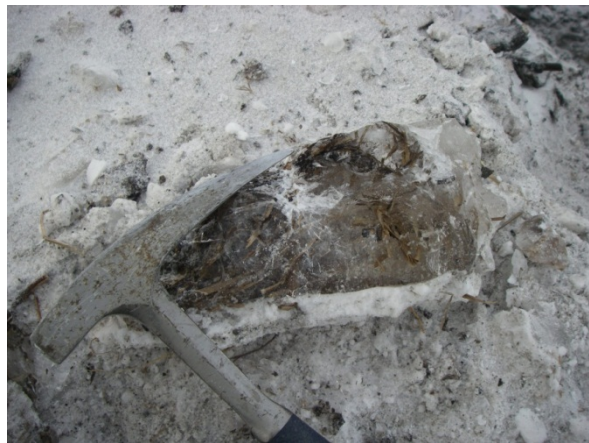
Closer look at ice from ice lenses, February 10, 2011

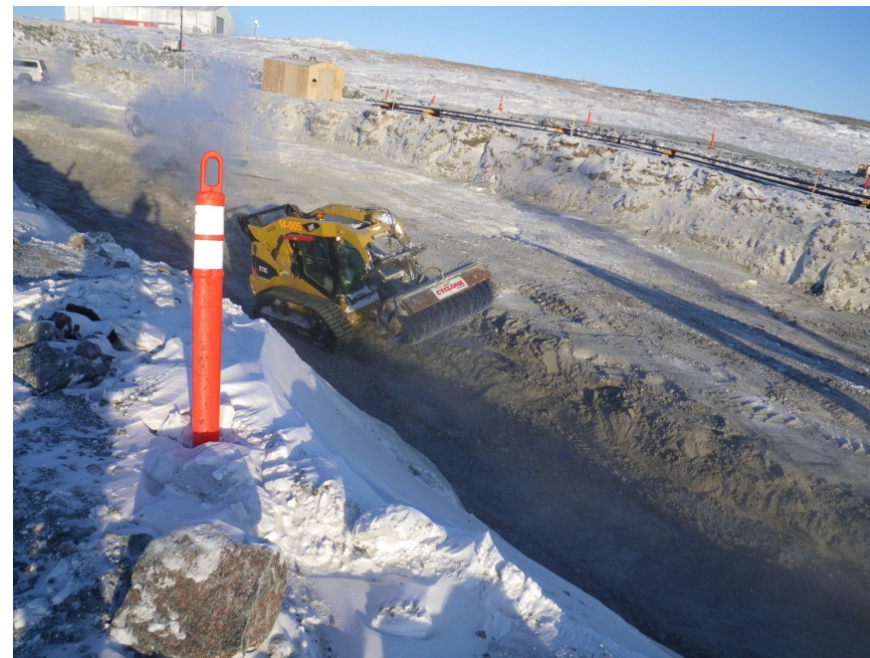
Cleaning of Key Trench after removal of non-spec. core material, March 12, 2011

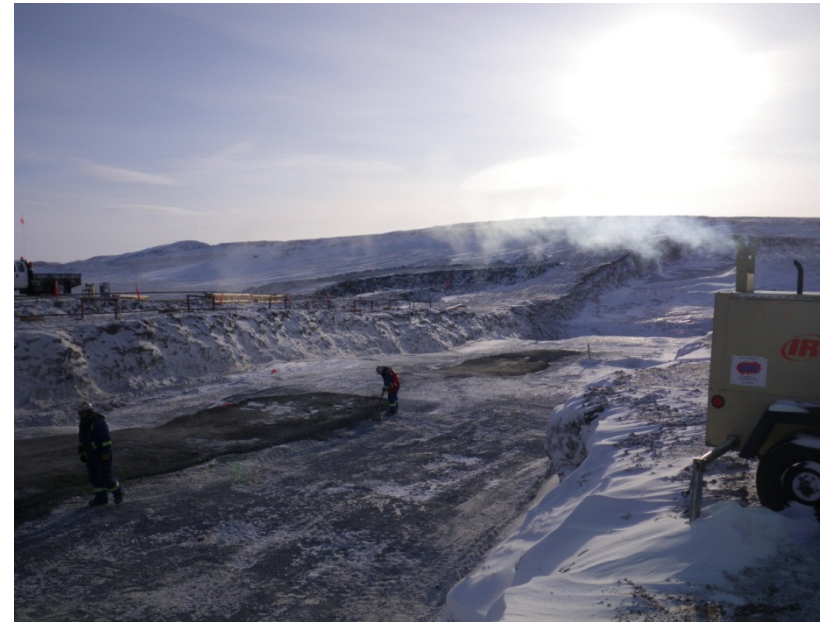
'Test pads' of blended core material placed within the dam footprint, bleeding of water still occurring. Photo taken March 6, 2011

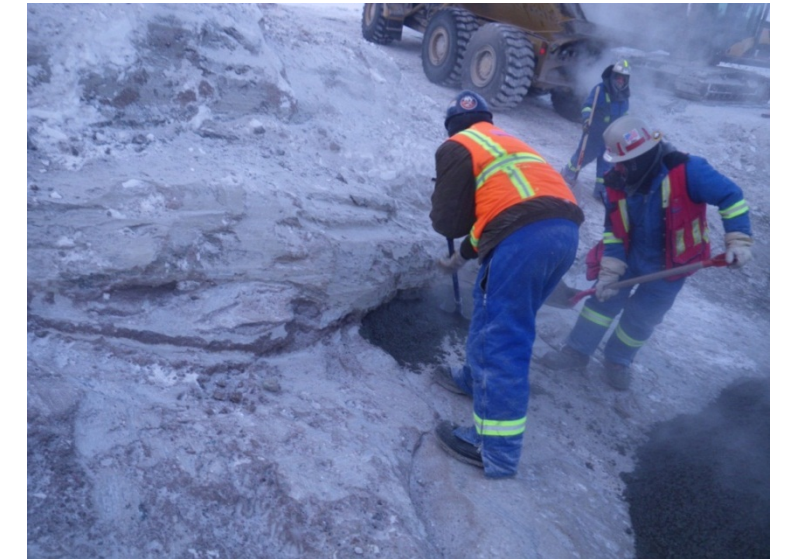
Labourers shoveling core material into holes at the base of the Key Trench, March 7, 2011

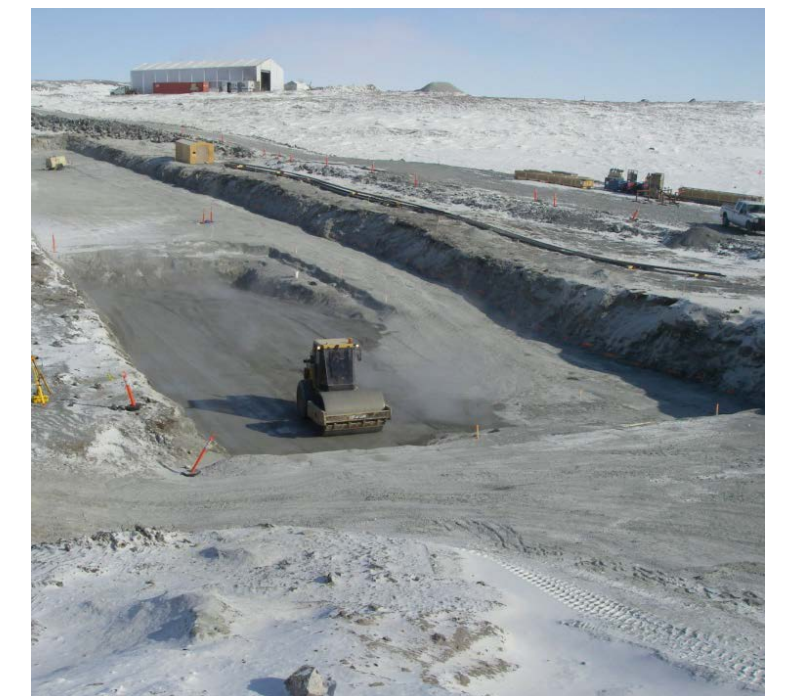
Vibratory compactor compacting core material placed in the low area created by the excavation of hyper-saline material in the Soft Spot, April 3, 2011

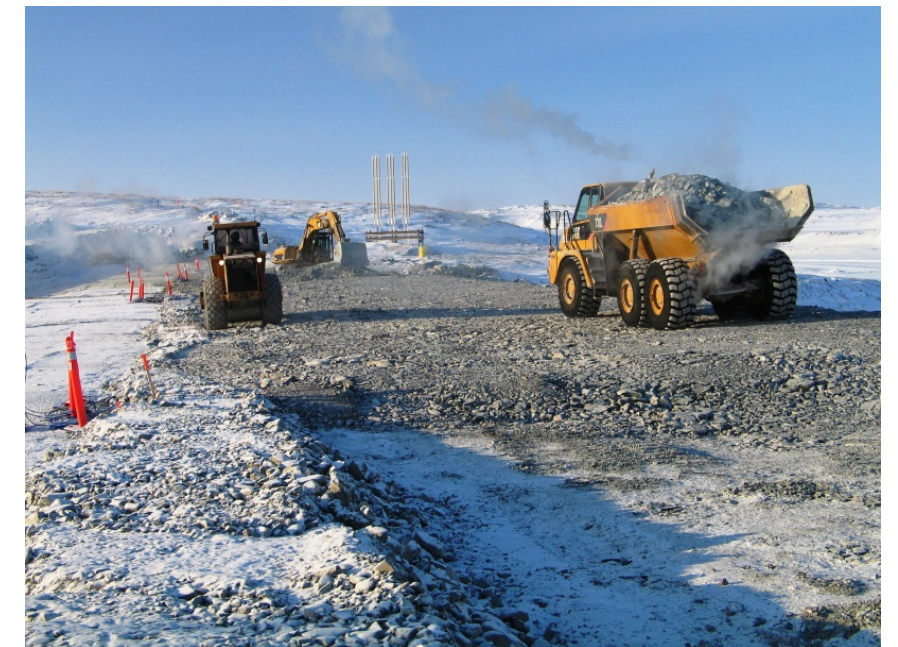
ROQ placement, March 12, 2012

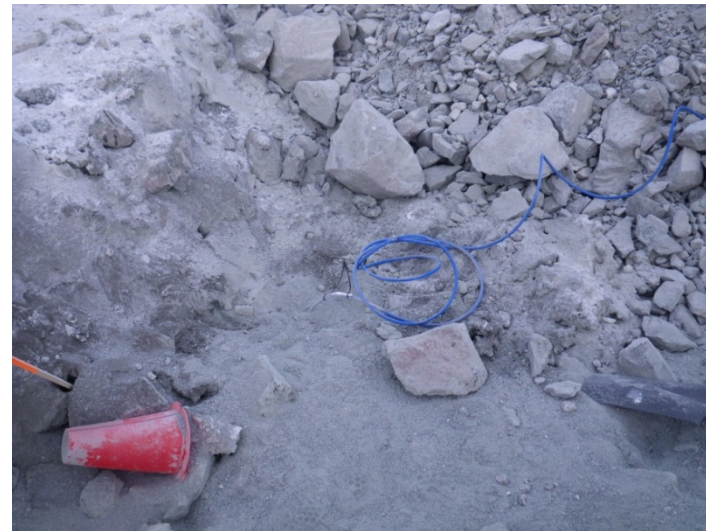
Vertical GTC installation, March 30, 2011

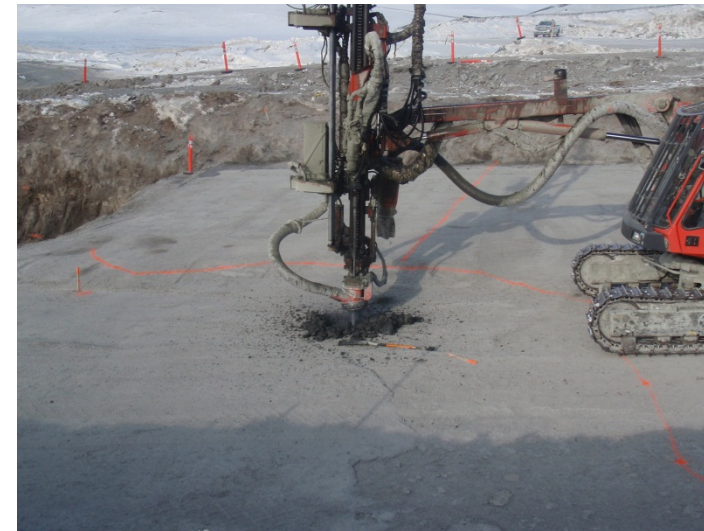
Drilling for installation of vertical Key Trench GTC, April 29, 2011

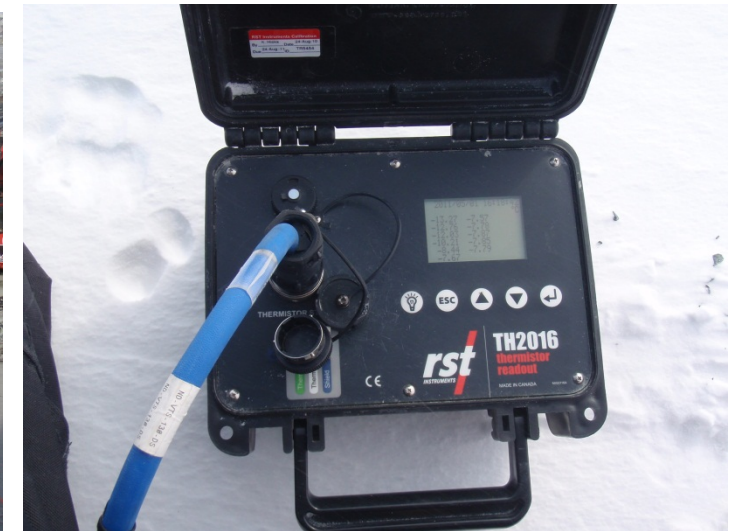
Taking GTC reading, May 1, 2011

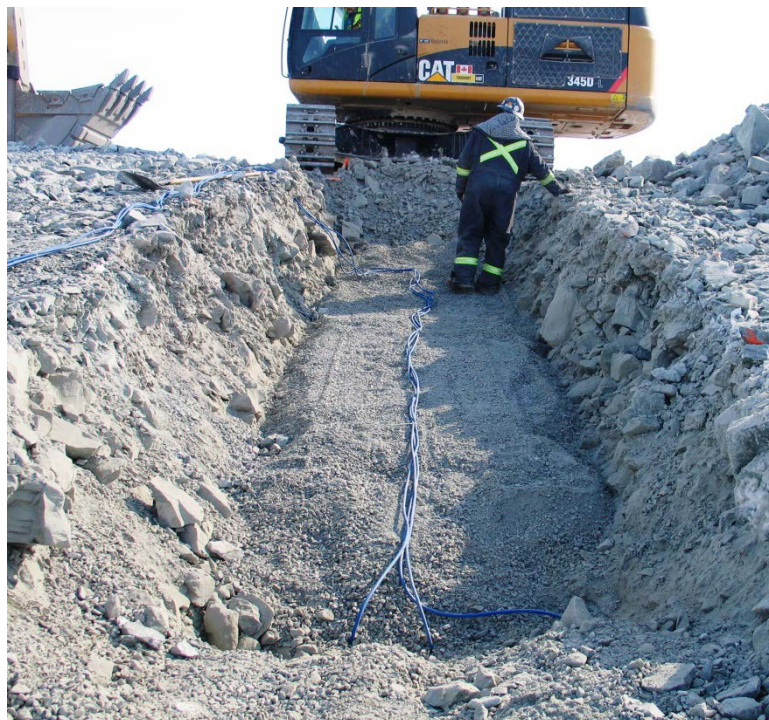
Bedding of cable cluster at station 0+40 along the downstream side of the dam, April 19, 2012

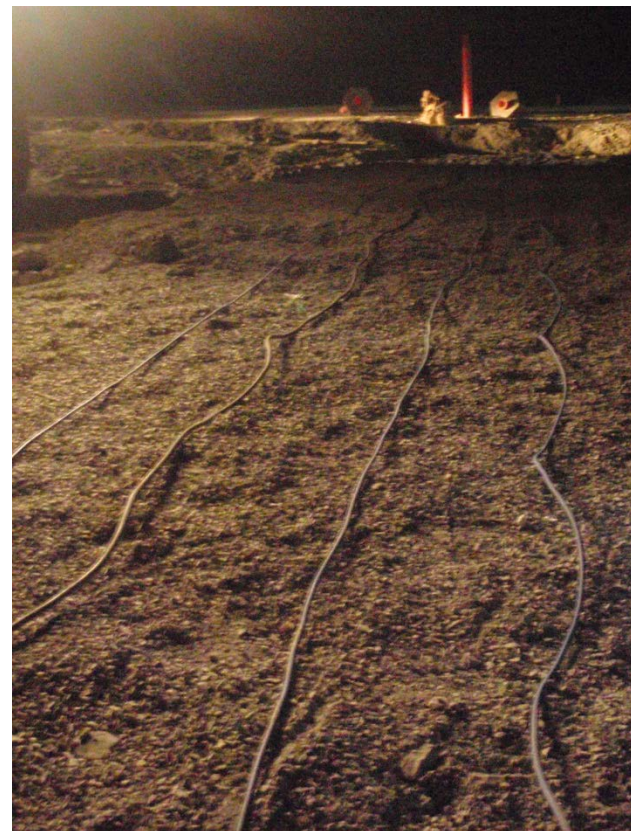
Laying out GTC cluster towards the downstream at station 0+85, preparation for covering, March 15, 2012

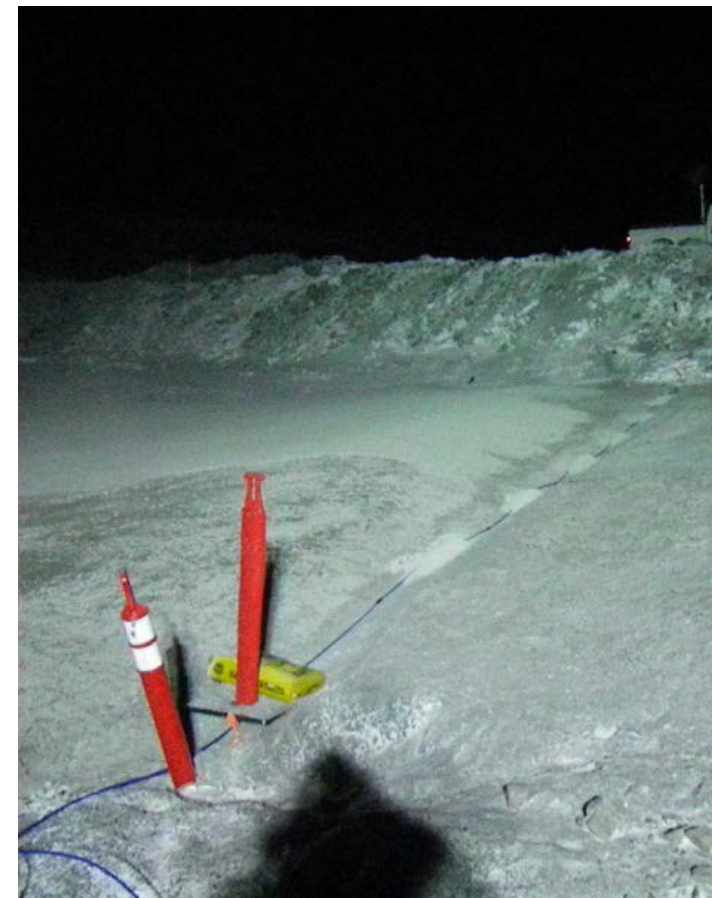
Installation of horizontal GTC in small trench, February 9, 2012

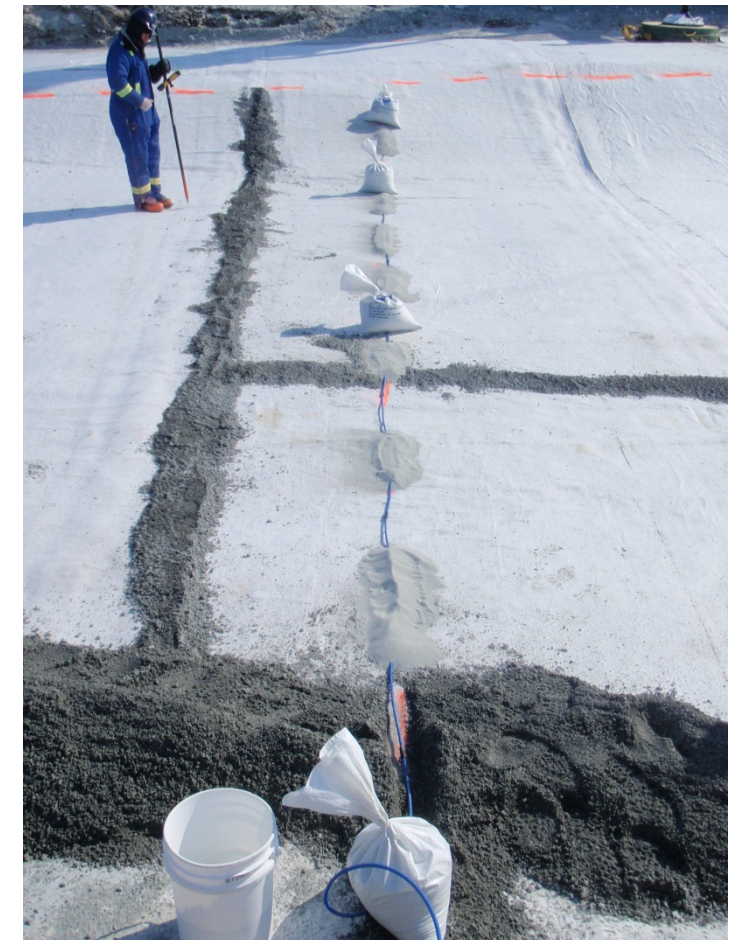
Placement of horizontal GTC on surface of lower GCL, April 25, 2011

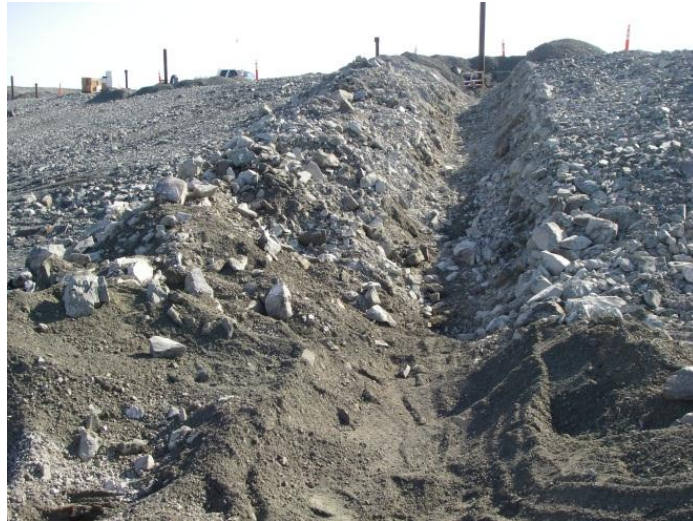
Cable trench excavated for thermosyphon status thermistors lead cables. Photo taken from south Thermosyphons looking east toward ISP 040.

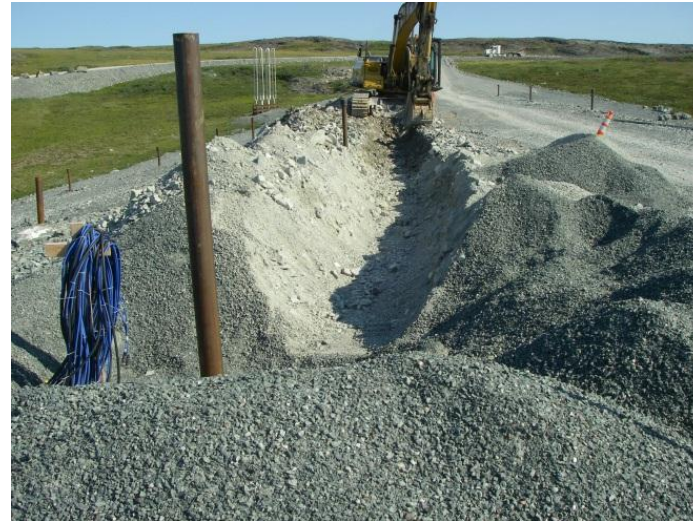
Excavating cable trench between ISP 085 and ISP 130. Photo looking north-east along the dam crest. Note the settlement monument (mid-was avoided when excavating the trench.

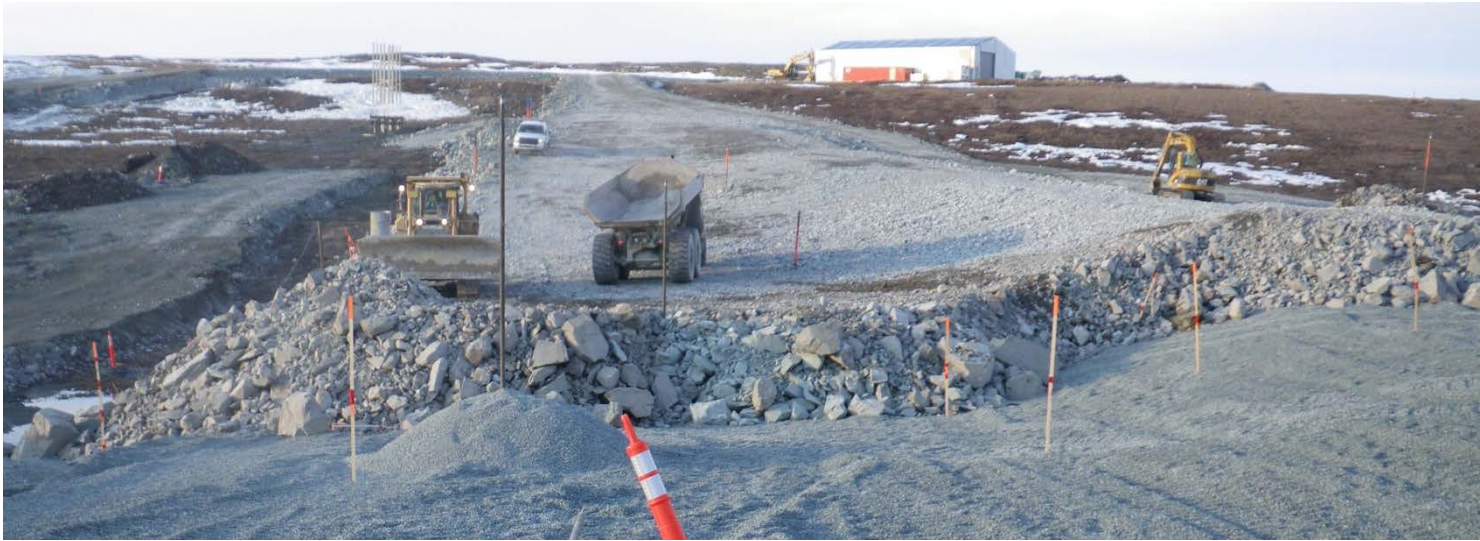
Thermal cover placement: placement of ROQ material for thermal cover, thermistor strings protected with steel pipes, May 14, 2011

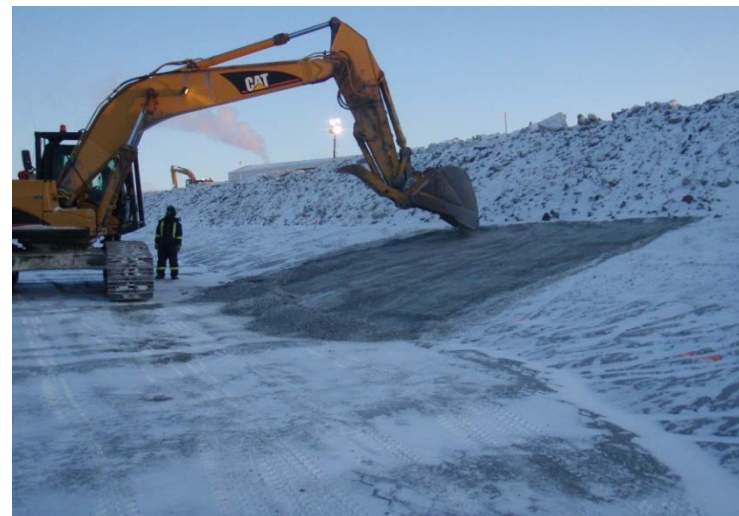
Removal of thermal cover: excavator scraping frozen 16 mm clear material from frozen core material surface, January 25, 2012

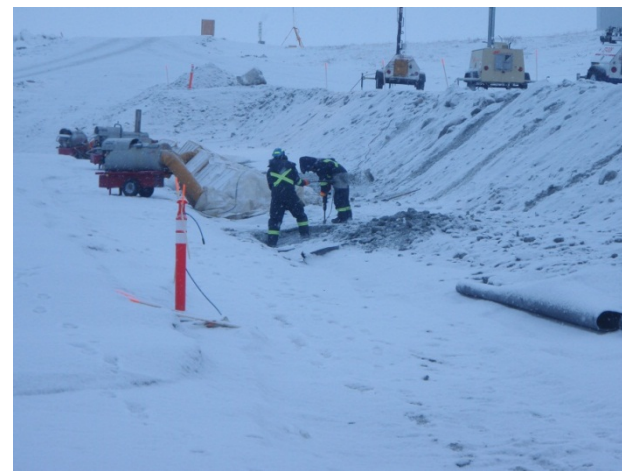
Thermal cover removal: labourers using a small jackhammer to remove frozen 16 mm clear material from above the lower GCL

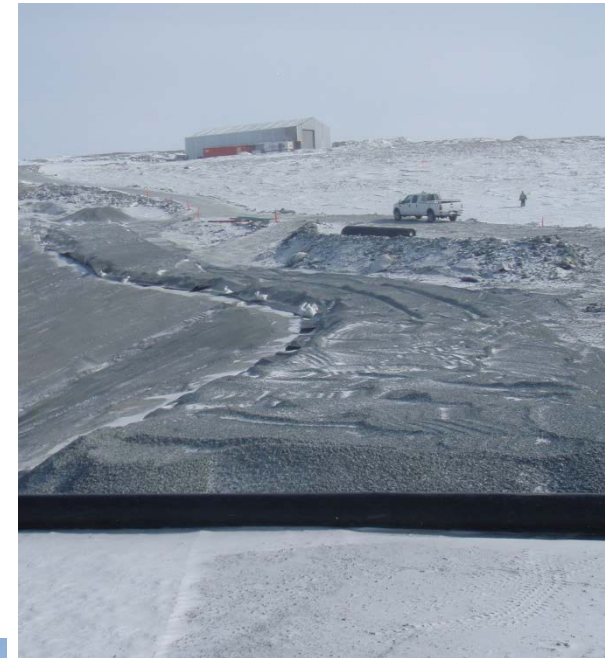
Thermal cover placement: HDPE liner covered with 16 mm clear material overlying exposed lower GCL, April 30, 2011
