# **2010 Annual Geotechnical Inspection, Doris North Project Hope Bay, Nunavut**

***Hope Bay Mining Ltd.***

*Project Reference Number  
SRK 1CH008.032*

*March 2011*

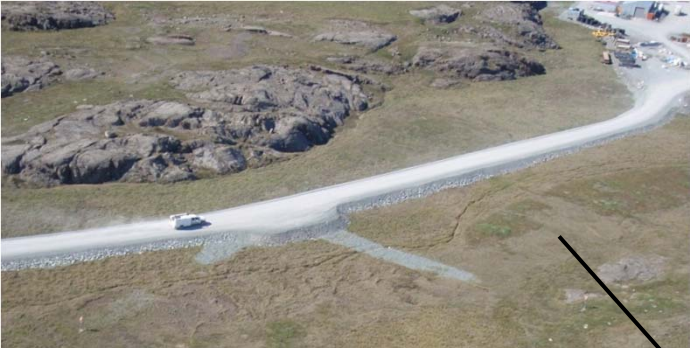
Oblique aerial of the north airstrip apron. Note air traffic control tower, emergency shelter and genset on right.

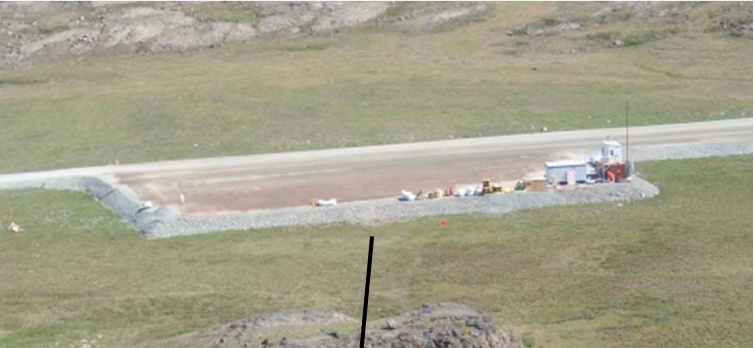
Oblique view explosive mixing plant.

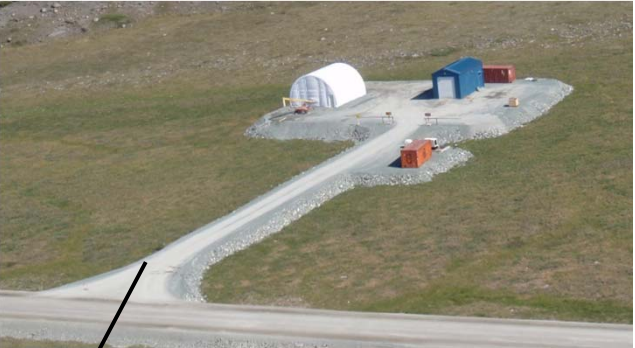
Looking south across Doris Camp and the road leading to Doris Lake.

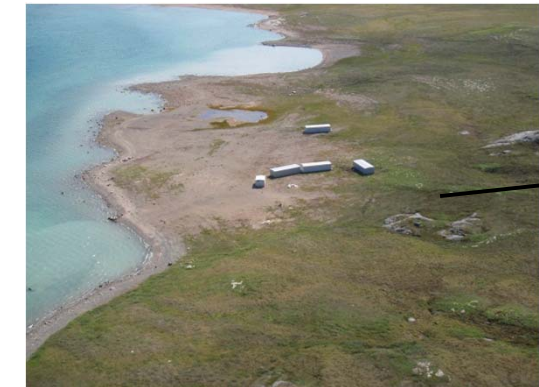
Southeast view over old beach laydown area.

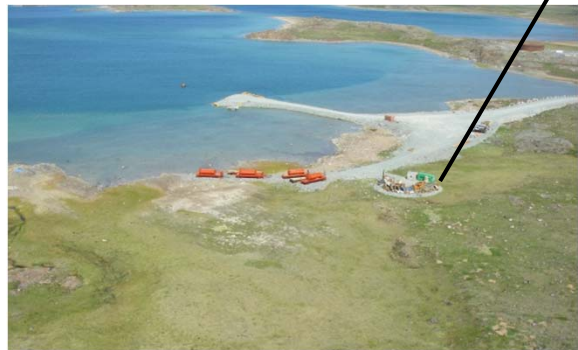
Looking northeast over jetty and jetty laydown area.

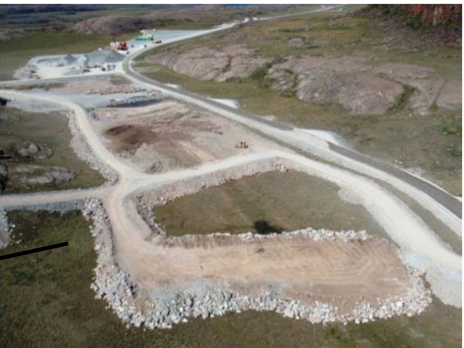
Looking west across the overburden dump.

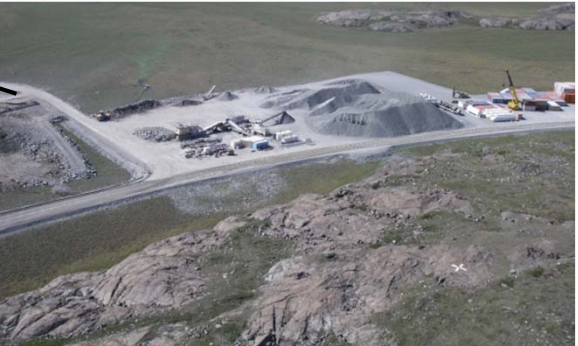
Looking south across the crushing plant.

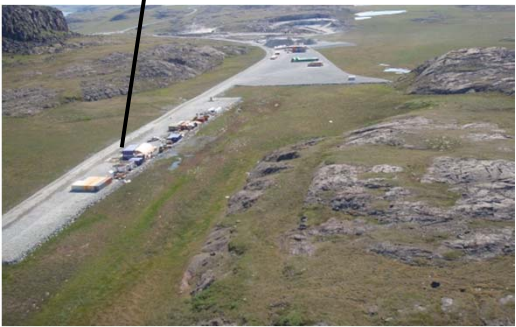
Oblique view of all weather road laydown area.

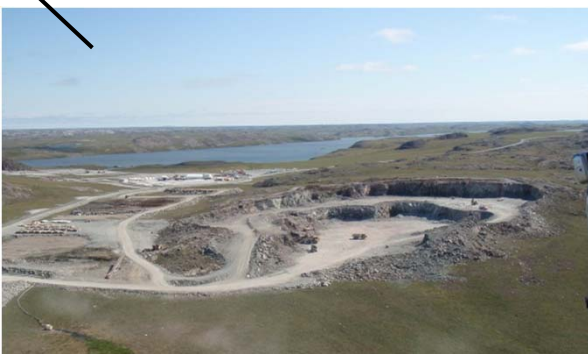
Looking southeast across Quarry #2.

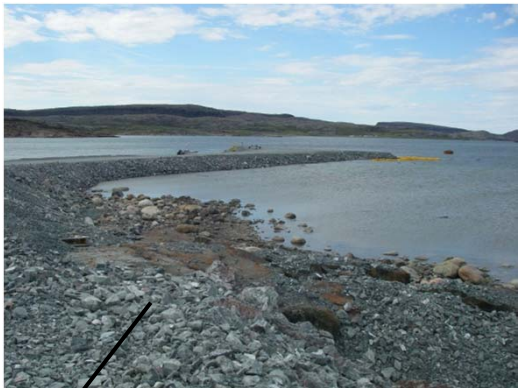
All weather road link with Roberts Bay laydown area.

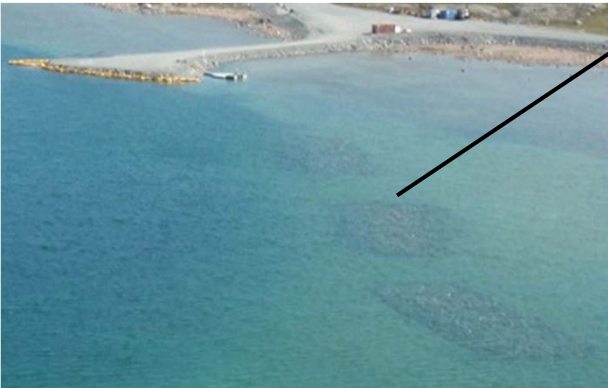
Fish habitat shoals visible under the water.

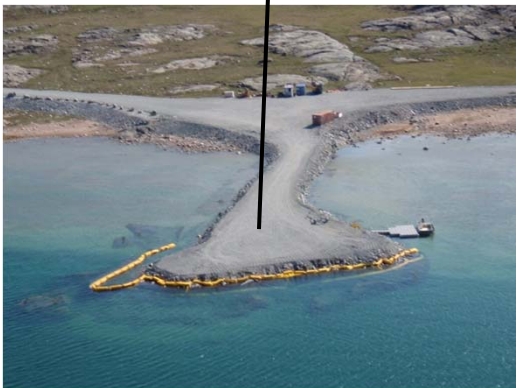
Oblique aerial view of jetty head looking south.

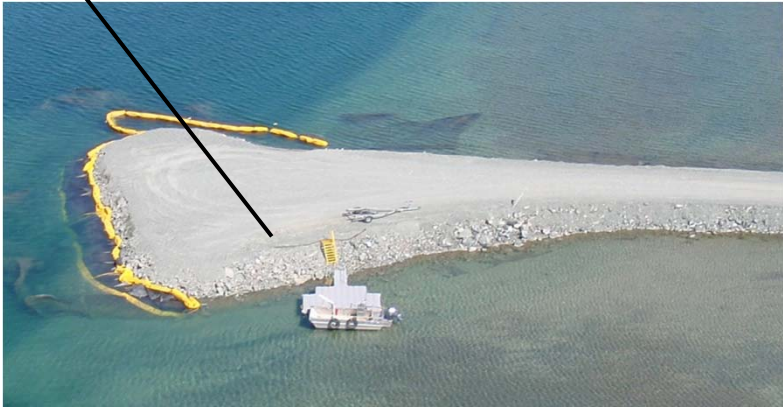
Oblique aerial view of jetty head looking northeast.

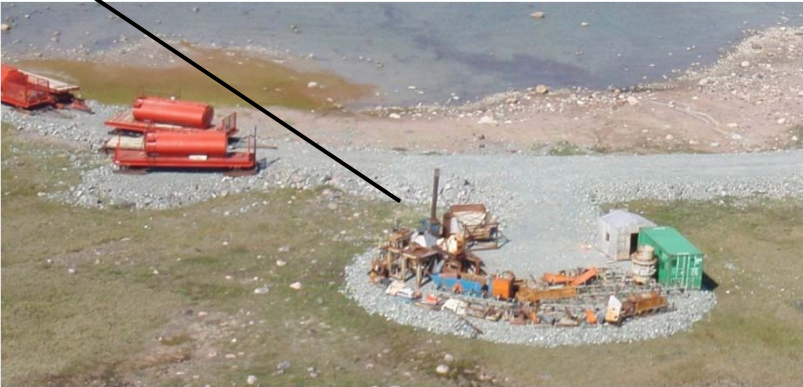
Looking north across western section of shoreline laydown area. Scrap stored on construction helipad is scheduled for backhaul. Red fuel transporters will be returned to Cambridge Bay.

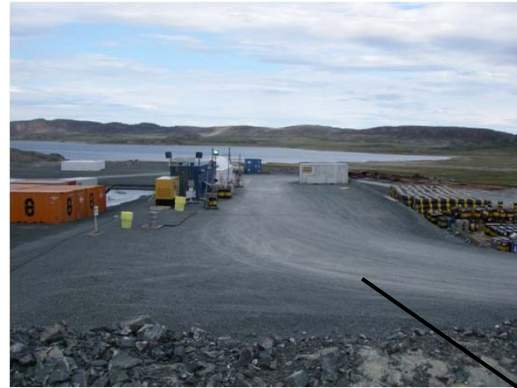
Jet fuel storage in seacans.

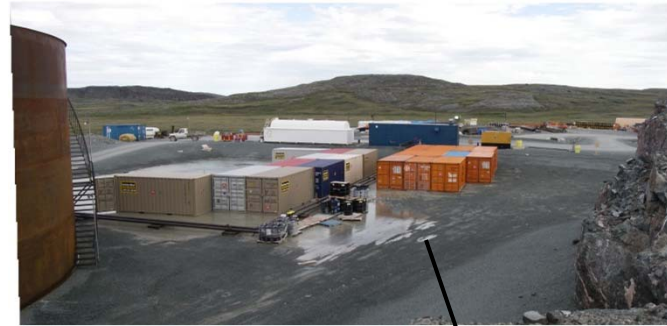
Jet fuel storage on crest of containment berm below highwall.

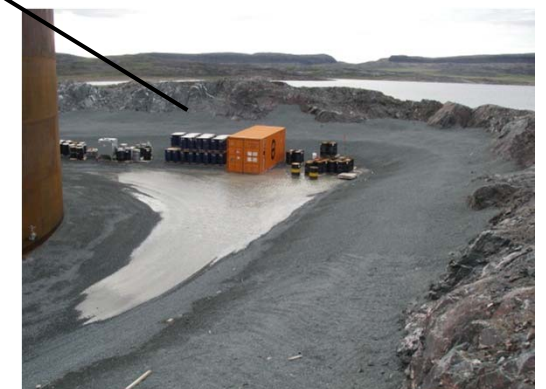
Ponded area with no sump.

Immediately north of the secondary containment area, a large deep pocket of frozen overburden soil was encountered overlying the quarry rock. During quarry development much of this overburden was relocated to a stockpile northeast of the tank farm (see Figure 7); however, this has resulted in areas of ponding above the north high wall of the secondary containment area. To alleviate any risk of overtopping and spilling of water into the secondary containment area, a drainage channel was constructed to convey this water away from the high wall towards the tundra east of the quarry. Thaw settlement of this drainage channel has occurred, and as a result the amount of ponding has increased. While there does not appear to be any immediate risk of overtopping, the increased ponding will further promote thermal erosion of the overburden pockets and possibly water may find its way through cracks in the rock and flow underneath the liner. This could compromise the performance of the liner. SRK recommends that these ponds be closely monitored, and during the 2011 summer season a new drainage channel should be constructed.

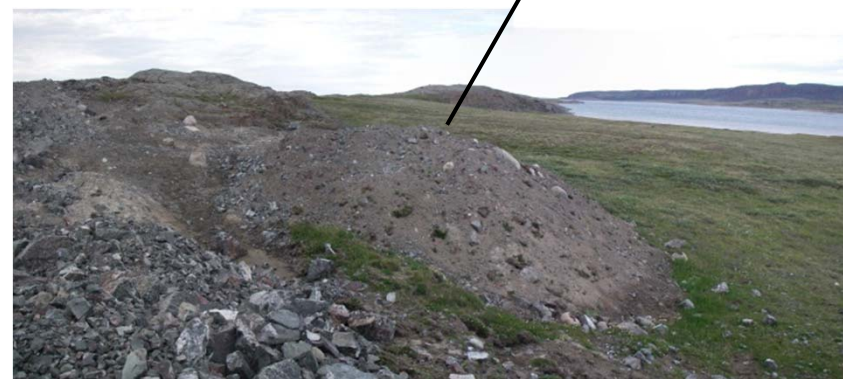
Overburden pile at base of quarry on north side of tank farm.

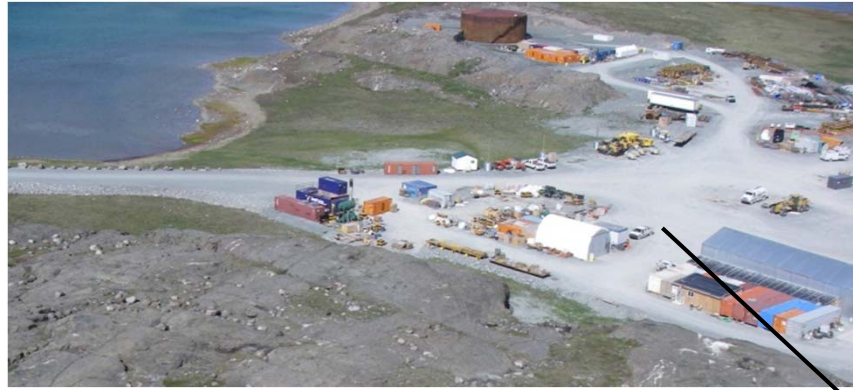
Northwest view across laydown area. Grey colour of tundra is where rock was removed. All drainage flows unhindered.

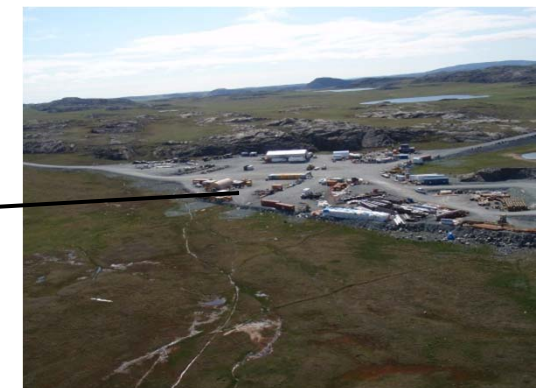
Light grey area in foreground is where stockpile crushed rock was stored. It has been removed without damaging tundra and drainage flows unimpeded.

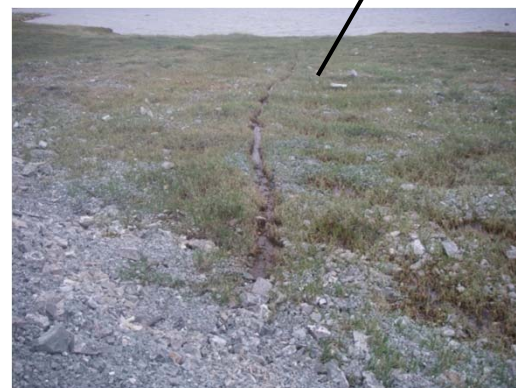
Example of unimpeded flow through pad.

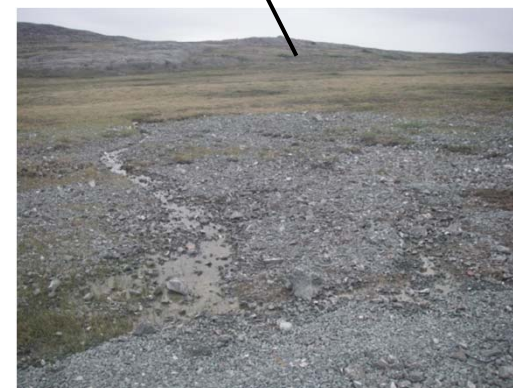
Example of unimpeded flow through pad.

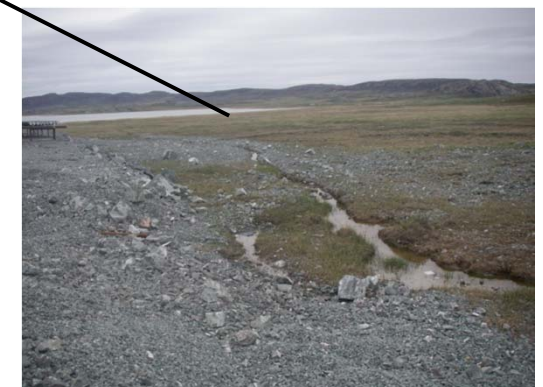
Example of unimpeded flow through pad.

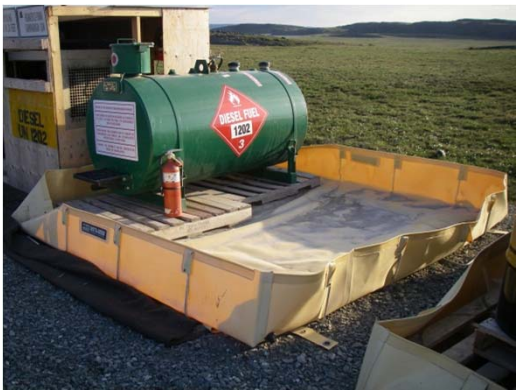
Secondary containment for fuel tank supplying the airstrip control tower generator. Note compromised berm.

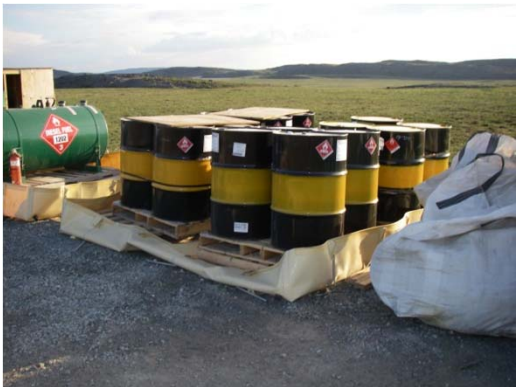
Secondary containment for jet fuel. Note compromised berm.

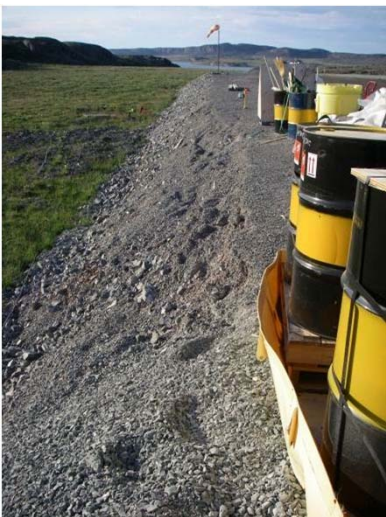
Fuel stored too close to edge of pad.

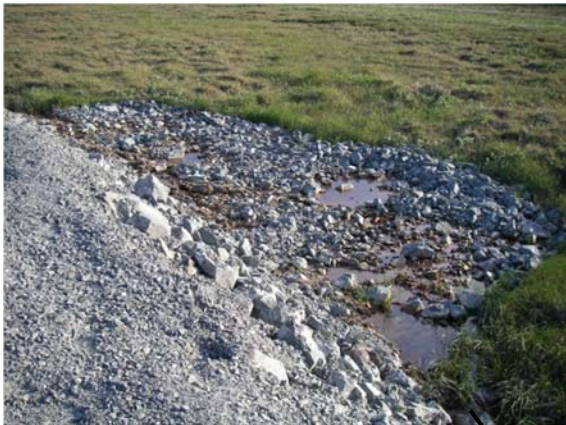
Ponding on west side of road north of road laydown area. Site of a road turnout that was removed.

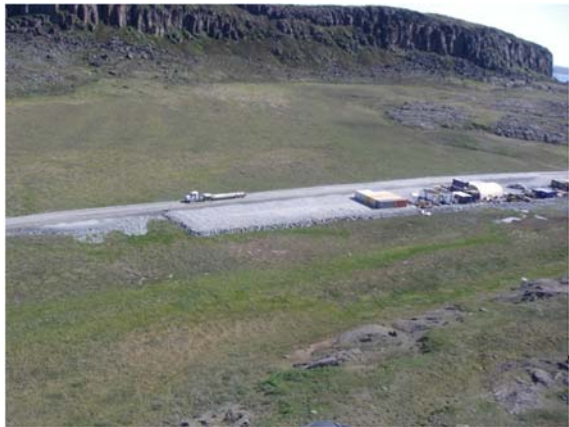
Oblique view looking south across road laydown area. Note rock pulled back of tundra adjacent to turnout.

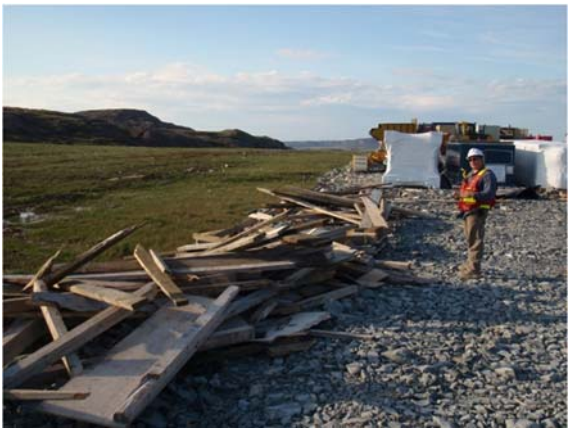
Wood debris on the pad.

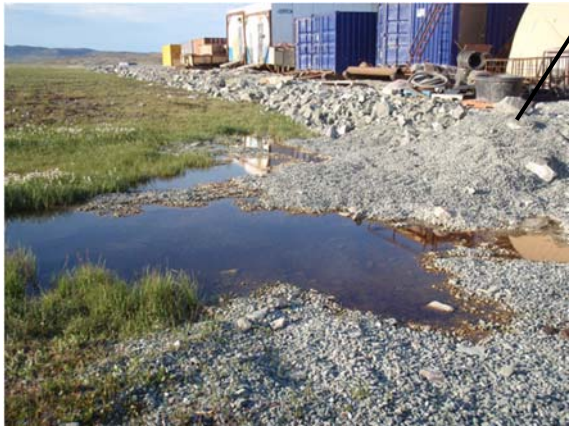
Ponded water at the toe of the pad.

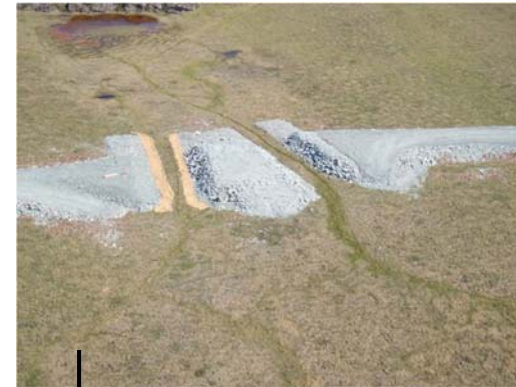
Crossing #1 looking east.

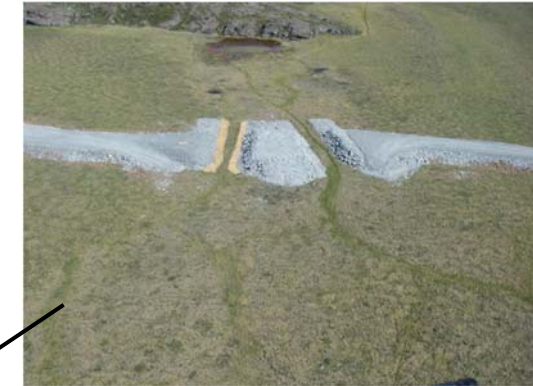
Crossing #2 and #3 looking east.

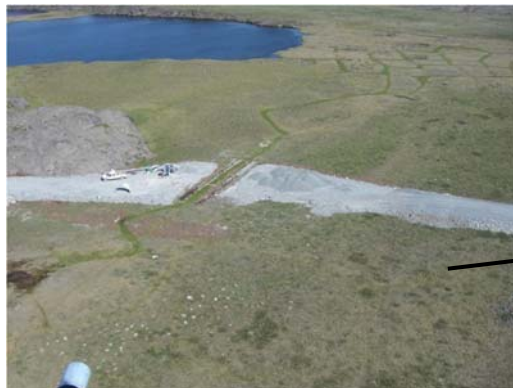
Crossing #2 and #3 looking east.

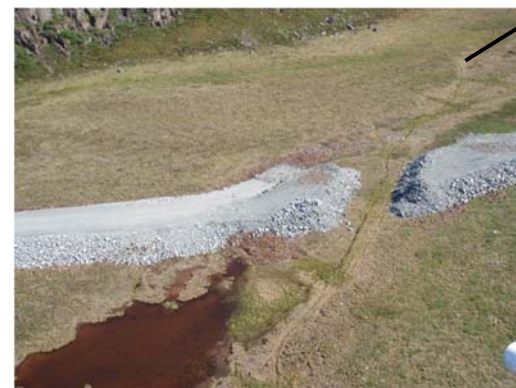
Crossing #1 looking southeast.

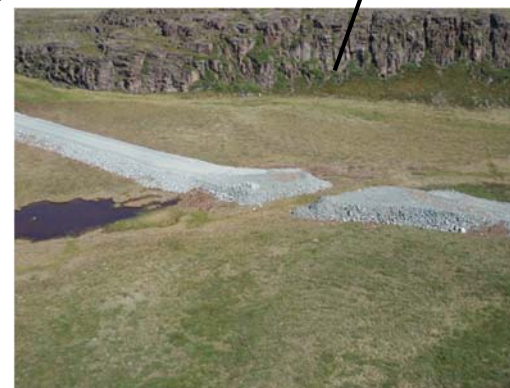
Crossing #4 looking east.

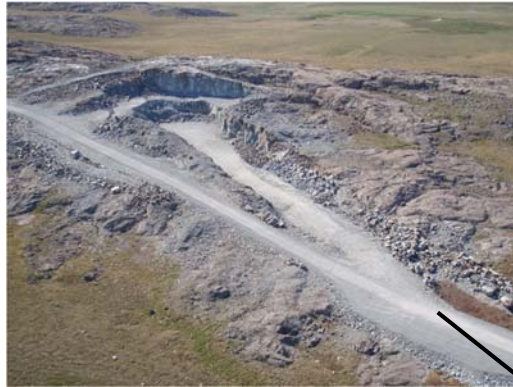
Quarry A looking northwest.

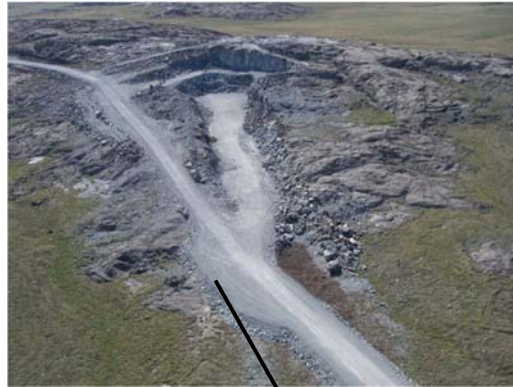
Quarry A looking south.

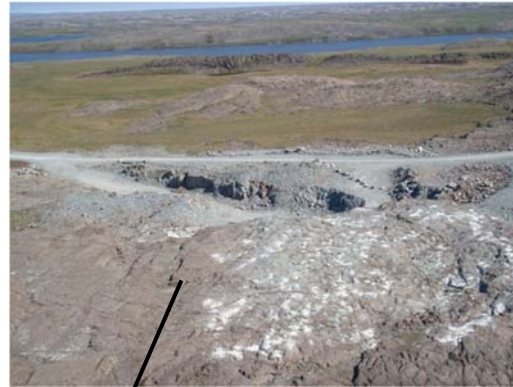
Quarry A looking east.

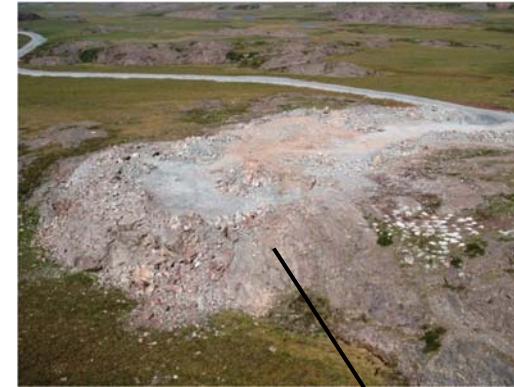
Quarry D looking northeast.

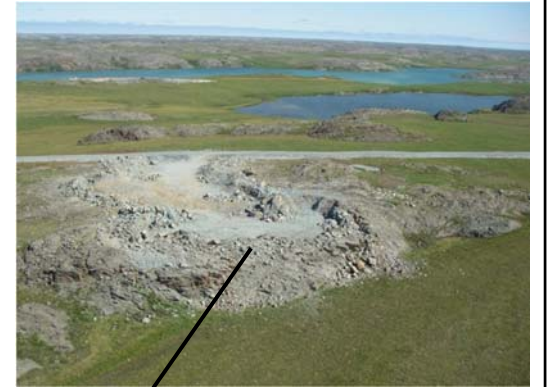
Quarry D looking east.
