# **2011 Annual Geotechnical Inspection Doris North Project, Hope Bay, Nunavut**

**Hope Bay Mining Ltd.**

SRK Consulting (Canada) Inc  
1CH008.046  
March 2012

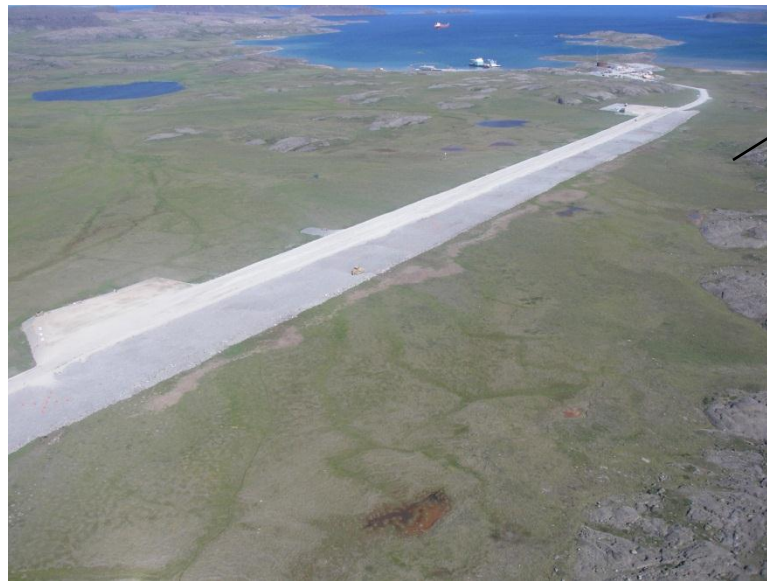
Looking northwest across Airstrip, the lighter grey material on the right side is the start of the airstrip expansion

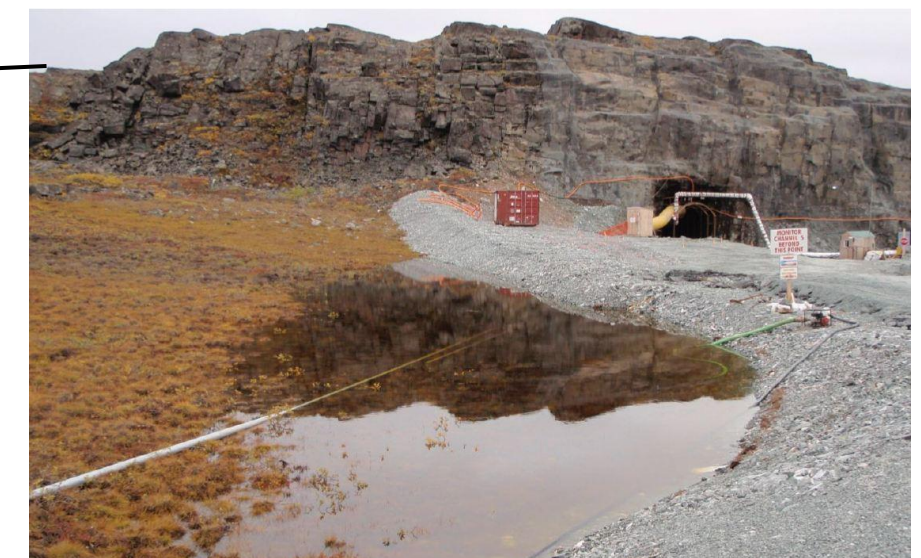
Water Ponding along the Doris Diversion Berm, near the Portal. Photo taken September 2011

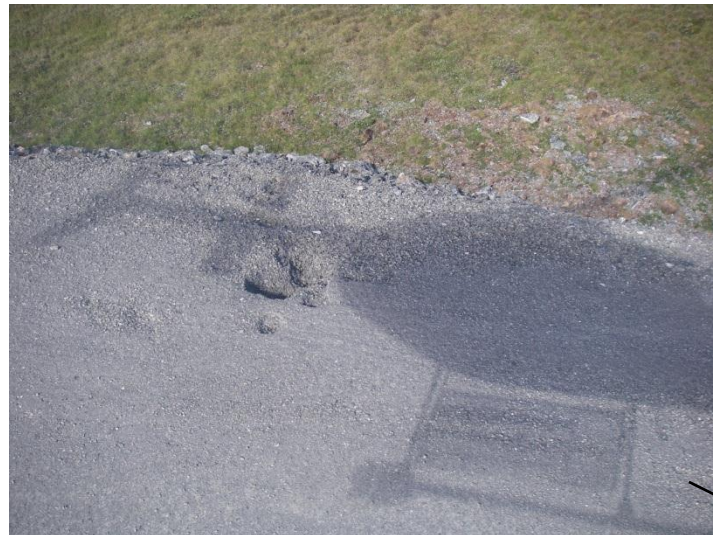
Settlement/ Pothole along the edge of the road

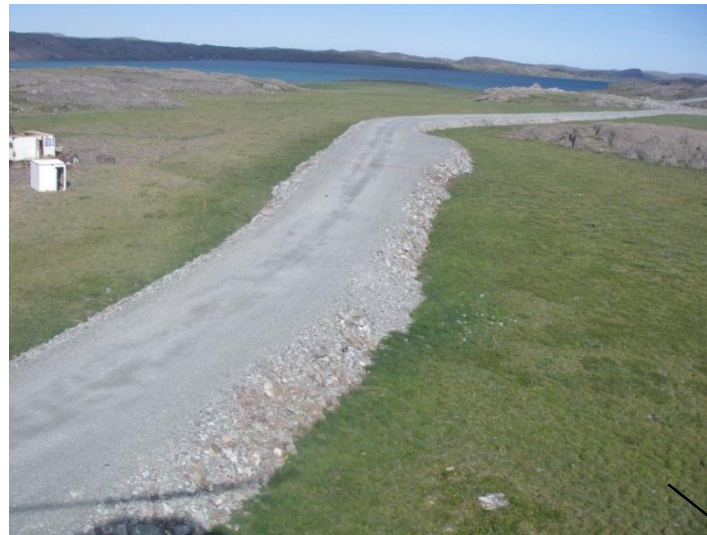
Doris-Windy Road, photo looking northeast

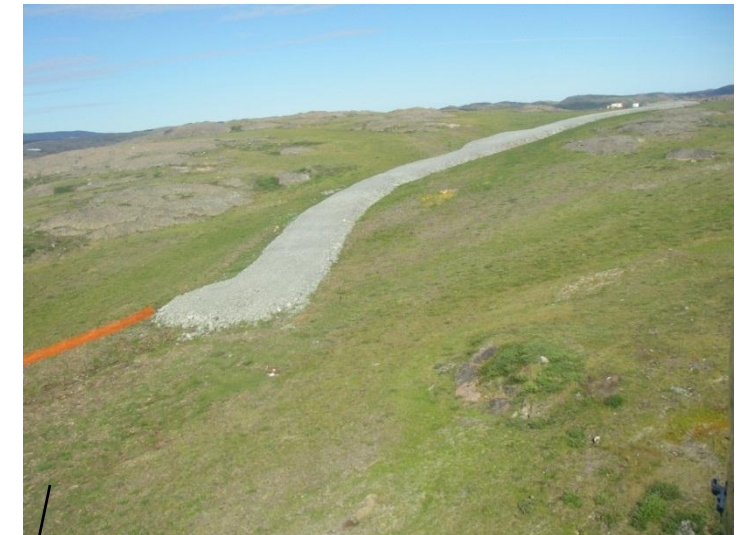
End of the constructed portion of the Doris-Windy Road. Photo looking northeast. The road was continued later in 2011

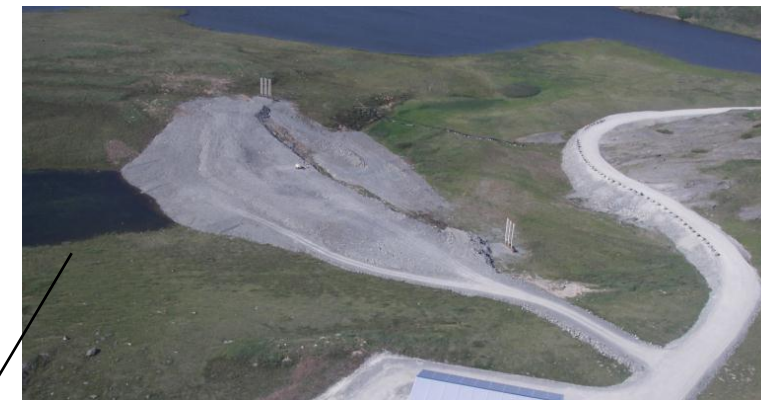
North Dam, not complete, looking west

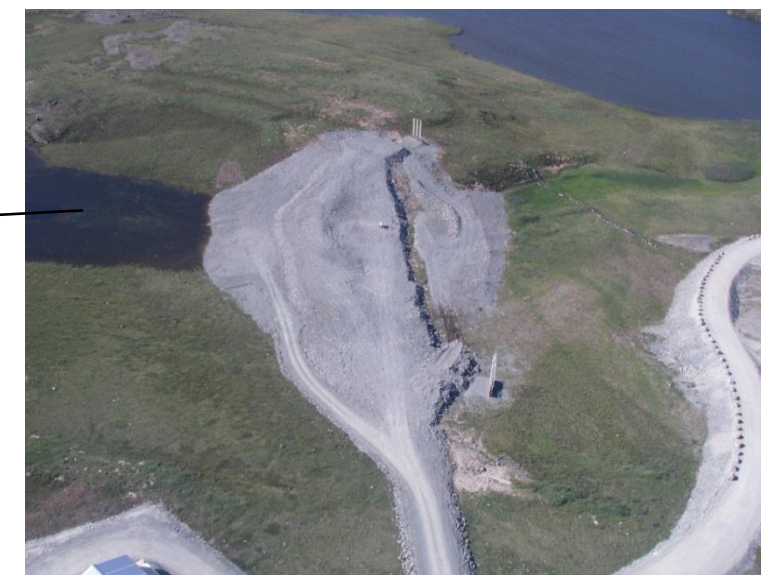
North Dam, not complete, looking southwest
