2012 Annual Geotechnical Inspection Doris North Project Hope Bay, Nunavut

SRK Consulting (Canada) Inc.
1CH008.066
March 2013

Site operations were conducted under a Type "A" Nunavut Water Board (NWB) Licence 2AM-DOH0713 (the Licence), dated September 19, 2007, which entitles HBML (the Licensee) to use water and dispose of waste associated with their operations. HBML contracted SRK Consulting (Canada) Inc. to conduct the annual geotechnical site inspection of the Doris North Project in accordance with stipulated Licence conditions. This annual investigation was carried out from September 7 to 10, 2012.

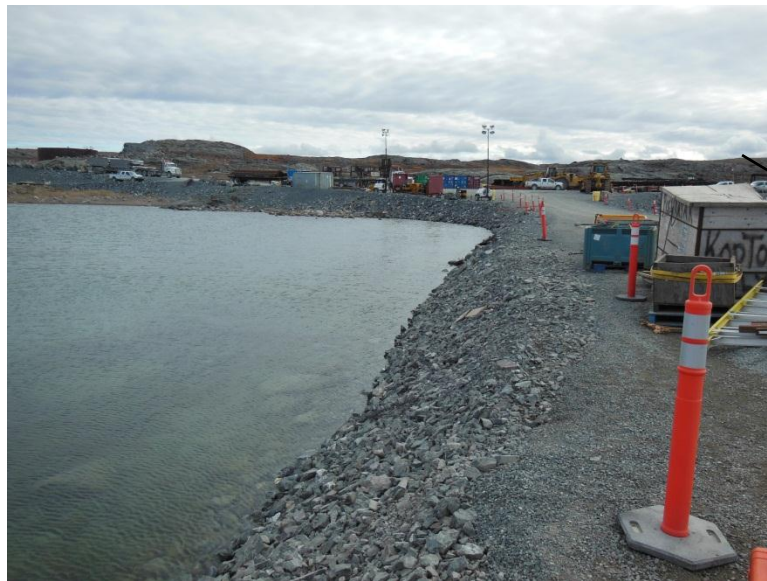
The 2012 geotechnical inspection of this structure revealed no cause for concern (Figure 6). There were no obvious signs of distress anywhere on the structure, and based on these observations, supported by verbal descriptions from site staff, settlement appears to have reached steady state. The SRK inspectors have inspected the jetty annually since construction, and no visual differences could be observed since the 2011 inspection, other than the fact that the facility was raised, and an earthen ramp constructed. SRK imposed strict design and operational limitations on the use of the jetty due to the weak foundation conditions (SRK 2005a, 2009c, d), and based on observations, supported by staff interviews, HBML are following these recommendations carefully.

Eastern shoreline of Jetty – looking south

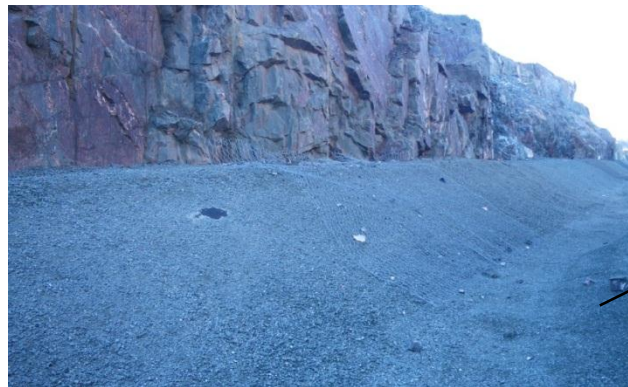
Interior Berm along western high wall showing the liner has been exposed

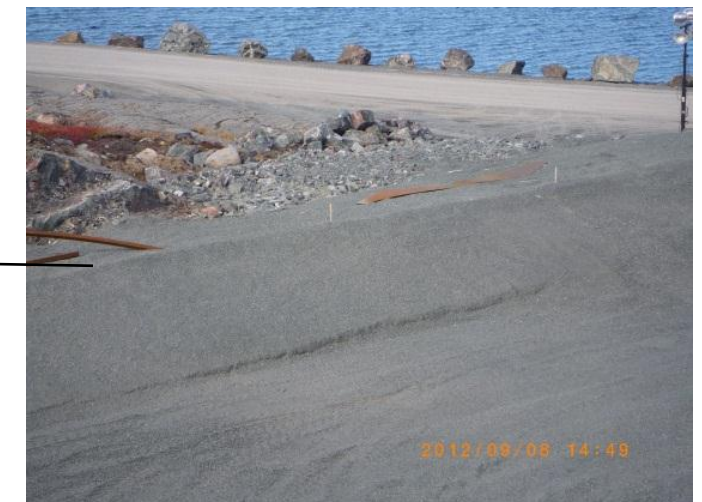
Interior Berm that show evidence of being in contact with the blade of a

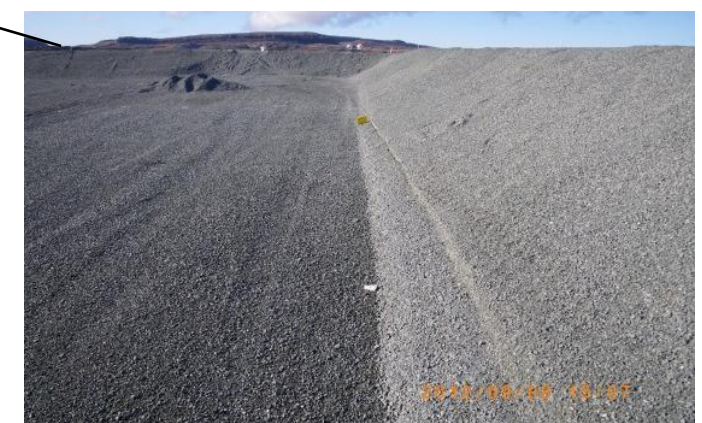
Interior Berm that shows evidence of wheeled traffic. Looking north from Tank #3

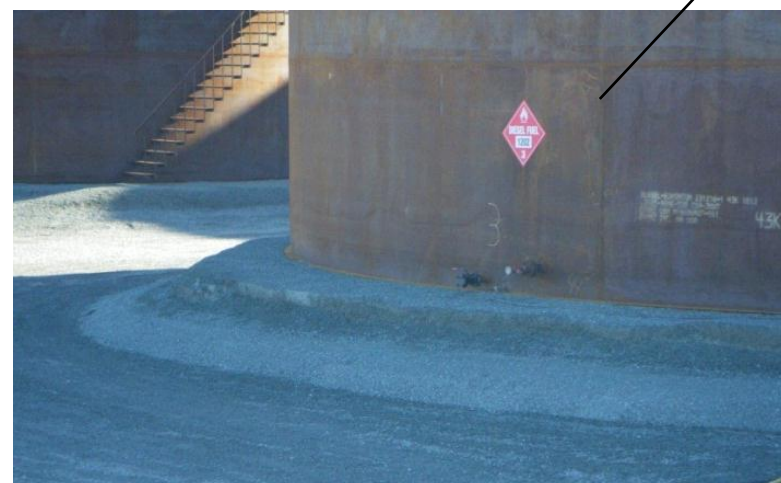
Pedestal of Tank #3 that has been undercut

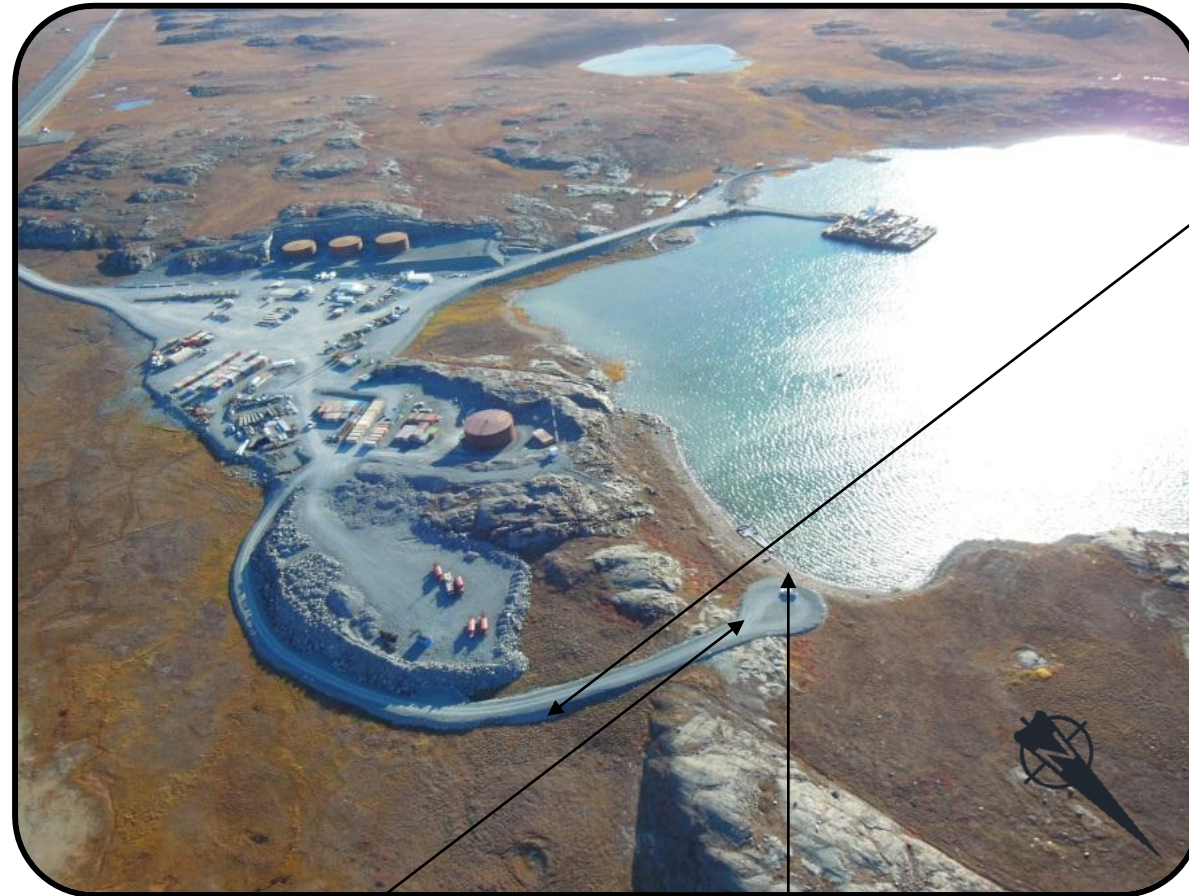
Toe of Roberts Bay access road looking east with the overburden stockpile to the right

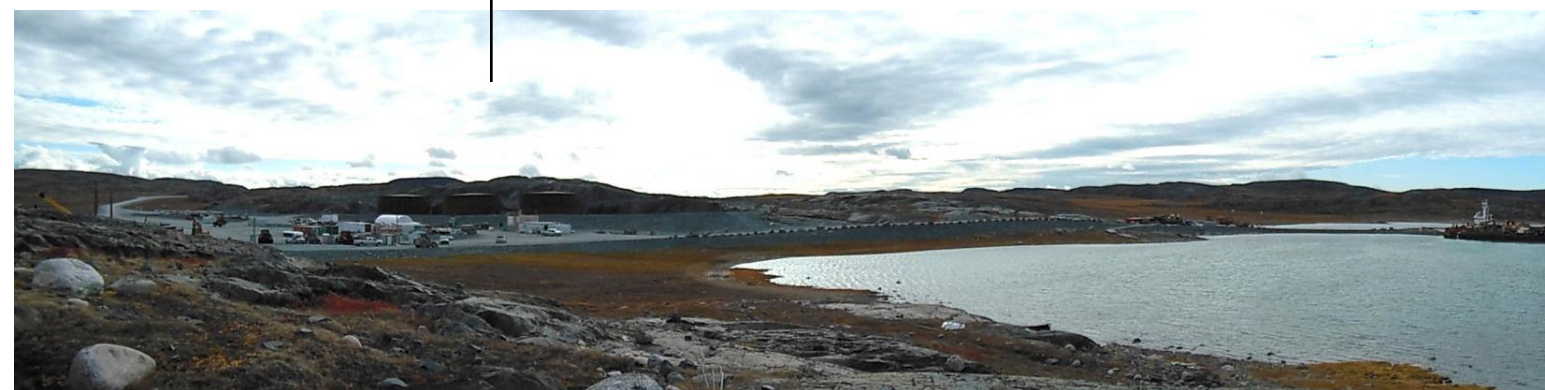
Looking south towards the Roberts Bay laydown from the end of the Roberts Bay access road

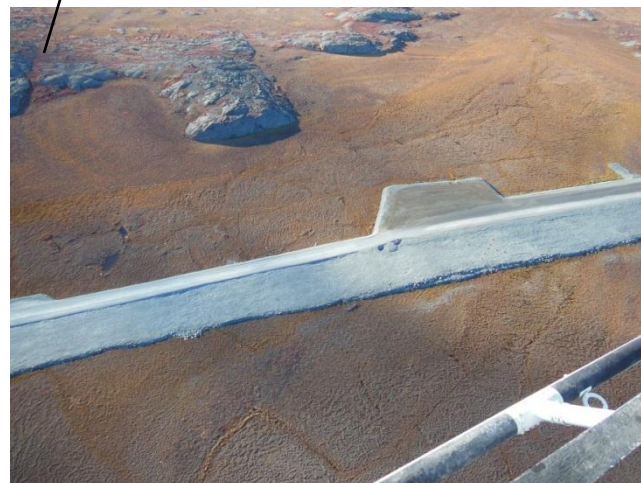
Aerial view of the South Apron

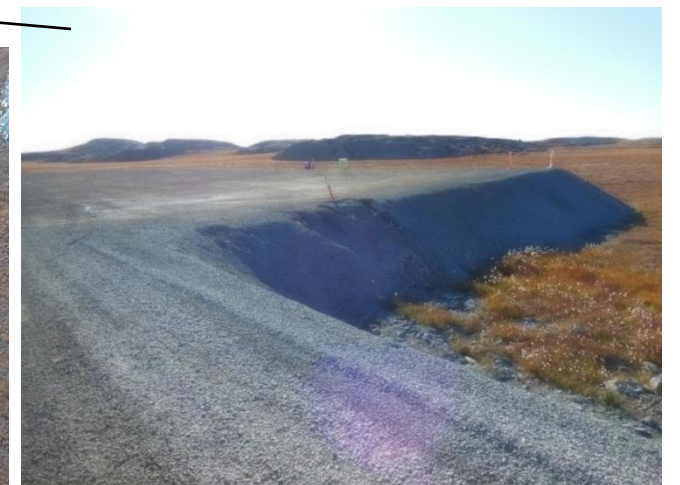
Sinkholes and erosion gully on South Apron

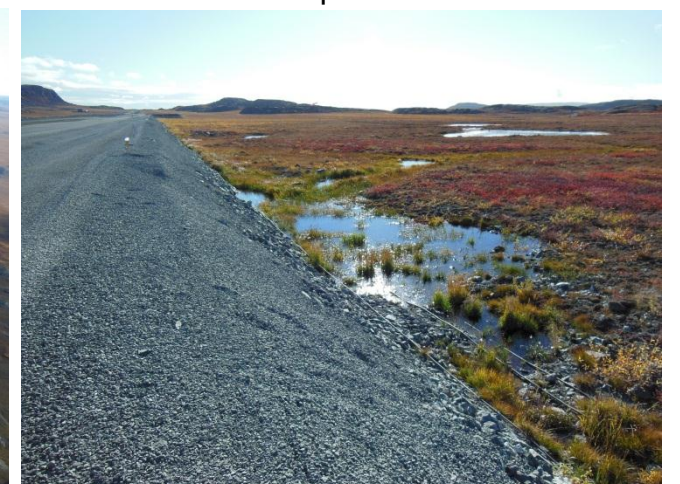
Ponding of surface water along the west side of the airstrip

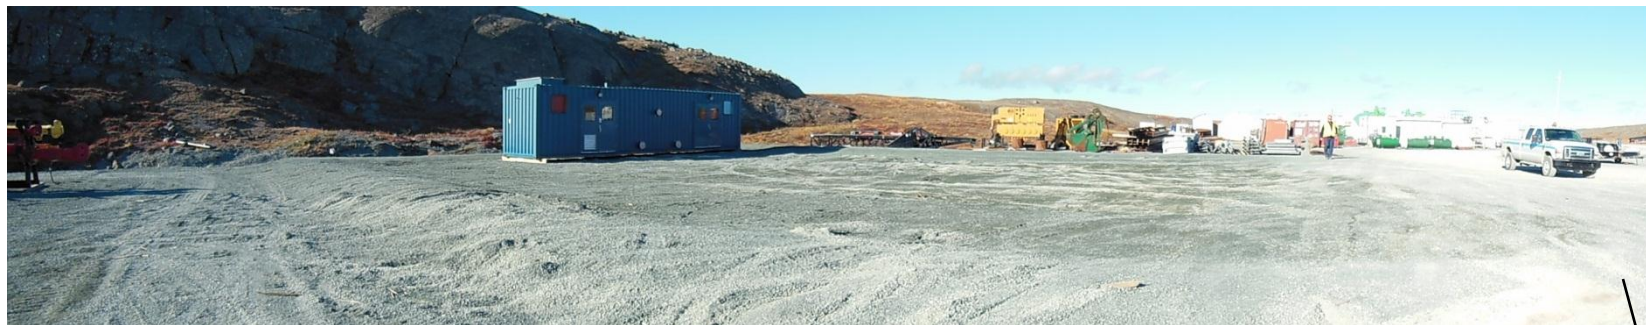
At the south end of the Upper Reagent Pad (Figure 12) a lined bulk ammonium nitrate (AN) storage area was constructed by HBML. No formal design for this facility was prepared and construction was carried out with no designated quality control or quality assurance. No as-built

Upper Reagent Pad AN storage

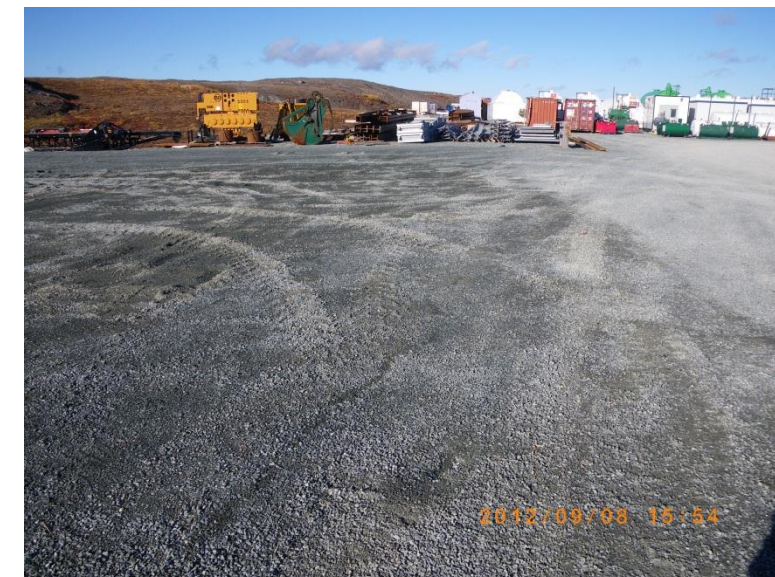
Upper Reagent Pad AN storage

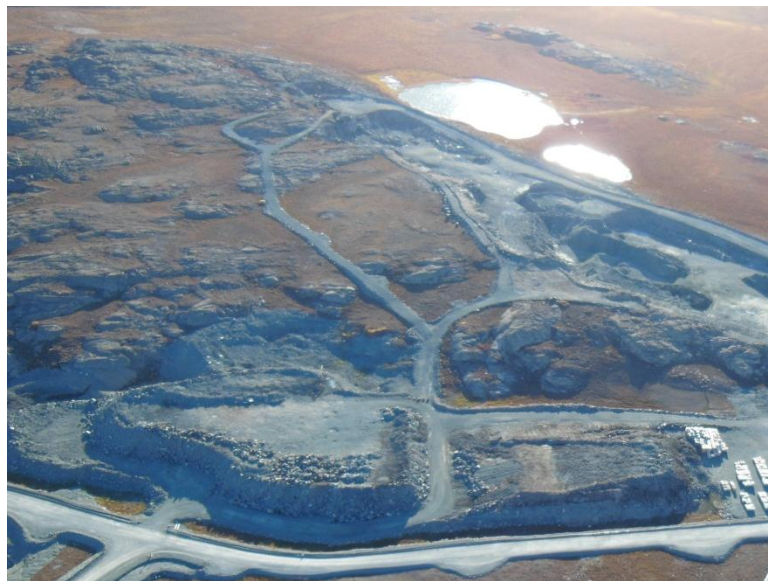
A permanent overburden dump has been constructed north of Quarry #2 as shown in Figure 13 and 11. Overburden stripped from Quarry # 2 and #4, and oversize quarry rock that was not

Aerial view of the Overburden Stockpiles

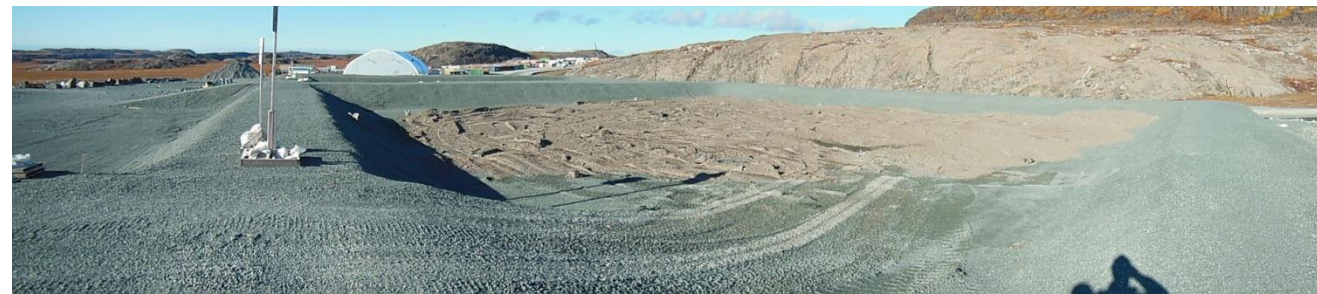
A landfarm has been constructed immediately north of Quarry #2 as shown in Figure 13. The facility consists of three lined cells: one for contaminated snow, one for contaminated soils, and the last for hydrocarbon contaminated water. The facility is a fully-lined facility designed to temporarily hold these contaminated materials rather than being a facility that can be used to remediate the materials. A Landfarm Management Plan has been prepared by HBML outlining its use.

Doris North Landfarm – Contaminated Soil Pond

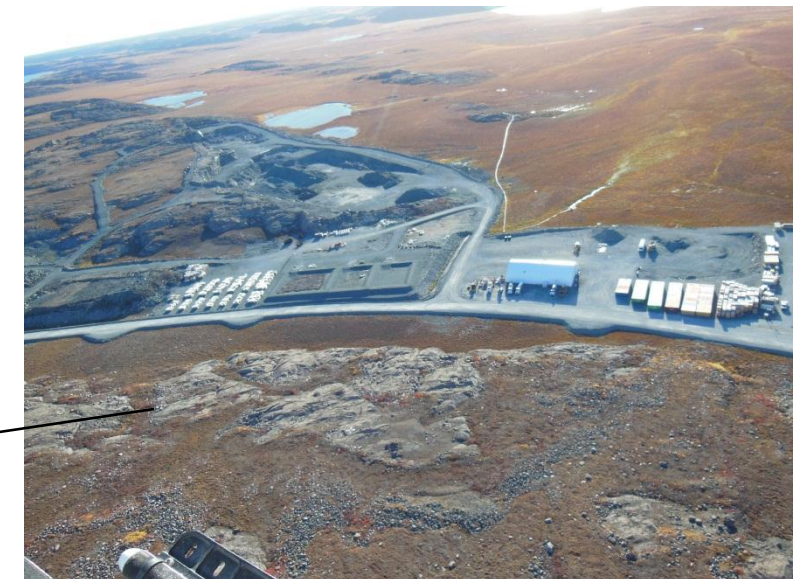
The grey water (sewage treatment effluent) pipeline used to discharge directly onto the tundra immediately south of the crusher pad (Figure 13). Visual inspection during 2010 and 2011 confirmed that there was significant ponding of water; and tundra vegetation dieback had started with associated erosion damage. As a result, discharging directly to the tundra was discontinued, and an alternate diffuser system was constructed and put into operation in 2012. The new discharge location is further to the west with the diffuser located on a bedrock outcrop.

Doris Camp Sewage Effluent Discharge Points

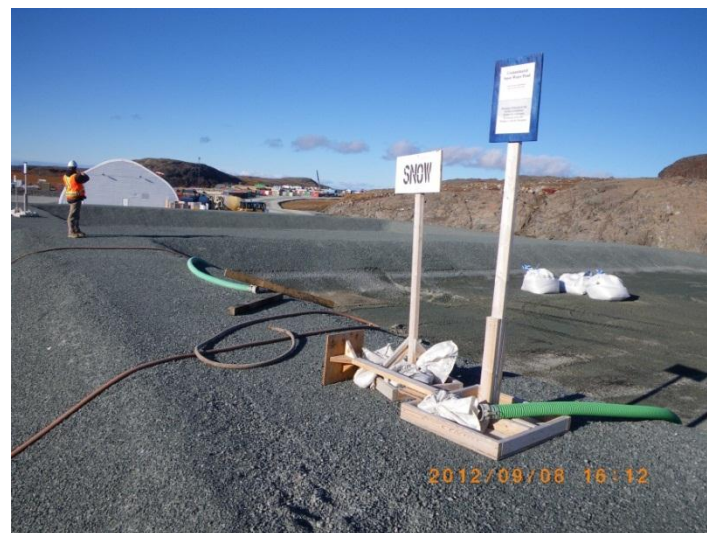
Doris North Landfarm Contaminated Snow Pond

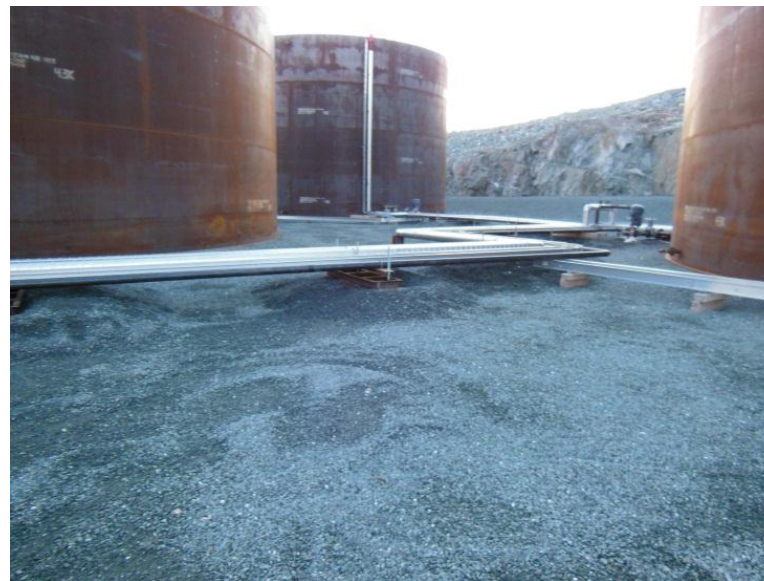
Internal Pipe Supports in the Pad R 5ML Fuel Tank Farm

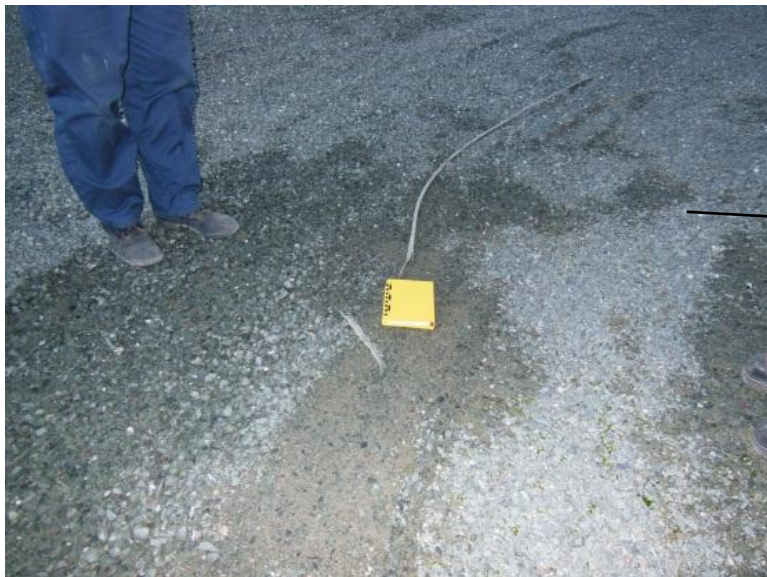
Exposed Grounding Cable in the 5ML Fuel Tank Farm in Pad R

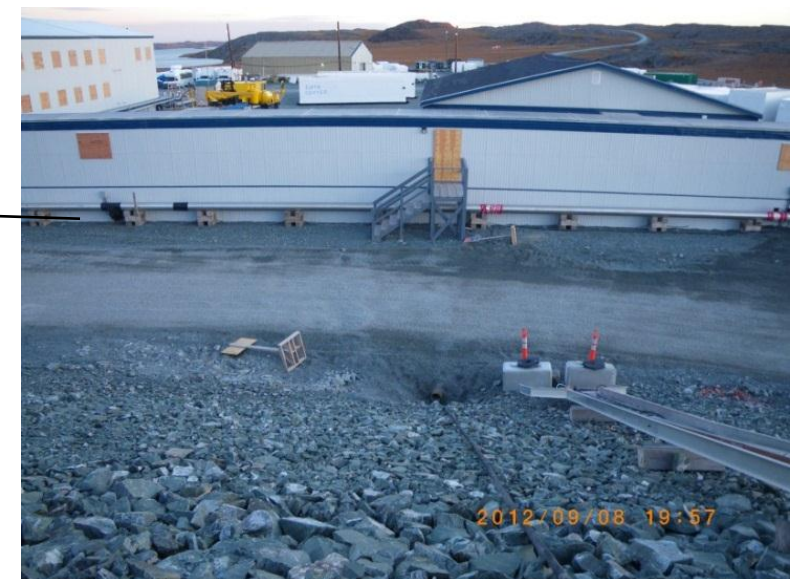
Conduit from the toe of Pad B under the access road coming out by the arctic corridor loading towards the admin and mine day buildings

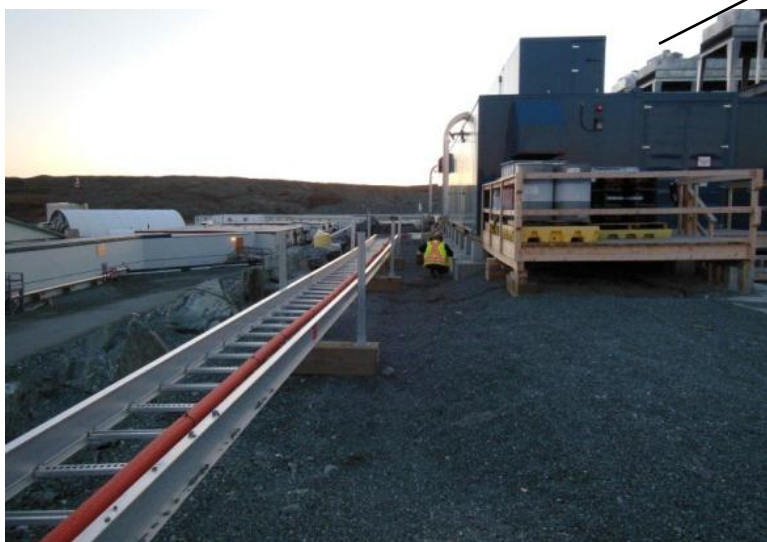
Crest of Pad B

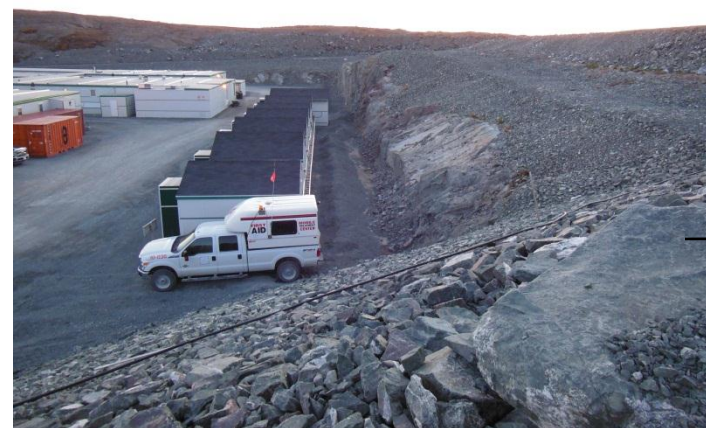
Pad X Highwall looking west from Pad B

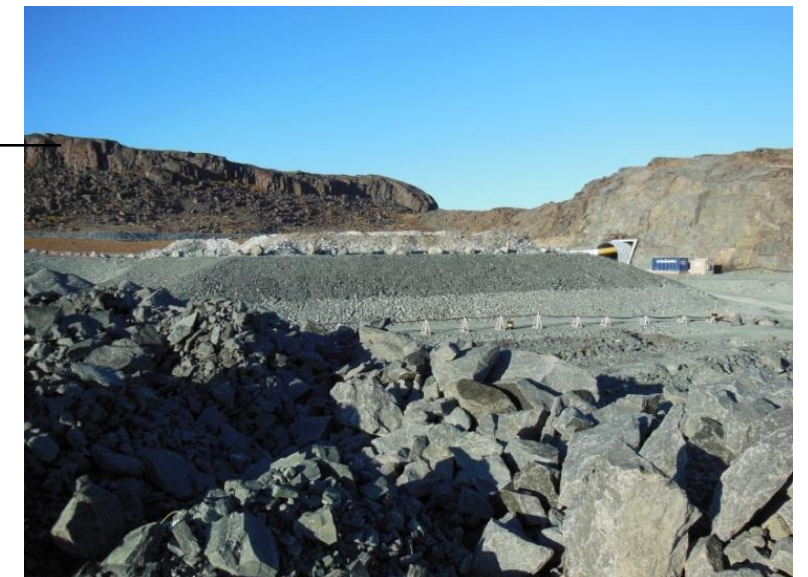
Pad Q expansion over Pads H/J with Waste Rock looking north from the top of the waste rock floor of Pad I

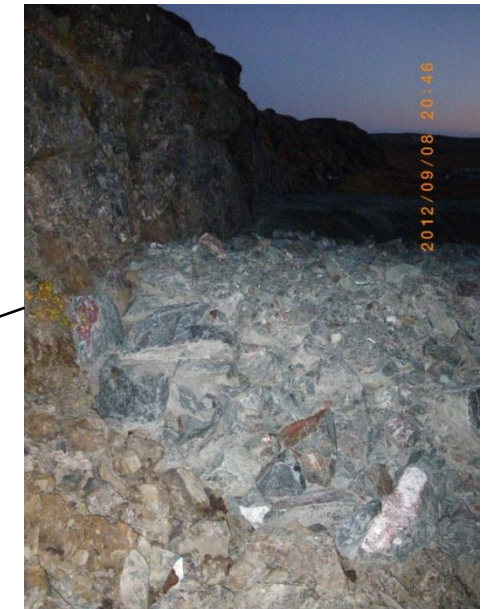
Start of the Diversion Berm north of the Portal

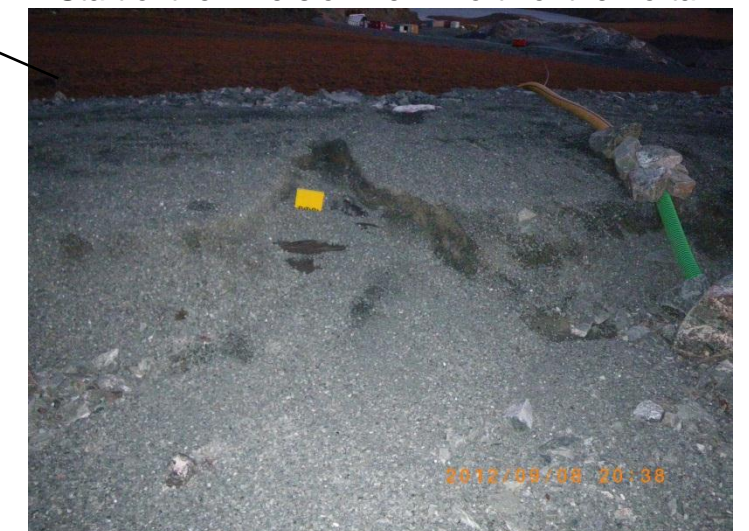
Exposed liner along the crest of the Berm

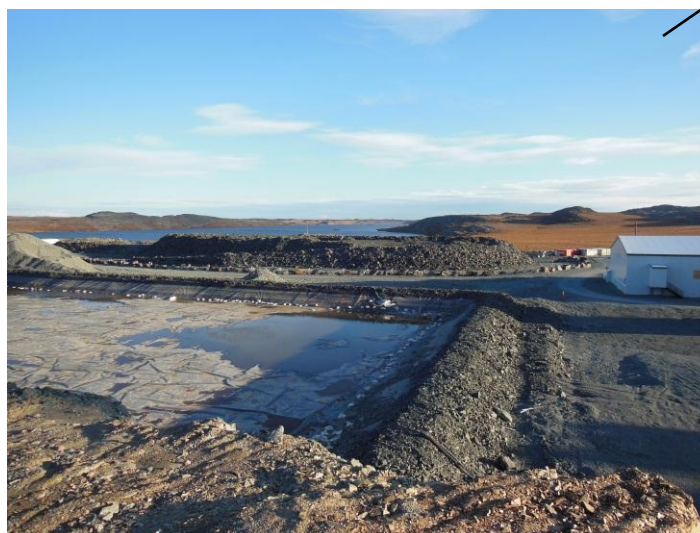
The exposed liner in the Temporary Pond on Pad D. Looking south from the Doris North Access Road

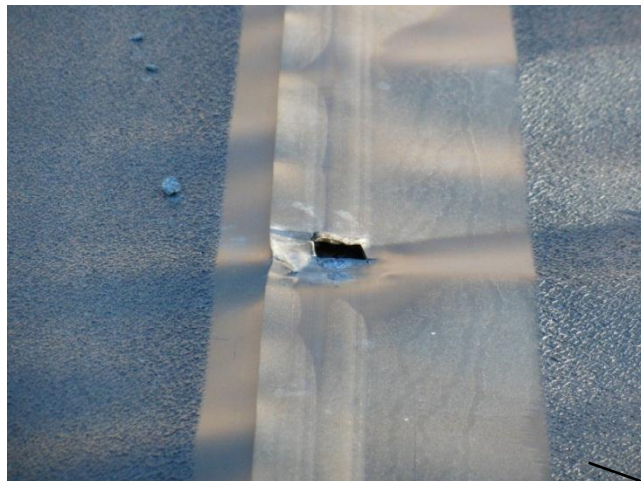
A puncture in the liner at the top northeast corner of the Sedimentation Pond

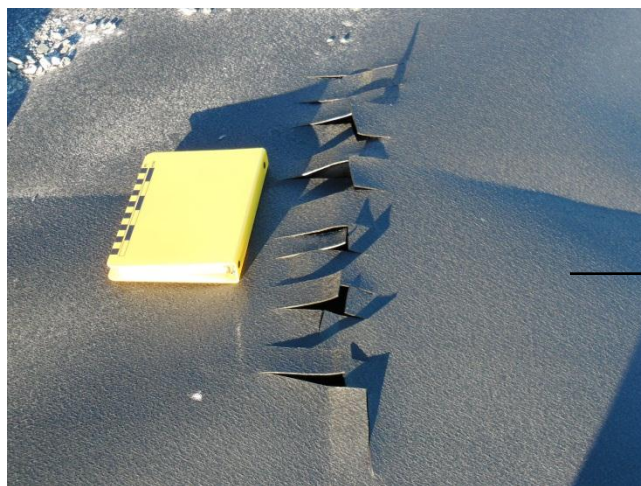
Cuts in the liner at the top northeast corner of the Sedimentation Pond

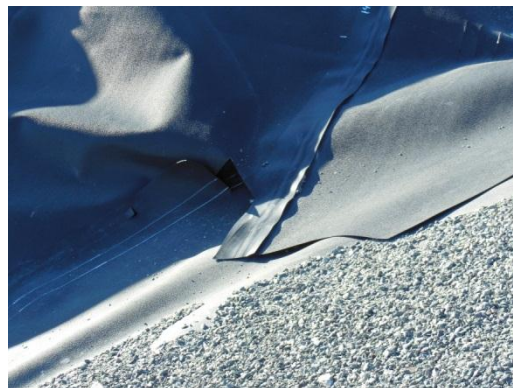
A gap in the overlap of two liner panels that has not been welded

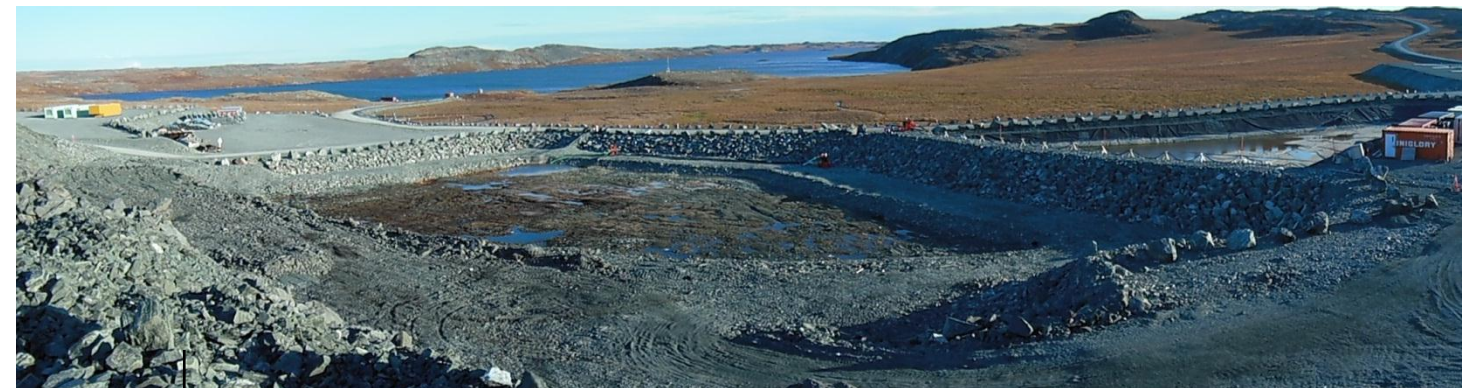
Tension cracks on the interior bench of the Pollution Control Pond

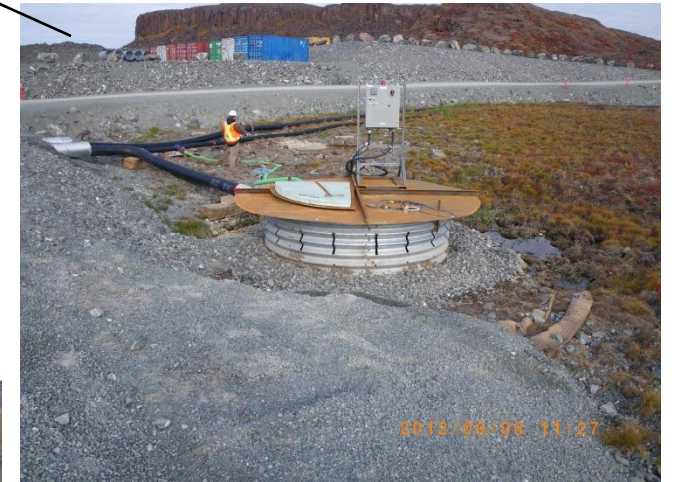
Two sumps (Figure 17) were constructed within the tundra to capture the water that manages to bypass the reconstructed Sedimentation and Pollution Control Ponds. Both sumps were full of water during the time of the inspection. Perimeter permafrost degradation was observed around Sump #1. This was to be expected, and the depression around the steel sump should be backfilled with saved and stockpiled overburden material and covered with coconut matting. Sump #2 appeared to be in good condition.

Sump #2 looking north into camp

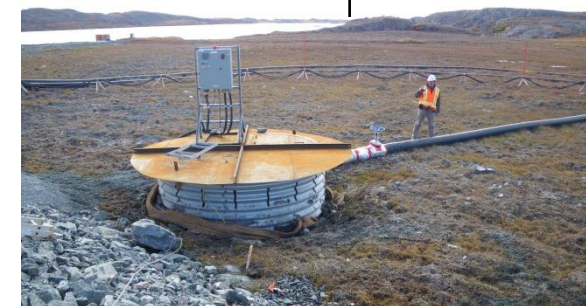
Sump #1 looking west out onto the tundra

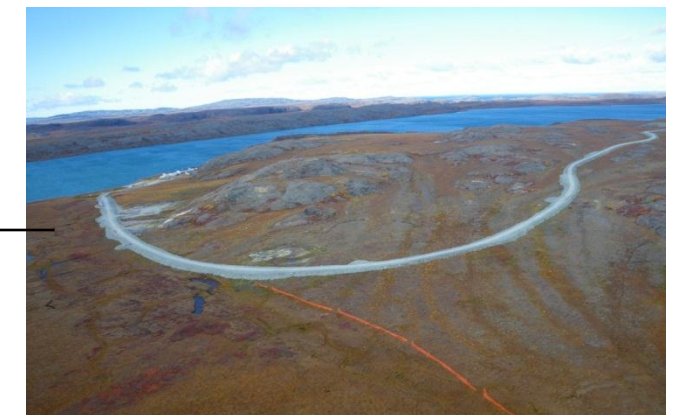
The Doris-Windy road is a 10 km all-weather road that stretches from the Doris Camp, due south to the Windy Camp (Figure 18). The road is an 8.3 m wide single lane road with turnouts designed based on lines of sight. Construction of this road started during the winter of 2009/2010 and was completed in 2011. No 2-inch crush was placed as a surfacing layer from 8+600 to the end of the alignment at 9+733. As a result the road is very rough but passable along this section.

Doris-Windy Road leading to Windy Camp where no surfacing material has been placed

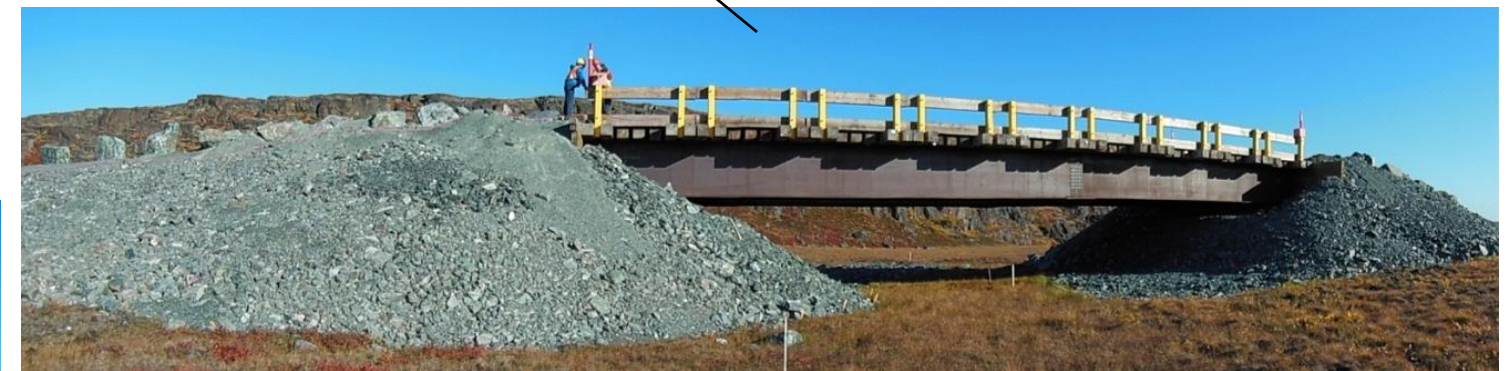
Sink holes were observed where the abutment joins the bridges for Stream Crossing #4

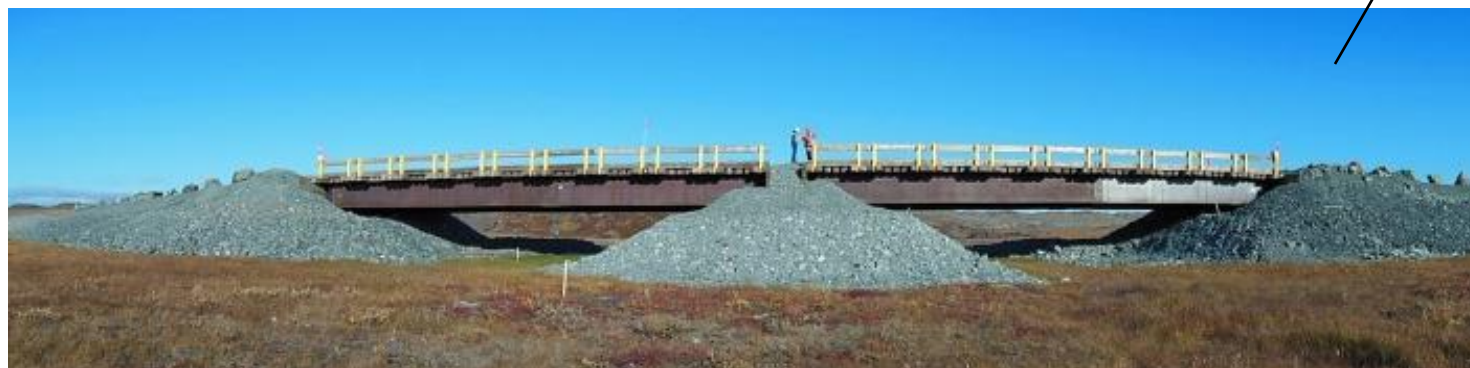
Stream Crossing #2 and #3

Small sinkholes were observed where the abutment joined the bridges for Stream Crossings #2 and #3

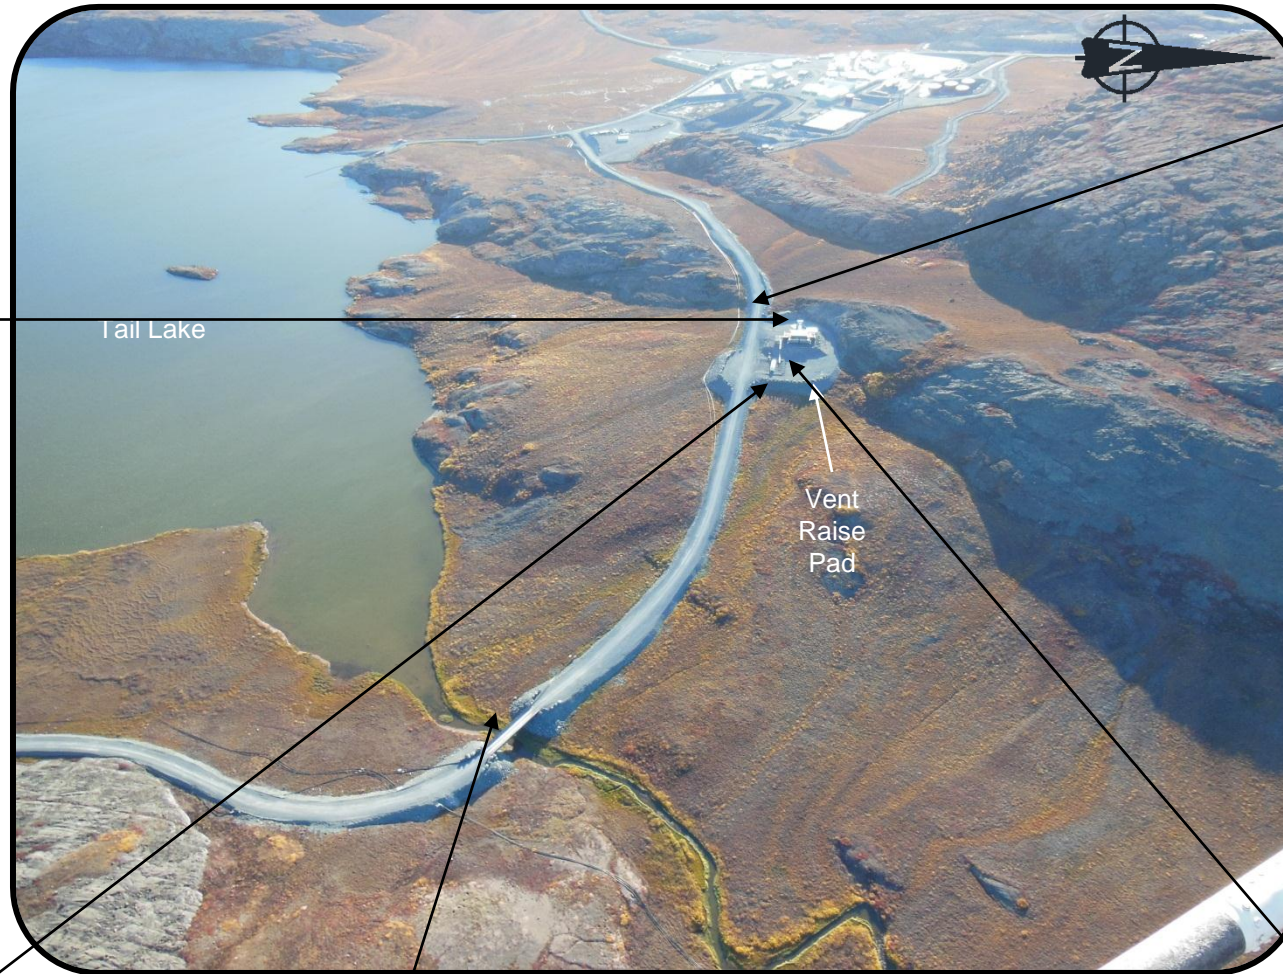
A surficial slope failure occurred in August 2010 during construction of the Secondary Road at approximately chainage 0+550 (Figure 17). At the time construction in this area was stopped and a temporary bypass was constructed. The ground was allowed to freeze during the subsequent winter season and road construction commenced completing this section of road in April 2011. SRK recommended that a buttress be constructed at the same time to ensure that the failure would not get remobilized. This buttress was not constructed; however, no further movement in the road shoulder was observed during the 2012 inspection.

Secondary Road slope failure

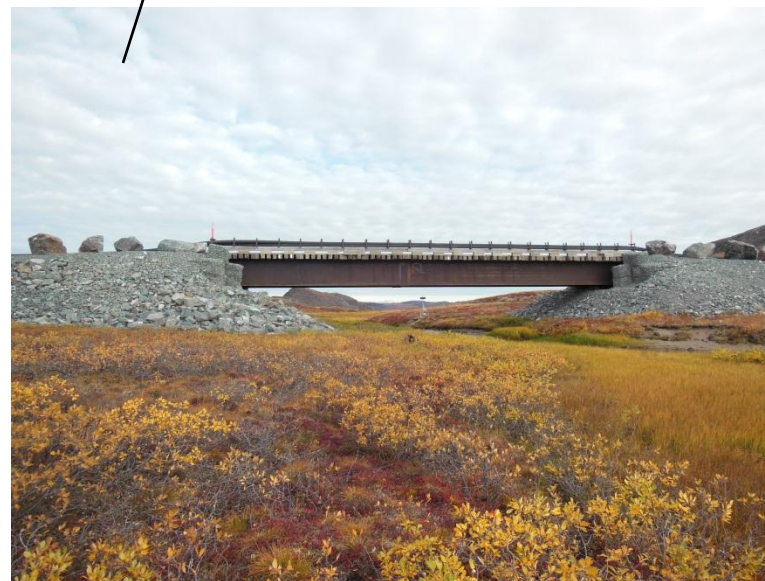
Doris Creek Bridge

The Secondary Road crosses Doris Creek (Figure 21) via a single span prefabricated bridge constructed on two thermal pad abutments. The bridge was installed in 2010. Two thermistor cables were installed in 2011 (one at each abutment) to monitor the integrity of permafrost conditions. Visual inspection revealed no issues of concern other than the poorly constructed rock gabions. These gabions are continuing to deform, and it is likely ultimately they will not fulfill their function of retaining the abutment. Their degradation should be monitored, and the gabions replaced when appropriate.

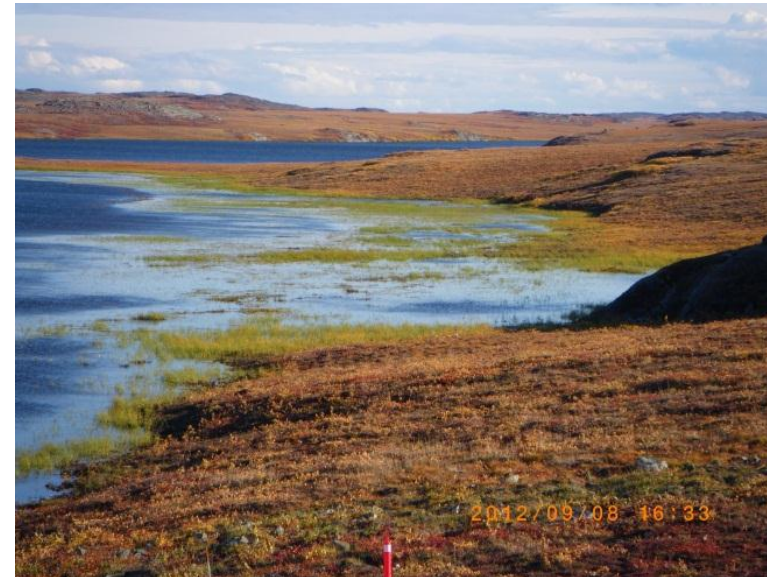
The shoreline of the lake has been flooded due to the increased elevation of Tail Lake

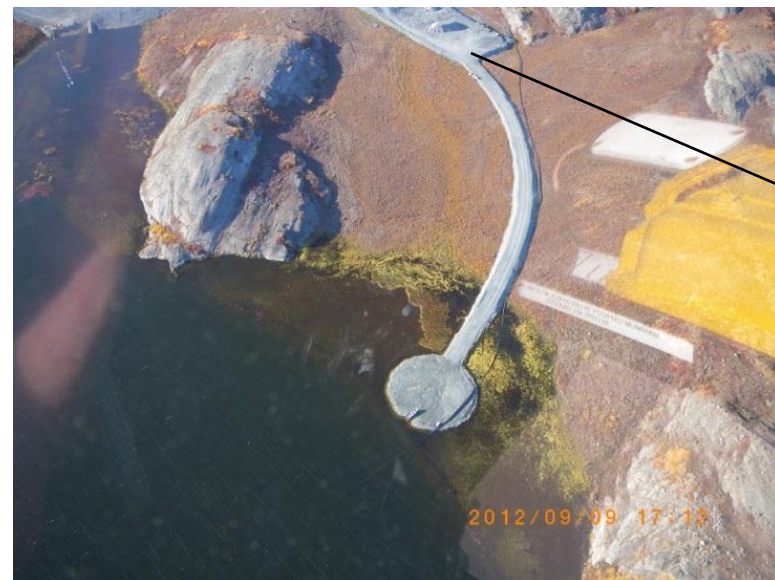
Pump station and water intake line located at the west upstream toe of the dam. The inundated Tail Lake shoreline in the background

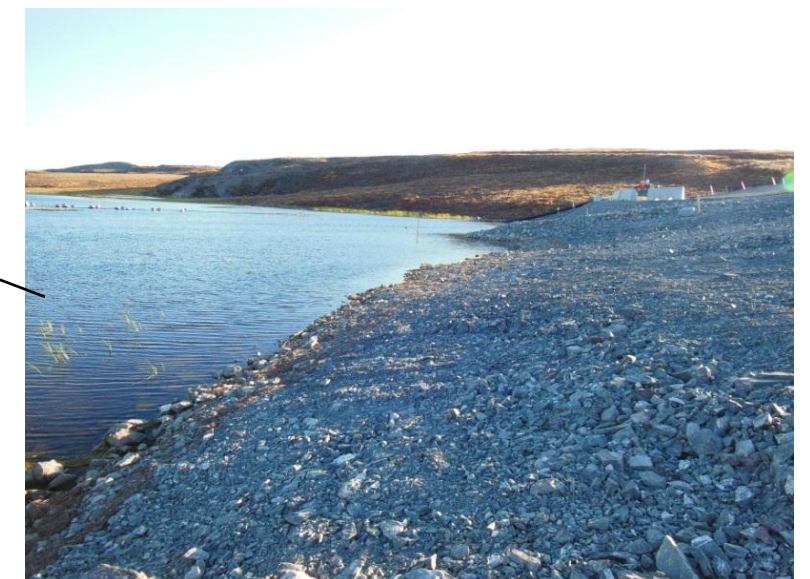
Tail Lake Access Road

Closer view of Tail Lake shoreline – looking west

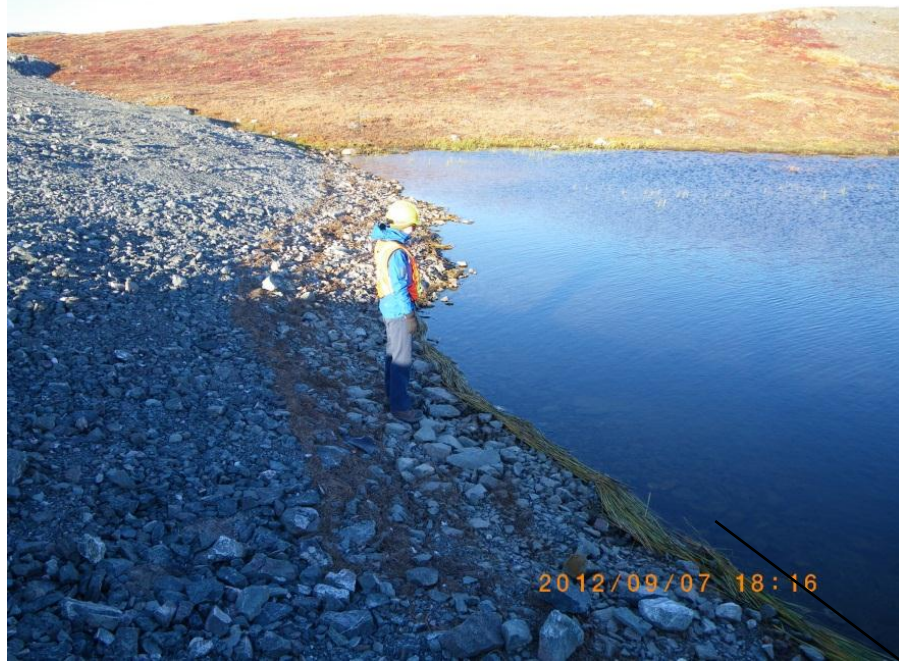
Upstream face looking east

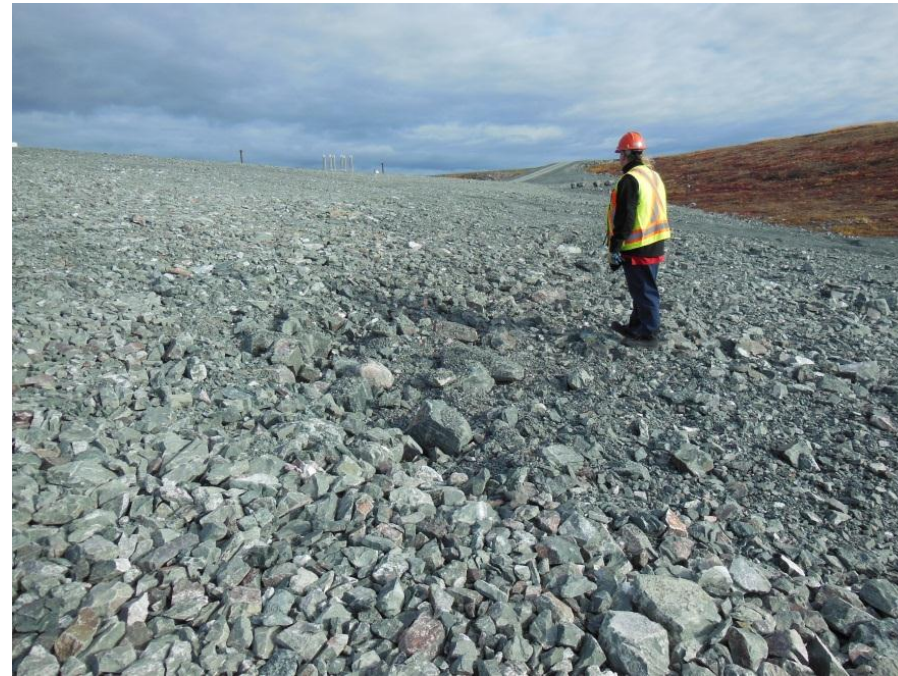
View of the upstream face of the North Dam looking northeast

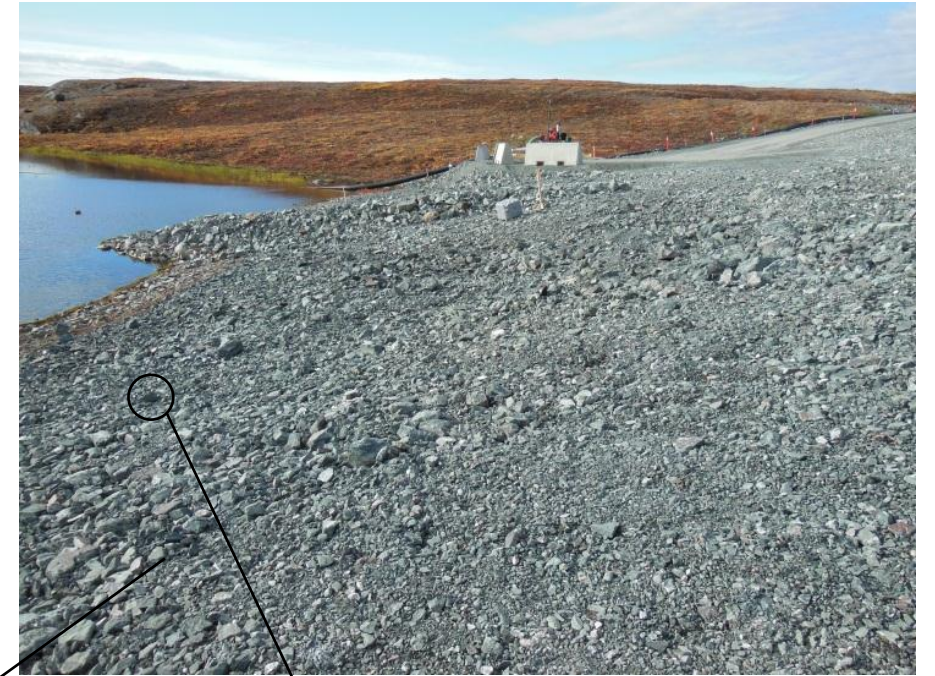
Upstream face looking west

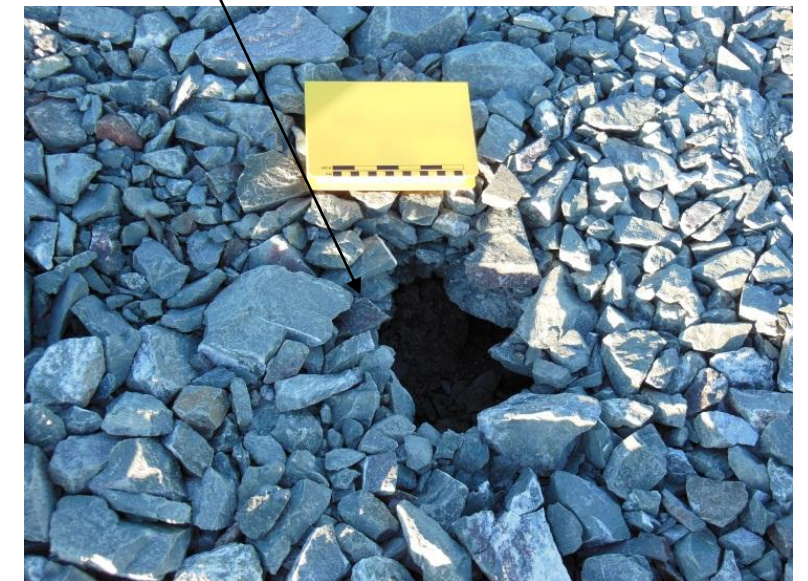
A sinkhole in the upstream face of the North Dam

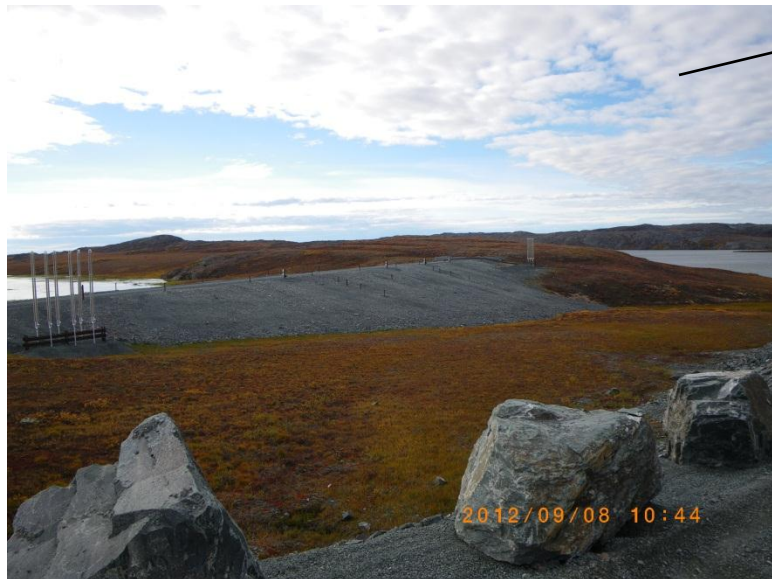
Instrumentation installed in the downstream face of the North Dam
