2012 Annual Geotechnical Inspection Doris North Project Hope Bay, Nunavut

SRK Consulting (Canada) Inc.
1CH008.066
March 2013

Site operations were conducted under a Type "A" Nunavut Water Board (NWB) Licence 2AM-DOH0713 (the Licence), dated September 19, 2007, which entitles HBML (the Licensee) to use water and dispose of waste associated with their operations. HBML contracted SRK Consulting (Canada) Inc. to conduct the annual geotechnical site inspection of the Doris North Project in accordance with stipulated Licence conditions. This annual investigation was carried out from September 7 to 10, 2012.

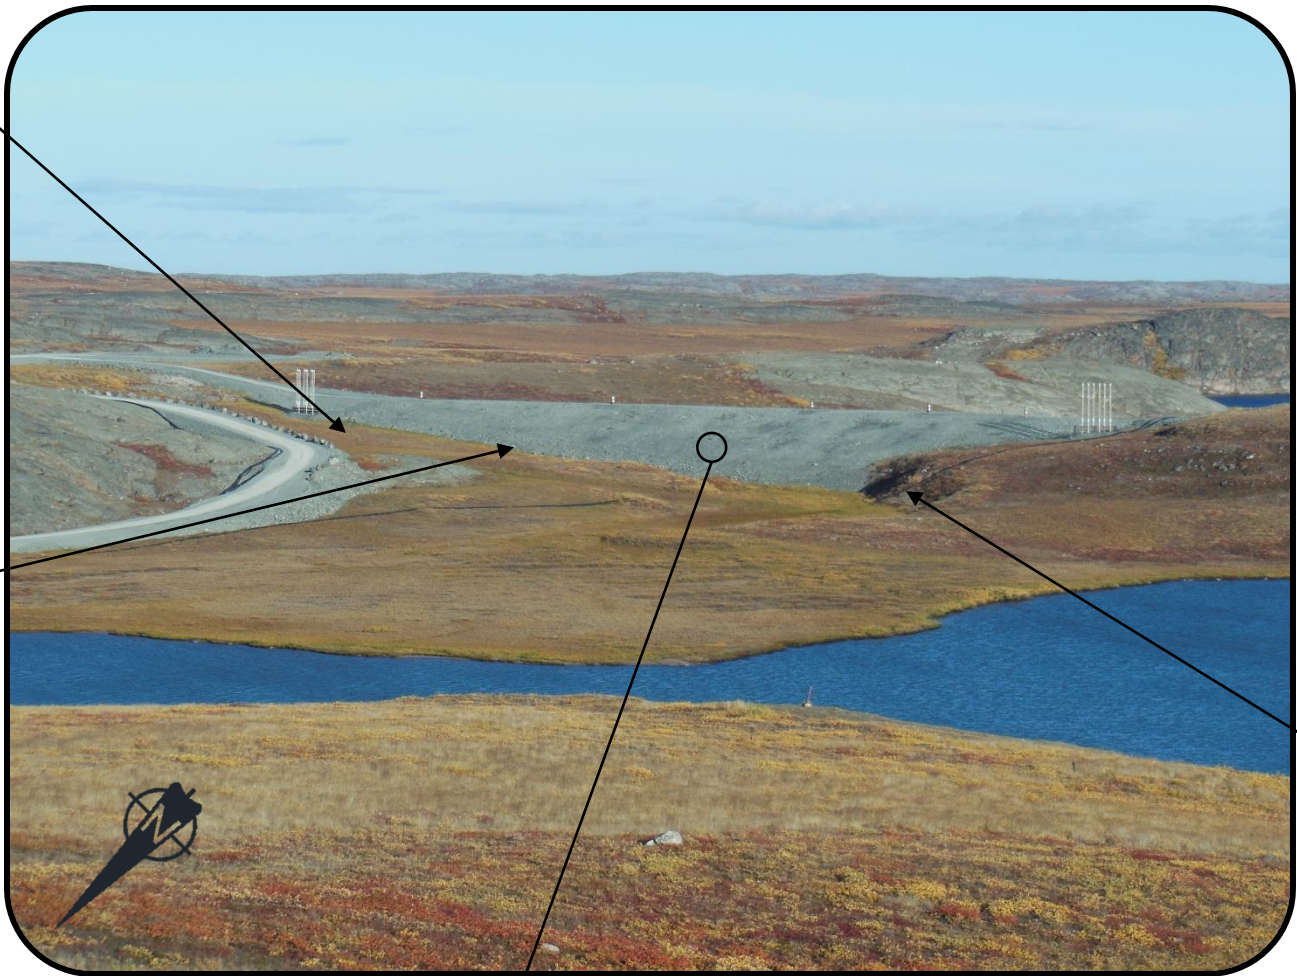
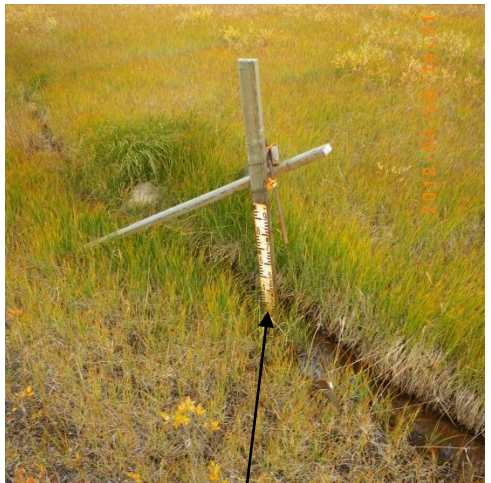
Stream gauge installed in Tail Lake Creek

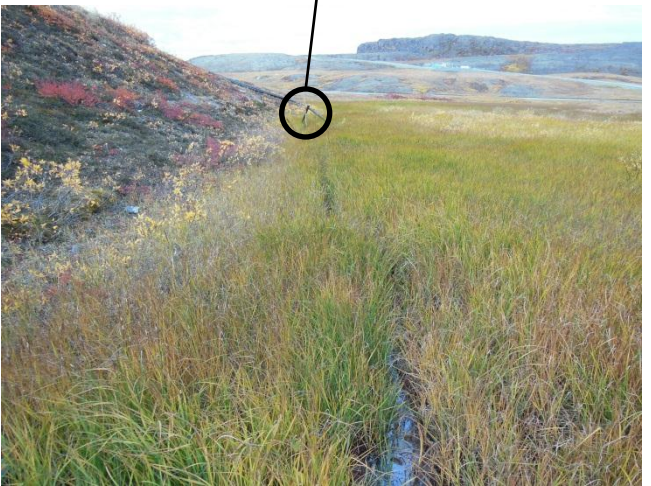
Tail Lake Creek Downstream of the North Dam

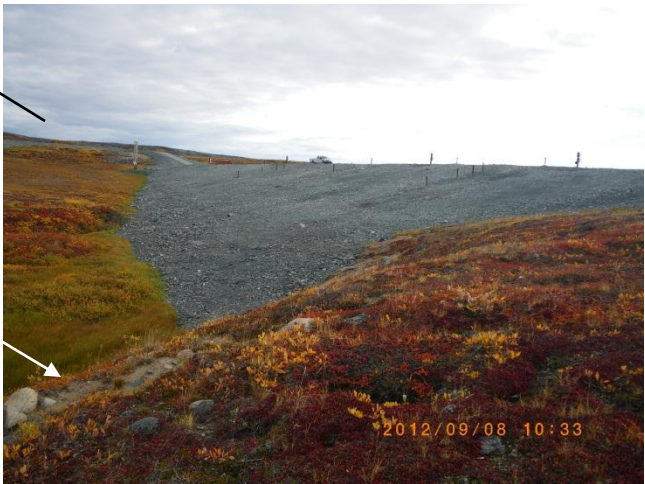
Down Stream Face of the North Dam. Tail Lake Creek in the foreground

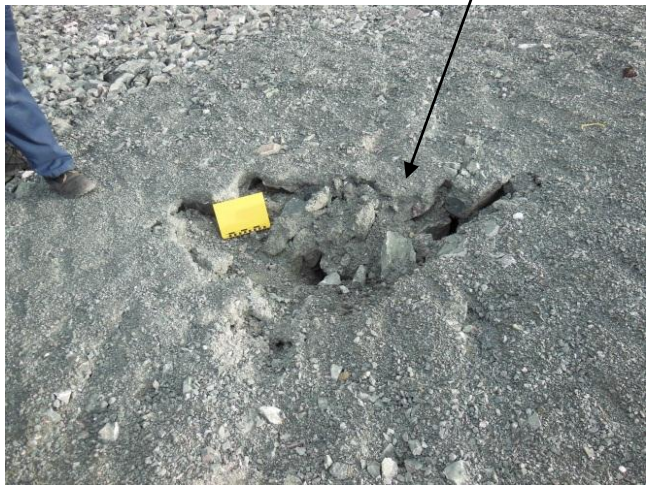
Sink Hole in the downstream face of the North Dam
