Re: 2AM-DOH1323 – 2013 Annual Geotechnical Inspection Report

Please find enclosed with this letter TMAC Resources Inc.'s ("TMAC") 2013 Annual Geotechnical Inspection Reports for water licence 2AM-DOH1323.

Table A: Summary of the Inspection Items and Associated Inspection Recommendations

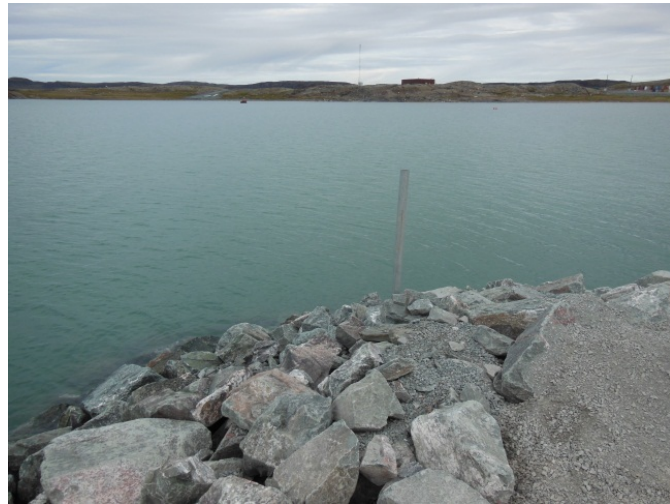
Survey monument 1500 on east end of jetty

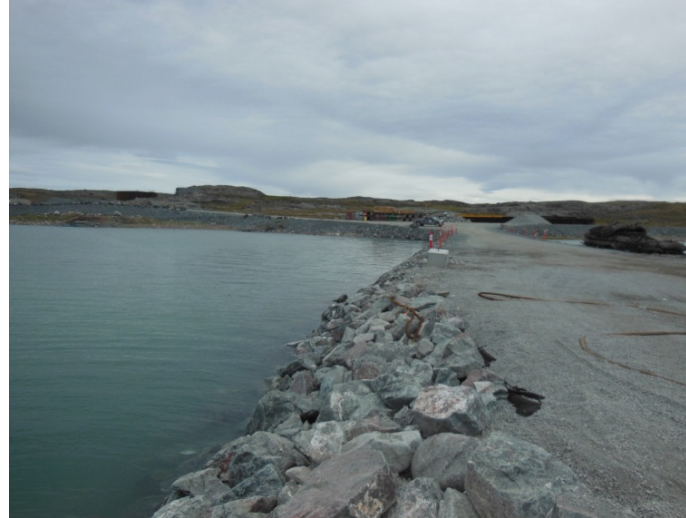
Eastern shoreline of jetty – looking south

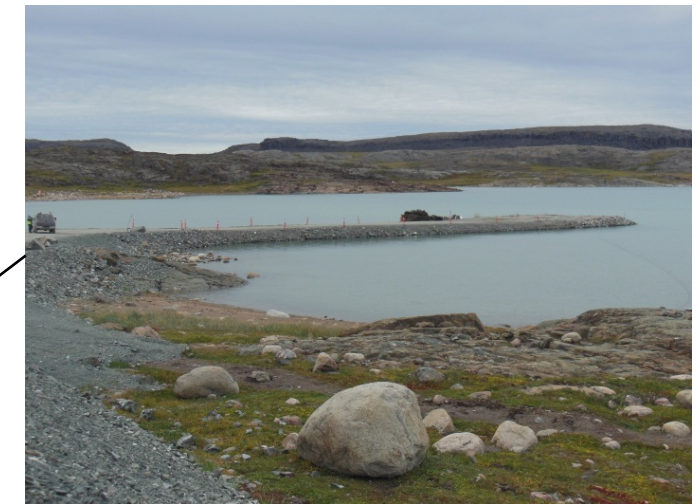
Eastern shoreline of Robert's Bay and jetty – looking west

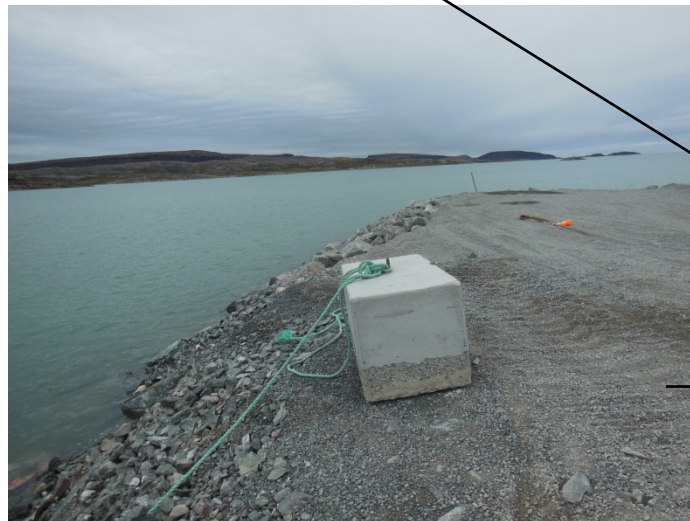
Survey monument 1501 on west end of the jetty

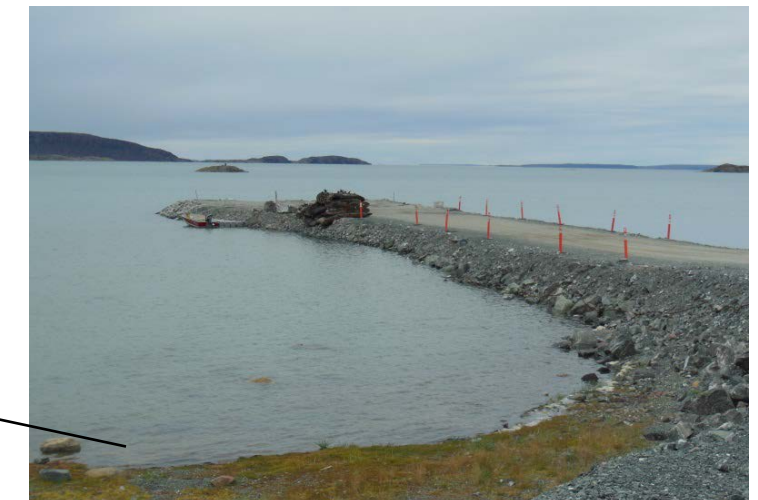
Western shoreline of Robert's Bay and jetty showing the ground temperature cables – looking north

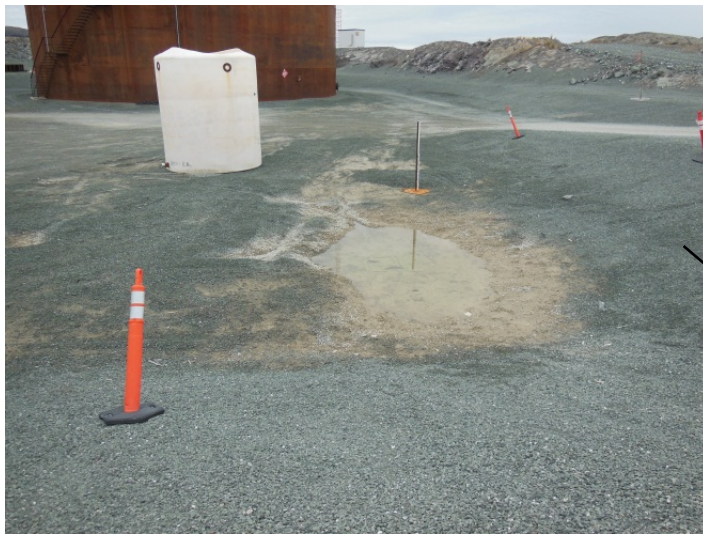
The sump by the access ramp into the Quarry #1 Tank Farm

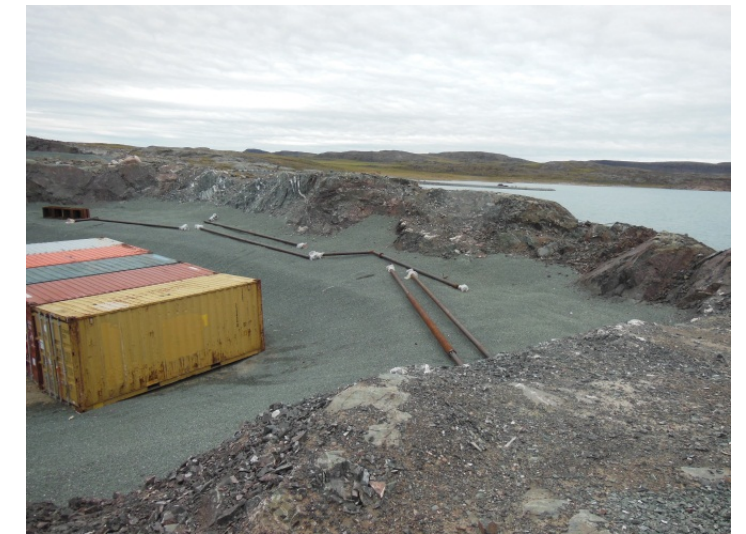
West high wall of the Quarry #1 Tank Farm with the fuel transfer pipes disconnected – looking southwest

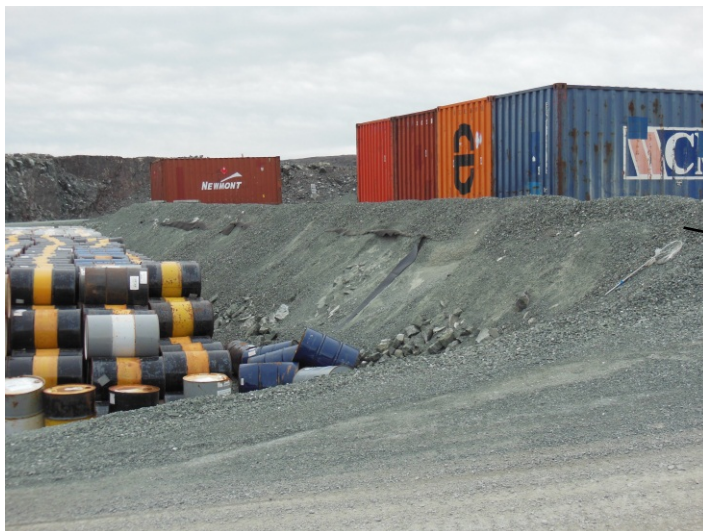
Fuel drum storage and the exposed liner along the back of the fuel transfer station

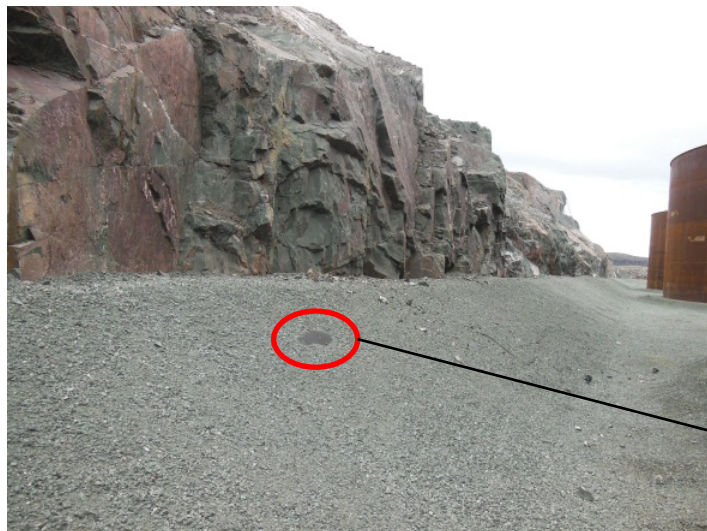
A 20 ML fuel tank farm was completed in late 2011 (Figure 9). The facility is constructed on a rock foundation which was created through drilling and blasting of a rock outcrop due south of the Roberts Bay laydown area. The high wall created is up to 17 m in height and has one catch bench. The high wall had been scaled and in areas, permanent slope stabilization had been installed in accordance with design recommendations. During the 2013 inspection, it was noted the grout around some of the rock bolts had crumbled. The IFC (SRK 2011c) drawings show 2.4 m long rock-bolts were to be installed but no as-built drawings were produced to confirm this. The remaining areas, of exposed high wall are undergoing significant spalling. Consideration should be given to expanding the rock mesh and implementing a management and safety protocol for falling rock. Rock debris within the containment area should be removed. There are indications that run-off from the high wall is being concentrated and running into the containment area at the north end of the facility. The containment facility was designed for this but erosion may cause silt loading or wash gravel off the liner. It is recommended to monitor and take remedial measures should this become worse.

Interior berm along the western high wall showing where the liner has been exposed.

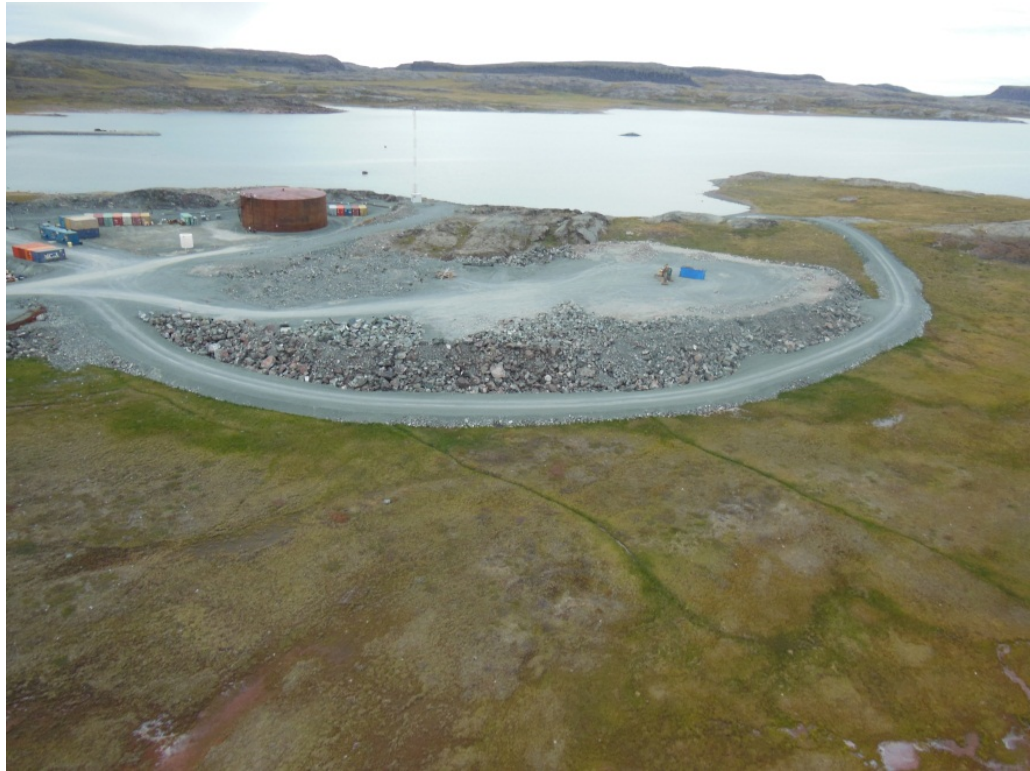
Aerial view of the Overburden Dump and the Robert's Bay Access Road – looking west

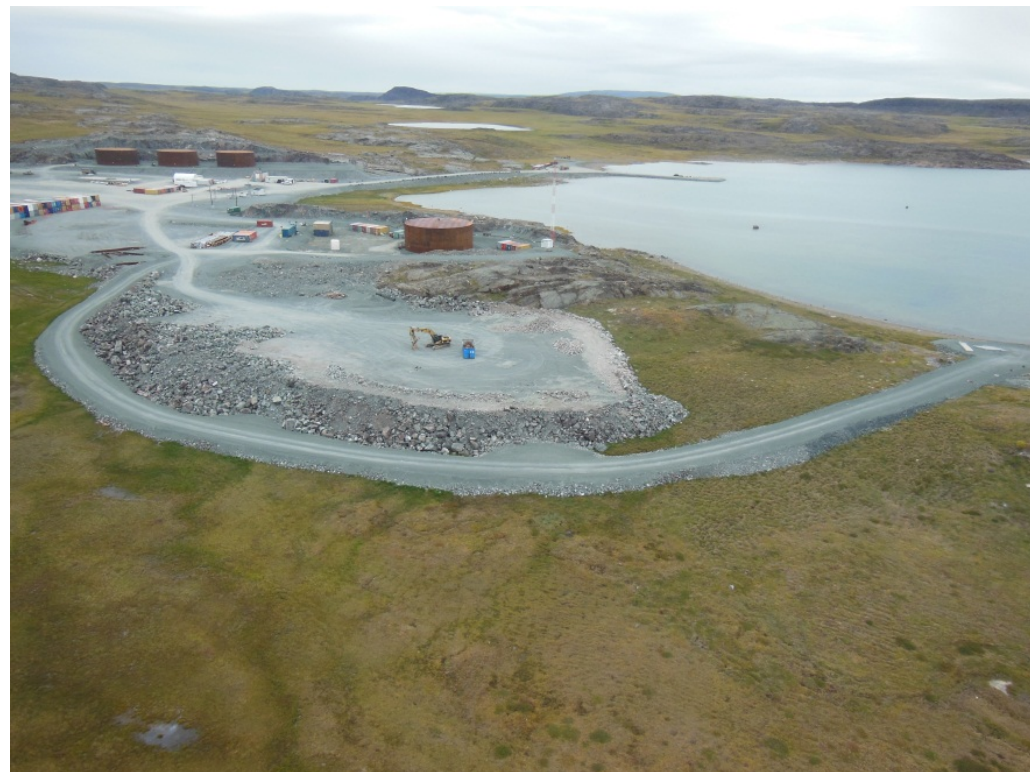
Aerial view of the overburden dump and the Roberts Bay Access Road to the eastern shore of Roberts Bay. The 20 ML Tank Farm is in the background – looking southeast

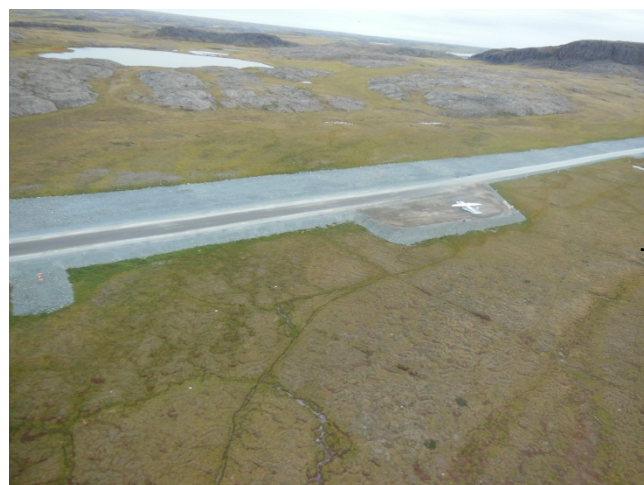
Aerial view of the south apron – looking east

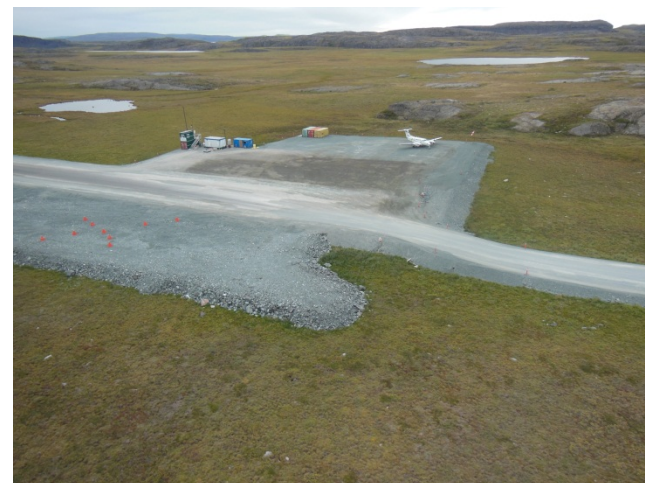
Aerial view of the north apron – looking east

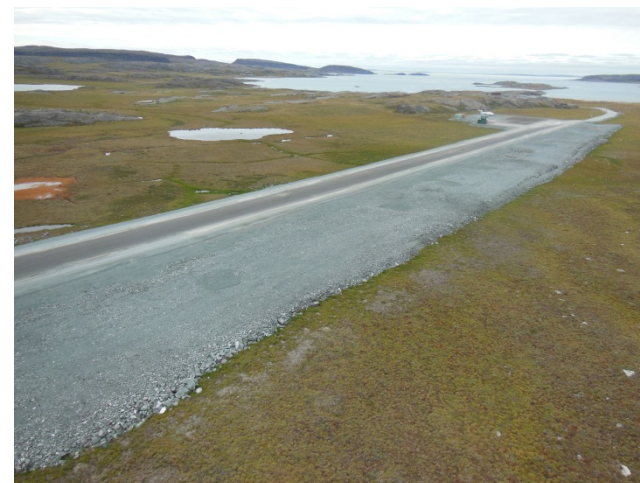
Aerial view of the airstrip and partially completed expansion – looking north to Roberts Bay

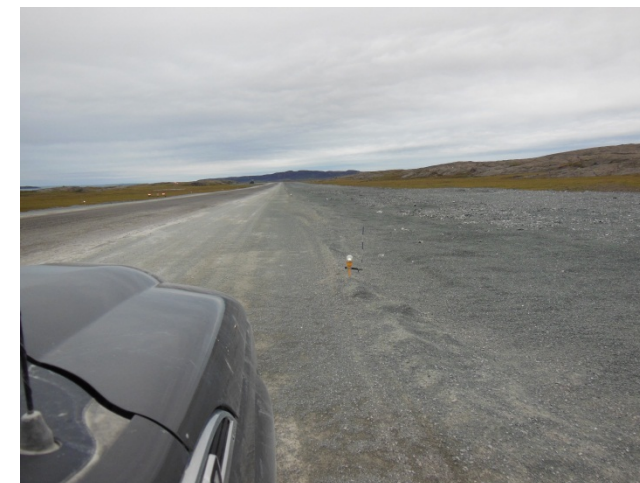
East side of existing airstrip with partially completed expansion – looking north

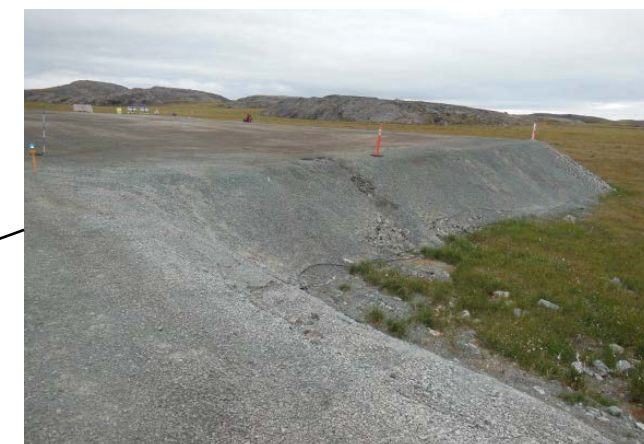
Sink holes and an erosion gully on the north edge of the south apron

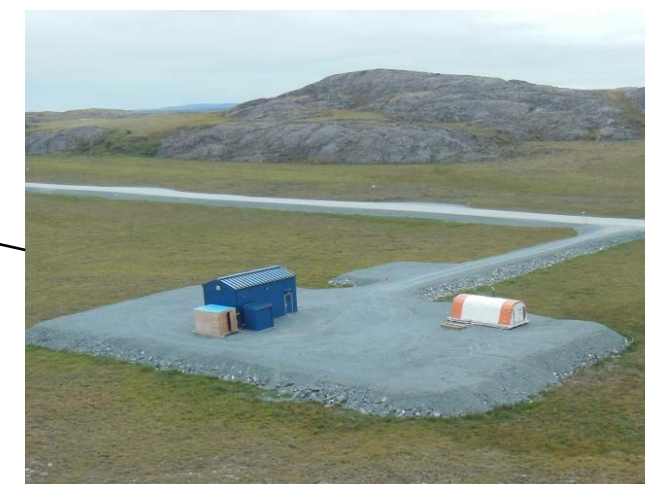
Explosives AN/FO Mixing Facility with the Primary Road in the background – looking west

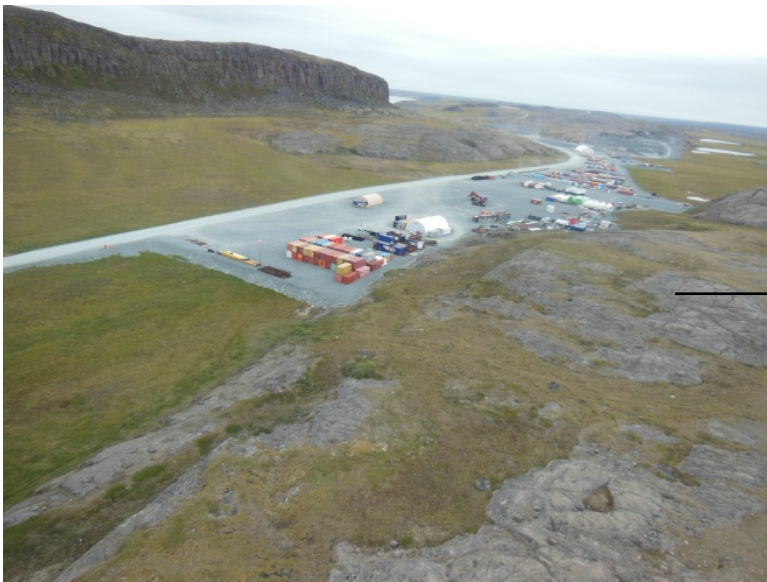
Aerial view of the north end of the Upper Reagent Pad – looking south

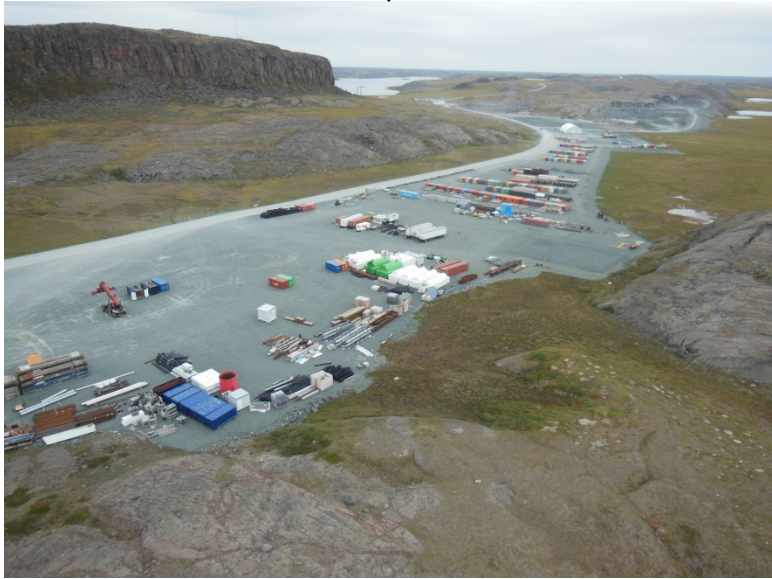
Aerial view of the Upper and Lower Reagent Pads – looking south. The AN storage area is in the middle of the photo

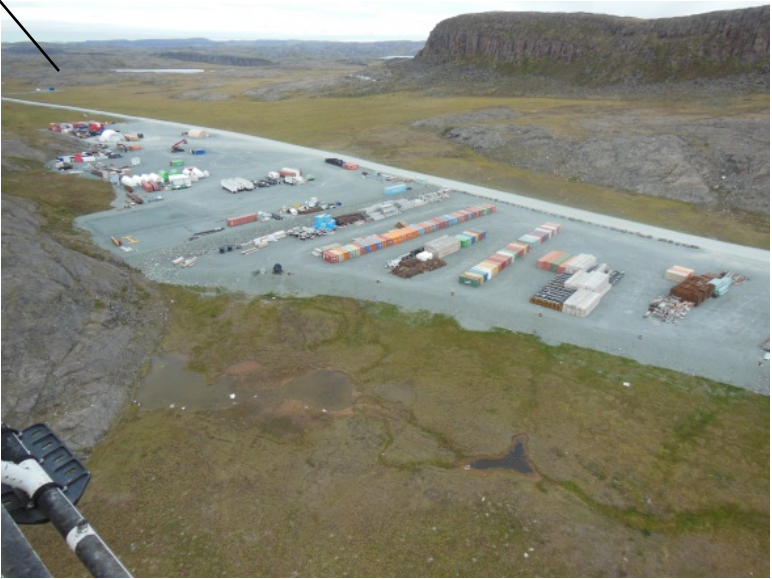
Aerial view of Lower and Upper Reagent Pads – looking northeast

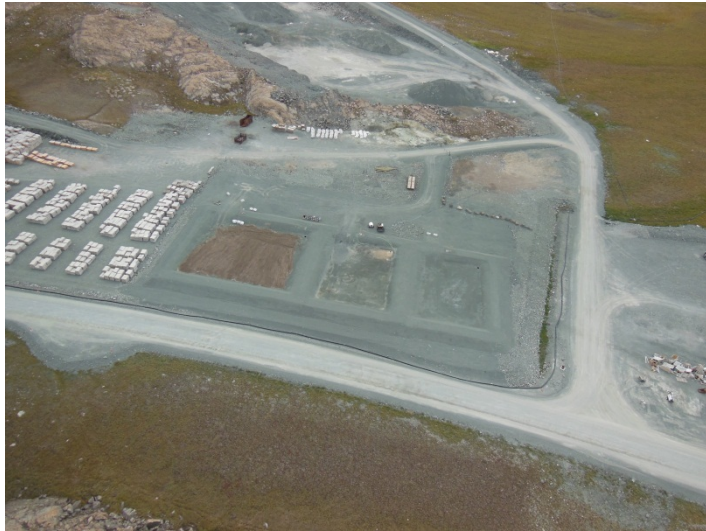
Aerial view of the Doris North Landfarm – looking east

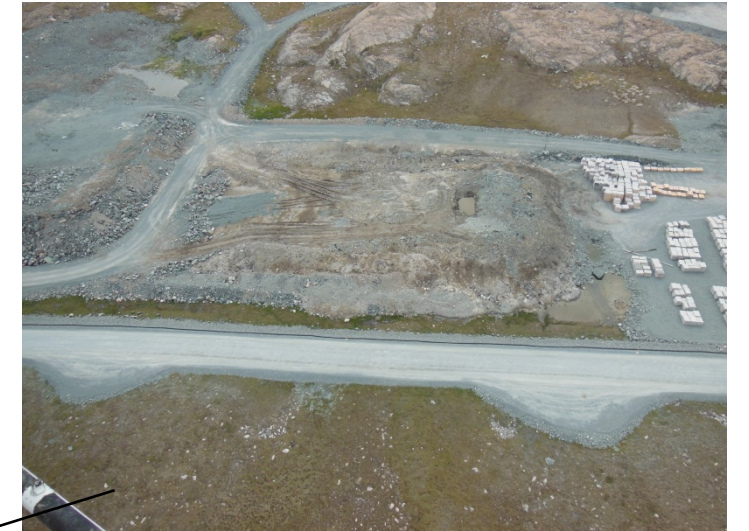
Aerial view of the north end of the Overburden Dump – looking west

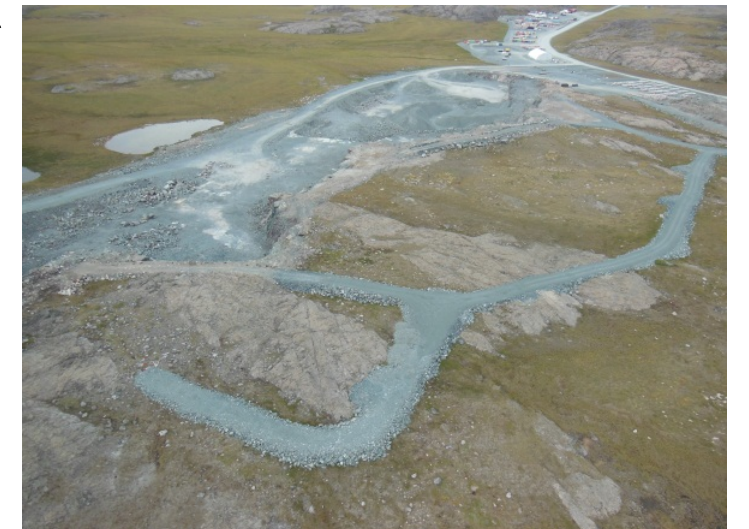
Aerial view of Quarry #2 – looking north

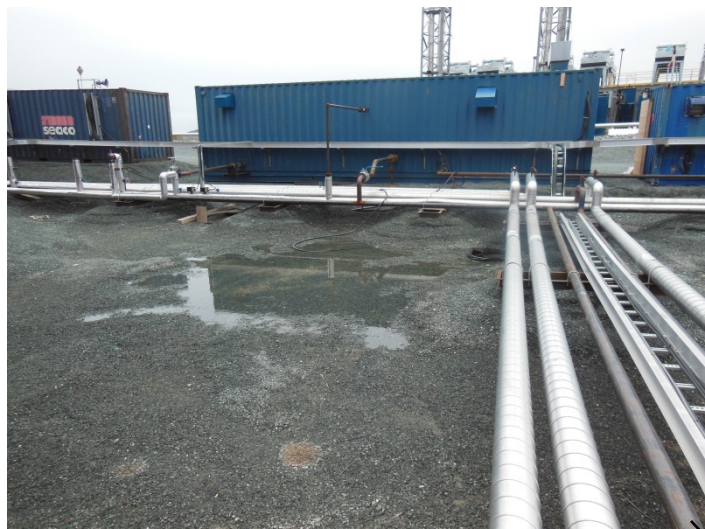
Doris 5 ML Tank Farm – looking south towards the fuel transfer station

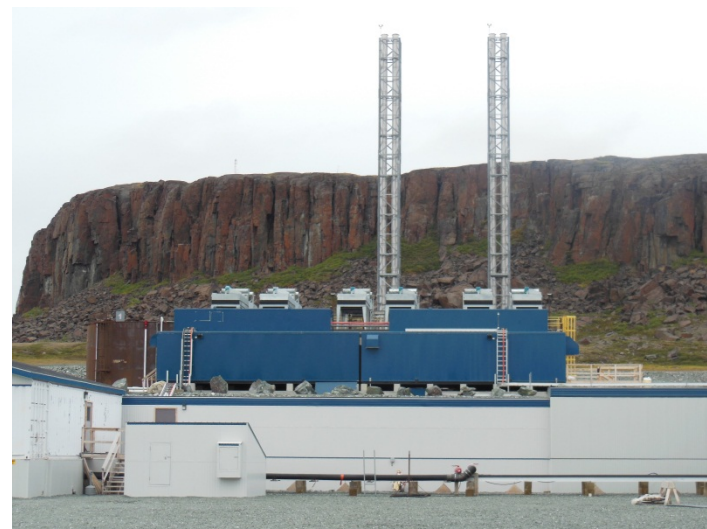
Power Plant on Pad B – looking north from Pad C

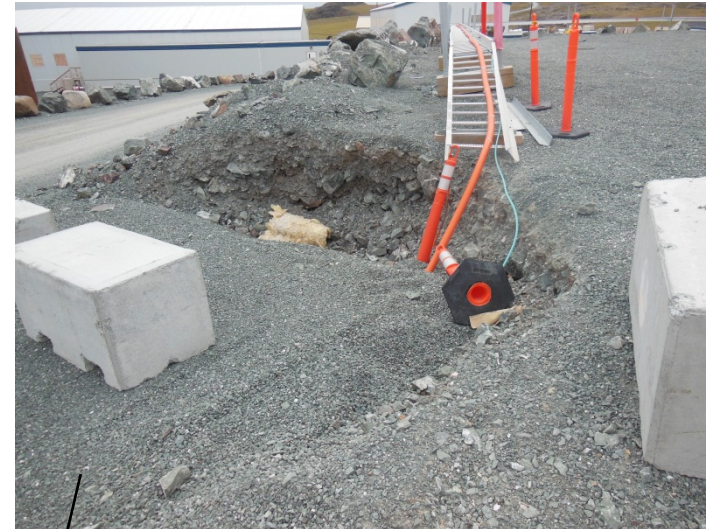
A large erosion gully on the crest of Pad B which can lead to erosion issues

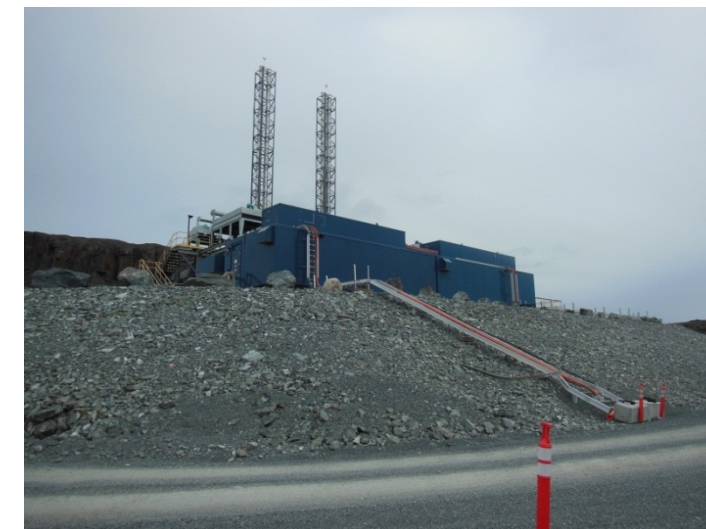
The Power Plant on Pad B – looking northeast from Pad X

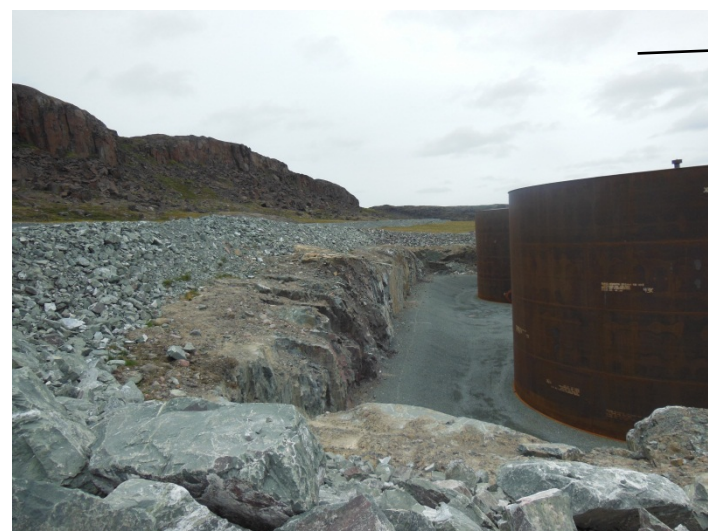
7.5 ML Doris North Camp Tank Farm north high wall looking down from the North Access Road

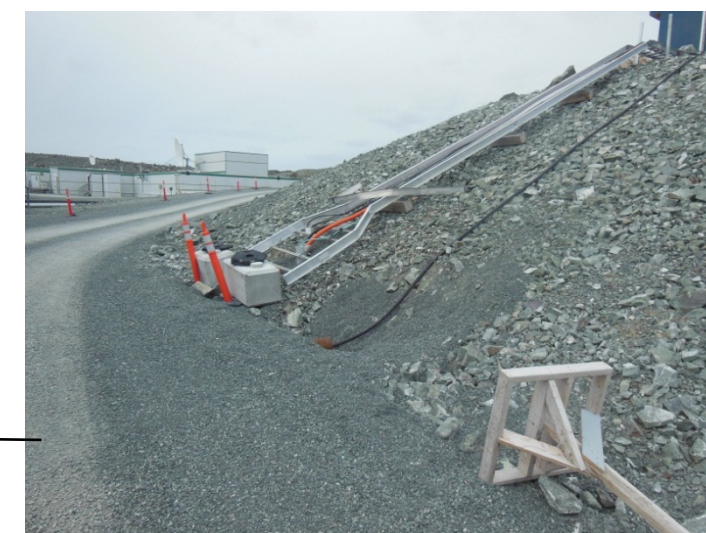
Conduit from the power plant running down to the toe of Pad B and under the Access Road to Doris North Camp

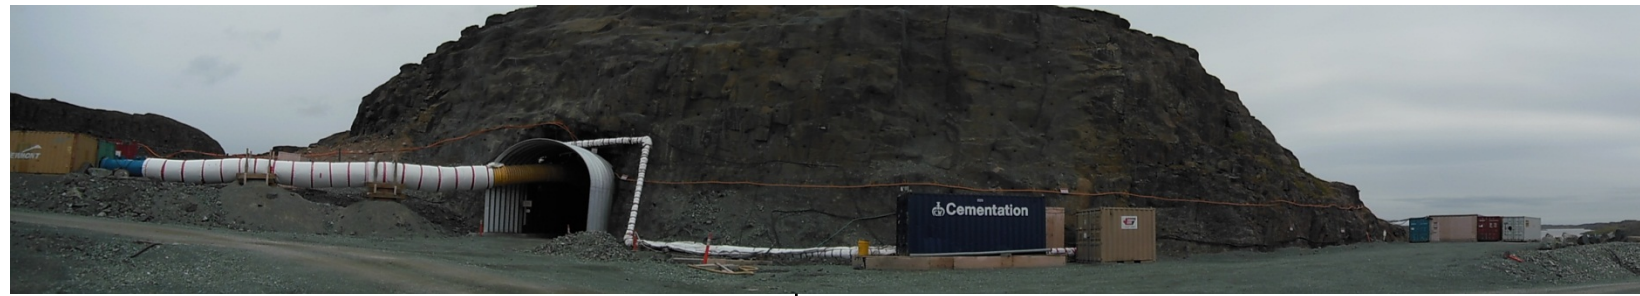
Portal entrance - looking east from Pad Q/H/J

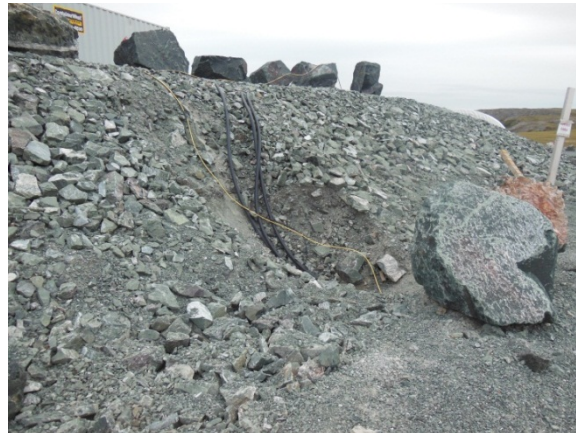
Conduit running down from Pad L and under the access ramps

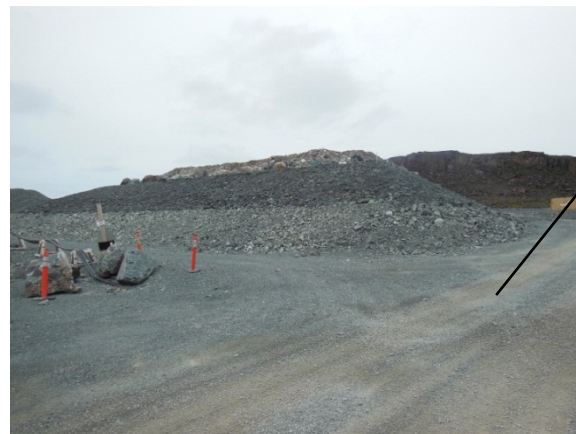
Pad Q Expansion over pads H/J waste rock looking north from Pad F

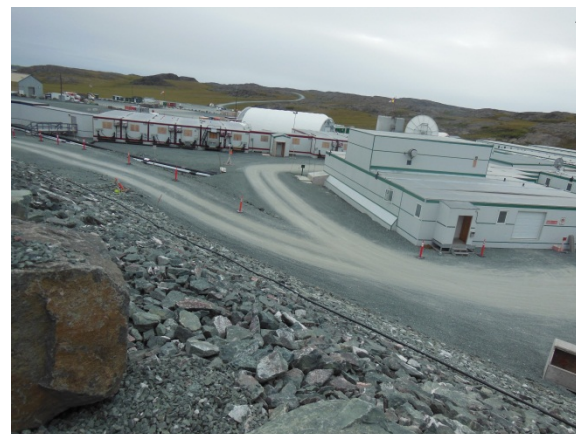
Doris Camp – looking south from Pad R

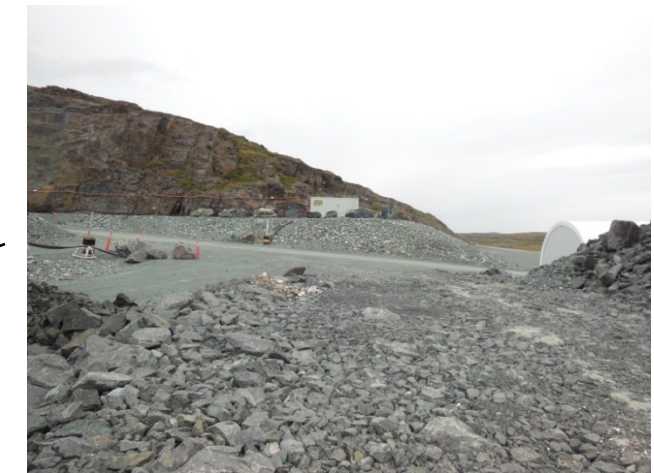
Pad L - looking east from the ramp to the entrance of the waste rock pile on Pad I

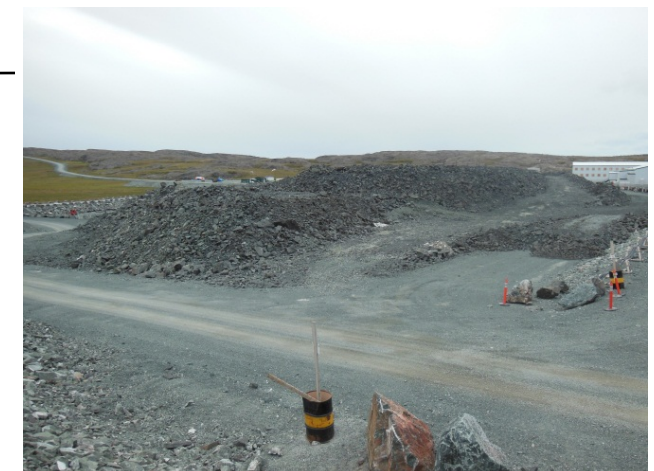
The waste rock pile on Pad I – looking down from Pad L

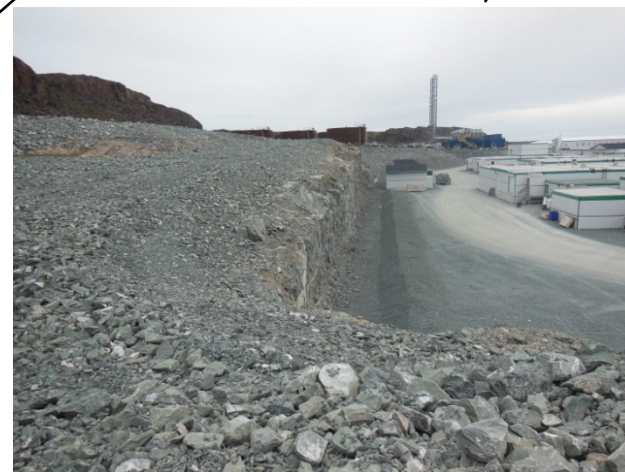
The north high wall of Pad X – looking east from the Primary Road

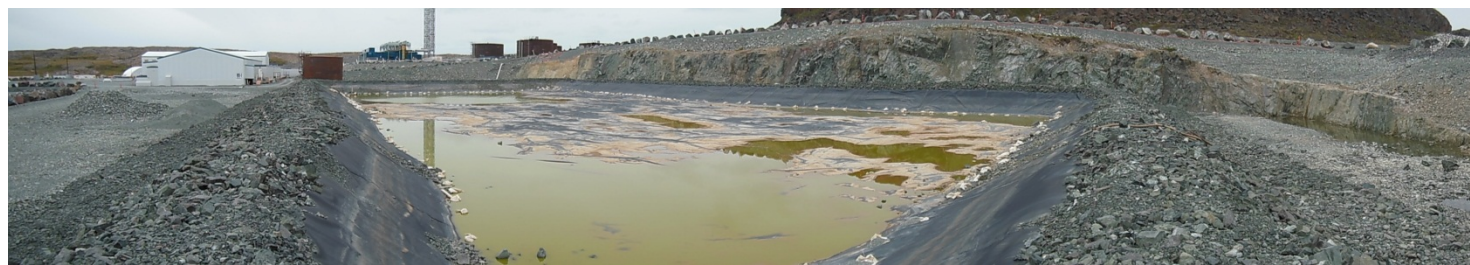
Panoramic view of the temporary pond on Pad D - looking northwest

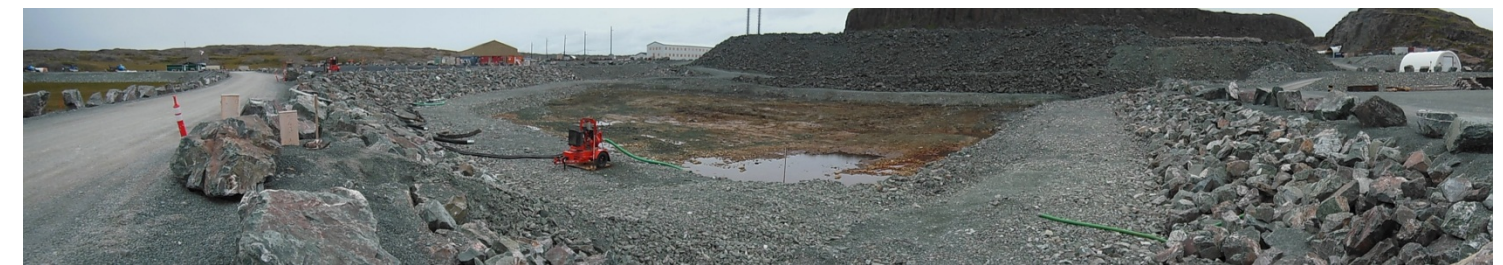
Panoramic view of the Pollution Control Pond - looking west from the Float Plane Dock Access Road and the ramp to Pad G

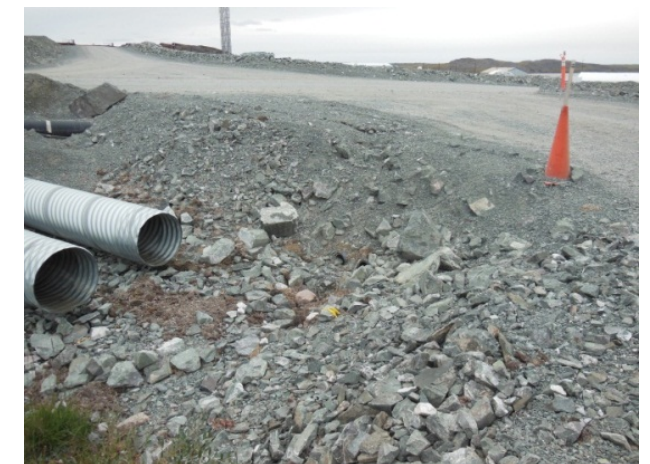
The culverts coming out from the Primary Road to the overburden stockpile area

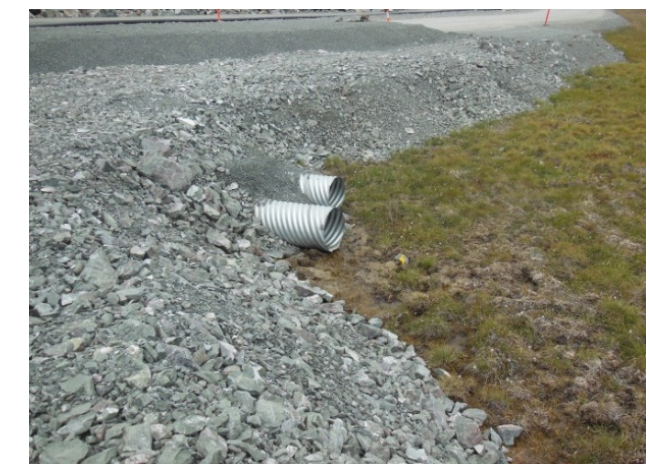
The culverts going under the Primary Road at the junction of the Primary Road and the North Access Road and Doris North Diversion Berm

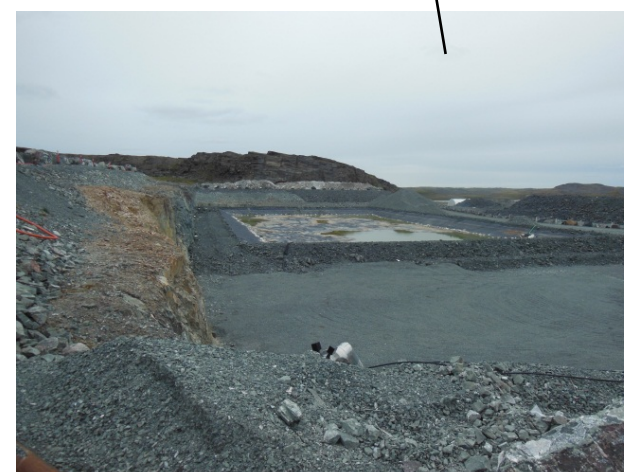
The Temporary Pond – looking east from the North Access Road by Pad B

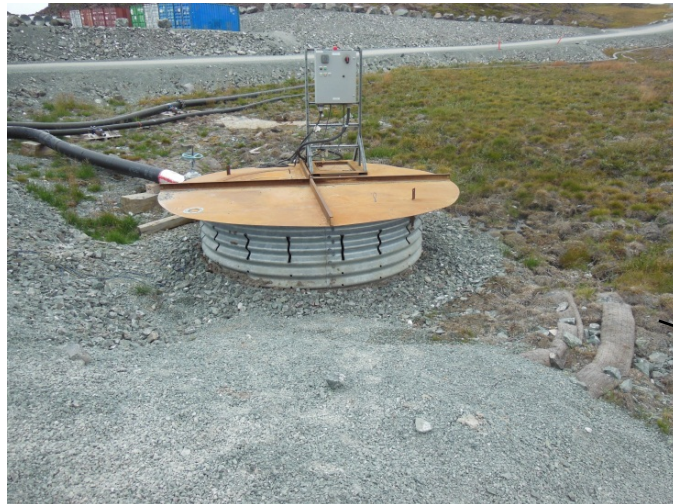
Two sumps (Figure 18) were constructed within the tundra to capture the water that manages to bypass the reconstructed Sedimentation and Pollution Control Ponds. Both sumps were full of water during the time of the inspection. Perimeter permafrost degradation was observed around Sump #1. This was to be expected, and the depression around the steel sump should be backfilled with the saved and stockpiled overburden material and covered with coconut matting. Sump #2 appeared to be in good condition.

Sump #2 - looking north towards Doris Camp

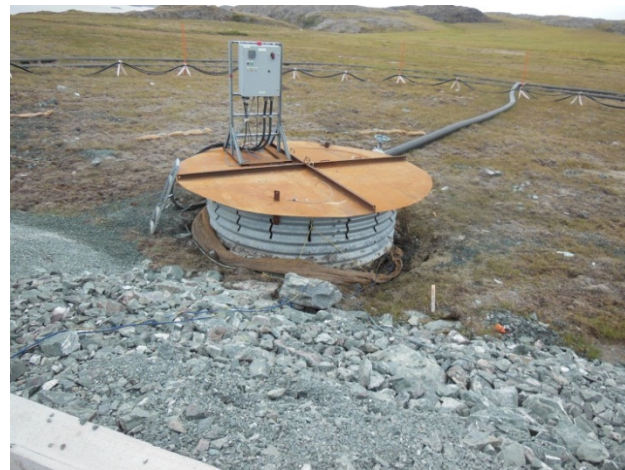
Sump #1 - looking southeast

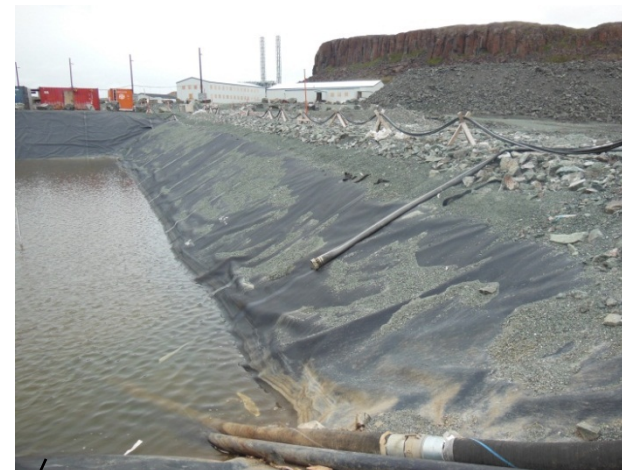
The east side of the Sediment Control Pond. Overliner material from the Divider Berm has washed down on to the exposed liner

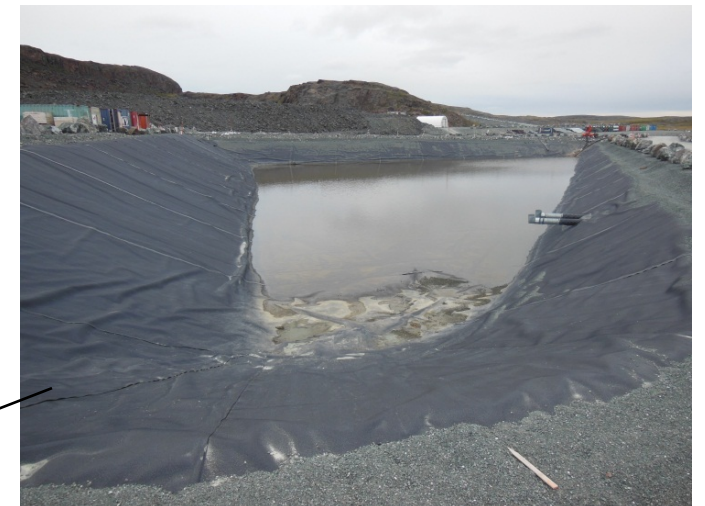
An overview of the Sediment Control Pond looking east from Pad E/P. There is a large rock at the bottom of the pond in the foreground

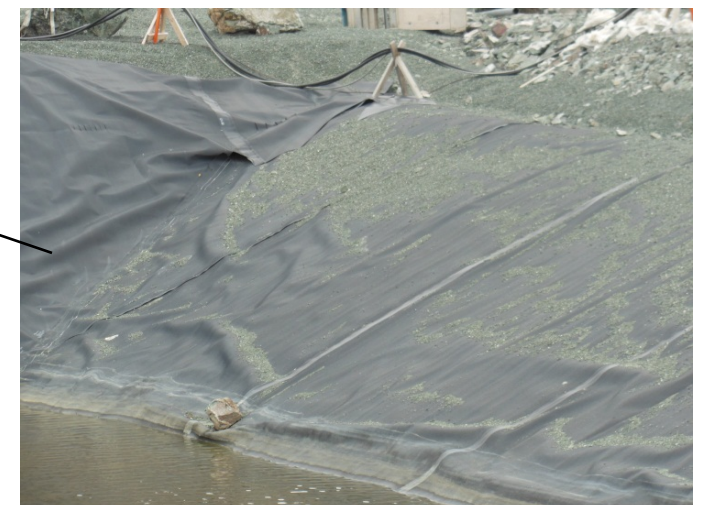
A large rock on the exposed liner at the north corner of the Sediment Control Pond

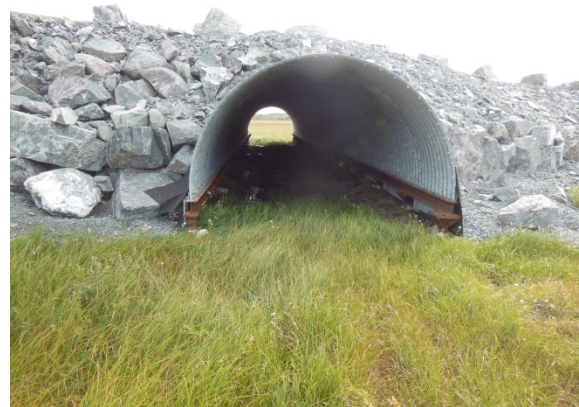
There are four designated Stream Crossings along the Doris-Windy All-Weather Road (Figure 20). The first Stream Crossing was installed in 2010 and consists of an arch culvert. The culvert is founded on add-freeze piles. The inspection revealed no major concerns. The web of the I-beam, on top of the fourth pile from the northwest corner of the culvert, has buckled. This deformation has not increased since it was first noticed during the 2012 inspection but should continue to be monitored. Structural repairs would be required if this deformation increases.

Arched Culvert #1 – looking east

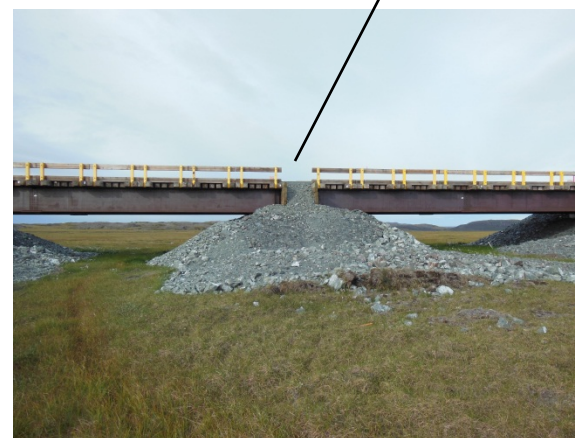
The abutments between the two bridges over Stream Crossings #2 and #3. Water is ponded against the abutment at the toe.

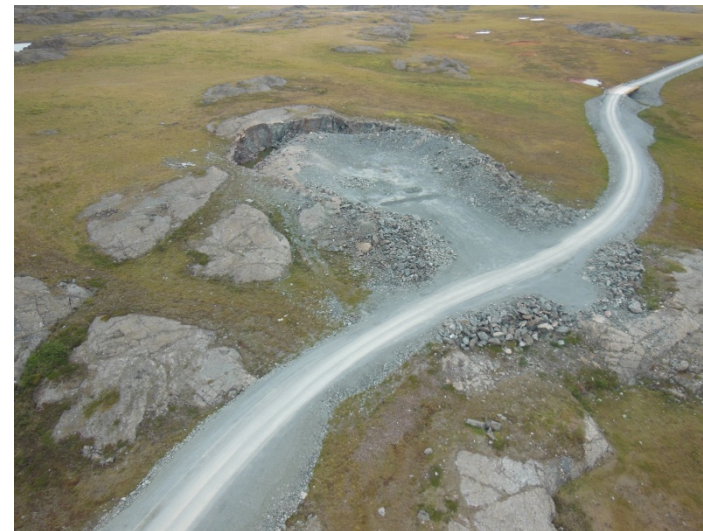
Quarry B with seismic monitoring stations.
There is water against the high wall at the back of the quarry – looking north

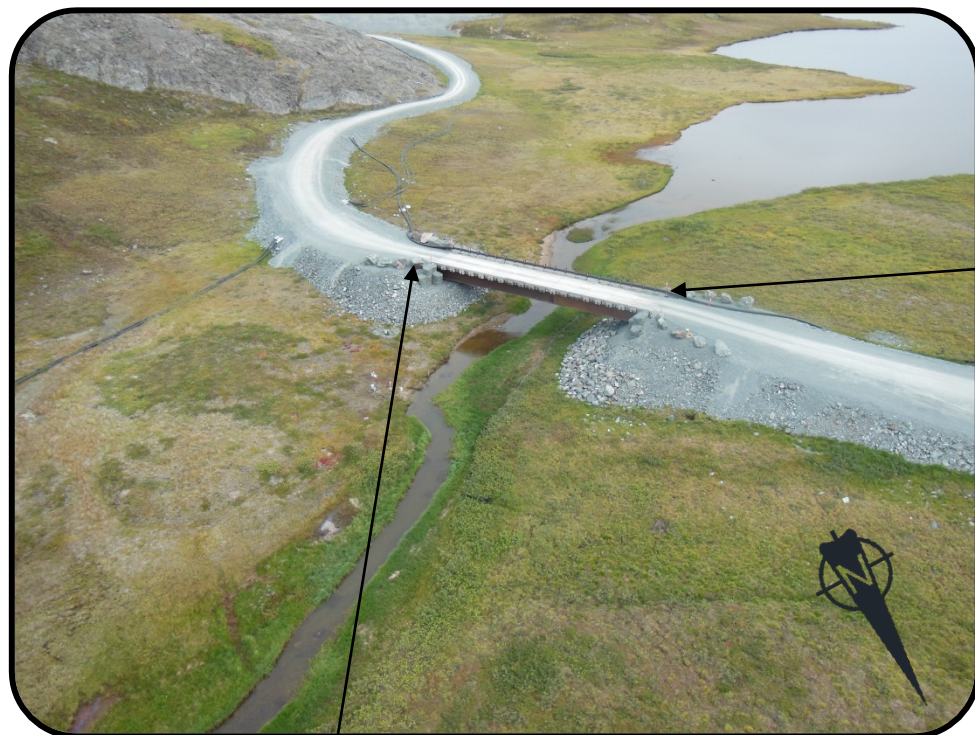
The condition of the rock gabions on the southwest side of the Doris Creek Bridge west abutment

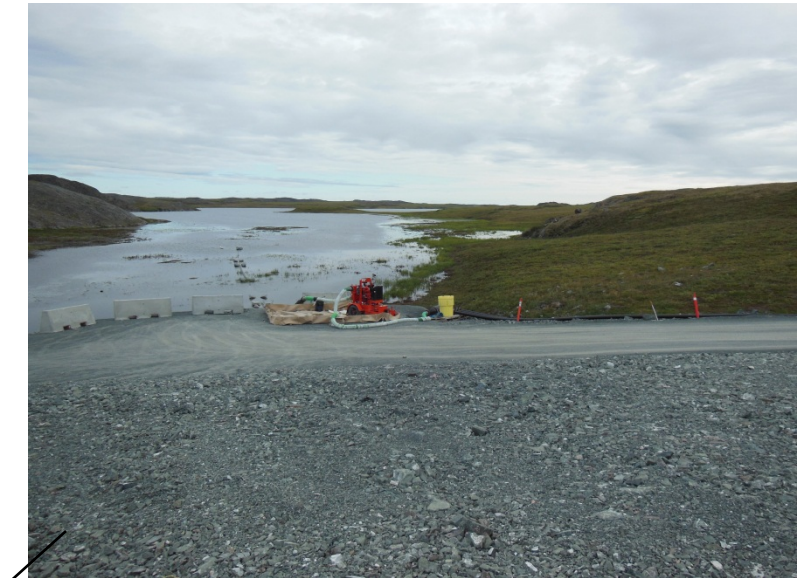
Pump station and water intake line located along the upstream toe at the west side of the North Dam. The condition of the Tail Lake Shoreline is in the background

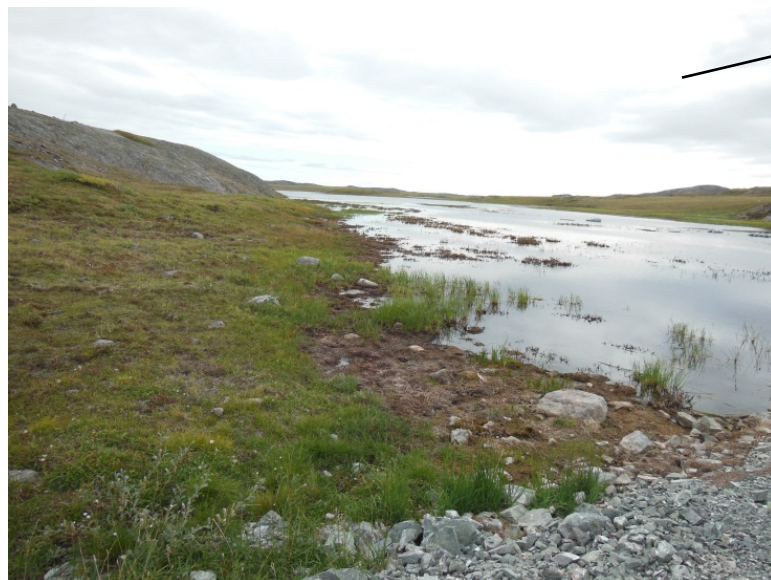
The west side of Tail Lake along the upstream toe of the North Dam – looking south

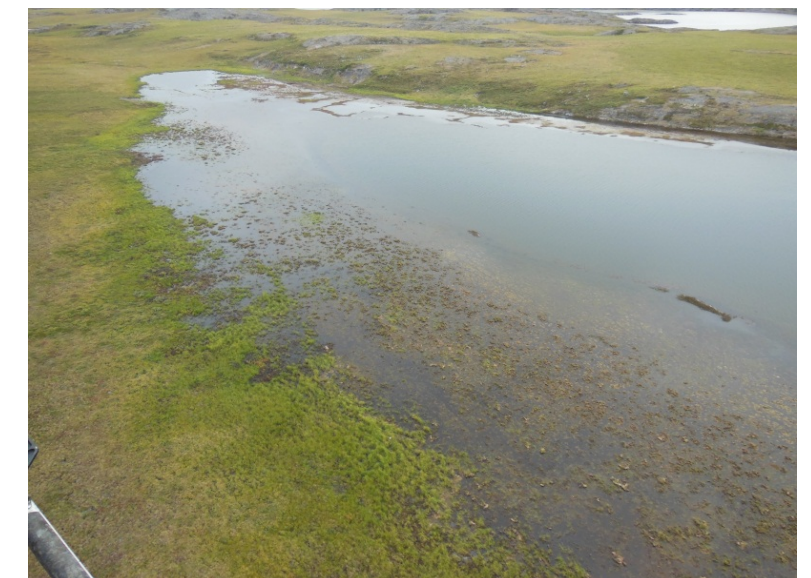
The normal water level in Tail Lake is 28.2 masl and the water level in Tail Lake was at elevation 28.9 masl during the time of the inspection. A large section of shoreline still remains flooded, which will result in irreversible vegetation die-back and ultimately will lead to permafrost damage (Figure 23). Such permafrost damage will result in thaw and erosion of the overburden soils, which will result in increased Total Suspended Solids (TDS) in Tail Lake. This was an expected consequence; however, with the Tailing Containment Area being under Care & Maintenance it would be prudent to continue to manage the water level in Tail Lake and to monitor the vegetation die back to prevent the onset of permafrost degradation and subsequent risk of increased TDS.

Aerial view of the south end of Tail Lake – looking southwest

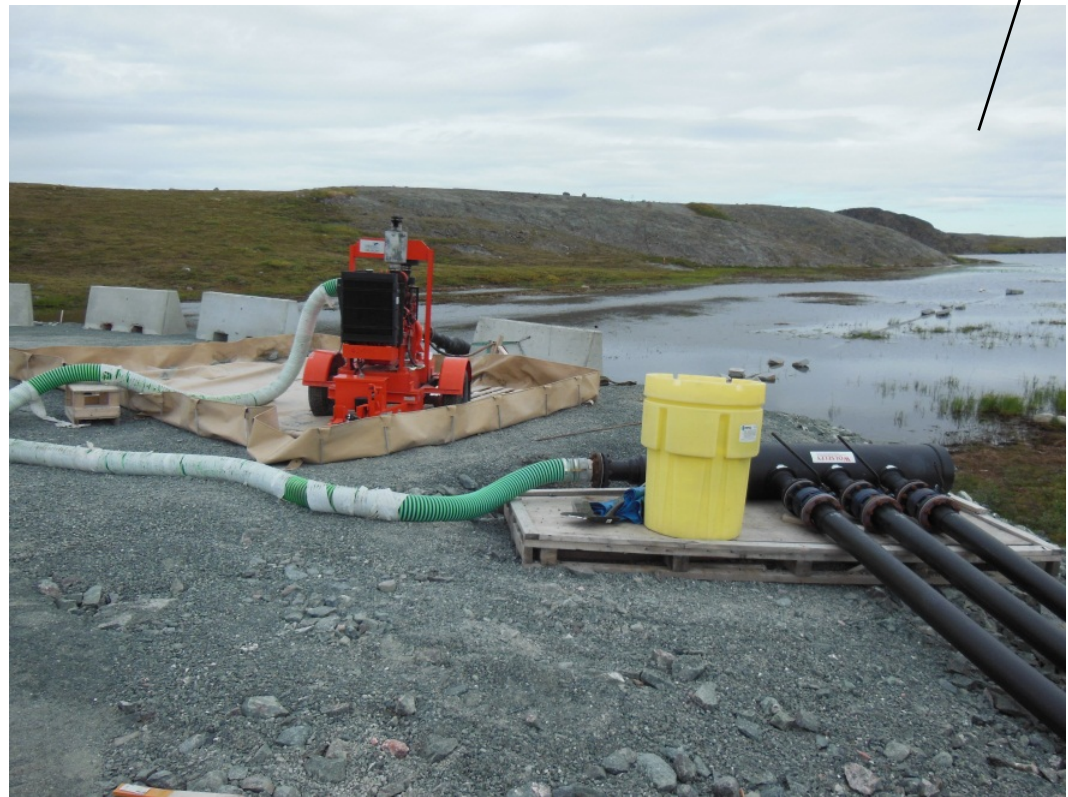
Pump station and water intake line located along the upstream toe at the west side of the North Dam
