Re: 2AM-DOH1323 – 2013 Annual Geotechnical Inspection Report

Please find enclosed with this letter TMAC Resources Inc.'s ("TMAC") 2013 Annual Geotechnical Inspection Reports for water licence 2AM-DOH1323.

Table A: Summary of the Inspection Items and Associated Inspection Recommendations

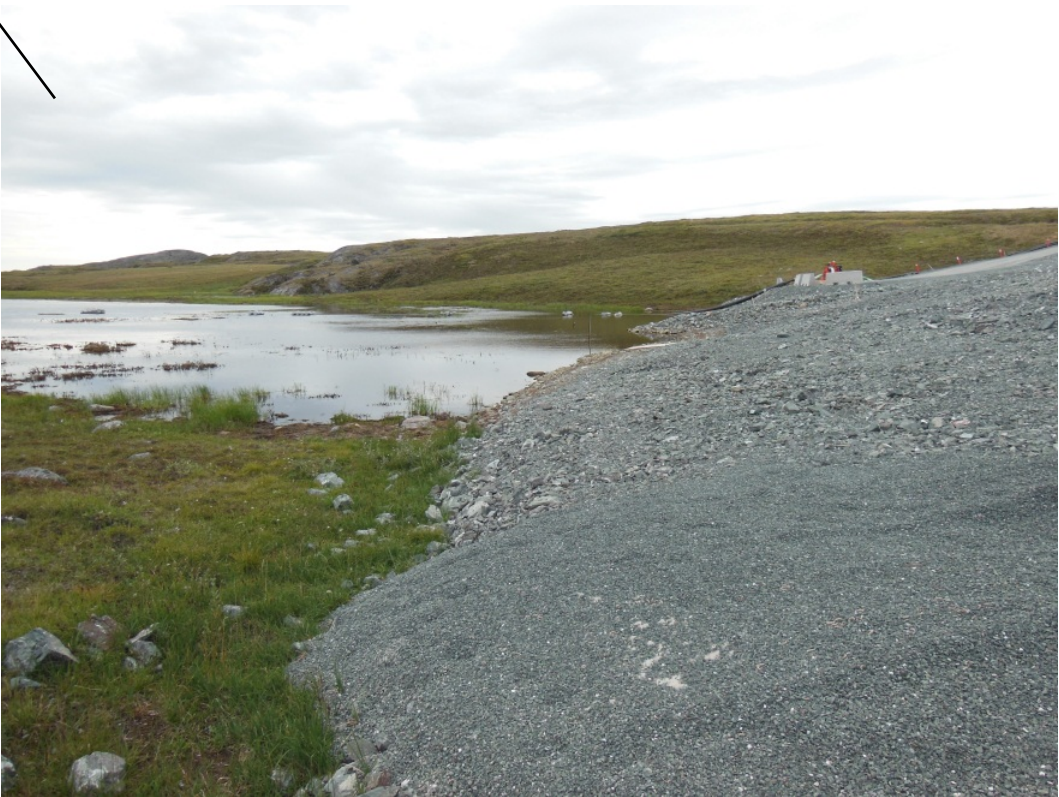
Upstream face of the North Dam – looking west

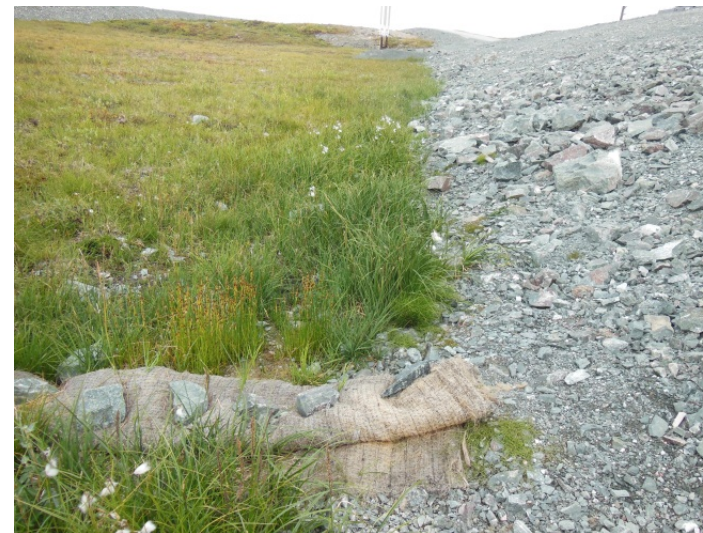
A roll of coconut matting along the down stream toe of the North Dam

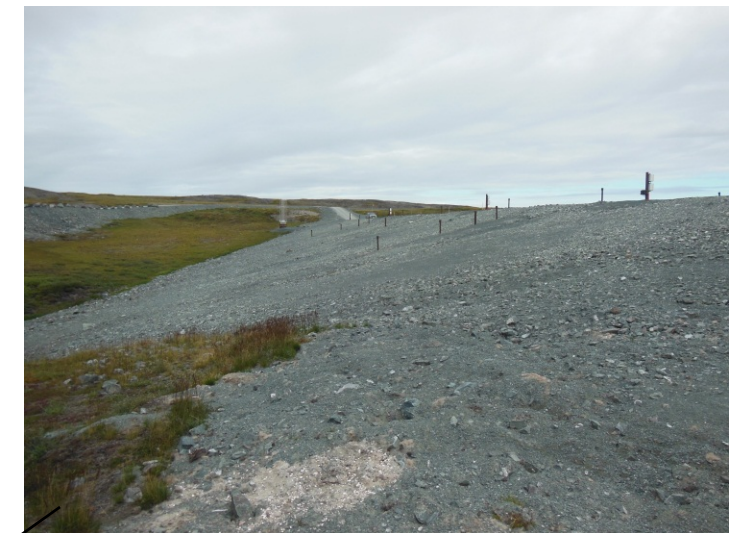
Downstream face and instrumentation of the North Dam – looking east

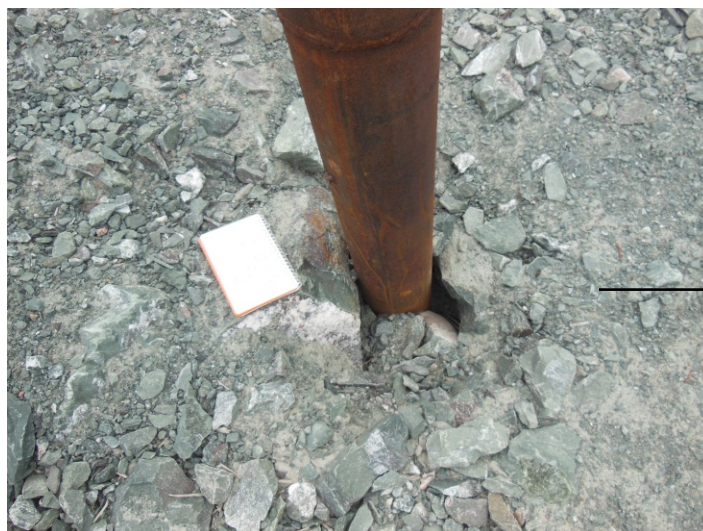
Erosion around instrumentation casing ND-DSP-100

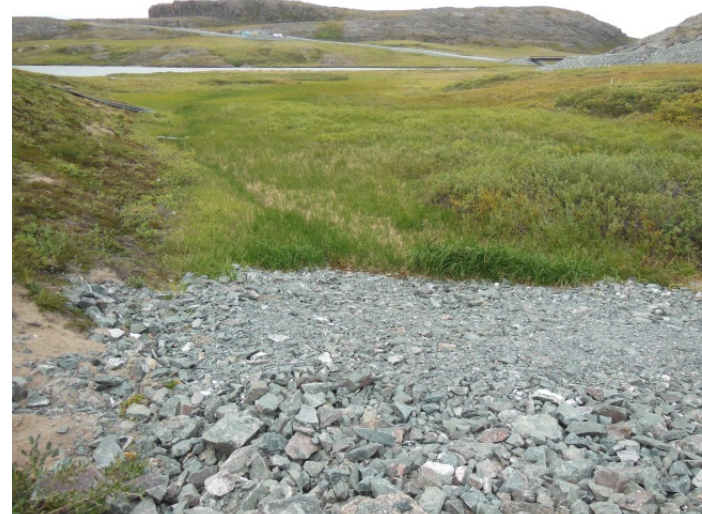
Tail Lake Creek downstream of the North Dam
