2014 Geotechnical Inspection		
		Quarry #2 and Landfarm		
Job No: 1CT022.001 Filename: 2014GeotechInsp_rev00.pptx	HOPE BAY MINING LTD.	Date: Oct 2014	Approved: LW	Figure: 13

2014 Geotechnical Inspection

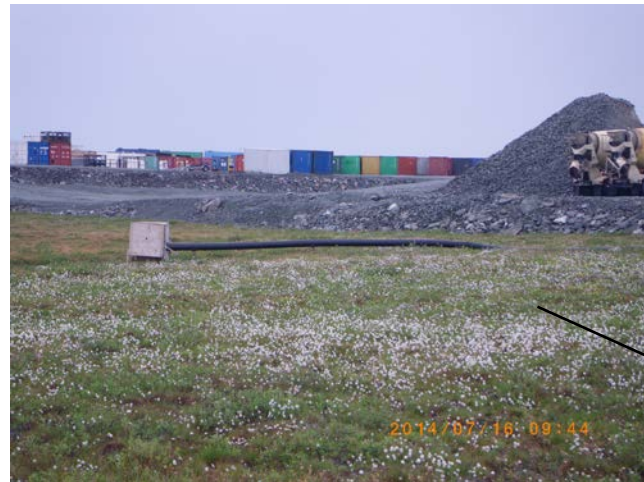
The old STP outflow – looking north from the Quarry #2 Access Road

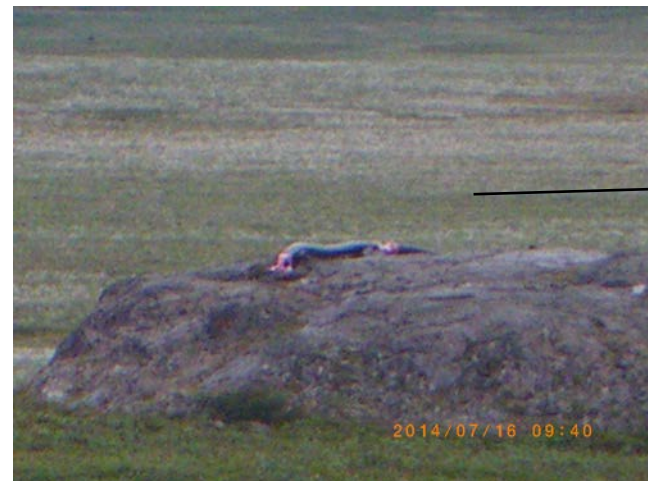
The new STP outflow – looking west from Quarry #2

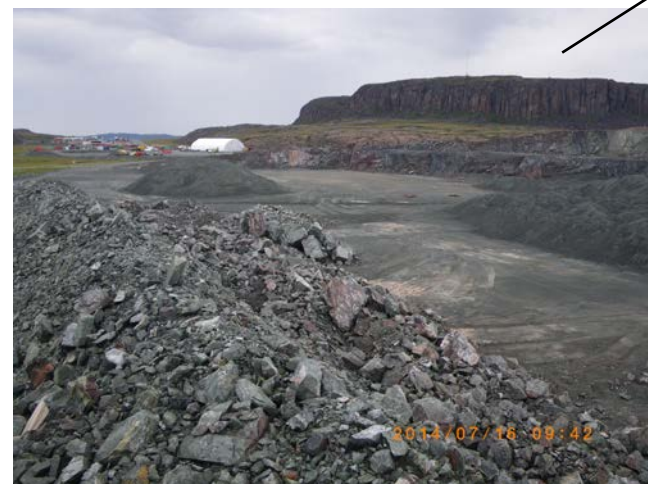
Crushed rock stockpiles in Quarry #2 – looking north

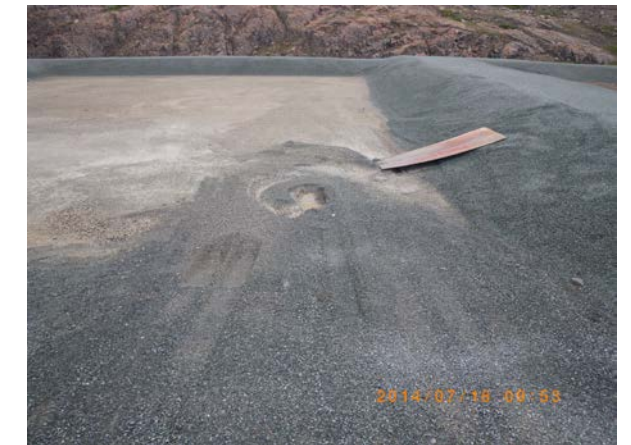
Access Ramp to the Soil Containment Pond

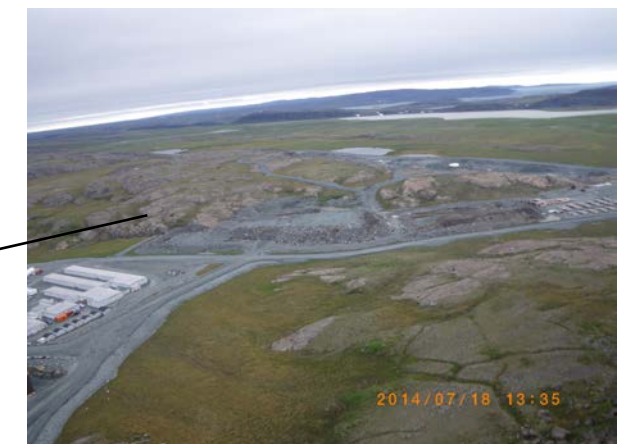
The Overburden Stockpile east of Quarry #2 and south of the Landfarm

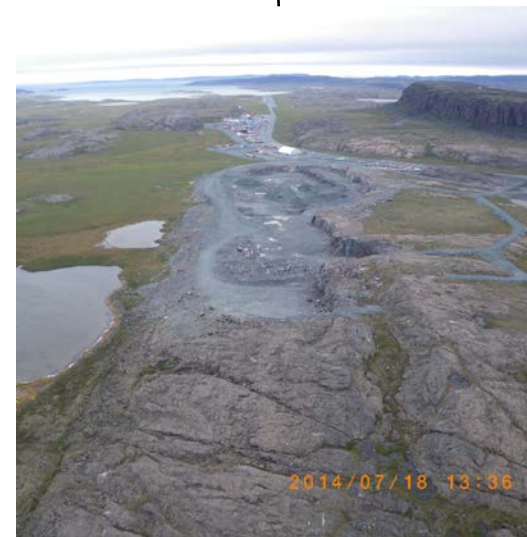
Aerial view of Quarry #2 – looking north

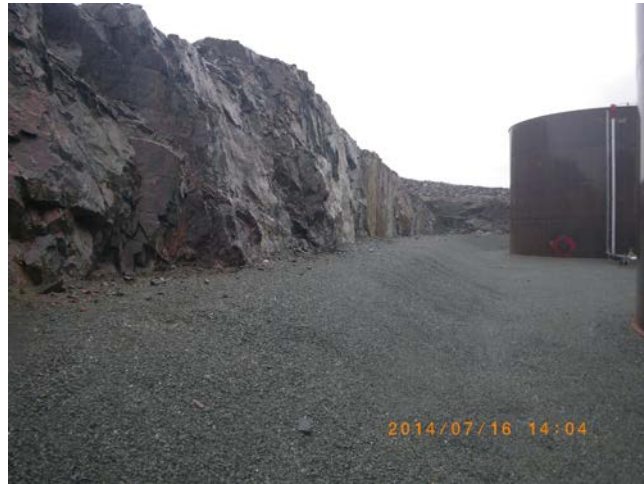
North high wall of the 7.5 ML Doris North Camp Tank Farm

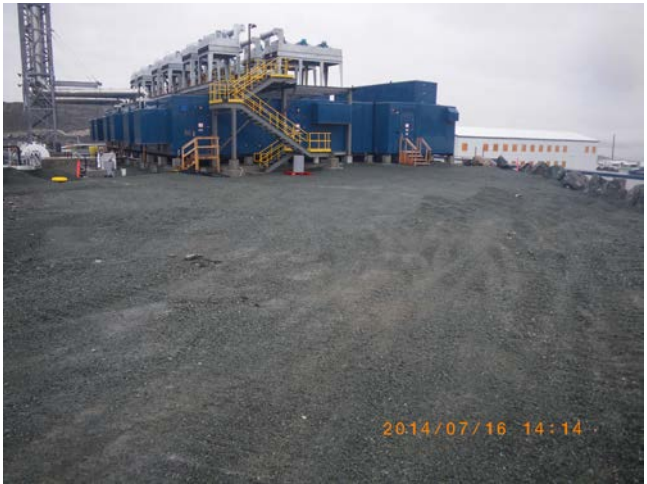
Power Plant on Pad B – looking southeast from the North Access Road

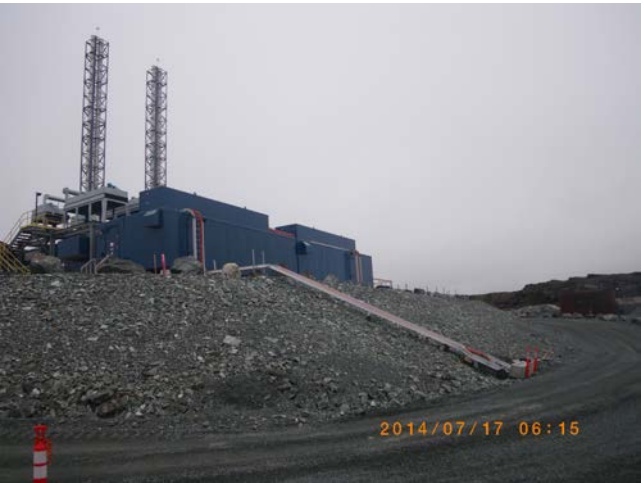
The Power Plant on Pad B – looking northeast from Pad X

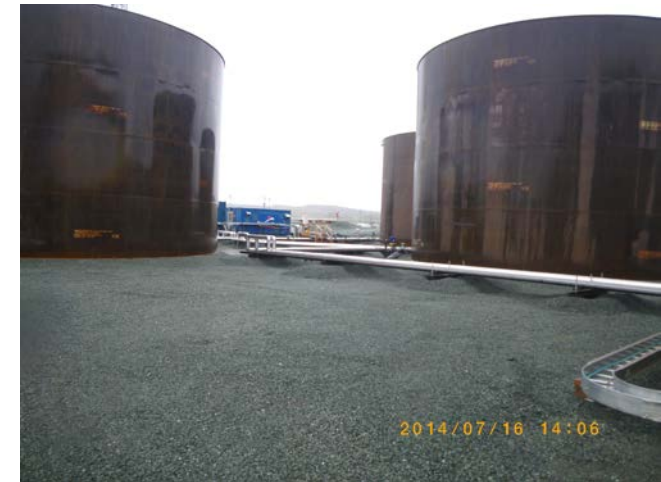
Interconnected fuel tanks within the 7.5 ML Doris North Camp Tank Farm – looking south

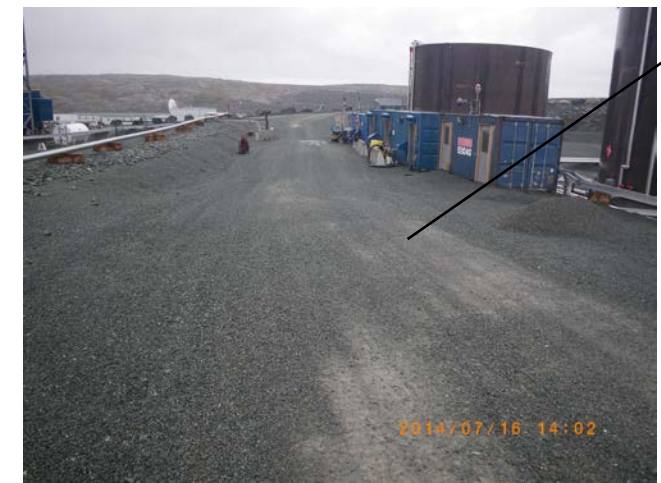
7.5 ML Doris North Camp Tank Farm Transfer Station – looking west from the North Access Road

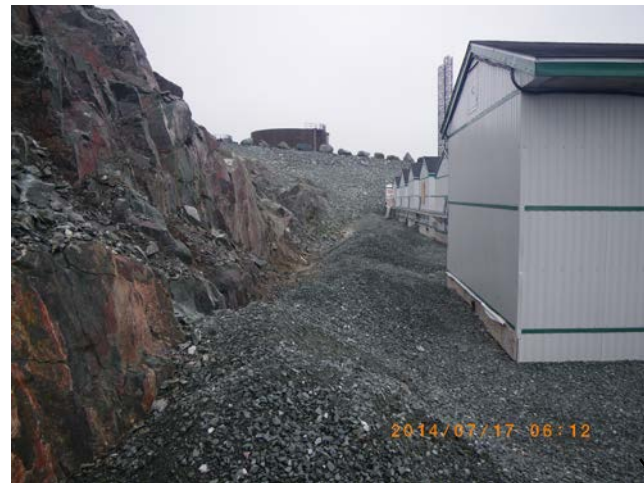
The north high wall of Pad X – looking east from Pad X

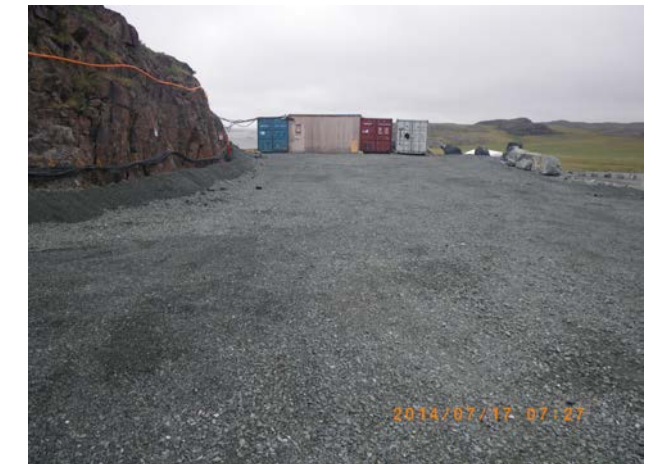
General surface conditions of Pad L - looking south from the Portal Entrance

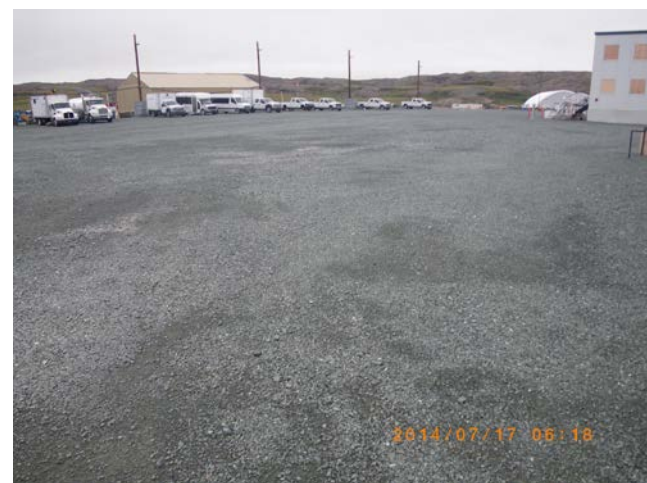
General Surface Conditions of Pad C – looking south from Pad D

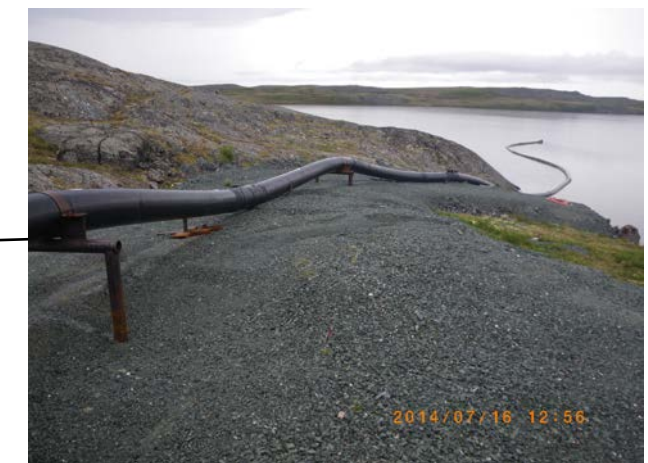
Fresh water intake pipeline – looking east from the Pump House on the Float Plane Dock Access Road

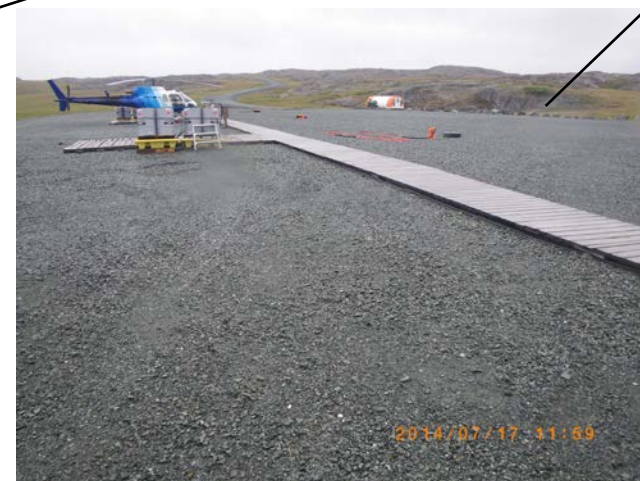
Condition of Helipad– looking south from the Float Plane Dock Access Road

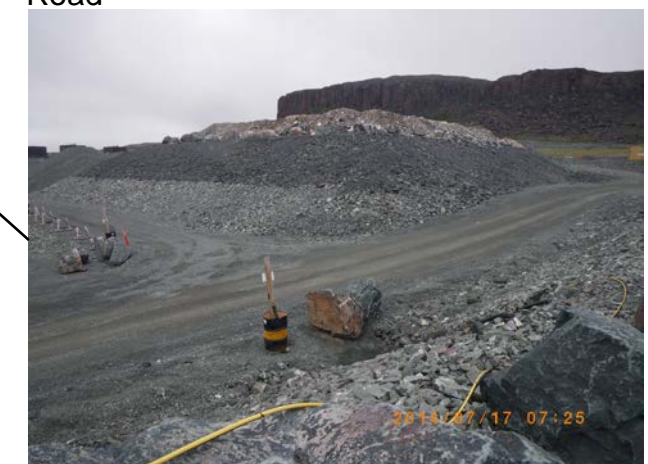
Pad Q Expansion over pads H/J waste rock - looking north from Pad F

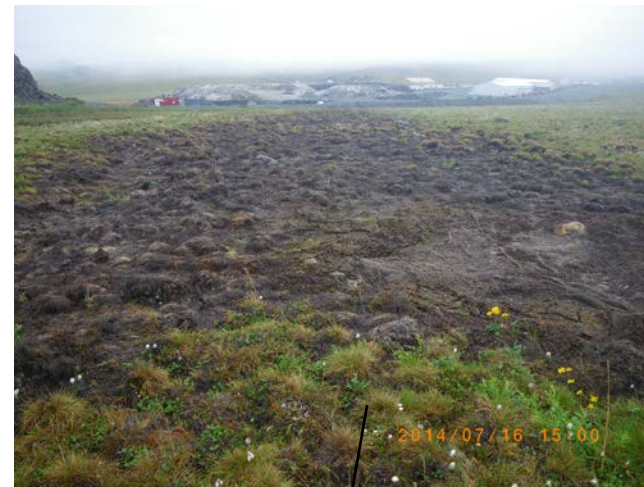
Historic saltburn from exploration drilling – looking south from the North Diversion Berm

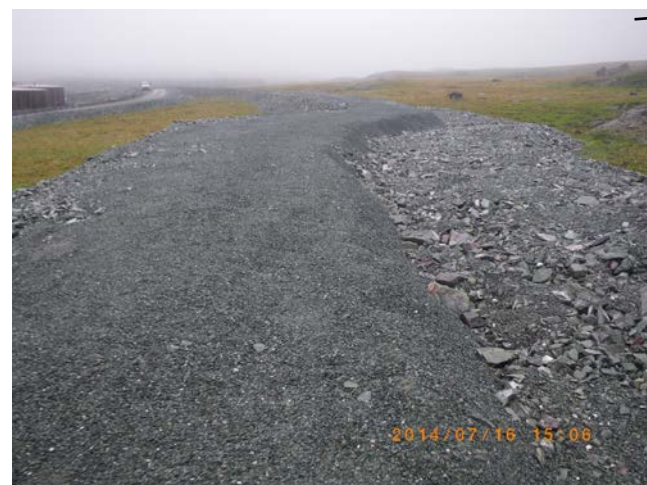
North Diversion Berm – looking west

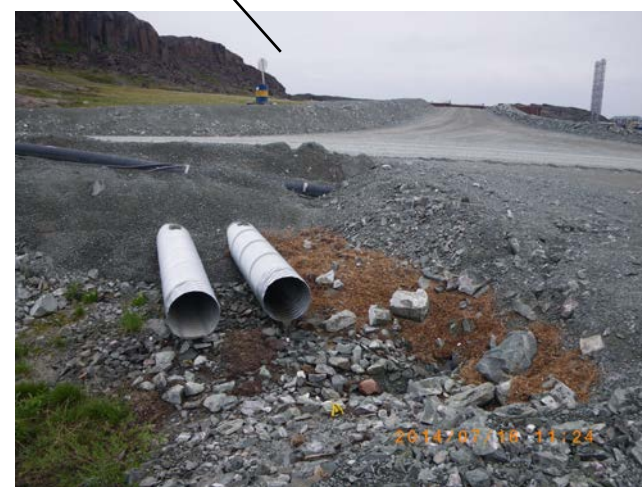
The culverts going under the Primary Road at the junction of the Primary Road and the North Access Road and Doris North Diversion Berm

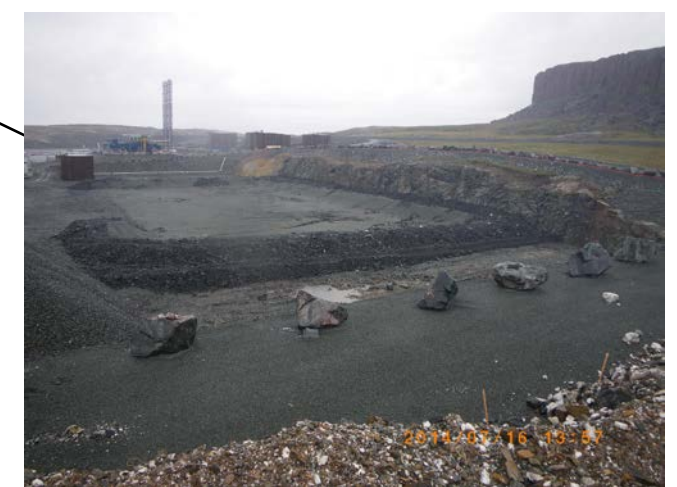
Temporary pond on Pad D has been dismantled - looking northwest

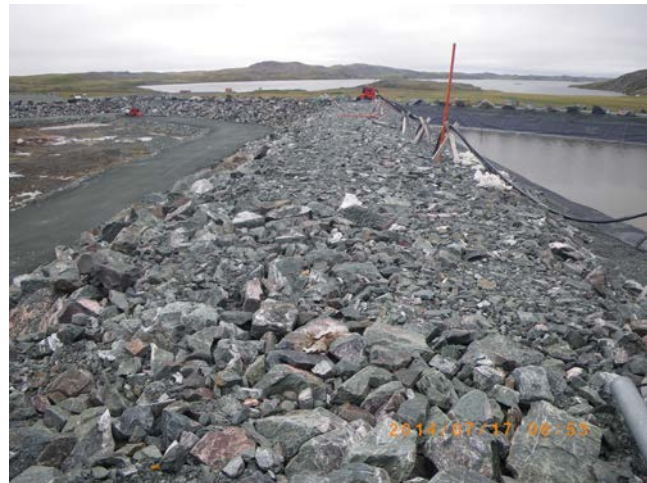
Divider Berm between the Ponds
- looking south from Pad E/P

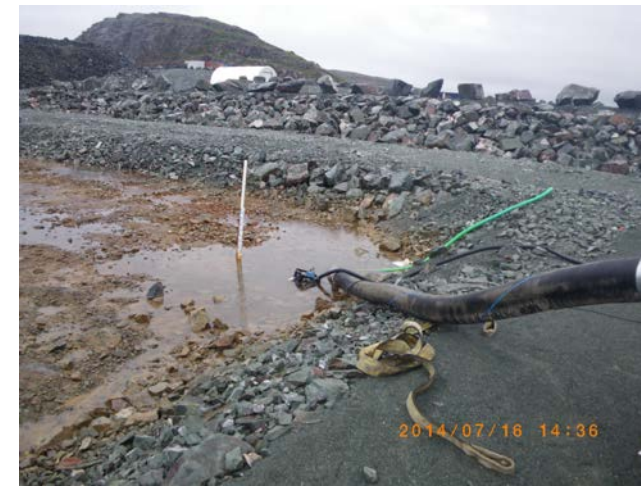
The sump in the southeast corner of the Pollution Control Pond – looking east

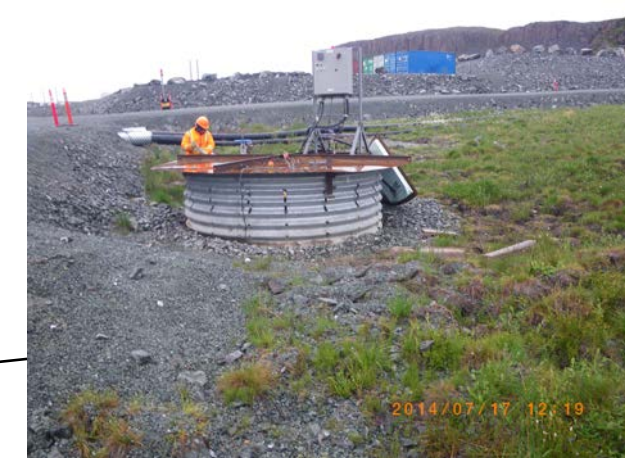
Sump #2 - looking northwest towards Doris Camp

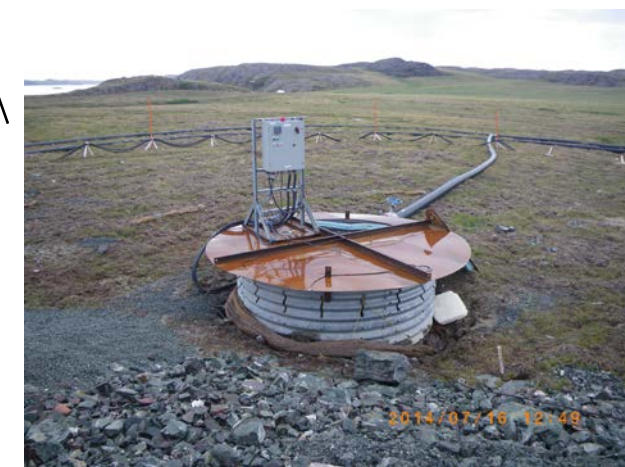
Sump #1 – looking southeast from the Float Plane Dock Access Road

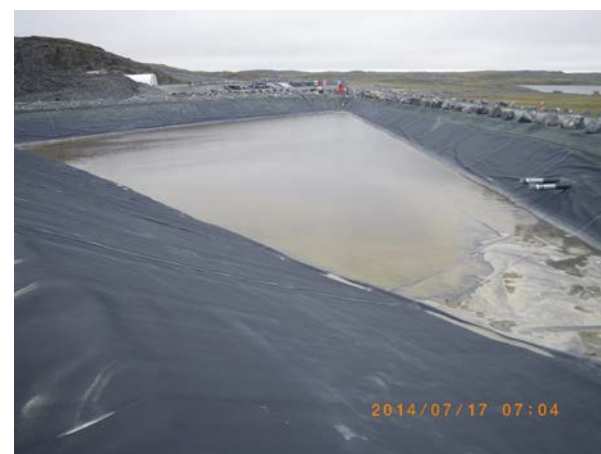
Sediment Control Pond – looking east from Pad E/P

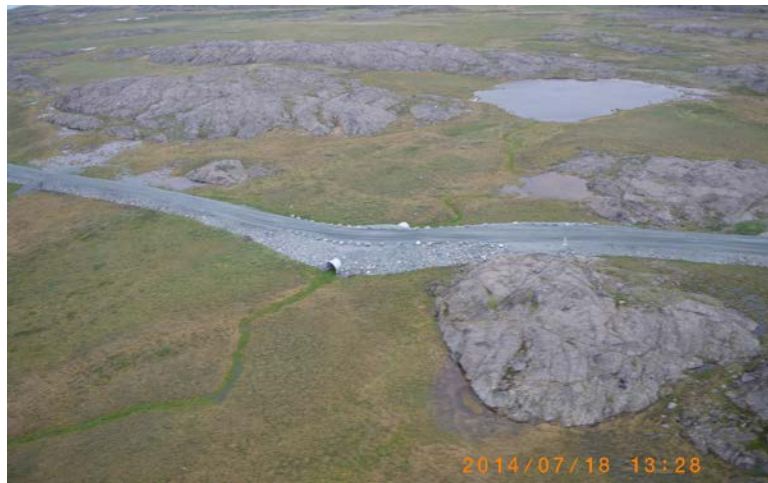
Aerial view of the arched culvert at Stream Crossing #1

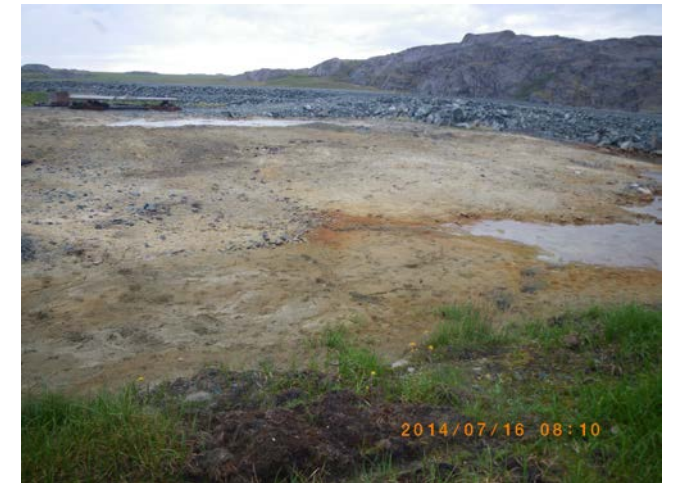
Old Drill Cutting Disposal Area

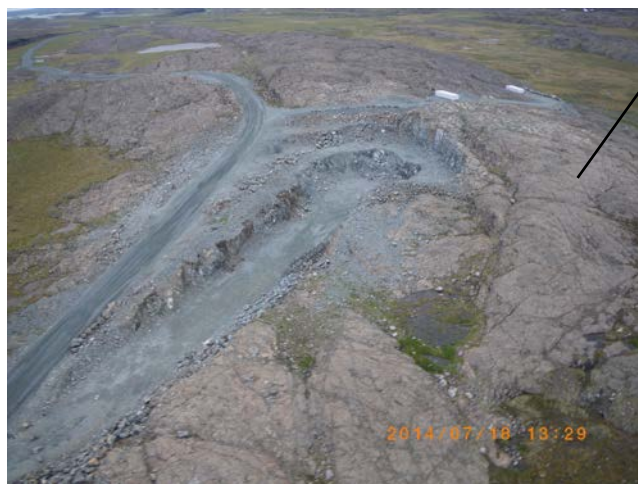
Doris-Windy Road by Quarry A – looking south

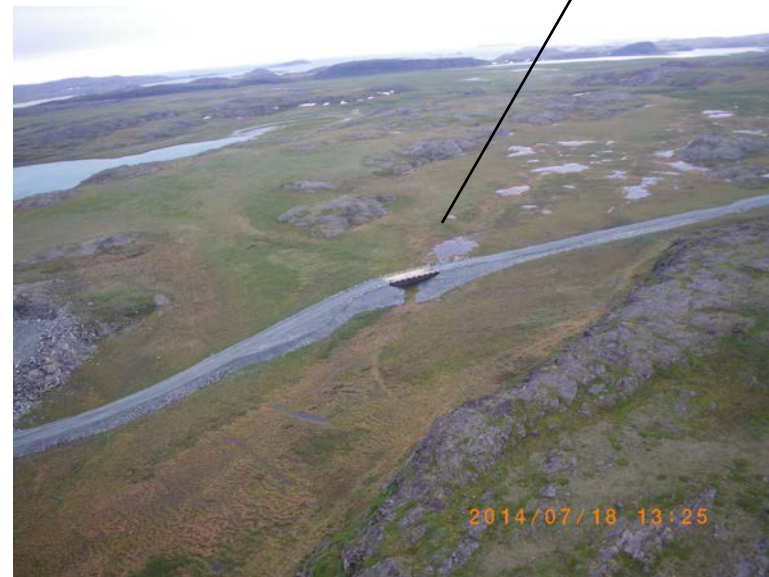
Aerial view of the single bridge at Stream Crossing #4 – looking northwest

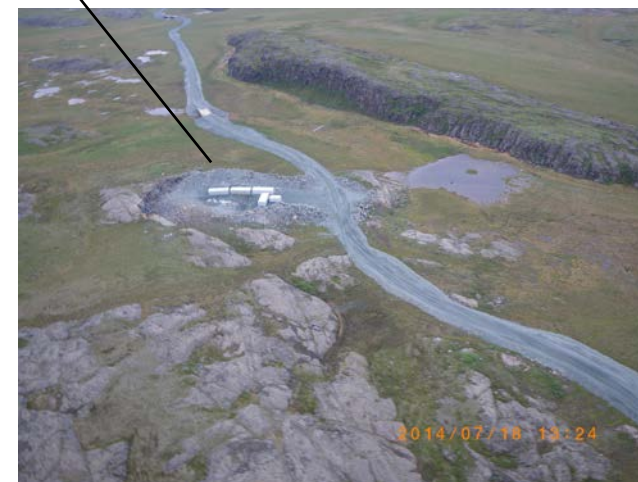
The Doris-Windy Road near Quarry B – looking north

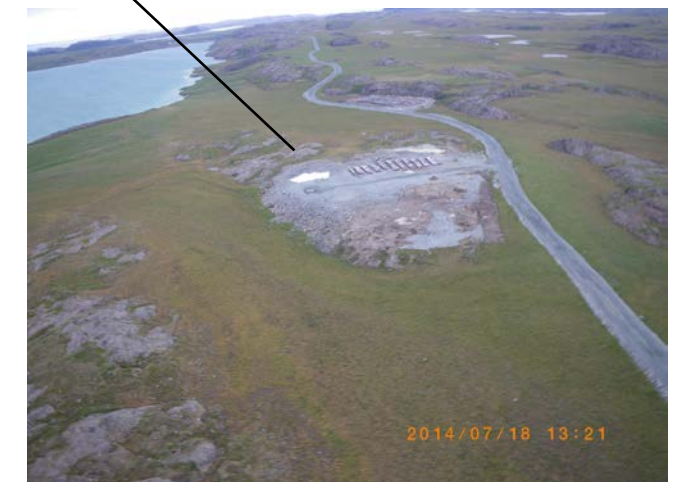
Core boxes being stored on Overburden Dump at Quarry D – looking north

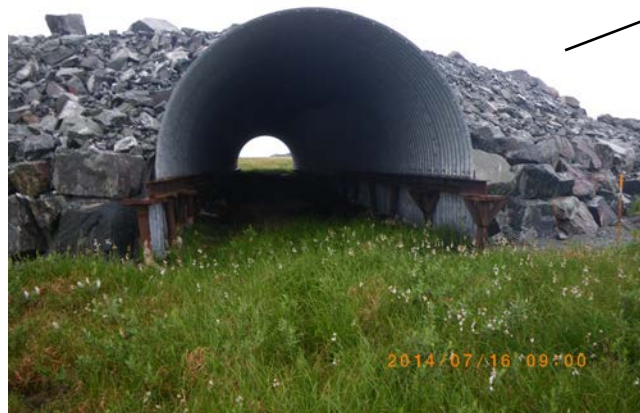
Arched Culvert #1 – looking east

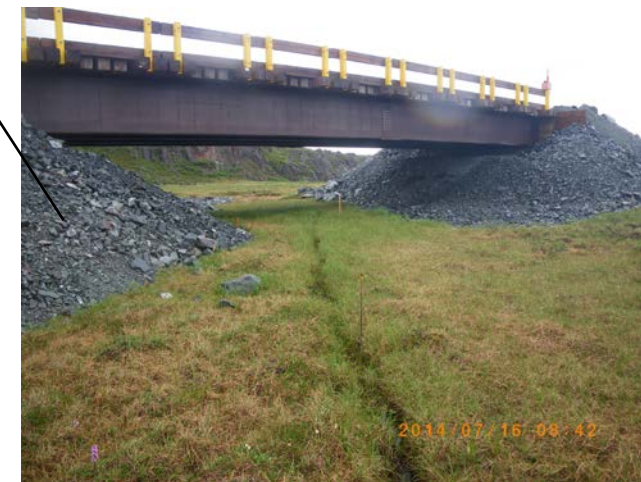
The bridge over Stream Crossing #4 – looking east

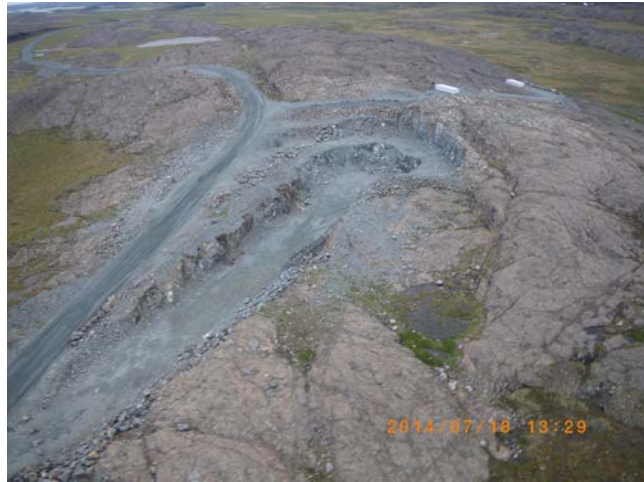
Aerial view of Quarry A and the Doris-Windy Road – looking south

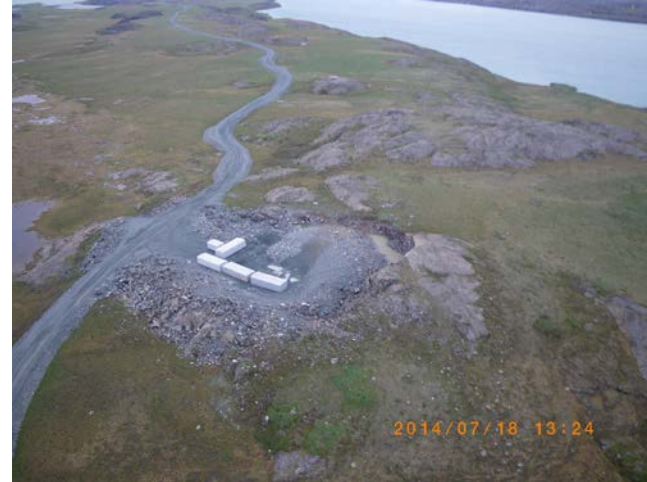
Aerial view of Quarry B with five Type 4 explosive magazines – looking west

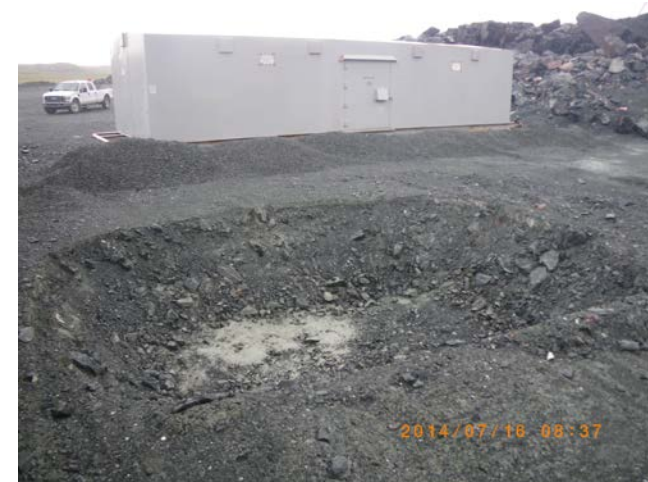
A sump has been excavated in the middle of Quarry B

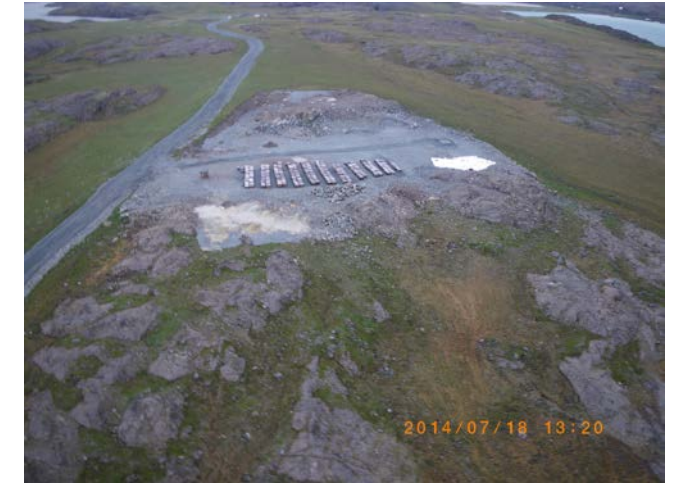
Aerial view of Quarry D with core box storage and tote bags of non-saline drill cuttings – looking south

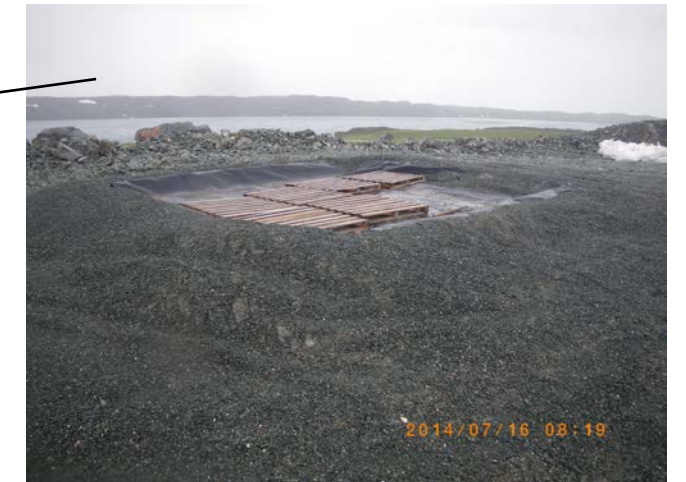
A lined containment area has been constructed at the western edge of Quarry D next to the tote bags of drill cuttings – looking west

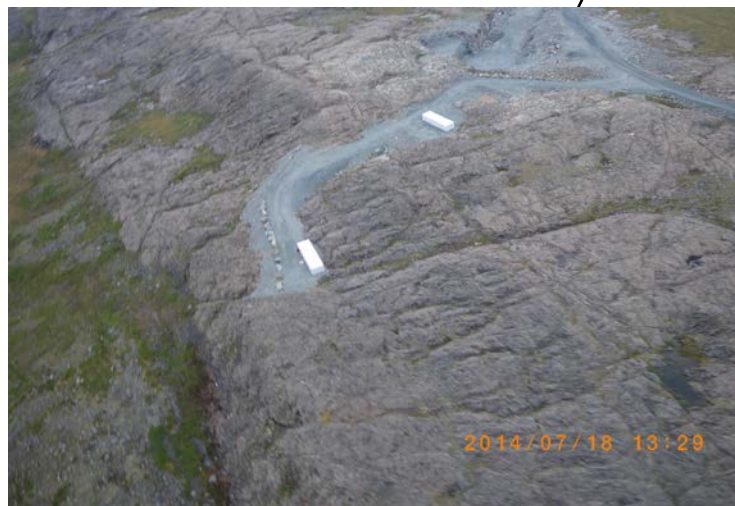
Aerial view of the south end of Quarry A with two type 4 Explosive Magazines – looking east

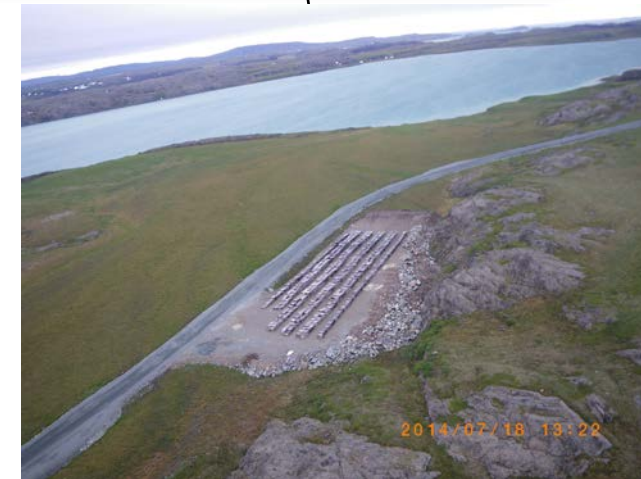
Aerial view of Quarry D Overburden Stockpile with core box storage – looking northwest

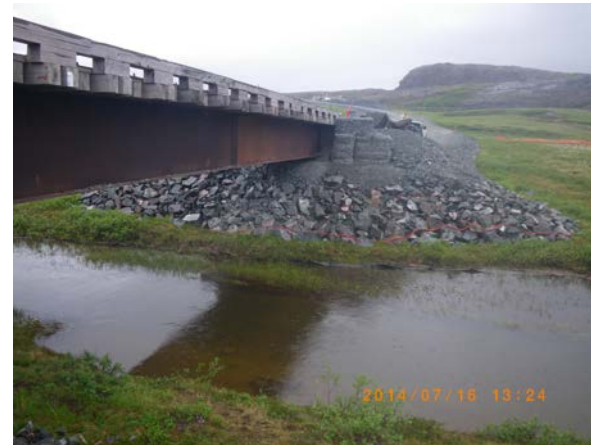
Northwest abutment and rock gabions at the Doris Creek Bridge

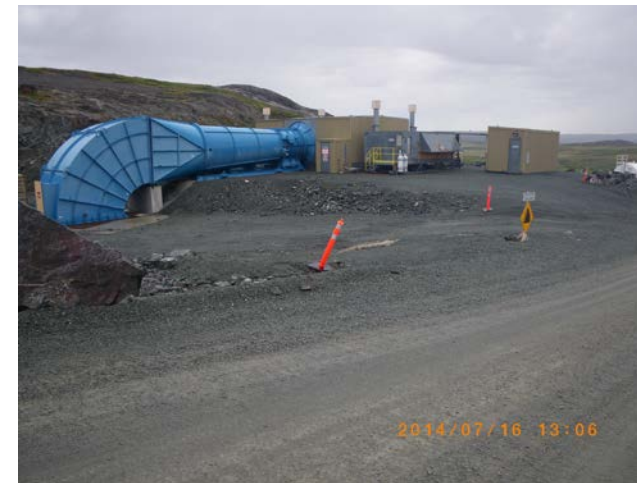
Primary Vent Raise – looking north

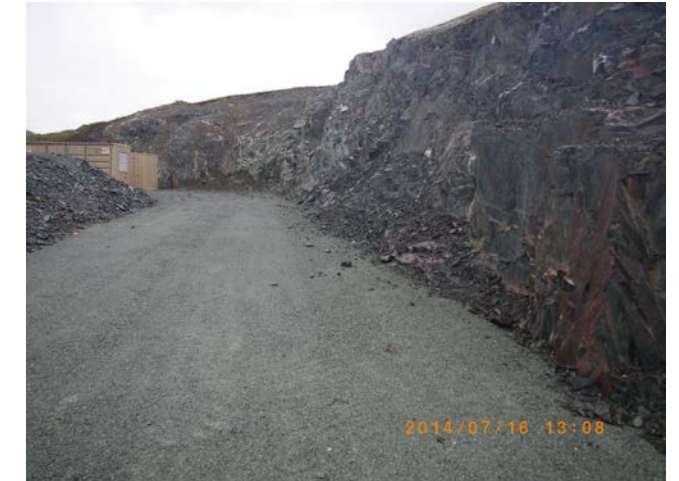
Condition of the high wall at the north end of the Primary Vent Raise – looking west

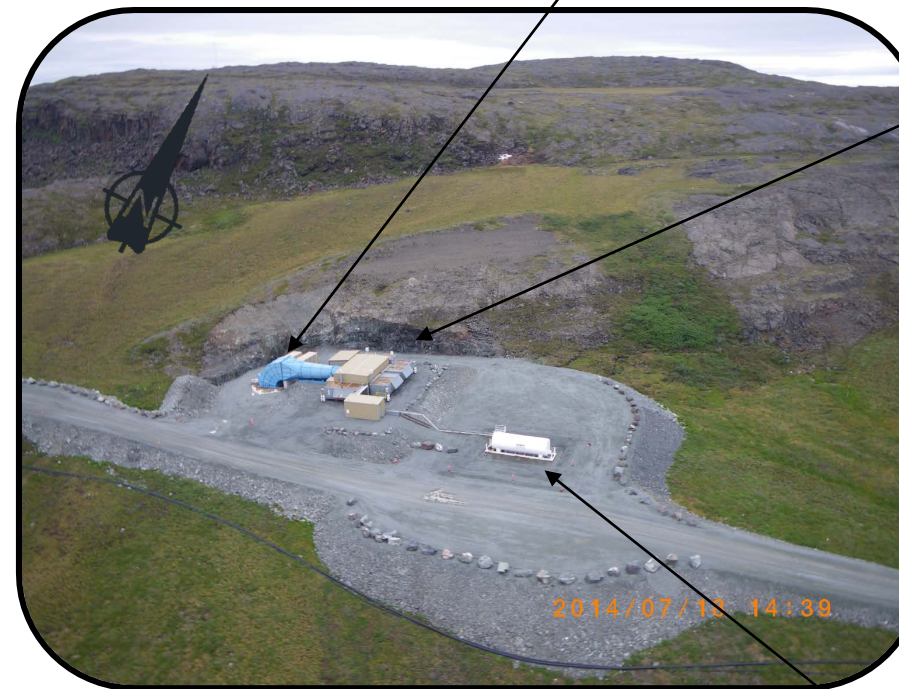
Aerial view of the Primary Vent Raise

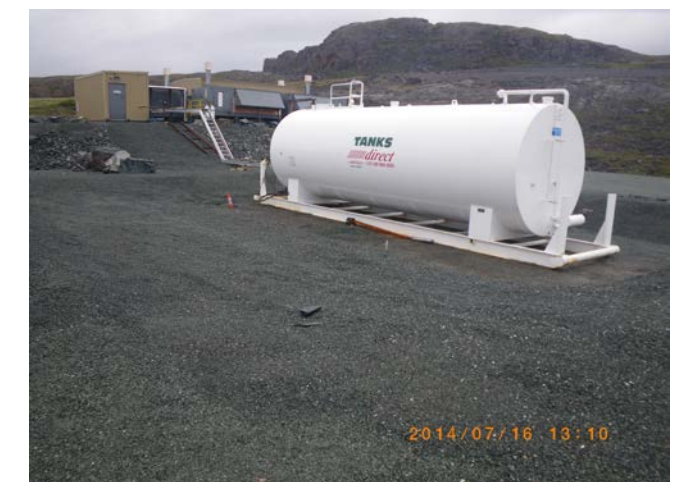
Primary Vent Raise Fuel Transfer Station – looking northwest

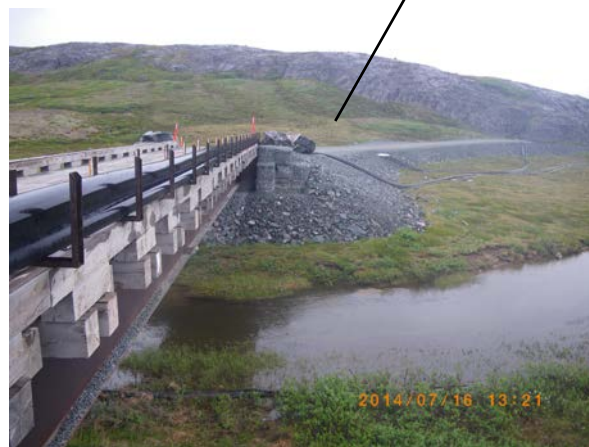
Southeast abutment and rock gabions at the Doris Creek Bridge

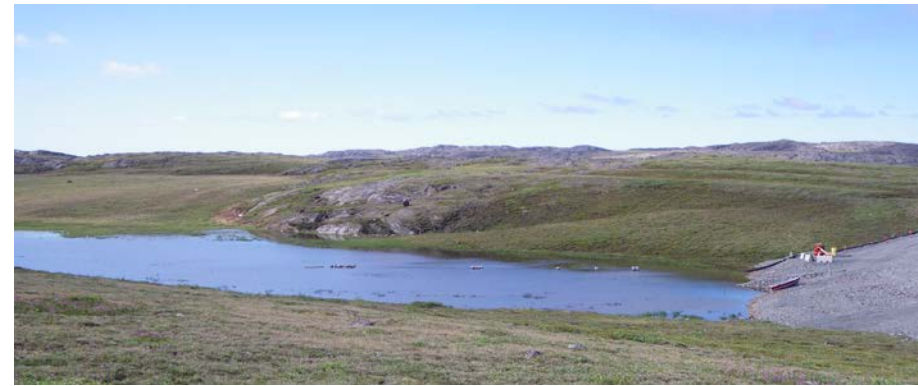
North end of Tail Lake – looking southwest

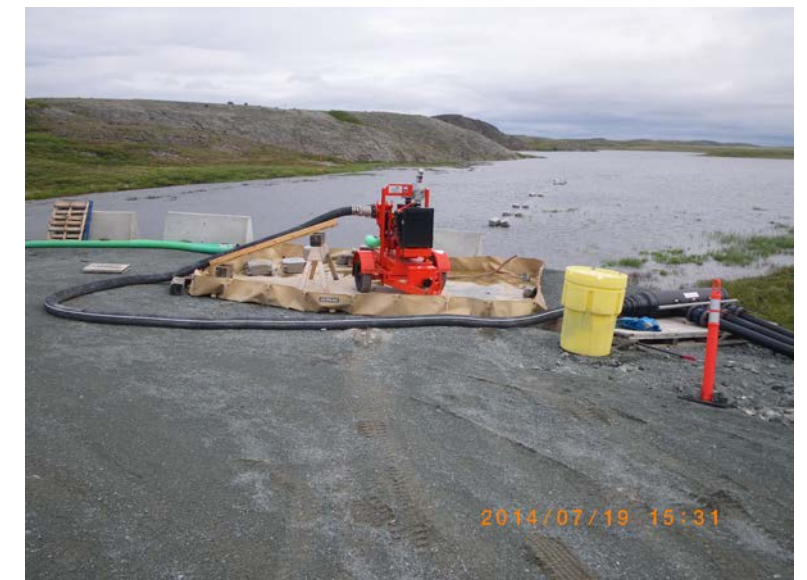
Pump station and water intake line located along the upstream toe at the west side of the North Dam

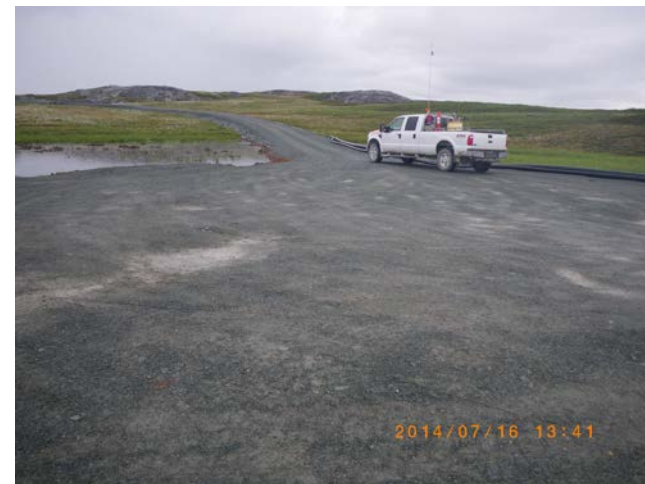
General surface condition of the Tail Lake Access Road turn-a-round – looking north along the Tail Lake Access Road alignment

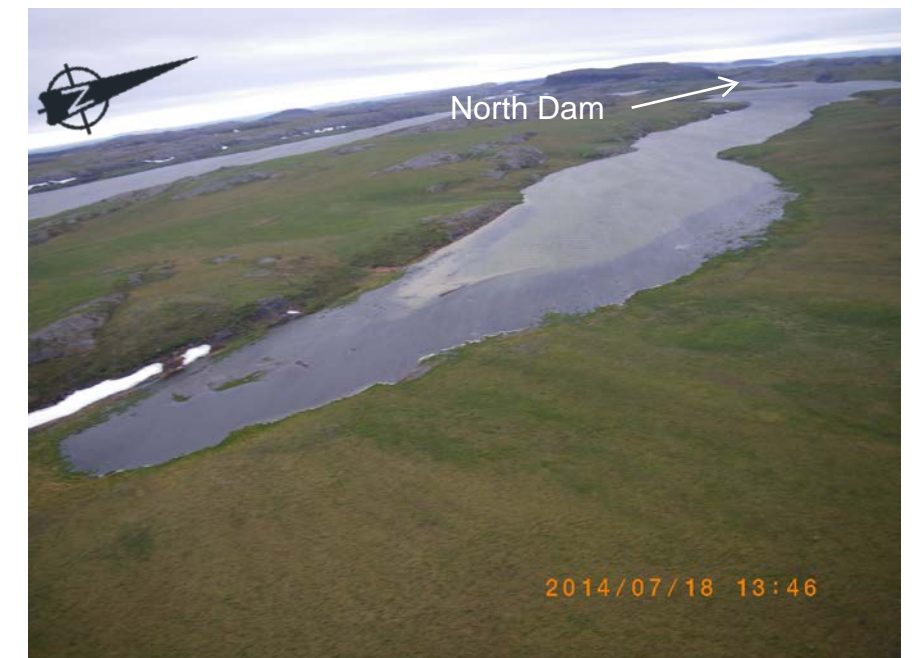
Aerial view of Tail Lake – looking northwest from the south end of Tail Lake
