Tahera Diamond Corporation

JERICO DIAMOND MINE  
2006 GEOTHECNICAL INSPECTION

1100060.010

September 2006

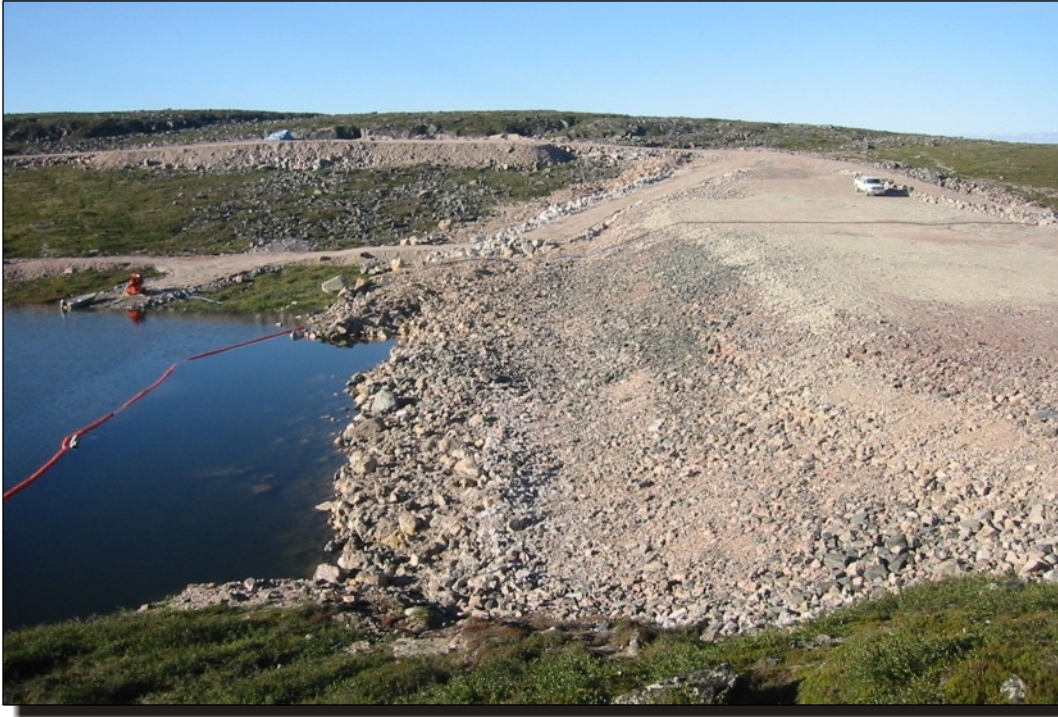
**Photo A1**  
West Dam - Upstream Slope, looking south.

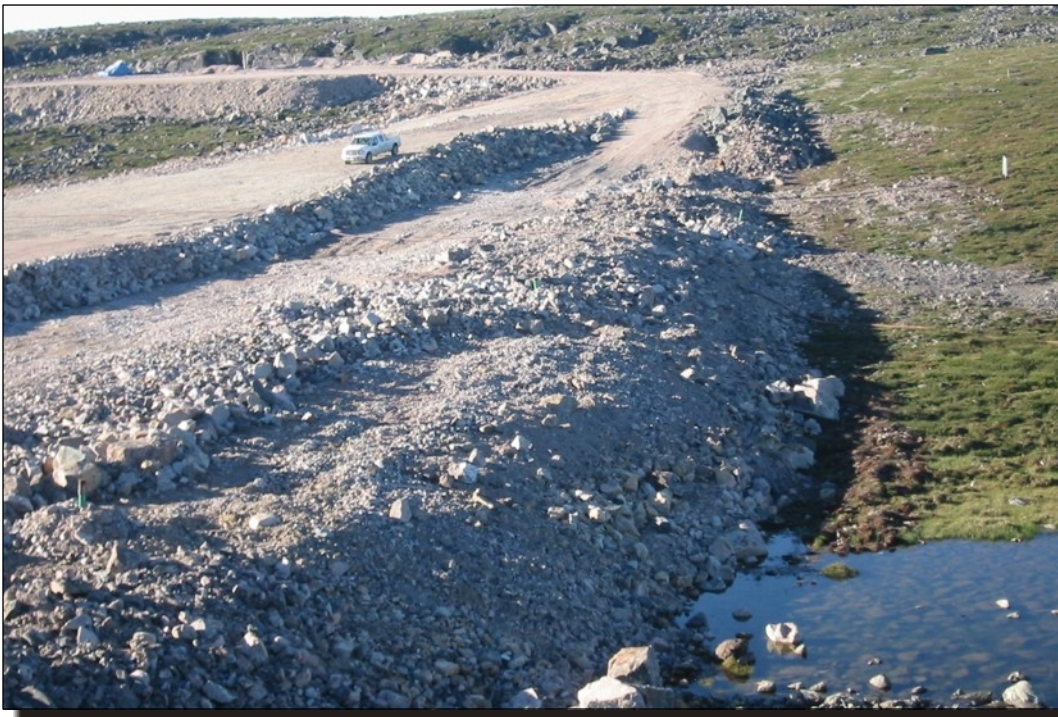
**Photo A2**  
West Dam - Downstream slope, looking south.

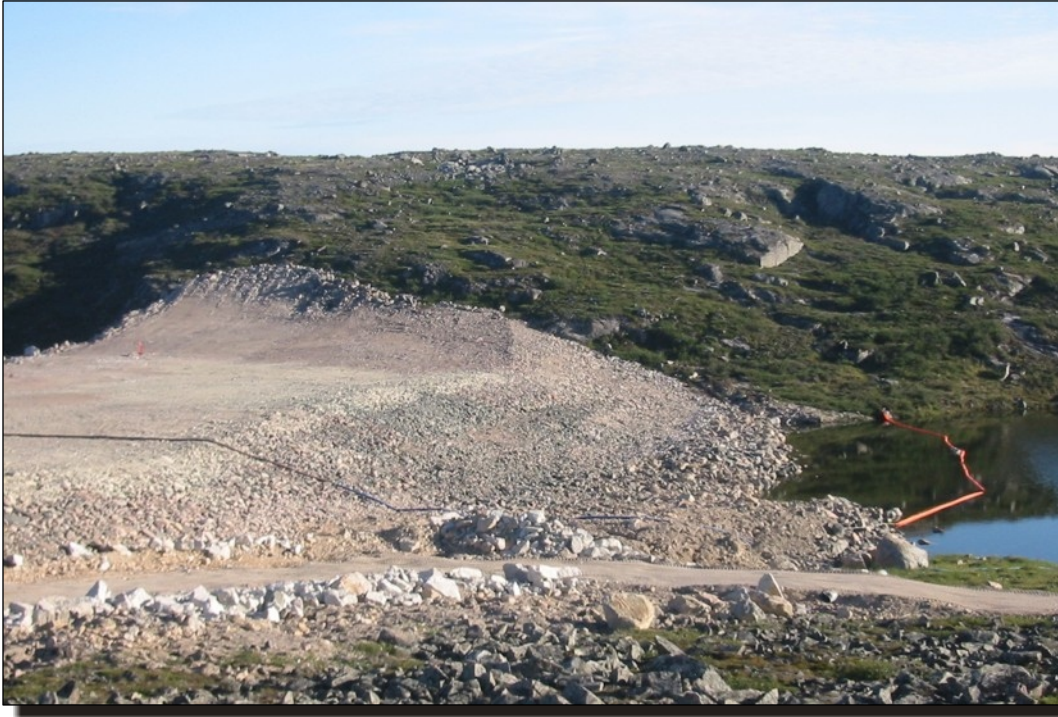
**Photo A3**  
West Dam - Upstream slope, looking north.

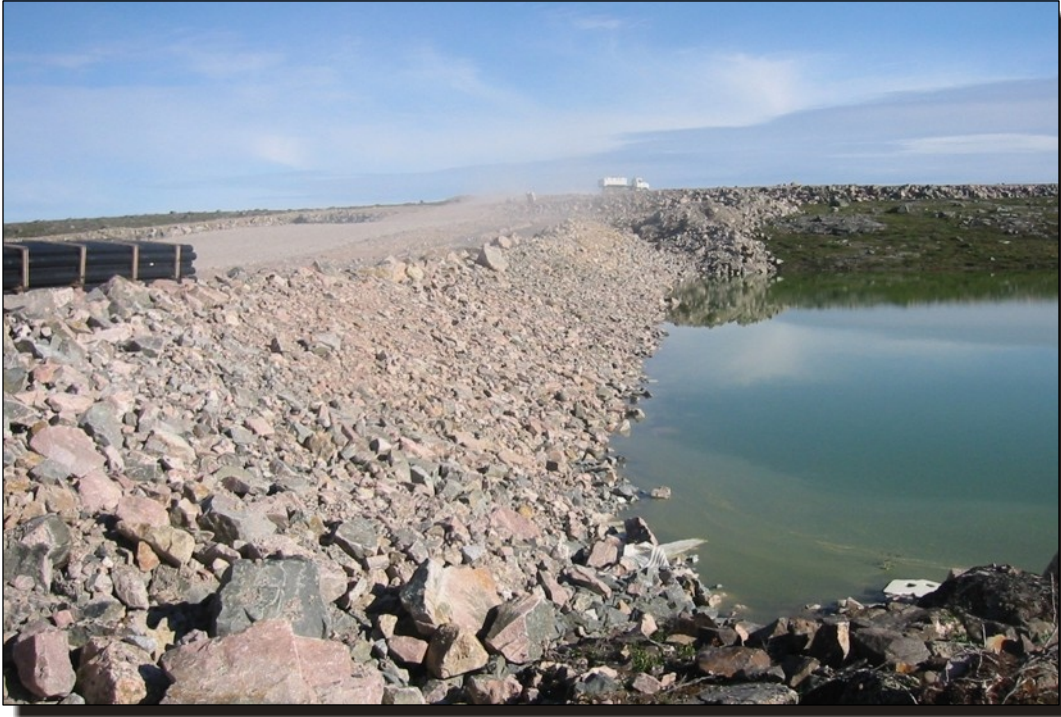
**Photo B1**  
Divider Dyke - Upstream slope, looking north.

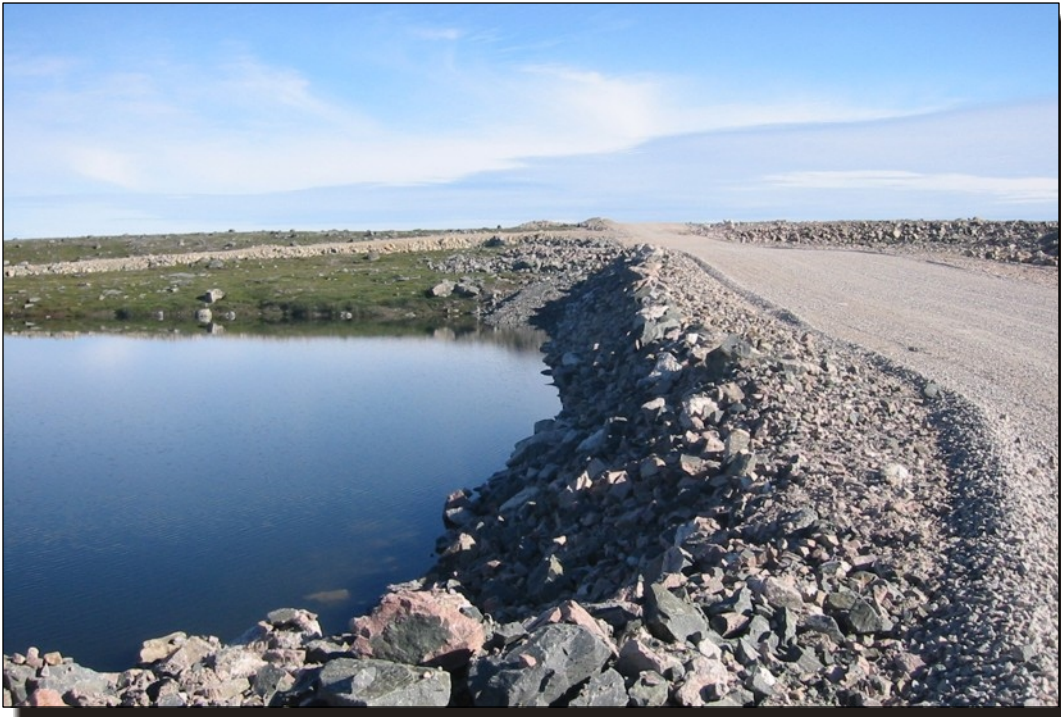
**Photo B2**  
Divider Dyke - Downstream slope, looking north.

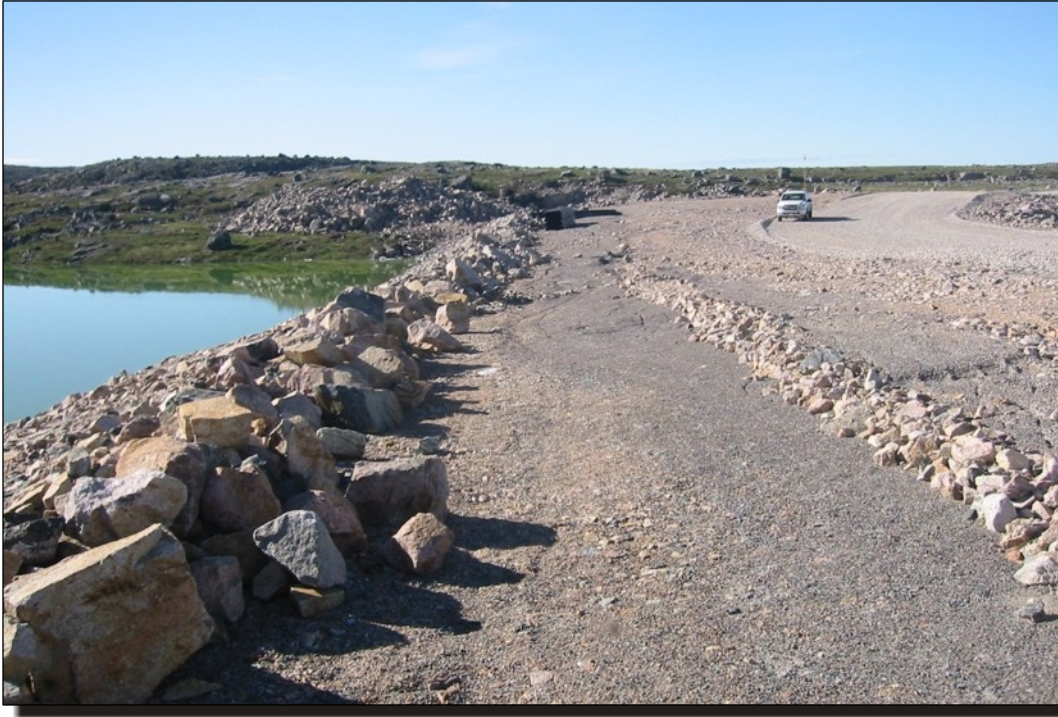
**Photo B3**  
Divider Dyke - Crest, looking south.

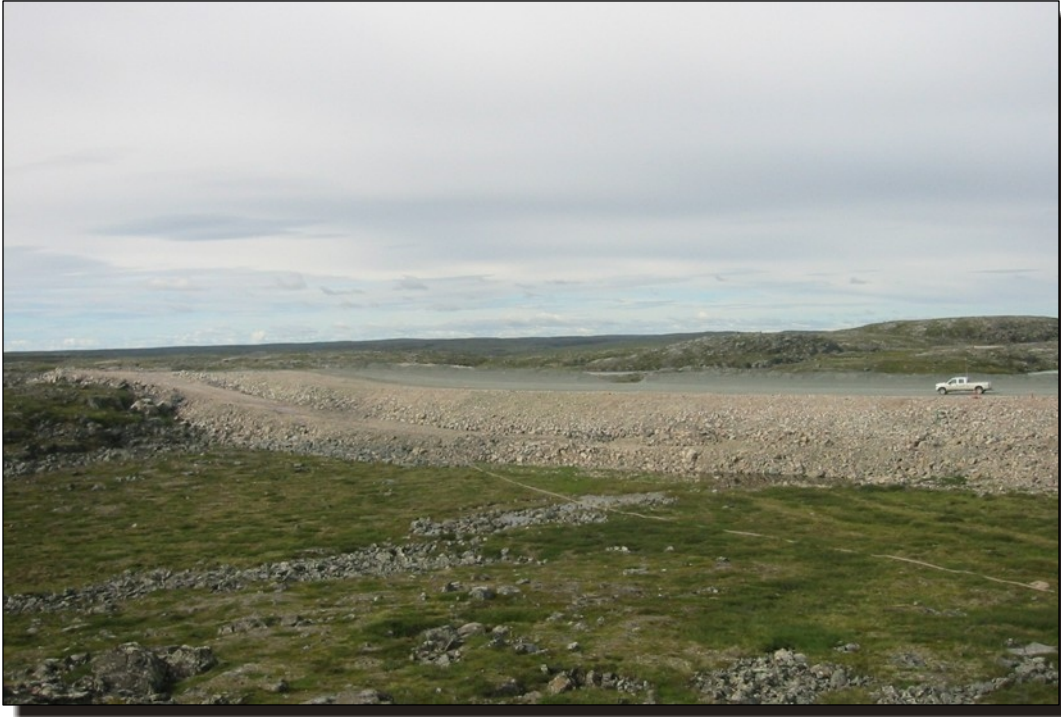
**Photo C1**  
East Dam - Downstream slope, looking southwest.

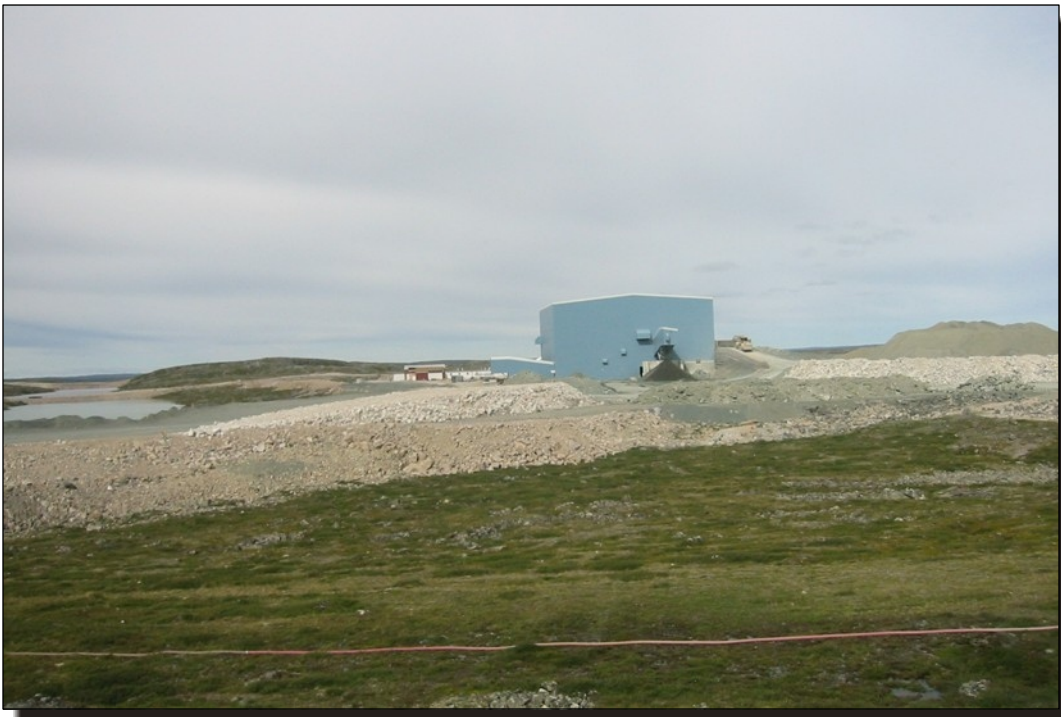
**Photo C2**  
East Dam - Downstream slope, looking west.

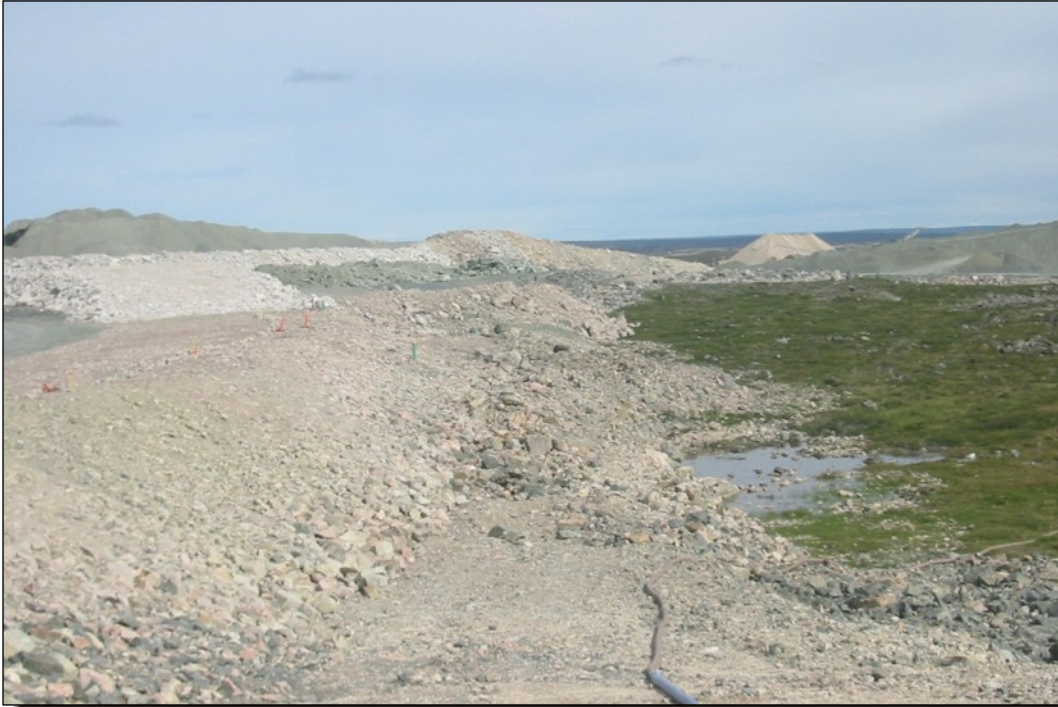
No significant signs of settlement or cracking were noted. A small pond was noted in a low lying area at the downstream dam toe. No seepage from the dam was noted.

Features:	Present	Dimensions	Extent	Description	Photographic Records
Erosion	None noted				
Cracking	None noted				
Settlement	None noted				
Seepage	None noted				
Other Features	ED-1 Wet area at dam toe	10 m by 6 m		Wet area in natural low area at dam toe Approximate Elev. 517.0 m	C3

**Photo C3**  
East Dam - Feature ED-1, ponded water at low area at downstream dam toe.

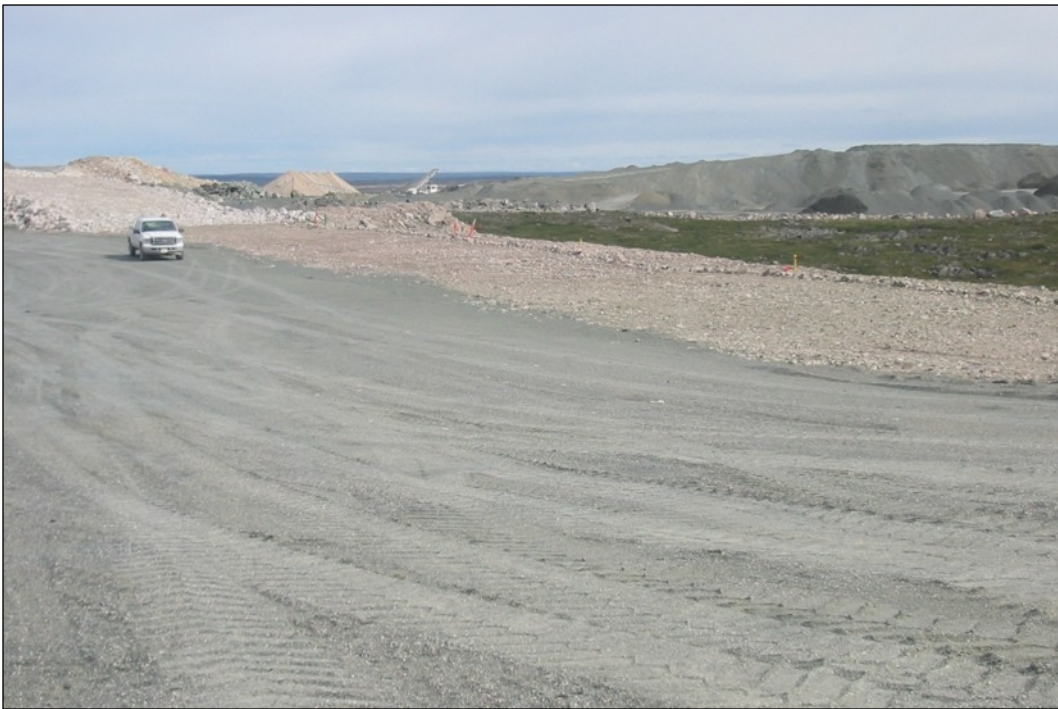
**Photo C4**  
Dam Crest - 200 mm minus material over lined portion of dam, coarse PK in upstream shell.

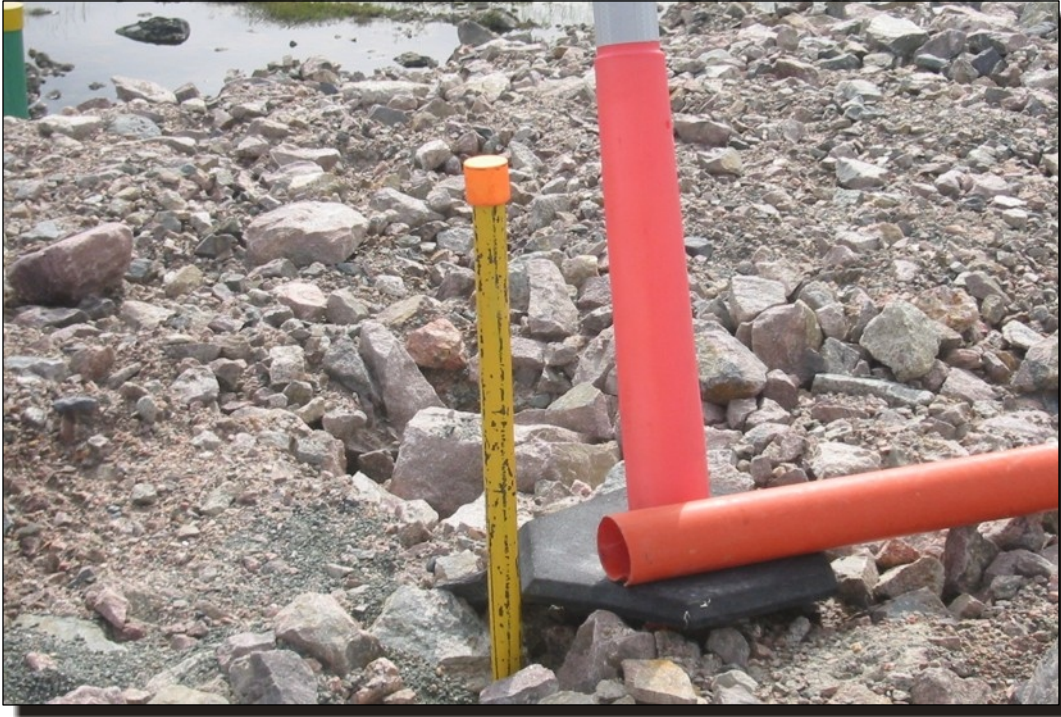
**Photo C5**  
East Dam - Settlement monitoring point.

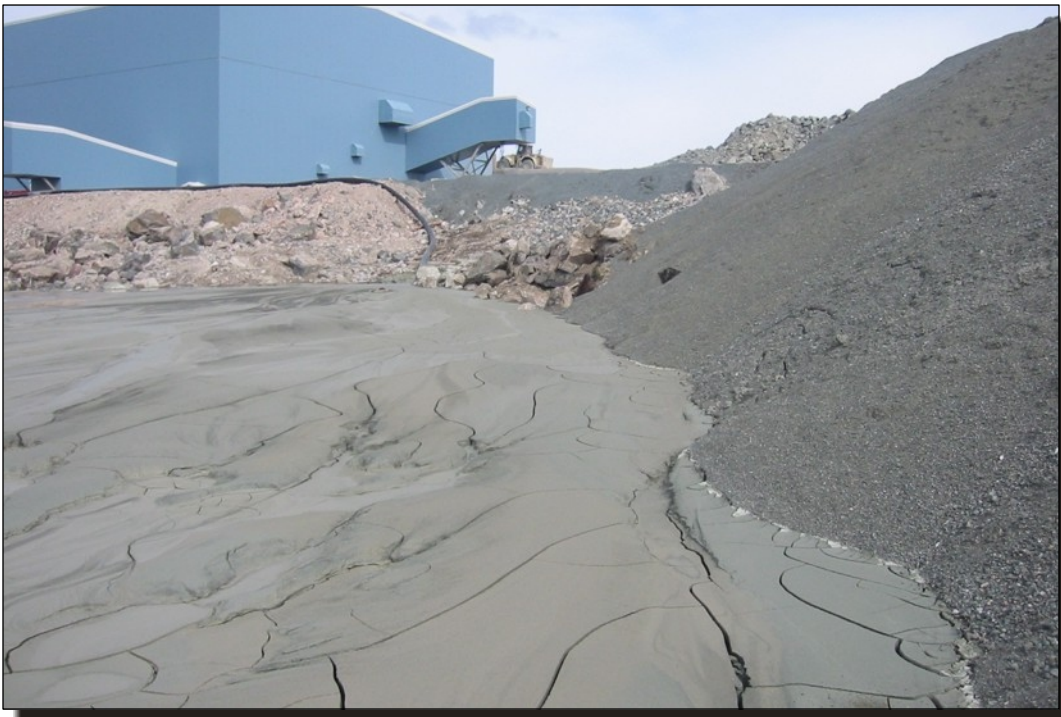
**Photo C6**  
East Dam - Upstream face, fine PK against coarse PK.

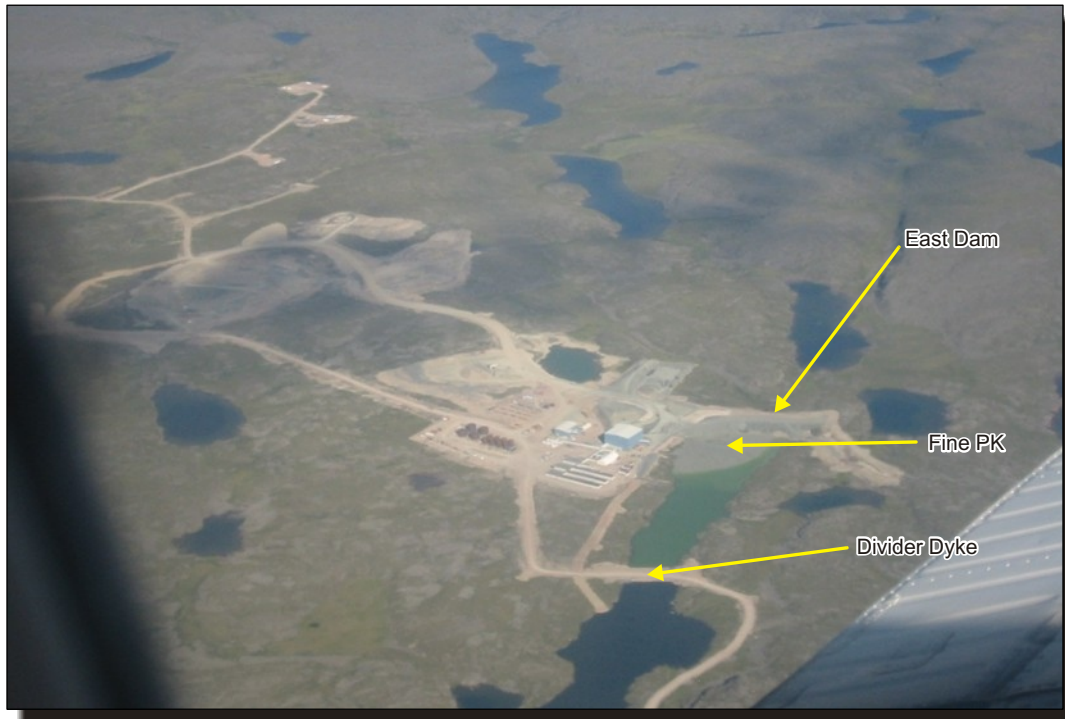
**Photo C7**  
PKCA- Extent of fine PK against East Dam visible. Divider Dyke visible in centre of PKCA.

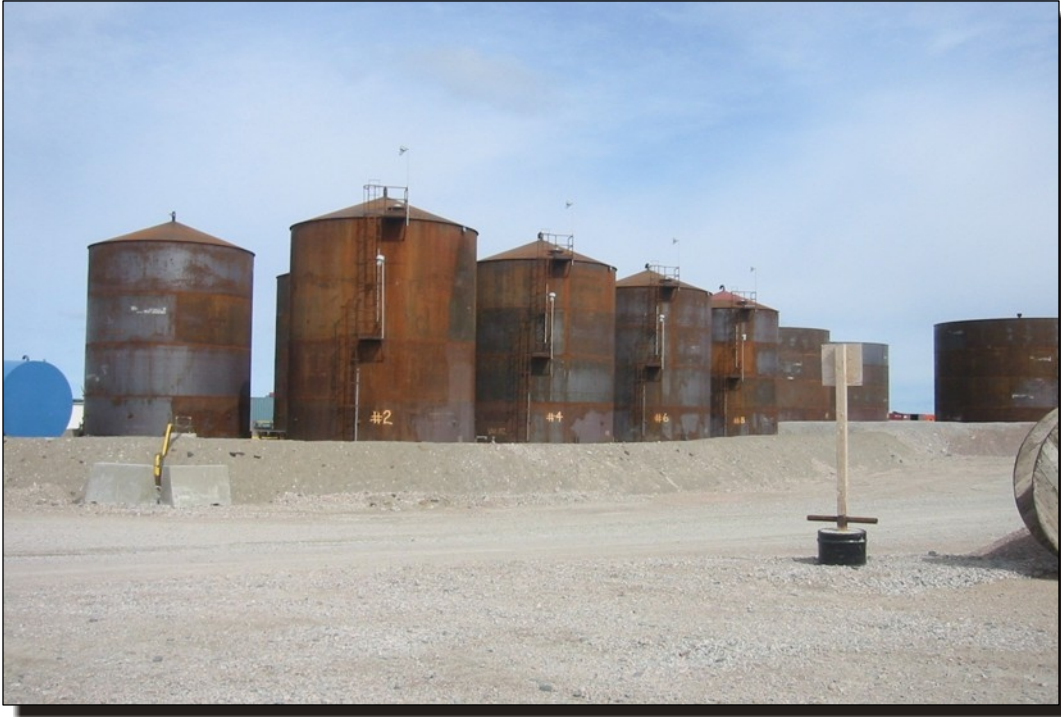
**Photo D1**

Tankfarm - first phase in foreground, second phase in background.

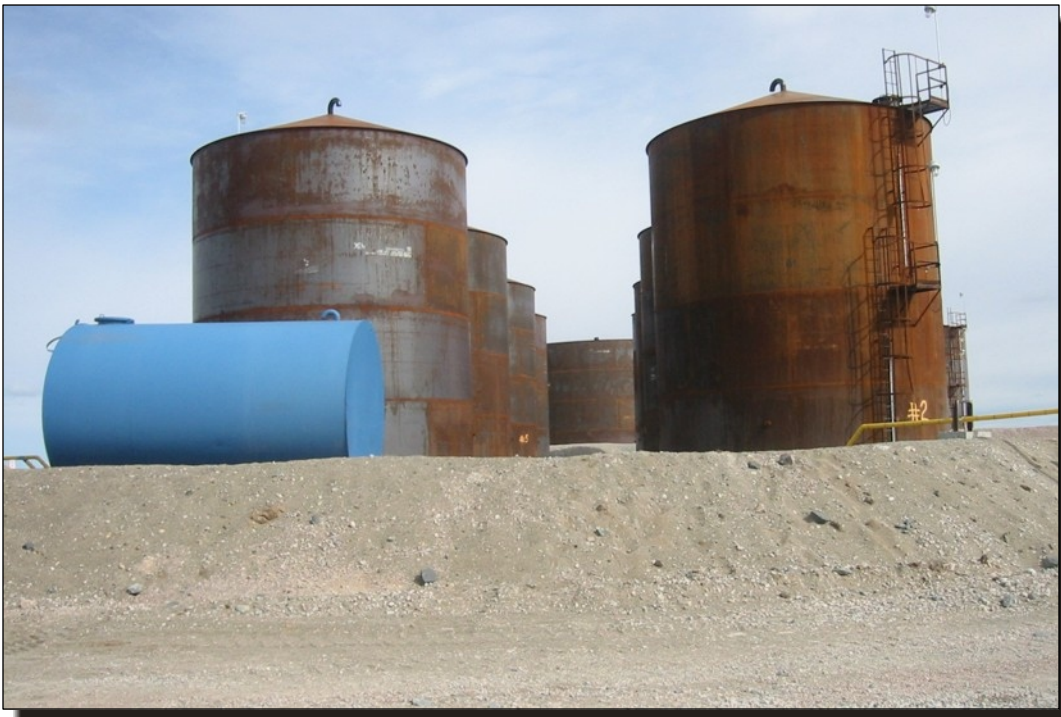
**Photo D2**

Tankfarm - first phase.

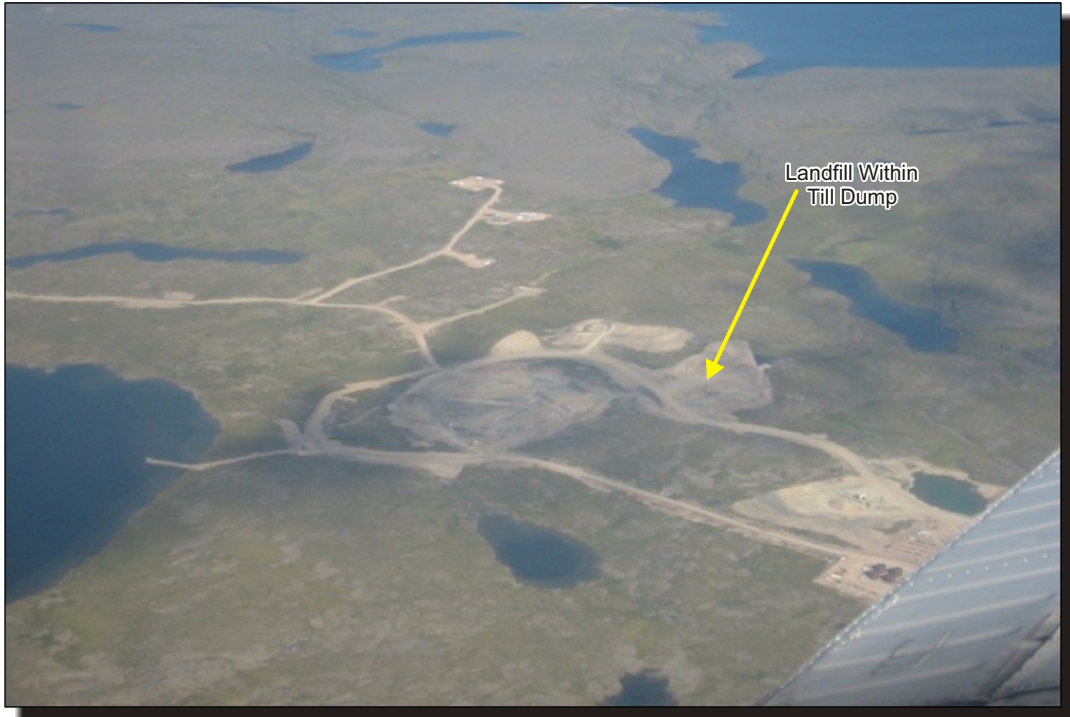
**Photo E1**  
Landfill location.

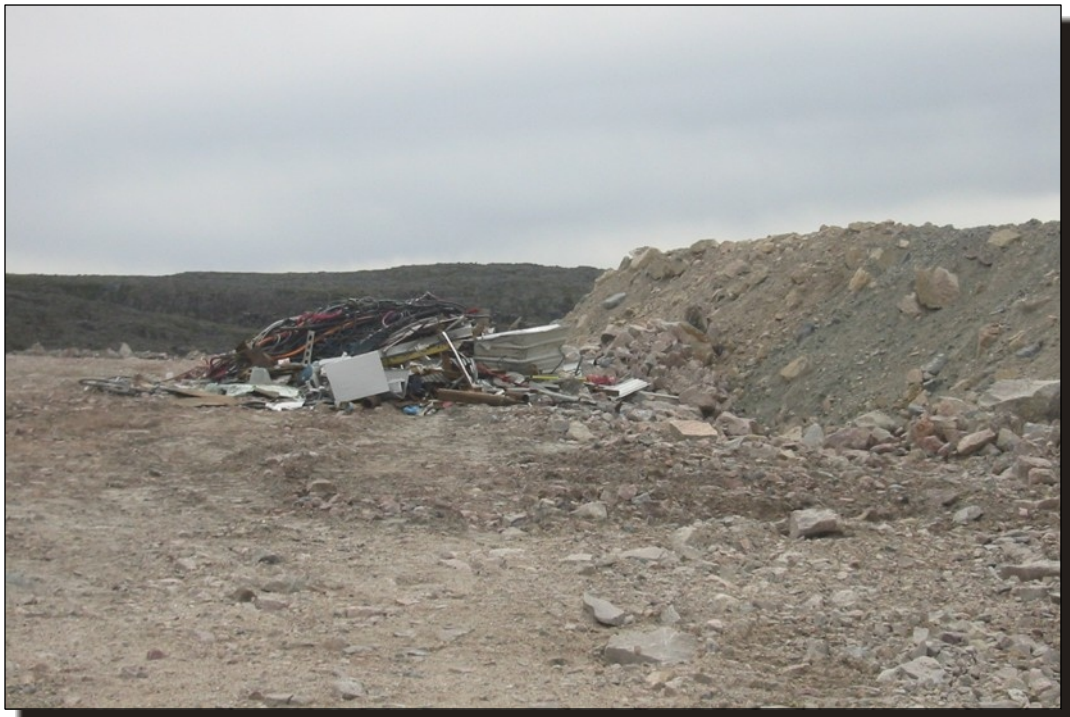
**Photo E2**  
Landfill - metal debris.

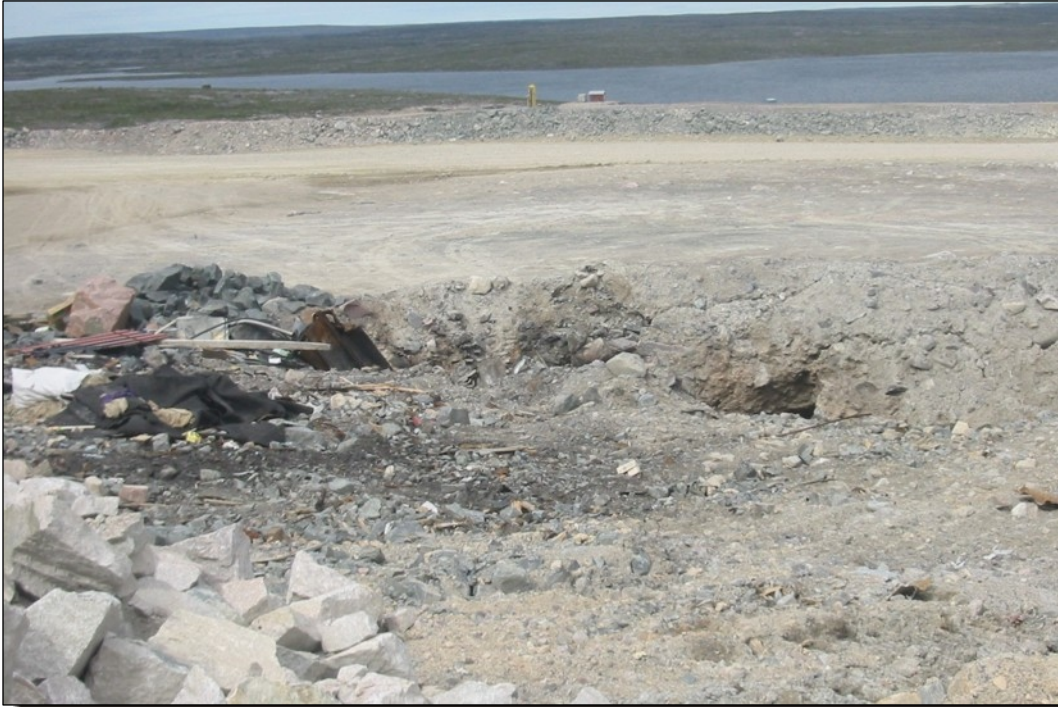
**Photo E3**  
Landfill - burnable debris.

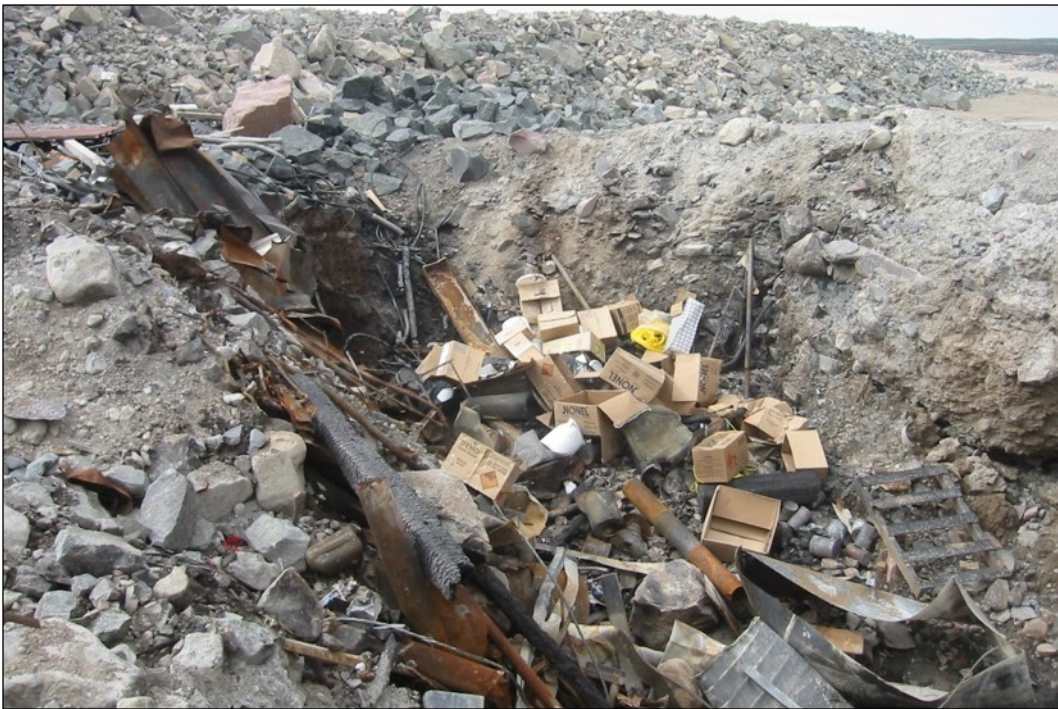
**Photo E4**  
Landfill - waste pit.

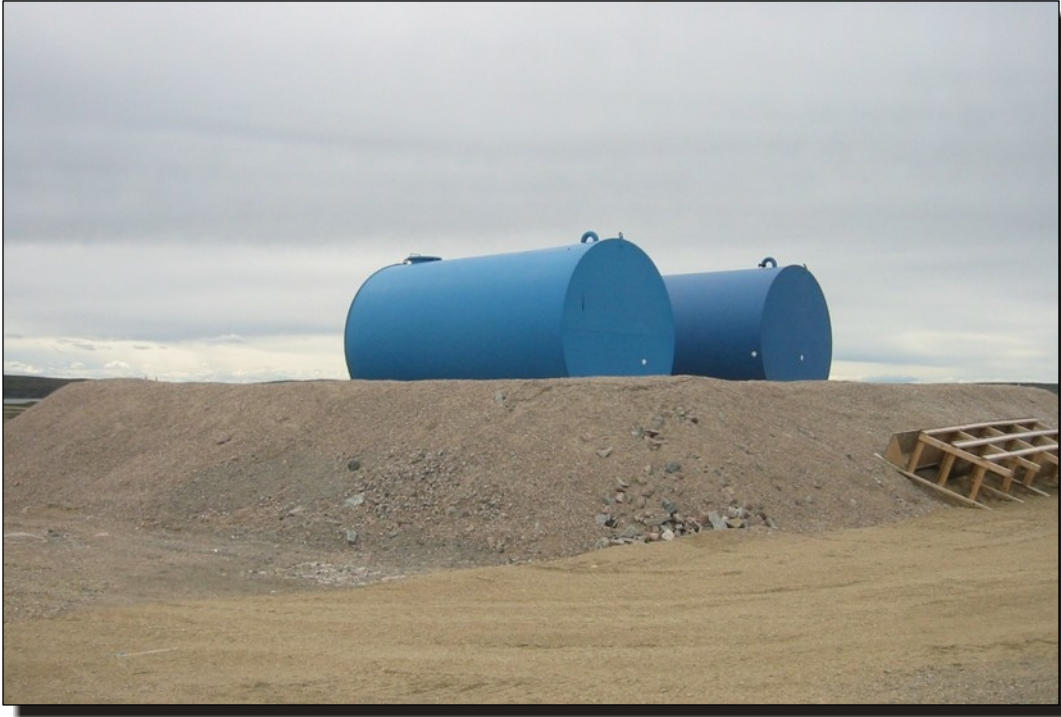
**Photo F1**  
Airstrip tank farm.

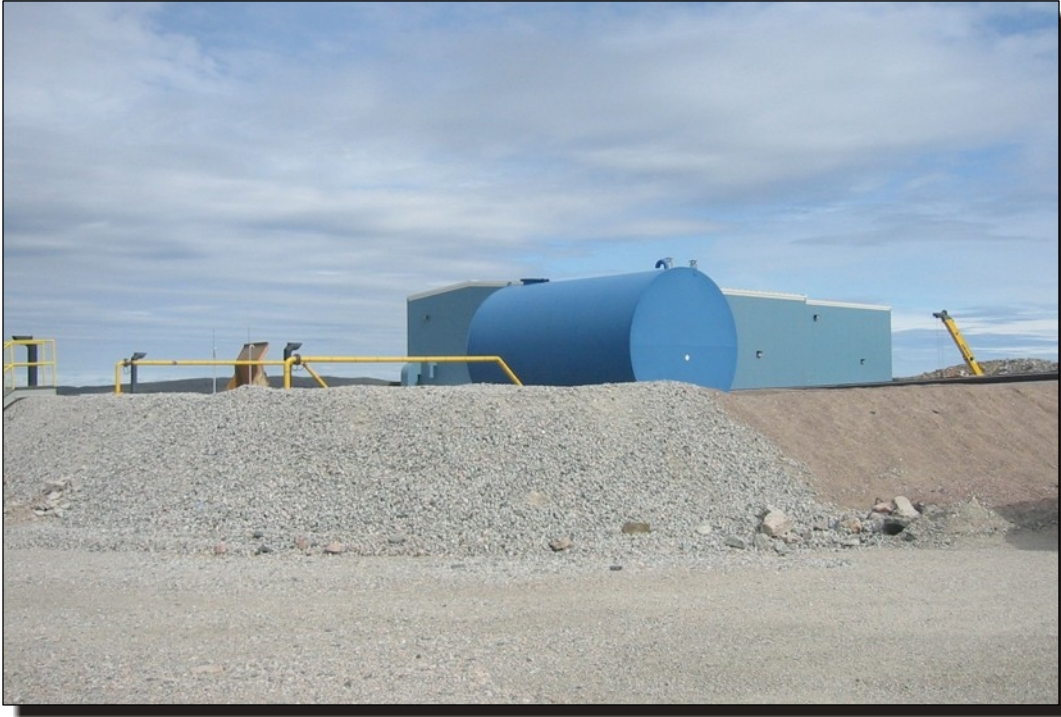
**Photo G1**  
Generator tank containment.

Features:	Present	Dimensions	Extent	Description	Photographic Records
Erosion	None noted				
Cracking	None noted				
Settlement	None noted				
Seepage	None noted				
Other Features	None noted

Satisfactory performance.

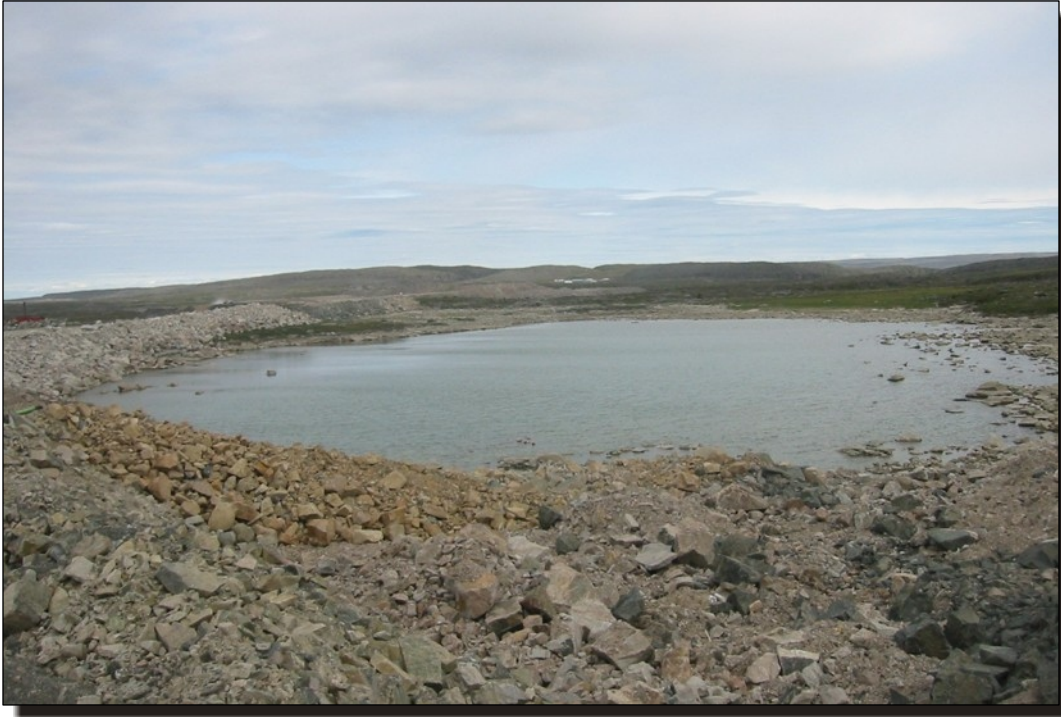
**Photo H1**  
East sump - looking north.

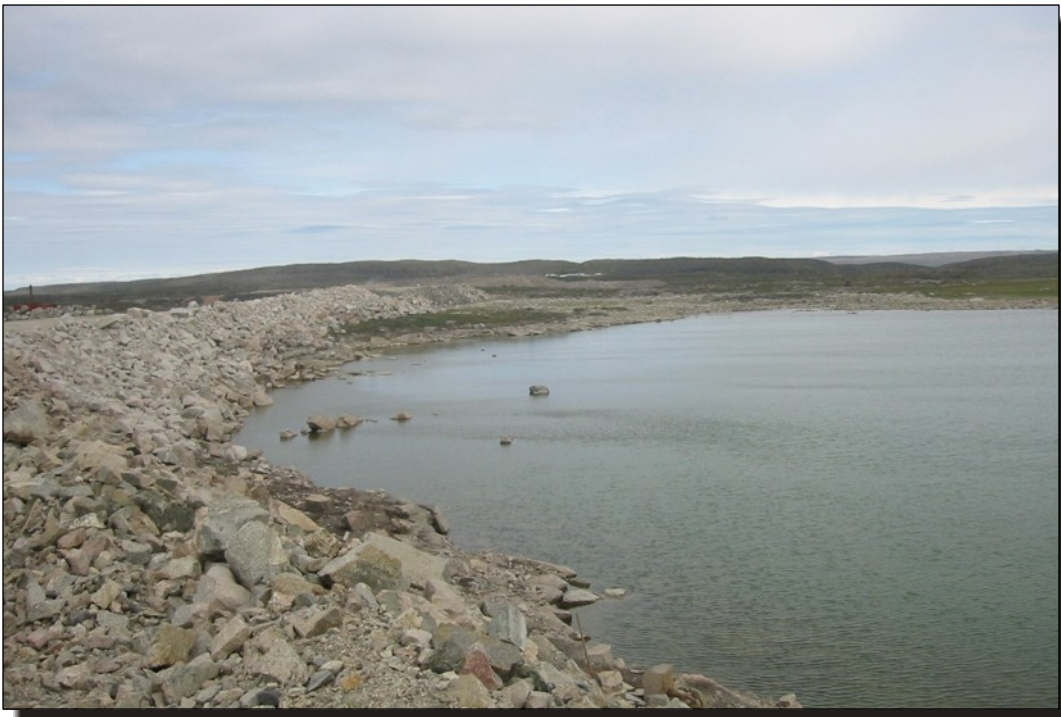
**Photo H2**  
East sump - looking north along road adjacent to area.

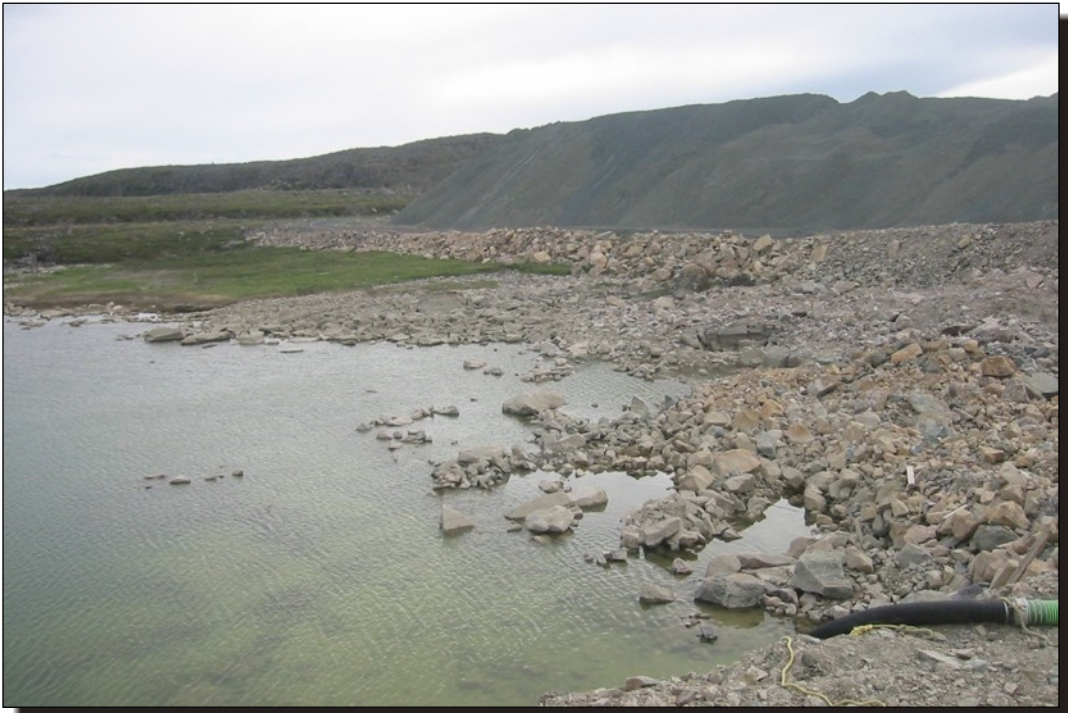
**Photo H3**  
East sump, south end looking east - coarse PK stockpile.

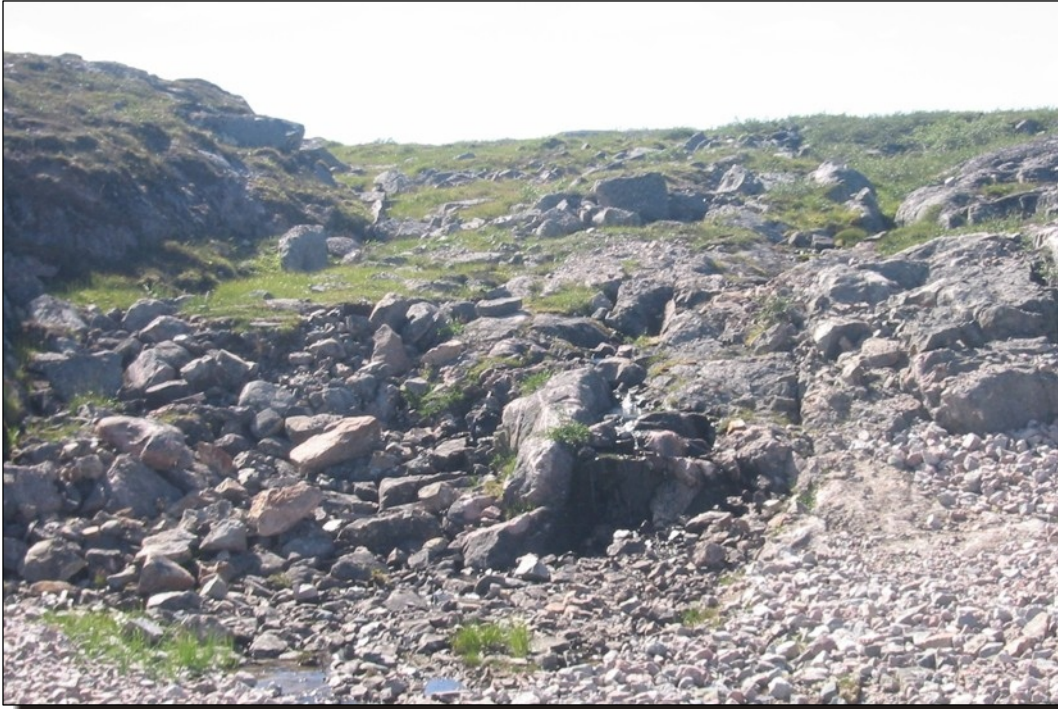
**Photo I1**  
C1 Diversion - Flow entering diversion channel.

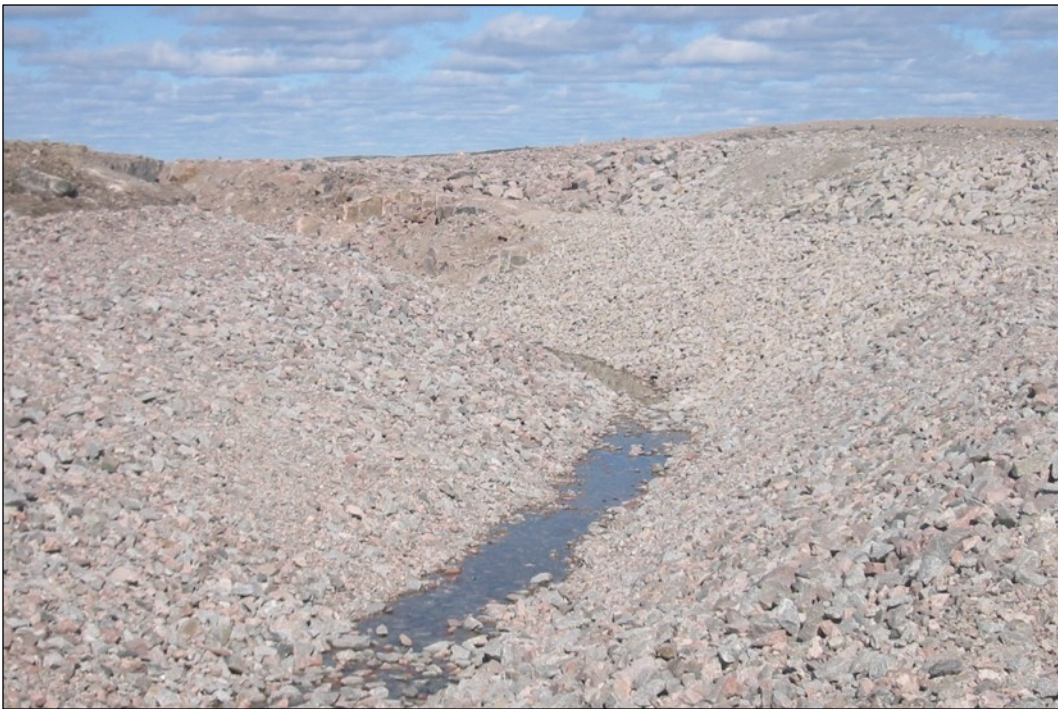
**Photo I2**  
C1 Diversion - start of diversion channel - lined cut off.

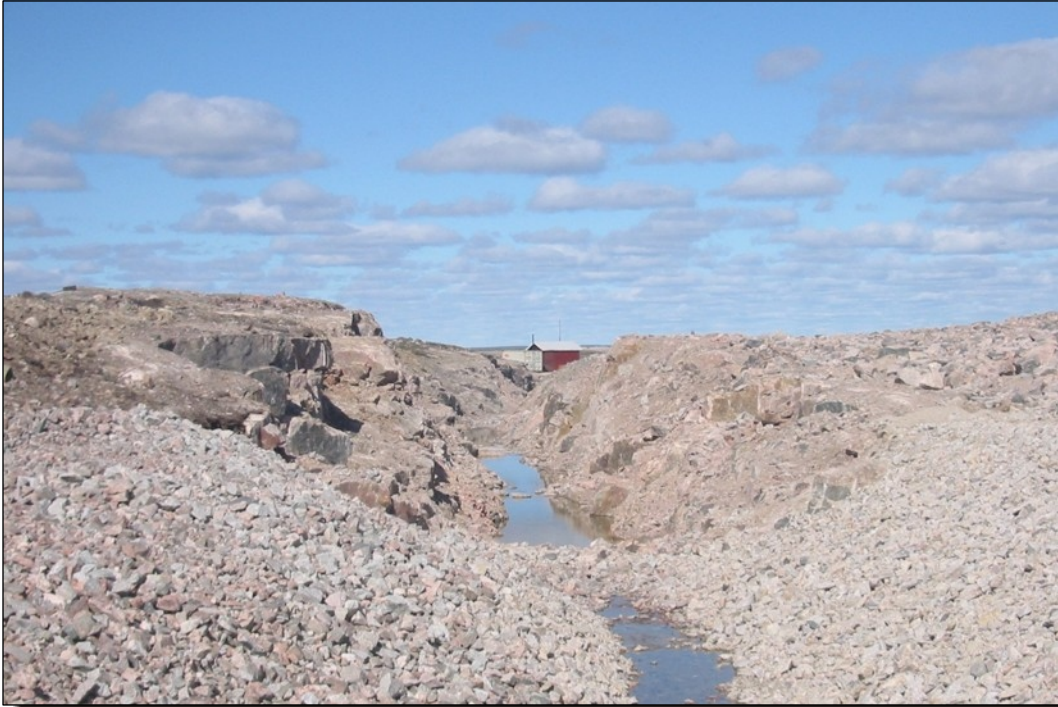
**Photo I3**  
C1 Diversion - flow through reach A - bedrock cut.

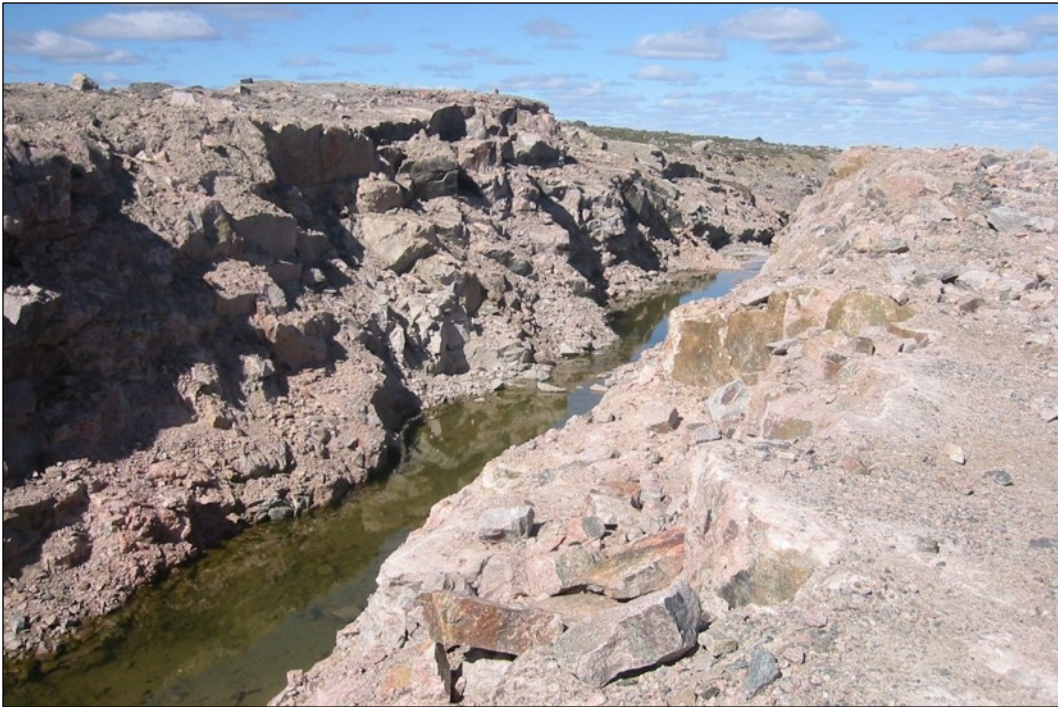
**Photo I4**  
C1 Diversion - Reach A - bedrock cut.

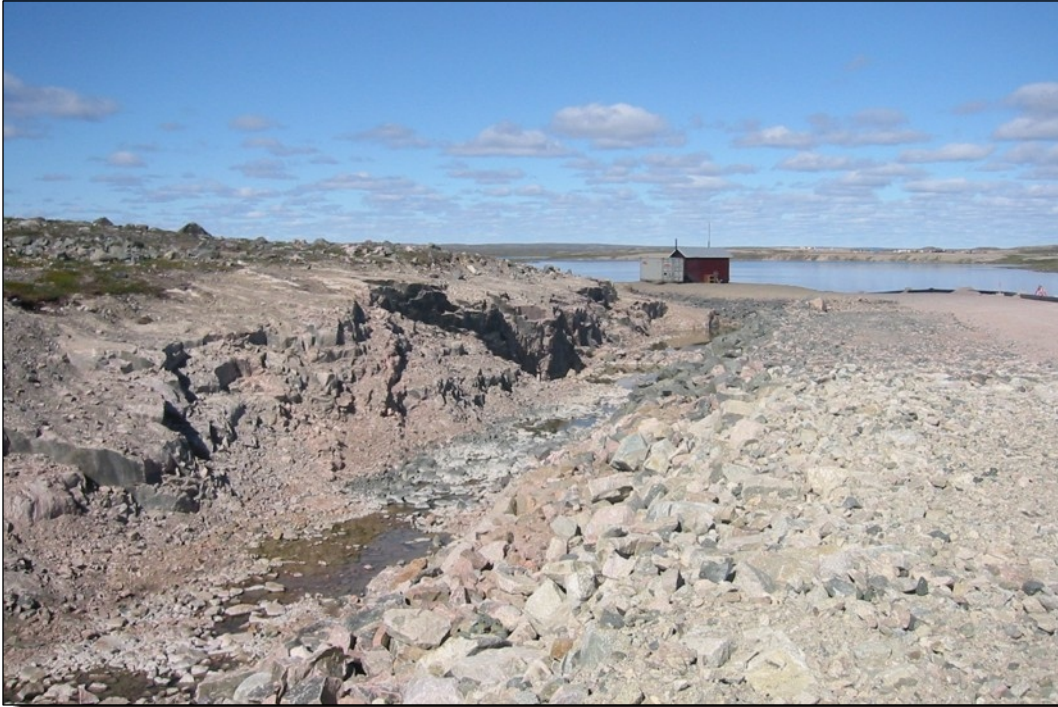
**Photo I5**  
C1 Diversion - Reach A - downstream end.
