Tahera Diamond Corporation

JERICO DIAMOND MINE  
2006 GEOTHECNICAL INSPECTION

1100060.010

September 2006

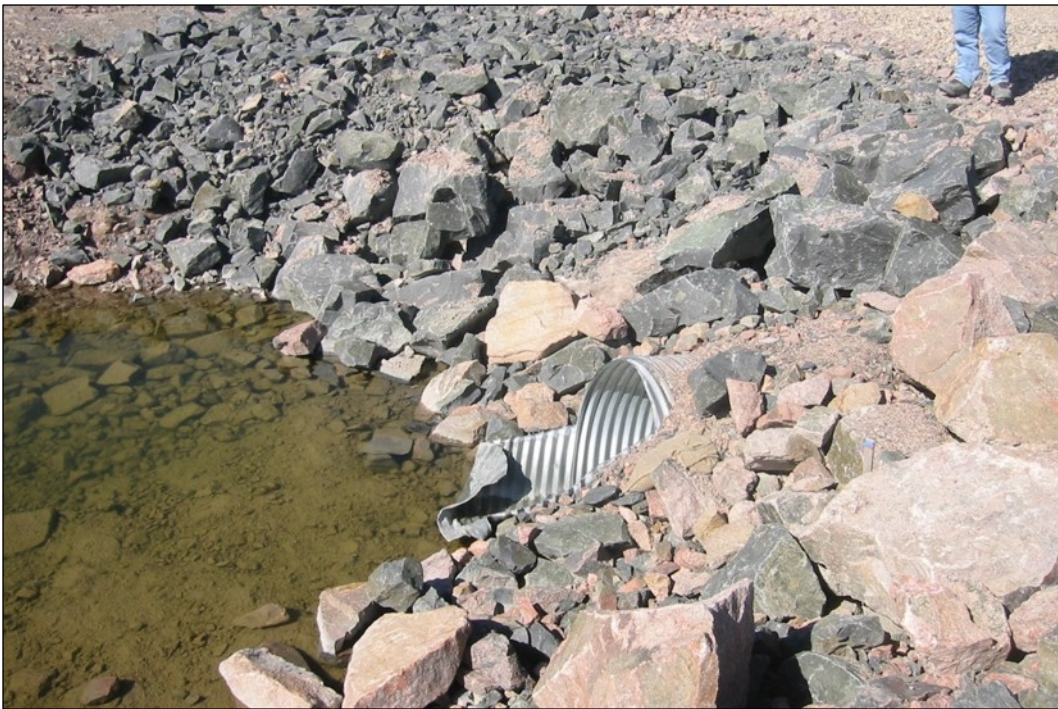
**Photo I6**  
C1 Diversion - Culvert below Reach A - bent culvert end.

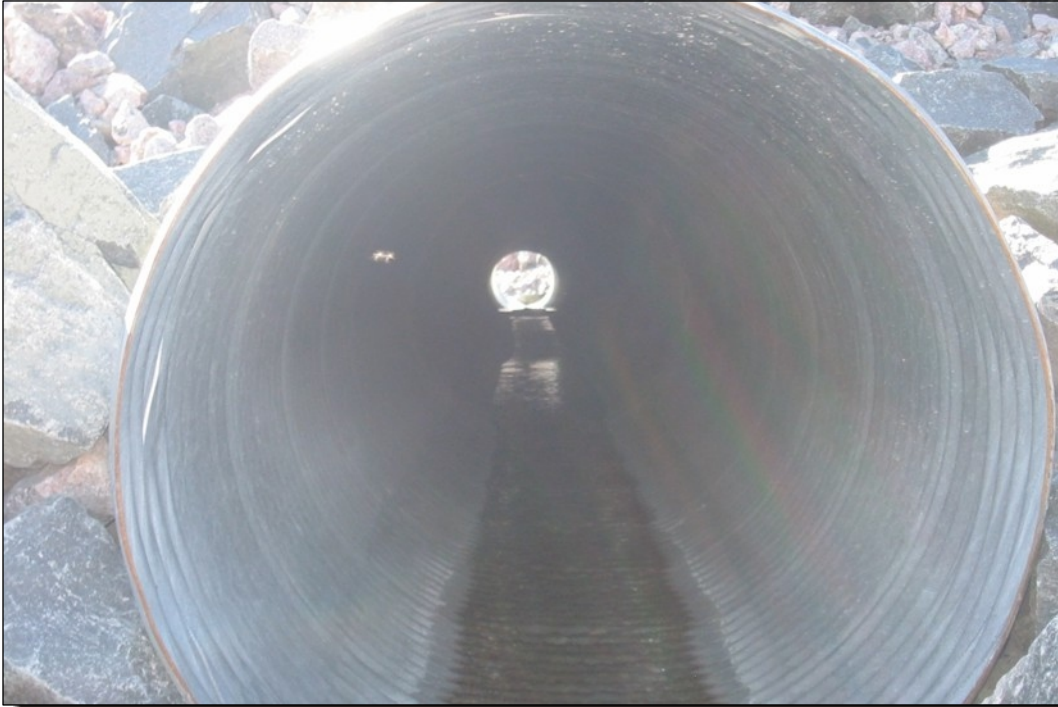
**Photo I7**

C1 Diversion - Culvert below Reach A - low flow- slight bend in base of culvert at upstream end.

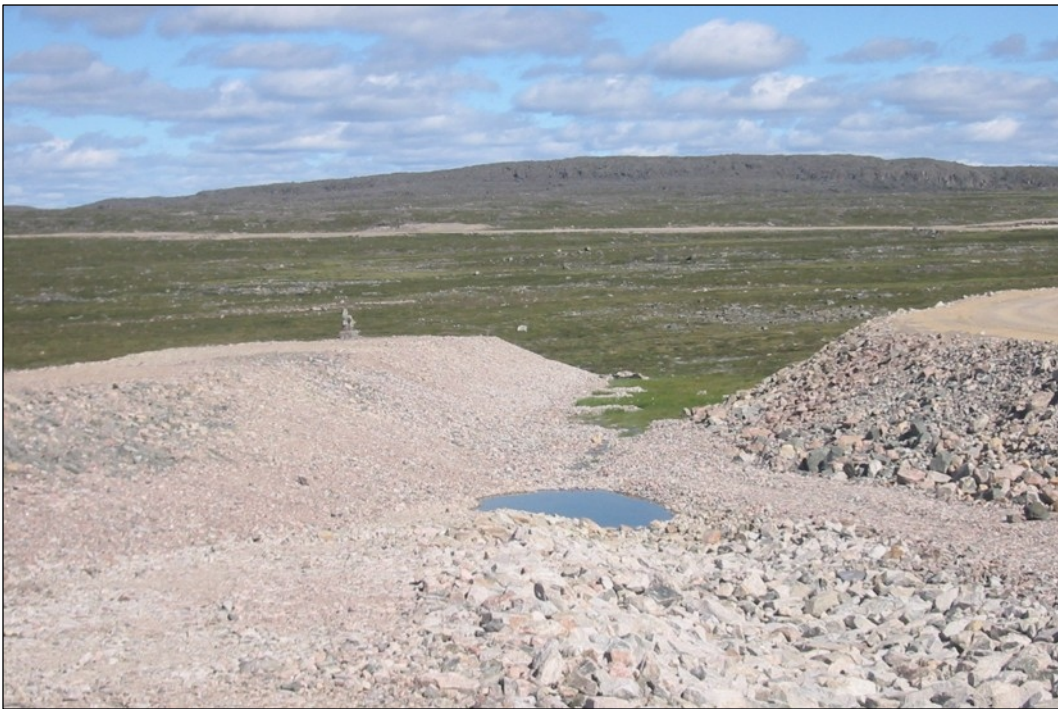
**Photo I8**

C1 Diversion - Reach B and C - below culvert - small pool in Reach B.

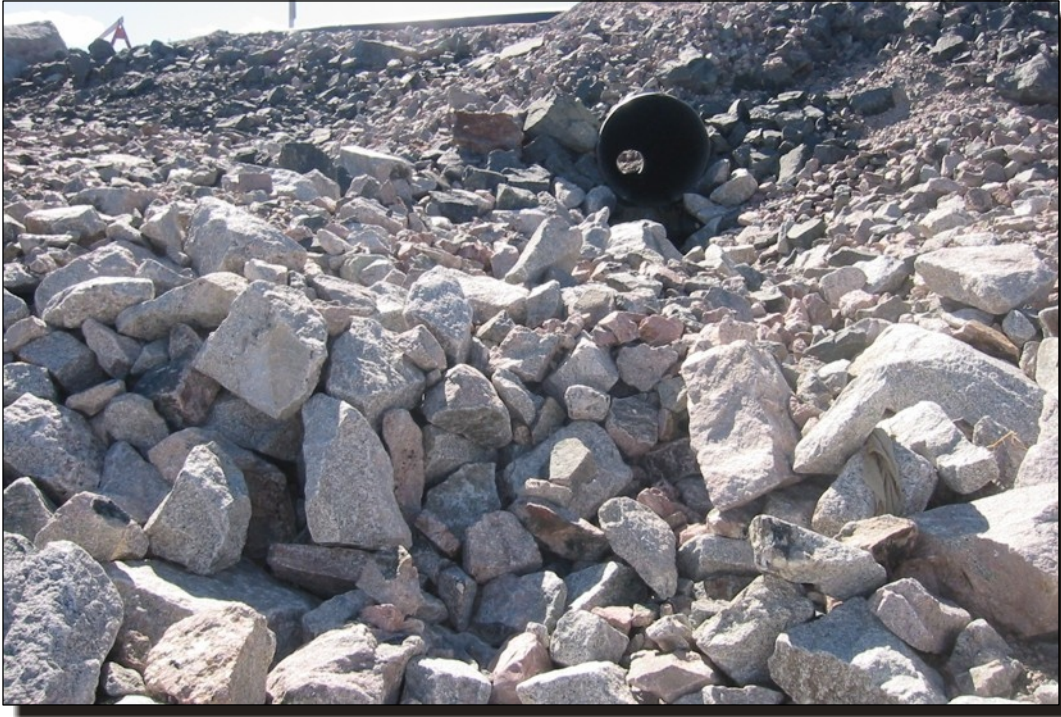
**Photo I9**  
C1 Diversion - Reach B - rip rap below culvert.

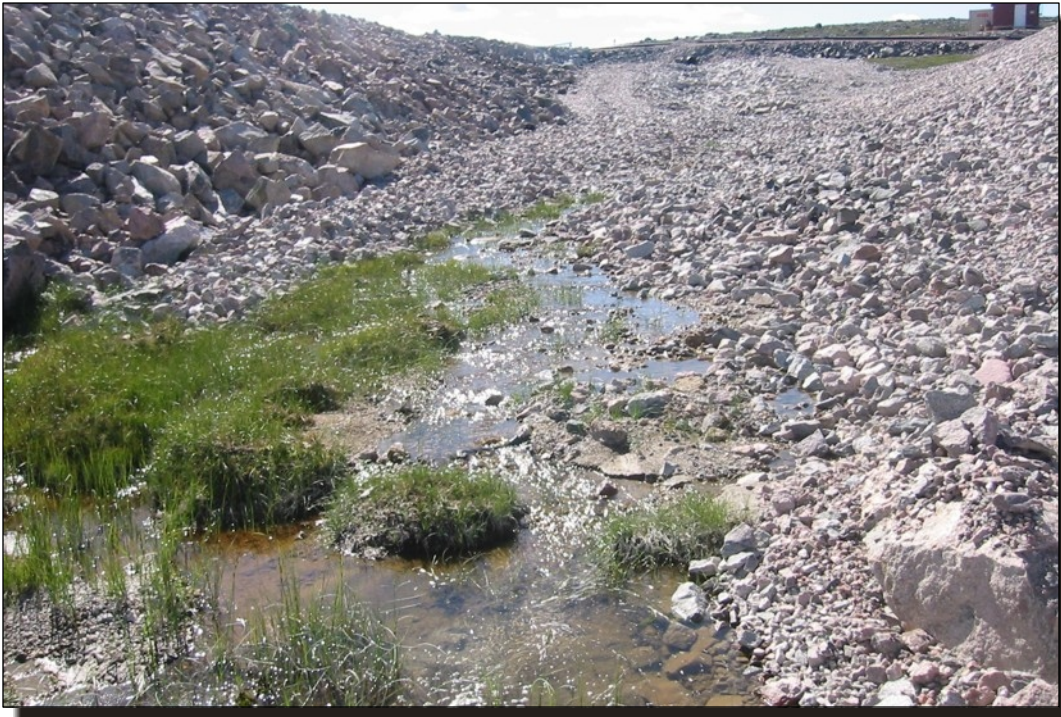
**Photo I10**  
C1 Diversion - Reach C - surface water, vegetation.

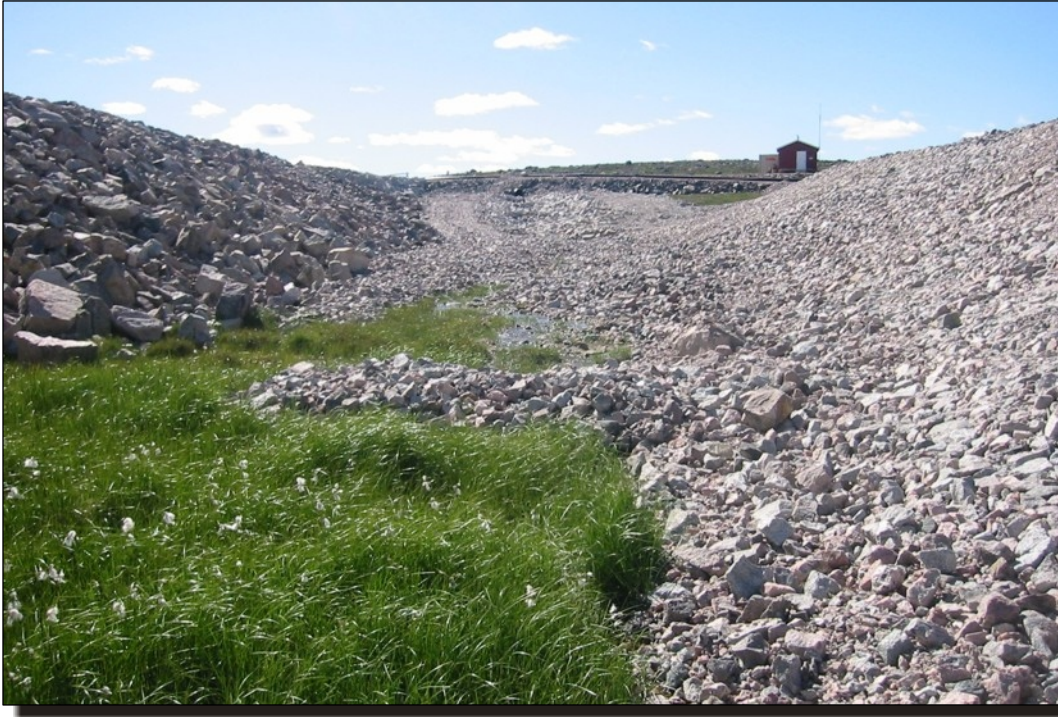
**Photo I11**  
C1 Diversion - Reach C - water diversion berm.

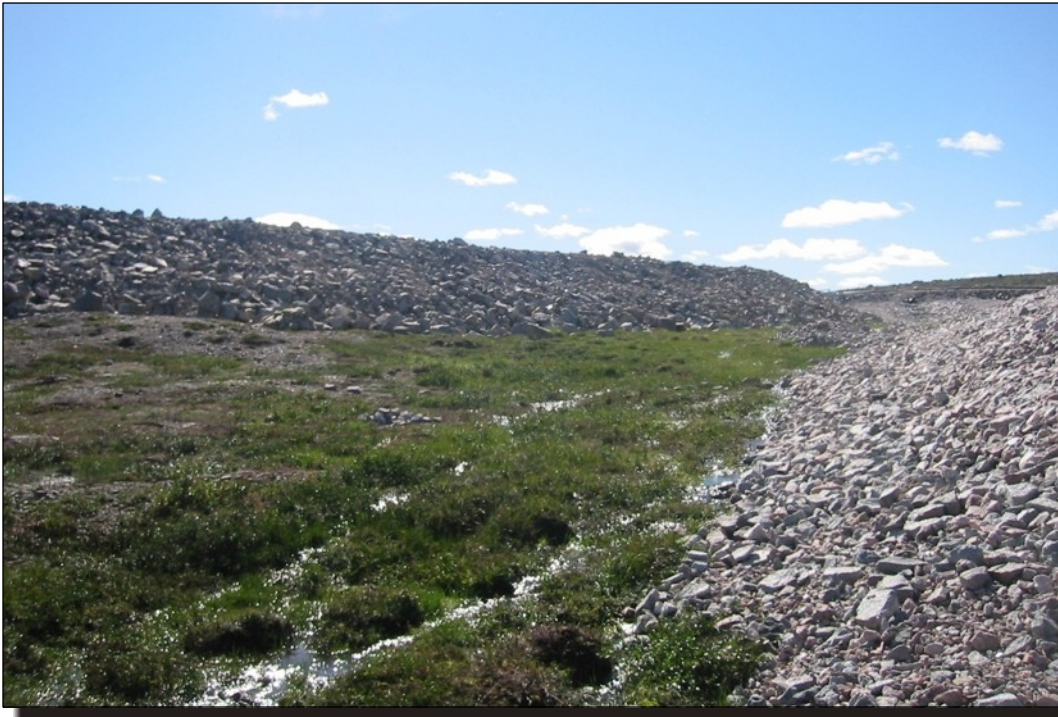
**Photo I12**  
C1 Diversion - Reach C - downstream end - surface water.

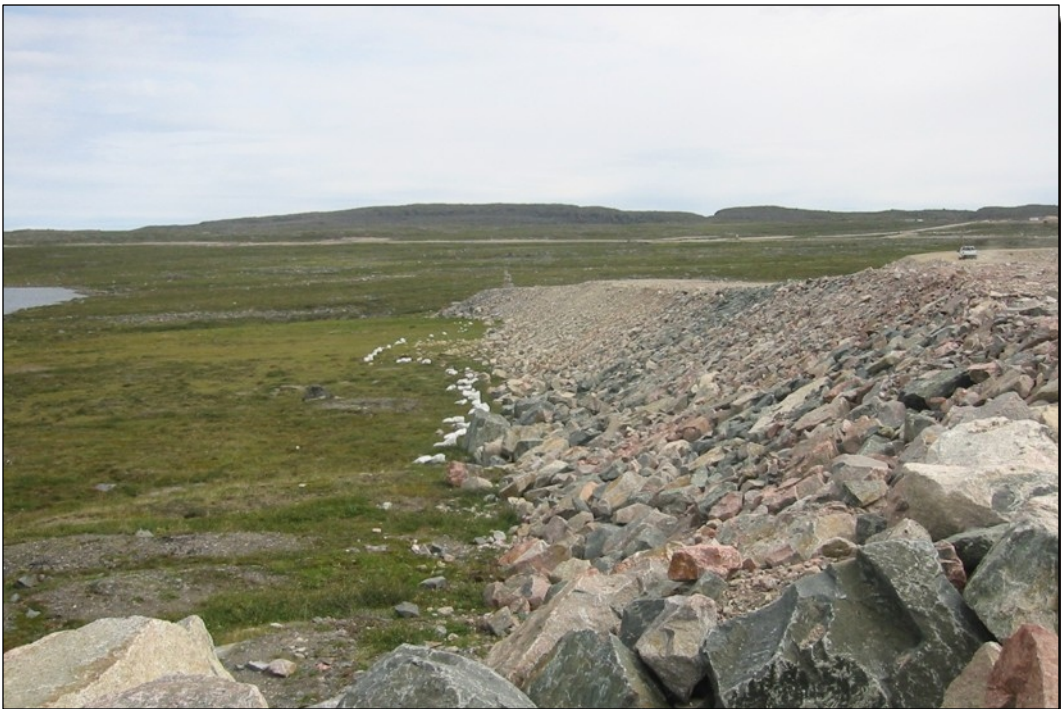
**Photo I14**

C1 Diversion - Reach C berm - downstream side.

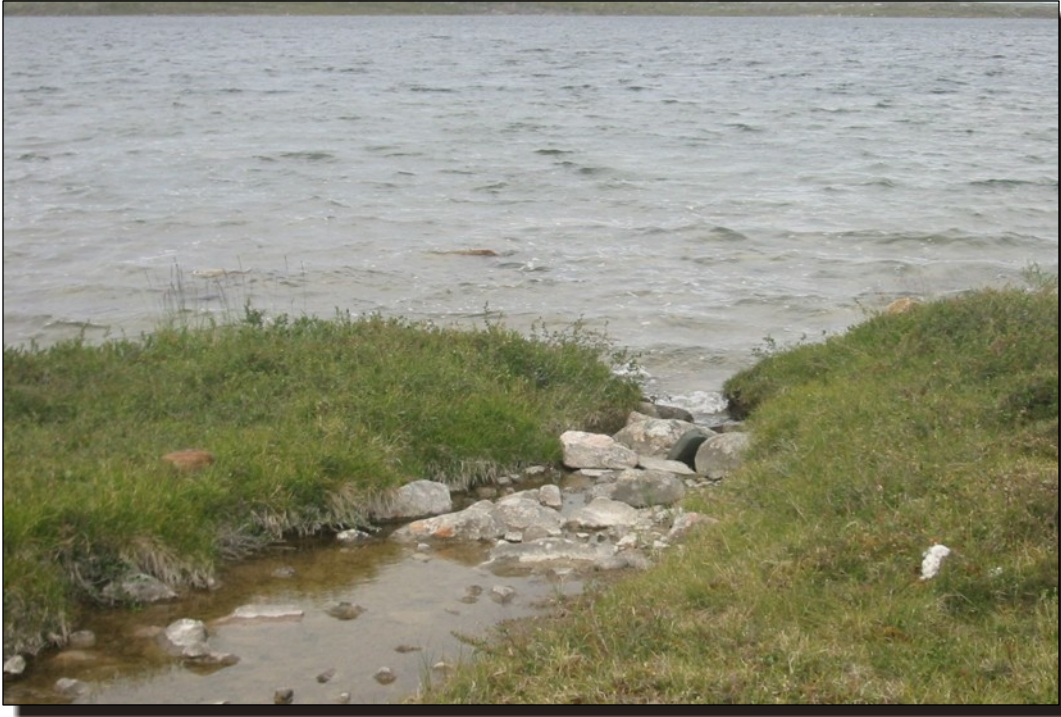
**Photo I15**  
Water entering Carat Lake below diversion channel.
