**Shear Minerals Ltd.**

**ISSUED FOR USE – REV 1**

**JERICO DIAMOND MINE  
2010 GEOTECHNICAL INSPECTION**

**E14101117**

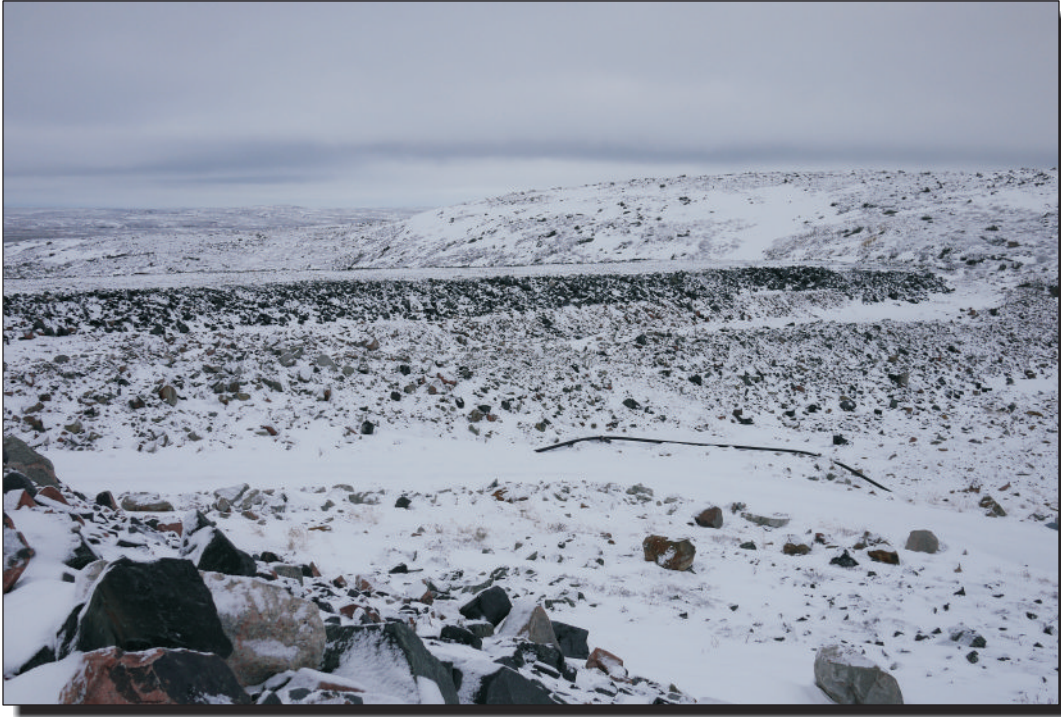
**Photo A-1**  
General condition of upstream of West Dam (Aspect: NW)

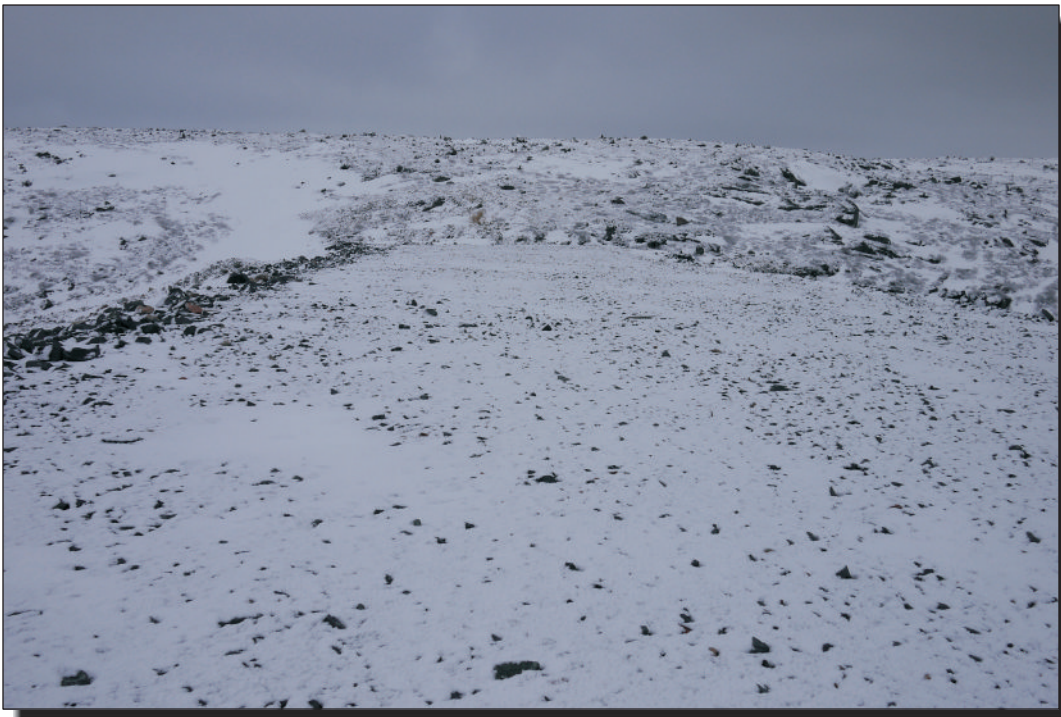
**Photo A-2**  
Crest of thermal cover on West Dam (Aspect: N)

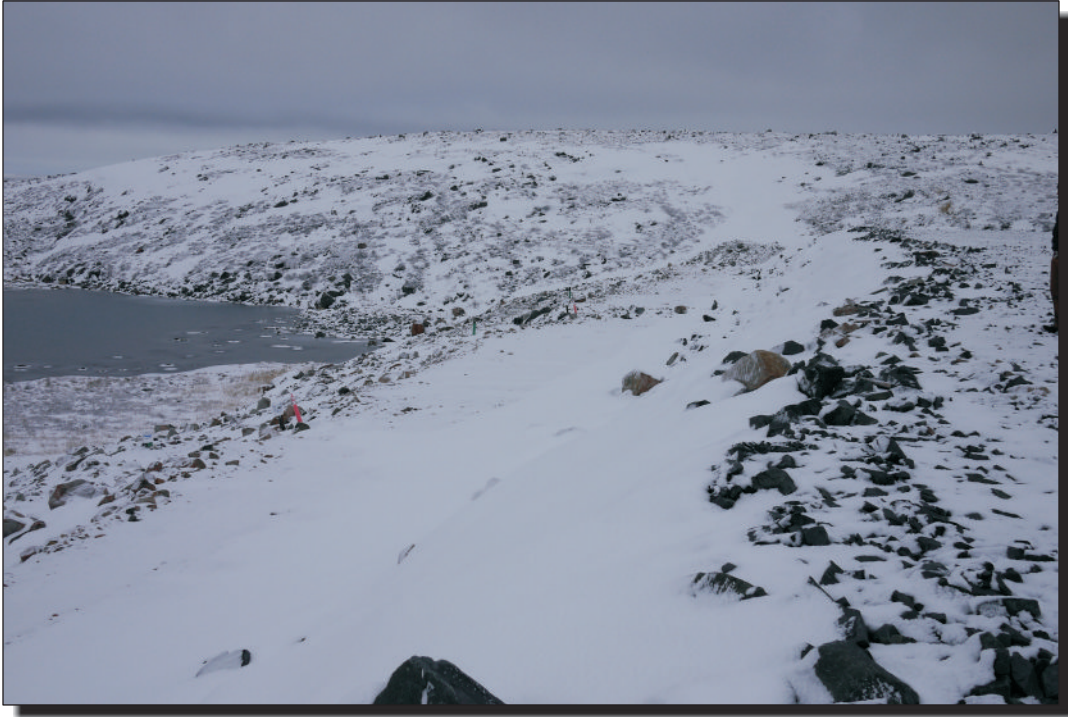
**Photo A-3**  
Downstream slope of West Dam (Aspect: N)

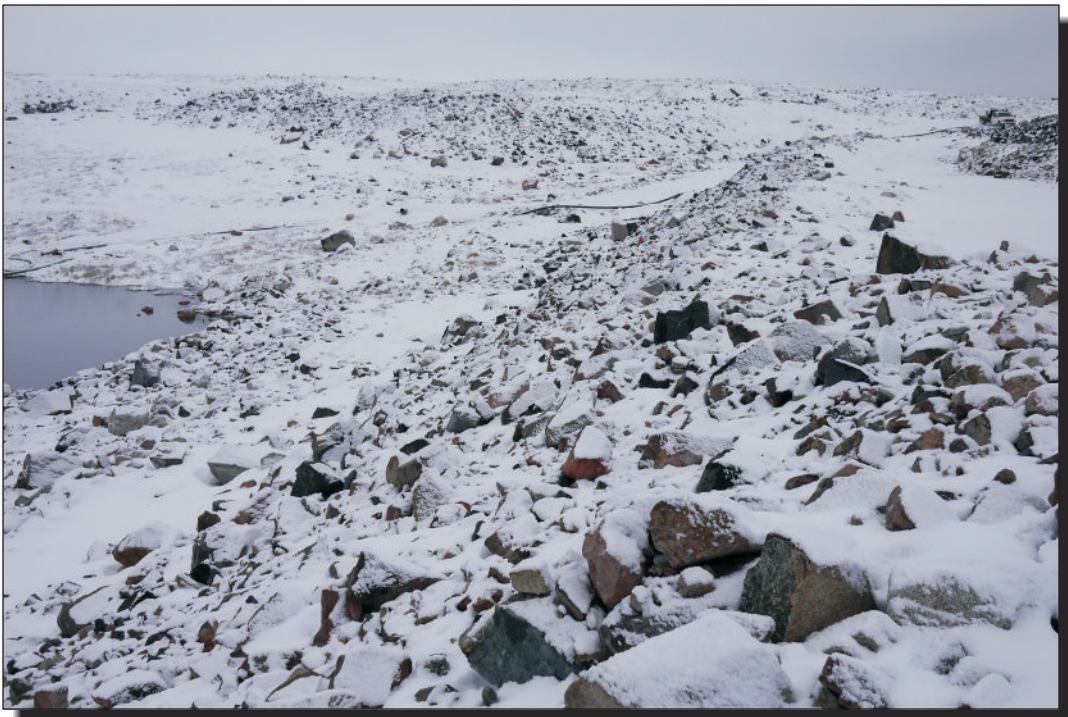
**Photo A-4**  
Upstream crest and thermal cover of West Dam (Aspect: S)

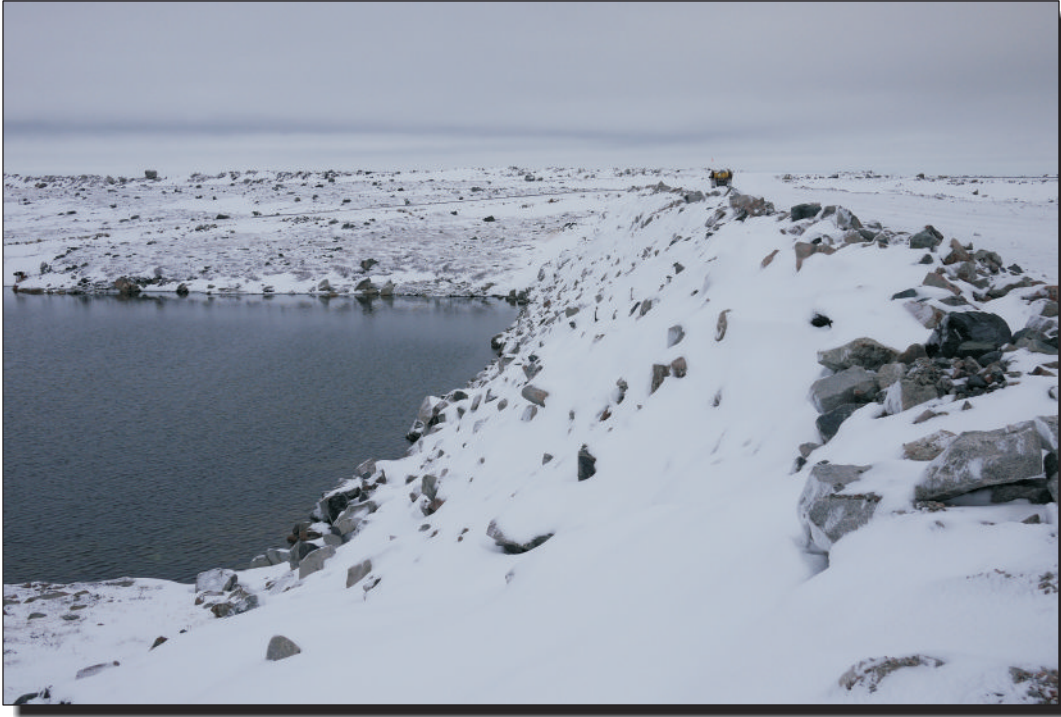
**Photo B-1**  
Downstream slope of Divider Dyke A (Aspect: N)

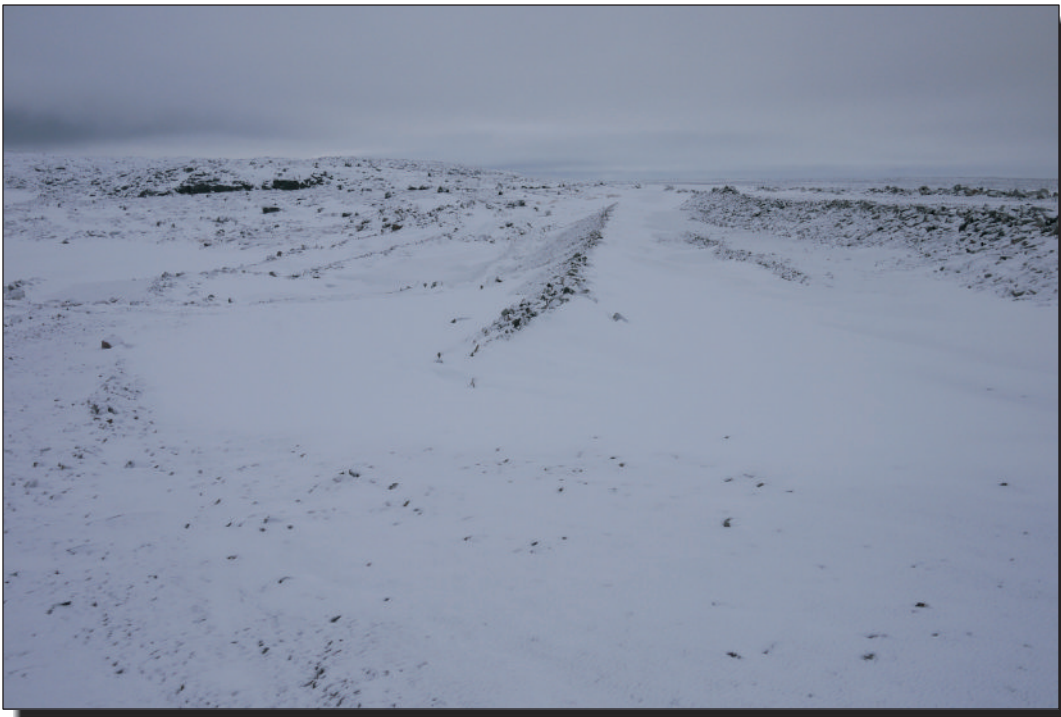
**Photo B-2**  
Upstream slope and filter zone of Divider Dyke A (Aspect: S)

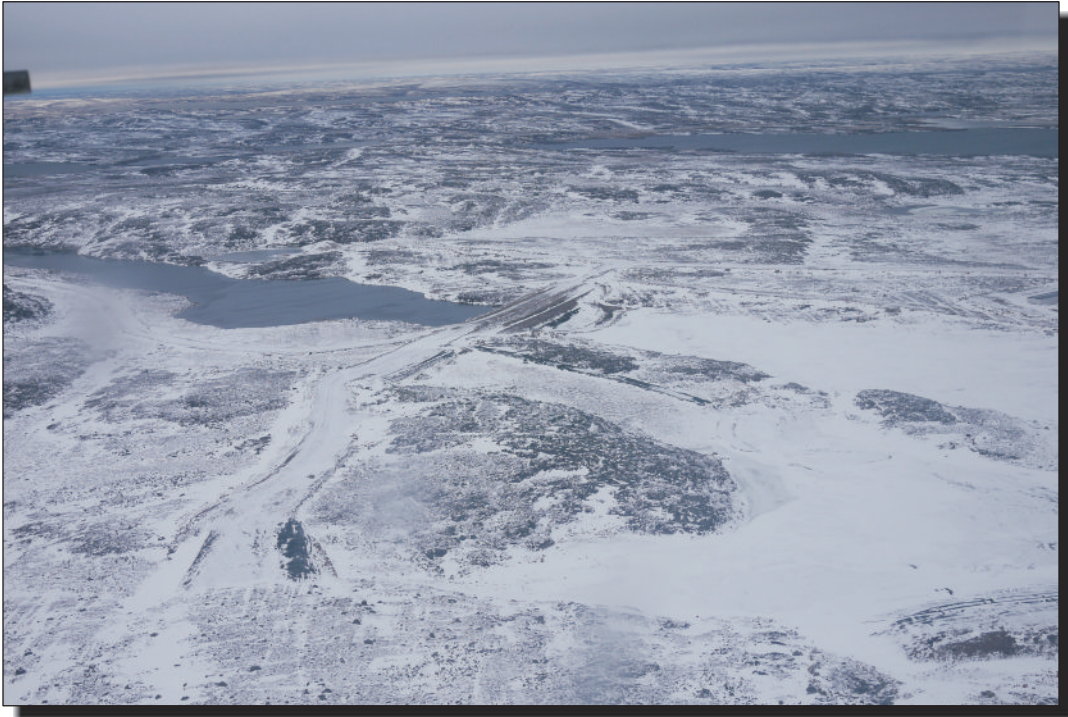
**Photo B-3**  
Aerial view of Divider Dyke A (Aspect: NW)

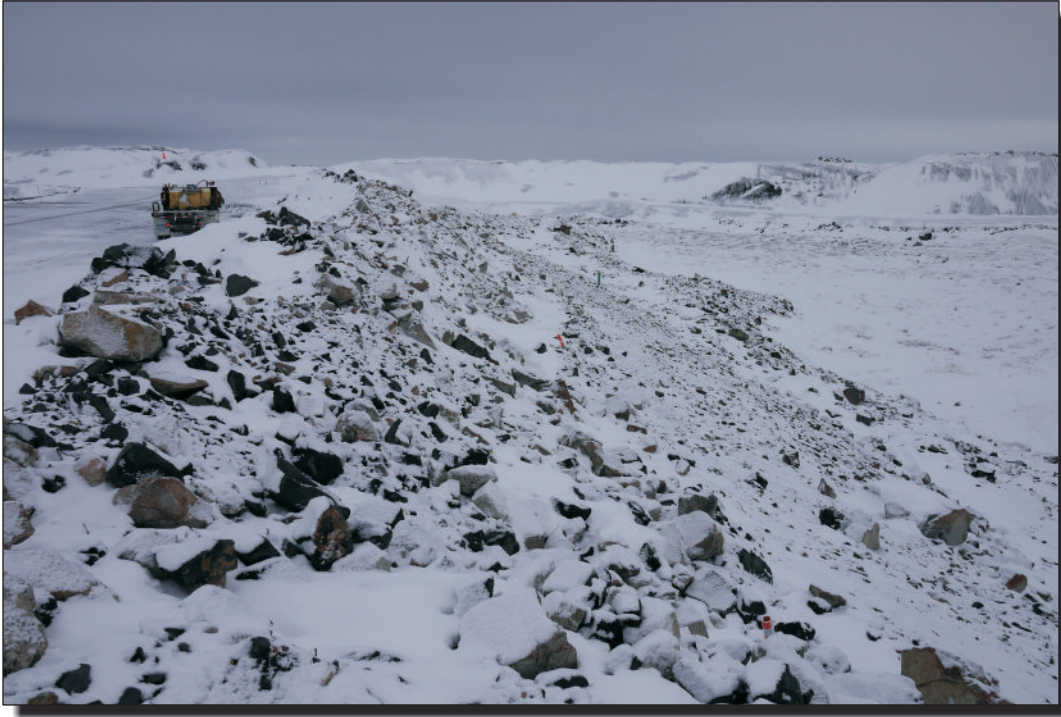
**Photo C-1**  
Downstream slope of East Dam (Aspect: N)

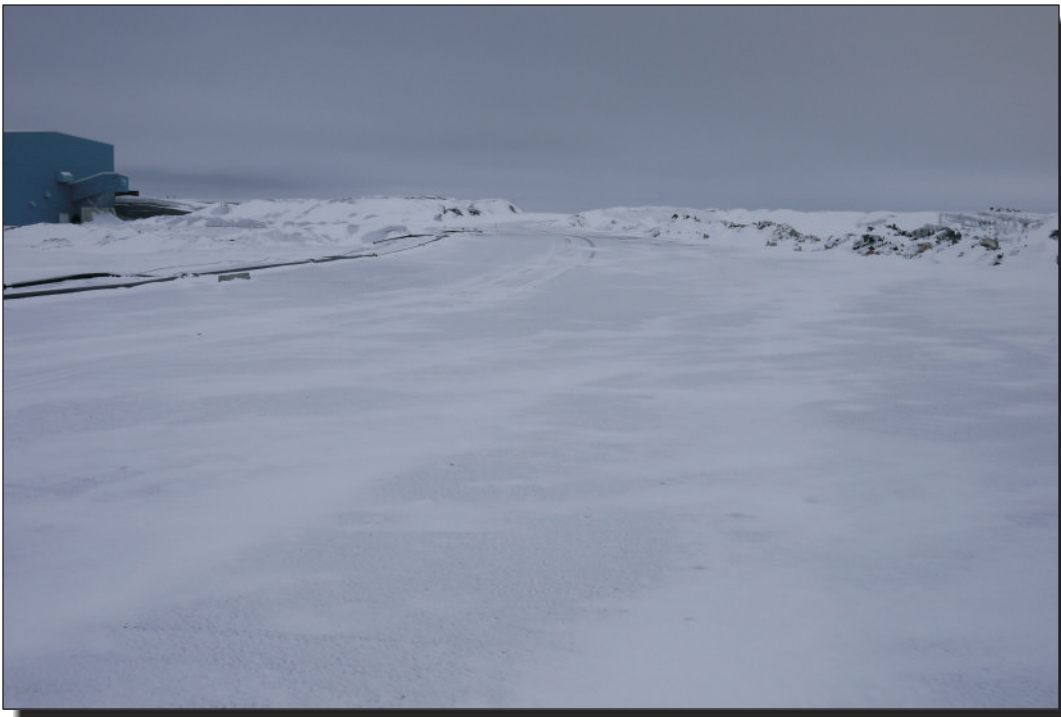
**Photo C-2**  
Crest surface of East Dam (Aspect: N)

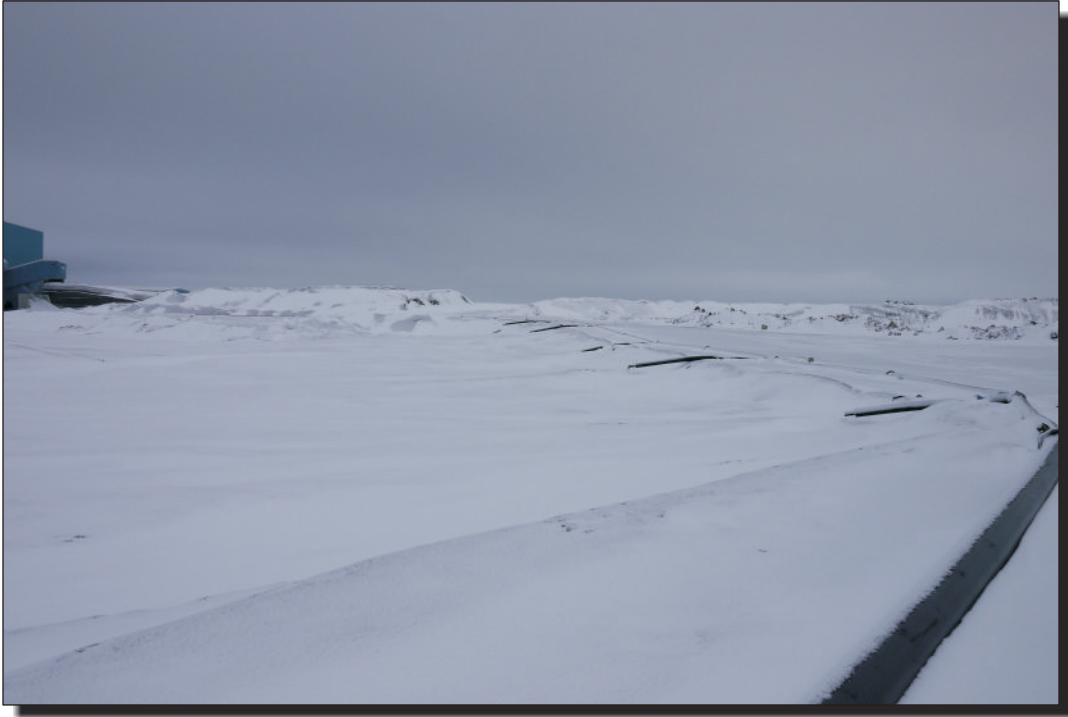
**Photo C-3**  
Upstream slope of East Dam (Aspect: NE)

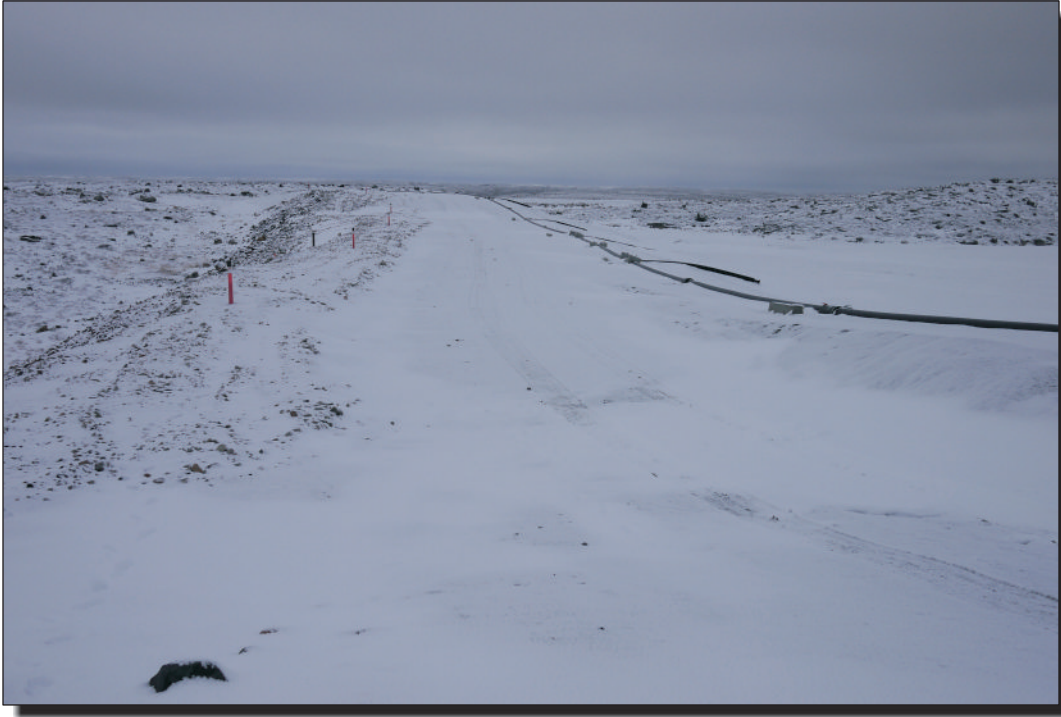
**Photo D-1**  
Crest surface of Southeast Dam (Aspect: SW)

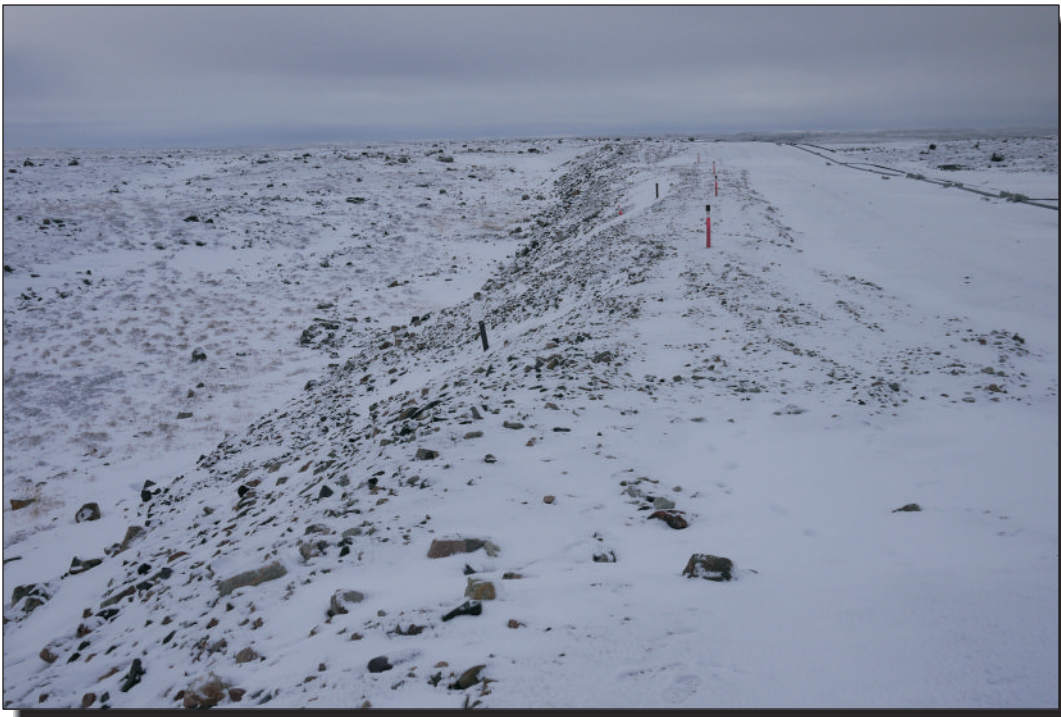
**Photo D-2**  
Downstream slope of Southeast Dam (Aspect: SW)

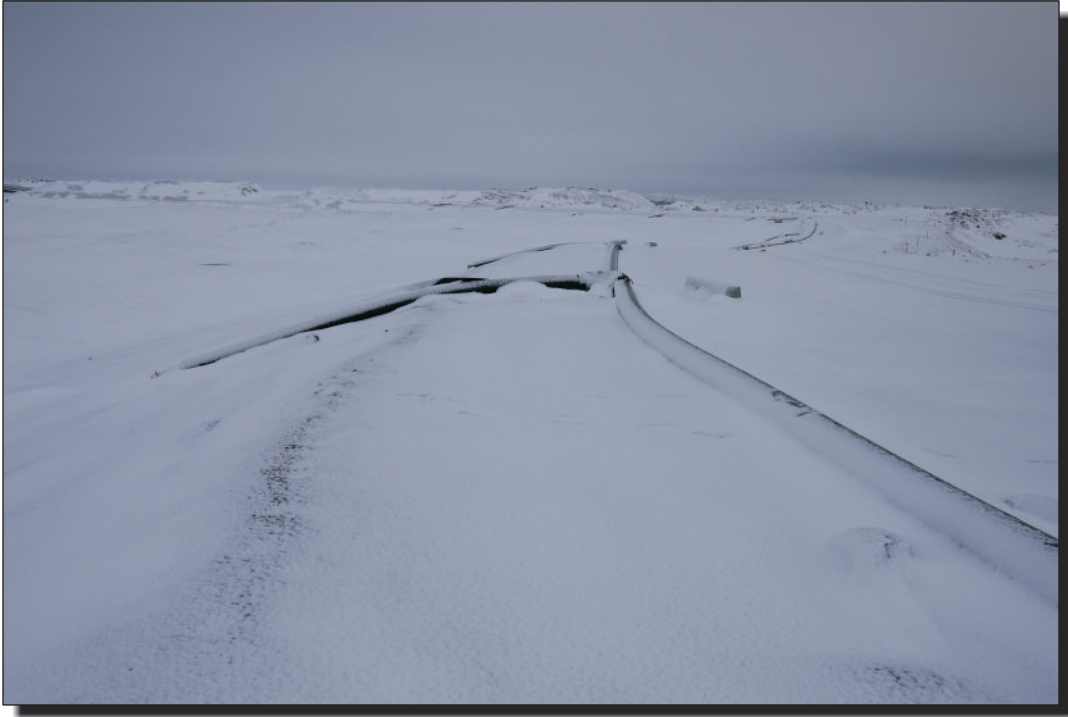
**Photo D-3**  
Upstream slope of Southeast Dam (Aspect: NE)

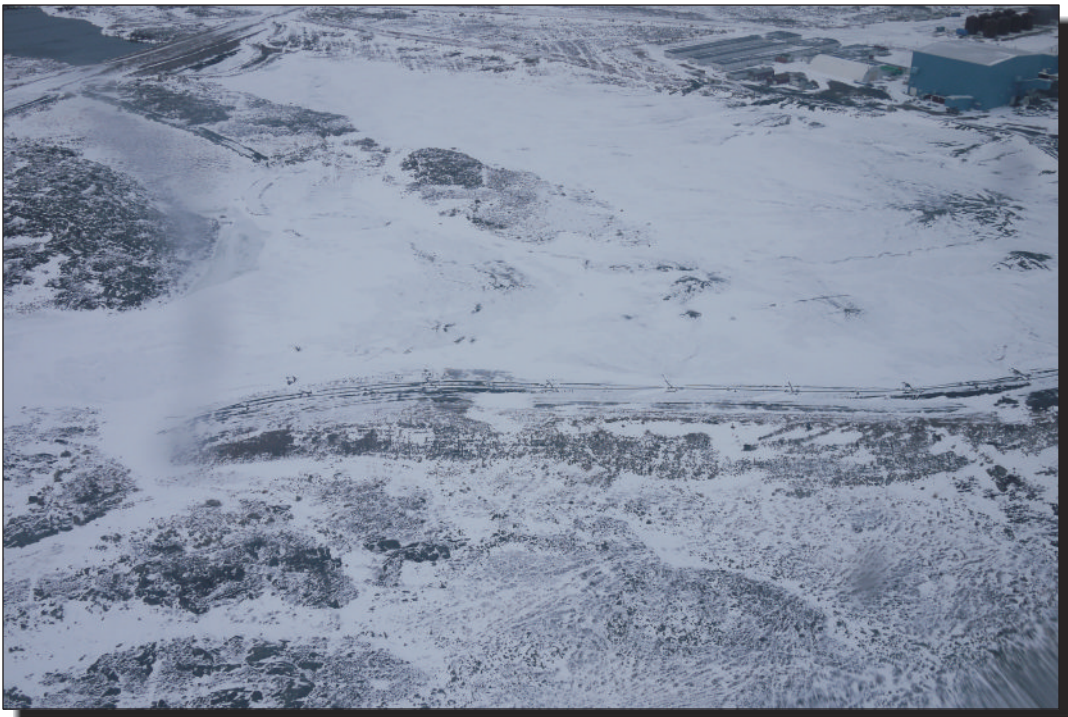
**Photo D-4**  
Aerial view of Southeast Dam

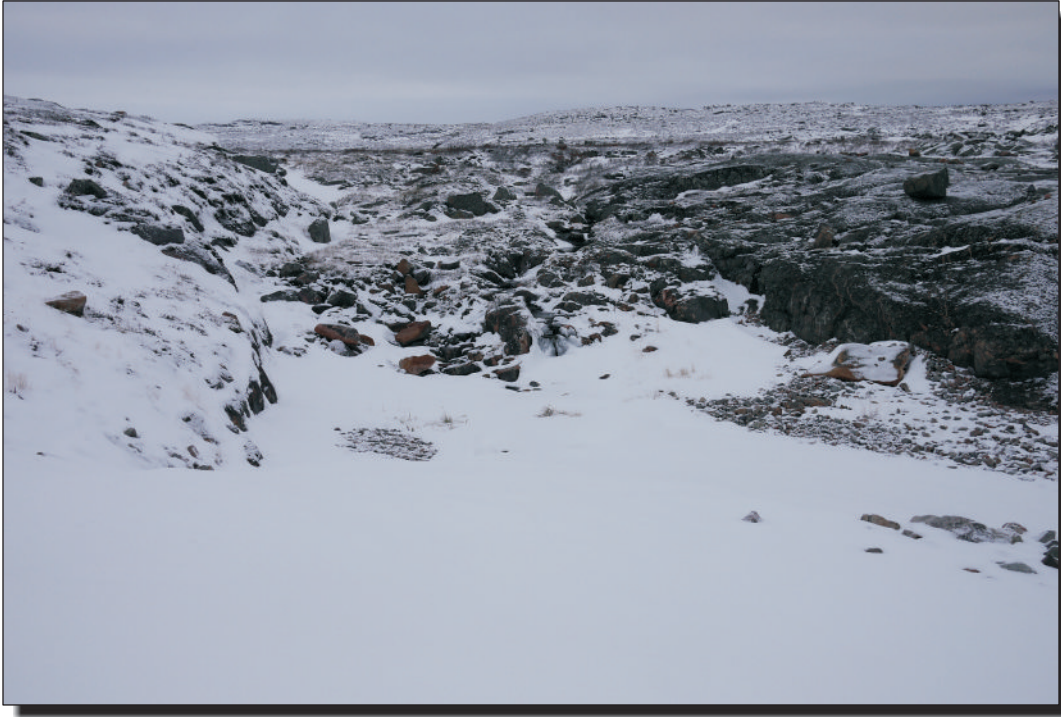
**Photo E-1**  
Reach A inlet (Aspect: SW)

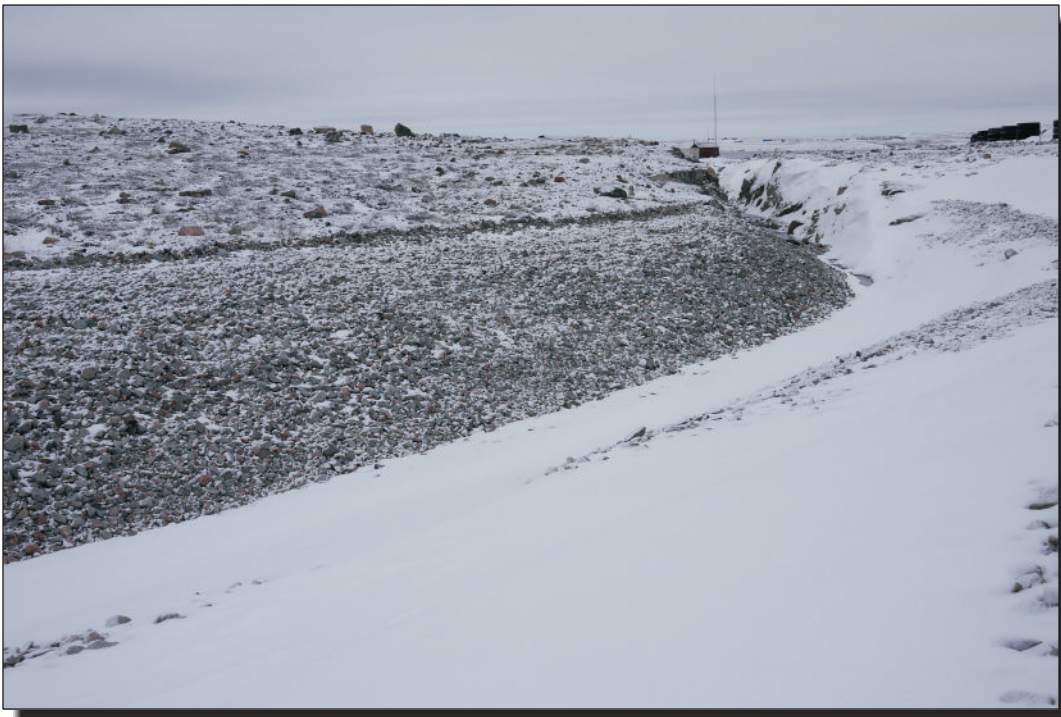
**Photo E-2**  
Fill zone along Reach A (Aspect: N)

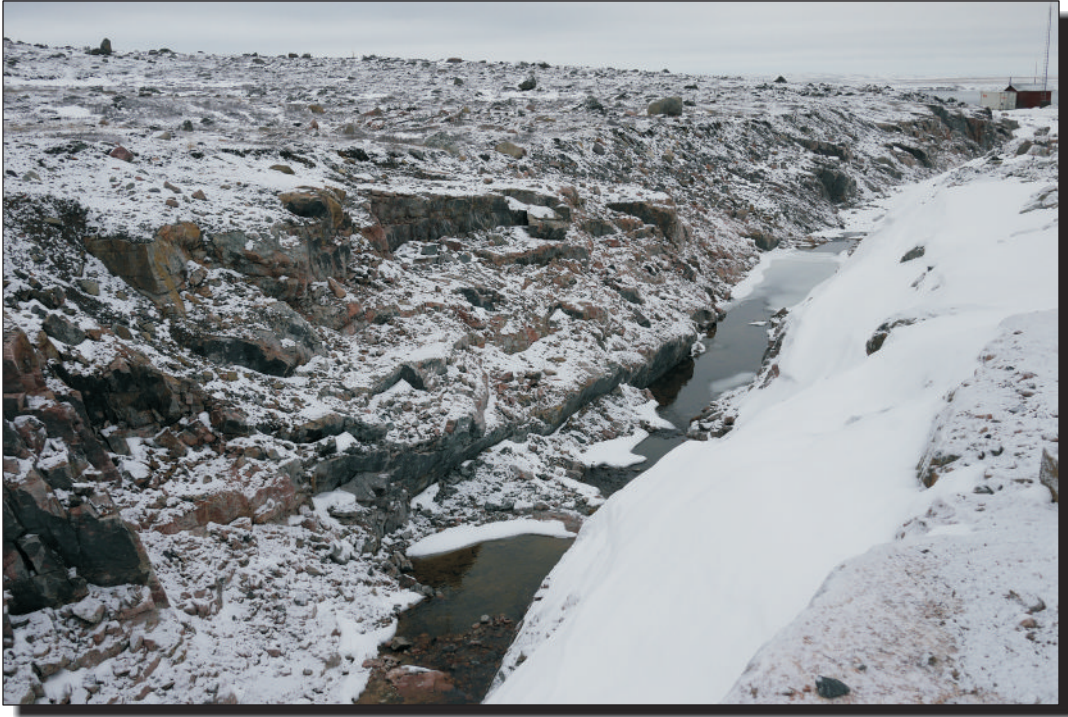
**Photo E-3**  
Rock cut in Reach A (Aspect: N)

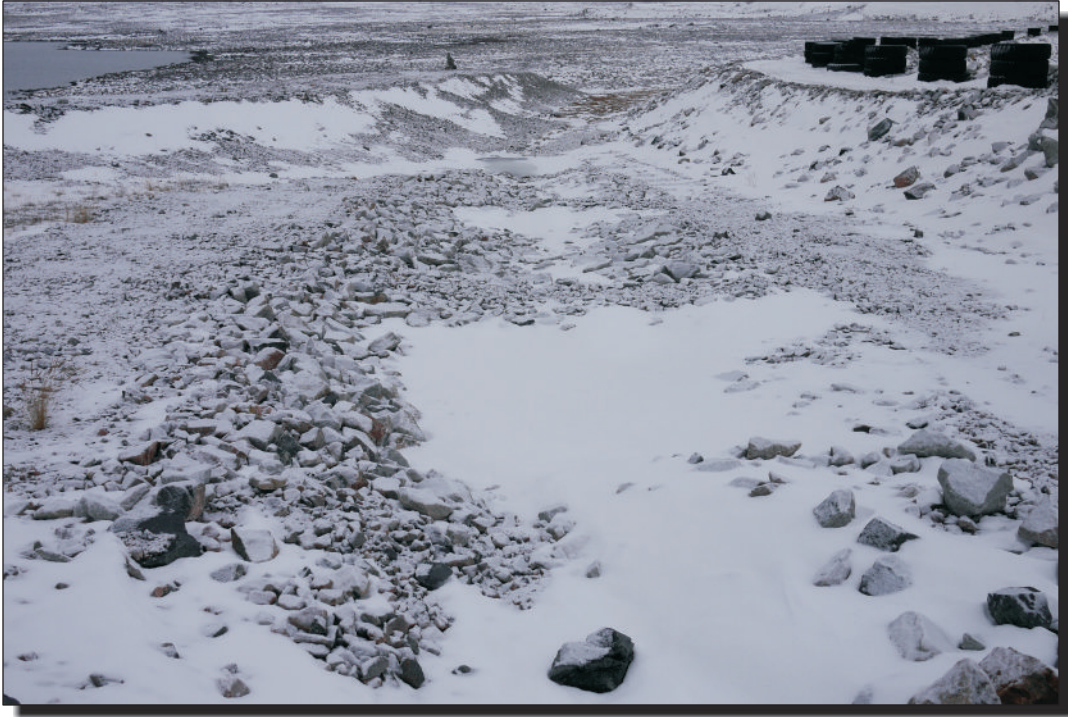
**Photo E-5**  
General condition of Reach C (Aspect: E)

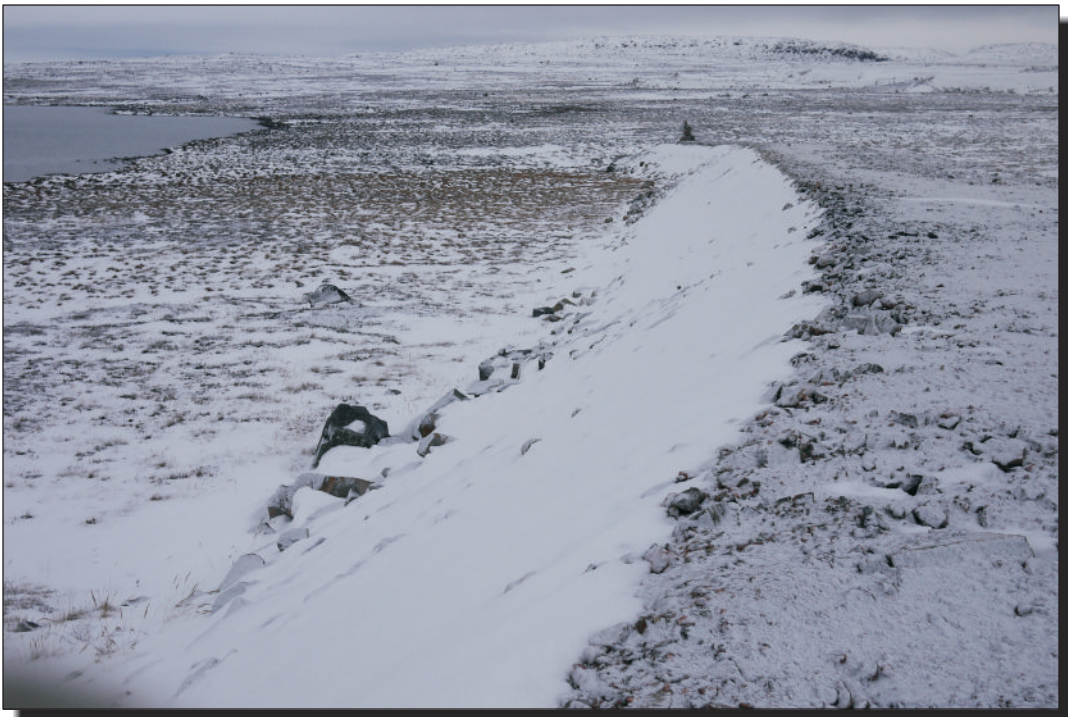
**Photo E-6**  
Downstream slope of Reach C berm (Aspect: E)

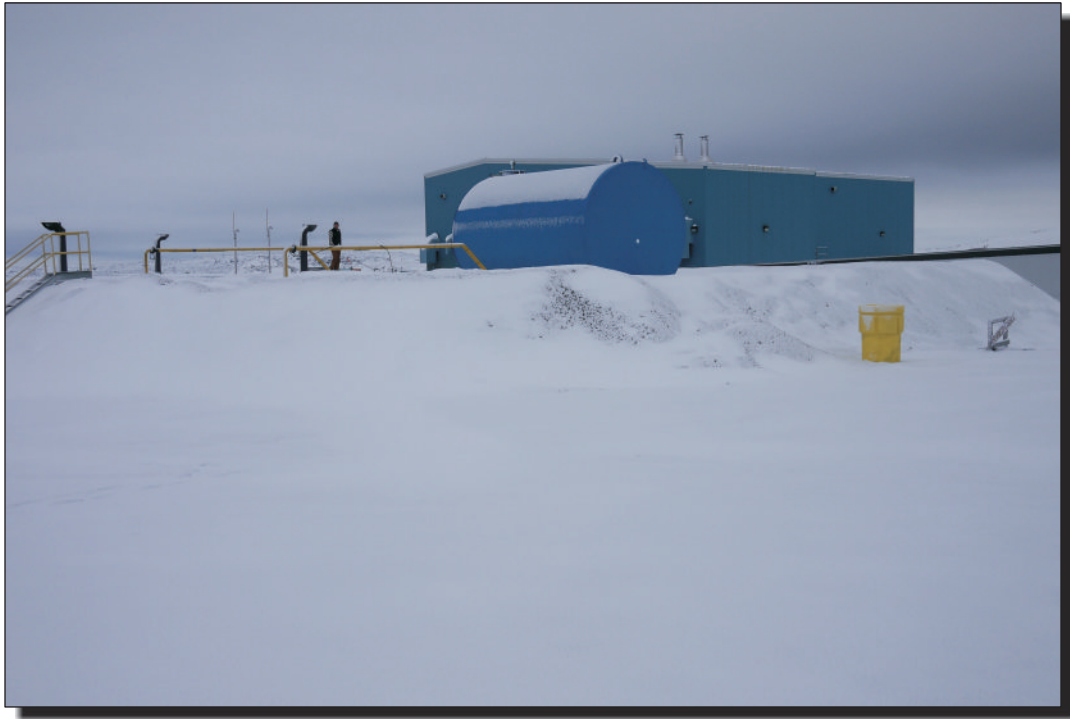
**Photo G-1**  
General view of Generator Tank containment (Aspect: NE)

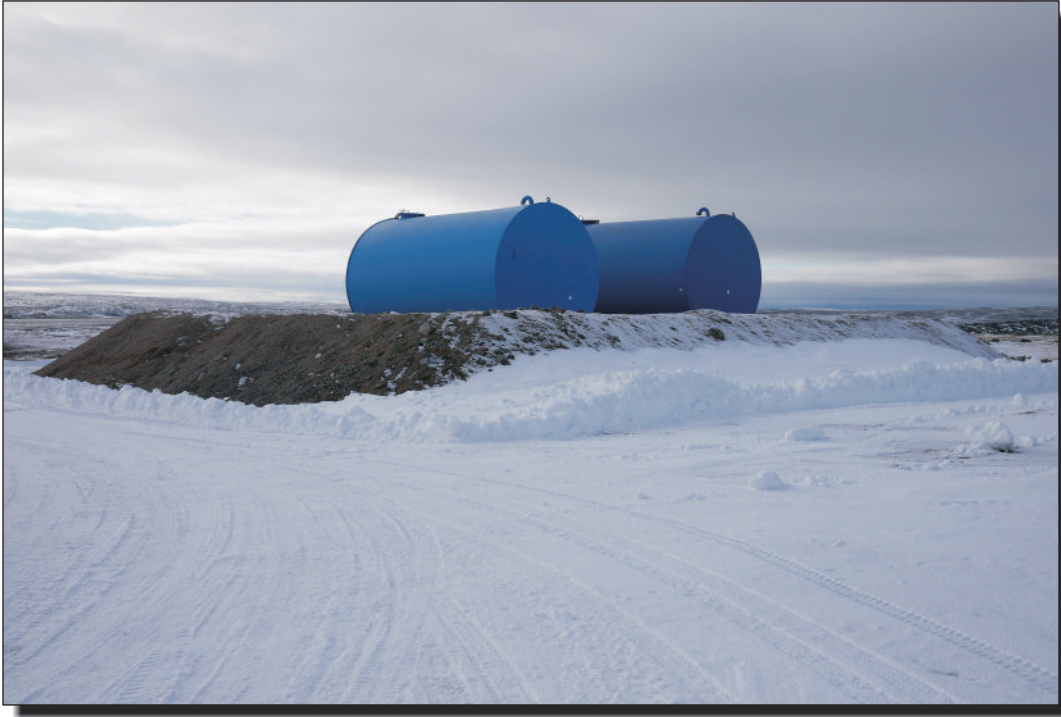
**Photo H-1**  
Airstrip tank containment (Aspect: SW)

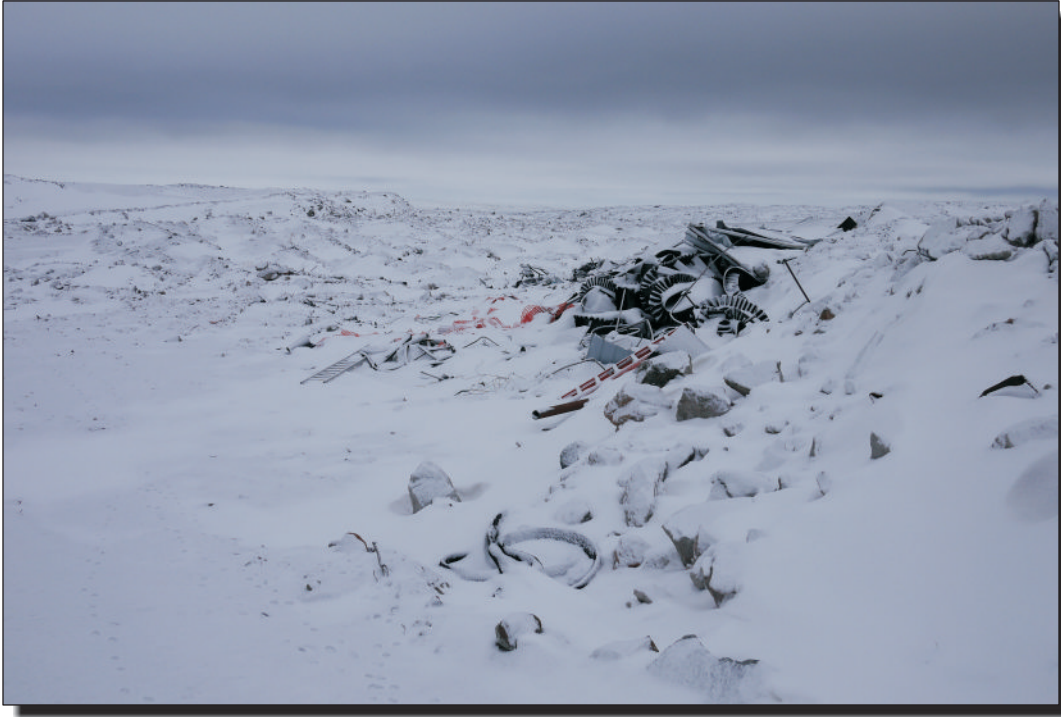
**Photo I-1**  
Non burnable waste in landfill

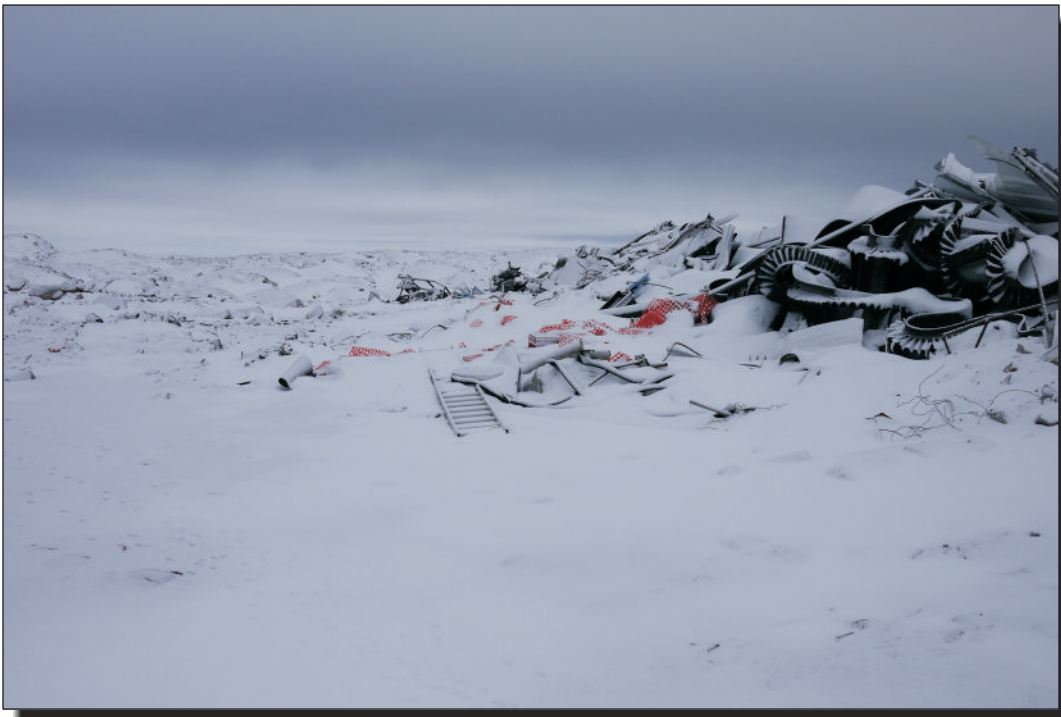
**Photo I-2**  
Non burnable waste in landfill

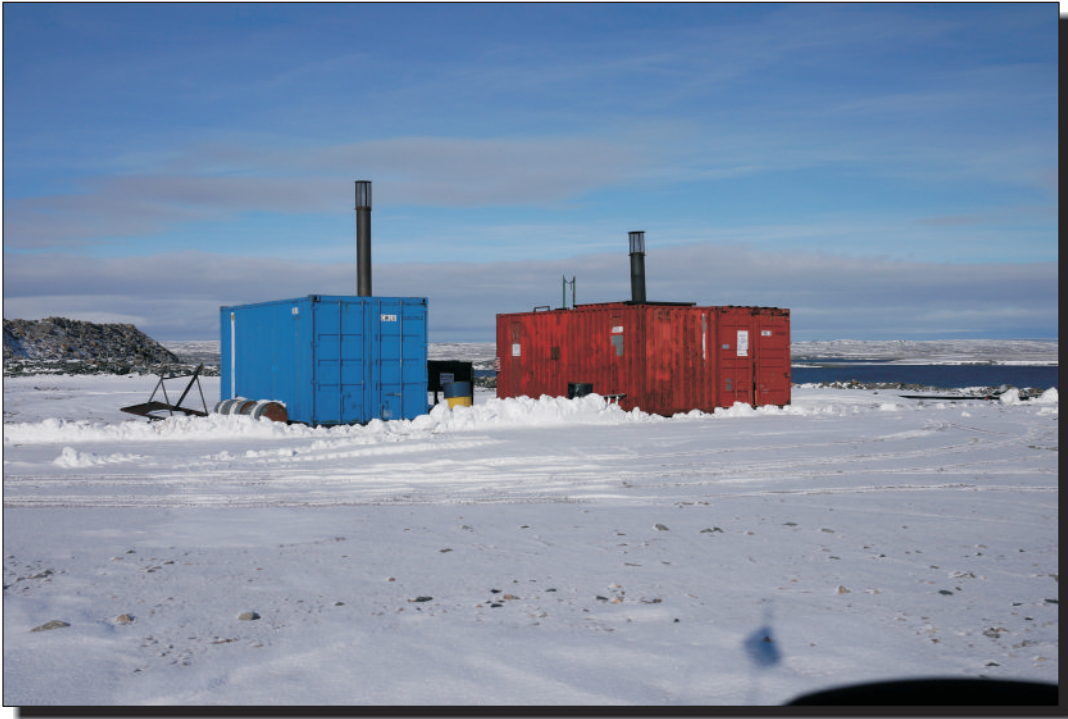
**Photo I-3**  
Incinerator at landfill
