# **Tahera Diamond Corporation**

# CONSTRUCTION RECORD REPORT EAST AND SOUTHEAST DAMS JERICHO DIAMOND MINE, NU

October 2007

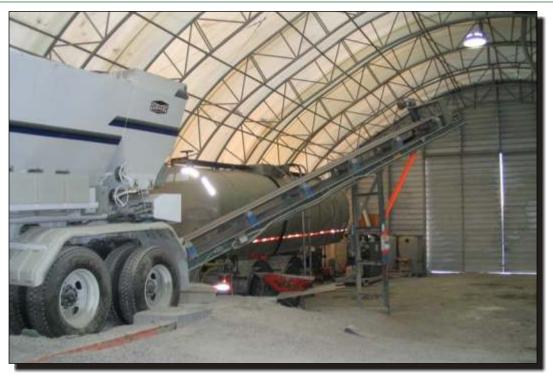
Photo 1 East Dam Reimer Truck Batch Plant.

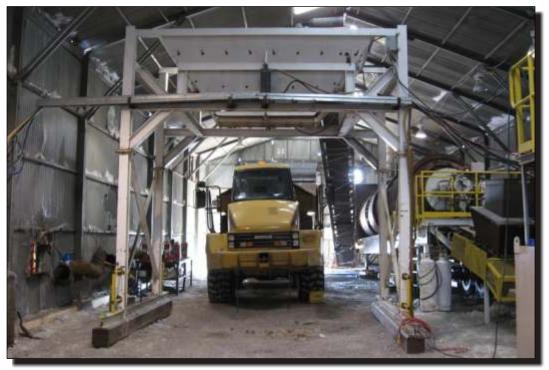
Photo 2 Southeast Dam Modified Asphalt Plant.

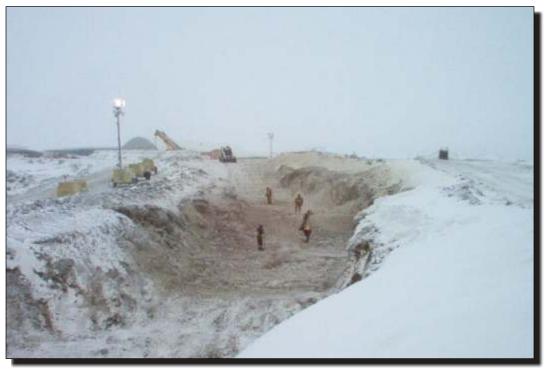
Photo 4
East Dam
Labour crew cleaning key trench with compressed air.

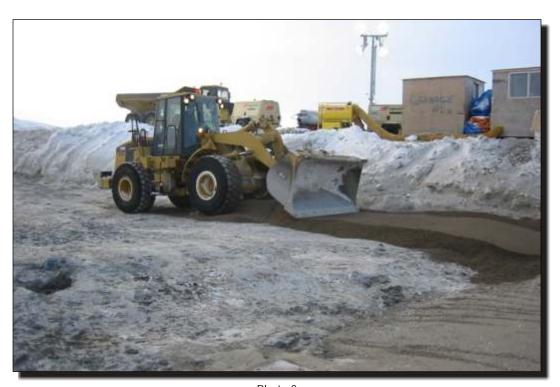
Photo 8
East Dam
Loader spreading 20 mm minus levelling course.

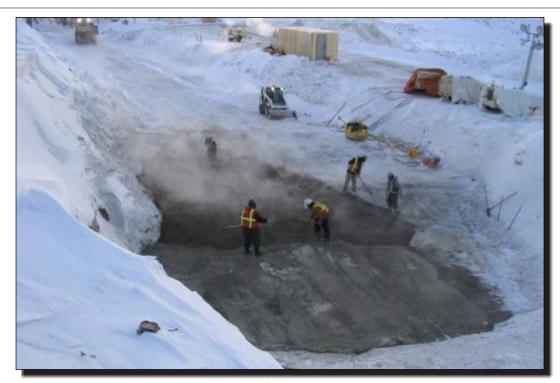
Photo 9 East Dam Levelling course placement.

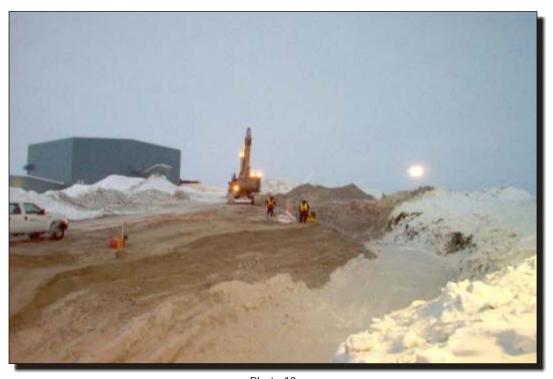
Photo 10 East Dam Placement and compaction of Fillet Zone.

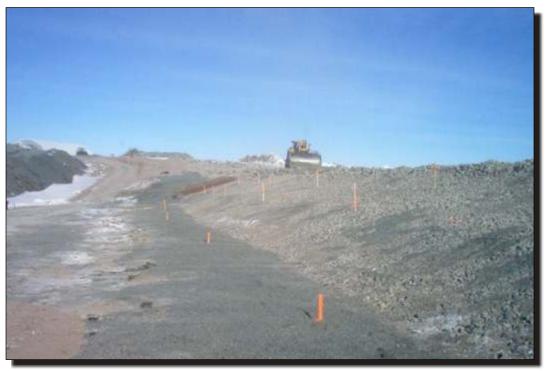
Photo 12 East Dam Construction of run-of-mine rockfill shell.

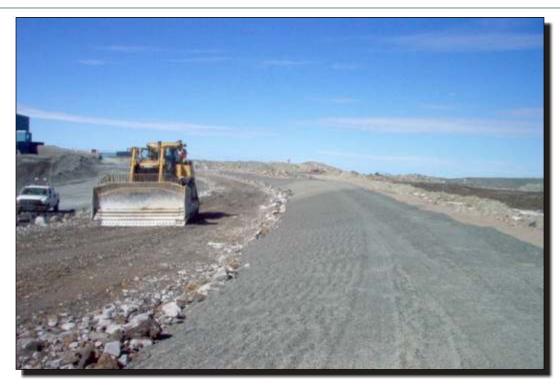
Photo 13 East Dam Placement of upstream till zone.

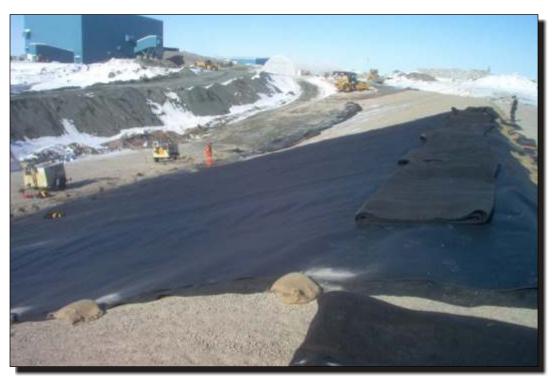
Photo 14 East Dam Installation of second liner phase.

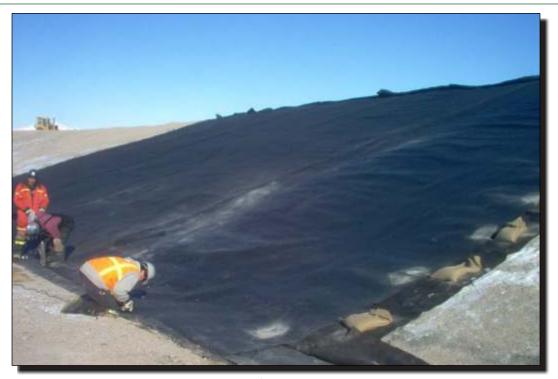
Photo 15 East Dam Extrusion welding of liner hinge.

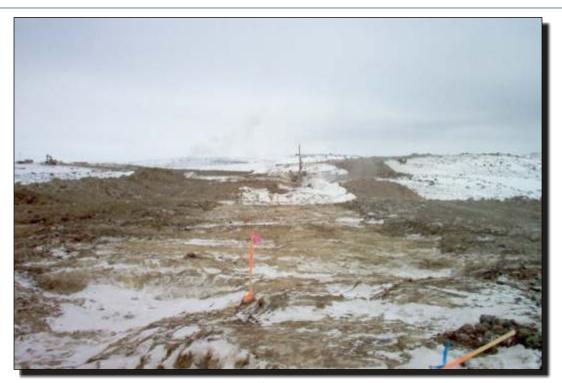
Photo 17 Southeast Dam Drilling percolation holes prior to key trench excavation.

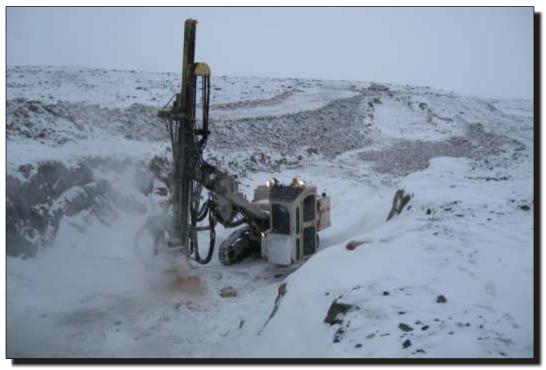
Photo 18 Southeast Dam Drilling percolation test holes after key trench was excavated.

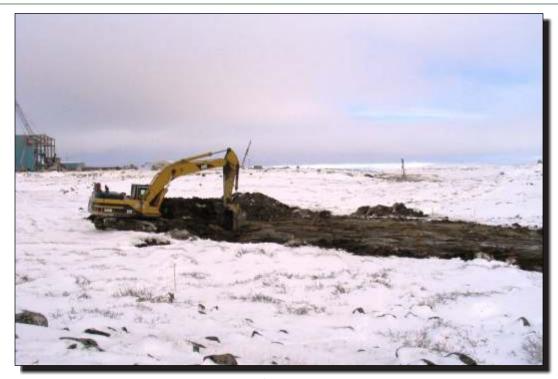
All surficial vegetation, organic soils and open-graded boulders were grubbed prior to starting key trench excavation. Grubbing was conducted with a bulldozer or excavator and grubbed materials were loaded into haul trucks and disposed of. Grubbing of the Southeast Dam is shown in Photo 19.

Photo 19 Southeast Dam Grubbing footprint of dam with an excavator.

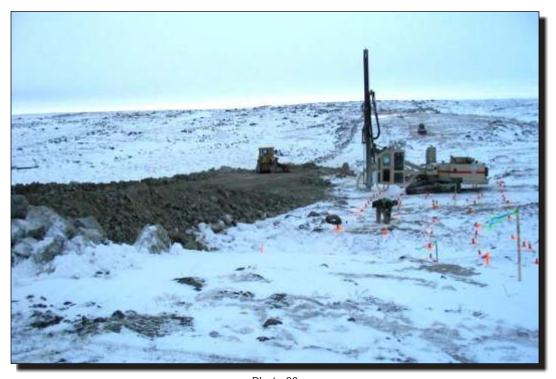
Photo 20 Southeast Dam Drilling holes for key trench blasting.

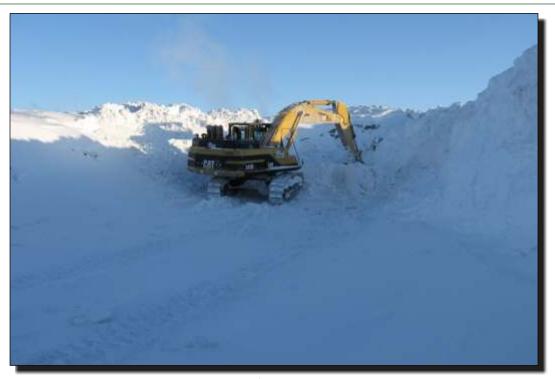
A large volume of snow had to be removed from the exposed Southeast Dam key trench prior to commencement of detail key trench cleaning. Nuna cleaned the base and walls of the key trench with compressed air hoses, hand tools and heavy equipment. The ripper tooth attachment on the Cat 345 excavator was modified to accept a 50 mm air hose and nozzle attachment. The excavator was then used to scratch loose material and blow it to the edges of the key trench where it could be removed with the excavator bucket. Labourers with hand tools and air lances performed the detailed cleaning, removing all loose frozen soil and bedrock in the key trench. The key trench was inspected and approved by EBA before fill placement was authorized. There were significant deposits of ice bonded to the bedrock since the key trench was open and exposed for an entire year. Removal of ice is a slow process, and the lack of available labour compounded the delays. When possible, levelling course material was placed immediately after a section of the trench was approved. Key trench cleaning was ongoing until the levelling course was completed. Various aspects of key trench cleaning are shown in Photos 21 through 23.

Photo 21 Southeast Dam Excavation of snow from key trench.

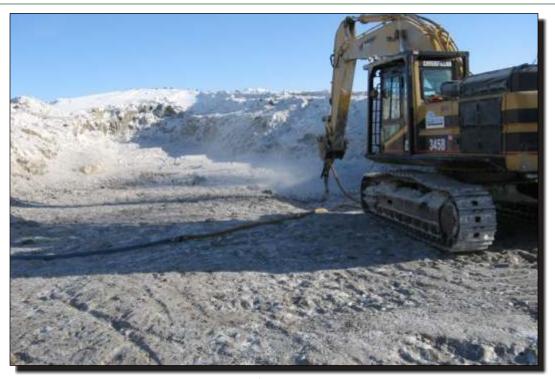
Photo 23 Southeast Dam Excavator cleaning key trench with compressed air and ripper tooth.

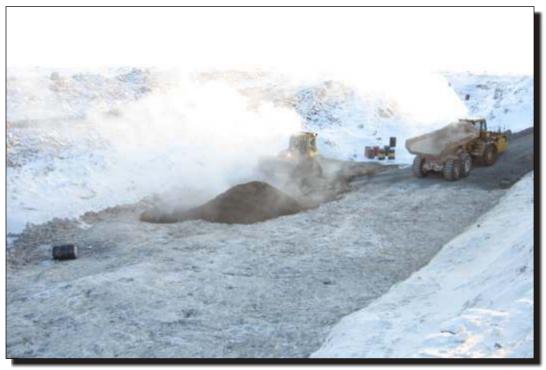
A levelling course of 20 mm material was required in the base of the key trench to provide a smooth subgrade beneath the liner system. The levelling course fill was constructed of saturated and compacted 20 mm material from the batch plant. The temperature of the saturated mix was typically increased to between 25 and 45°C when placing the first lift of material over the base of the key trench. Subsequent lifts of levelling course and key trench backfill were placed with a reduced mix temperature to accelerate freezeback. Levelling course placement is shown in Photo 24.

Photo 24 Southeast Dam Placement of levelling course.

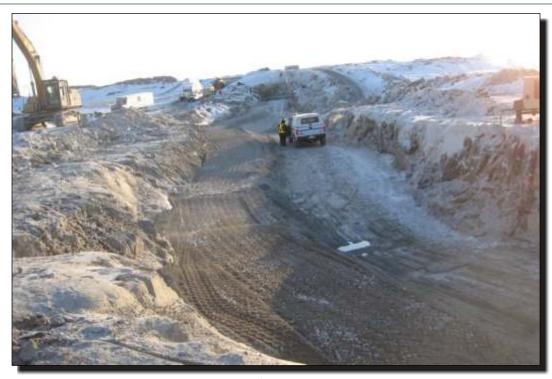
The fillet is a wedge of 20 mm material constructed above the levelling course on the upstream side of the key trench and serves to support the liner in the key trench. The fillet was constructed of moisture conditioned compacted 20 mm material. The fill was placed in lifts using an excavator and compacted with a 10-tonne drum roller or a walk-behind compactor. The lifts of material were then shaped using an excavator to provide a flat surface for the liner to be laid. Fillet placement is shown in Photo 25.

Photo 25 Southeast Dam Fillet zone along upstream side of key trench.

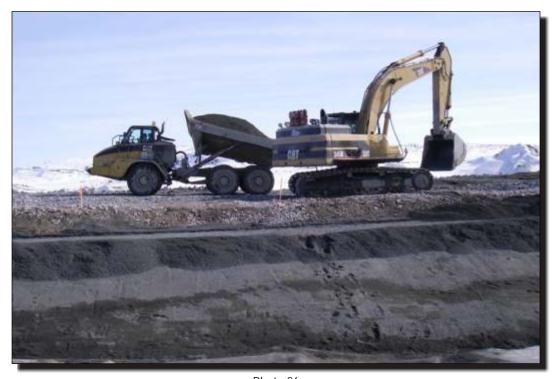
The key trench backfill and fillet zones are the bedding for the liner within the key trench. Above the key trench, CPK was placed above and below the liner for bedding. The CPK material was placed up the slope using a Cat D4 dozer or an excavator. The material was compacted as the upstream till zone was placed. Bedding placement is shown in Photo 26.

Photo 26 Southeast Dam Placement of downstream liner bedding.

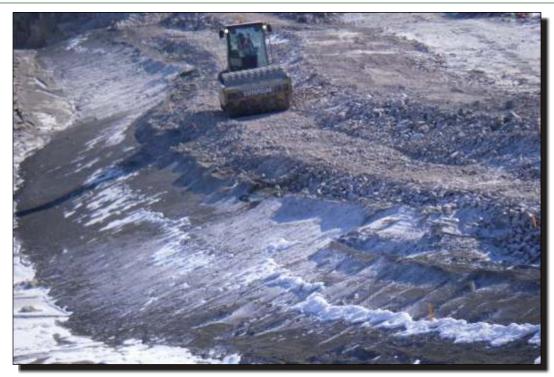
The 200 mm material was used as a transition material between the run-of-mine superstructure and the liner bedding. The 200 mm fill placed in the transition zone of the dam was placed by a Cat D4 dozer or Cat 345 excavator in lifts approximately 0.5 m in thickness. Compaction of the fill was performed by the Cat CS-573E drum compactor. Due to the freezing conditions, the 200 mm material was placed without moisture conditioning. The 200 mm placement is shown in Photo 27.

Photo 27 Southeast Dam Placement of transition material.

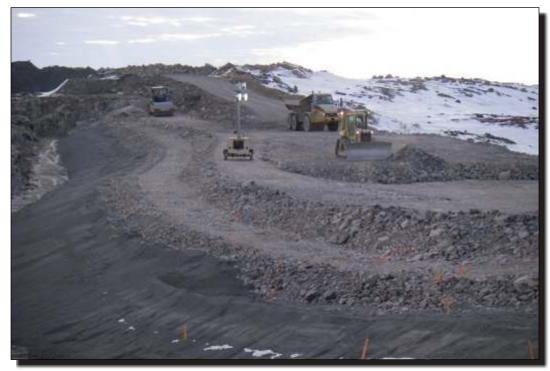
The run-of-mine superstructure downstream of the liner was placed and compacted in 1000 mm lifts. The construction specifications call for a maximum lift thickness of 700 mm; however, this requirement was relaxed by the EBA site representative to improve placement of the material. Oversize particles were placed at the downstream edge of the dam shell. The run-of-mine shell was constructed primarily of granite rock; however, numerous loads of diabase rock were also used in the structure. The run-of-mine material was hauled from the Jericho Pit using Cat 777, 769 or 730 hauls trucks and placed using a Cat D4 or D8 dozer and a Cat 345 excavator. Compaction of the material was achieved by truck traffic operating on the surface and using a Cat CS-573E waffle drum compactor. During placement, additional run-of-mine was stockpiled on the crest of the East Dam and used as required. TDC was instructed to remove any excess material upon completion of the Southeast Dam. Run-of-mine placement is shown in Photo 28.

Photo 28 Southeast Dam Placement of run-of-mine rockfill shell.

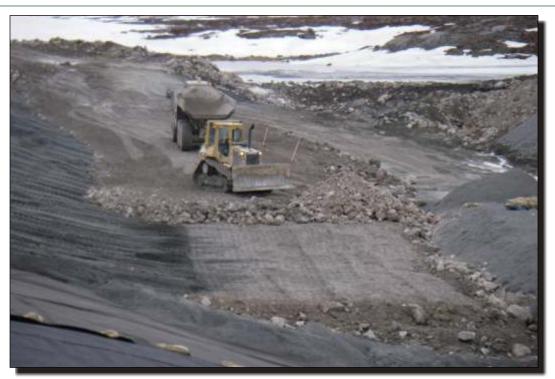
of 500 mm for the remaining lifts. The till was excavated from the till dump adjacent to the Jericho pit as no till source was available from the pit itself. The till zone construction is shown in Photo 29.

Photo 29 Southeast Dam Placement of till zone upstream of liner.

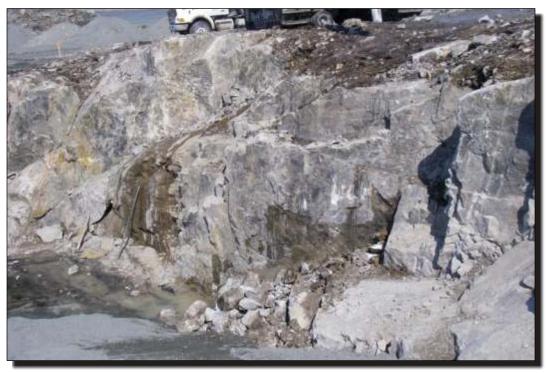
Various aspects of the installation are presented in Photos 30 through 32.

Photo 30 Southeast Dam Removal of loose rock from north abutment.

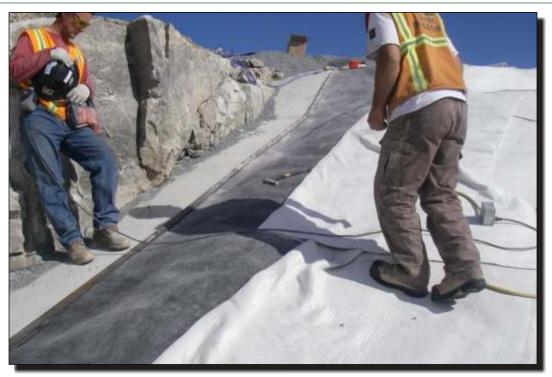
All of the liner system components were purchased from A&A, and the first two phases of the Southeast Dam's liner were installed under their supervision with logistical support provided by Nuna. Scheduling conflicts meant that A&A was not available to install the final phase of the liner. TDC contracted Western Tank and Lining Ltd. (WTL) of Okotoks, Alberta to complete the tie-in of the liner to the concrete beam. EBA oversaw the installation of all phases of the liner, but liner quality assurance testing was the responsibility of the installer. The liner concrete beam tie-in is shown in Photo 33.

Photo 33 Southeast Dam HDPE Liner attached to concrete beam.

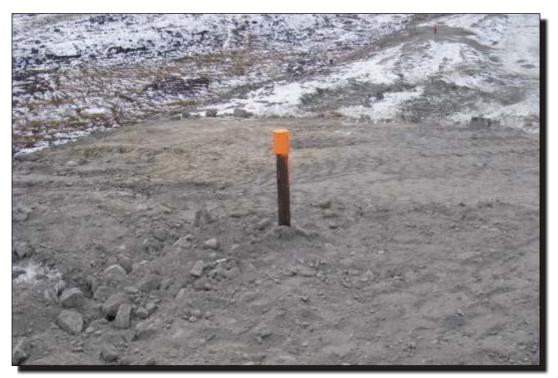
A total of seven survey monitoring points were installed above the liner crest along the alignment of the dam. The monitoring points consist of 300 mm by 300 mm flat plates with a rod sticking up though the fill. The rod is protected by 50 mm pipe. The northings, eastings and elevations of the survey monitoring points are to be regularly surveyed to monitor settlement or lateral movement. The data will serve as the baseline against which all subsequent surveys will be compared. The locations of the survey monitoring points are presented in the Construction Record Drawings. A survey monitoring point is shown in Photo 35.

Photo 35 Southeast Dam Survey monitoring point.

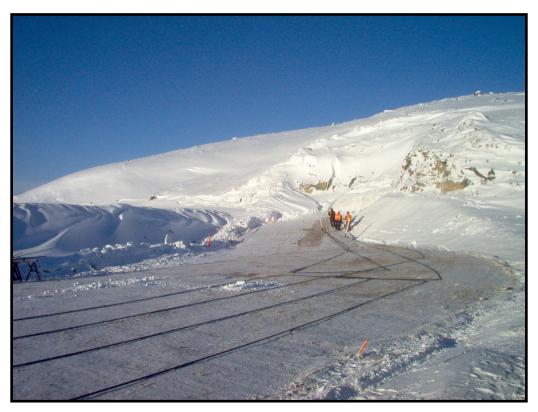
Arctic Foundations mobilized to site on Wednesday February 22. Installation of the themosyphon evaporators commenced on the 23<sup>rd</sup> and was completed and tested by the evening of the 25<sup>th</sup>. The northern evaporator loop was terminated at approximately 0+030 to allow equipment access to the north abutment. The north abutment requires snow removal and levelling course placement along the rock face so the Geo-synthetic Clay Liner (GCL) can be extended to the final 523.5 m elevation. The thermosyphon evaporator pipe can then be extended up the north abutment and out to the radiator location. The extension of evaporator pipes requires an Arctic Foundations welder to return to site.

Figure 1. Installation of thermosyphon evaporator loops at West Dam. Aspect: N
