Lupin Mines Incorporated

**RE: 2015 Annual Geotechnical Inspection – Lupin Mine Tailings Containment Area, Nunavut
Lupin Mine, Nunavut, License Number 2AM-LUP1520**

2015 Annual Geotechnical Inspection on
Perimeter Dams

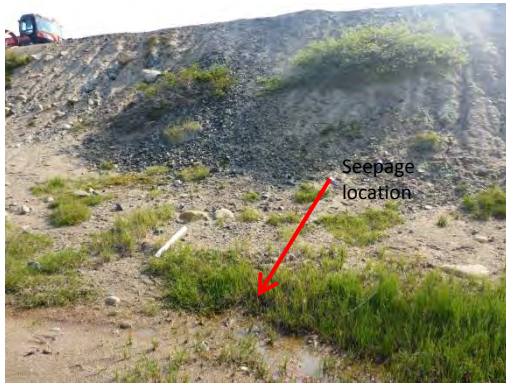
The previous annual inspection found seepage in the western buttress toe of Dam 4 into Ferguson Lake and the northern buttress toe of Dam 2 into a pond created by a cofferdam adjacent to Dam 2 Lake. Seepage at Dam 4 has not been observed since the 2011 inspection. Seepage at the toe of Dam 2 was observed in 2015, at similar flowrates since 2012. In 2015, this seepage was contained by the cofferdam downstream of north abutment and pumped back into Pond 2 when it pooled.

Photo 1: Seepage in the north abutment of Dam 2 and surface erosion

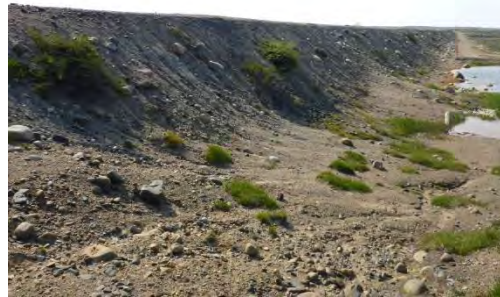
Photo 2: Looking south at the seepage collection ponds at toe of Dam 2.

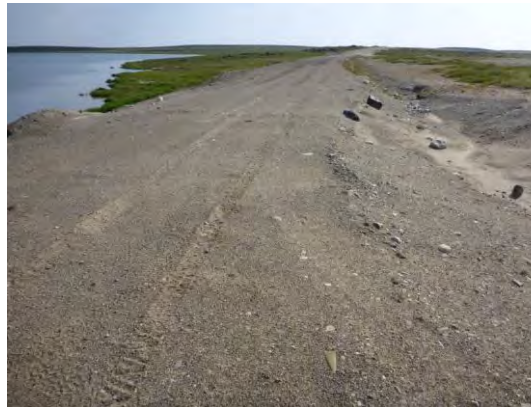
The storm ditch built within the top 2 m of Dam 3 has suffered some erosion damages from the 2014 freshet. It is believed that ponding in sections of the ditch is the main cause of the erosion damage. Because of the poor grading, the closure cover runoff water pooled, froze, and created an ice dam; which in turn forced the freshet water to overtop the ditch, over a small portion of Dam 3. Repair was completed on the damaged area in 2015 by constructing an armored channel along the alignment of the erosion, to let the drainage bypass the ponding section.

Photo 23: Looking east at the storm channel on Dam 3.

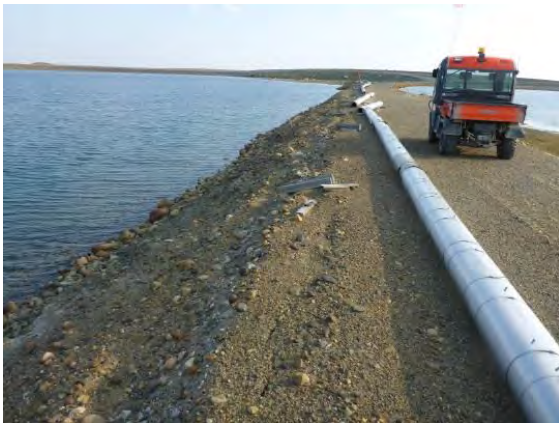
Photo 43: Looking south at the crest of Dam L with Cell 4 at the left.

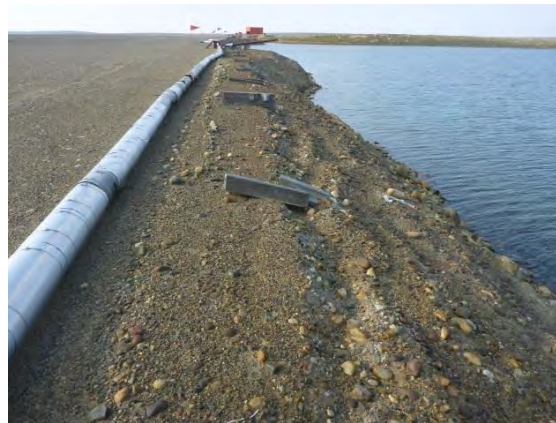
Photo 44: Looking north at the crest and dam face with Cell 4 to the right.

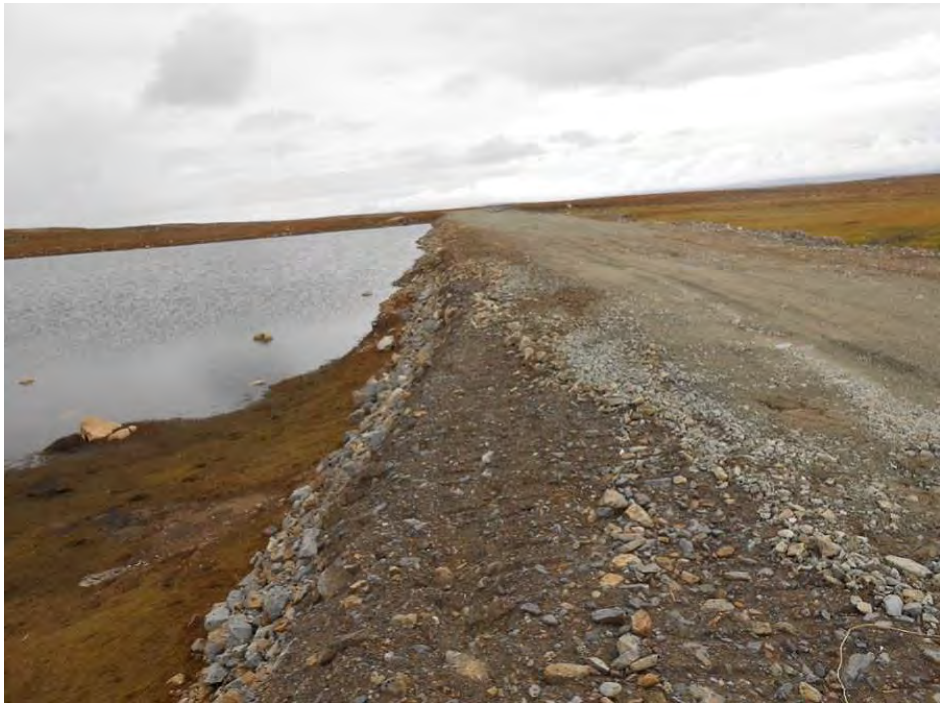
Photo 1: Looking north from the Lower Sewage Dam south abutment on the repaired crest and upstream face.

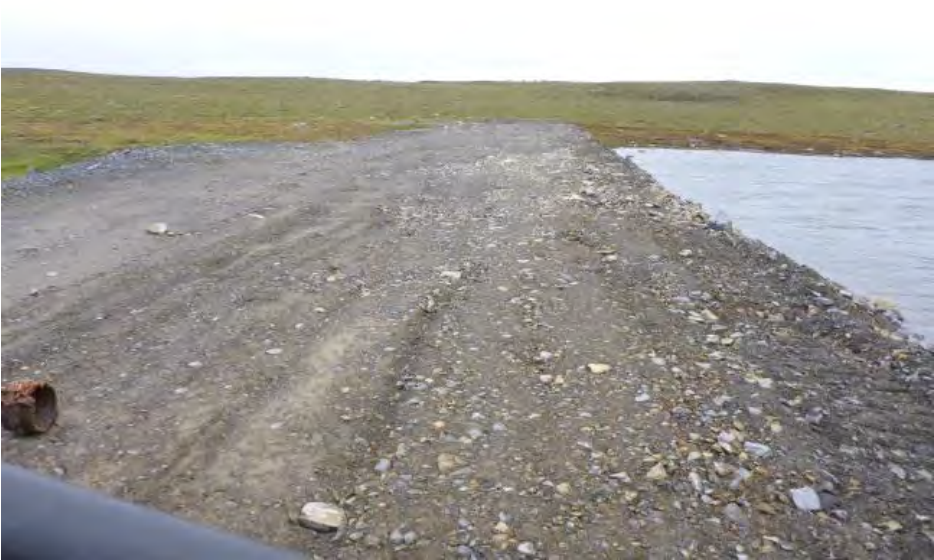
Photo 2: Looking south at the Lower Sewage Dam southern abutment on the additional fill placed to raise the elevation.

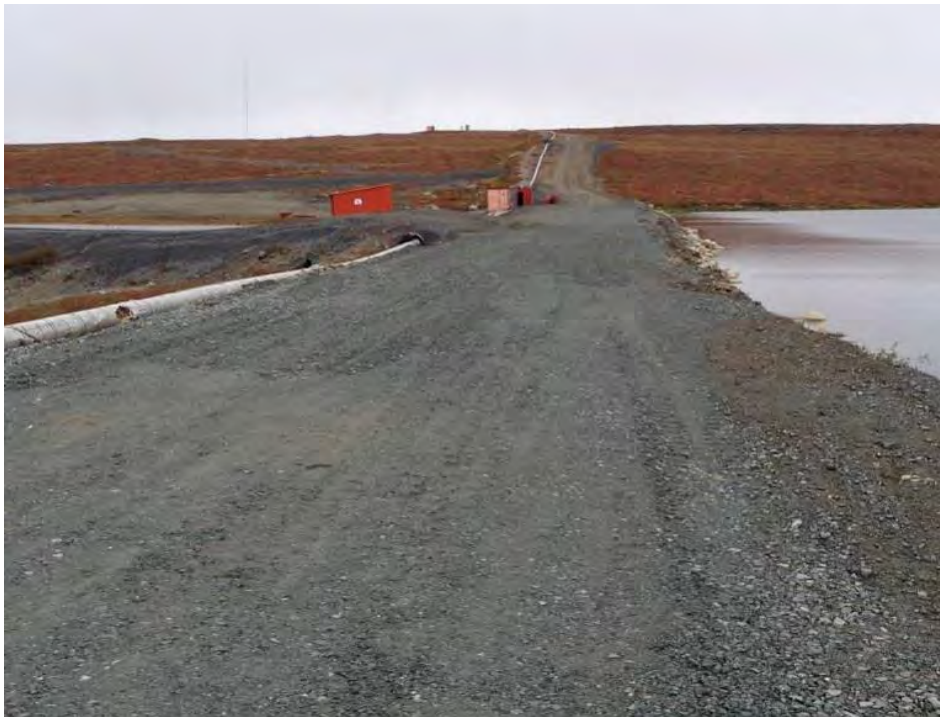
Photo 4: Looking south from the Upper Sewage Dam north abutment on the repaired crest with additional fill placement.

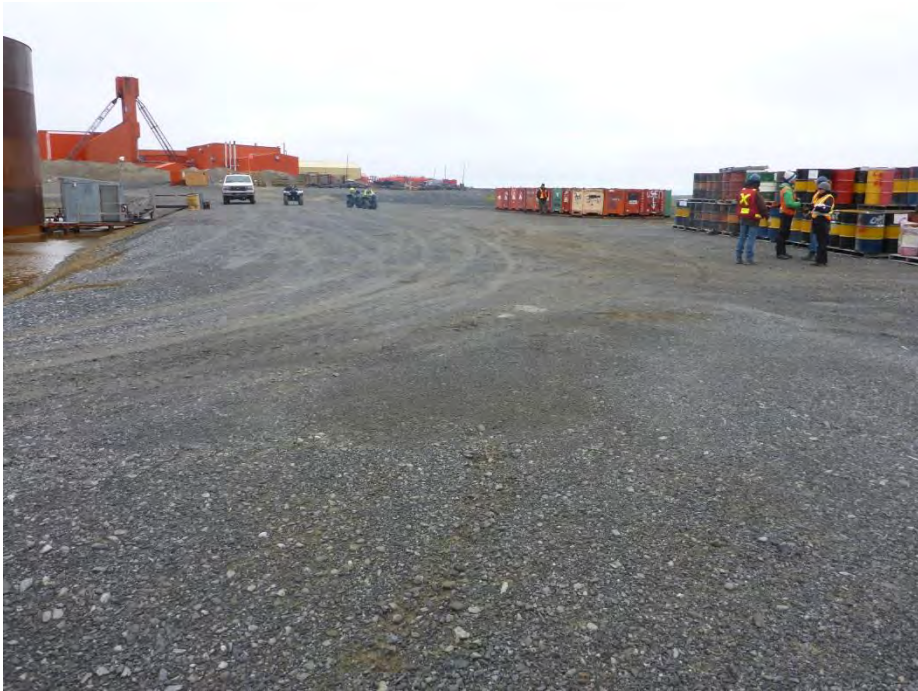
Photo 6: Looking east from the back of the WOMF.

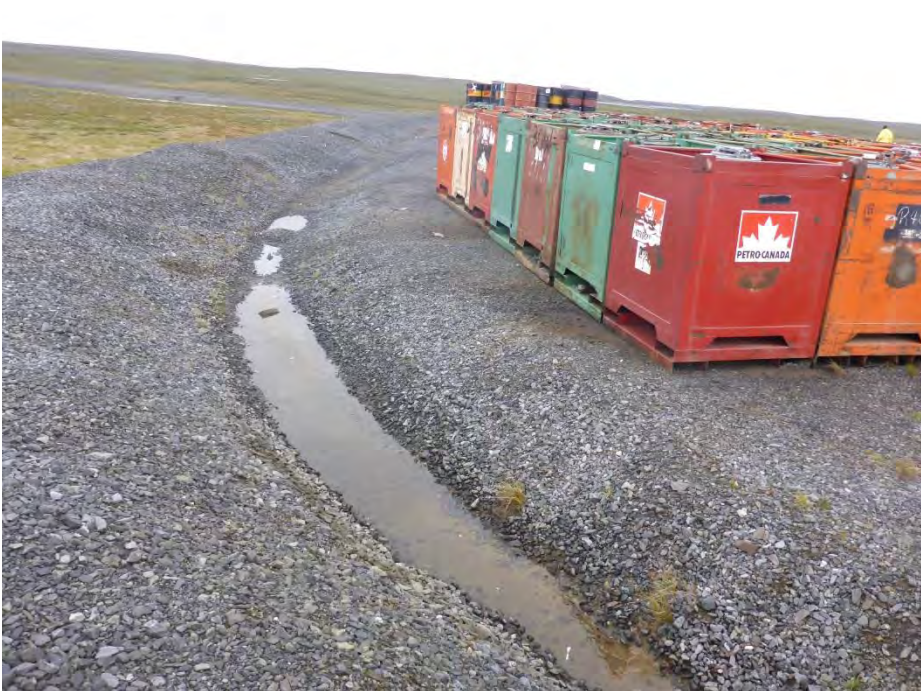
Photo 7: Looking west from the front of the WOMF at the ditch.

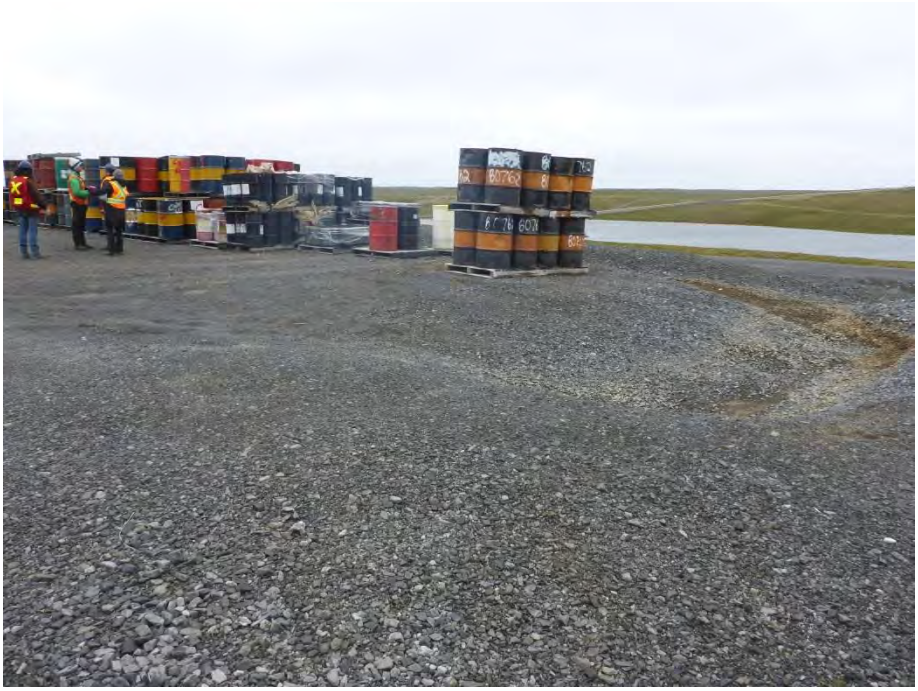
Photo 8: Looking south at the back of the WOMF and the ditch.

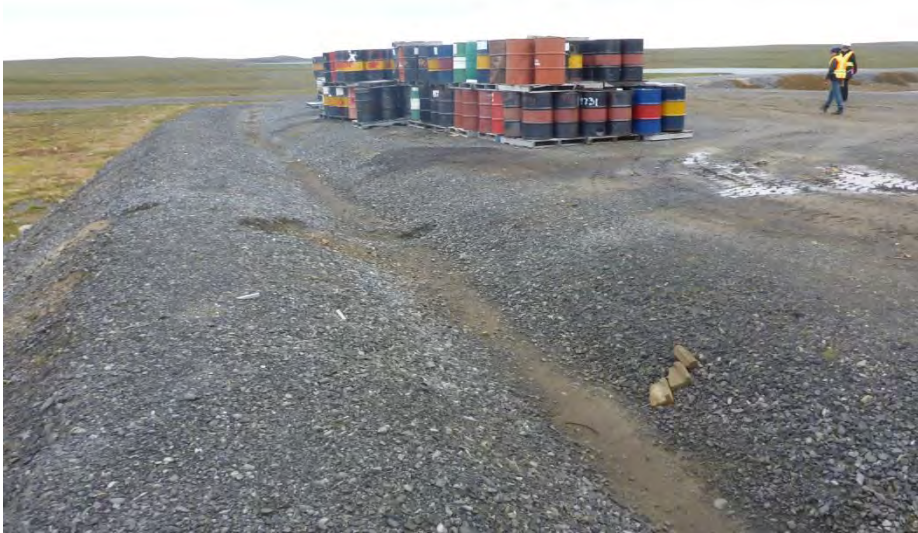
Photo 9: Looking west at the WOMF and the downstream slope.
