# 2AM-LUP2032 LUPIN MINE SITE 2022 ANNUAL REPORT

Nunavut Water Board

Frazer Bouchier, President & CEO Mandalay Resources

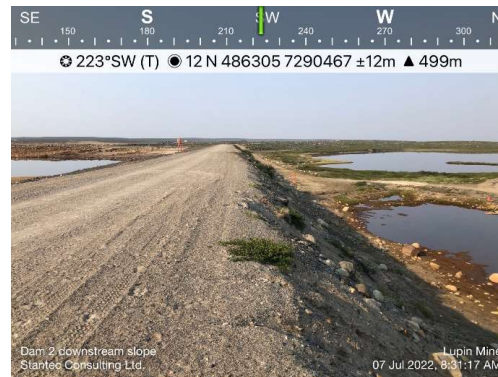
Previous annual inspections noted seepage from the northern toe buttress of Dam 2 into the seepage collection pond. Since the 2021 closure work, the Pond 2 water level is now lower than the seepage collection pond. This supports the conclusion that the source of water in the Dam 2 collection pond is not seepage from the TCA, but likely to be overland flow from up gradient. Regardless, the water in the collection pond was pumped back into the TCA.

Photo 11: Looking southwest at the downstream slope of Dam 2 with the seepage collection pond.

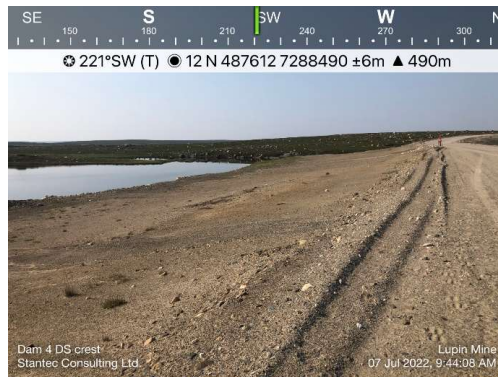
Some recently developed erosions were identified along the downstream slope of Dam 4. This was communicated to site services and was repaired by the end of the inspection. There are historical minor erosions along the downstream slopes of other dams which were compared to previous photographs and progressive deterioration was not observed. Since there is no active erosion, immediate mitigation is not needed. These minor erosions could be addressed during final closure spillways construction for post-closure monitoring.

Photo 22: Looking southwest at the downstream crest of Dam 4.

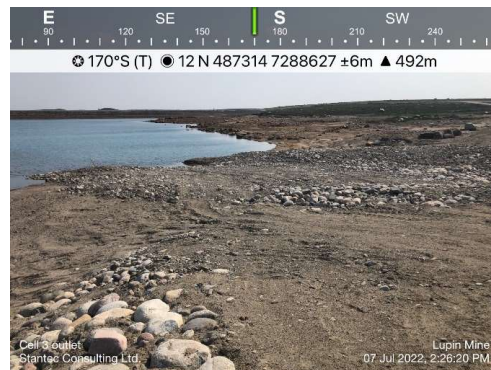
Photo 39: Looking south at the Cell 3 outlet that transitions into the shoreline.

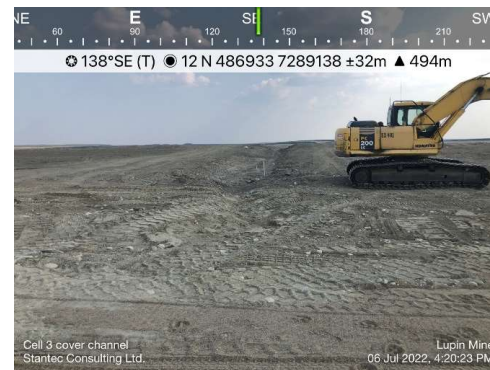
Photo 40: Cell 3 cover channel.

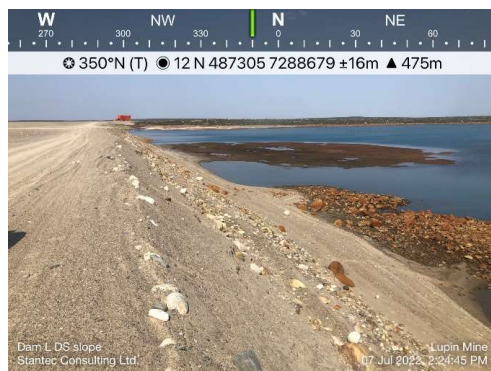
Photo 41: Looking north at the Dam L crest from the south abutment.

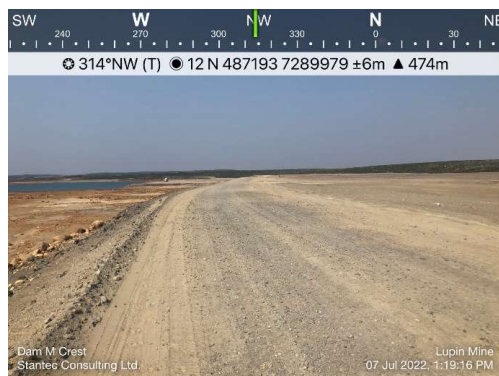
Photo 42: Looking northwest at the crest of Dam M with Cell 5 to the right.

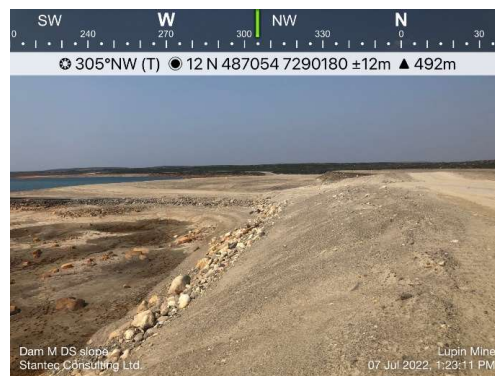
Photo 43: Looking northwest at the downstream slope of Dam M with Cell N in the background.

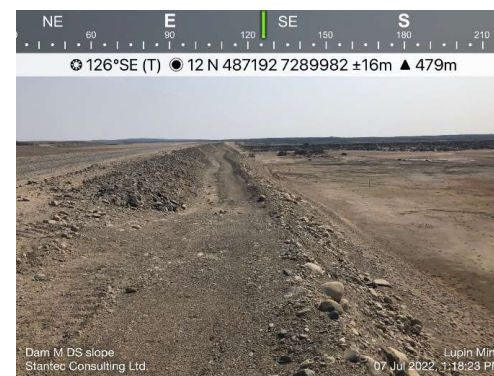
Photo 44: Looking at the D/S of Dam M.

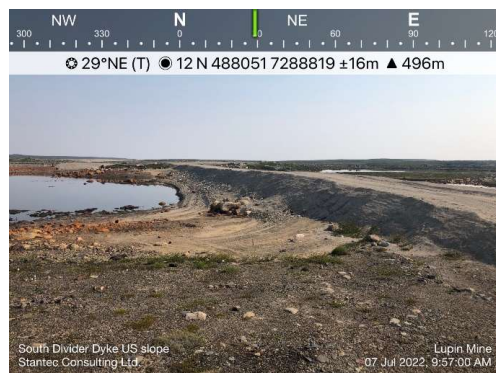
Photo 47: Looking northeast at the upstream slope of the south divider dyke.

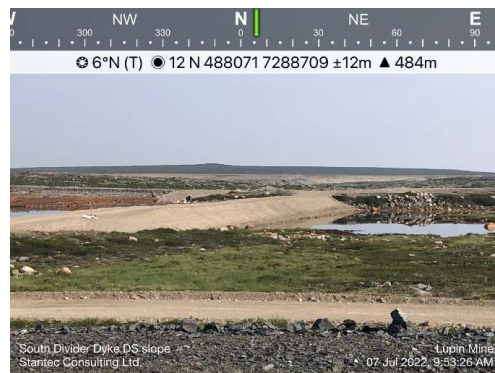
Photo 48: Looking north at the downstream slope of the south divider dyke.

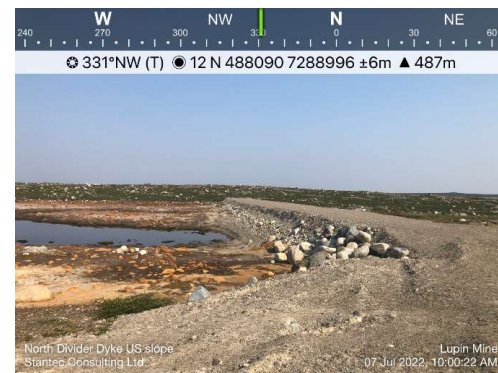
Photo 49: Looking northwest at the upstream slope of the north divider dyke.

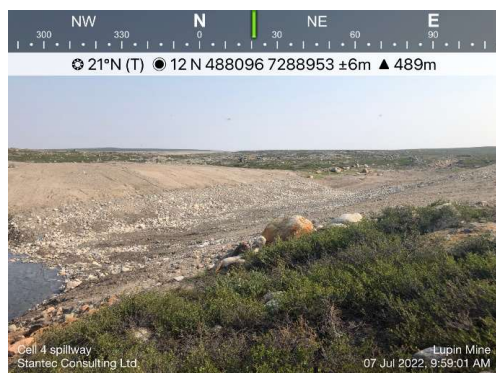
Photo 50: the newly constructed Cell 4 spillway through the Divider Dyke.

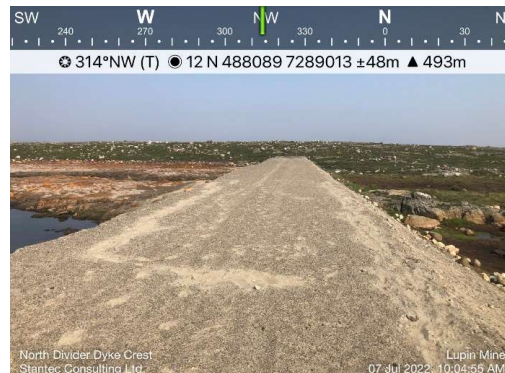
Photo 51: Looking northwest at the crest of north divider dyke.

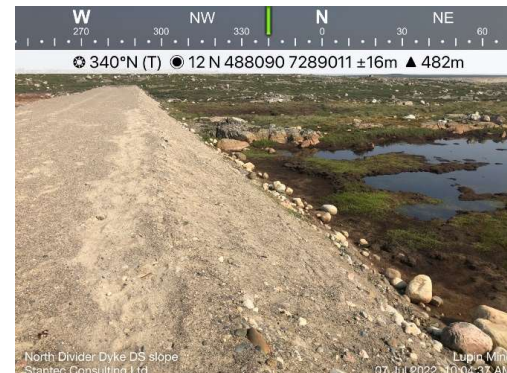
Photo 52: Looking north at the downstream slope of north divider dyke.
