# 2023 Dam Safety Review

## Lupin Mine Tailings Containment Area (TCA)

**Lupin Mines Inc.**

**SLR Consulting (Canada) Ltd.**

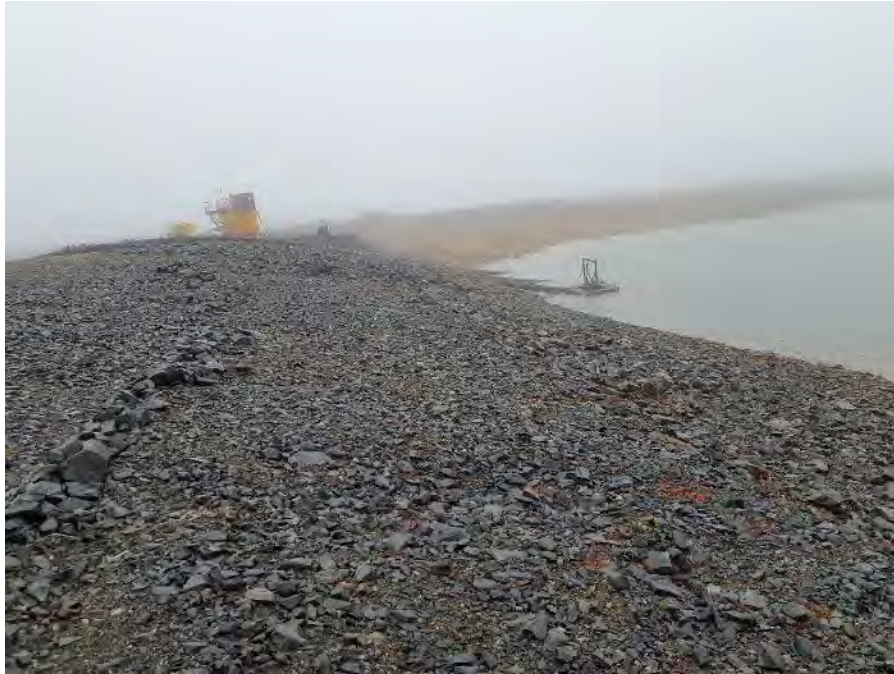
**Photo 1: Dam 1A upstream slope and syphon inlets, facing northwest (Fig. A1 ID#21)**

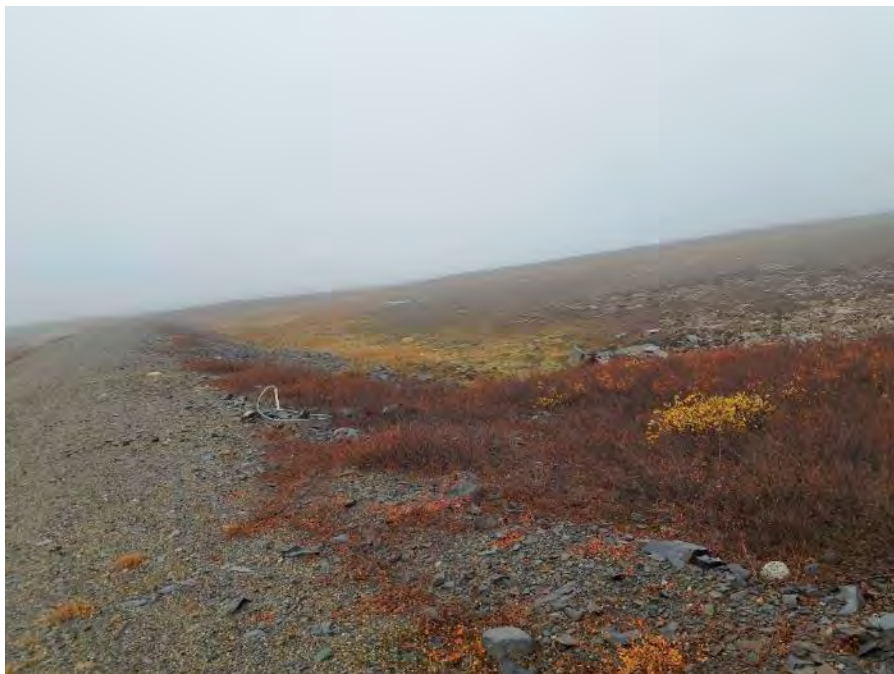
**Photo 4: Dam 1B crest and upstream area, facing north (Fig. A1 ID#18)**

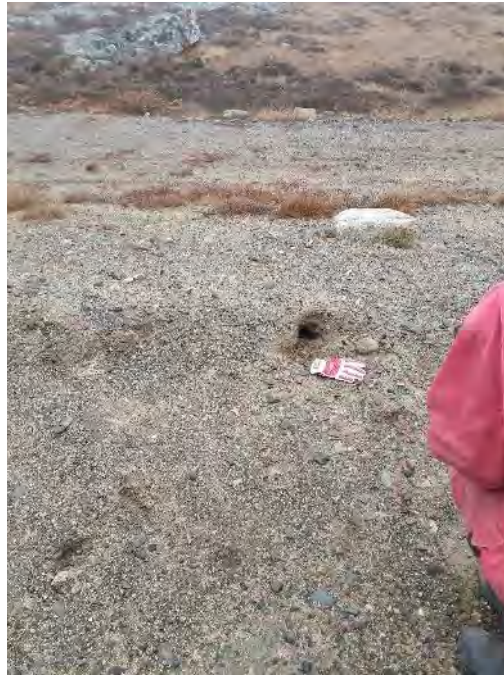
**Photo 5: Dam 1C animal burrow in crest, downstream shoulder (Fig. A1 ID#27)**

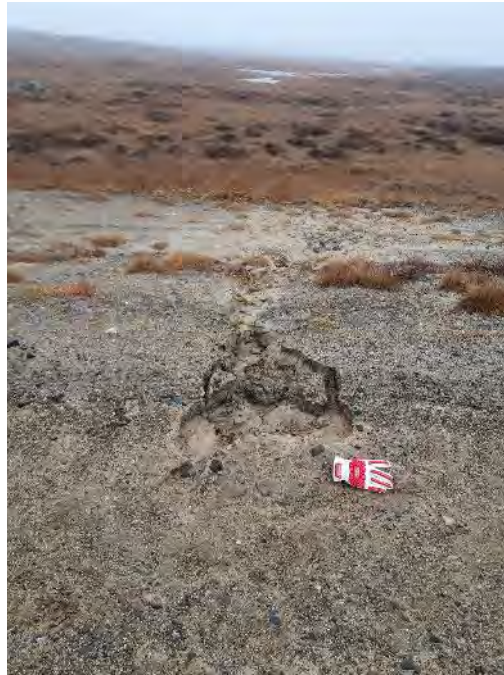
**Photo 9: Dam 1C erosion rill on upstream crest and slope (Fig. A1 ID#26)**

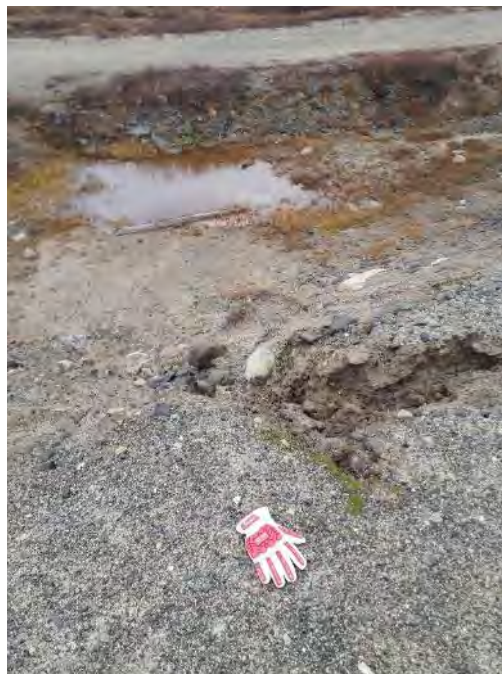
**Photo 14: Dam 2 erosion rill on downstream slope (Fig. A1 ID#2)**

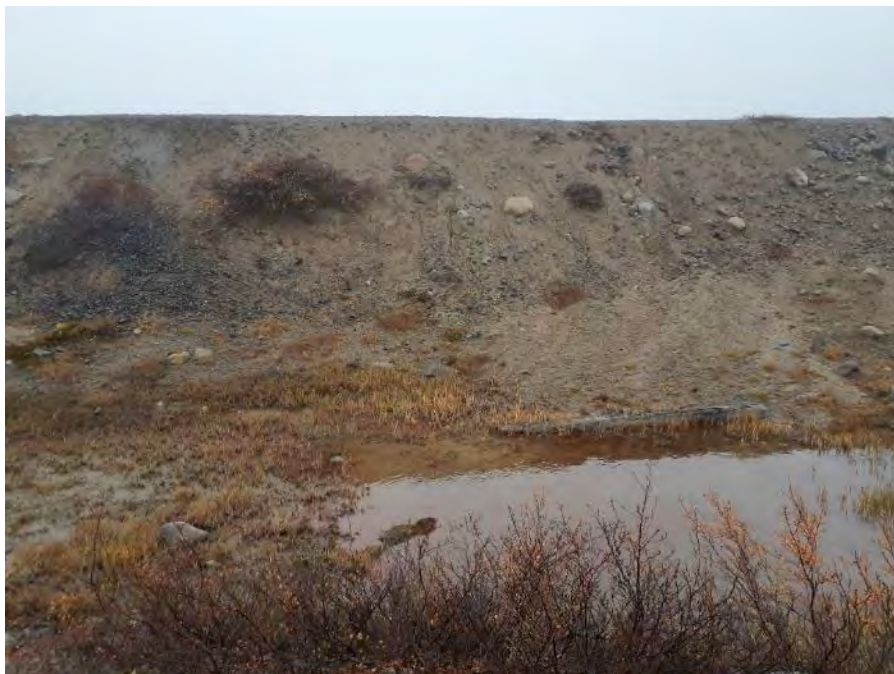
**Photo 16: Dam 2 downstream slope sloughing (Fig. A1 ID#9)**

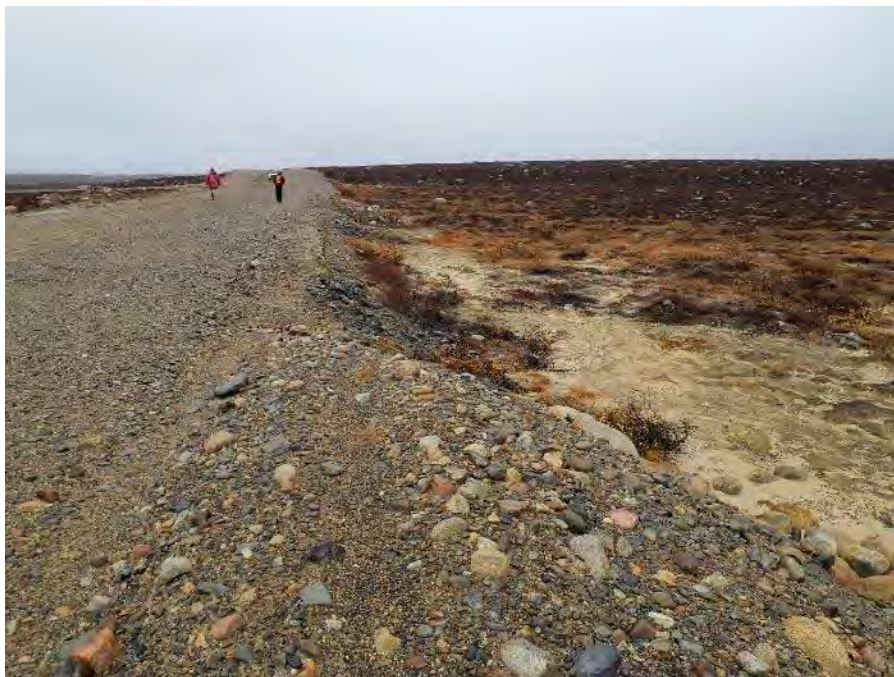
**Photo 30: Dam 5 downstream slope facing east (Fig. A1 ID#39)**

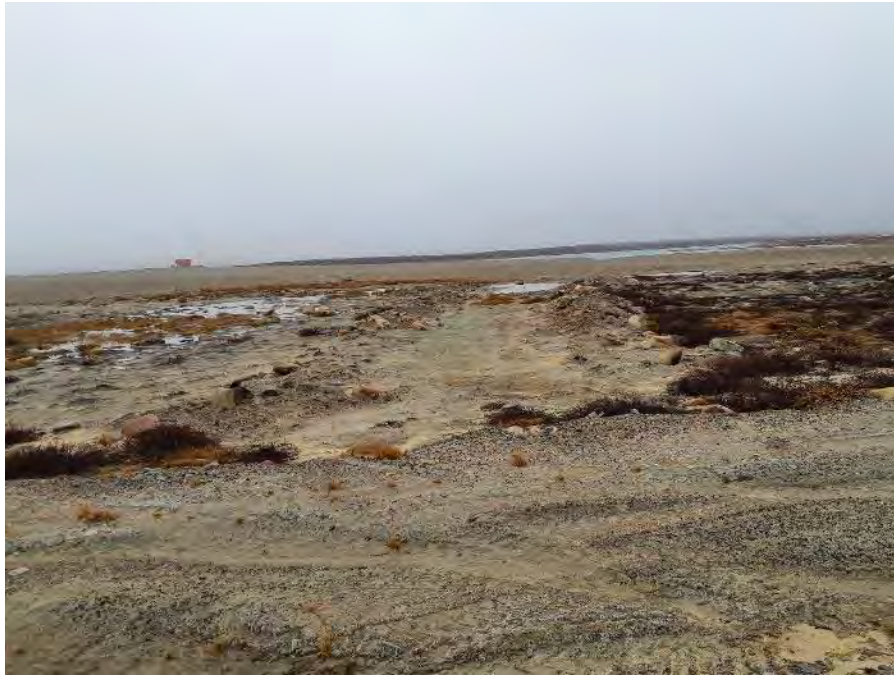
**Photo 31: Dam 5 drainage feature upstream of dam (Fig. A1 ID#38)**

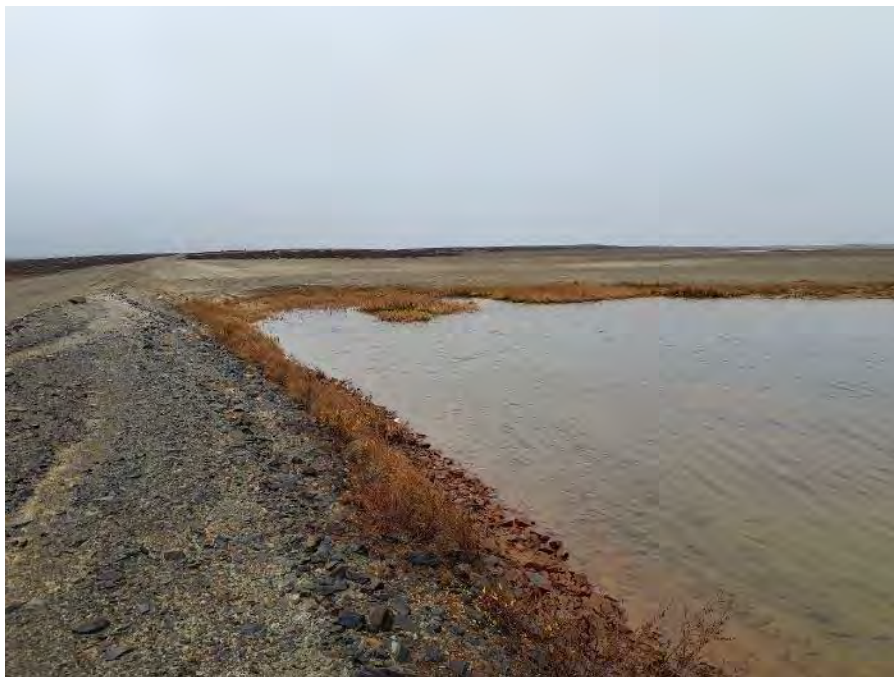
**Photo 32: Dam 6 ponded water upstream of dam, edge of tailings cover, facing north (Fig. A1 ID#34)**

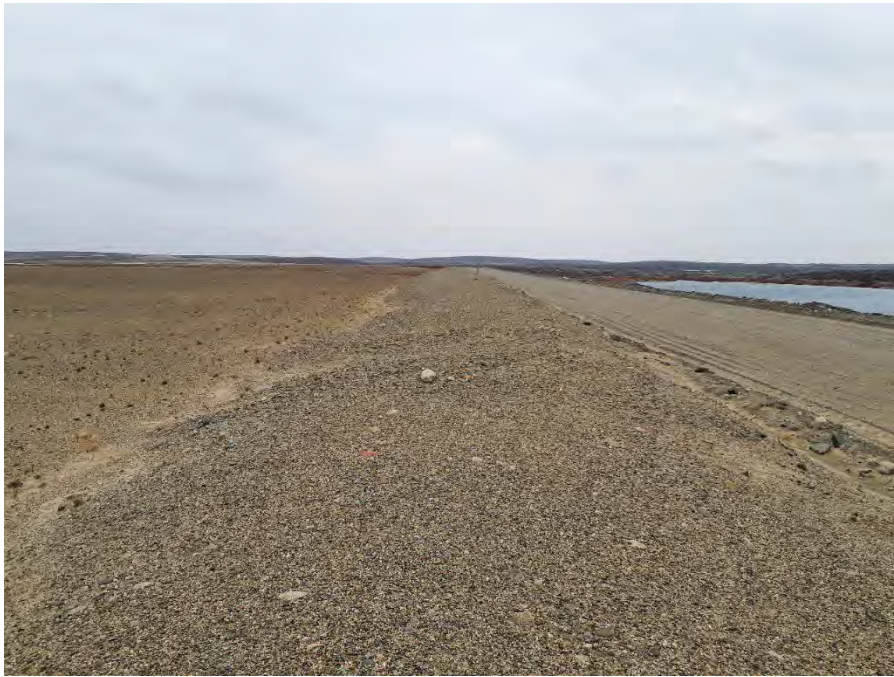
**Photo 37: Dam 3D berm upstream of dam crest to reduce runoff over dam (Fig. A1 ID#111)**

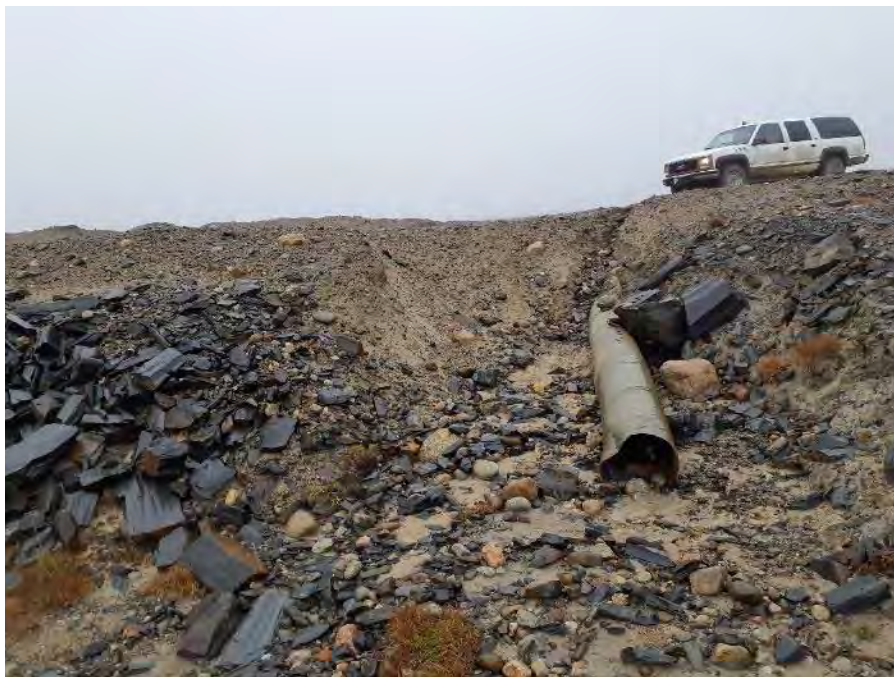
**Photo 38: Dam 3D pipe exiting downstream slope, facing north (Fig. A1 ID#94)**

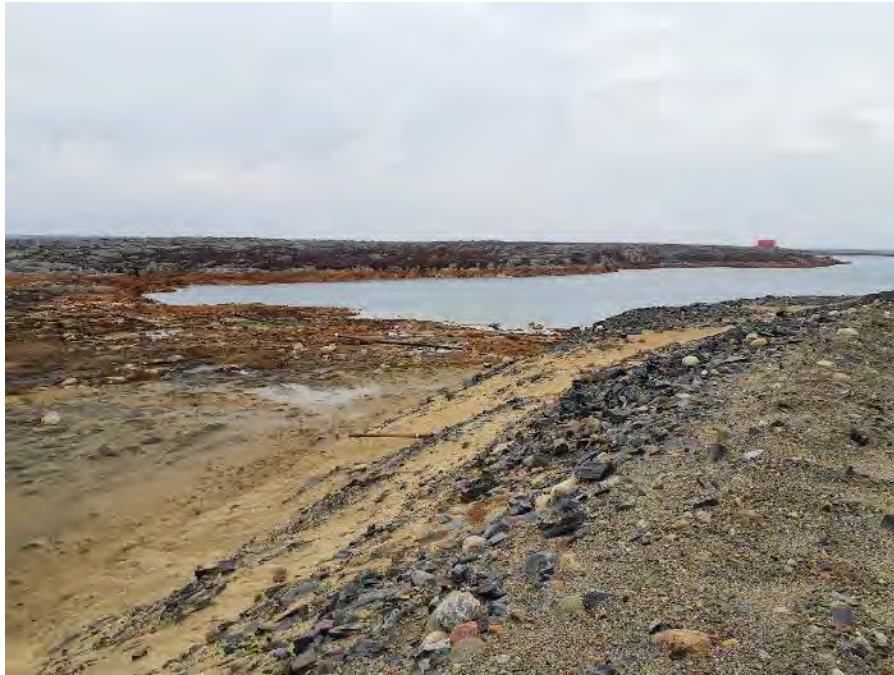
**Photo 39: Pond 1 high water mark, viewed from Dam 3D (Fig. A1 ID#111)**

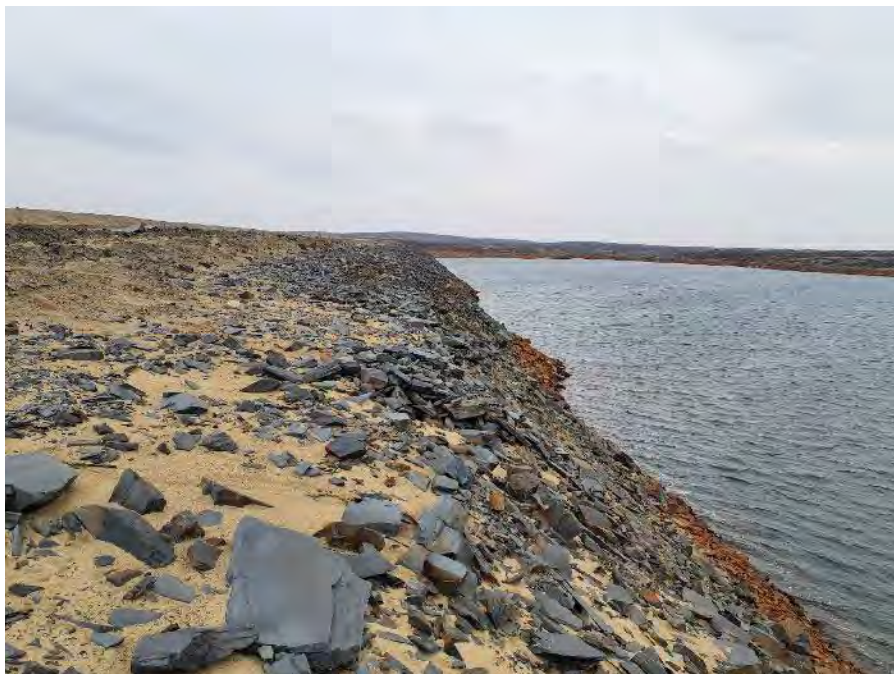
**Photo 40: Dam 3D downstream slope, high water mark evident at toe (Fig. A1 ID#112)**

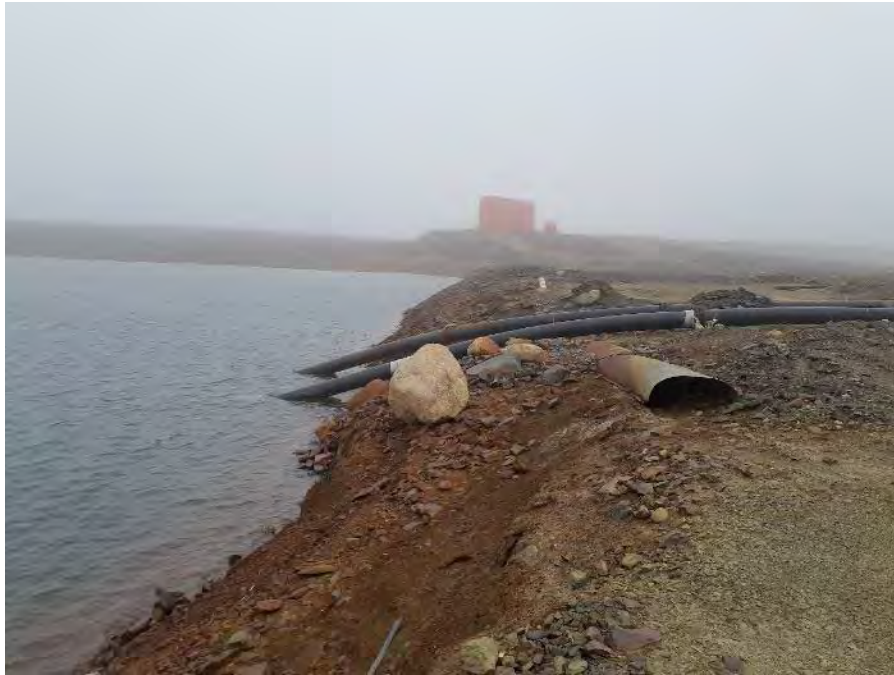
**Photo 41: J Dam syphons, Pond 1, facing south (Fig. A1 ID#82)**

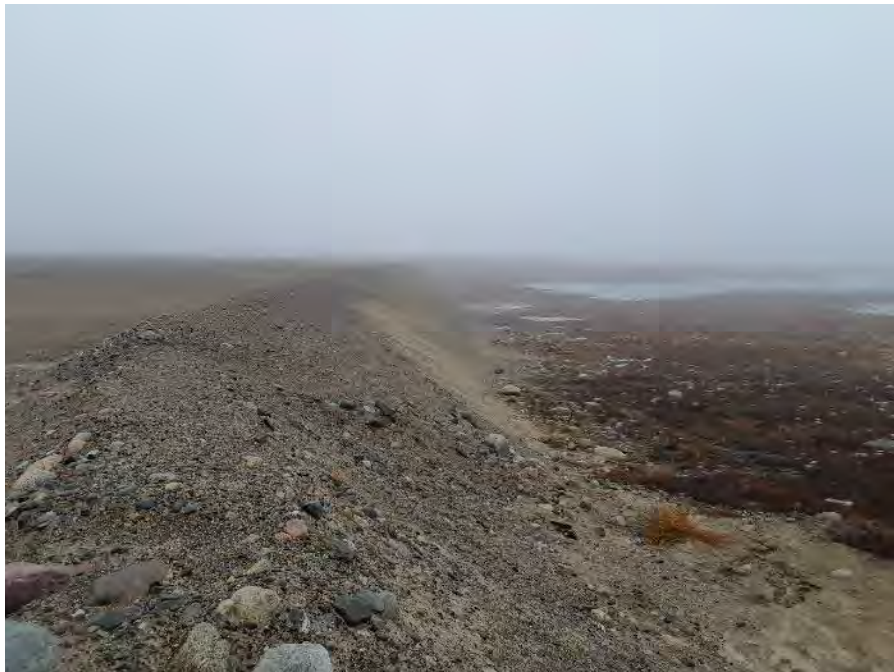
**Photo 44: K Dam downstream slope, recently regraded, facing southwest (Fig. A1 ID#91)**

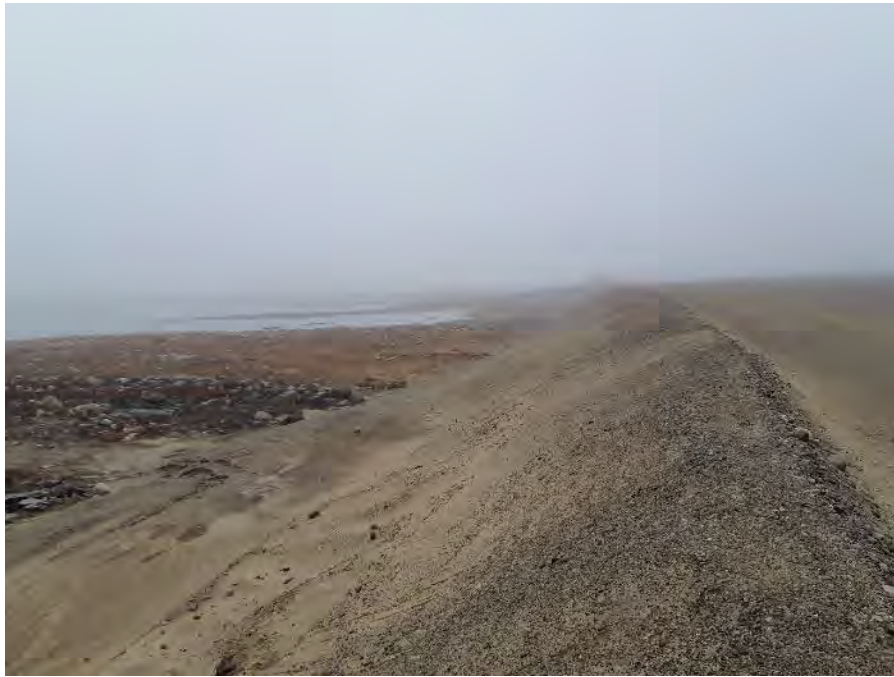
**Photo 45: K Dam downstream slope, recently regraded, facing northeast (Fig. A1 ID#93)**

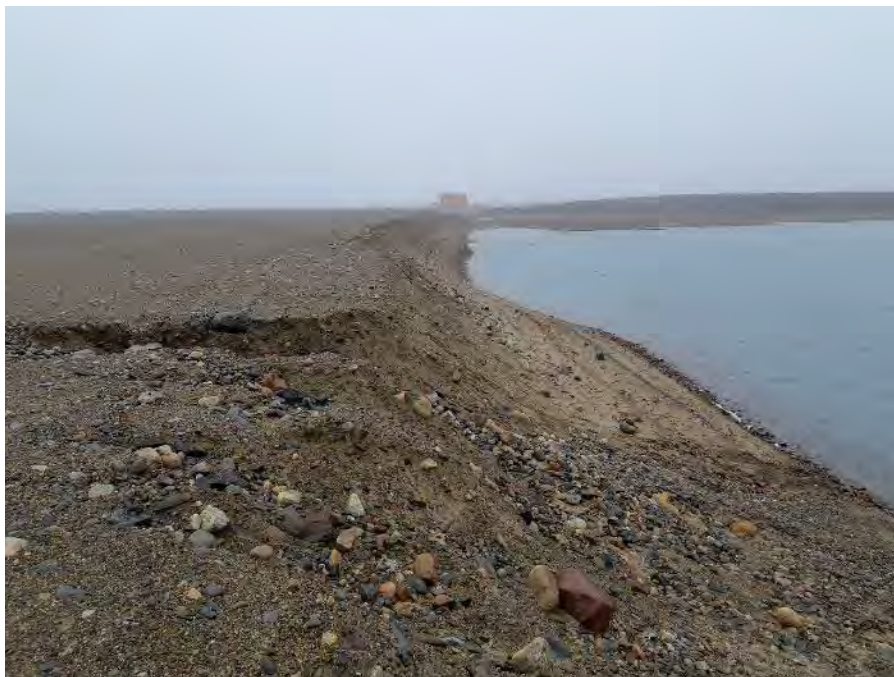
**Photo 46: L Dam downstream slope, facing north (Fig. A1 ID#89)**

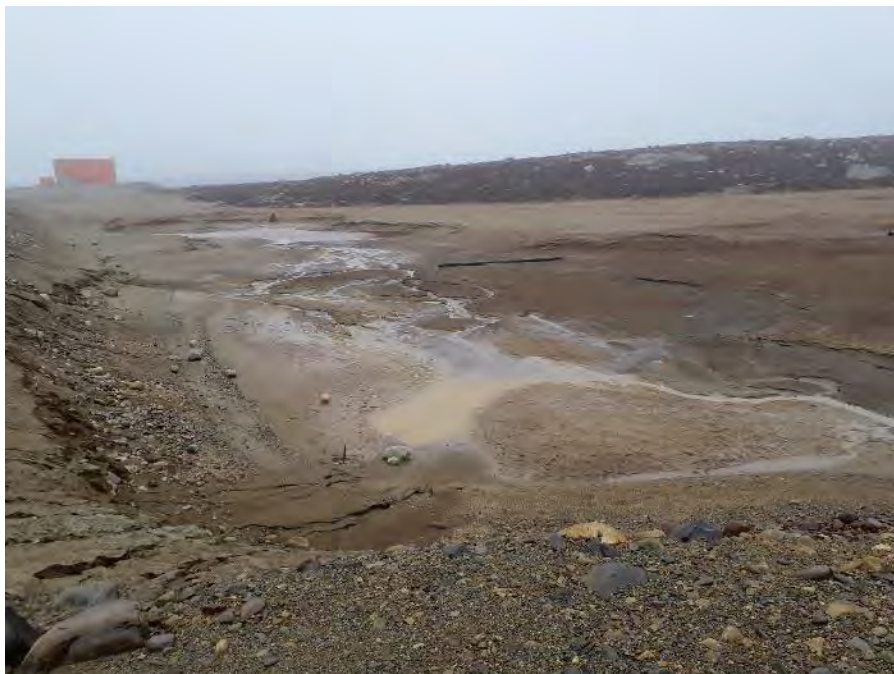
**Photo 48: L Dam exposed tailings downstream of dam, facing north (Fig. A1 ID#87)**

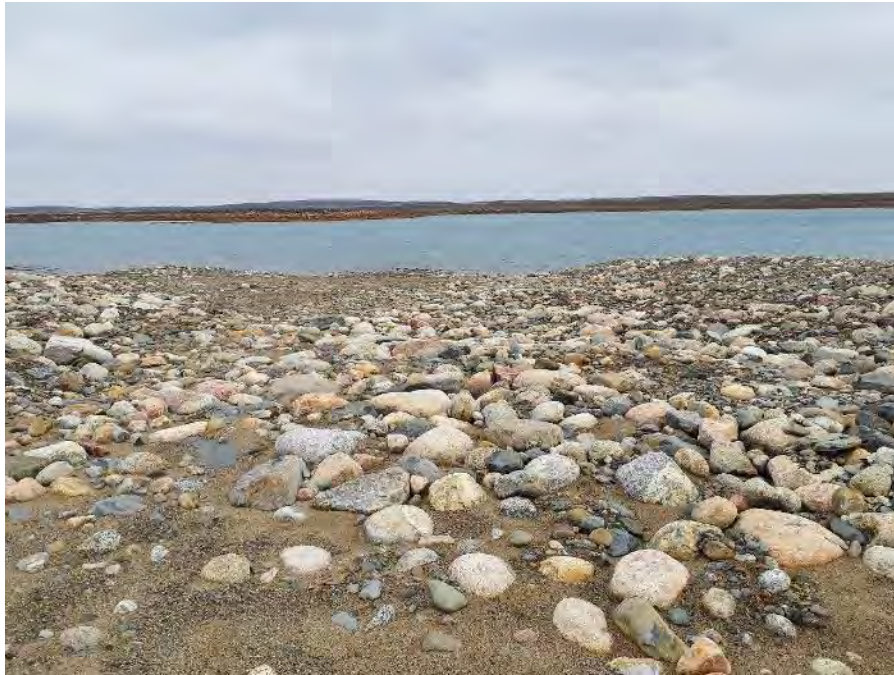
**Photo 49: Cell 3 outfall structure facing downstream to Cell 4 (Fig. A1 ID#106)**

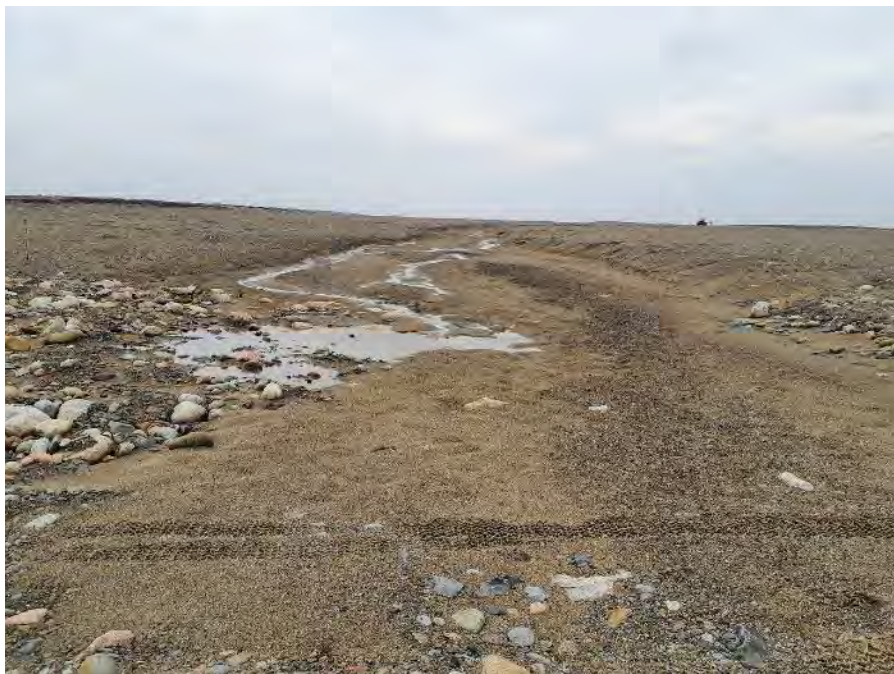
**Photo 50: Cell 3 outfall structure erosion on channel slopes (Fig. A1 ID#107)**

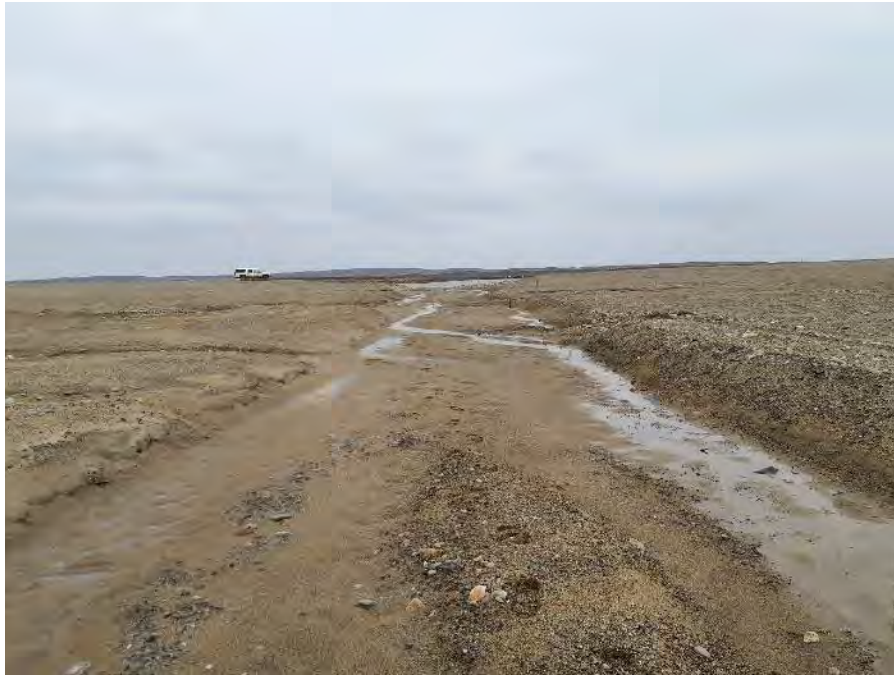
**Photo 51: Cell 3 outfall structure, facing downstream (Fig. A1 ID#109)**

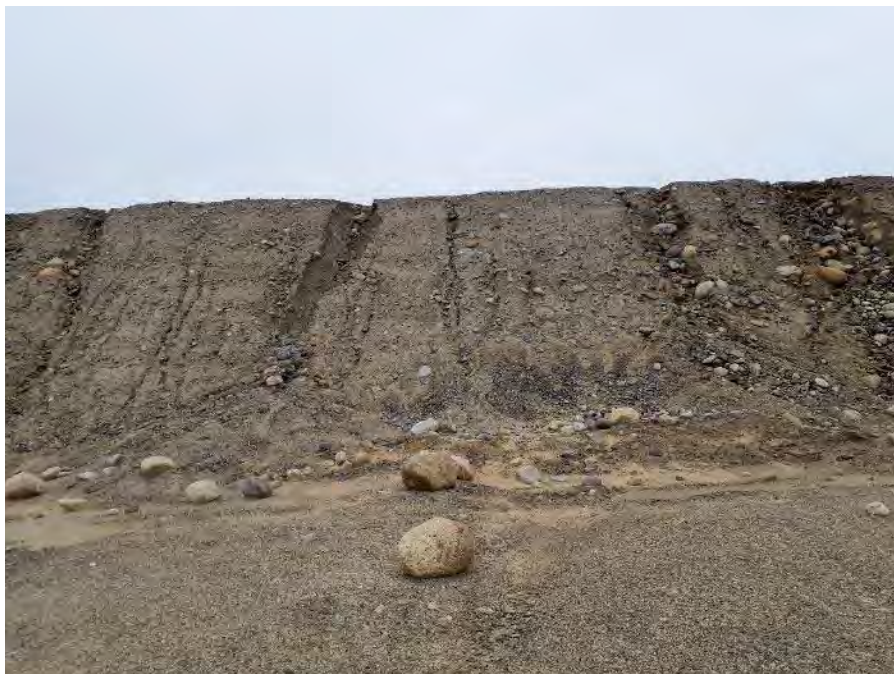
**Photo 52: M Dam erosion rills on downstream slope, facing northeast (Fig. A1 ID#71)**

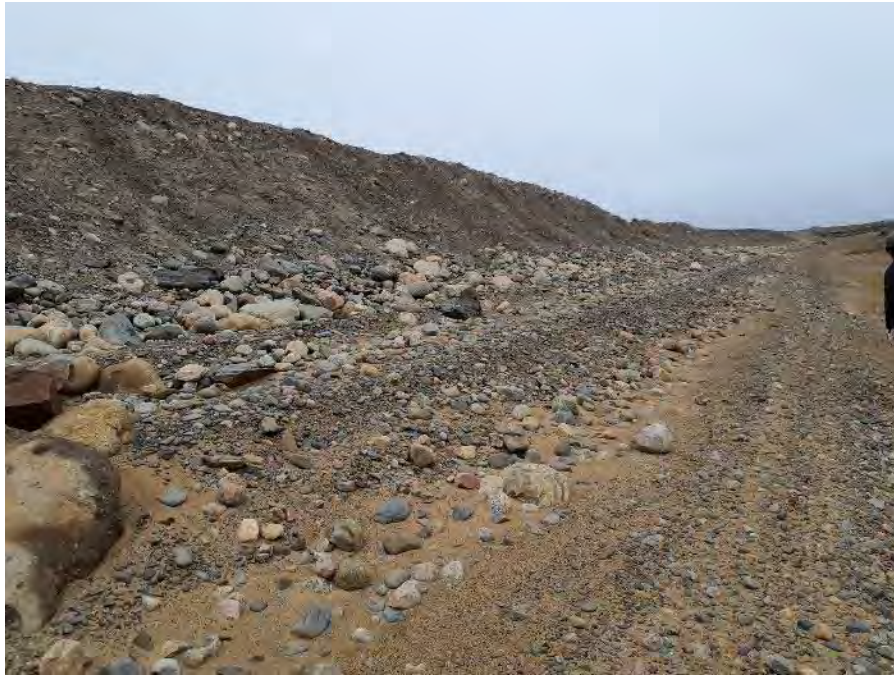
**Photo 55: M Dam downstream slope, facing east (Fig. A1 ID#74)**

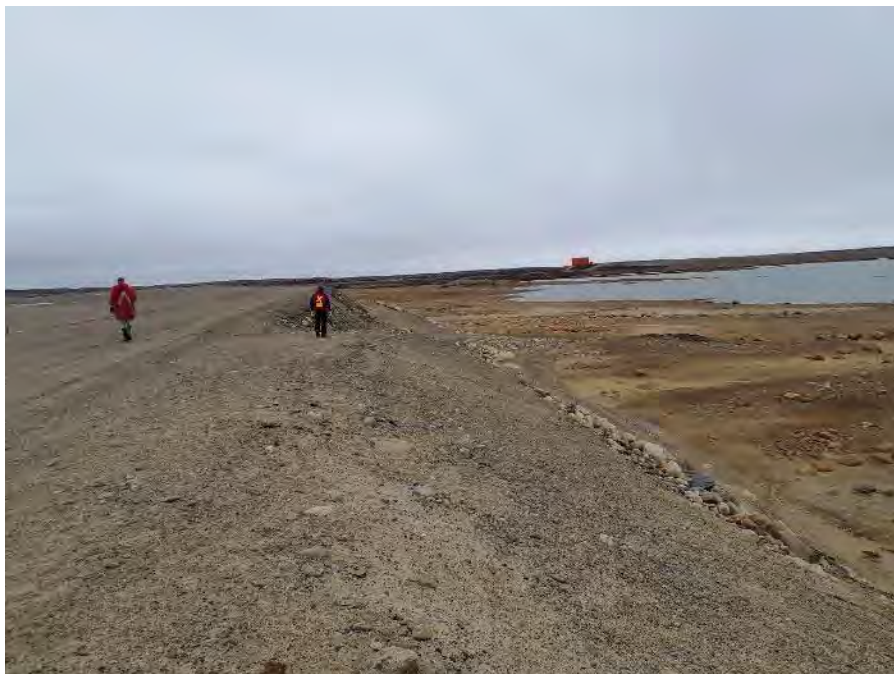
**Photo 56: M Dam downstream slope facing southeast (Fig. A1 ID#69)**

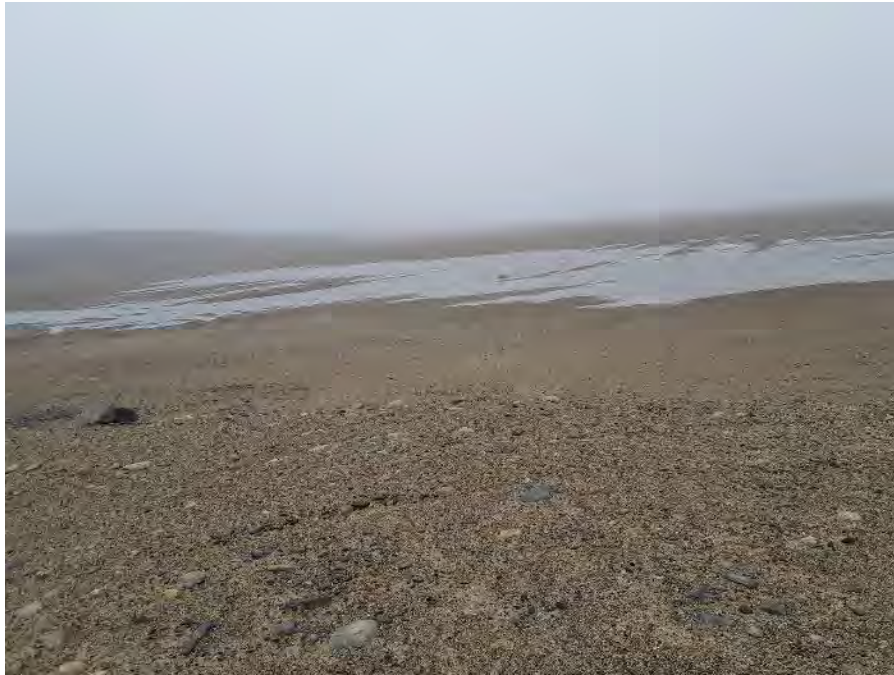
**Photo 57: M Dam ponded water in cover upstream of dam, facing east (Fig. A1 ID#80)**

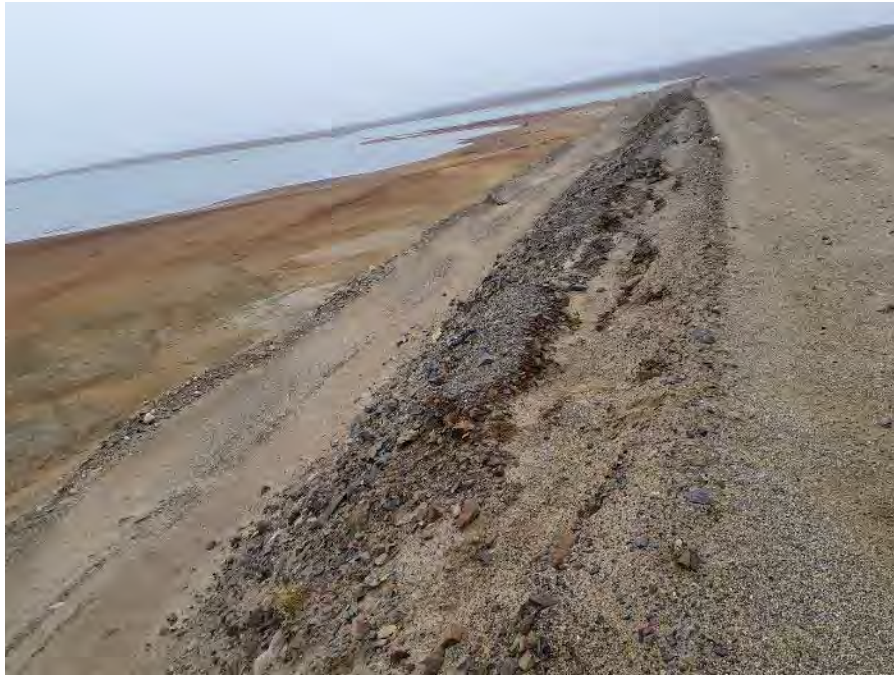
It is understood that this dam was constructed on deposited tailings and the soil downstream of the dam was a reddish silty sand which appears to be tailings (**Photo 58, 59**).

**Photo 59: M Dam downstream slope from crest, facing northwest (Fig. A1 ID#78)**

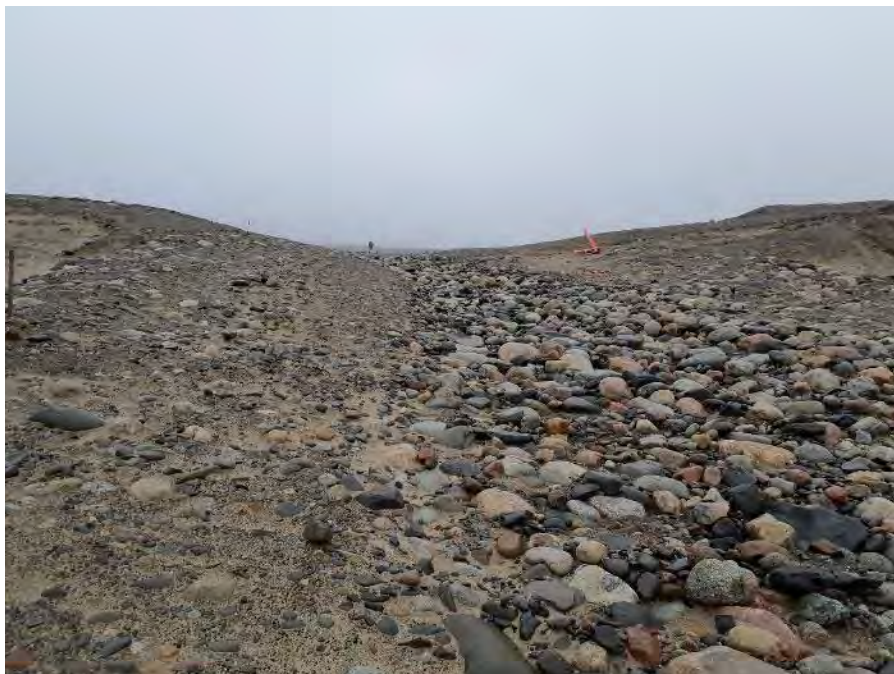
**Photo 60: Cell 5 outfall structure facing upstream (Fig. A1 ID#100)**

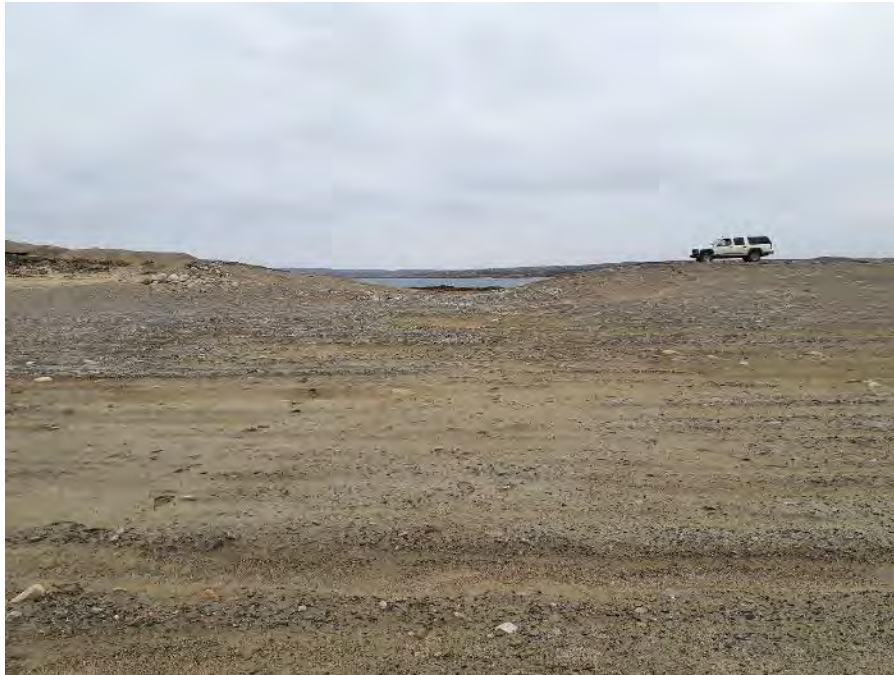
**Photo 61: Cell 5 outfall structure, facing downstream (Fig. A1 ID#104)**

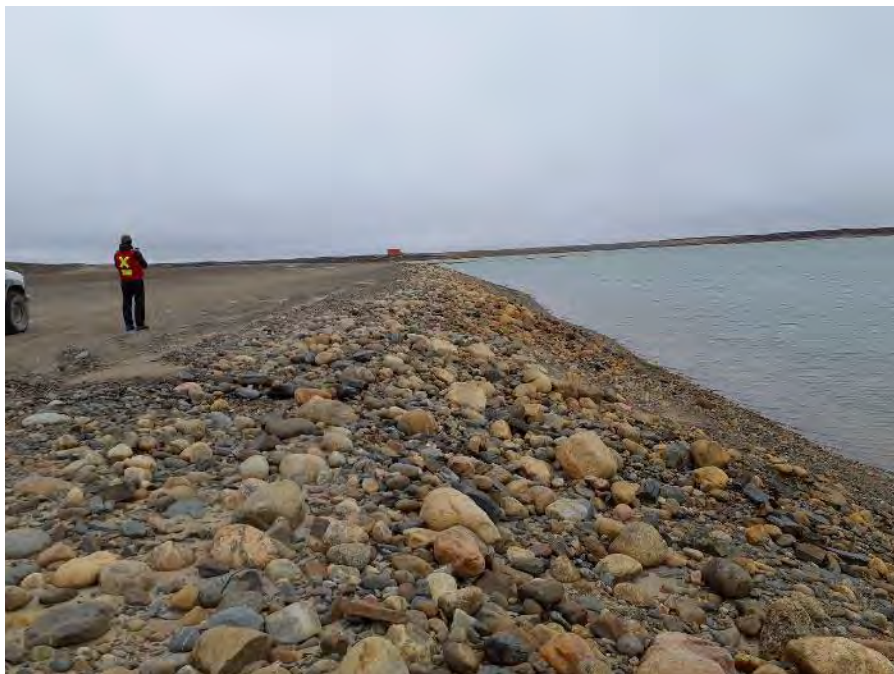
**Photo 62: N Dam downstream slope, facing south (Fig. A1 ID#65)**

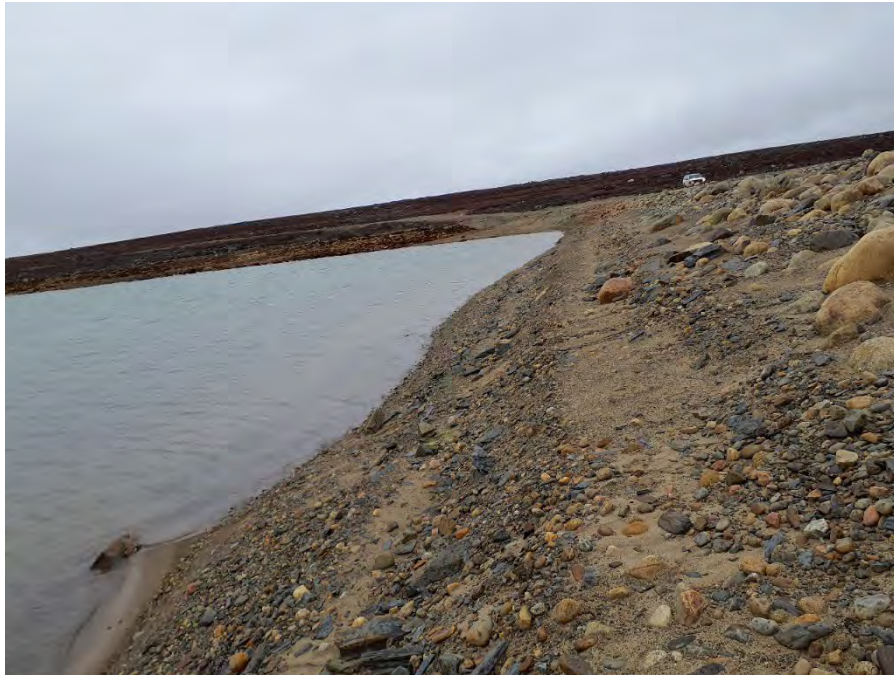
**Photo 63: N Dam downstream slope, facing north (Fig. A1 ID#66)**

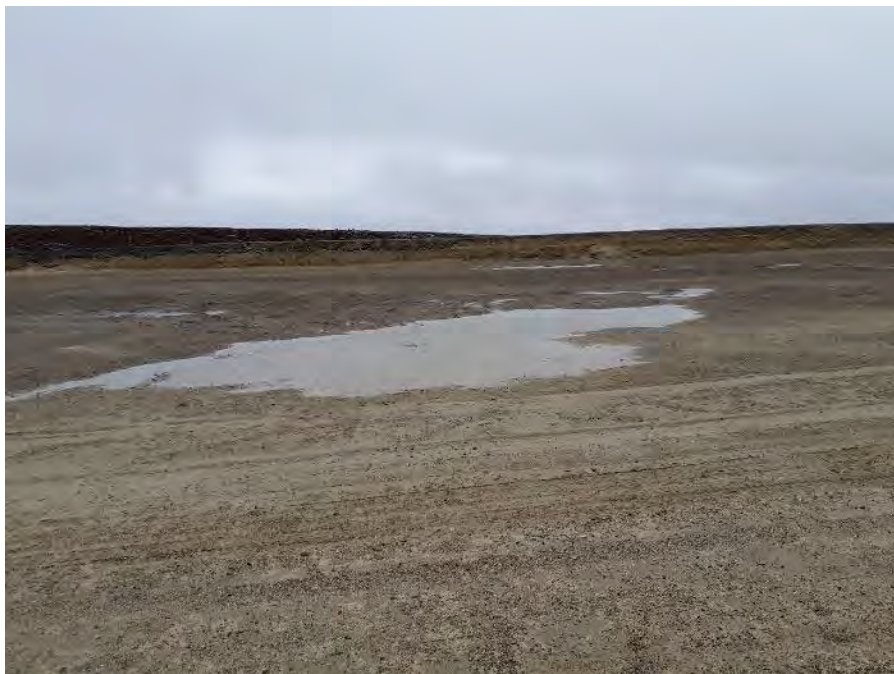
**Photo 64: N Dam ponded water on cover upstream of dam, facing east (Fig. A1 ID#67)**

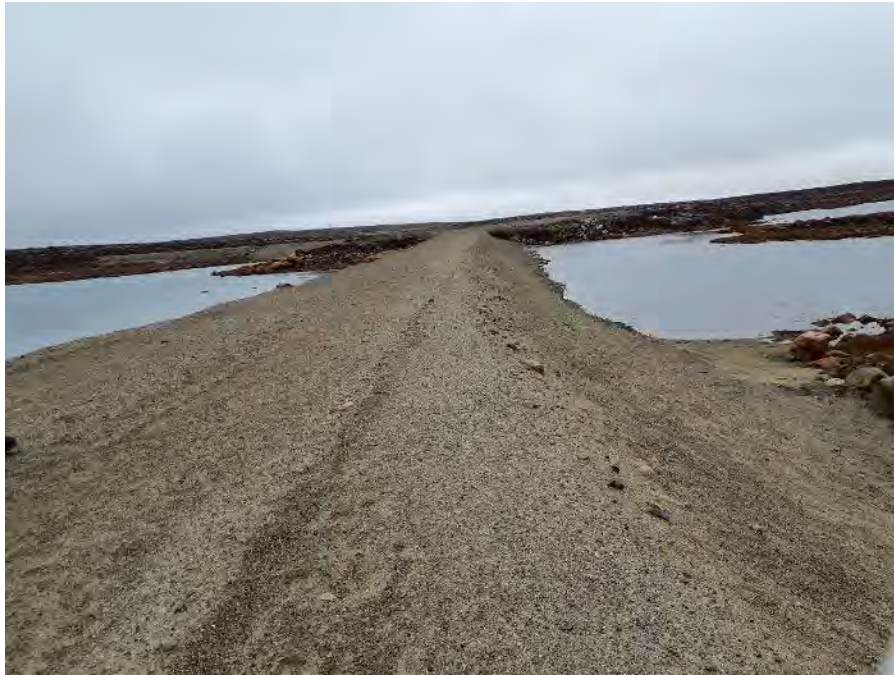
**Photo 65: Divider dyke crest and downstream slope, facing north (Fig. A1 ID#50)**

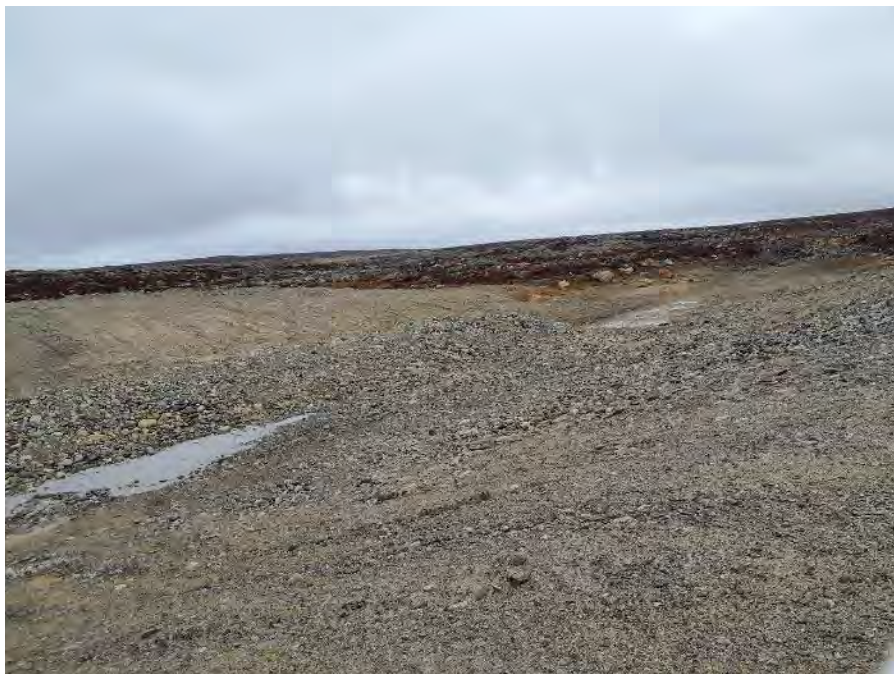
**Photo 66: Divider dyke spillway channel facing northeast (Fig. A1 ID#51)**

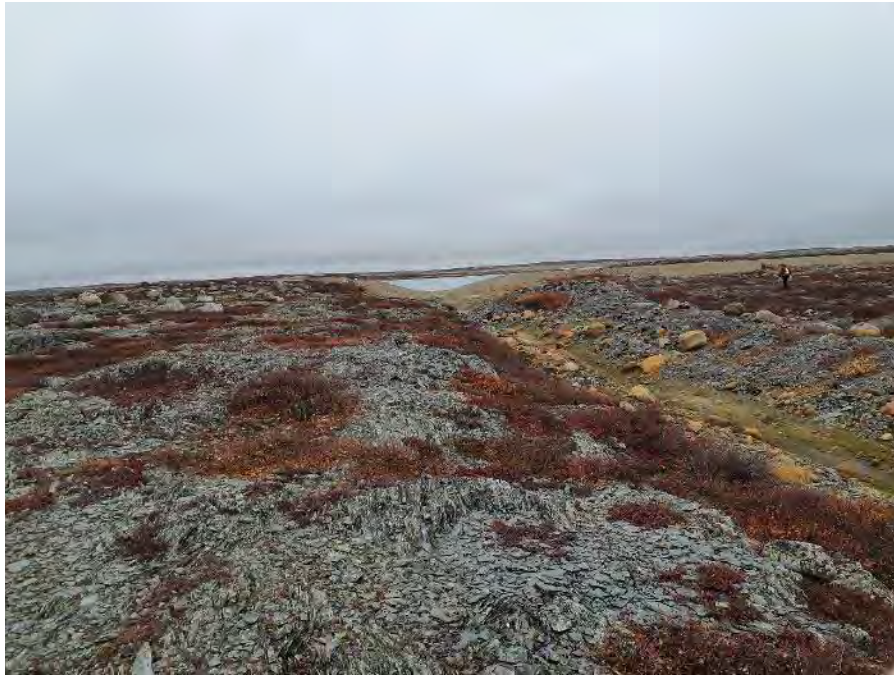
**Photo 67: Divider dyke spillway, facing southwest (Fig. A1 ID#52)**
