2011 Annual Geotechnical Inspection
Perimeter Dams
Tailings Containment Area
Lupin Mine, Nunavut

Prepared By:
TBT Engineering Consulting Group

November 22, 2011
TBTE Ref. No. 11-293

**Re: 2011 Annual Geotechnical Inspection (Revision 1)
Perimeter Dams Tailings Containment Area
Lupin Mine, Nunavut**

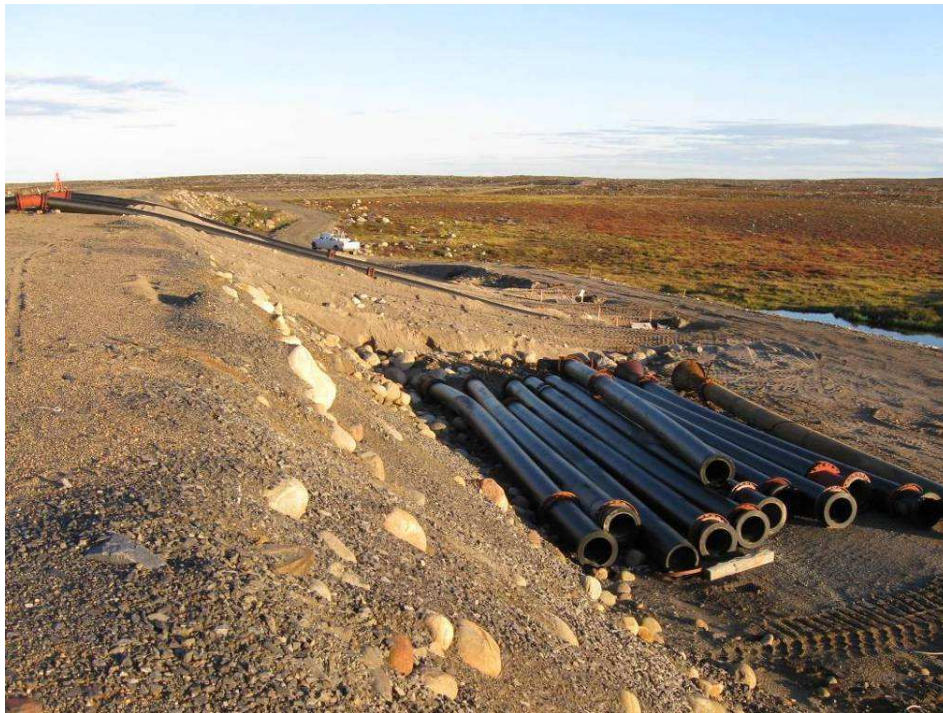
Dam 1A: Downstream – Looking South (north side of siphons) – 2010

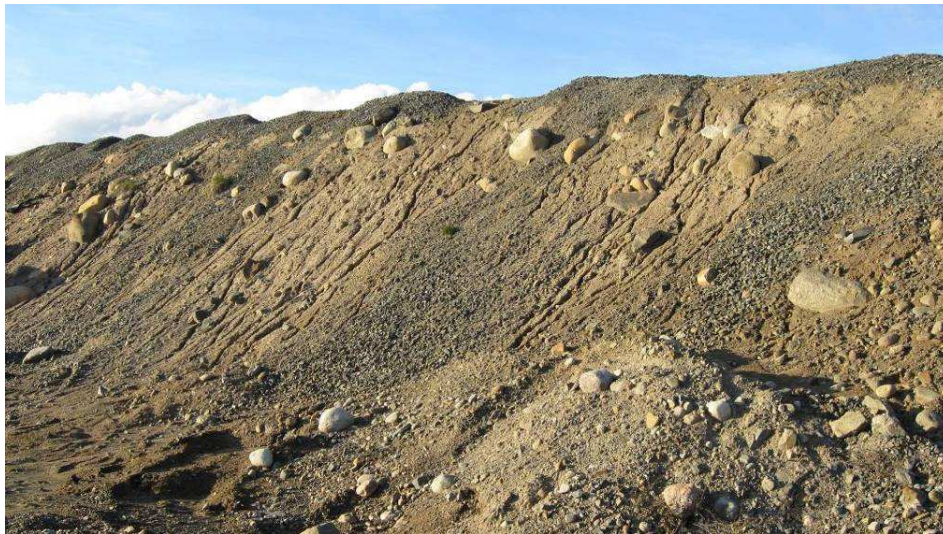
Dam 1A – Downstream Slope (south side of Siphons) Erosion Gullies – 2010

Maintenance is recommended to repair erosion along areas of the downstream slope.

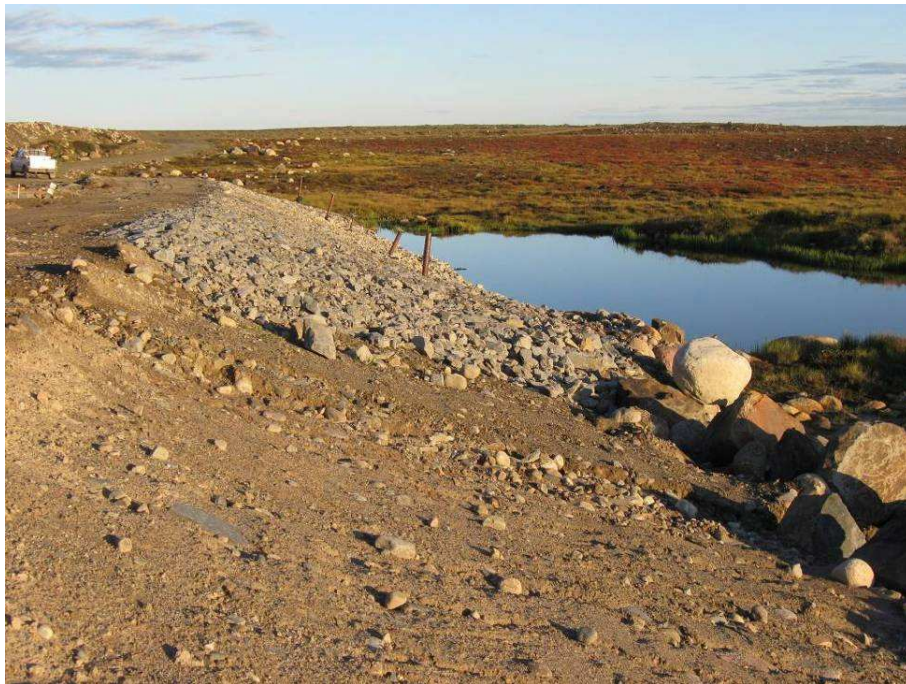
Dam 1A: Downstream Access Road Toe Berm Looking South – 2010

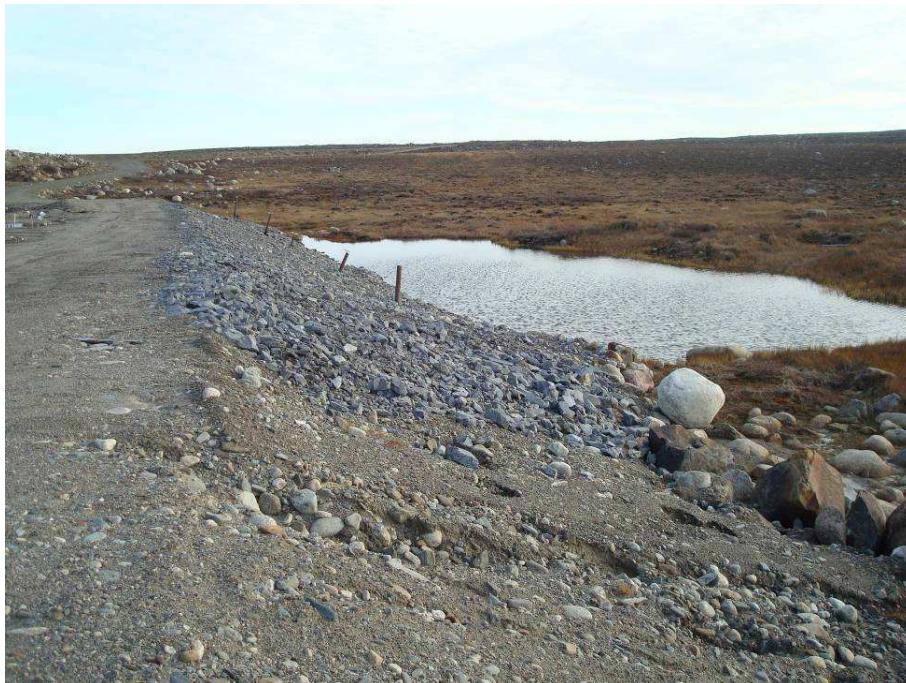
ACCESS ROAD TOE BERM	Last year the downstream slope of the access road toe berm was regraded and provided with riprap over a 48 m long section. The access road / toe berm is in good condition.
SEEPAGE:	No evidence of seepage.
INSTRUMENTATION:	Thermistor D1A-00-2 is located on the crest near the north side of the dam. However, this thermistor could not be read as the adapter is missing. Thermistor D1A-00-1 was read; however, the 3 rd deepest thermal couple is not operational.

Dam 1A: Downstream Access Road Toe Berm Looking South – 2011

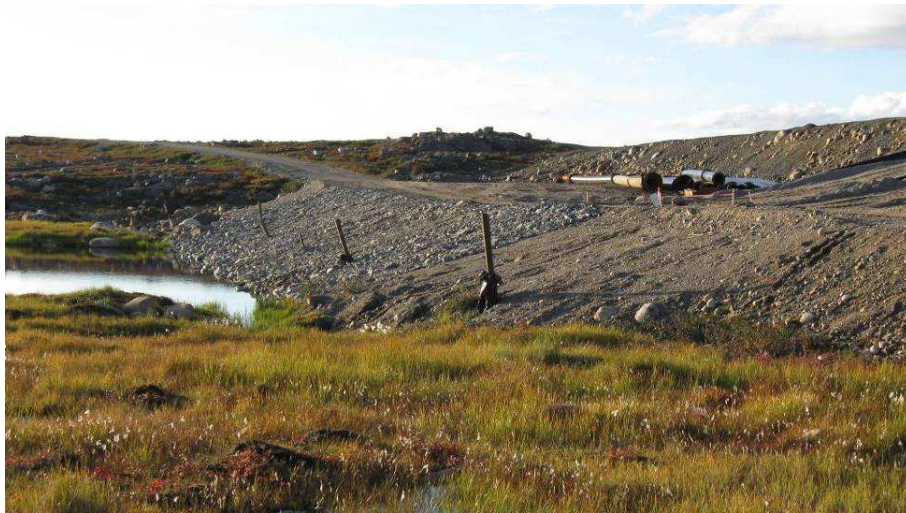
Dam 1A: Downstream Access Road Toe Berm Looking North – 2010

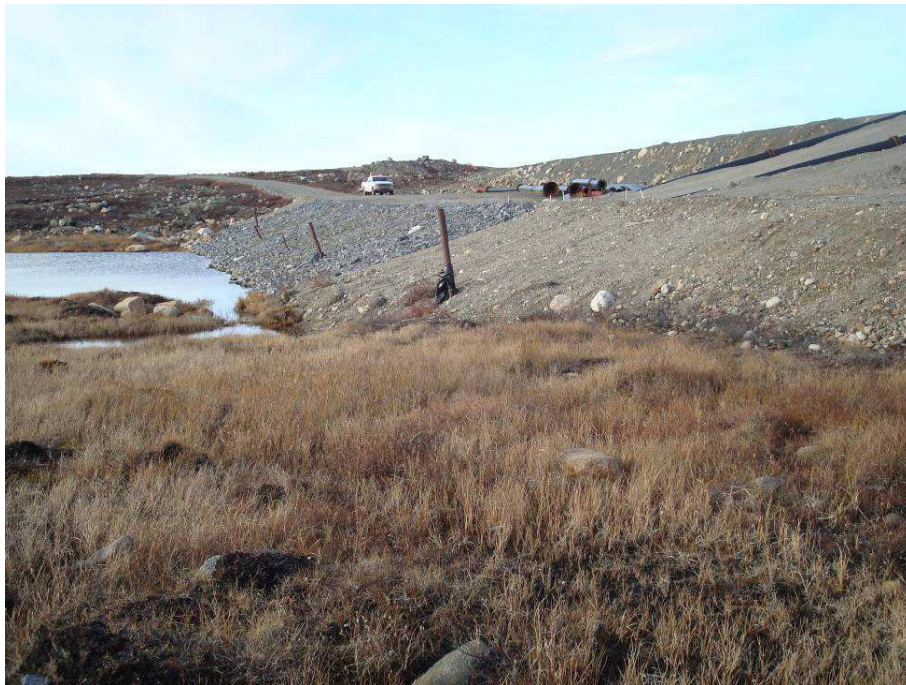
Dam 1A: Downstream Access Road Toe Berm Looking North – 2011

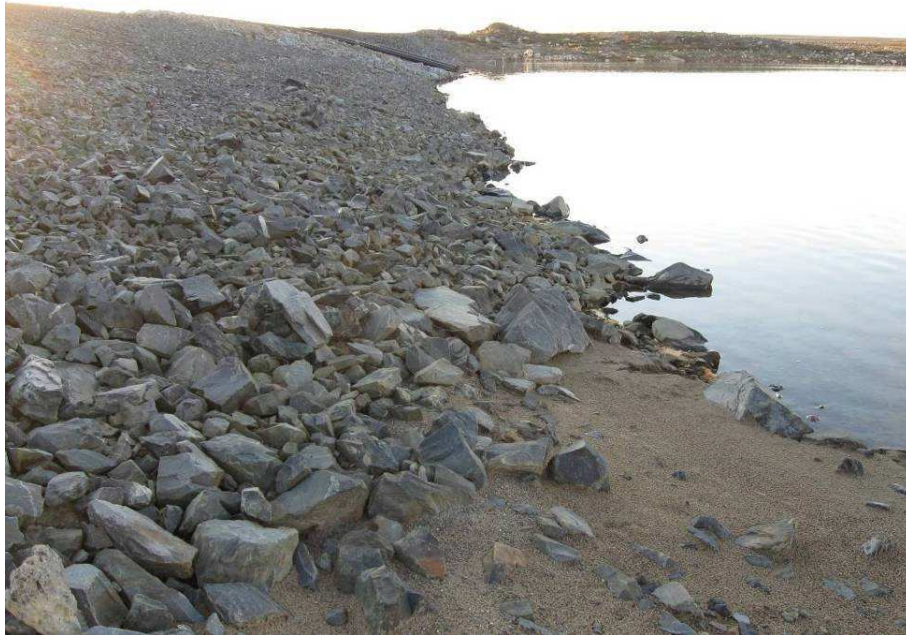
Dam 1A: Upstream Looking North – 2010

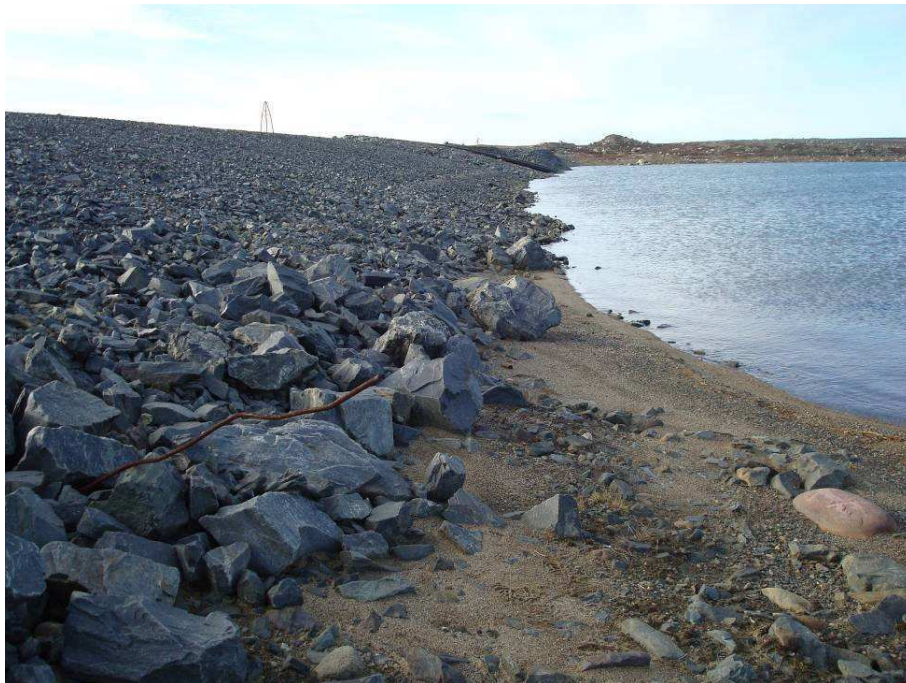
Dam 1A: Upstream Looking North – 2011

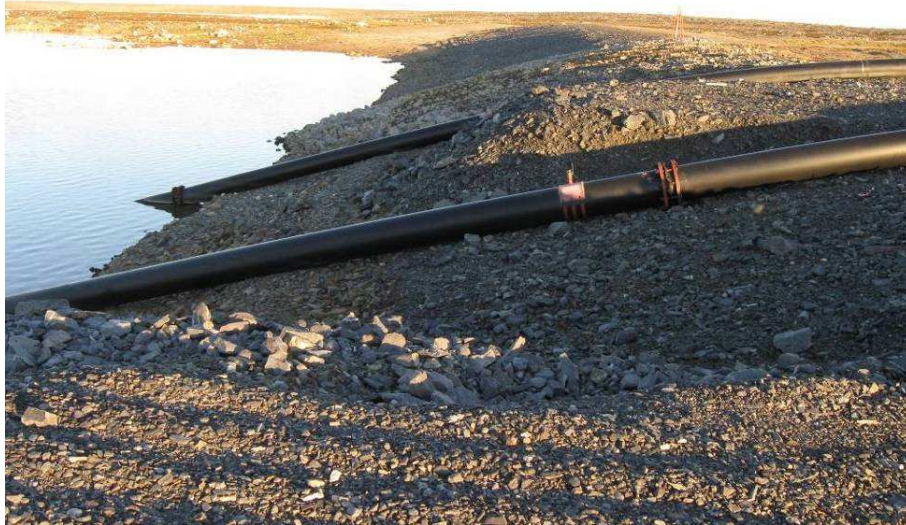
Dam 1A: Upstream Looking South – 2010

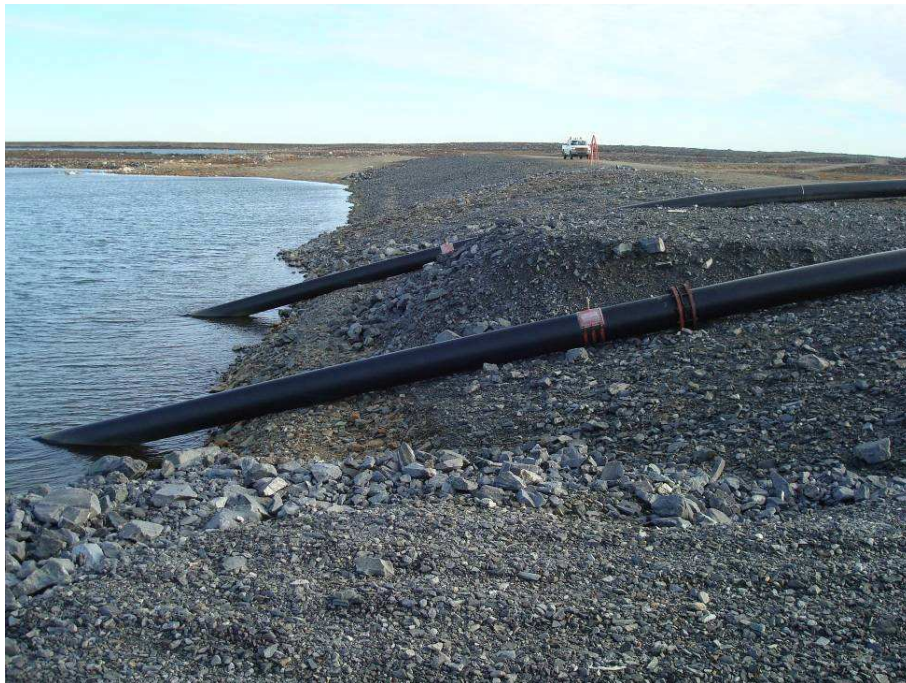
Dam 1A: Upstream Looking South – 2011

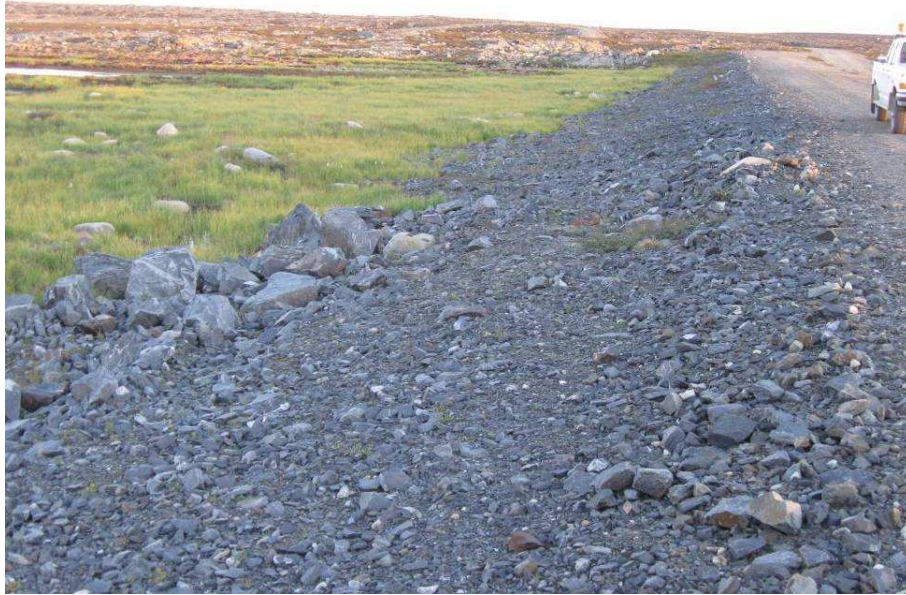
Dam 1B: Upstream – 2010

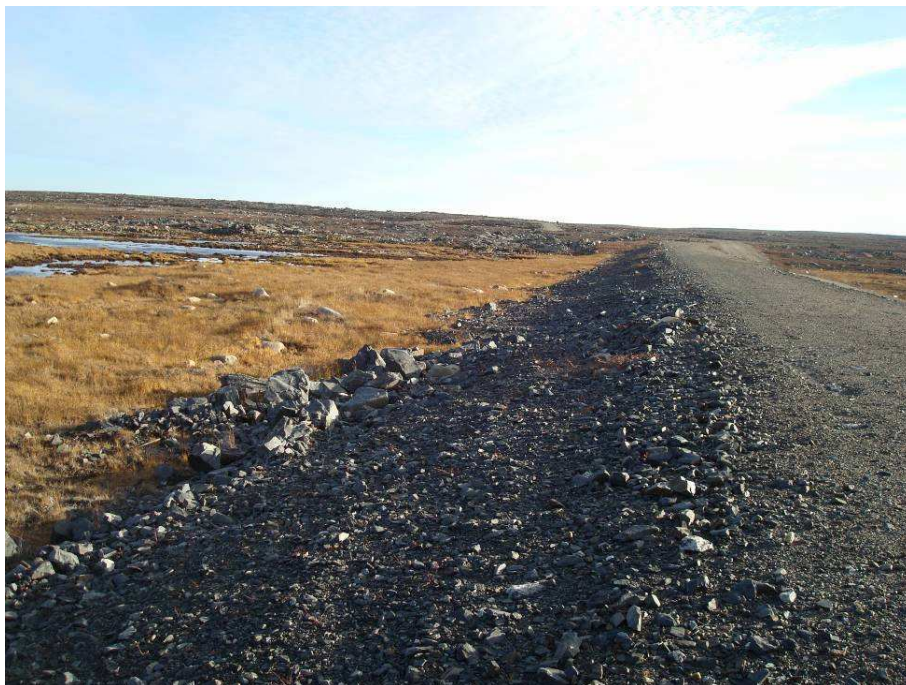
Dam 1B: Upstream – 2011

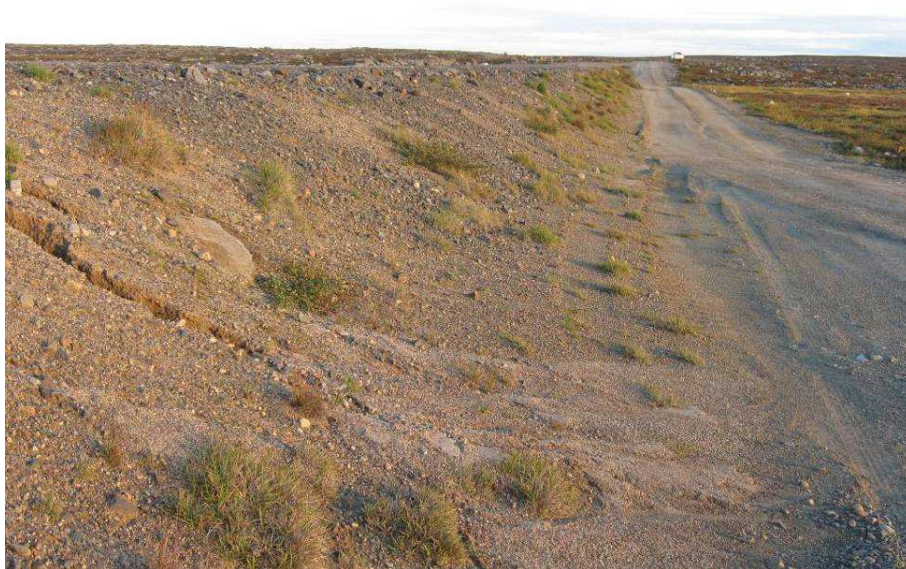
Dam 1B: Downstream – 2010

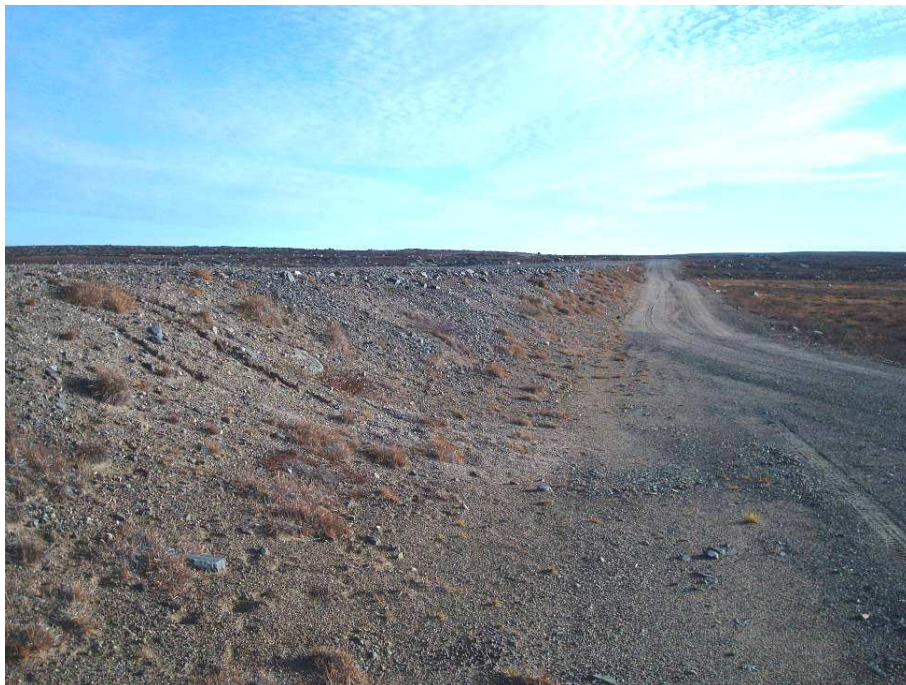
Dam 1B: Downstream – 2011

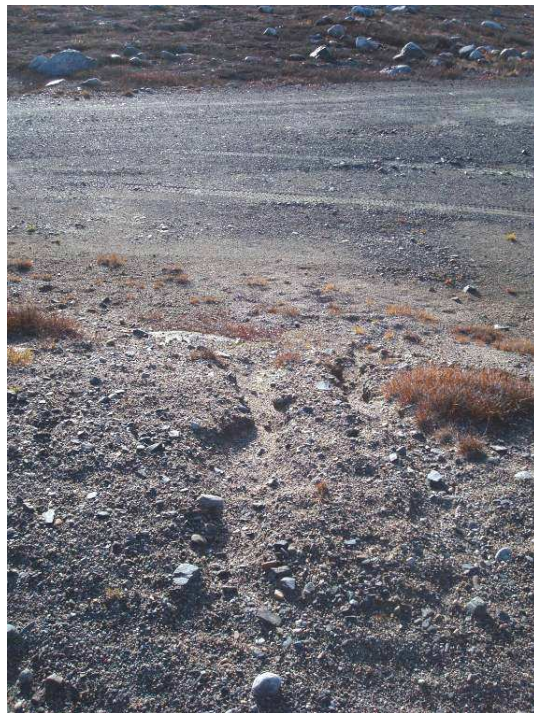
Downstream Slope: Erosion Gullies – 2011

MAINTENANCE RECOMMENDATIONS:	Maintenance of downstream surface erosion should be considered.
CONCLUSIONS:	The dam appears to be in a stable condition. Maintenance of downstream erosion is recommended.

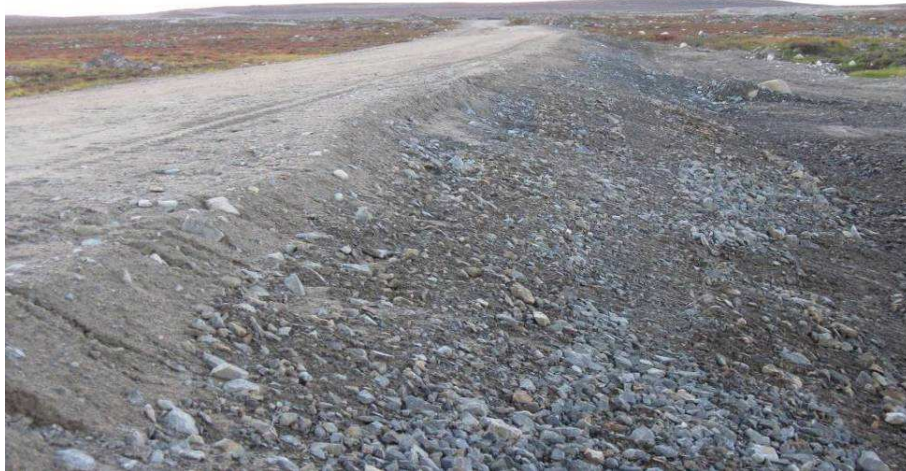
Dam 1C: Upstream (Minor Erosion Gullies on Shoulder of Granular Surfacing) – 2010

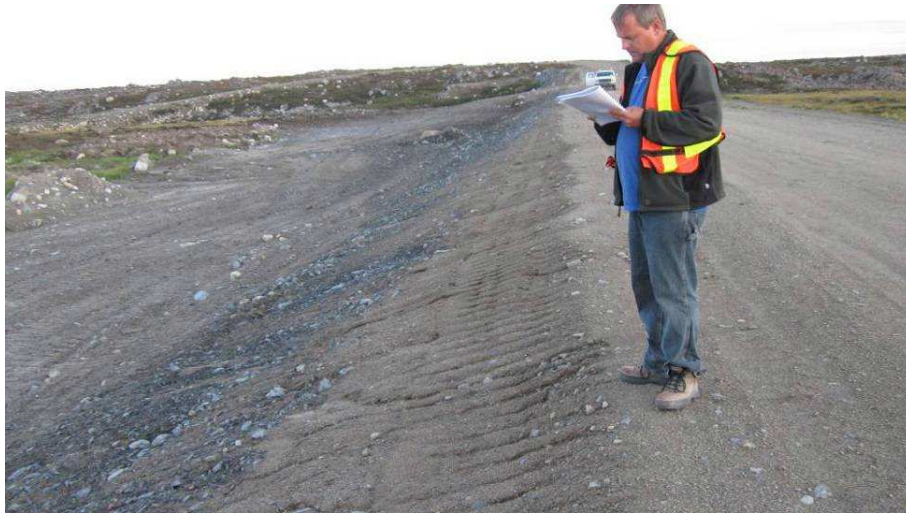
Dam 1C: Upstream (Minor Erosion Gullies on Shoulder of Granular Surfacing) Southern 2/3 of Upstream Slope Has Been Regraded/Extended with a Mixture of Rip Rap and Esker Material – 2010

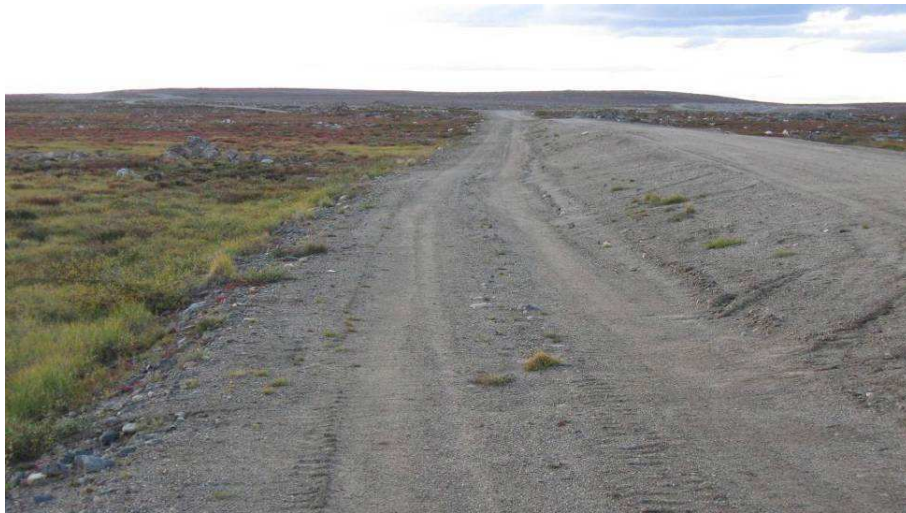
Dam 1C: Downstream Slope (Some Minor Erosion Gullies) – 2010

MAINTENANCE RECOMMENDATIONS:	Maintenance of cracking/sloughing conditions along downstream slope is recommended.
CONCLUSIONS:	The dam appears to be in a stable condition. Maintenance of downstream erosion and sloughing is recommended.

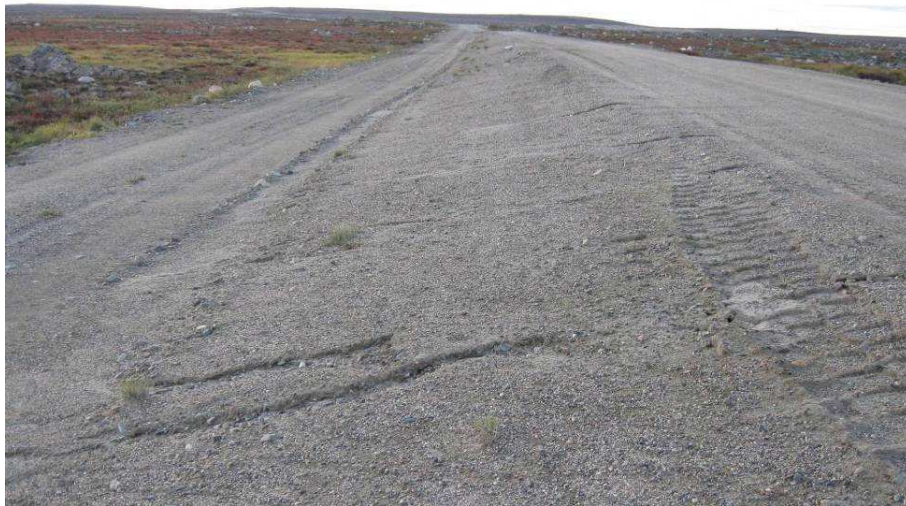
Dam 1C: Downstream Slope (Some Minor Erosion Gullies) – 2010

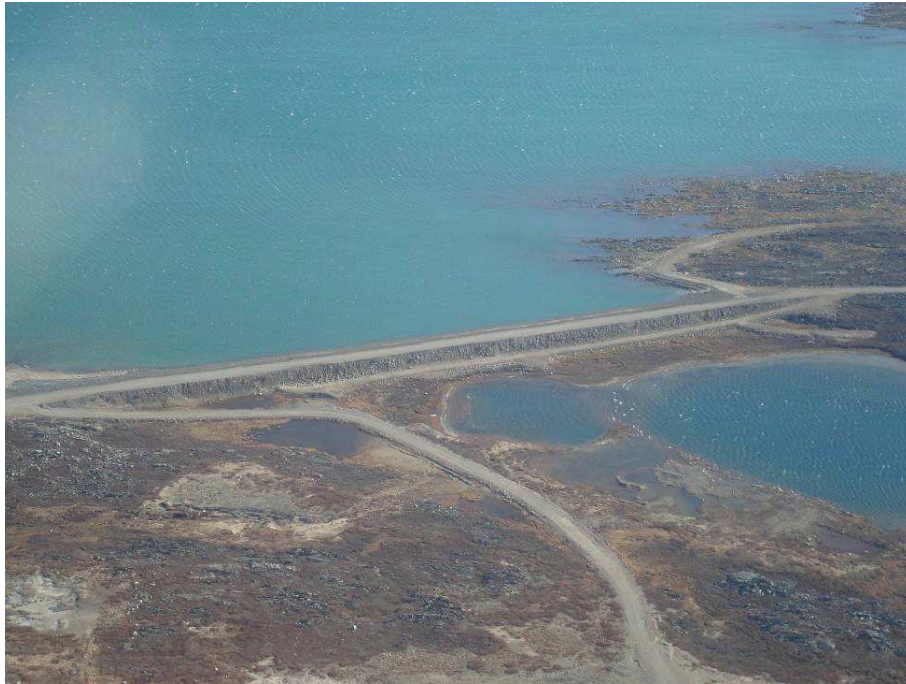
Overview of Dam 2 – 2011

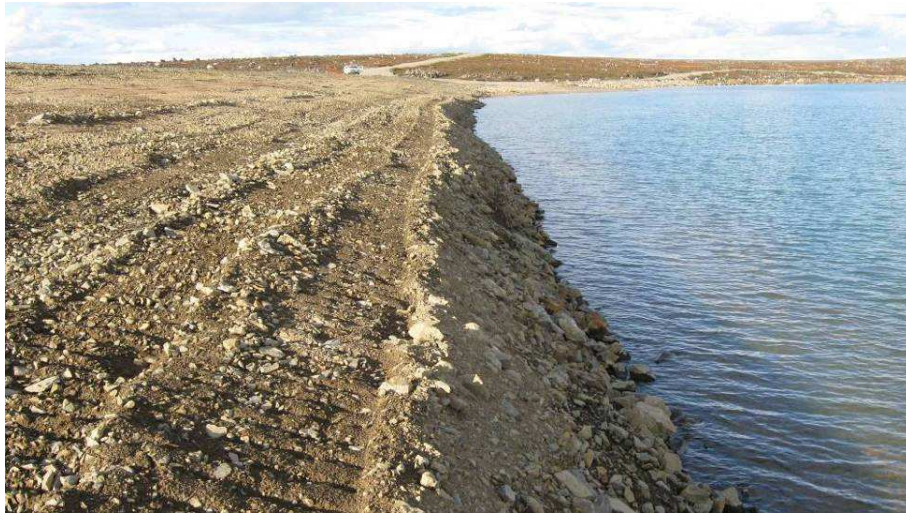
Dam 2: Upstream Slope Looking Northeast – 2010

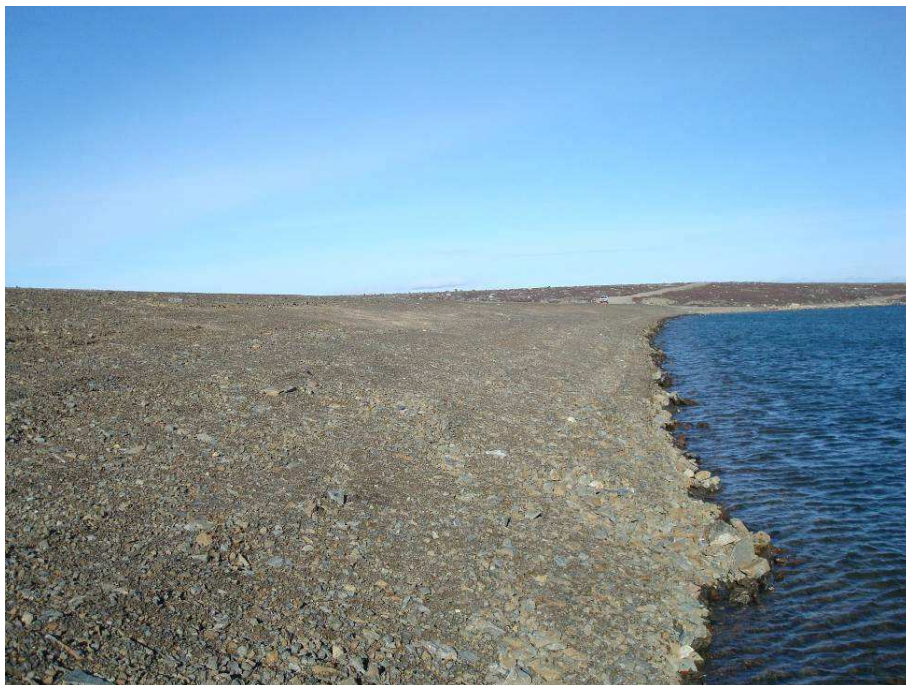
Dam 2: Upstream Slope Looking Northeast – 2011

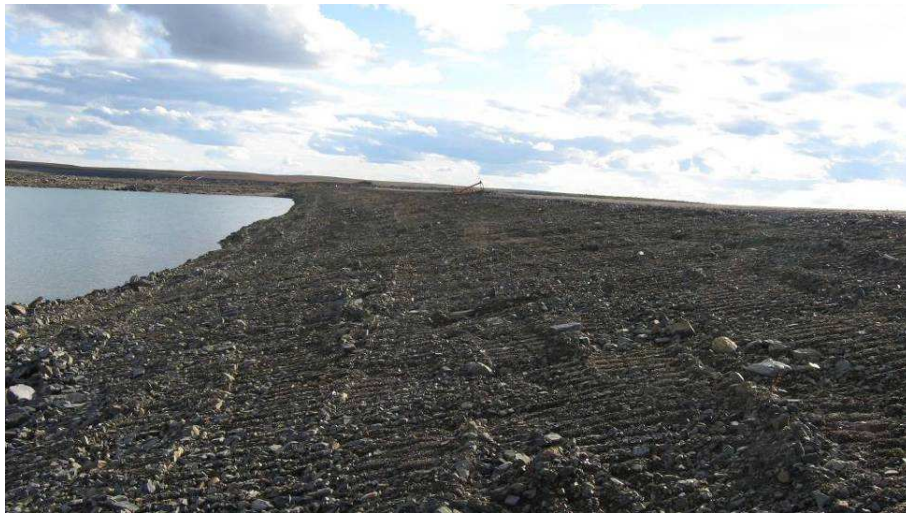
Dam 2: Upstream Looking Southwest – 2010

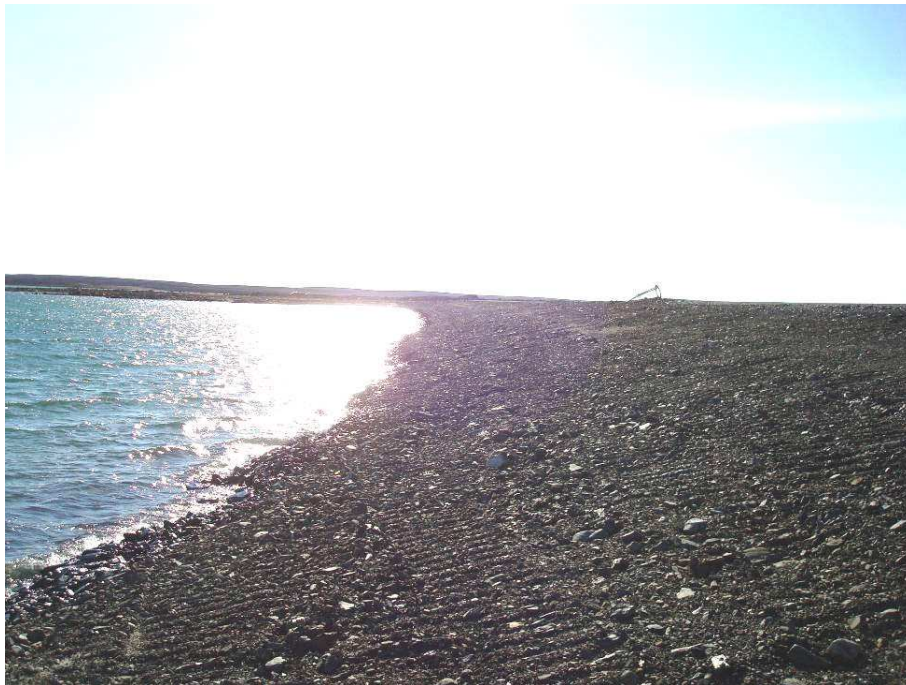
Dam 2: Upstream Looking Southwest – 2011

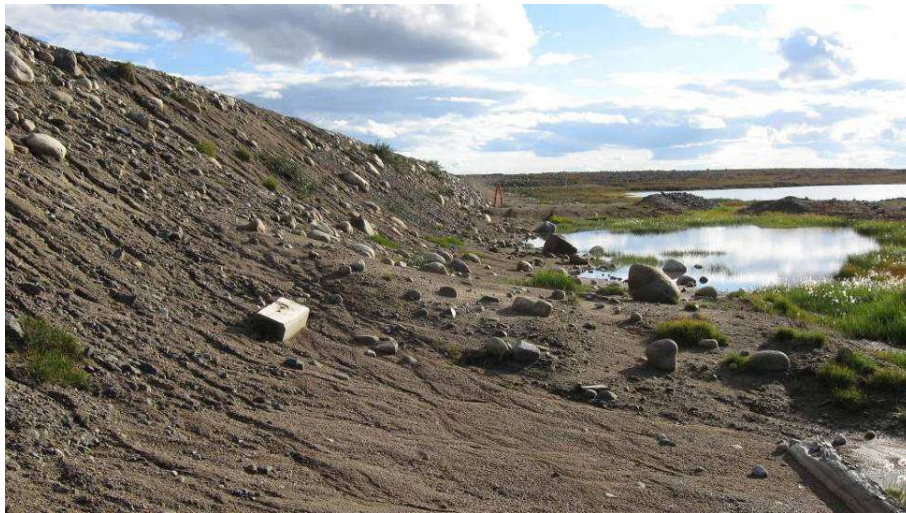
Dam 2: Downstream Slope – 2010

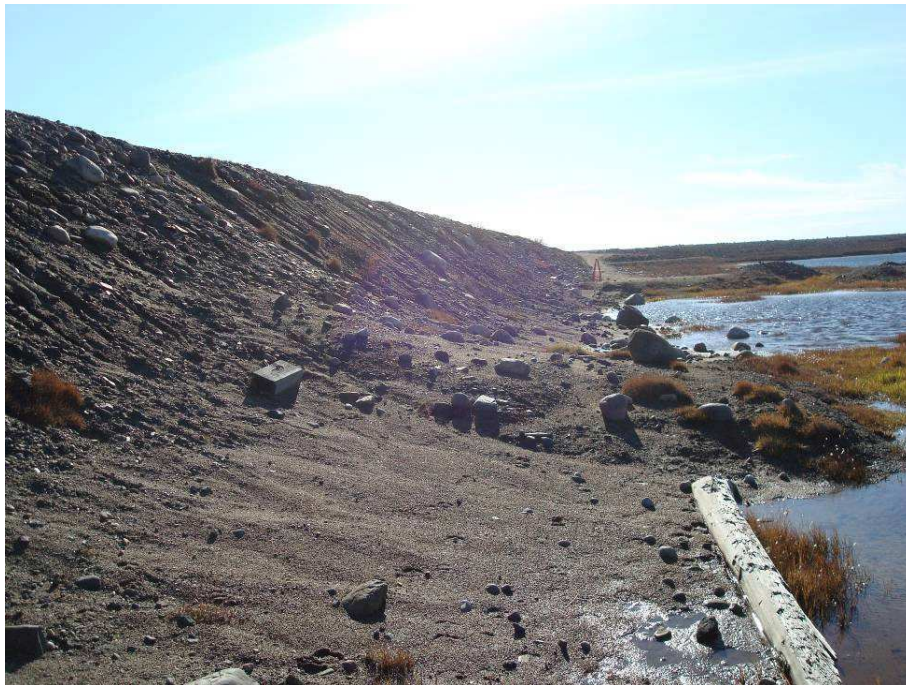
Dam 2: Downstream Slope – 2011

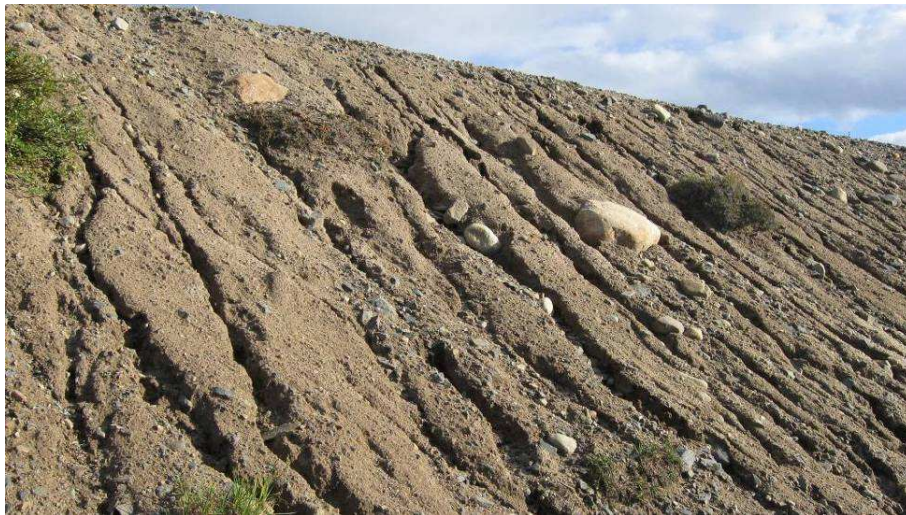
Dam 2: Downstream Slope Erosion Gullies and Rills – 2010

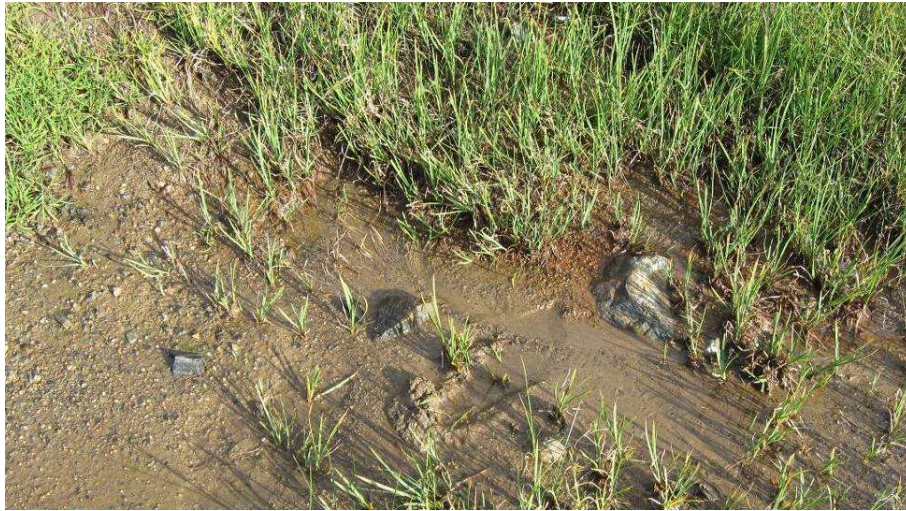
One small area of light seepage was noted along the downstream toe. This is at the same location as observed last year. The seepage rate was estimated at 4 litres/min (approximately twice as much as last year). The current freeboard has been estimated at 3.4 m (the pond level is about 0.4 m higher than last year). The increased pond level may have resulted in the observed increased seepage rate. It should also be noted that the depth to the frozen core as measured at the nearby thermistor station (Thermistor D2-002 n) is approximately 3 m. The depth to the frozen core (as measured in the fall of each year) was also noted to be low in 2006 and 2010 which likely corresponds to the warmer average annual temperatures for these years. It is possible that the depth to the frozen core locally drops to below the pond level in the area of the noted seepage. At the time of this inspection, the seepage water was free of sediment and piping conditions were not evident. It is possible the seepage conditions may become worse over time and with an increase in level of Pond 2. It is possible that some of the water ponding on the downstream side of the dam originates from seepage through the dam and/or under the dam, through the foundation soils. A sample of the seepage was collected (by representative of Elgin Mining Inc.) to assess if the source of the seepage can be correlated to Pond 2. In reviewing the 2007 annual inspection report, it appears that natural ground downstream of the toe area was usually wet prior to 2007, but was dry in 2007.

**MAINTENANCE
RECOMMENDATIONS:** Maintenance of erosion is recommended. At the area of seepage observed along the downstream toe, it appears that the seepage rate has increased from last year. This may be a result of a higher pond level. Currently, the seepage rate does not appear to be causing internal erosion. The seepage may be a result of thawing conditions near the northeast abutment. A sample of the seepage was collected by the client to possibly determine if seepage is from Pond 2. The results of this testing were not provided at the time of this report. This area should be monitored to identify if seepage stops during colder months, or for signs of erosion. As seepage has been observed over the last two years and it appears to be increasing, additional investigation, analyses and/or remedial measures should be considered.

Dam 2: Downstream Toe (approx. 20 m South of D2-00-02) Clear Seepage at a Rate of Approx. 2 litres/min. – 2010

As recommended last year, the geotechnical conditions at Dam 2 should be investigated to determine the in-situ fill conditions and to measure pore water levels in the dam. In addition, installation of an additional thermistor string may be considered at the seepage location to review the depth of frozen ground. Once conditions at the site are determined, remediation of the downstream slope should be undertaken. Remediation options may involve construction of suitable granular filter zones and/or construction of a suitable impermeable barrier to significantly reduce seepage losses. Widening and/or thickening of the dam to attract the aggradation of permafrost conditions into the deep foundation of the dam may also be considered as a design alternative.

It is understood that investigation, design and approvals will be undertaken in 2012 with the work scheduled for 2013. In the interim, the water ponded downstream of the dam should be sampled to ensure environmental compliance and may require containment and pump back over the dam. The water level in Pond 2, should be lowered as much as possible to reduce seepage gradients until such time as the seepage conditions are understood and/or corrective measures

can be implemented. The seepage conditions at Dam 2 should be monitored and the mine should be prepared to implement immediate temporary repair to the dam should conditions deteriorate.

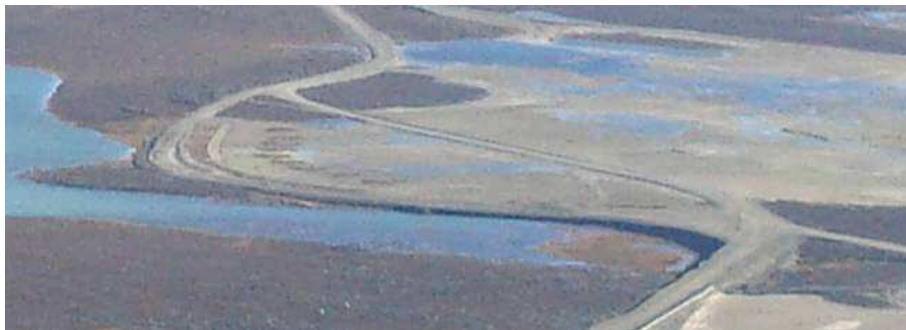
Dam 3: Overview – 2011

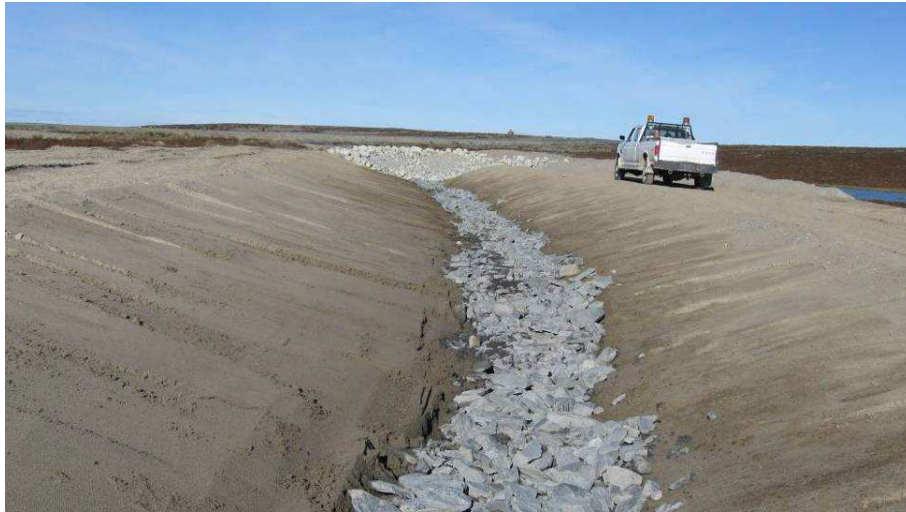
Dam 3: Upstream slope looking northwest at area of last year's ditch regrading leading to reconstructed spillway. Ditch invert lined with riprap (no geotextile observed). – 2010

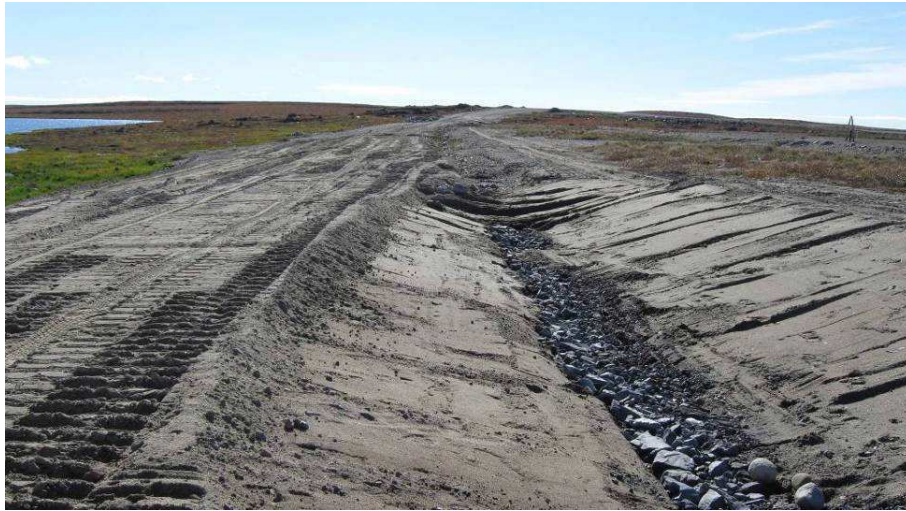
DAM 3: Upstream crest looking southeast. Loose fill on crest. End of ditch regrading. Ditching upstream of ditch regrading treatment contains some sediment. – 2010

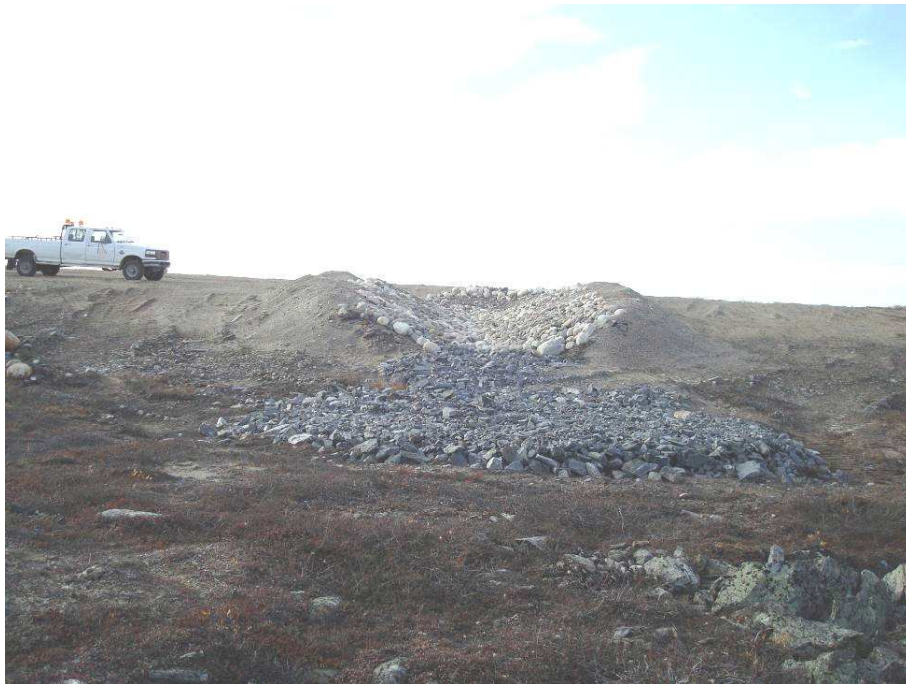
Dam 3: Downstream side of spillway (splash pad) – 2011

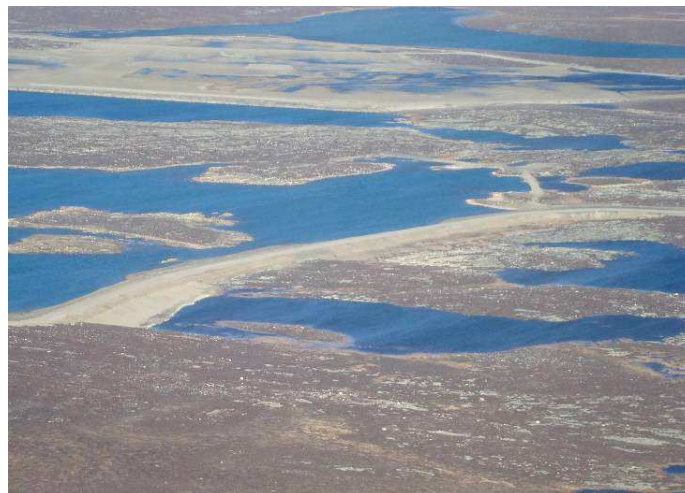
Dam 4: Overview – 2011

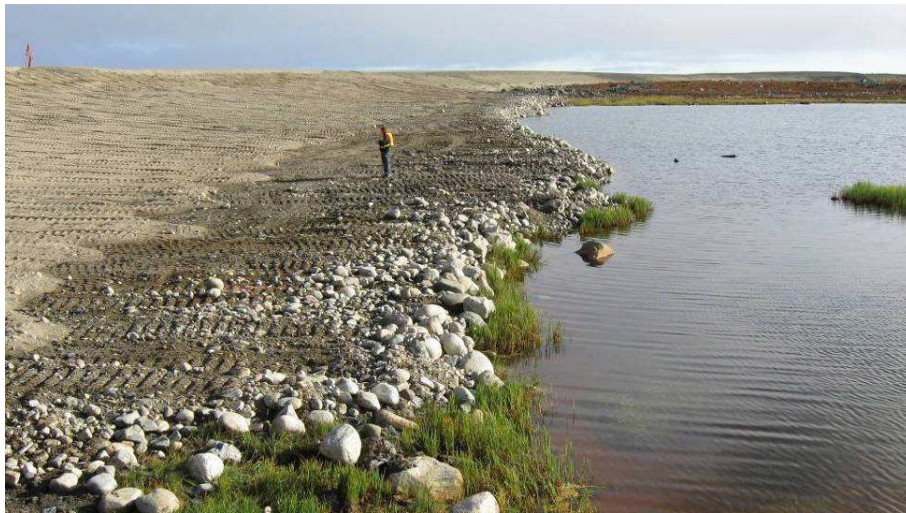
Dam 4: Downstream slope in area of old coffer dam (cobble stone). – 2010

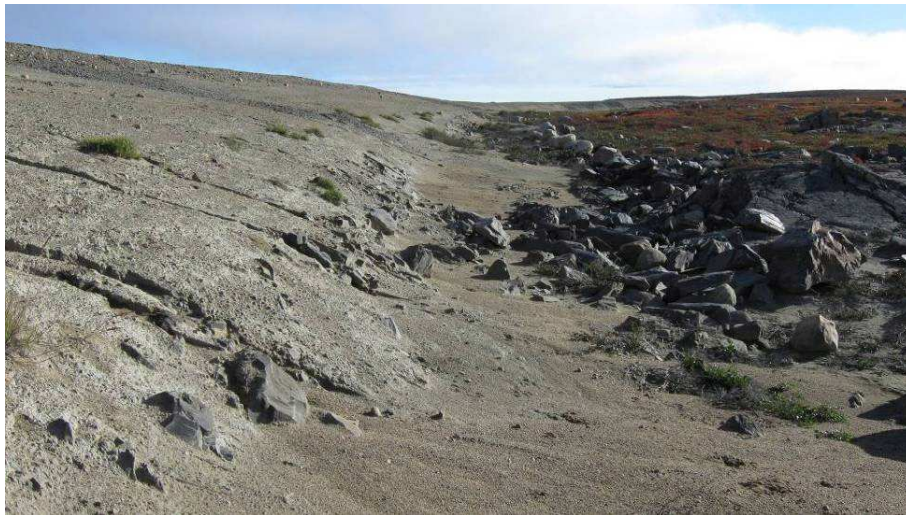
Dam 4: Downstream slope, east of cofferdam. Extensive erosion gullies (exposed geogrid). – 2010

Dam appears to be in a stable condition. Maintenance of extensive downstream erosion should be carried out to prevent further deterioration of the dam.

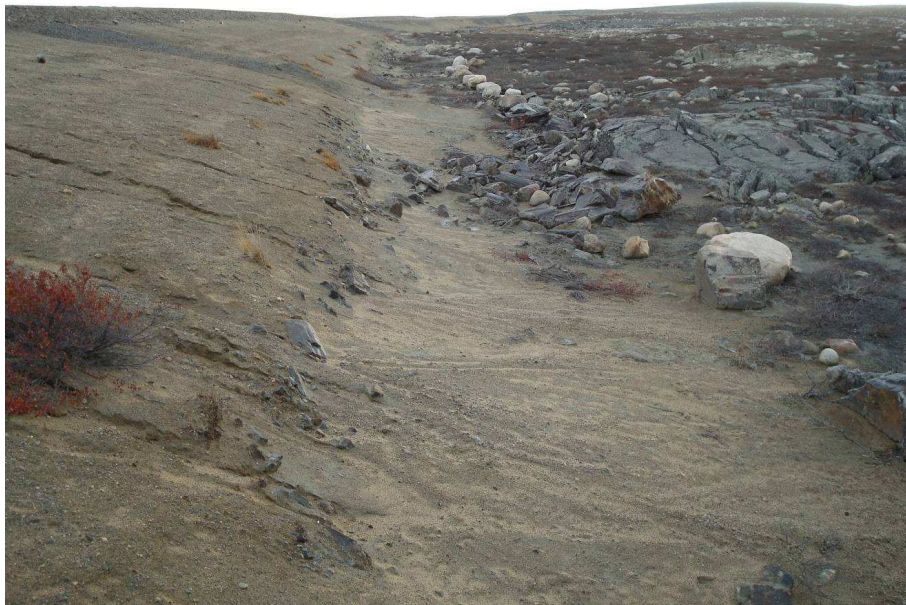
Dam 4: Downstream slope, east of cofferdam. Extensive erosion gullies (now partially in-filled). – 2011

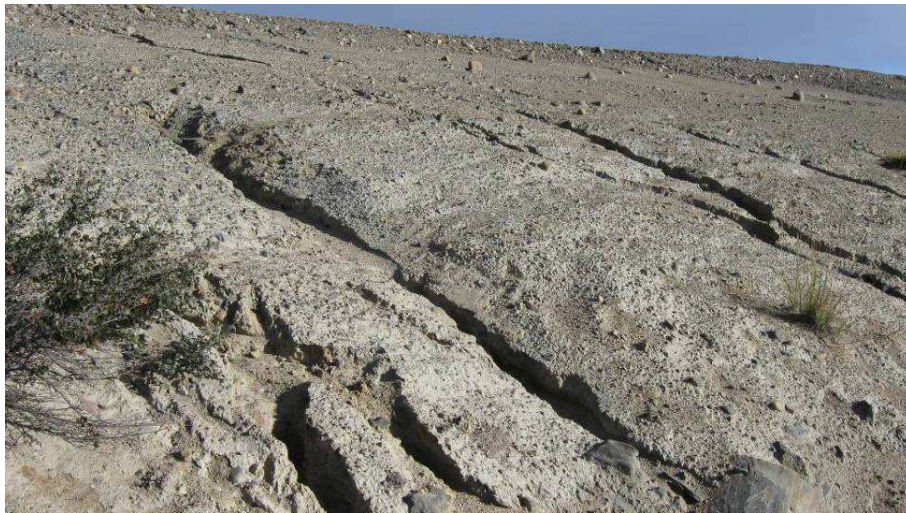
Dam 4: Downstream slope, east of cofferdam. Extensive erosion gullies – 2010

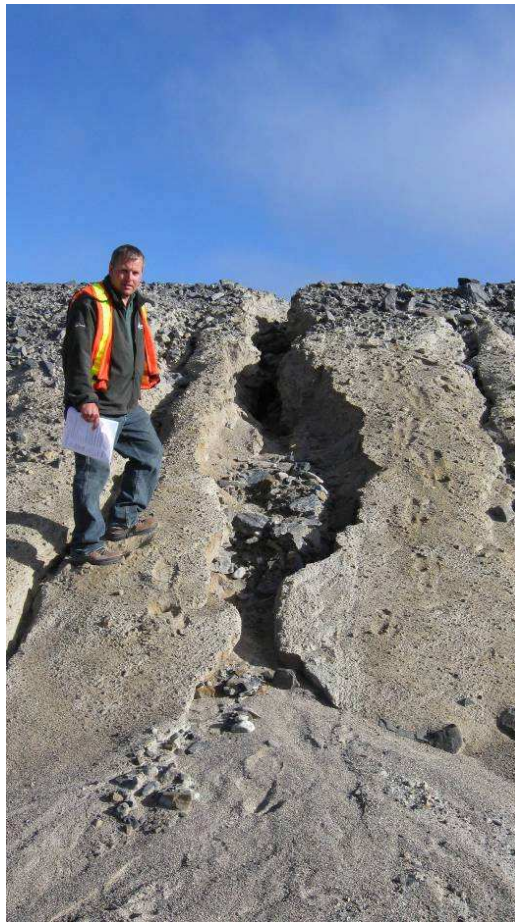
Dam 4: Downstream slope, east of cofferdam. Extensive erosion gullies - 2010

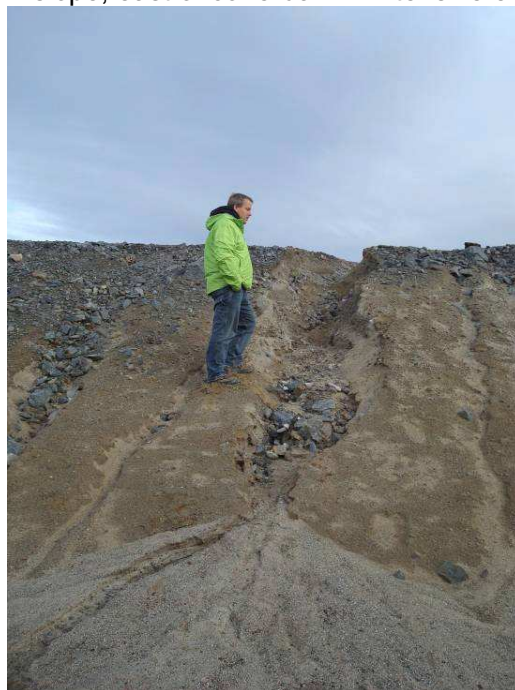
Dam 4: Downstream slope, east of cofferdam. Extensive erosion gullies - 2011

1 m deep) have not been properly maintained along the eastern 2/3 of the dam. These were noted last year and should be repaired.

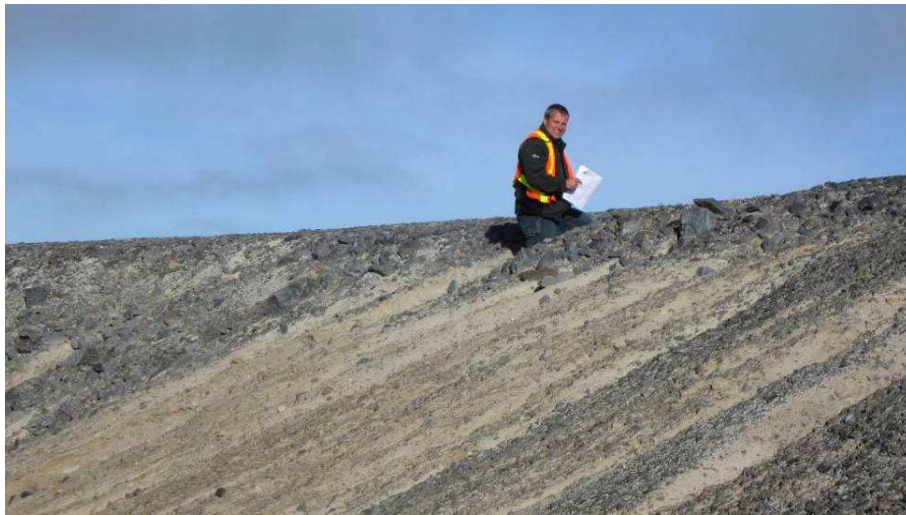
Dam 4: Downstream slope, east of cofferdam. Extensive erosion gullies – 2010
