2011 Annual Geotechnical Inspection
Perimeter Dams
Tailings Containment Area
Lupin Mine, Nunavut

Prepared By:
TBT Engineering Consulting Group

November 22, 2011
TBTE Ref. No. 11-293

**Re: 2011 Annual Geotechnical Inspection (Revision 1)
Perimeter Dams Tailings Containment Area
Lupin Mine, Nunavut**

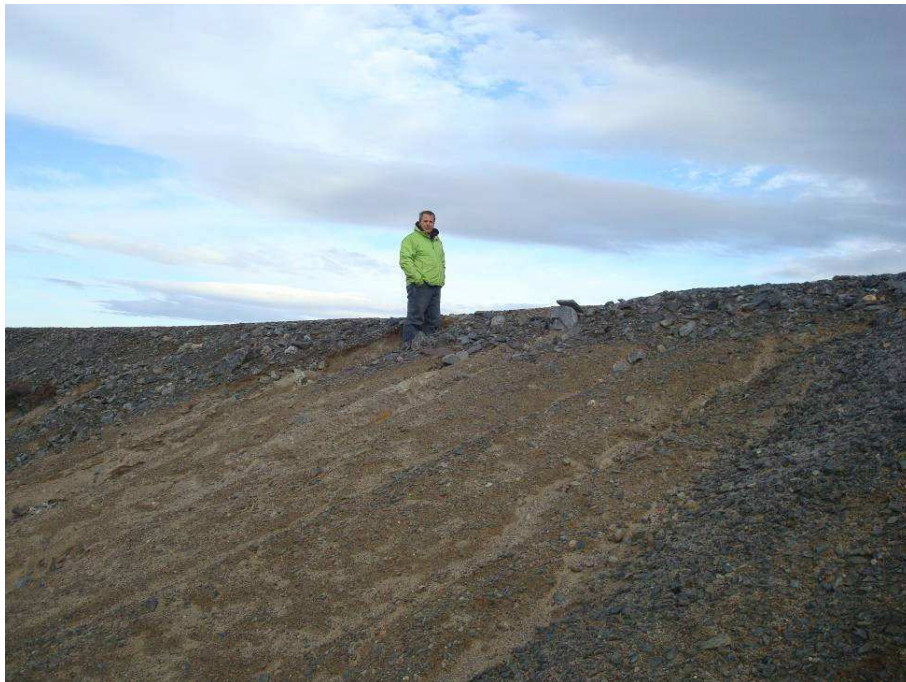
Dam 4: Downstream slope, east of cofferdam. Extensive erosion gullies – 2011

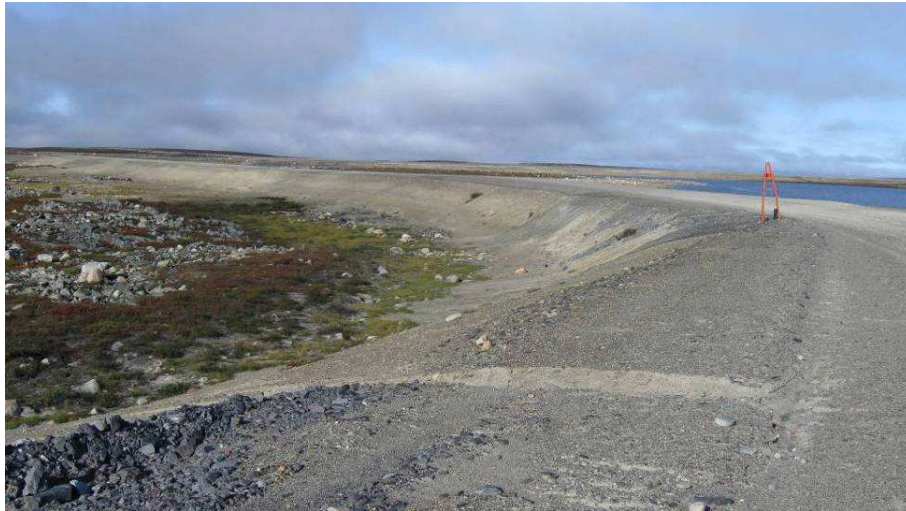
Dam 4: Downstream slope, east of cofferdam (looking west). Extensive erosion gullies – 2010

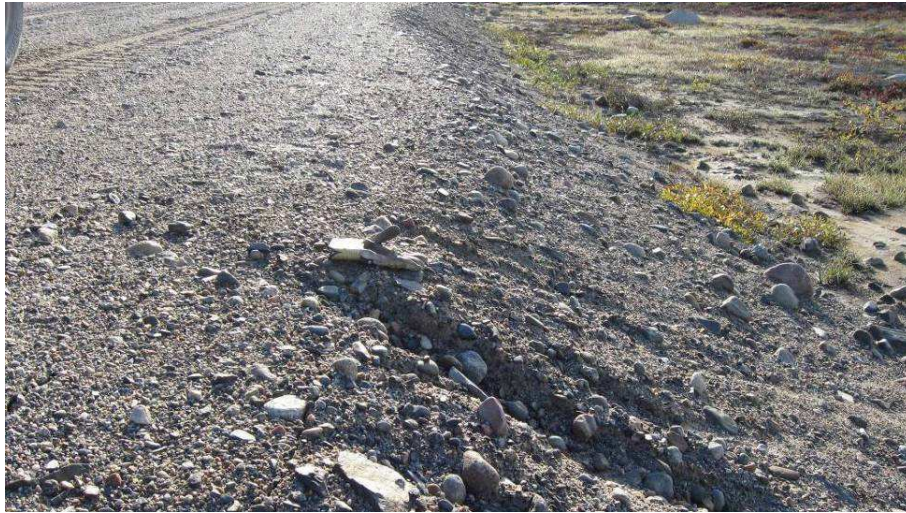
Dam 5: Downstream. Erosion gullies. – 2010

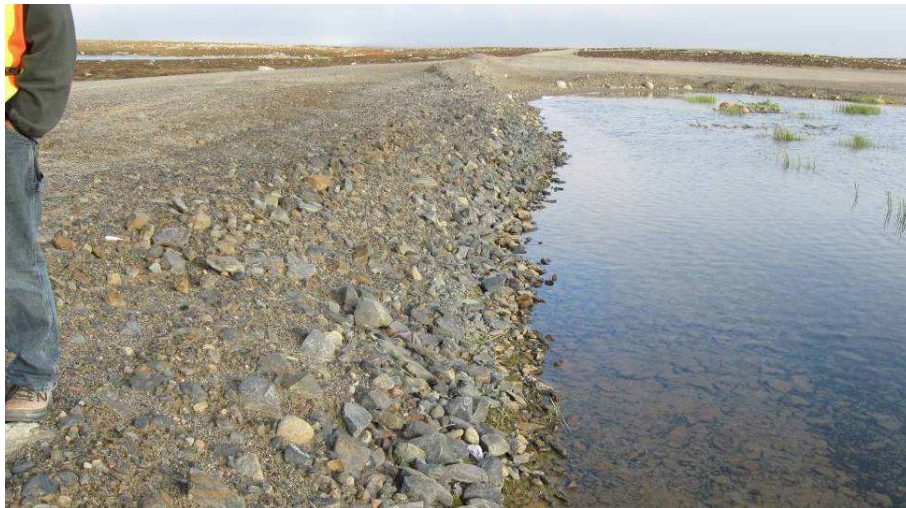
Dam 6: Upstream. Riprap in area of small pond. – 2010

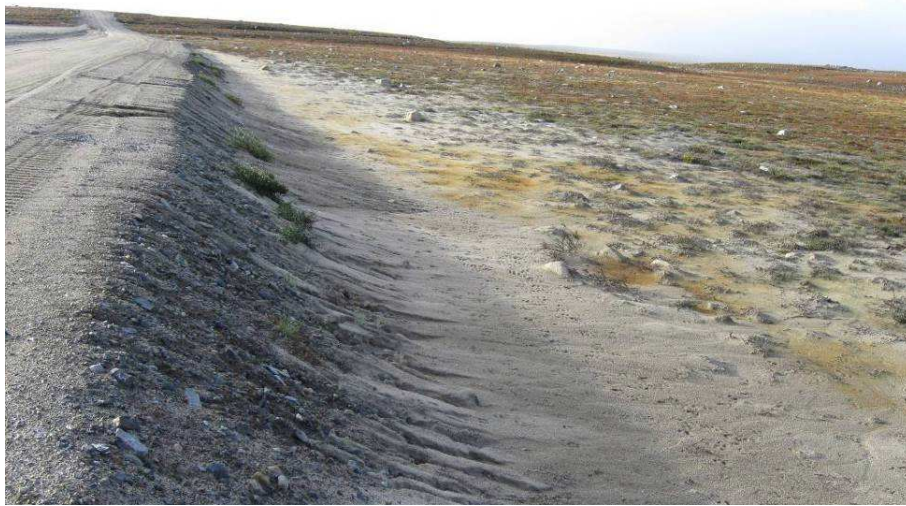
Dam 6: Downstream. Erosion gullies. – 2010

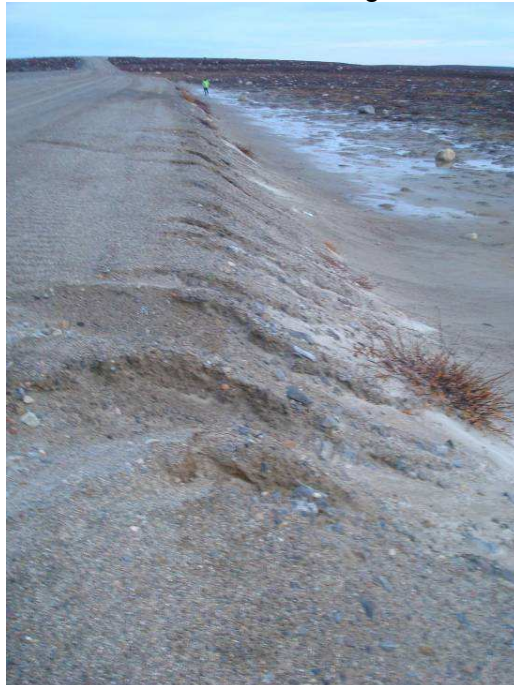
Dam 6: Down stream erosion gullies – 2011

CONCLUSIONS:	The dam appears to be in a stable condition. Maintenance of downstream erosion is recommended. Additional investigation (including review of design) should be considered to assess potential for seepage losses and/or potential for instability of downstream slope.
