2016 Lupin Mine Tailings Containment Area Geotechnical Inspection

Submitted to:
Lupin Mines Incorporated

Project Number: 924-1

Date:
October 31, 2016

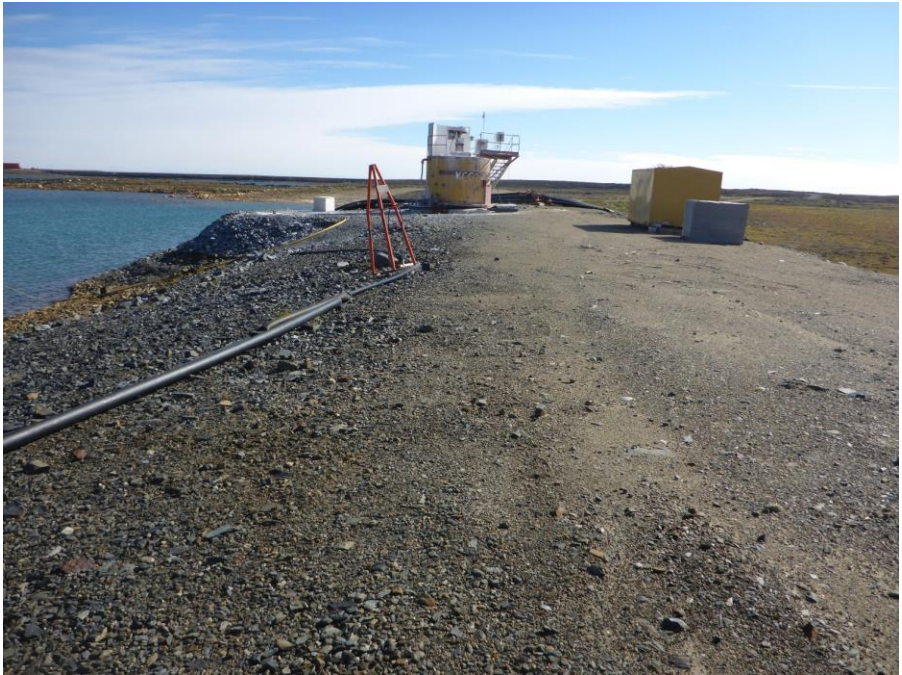
Photo 2: Looking east along the crest. Note the water treatment equipment and work pad extending over the upstream slope

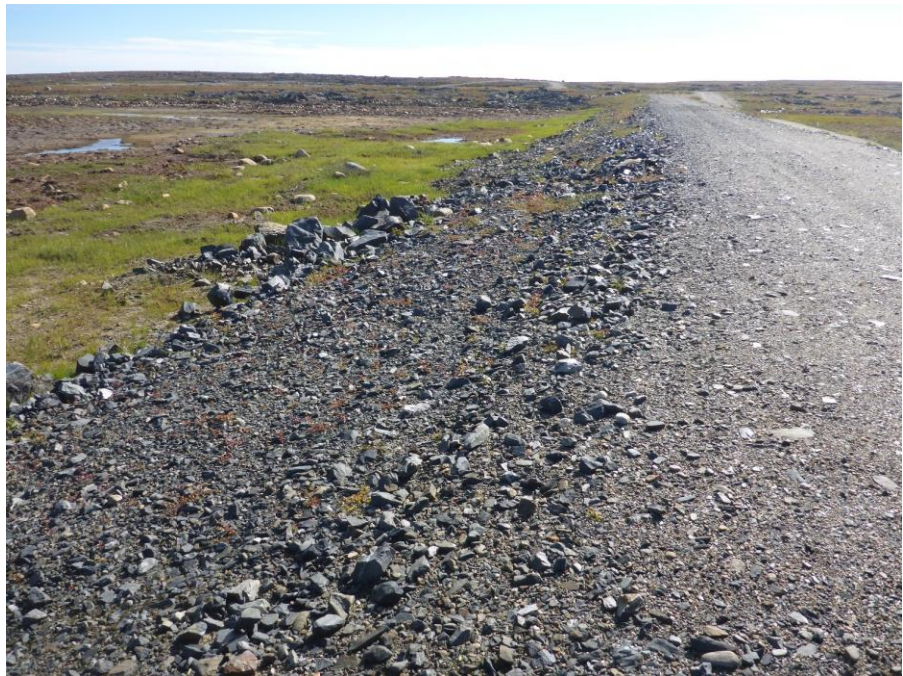
Photo 6: Looking south along the upstream slope. Note there is no adjacent water.

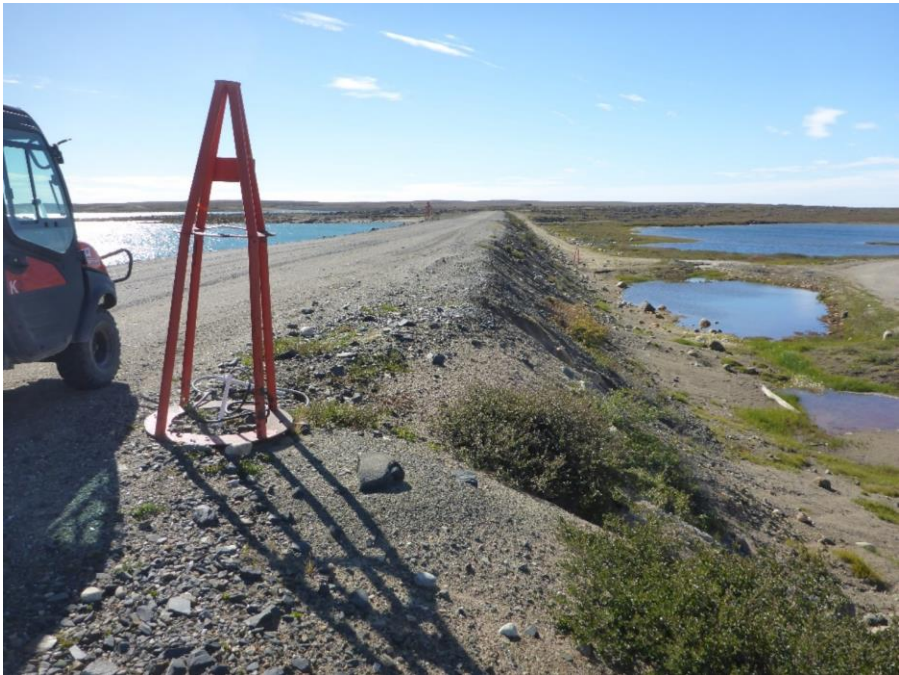
Photo 15: Looking south along the downstream slope at the thermistor D2-00-2n.

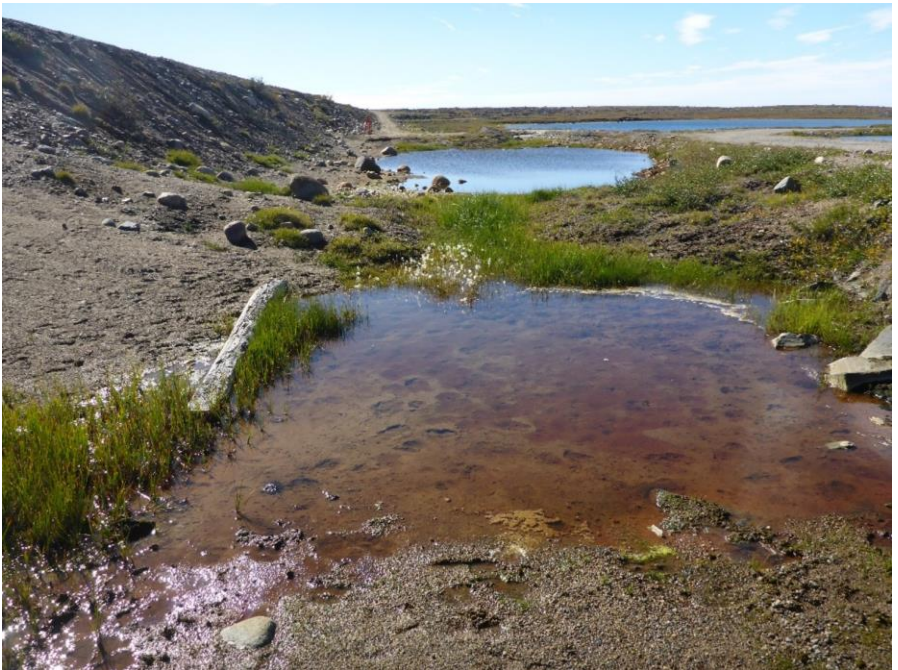
Previous annual inspections found seepage from the northern toe buttress of Dam 2 into the seepage collection pond adjacent to Dam 2 Lake. This seepage was observed in 2016 at less than 0.5L/min, similar to the flowrates observed since 2012 (Photo 16). The seepage was collected and periodically pumped back into Pond 2. Historically, seepage was observed in the western buttress of Dam 4 into Ferguson Lake back dating back to 2011. This seepage was not observed in 2016 and was not found in the previous four years.

Photo 16: Looking south at the seepage collection pond at northern buttress.

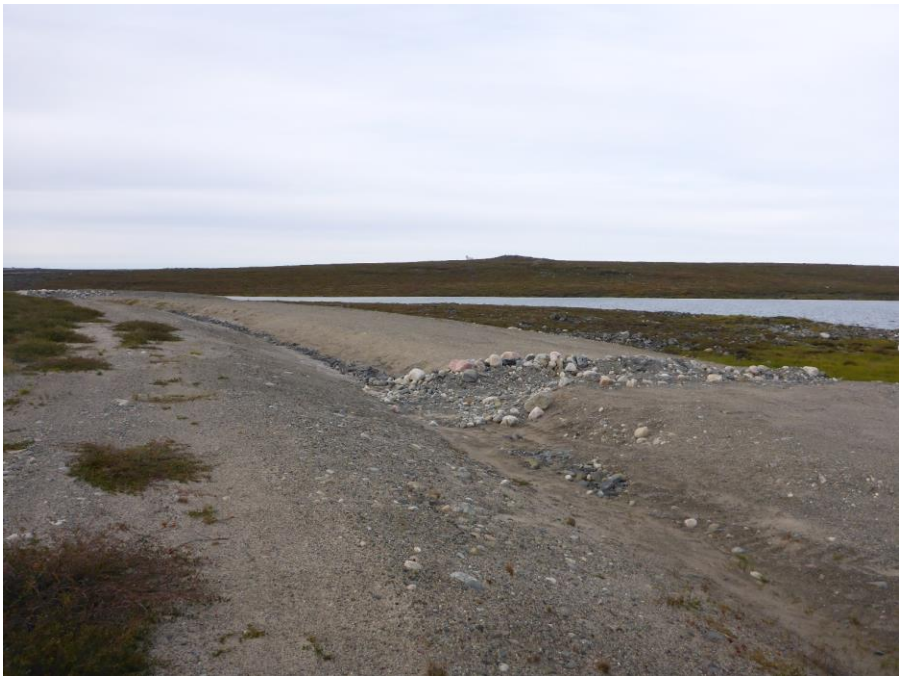
The 2015 annual inspection noted work was done to repair an erosion gully over the crest of Dam 3 (Photo 20 to 23). The repair work was done by converting the erosion gully into an armored channel to facilitate the drainage in that area. Previously this area was vulnerable to erosion due to the poor grading in the storm drain along the upstream crest of Dam 3. The 2015 repair allows the flow to bypass the problematic section of the storm drain and prevent erosion damage to Dam 3. No new erosion damage was observed in the 2016 inspection along Dam 3.

Photo 20: Looking west along crest and storm drain.

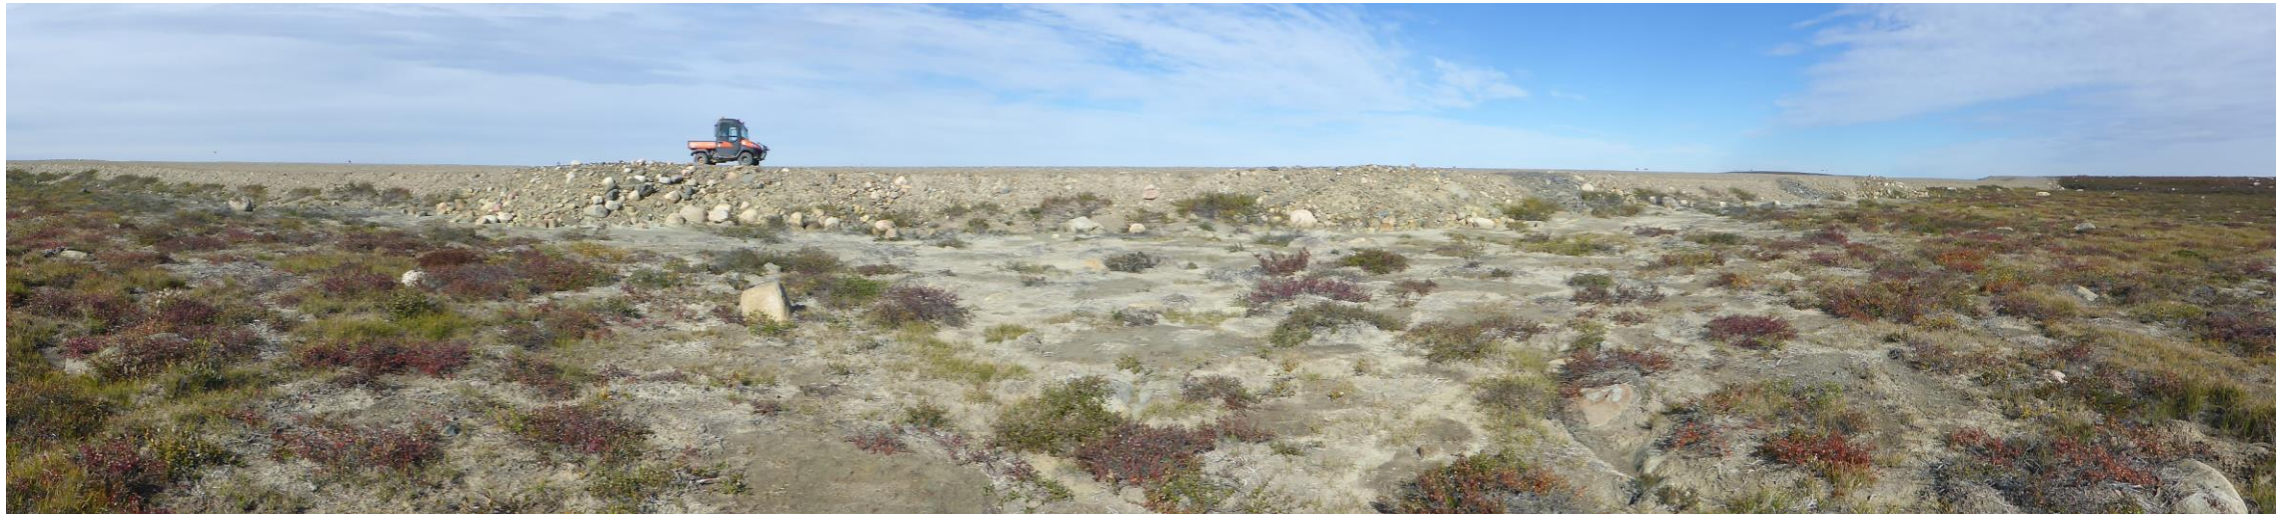
Photo 32: Panoramic view of the downstream slope.

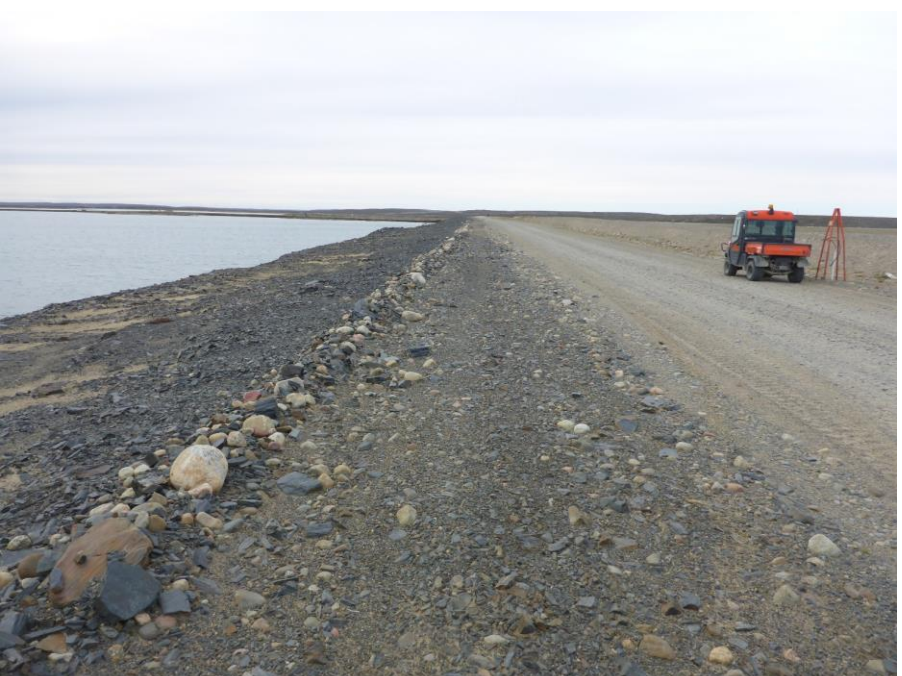
Photo 40: Looking east at the crest from thermistor D3D-1, with the Cell 1 cover to the right and mine rock buttress to the left.

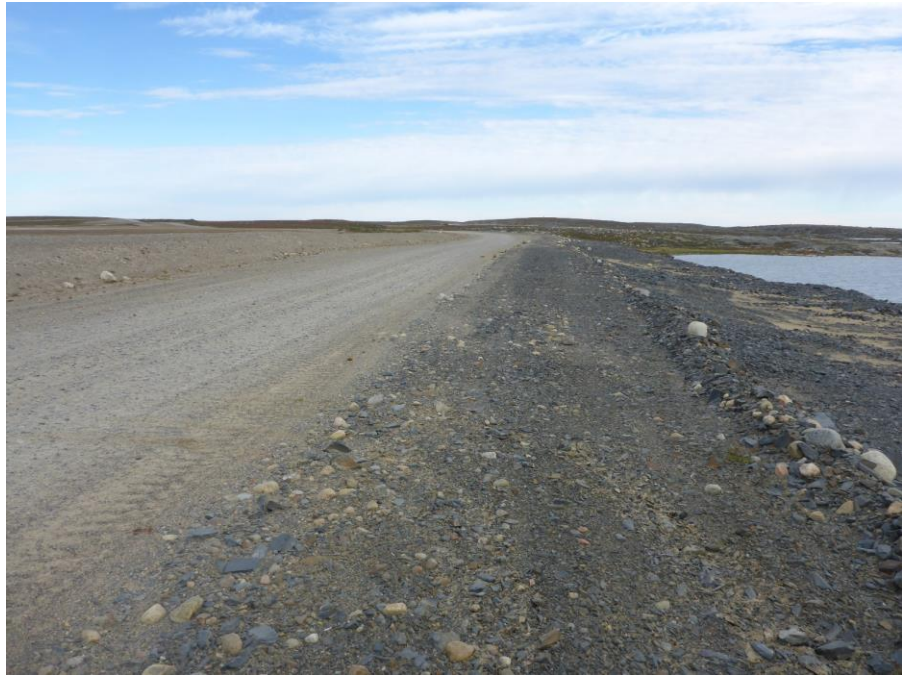
Photo 41: Looking east at the crest from the thermistor D3D-1, with the Cell 1 cover to the left and mine rock buttress to the right.

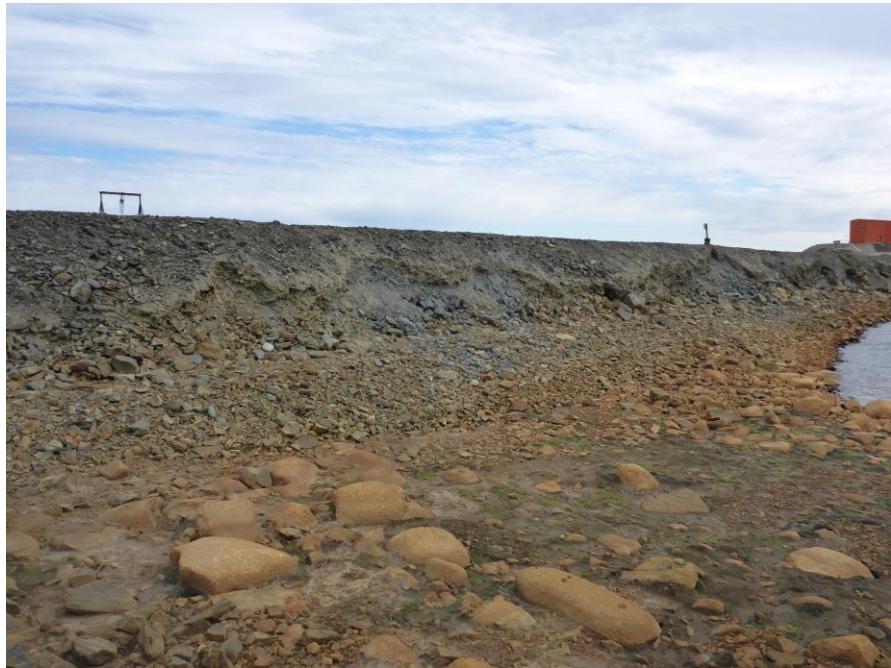
All of the internal dams have some erosion on their slopes, associated with the sand and gravel construction material from either surface runoff or wave action at the HWM. Dam 3D also has some crest erosions from the surface runoff. Dam J (Photo 46 and 47) and Dam L (Photo 54) both have wave action erosion at the HWM that has reduced their crest widths. Maintenance should be considered to repair the erosion on the slope of Dam 3D, Dam J and Dam L.

Photo 46: Looking south at the downstream slope (facing Pond 2). Note the undercut and erosion at the HWM.

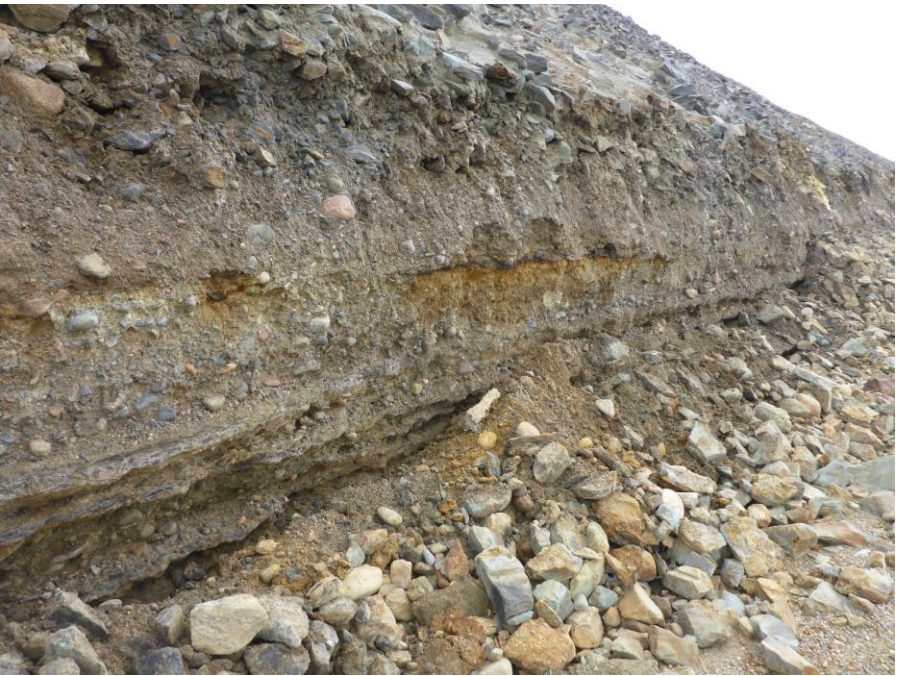
Photo 50: Close up look at the undercut erosion and the near vertical slope.

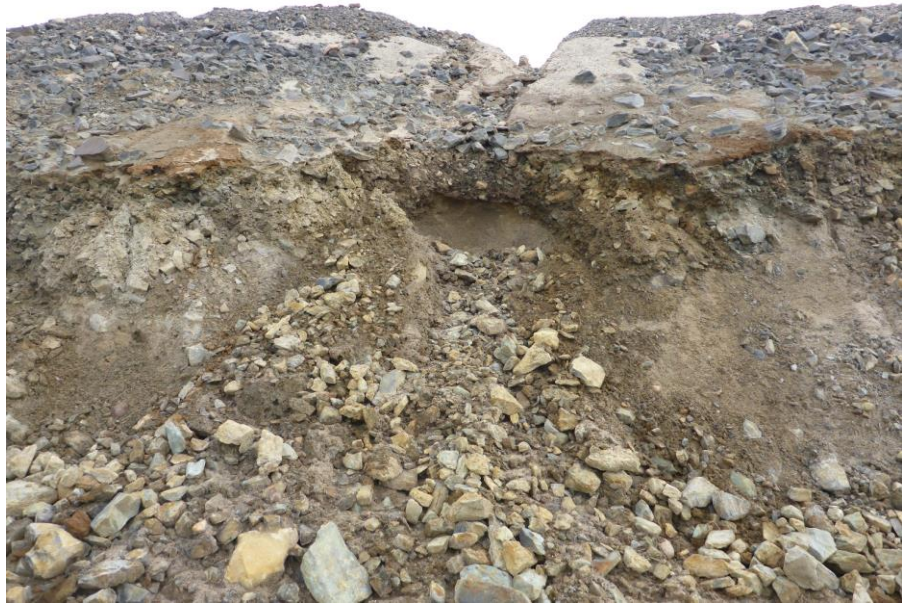
Photo 51: Close up look at an erosion gully over the downstream crest at mid-point of the dam. Note the sloughing at the toe.

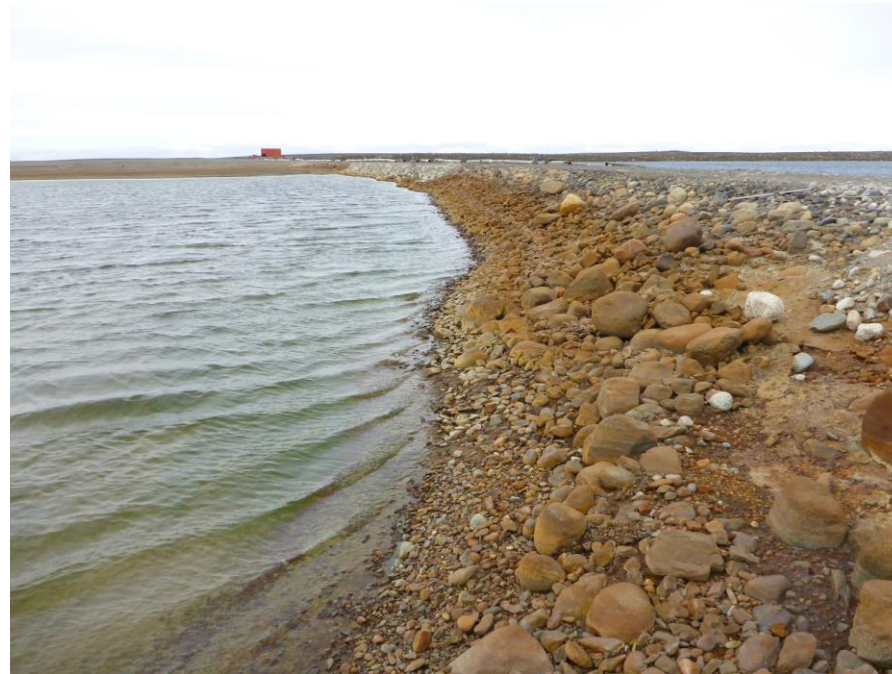
Photo 54: Looking north at the upstream slope (facing Cell 3). Note the erosion at the HWM.

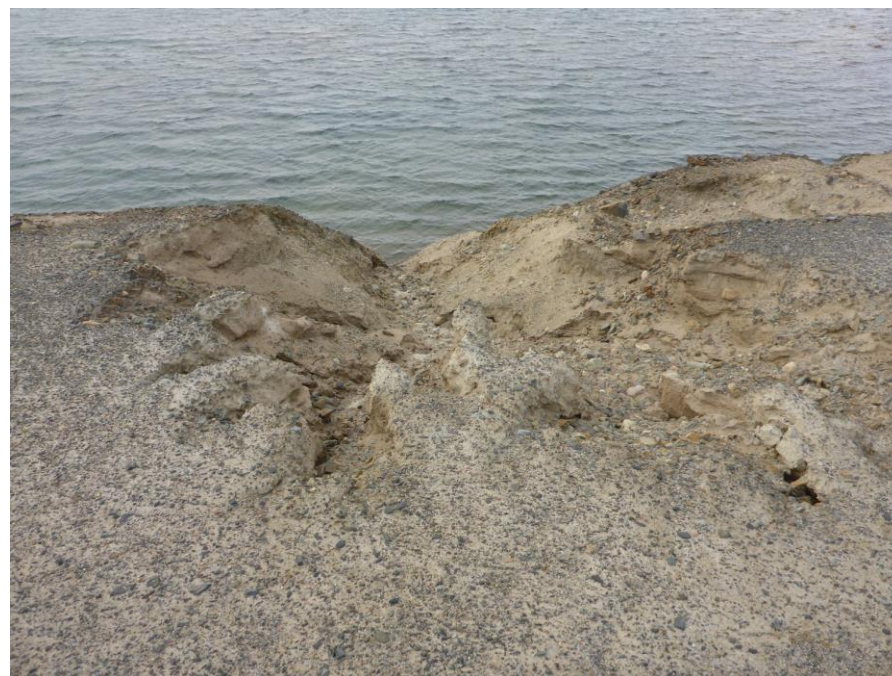
Photo 57: Close up look at an erosion gully over the downstream crest south of the Cell 3 cover boundary.

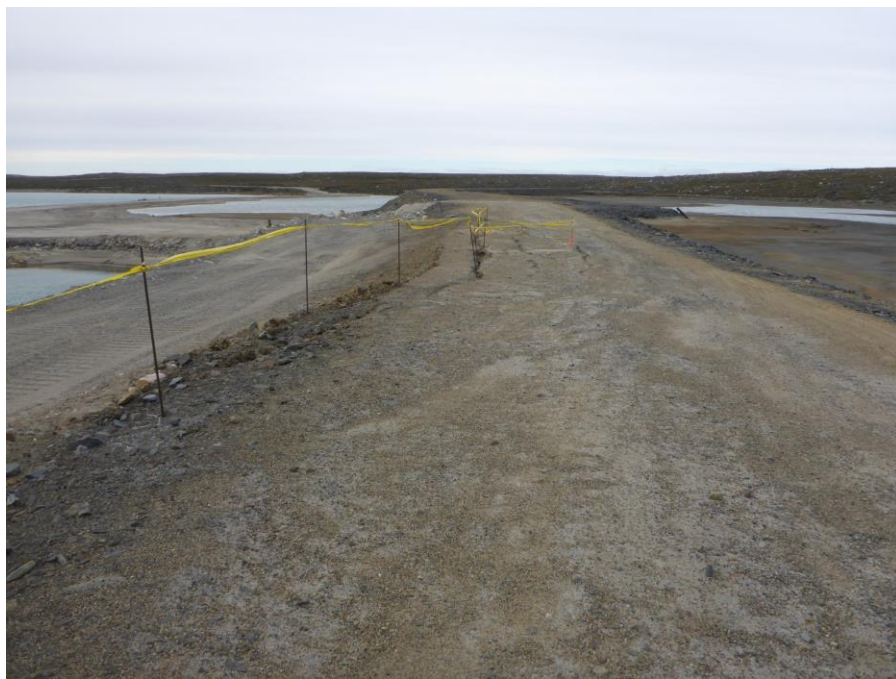
Previous inspections identified significant tension cracks in Dam M along the eastern (abutment to Dam J) and western (abutment to Dam N) sections of the downstream crest facing Pond 2. The cracks have been monitored since they were first observed back in 2012 (Photo 58). Recommendations were provided to mitigate the compromised sections in previous reports (SRK 2016 and SRK 2015). The lowered water level in Pond 2 allowed inspection of the downstream

Photo 58: Looking northwest at the start of the western buttress in front of the downstream cracks at the Dam N abutment.

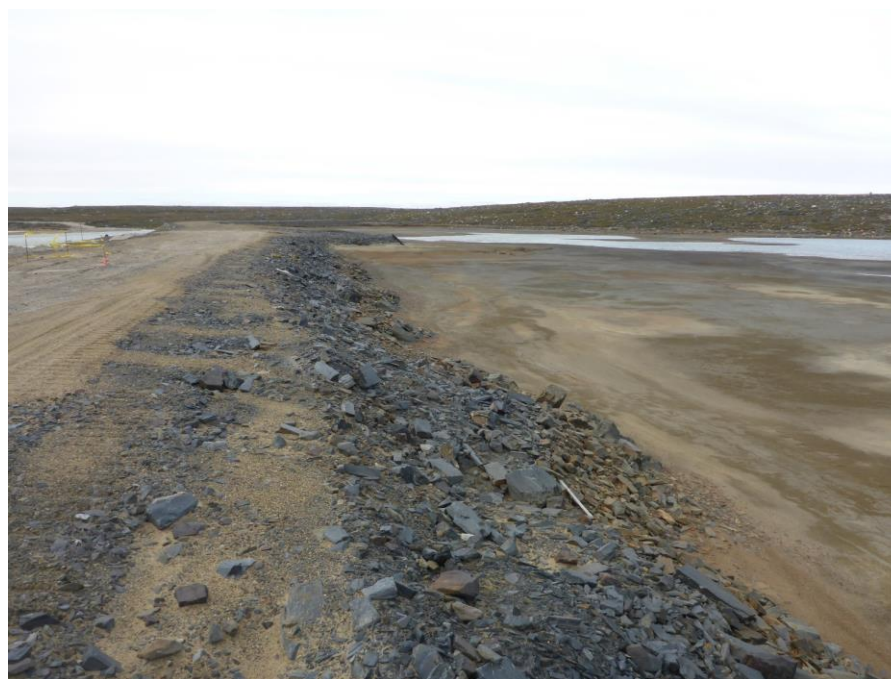
Photo 59: Looking northwest at the upstream slope (facing Cell 5). Note the lowered water level and exposed tailings beach.

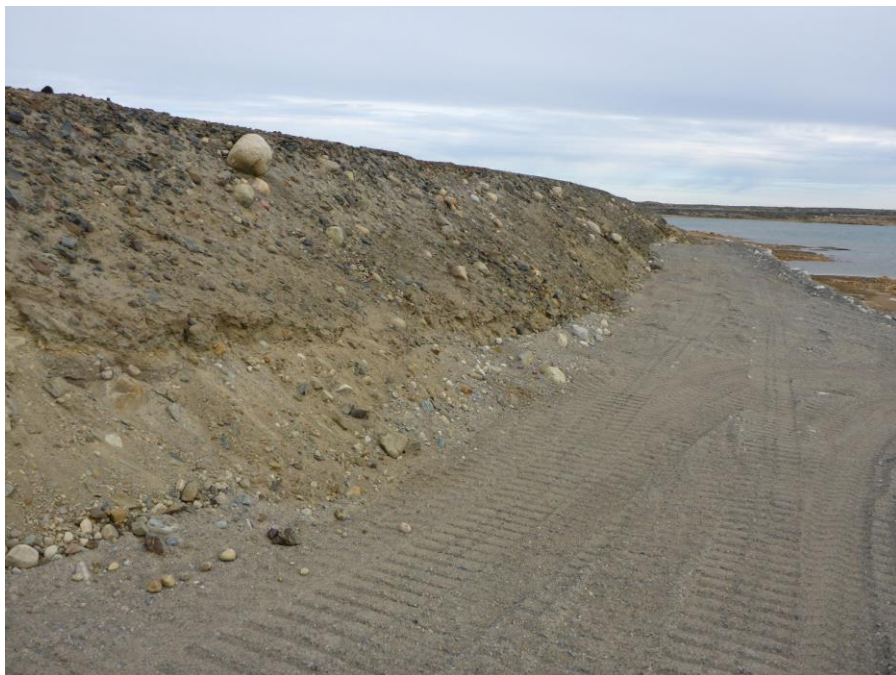
Photo 61: Looking southeast at the downstream slope from the western buttress.

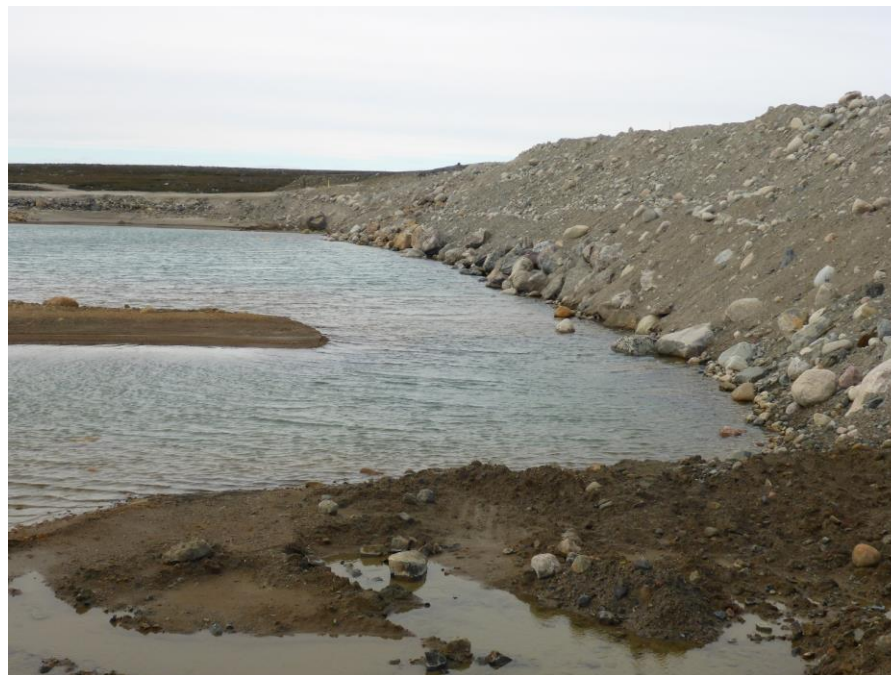
Photo 62: Looking northwest at the western buttress from the toe near the mid-point of the dam.

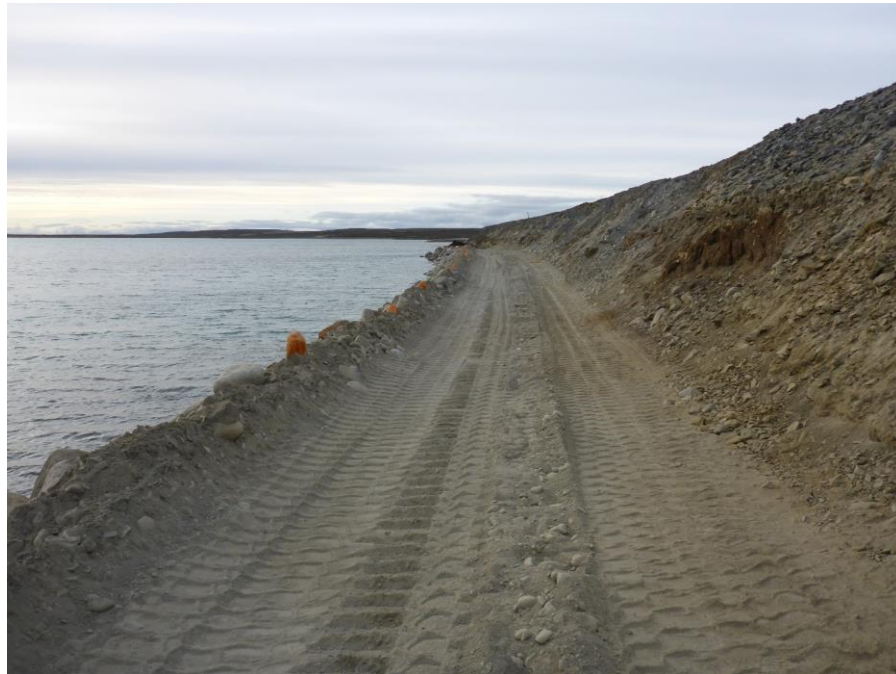
Photo 66: Looking northwest from the start of the eastern buttress on its first lift.

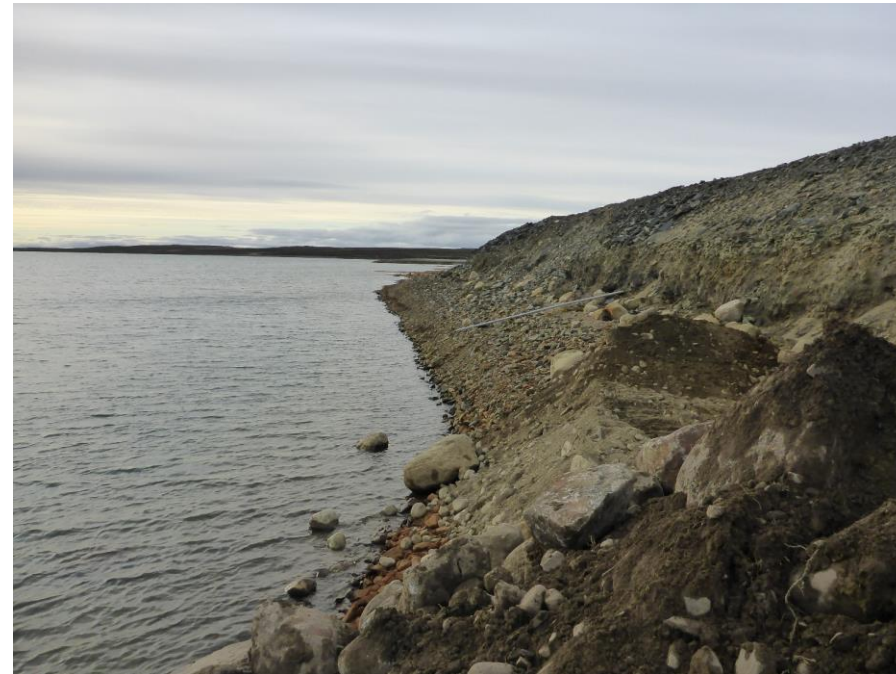
Photo 67: Looking northwest at the undercut erosion at the HWM beyond the eastern buttress.

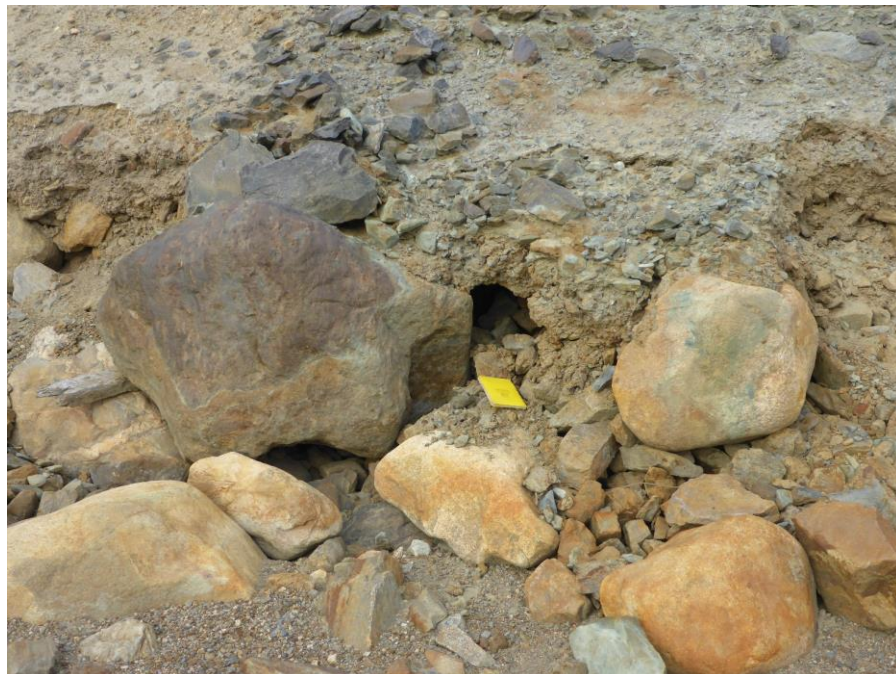
Photo 69: Close up look at the significant undercut.

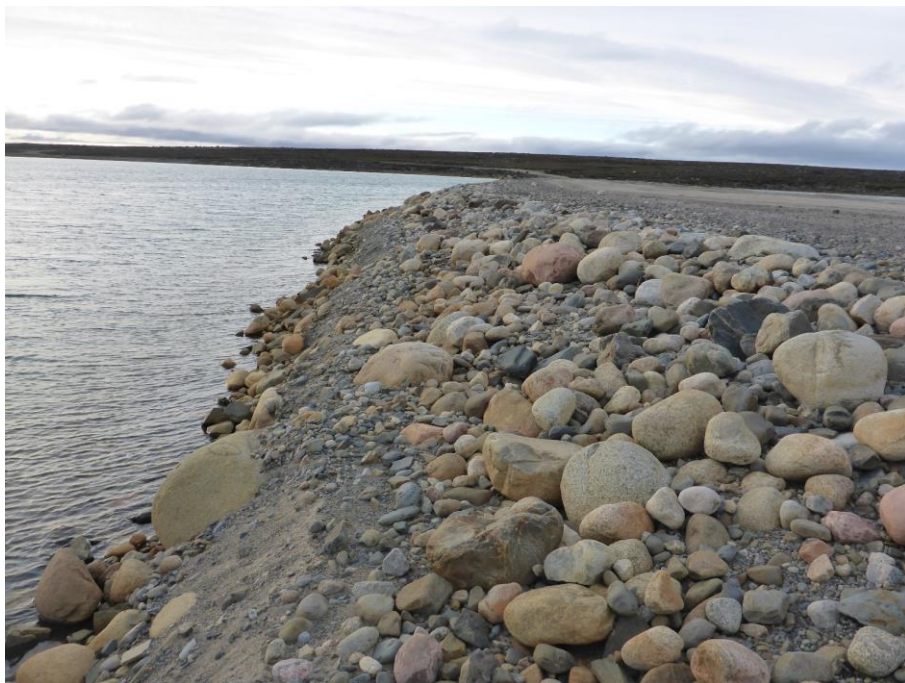
Photo 71 Looking northwest at the downstream slope (facing Pond 2).

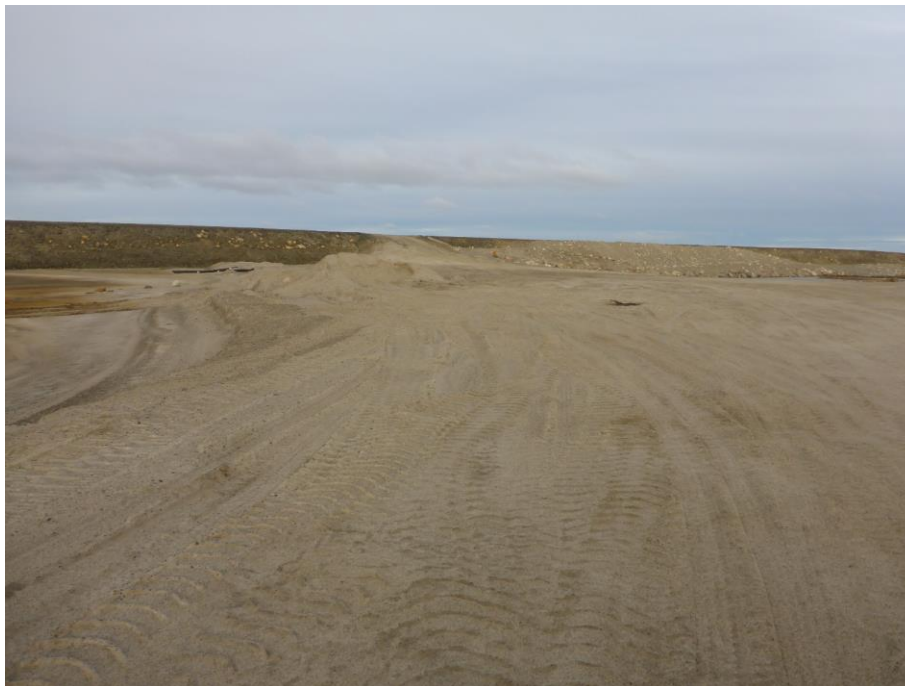
Photo 74: Looking north at the Dam M abutment. Note the Dam M western buttress right of the abutment.

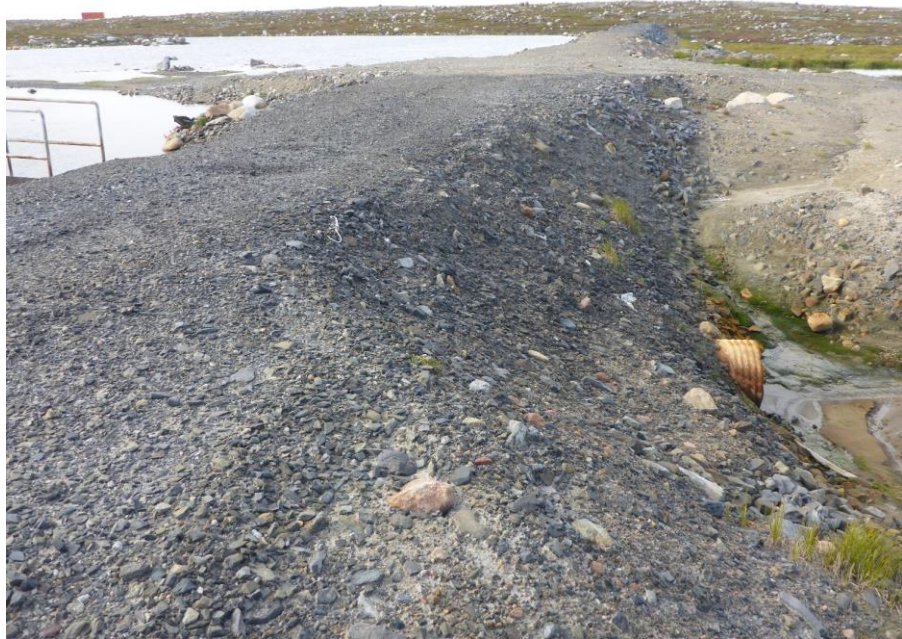
Photo 78: Looking south at the downstream slope of the North Divider Dyke. Note the flow control culvert at the toe of the dyke.
