Report: *2012 Annual Review of Portage and Goose Pit Slope Performance*

2012 Annual Geotechnical Inspection Meadowbank Gold Mine, Nunavut

Agnico-Eagle Mines Limited
Meadowbank Division
PO Box 540
Baker Lake, Nunavut
X0C 0A0

Report Number: Doc 1394 1212210073 0115_13

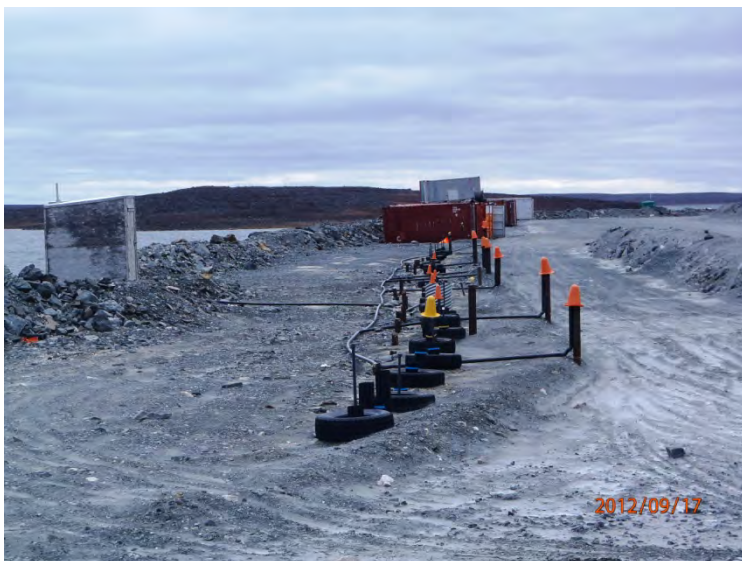
Photograph A1-3 East Dike

Description: Looking south from about Sta. 60+550 at centreline. Note the presence of instrumentation located in the old sinkhole area. The shack (on the left of the picture) contains the system automatically collecting and transmitting the instrumentation data.

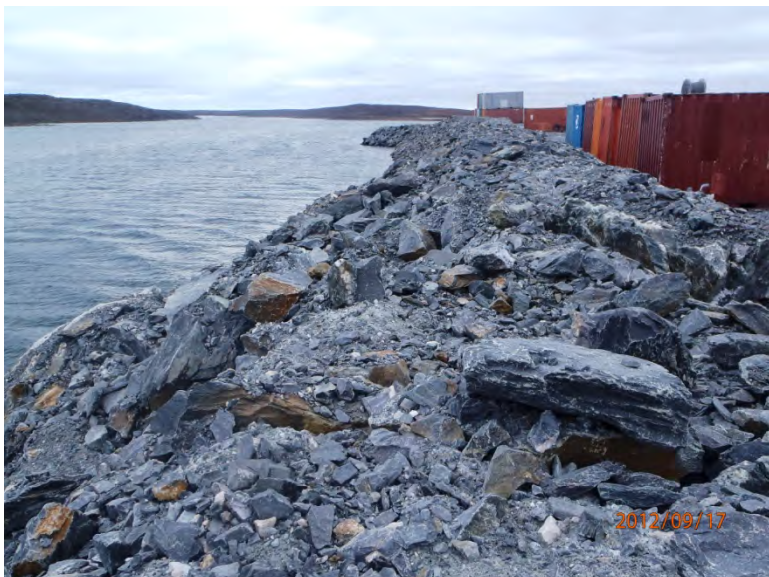
Photograph A1-5 East Dike

Description: From about Sta. 60+400, looking south at upstream slope. Notice the presence of containers on dike crest.

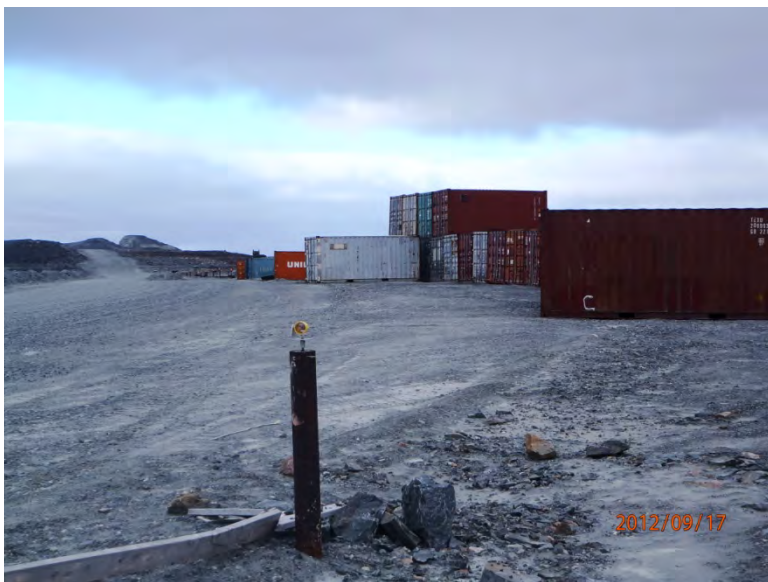
Photograph A1-9 East Dike

Description: From about Sta. 60+200, looking north along centreline. Notice the survey monument and the presence of containers.

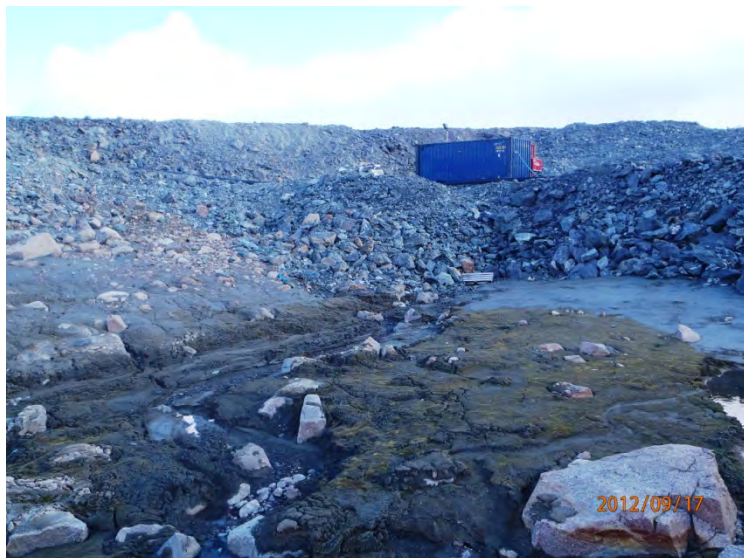
Photograph A1-11 East Dike

Description: Downstream toe water seepage at Sta. 60+247, looking east toward the dike. The pump is in the blue seacan container. No seepage was observed on the surface at this location during the inspection (all water captured in sump).

3.6 Vegetation Growth	None observed		
3.7 Other Unusual Conditions	None		
4. DOWNSTREAM TOE AREA			
4.1 Seepage from Dam	Yes, presence of 3 zones	469, 475	Zone of seepage downstream near Sta. 60+247 where a sump is installed (pumping system located in container on the photo). No additional seepage observed on the surface of the ground. Pumping collection system started on April 4, 2012. Flow is not currently being monitored (a system will be installed).
		476	Zone of seepage downstream near Sta. 60+498 where a sump is installed (pumping system located in container on the photo). Pondered water nearby. No additional seepage observed on the surface of the ground during the inspection. Pumping collection system started on April 4, 2012. Flow is not currently being monitored (a system will be installed).
		483, 486, 487	Seepage observed downstream near Sta. 60+575. Flow measured by the mine every 3 days (mean flow of 2.3 m ³ /days. In 2011 and 2010 small defined seepage was observed in the same area and the flow rate is consistent.

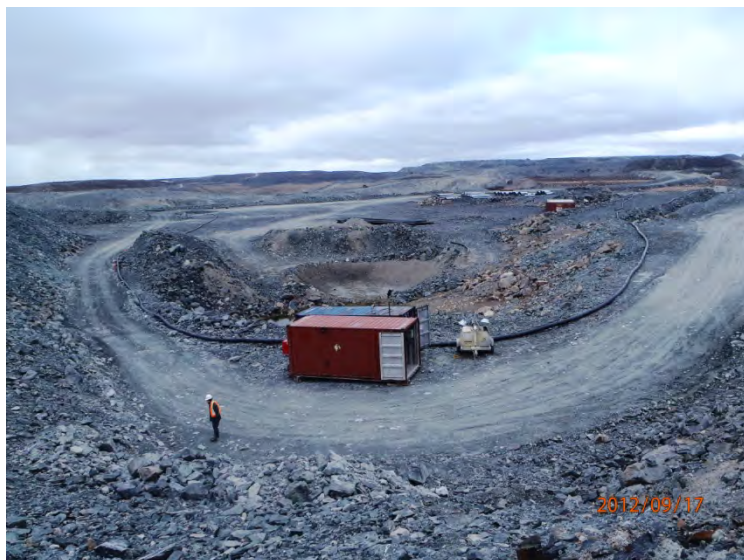
Photograph A1-12 East Dike

Description: Looking west to the downstream toe water seepage at Sta. 60+247 from the crest of the dike. The pump and sump is in the blue seacan container. No seepage was observed on the surface at this location during the inspection (all water captured in sump).

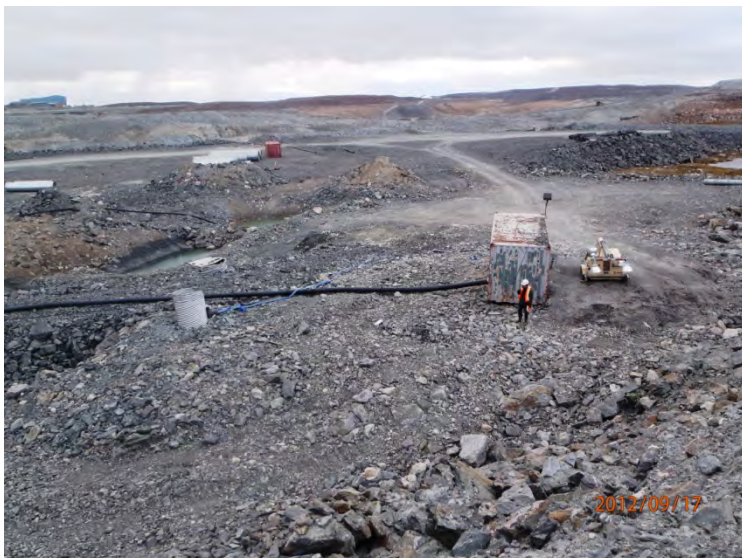
Photograph A1-13 East Dike

Description: Looking west to the downstream toe water seepage at Sta. 60+498 from the crest of the dike. The sump and pump is in the seacan container. No seepage was observed on the surface at this location during the inspection (all water captured in sump). Notice the ponded water (on the left).

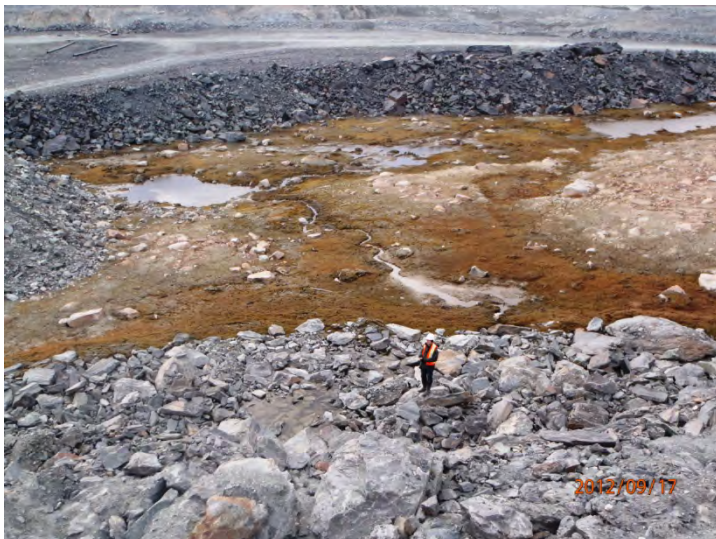
Photograph A1-15 East Dike

Description: Looking west to the downstream toe water seepage and ponding at Sta. 60+575 from the dike crest.

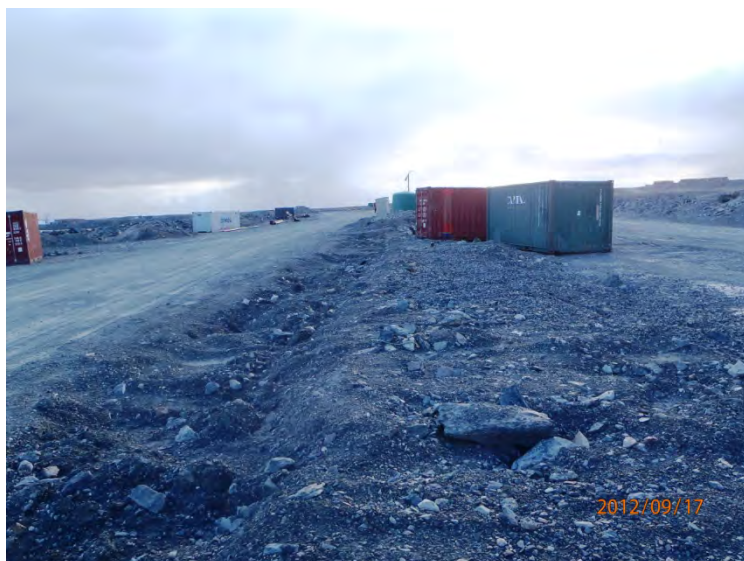
Photograph A3-1 Bay Goose Dike

Description: From Sta.30+197 (north channel), looking southwest along crest centreline. Note seacan container present near centreline.

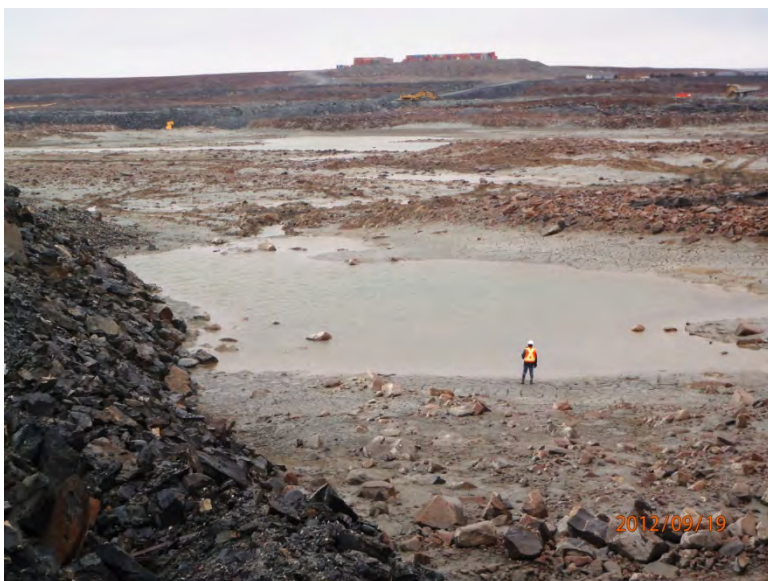
Photograph A3-5 Bay Goose Dike

Description: From crest looking southwest at the north channel seepage located at Sta. 30+378 from sand boils.

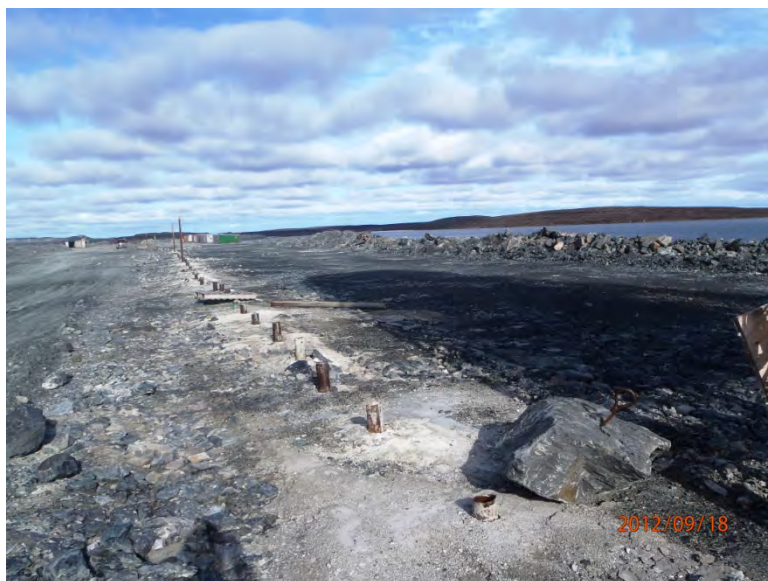
Photograph A3-11 Bay Goose Dike

Description: Looking northeast from Sta. 30+960, along the crest centreline.

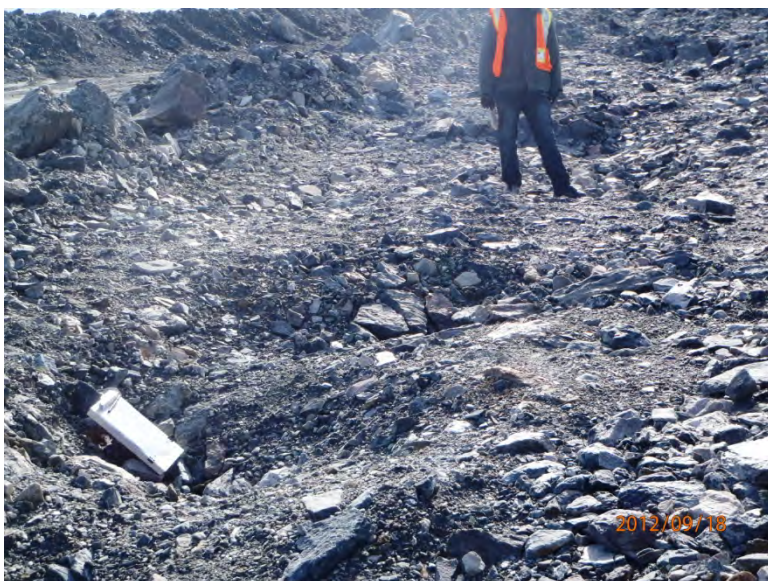
Photograph A3-13 Bay Goose Dike

Description: Depression on the crest 4 m from centreline at Sta. 31+130.

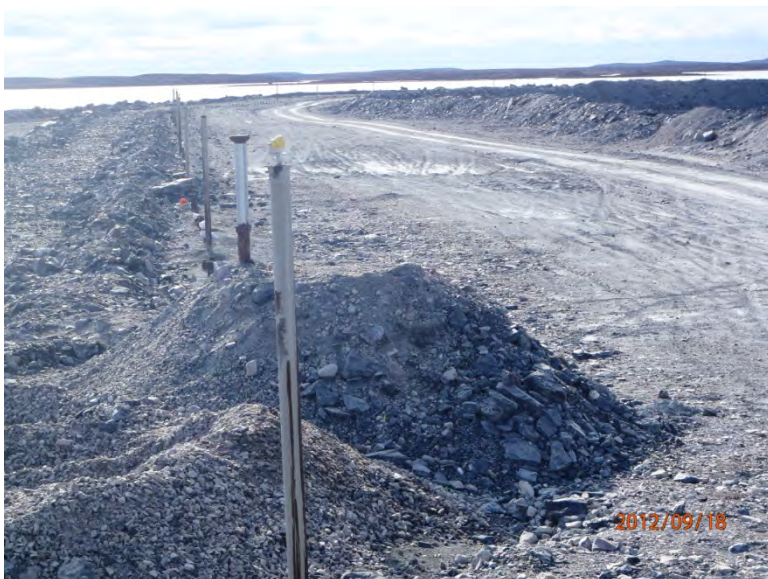
Photograph A3-15 Bay Goose Dike

Description: From Sta. 30+225, looking southwest along the crest centreline.

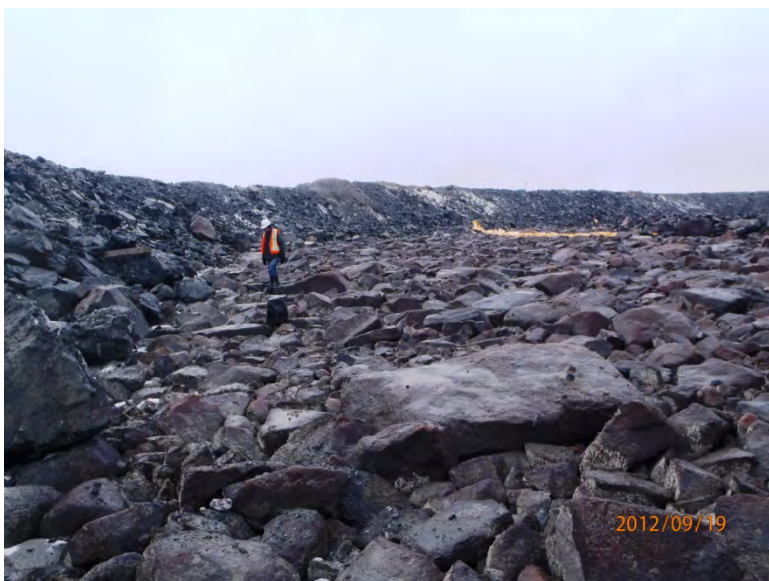
Photograph A3-17 Bay Goose Dike

Description: From Sta. 31+425 downstream, looking southwest.

2.5 Face liner condition (if applicable)	Not applicable		
2.6 Other Unusual Conditions	None		
3. DOWNSTREAM SLOPE		612, 589, 590 568	
3.1 Slope angle	Approx. 1.6H:1V

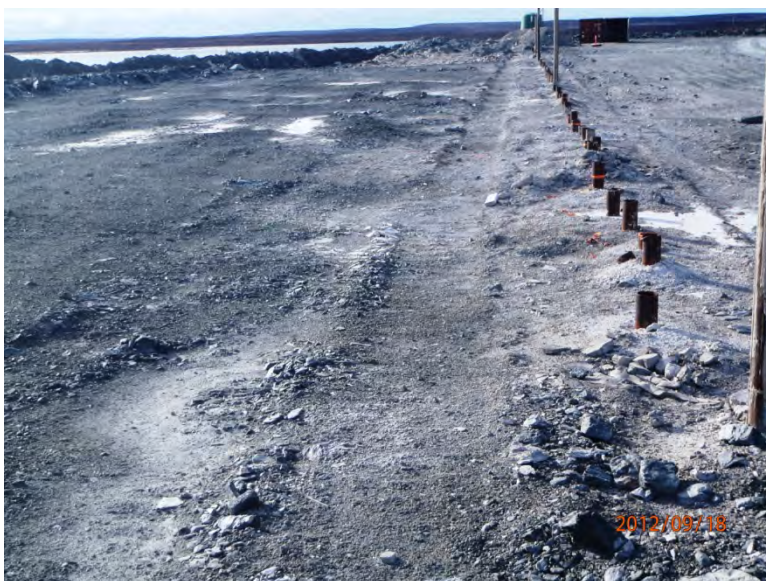
Photograph A3-21 Bay Goose Dike

Description: From Sta. 31+450, looking west along the crest centreline.

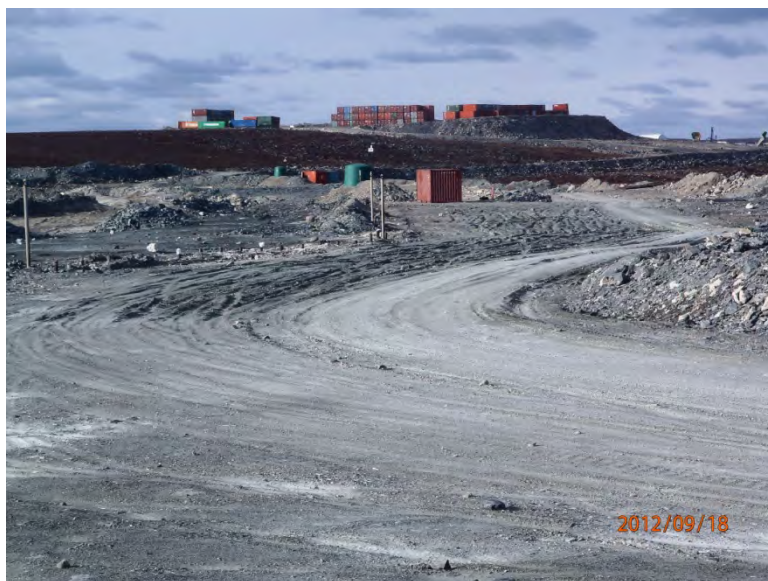
Photograph A3-23 Bay Goose Dike

Description: From Sta. 31+600, looking west along the crest centreline.

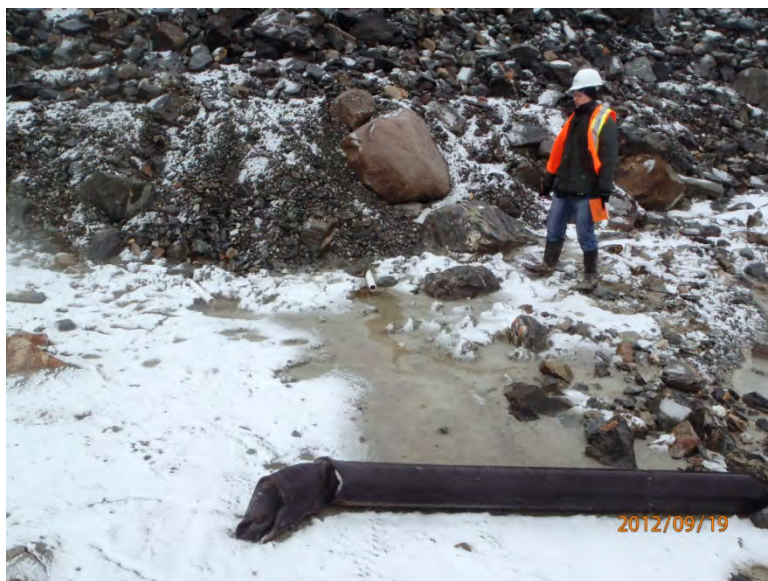
Photograph A3-25 Bay Goose Dike

Description: Close up of the zone of seepage at Channel 3 at Sta. 31+583. Notice the 3 pipes with no flow.

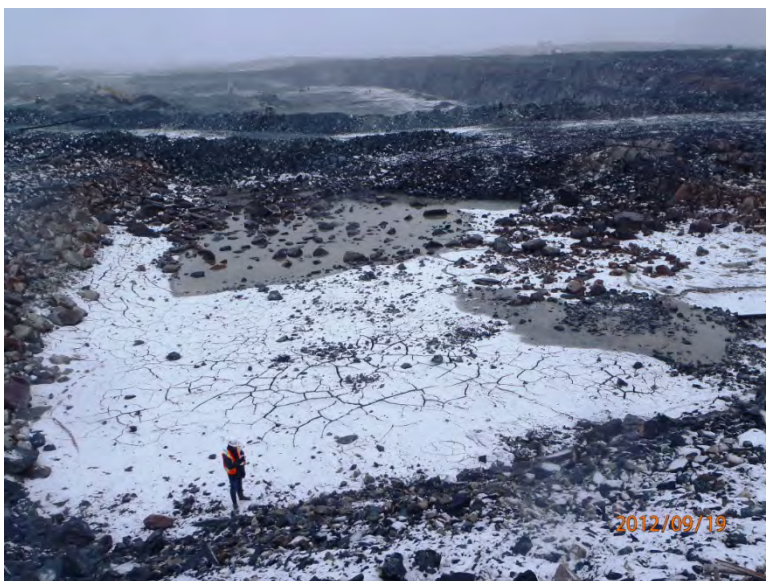
Photograph A3-27 Bay Goose Dike

Description: From the crest at Sta. 31+650 looking north downstream at the Channel 3 zone of seepage and the resulting water pond.

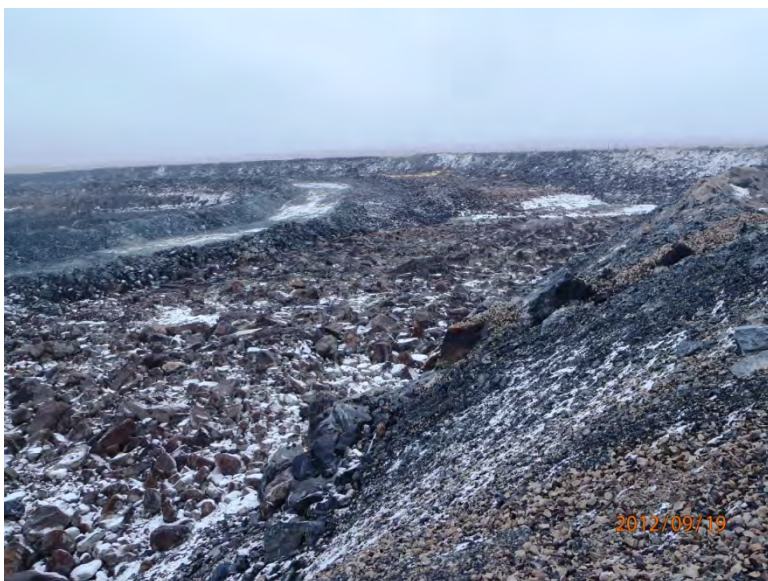
Photograph A3-29 Bay Goose Dike

Description: From the crest at Sta.31+760, looking east downstream.

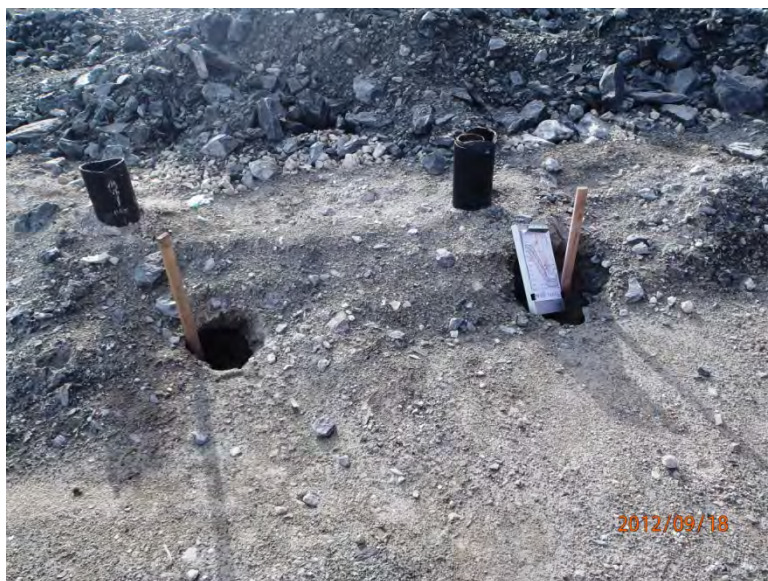
Photograph A3-31 Bay Goose Dike

Description: Close up of the settlement of upper cut-off wall at Sta. 31+806.

INSPECTION ITEM	OBSERVATIONS DATA	PHOTO	COMMENTS & OTHER DATA
		539, 542	Settlement of upper cut-off wall (coarser materials) at Sta. 31+806. No extension of hole to CSB (0.3 to 0.4 m depth). Two others were present before at 31+795. Test pits by AEM show that they end 1.4-1.7 m depth into frozen CSB.
	Channel 1 and 2	549, 555	From Sta. 31+880 to 31+930, newly observed tension cracks and holes above an old trench dug for jet grout activities and backfilled prior to the 2011 annual inspection where none of the actual movement signs were observed.

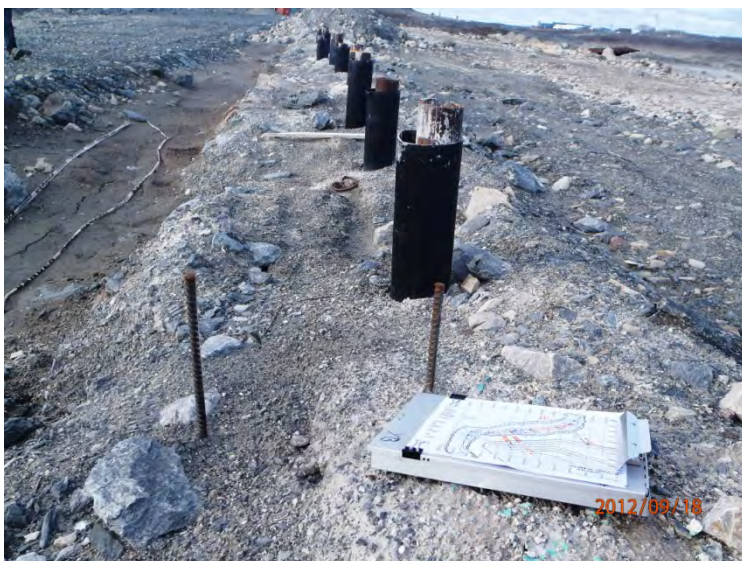
Photograph A3-33 Bay Goose Dike

Description: From Sta. 31+850 looking northwest along the crest centreline. Notice the tension cracks and the rebars.

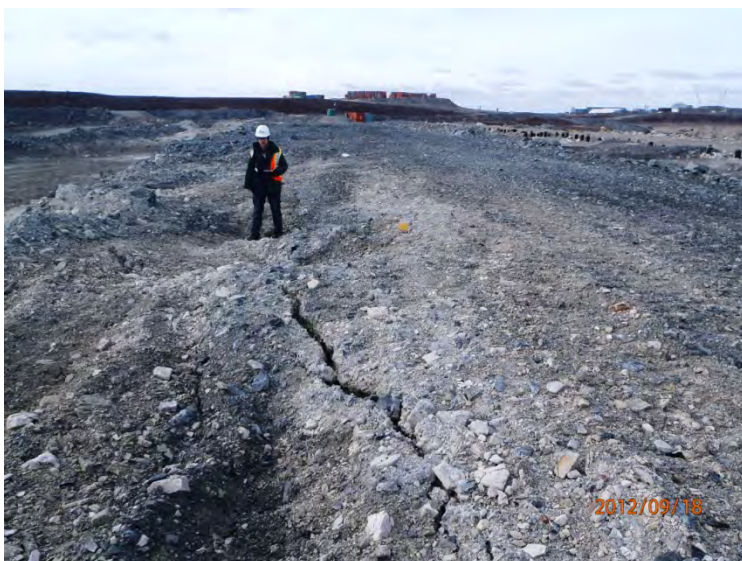
Photograph A3-35 Bay Goose Dike

Description: Presence of tension cracks up to 150 mm wide associated with settlement in the zone between Sta. 31+880 and 31+930. This area contained the trench used to collect wastage from the jet grouting.

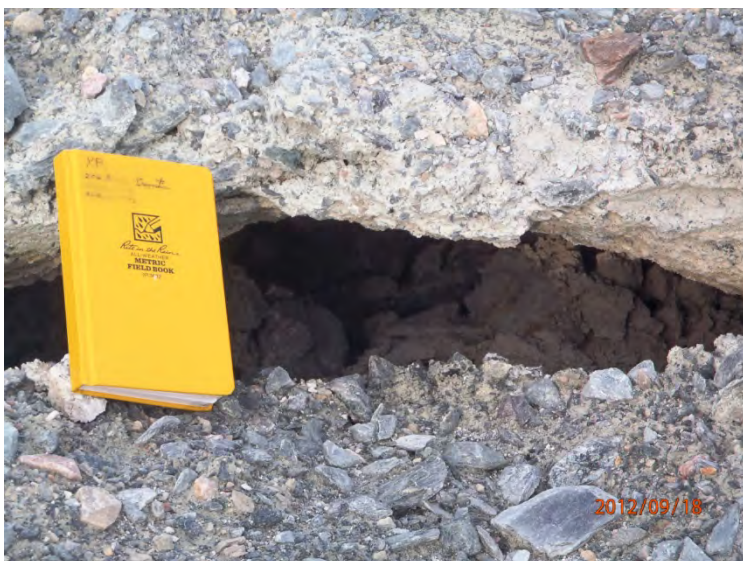
Photograph A3-37 Bay Goose Dike

Description: Close up of one of the holes in the zone between Sta. 31+880 and 31+930. This area overlay a backfilled jet grouting trench.

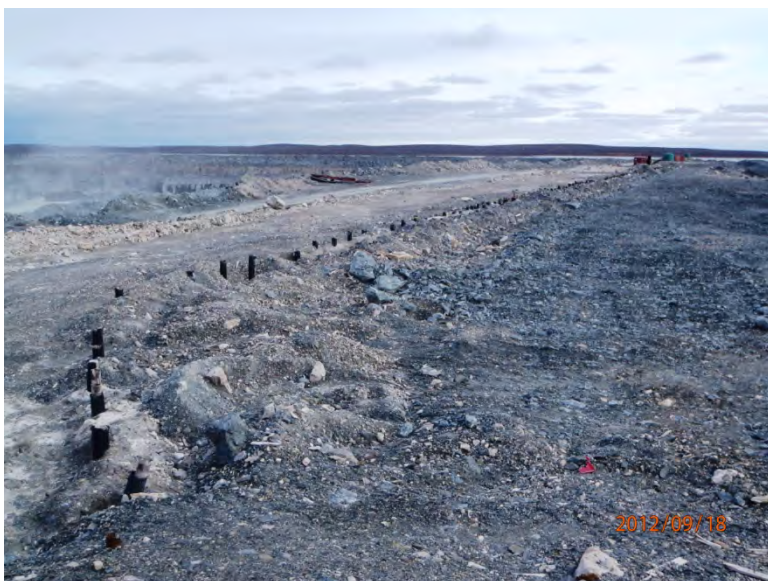
Photograph A3-39 Bay Goose Dike

Description: From Sta. 32+000 looking southeast along the crest centreline.

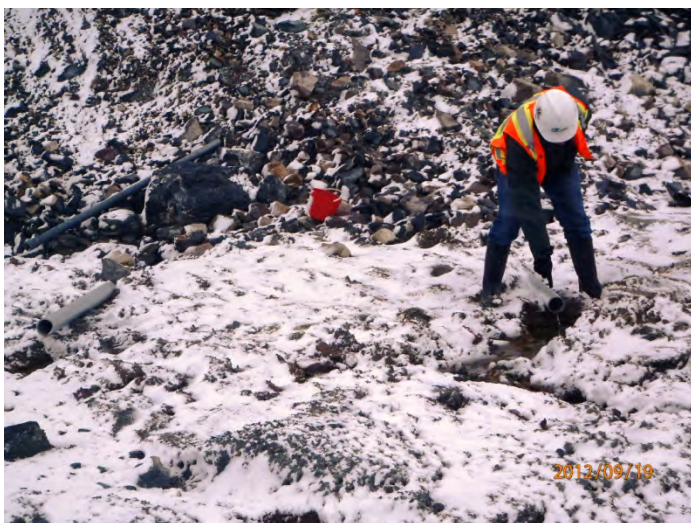
Photograph A3-41 Bay Goose Dike

Description: Looking at seepage Channel 1 located at Sta. 32+011 and 32+014. Notice that only one pipe is flowing.

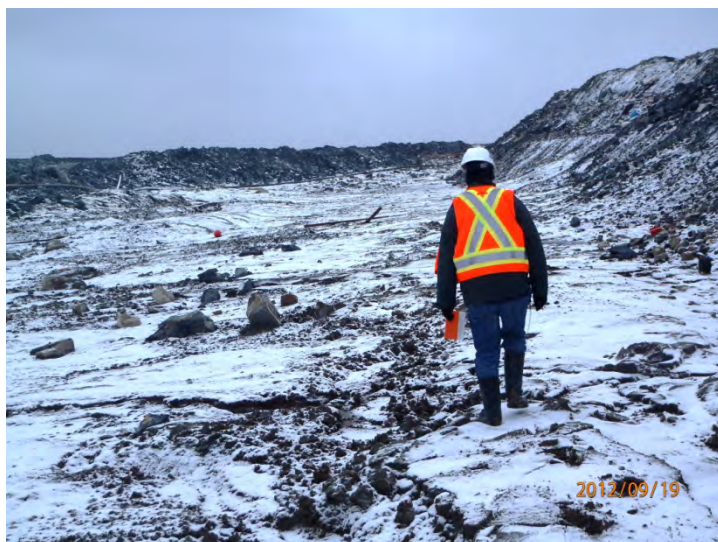
Photograph A3-43 Bay Goose Dike

Description: From Sta. 32+050 looking southeast on the downstream face toward Channel 1.

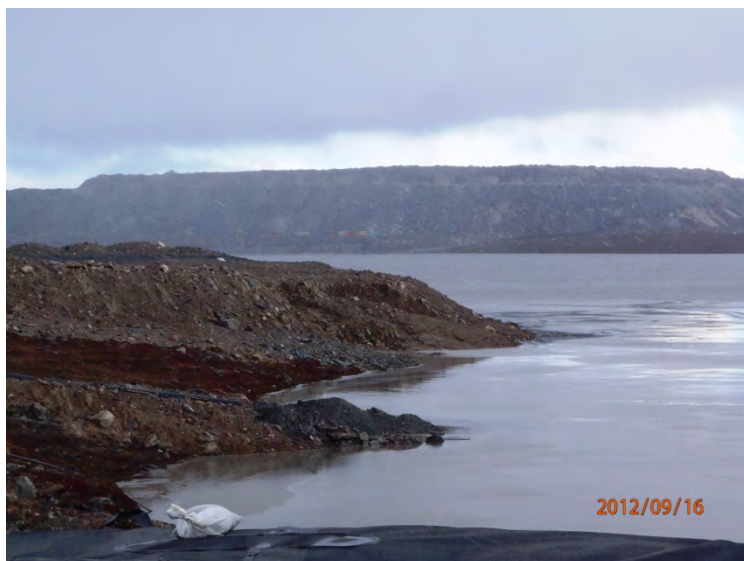
Photograph B1-1 Tailings Storage Facility

Description: From Saddle Dam 1 looking east toward the North Cell of the Tailings Storage Facility. Notice the unstable pad from SD1 foundation stripping having slope failure at coordinate 637205E/7216044N.

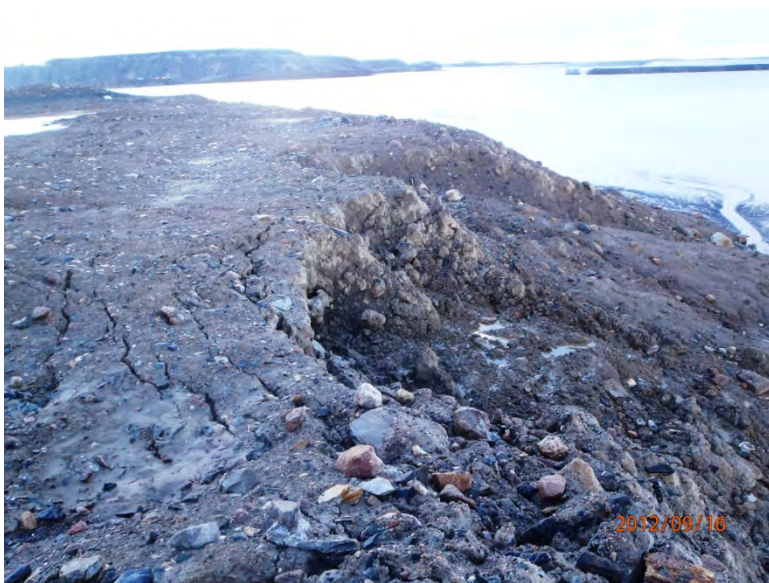
Photograph B1-3 Tailings Storage Facility

Description: From unstable pad at coordinate 637205E/7216044N looking east toward the North Cell of the Tailings Storage Facility. Notice the slope failure and the presence of tension cracks (10 to 15 mm opening).

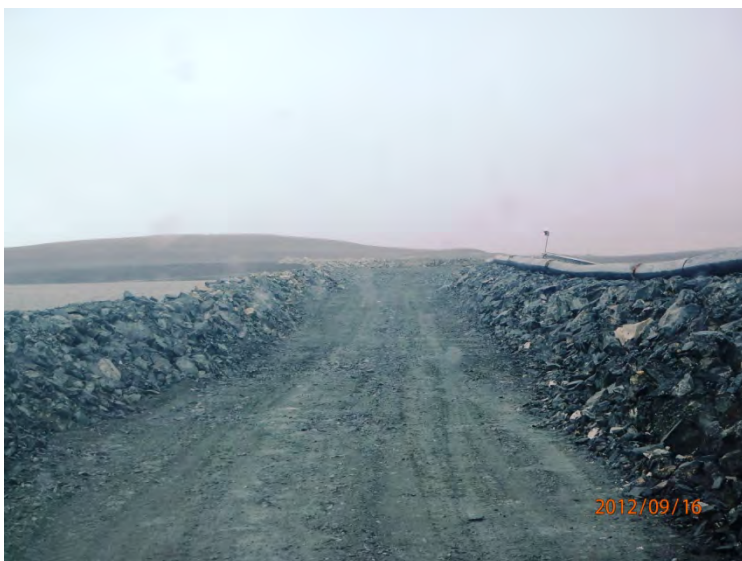
Photograph B1-5 Tailings Storage Facility

Description: Looking at the reclaim access ramp from its crest.

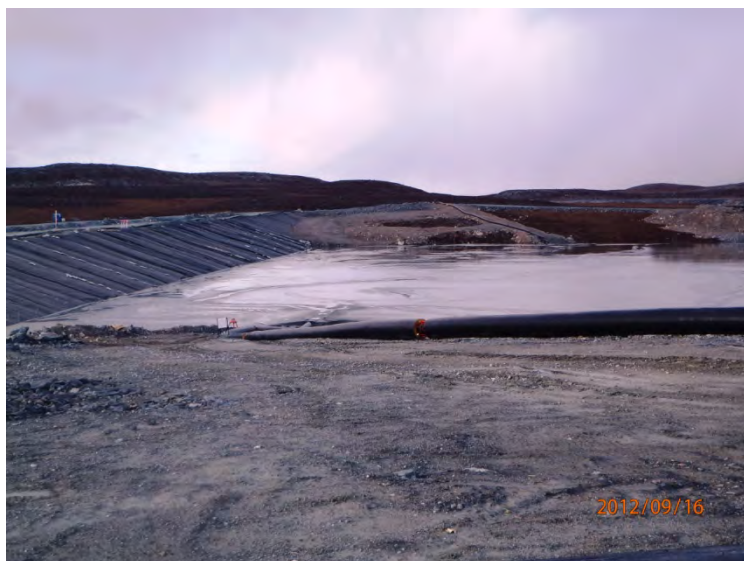
Photograph B2-1 Saddle Dam 1

Description: From the south abutment looking north at the upstream face. Notice the adequate beach against the liner.

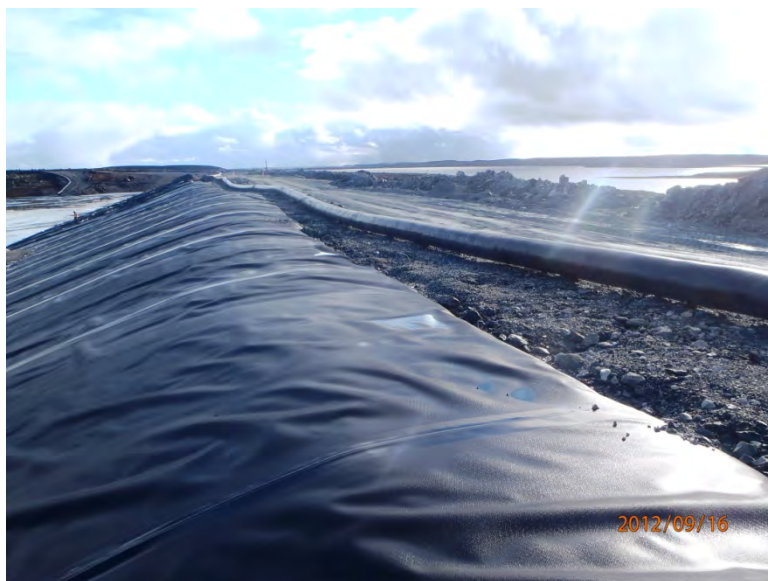
Photograph B2-3 Saddle Dam 1

Description: Looking south at the crest and the upstream side.

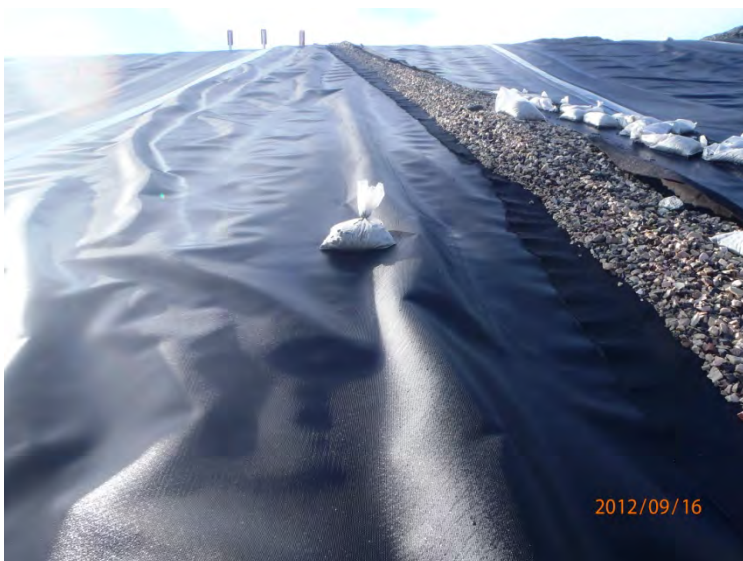
Photograph B2-5 Saddle Dam 1

Description: Presence of longitudinal wrinkles in the liner due to thermal expansion and contraction of the liner and material movement. Notice the sand bag ballast on the right that had been moved by the wind.

INSPECTION ITEM	OBSERVATIONS DATA	PHOTO	COMMENTS & OTHER DATA
2.5 Face liner condition (if applicable)	Presence of wrinkles	440, 437, 436	<p>Presence of wrinkles in the liner. Most of the wrinkles were longitudinal to the panel seam and will likely flatten during the deposition of tailings without pinching. The condition of the wrinkles and liner in general should continue to be monitored.</p> <p>Inadequate ballast exists. Placement of additional ballast to the liner is strongly recommended.</p>

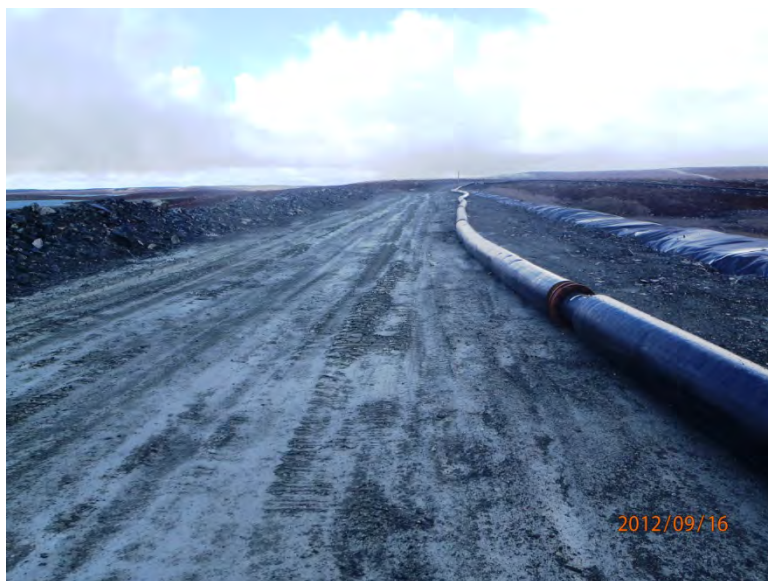
Photograph B3-1 Saddle Dam 2

Description: From Sta. 20+295 looking northwest at the crest.

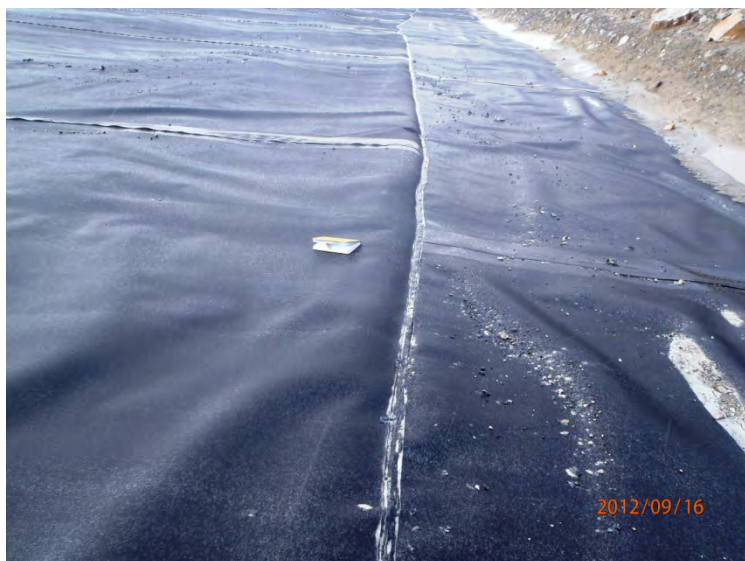
Photograph B3-3 Saddle Dam 2

Description: Looking northwest at water caught between liner horizontal joint at El. 146 m from Sta. 20+444 to Sta. 20+476. Balloon height of 100 mm.

INSPECTION ITEM	OBSERVATIONS DATA	PHOTO	COMMENTS & OTHER DATA
2.5 Face liner condition (if applicable)	Balloons in the liner	418, 419, 420	Water is caught in between the liner horizontal joint at El. 146 m in 3 locations "zones". Zone 1 from Sta. 20+444 to Sta. 20+476. Zone 2 from Sta. 20+250 to Sta. 20+295. Zone 3 from Sta. 20+122 to Sta. 20+130. Water balloons height varies from 100 mm to 170 mm. Other areas with the same condition were repaired in 2012 prior to the inspection, areas not know by Golder.

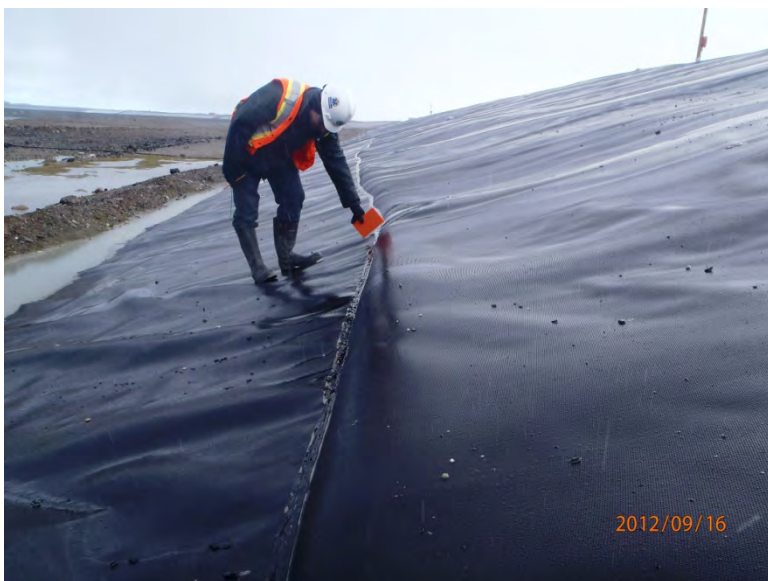
Photograph B3-5 Saddle Dam 2

Description: From Sta. 20+130, looking southeast at water caught between liner horizontal joint at El. 146 m on a distance of 8 m approximately. Balloon height of 100 mm.

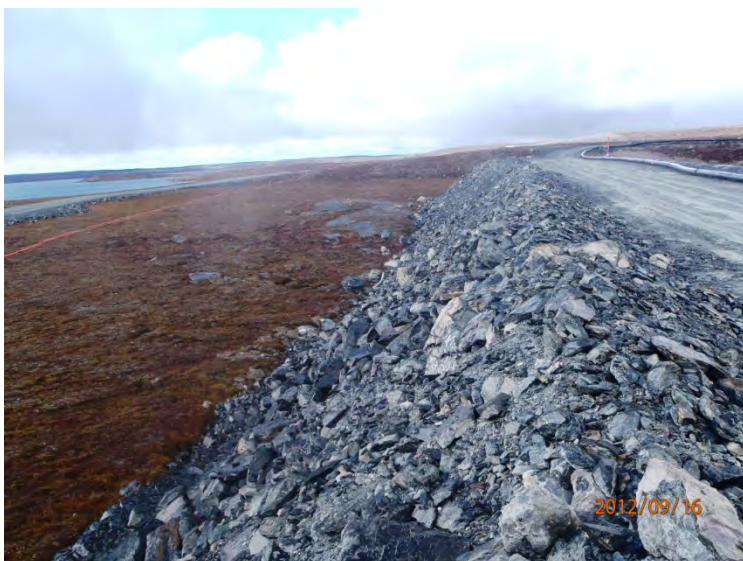
Photograph B3-7 Saddle Dam 2

Description: From Sta. 20+295 on the crest, looking northwest at the downstream face.

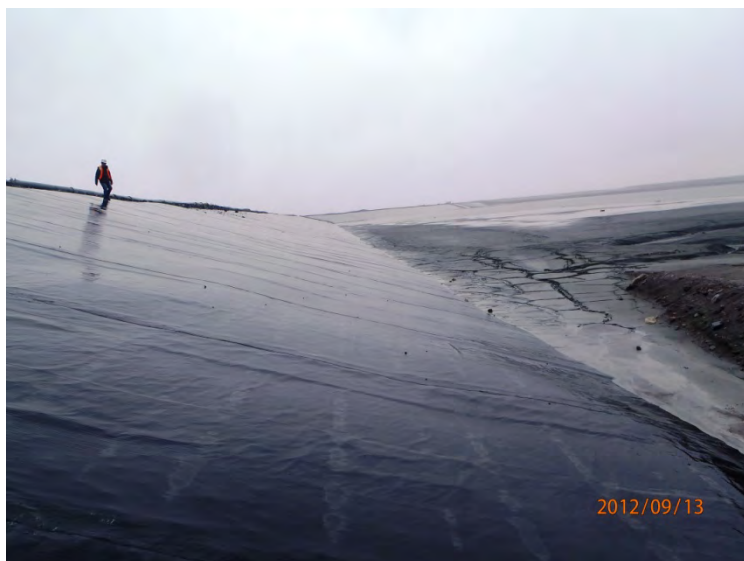
Photograph B4-1 Stormwater Dike

Description: From Sta. 11+074 near the east access ramp, looking southwest at the upstream face.

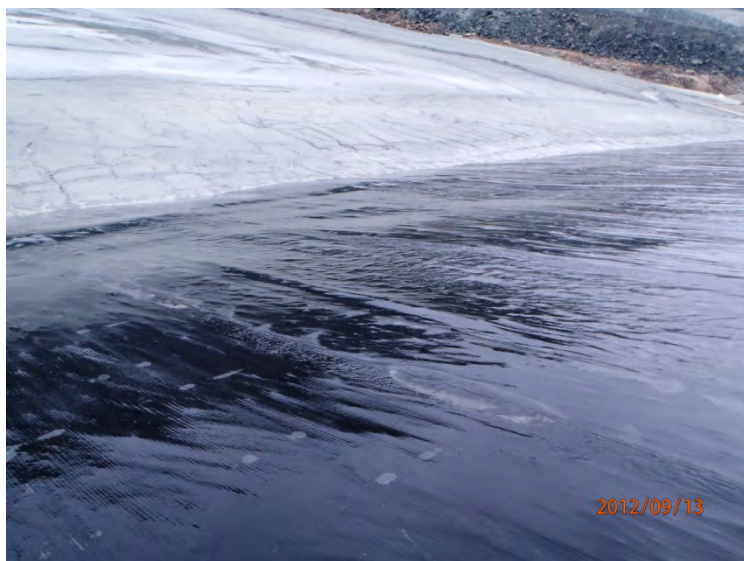
Photograph B4-3 Stormwater Dike

Description: From Sta.10+949, looking northwest at the zone of differential settlement in the liner between Sta. 11+045 and 10+735, from actual beach elevation to crest edge. Notice the appropriate tailings beach against the upstream face.

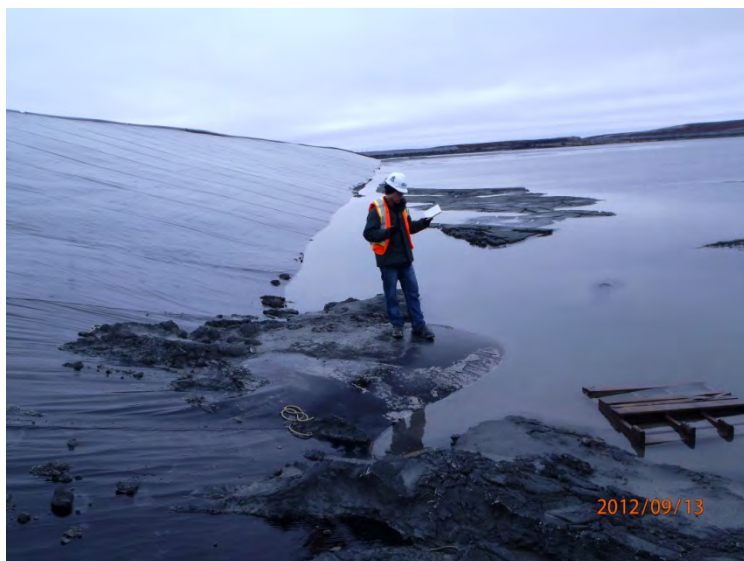
Photograph B4-5 Stormwater Dike

Description: Looking at the bulge in the liner about 75 mm above the granular foundation at Sta. 10+672.

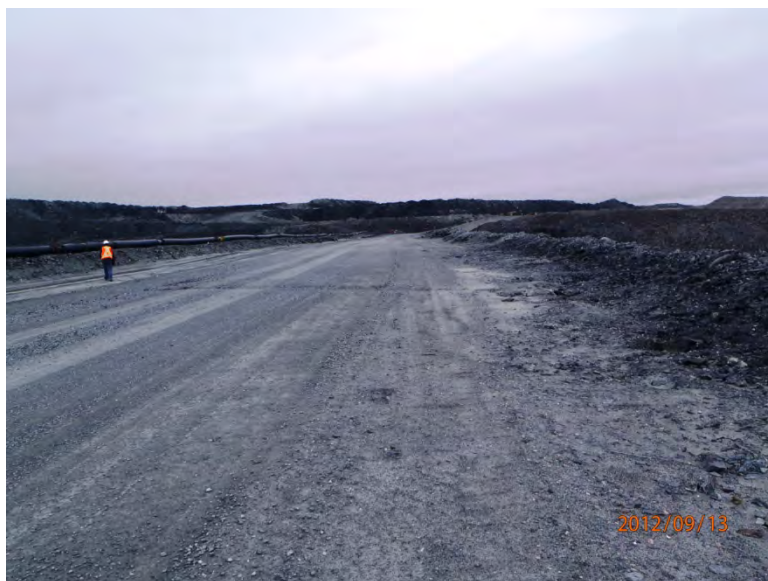
Photograph B4-7 Stormwater Dike

Description: From Sta.10+821, looking northeast at the crest.

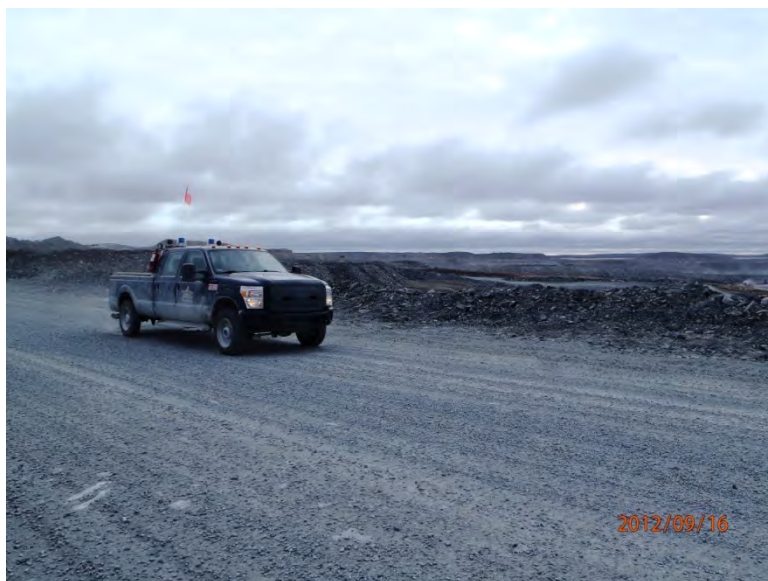
Photograph B4-9 Stormwater Dike

Description: From Sta.10+778 on the crest, looking south east from toward the downstream face berm.

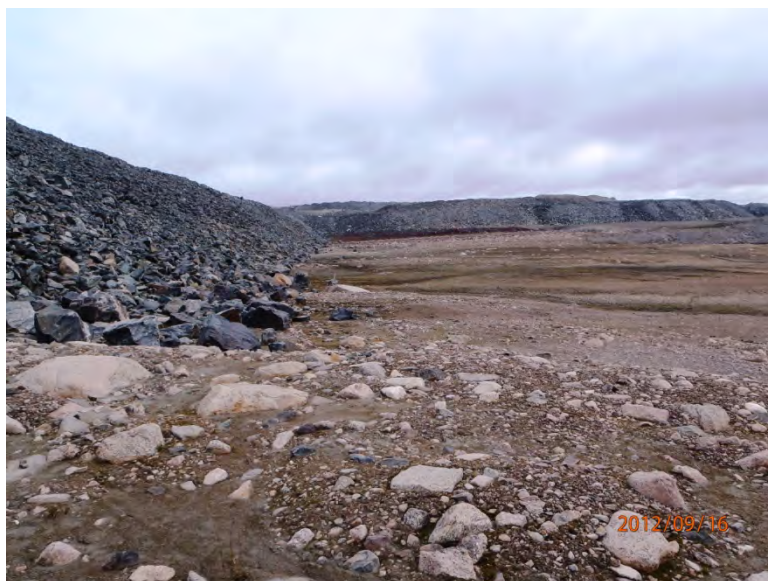
Photograph B4-13 Stormwater Dike

Description: From Sta.10+709, looking northeast at the downstream face.

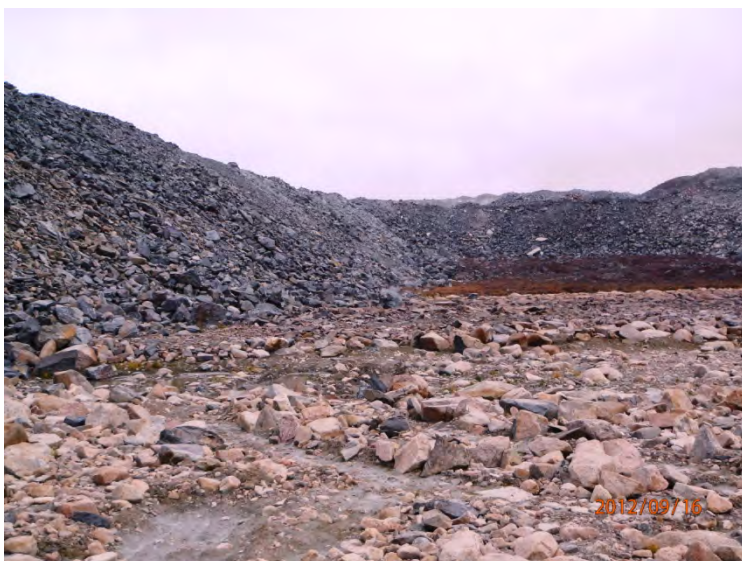
Photograph B4-15 Stormwater Dike

Description: From Sta.10+880, looking northeast at the downstream face.

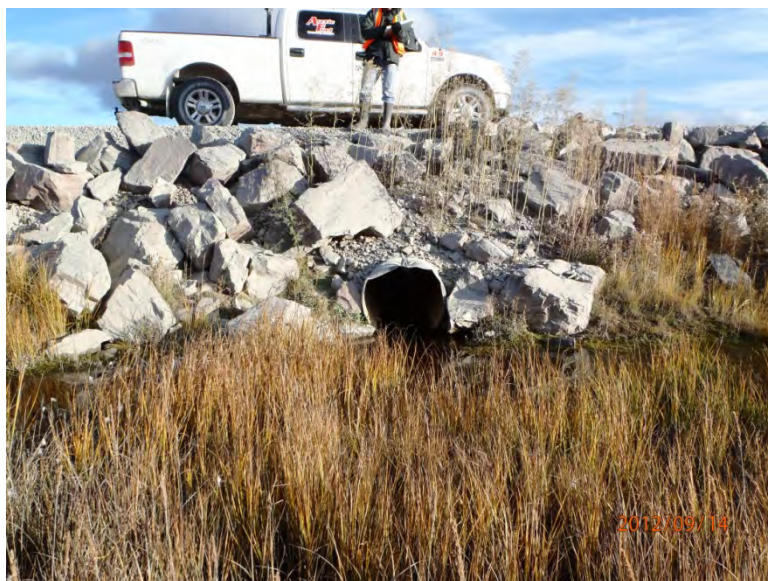
Photograph D1-1 : PRC1 km 0+430

Description: Upstream view of culvert, in good condition no sign of obstruction.

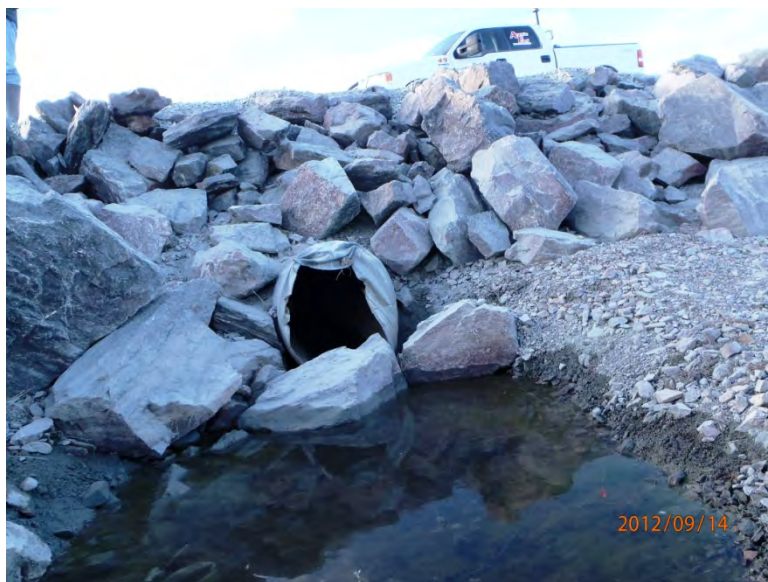
Photograph D1-2 : PRC1 km 0+430

Description: Downstream view of culvert. The outlet is slightly damaged and obstructed. The culvert is still functional and in overall good condition.

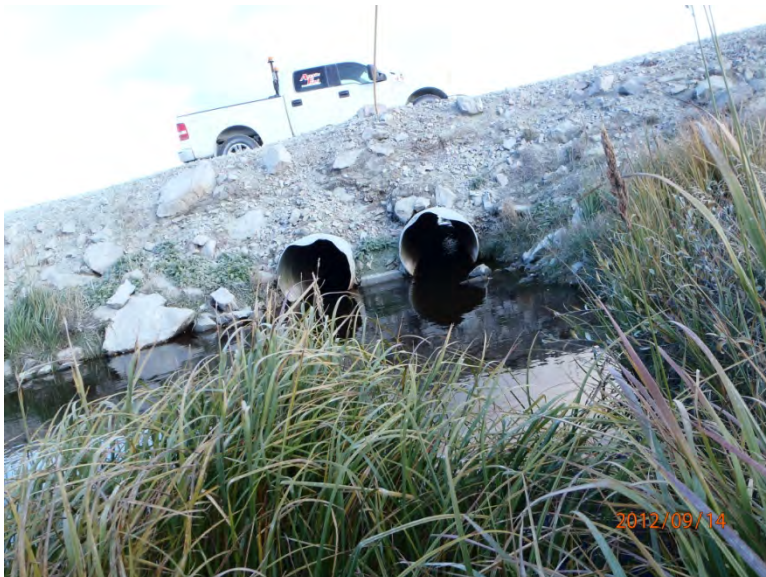
Photograph D1-3 : PRC2 km 0+470

Description: Upstream view of culverts. Good condition.

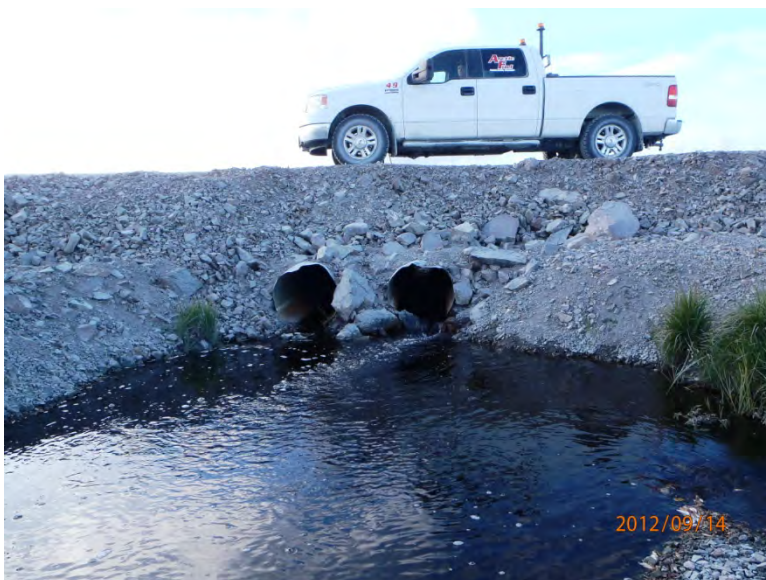
Photograph D1-4 : PRC2 km 0+470

Description: Downstream view of culverts. Good condition.

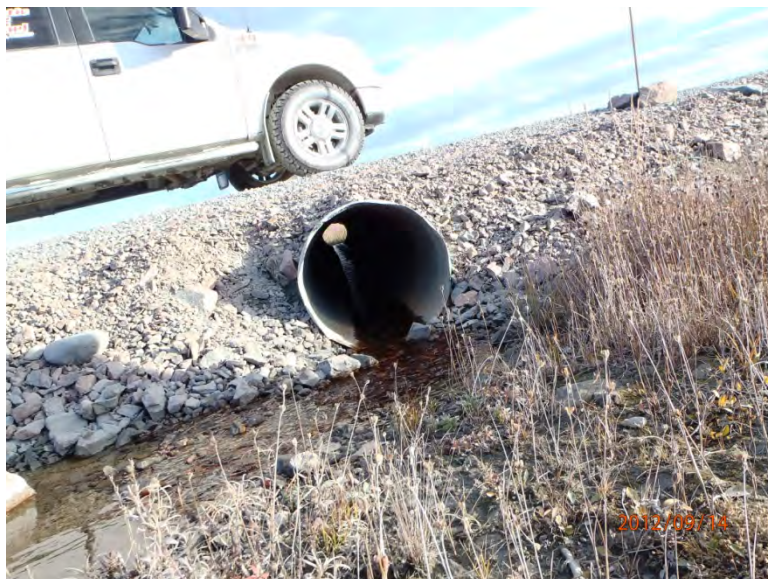
Photograph D1-5 : PRC3 km 1+380

Description: Upstream view of culvert. Good condition.
