Report: *2012 Annual Review of Portage and Goose Pit Slope Performance*

2012 Annual Geotechnical Inspection Meadowbank Gold Mine, Nunavut

Agnico-Eagle Mines Limited
Meadowbank Division
PO Box 540
Baker Lake, Nunavut
X0C 0A0

Report Number: Doc 1394 1212210073 0115_13

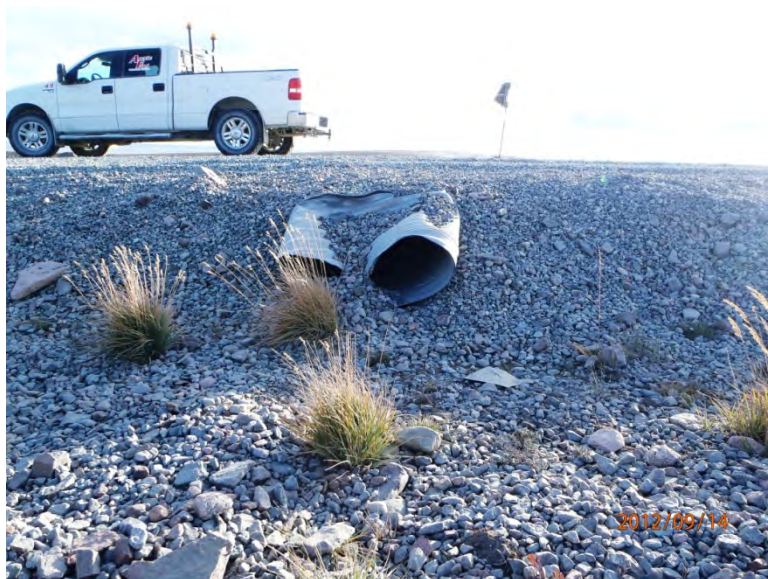
Photograph D1-7 : R-00A km 2+550

Description: Downstream view of culvert. The outlet is collapsed. Road bed cover is too thin to provide protection.

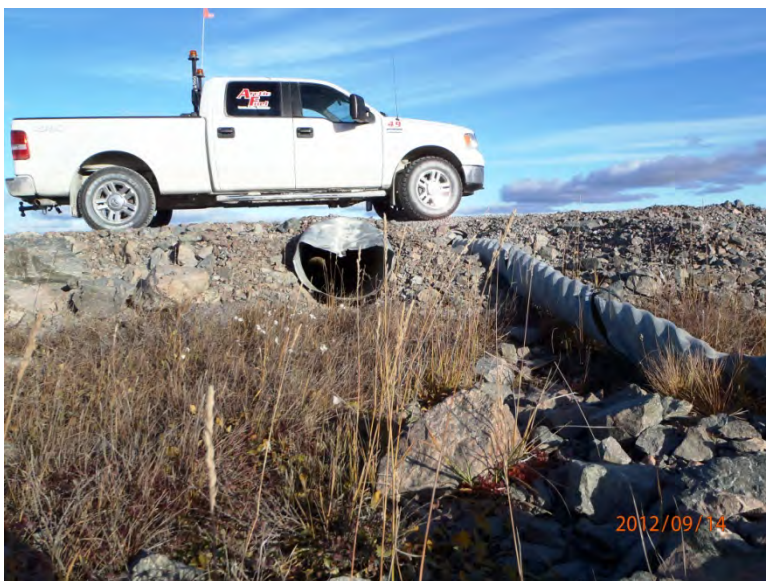
Photograph D1-9 : PC-14 km 4+260

Description: Upstream view of the culverts. Culvert on the right is filled with gravel, crushed and damaged. Culvert on the left is slightly damaged but still functioning. Notice the too thin road bed cover.

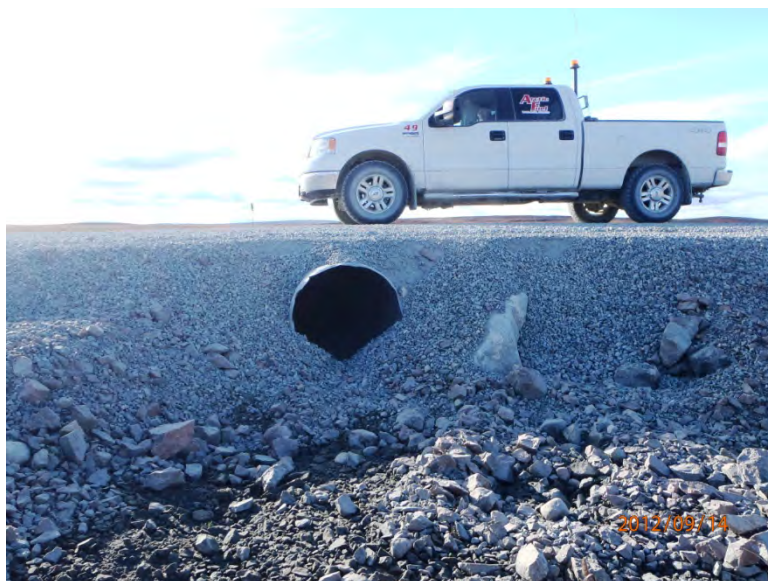
Photograph D1-11 : unnamed km 5+700

Description: Upstream view of the culvert. Good condition, inlet slightly obstructed.

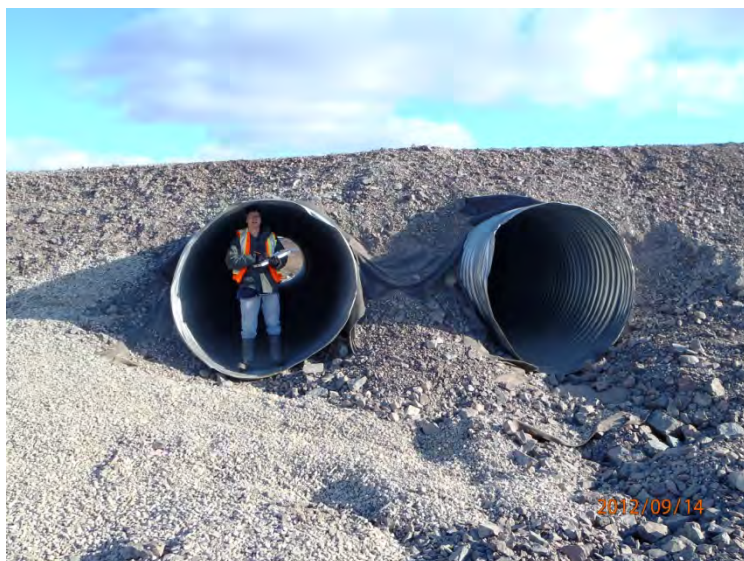
Photograph D1-13 : PC-17A km 8+830

Description: Upstream view of the culverts. Good condition.

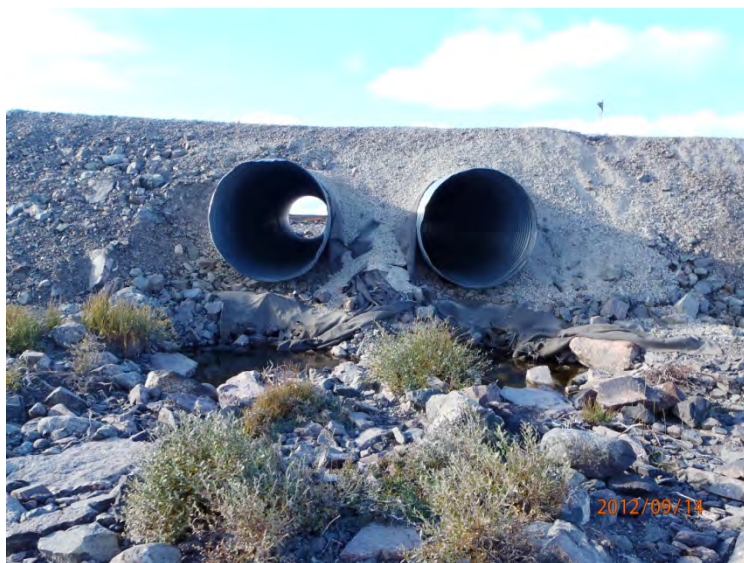
Photograph D1-14 : PC-17A km 8+830

Description: Downstream view of the culverts. Good condition.

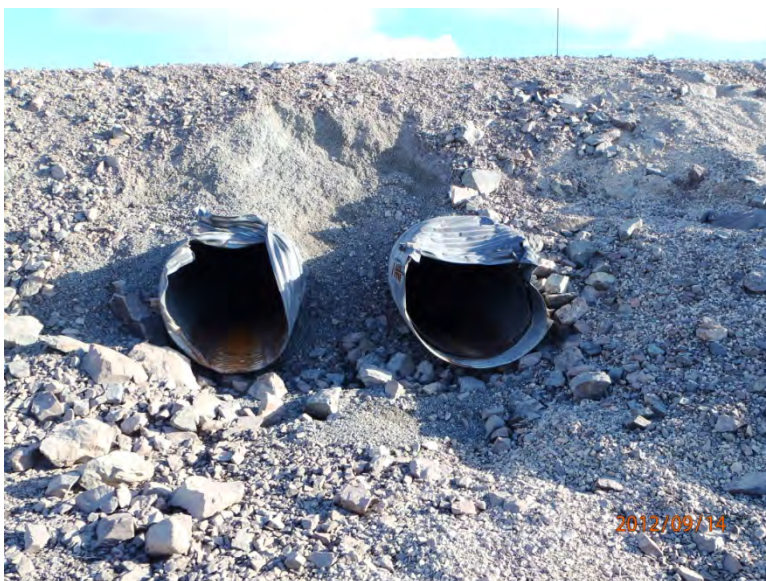
Photograph D1-15 : PC-17 km 8+850

Description: Upstream view of the culverts. Good condition other than slight damages observed at the inlet.

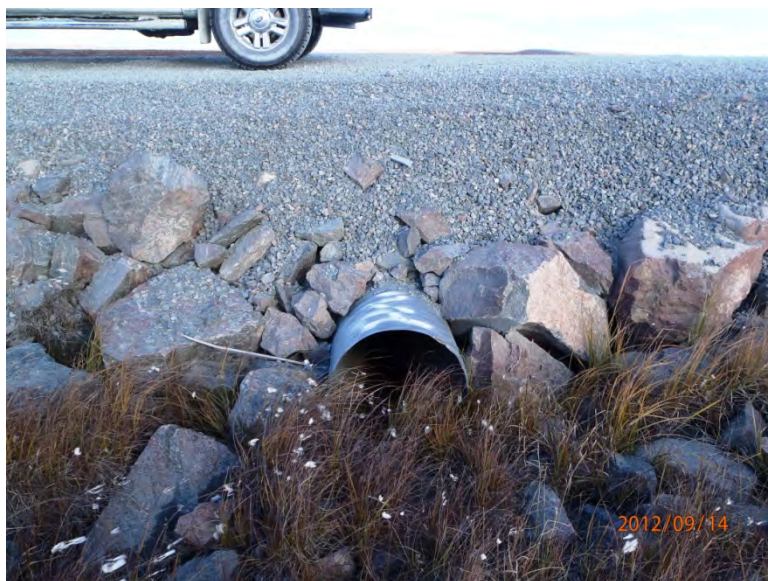
Photograph D1-17 : PC-1 km 9+952

Description: Upstream view of the culvert inlet. Good condition.

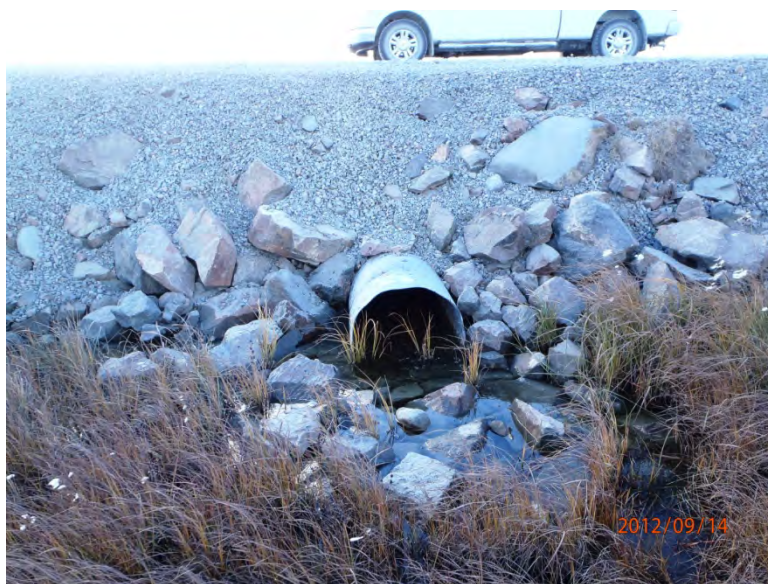
Photograph D1-18 : PC-1 km 9+952

Description: Downstream view of the culvert outlet. Good condition.

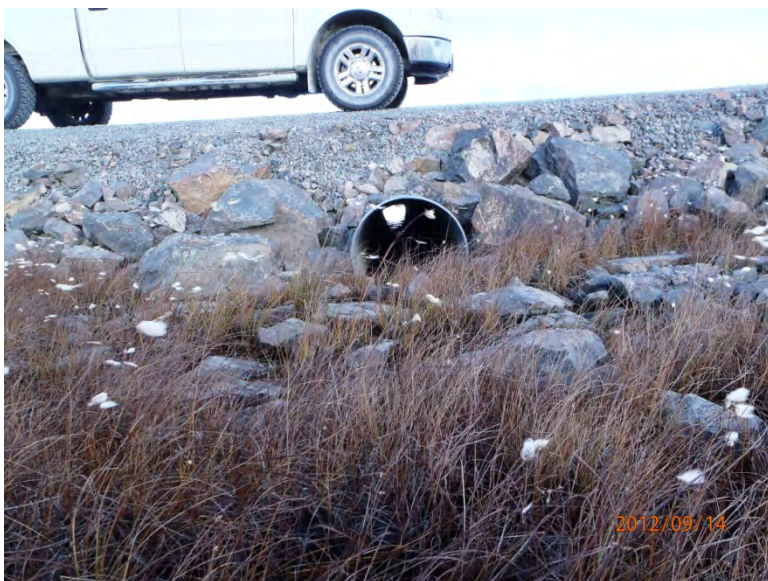
Photograph D1-19 : R-03 km 10+580

Description: Upstream view of the culvert inlet. Good condition.

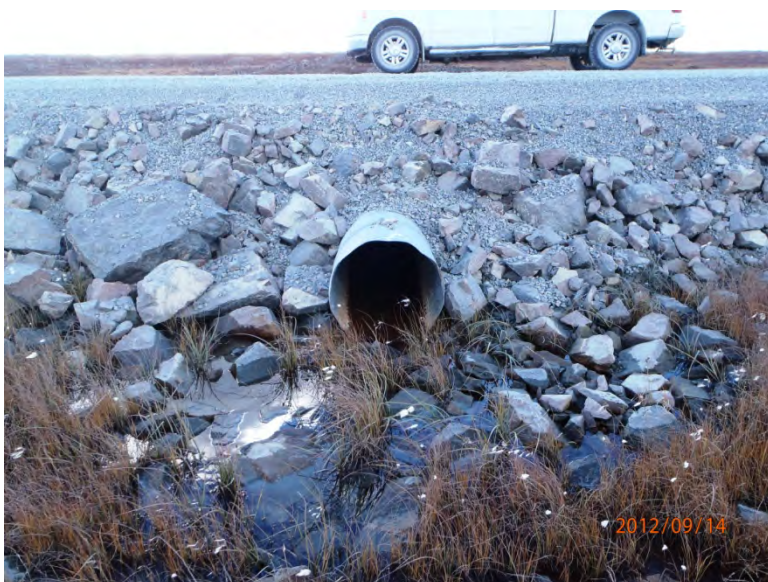
Photograph D1-20 : R-03 km 10+580

Description: Downstream view of the culvert inlet. Good condition.

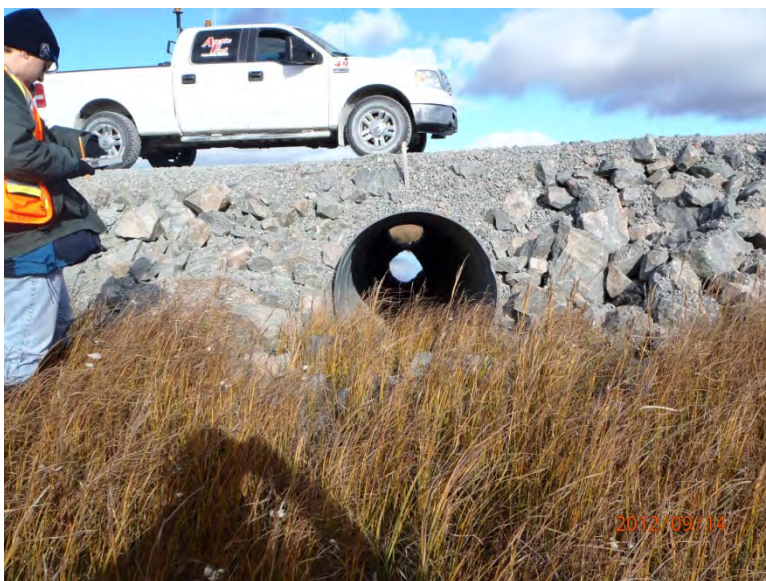
Photograph D1-21 : R-04 km 12+050

Description: Upstream view of the culvert inlet. Good condition.

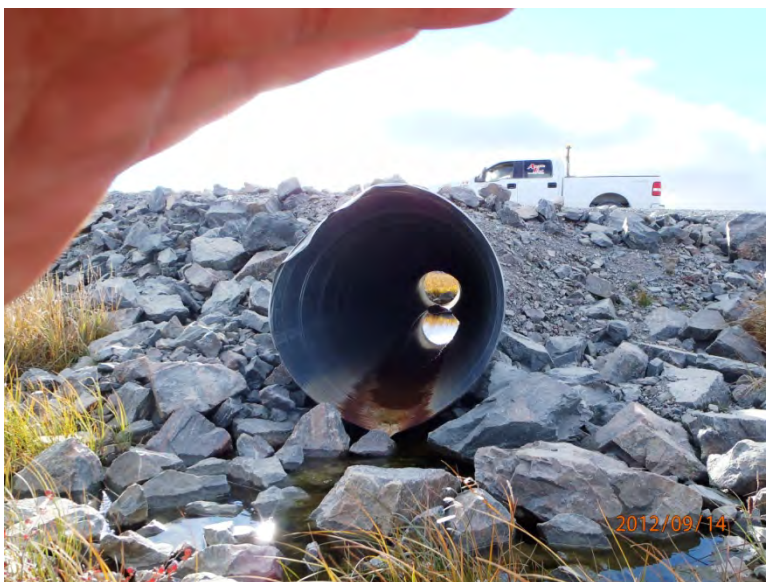
Photograph D1-22 : R-04 km 12+050

Description: Downstream view of the culvert outlet. Good condition.

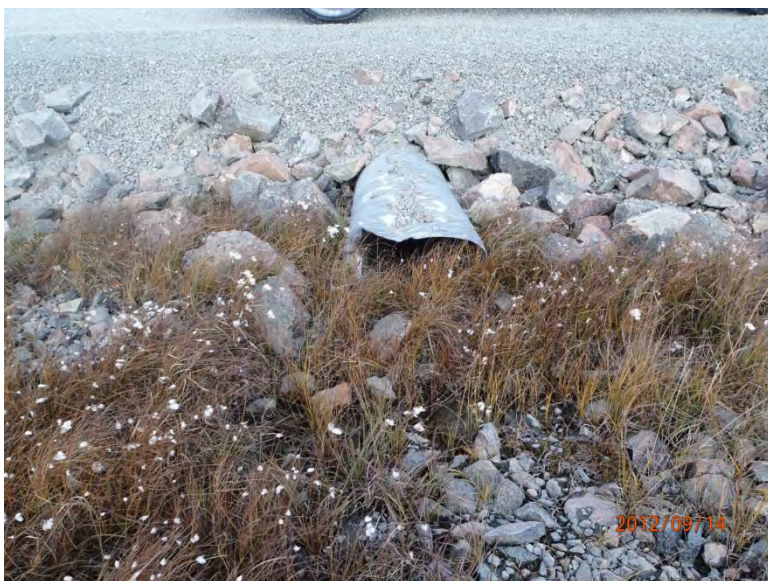
Photograph D1-23 : PC-13 km 12+745

Description: Upstream view of the culvert. The inlet is partially collapsed but still functional.

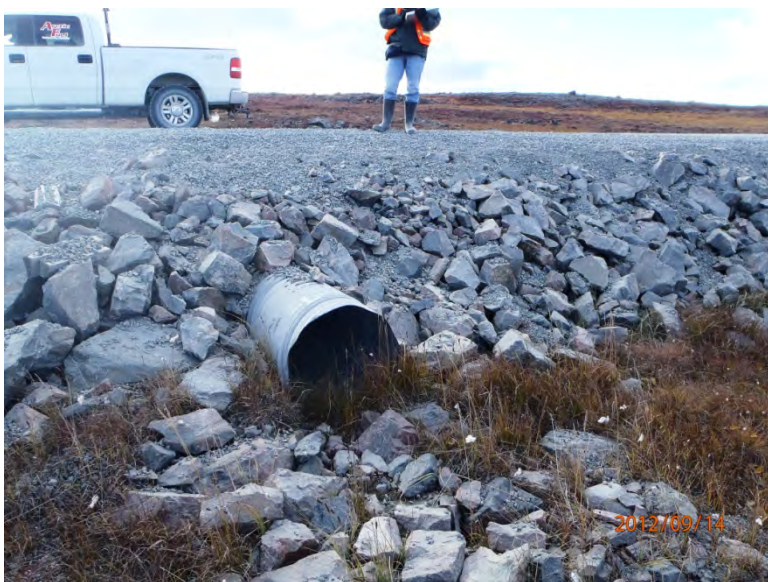
Photograph D1-24 : PC-13 km 12+745

Description: Downstream view of the culvert. Good condition.

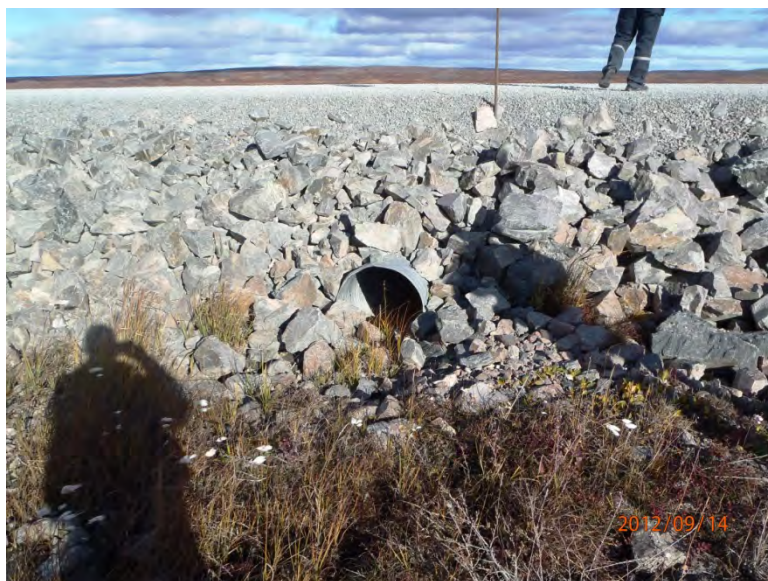
Photograph D1-25 : PC-2 km 13+405

Description: Upstream view of the culvert. Minor obstruction of the inlet.

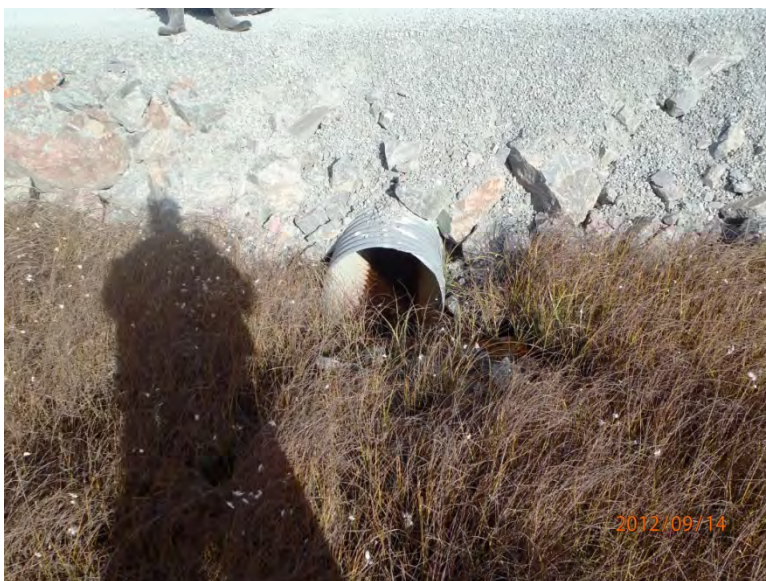
Photograph D1-27 : PC-3 km 13+685

Description: Upstream view of the culvert. Good condition.

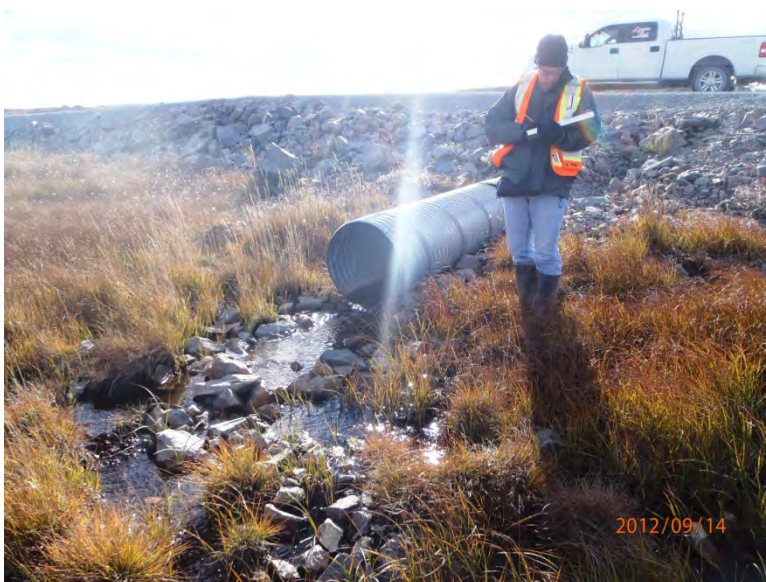
Photograph D1-28 : PC-3 km 13+685

Description: Downstream view of the culvert. Good condition.

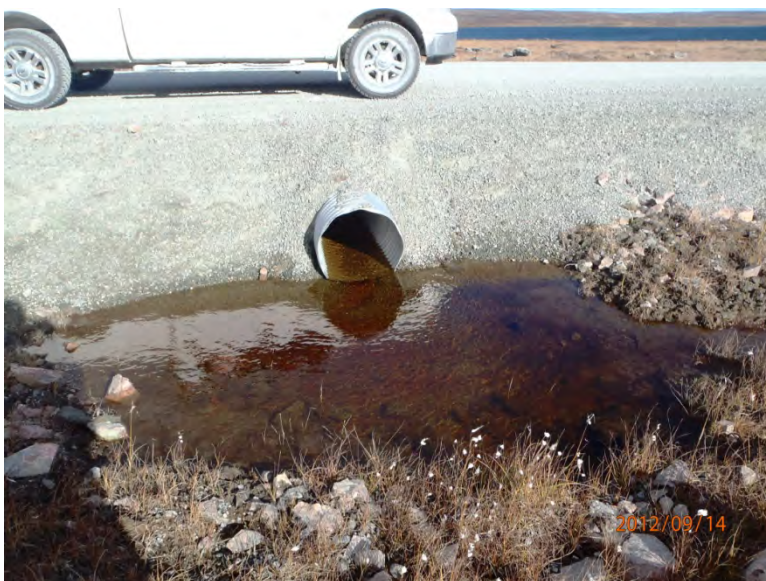
Photograph D1-29 : unnamed km 13+950

Description: Upstream view of the culvert. Good condition.

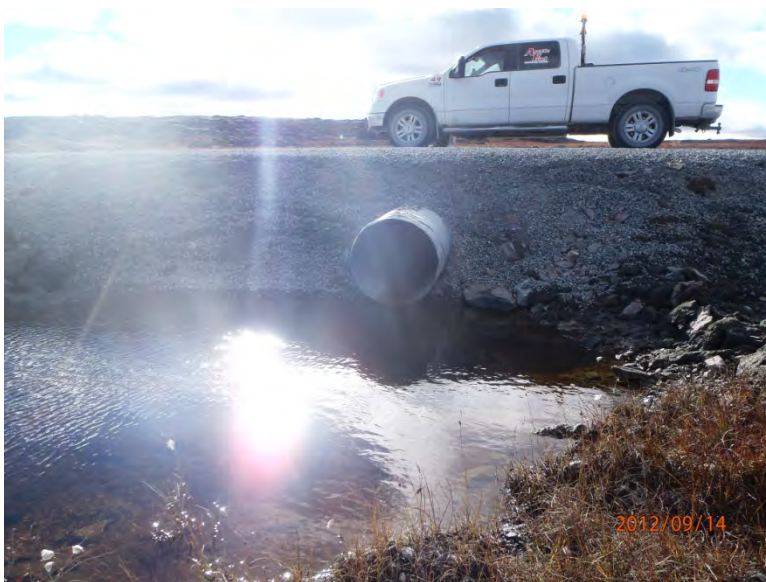
Photograph D1-30 : unnamed km 13+950

Description: Downstream view of the culvert. Good condition.

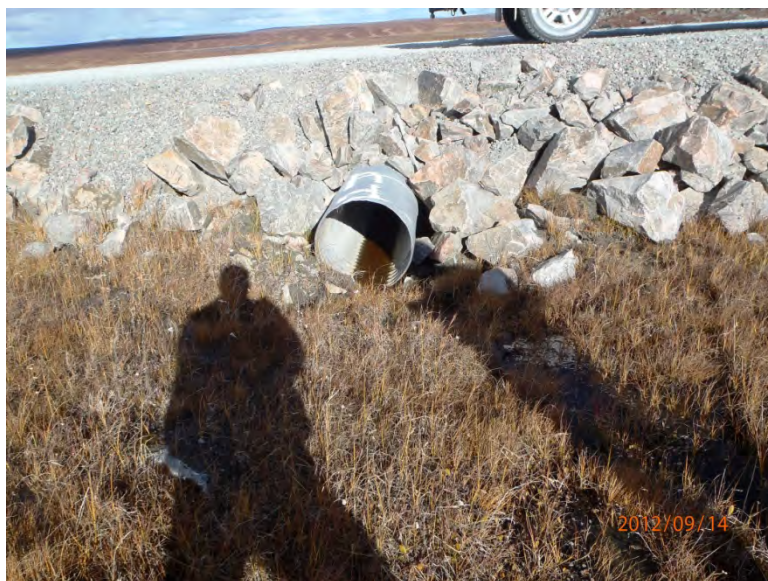
Photograph D1-31 : PC-4 km 14+910

Description: Upstream view of the culvert. Good condition.

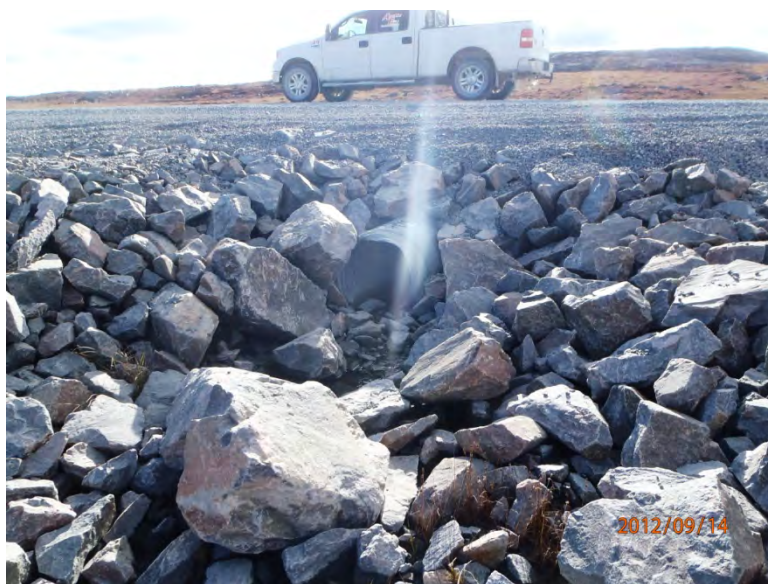
Photograph D1-32 : PC-4 km 14+910

Description: Downstream view of the culvert. Good condition. Large boulders piled around outlet.

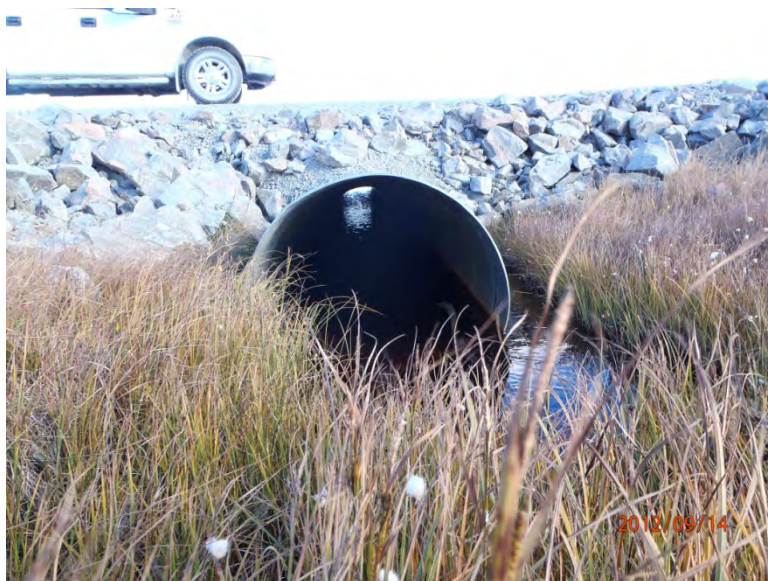
Photograph D1-33 : R-05A km 15+745

Description: Upstream view of the culvert. Good condition.

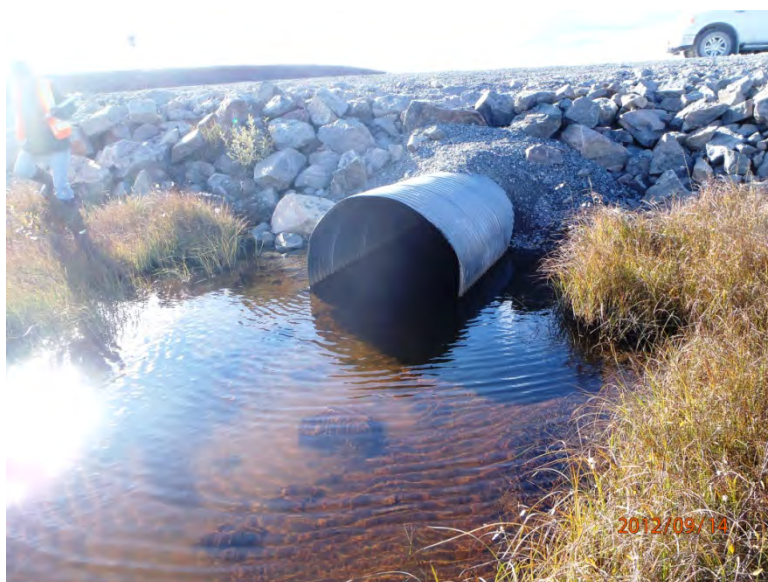
Photograph D1-34 : R-05A km 15+745

Description: Downstream view of the culvert. Good condition.

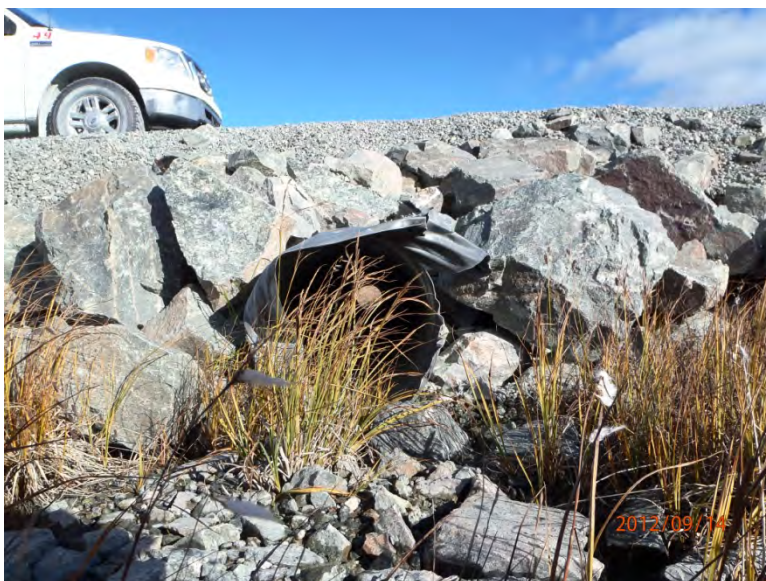
Photograph D1-35 : PC-5 km 18+280

Description: Upstream view of the culvert. The inlet is a little bit damaged and shows small signs of erosion.

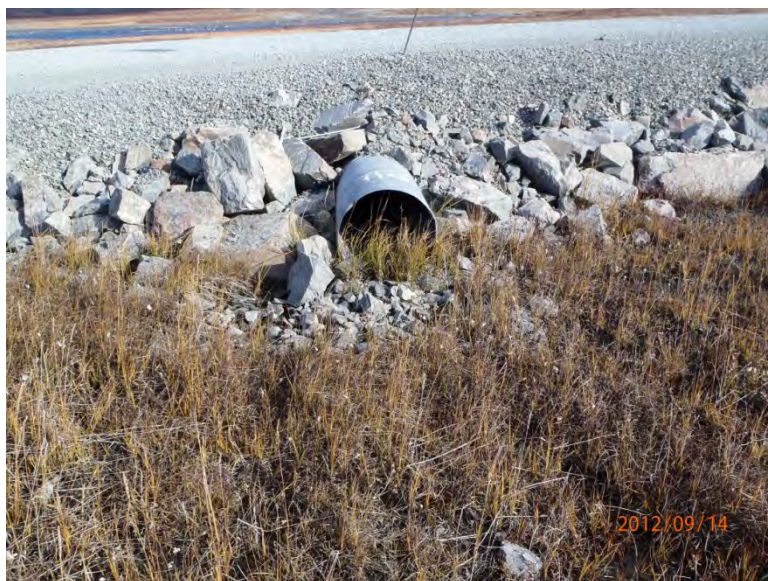
Photograph D1-37 : PC-6 km 18+900

Description: Upstream view of culvert. Good condition.

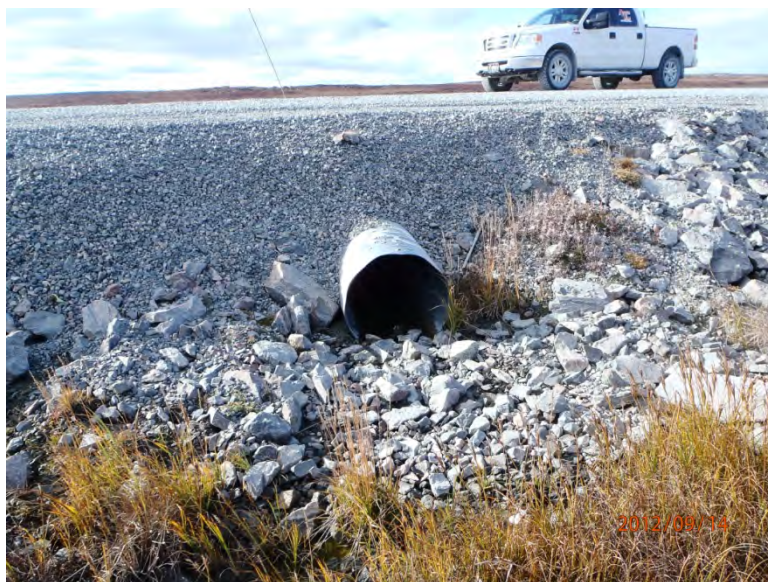
Photograph D1-38 : PC-6 km 18+900

Description: Downstream view of culvert. Good condition.

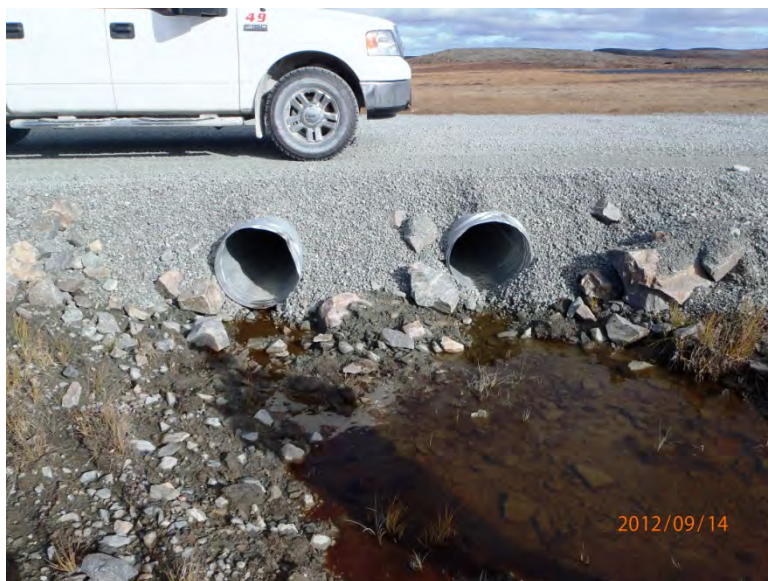
Photograph D1-39 : PC-7A km 20+495

Description: Upstream view of culverts. Good condition.

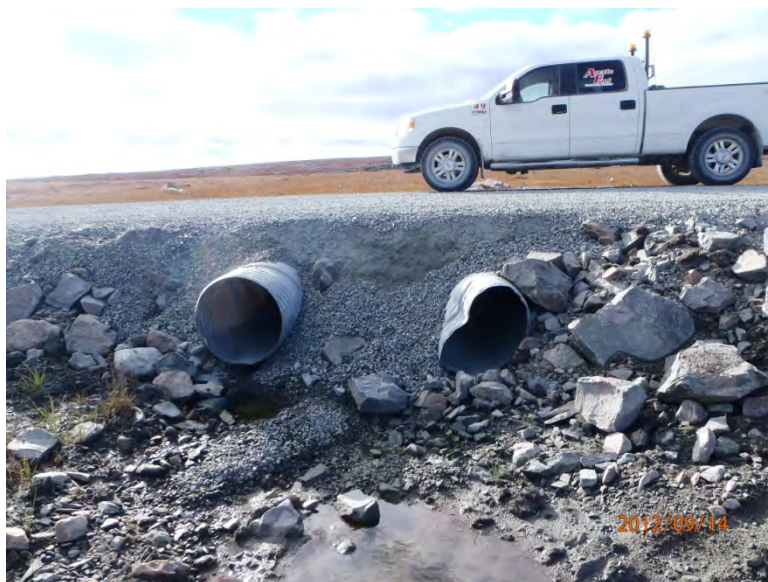
Photograph D1-40 : PC-7A km 20+240

Description: Downstream view of culverts. Outlet of the north culvert (right) is slightly damaged. A little bit of erosion at the base of the outlet of the south culvert (left).

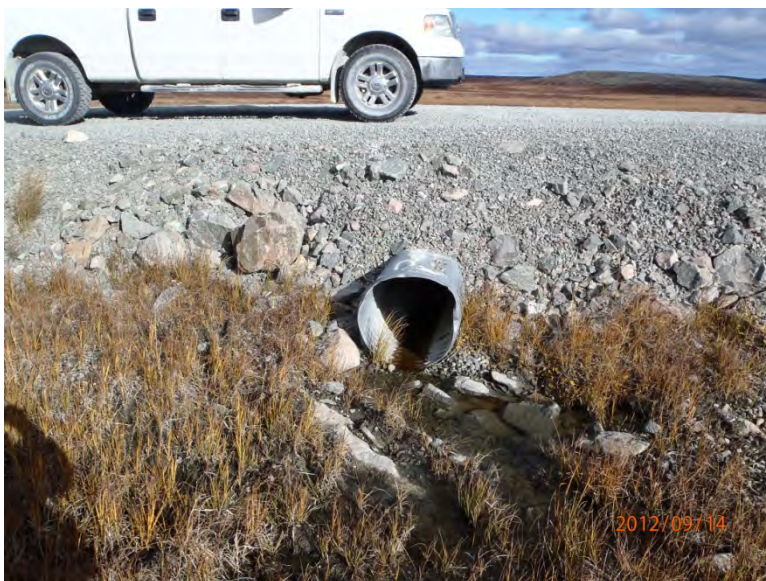
Photograph D1-41 : PC-7 km 20+250

Description: Upstream view of the culvert. Good condition.

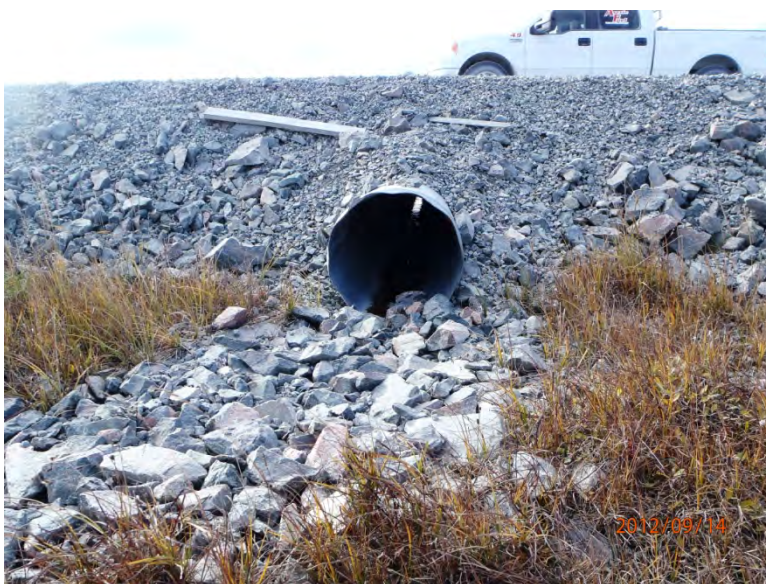
Photograph D1-42 : PC-7 km 20+250

Description: Downstream view of the culvert. Good condition. Streambed covered by road material.

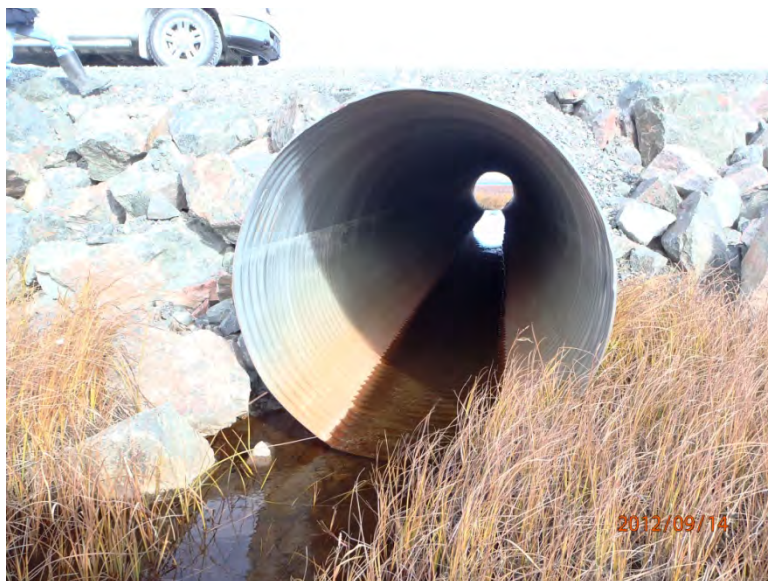
Photograph D1-43 : R-07 km 25+900

Description: Upstream view of the culvert. Good condition.

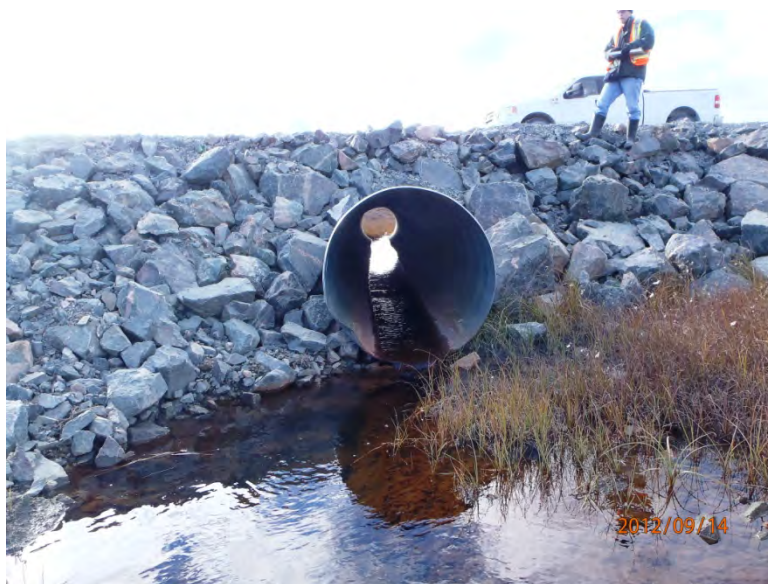
Photograph D1-44 : R-07 km 25+900

Description: Downstream view of the culvert. Good condition.

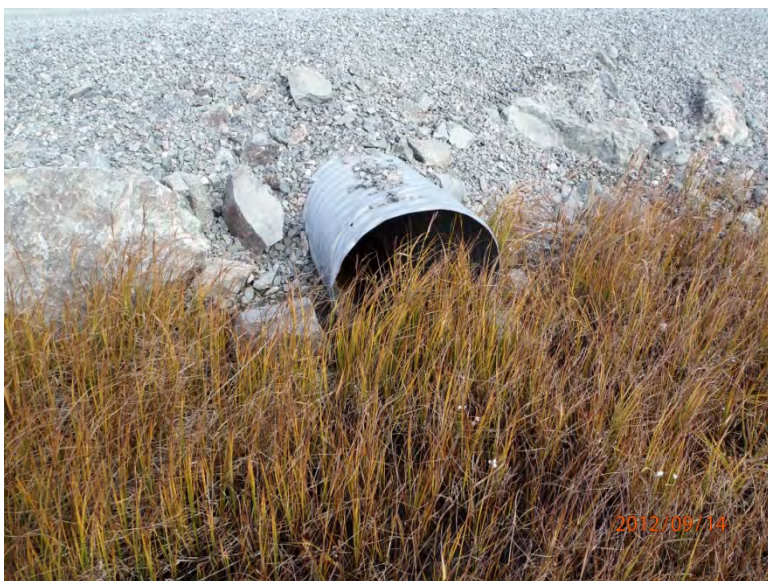
Photograph D1-45 : PC-8 km 29+420

Description: Upstream view of the culvert. Good condition.

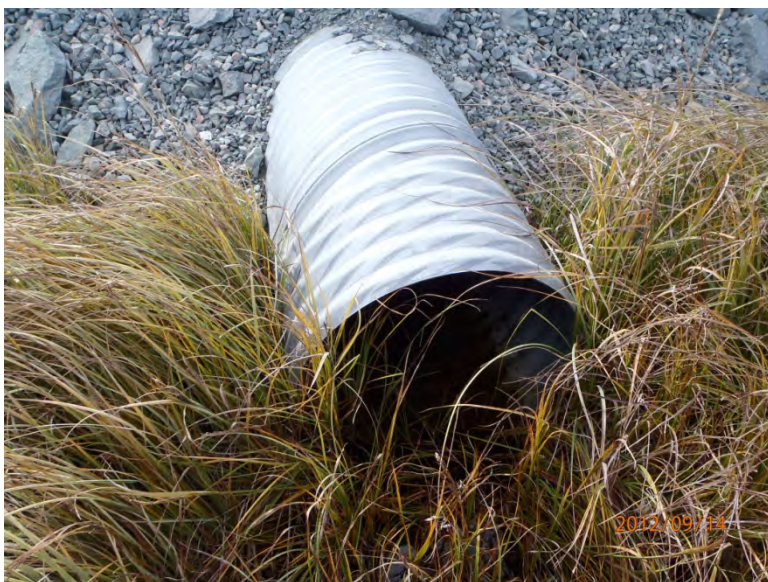
Photograph D1-46 : PC-8 km 29+420

Description: Downstream view of the culvert. Good condition.

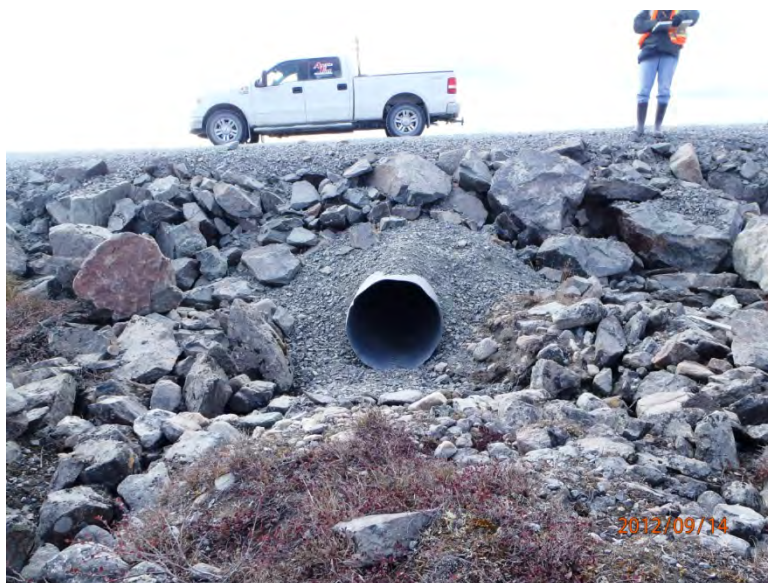
Photograph D1-47 : PC-9 km 35+690

Description: Upstream view of the culvert. Good condition.

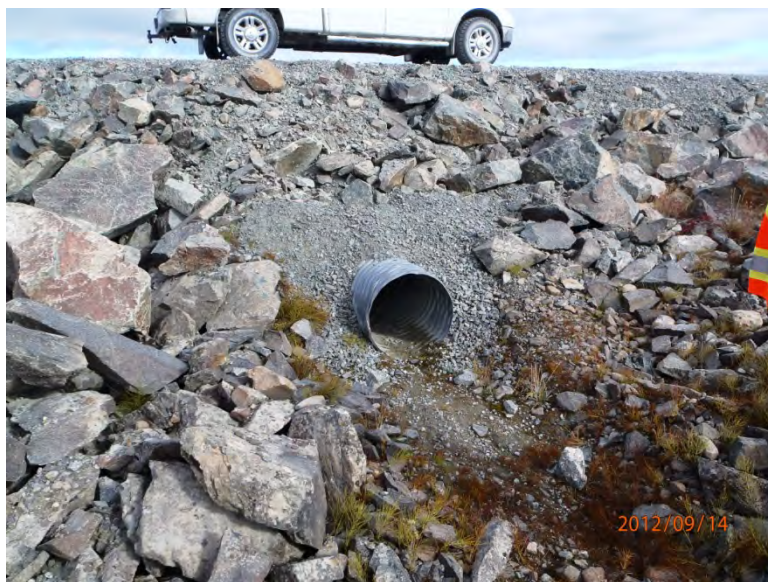
Photograph D1-48 : PC-9 km 35+690

Description: Downstream view of the culvert. Good condition.

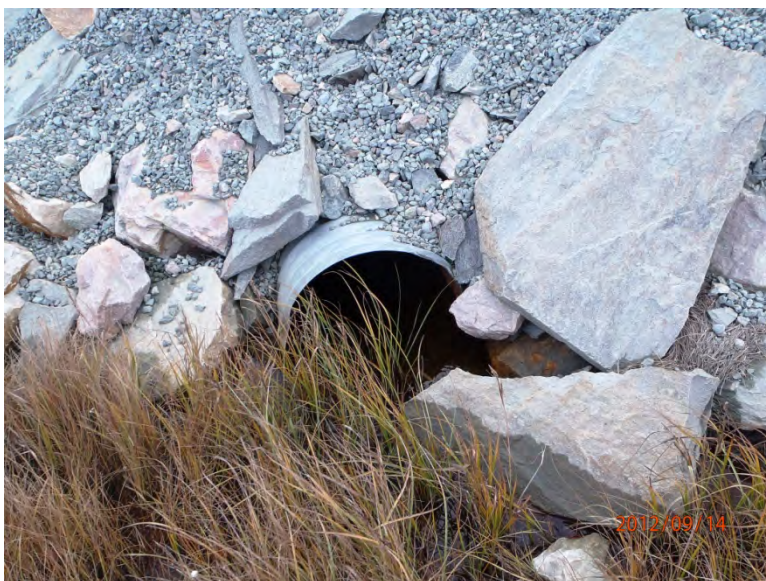
Photograph D1-49 : PC-10 km 36+865

Description: Upstream view of the culvert. Good condition.

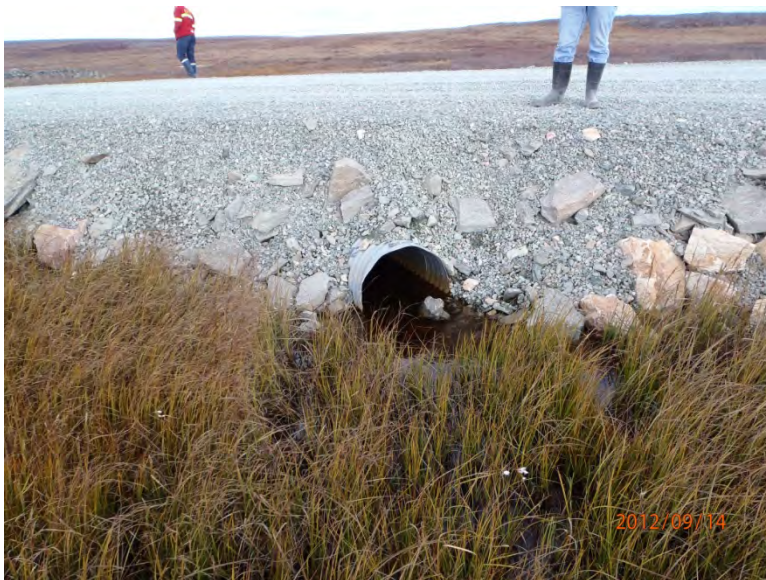
Photograph D1-50 : PC-10 km 36+865

Description: Downstream view of the culvert. Good condition.

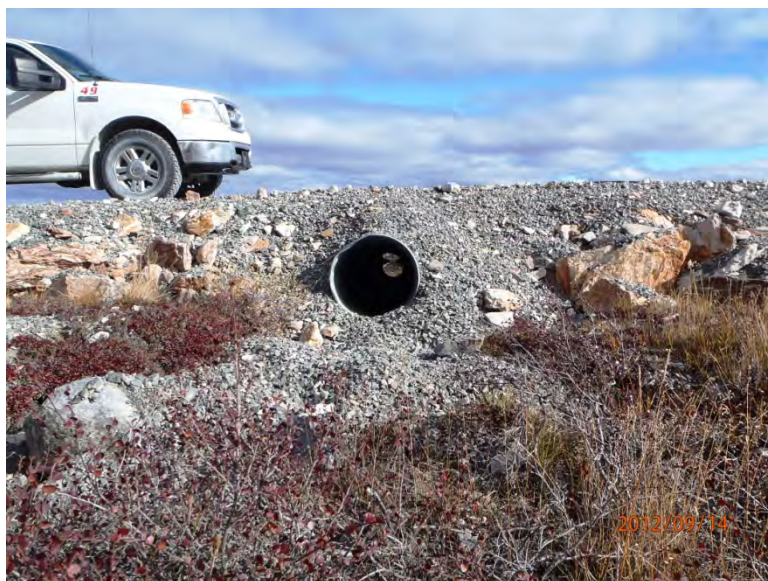
Photograph D1-51 : PC-11 km 39+552

Description: Upstream view of the culvert. Good condition.

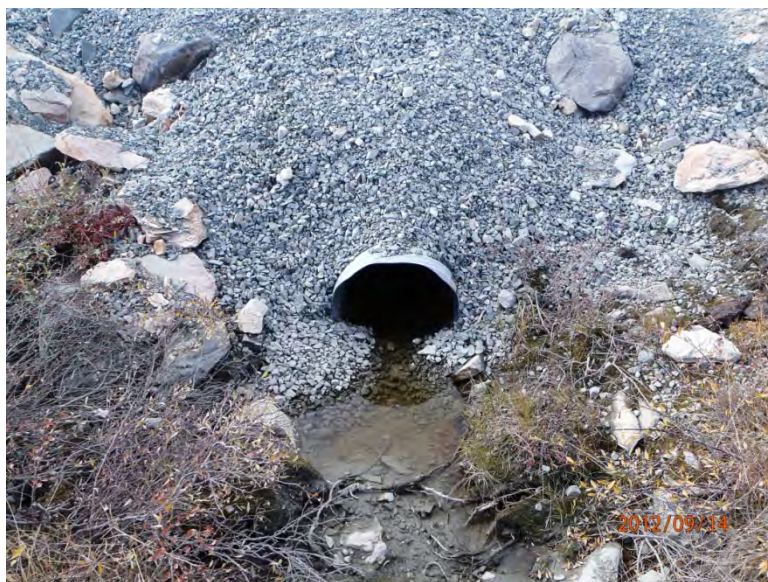
Photograph D1-52 : PC-11 km 39+552

Description: Downstream view of the culvert. Minor obstruction of the outlet, but in good condition.

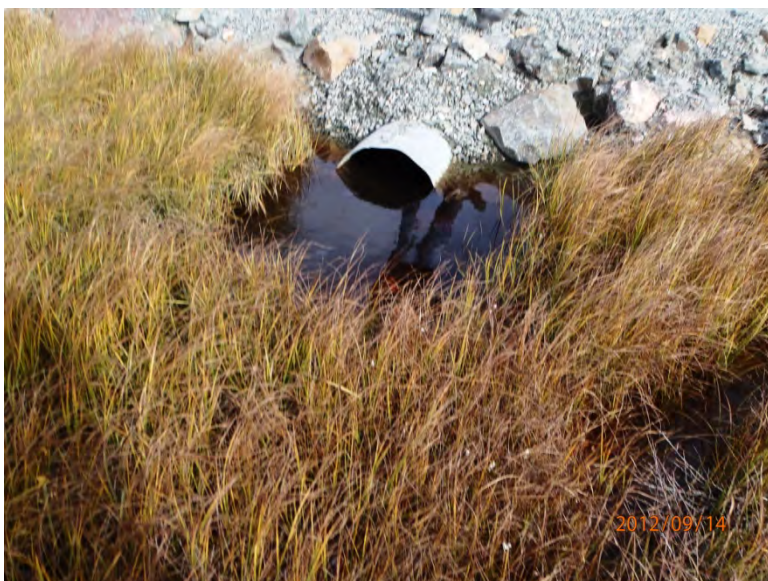
Photograph D1-53 : PC-12 km 41+300

Description: Upstream view of the culvert. Good condition. Culvert practically submerged.

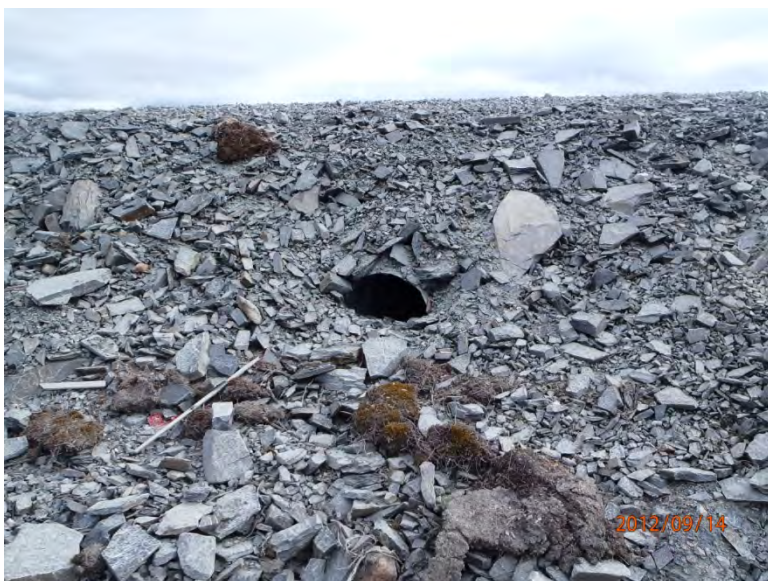
Photograph D1-55 : PC-16 km 54+950

Description: Upstream view of the culvert. Halfway buried by road material.

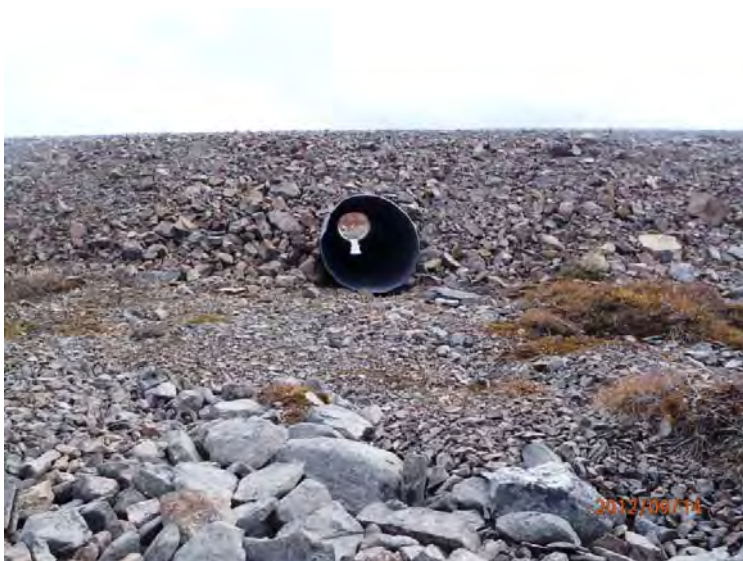
Photograph D1-57 : R-14 km 67+840

Description: Upstream view of the northern culvert (out of three). Small signs of erosion, collapsed inside (hole in the middle). Expected to continue performing well.

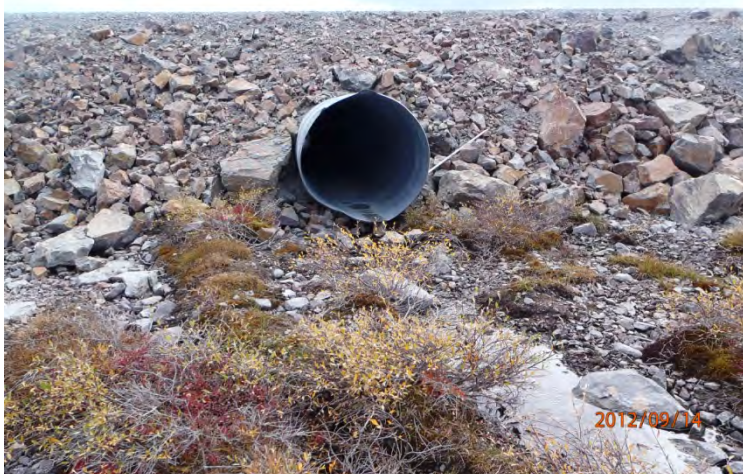
Photograph D1-59 : R-14 km 67+840

Description: Upstream view of the middle culvert (out of three). Small signs of erosion, collapsed inside (hole in the middle) but still in good condition.

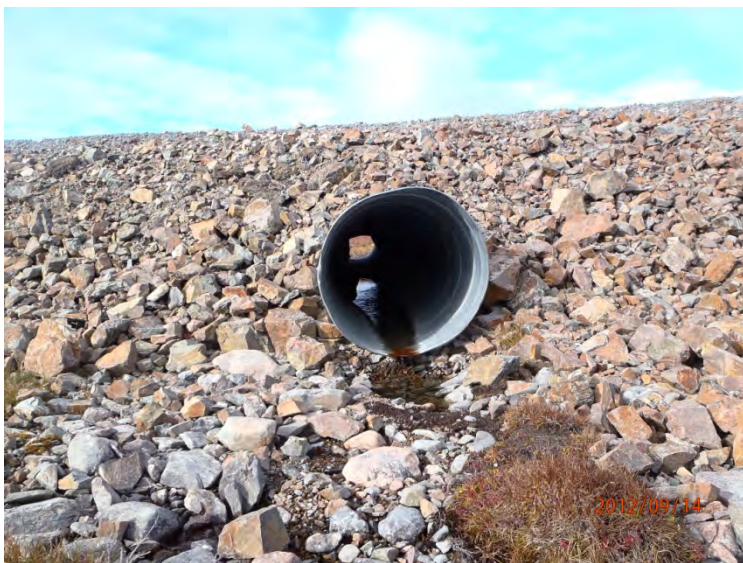
Photograph D1-60 : R-14 km 67+840

Description: Downstream view of the middle culvert (out of three). Small signs of erosion, collapsed inside (hole in the middle) but still in good conditions.

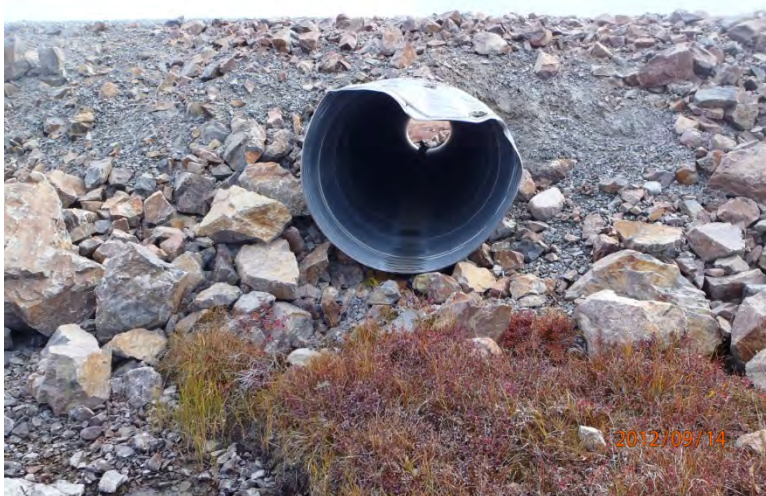
Photograph D1-61 : R-14 km 67+840

Description: Upstream view of the southern culvert (out of three). Good condition. Minor damage to the inlet.

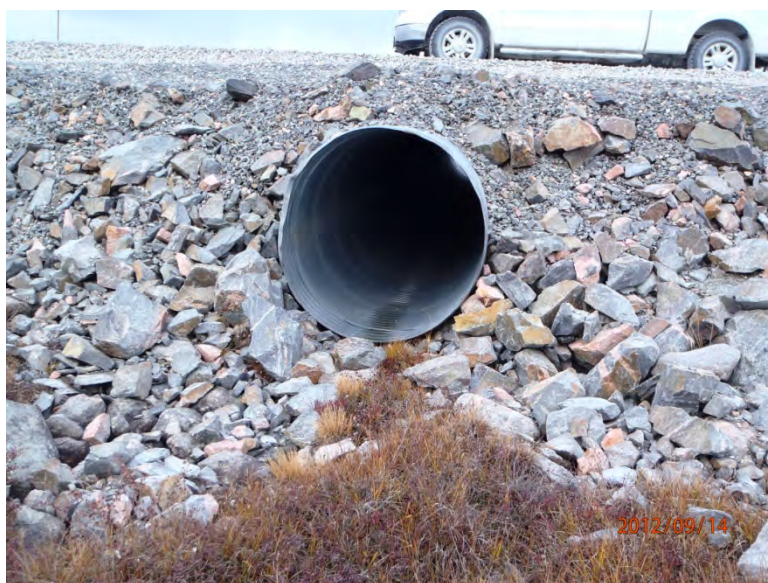
Photograph D1-63 : R-17 km 77+440

Description: Upstream view of the culvert. Good condition.

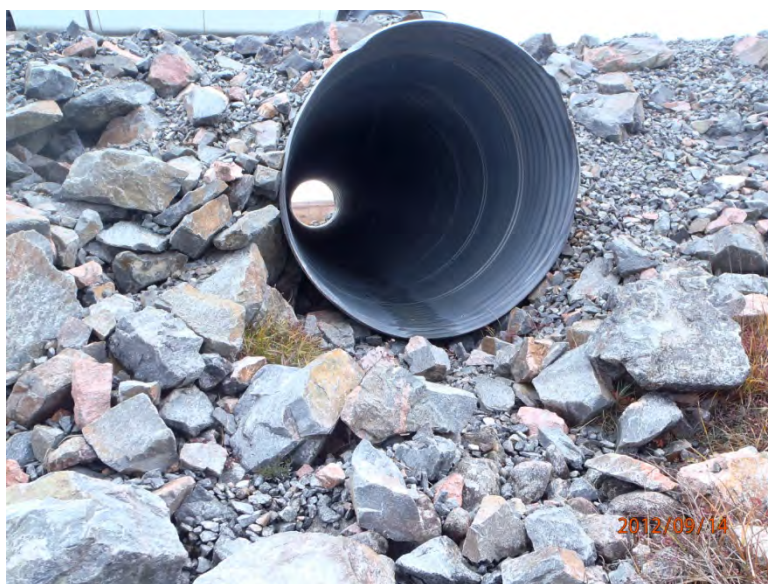
Photograph D1-64 : R-17 km 77+440

Description: Downstream view of the culvert. Good condition.

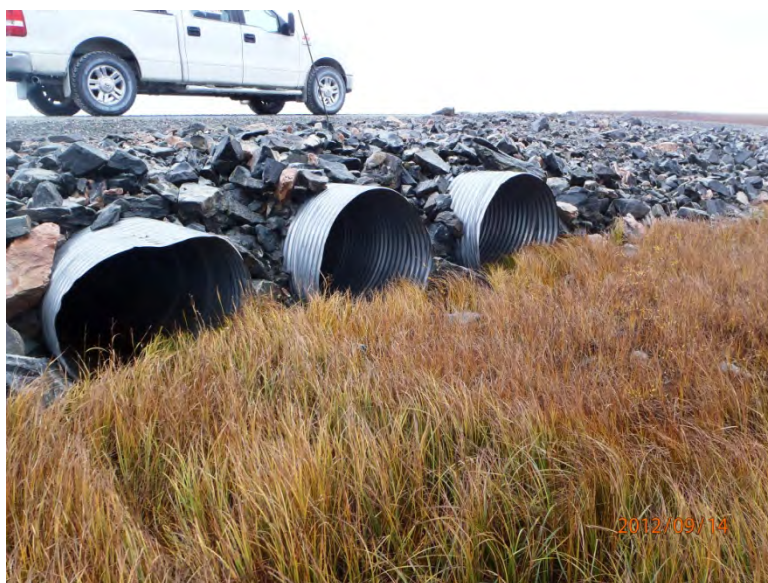
Photograph D1-65 : R-18A km 80+950

Description: Upstream view of the culverts. Good condition.
