Report: *2012 Annual Review of Portage and Goose Pit Slope Performance*

2012 Annual Geotechnical Inspection Meadowbank Gold Mine, Nunavut

Agnico-Eagle Mines Limited
Meadowbank Division
PO Box 540
Baker Lake, Nunavut
X0C 0A0

Report Number: Doc 1394 1212210073 0115_13

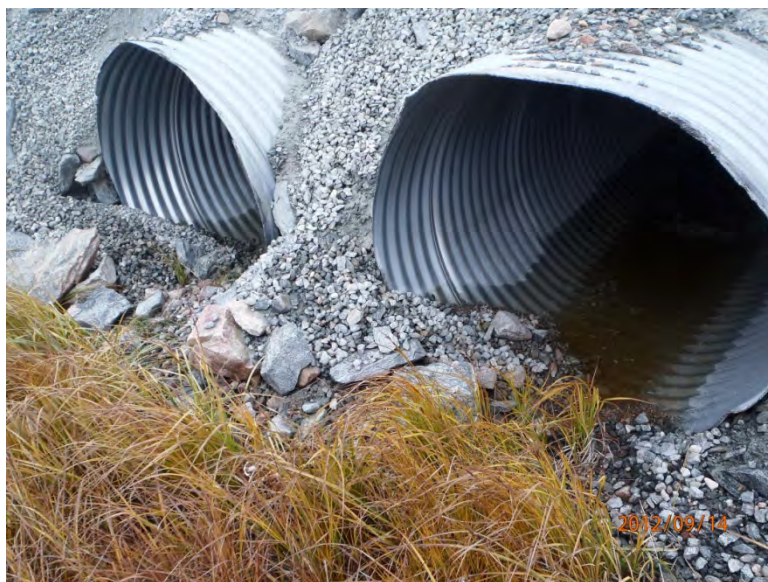
Photograph D1-66 : R-18A km 80+950

Description: Downstream view of the culverts. Good condition. Minor obstruction of the southern culvert outlet (right) caused by accumulation of road material.

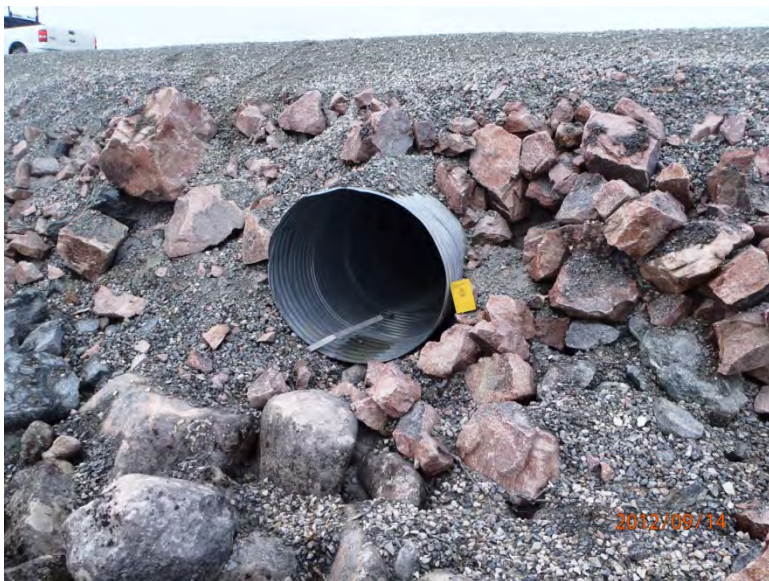
Photograph D1-67 : R-20 km 85+490

Description: Upstream view of the culvert. Good condition.

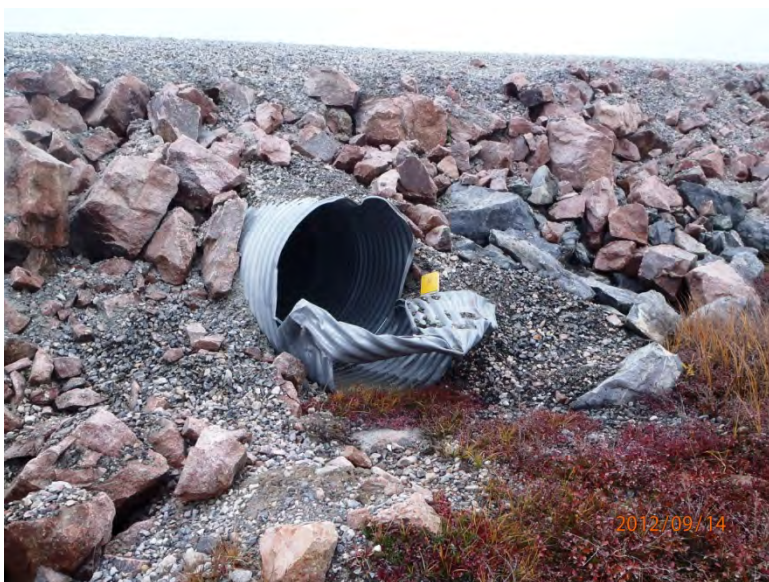
Photograph D1-68 : R-20 km 85+490

Description: Downstream view of the culvert. Outlet is damaged but in good condition overall.

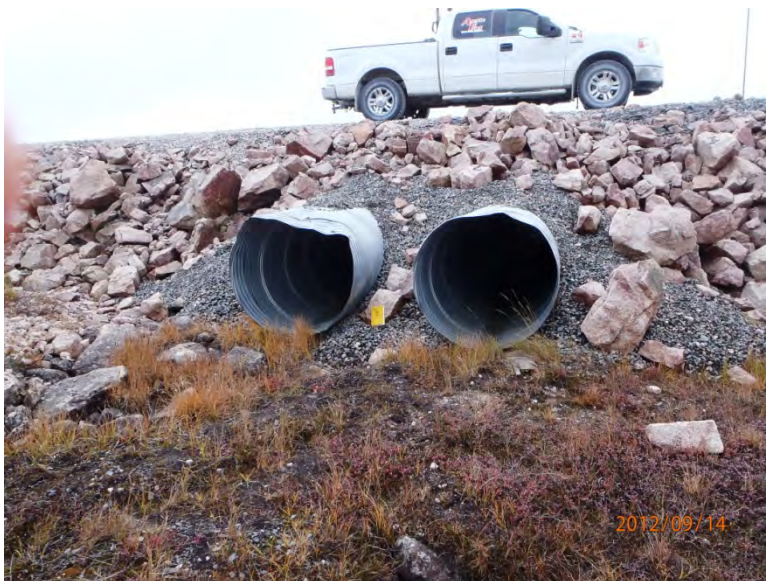
Photograph D1-69 : R-21 km 87+300

Description: Upstream view of the culverts. Good condition.

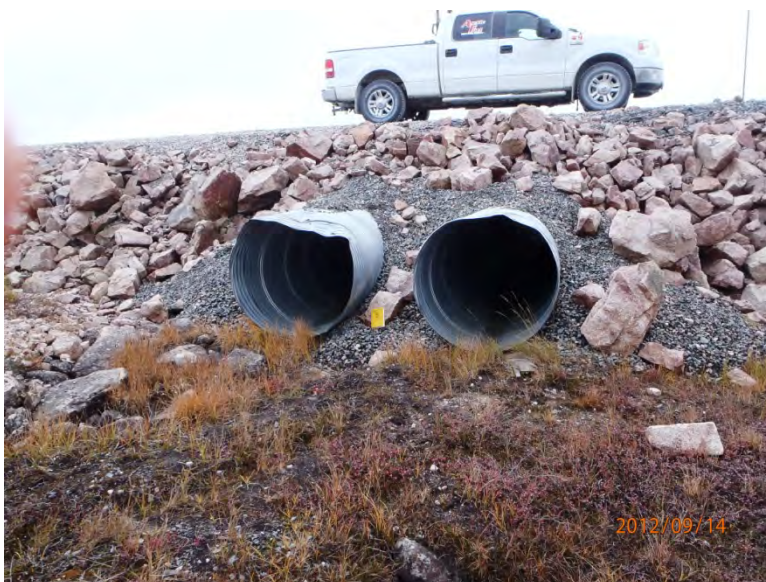
Photograph D1-70 : R-21 km 87+300

Description: Downstream view of the culverts. Good condition.

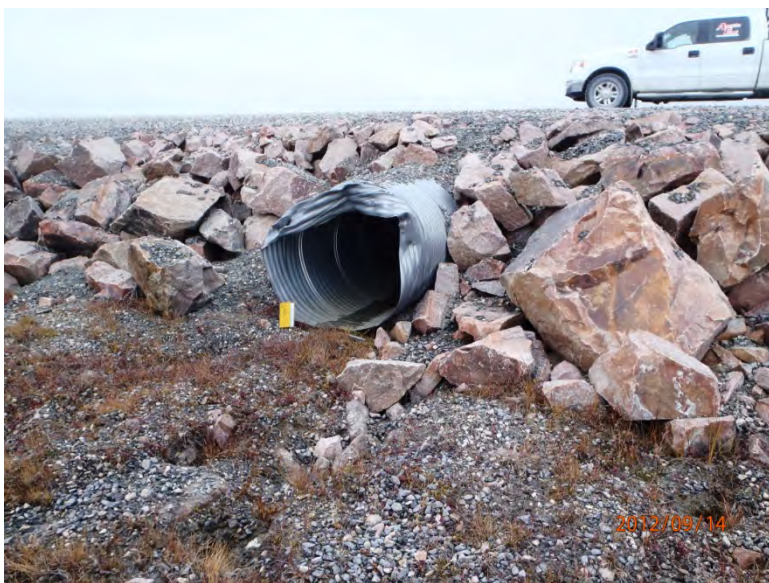
Photograph D1-71 : R-23 km 93+600

Description: Upstream view of the culvert. Inlet has minor damage near the top, but is in good condition.

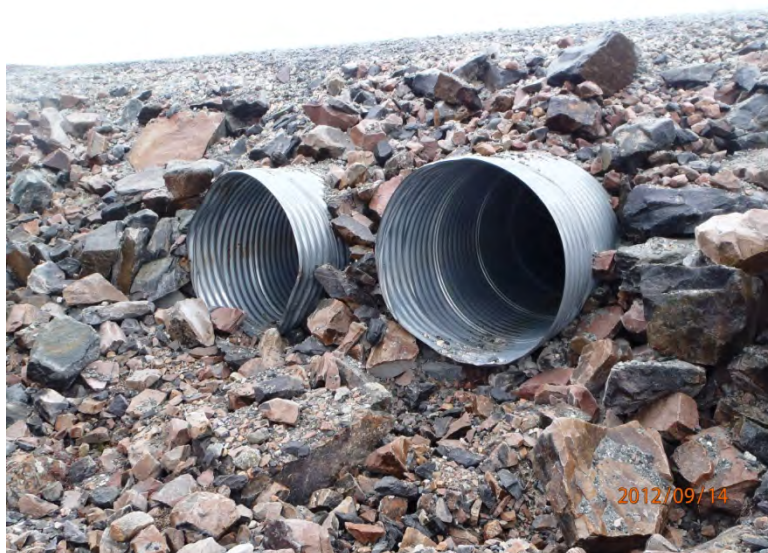
Photograph D1-73 : R-24 km 98+100

Description: Upstream view of the culverts. Good condition.

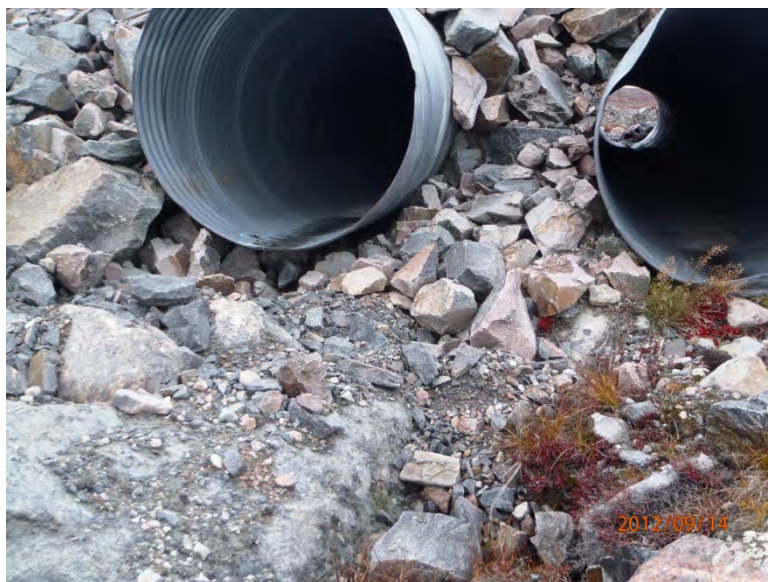
Photograph D1-74 : R-24 km 98+100

Description: Downstream view of the culverts. Good condition. The outlet of the southern culvert (left) shows signs of underneath erosion.

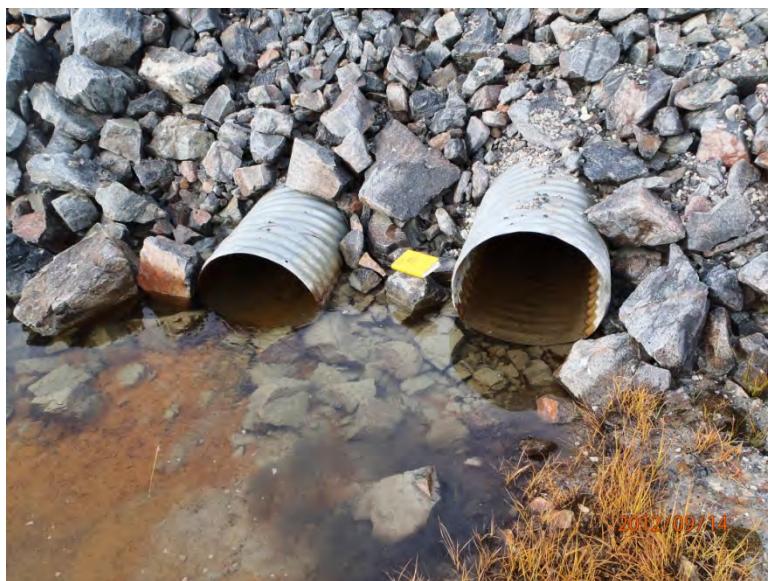
Photograph D1-75 : R-25 km 101+950

Description: Upstream view of the culverts. Good condition.

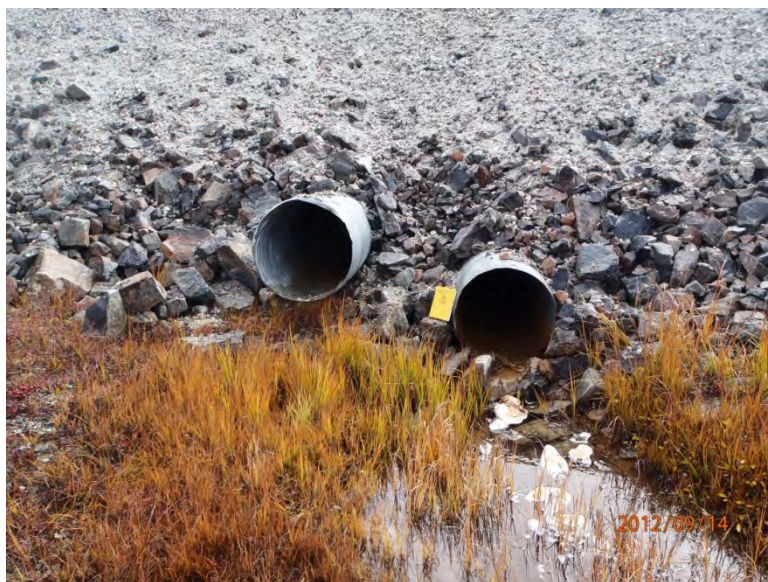
Photograph D1-76 : R-25 km 101+950

Description: Downstream view of the culverts. Good condition.

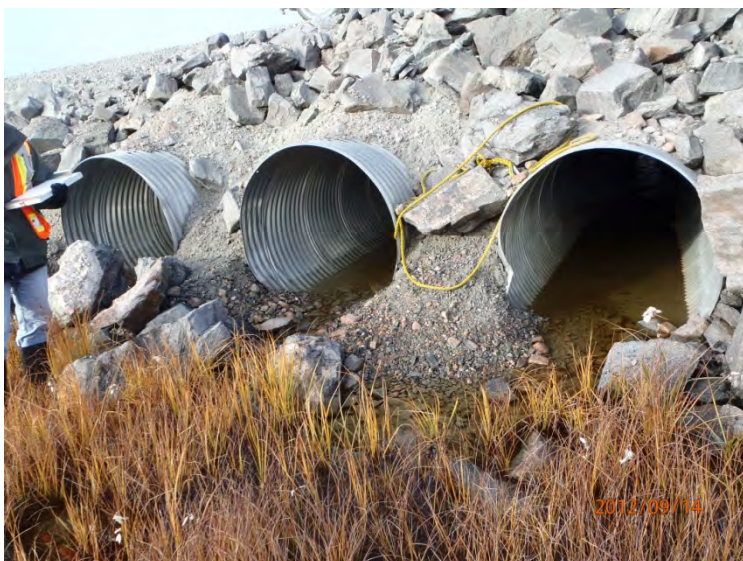
Photograph D1-77 : R-26 km 104+400

Description: Upstream view of the culverts. Good condition.

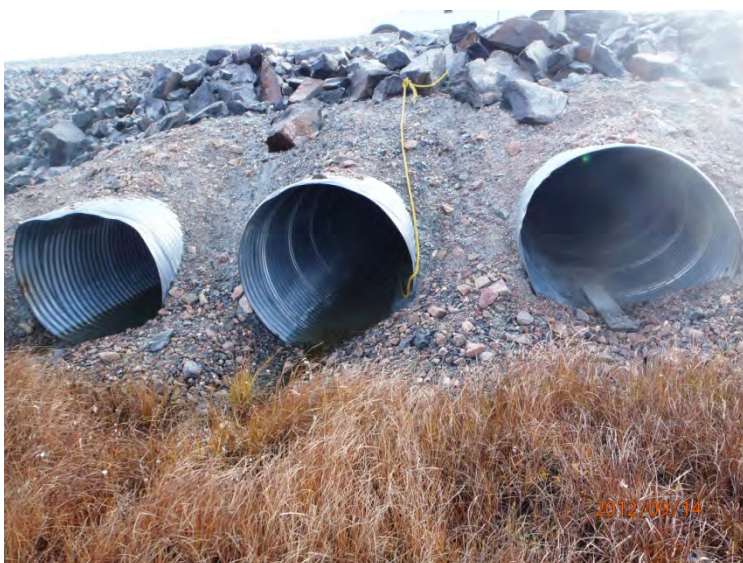
Photograph D1-78 : R-26 km 104+400

Description: Downstream view of the culverts. Good condition.

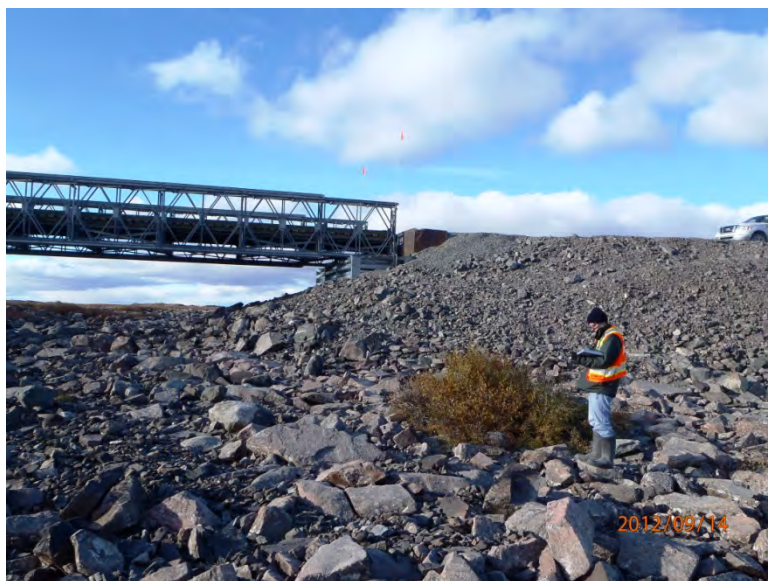
Photograph D2-1 Bridges 1 – R02 km 8+750

Description: Looking at the north abutment from downstream.

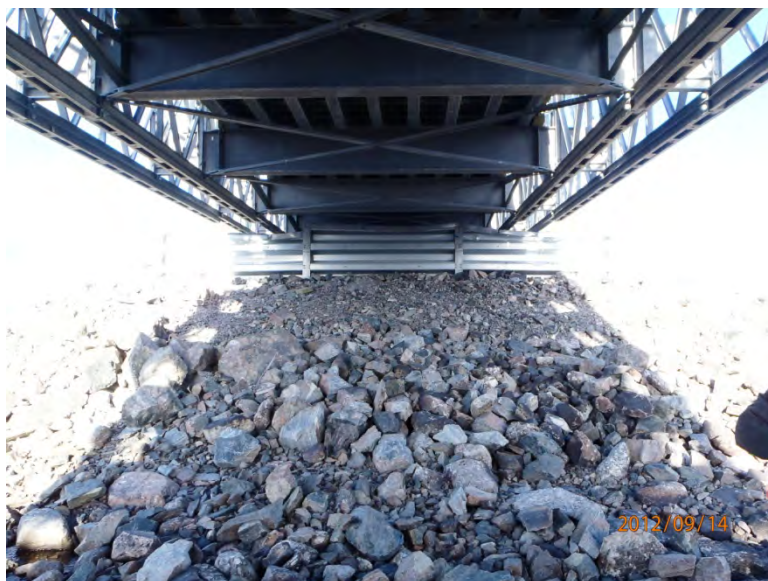
Photograph D2-3 Bridges 1 – R02 km 8+750

Description: Looking beneath the bridge at the north abutment.

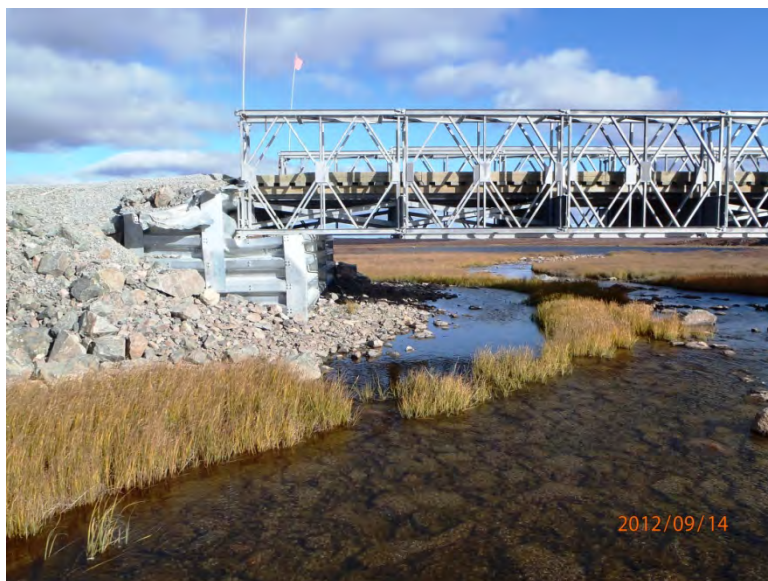
Photograph D2-5 Bridges 2 – R05 km 17+600

Description: Looking at the north abutment from upstream. Damage of the bin wall likely caused during snow removal activities.

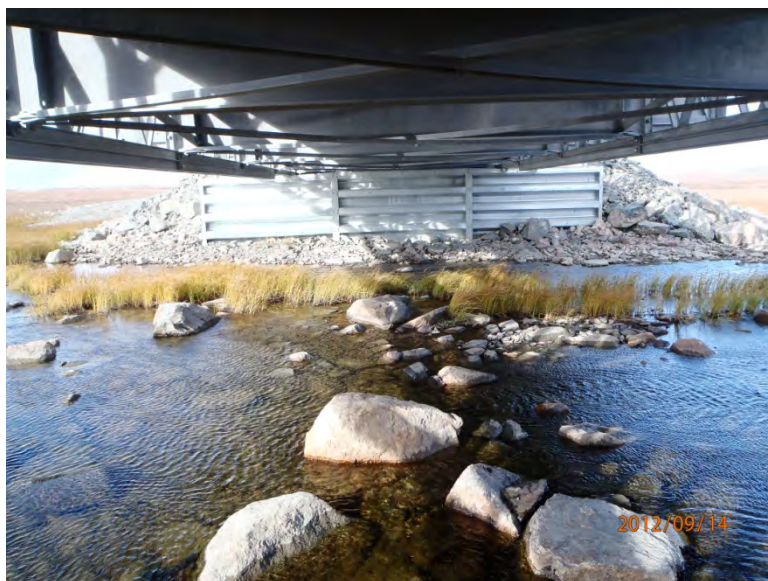
Photograph D2-7 Bridges 2 – R05 km 17+600

Description: Looking beneath the bridge at the north abutment.

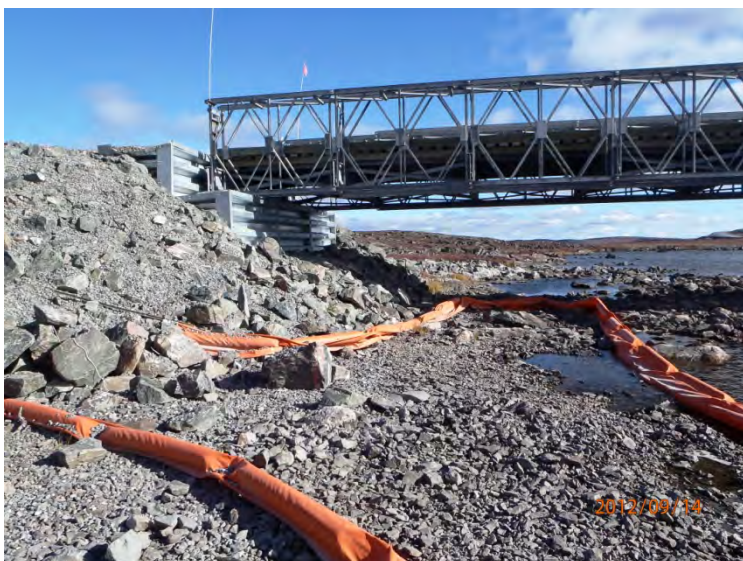
Photograph D2-9 Bridges 3 – R06 km 23+100

Description: Looking at the east abutment from upstream.

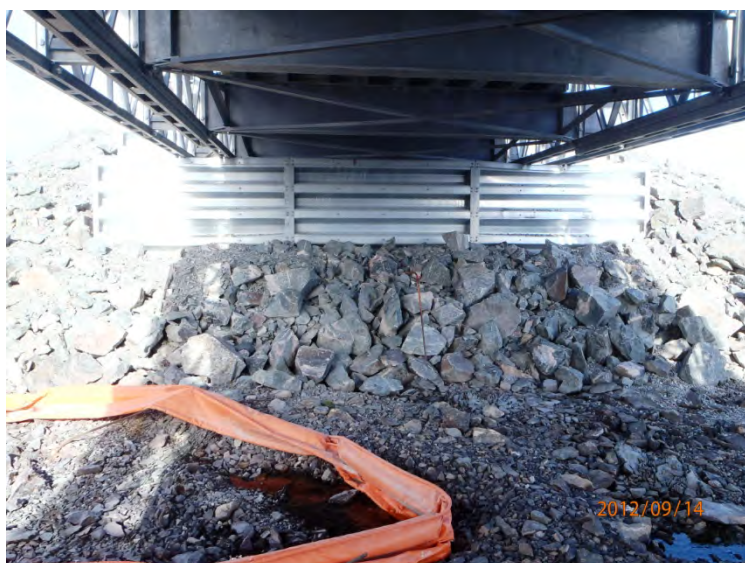
Photograph D2-11 Bridges 3 – R06 km 23+100

Description: Looking beneath the bridge at the east abutment.

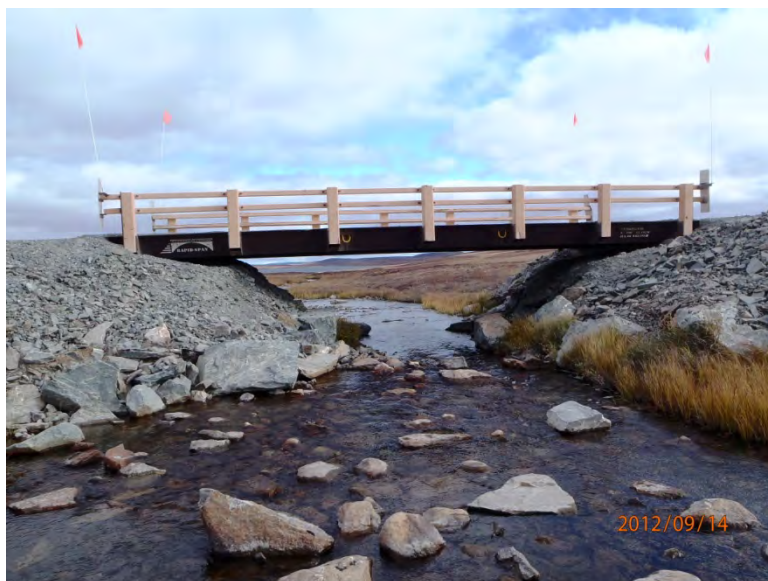
Photograph D2-13 Bridges 4 – R09 km 48+500

Description: Looking at the bridge from upstream.

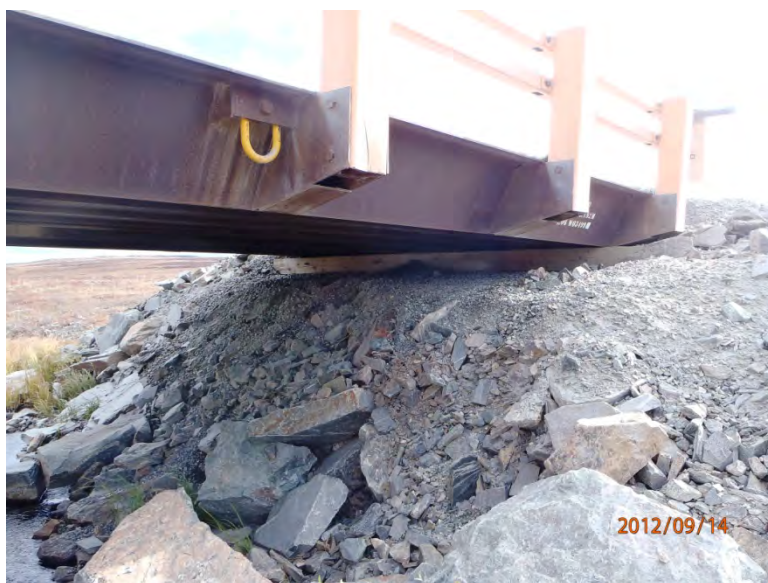
Photograph D2-15 Bridges 4 – R09 km 48+500

Description: Looking at the south abutment from upstream.

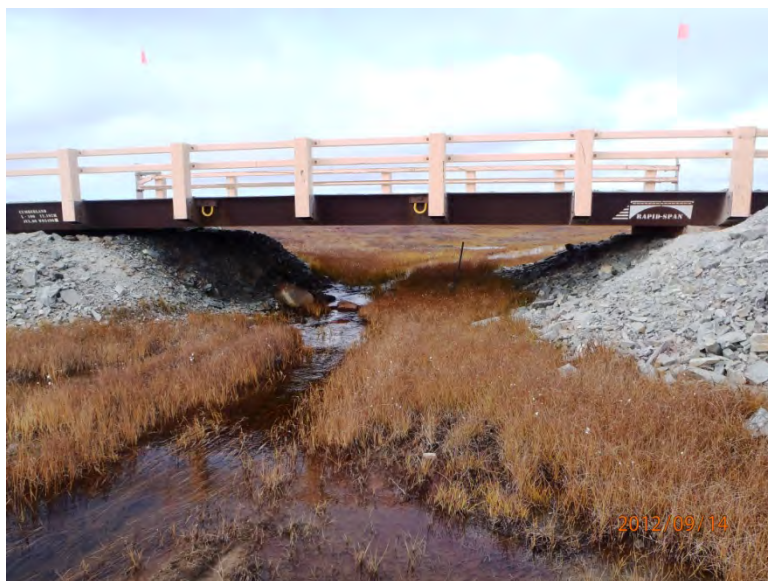
Photograph D2-17 Bridges 5 – R13 km 62+060

Description: Looking at the bridge from downstream.

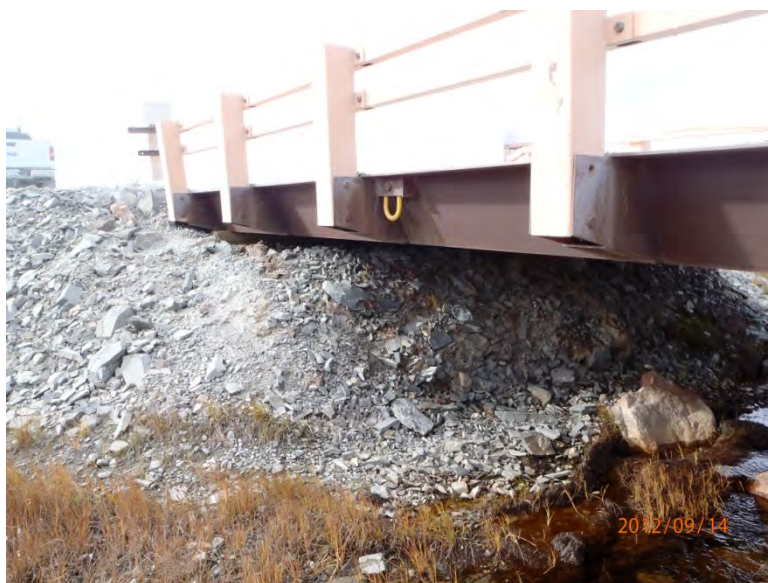
Photograph D2-19 Bridges 5 – R13 km 62+060

Description: Looking at the south abutment from downstream.

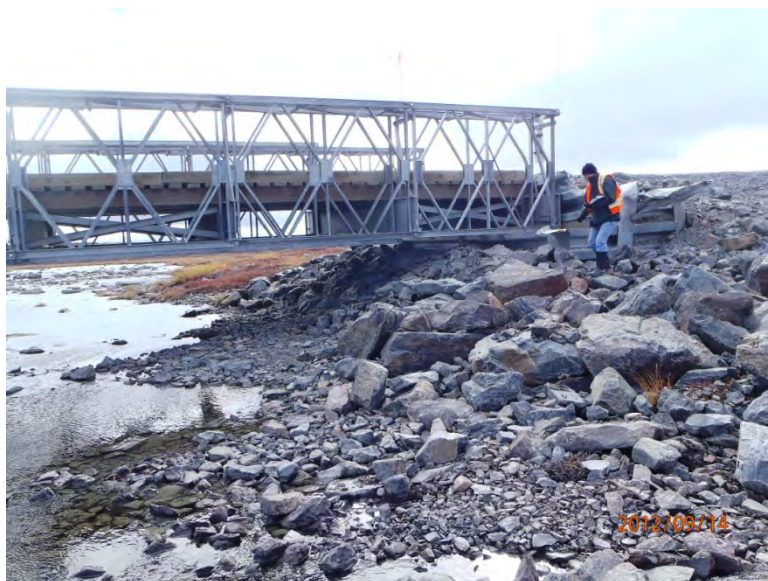
Photograph D2-21 Bridges 6 – R15 km 69+200

Description: Looking at the south abutment from downstream. Damage of the bin wall likely caused during snow removal activities.

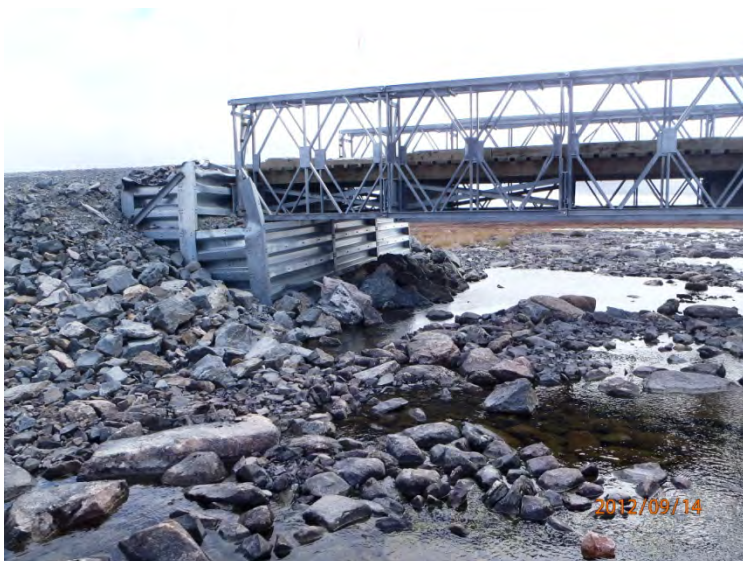
Photograph D2-23 Bridges 6 – R15 km 69+200

Description: Looking at the north abutment from downstream. Damage of the bin wall likely caused during snow removal activities.

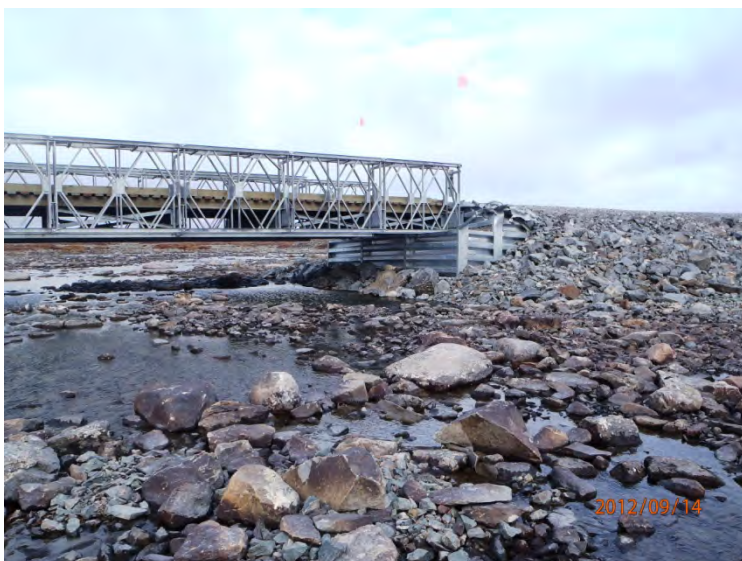
Photograph D2-25 Bridges 6 – R15 km 69+200

Description: Looking at the north abutment from upstream. Damage of the bin wall likely caused during snow removal activities.

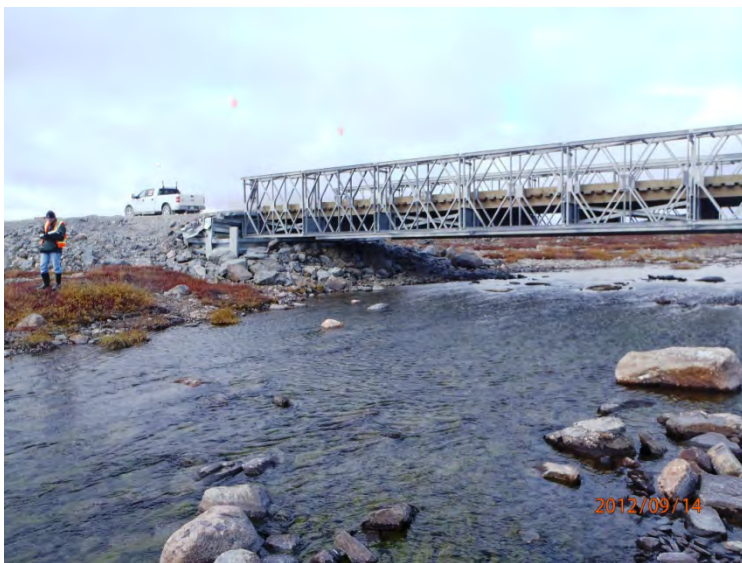
Photograph D2-26 Bridges 6 – R15 km 69+200

Description: Looking at the south abutment from upstream. Damage of the bin wall likely caused during snow removal activities.

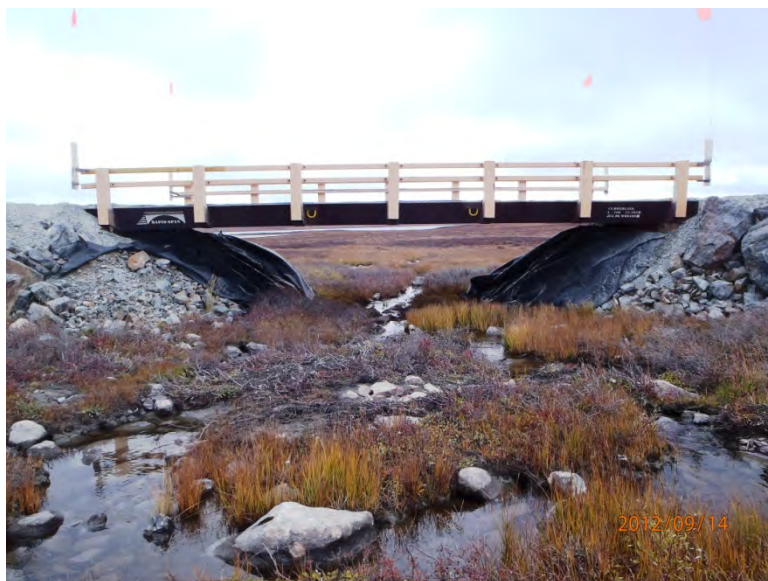
Photograph D2-27 Bridges 7 – R16 km 73+800

Description: Looking at the bridge from downstream.

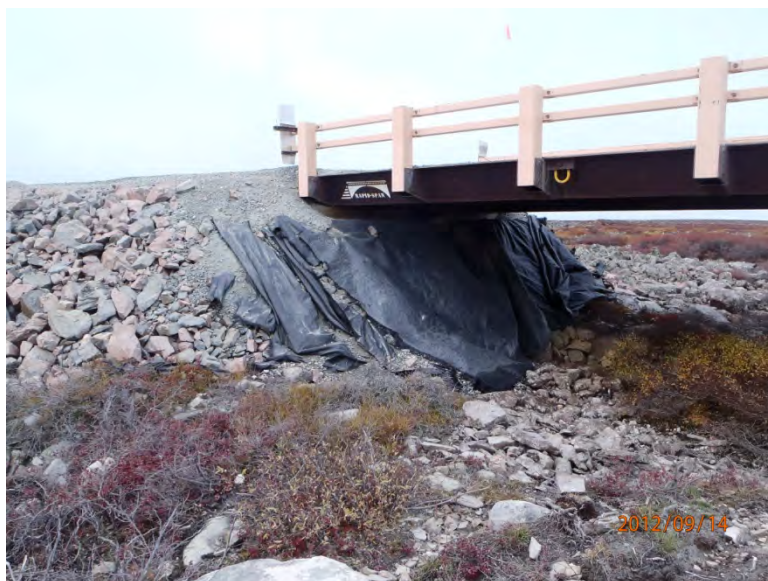
Photograph D2-29 Bridges 8 – R18 km 79+500

Description: Looking at the north abutment from downstream.

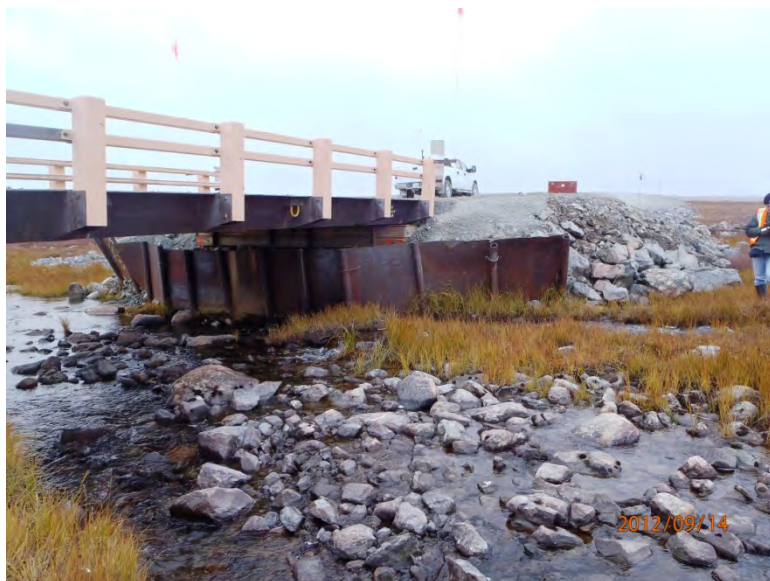
Photograph D2-31 Bridges 9 – R19 km 83+150

Description: Looking at the northwest abutment from upstream.

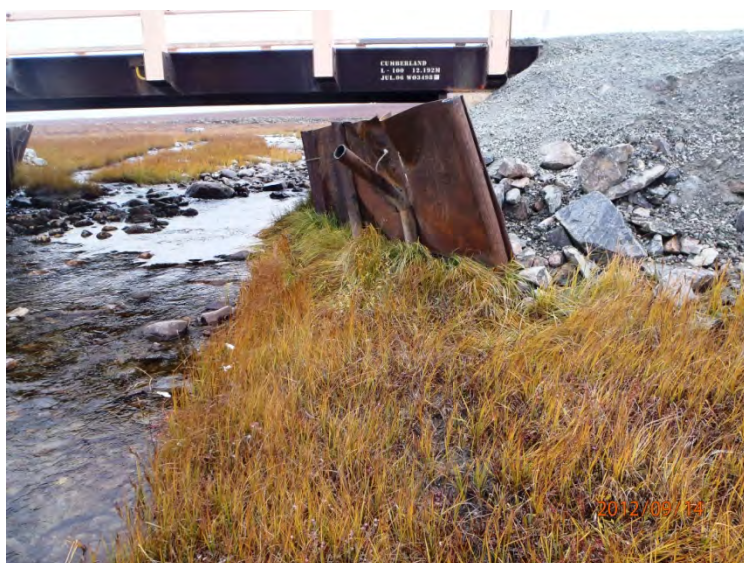
Photograph D2-33 Bridges 9 – R19 km 83+150

Description: Looking at the southeast abutment from downstream.

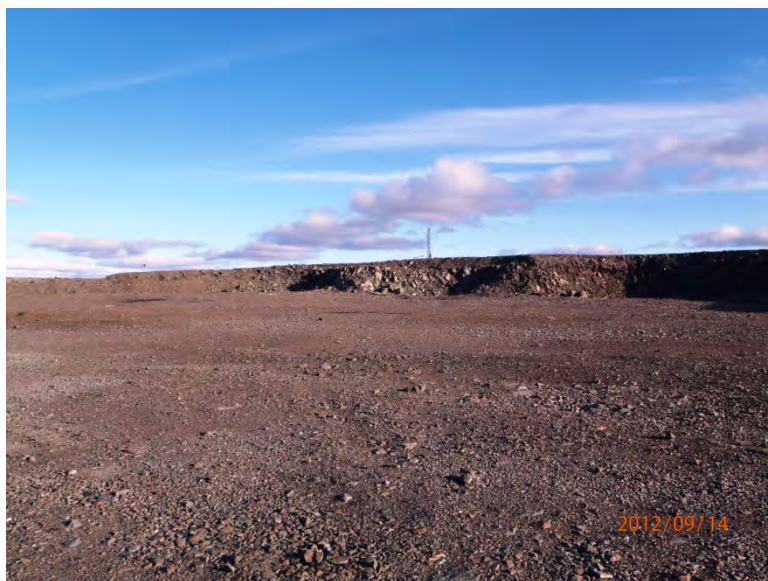
Photograph E1-1: Quarry 1 – km 5+200

Description: View of east wall.

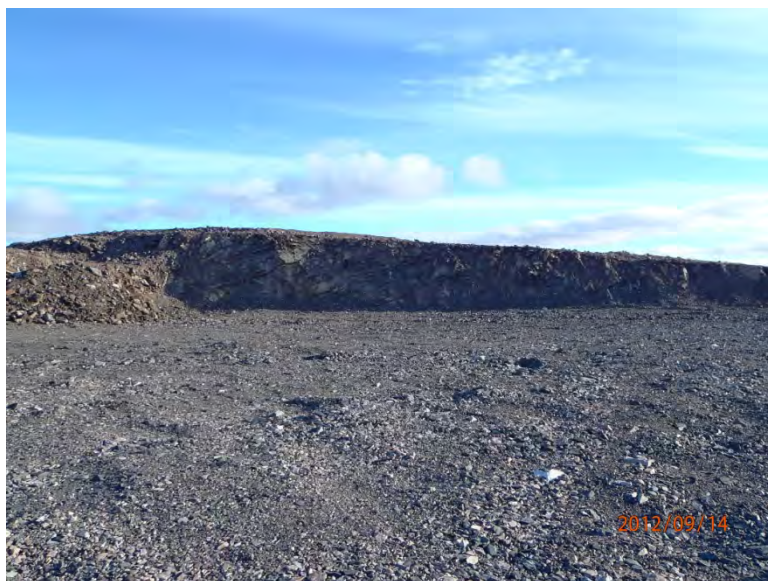
Photograph E1-3: Quarry 1 – km 5+200

Description: View of west wall.

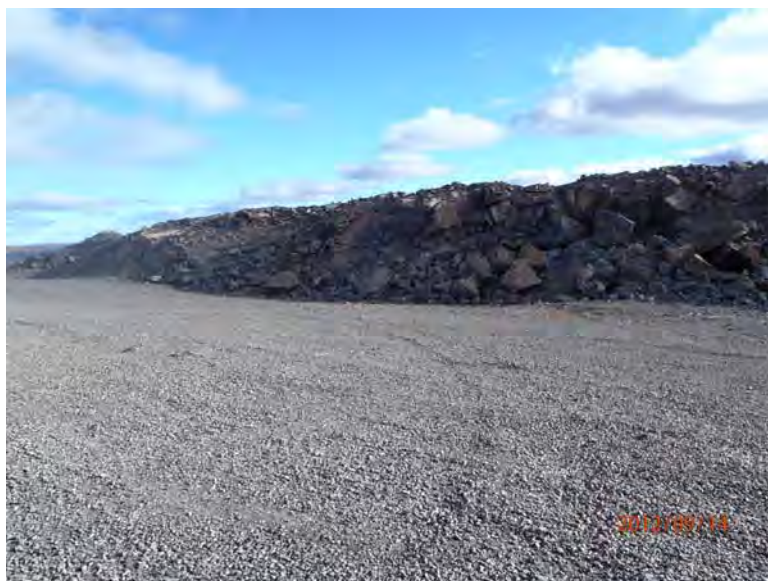
Photograph E1-5 : Quarry 2 – km 13+250

Description: View of south wall.

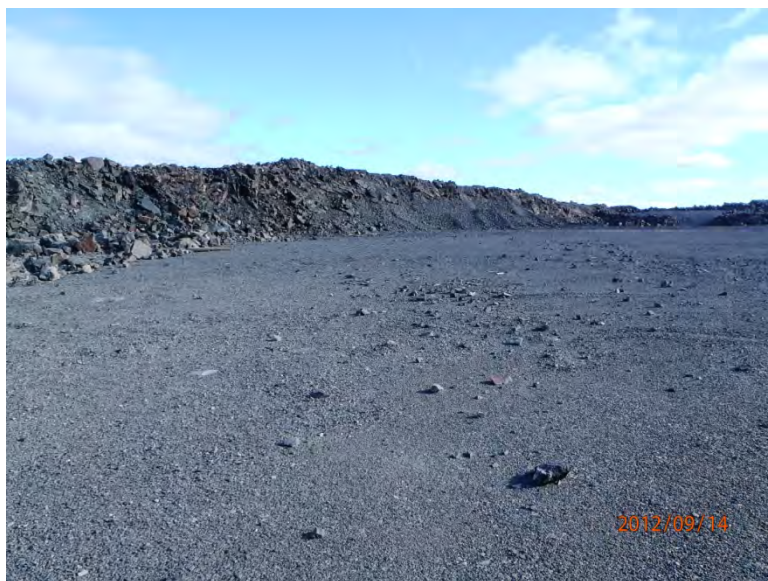
Photograph E1-7 : Quarry 3 – km 23+700

Description: View of east wall.

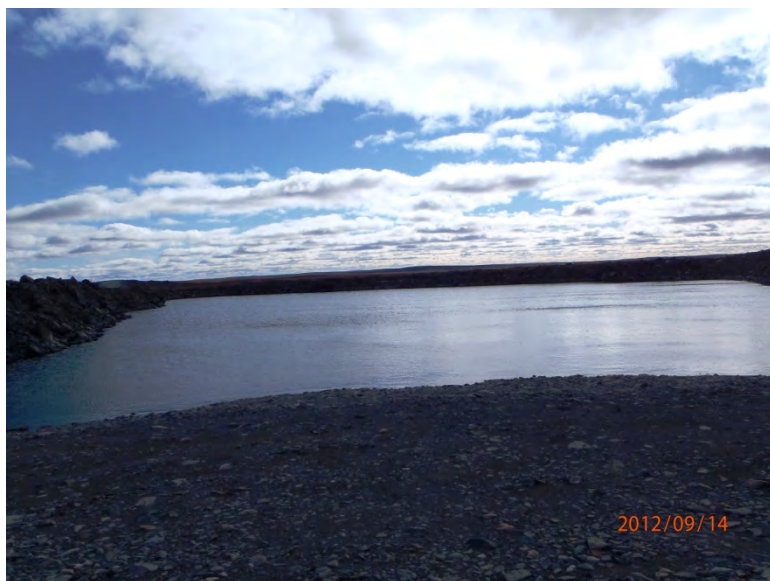
Photograph E1-9 : Quarry 4 – km 31+300

Description: View of Quarry 4, quarry is flooded, south and east wall not exposed.

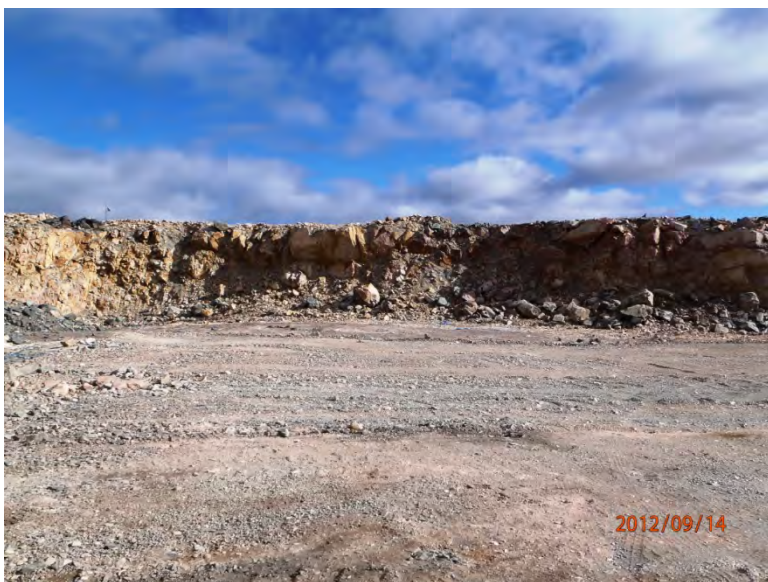
Photograph E1-12 : Quarry 5 – km 34+650

Description: View of northwest wall. Note contaminate soils temporary stored in this quarry.

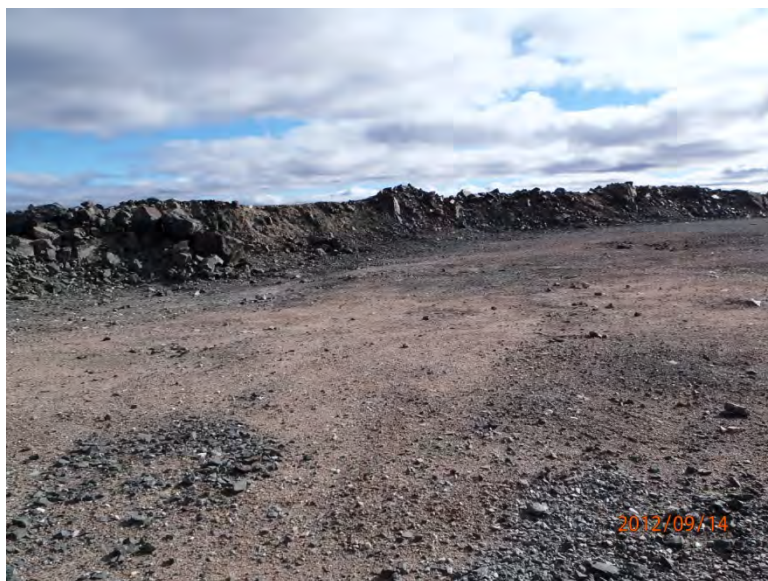
Photograph E1-13 : Quarry 6 – km 36+470

Description: View of east wall.

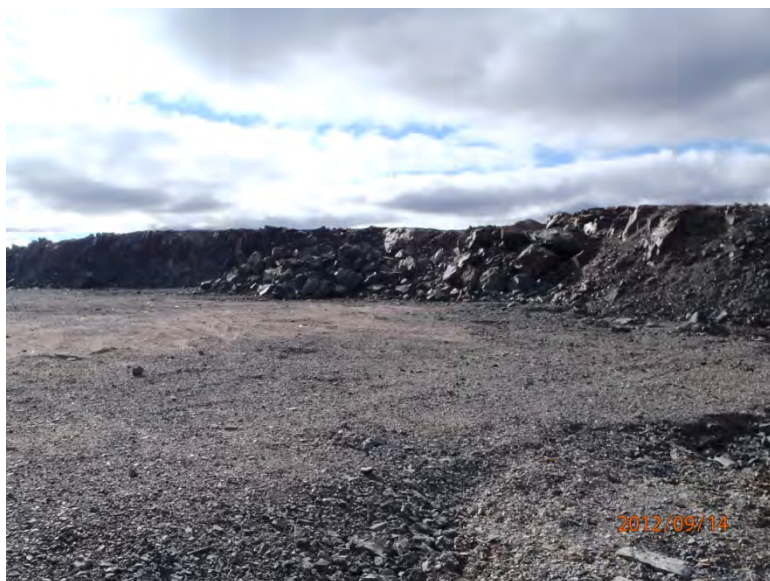
Photograph E1-15 : Quarry 6 – km 36+470

Description: View of west wall.

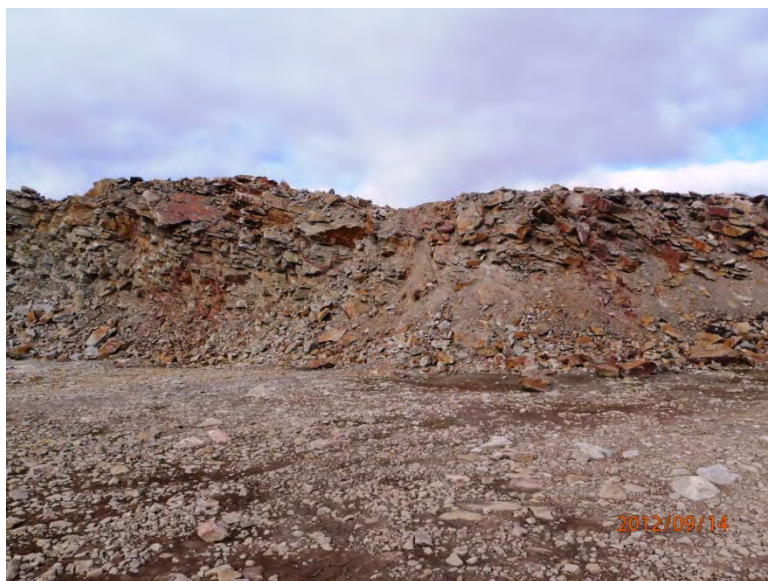
Photograph E1-17 : Quarry 7 – km 39+800

Description: View of north wall.

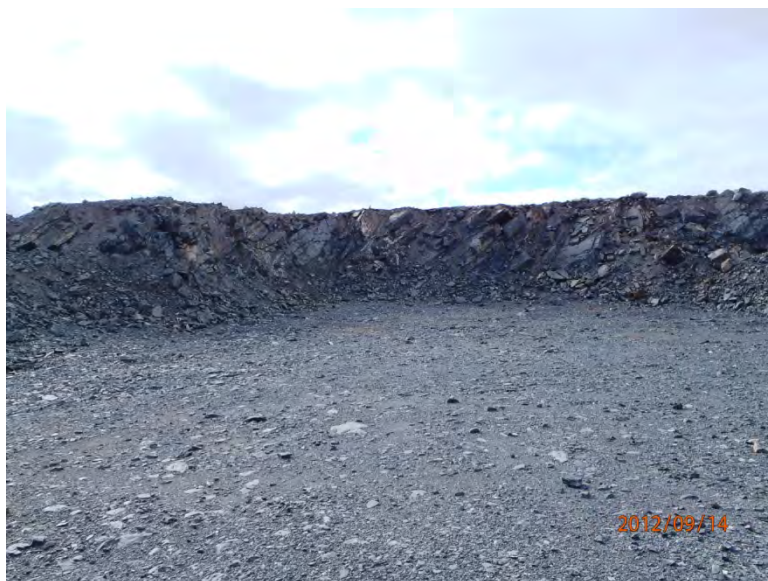
Photograph E1-19 : Quarry 8 – km 42+950

Description: View of southwest wall.

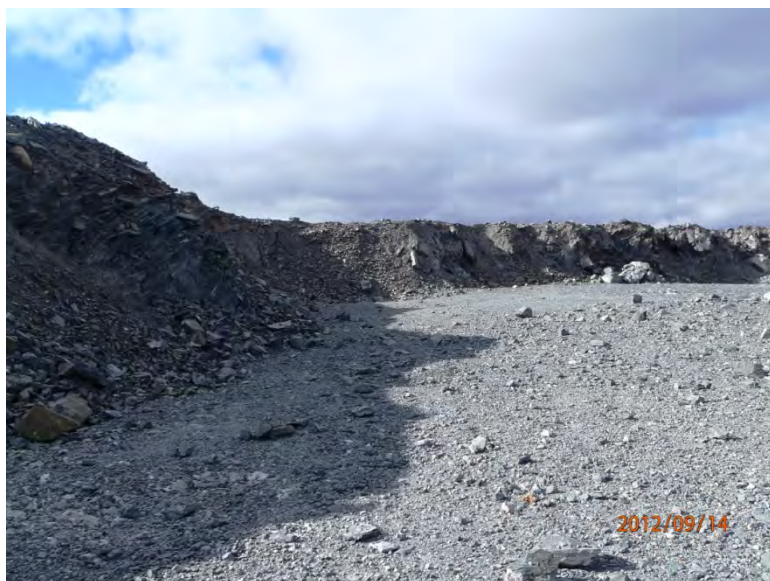
Photograph E1-21 : Quarry 9 – km 44+600

Description: View of southwest and west wall.

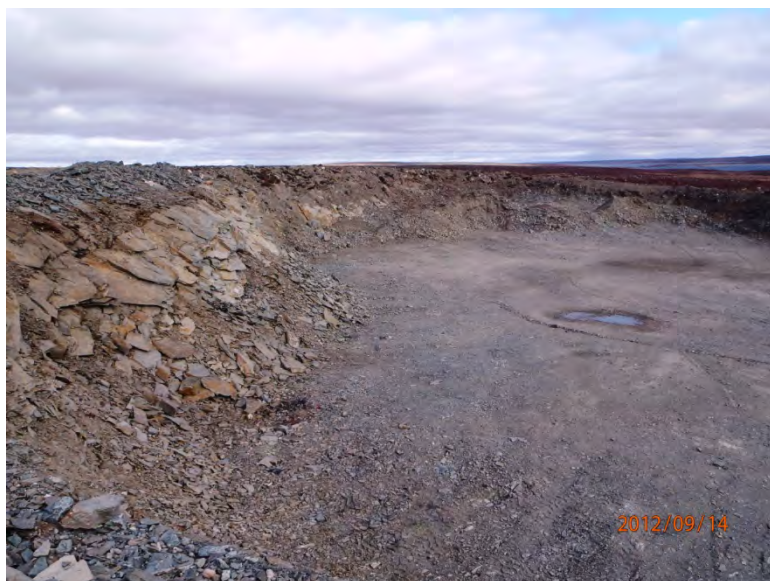
Photograph E1-23 : Quarry 10 – km 48+900

Description: Overview of the quarry looking north at the west and north wall.

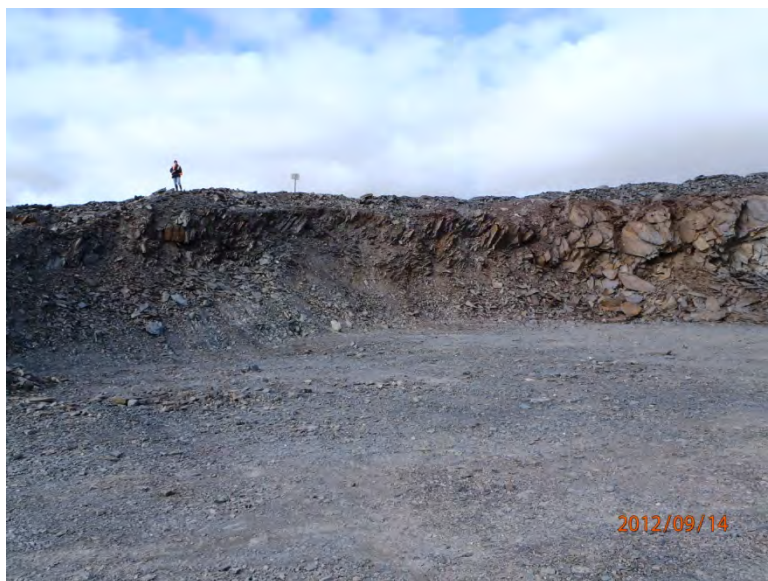
Photograph E1-25 : Quarry 10 – km 48+900

Description: View of the west wall.

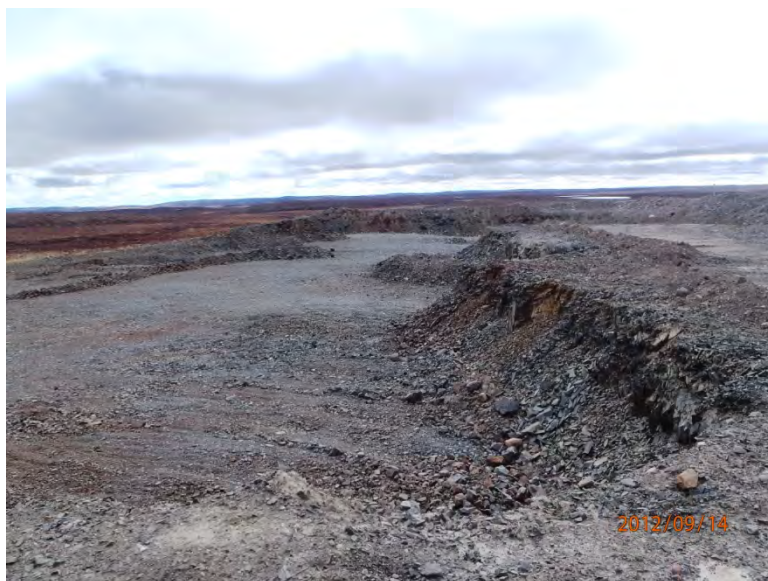
Photograph E1-27 : Quarry 12 – km 58+300

Description: Overview of quarry 12 looking southeast.

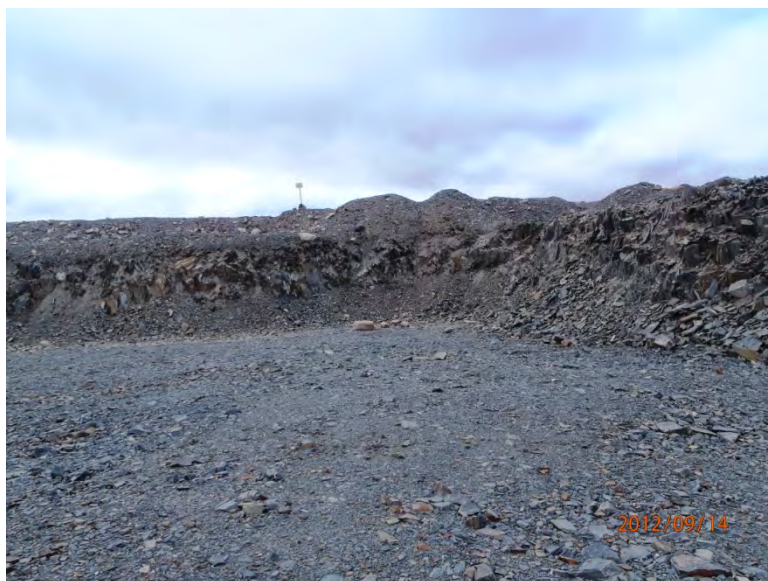
Photograph E1-29 : Quarry 12 – km 58+300

Description: View of the west and southwest wall.

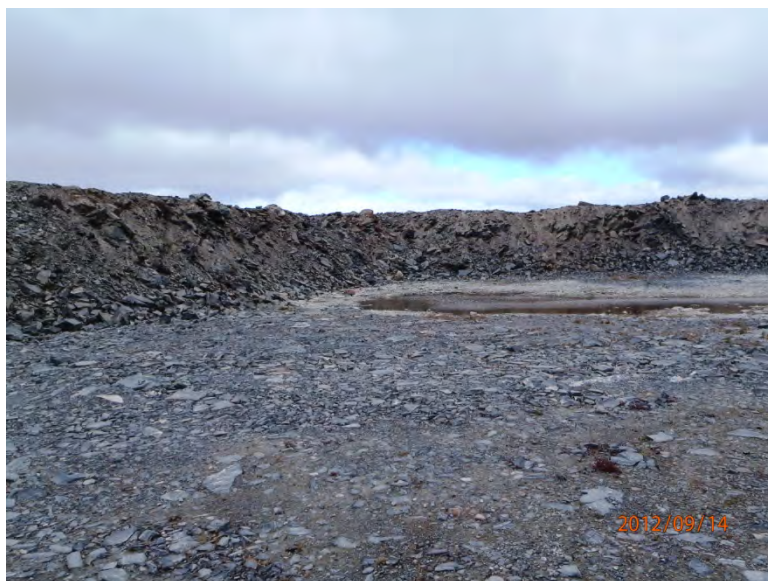
Photograph E1-31 : Quarry 13 – km 62+350

Description: View of the northwest and northeast wall.

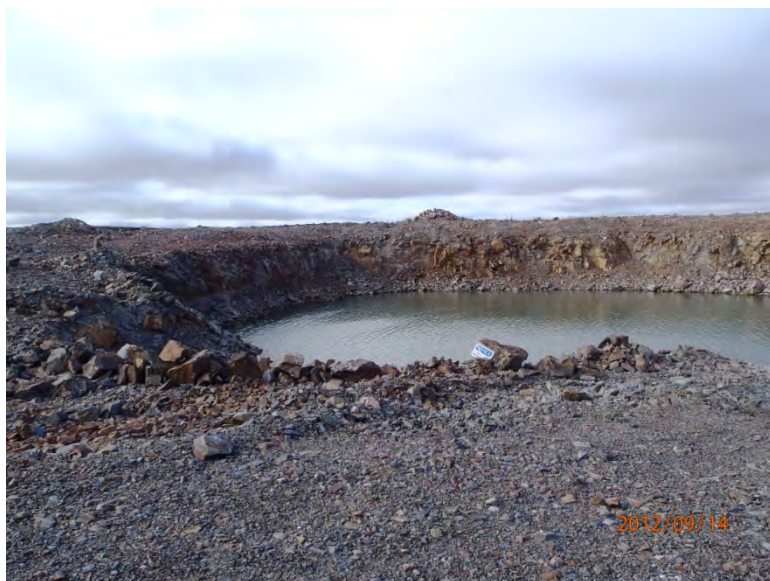
Photograph E1-33 : Quarry 14 – km 65+700

Description: View of west and south wall.

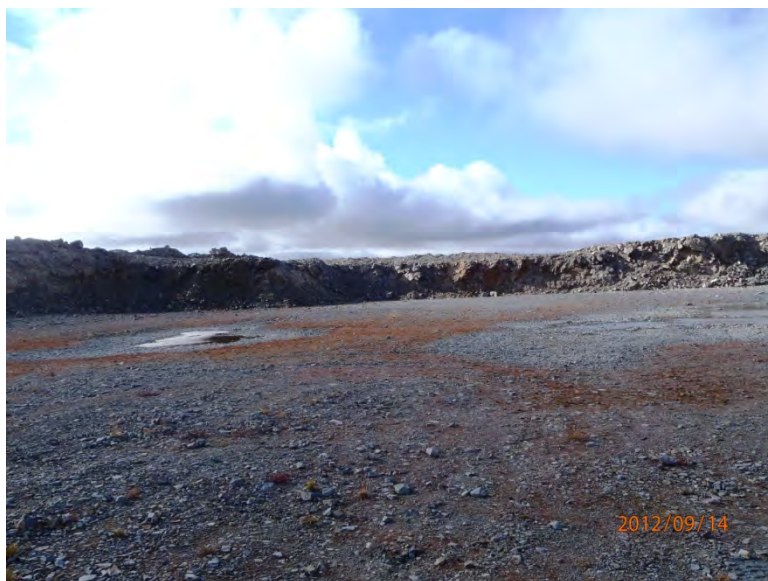
Photograph E1-35 : Quarry 15 – km 67+600

Description: Overview of Quarry 15 looking at the southwest wall.

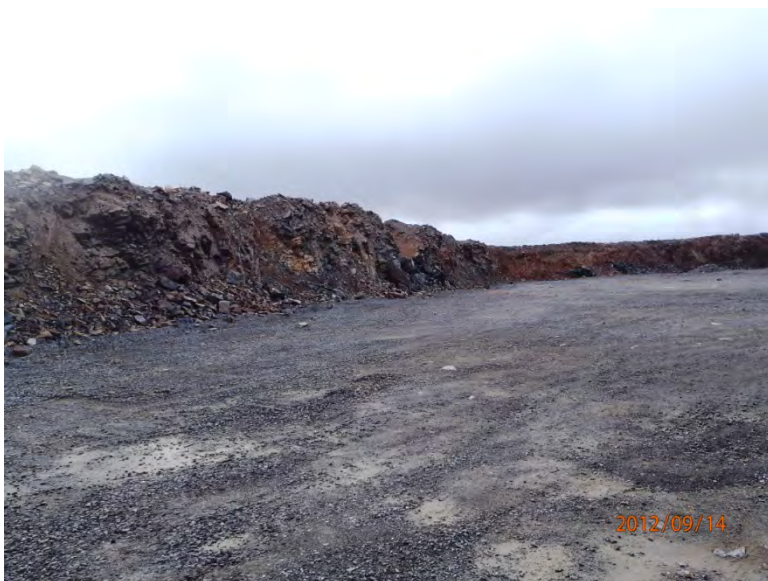
Photograph E1-37 : Quarry 16 – km 70+400

Description: View of the south and southwest wall.
