Report: *2012 Annual Review of Portage and Goose Pit Slope Performance*

2012 Annual Geotechnical Inspection Meadowbank Gold Mine, Nunavut

Agnico-Eagle Mines Limited
Meadowbank Division
PO Box 540
Baker Lake, Nunavut
X0C 0A0

Report Number: Doc 1394 1212210073 0115_13

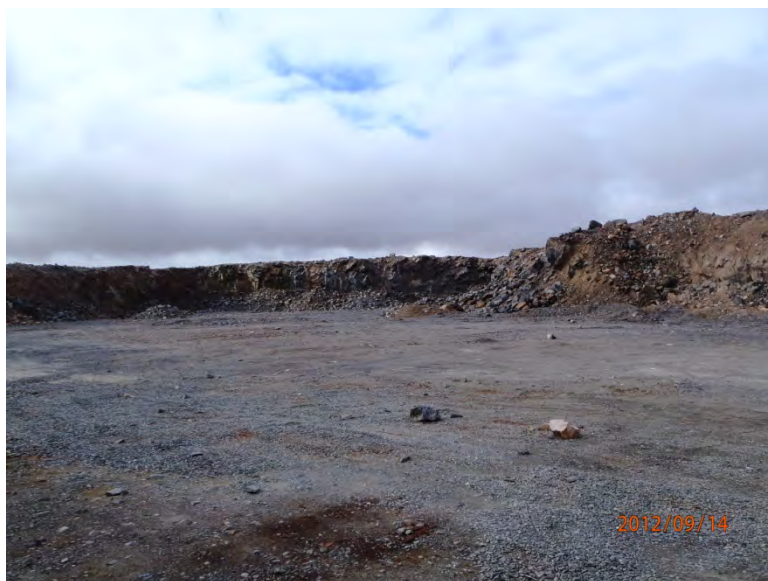
Photograph E1-39 : Quarry 16 – km 70+400

Description: View of the south, southwest and northwest wall.

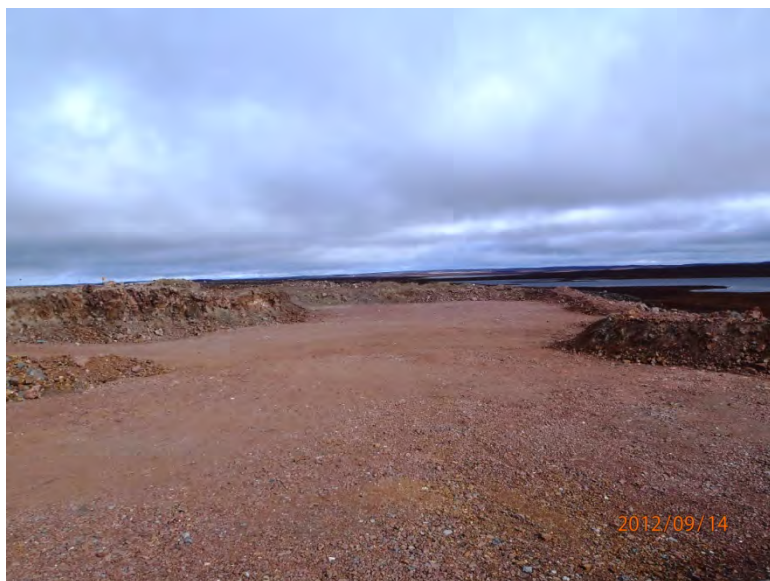
Photograph E1-41 : Quarry 17 – km 72+800

Description: Looking at the northwest wall.

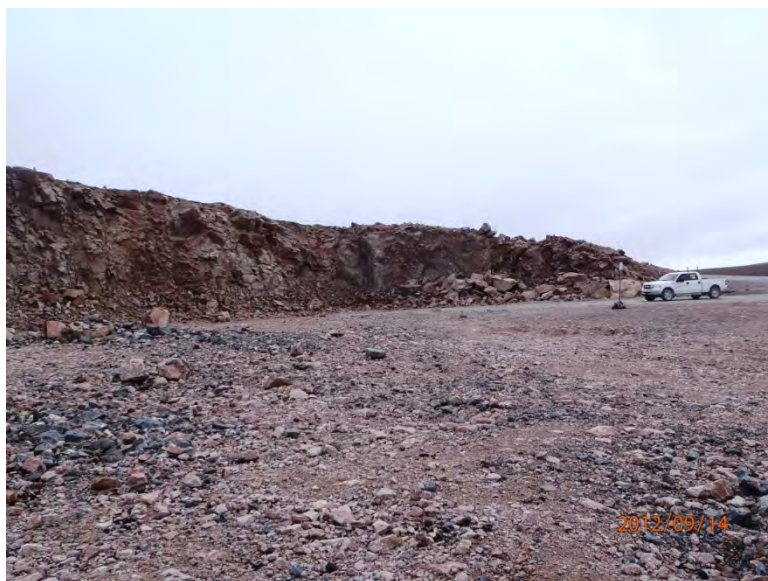
Photograph E1-43 : Quarry 19 – km 84+300

Description: Looking east at the north and east wall.

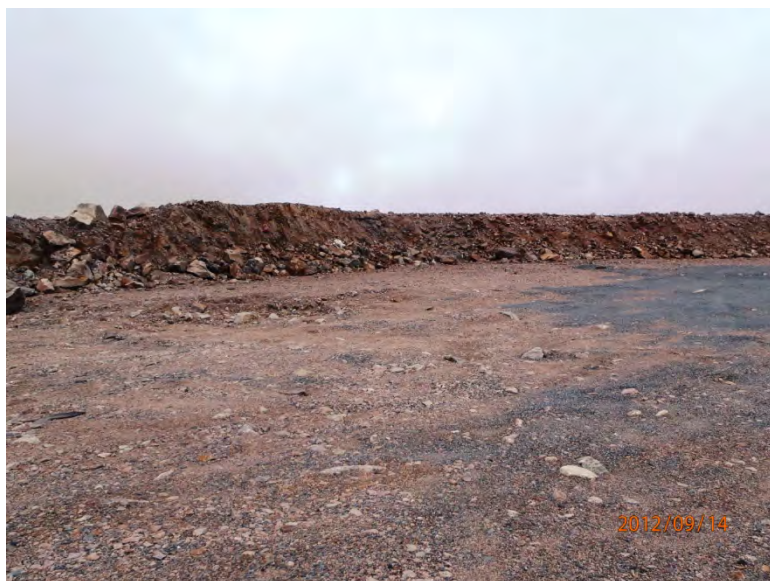
Photograph E1-45 : Quarry 20 – km 89+550

Description: Looking at the northwest wall.

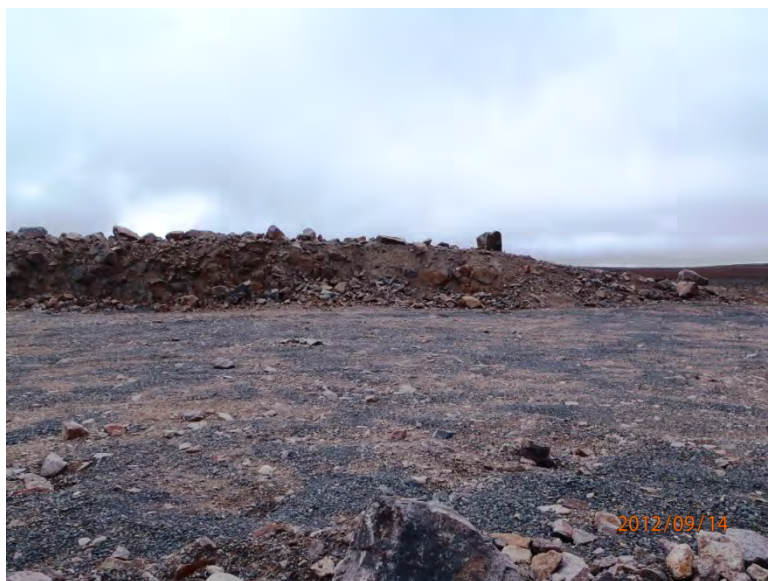
Photograph E1-47 : Quarry 20 – km 89+550

Description: Looking at the southeast wall.

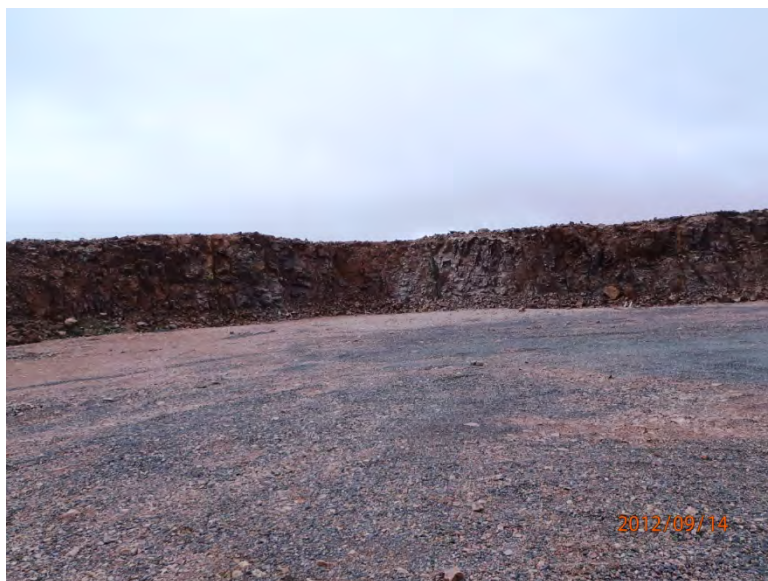
Photograph E1-49 : Quarry 21 – km 93+400

Description: Looking at the west wall.

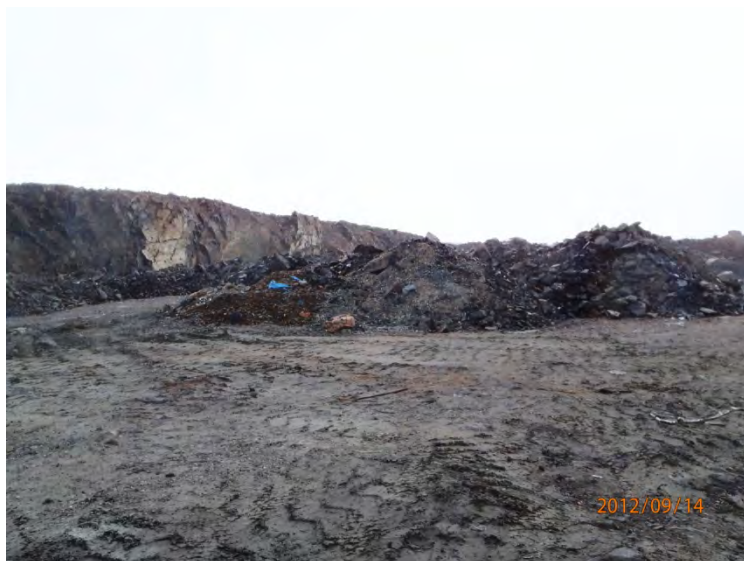
Photograph E1-52 : Quarry 22 – km 99+200

Description: Overview of the quarry, looking northwest. Note the presence of contaminated soil temporary stored inside the quarry.

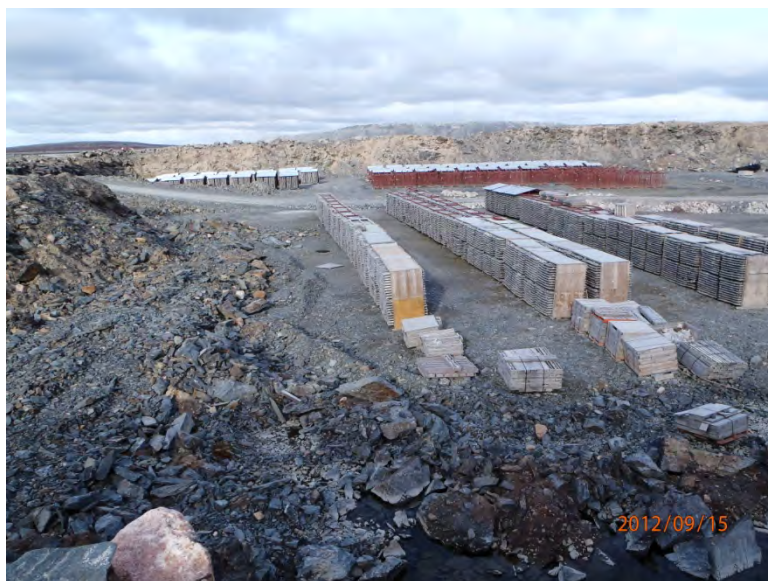
Photograph E1-53 : Quarry 23 (Airstrip Quarry)

Description: Looking northeast at northeast wall.

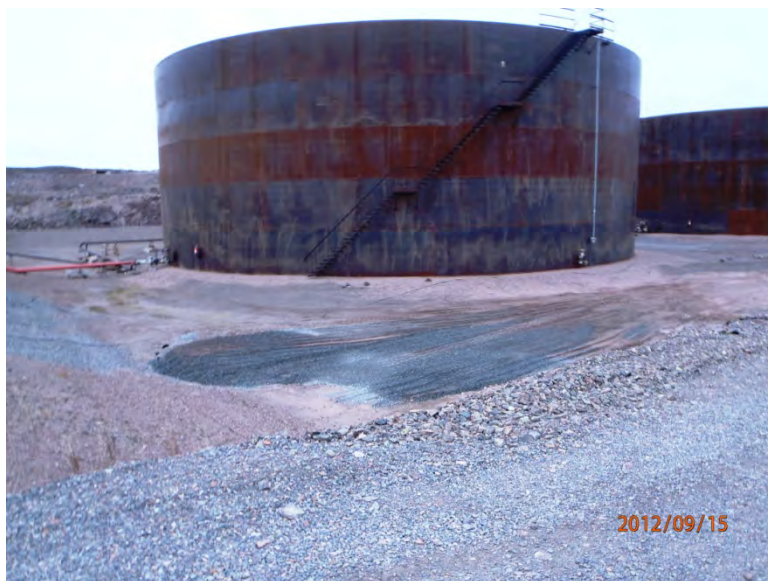
Photograph F1-1 Baker Lake Tank Farm

Description: From southwest corner of southern tanks, looking northeast at tanks 1 and 2.

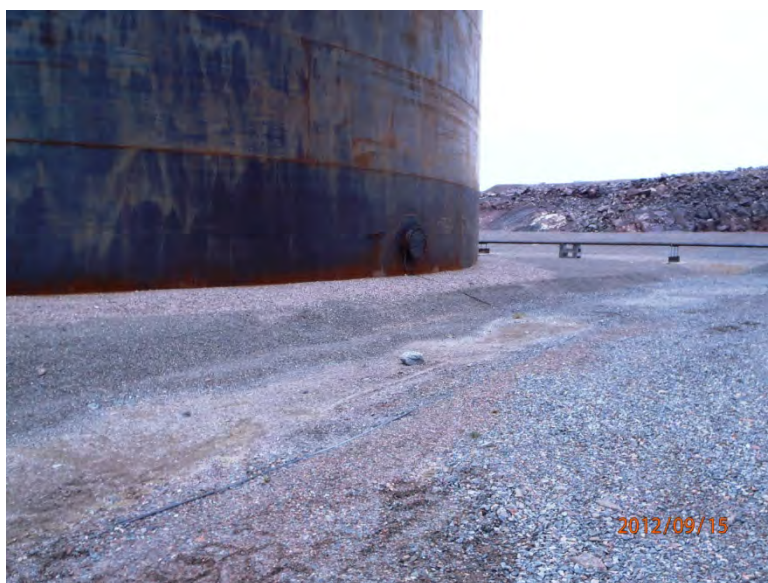
Photograph F1-3 Baker Lake Tank Farm

Description: Looking at the northeast corner of tank 1.

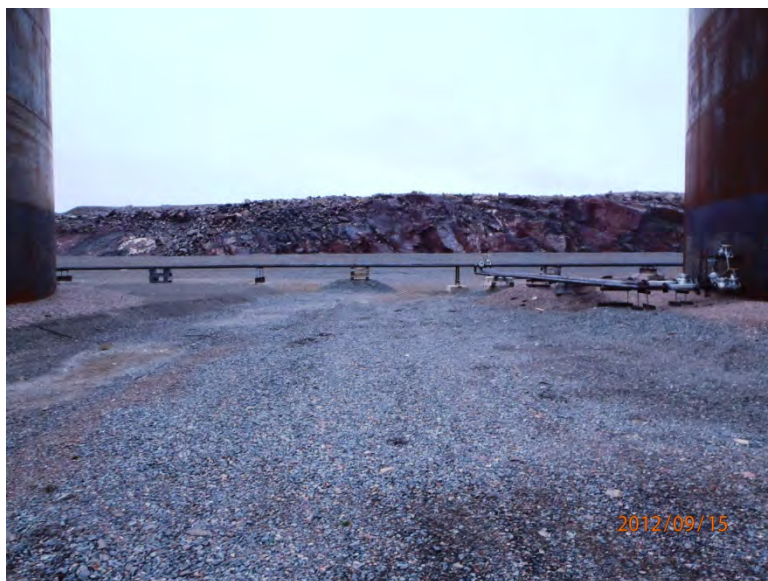
Photograph F1-5 Baker Lake Tank Farm

Description: Looking northeast between tanks 1 and 2.

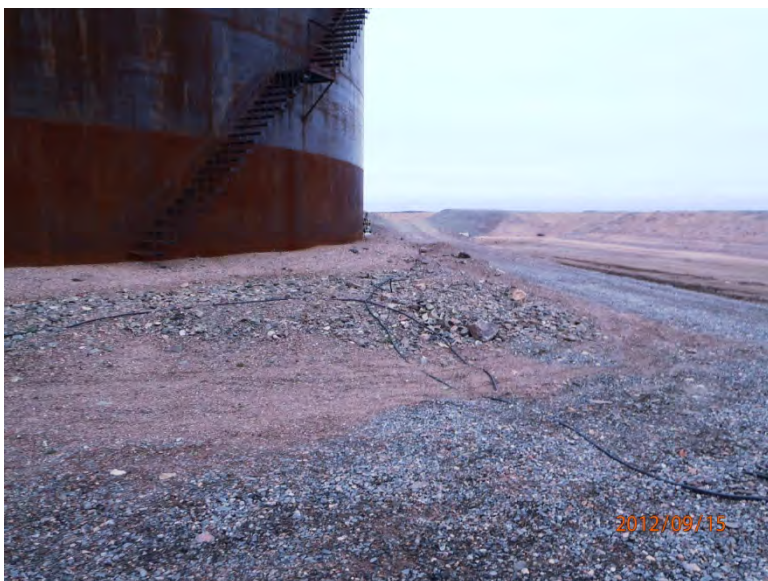
Photograph F1-7 Baker Lake Tank Farm

Description: Looking at the southwest corner of tank 2.

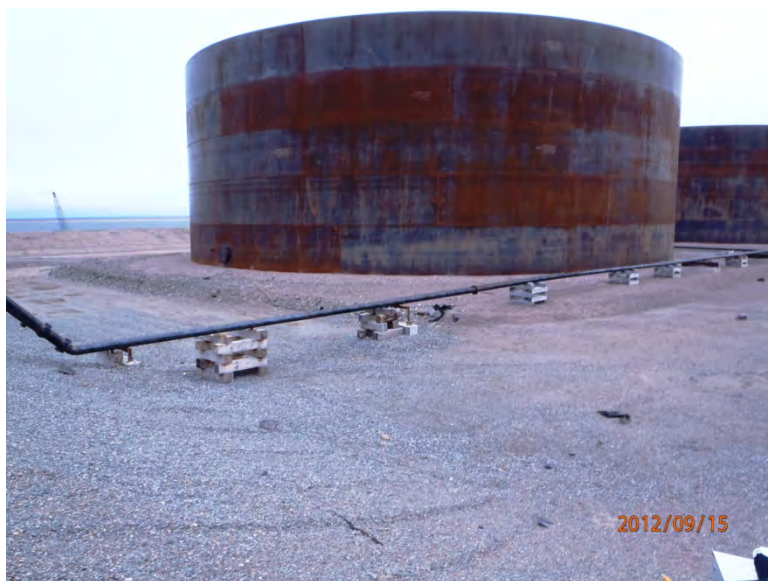
Photograph F1-9 Baker Lake Tank Farm

Description: Looking southwest at the northeast corner of tank 2.

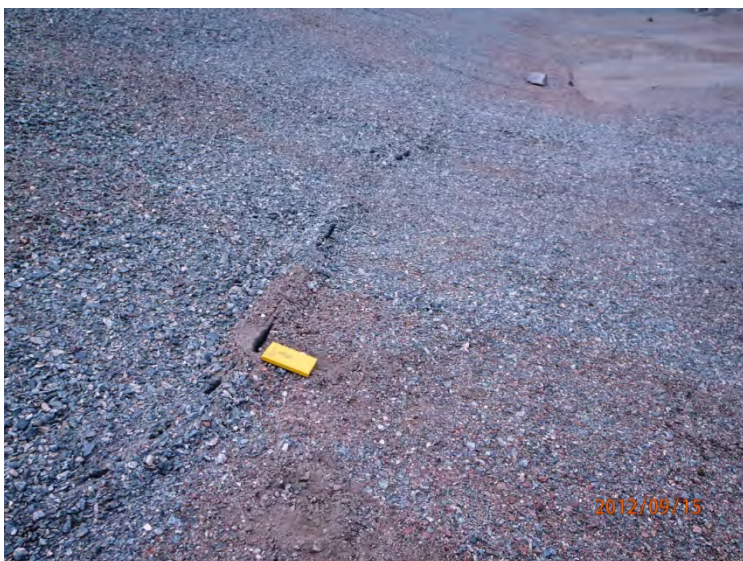
Photograph F1-11 Baker Lake Tank Farm

Description: Unprotected exposed geomembrane over 5 m at the base of the slope separating the lower and upper tank. The exposed area is located at the base of the slope between tanks 1 and 2.

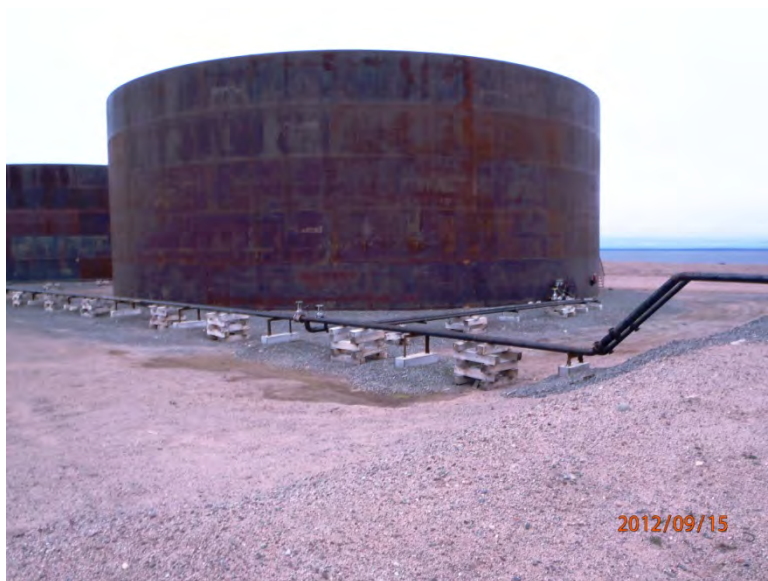
Photograph F1-13 Baker Lake Tank Farm

Description: Looking southwest at the northwest corner of tanks 3 and 4.

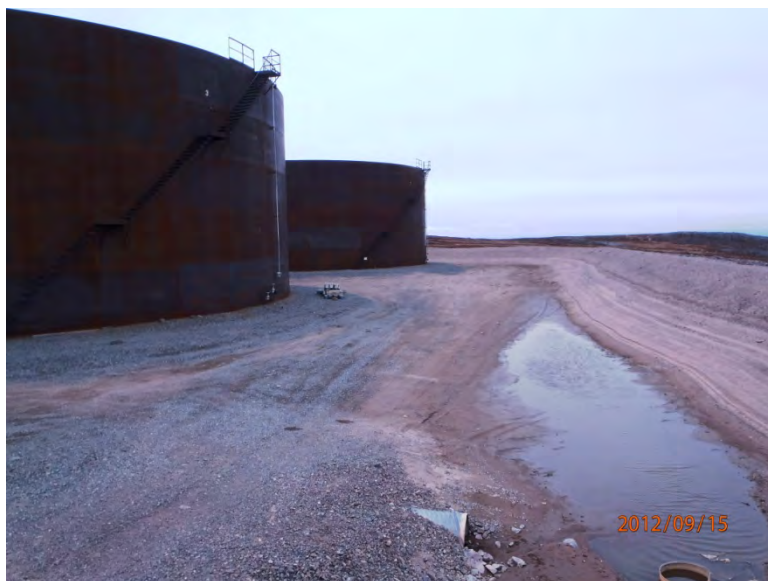
Photograph F1-15 Baker Lake Tank Farm

Description: Looking northwest at tanks 3 and 4. Notice the accumulation of water in the corner and the sign of high elevation of water that probably submerged the tank foundation fill at freshet.

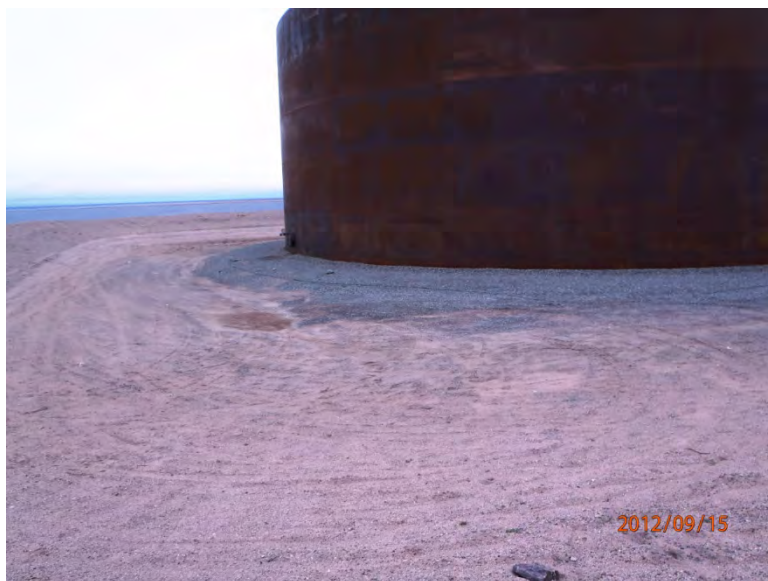
Photograph F1-17 Baker Lake Tank Farm

Description: Looking south at the northeast corner of tank 4.

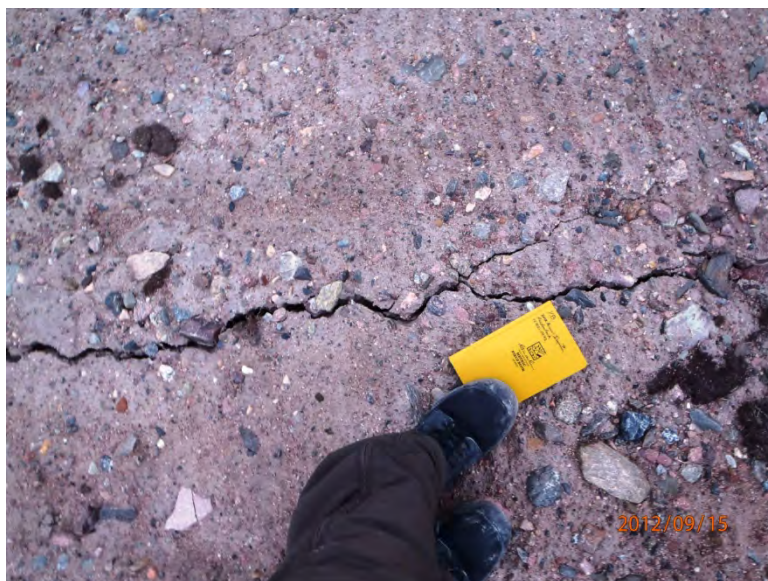
Photograph F1-19 Baker Lake Tank Farm

Description: Presence of longitudinal tension crack (10 mm open) on the upper bench north of tanks 3 and 4.

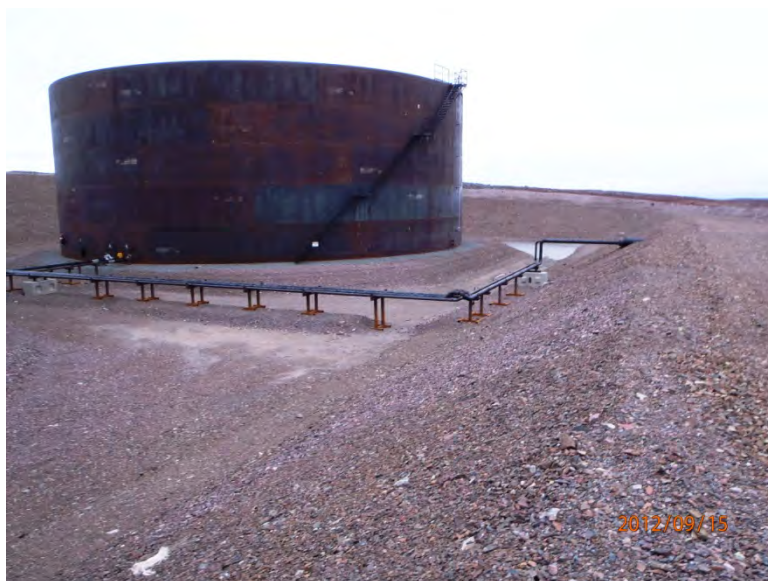
Photograph F1-21 Baker Lake Tank Farm

Description: Looking northeast at southwest corner of tank 6.

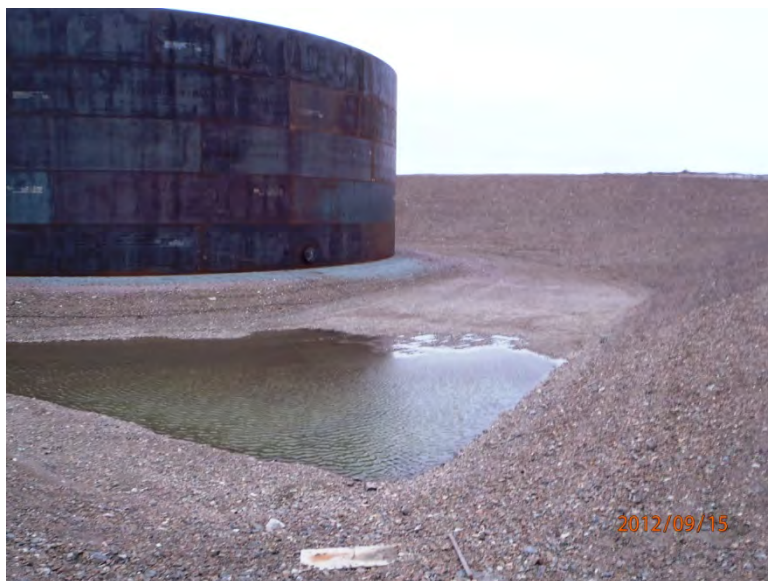
Photograph F1-23 Baker Lake Tank Farm

Description: Looking northwest at south east corner of tank 6. Notice the accumulation of water.

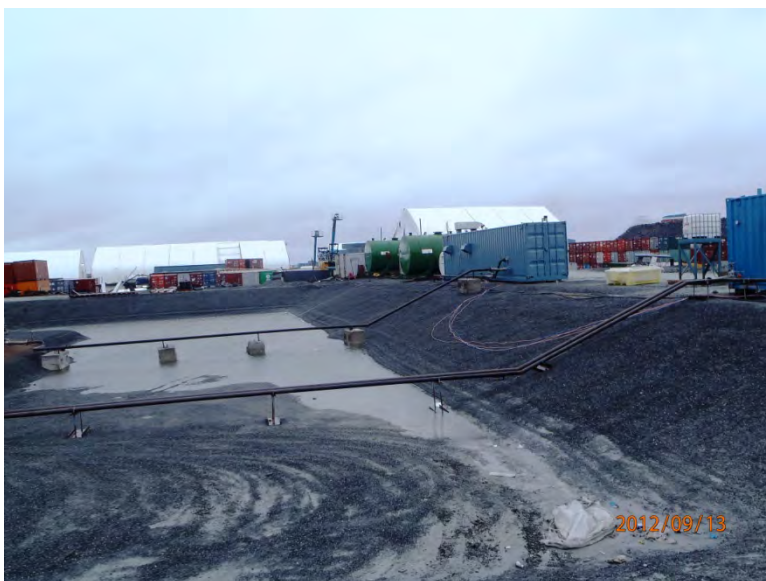
Photograph F2-5 Meadowbank Tank Farm

Description: Accumulation of water in the northeast corner. Note the sign of higher water level in the past.

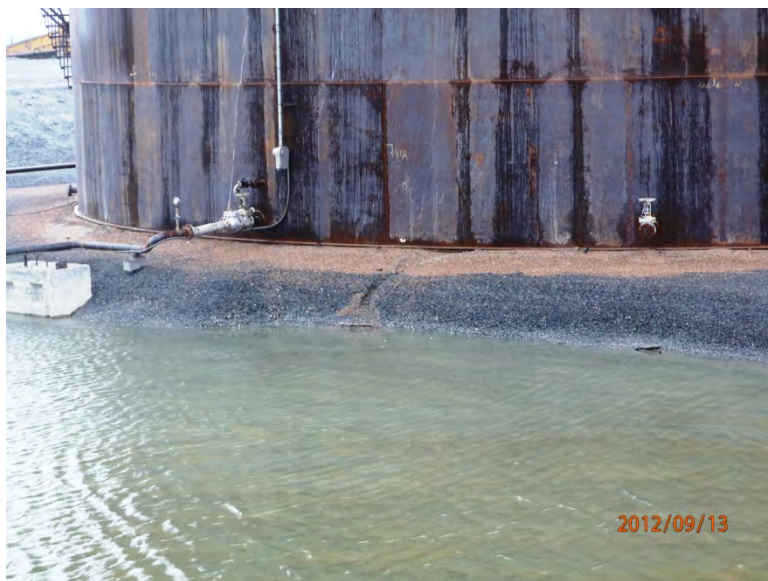
Photograph F2-7 Meadowbank Tank Farm

Description: Small erosion at the base of the north side of the tank.

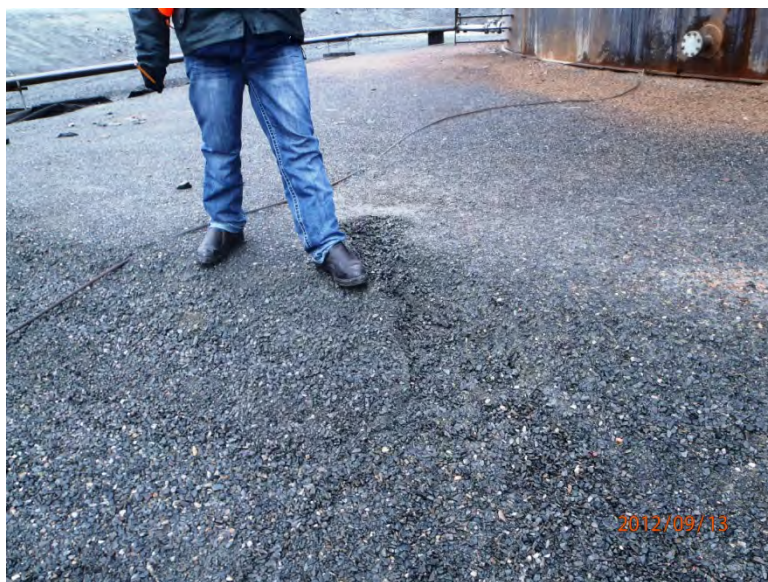
Photograph F2-8 Meadowbank Tank Farm

Description: Small erosion on southeast of the tank foundation fill side.

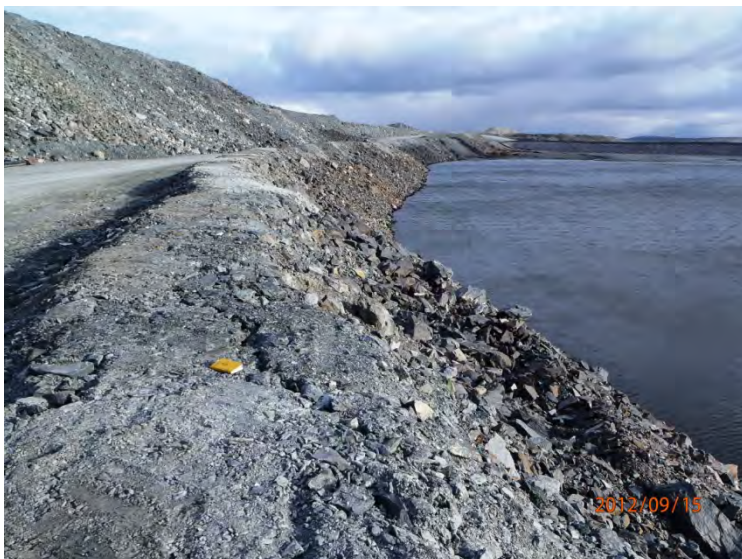
Photograph G1-3 Mine Site Road - RF1

Description: Looking at a longitudinal tension cracks (50 mm open), 5 m length on the crest of the berm (near rusted container) at coordinate 638132E/7215710N on RF1.

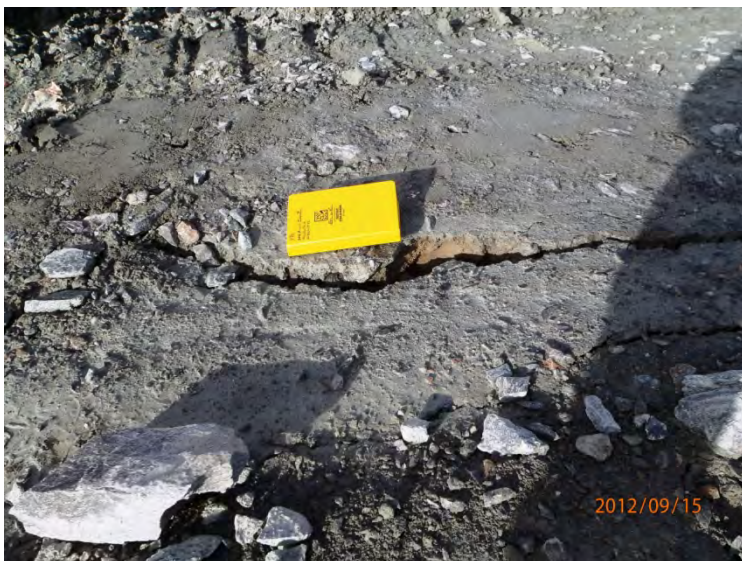
Photograph G1-4 Mine Site Road - RF1

Description: Looking at a longitudinal tension cracks (50 mm open), 5 m length at the base of the safety berm (near rusted container) at coordinate 638132E/7215710N on RF1.

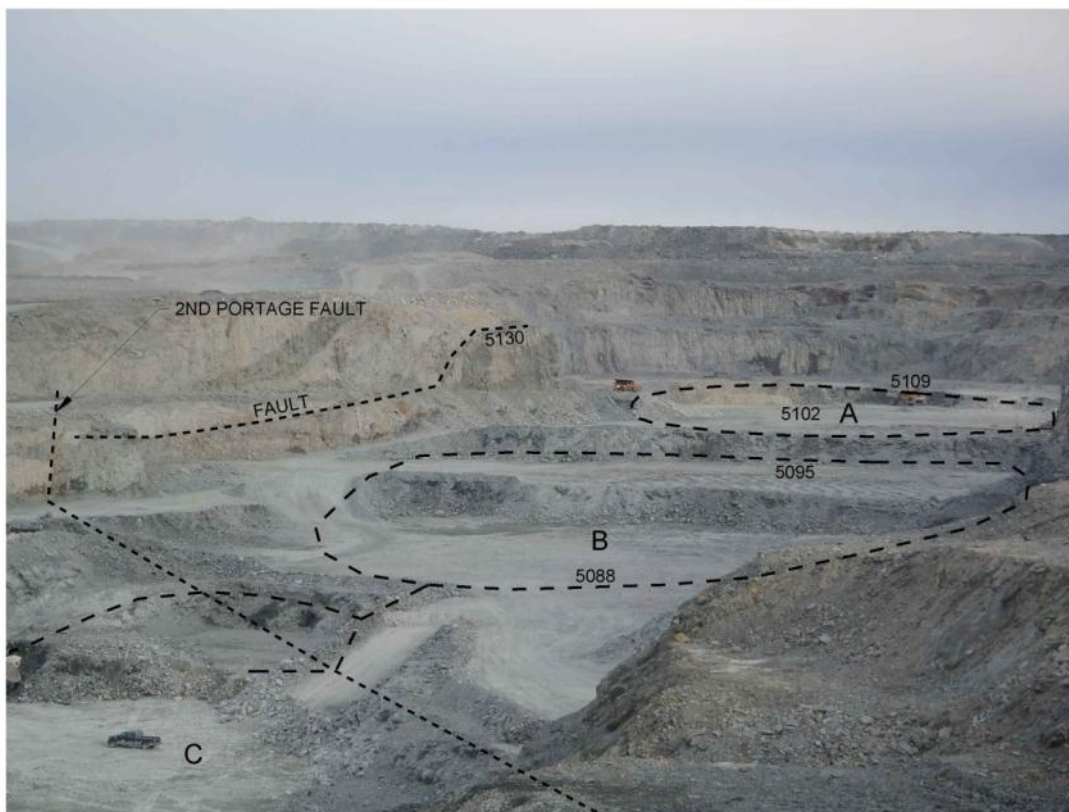
Photograph 1: Overview of Pits A and B Looking North

The photograph was taken from the east pit crest looking north, between Pits B and C. Shown are the approximate extents of Pits A and B at the time of the site visit. The approximate pit floor elevations are identified on the photograph. Also shown are some important structural features of the west wall of the pit, such as the fault exposed on the 5130 bench and identified during the 2011 site visit which is potentially the Bay Fault, and the possible location of the Second Portage Fault in the west pit wall identified during the 2012 site visit. These features and their implications to slope stability are discussed in greater detail in the following sections.

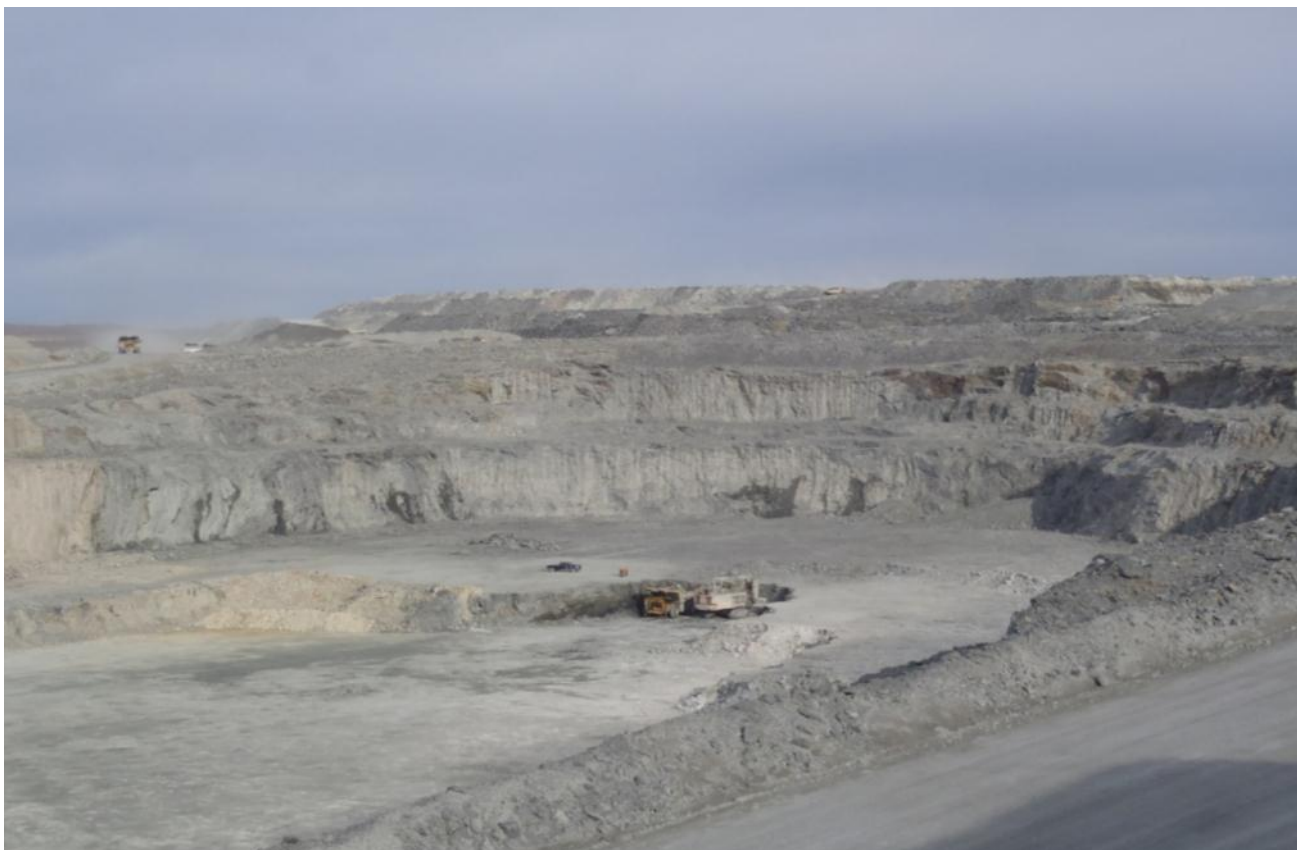
Photograph 2: Pit A looking northwest (haul truck and shovel are at 5,102 RL, pickup truck is at 5,109 RL) north wall (from Stop 4 in Figure 5)

In general the performance of the Pit A walls is satisfactory. One area of bench scale instability on the west wall was noted and is described below. No potential large-scale, multiple bench instabilities were observed.

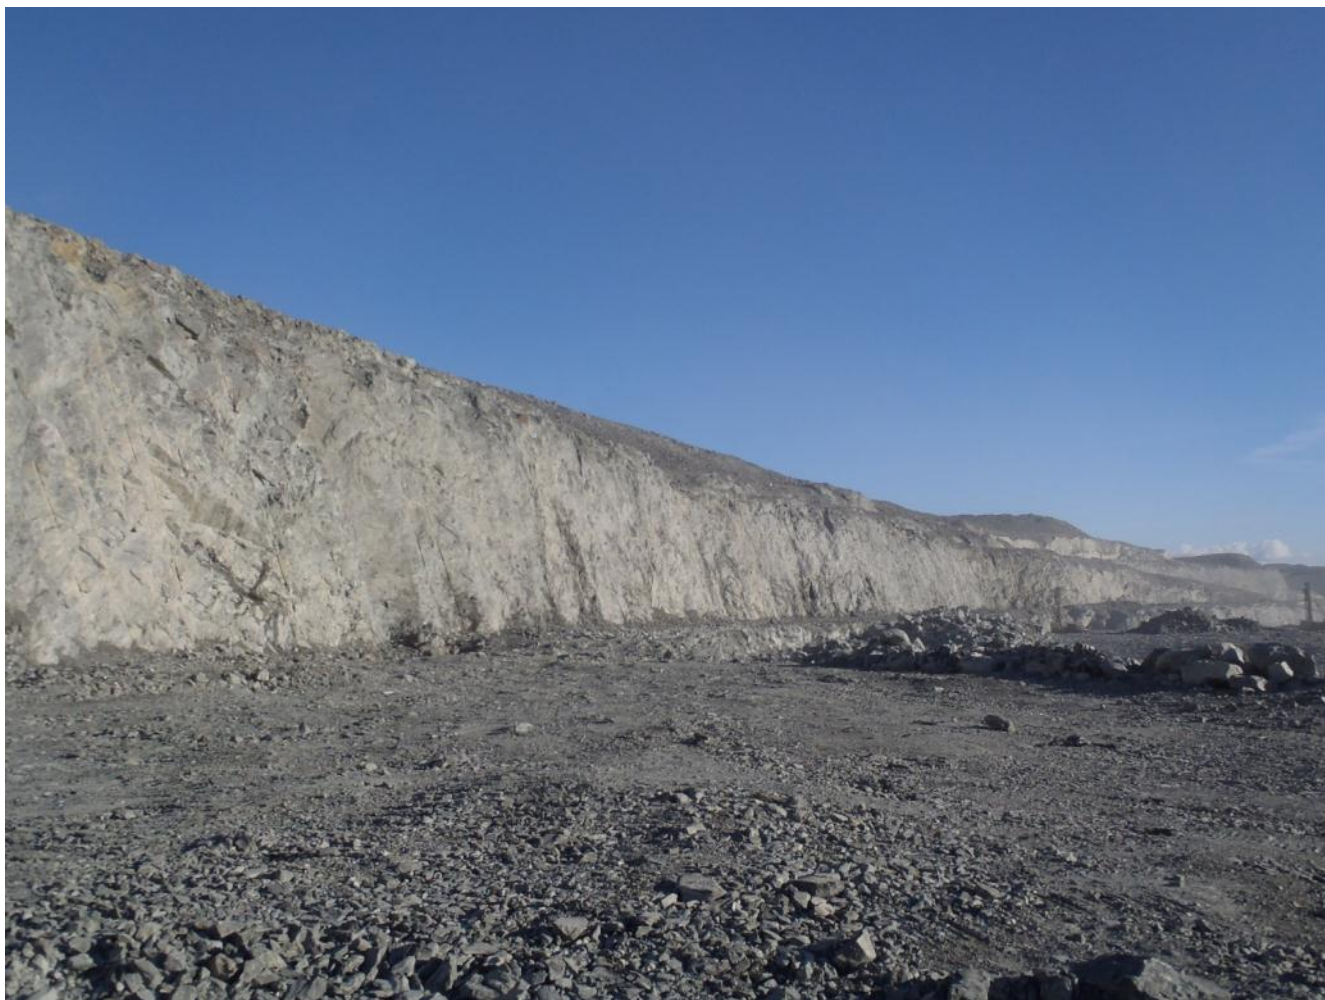
No potentially large-scale instabilities were identified along the east wall of Pit A. In general the performance of the east wall of Pit A is satisfactory. The 5109 bench has been cleaned well, and there is very little evidence of ravelling of material on to the bench.

Photograph 6: Pit A east wall looking south on 5109 bench

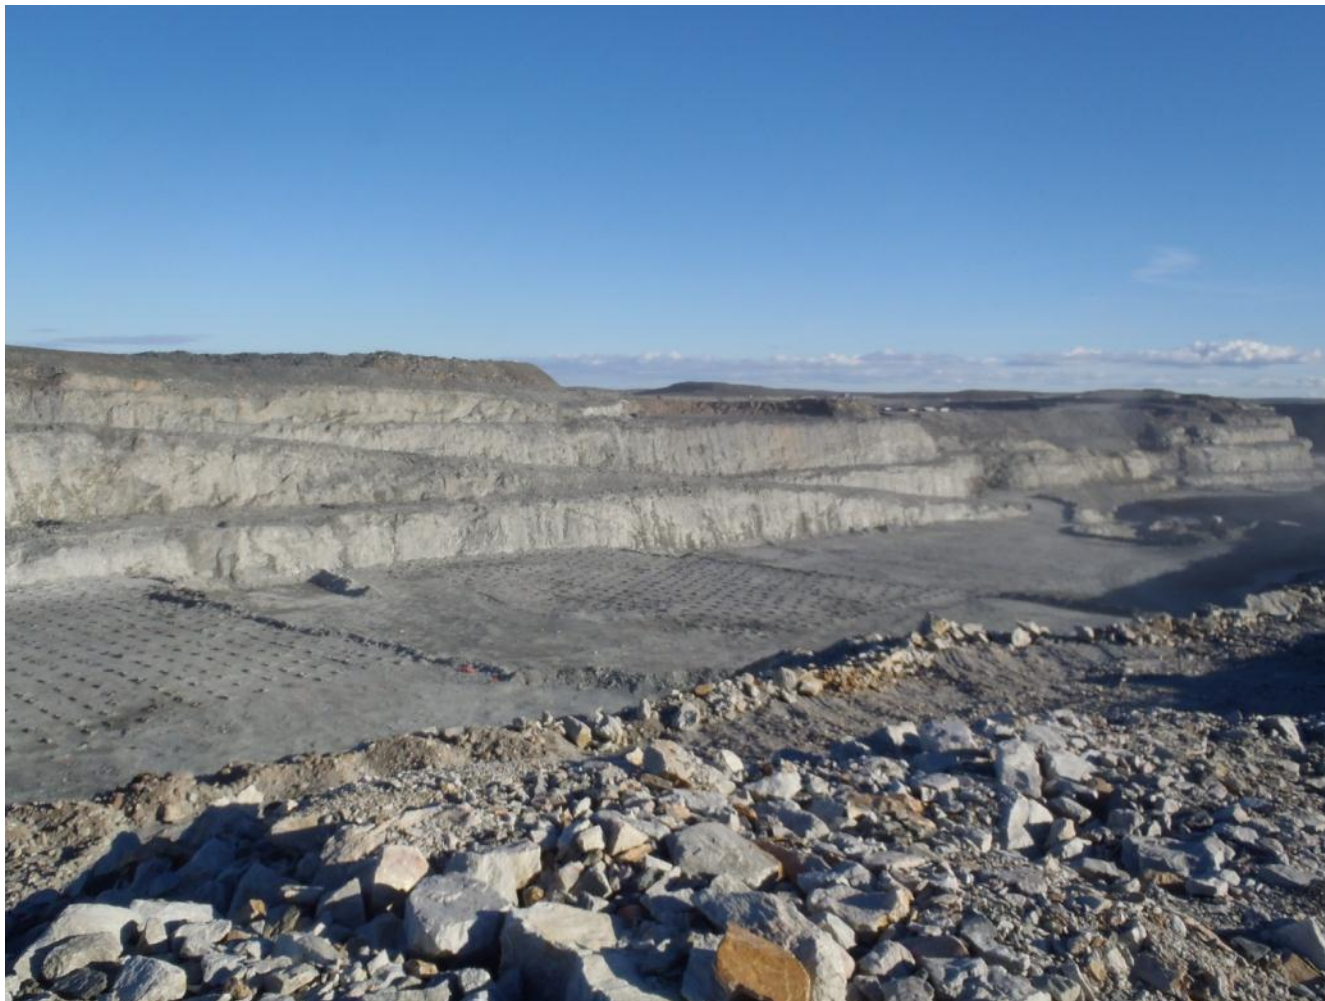
The east wall of Pit B was inspected from several viewpoints, as well as from within the pit. No significant structures or instabilities were noted on this wall during the site inspection. The wall is performing satisfactorily.

The east wall ramp extends from Pit A into Pit B. No stability concerns were identified with the ramp during the pit inspection.

Photograph 12: The east wall of Pit B, seen from above the west wall of Pit B

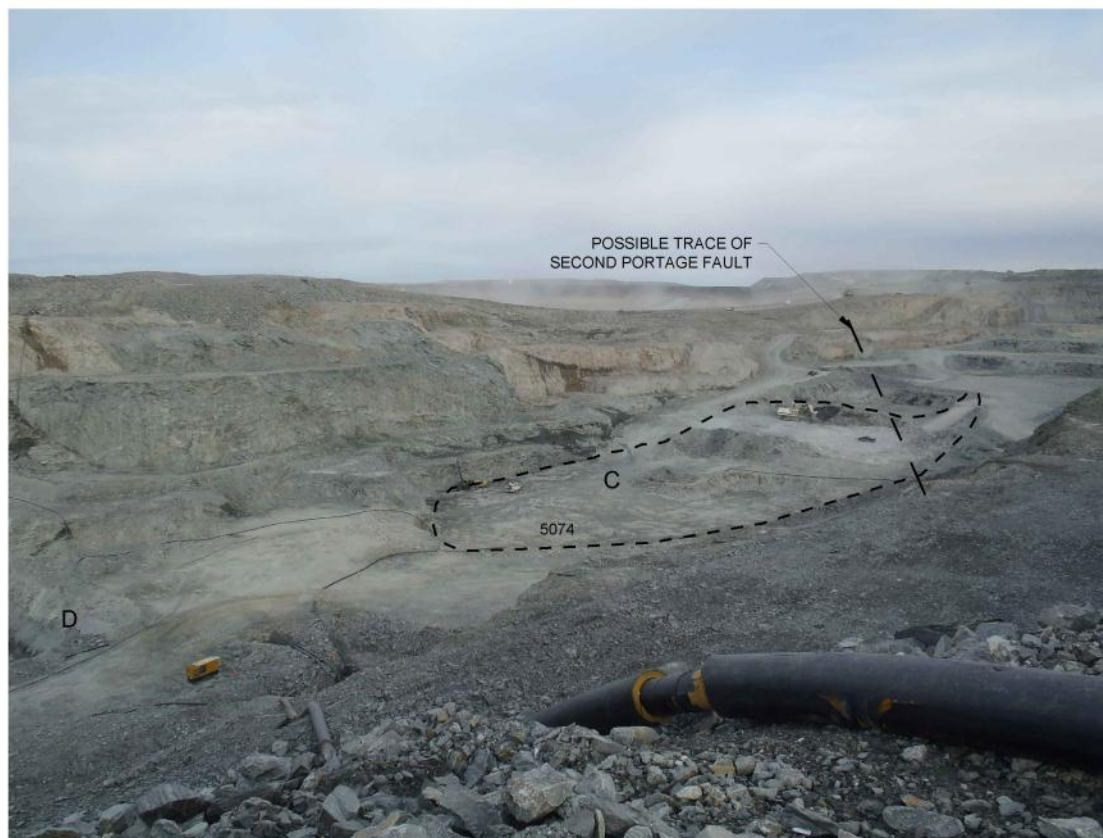
Photograph 13: Pit C looking north from east wall showing possible location of Second Portage Fault

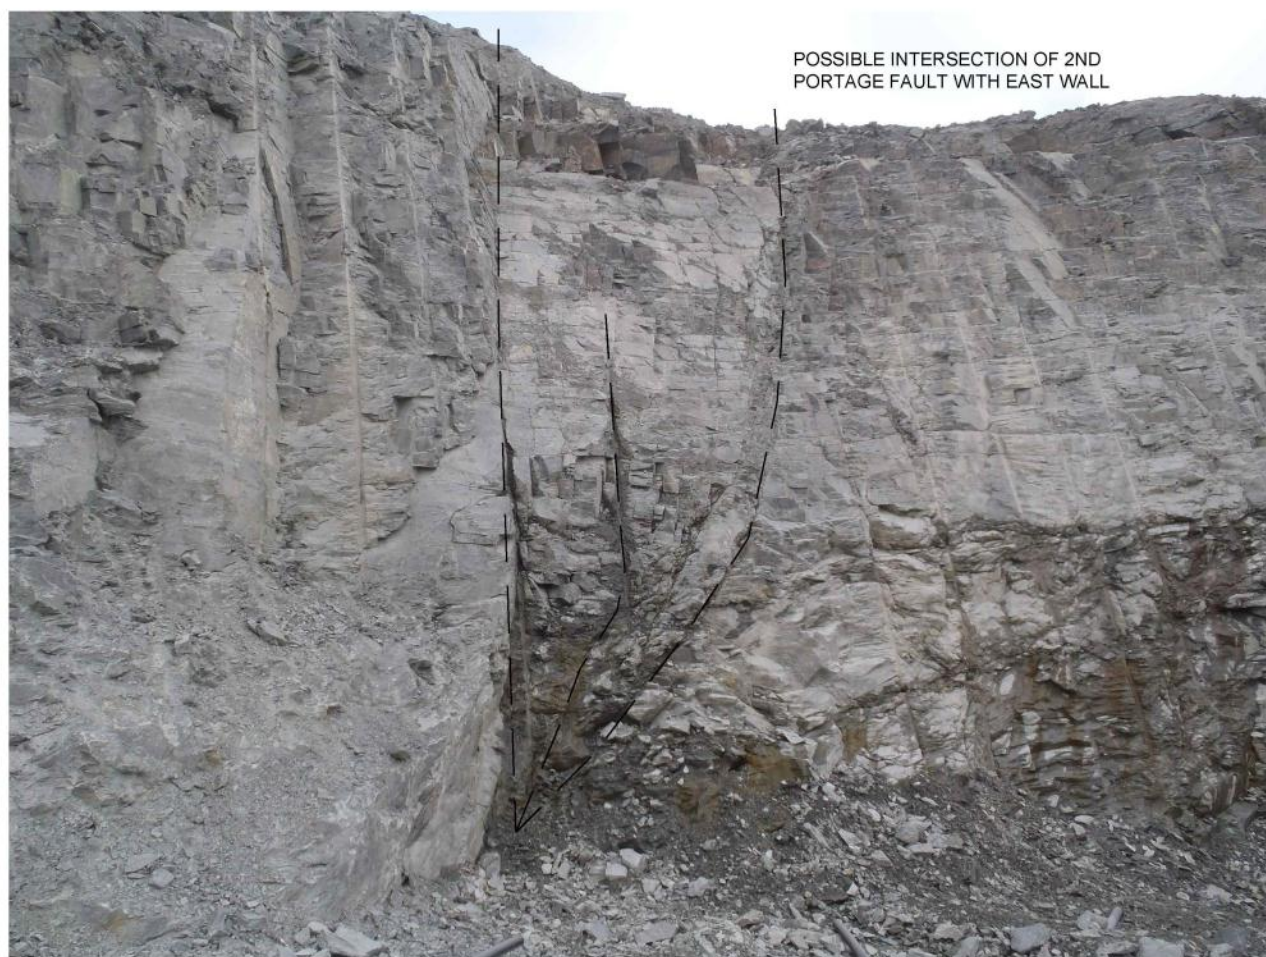
A structure was identified intersecting the east wall of Pit C approximately midway along the wall that may be the expression of the Second Portage Fault, or a splay of that fault. The area of the wall that is intersected consists of strongly fractured rock. The fault is shown in the following photograph.

Photograph 14: Possible intersection of Second Portage Fault with east wall of Pit C

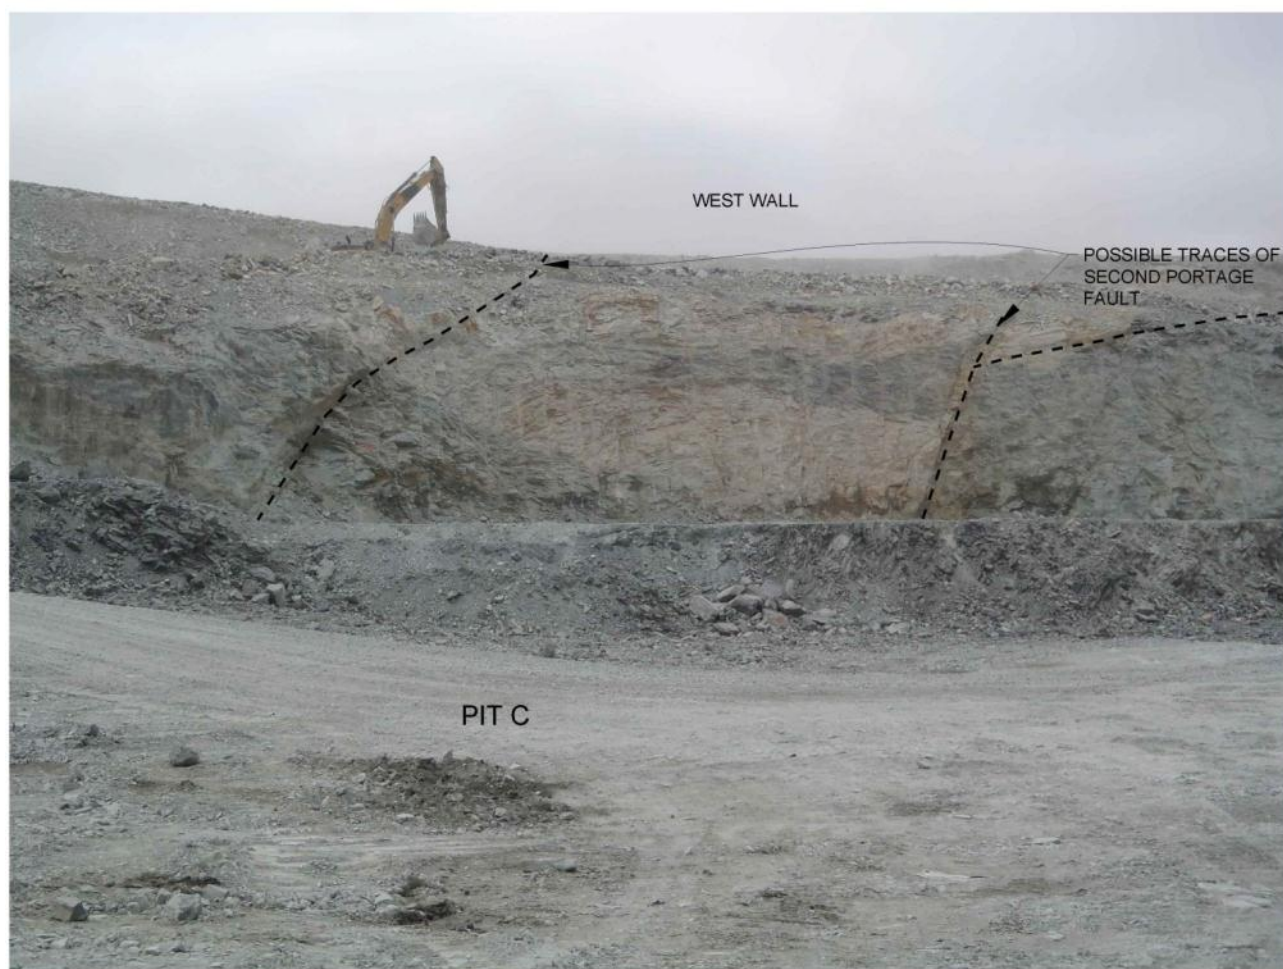
Photograph 15: Possible intersection of Second Portage Fault with west wall of Pit C

A remote estimate of the orientation of the structure taken from across the pit indicated a dip and dip direction of 80/195. Historically, the Second Portage Fault has been reported with a dip and dip direction of about 70 degrees towards 235 degrees azimuth. Remotely estimated orientations are unreliable and a request was made to AEM to have the location and traces of the features surveyed in order to determine more clearly the orientation of the feature, and its possible relationship to the interpreted location and orientation of the Second Portage Fault.

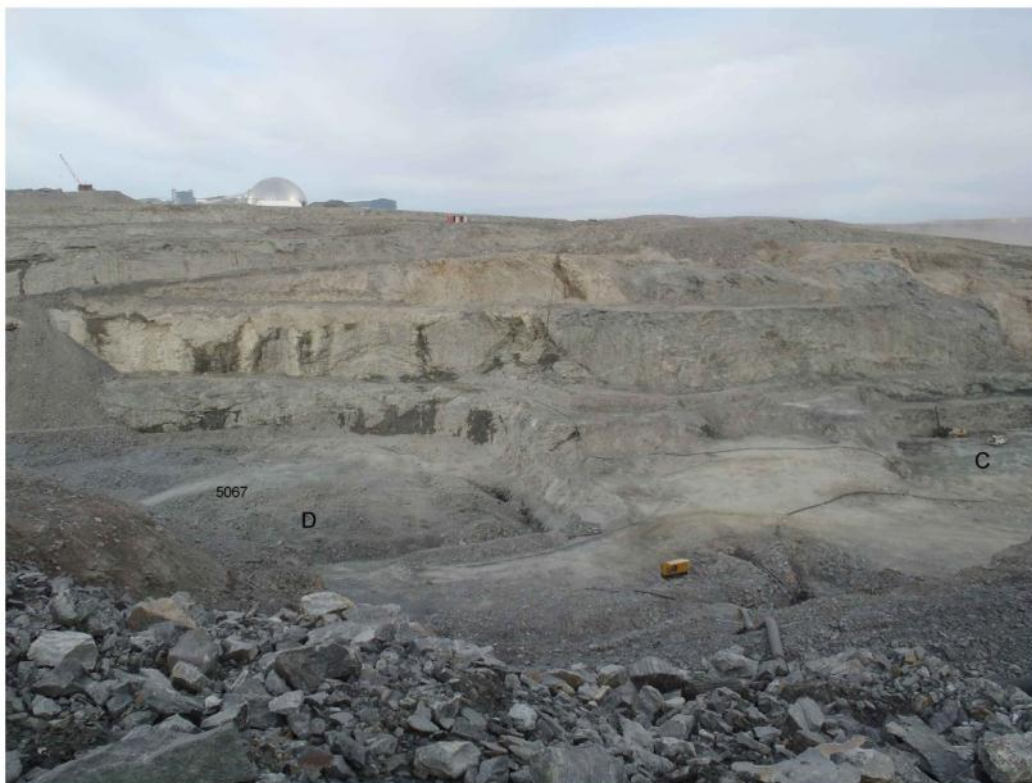
The east wall of Pit D is currently being excavated in shallow to moderately dipping foliation, extending southwards into a transition zone to more steeply dipping foliation. The west wall of Pit D is being excavated within Structural Domain TP-4 (Design Sector 8 of the 2006 study). A fault (the Bay Fault or a splay of the Bay Fault) has been previously interpreted to intersect the base of the pit, striking north–south and dipping steeply to the west, but the blasted muck prevented any additional observations on this visit.

Photograph 17: North End of Pit D Looking West
