Report: *2012 Annual Review of Portage and Goose Pit Slope Performance*

2012 Annual Geotechnical Inspection Meadowbank Gold Mine, Nunavut

Agnico-Eagle Mines Limited
Meadowbank Division
PO Box 540
Baker Lake, Nunavut
X0C 0A0

Report Number: Doc 1394 1212210073 0115_13

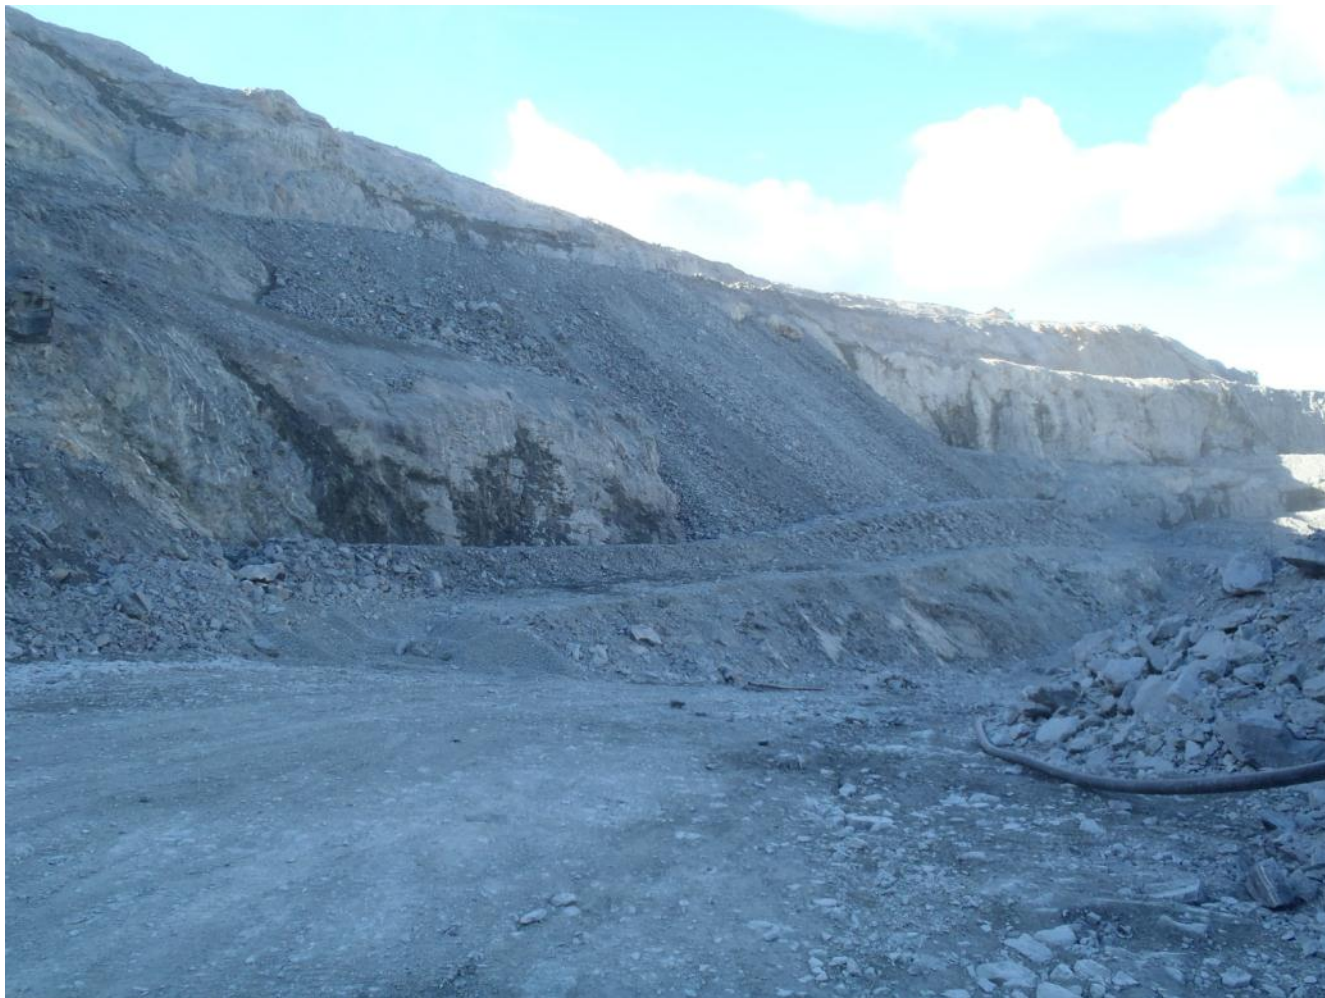
The west wall of Pit D exposes intermediate volcanic and quartzite rock in its upper slopes, and ultramafic rock in the lower slopes. The intermediate volcanic and quartzite are generally good quality rock, whereas the ultramafic rock is generally fair quality. The ultramafic rock is variably altered, and when exposed to water its quality and strength degrade rapidly. The ramp access to Pit D and Pit E is from the west side of the pit, and cuts down through quartzite and then ultramafic rock. Rock falls within the ultramafic rock have undermined and caused damage to the ramp. This has been successfully controlled by buttressing of the slope below the ramp with waste rock, and this is shown in the following photograph. Geotechnical inspections should include ramp inspections to identify any tension cracks forming at the crest which may be an indication of slope movement.

Photograph 18: Buttrressing of slope below ramp on the west wall of Pit D

As the west pit wall continues to be excavated within the ultramafic materials, on-going bench scale instability can be expected due to the degradation of the rock on exposure to atmosphere and water. The bench faces within the ultramafic rocks in the lower slopes are currently being pre-sheared at 70 degrees, which is steeper than previously recommended. However, the greatest contributor to the ravelling of the rock material is the poor durability of the ultramafic, and not necessarily the bench face angle. It will therefore be important to continue to use appropriate pre-shearing methods to minimize damage to the rock behind blast lines, to maintain catchment berms beneath the bench faces at full 10 m width, and to clean the catch benches prior to excavating to the next bench elevation. If on-going instability is encountered, then double benching on this wall should be considered.

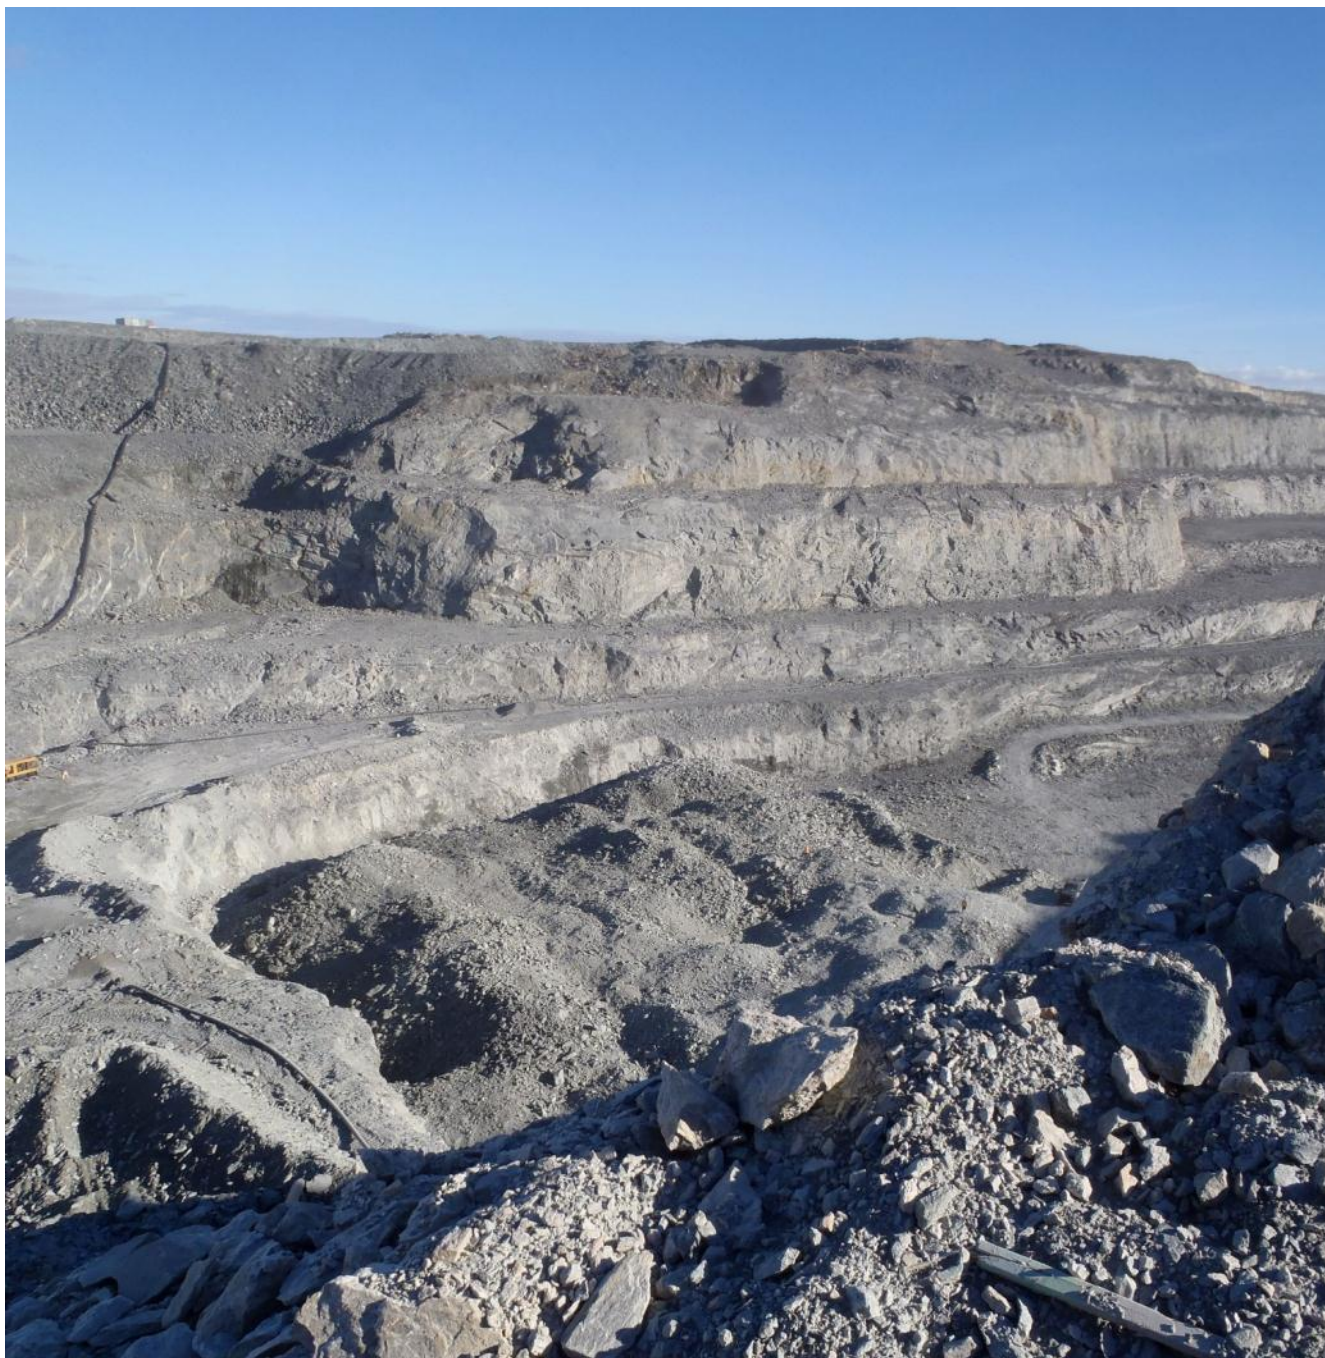
Where the foliation is inclined at angles greater than about 35 degrees, and has been undercut by bench face angles, significant catchment loss has resulted. This area was identified during the 2010 and 2011 pit inspections. During the 2012 site visit this area could not be safely accessed on foot, but was observed from several vantage points at the crest of the west wall of the pit (Stops 7 and 8 in Figure 5).

Photograph 20: East wall of Pit D showing loss of catchment looking southeast

The blast shot during the site visit was to elevation 5060 RL, and there are two remaining single benches to be shot and mined before the pit is completed in March 2013. Once mining activities in this pit have finished, the area should be bermed to prevent future access below this slope. Buttressing of the slope could be an effective solution to potential slope instability, if longer-term access below this slope is required. Such an approach would need to be reviewed in detail prior to implementation.

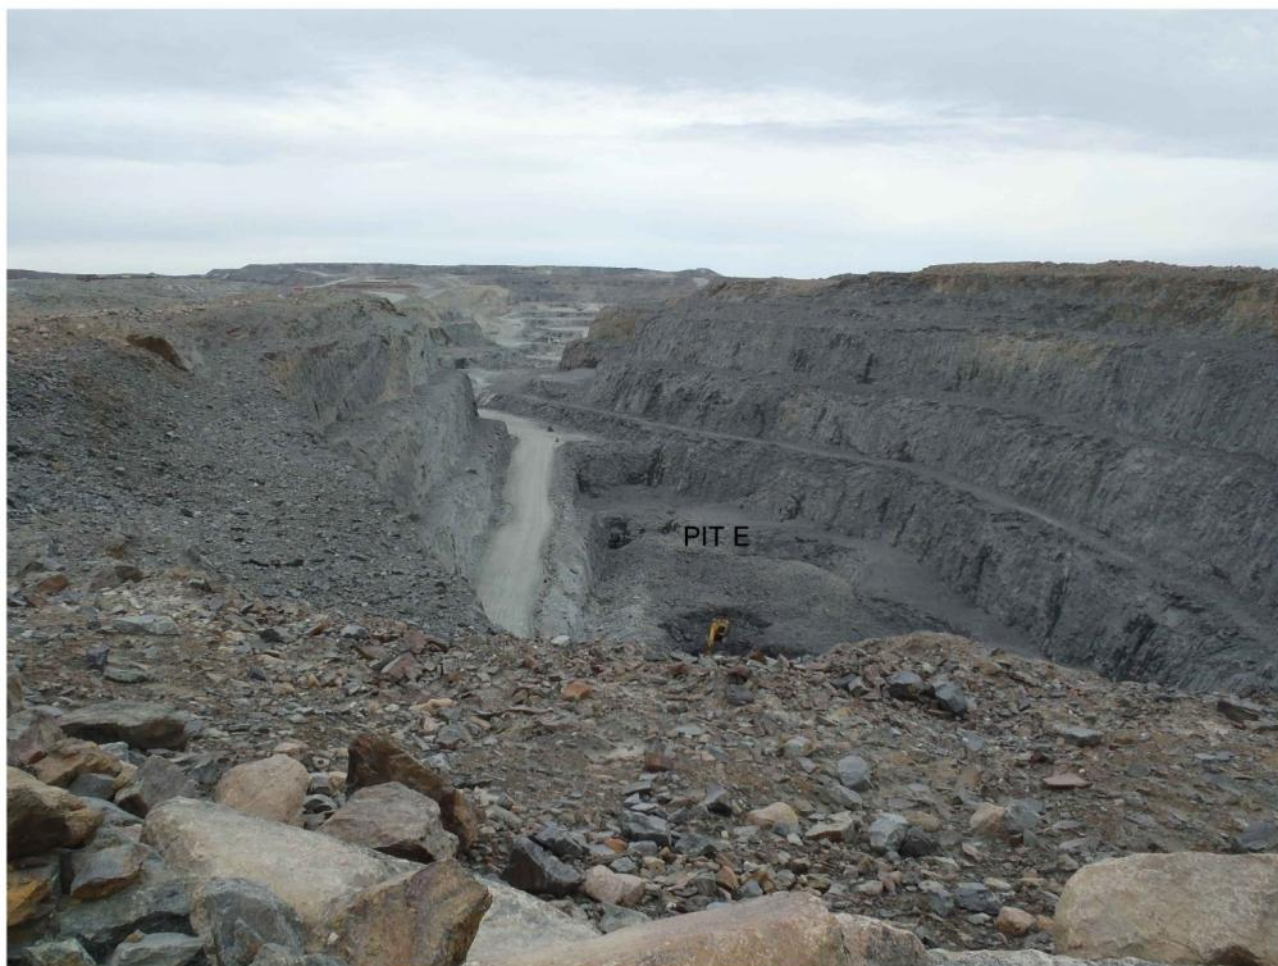
Photograph 21: Pit E looking north (viewed from Stop 9 in Figure 5)

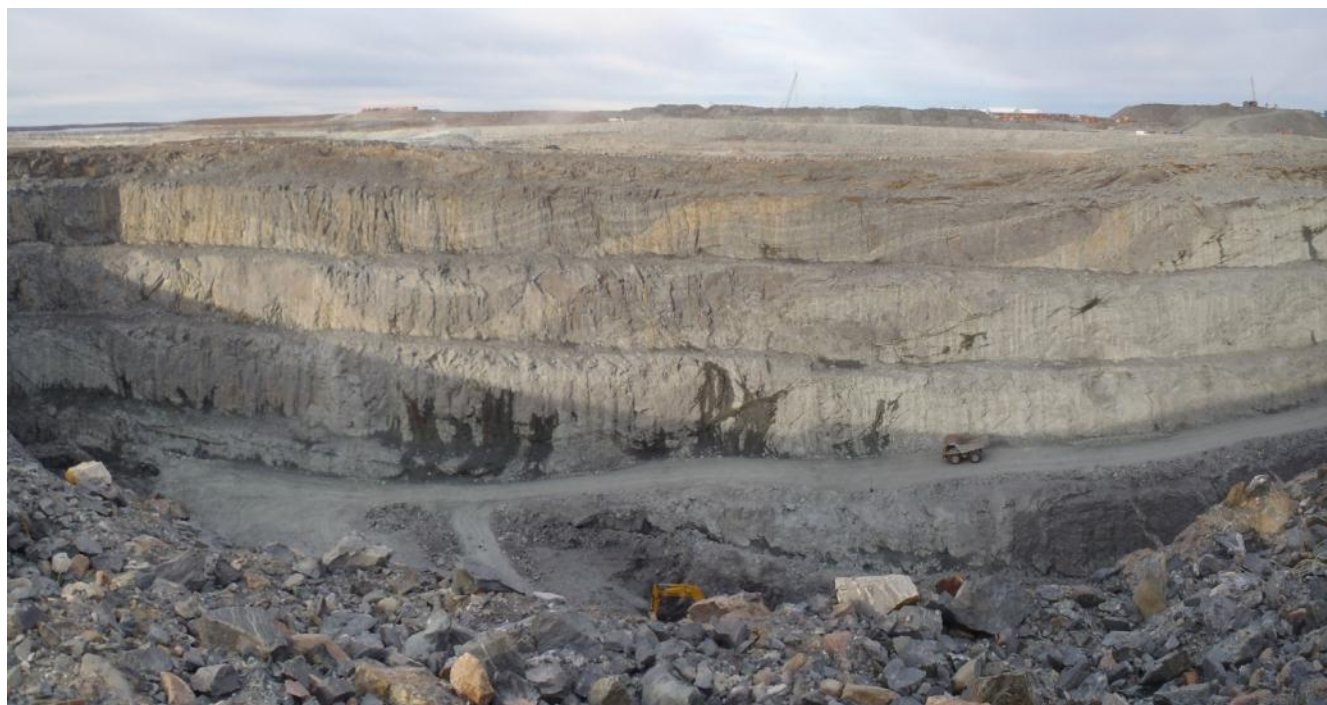
The west wall of Pit E currently exposes intermediate volcanic and iron formation rock in its upper slopes and ultramafic rock in the lower benches. The intermediate volcanic and iron formation are generally good quality rock, whereas the ultramafic rock is generally fair quality. Seepage was noted on the west wall, apparently associated with a discrete, south dipping stratigraphic contact on a fold limb. This is shown in the following photograph.

Photograph 22: Pit E viewed from above showing the generally good performance of the west wall (viewed from Stop 10 in Figure 5)

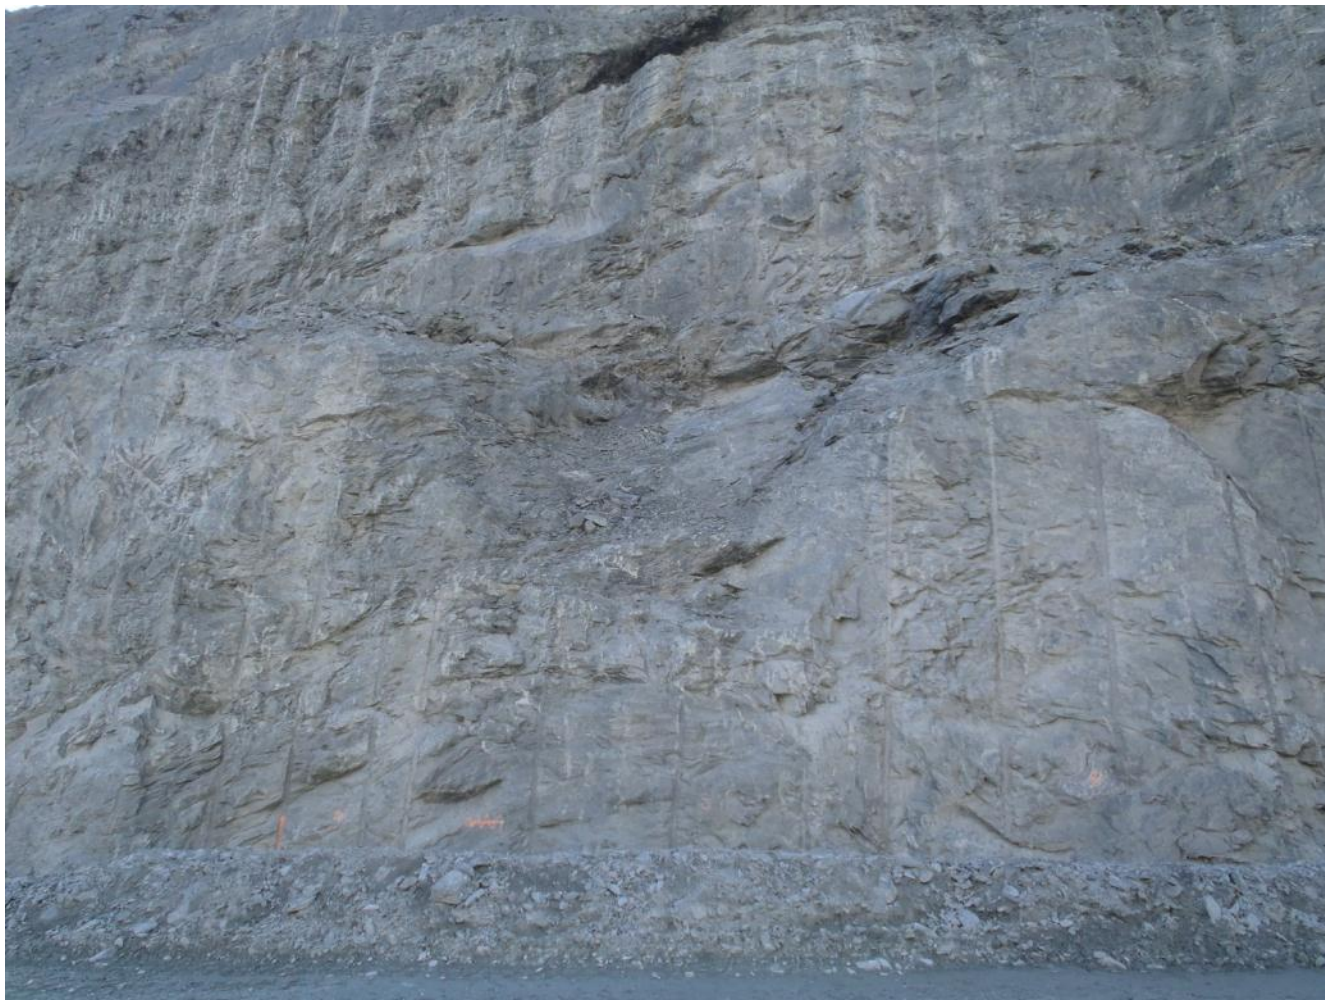
Some areas of the west wall adjacent to the road display bench scale ravelling associated with “scallop-type” structure (Figure 5, Stop 11). These are relatively shallow failures resulting from undulations in secondary foliation. A scallop-type structure is shown in the following photograph.

Photograph 24: Scallop-type structure in the west wall of Pit E, adjacent to ramp, with containment berm at base

While the failures are bench scale and do not pose a hazard to the overall stability of the wall, they do pose a potential hazard to equipment and personnel. Where these structures are identified during regular geotechnical inspections, containment berms should be constructed, as shown below.

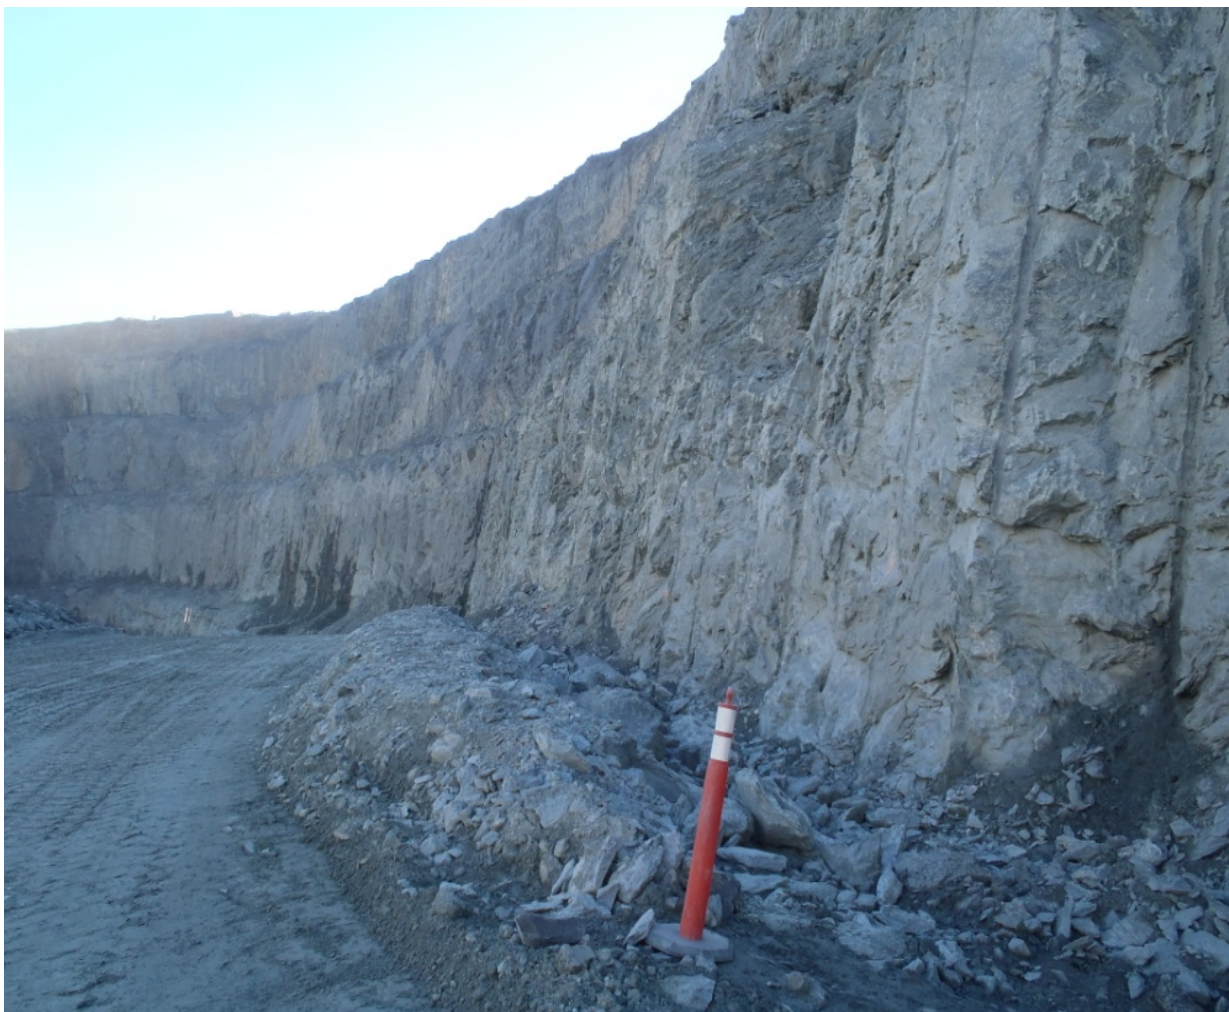
Photograph 25: Scallop-type structure in west wall of Pit E, adjacent to ramp and showing additional containment berm at toe of bench

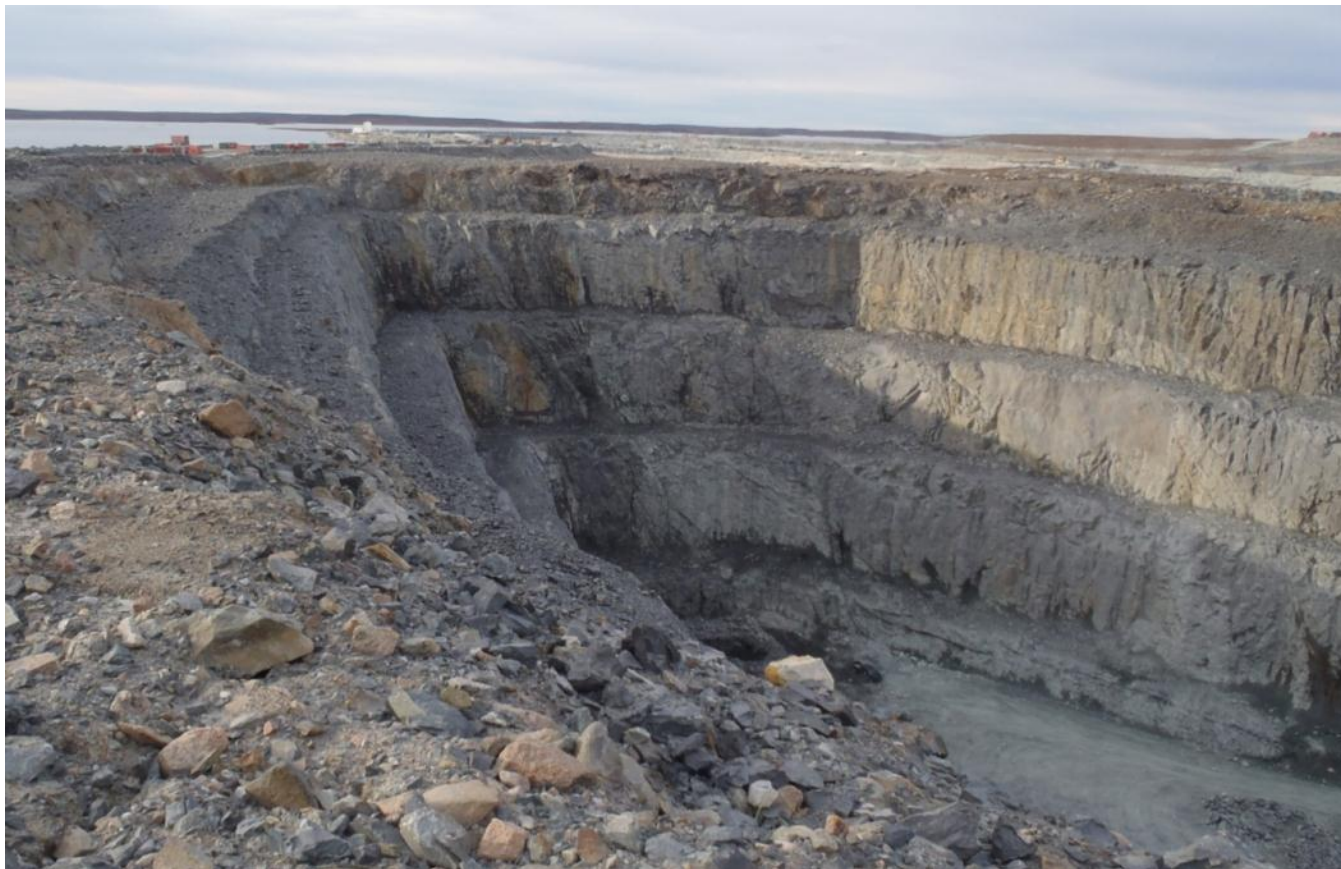
The south wall of the pit currently exposes intermediate volcanic rock to the east, iron formation and ultramafic rock through the centre, and ultramafic rock to the west. The foliation, stratigraphy, and north–south trending joint and fault structures trend into the wall. The overall performance of the wall is satisfactory. Pre-shear blasting methods are shown to be effective at minimizing damage behind blast lines. There is some build-up of talus material on the lowest bench due to ravelling of ultramafic rock but, the 10 m wide catch benches are adequately containing this material.

Photograph 26: The south wall of Pit E, looking southwest, viewed from the crest of the east wall (Stop 10 in Figure 5)

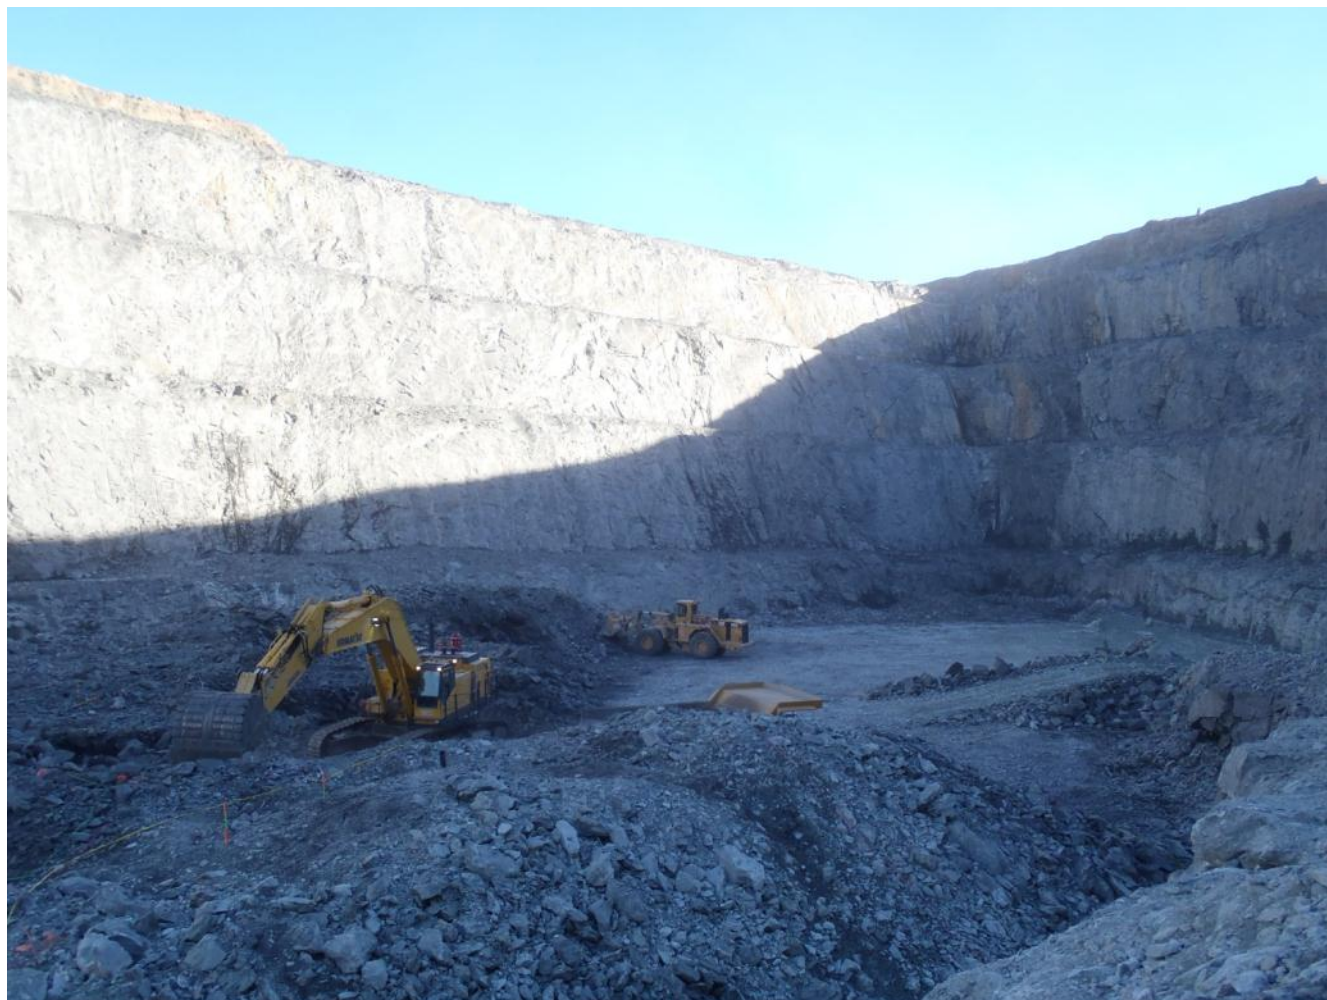
The foliation and stratigraphy exposed in the east wall of Pit E are inclined at steep angles to the west. Pre-shear blasting is taking advantage of the steep orientation of the dominant structure, and the pit walls are performing satisfactorily. Catch benches are generally clean, and currently there do not appear to be any significant stability concerns with the wall. As the east wall continues to be exposed during mining, ultramafic rock with shallower dipping foliation may be encountered, as discussed in the 2011 site visit report. As the foliation becomes shallower with depth, care will need to be taken to minimize undercutting of the structure as this may lead to multiple bench failure particularly in ultramafic rock. Bench faces should be excavated parallel to the foliation as it becomes shallower. Once this is no longer practical for operational or equipment reasons, single benching may be required for the final two or three benches, or until the foliation and stratigraphy are dipping less than 30 degrees. Careful geotechnical mapping should continue with emphasis placed on understanding how the orientation of the foliation and stratigraphy exposed in the east wall may be changing as the pit is mined. The east wall was observed from Stops 12 and 13 in Figure 5.

Photograph 27: East and southeast wall of Pit E showing generally good bench performance

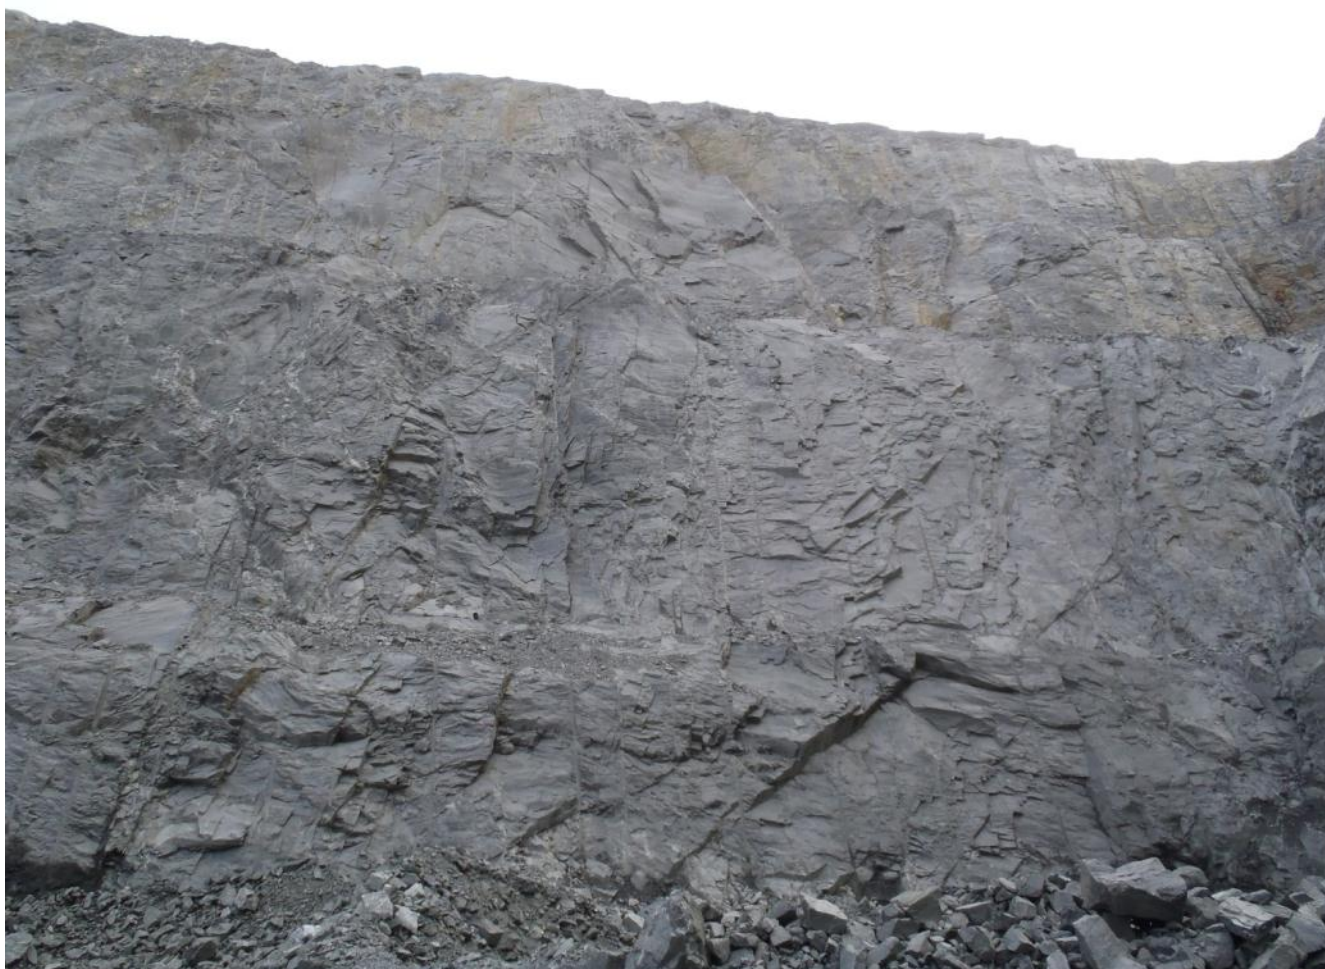
Photograph 28: Pit E east wall showing bench faces breaking to foliation

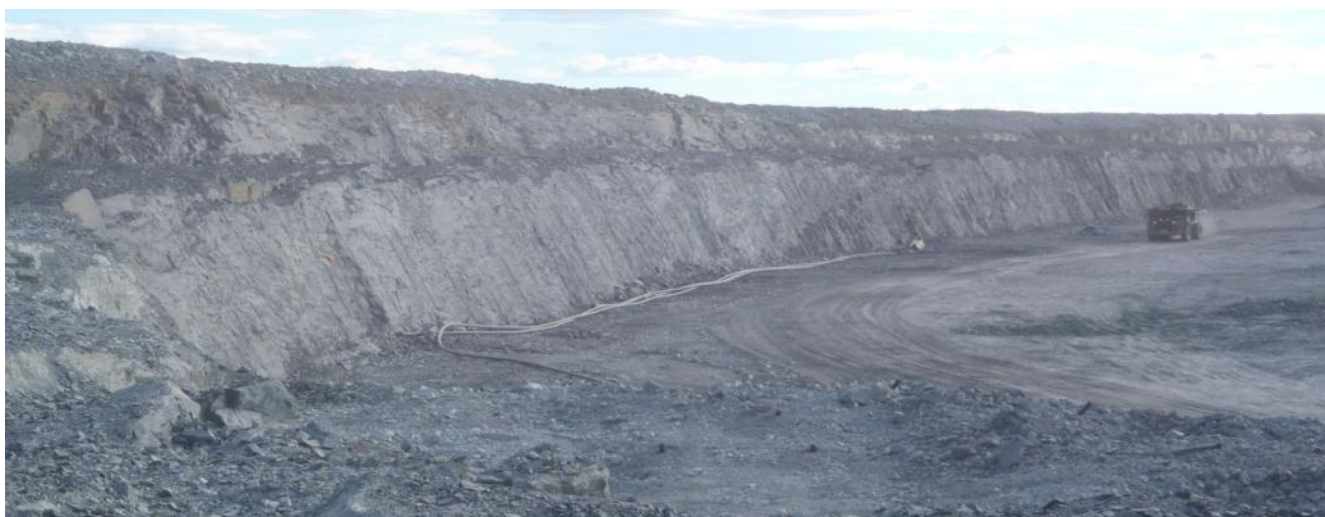
The following photograph shows the east wall of the Goose Pit, looking south, and illustrates the relatively smooth bench faces achieved by careful pre-shear blasting methods breaking to foliation.

Photograph 29: East wall of the Goose Pit, viewed from the North Crest

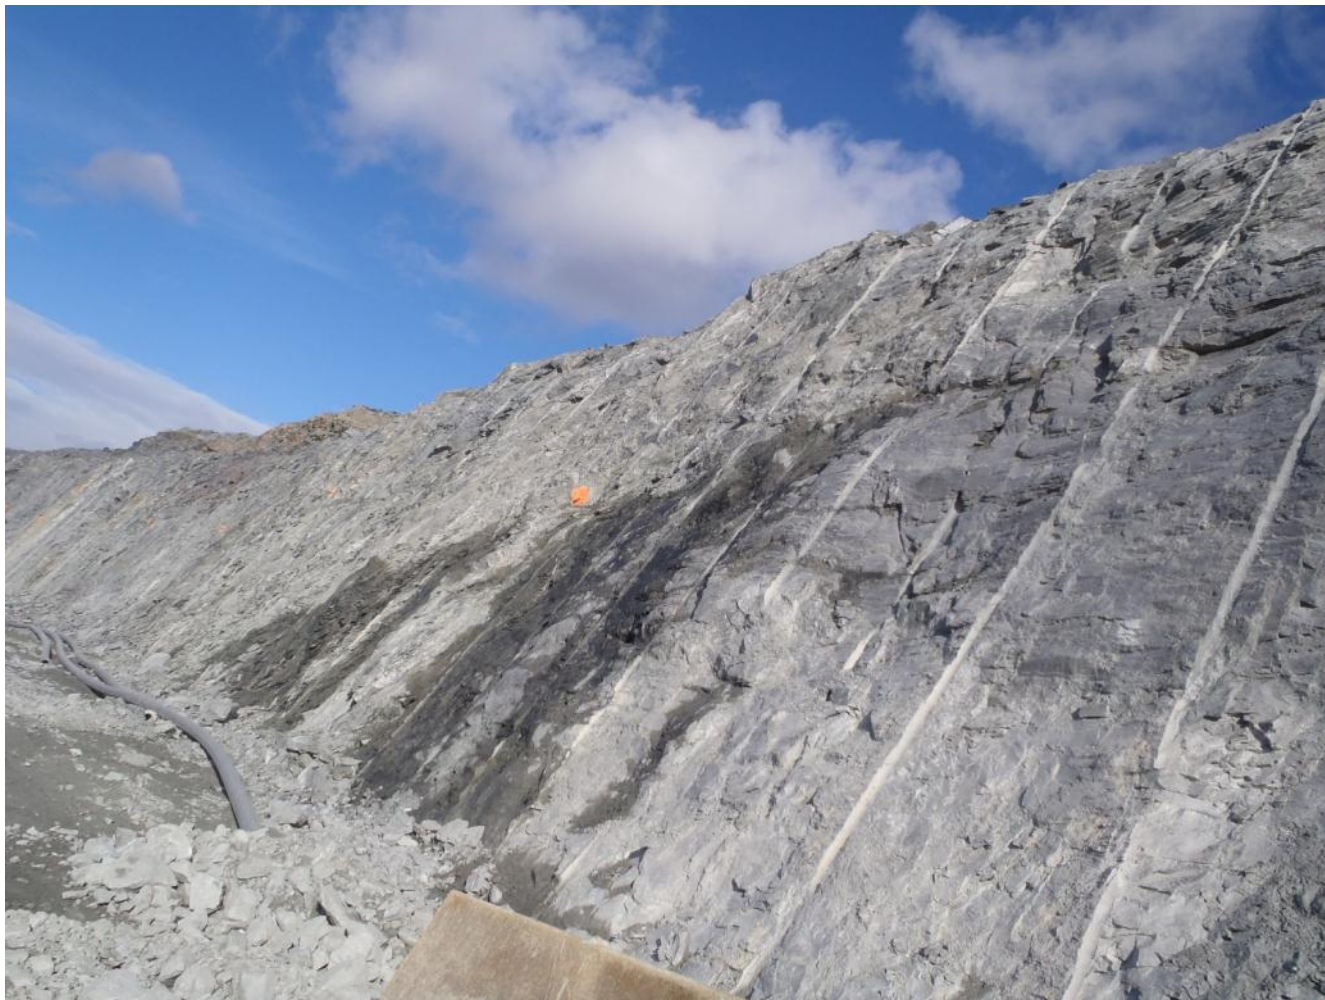
The east wall of the Goose Pit was observed to be in very good condition. Angled pre-shear blasting methods are being used effectively to break the rock parallel to the steeply west-dipping foliation. The following figure shows the east wall with clearly visible pre-shear half barrels. It was noted that there is very little deviation in the blast holes.

Photograph 30: East wall of Goose Pit showing pre-shear half barrels and west dipping foliation

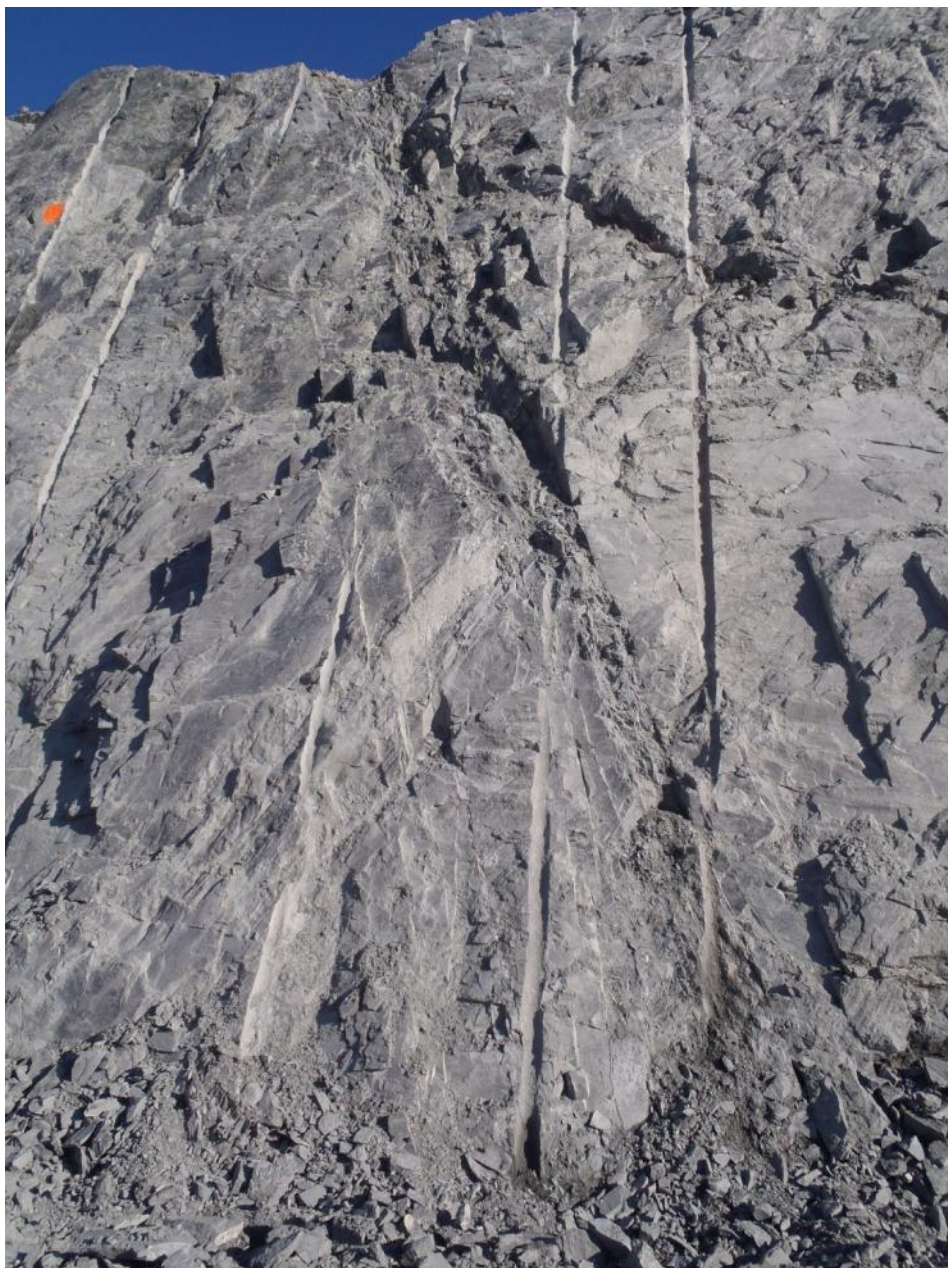
A narrow (20 to 30 cm) steeply south dipping fault was observed midway along the east wall, and AEM were requested to survey the location and orientation of this feature. The feature is shown in the following photograph.

Photograph 32: Discrete fault structure (south dipping) exposed in east wall of Goose Pit

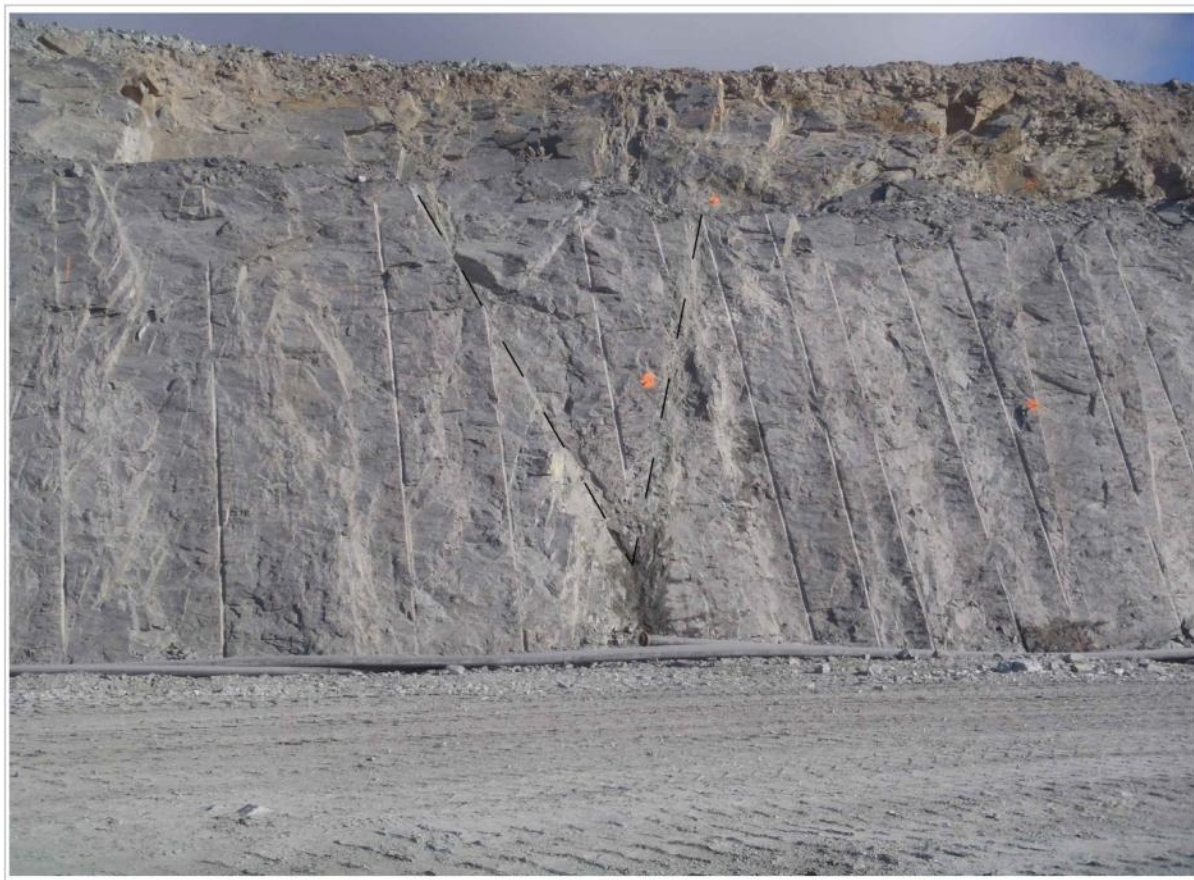
During a brief mapping training exercise on the east wall, a bench scale wedge was identified.

Photograph 33: Bench scale wedge formed by south dipping joint and north dipping sheared joint in the east wall of the Goose Pit. Viewed from 5,116 RL.

The orientation of the planes was measured; however, the dip direction of the planes is unreliable due to the influence of the magnetic iron formation. Nevertheless, an estimate of the plunge of this wedge was possible, and was determined to be approximately 10 degrees out of the face. Therefore, this wedge is expected to be stable. This wedge was used as an example of the types of features that should be identified during geotechnical mapping exercises.

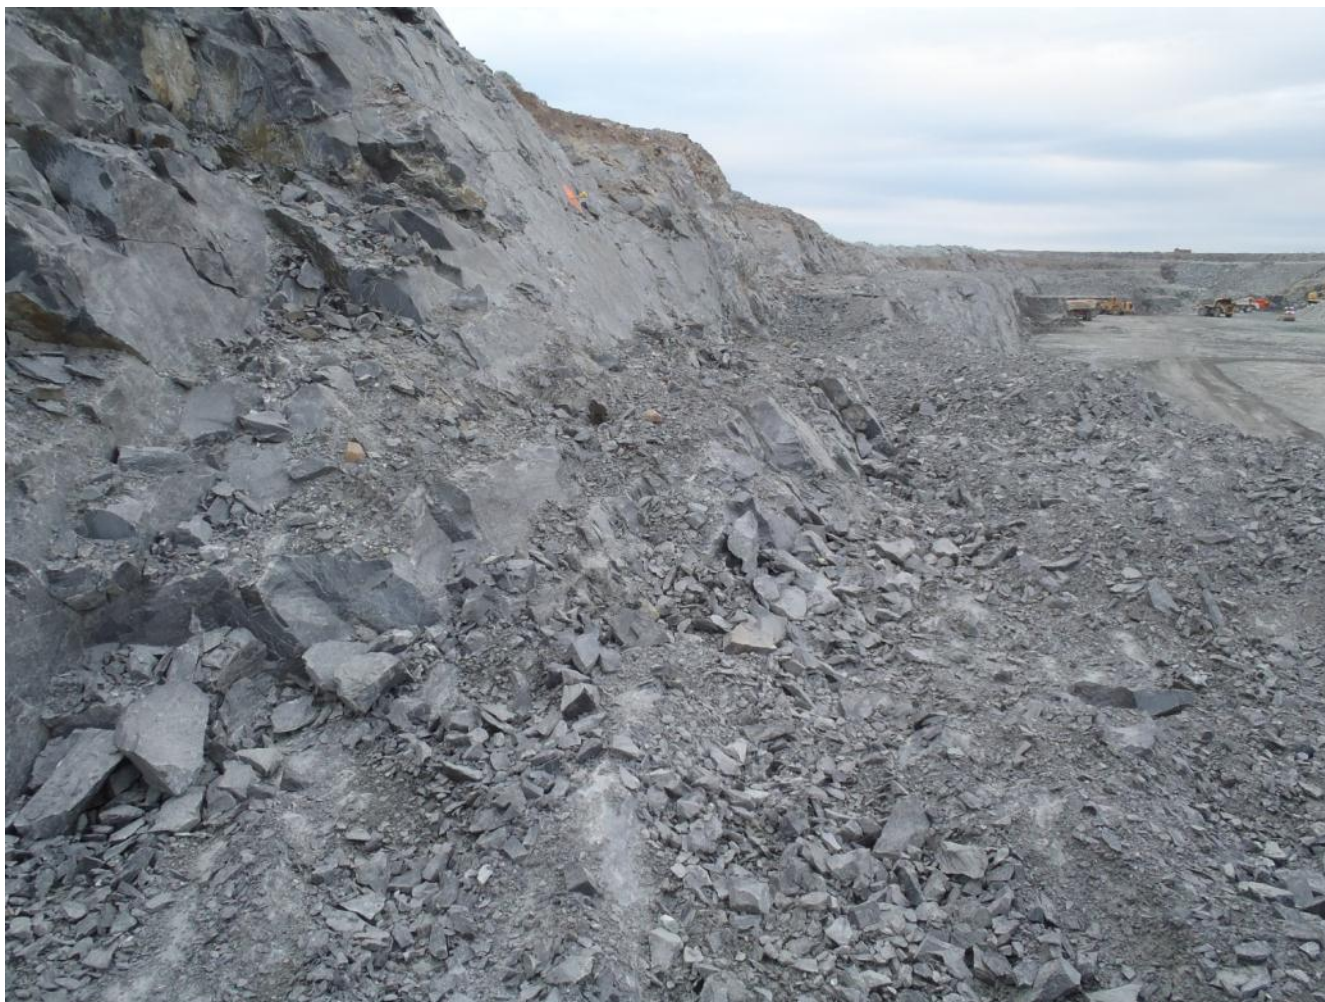
A traverse along the 5130 bench, identified as Stop 4 in Figure 8, noted that at the north end of the bench where the foliation is shallower and was undercut locally, some catchment loss resulted.

Photograph 34: Shallow dipping foliation at north end of Goose Pit

The orientation of the foliation at the north end has been interpreted by the engineering geological model to be shallower dipping near surface and steepening with depth. This was confirmed during the site visit.

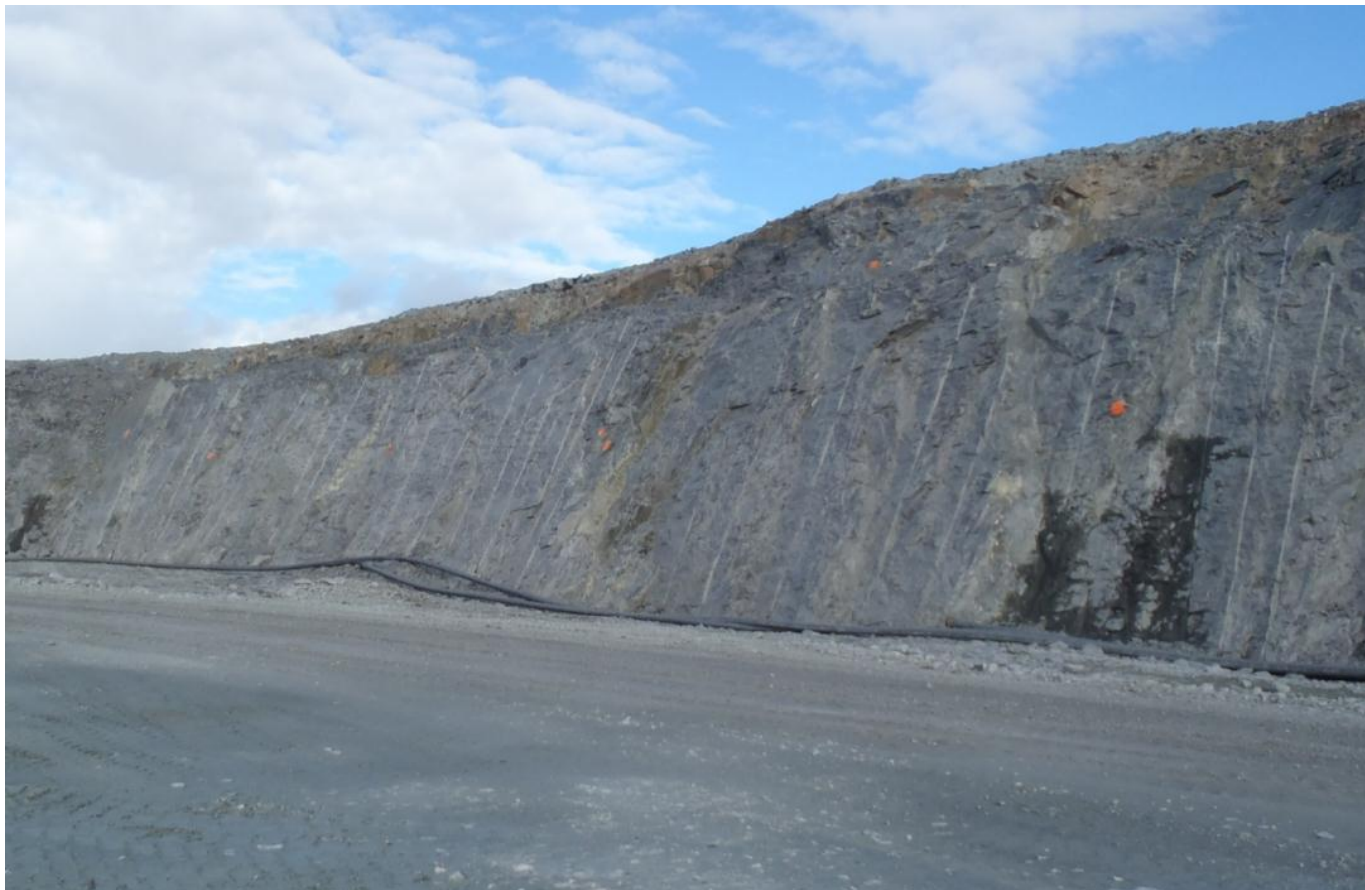
There are currently prisms in place at approximately 25 m spacing along the east wall. AEM has indicated that reading of these prisms will begin in the two-week rotation following the pit wall inspection. The prisms are to be read every week until a baseline pattern is established, at which point readings may be reduced to once per rotation, weather permitting.

Photograph 36: East wall of Goose Pit showing prism density

The monitoring prisms which are in place on the wall should begin to be read regularly beginning as soon as possible. There is an opportunity to gain important baseline data about current pit behaviour, which will be lost if regular weekly readings of the prisms do not begin very soon.

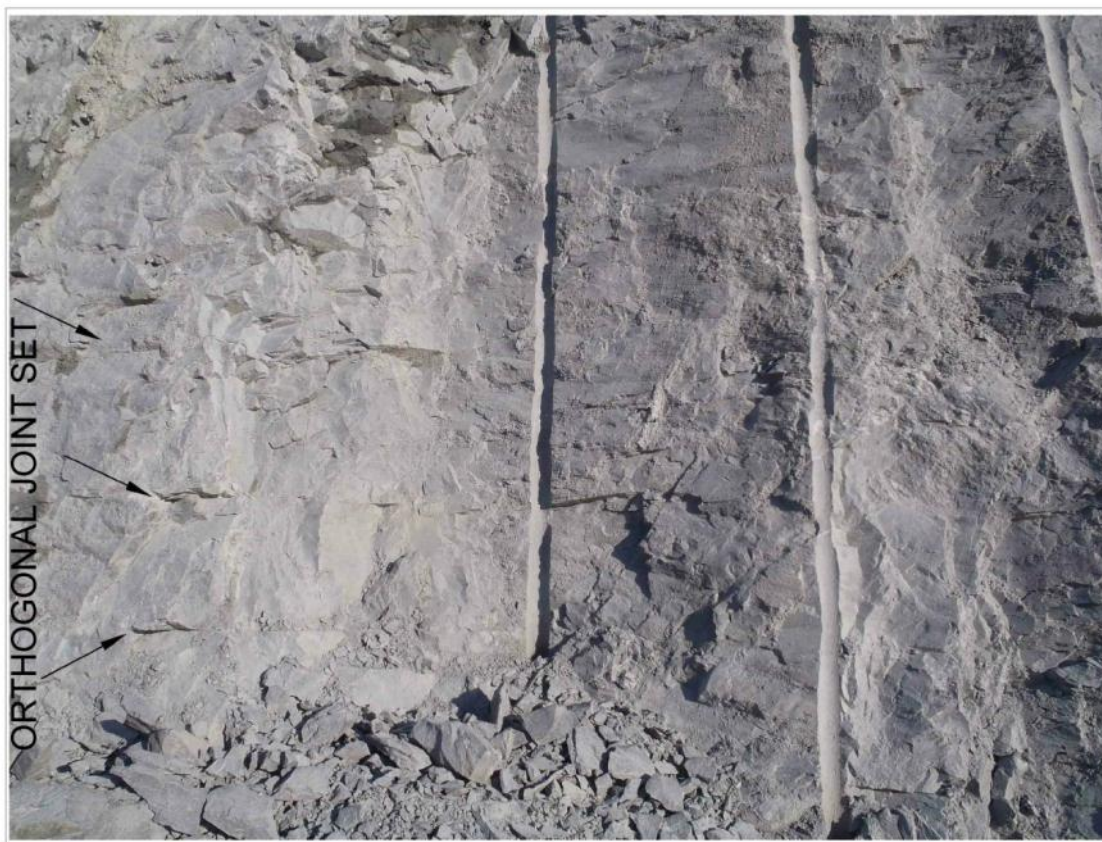
Photograph 37: Continuous orthogonal joint in the east wall showing significant rock bridging
