Report: *2012 Annual Review of Portage and Goose Pit Slope Performance*

2012 Annual Geotechnical Inspection Meadowbank Gold Mine, Nunavut

Agnico-Eagle Mines Limited
Meadowbank Division
PO Box 540
Baker Lake, Nunavut
X0C 0A0

Report Number: Doc 1394 1212210073 0115_13

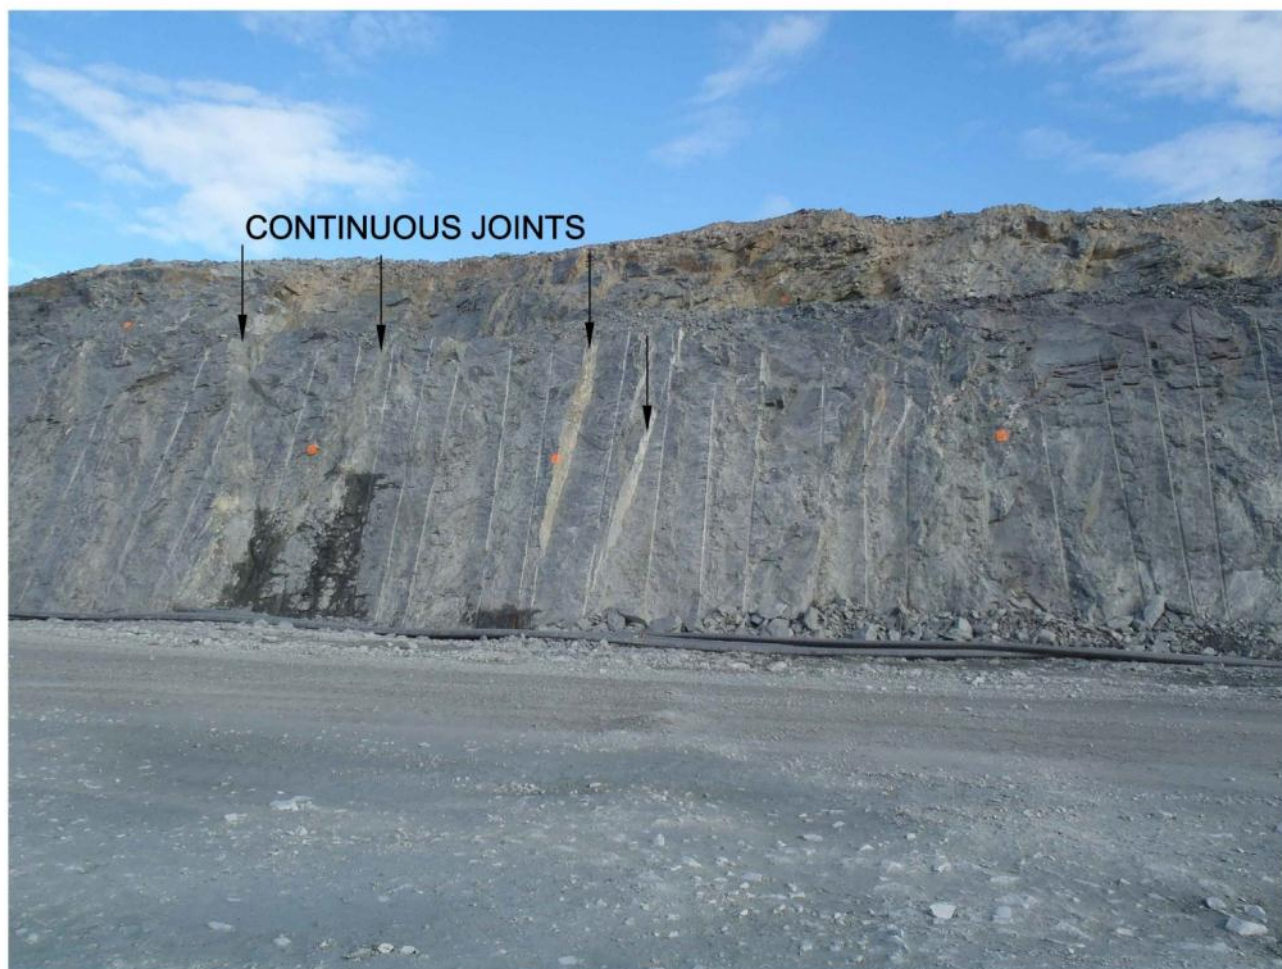
Photograph 38: Steep north- and south-dipping continuous joints exposed in east wall (potential side release planes)

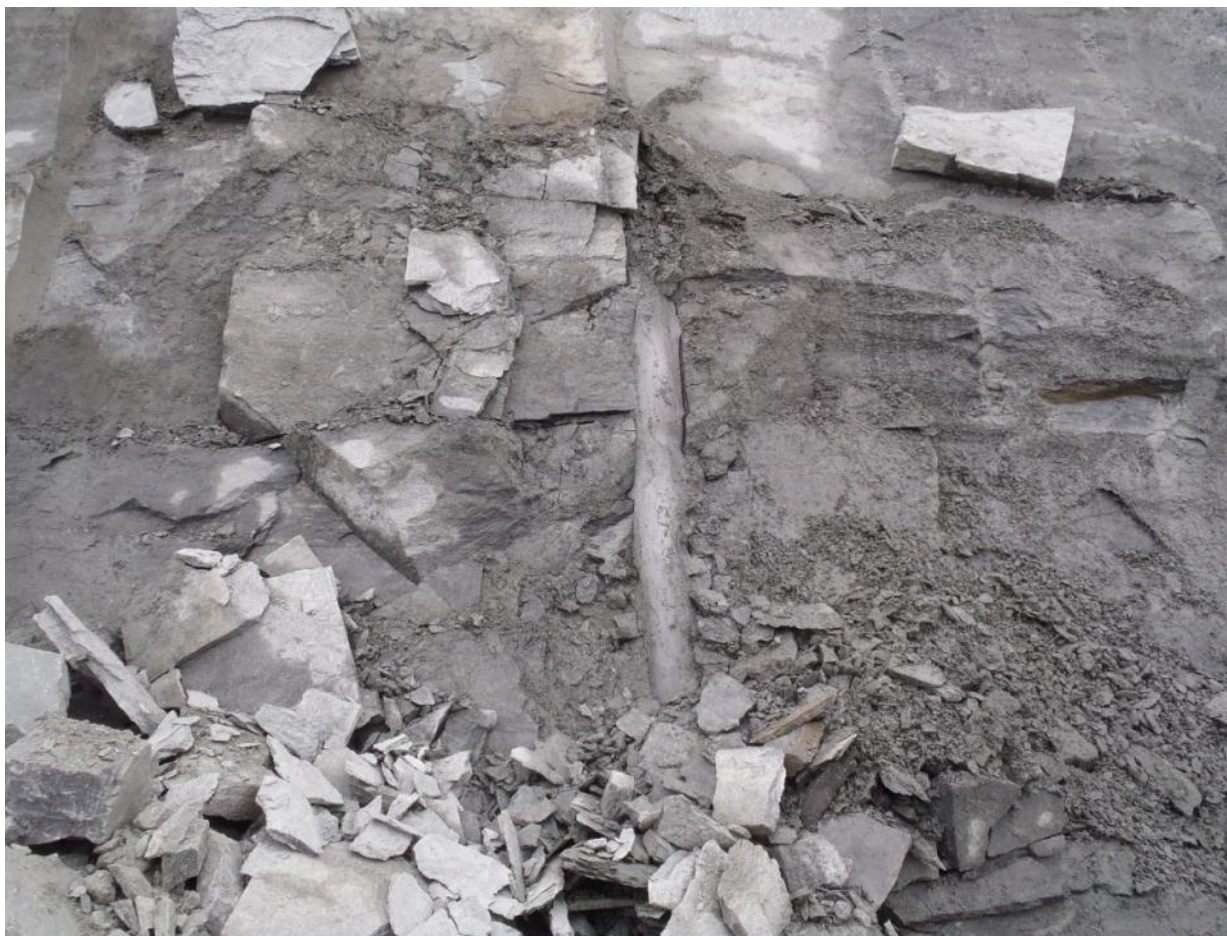
Photograph 39: Ice in blast holes near the south end of the current Goose Pit (Stop 6 in Figure 8)

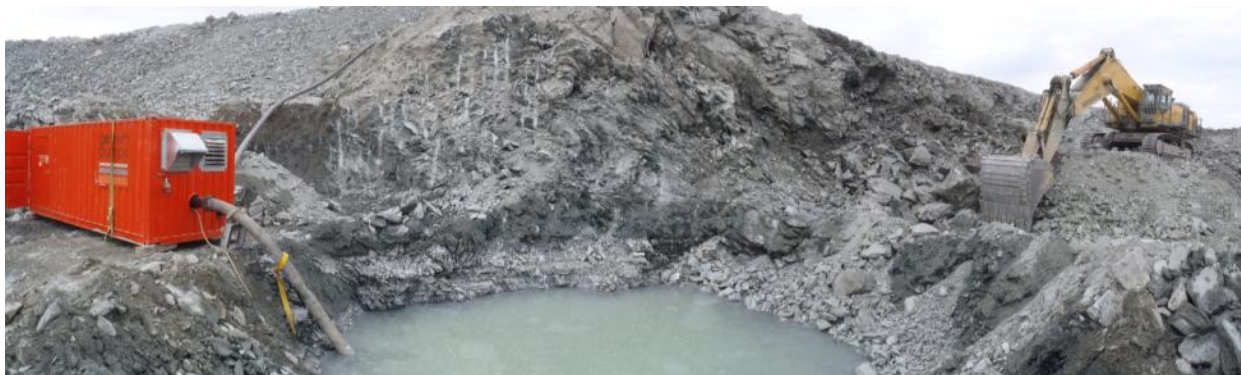
On September 10, 2012, a significant inflow of water was encountered in the active working area at the south end of the Goose Pit. A sump was excavated to manage the water inflow which was estimated by AEM to be approximately 30 L/sec. The location of the inflow, identified in Figure 8 as Stop 7, was visited early in the afternoon of September 10. At that time the sump was turned off and there was no noticeable movement in the level of the ponded water, suggesting that the inflow was due to the release of stored water from a local, confined aquifer, and not due to flow along a potential structure such as a fault. It is possible that the absence of water level change is a result of sump leakage, however AEM have not reported any additional or on-going water problems in this area. The current engineering geological model suggests a north-south trending fault may be encountered in this area of the south wall. However, the poor exposure of bedrock did not allow the clear identification of any tectonic structure. During the ongoing excavation of the pit in this area, care should be taken to identify this potential structure if it exists, and to survey its location.

This inflow occurred adjacent to a contact between the intermediate volcanic rock and the ultramafic rock, marked in Figure 8 as Item 8. The ultramafic rock is talcose and fissile, and there is significant local variability in the foliation in the rock around this location. AEM was requested to survey the contact as this may be helpful for future interpretation of the engineering geological model for the south wall as the pit continues to be deepened.

Photograph 40: Location of inflow in the South Goose Pit showing irregularly foliation and highly fissile material
