Report: 2015 Annual Geotechnical Inspection

2015 Annual Geotechnical Inspection Meadowbank Gold Mine, Nunavut

Agnico-Eagle Mines Limited
Meadowbank Division
PO Box 540
Baker Lake, Nunavut
X0C 0A0

Document Number: Doc1533 1535715-Rev0

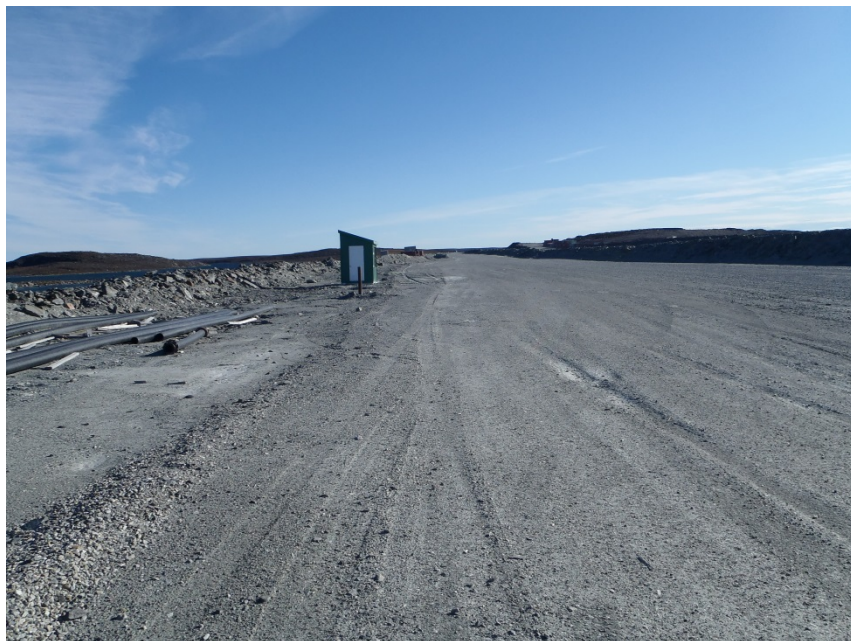
Photograph A1-1 East Dike

2. UPSTREAM SLOPE		98,102,103,106	
2.1 Slope angle	Approx. 1.6H:1V		
2.2 Signs of Erosion	Stable		
2.3 Signs of Movement (Deformation)	None observed		
2.4 Cracks	None observed

Description: From Sta. 60+811, looking south at the crest.

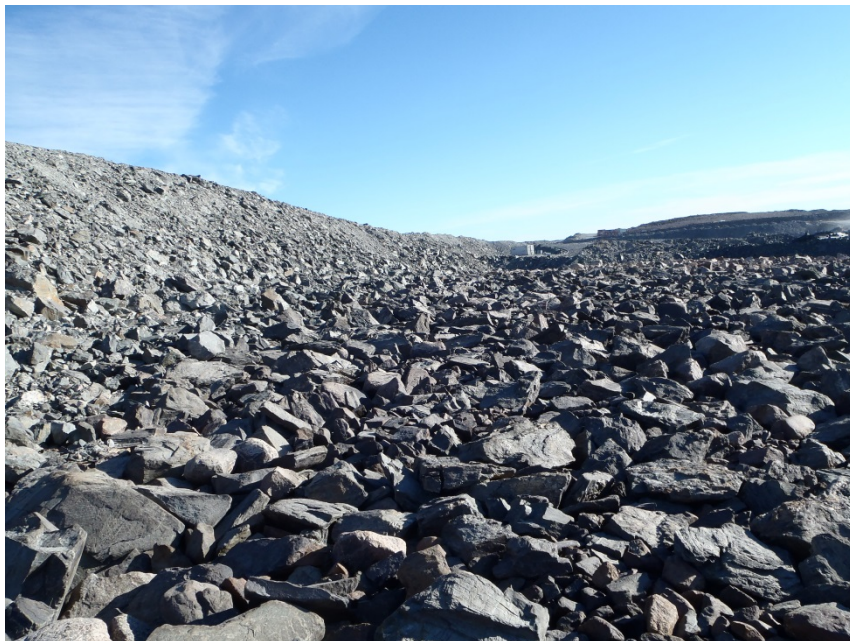
Photograph A1-3 East Dike

INSPECTION ITEM	OBSERVATIONS DATA	PHOTO	COMMENTS & OTHER DATA
2.6 Other Unusual Conditions	None		
3. DOWNSTREAM SLOPE		97,101,107,108, 109,110	
3.1 Slope angle	Approx. 1.6H:1V

3.6 Vegetation Growth	None observed		
3.7 Other Unusual Conditions	None		
4. DOWNSTREAM TOE AREA		97,101,107,108, 109,110	
4.1 Seepage from Dam	Yes, presence of 3 zones	97	Zone of seepage downstream near Sta. 60+247. A sump is installed (pumping system located in container on the photo). No additional seepage observed at the surface of the ground. Pumping collection system started on April 4' 2012. Flow is being monitored since July 2013.
		101	Zone of seepage downstream near Sta. 60+498. A sump is installed (pumping system located in container on the photo). Ponded water nearby. No additional seepage observed at the surface of the ground during the inspection. Pumping collection system started on April 4, 2012. Flow is being monitored since July 2013.
			Seepage zone near Sta. 60+575. Mean flow from 2010 to 2012 was 2 m ³ /days. According to AEM, this zone was practically dry all year. A very slow trickle of water was observed in the summer of 2014 and 2015 and during the inspection

Description: From Sta. 60+700 downstream, looking south.

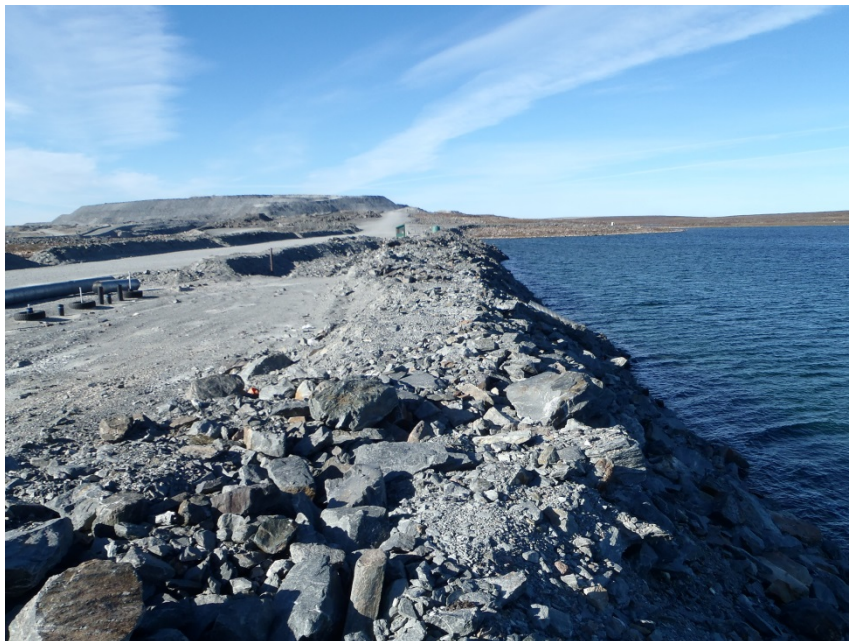
Photograph A1-5 East Dike

Description: From Sta. 60+553, looking north at the upstream slope.

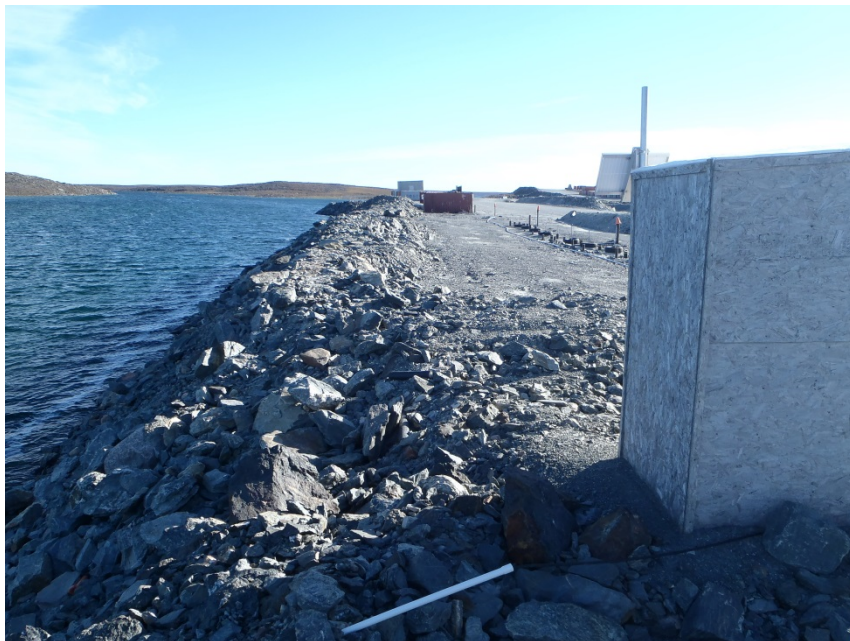
Photograph A1-7 East Dike

Description: From Sta. 60+553, looking south at the upstream slope.

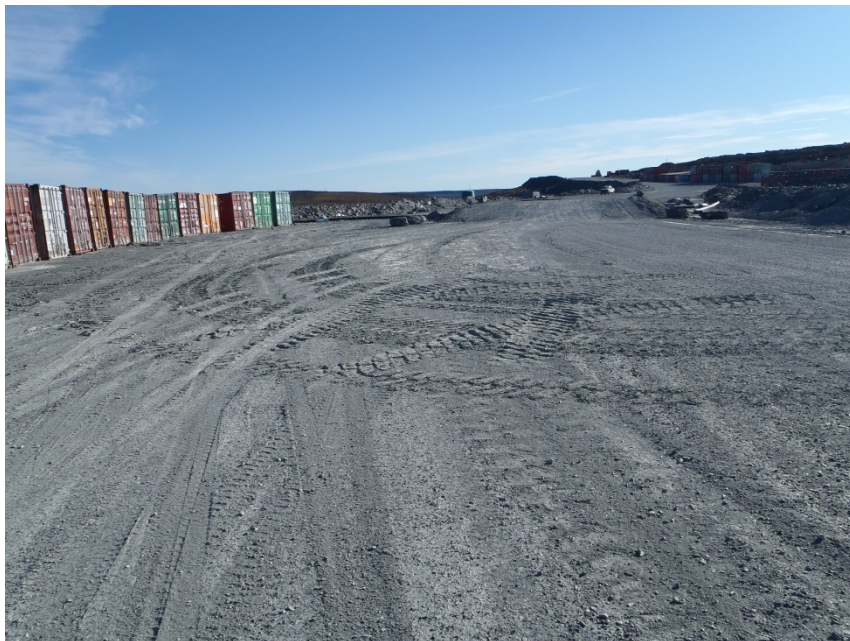
Photograph A1-9 East Dike

Description: From Sta. 60+394, looking south at the crest.

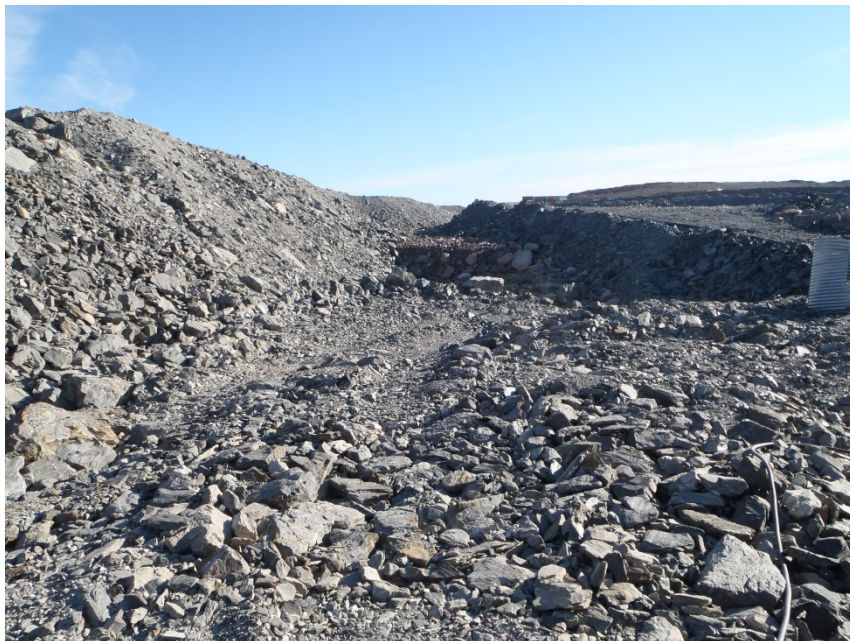
Photograph A1-11 East Dike

Description: From approximately Sta. 60+475 downstream, looking south.

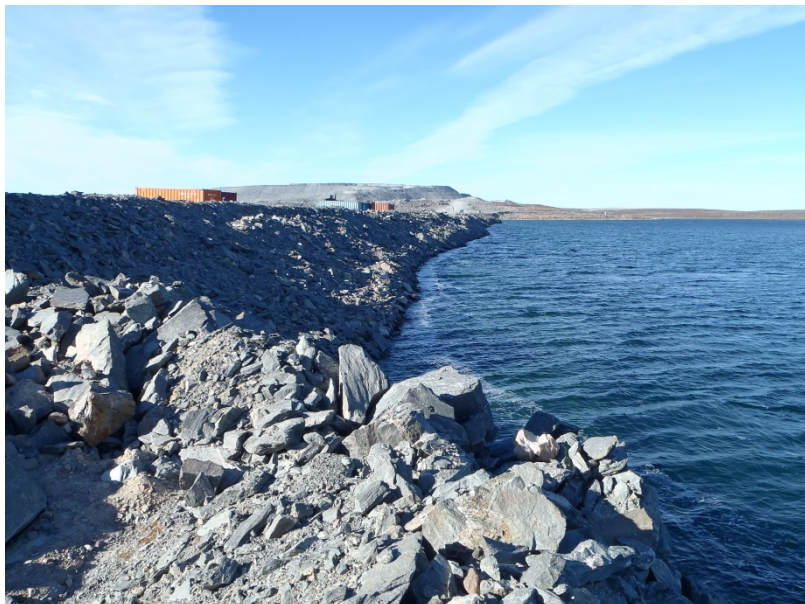
Photograph A1-13 East Dike

Description: From approximately Sta. 60+300, looking north at the upstream slope.

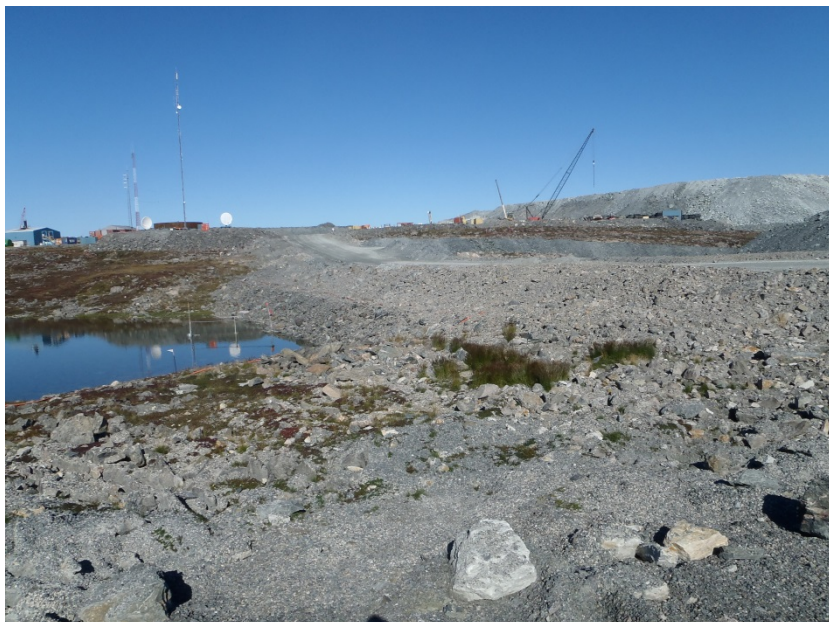
Photograph A2-1 South Camp Dike

Description: From the south abutment, looking north at the upstream slope and the thermistors instrumentation set-up.

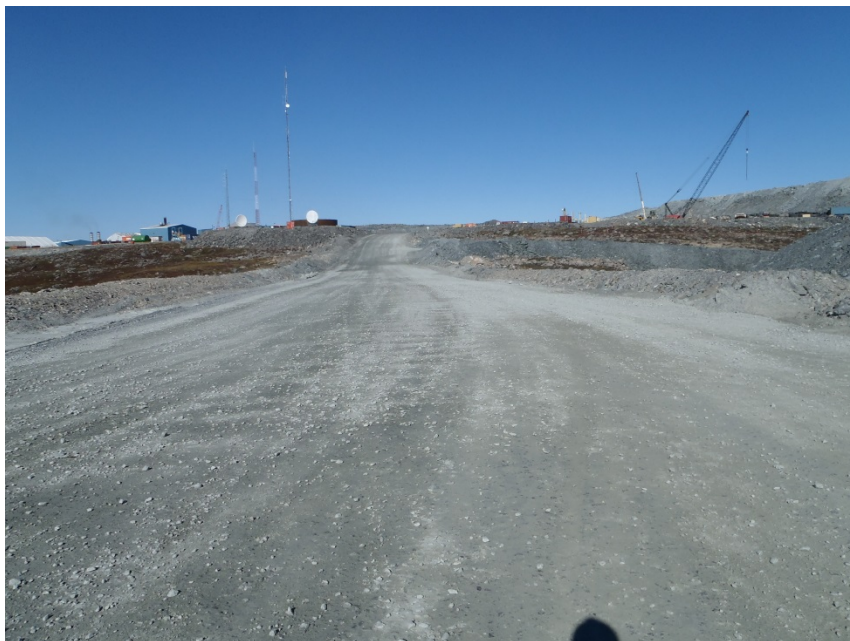
Photograph A2-3 South Camp Dike

INSPECTION ITEM	OBSERVATIONS DATA	PHOTO	COMMENTS & OTHER DATA
1. DAM CREST		17,20	
1.1 Crest elevation	El. 136.6 m (rockfill) El 134.7 m (liner)		
1.2 Reservoir Level	U/S El.133.6 m D/S		No water downstream since 2011.
Current Freeboard	3 m (rockfill crest) 1.1 m (liner crest)		
1.3 Distance to Tailings Pond (if applicable)	Not applicable		
1.4 Surface Cracking	None at the time of inspection		
1.5 Unexpected Settlement	None at the time of inspection		
1.6 Lateral Movement	Not apparent		
1.7 Other Unusual Conditions	None		
2. UPSTREAM SLOPE		16, 22	
2.1 Slope Angle	Approx. 1.3V: 1H		Adequate for a rockfill shell with small height.
2.2 Signs of Erosion	None observed		
2.3 Signs of Movement (Deformation)	None observed		
2.4 Cracks	None observed

Description: From the south abutment, looking north at the crest.

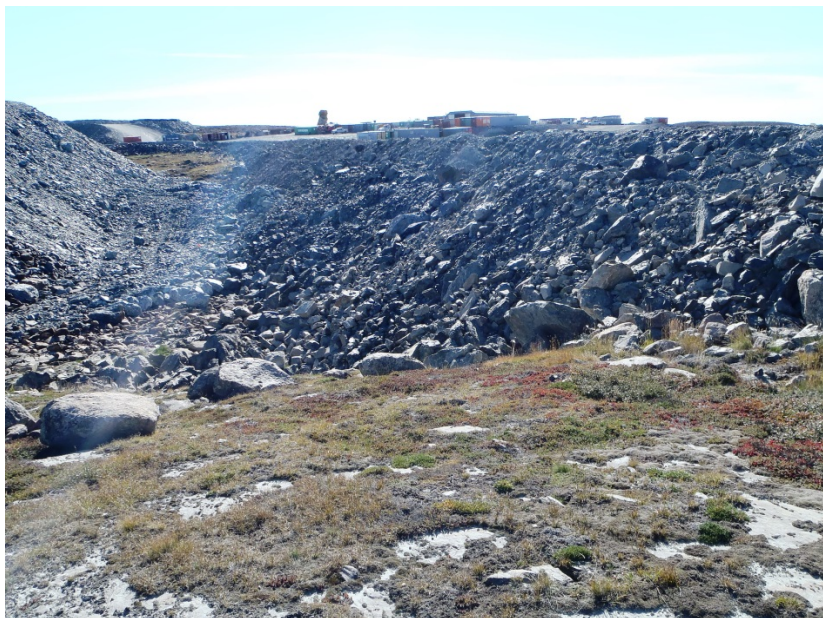
Photograph A2-5 South Camp Dike

2.6 Other Unusual Conditions	None		
3. DOWNSTREAM SLOPE		18,19	
3.1 Slope angle	Approx. 1.4V: 1H		Adequate for a rockfill shell with small height.
3.2 Signs of Erosion	None observed

Description: From the north abutment, looking south at the downstream slope.

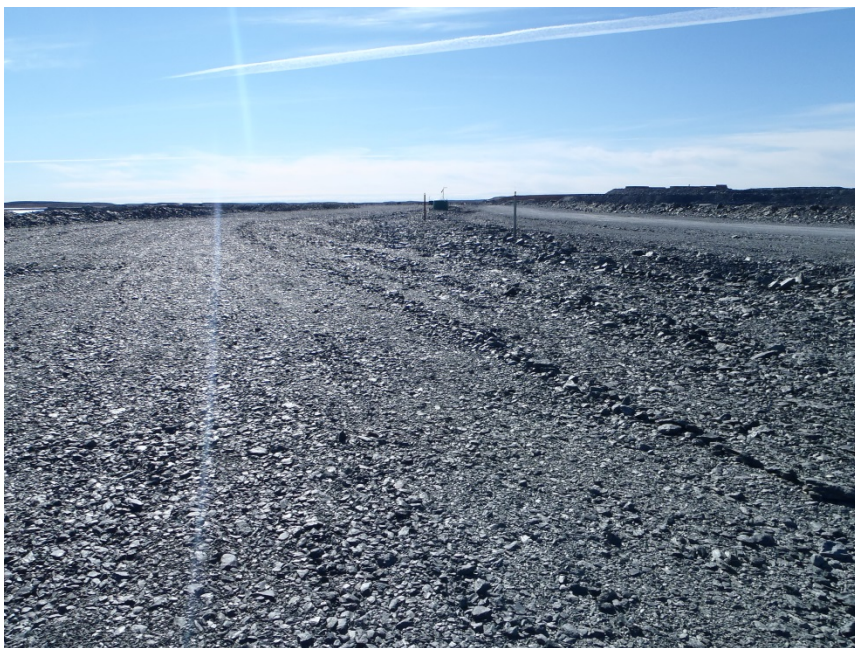
Photograph A3-1 Bay Goose Dike

Description: From Sta.30+142 (north abutment) looking southwest along the crest centreline.

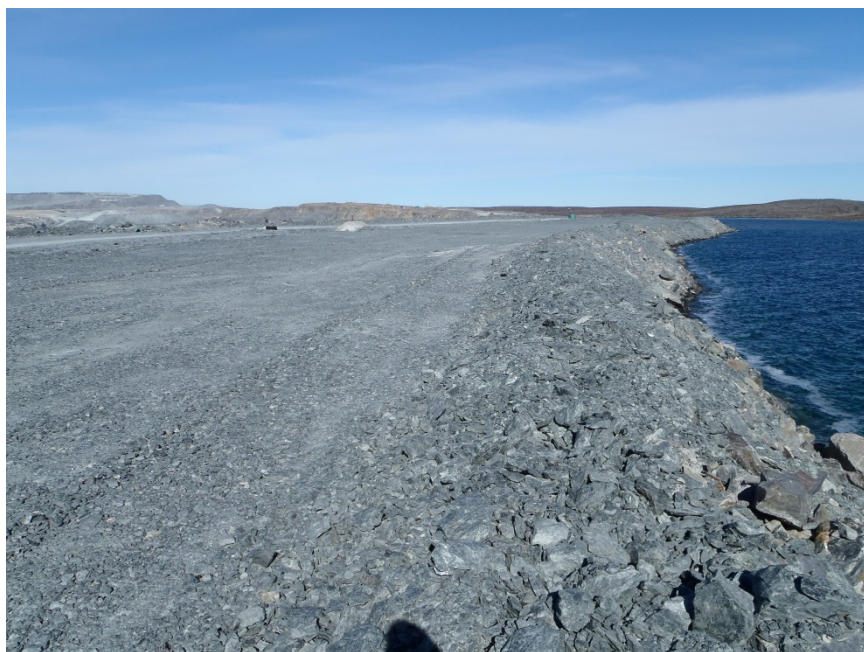
Photograph A3-7 Bay Goose Dike

Description: From Sta.30+499, looking northeast at the crest and upstream slope.

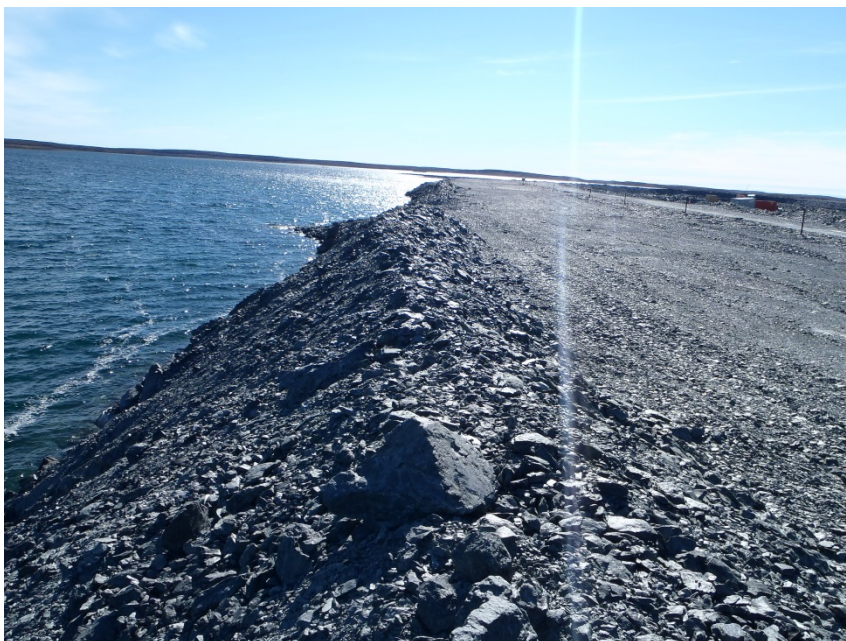
Photograph A3-10 Bay Goose Dike

Description: From Sta.30+499, looking west at the crest centreline.

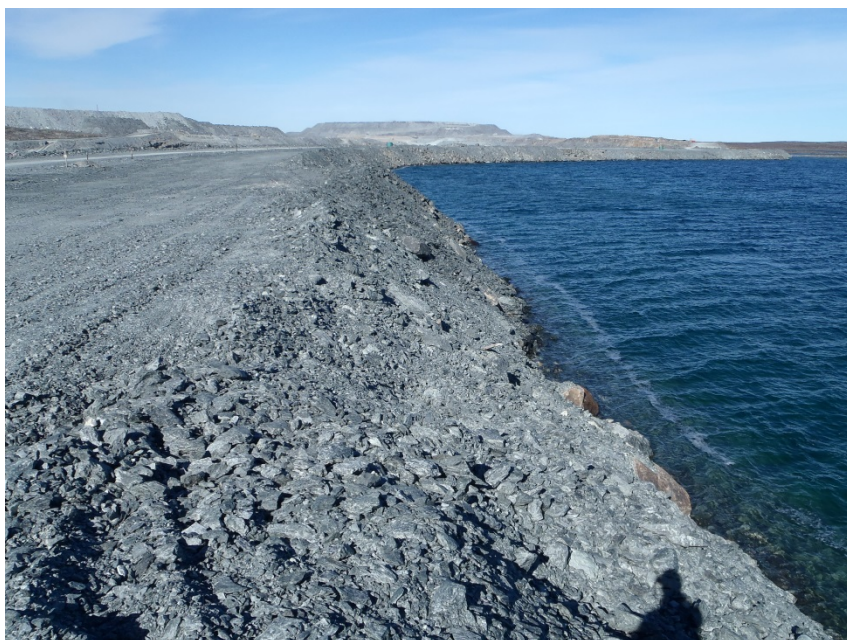
Photograph A3-11 Bay Goose Dike

Description: From Sta.30+680, looking north at the crest and upstream slope.

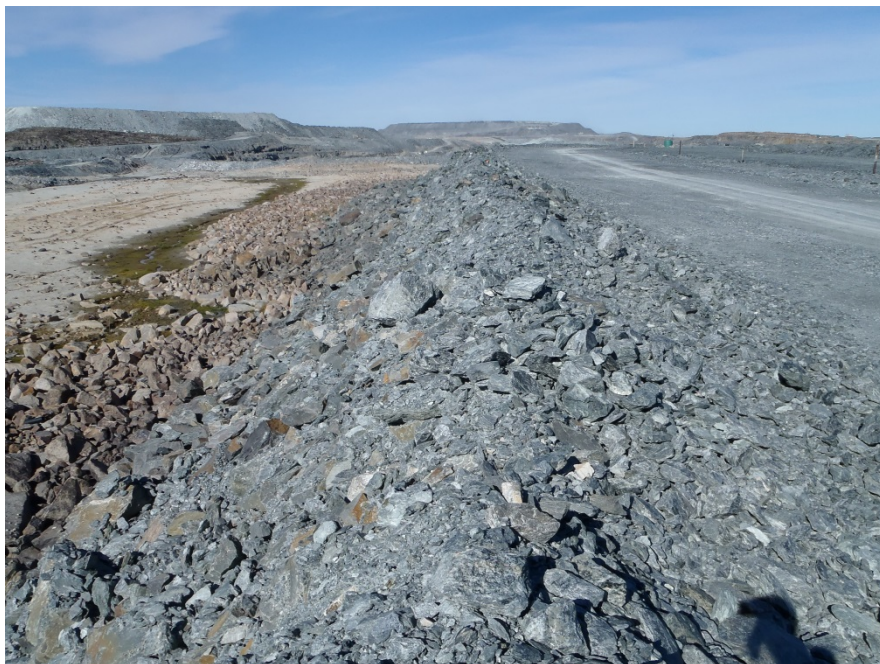
Photograph A3-13 Bay Goose Dike

Description: From Sta.30+680 on the crest, looking north at the downstream slope and downstream toe.

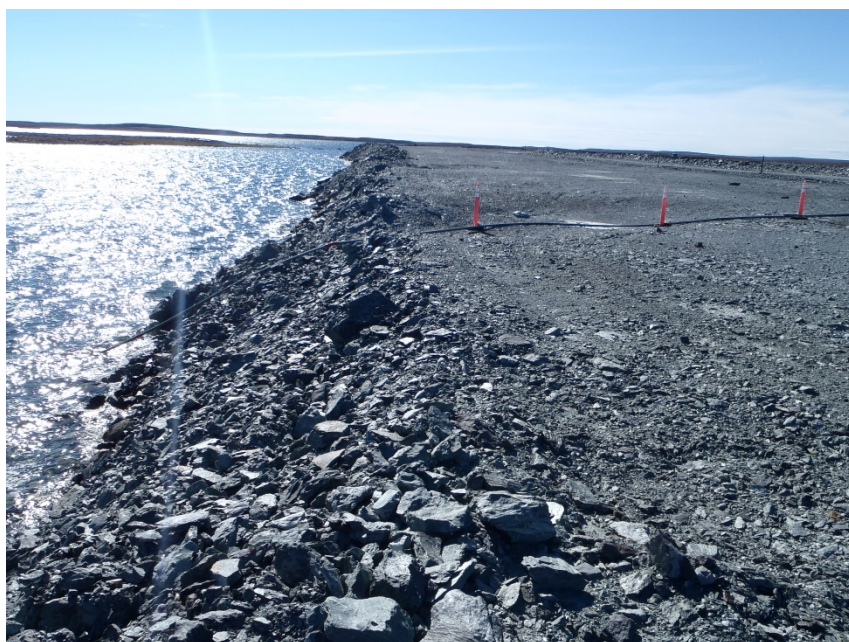
Photograph A3-15 Bay Goose Dike

1.6 Lateral Movement	Not apparent.		
1.7 Other Unusual Conditions	Yes		Safety berms on both sides are inadequate in some sections.

Description: From Sta. 31+130, looking south at the crest and upstream slope. There are no safety berms.

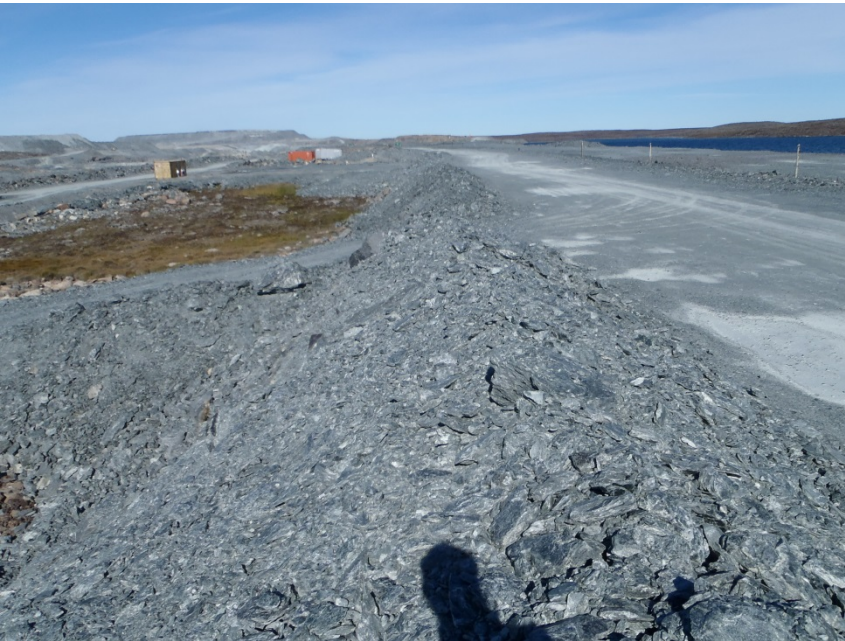
Photograph A3-17 Bay Goose Dike

Description: From Sta. 31+080 on the crest, looking north at the downstream slope and toe.

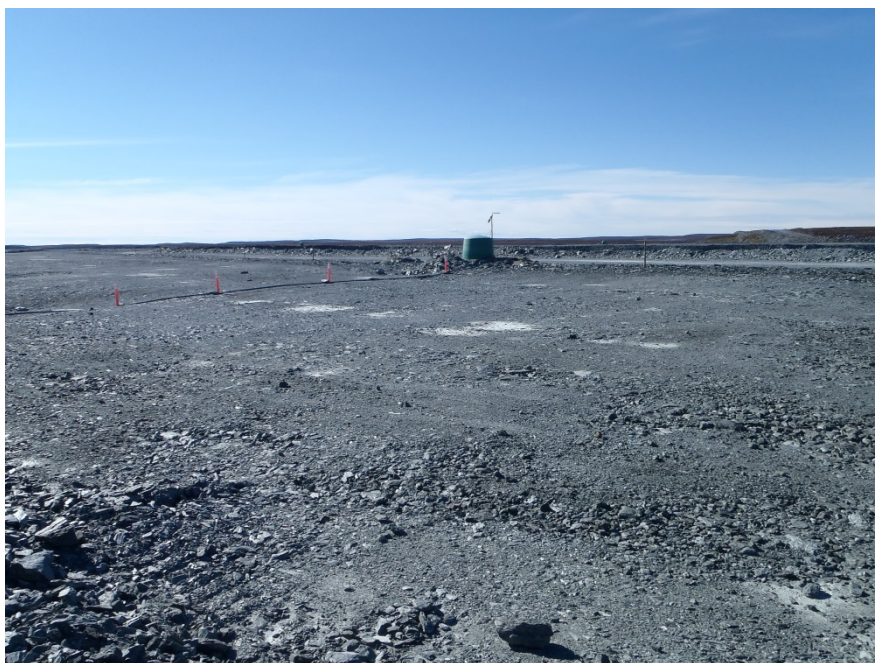
Photograph A3-19 Bay Goose Dike

Description: From Sta. 31+130, looking southwest at the crest centreline.

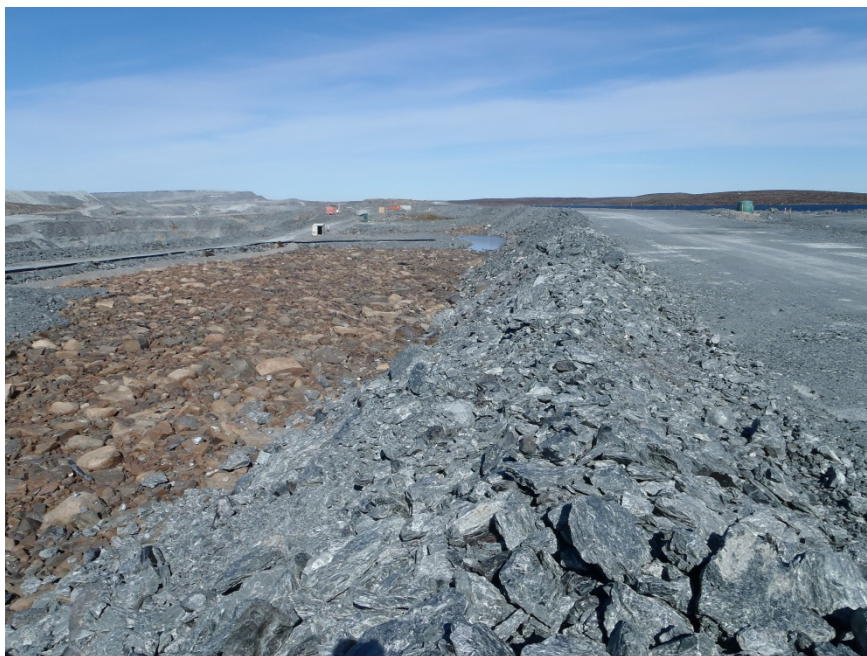
Photograph A3-21 Bay Goose Dike

INSPECTION ITEM	OBSERVATIONS DATA	PHOTO	COMMENTS & OTHER DATA
	Central Channel	74,81	Presence of a seepage channel at Sta. 31+165. Water ponding was observed at the time of the inspection. The recharge of this pond has been assessed by AEM
	Channel 3	70	No flow observed during inspection. Monitored by station 6.
	Chanel 1	63	This seepage channel was not flowing at the time of the inspection. According to the mine it was not active this year.
	Water Ponds	66,73,74	Presence of 2 water ponds with no sign of seepage. Located at 31+350 and 31+750.

Description: From Sta. 31+280 on the crest, looking north at the downstream slope and toe area.

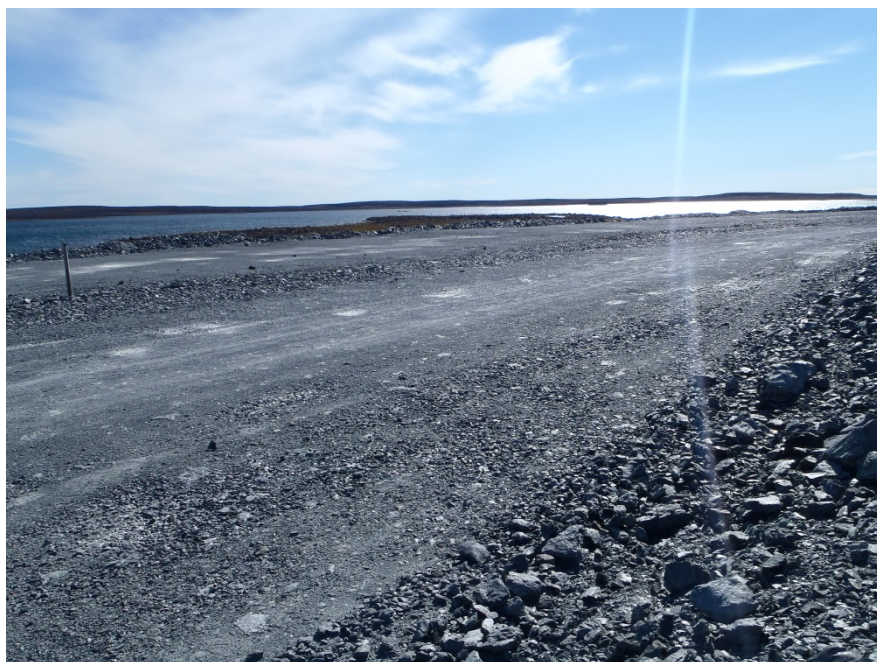
Photograph A3-23 Bay Goose Dike

Description: From Sta. 31+280, looking south at the crest.

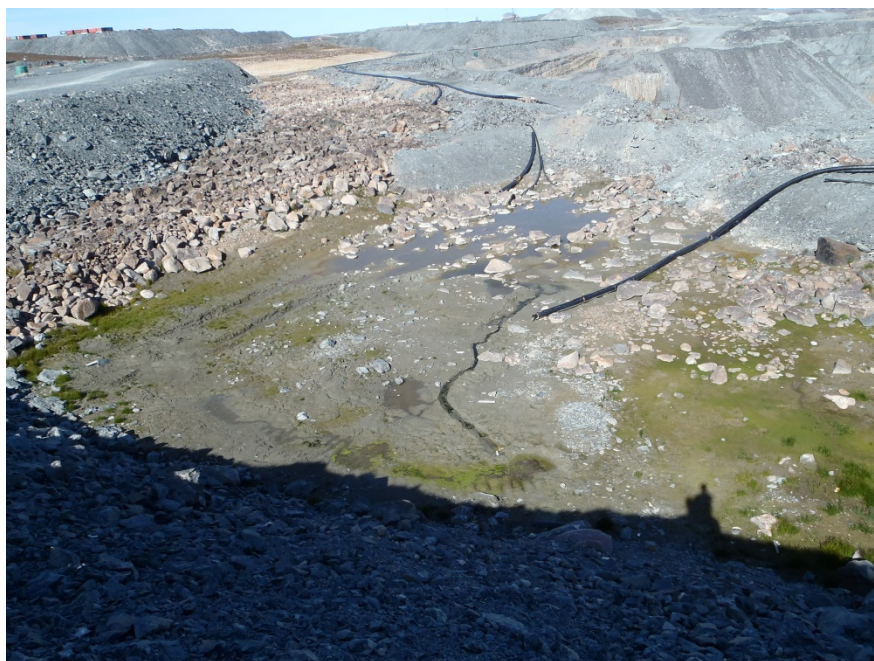
Photograph A3-27 Bay Goose Dike

Description: From Sta. 31+570, looking north toward Channel 3.

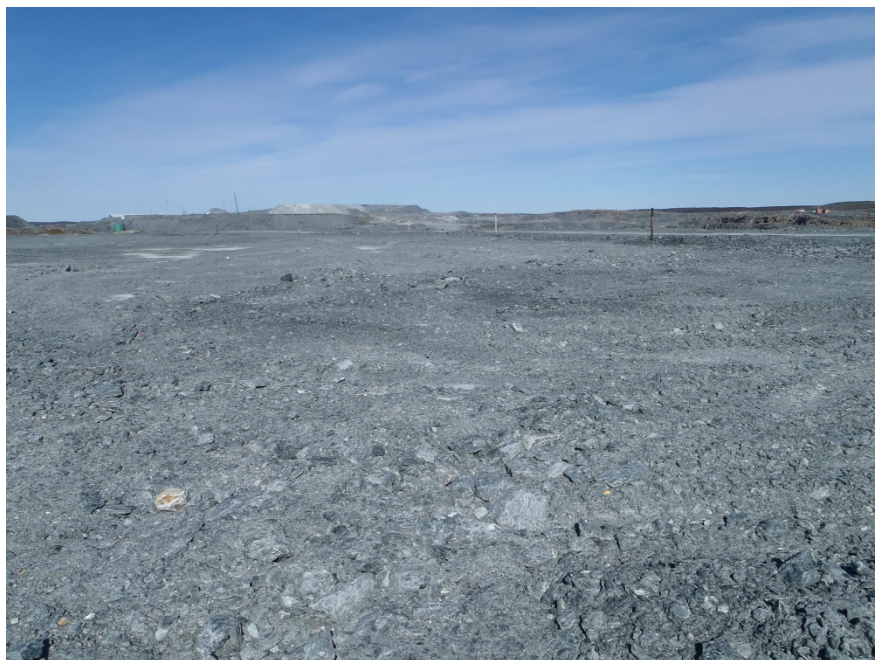
Photograph A3-29 Bay Goose Dike

Description: From Sta. 31+645, looking northwest at the crest.

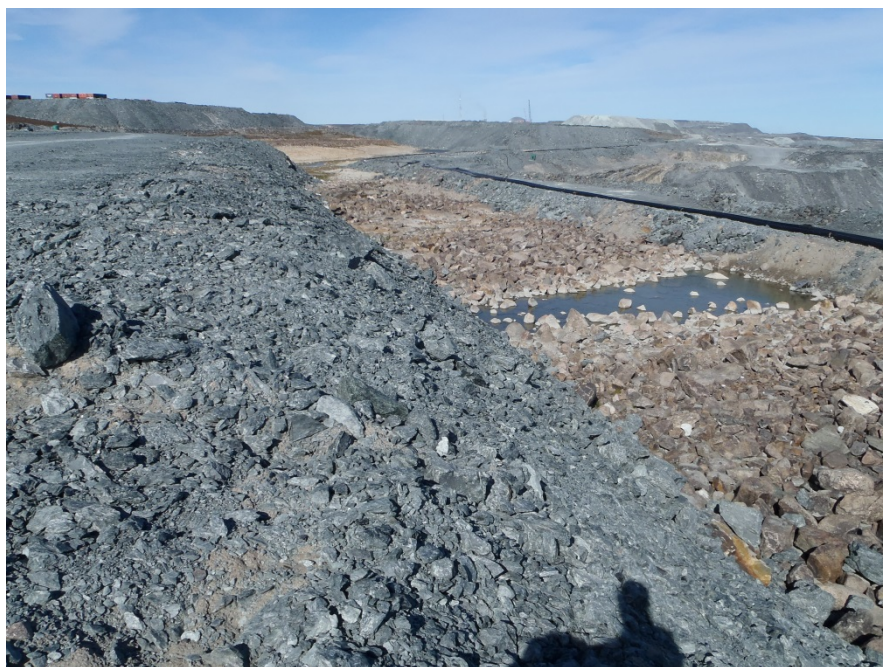
Photograph A3-31 Bay Goose Dike

Description: From the crest at Sta. 31+740, looking north downstream at the water pond at Sta. 31+750.

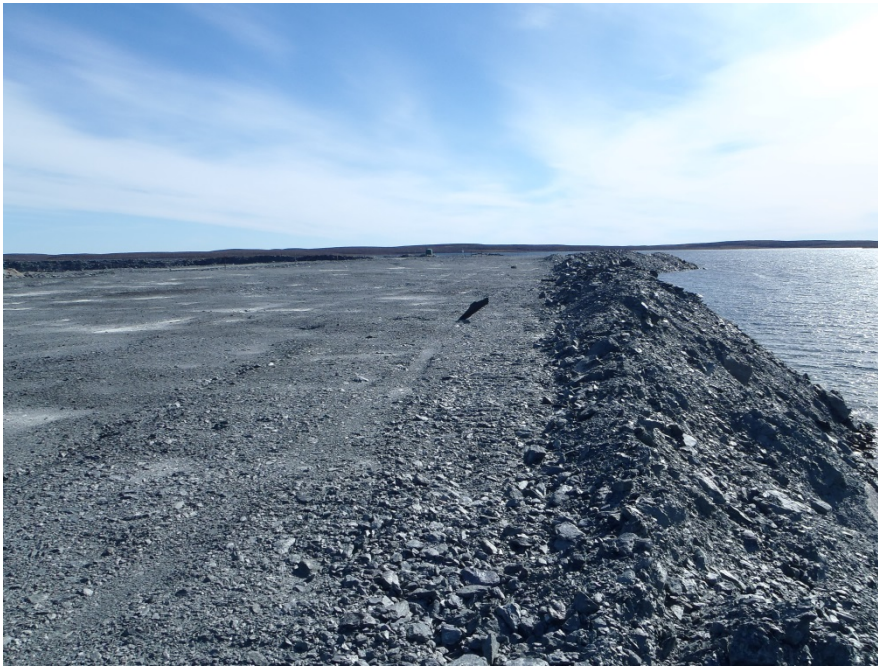
Photograph A3-33 Bay Goose Dike

Description: From Sta. 31+870, looking southeast at the crest and upstream slope.

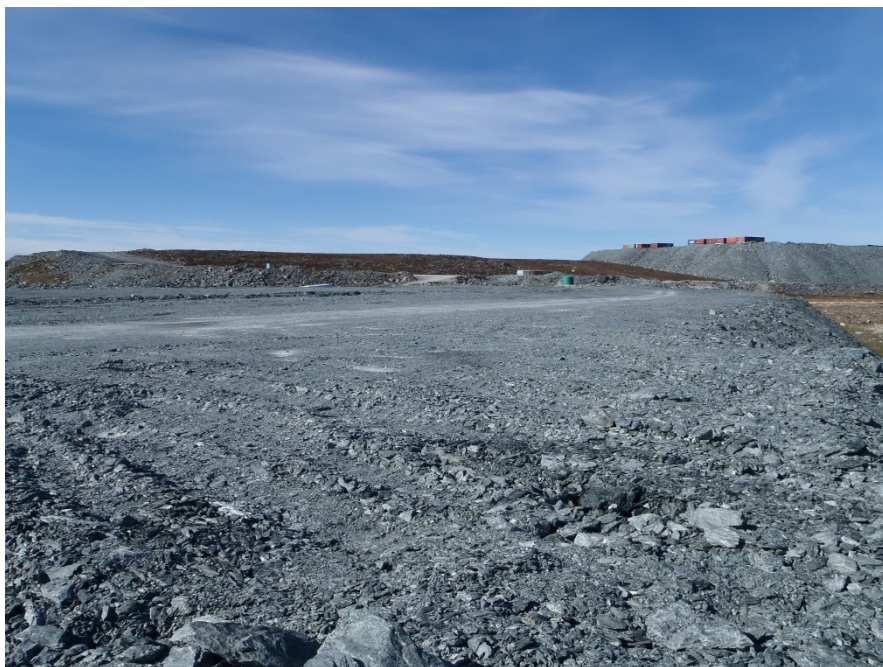
Photograph A3-35 Bay Goose Dike

Description: From Sta. 31+920, looking northwest at the crest.

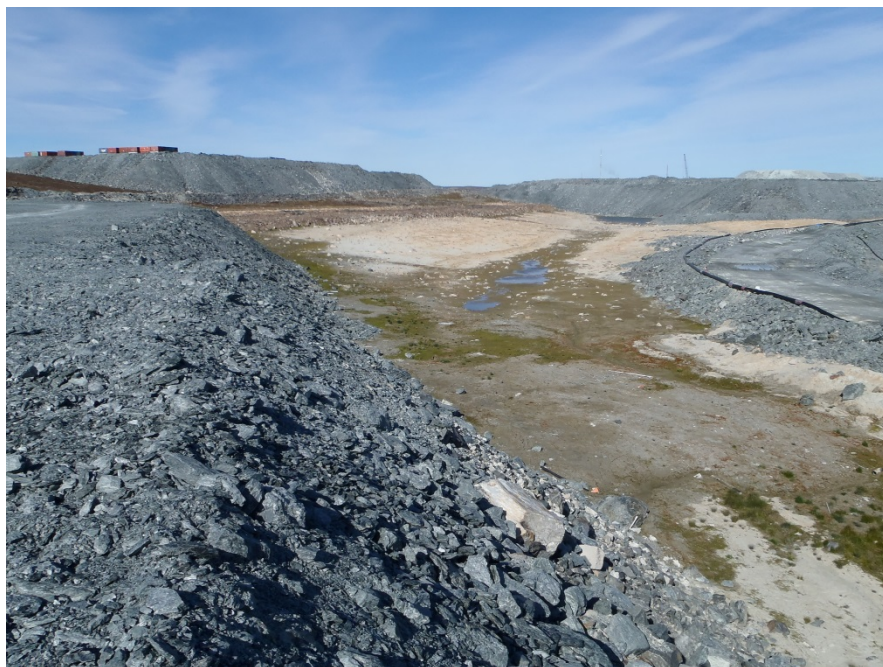
Photograph A3-37 Bay Goose Dike

Description: From Sta. 31+920 on the crest, looking northwest toward Channel 1 monitoring station.

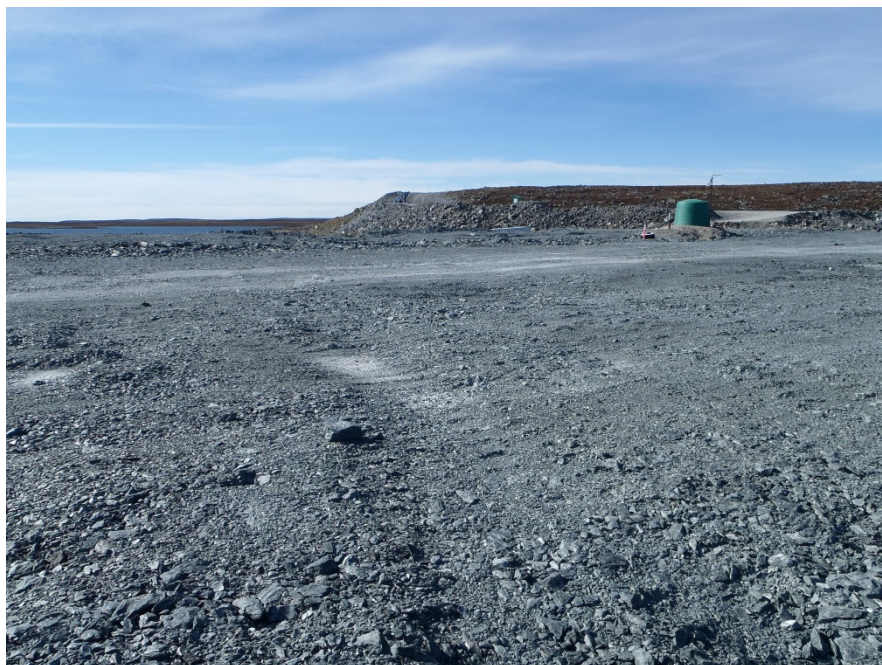
Photograph A3-39 Bay Goose Dike

Description: From Sta. 32+030 looking southwest at the crest.

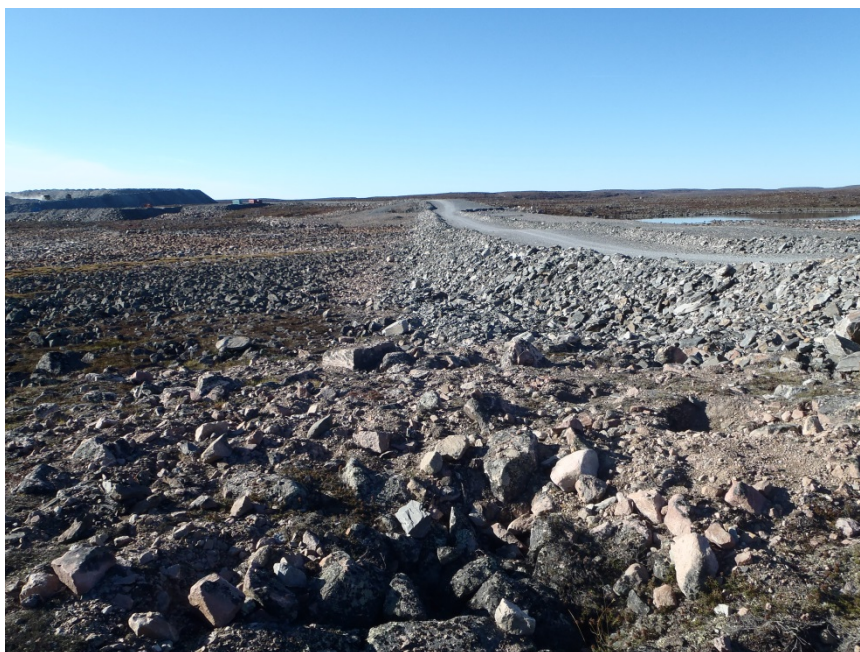
Photograph A4-1 Vault Dike

Description: General view of the dike from the east abutment looking north. Wally Lake on the right side of the picture and Vault Lake on the left side.

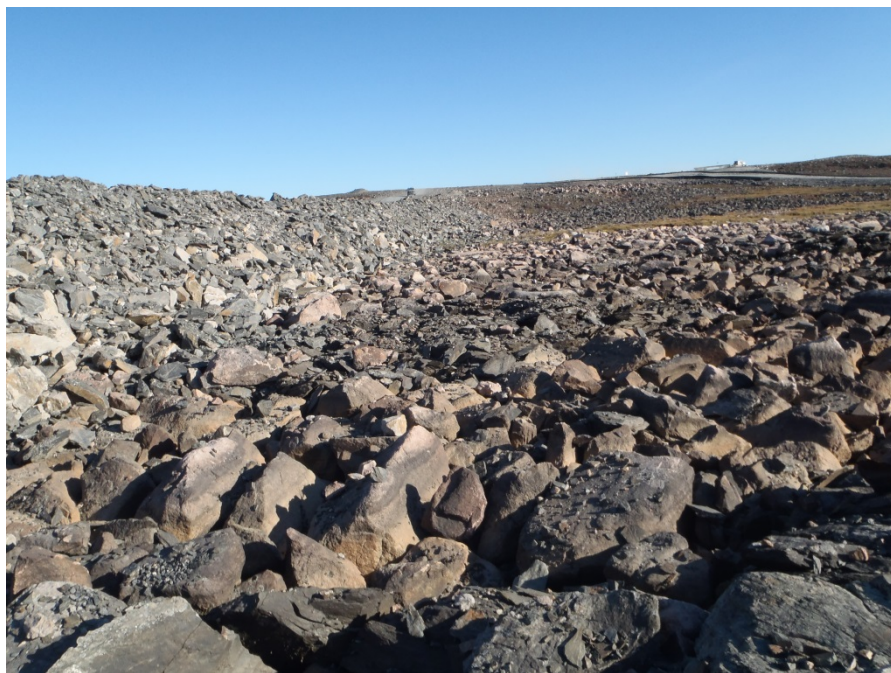
Photograph A4-3 Vault Dike

Description: From downstream, looking southeast.

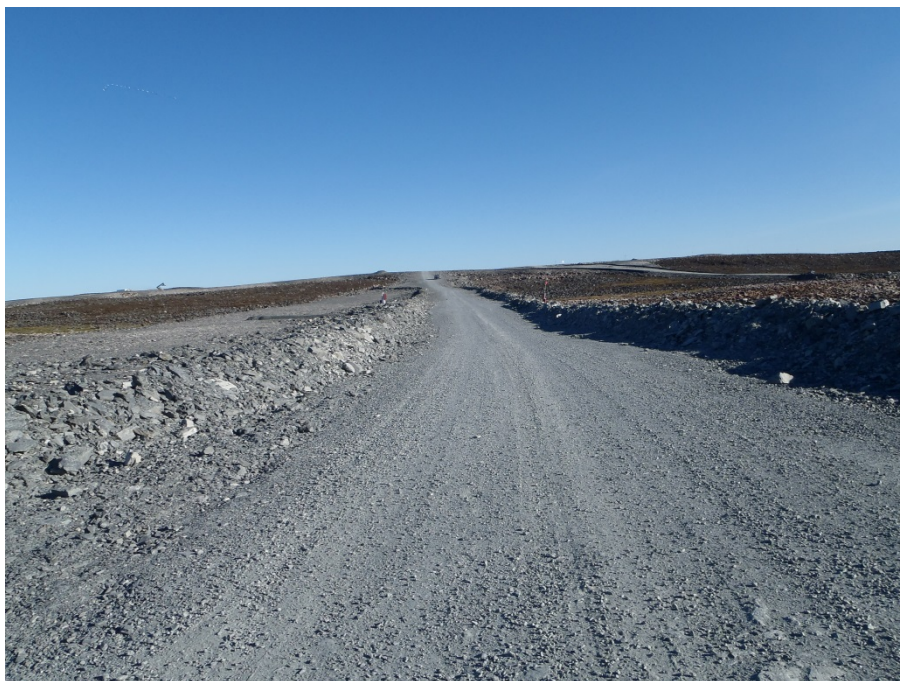
Photograph A4-5 Vault Dike

Description: From the west abutment, looking southeast at the crest

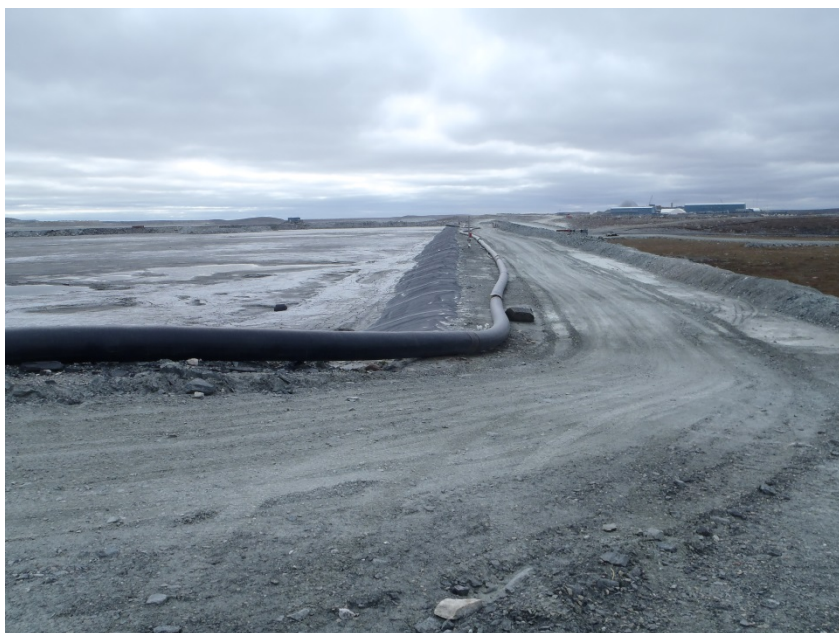
Photograph B1-1 Tailings Storage Facility

Description: From Saddle Dam 2 (Sta. 20+110) looking southeast at the North Cell tailings pond. Adequate tailings beach against SD2

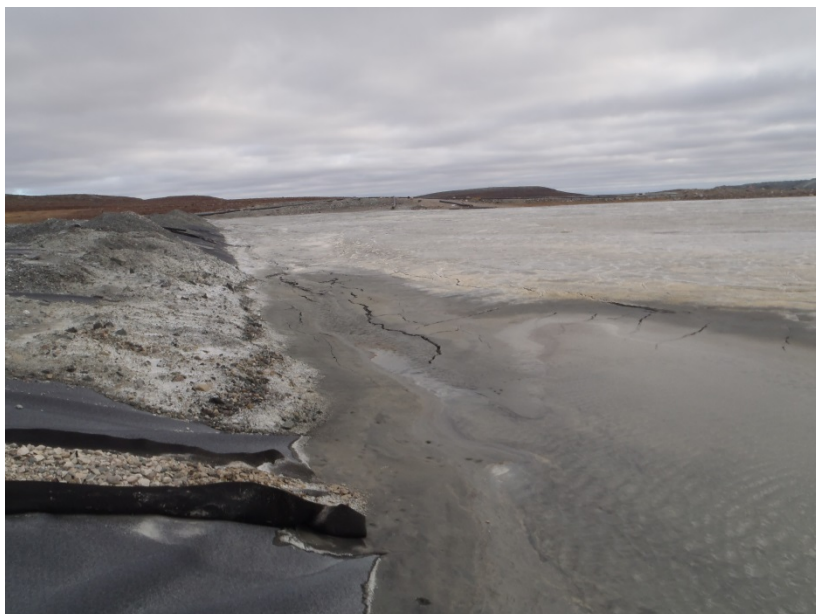
Photograph B1-3 Tailings Storage Facility

Description: From Saddle Dam 1 (Sta. 0+195), looking north at the North Cell tailings pond. Adequate tailings beach against SD1.

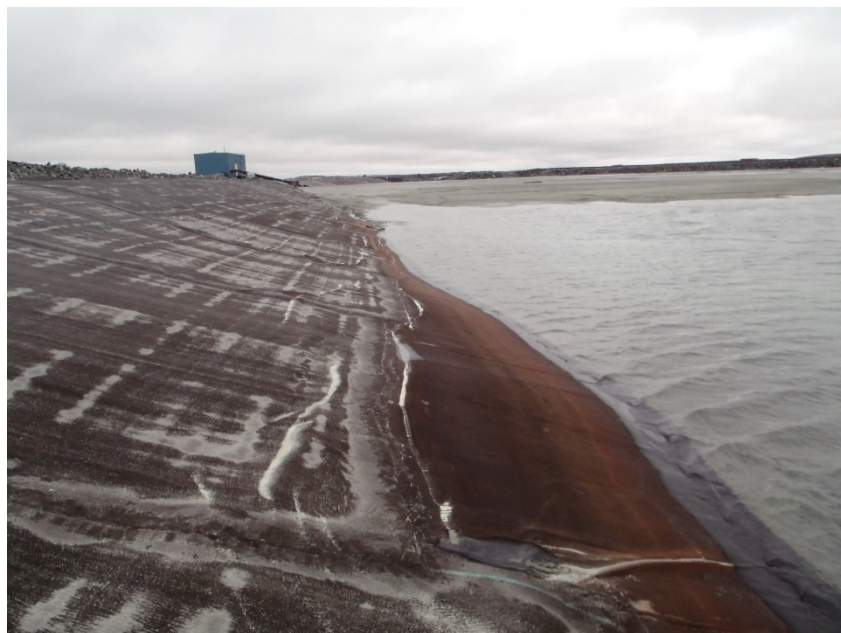
Photograph B1-4 Tailings Storage Facility

Description: From Sta. 10+375 on Stormwater Dike looking west. Inadequate tailings beach against portion of Stormwater Dike.

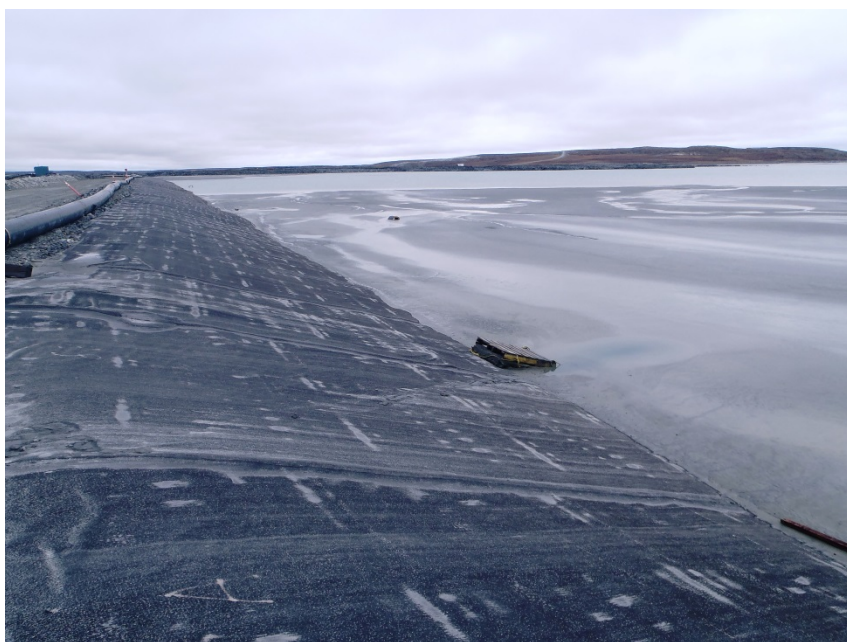
Photograph B1-5 Tailings Storage Facility

Description: From Sta. 10+650 on Stormwater Dike looking west. Inadequate tailings beach against portion of Stormwater Dike.

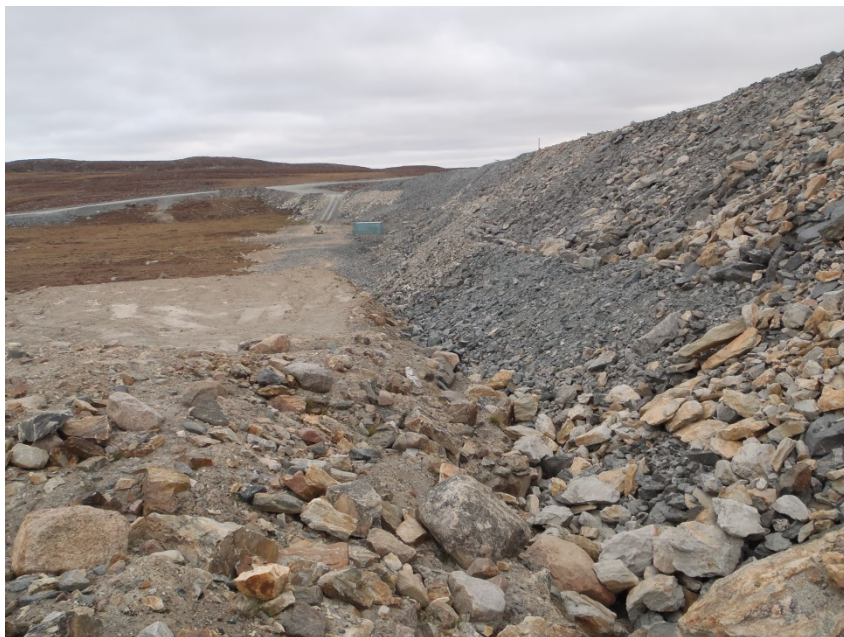
Photograph B2-1 Saddle Dam 1

Description: From the south abutment (Sta. 0+350) looking north at the downstream face. Notice the sea-can container where a sump is installed.

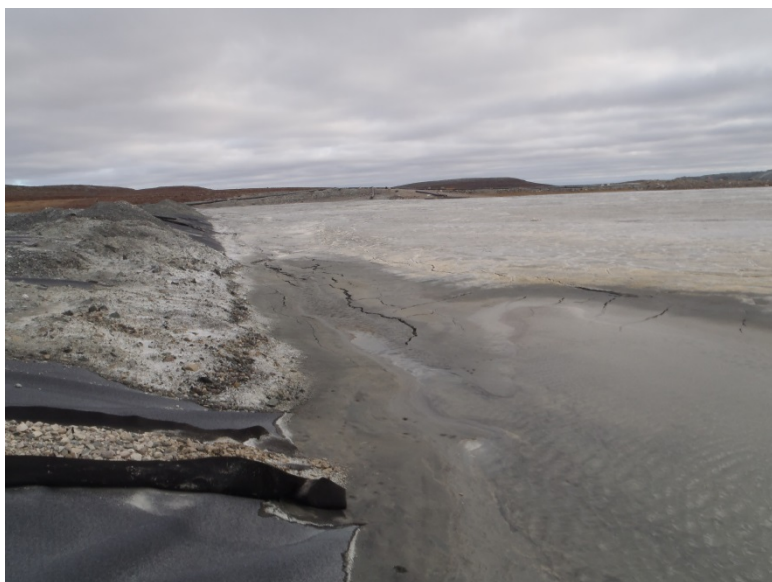
Photograph B2-7 Saddle Dam 1

Description: From Sta. 0+195 upstream, looking north at the upstream slope. Adequate tailings beach against SD1.

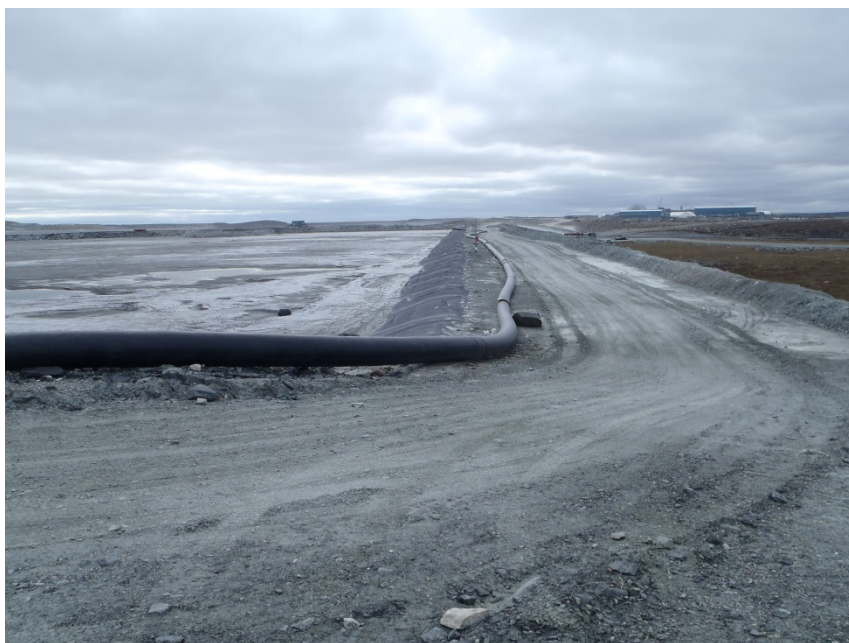
Photograph B3-1 Saddle Dam 2

Description: From Saddle Dam 2 (Sta. 20+110) looking southeast at the crest and upstream slope of Saddle Dam 2. The tailings beach against SD2 is adequate.

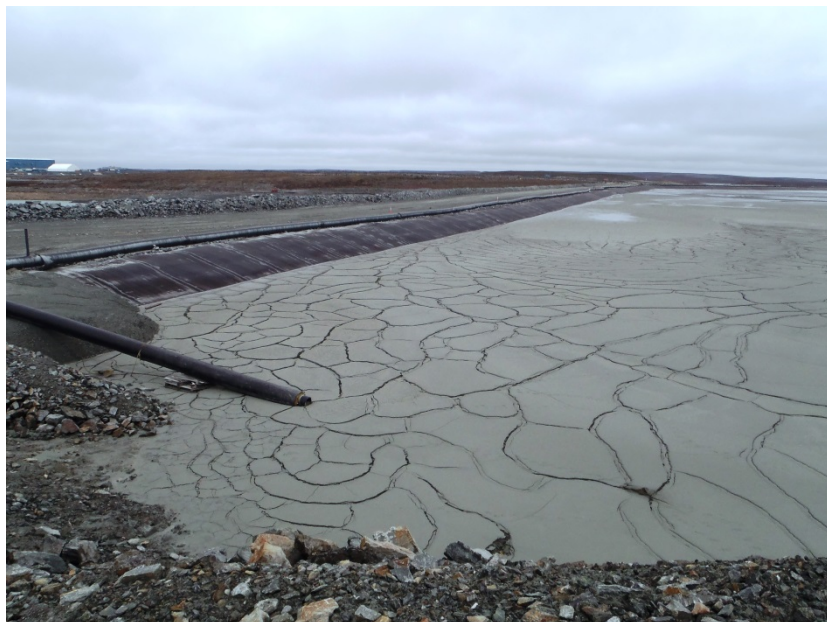
Photograph B4-1 Stormwater Dike

Description: From the east abutment (11+100 approximately), looking west at the upstream face.
