Report: 2015 Annual Geotechnical Inspection

2015 Annual Geotechnical Inspection Meadowbank Gold Mine, Nunavut

Agnico-Eagle Mines Limited
Meadowbank Division
PO Box 540
Baker Lake, Nunavut
X0C 0A0

Document Number: Doc1533 1535715-Rev0

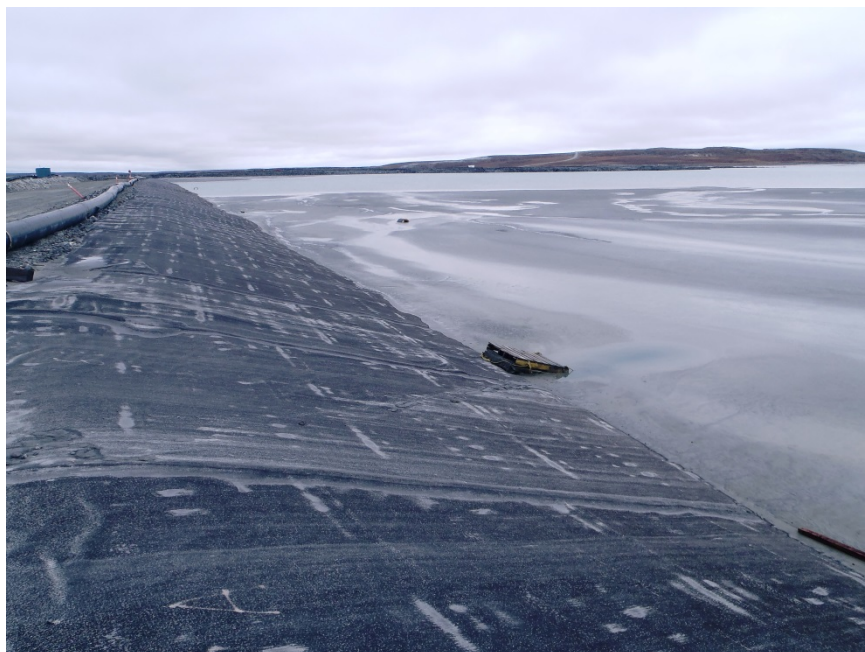
Photograph B4-3 Stormwater Dike

Description: From Sta. 10+650 looking west at the upstream slope. No tailings beach against portion of Stormwater Dike.

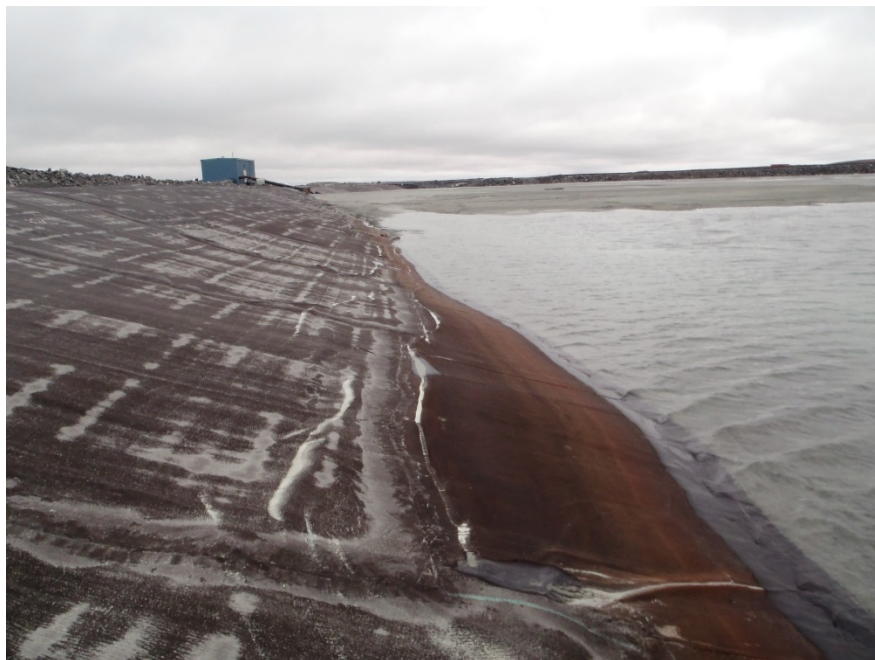
Photograph B4-5 Stormwater Dike

Description: From Sta. 10+375 looking west at the upstream slope. No tailings beach against portion of Stormwater Dike.

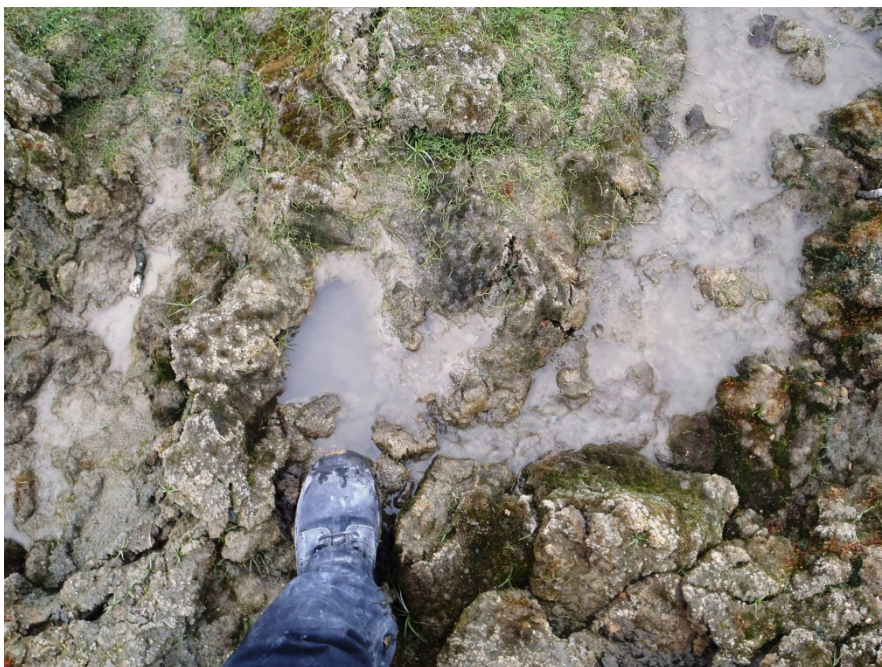
Photograph B4-12 Stormwater Dike

Description: Water outcome observed at the downstream toe of the dike (Sta. 10+660 approximately).

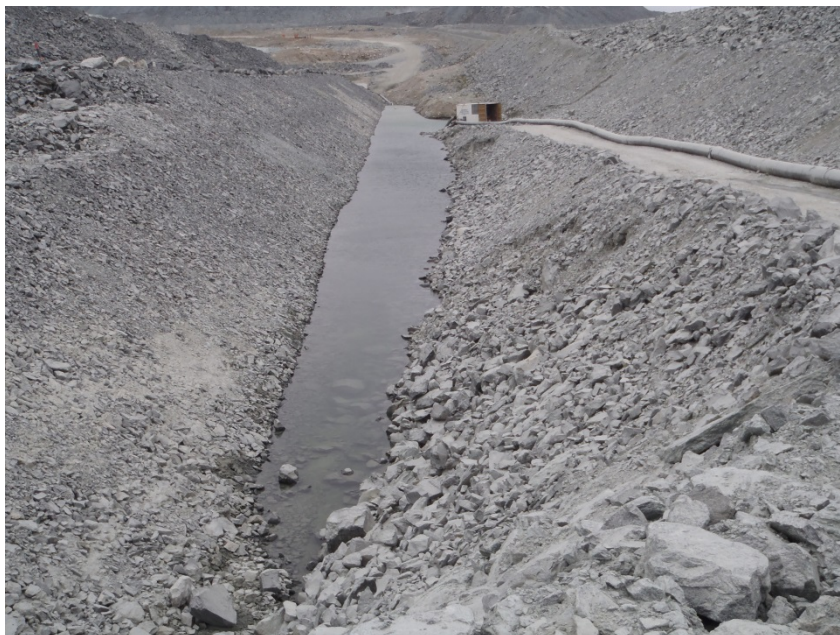
Photograph B5-1 Central Dike

4.1 Seepage from Dam	Yes	157,158,160,163, 164,166,167	A water pond was observed in 2014 in the downstream area from Sta. 0+545 to the access road (Sta. 0+830). It was determined in 2015 that the pond is feeded by seepage from the South Cell. Calculated seepage is estimated at 800 m ³ /hr.

Description: From Sta. 0+850 downstream, looking north. View of the seepage water ponding downstream between Central Dike and the West Road. A pump has been installed in the container.

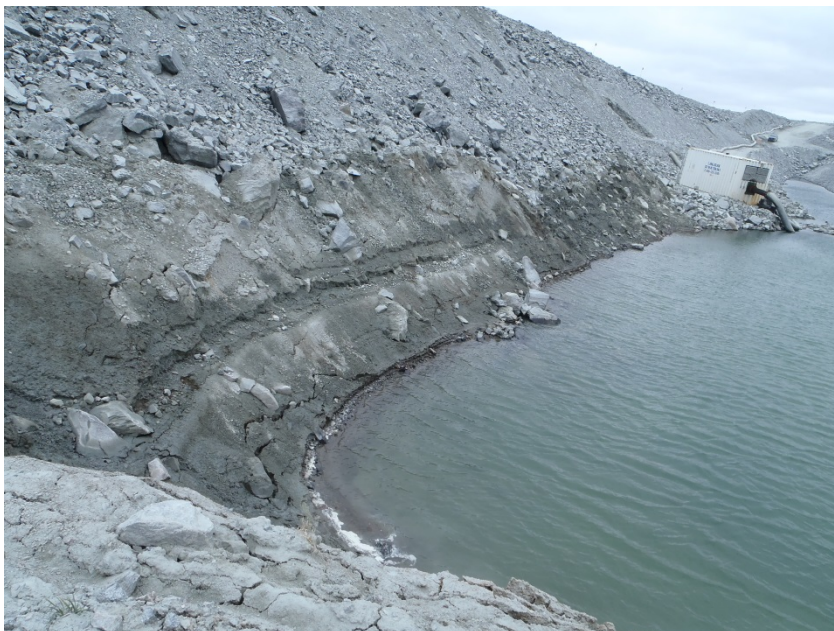
Photograph B5-3 Central Dike

Description: From approximately Sta. 0+625 downstream, looking south. View of the seepage water ponding downstream between Central Dike and the West Road. Presence of a zone of superficial material sloughing.

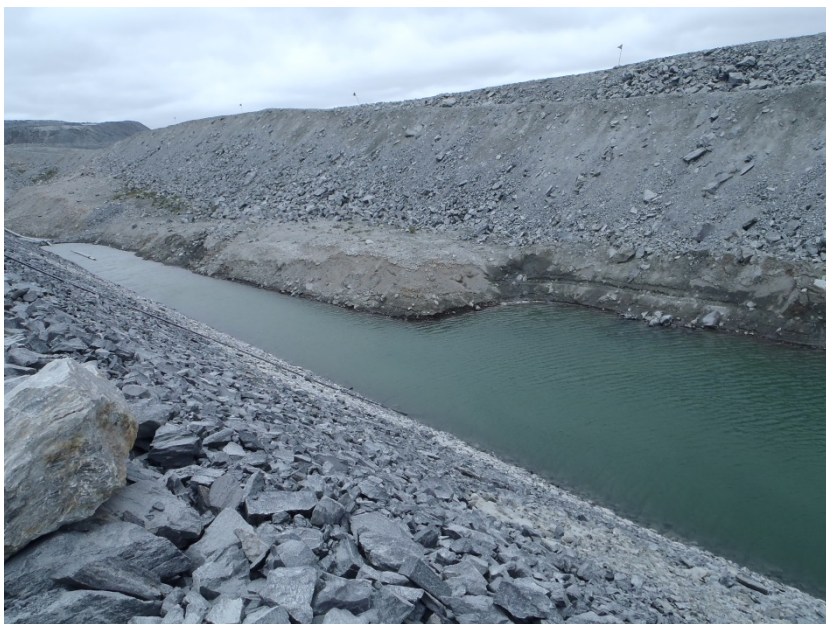
Photograph B5-5 Central Dike

Description: From approximately Sta. 0+650 downstream, looking north. View of the seepage water ponding downstream between Central Dike and the West Road.

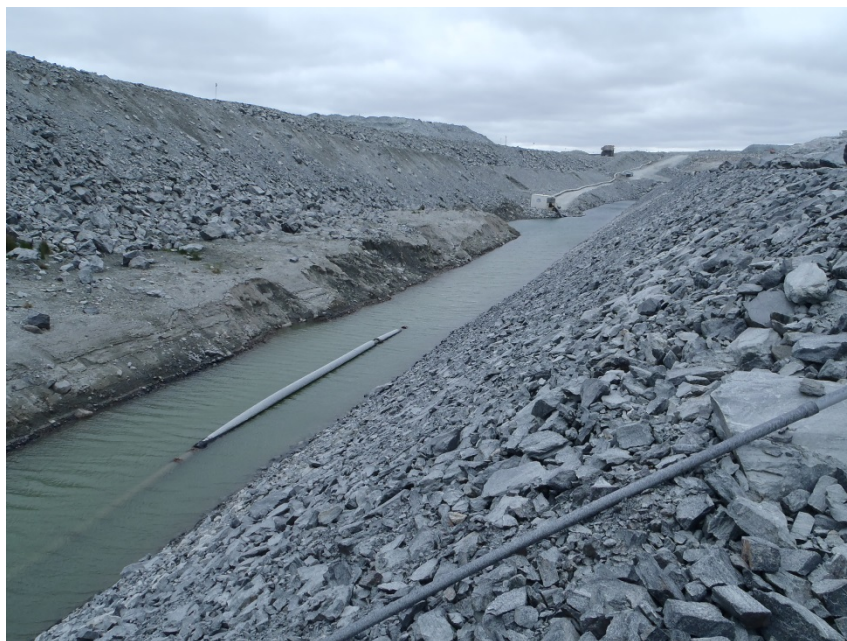
Photograph B5-7 Central Dike

Description: From approximately Sta. 0+500 downstream, looking south. View of the seepage water ponding downstream between Central Dike and the West Road. A pump has been installed in the container.

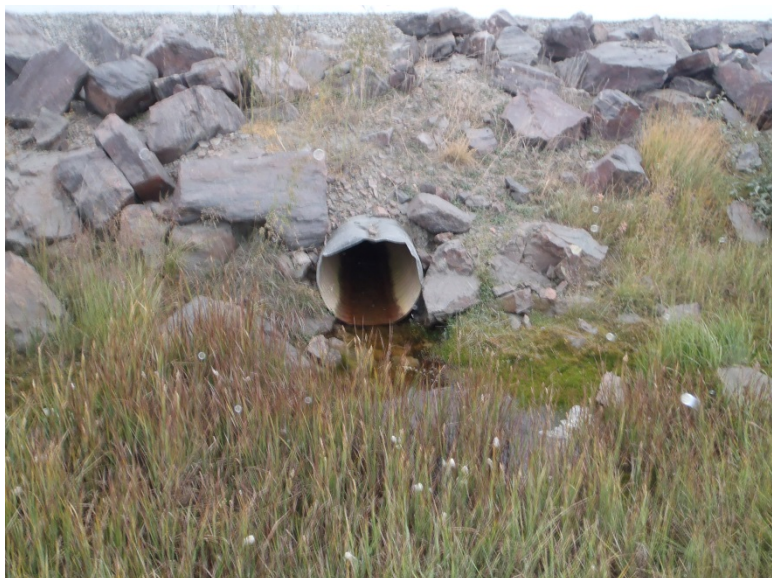
Photograph D1-1: PRC1 km 0+430

Description: View of culvert inlet, in good condition no sign of obstruction.

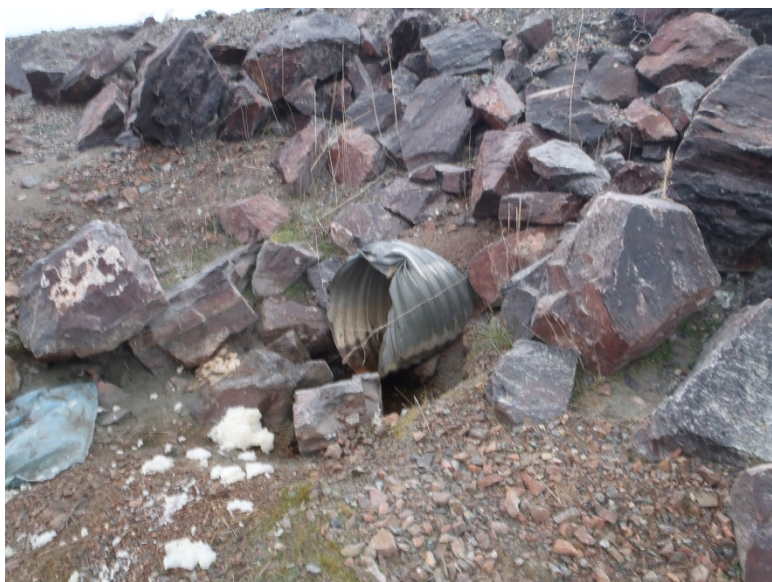
Photograph D1-2: PRC1 km 0+430

Description: View of culvert outlet. The outlet is slightly damaged and obstructed. The culvert is still functional and in overall good condition.

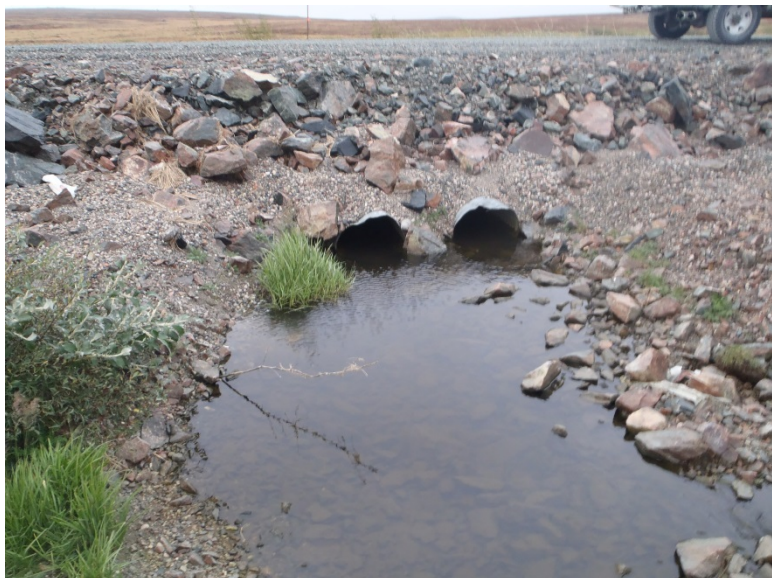
Photograph D1-3: PRC2 km 0+470

Description: View of culverts inlet. In good condition.

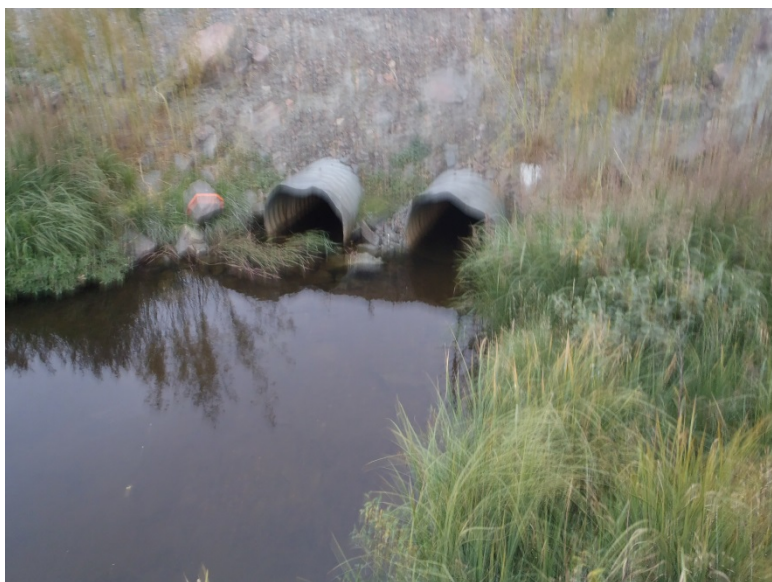
Photograph D1-4: PRC2 km 0+470

Description: View of culverts outlet. In good condition.

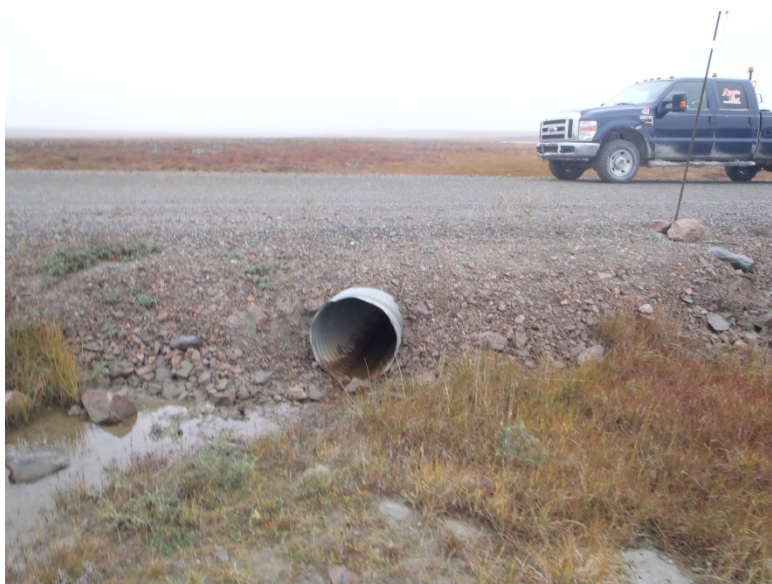
Photograph D1-5: PRC3 km 1+380

Description: View of culvert inlet. In good condition.

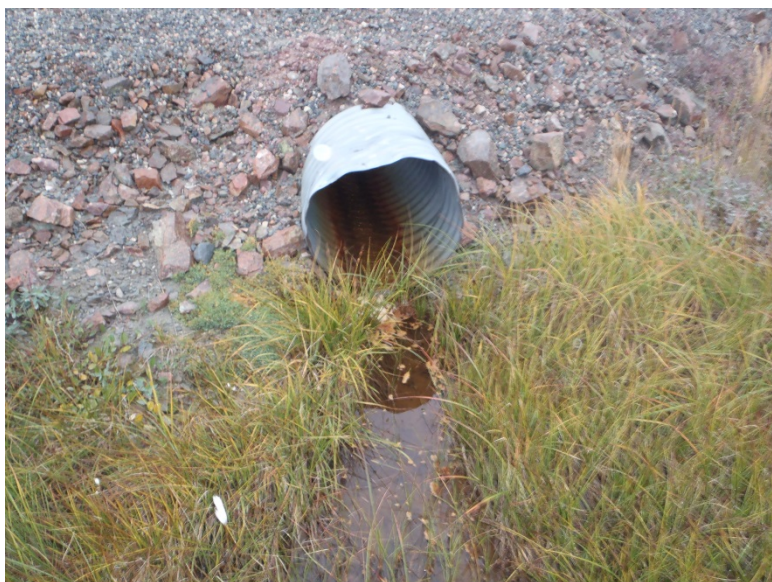
Photograph D1-6: PRC3 km 1+380

Description: View of culvert outlet. In good condition.

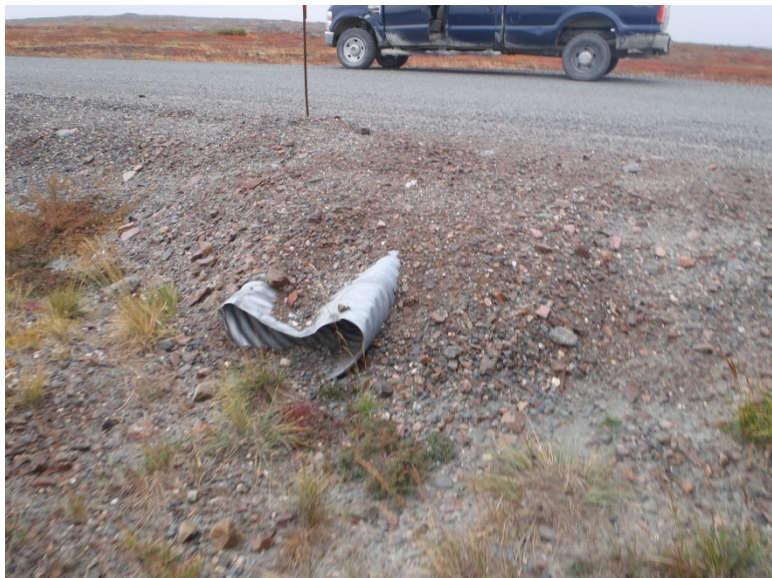
Photograph D1-7: R-00A km 2+550

Description: View of culvert inlet. The inlet is partially collapsed. No sign of flow.

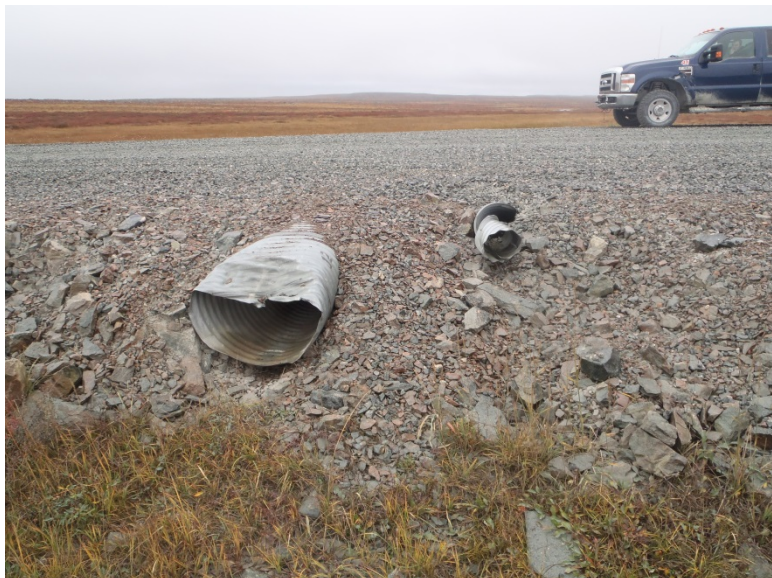
Photograph D1-9: PC-14 km 4+260

Description: View of the culverts inlet. Culvert on the right is filled with gravel, crushed and damaged. Culvert on the left is slightly damaged but still functional.

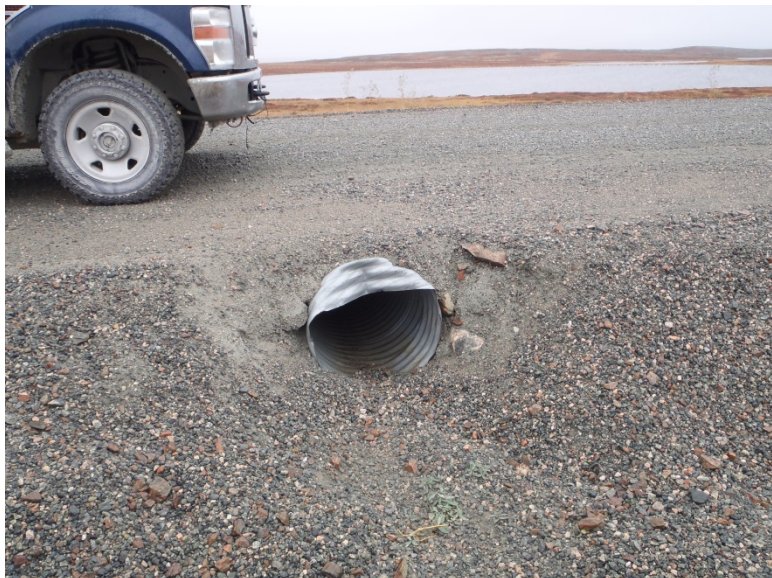
Photograph D1-11: unnamed km 5+700

Description: View of the culvert inlet. Good condition, inlet is short in length as the road rolling surface is at the edge of the inlet.

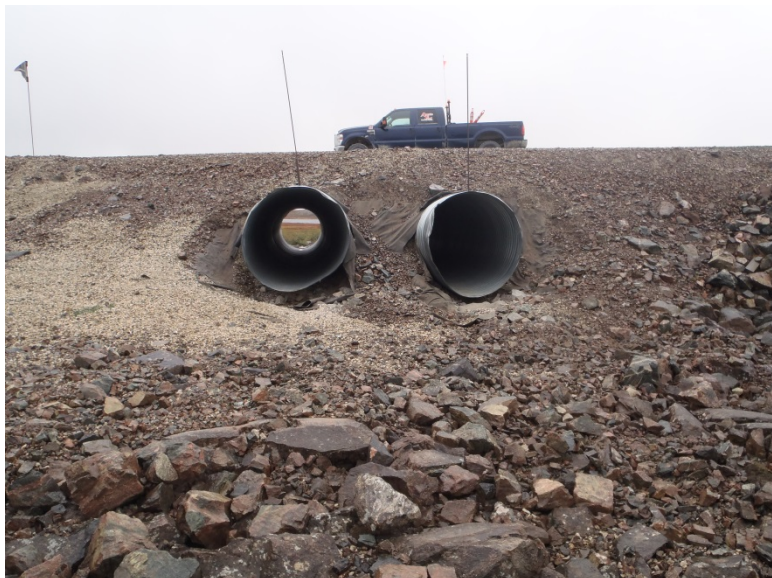
Photograph D1-13: PC-17A km 8+830

Description: View of the culverts inlet. Sign of erosion and flow of water beneath the inlet.

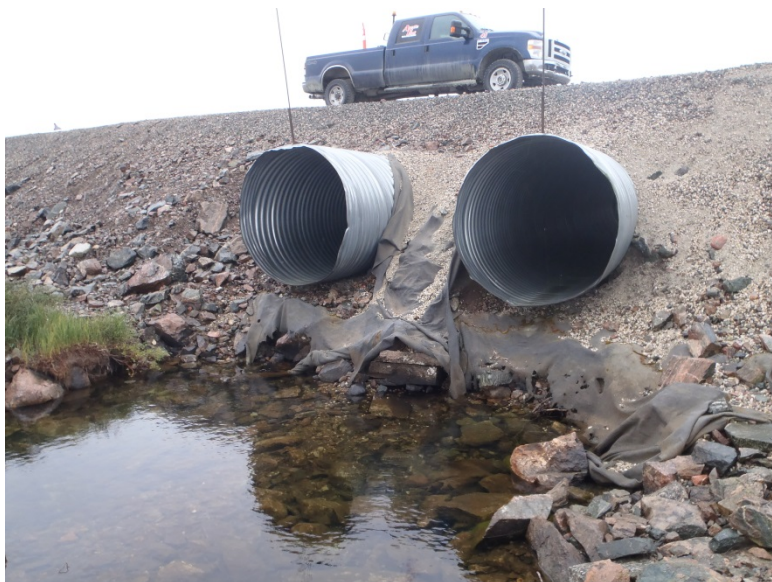
Photograph D1-14: PC-17A km 8+830

Description: View of the culverts outlet (left side of the picture). The culverts were installed too high. Sign of erosion, flow of water beneath the culverts and deterioration.

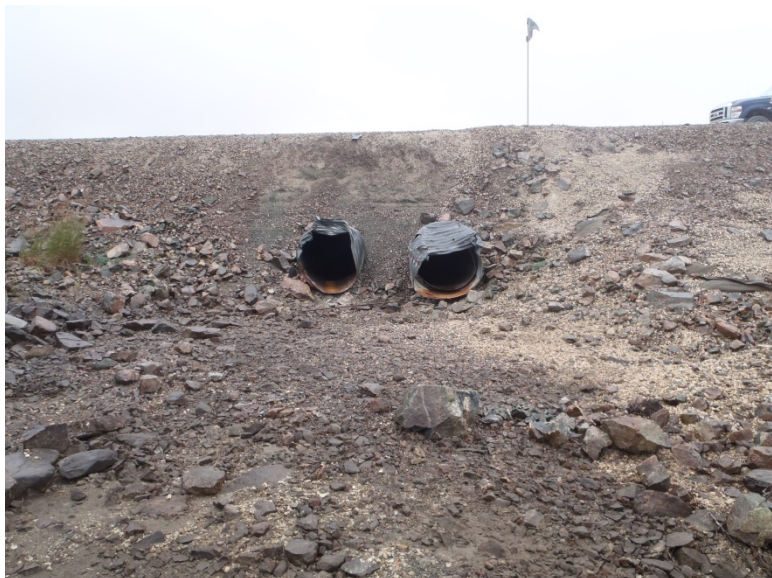
Photograph D1-15: PC-17 km 8+850

Description: View of the culverts inlet. Sign of erosion beneath the inlet.

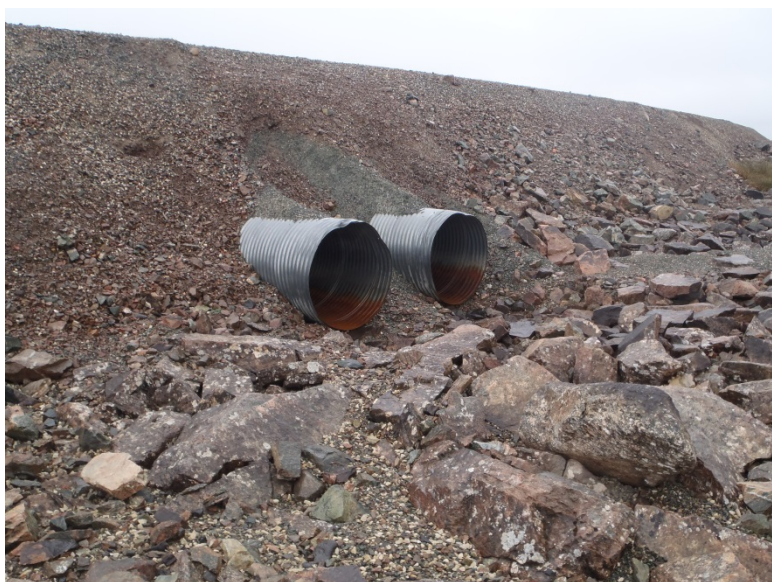
Photograph D1-16: PC-17 km 8+850

Description: View of the culverts outlet (right side of the picture). Sign of erosion and deterioration.

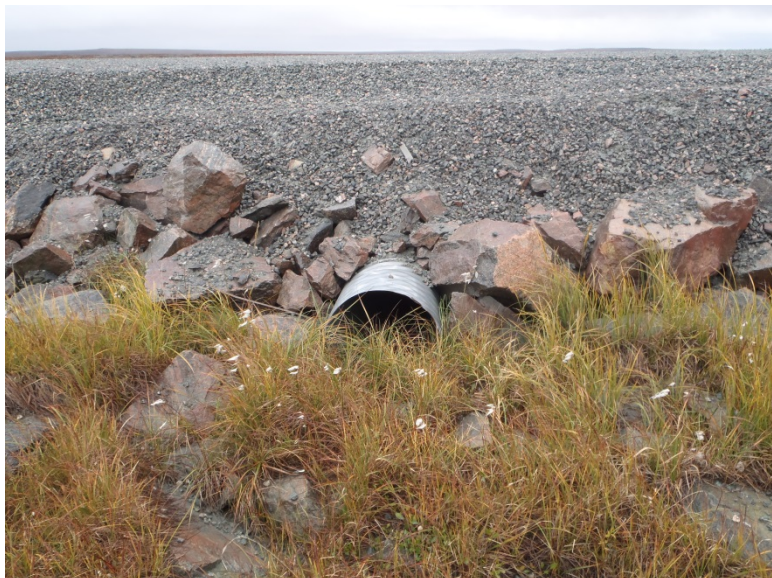
Photograph D1-17: PC-1 km 9+952

Description: View of the culvert inlet. In good condition.

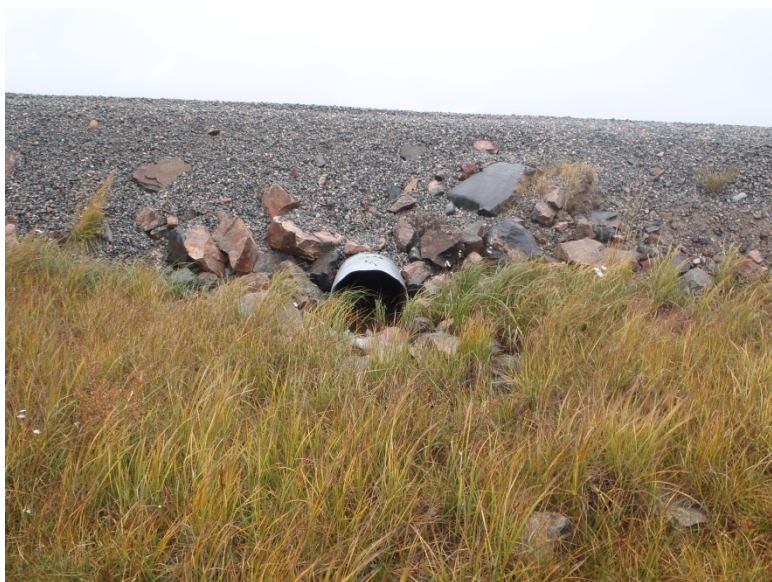
Photograph D1-18: PC-1 km 9+952

Description: View of the culvert outlet. In good condition.

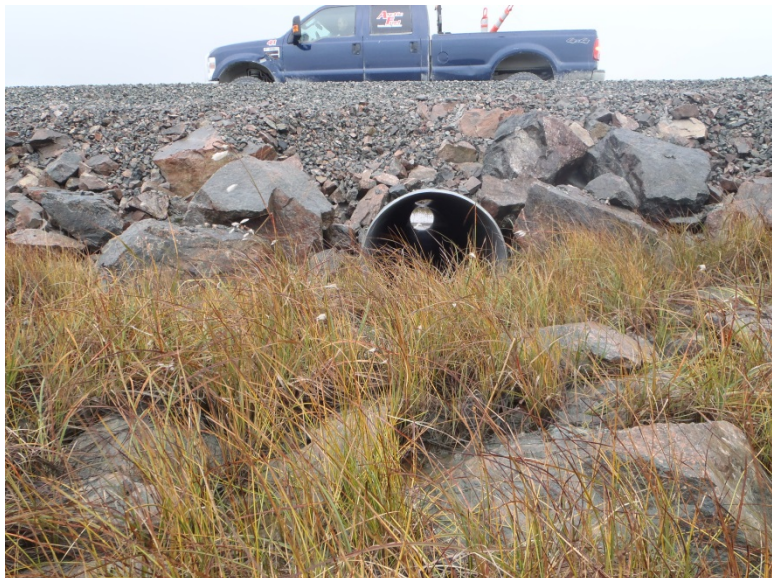
Photograph D1-19: R-03 km 10+580

Description: View of the culvert inlet. In good condition.

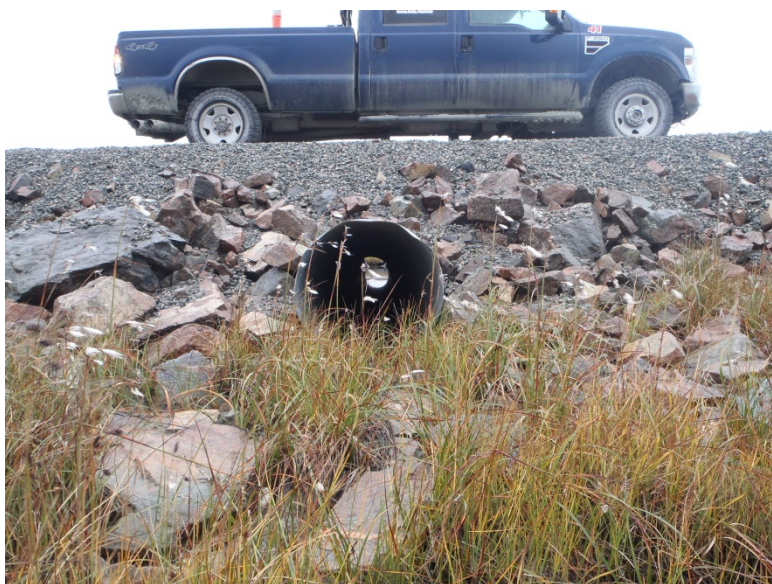
Photograph D1-20: R-03 km 10+580

Description: View of the culvert outlet. In good condition.

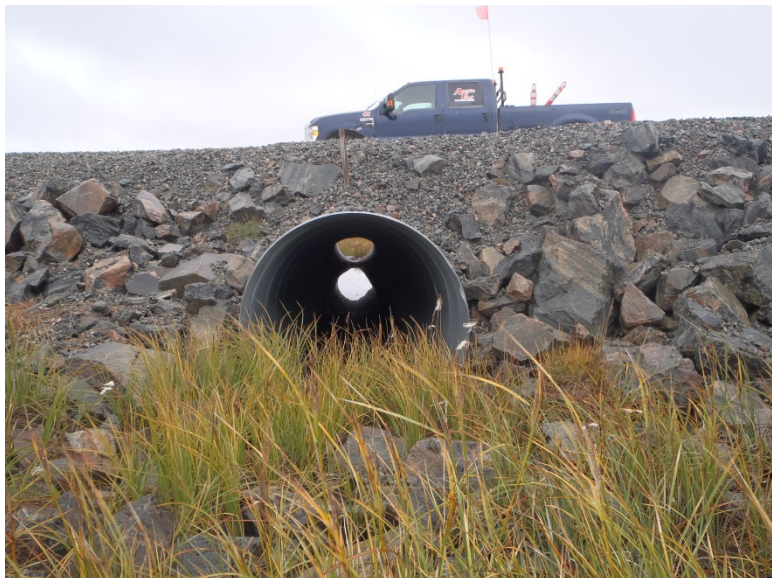
Photograph D1-21: R-04 km 12+050

Description: View of the culvert inlet. In good condition.

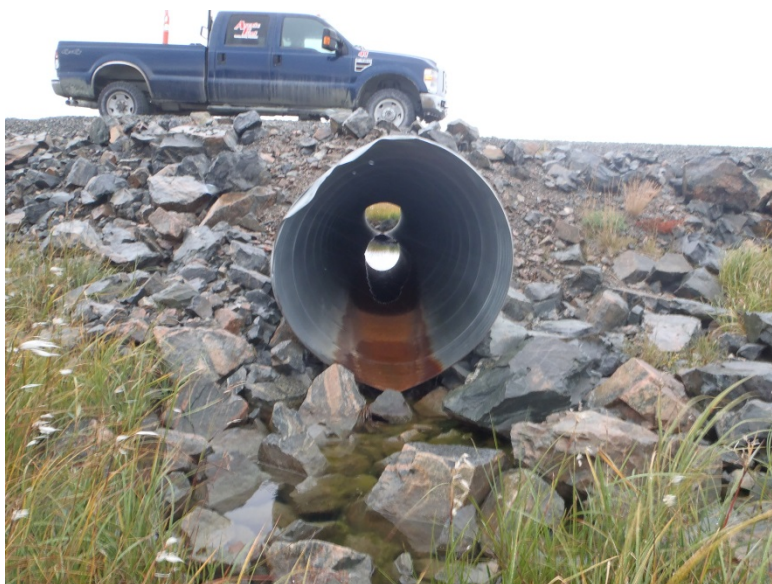
Photograph D1-22: R-04 km 12+050

Description: View of the culvert outlet. In good condition.

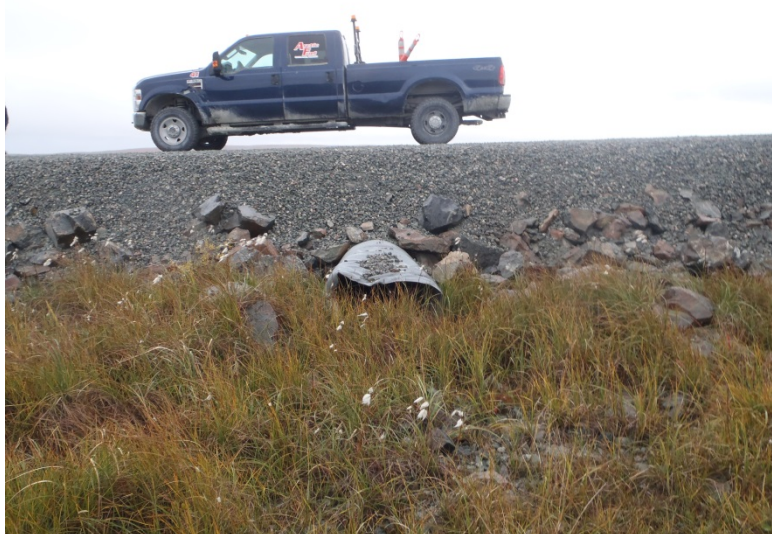
Photograph D1-23: PC-13 km 12+745

Description: View of the culvert inlet. In good condition.

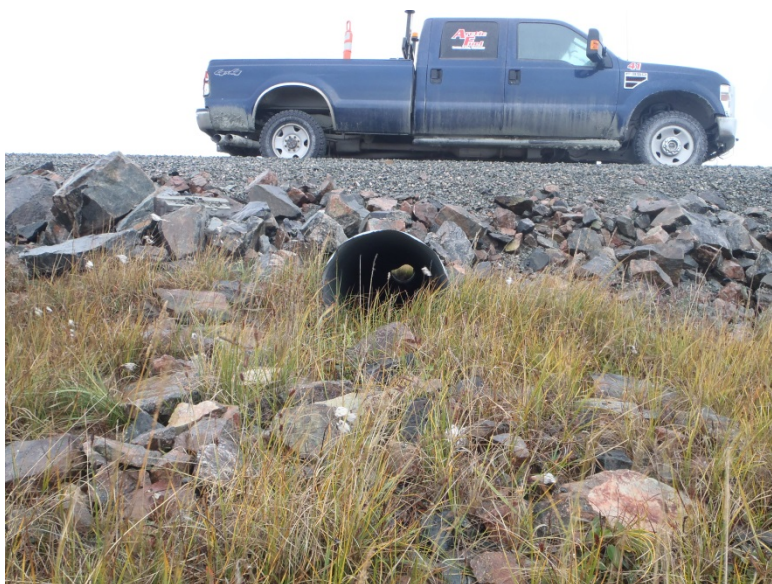
Photograph D1-24: PC-13 km 12+745

Description: View of the culvert outlet. In good condition.

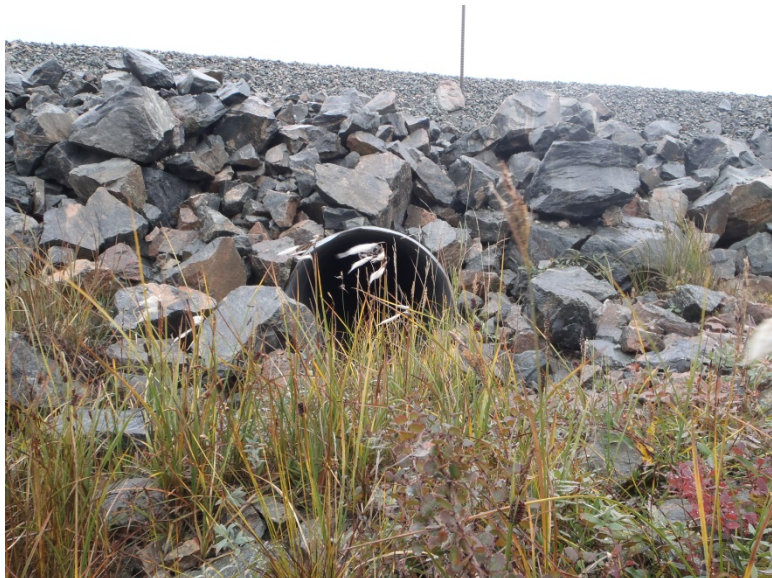
Photograph D1-25: PC-2 km 13+405

Description: View of the culvert inlet. In good condition.

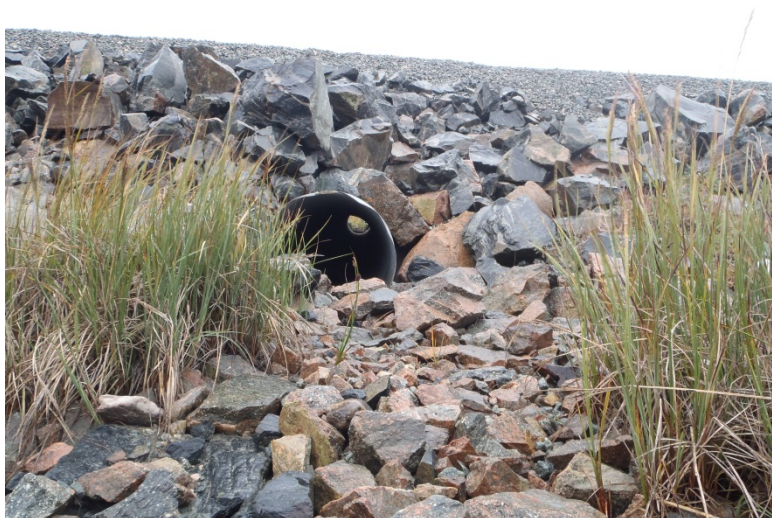
Photograph D1-26: PC-2 km 13+405

Description: View of the culvert outlet. In good condition.

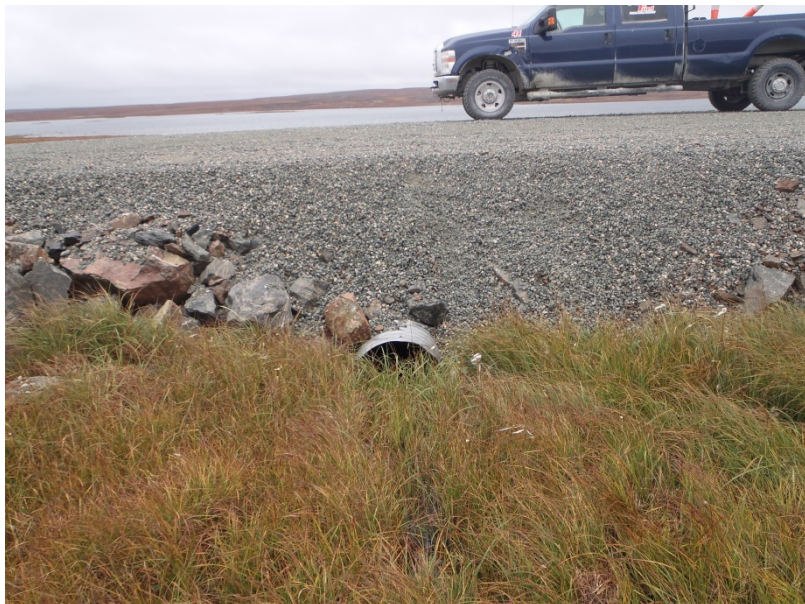
Photograph D1-27: PC-3 km 13+685

Description: View of the culvert inlet. In good condition.

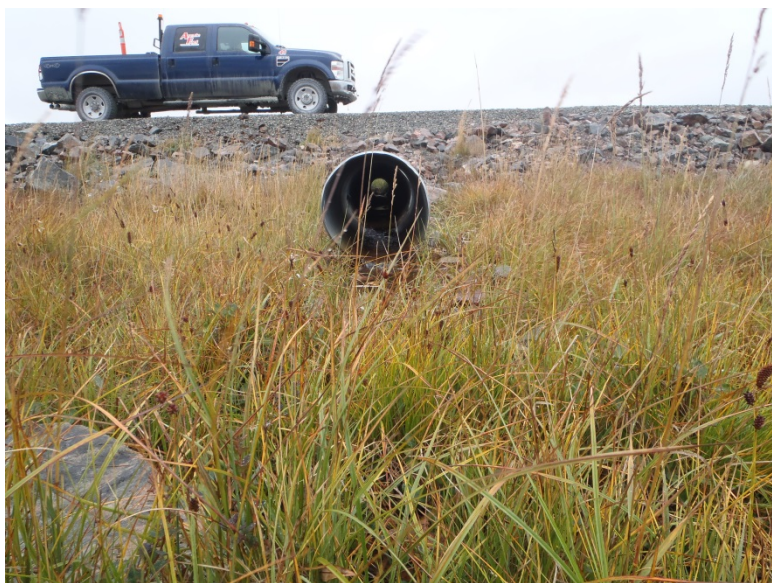
Photograph D1-28: PC-3 km 13+685

Description: View of the culvert outlet. In good condition.

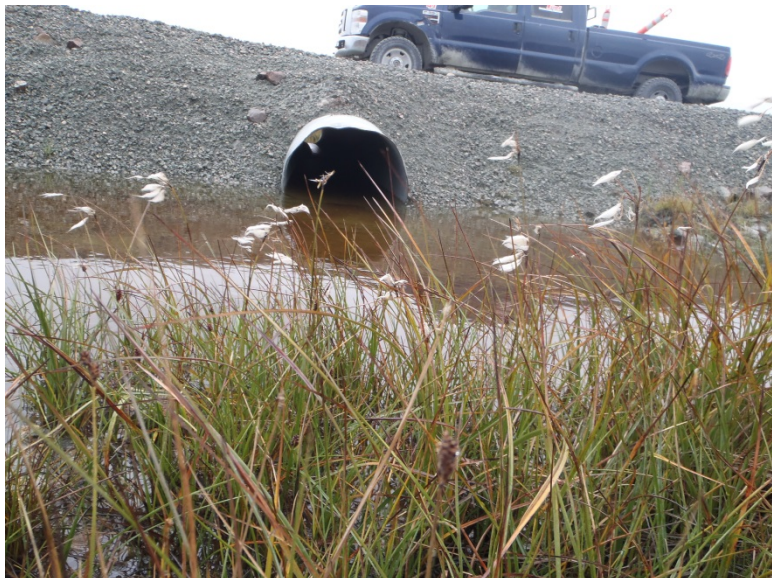
Photograph D1-29: unnamed km 13+950

Description: View of the culvert inlet. In good condition.

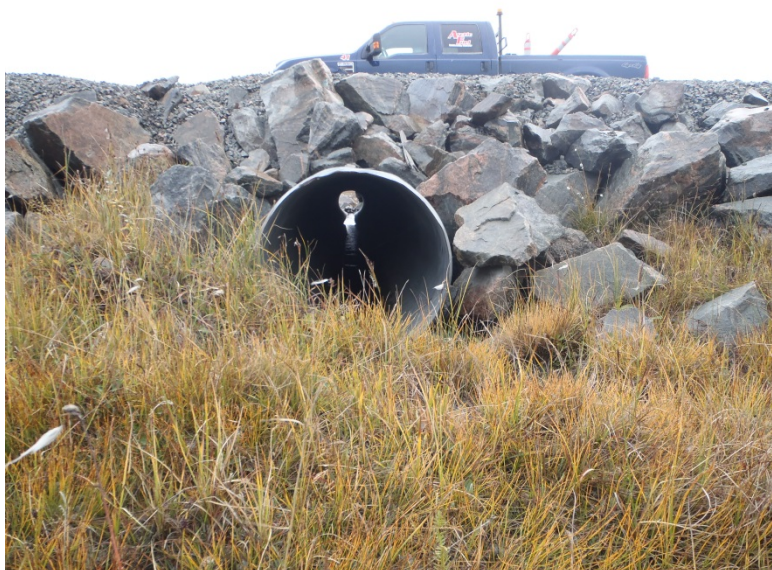
Photograph D1-31: PC-4 km 14+910

Description: View of the culvert inlet. In good condition.

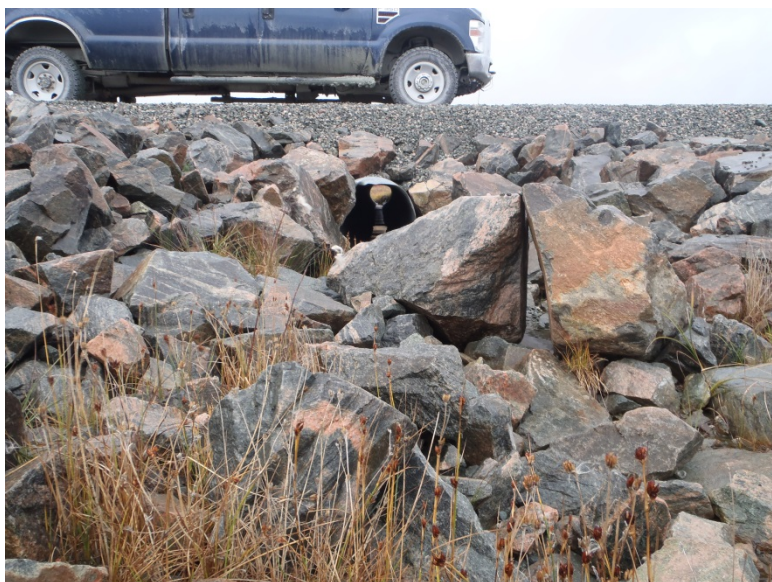
Photograph D1-32: PC-4 km 14+910

Description: View of the culvert outlet. In good condition. Large boulders around the outlet.

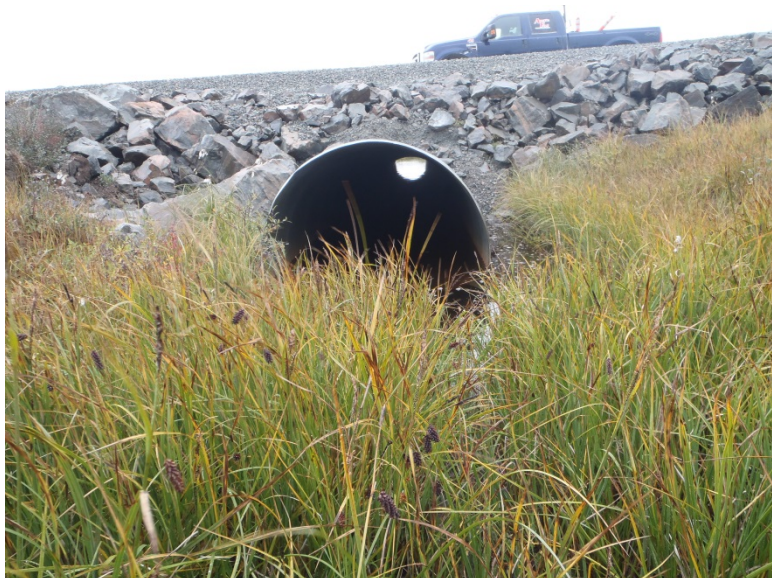
Photograph D1-33: R-05A km 15+745

Description: View of the culvert inlet. In good condition.

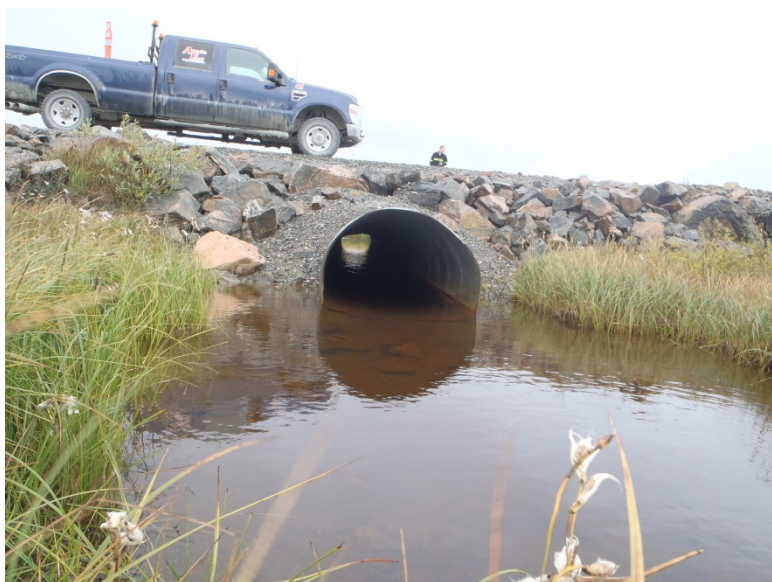
Photograph D1-34: R-05A km 15+745

Description: View of the culvert outlet. In good condition.

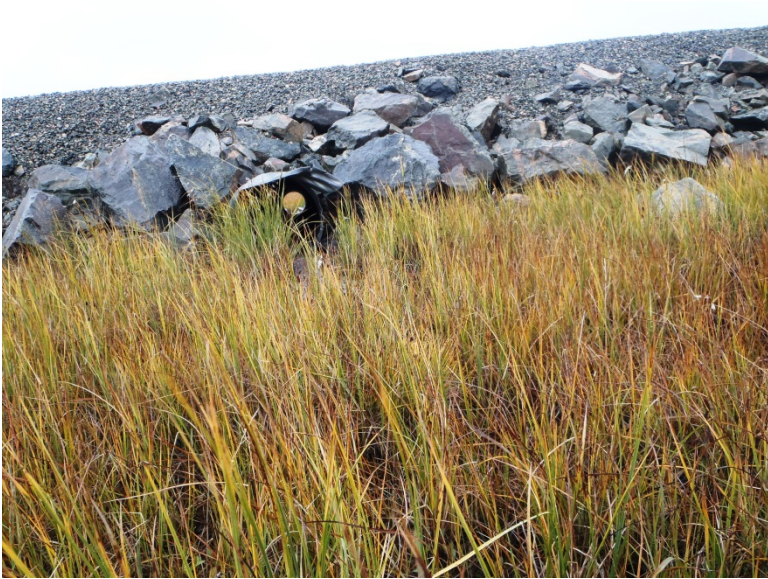
Photograph D1-35: PC-5 km 18+280

Description: View of the culvert inlet. In good condition.

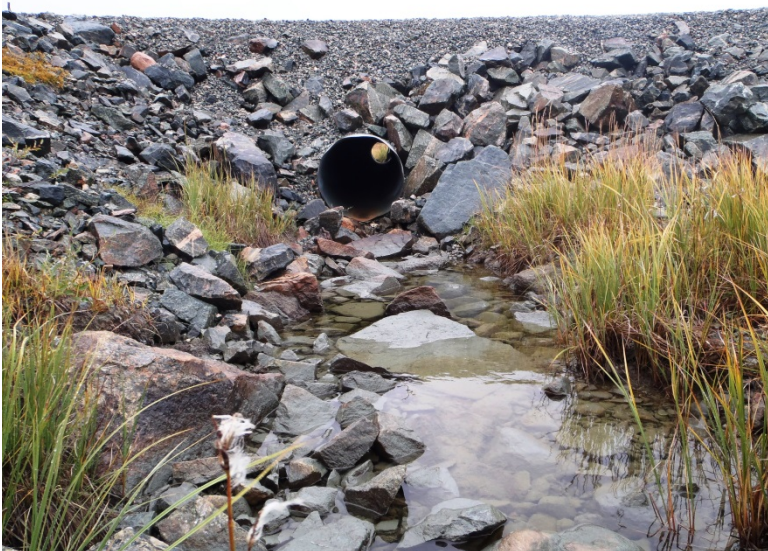
Photograph D1-36: PC-5 km 18+280

Description: View of the culvert outlet. In good condition.

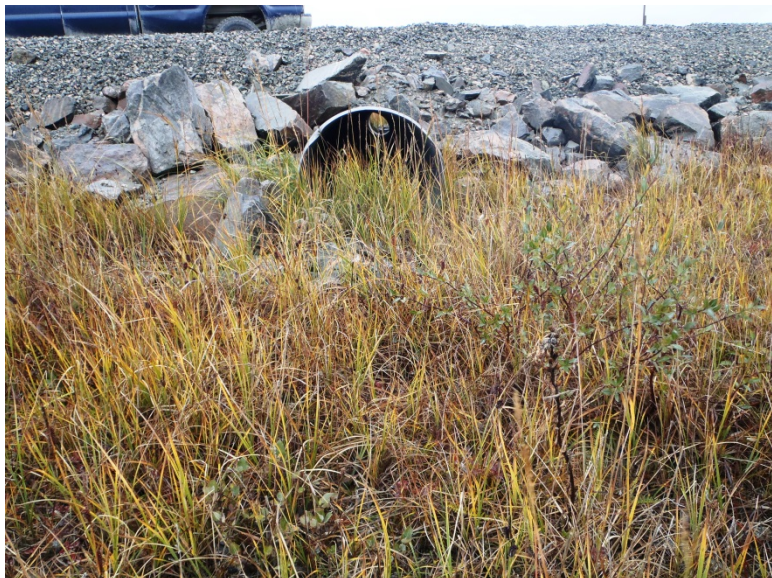
Photograph D1-37: PC-6 km 18+900

Description: View of culvert inlet. In good condition.

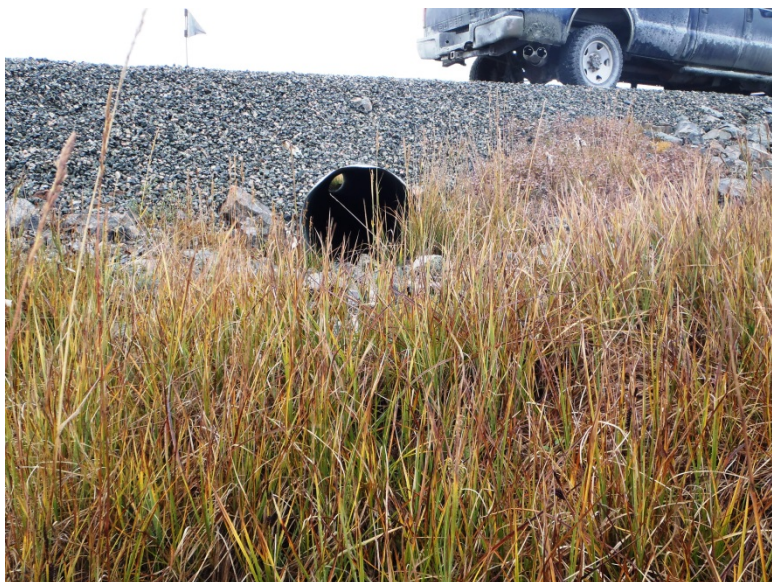
Photograph D1-38: PC-6 km 18+900

Description: View of culvert outlet. In good condition.

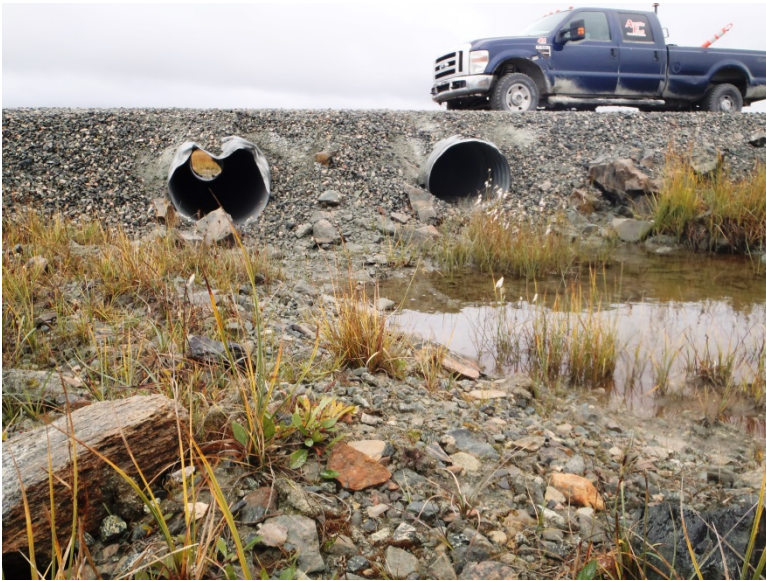
Photograph D1-39: PC-7A km 20+240

Description: View of culverts inlet. In good condition.

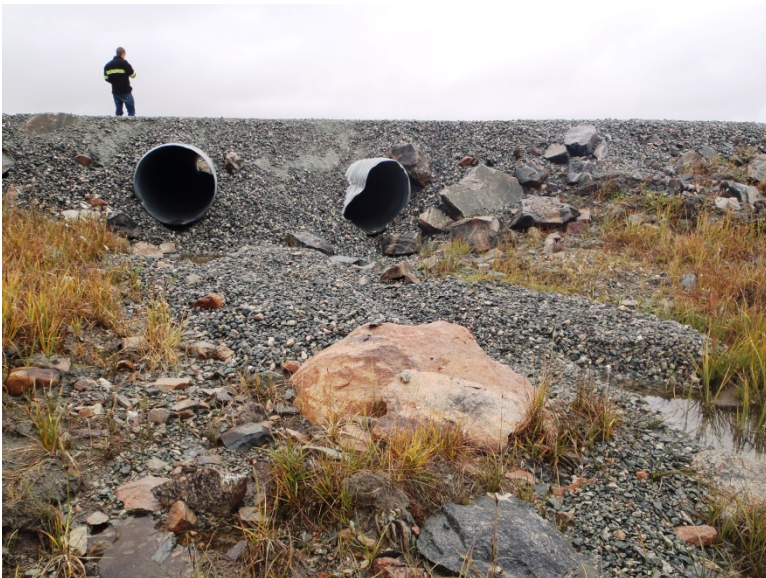
Photograph D1-40: PC-7A km 20+240

Description: View of culverts outlet. In good condition.

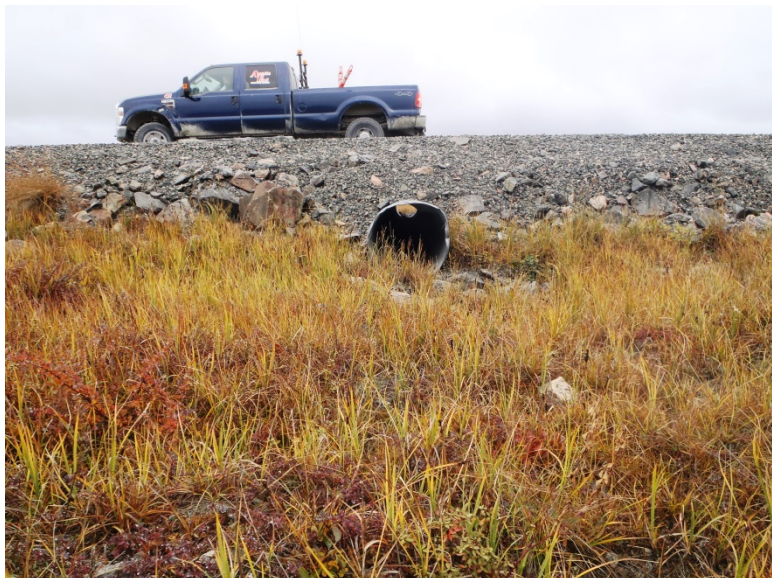
Photograph D1-41: PC-7 km 20+250

Description: View of the culvert inlet. In good condition.

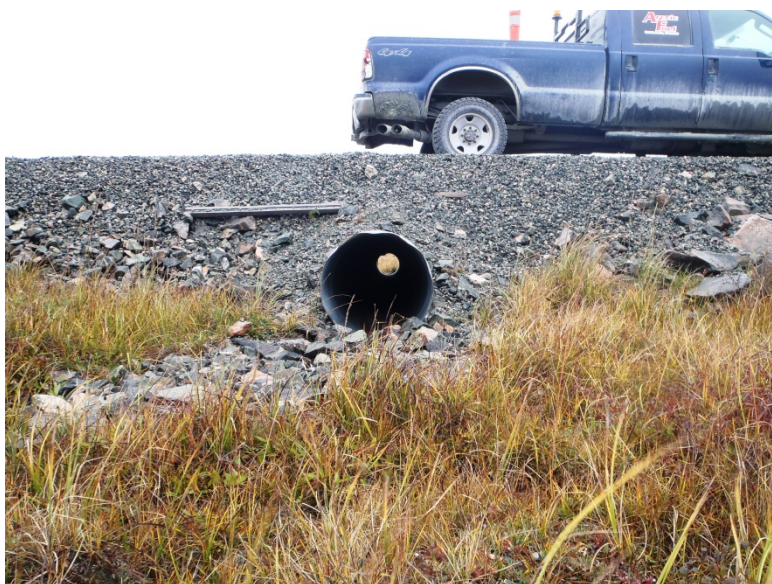
Photograph D1-42: PC-7 km 20+250

Description: View of the culvert outlet. In good condition.

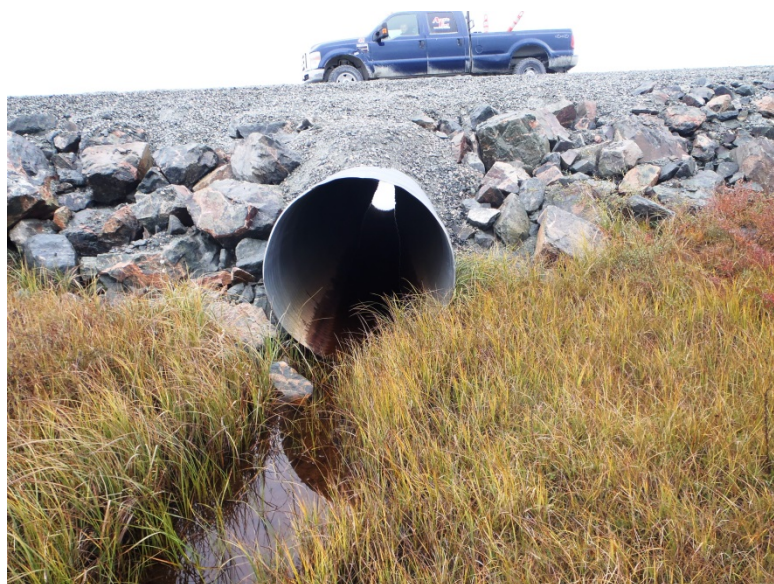
Photograph D1-43: R-07 km 25+900

Description: View of the culvert inlet. In good condition.
