Report: 2015 Annual Geotechnical Inspection

2015 Annual Geotechnical Inspection Meadowbank Gold Mine, Nunavut

Agnico-Eagle Mines Limited
Meadowbank Division
PO Box 540
Baker Lake, Nunavut
X0C 0A0

Document Number: Doc1533 1535715-Rev0

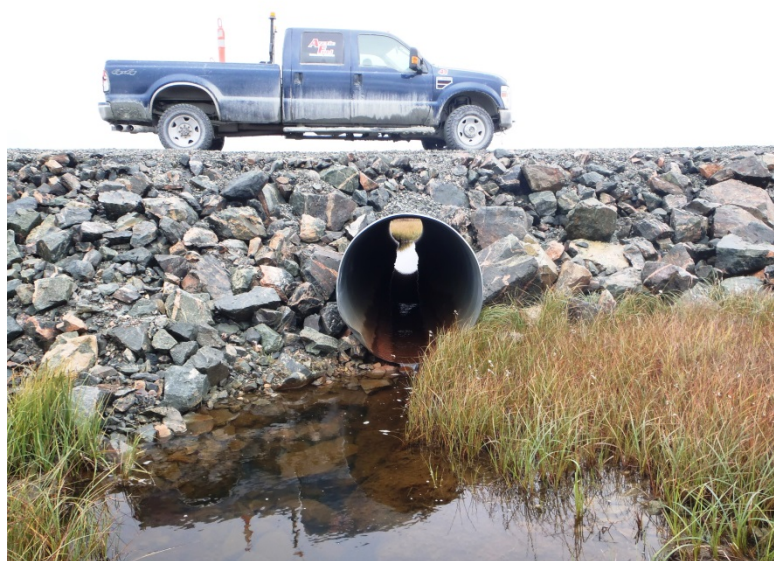
Photograph D1-44: R-07 km 25+900

Description: View of the culvert outlet. In good condition.

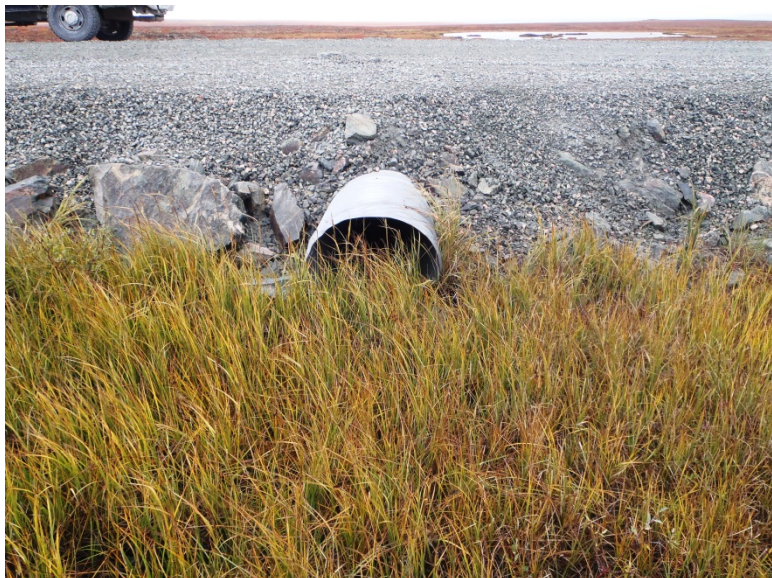
Photograph D1-45: PC-8 km 29+420

Description: View of the culvert inlet. In good condition.

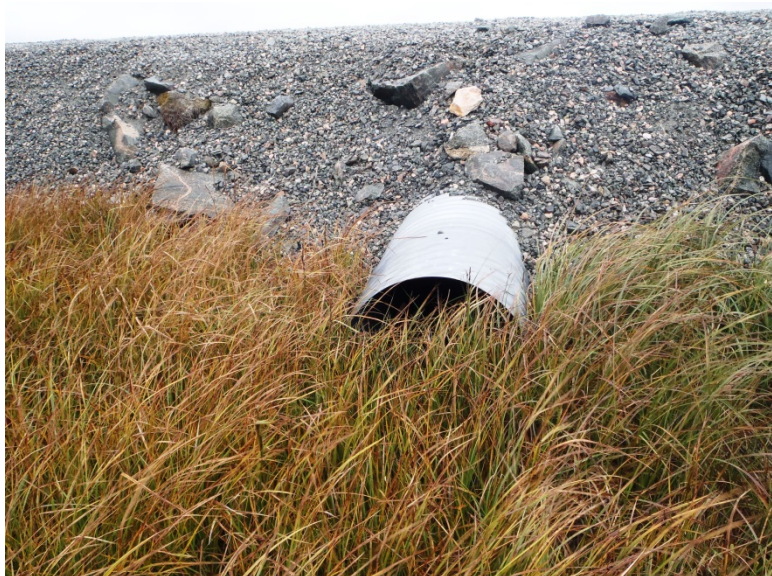
Photograph D1-46: PC-8 km 29+420

Description: View of the culvert outlet. In good condition.

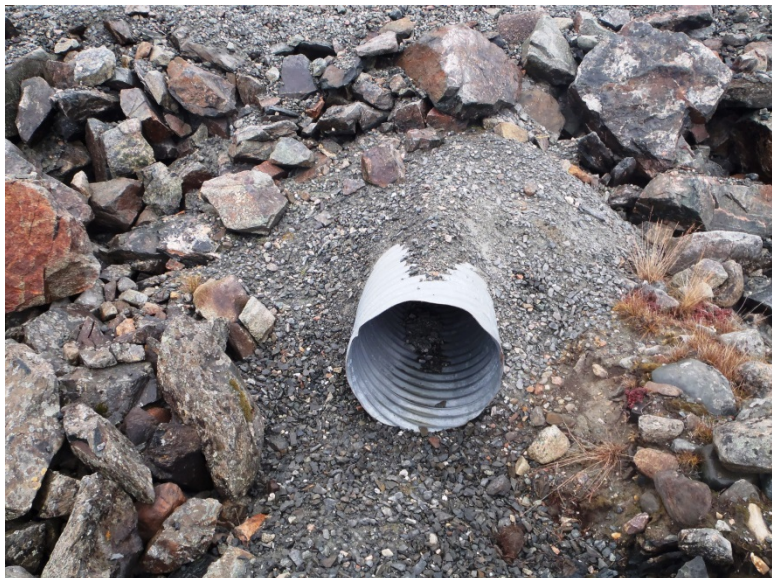
Photograph D1-47: PC-9 km 35+690

Description: View of the culvert inlet. In good condition.

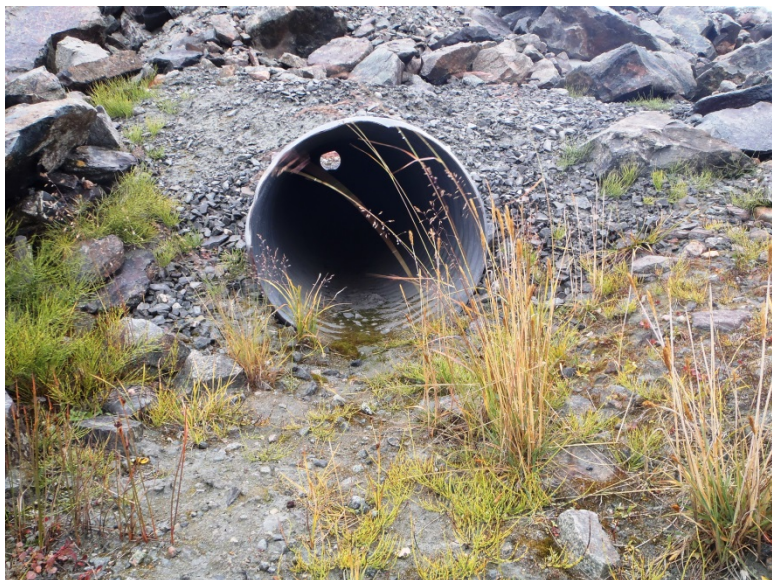
Photograph D1-48: PC-9 km 35+690

Description: View of the culvert outlet. In good condition.

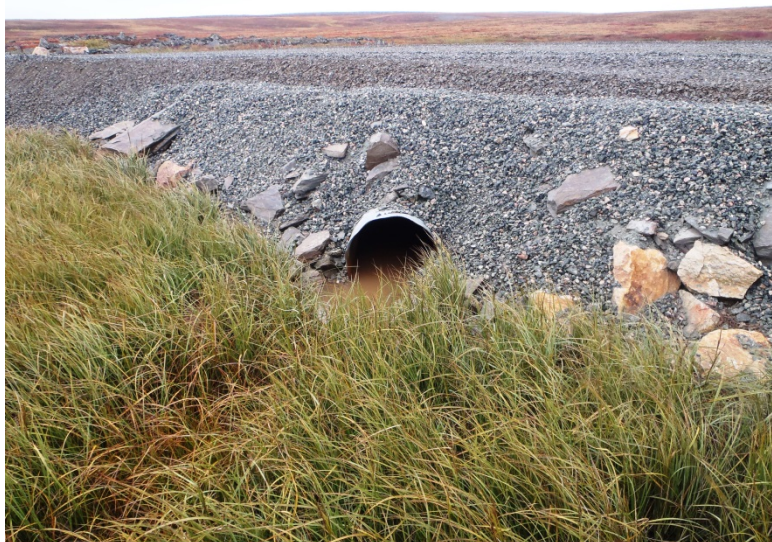
Photograph D1-49: PC-10 km 36+865

Description: View of the culvert inlet. In good condition.

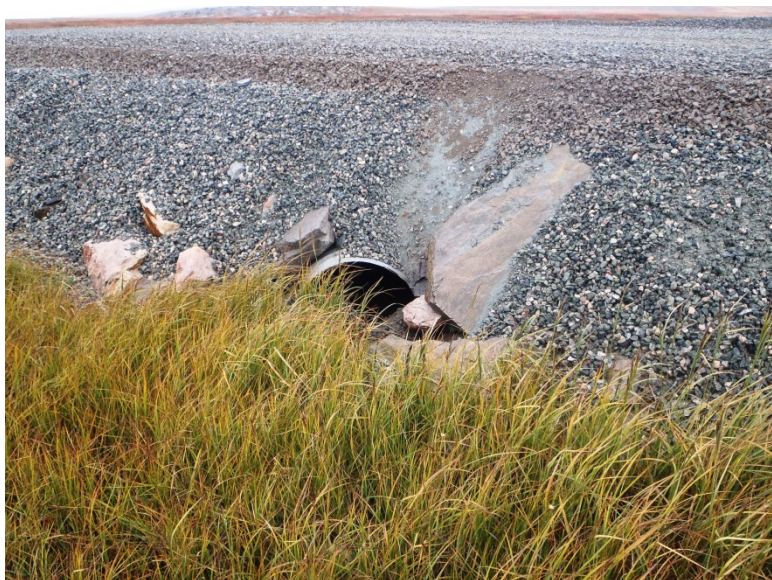
Photograph D1-50: PC-10 km 36+865

Description: View of the culvert outlet. In good condition.

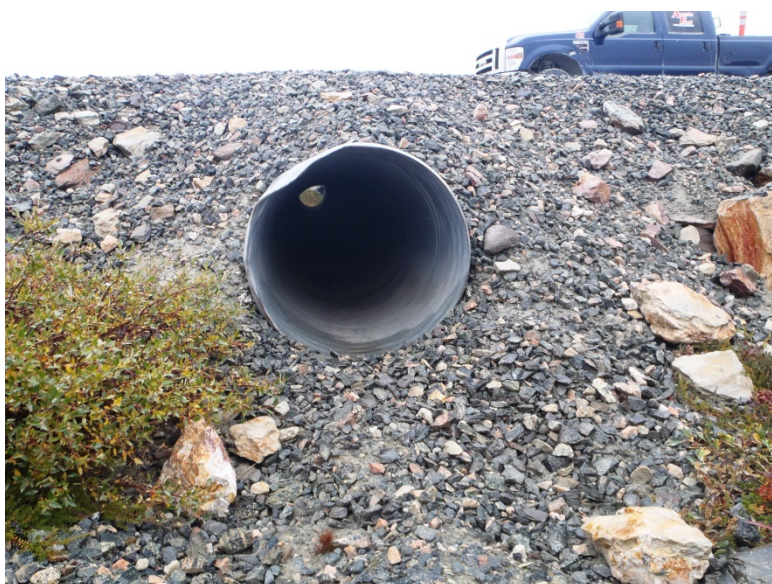
Photograph D1-51: PC-11 km 39+552

Description: View of the culvert inlet. In good condition.

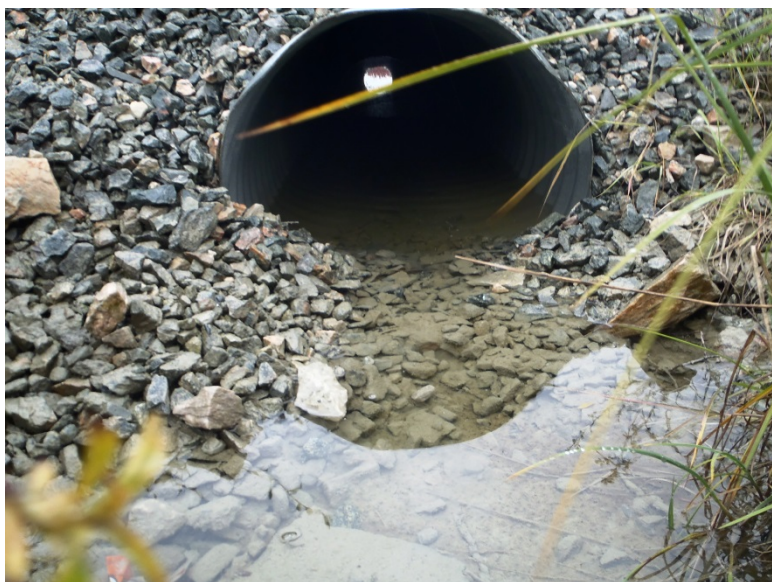
Photograph D1-52: PC-11 km 39+552

Description: View of the culvert outlet. In good condition.

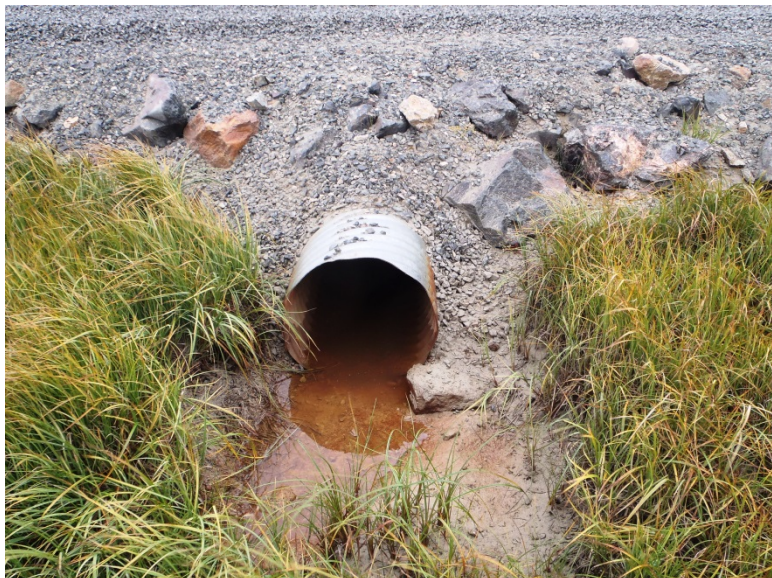
Photograph D1-53: PC-12 km 41+300

Description: View of the culvert inlet. In good condition.

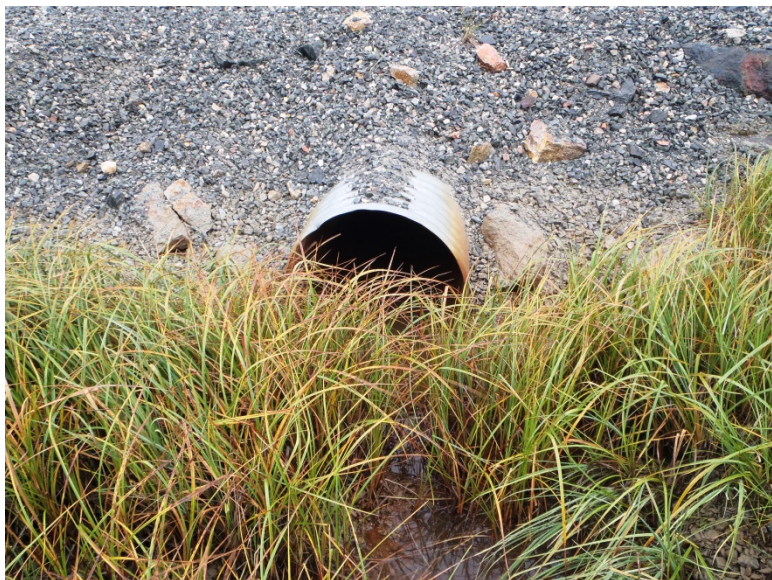
Photograph D1-54: PC-12 km 41+300

Description: View of the culvert outlet. In good condition.

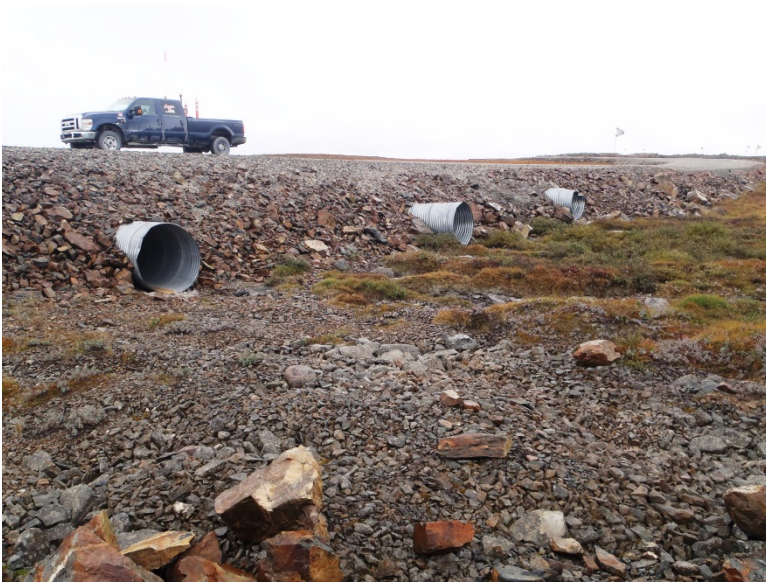
Photograph D1-55: R-14 km 67+840

Description: View of the inlet culverts. Middle and northern culverts are collapsed inside (hole in the middle). Expected to continue performing well.

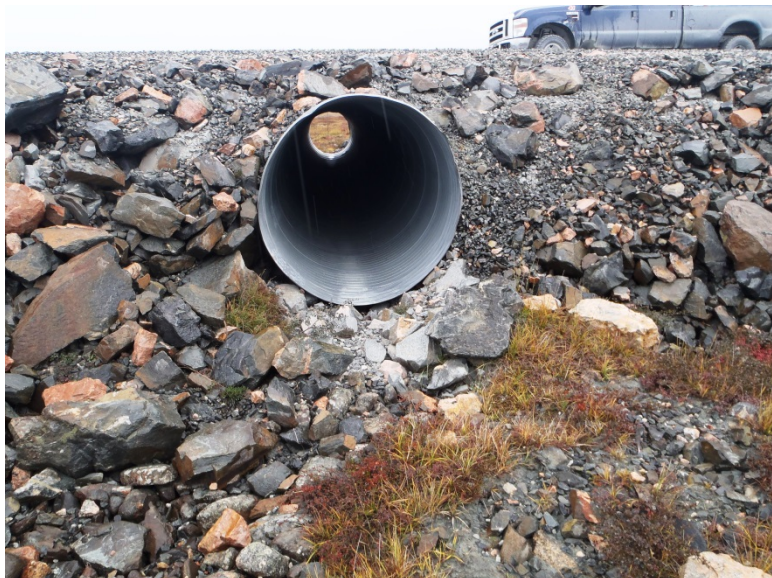
Photograph D1-57: R-17 km 77+440

Description: View of the culvert inlet. In good condition.

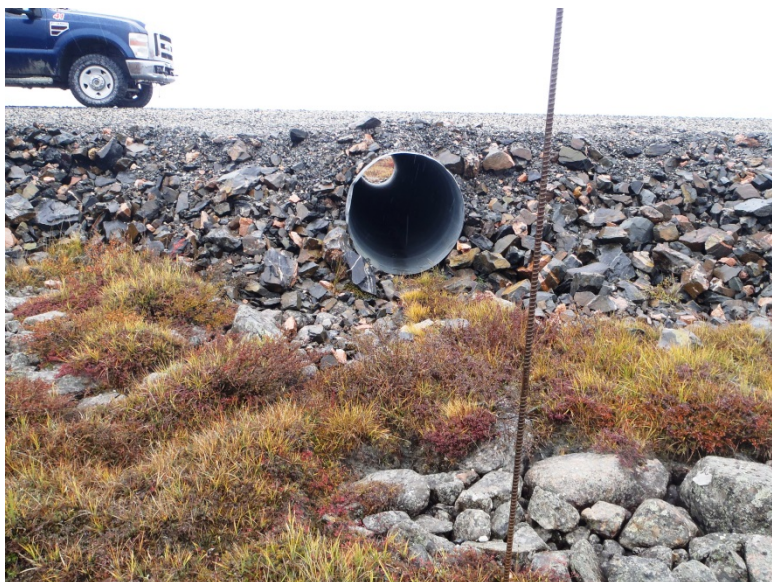
Photograph D1-58: R-17 km 77+440

Description: View of the culvert outlet. In good condition.

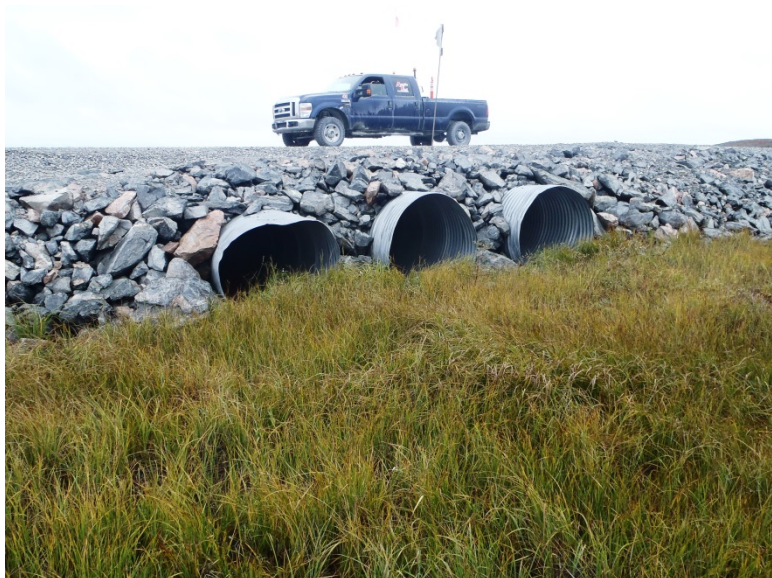
Photograph D1-59: R-18A km 80+950

Description: View of the culverts inlet. In good condition.

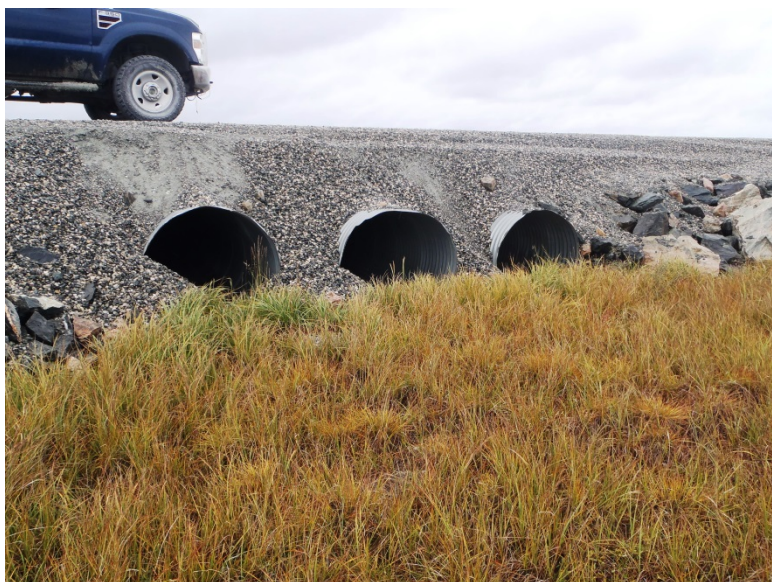
Photograph D1-60: R-18A km 80+950

Description: View of the culverts outlet. In good condition.

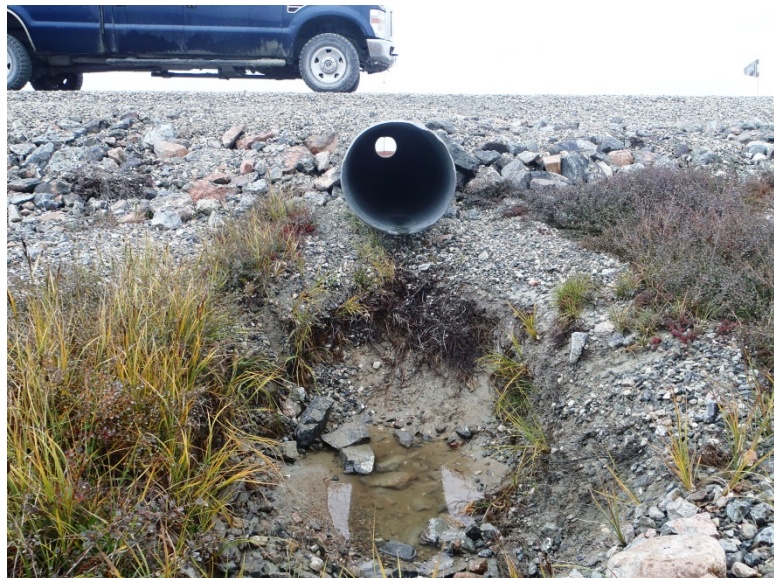
Photograph D1-61: R-18B km 80+950

Description: View of the culverts inlet. The inlet was installed above the ground surface and granular material under the culvert was washed out.

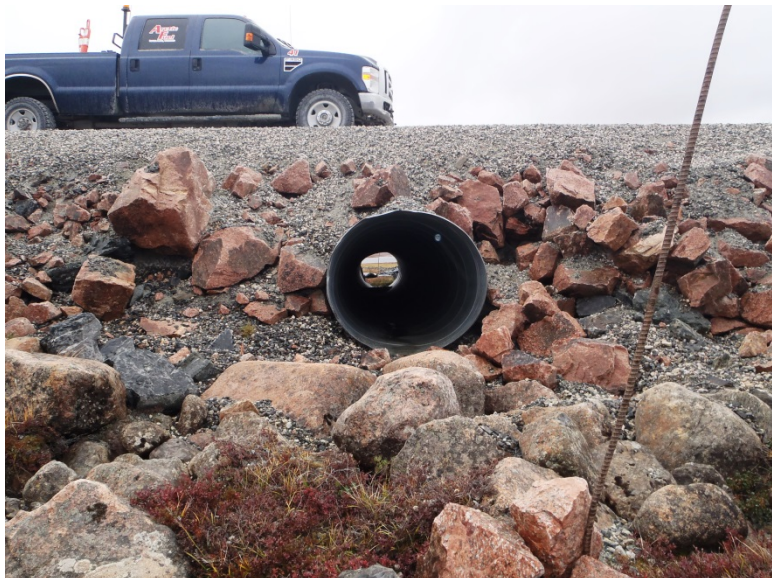
Photograph D1-63: R-20 km 85+490

Description: View of the culvert inlet. The middle of the culvert is slightly collapsed. The inlet is installed above the ground surface and water flows beneath the culvert. The culvert is in stable condition.

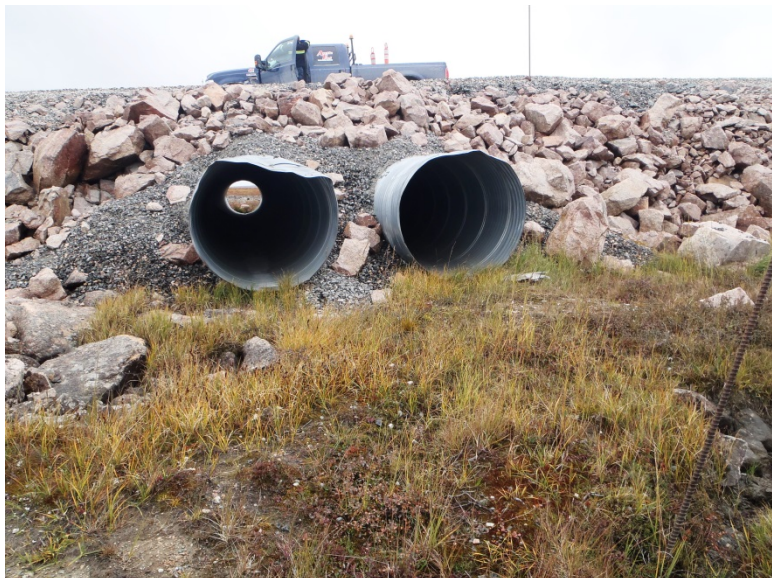
Photograph D1-65: R-21 km 87+300

Description: View of the culverts inlet. Both culverts are slightly collapsed in the middle. In stable condition, but should have been installed lower to avoid erosion issue.

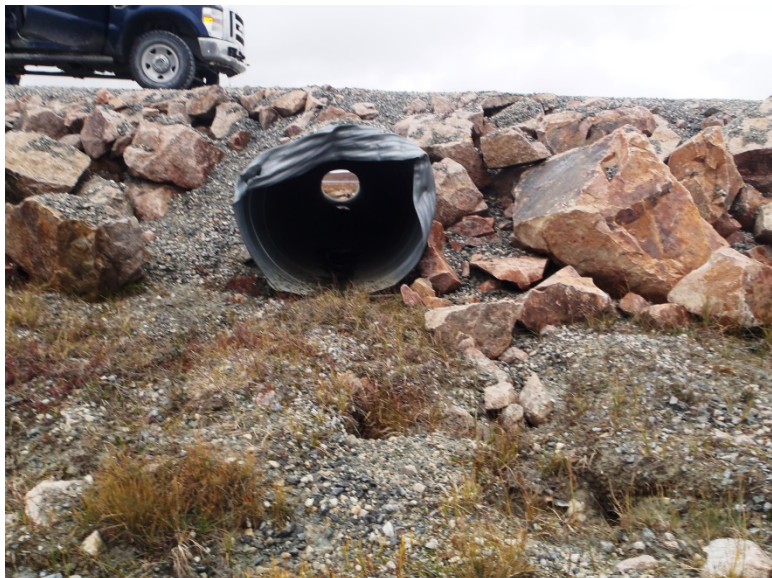
Photograph D1-67: R-23 km 93+600

89+550	Quarry 20		Slope remediation is in progress.
93+400	Quarry 21		Slope remediation is in progress.
93+600	R-23	1x1200 mm CSP	Minor damage near the top of the culvert, but still in good condition. The culvert is installed too high and as a results there is a flow of water through the road rockfill.
98+100	R-24	2x1200 mm CSP	Both outlets are installed too high. The outlet of the southern culvert shows small signs of erosion. Both culvert show deformation in the upper part.
99+200	Quarry 22		Slope remediation is in progress.
101+950	R-25	2x600 mm CSP	One culvert is angling up toward the downstream end and natural drainage by gravity does not occur. During the freshet, because the water level is high, the culvert will evacuate the flow from upstream to downstream. A second culvert alongside is well installed and should drain water for the remainder of the season. No sign of erosion observed during the inspection.

Description: View of the culvert inlet. The culvert is installed too high and there is a low flow of water through the road rockfill. In good condition.

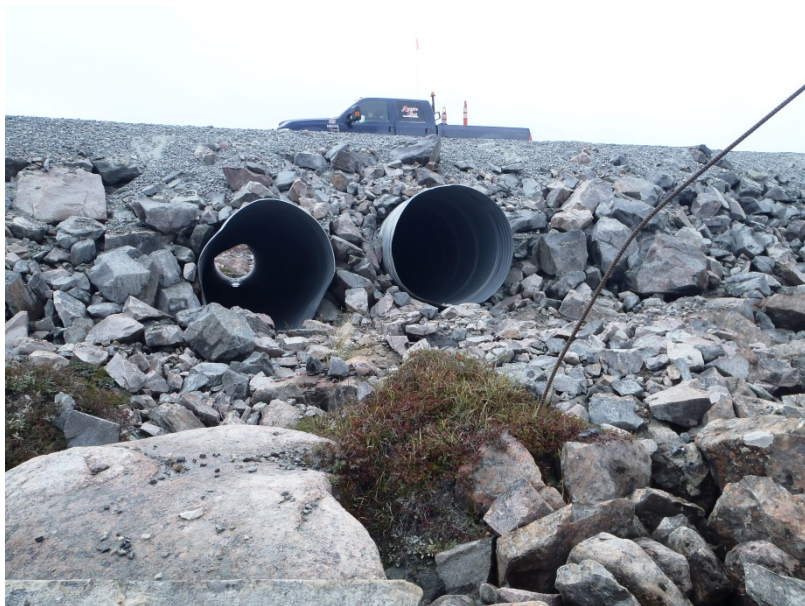
Photograph D1-69: R-24 km 98+100

Description: View of the culverts inlet. South inlet is installed too high. Both culverts show deformation in the upper part.

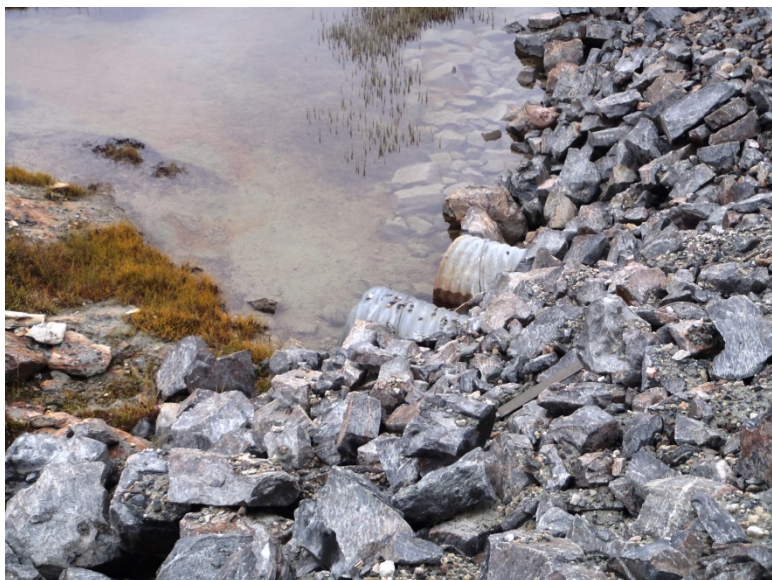
Photograph D1-71: R-25 km 101+950

Description: View of the culverts inlet. In good condition.

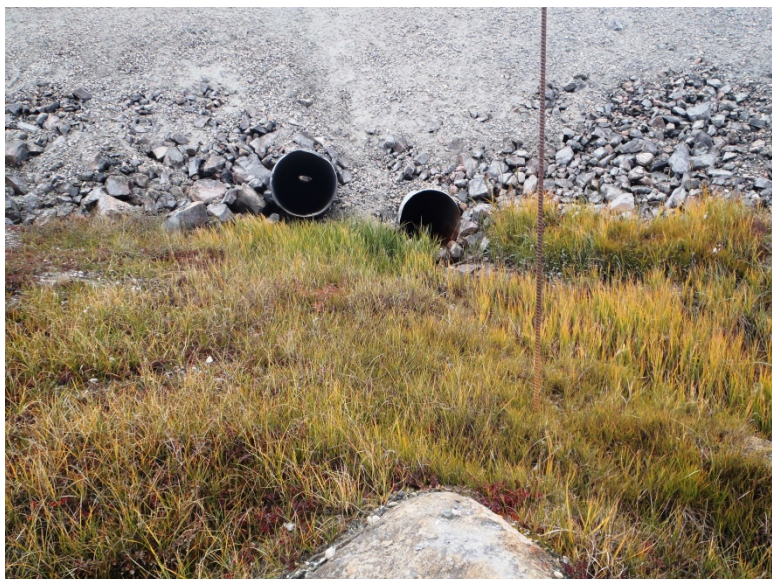
Photograph D1-72: R-25 km 101+950

Description: View of the culverts outlet. In good condition.

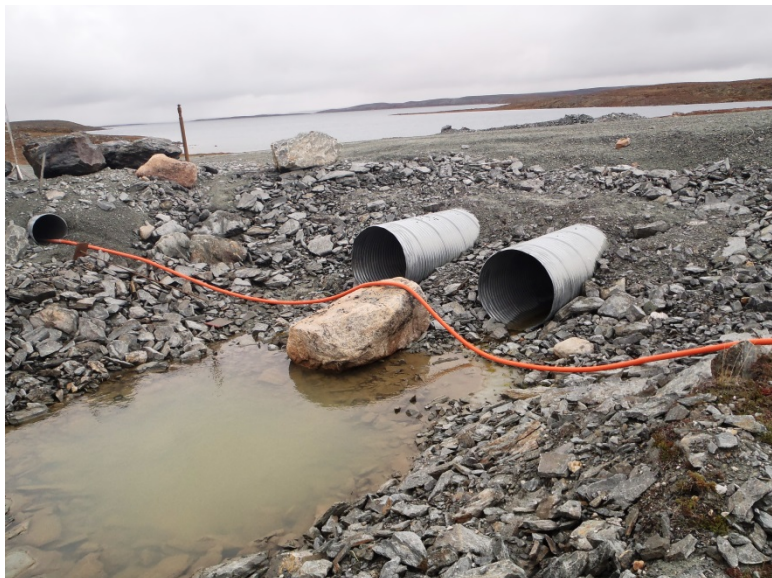
Photograph D1-73: Western Diversion Ditch

Description: View of the culverts inlet. In good condition.

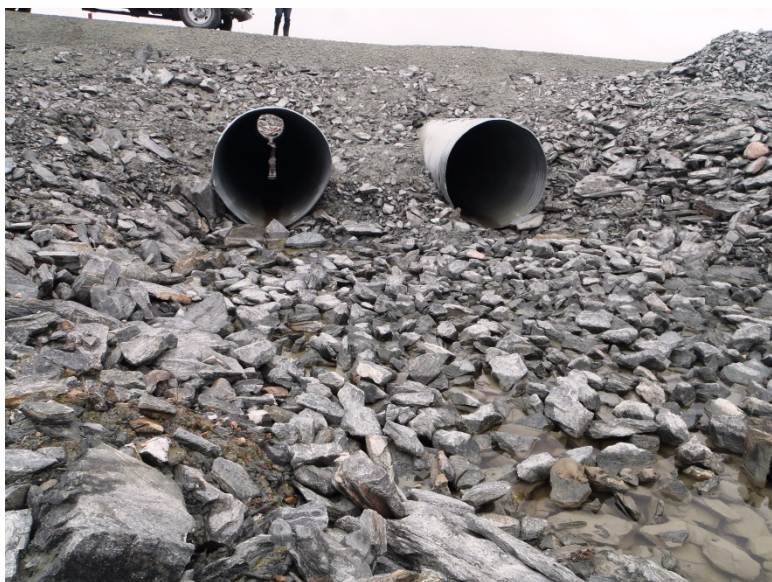
Photograph D1-74: Western Diversion Ditch

Description: View of the culverts outlet. In good condition.

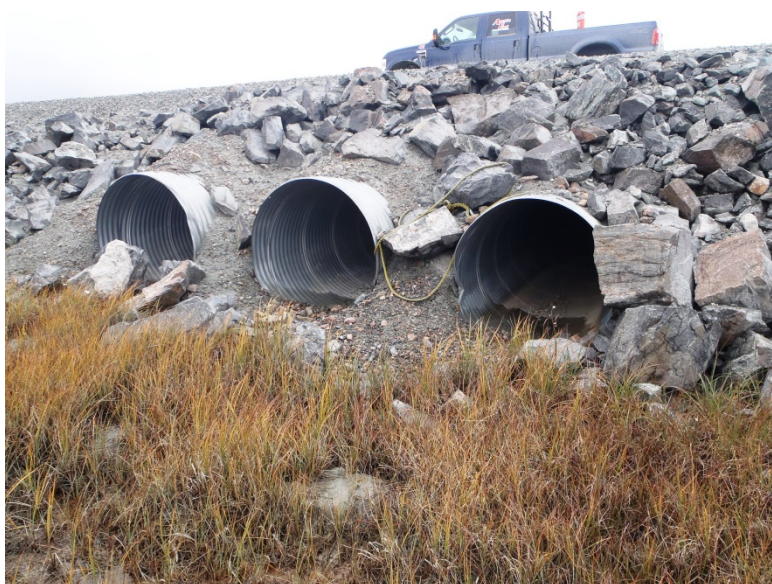
Photograph D1-75: R-26 km 104+400

104+400	R-26	3x1200 mm CSP	Small obstruction of the west inlet by a boulder (0.4 m). The culvert is in good condition, no follow-up required.
	Quarry 23		Presence of loose rocks on top of steep wall.

Description: View of the culverts inlet. Presence of a 0.4 m boulder in front of the west inlet. In good condition.

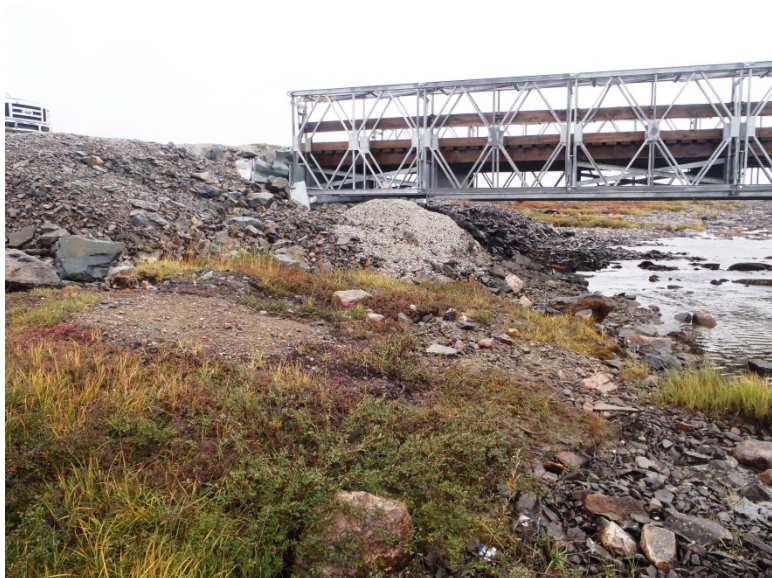
Photograph D2-17 Bridges 6 – R15 km 69+200

Description: Looking at the south abutment from downstream. Damage to the bin wall likely caused during snow removal activities.

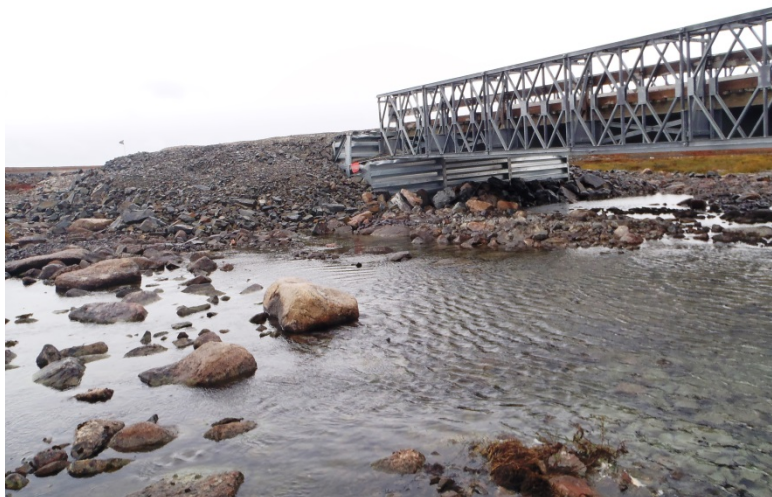
Photograph D2-19 Bridges 6 – R15 km 69+200

Description: Looking at the north abutment from upstream. Damage to the bin wall likely caused during snow removal activities.

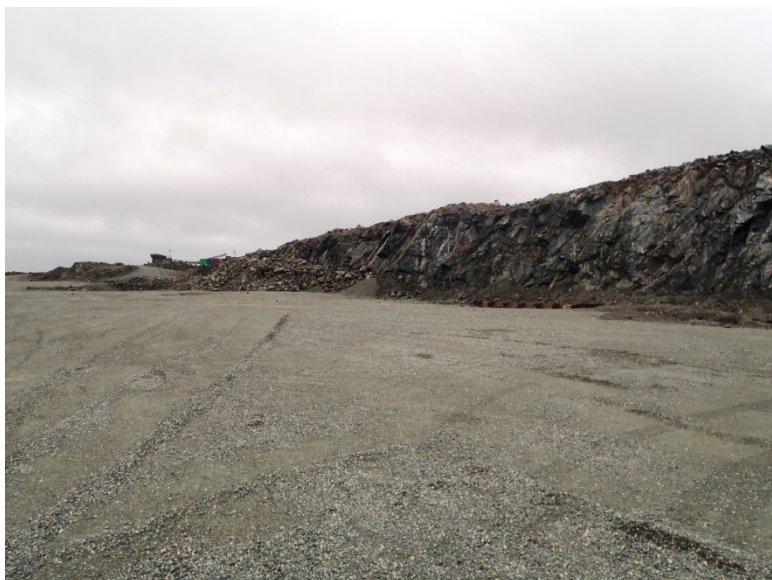
Photograph E1-5: Quarry 3 – km 23+700

Description: View of west wall. Presence of loose rock along steep wall.

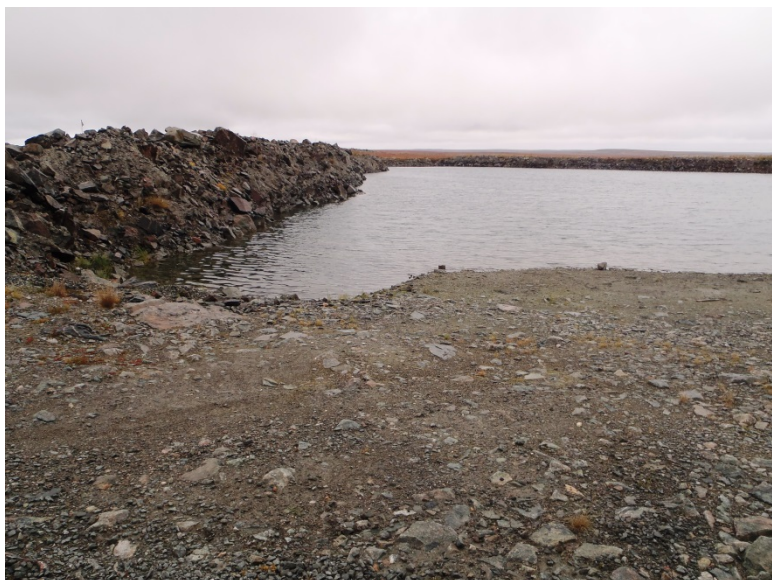
Photograph E1-7: Quarry 4 – km 31+300

Description: View of the east and south walls of Quarry 4. The quarry is flooded.

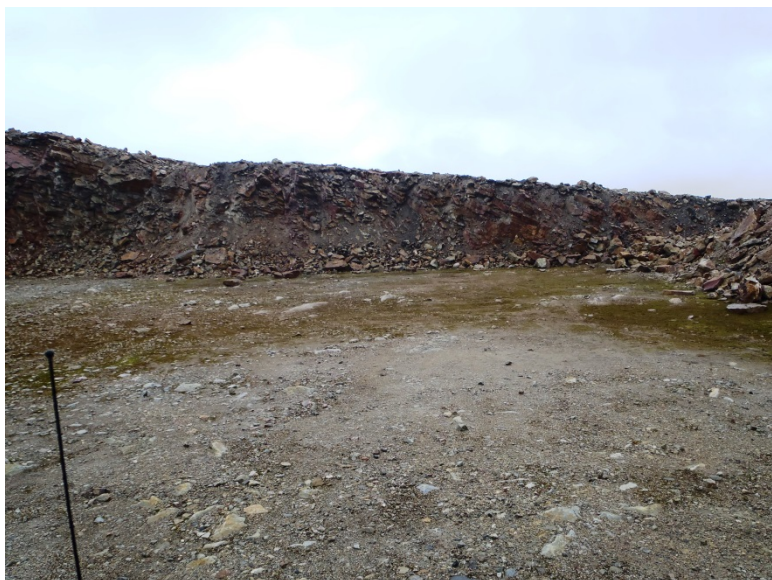
Photograph E1-13: Quarry 7 – km 39+800

Description: View of west wall. Presence of loose blocks.

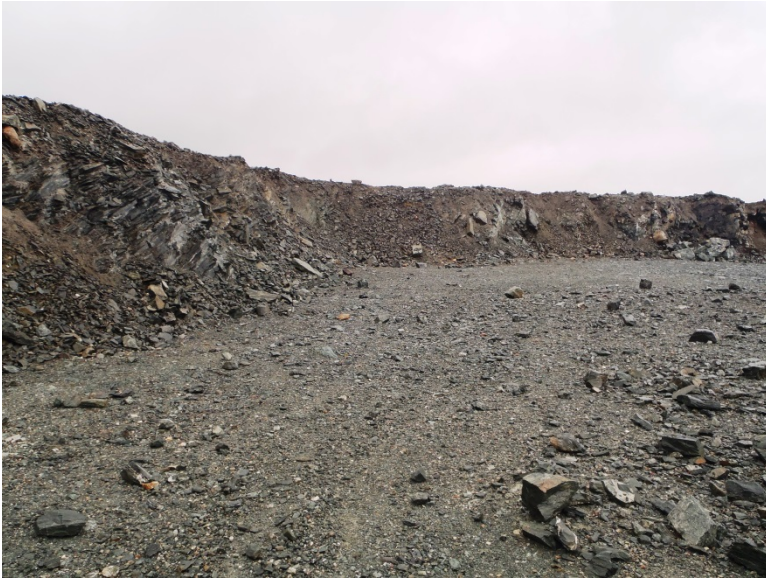
Photograph E1-17: Quarry 9 – km 44+600

Description: View of west and south walls. Presence of loose blocks.

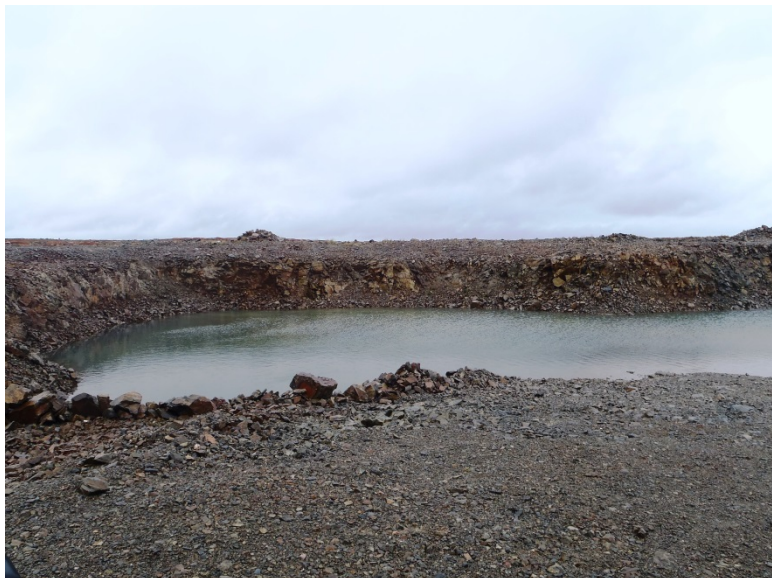
Photograph E1-27: Quarry 14 – km 65+700

Description: View of west and south walls. Quarry flooded.

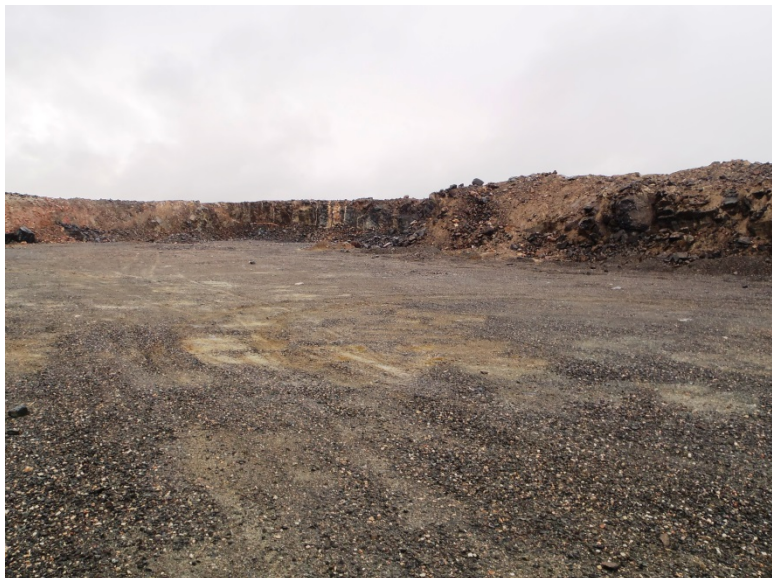
Photograph E1-31: Quarry 16 – km 70+400

Description: View of the south and west walls. Presence of loose rocks on steep wall.

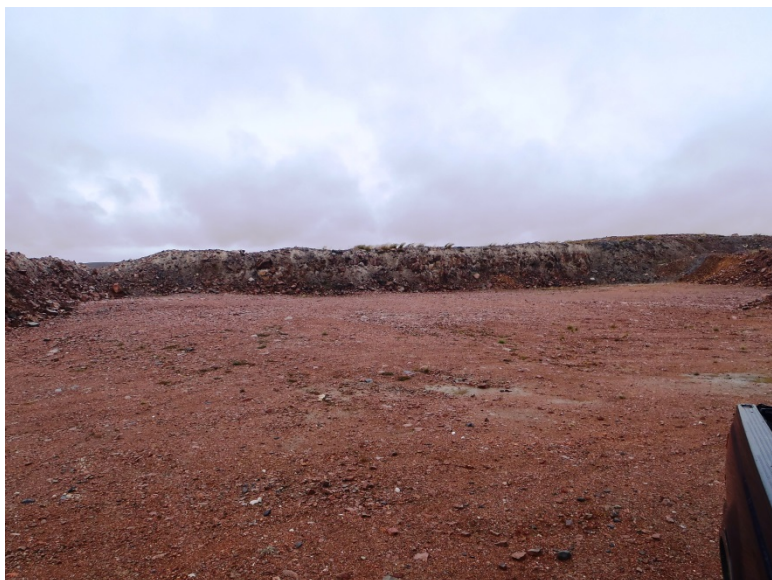
Photograph E1-33: Quarry 17 – km 72+800

Description: Looking at the south and east walls.

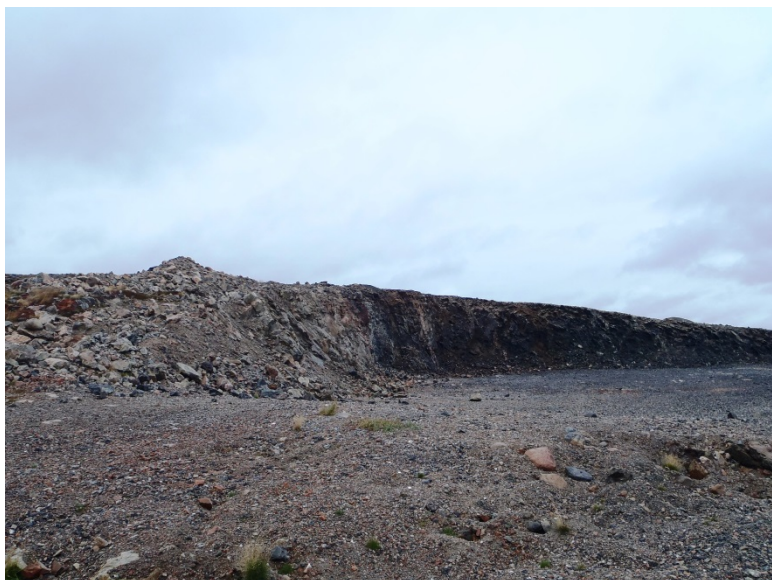
Photograph E1-35: Quarry 18 – km 80+200

Description: View of the west and of the south wall.

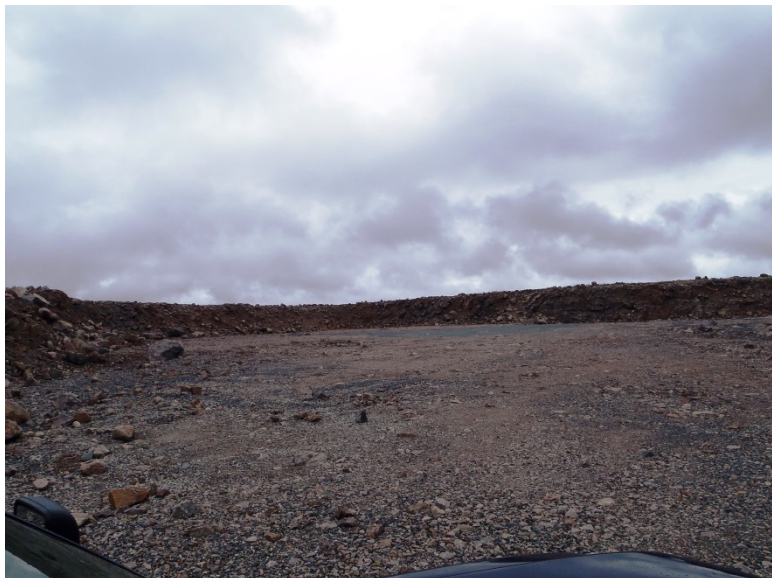
Photograph E1-39: Quarry 20 – km 89+550

Description: Looking at the north and west walls.

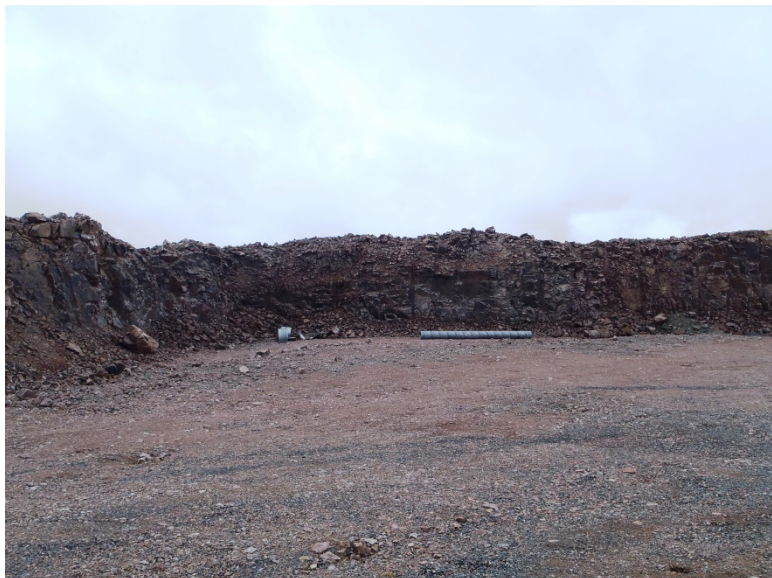
Photograph E1-41: Quarry 21 – km 93+400

Description: Looking at the south and east walls.

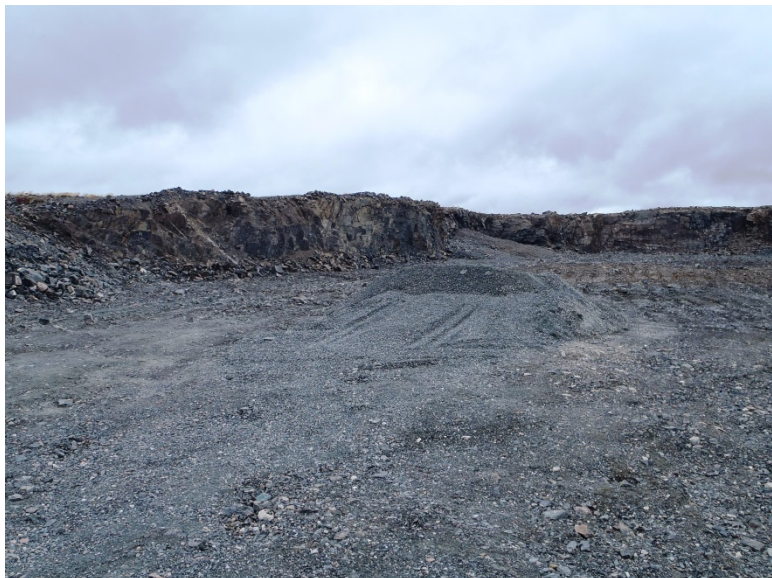
Photograph E1-43: Quarry 22 – km 99+200

Description: View of the north and west walls.

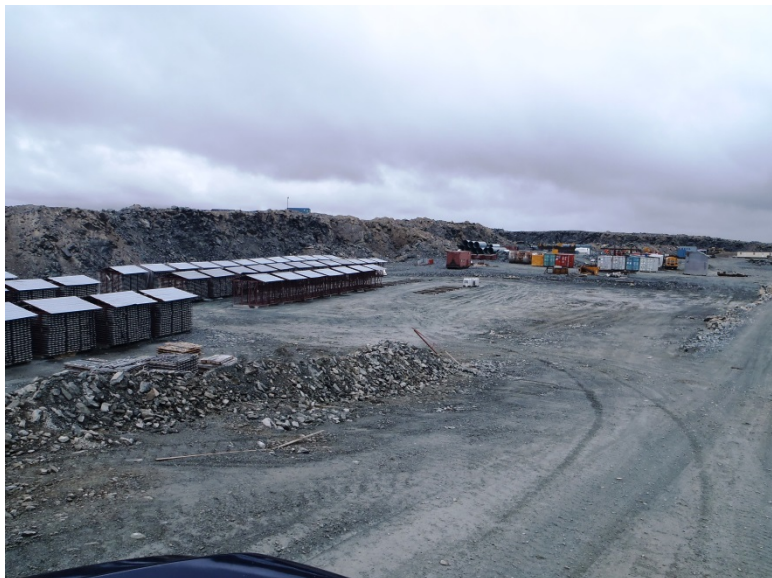
Photograph E1-45: Quarry 23 (Airstrip Quarry)

Description: Looking at the north wall.

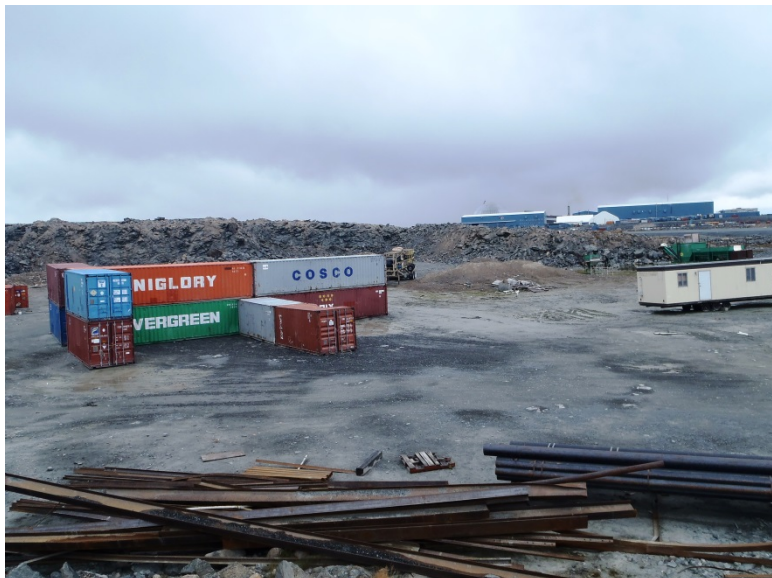
Photograph E1-47: Quarry 23 (Airstrip Quarry)

Description: Looking at the east and the south walls. Presence of loose rocks along steep wall.

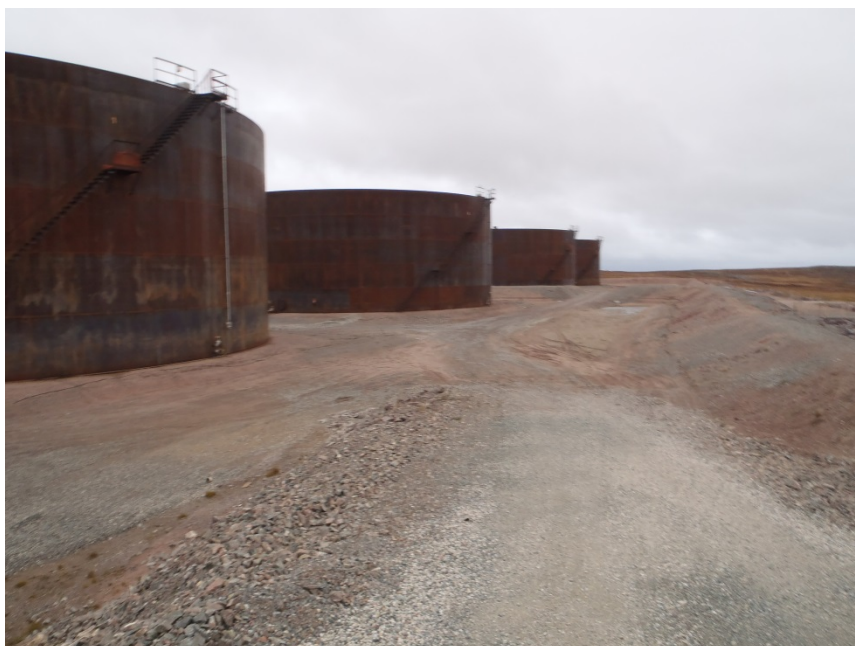
Photograph F1-1 Baker Lake Tank Farm

Description: From the south side of Tank 1, looking southeast at Tanks 1, 2, 3, and 4.

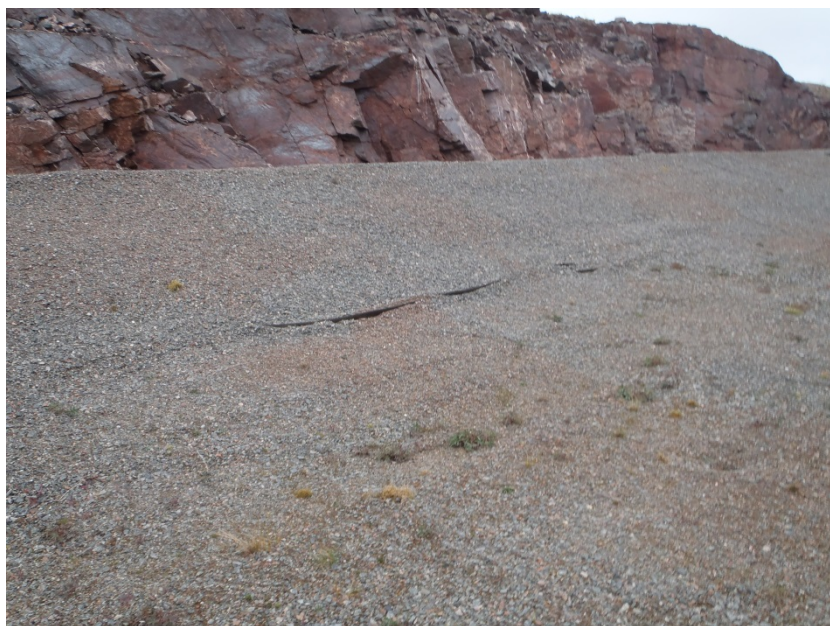
Photograph F1-3 Baker Lake Tank Farm

Description: Unprotected exposed geomembrane at the base of the slope separating the lower and upper tank. The exposed area is located at the base of the slope between Tanks 1 and 2.

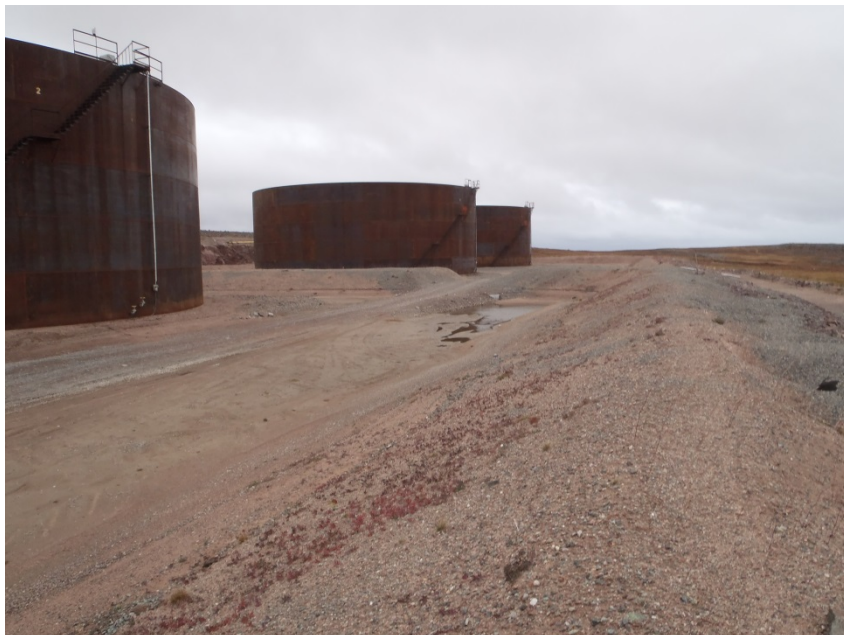
Photograph F1-5 Baker Lake Tank Farm

Description: Looking northeast toward the south side of Tanks 3 and 4. Some water ponding.

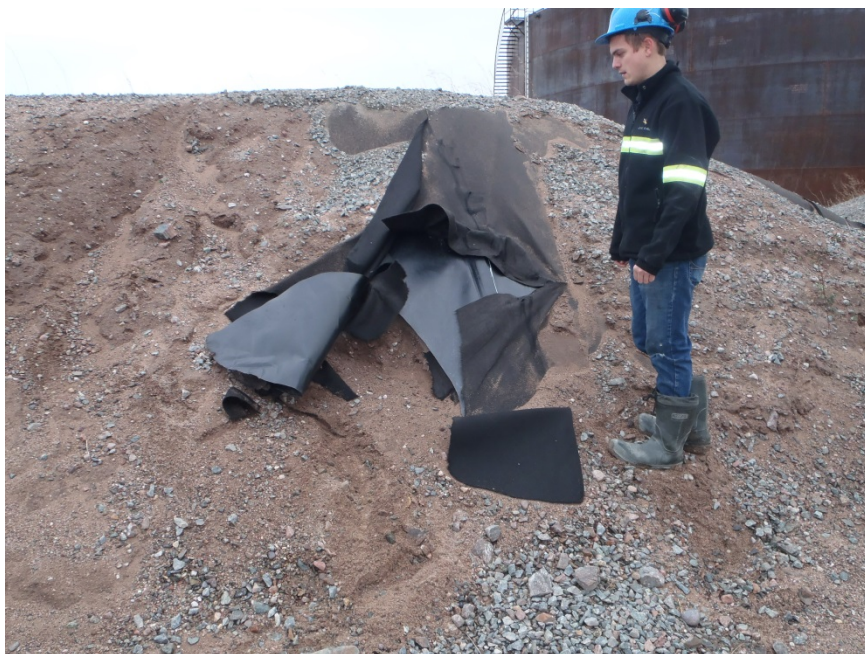
Photograph F1-6 Baker Lake Tank Farm

Description: The geomembrane between the south side of tank 2 and 3 is damaged.

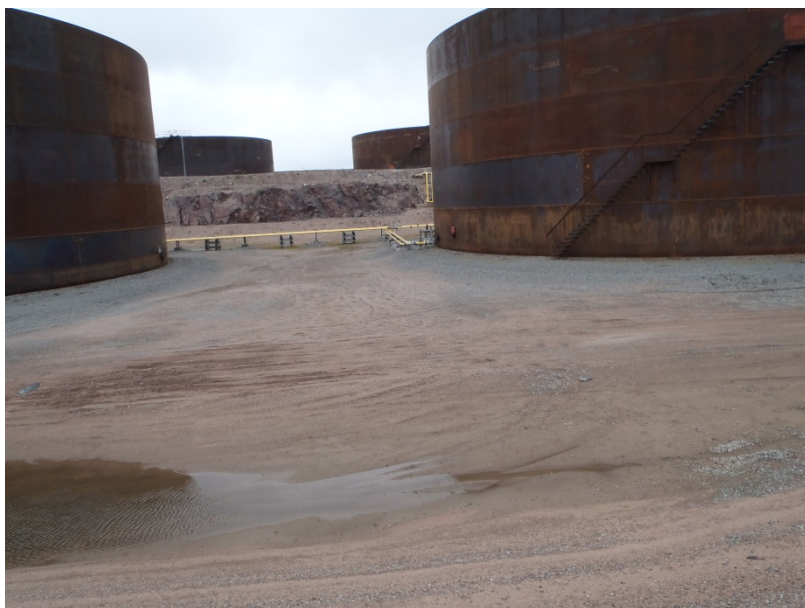
Photo Number: 181

Description: From the southeastern corner of Tank 3, looking northwest at the south side of Tank 3, 2 and 1. Presence of water ponding.
