Report: 2015 Annual Geotechnical Inspection

2015 Annual Geotechnical Inspection Meadowbank Gold Mine, Nunavut

Agnico-Eagle Mines Limited
Meadowbank Division
PO Box 540
Baker Lake, Nunavut
X0C 0A0

Document Number: Doc1533 1535715-Rev0

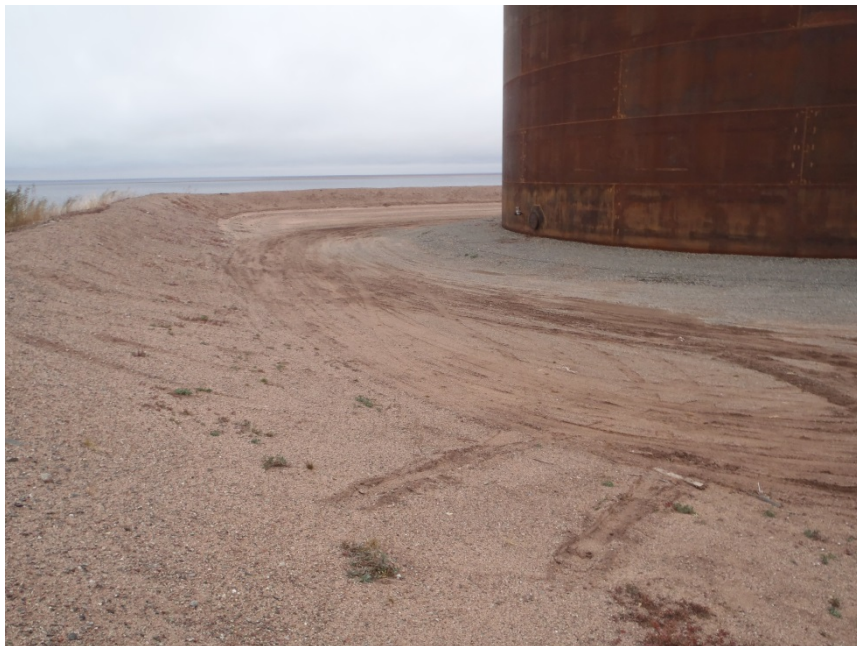
Photo Number: 183

Description: From the northeastern corner of Tank 4 looking southwest toward Tank 4.

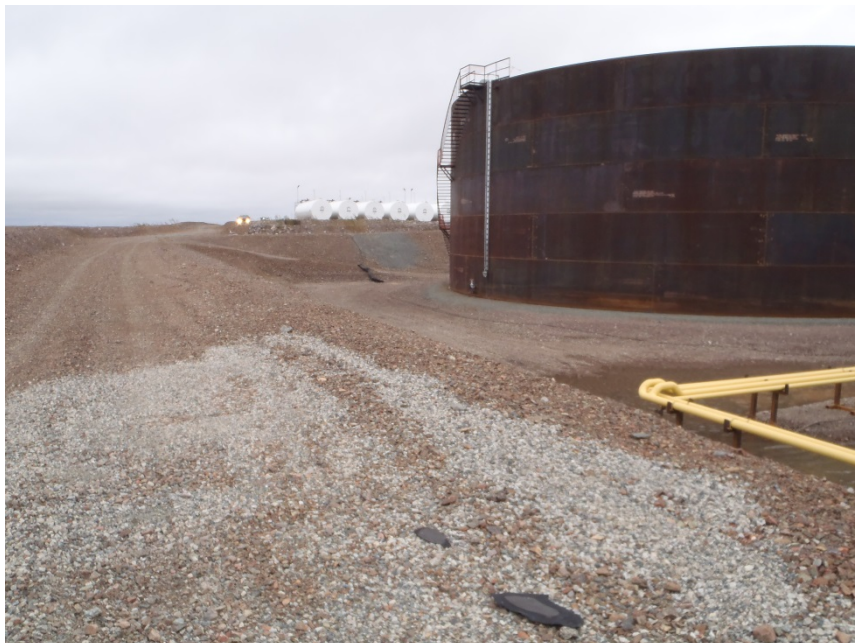
Photo Number: 187

Description: Looking northwest at the southern and western sides of Tank 5.

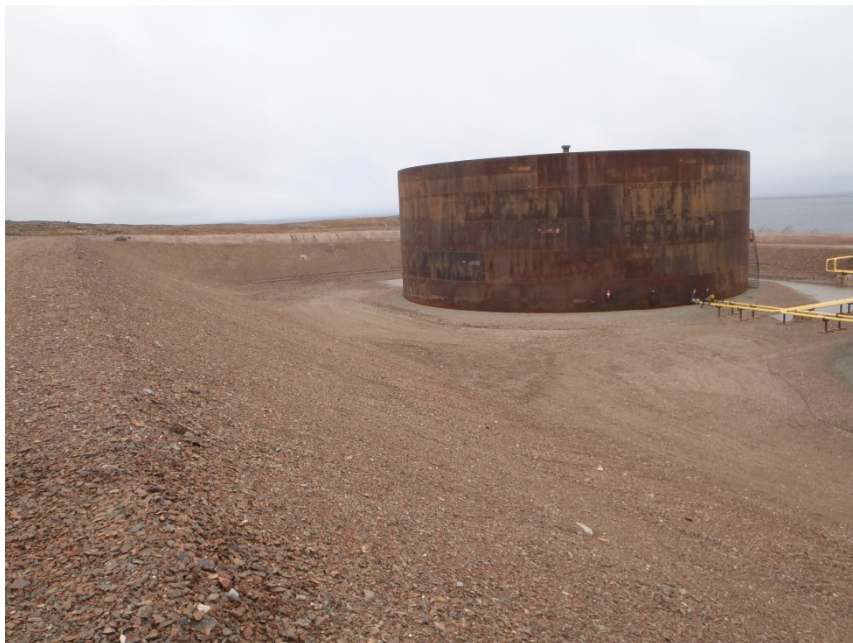
Photo Number: 189

Description: From the northern side of Tank 5 looking southeast at the northern side of Tanks 6. Presence of water ponding.

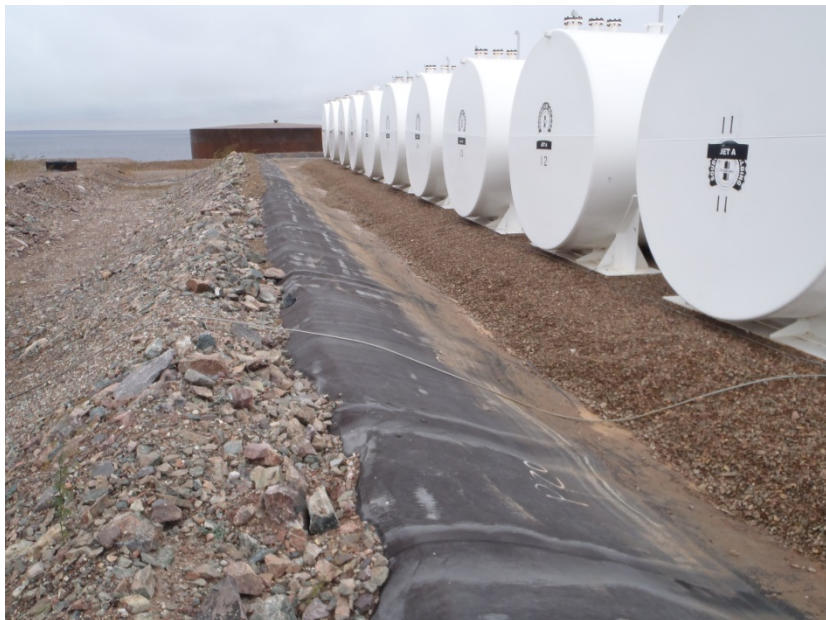
Photo Number: 192

Description: From the northeastern corner of the Jet A fuel tanks looking south. Presence of exposed geomembrane.

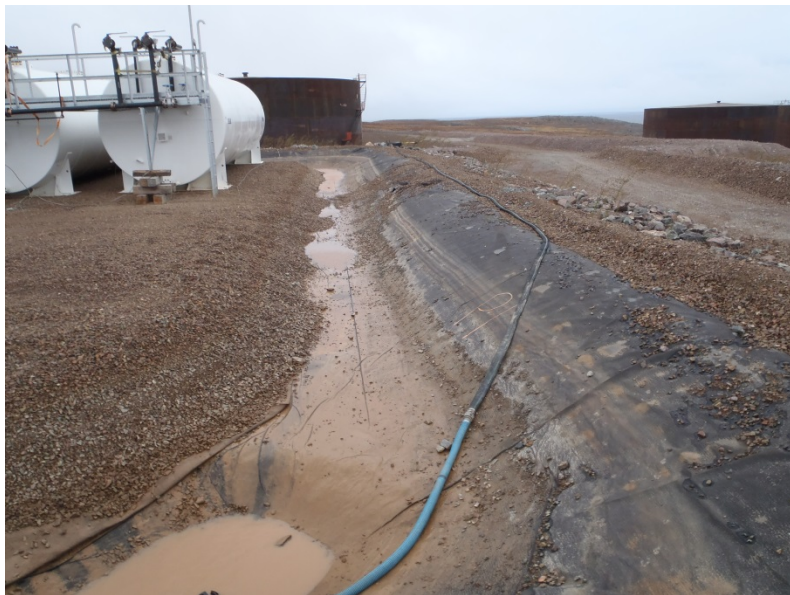
Photo Number: 193

Description: From the southwestern corner of the Jet A fuel tanks looking east. Presence of exposed geomembrane. Presence of holes in the geomembrane.

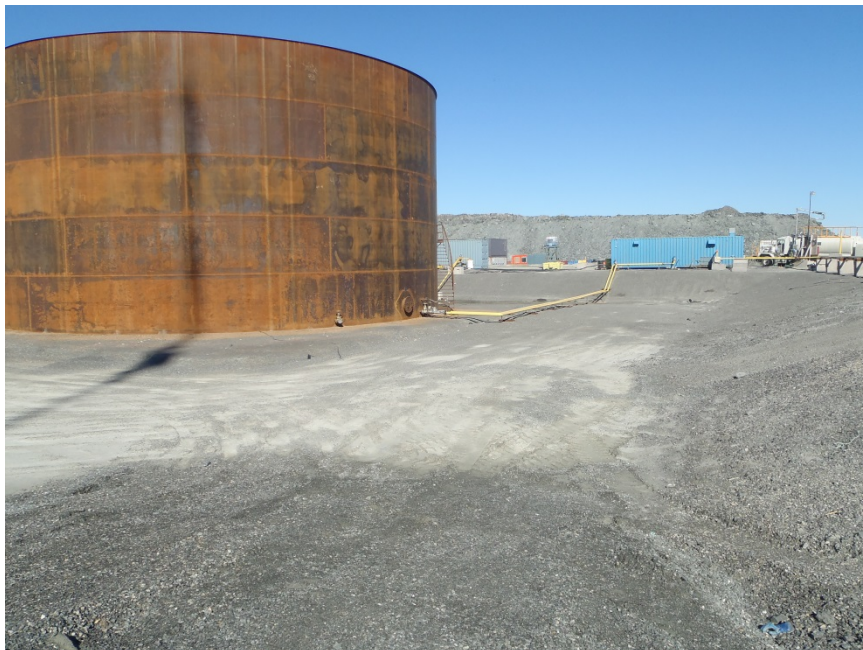
Photo Number: 2

Description: From the western corner, looking east at the tank.

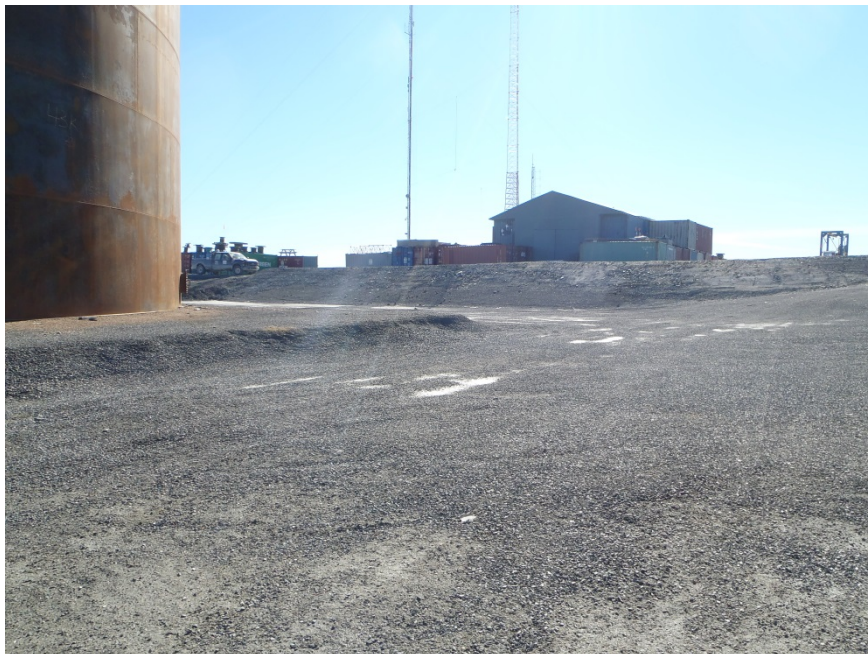
Photo Number: 8

Description: From the eastern side, looking northwest.

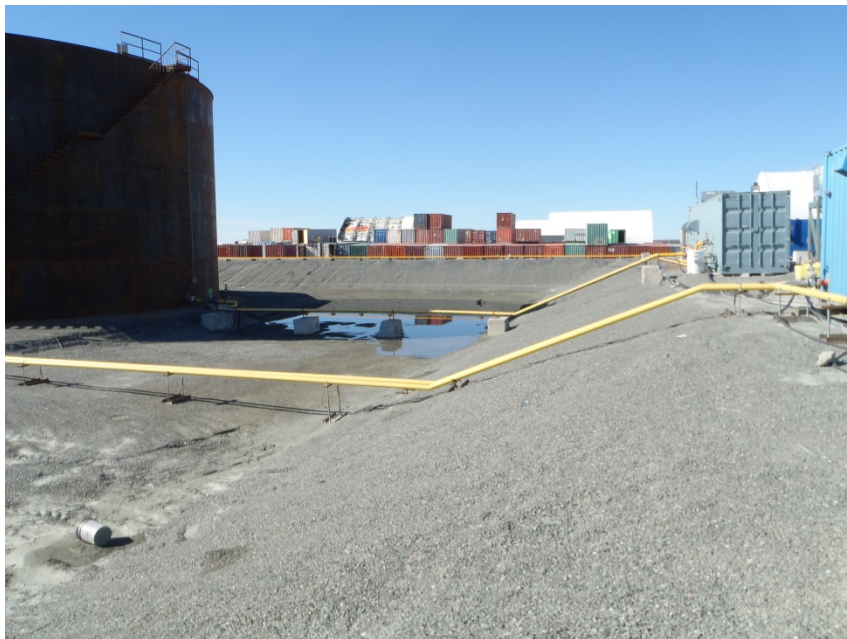
Photo Number: 5

Description: Looking northeast from the southern corner. Notice the accumulation of water in the eastern corner.

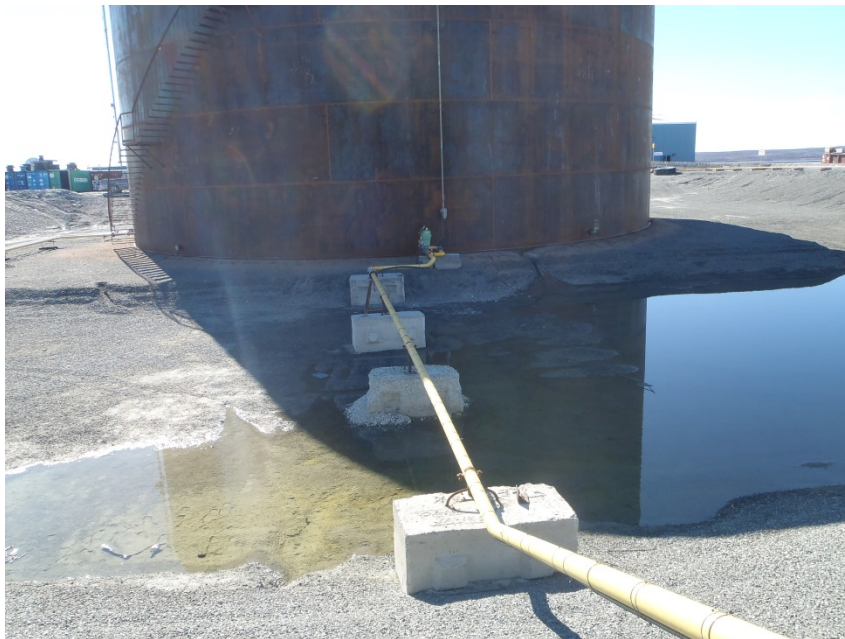
Photo Number: 6

Description: Looking northwest from the northeastern side. Presence of an accumulation of water

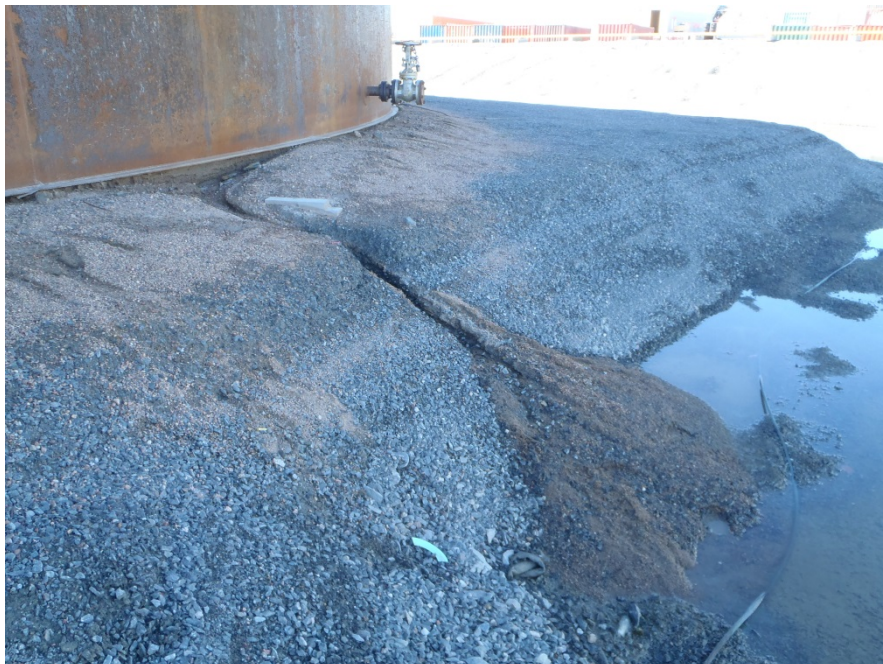
Photograph F2-9 Meadowbank Tank Farm

Description: From the southeast corner of the Tank, looking northeast. Presence of a small channel of erosion that should be repaired.

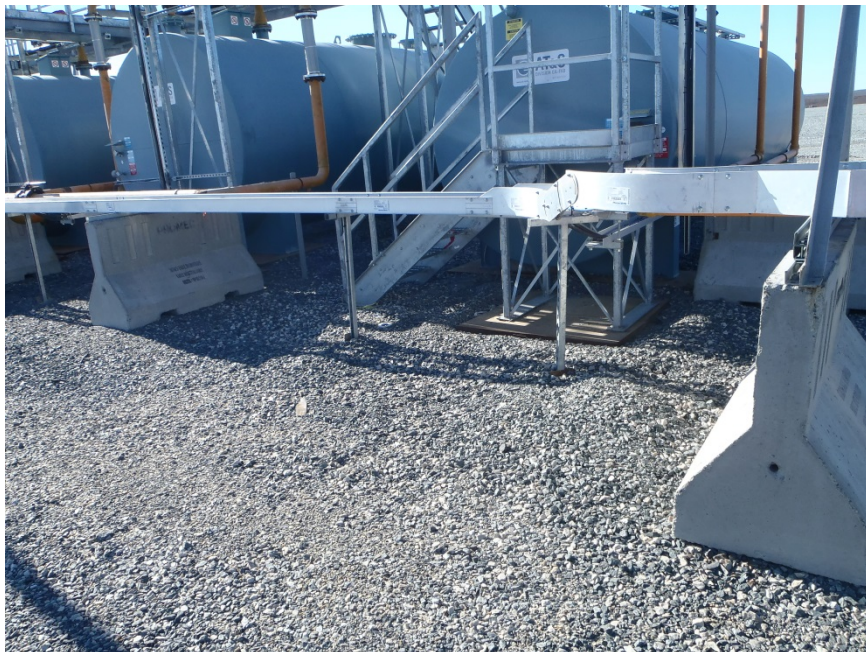
Photo Number: 41

Description: From the east corner of the Tanks looking northwest toward the Vault Tank Farm.

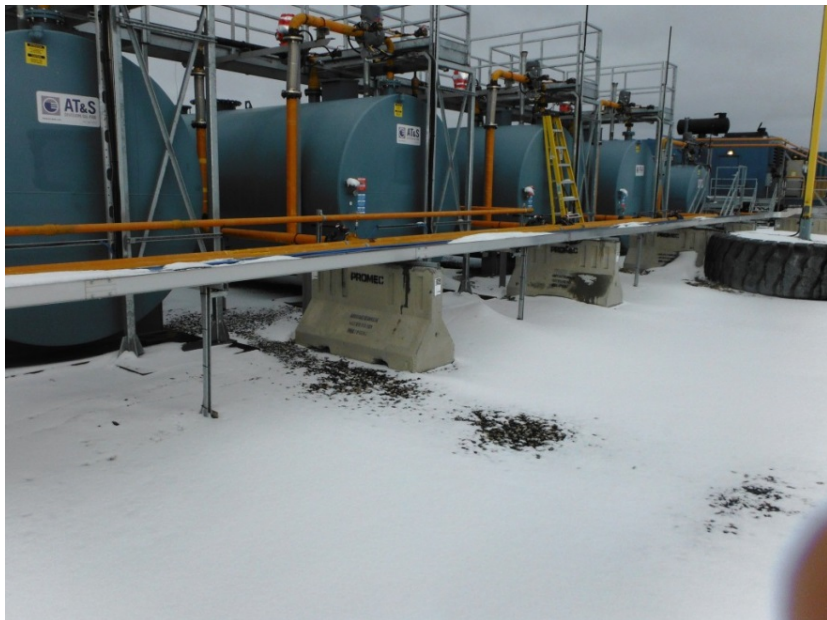
Photo Number: 42

Description: From the south corner of the Tanks Looking northeast toward the Vault Tank Farm.

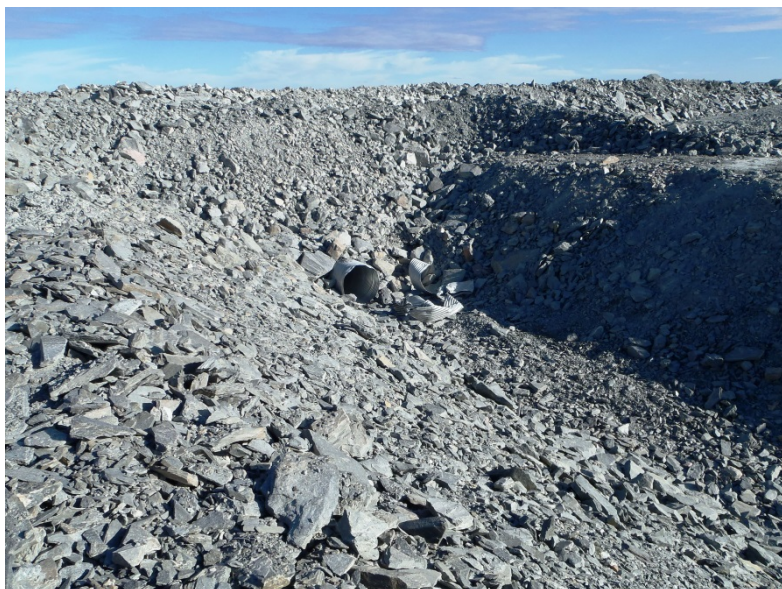
Photo Number: 121

Description: Looking at the inlet of the two culverts for NP2 exit to the environment on Vault Road (near the waste rock pile at 639214E/7216189N). The SW culvert is entirely obstructed by rockfill.

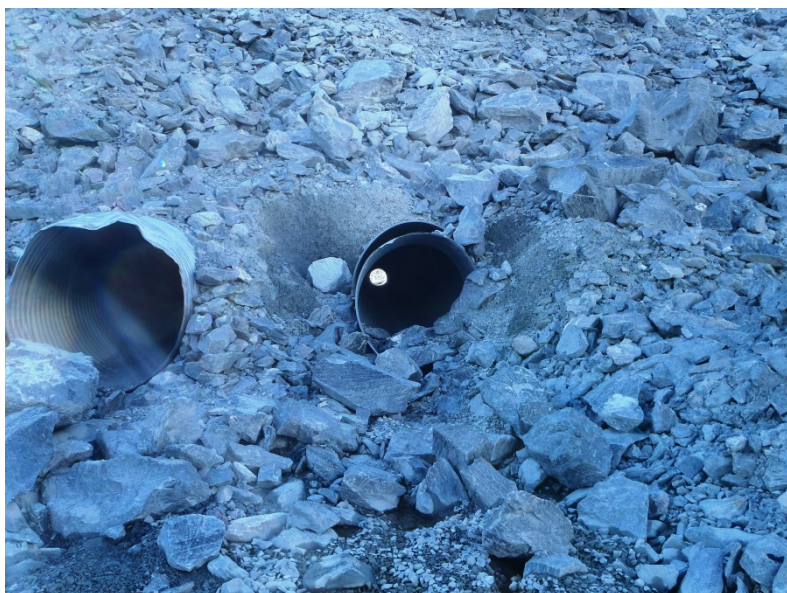
Photograph G1-2 Vault Road Culverts

Description: Looking at the outlet of the two culverts for NP2 exit to the environment on Vault Road (near the waste rock pile at 639214E/7216189N). The outlet is partially obstructed and the end of the NE culvert is broken.

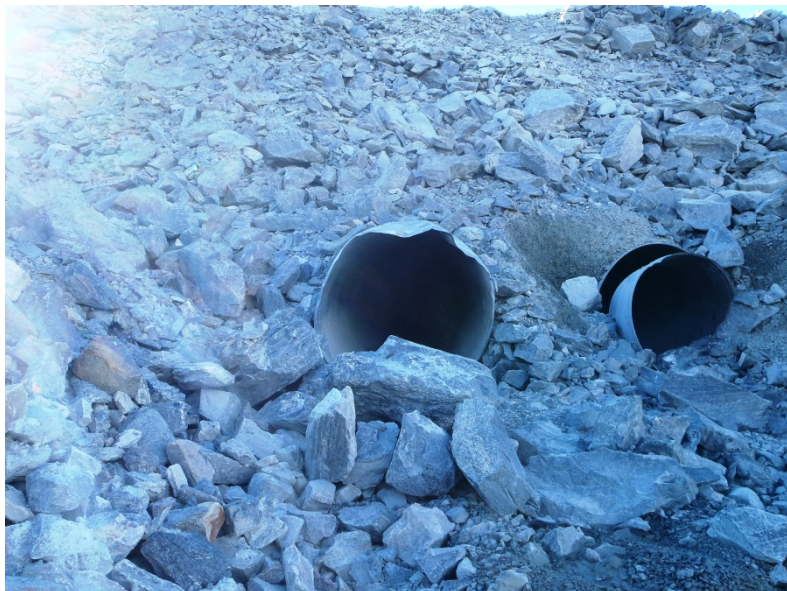
Photo Number: 120

Description: Looking at the outlet of the two culverts for NP2 exit to the environment on Vault Road (near the waste rock pile at 639214E/7216189N). The outlet is partially obstructed with boulders.

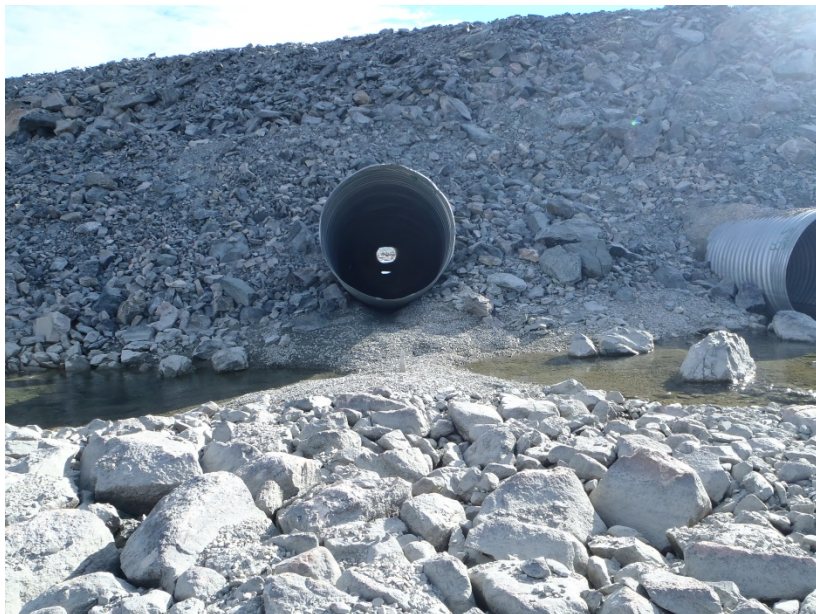
Photo Number: 115

Description: From the inlet side of the three culverts located on Vault Road at 640964E/7217466N. Looking inside the northern culvert. The culvert is slightly deformed on top in the middle.

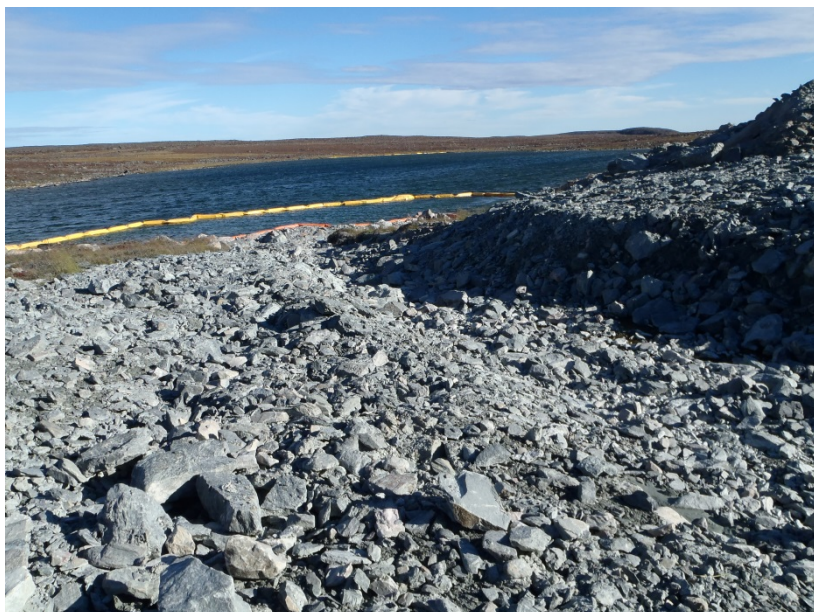
Photo Number: 118

Description: Looking south toward Lake NP1 at the sediment and erosion protection structure.

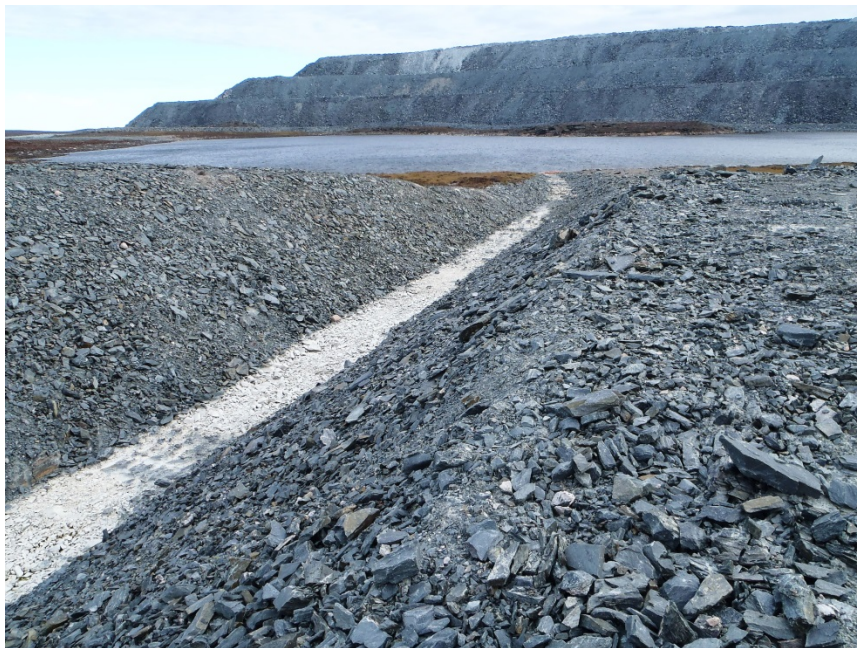
Photo Number: 126

Description: From the northern diversion ditch (638710E/7216493N), looking southeast toward Lake NP2 and the installed sediment barrier.

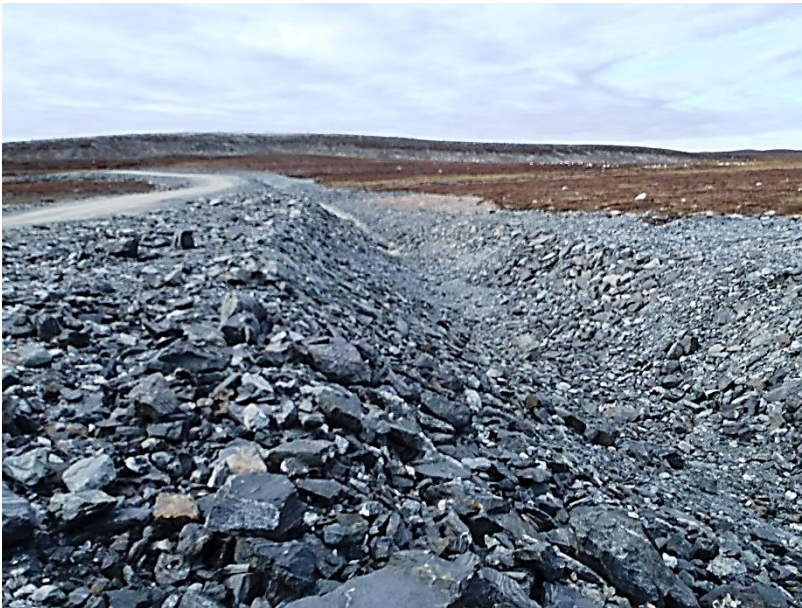
Photograph G2-5 Diversion Ditch and its Sediment and Erosion Protection Structure

Description: From the northern diversion ditch (638709E/7216571N) looking northwest.

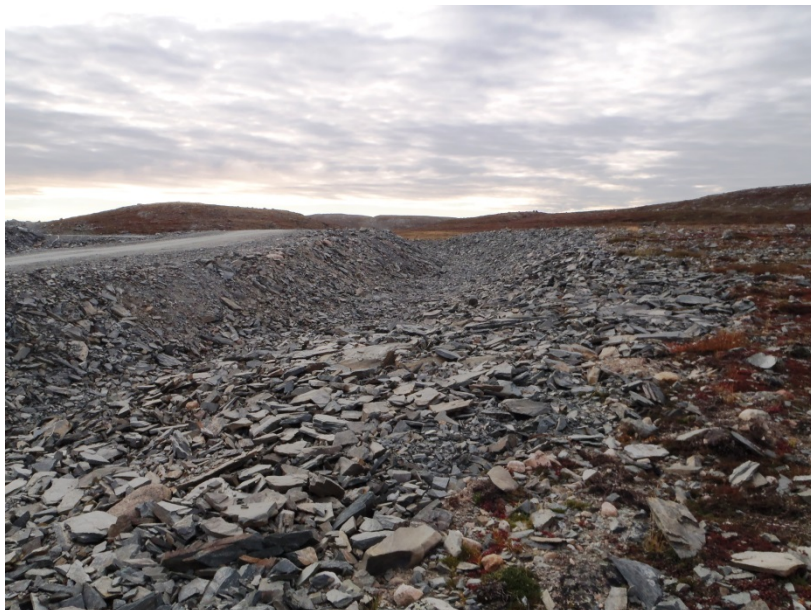
Photograph G2-7 Diversion Ditch and its Sediment and Erosion Protection Structure

Description: From the northern diversion ditch (638396E/7216813N) looking northwest.

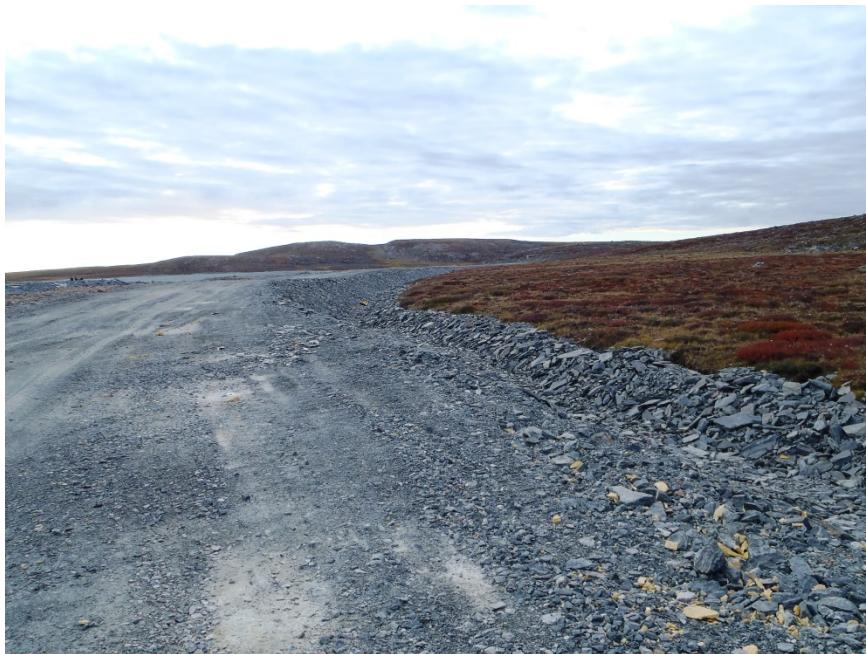
Photograph G2-9 Diversion Ditch and its Sediment and Erosion Protection Structure

Description: From 637919E/7216884N, looking west at the northern diversion ditch.

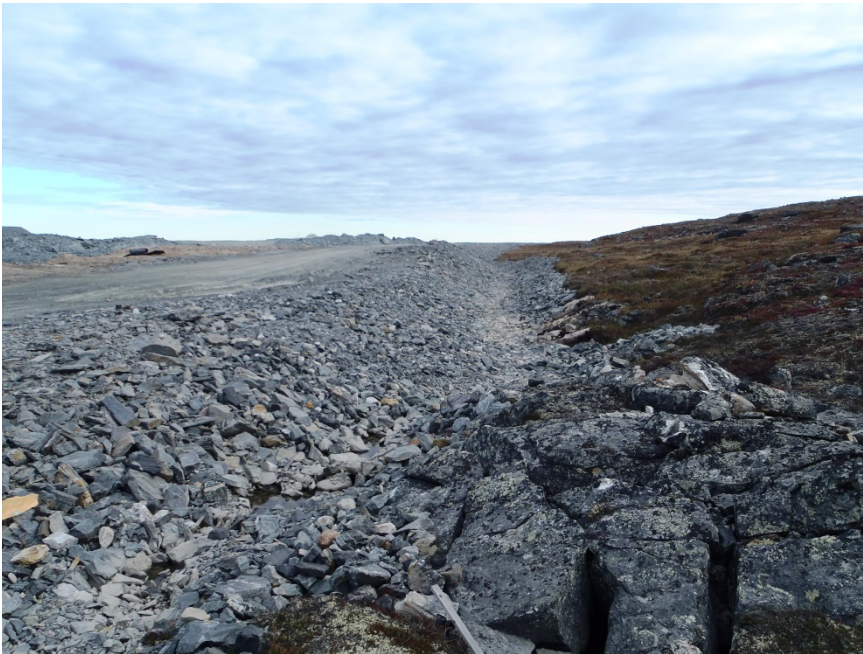
Photograph G2-11 Diversion Ditch and its Sediment and Erosion Protection Structure

Description: From 637281E/7216790N, looking south at the western diversion ditch.

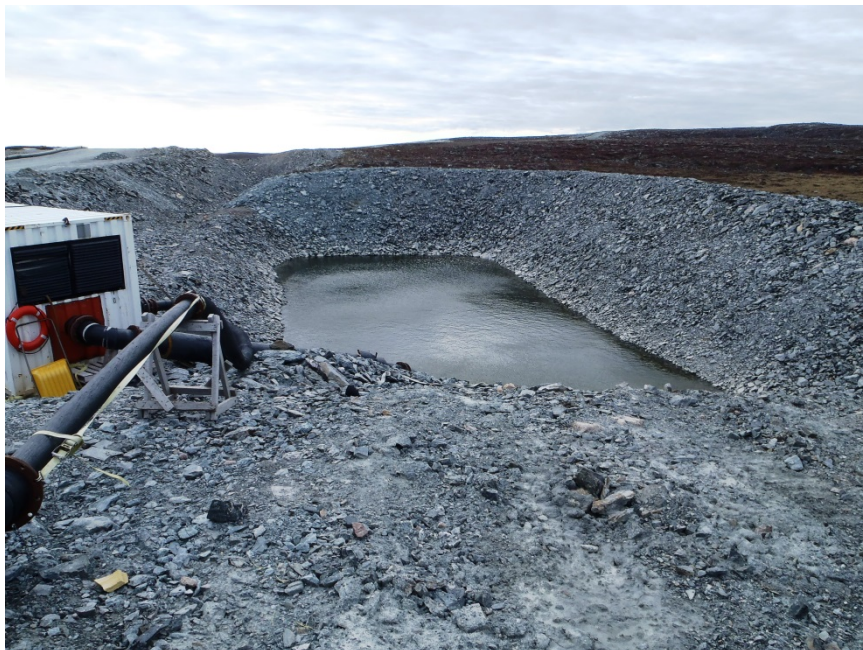
Photograph G2-13 Diversion Ditch and its Sediment and Erosion Protection Structure

Description: From 637251E/7216171N, looking west at the western diversion ditch and its retention basin.

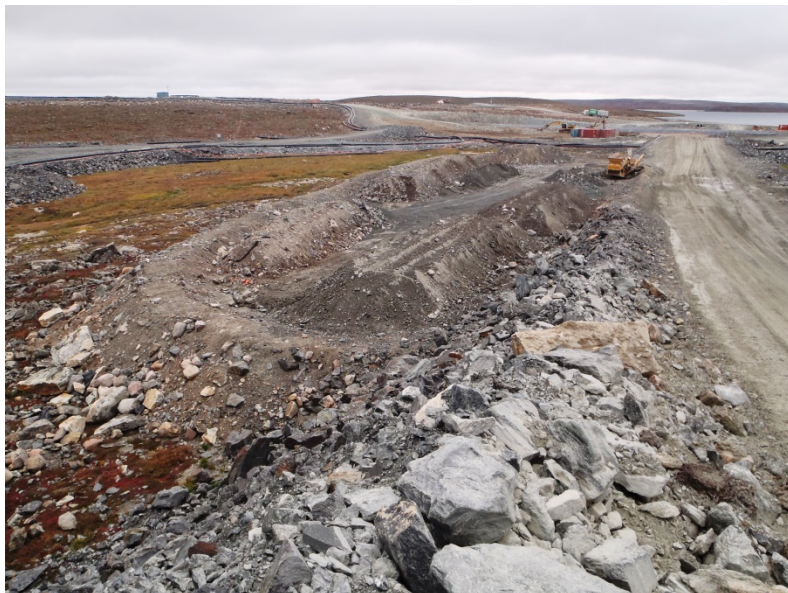
Photograph G5-1 Contaminated Soil Storage and Bioremedial Landfarm Facility

Description: From 637795E/7215278N looking southeast at the Contaminated Soil Storage and Bioremedial Landfarm Facility located within the South Cell of the TSF.

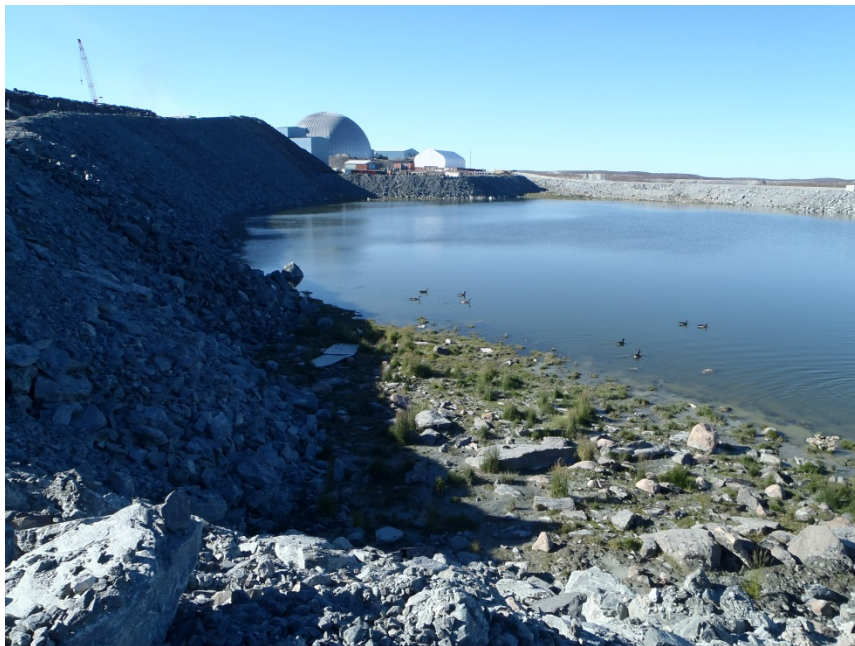
Photograph G6-1 Stormwater Pond

Description: From the base of the crusher access ramp, looking northwest at Stormwater Pond and the crusher access ramp.

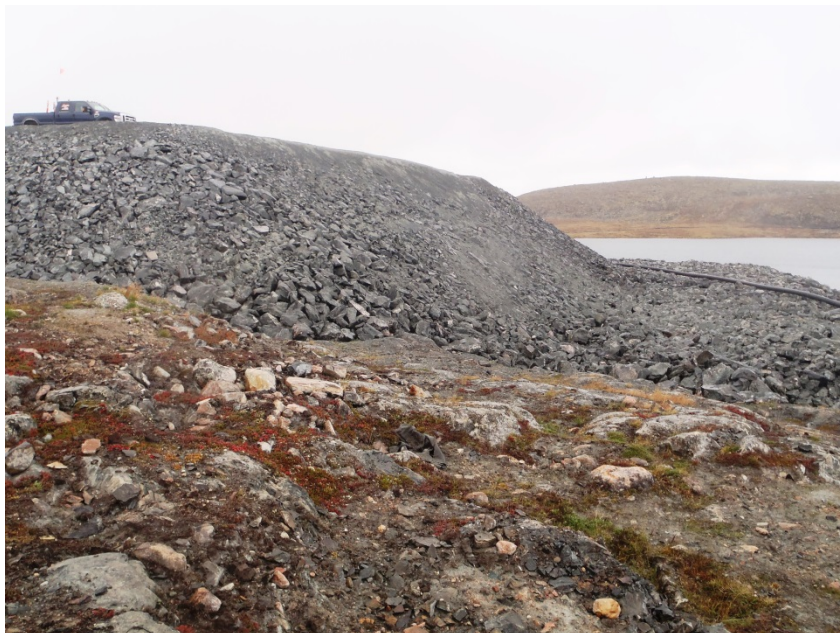
Photograph G7-1 Airstrip

Description: Looking south at the extremity of the airstrip located within Third Portage Lake.
