APPENDIX A

Construction Photographs

1.0 NORTHERN PORTION – 2009 CONSTRUCTION

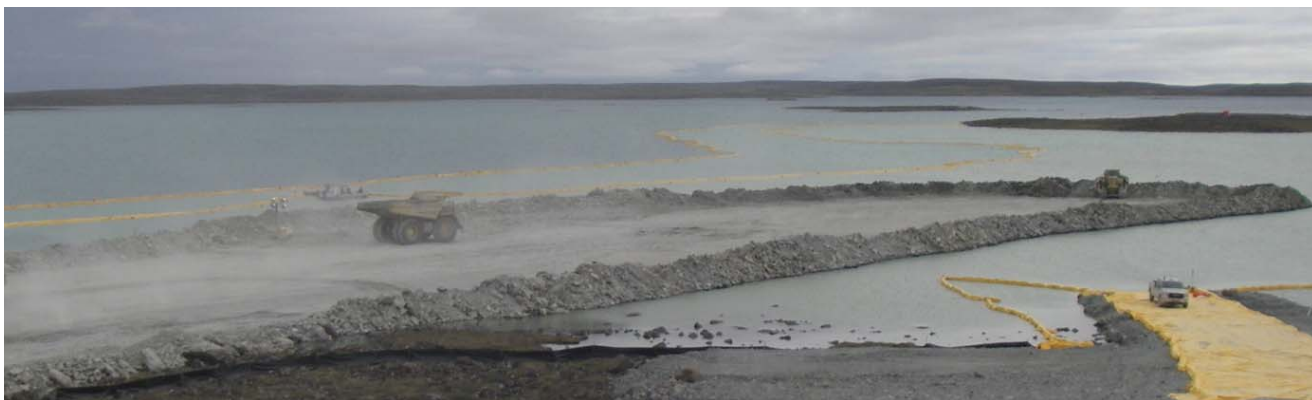
Photograph 1: Turbidity barriers functioning during rockfill placement - August 1, 2009

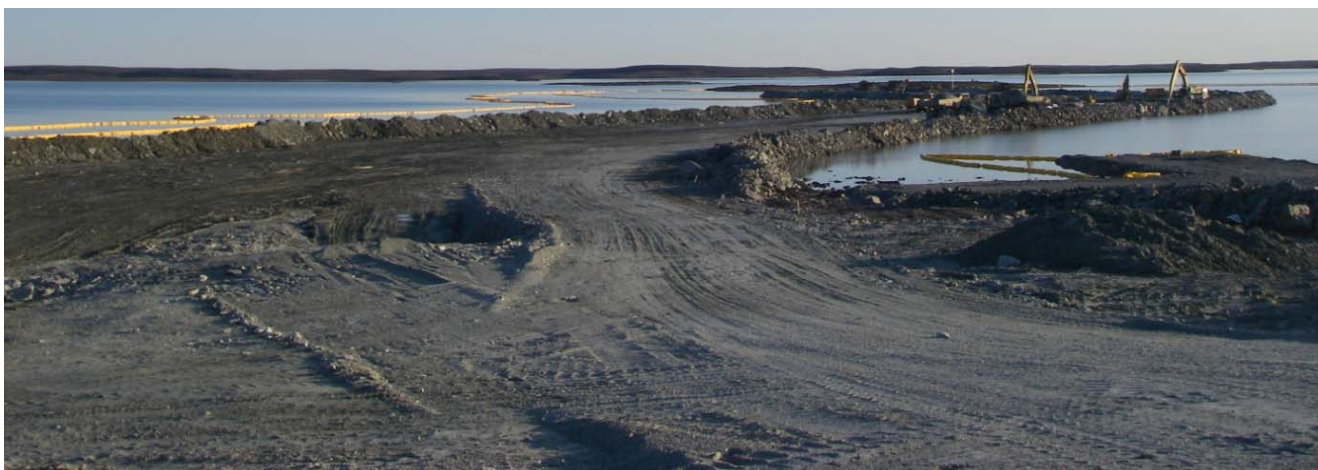
Photograph 5: Advancement of the rockfill platform at approximately Sta. 30+700, looking from the north abutment - August 24, 2009

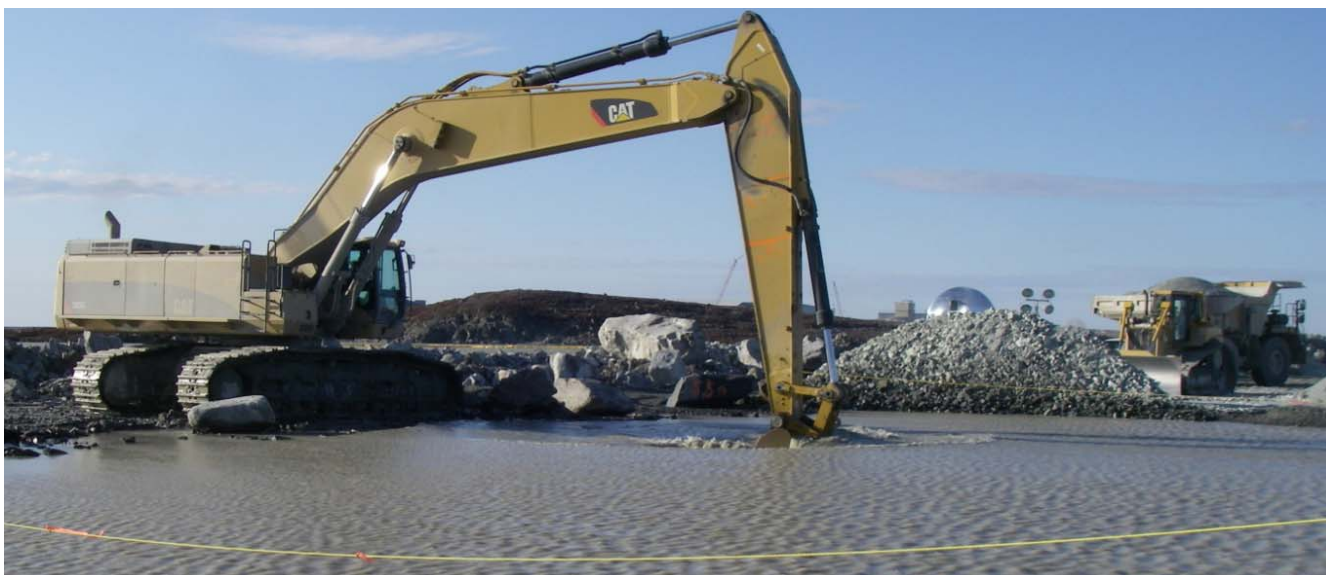
Photograph 20: Placement of Core Backfill on the downstream side of the initial trench excavation up to the level of the lakebed sediments, Sta. 30+550 - September 6, 2009

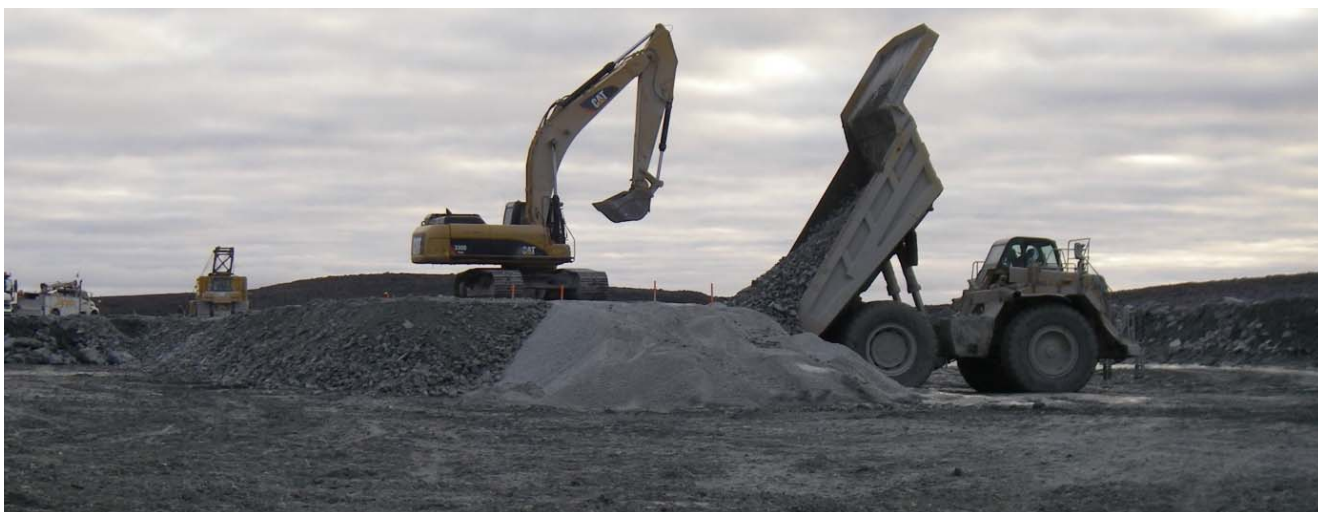
Photograph 23: Placement of the Densification Platform using Core Backfill in the center and Coarse Filter adjacent to the Core Backfill, Sta. 30+380 - September 4, 2009

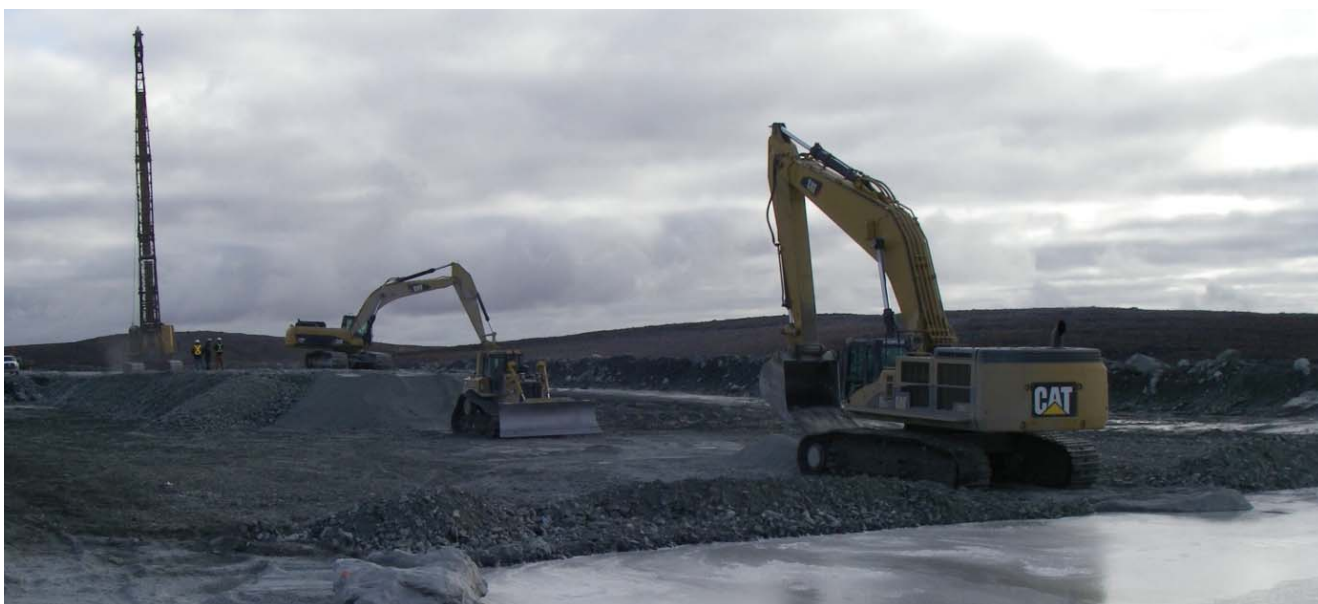
Photograph 24: Dynamic compaction and construction of the densification platform in the background and placement of Core Backfill and Coarse Filter within the initial trench excavation in the foreground, looking north from Sta. 30+450 - September 4, 2009

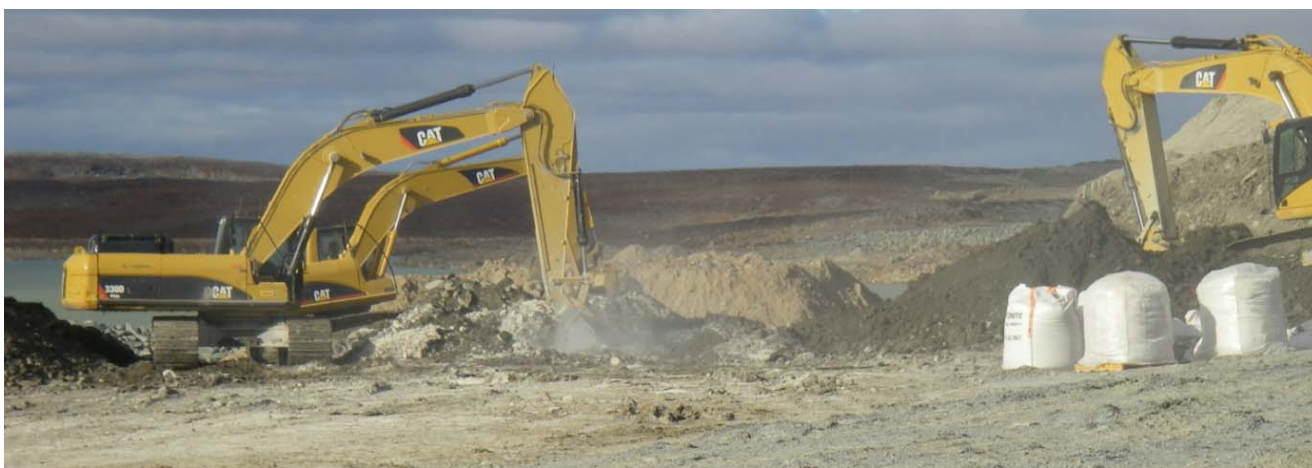
Photograph 26: Till screening to remove oversized particles and mixing of the till with dry bentonite powder - September 10, 2009

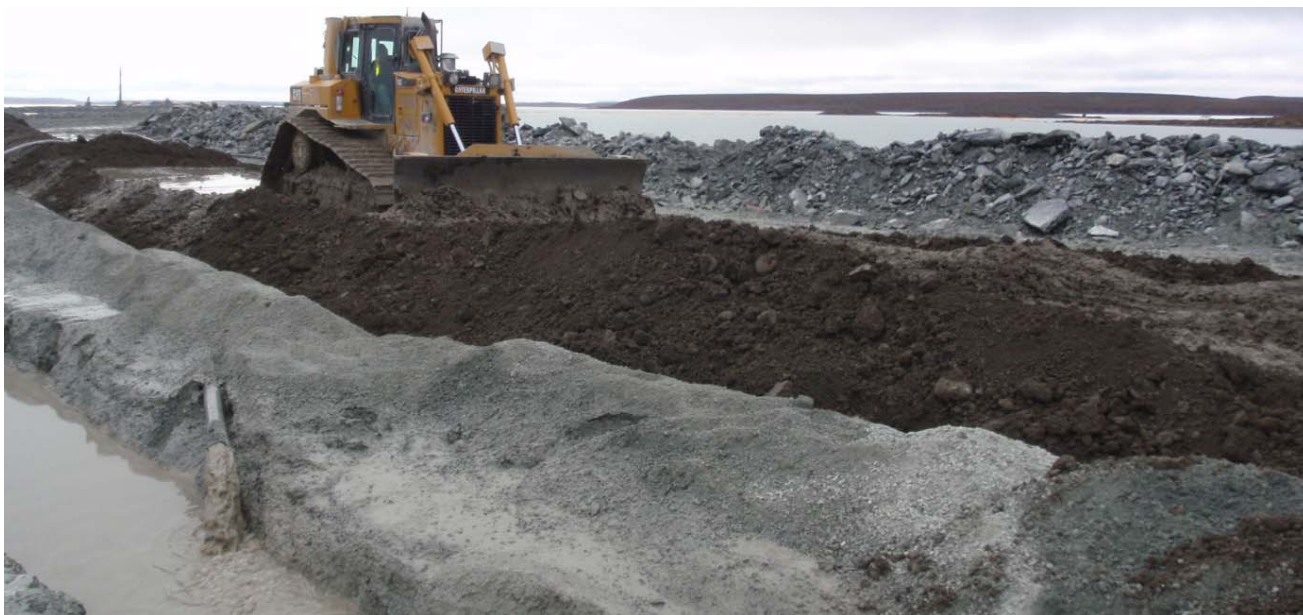
Photograph 28: The dry till and bentonite mixed with the bentonite slurry by a dozer to form the soil bentonite mix, Sta. 30+075 - September 12, 2009

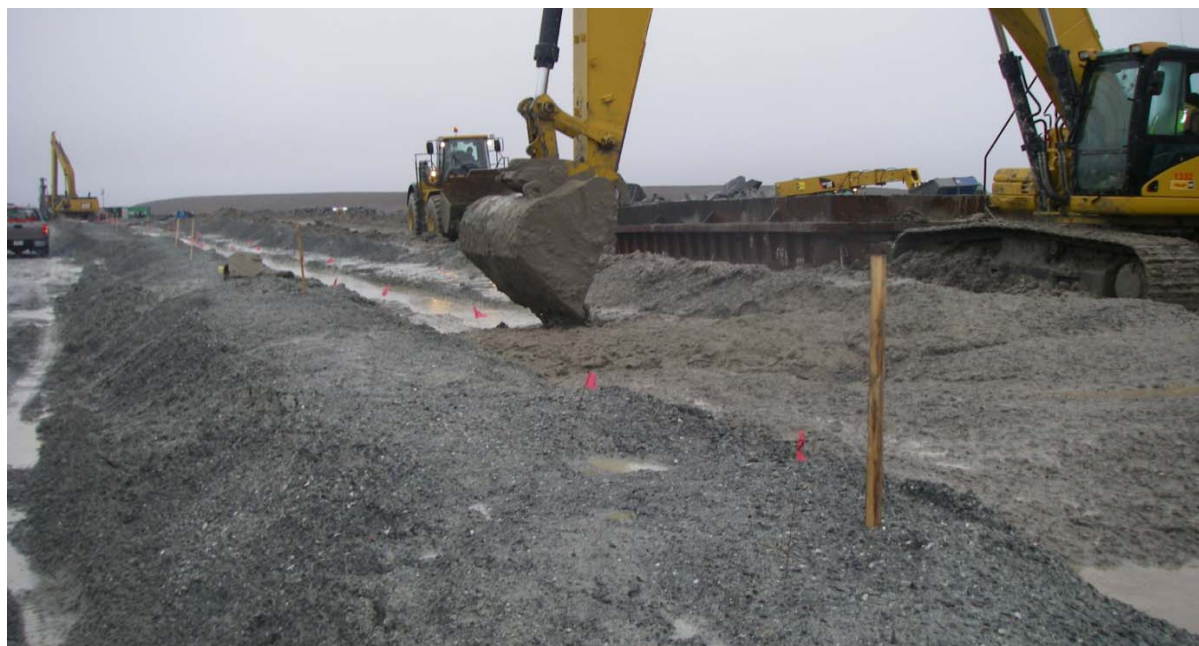
Photograph 31: Placement of cement soil bentonite mix within the cutoff trench. The cement soil bentonite (CSB) mixed on site within the box visible in front of the excavator - September 18, 2009

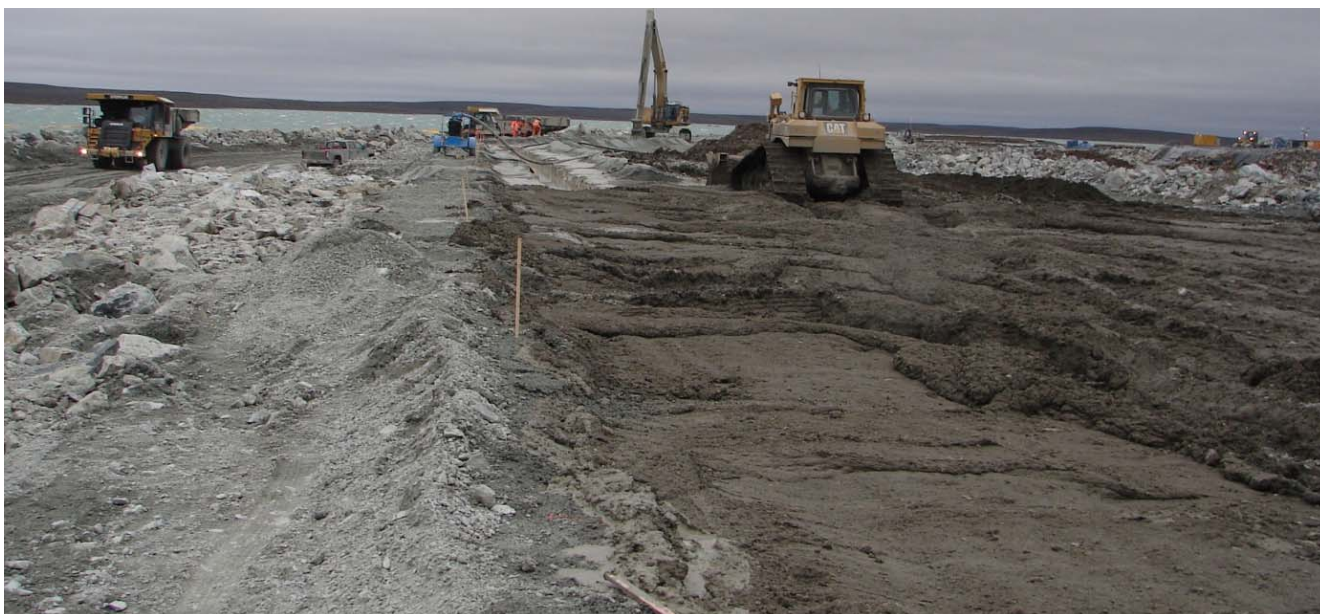
Photograph 34: Soil bentonite placed within the cutoff trench by a dozer, Sta. 30+628 to 670 - September 24, 2009

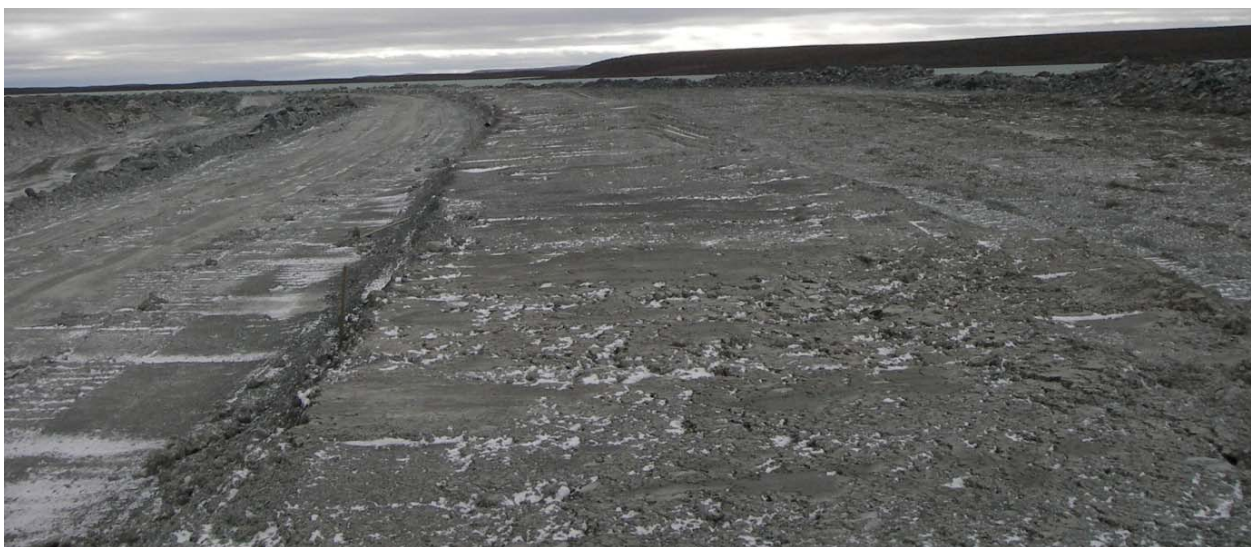
Photograph 36: Completed surface of cutoff trench - September 27, 2009

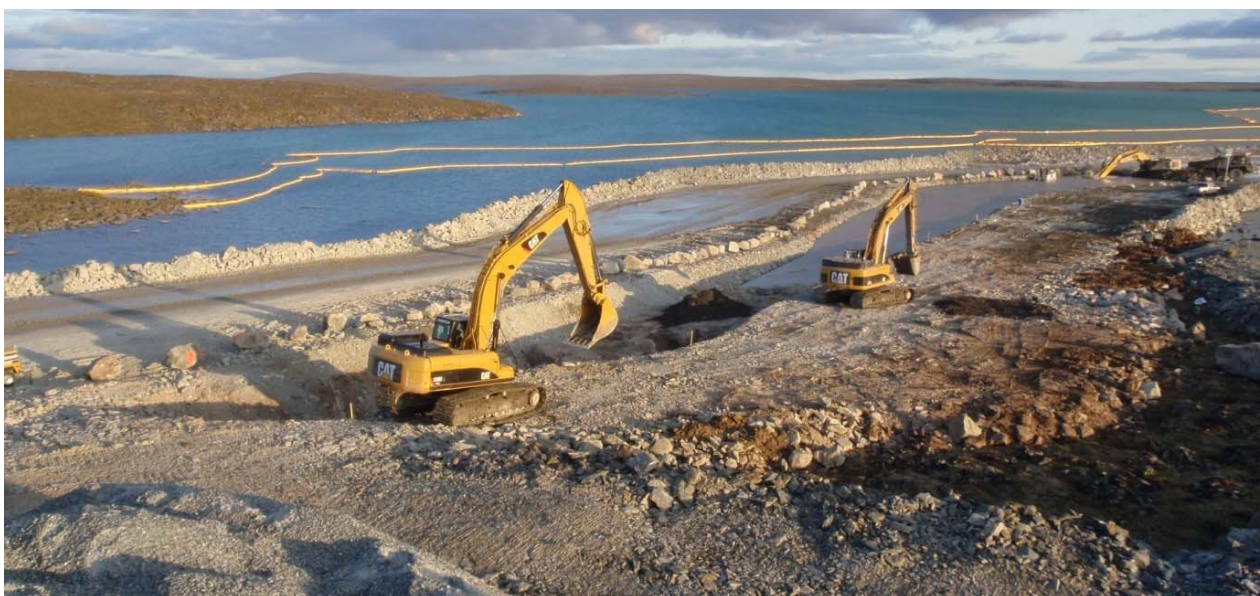
Photograph 38: Abutment excavation and initial trench excavation up to Sta. 30+190 - August 13, 2009

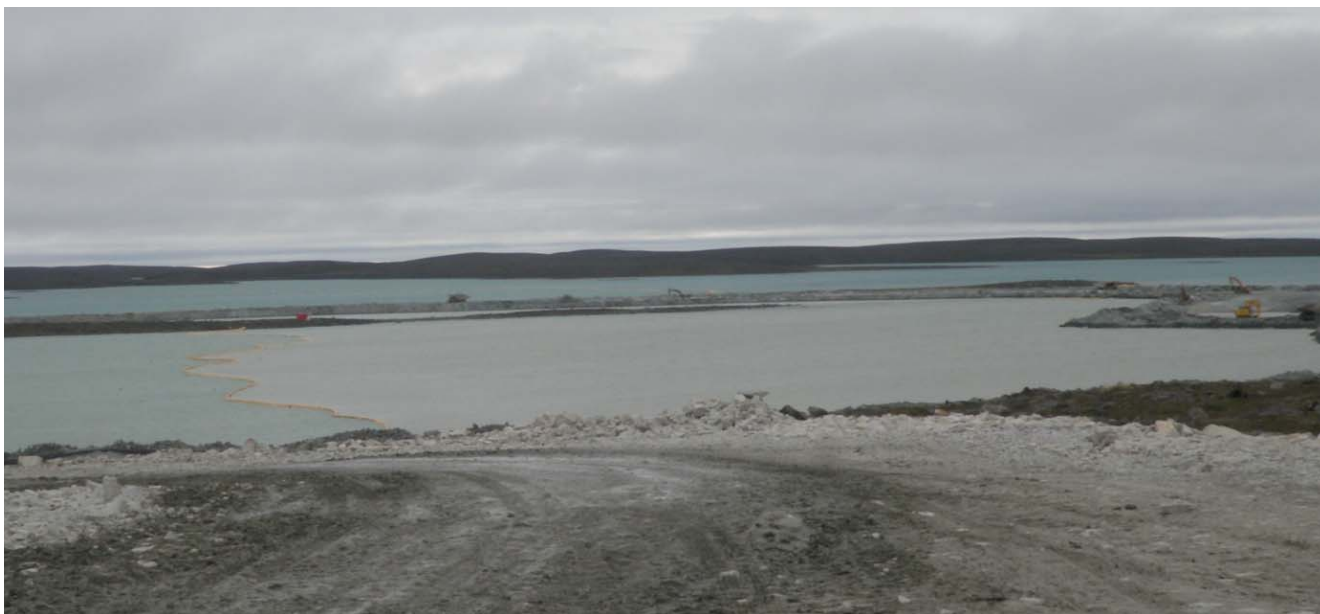
Photograph 46: Turbidity barriers on downstream side of dike, looking east from South Camp Island - August 13, 2010

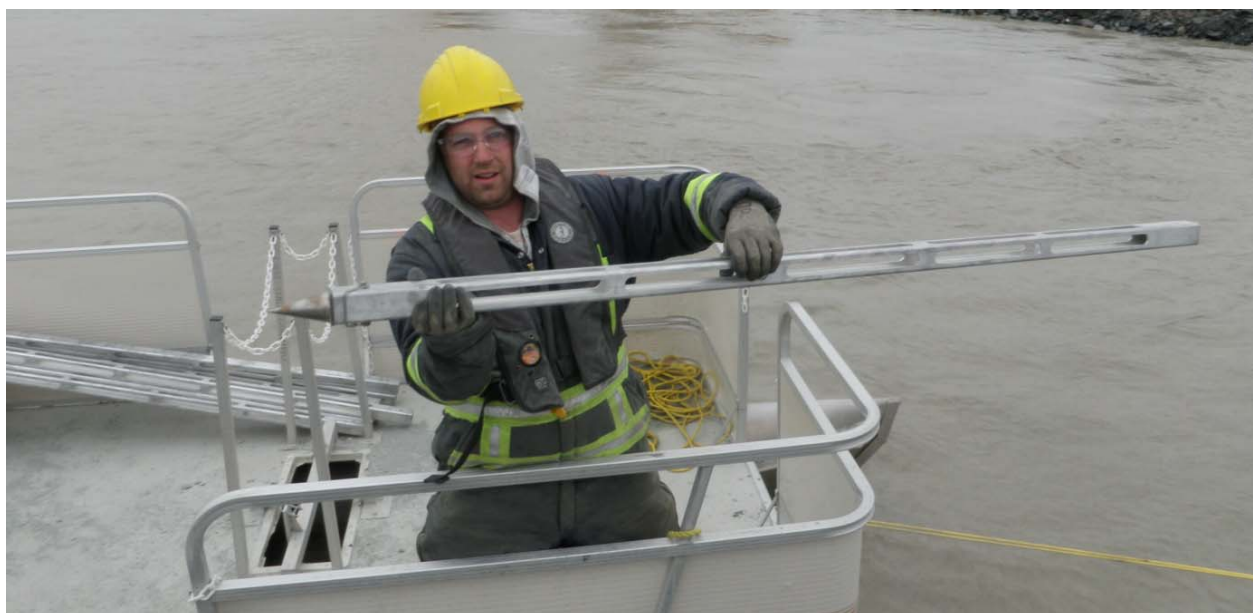
Photograph 59: Sample showing one of the rods used to survey base of initial trench excavation – August 16, 2010

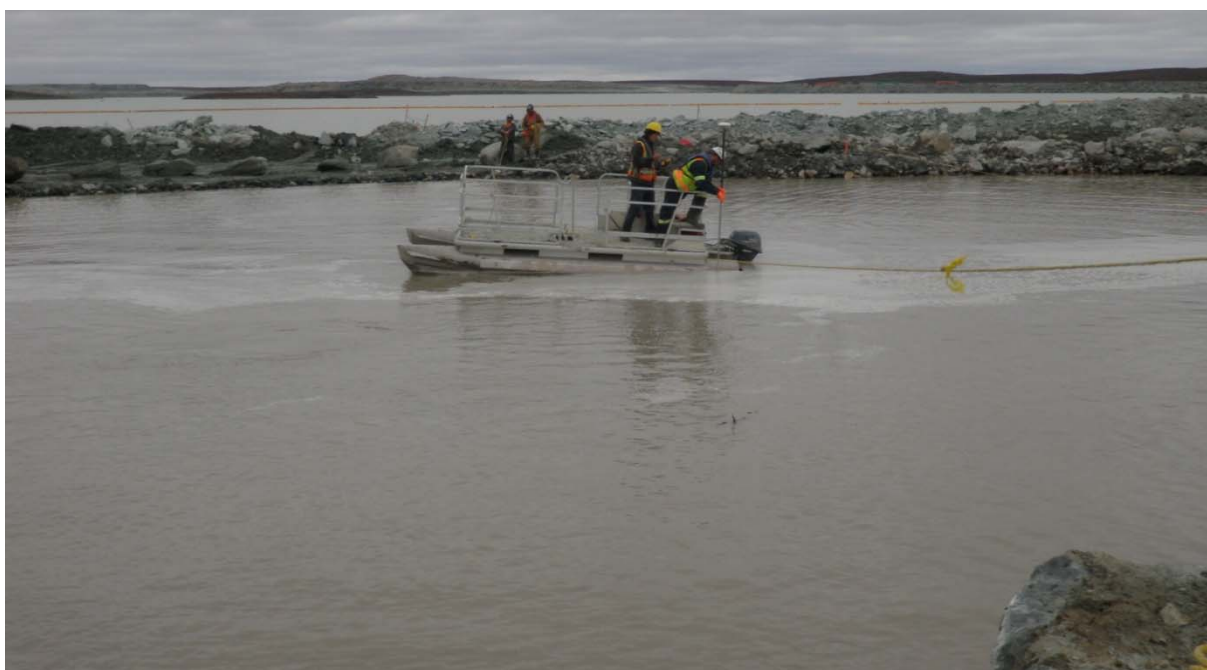
Photograph 61: Manual sounding of trench excavation, Sta. 32+050 - September 11, 2010

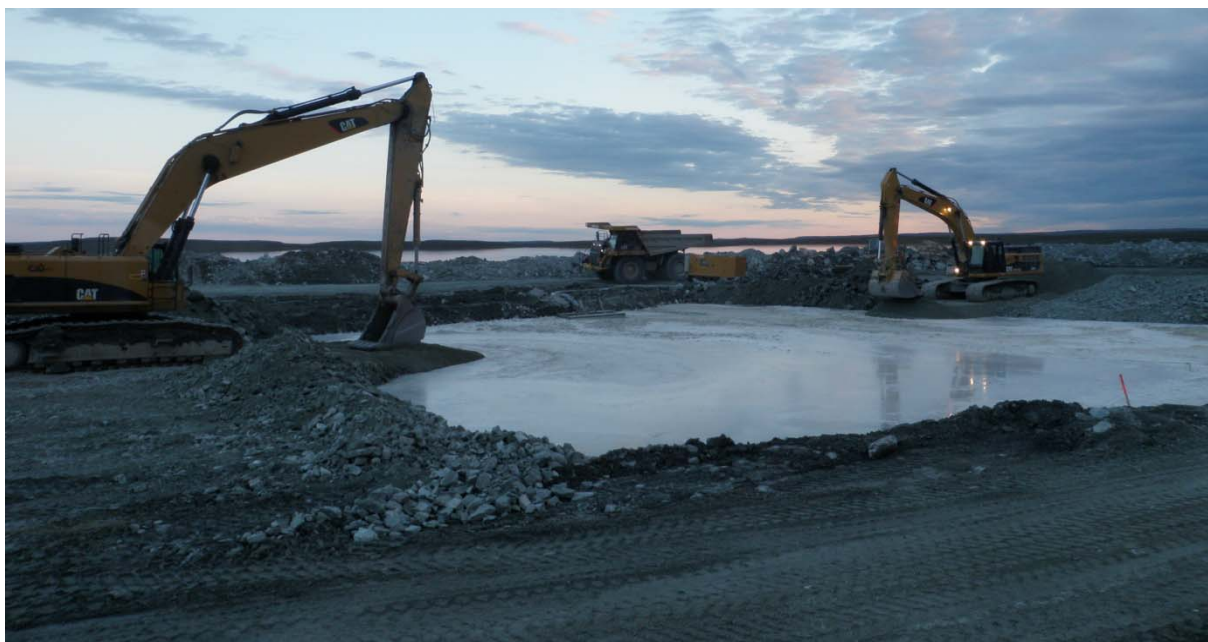
Photograph 66: Core backfill placement at Sta. 31+565 and 31+605 to connect work fronts 1 and 2 - August 12, 2010

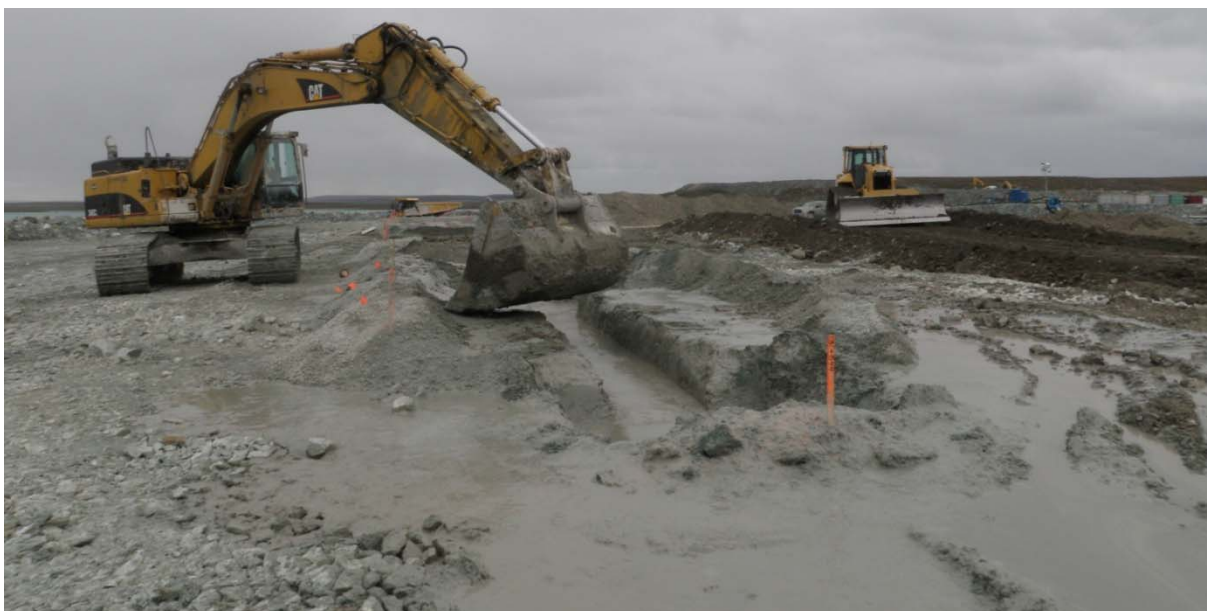
Photograph 79: CSB plug between Sta. 31+552 and 31+570. Dozer spreading till mixed with dry bentonite for SB preparation - August 25, 2010

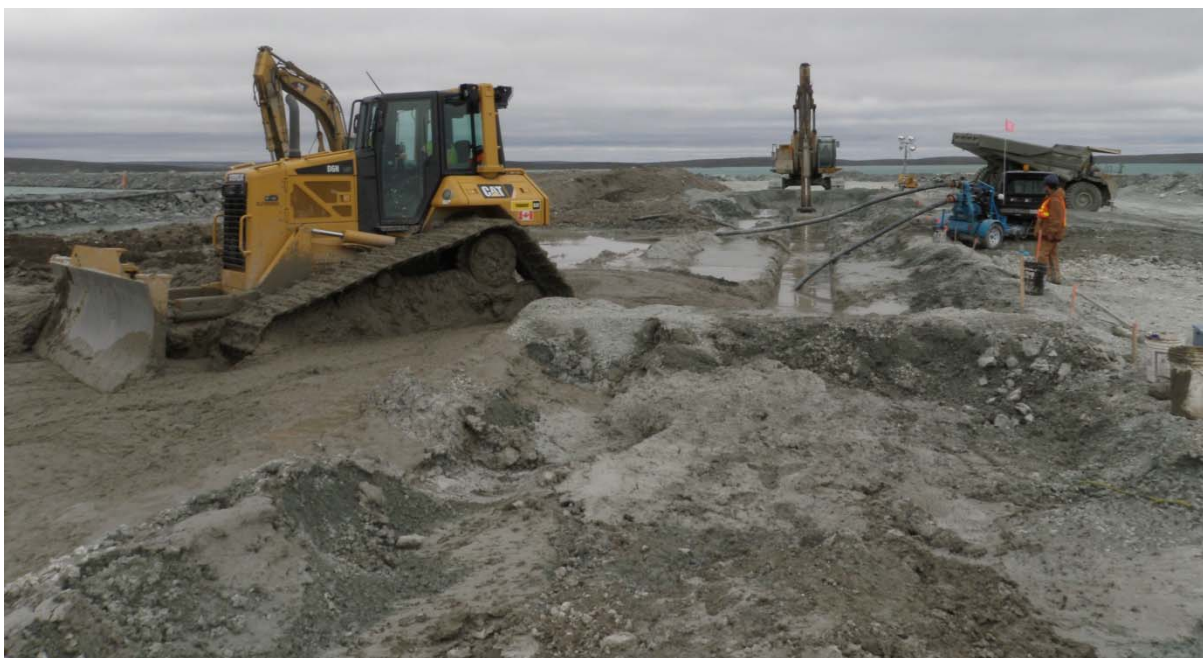
Photograph 80: SB placement into cutoff wall with dozer - August 26, 2010

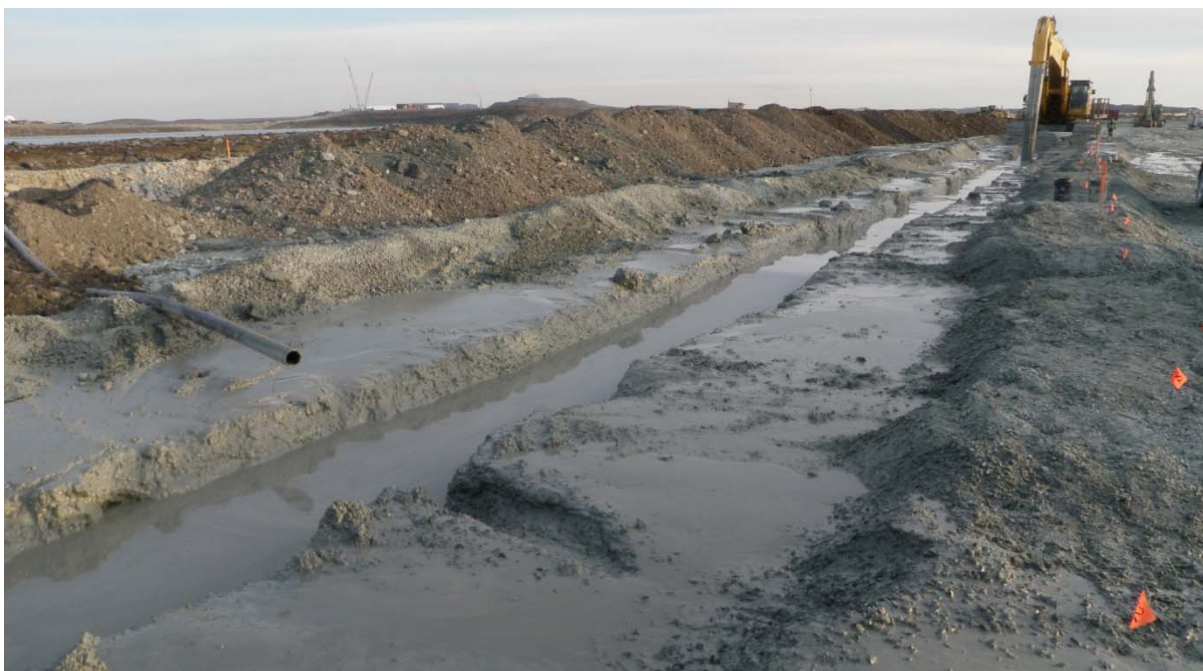
Photograph 82: Excavation of the cutoff trench at Sta. 31+091 and erosion of cutoff wall crest due to slurry placement – September 1, 2010

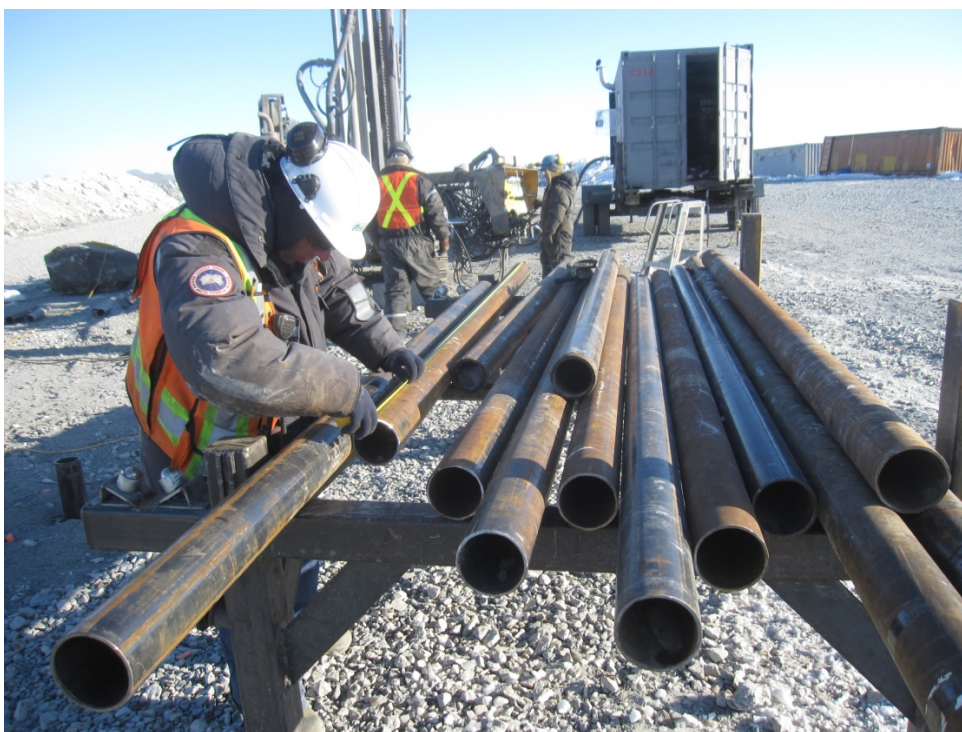
Photograph 100: QA measurement of installed casing lengths - May 2010

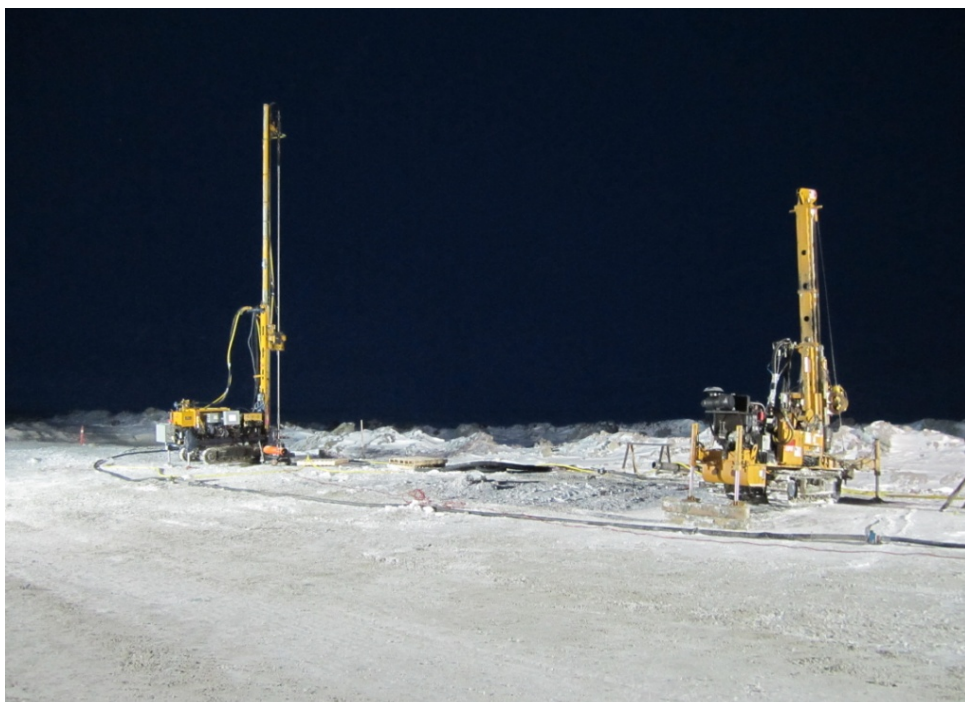
Photograph 110: Jet grouting early stages with two rig operation / pre-drilling - November 5, 2010

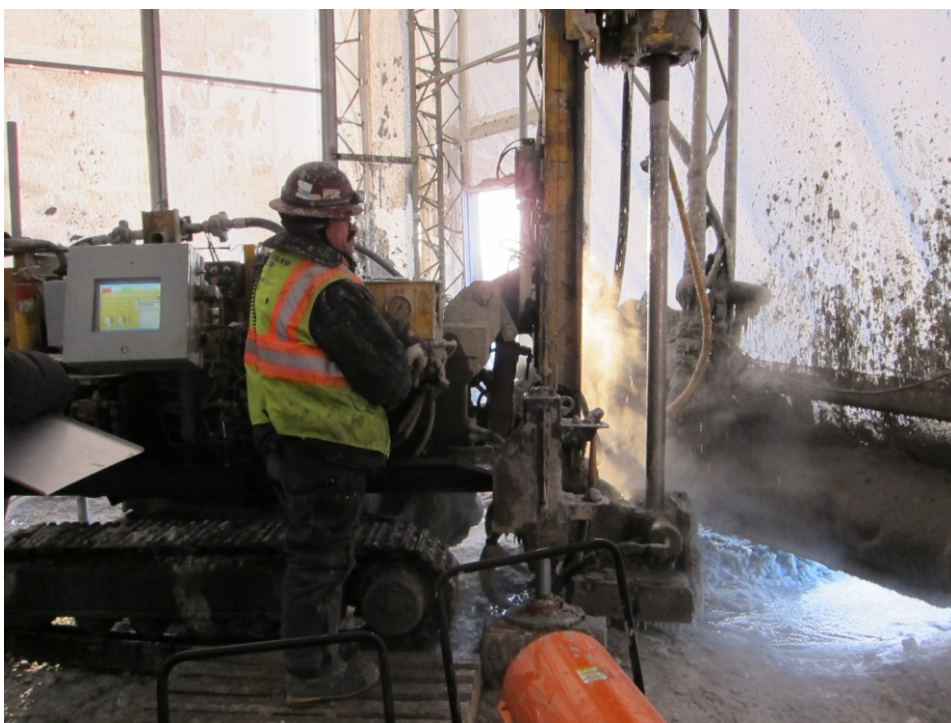
Photograph 111: Jet grouting single rig operation within coverall tent - November 20, 2010
