2018 Annual Geotechnical Inspection

Meliadine Gold Project, Rankin Inlet, Nunavut

Golder Associates Ltd.

Reference No. 18105719-002-R-Rev0-3000

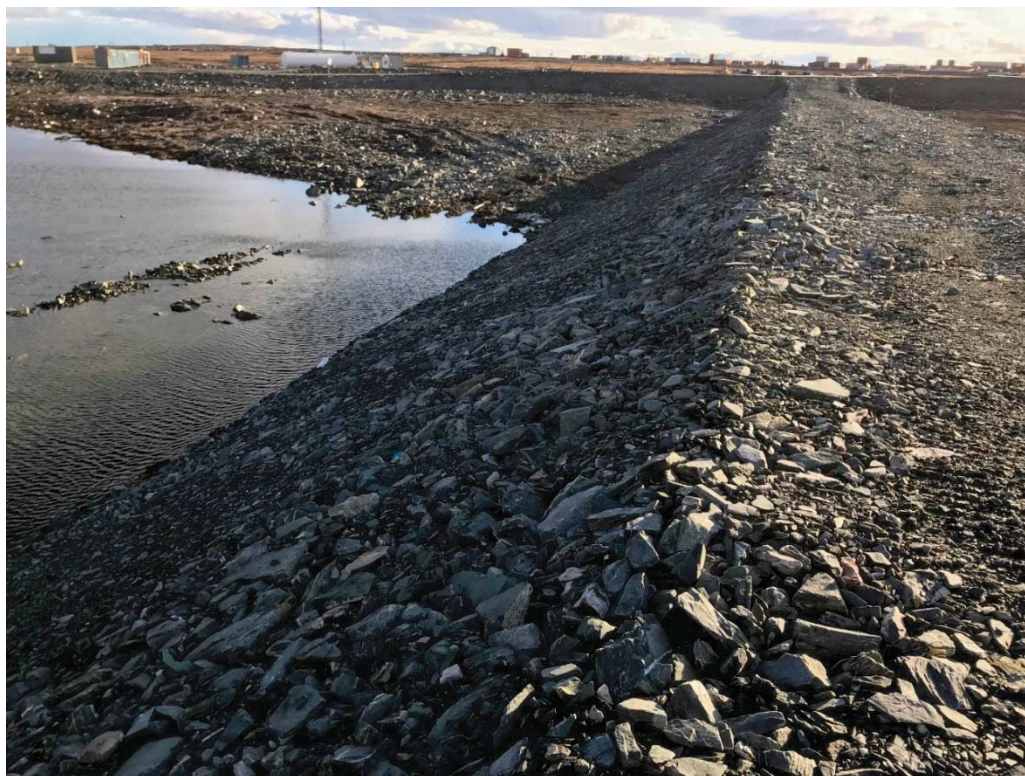
Photograph 5: DP1-A, South Slope, Looking Southwest (12 September 2018)

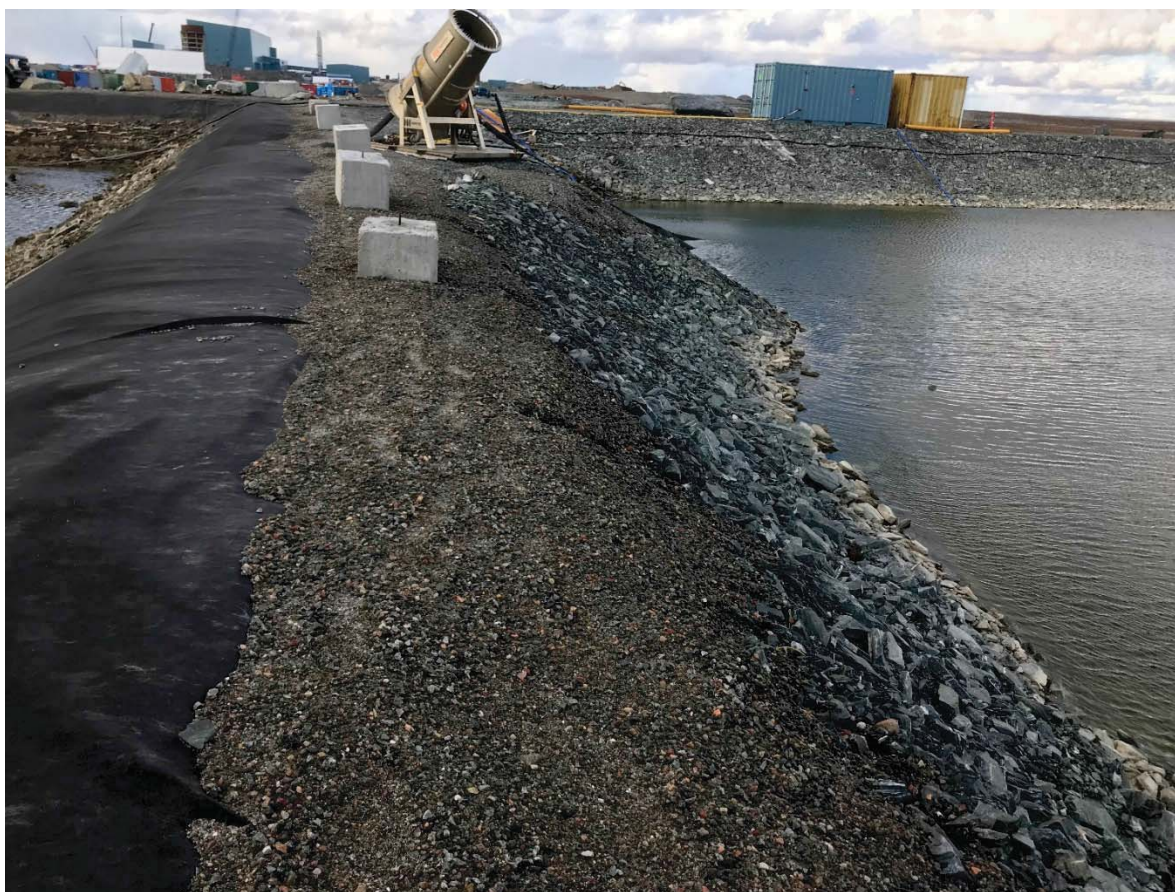
Photograph 8: Snow Melt Management Pond, East Berm Downstream Slope, Looking North (12 September 2018)

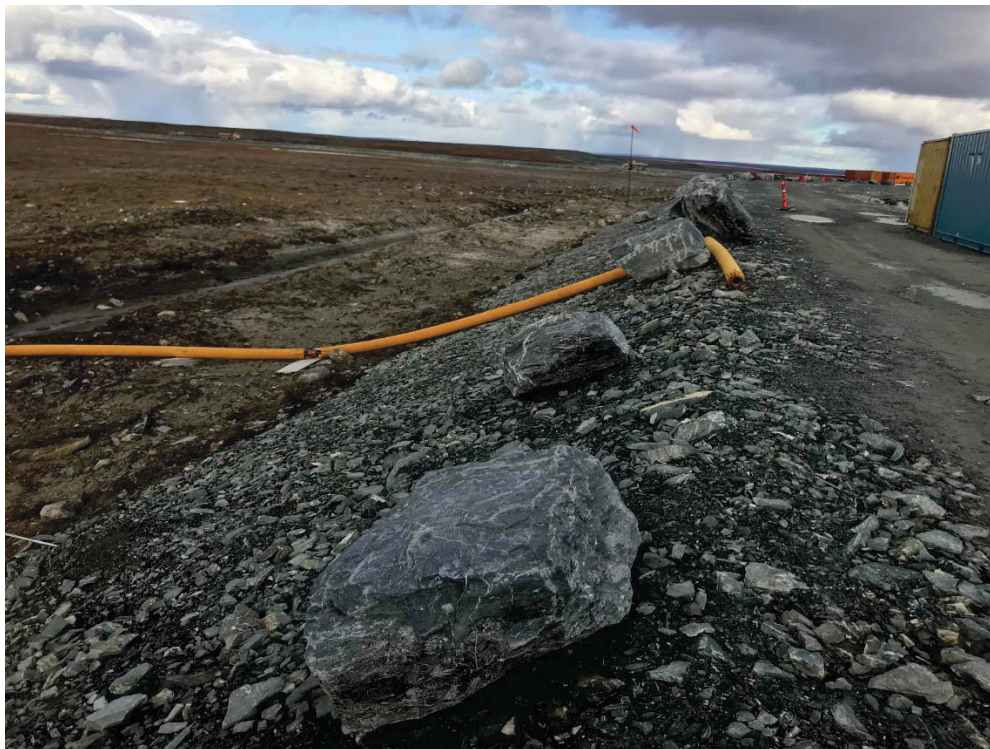
Photograph 11: DP1-B, Downstream Slope, Looking East. Orange Delineator on Crest Marks Thermistor Location (12 September 2018)

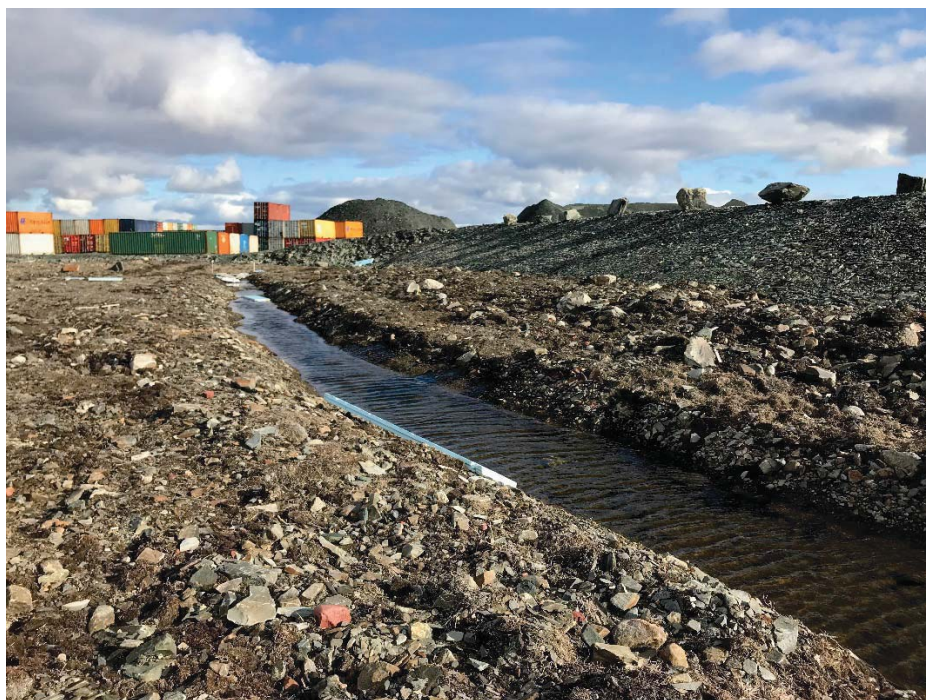
- The P1 divider berm appears to have been constructed of till with some rockfill on the downstream slope, as shown in Photograph 22 (Appendix A1).
- Water was ponded in the seepage collection channels and sumps constructed downstream of DP1-B and DP3-A and water was being actively pumped back into the ponds from the downstream collection systems at the time of the site visit. Water in the collection channels was clear. Seepage from DP1-B was slightly less than in 2017 and the water level in the seepage collection channel was also slightly lower. The ground between the downstream dike toes and the seepage collection channels was saturated at DP1-B and DP3-A and water was ponded along the toe, over the tundra at DP3-A which was more substantial than in 2017 (e.g., Photographs 13 through 16 and Photographs 30, 35, and 36, Appendix A1). Due to the ponded water and saturated tundra, it was not possible to walk directly along the toes of DP1-B and DP3-A.

Photograph 14: DP1-B, Run-off and Seepage Collection Channel Downstream of Dike, Looking East. Seepage in Channel was Clear and at a Similar Level to 2017 (12 September 2018)

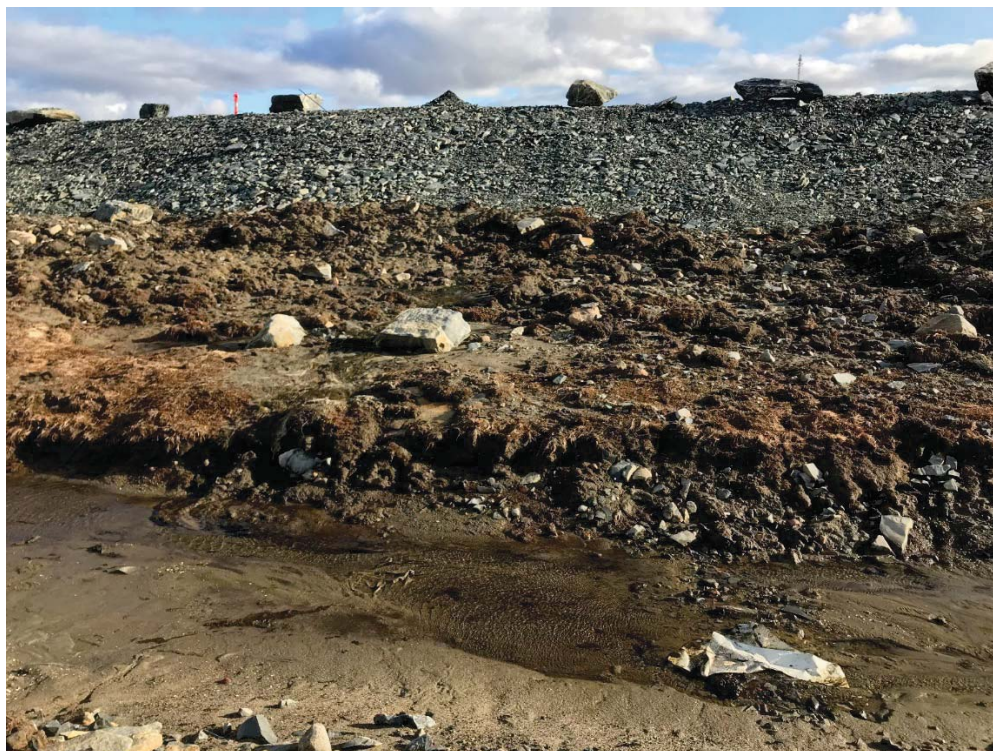
Photograph 15: DP1-B, Clear Seepage Visible from Dike Toe near Station 0+190. Less Seepage at This Location than in 2017 (12 September 2018)

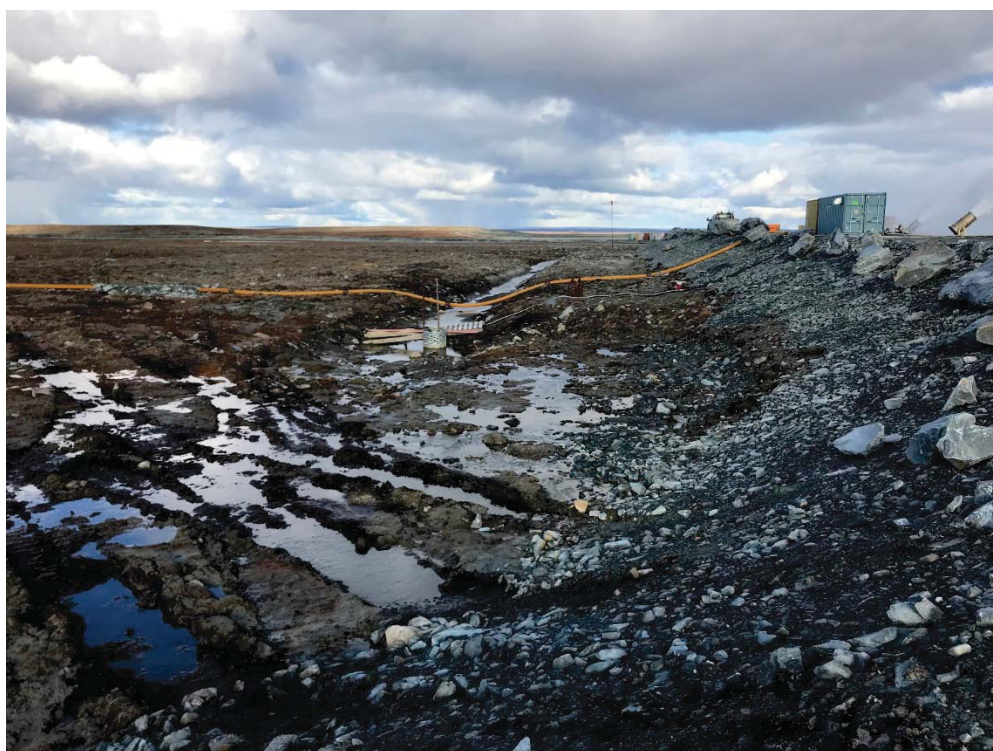
Photograph 16: DP1-B, Downstream Channel and Sump near Station 0+120, Looking East. Slightly Lower Water Level at Sump Location than in 2017 (12 September 2018)

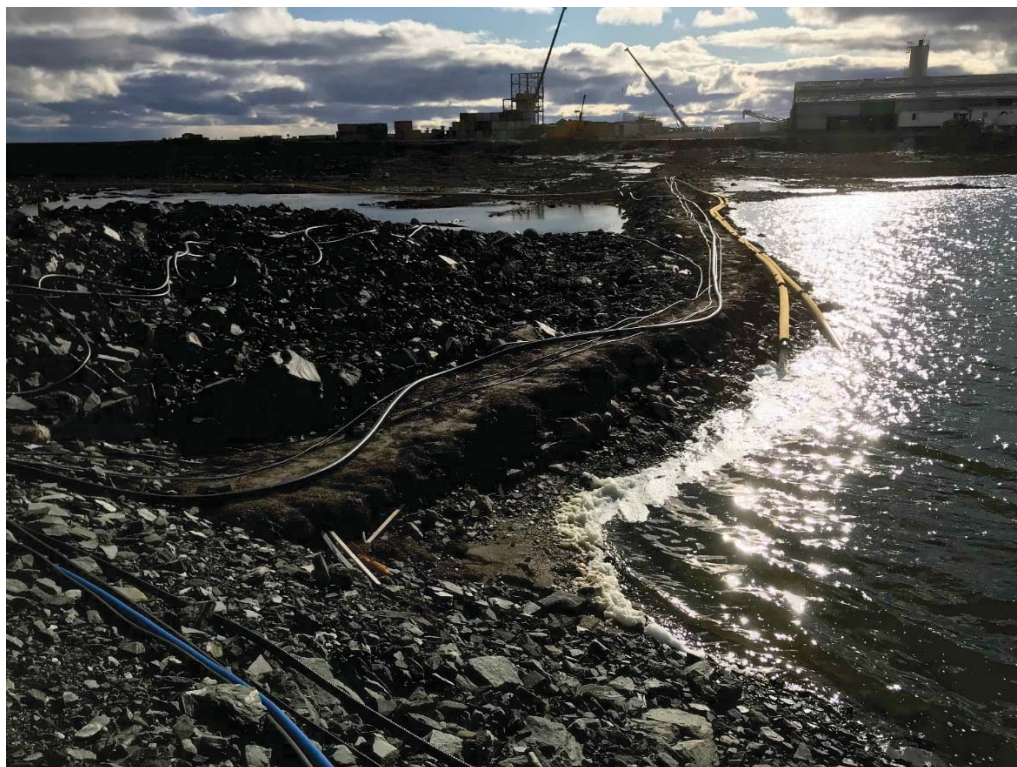
Photograph 22: P1 Till Dividing Berm, Looking West (12 September 2018)

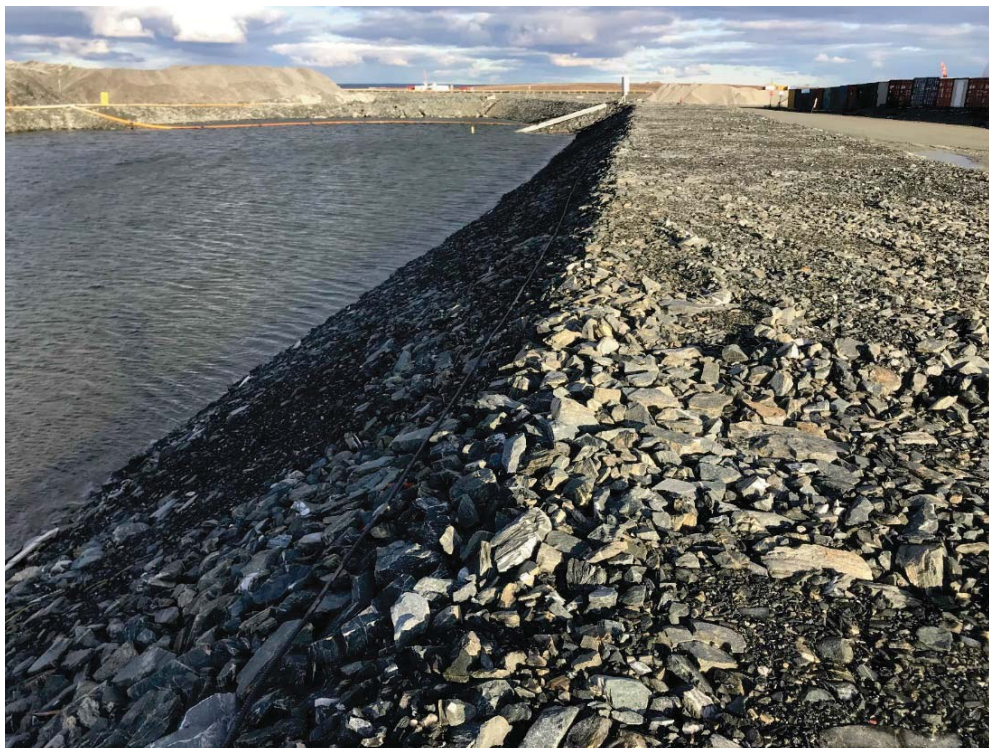
- As noted in previous annual inspection reports (Golder 2017 and 2018), the rockfill used as thermal cover above the core and on the upstream and downstream slopes of the dikes was of variable grain size, particularly for DP2-A and DP3-A (e.g., Photograph 24 and Photograph 36 Appendix A1). Finer rockfill was observed on the crest of DP3-A (e.g., Photographs 32 and 34, Appendix A1). The crest of DCP1-B was also observed to have a cap of finer material which may have been placed or may be due to traffic on the dike crest.

Photograph 24: DP2-A, Upstream Slope near Station 0+025, Looking East (12 September 2018)

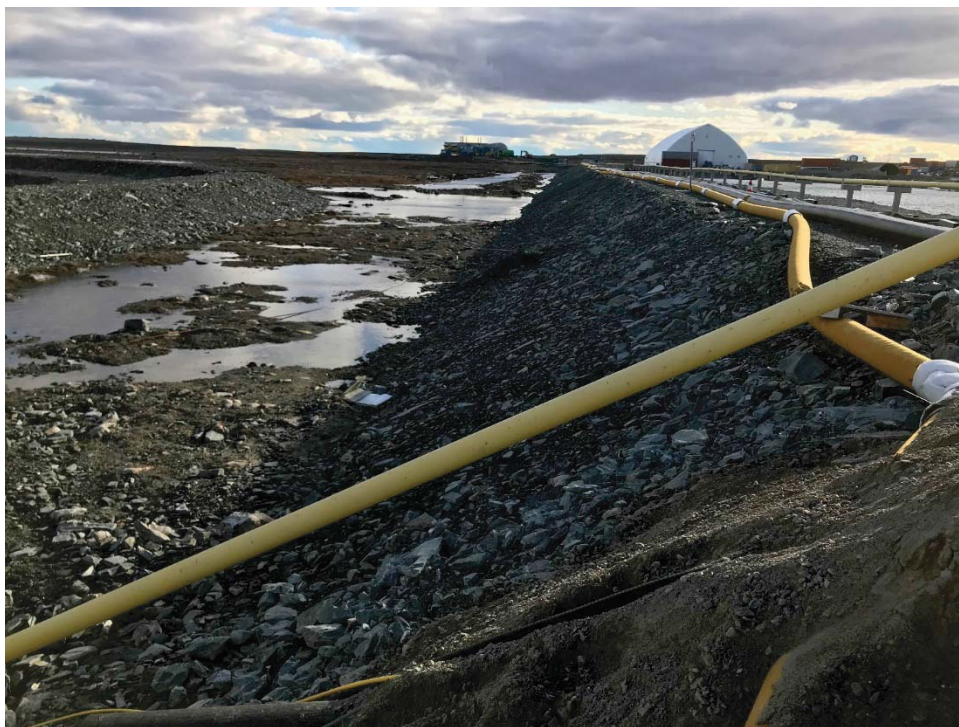
Photograph 30: DP3-A, Downstream Slope and Seepage Collection Channel, Looking Southwest near Station 0+300. More Water Pooled Downstream than in 2017 (12 September 2018)

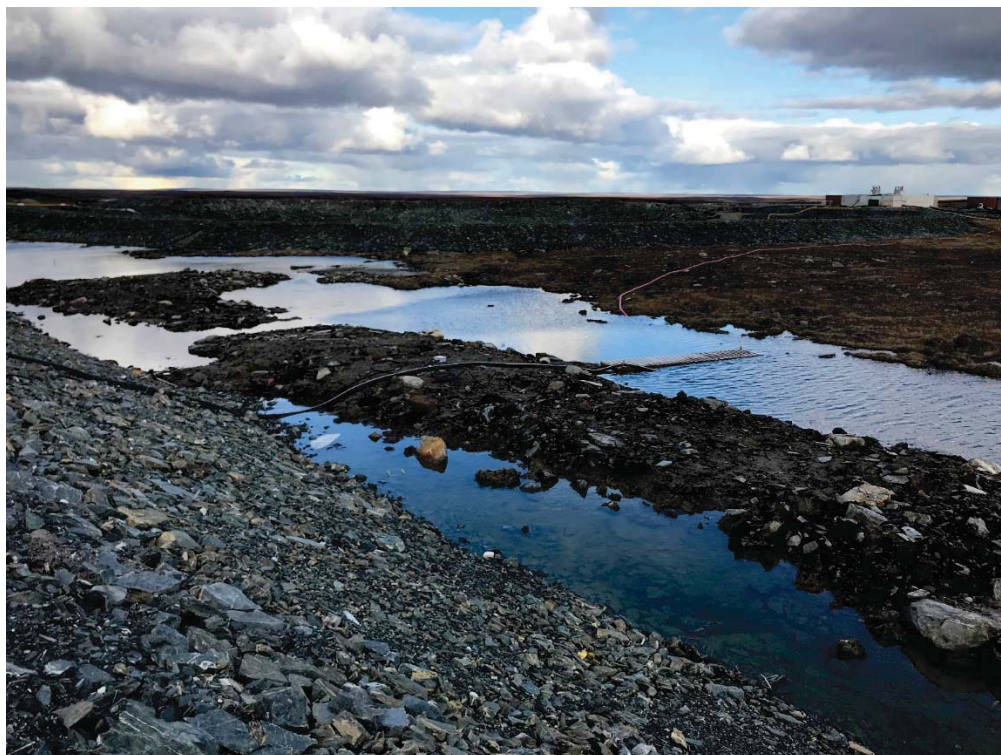
Photograph 35: View Northeast of the Saline Pond from near Station 0+150 of DP3-A. Clear Seepage Water Poned in Downstream Collection Channel and Along Dike Toe. More Poned Water than in 2017 (12 September 2018)

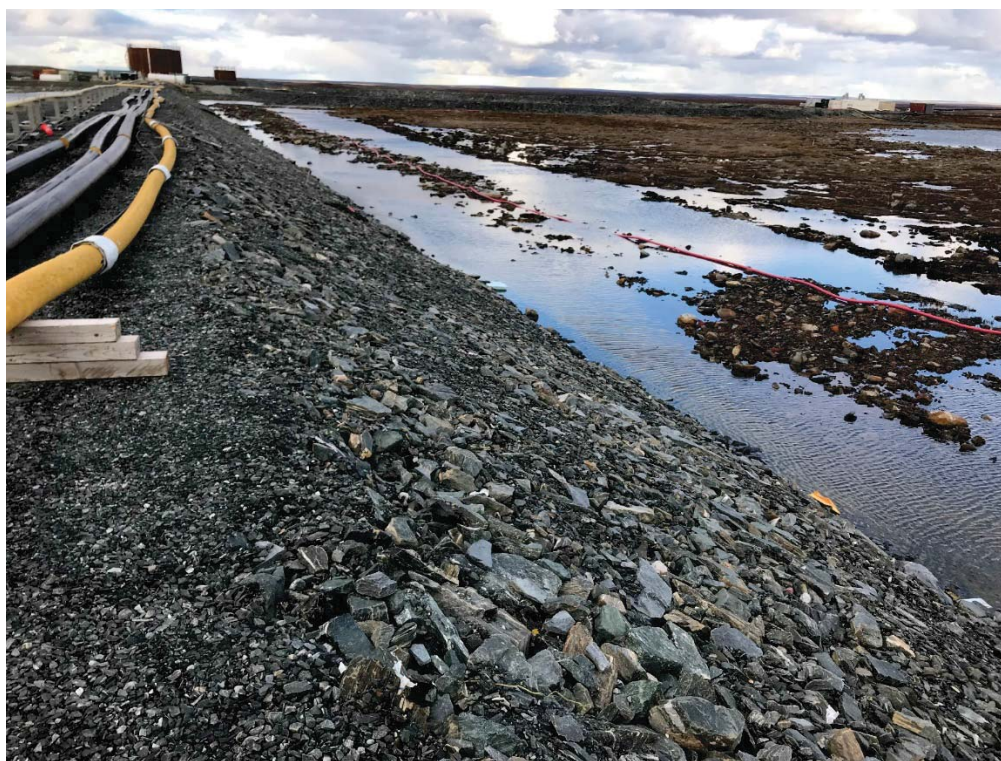
Photograph 36: DP3-A Downstream Slope and Seepage Collection Channel, looking Northeast near Station 0+40. More Poned Water Downstream than in 2017 (12 September 2018)

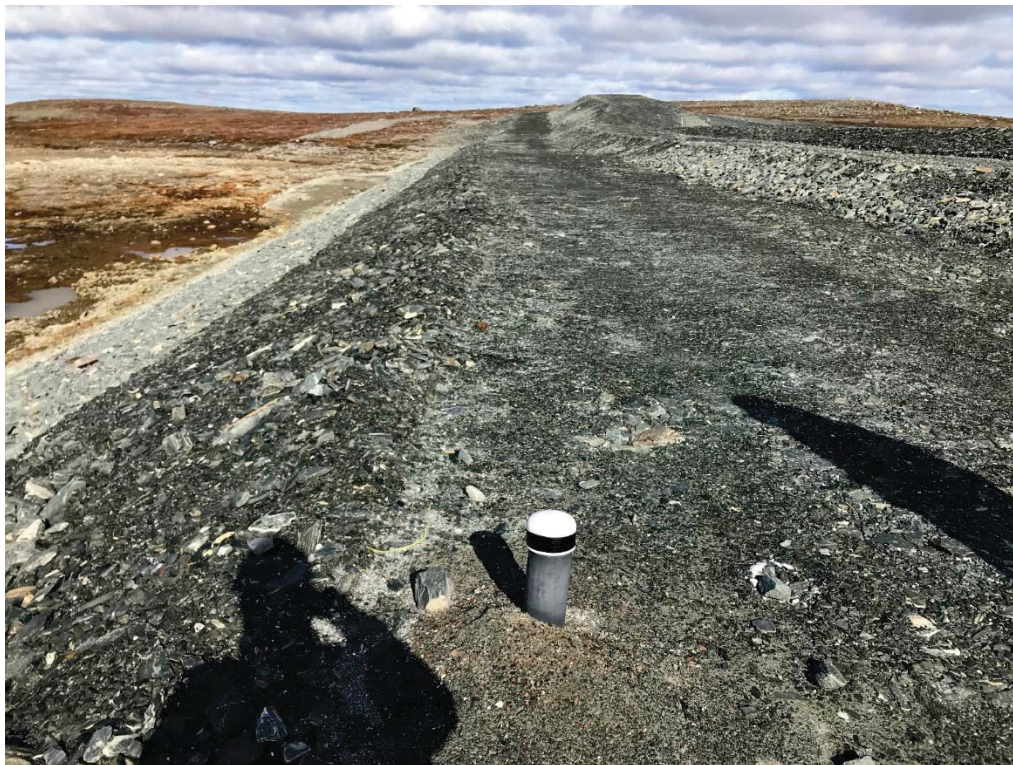
Photograph 11: D-CP1, VGTC-03 on Upstream Bench, Station 1+460, Looking North (12 September 2018)

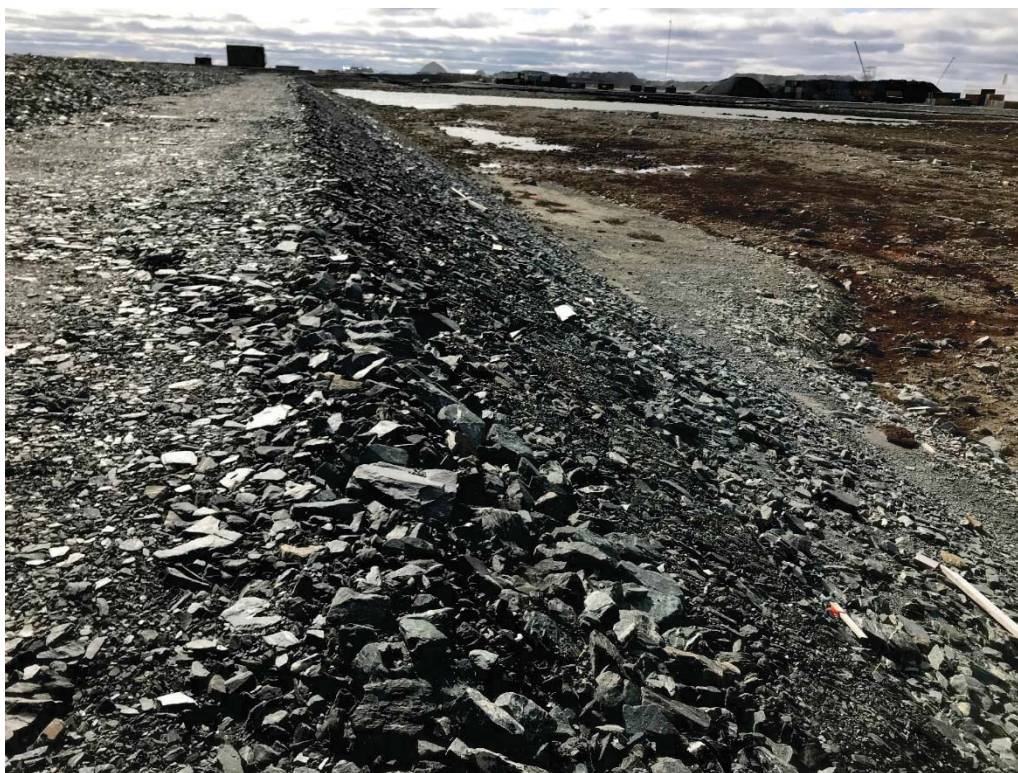
Photograph 12: D-CP1, Upstream Slope and Crest Near Station 1+540, Looking South (12 September 2018)

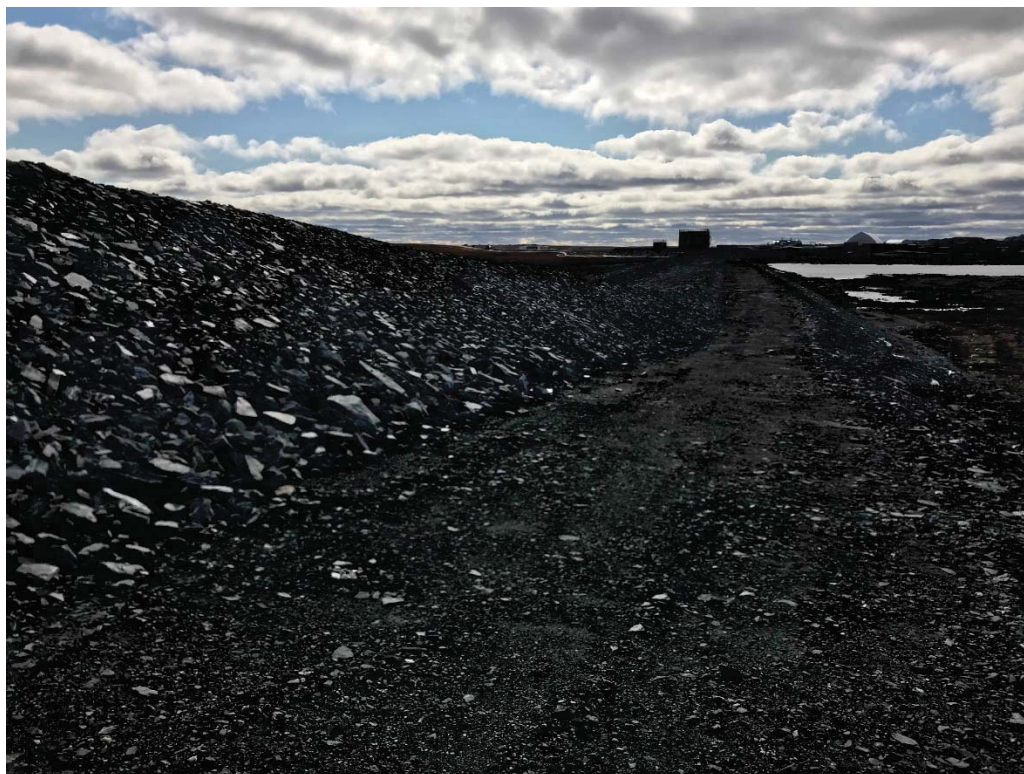
Photograph 13: D-CP1, Upstream Bench Crest Near Station 1+575, Looking South (12 September 2018)

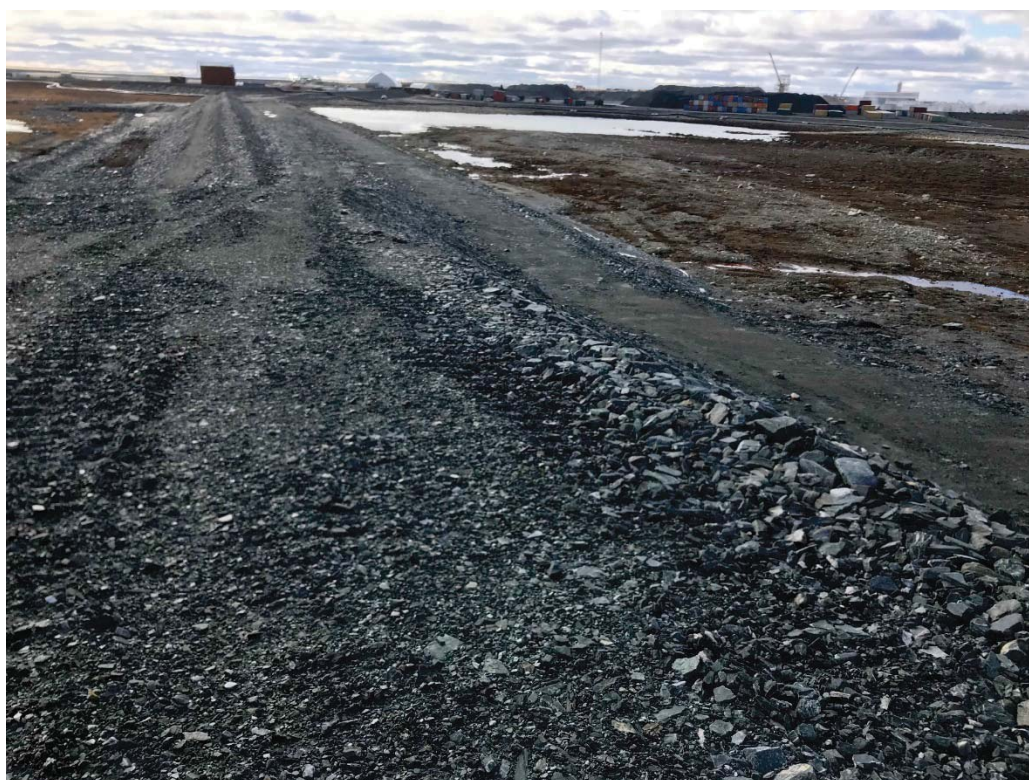
Photograph 14: D-CP1, Crest Looking South Near Station 1+575, Looking South (12 September 2018)

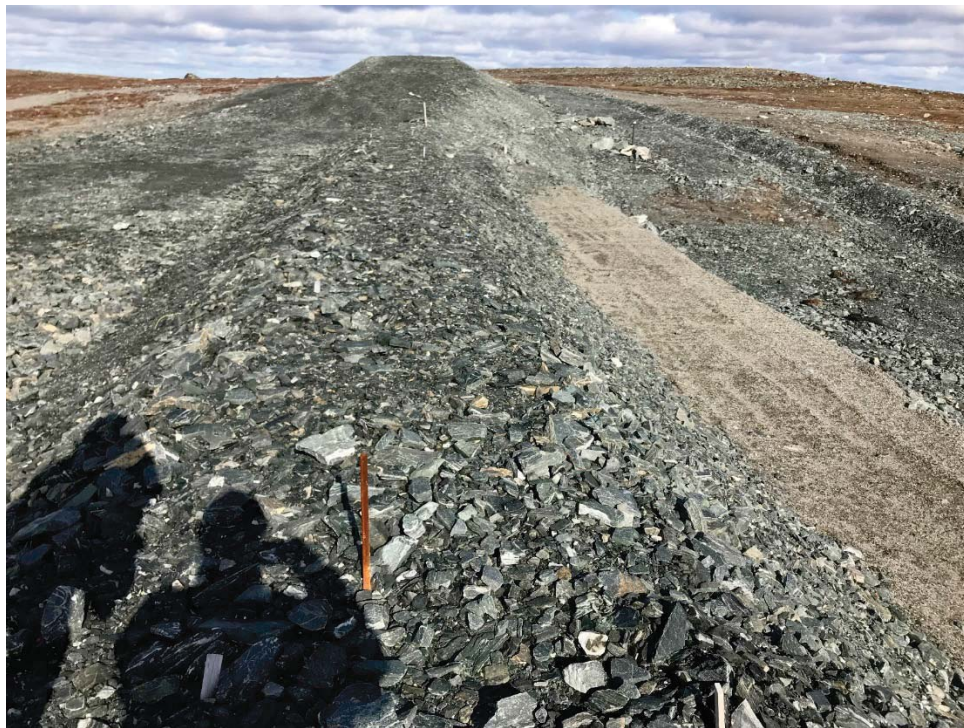
Photograph 15: D-CP1, Crest Looking North Near Station 1+510 (12 September 2018)

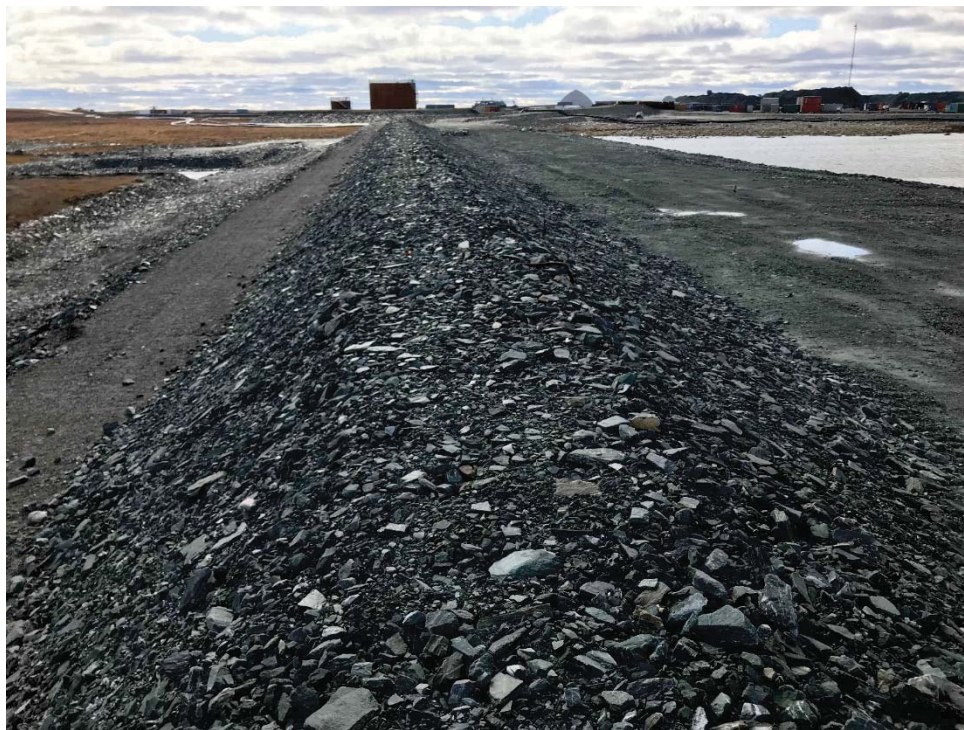
Photograph 16: D-CP1, Crest Looking South Near Station 1+420 (12 September 2018)

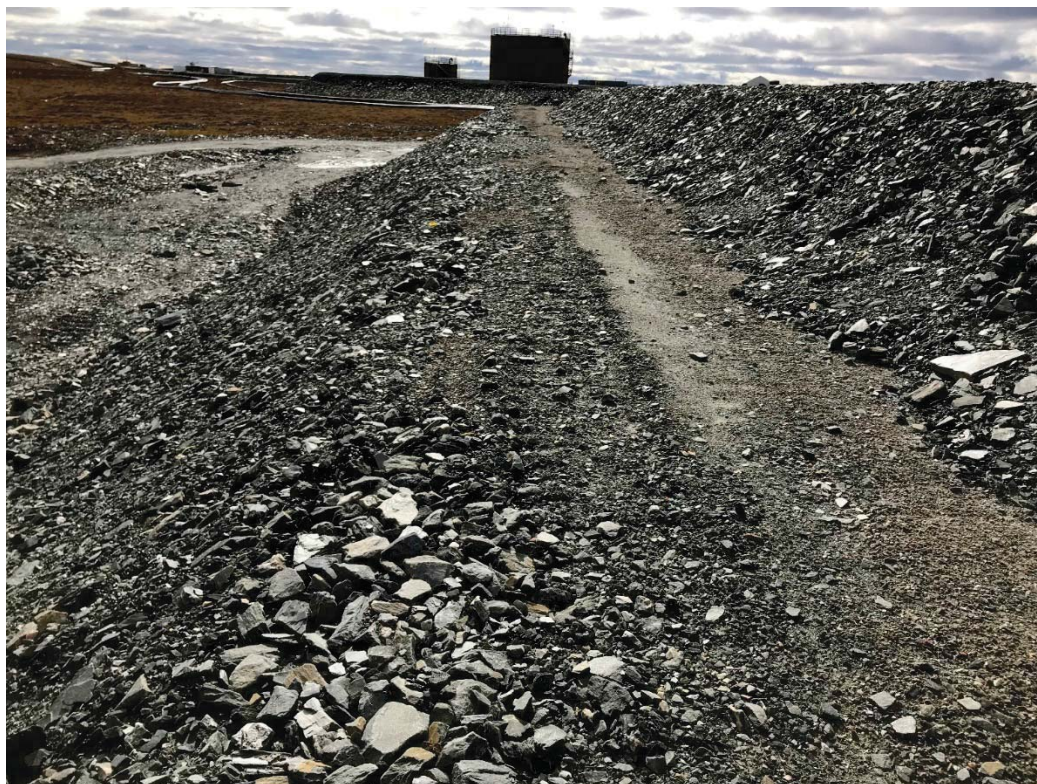
Photograph 17: D-CP1, Downstream Slope and Crest Looking South Near Station 1+250 (12 September 2018)

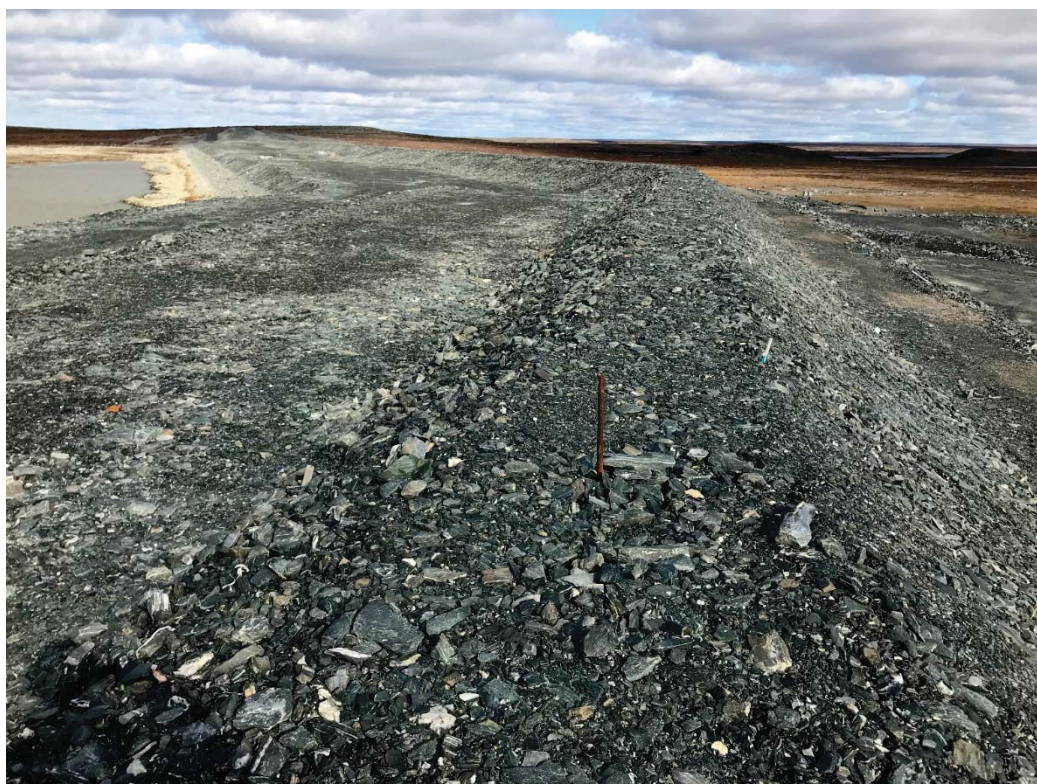
Photograph 18: D-CP1, Crest Overview Looking Northeast Near Station 1+160 (12 September 2018)

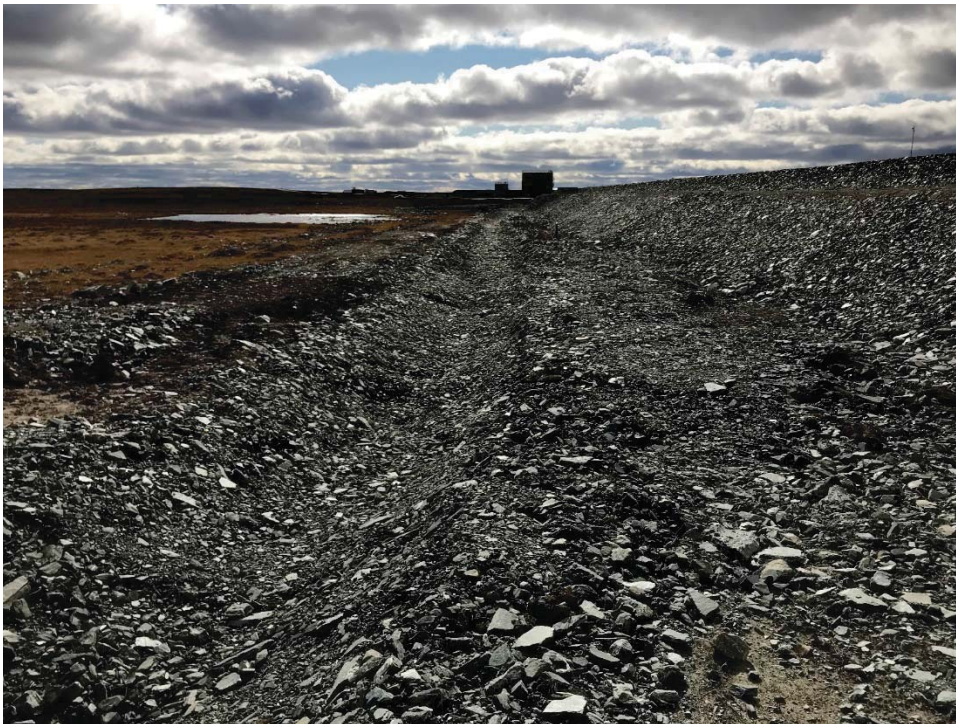
Photograph 20: D-CP1, Downstream Slope and Seepage Collection Channel Looking South, Near Station 1+550 (12 September 2018)

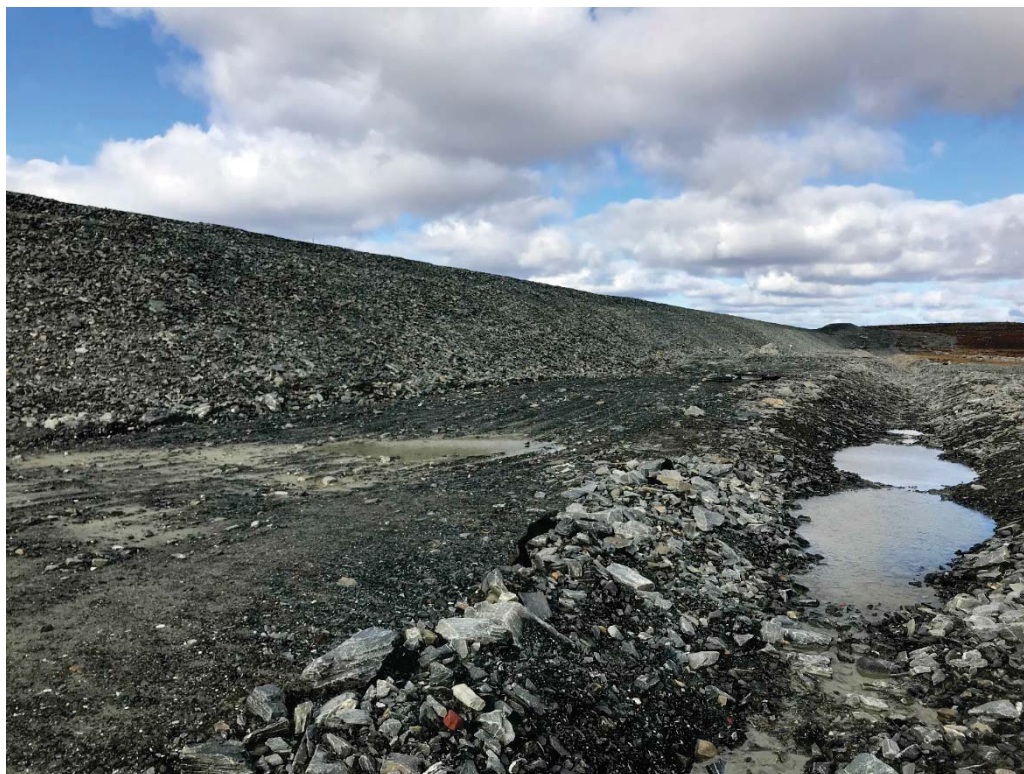
Photograph 21: D-CP1, Downstream Slope Looking Northwest, Near Station 1+250 (12 September 2018)

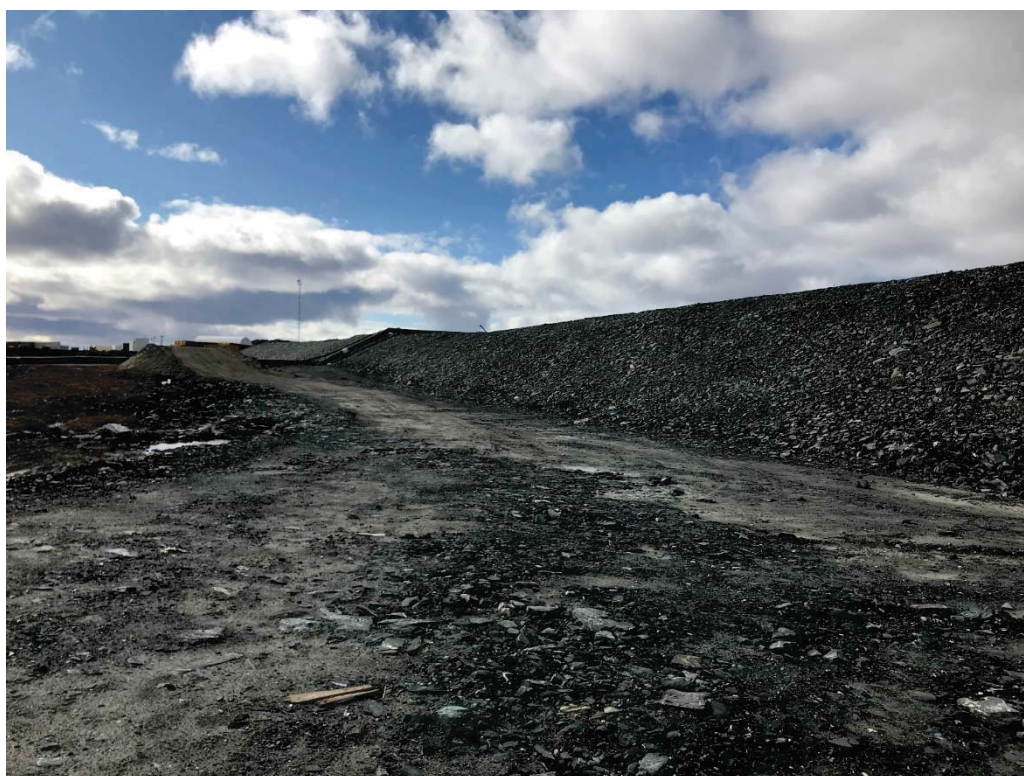
Photograph 22: D-CP1, Downstream Slope Looking Southwest, Near Station 1+210 (12 September 2018)

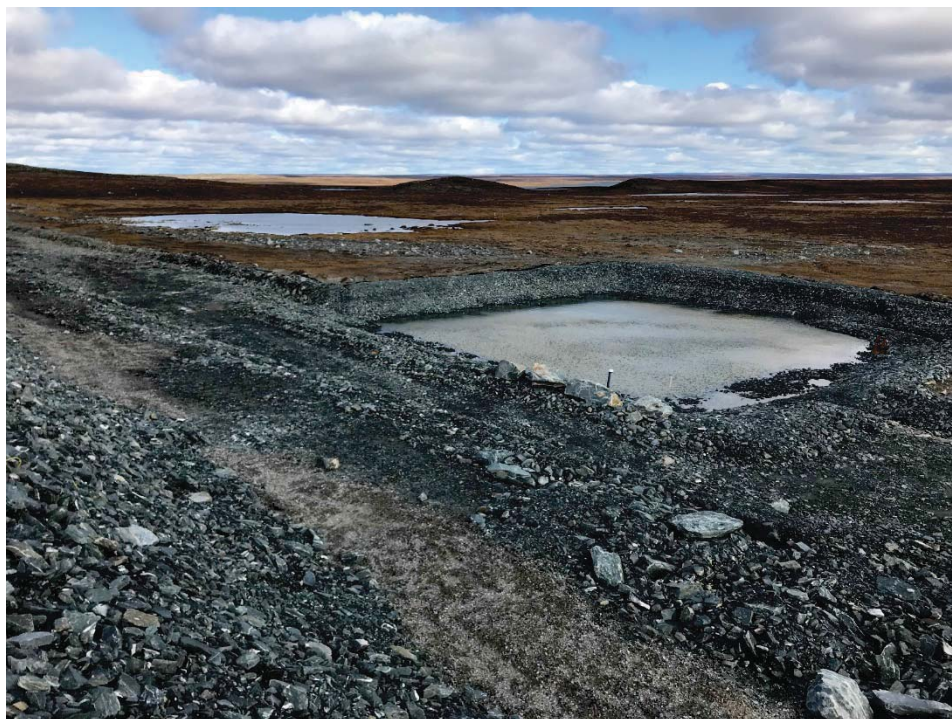
Photograph 23: D-CP1, Downstream Sump Looking Northeast Near Station 1+220 (12 September 2018)

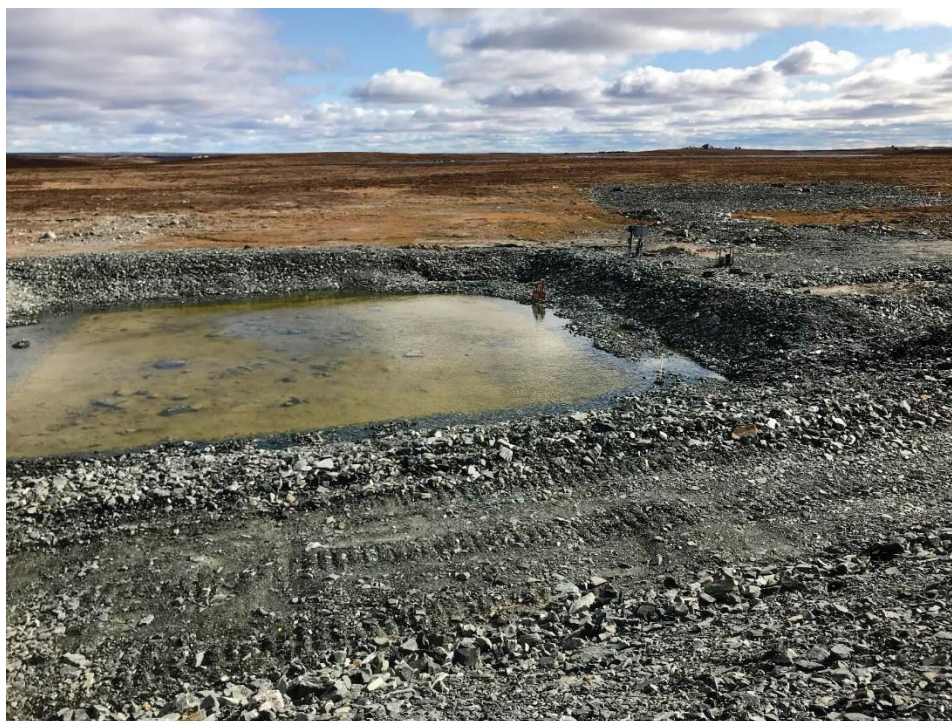
Photograph 24: D-CP1, Downstream Sump Looking Southeast Near Station 1+240 (12 September 2018)

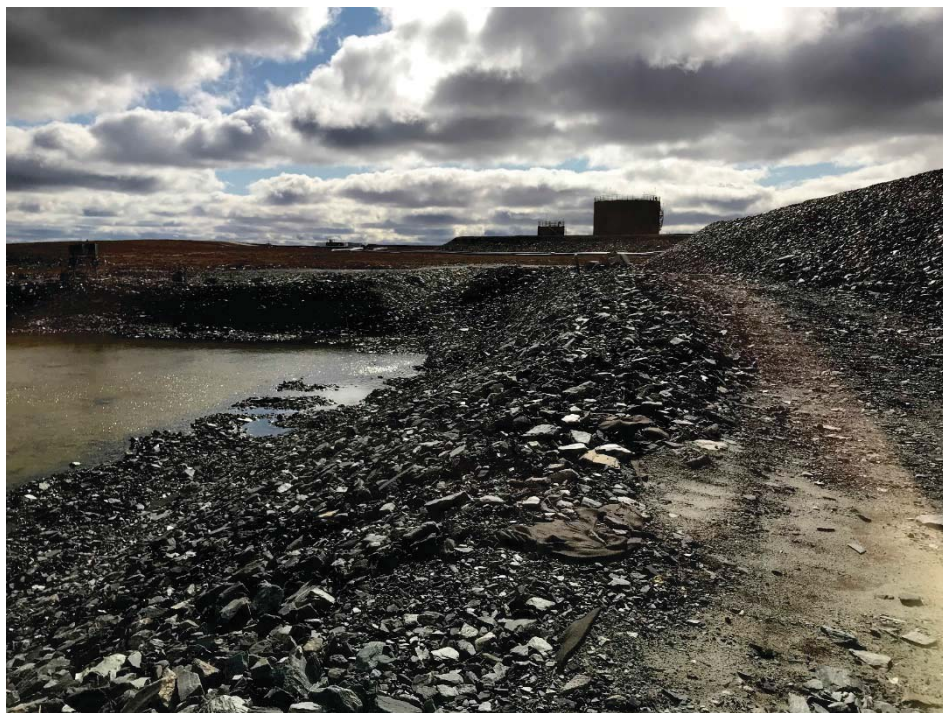
Photograph 25: D-CP1, Downstream Sump and Downstream Slope Looking South Near Station 1+240 (12 September 2018)

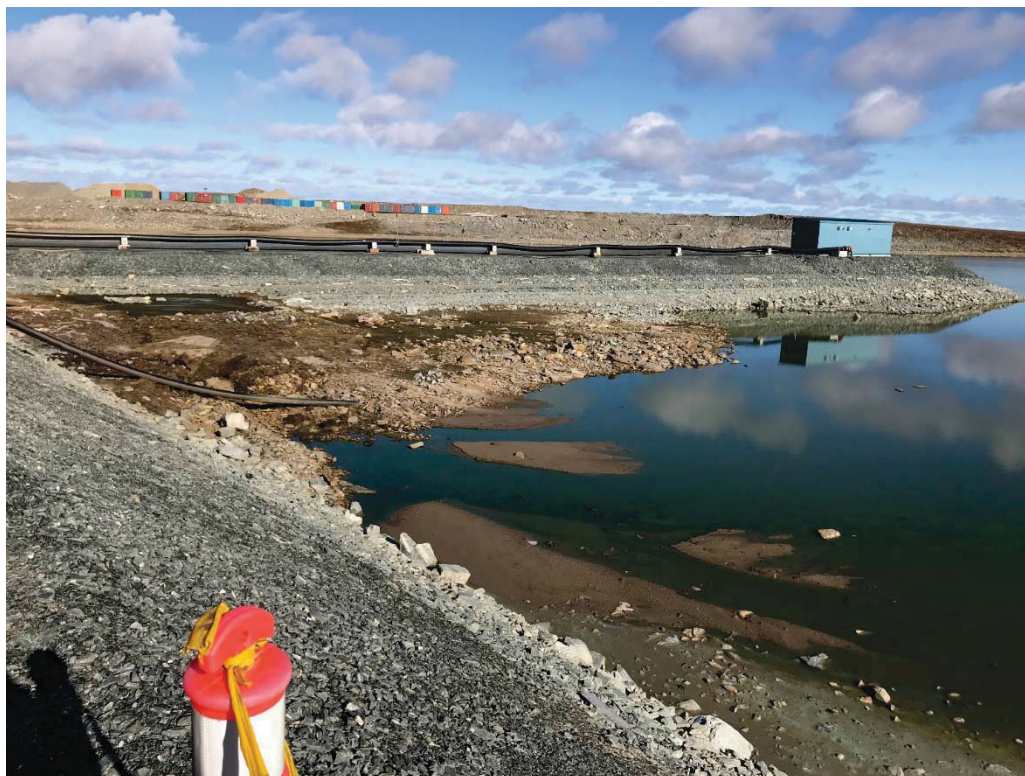
Photograph 27: CP1 Jetty 1, Southeast Slope Overview, Looking North (13 September 2018)

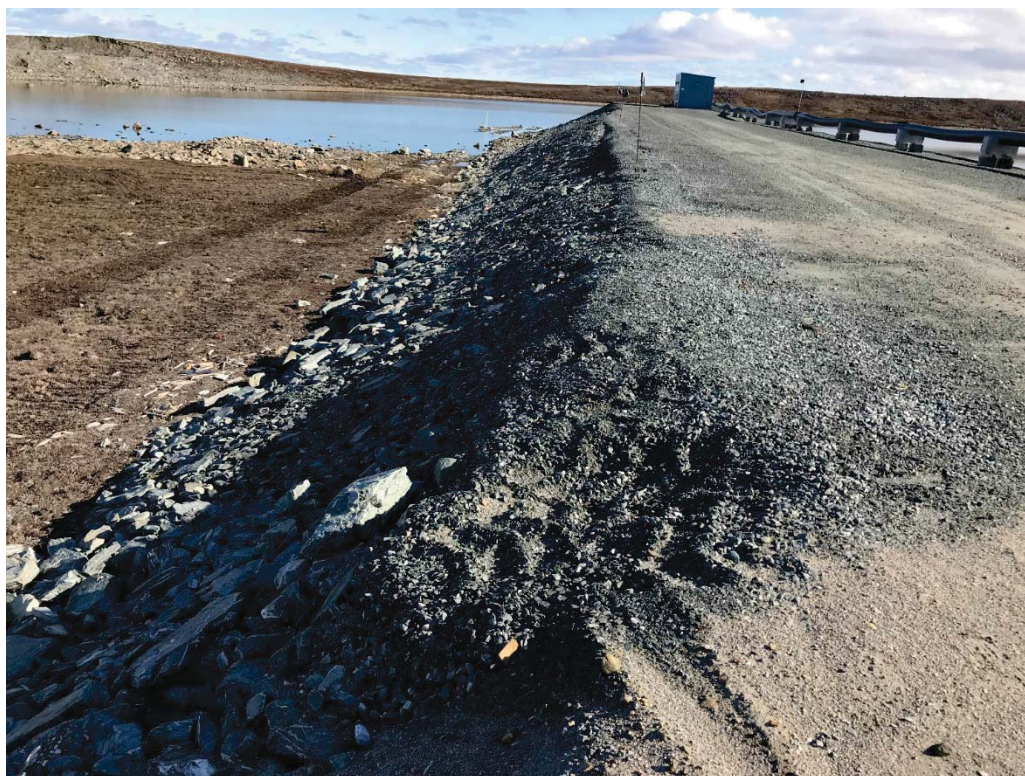
Photograph 28: CP1 Jetty 1, Northwest Slope, Looking Northeast (13 September 2018)

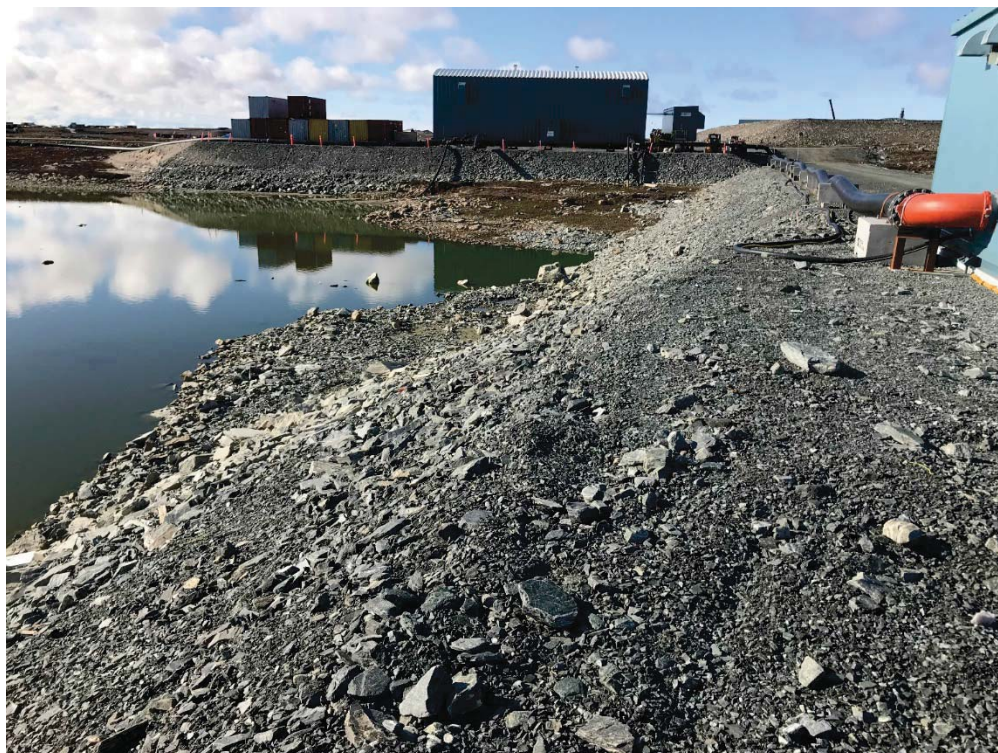
Photograph 29: Jetty 1, Southeast Slope, Looking Southwest (13 September 2018)
