2018 Annual Geotechnical Inspection

Meliadine Gold Project, Rankin Inlet, Nunavut

Golder Associates Ltd.

Reference No. 18105719-002-R-Rev0-3000

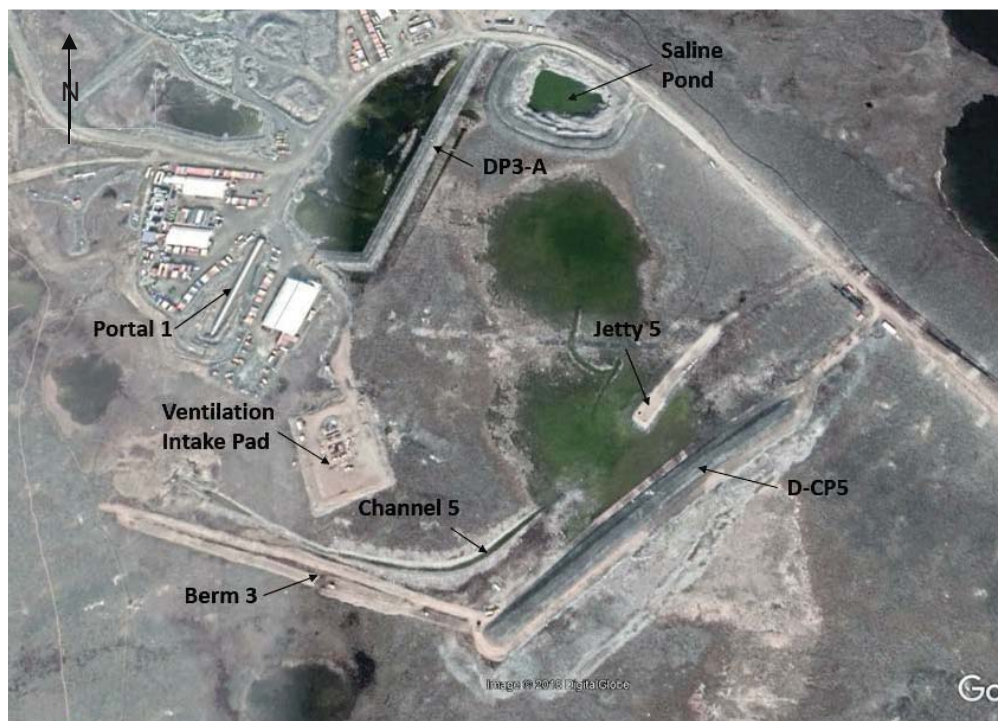
Photograph 30: General overview of D-CP5, Berm 3, Channel 5, and the Saline Pond, Google Earth Image (August 2017)

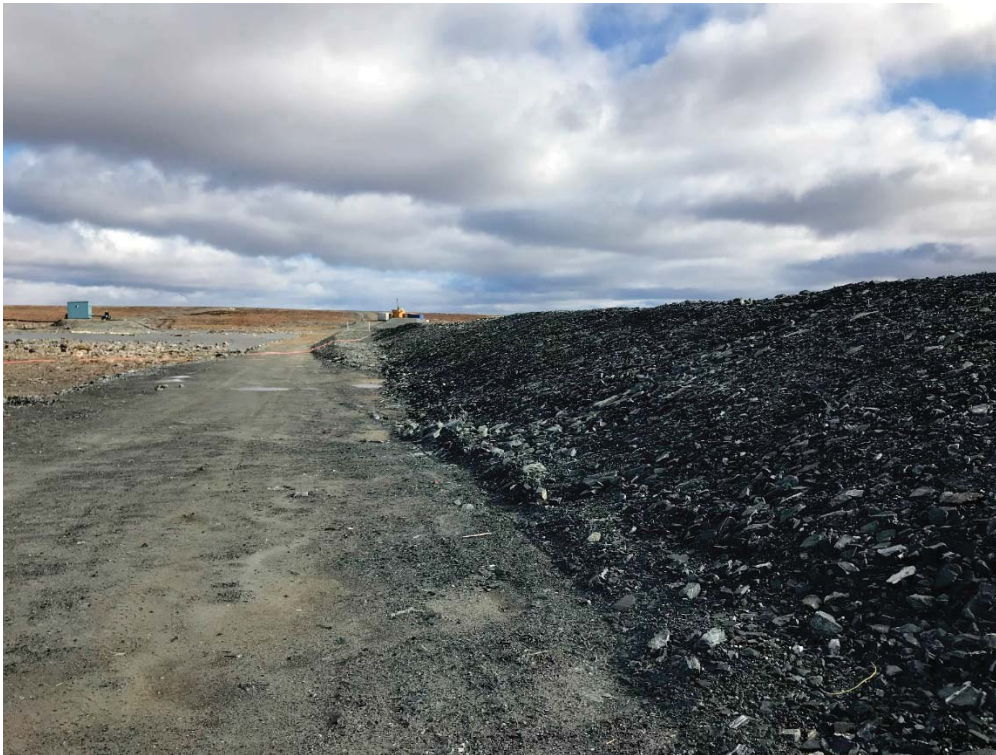
Photograph 31: D-CP5, Upstream Bench at Southwest Abutment Looking Northeast Near Station 1+025 (12 September 2018)

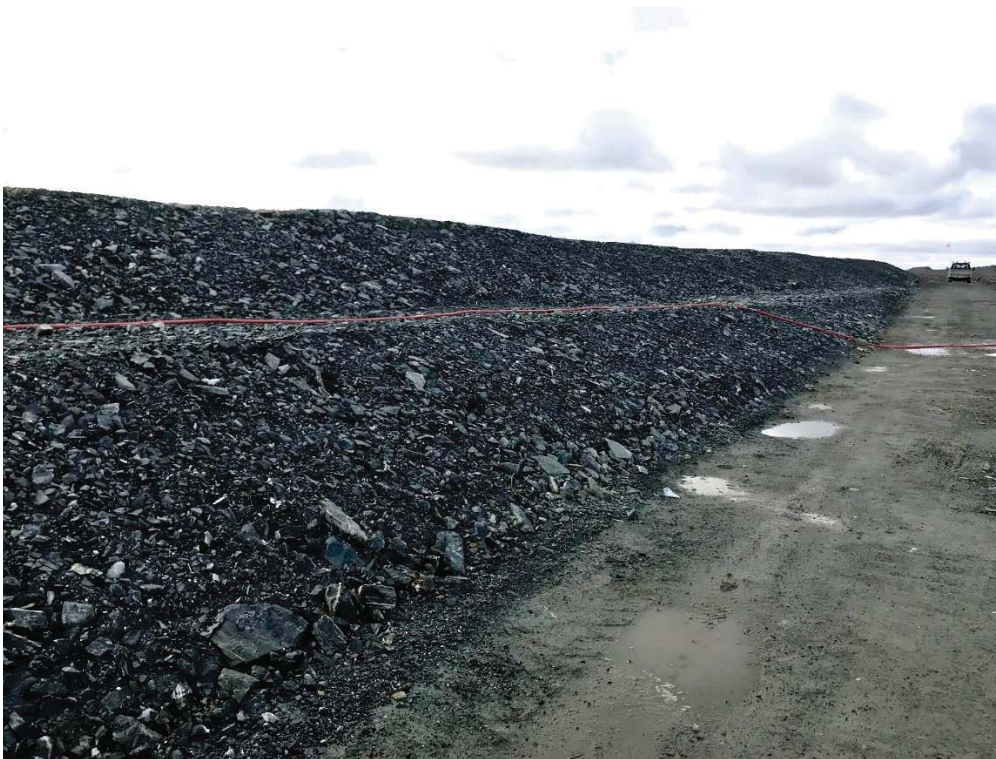
Photograph 32: D-CP5, Upstream Slope, Looking South Near Station 1+170 (12 September 2018)

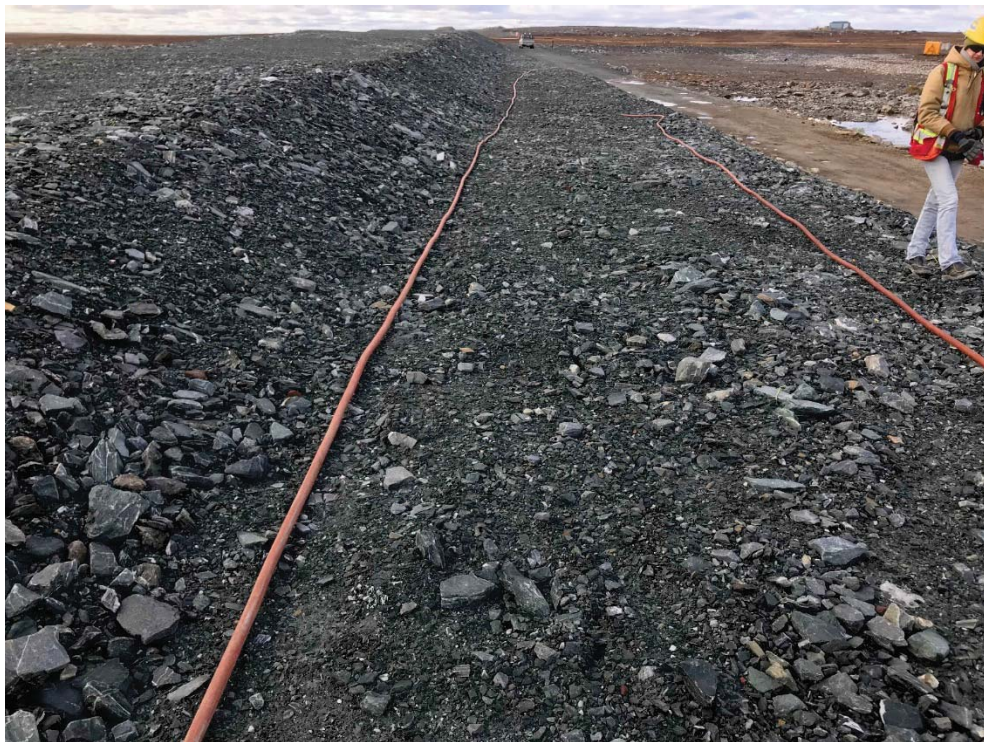
Photograph 33: D-CP5, Upstream Crest Looking Southwest Near Station 1+170 (12 September 2018)

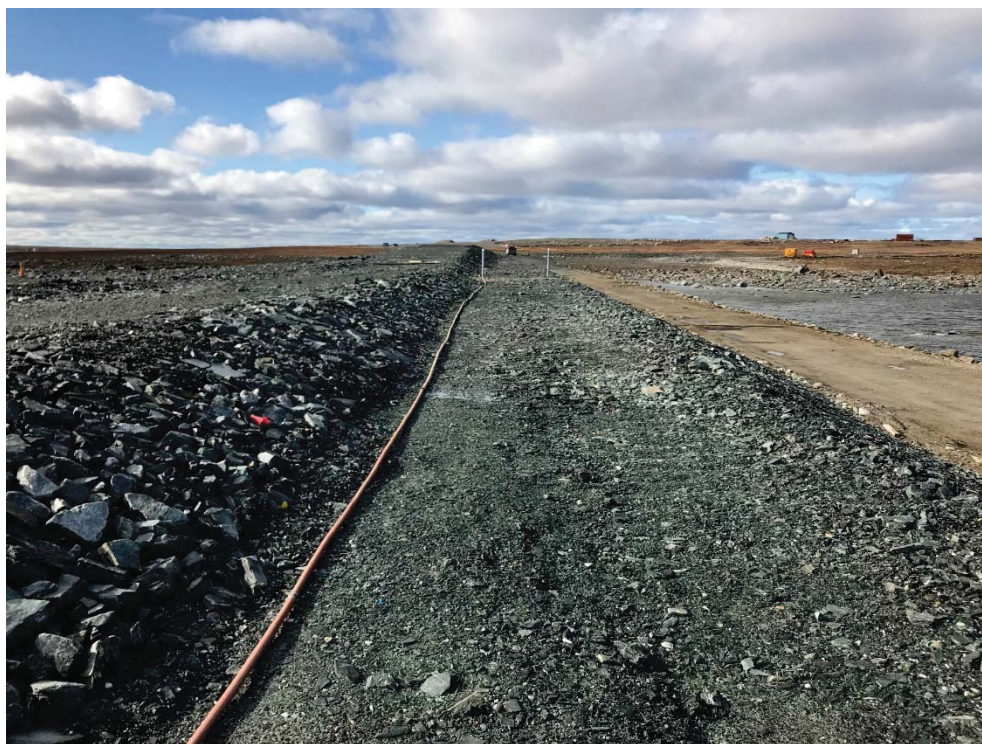
Photograph 36: D-CP5, Upstream Crest Looking Southwest Near Station 1+250 (12 September 2018)

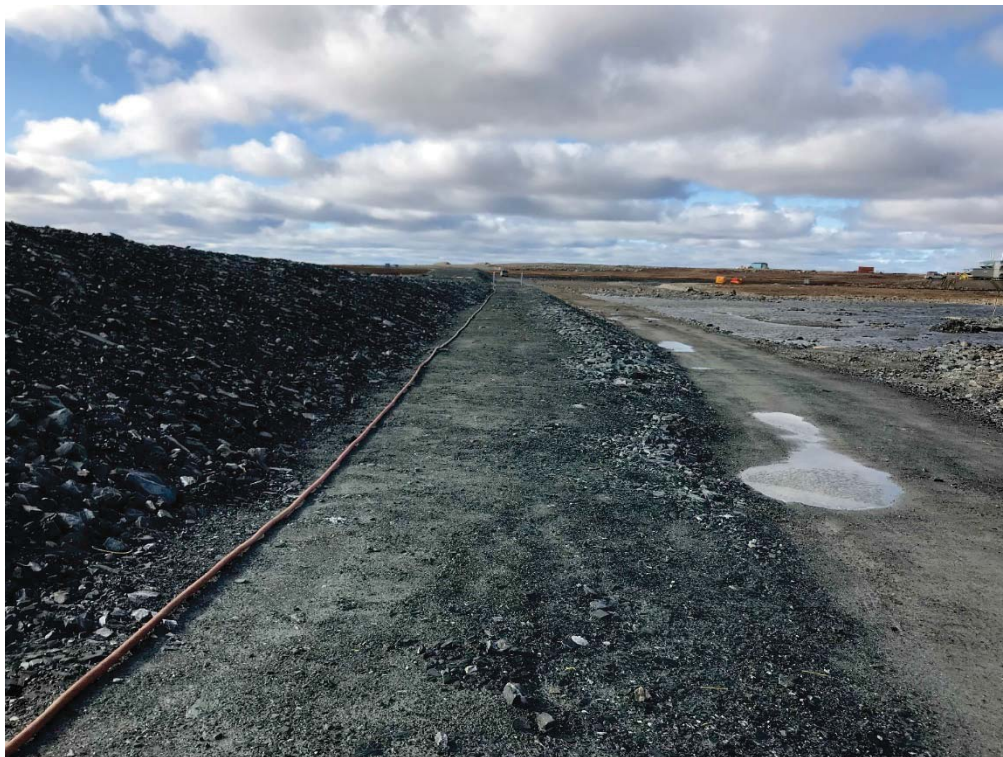
Photograph 37: D-CP5, Upstream Crest Looking Southwest Near Station 1+300 (12 September 2018)

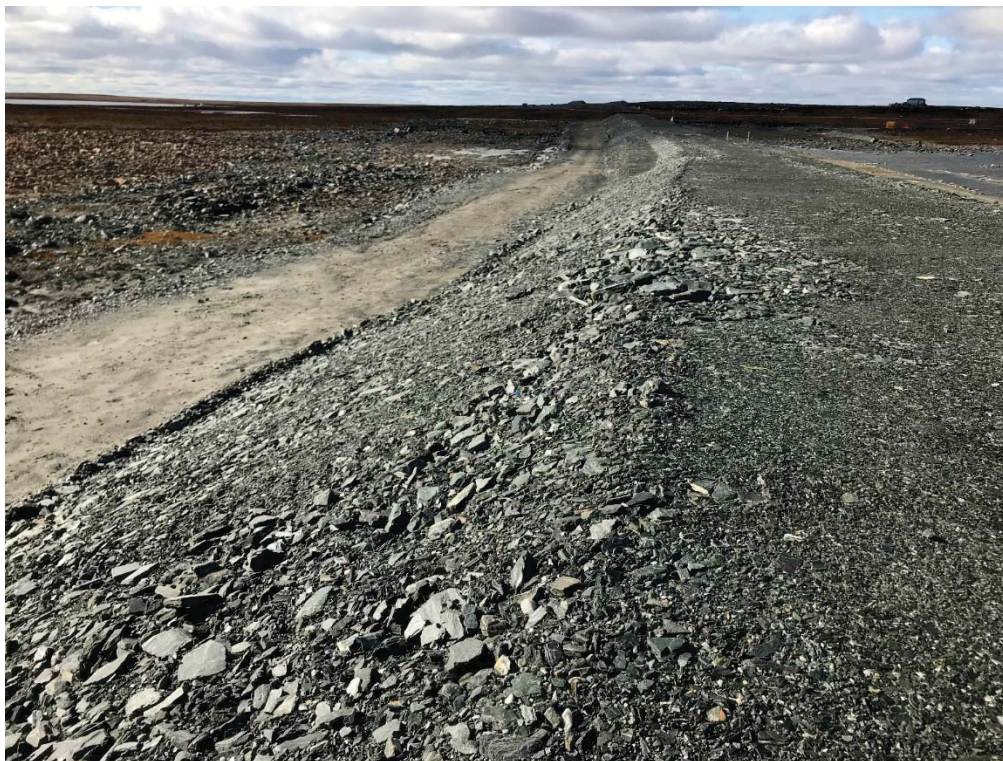
Photograph 38: D-CP5, Downstream Slope and Crest Overview Looking Southwest Near Station 1+275 (12 September 2018)

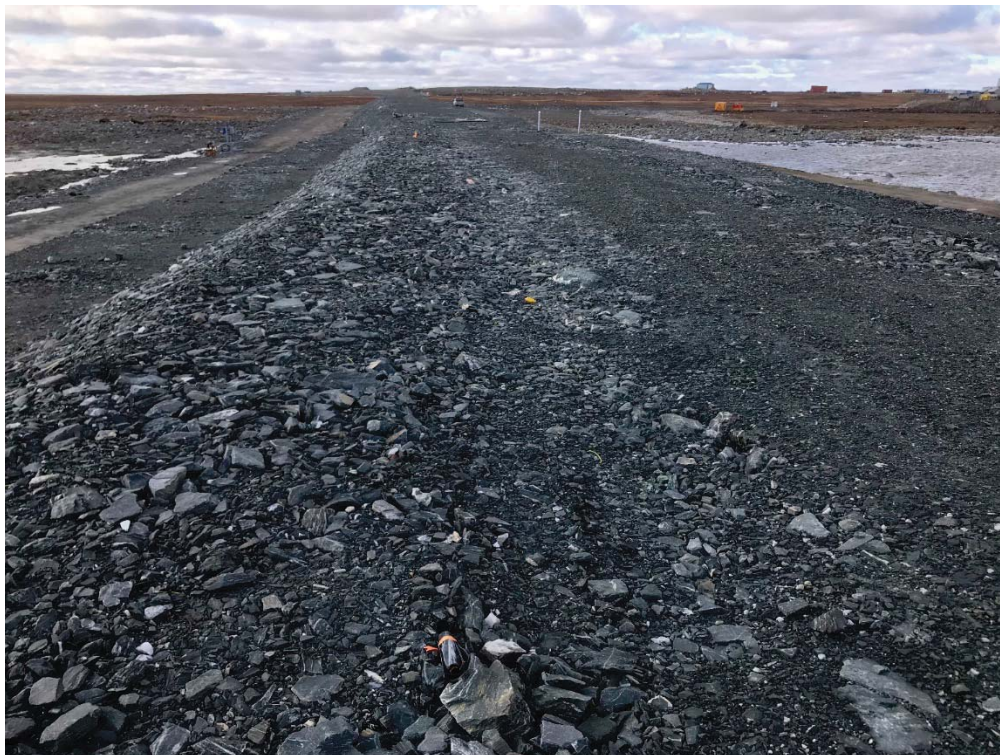
Photograph 39: D-CP5, Crest Overview Looking Southwest Near Station 1+250 (12 September 2018)

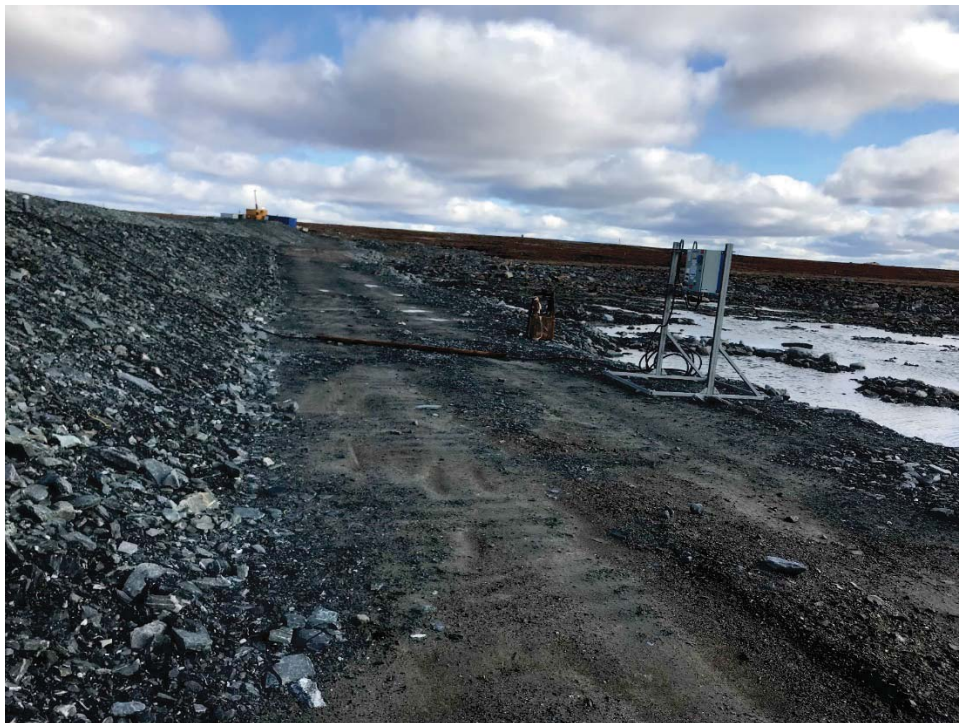
Photograph 42: D-CP5, Downstream Slope and Pump Location Looking Northeast Near Station 1+170 (12 September 2018)

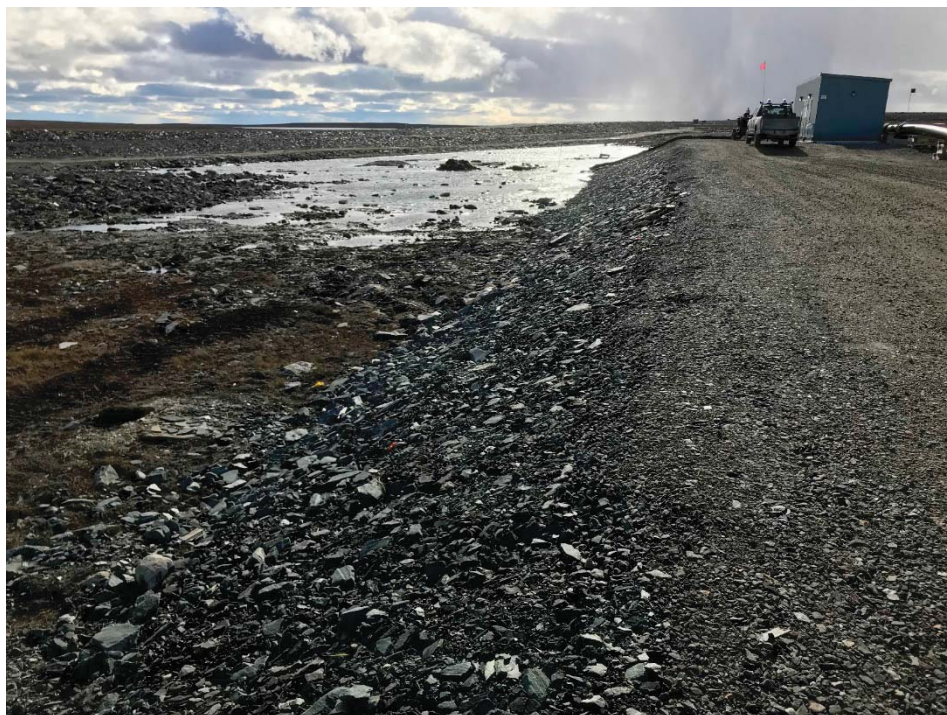
Photograph 43: CP5, Jetty 5 and Pumping Station. South Slope of Jetty, Looking West (12 September 2018)

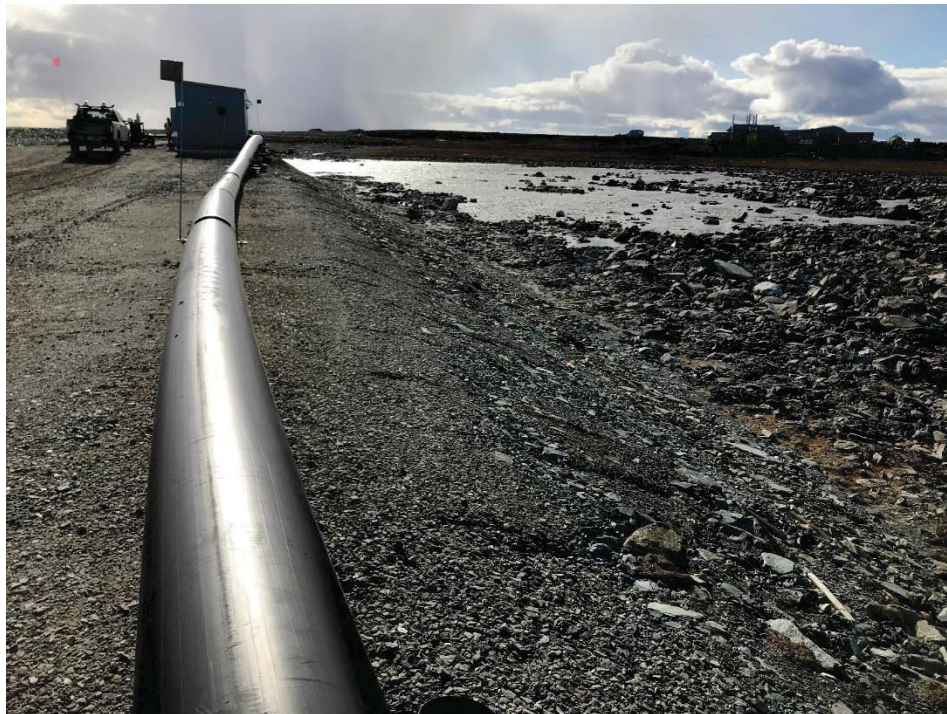
Photograph 44: CP5, Jetty 5 Pipeline and Pumping Station. North Slope of Jetty, Looking West (12 September 2018)

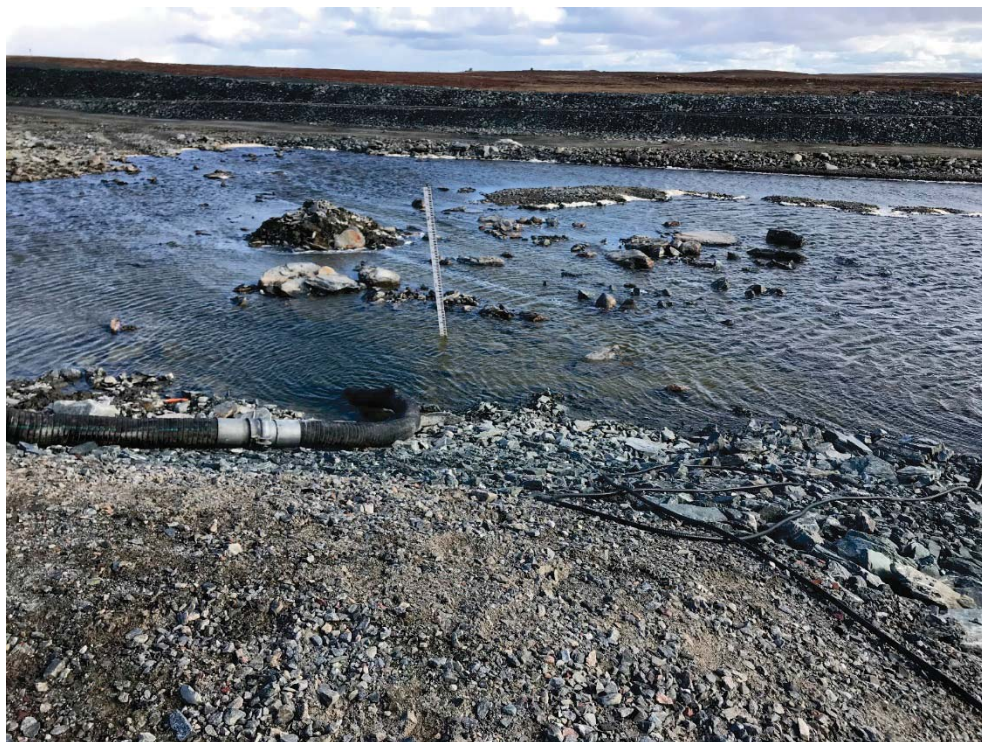
Photograph 45: CP5, Jetty 5 Intake and Southwest Toe Looking Southeast (12 September 2018)

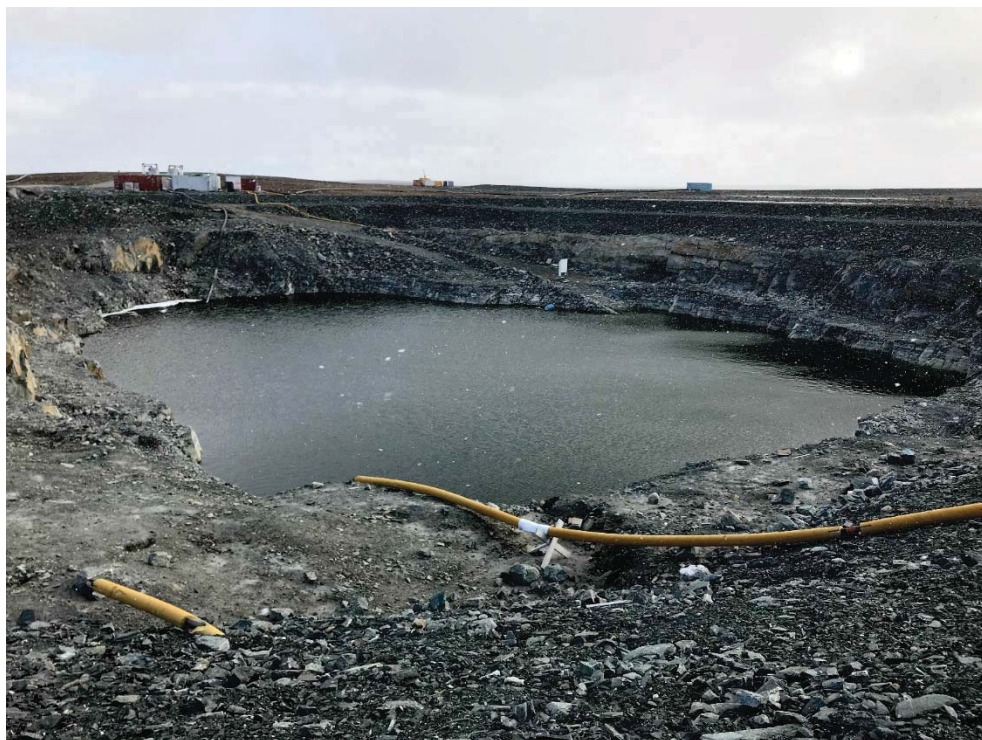
Photograph 46: Saline Pond, Looking Southeast (12 September 2018)

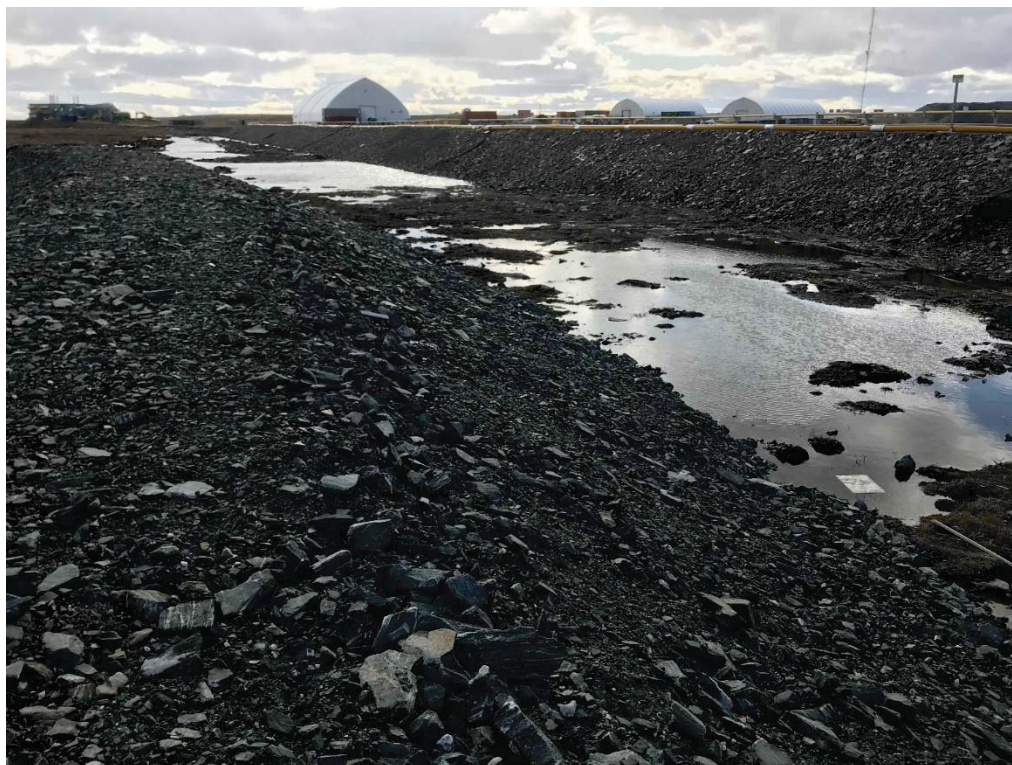
Photograph 50: Saline Pond, Downstream Slope of the Northwest Perimeter Berm and Water Ponded Between Saline Pond and DP3-A (12 September 2018)

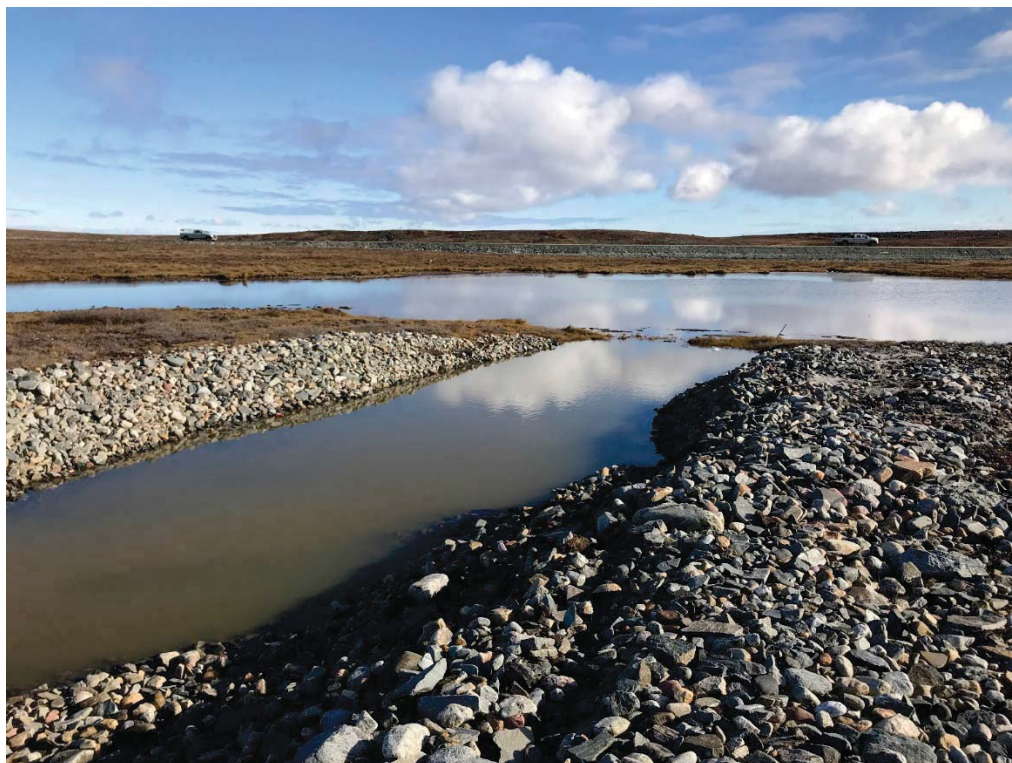
Photograph 51: Channel 1, Outlet of Channel at East End, Looking Northeast towards CP1 (13 September 2018)

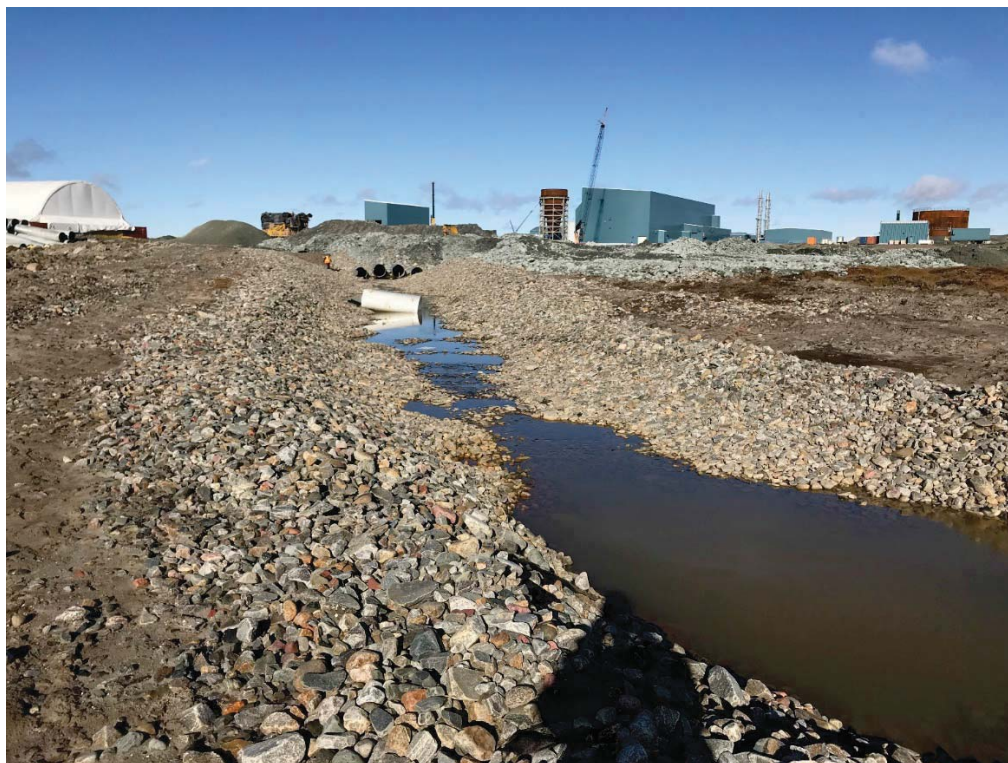
Photograph 53: Channel 1, Looking Upstream Northwest Towards Culvert 16 (13 September 2018)

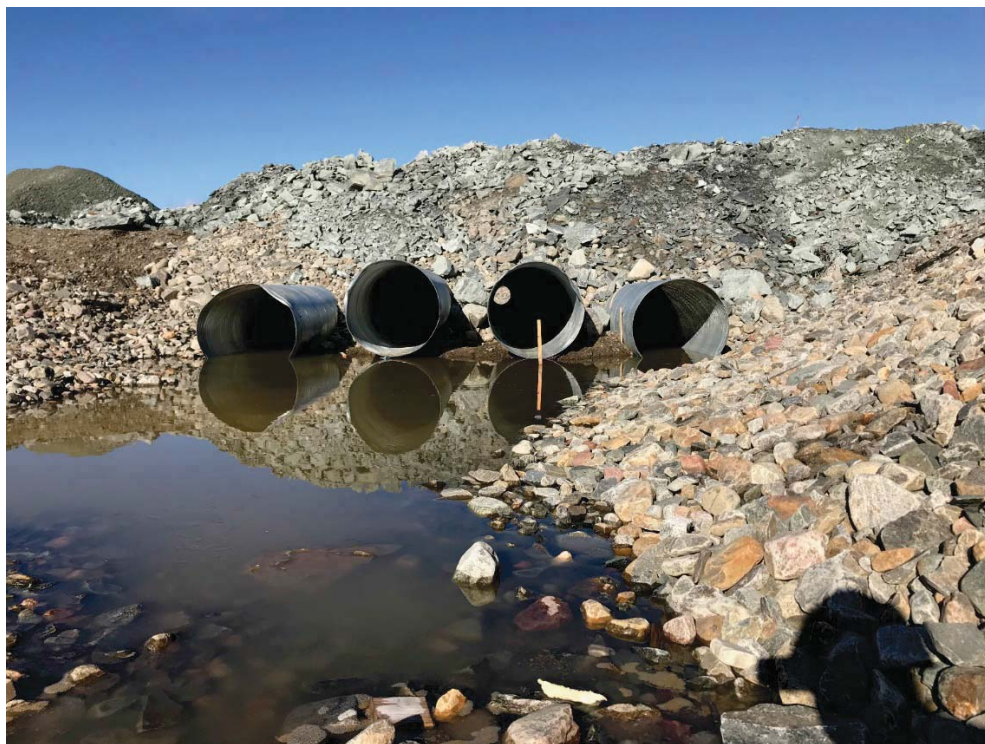
Photograph 54: Channel 1, Outlets of Culvert 16 Looking Southwest (13 September 2018)

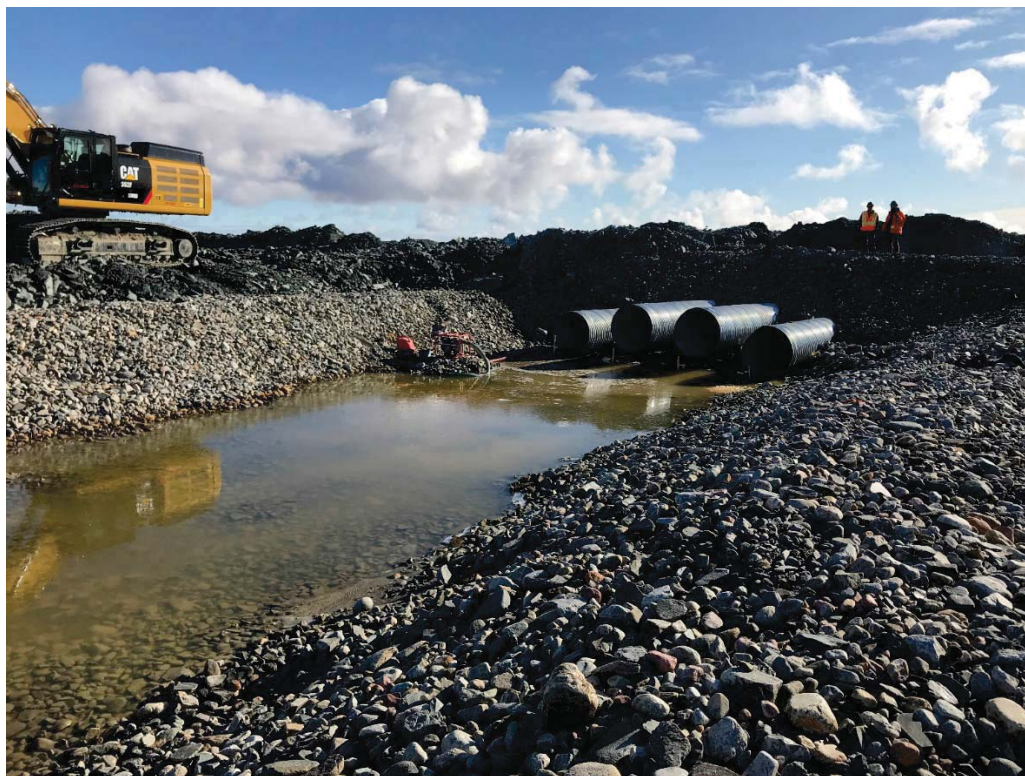
Photograph 56: Channel 1, Inlets of Culvert 16, Looking Northeast (13 September 2018)

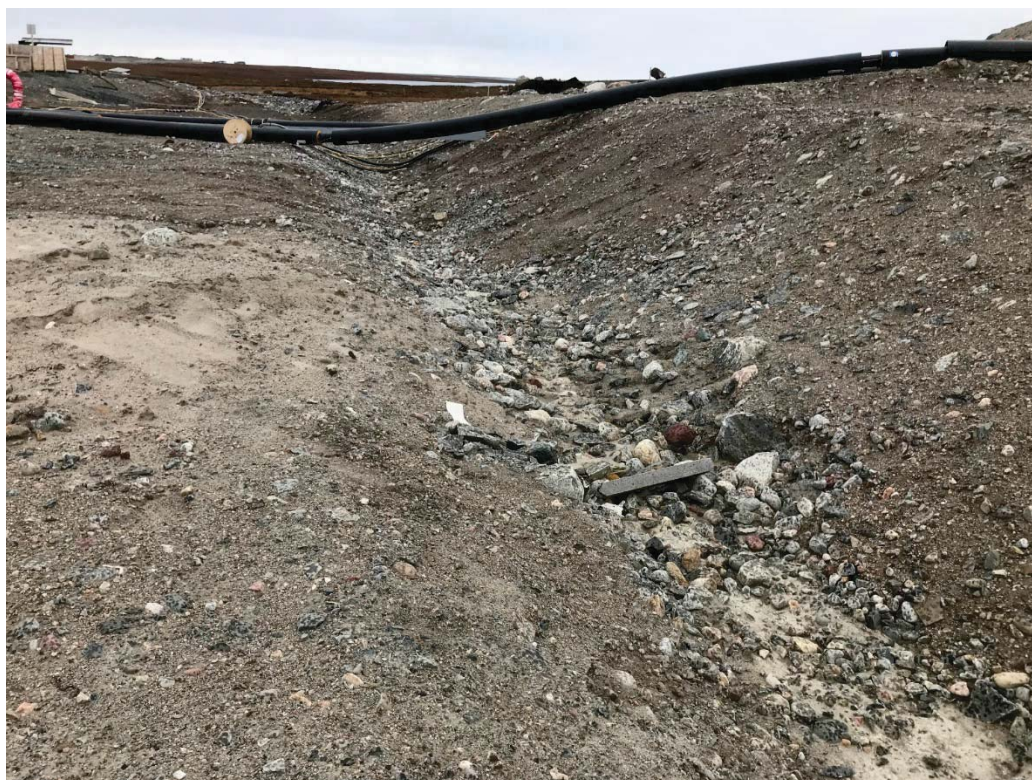
Photograph 57: Channel 2, Unlined Extension of East End of Channel 2, Looking Northwest (11 September 2018)

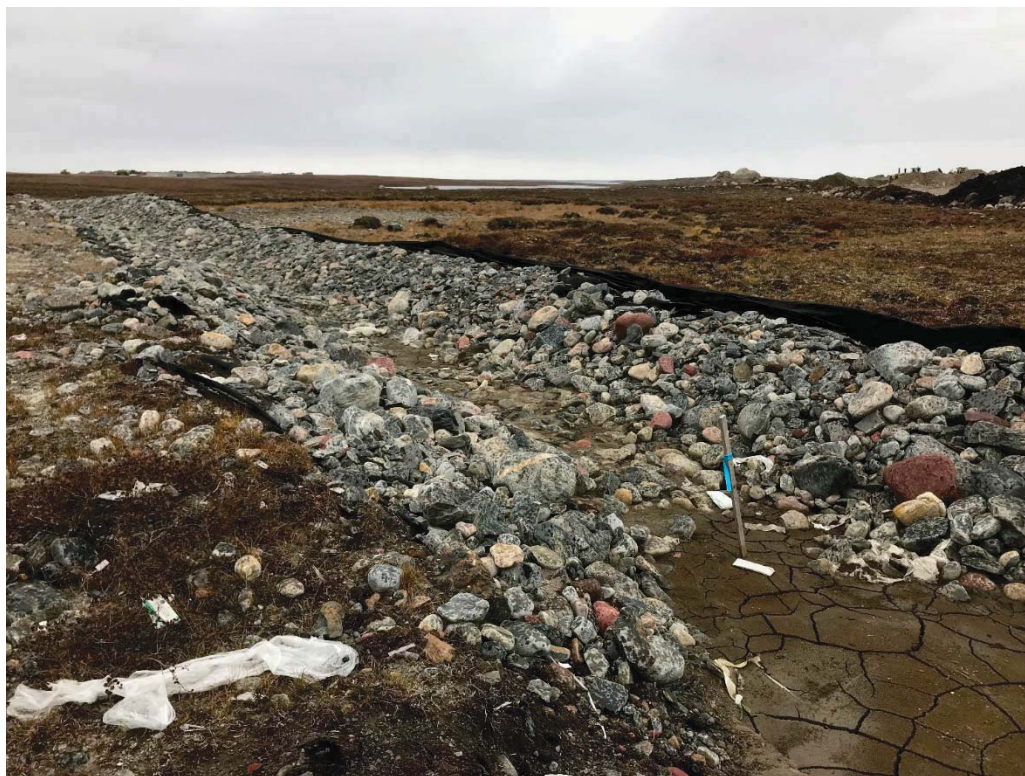
Photograph 58: Channel 2, Start of Lined Channel at East End, Looking Northwest (11 September 2018)

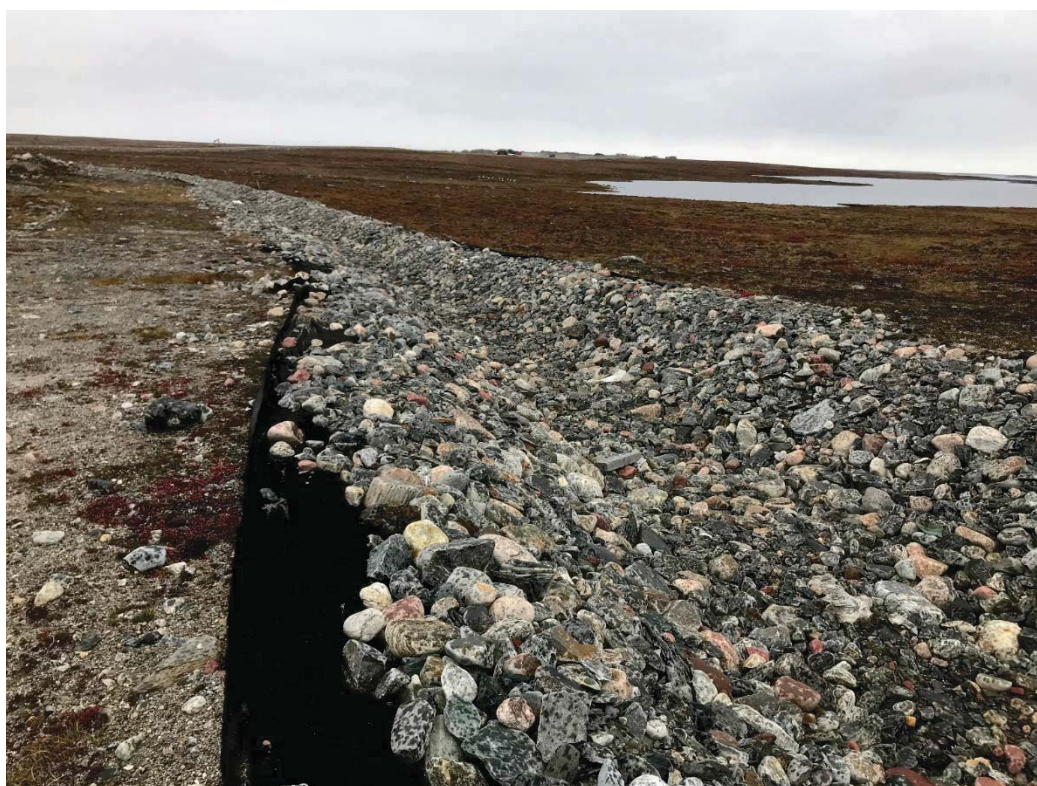
Photograph 59: Channel 2, Eastern End, Looking Northwest (11 September 2018)

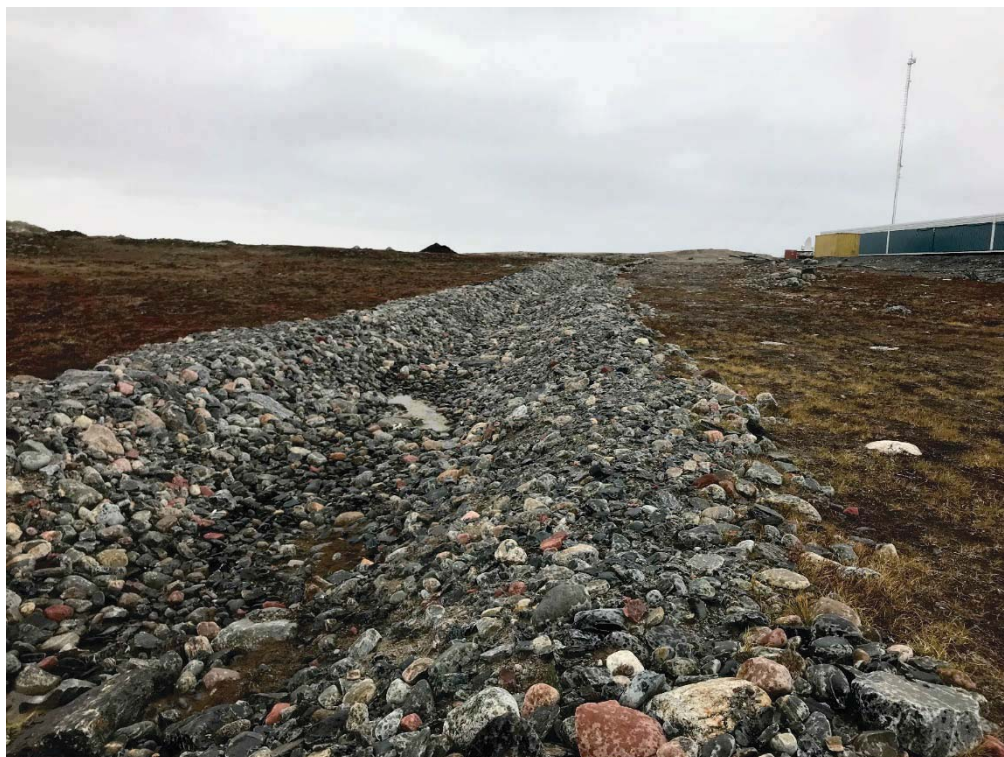
Photograph 60: Channel 2, Western Section, Looking East (11 September 2018)

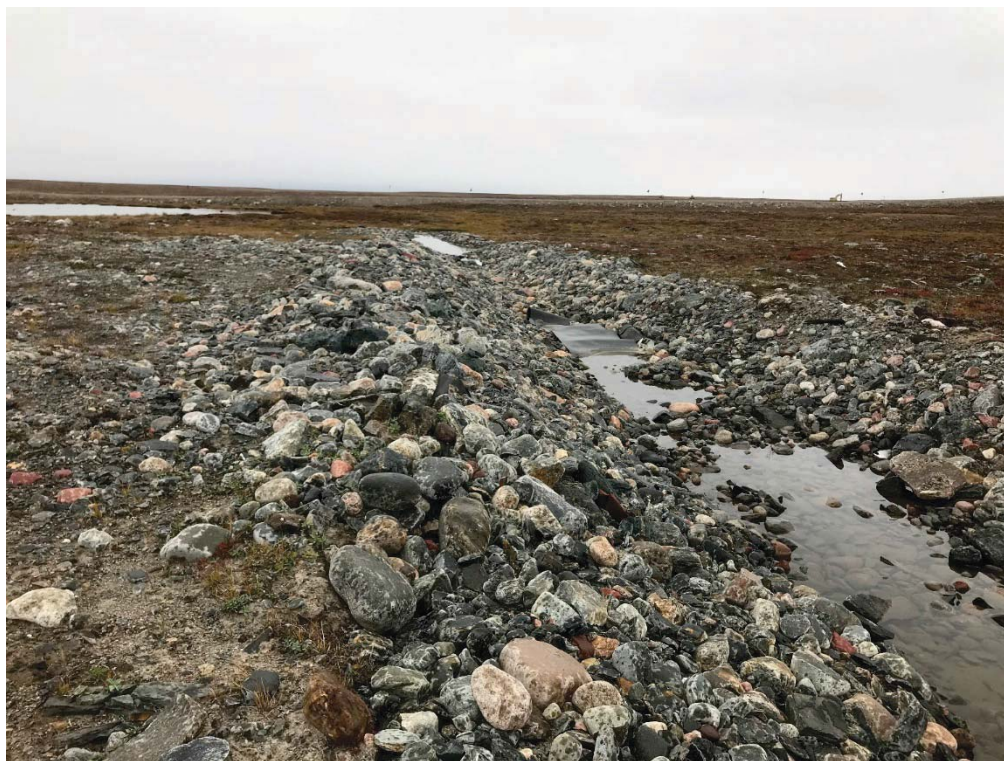
Photograph 61: Channel 2, West End Near Outlet, Looking West. Some Water Poned in Base of Channel (11 September 2018)

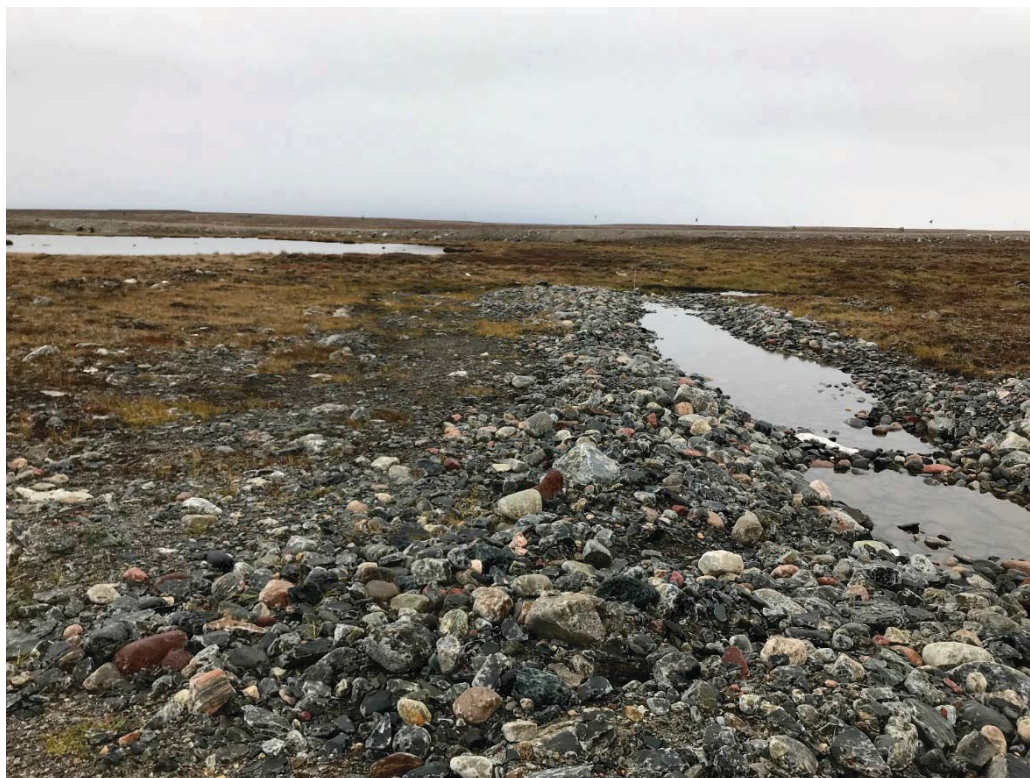
Photograph 62: Channel 2, Outlet of Channel at West End, Looking West (11 September 2018)

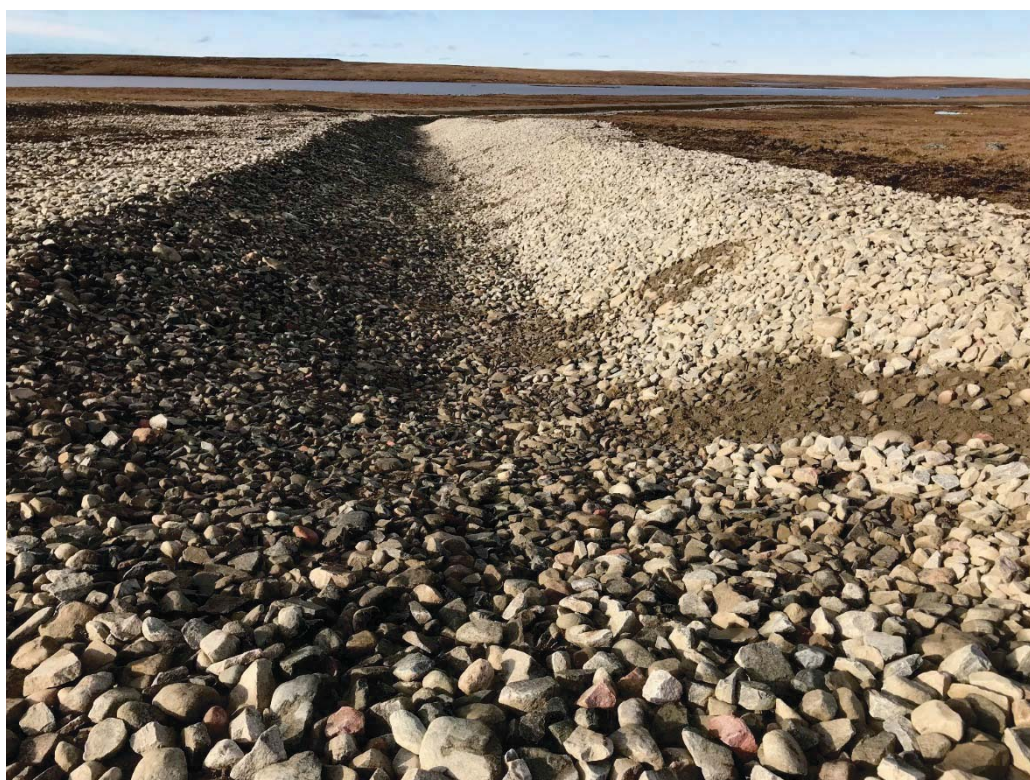
Photograph 63: Channel 3, Beginning of Alignment at Station 0+000 Looking Southwest (13 September 2018)

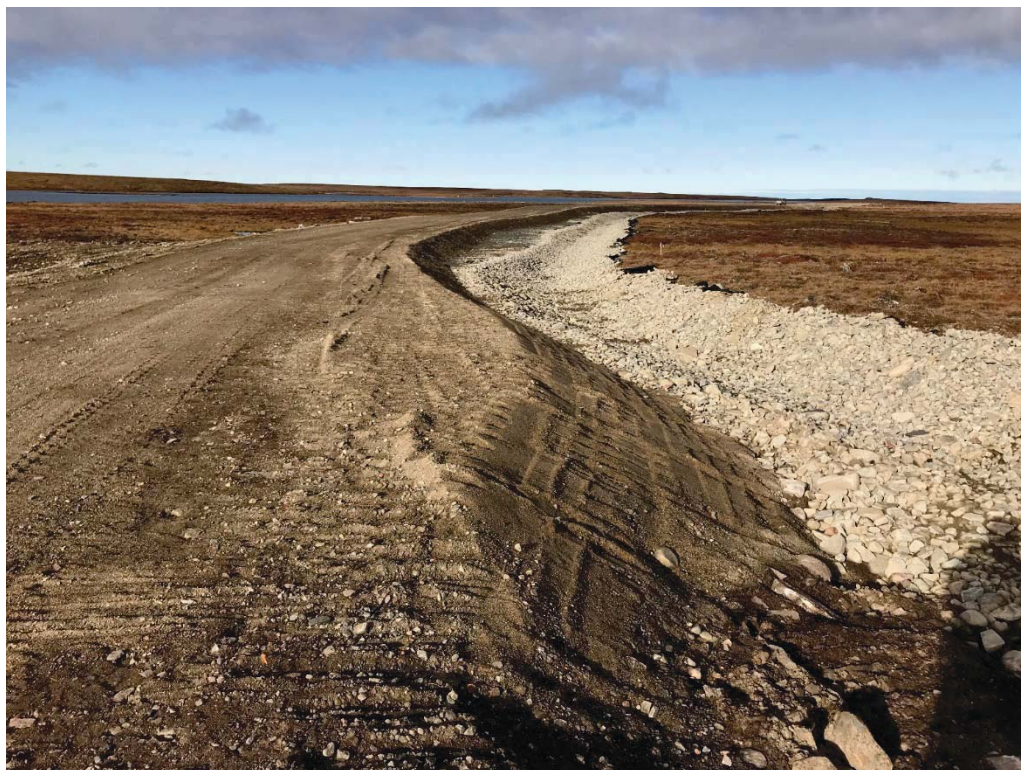
Photograph 64: Channel 3, Near Station 0+140 Looking West (13 September 2018)

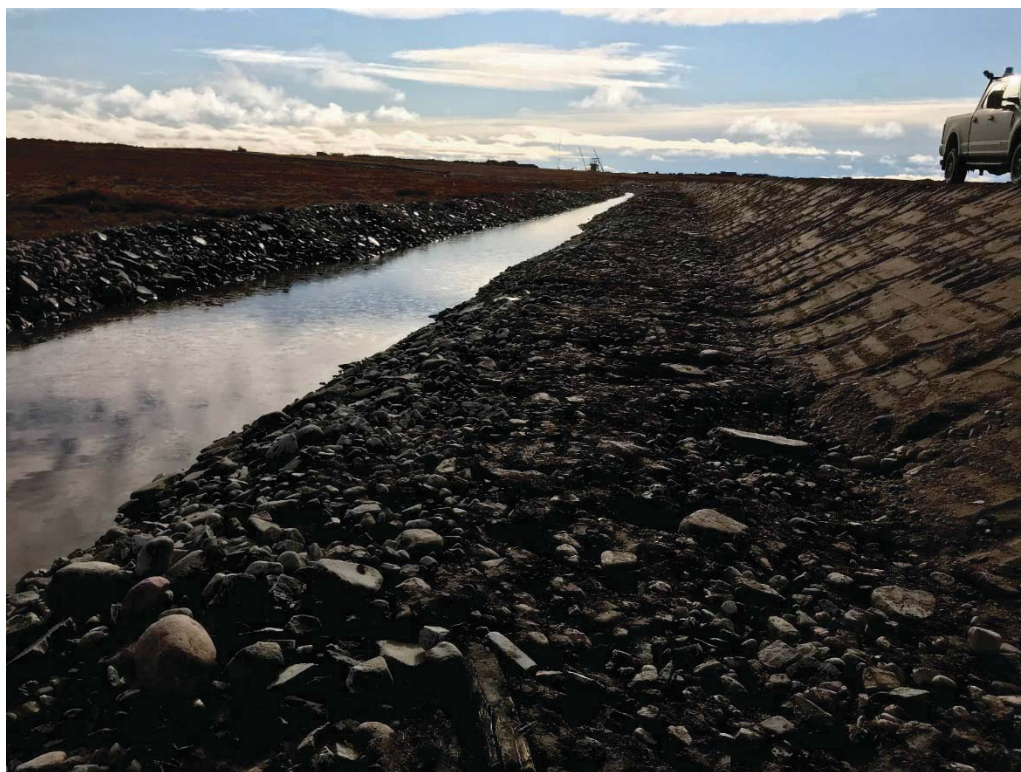
Photograph 65: Channel 3, Extent of Completed Channel Looking East (13 September 2018)

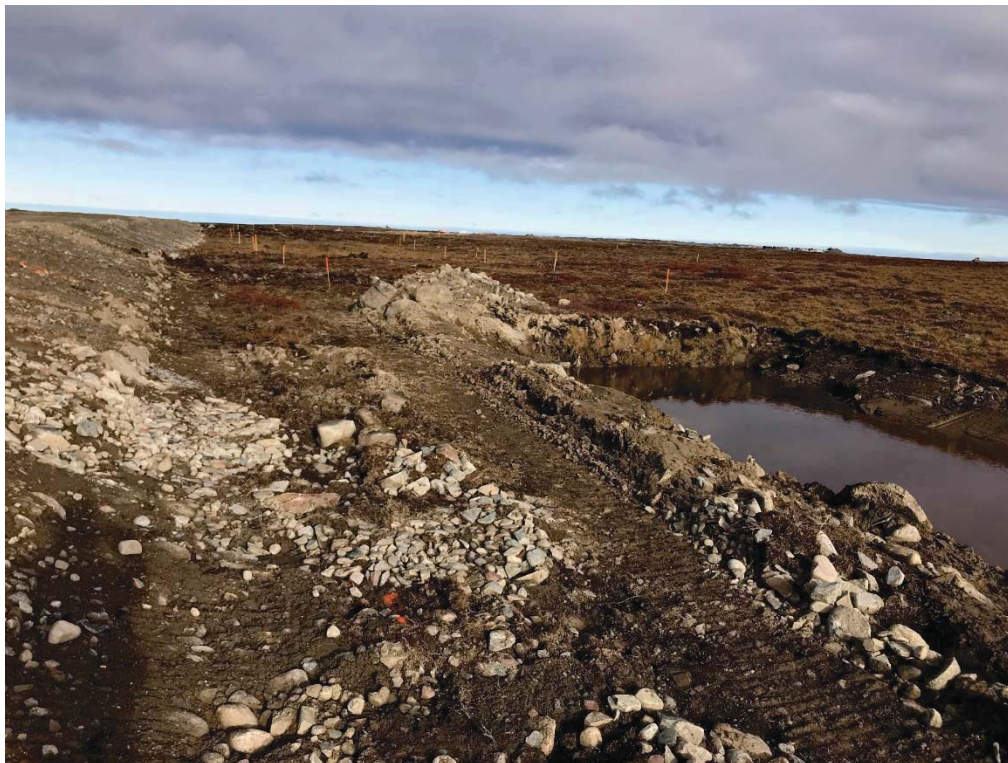
Channel 3 was inspected by walking from the start of the channel at the east end to the northwest end. Most of the construction of Channel 3 had been recently completed at the time of the inspection, except the northwest section (Photograph 66). A selection of photos from the inspection are included in Appendix A2 (Photographs 63 through 66). The access road to the future location of CP3 runs along the western boundary of Channel 3 (Photograph 64 and 65). Water was ponded in the northwestern section of the channel which is the lowest elevation and close to the outlet to CP3. No geotechnical concerns associated with Channel 3 were identified.

Photograph 66: Channel 3, Alignment of Remaining Construction Looking West from the West end of the Completed Channel (13 September 2018)

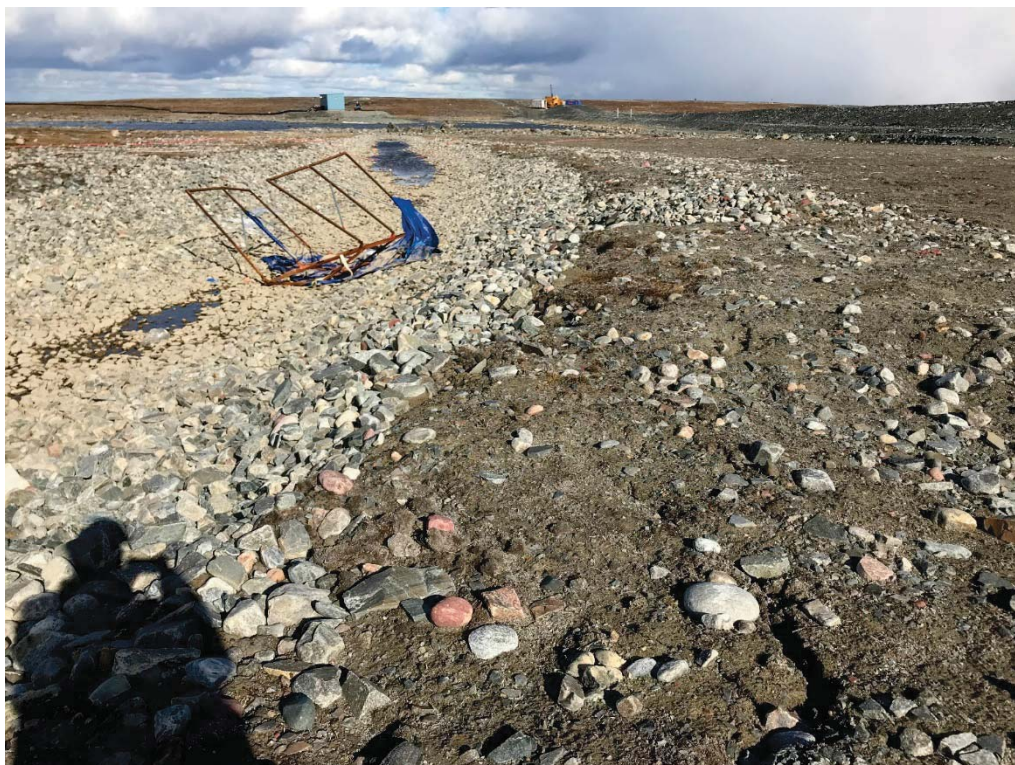
Channel 5 was inspected by walking the southern crest from near the northwestern end of the channel to the outlet near CP5. A selection of photos from the inspection are included in Appendix A2 (Photographs 67 to 71). Overall Channel 5 appeared stable, with no significant geotechnical concerns identified. There was some cracking observed adjacent to Channel 5 (Photographs 67 and 71, Appendix A2). The most substantial cracking was observed at the northwestern end of the channel where lakes H12 and H13 were located. Water was ponded within the channel in this area (Photograph 71). There was some shallow ponding of water in the channel near the outlet to CP5 and near station 0+220.

Photograph 67: Channel 5, Looking Northeast from Near Station 0+250 (12 September 2018)
