2018 Annual Geotechnical Inspection

Meliadine Gold Project, Rankin Inlet, Nunavut

Golder Associates Ltd.

Reference No. 18105719-002-R-Rev0-3000

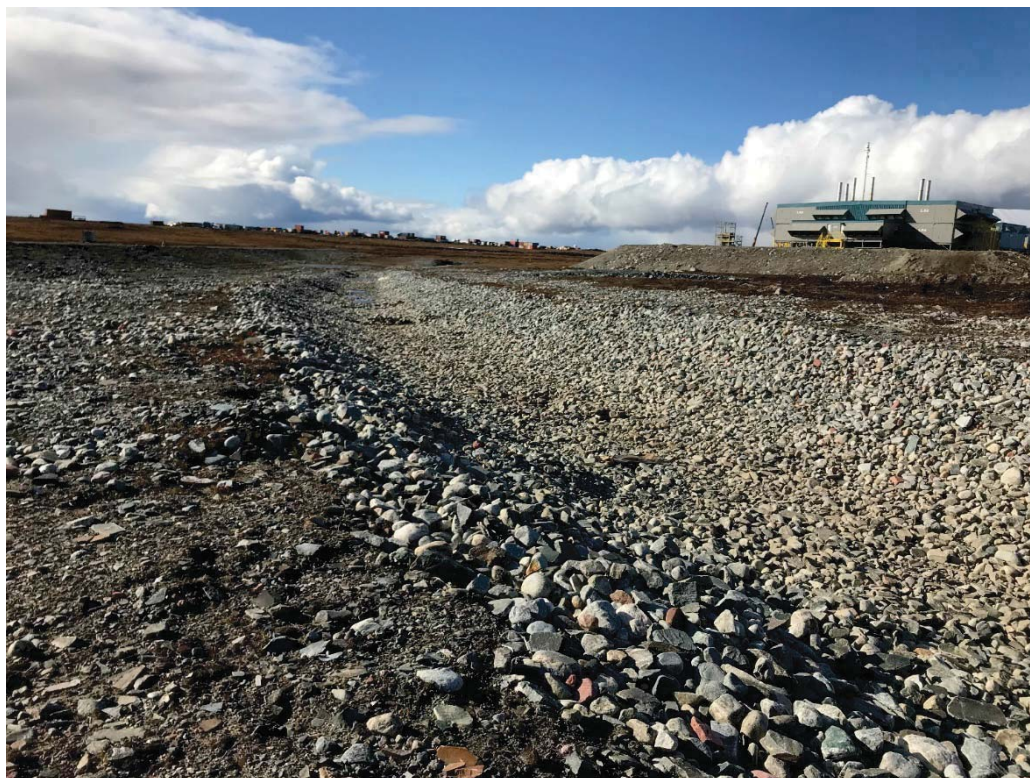
Photograph 68: Channel 5, Looking West from Near Station 0+250

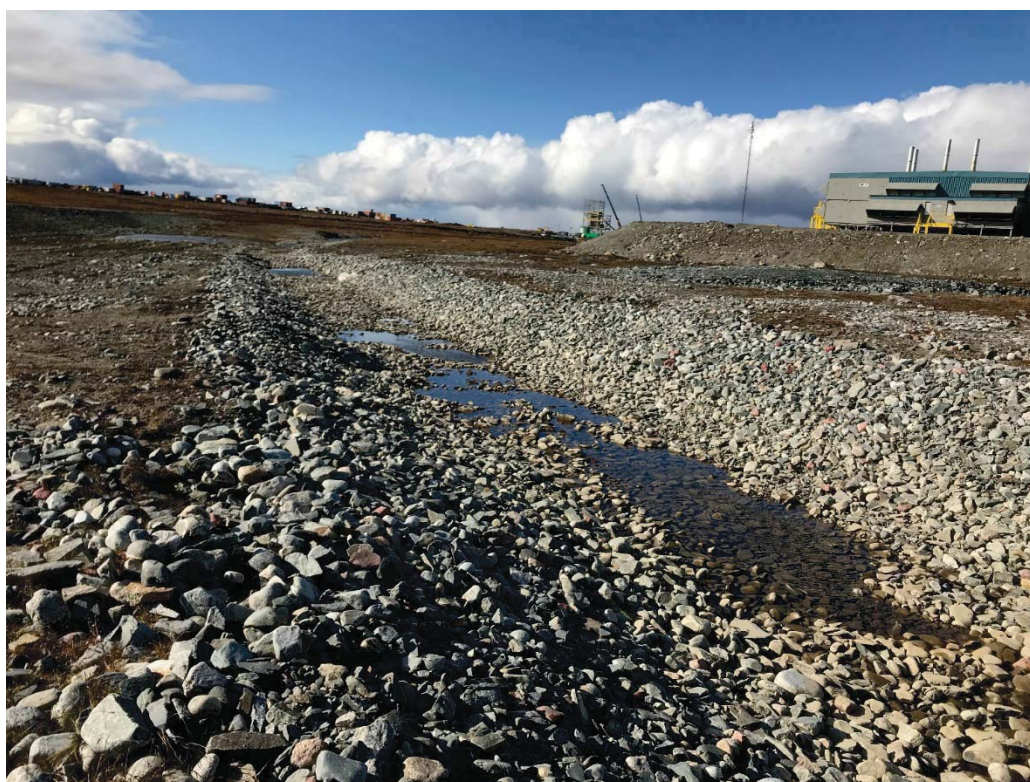
Channel 5 was inspected by walking the southern crest from near the northwestern end of the channel to the outlet near CP5. A selection of photos from the inspection are included in Appendix A2 (Photographs 67 to 71). Overall Channel 5 appeared stable, with no significant geotechnical concerns identified. There was some cracking observed adjacent to Channel 5 (Photographs 67 and 71, Appendix A2). The most substantial cracking was observed at the northwestern end of the channel where lakes H12 and H13 were located. Water was ponded within the channel in this area (Photograph 71). There was some shallow ponding of water in the channel near the outlet to CP5 and near station 0+220.

Photograph 69: Channel 5, Looking West Near Station 0+220 (12 September 2018)

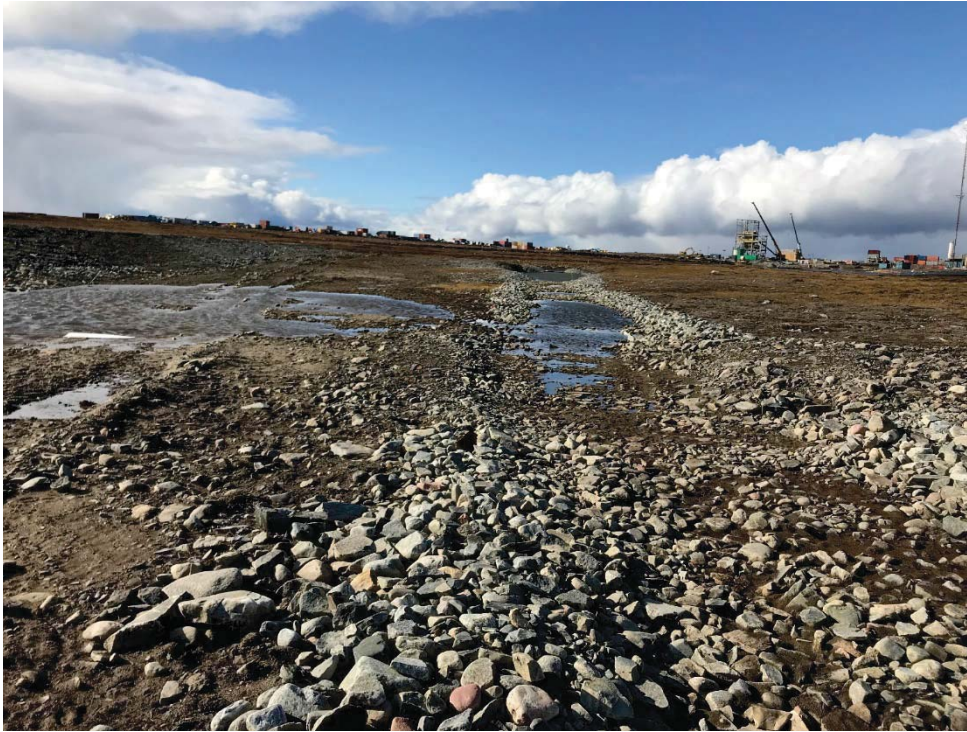
Photograph 70: Channel 5, Looking West Near Station 0+145. Less Water Poned in this Area Compared to 2017 (12 September 2018)

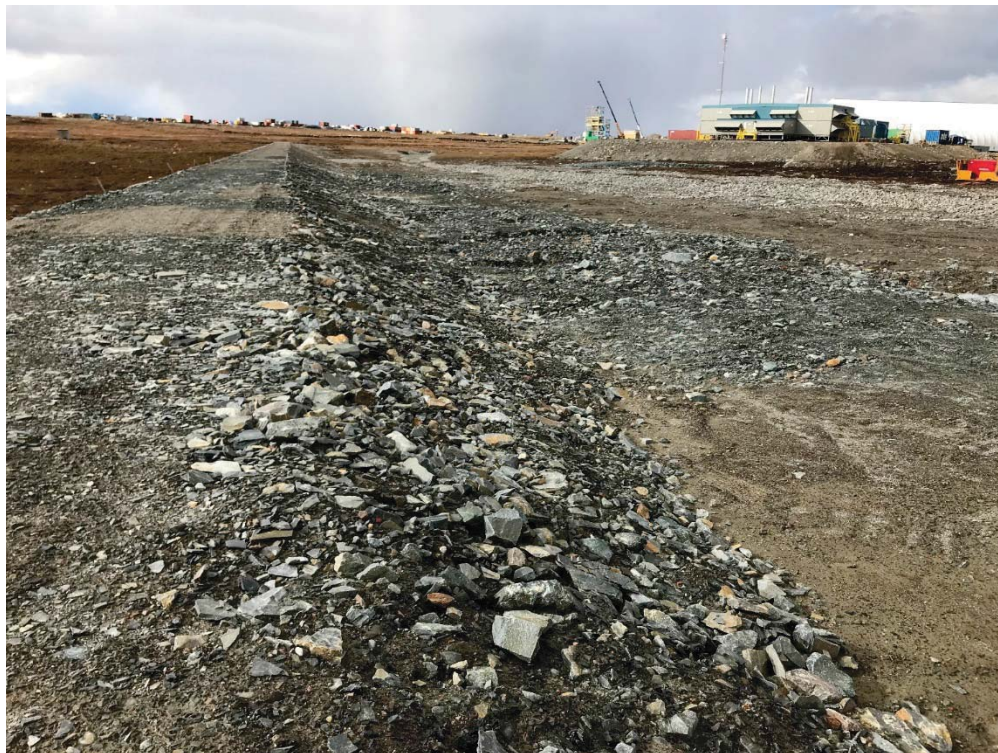
Photograph 72: Berm 3, Upstream Slope and Crest Near Abutment with D-CP5, Looking Northwest (12 September 2018)

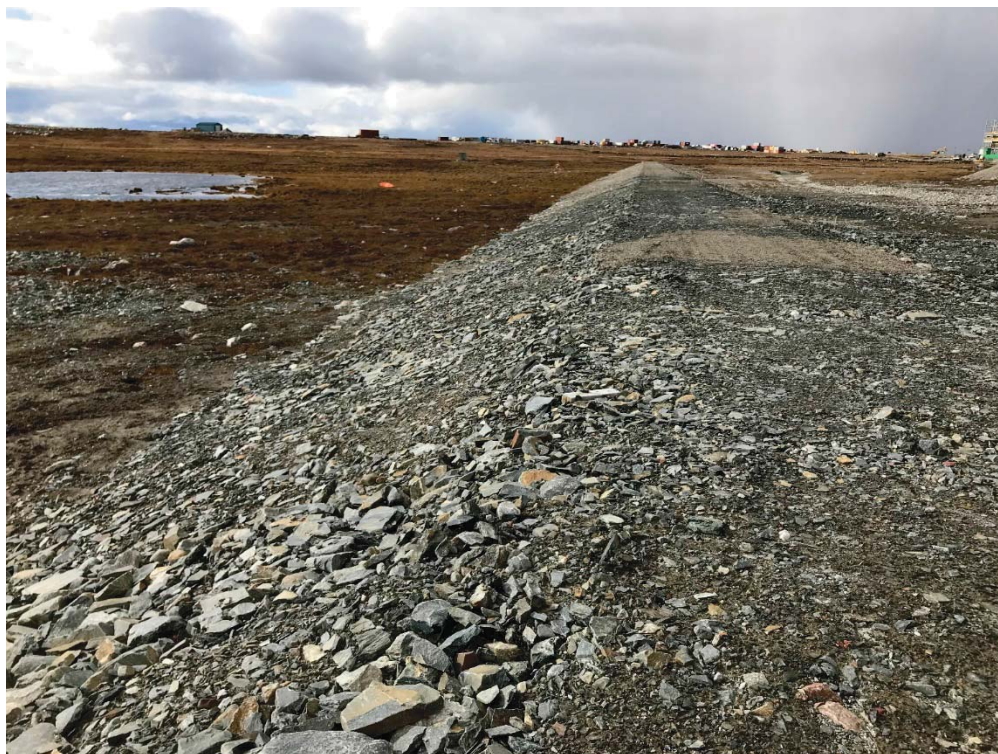
Photograph 73: Berm 3, Downstream Slope and Crest Near Abutment with D-CP5, Looking Northwest (12 September 2018)

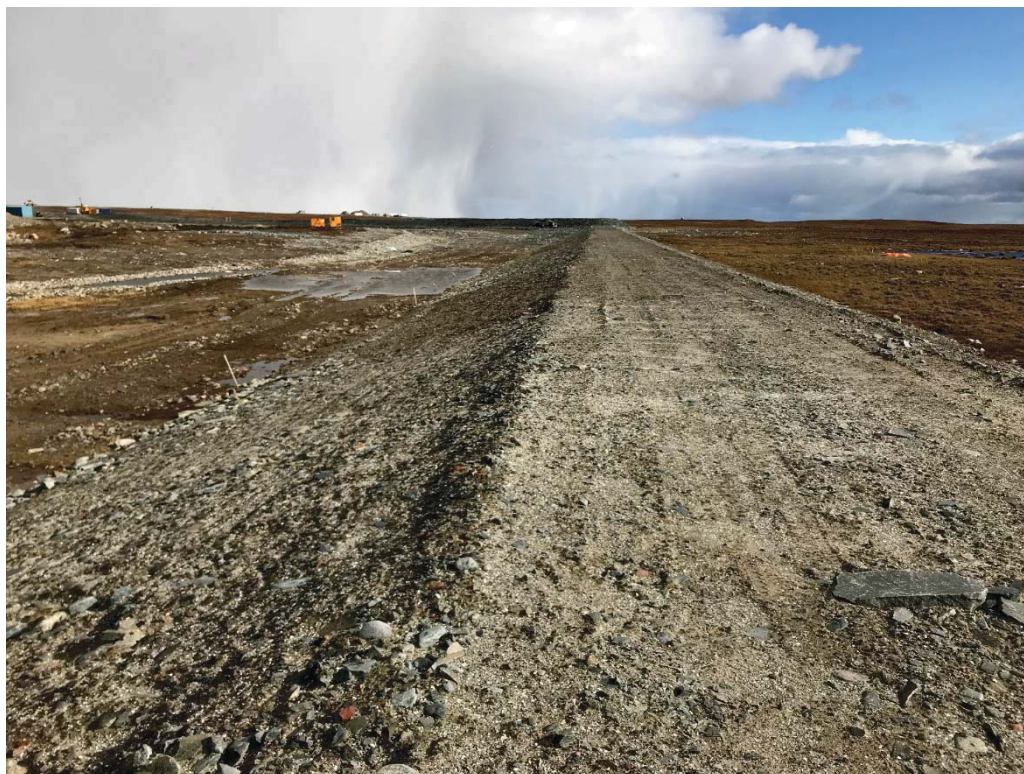
- Overall, Berm 3 appeared stable with no significant geotechnical concerns identified.
- Water was ponding near the upstream toe of Berm 3 near station 0+100 (Photograph 74, Appendix A2).
- Erosion and minor cracking observed on upstream and downstream slopes (e.g., Photographs 76 to 78).
- Water was ponded over the tundra in some areas downstream of the dam, but there was no seepage observed from the downstream slope.

Photograph 74: Berm 3, Upstream Slope and Crest Near Station 0+060, Looking Southeast (12 September 2018)

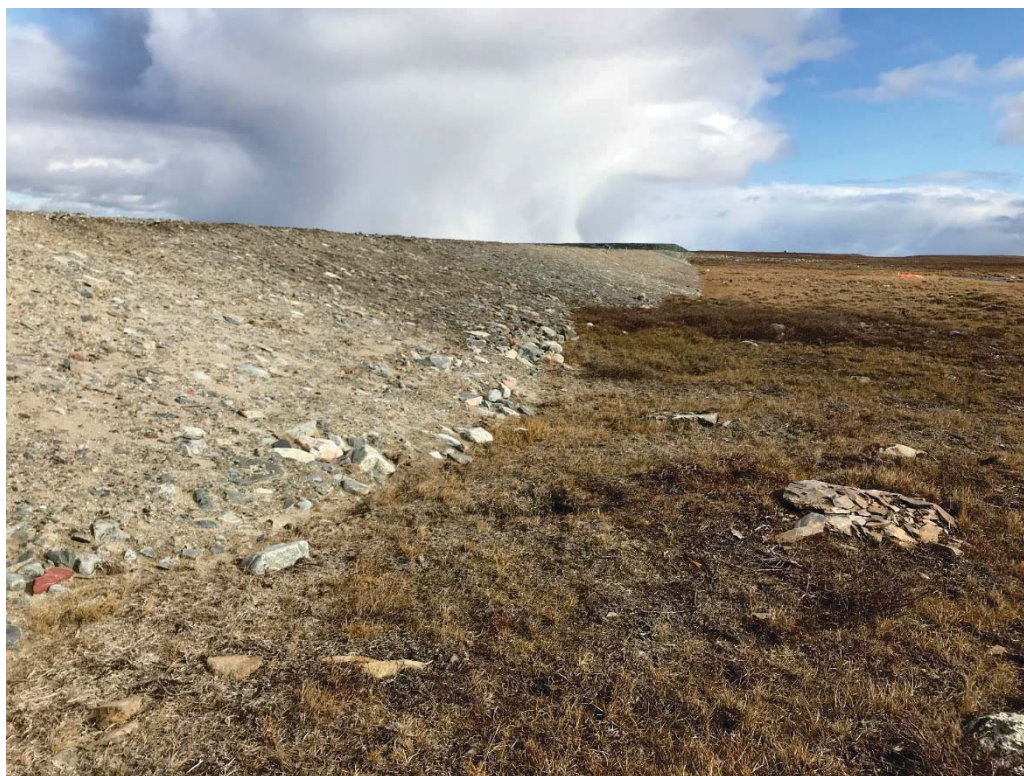
Photograph 75: Berm 3, Downstream Slope and Crest Near Station 0+060, Looking Southeast (12 September 2018)
