APPENDIX A-3

Site Roads, Culverts, and
Tiriganiaq and Wesmeg Areas

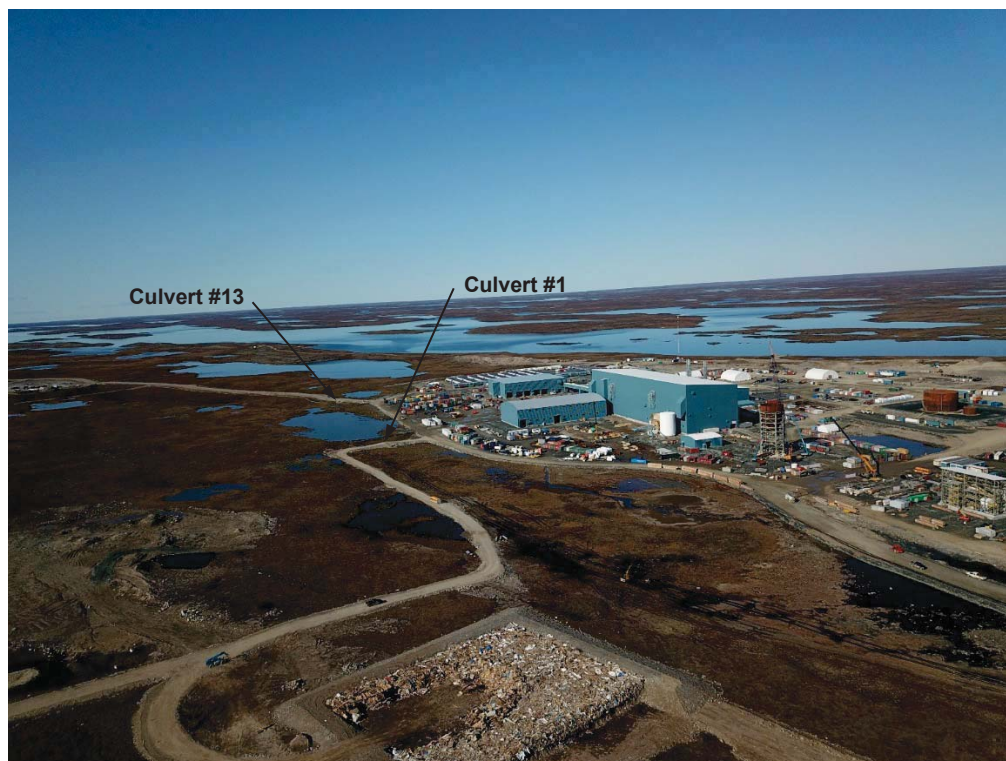
Photograph 1: Overview of Location of Culvert #1 (AEM Drone Photo 1 September 2018)

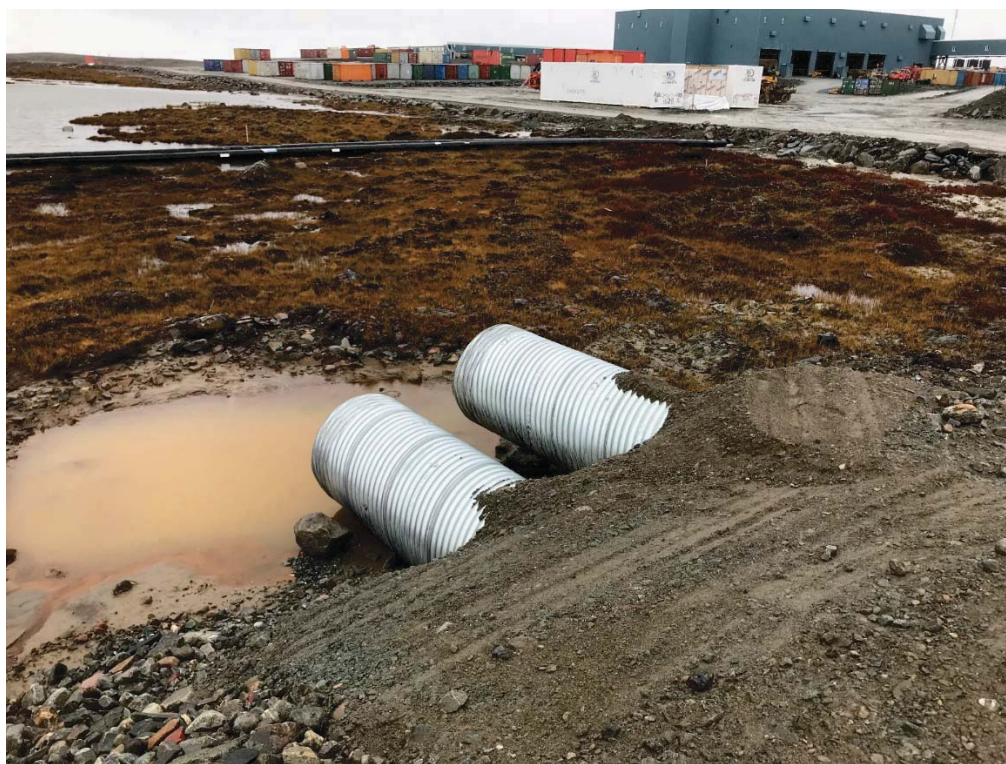
Photograph 2: Culvert #1, Upstream Ends of Culverts, Looking Northeast (11 September 2018)

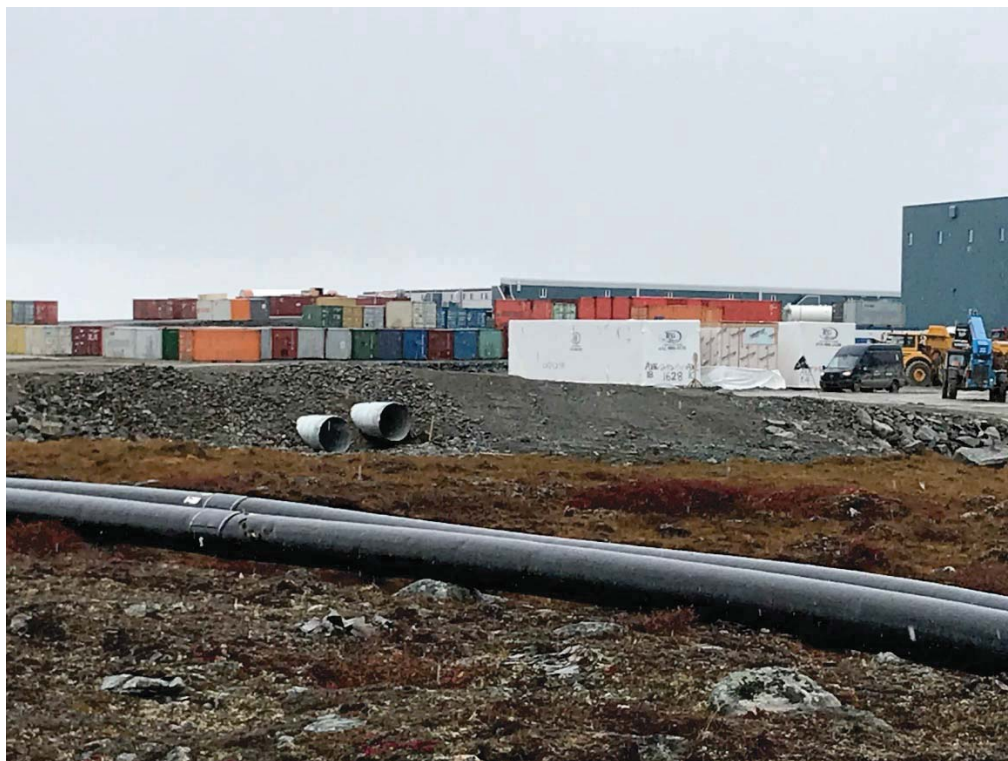
Photograph 3: Culvert #1, Downstream Ends of Culverts, Looking Northeast (11 September 2018)

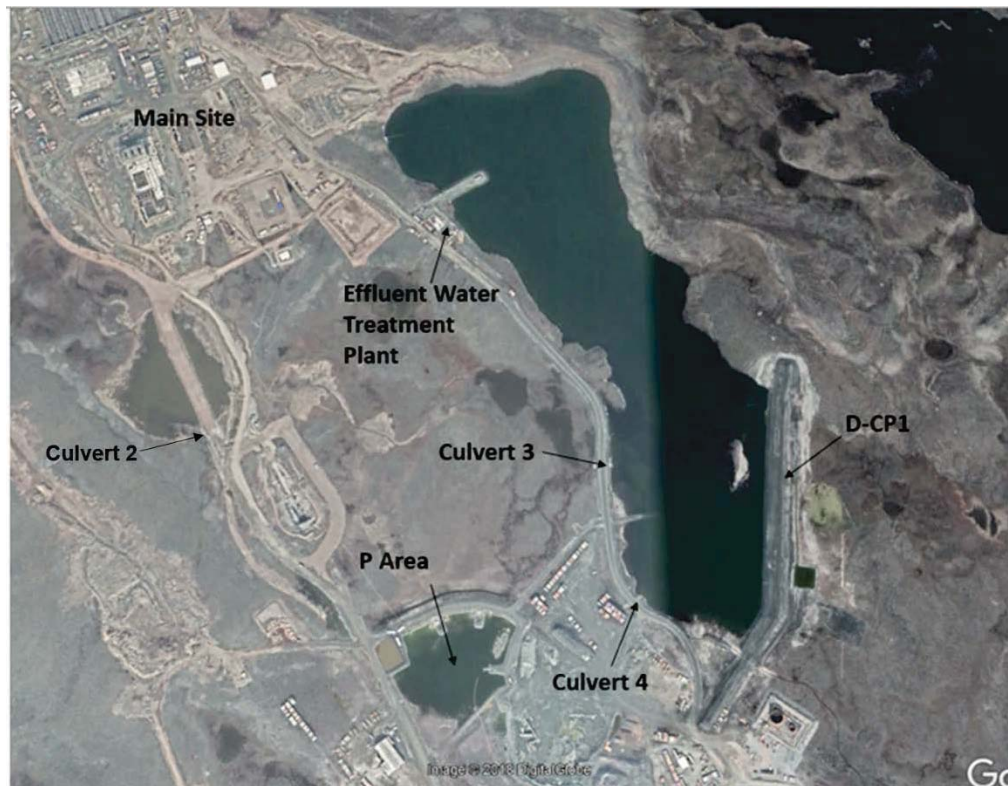
Photograph 4: Overview Showing Locations of Culverts #2, 3 and 4, Google Earth Image (August 2017)

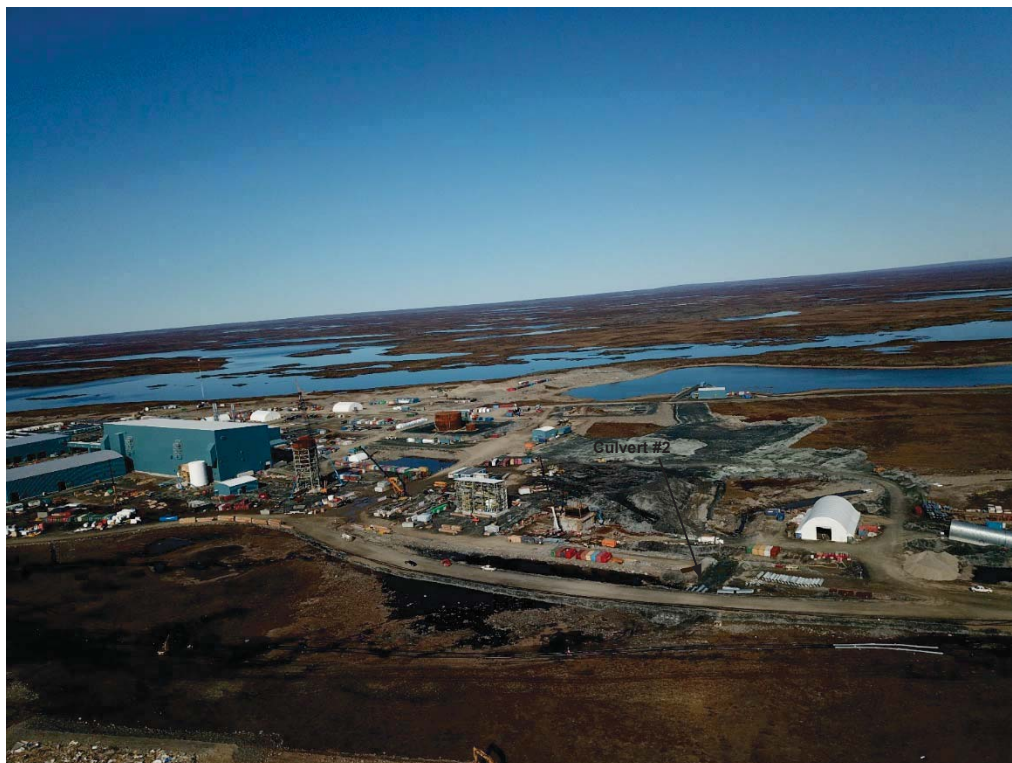
Photograph 5: Areal Photo of Main Site, Service Road and Culvert #2 Shown in Foreground (AEM Drone Photo 1 September 2018)

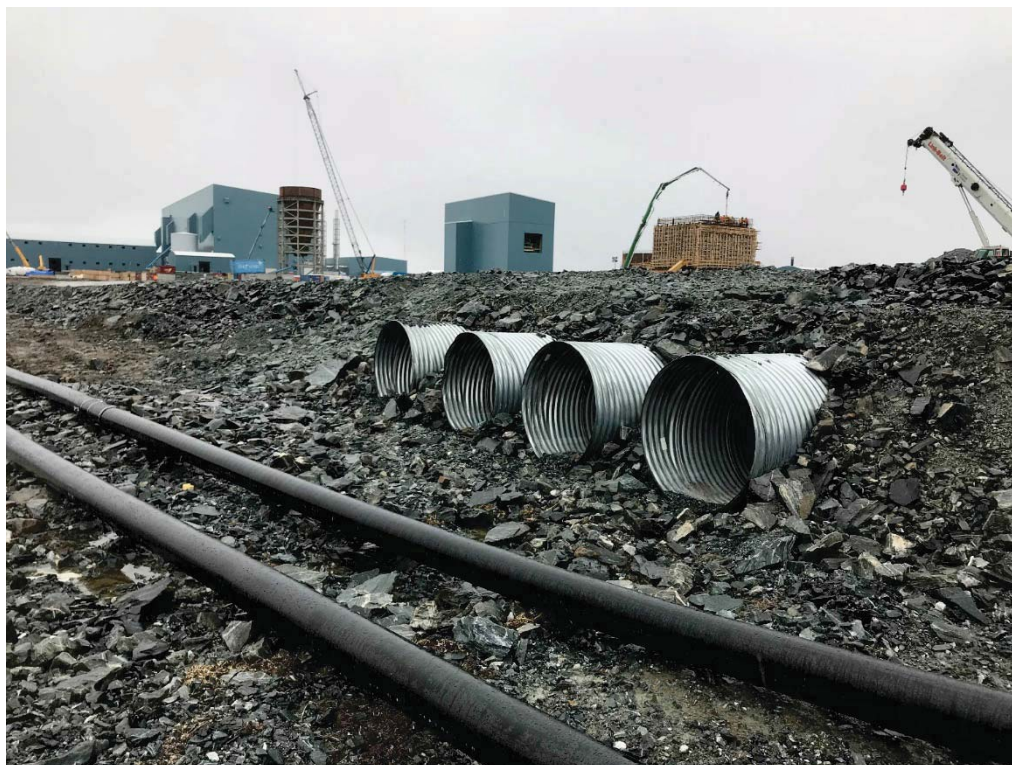
Photograph 6: Culvert #2, Upstream Ends of Culverts, Looking Northeast (12 September 2018)

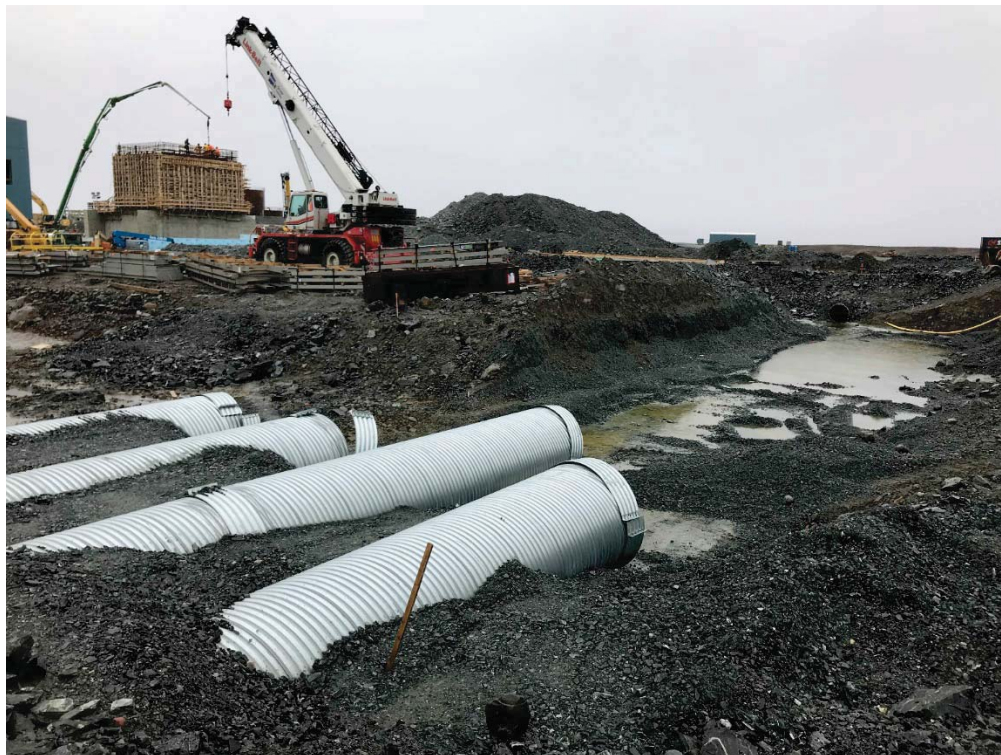
Photograph 7: Culvert #2, Downstream Ends of Culverts, Looking Southeast. Temporary Culvert in background. Culvert #2 to be Extended and Will Connect with Channel #1 (12 September 2018)

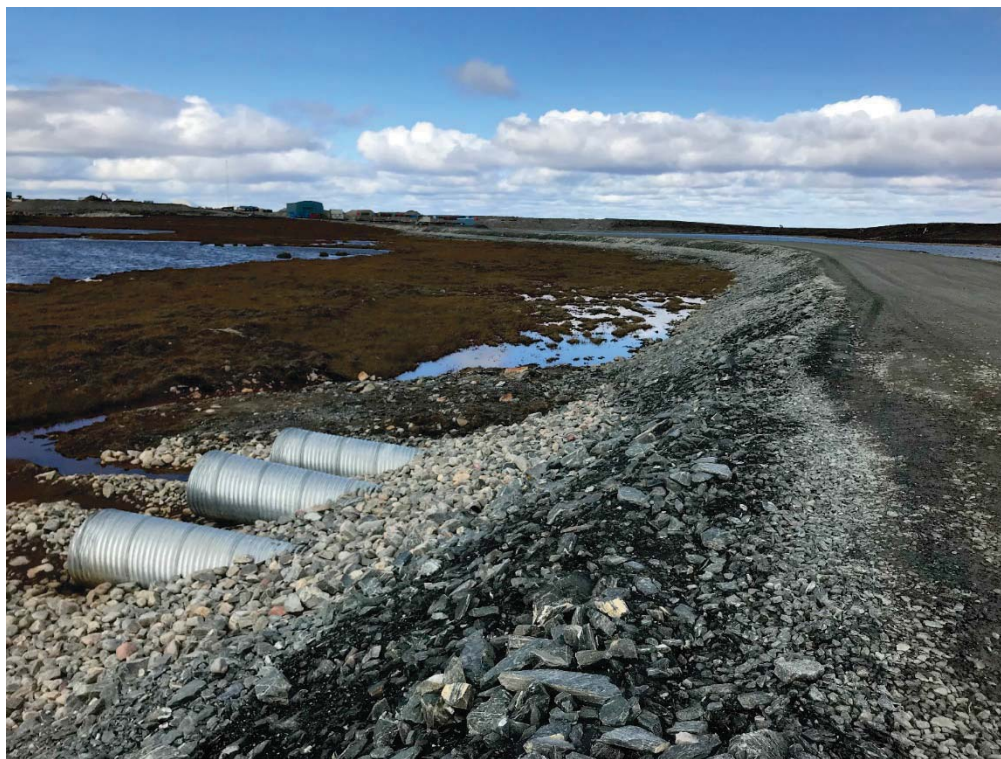
Photograph 8: Culvert #3, Upstream Ends of Culverts, Looking North. Service Road on Right (12 September 2018)

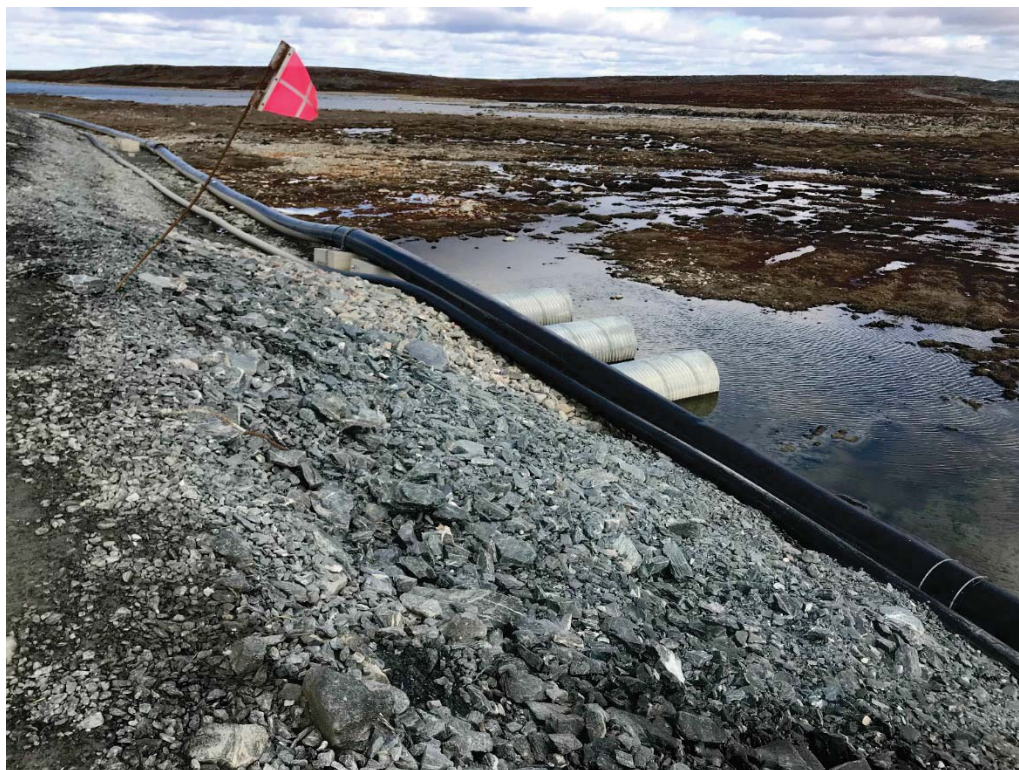
Photograph 9: Culvert #3, Downstream Ends of Culverts into CP1, Looking Northeast (12 September 2018)

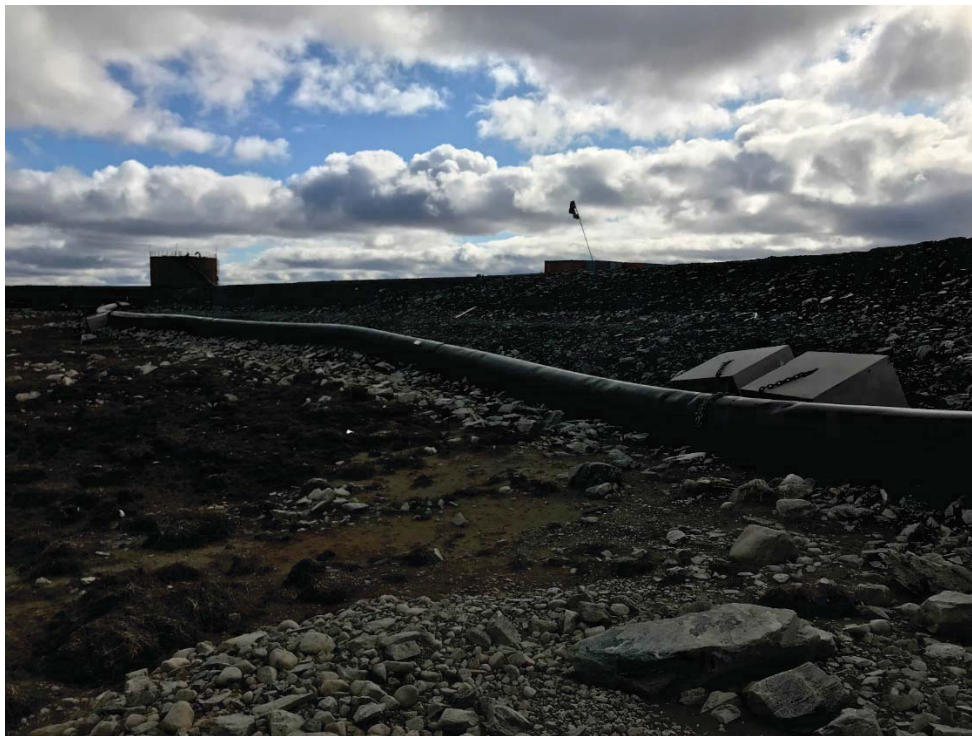
Photograph 13: Site Road, South of Culvert #4, Looking South (12 September 2018)

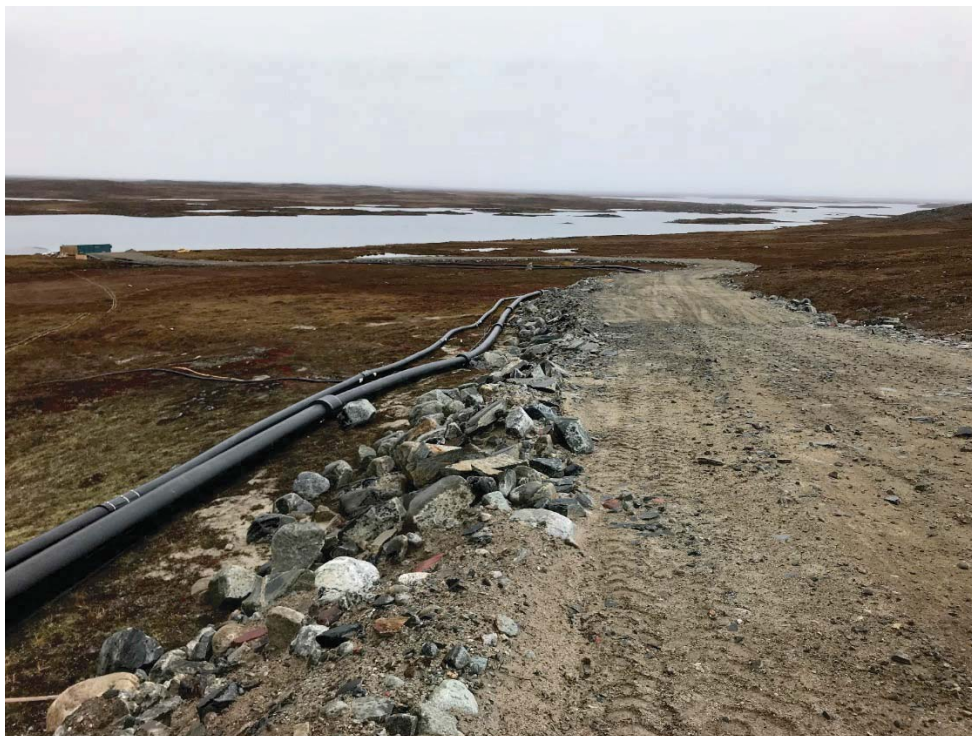
Photograph 14: Main Camp Water Intake, Access Road, Looking Southeast (11 September 2018)

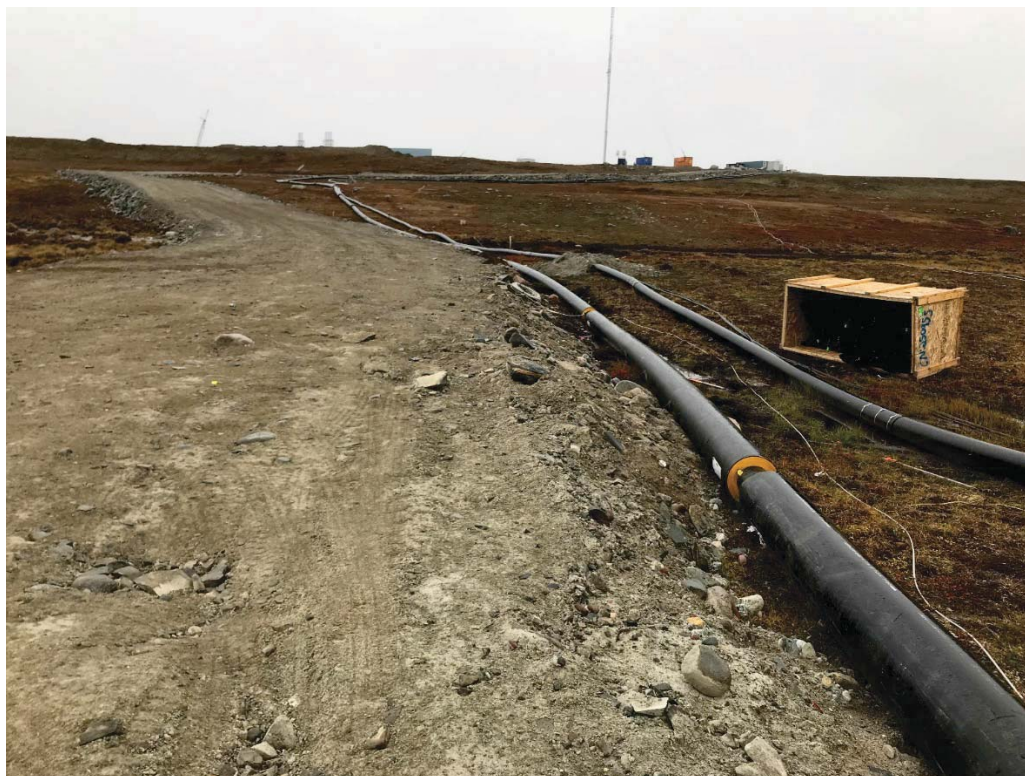
Photograph 15: Main Camp Water Intake, Access Road, Looking Southwest (11 September 2018)

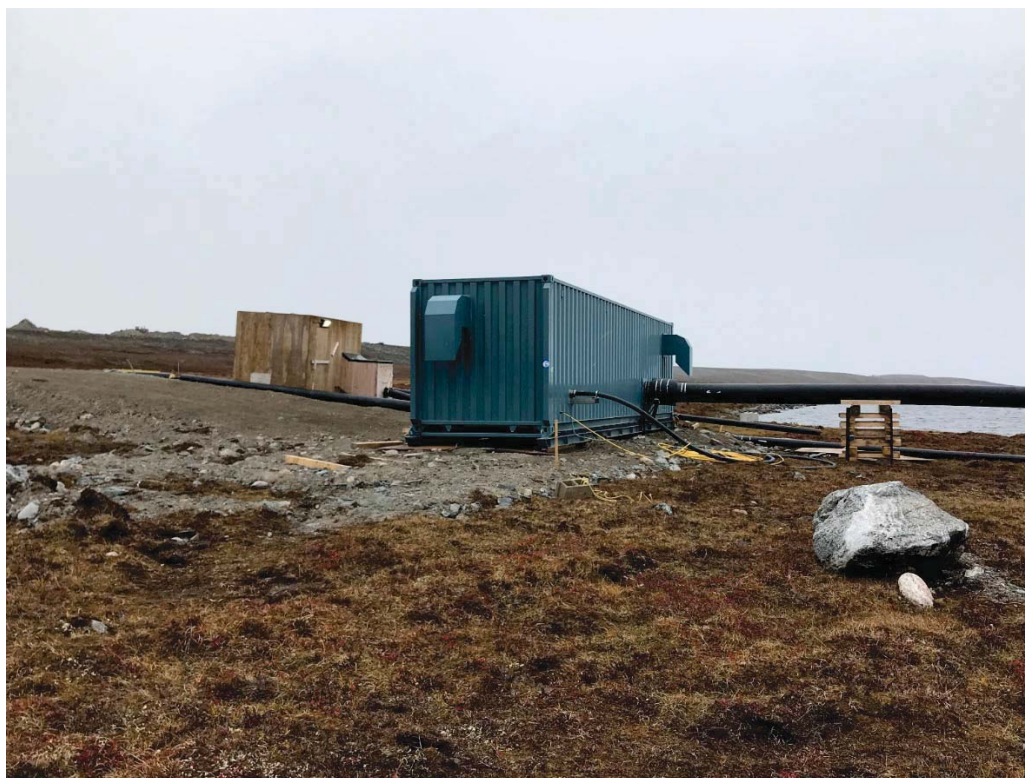
Photograph 16: Main Camp Water Intake, Pump Shack, Looking Northwest (11 September 2018)

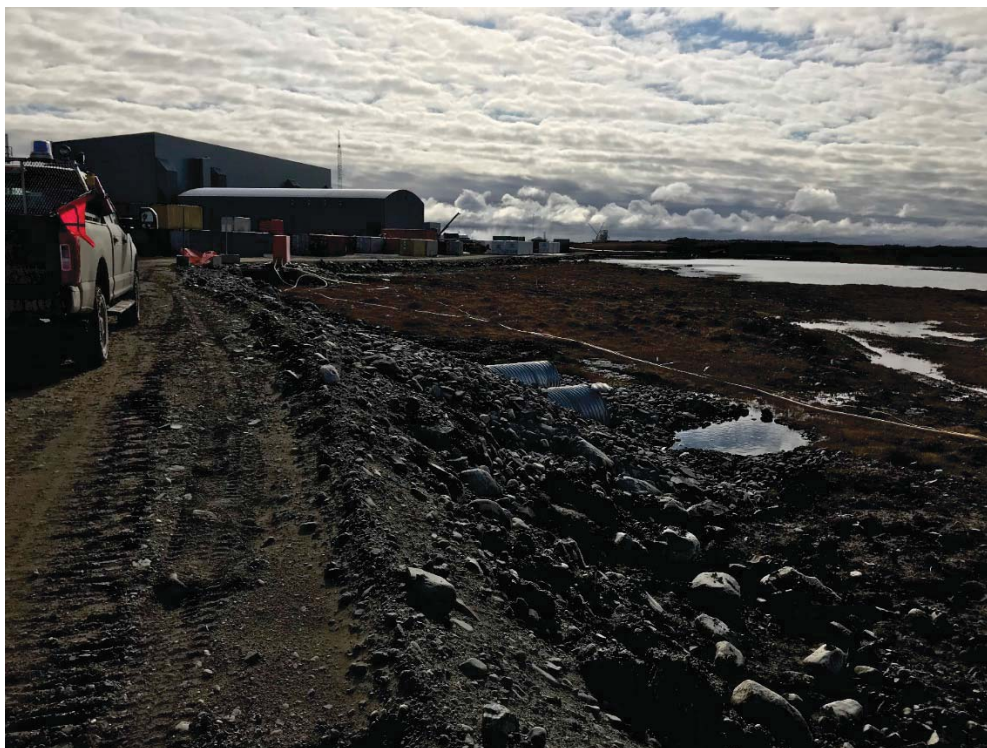
Photograph 18: Emulsion Plant Access Road, Downstream Ends of Culvert #13 Near H15E (14 September 2018)

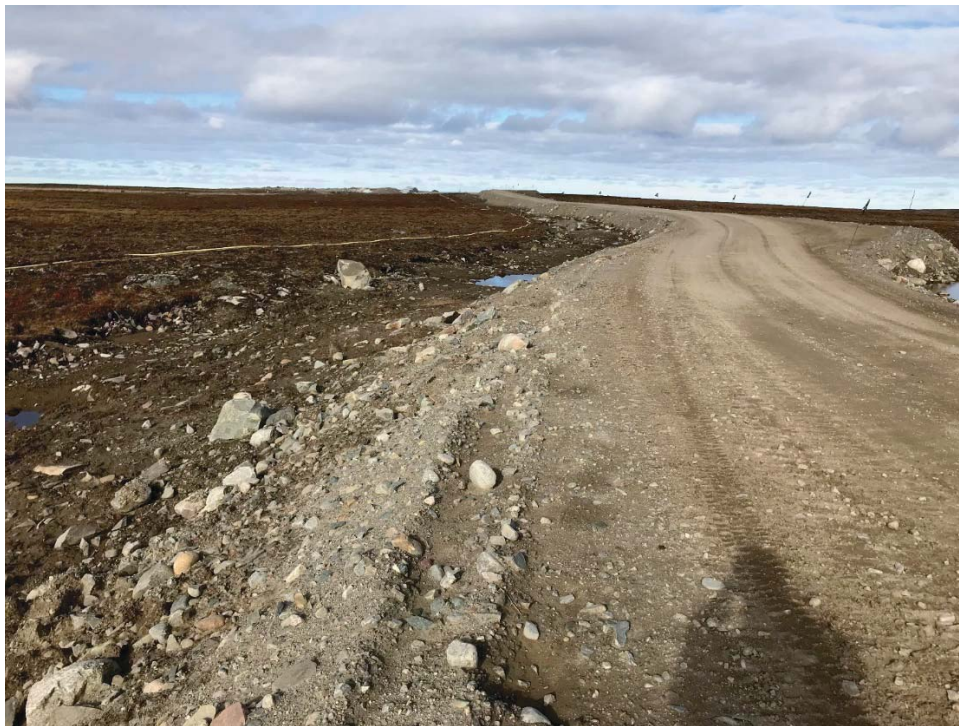
Photograph 19: Emulsion Plant Access Road, Looking Northwest from South End of Road Near Culvert #13 (14 September 2018)

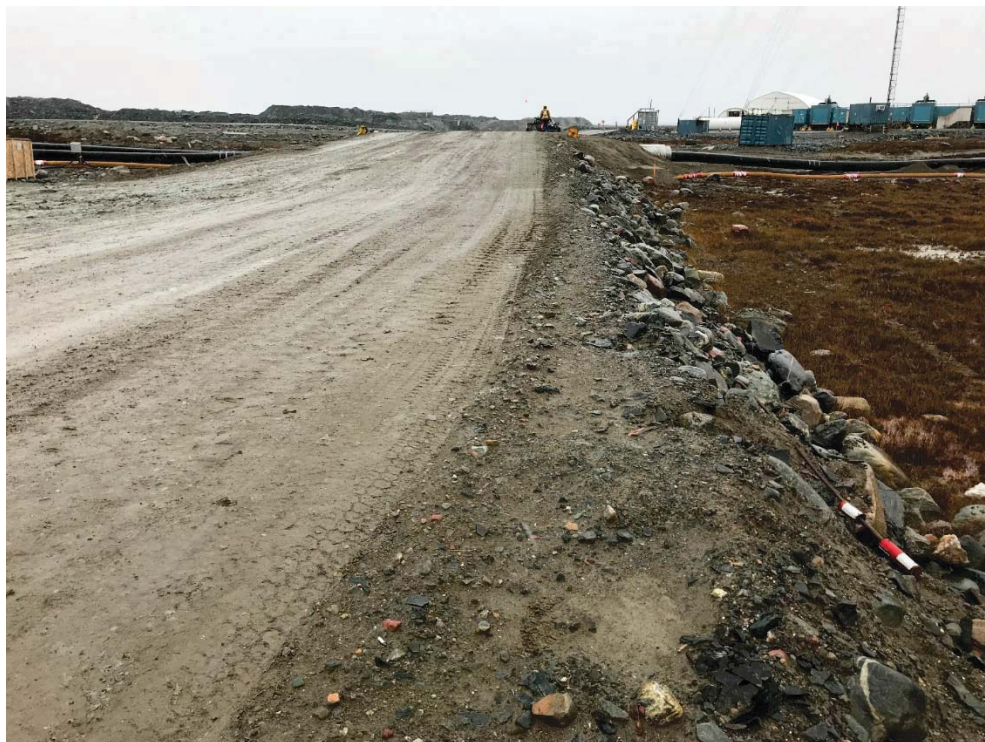
Photograph 24: Tiriganiaq Access Road, Looking East (11 September 2018)

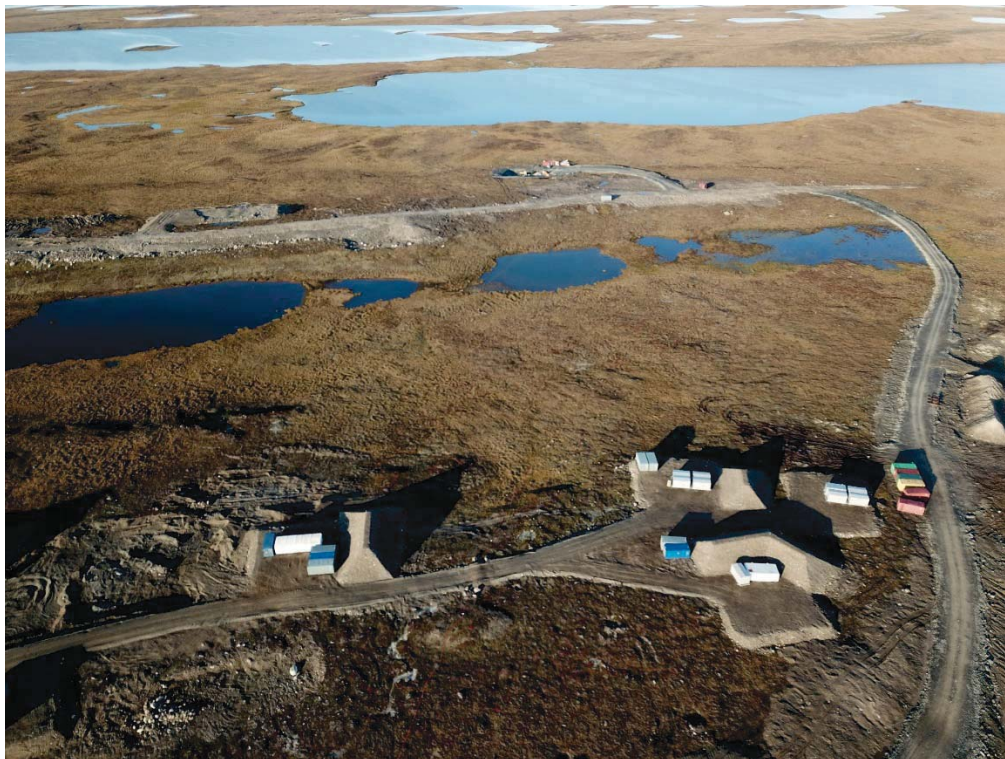
Photograph 25: Overview of Magazine Storage Area, Wesmeg Access Road, Vent Raise, and Borrow Area (AEM Drone Photo 1 September 2018)

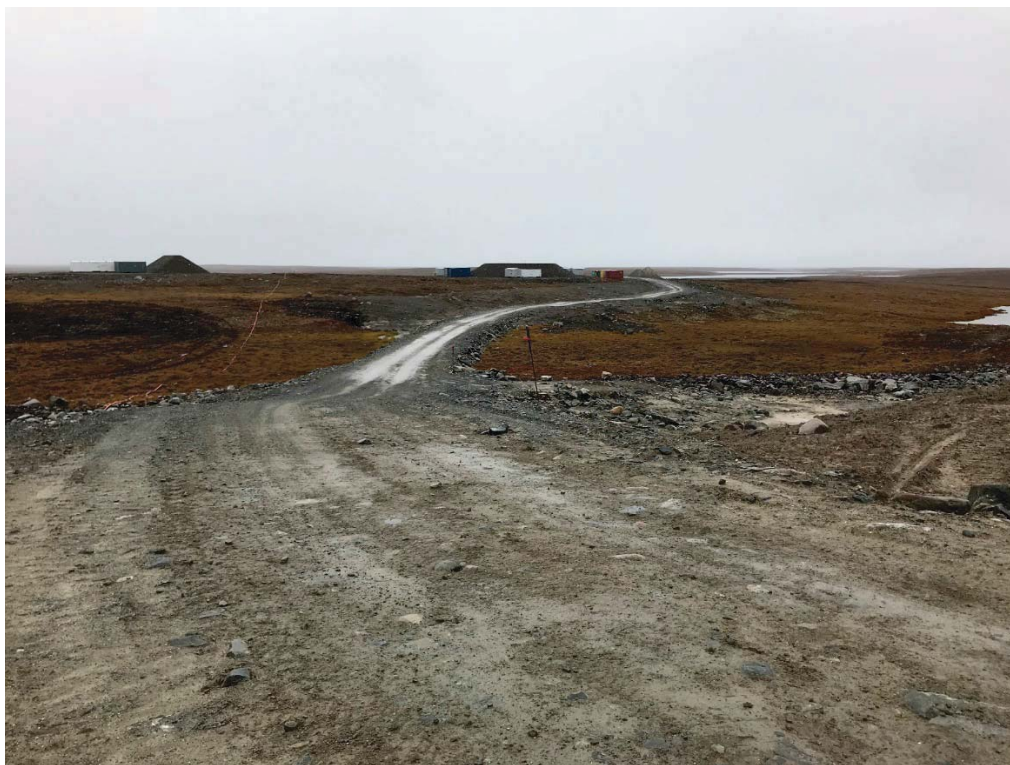
Photograph 26: Wesmeg Access Road, Looking West from Near Tiriganiaq Esker (11 September 2018)

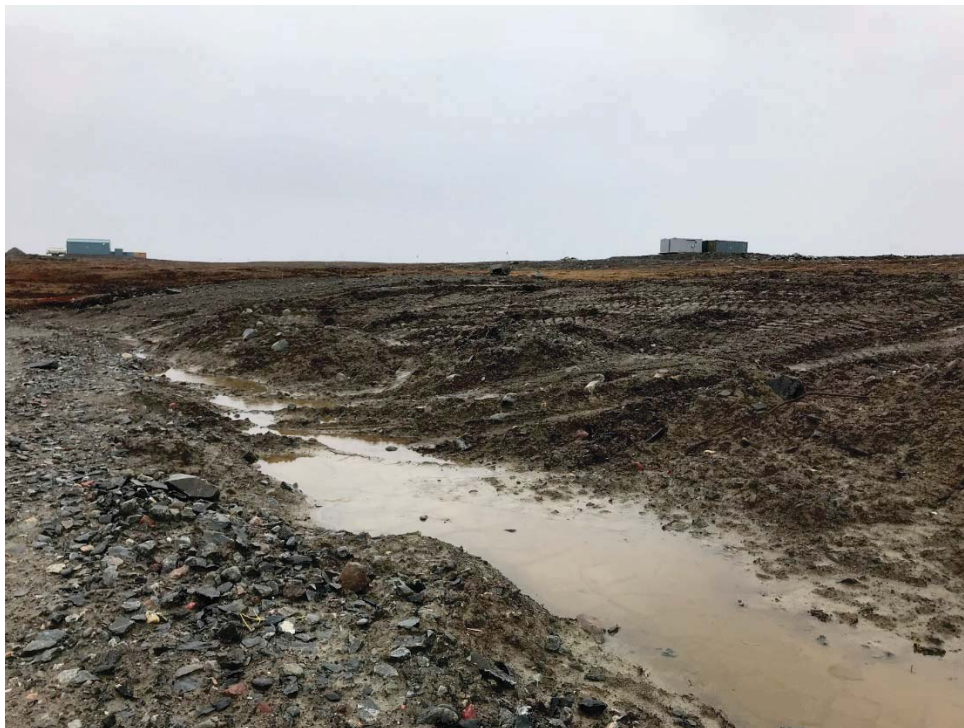
Photograph 27: Wesmeg Access Road Near Magazine Storage Area. Ponding Water and Disturbed Tundra (11 September 2018)

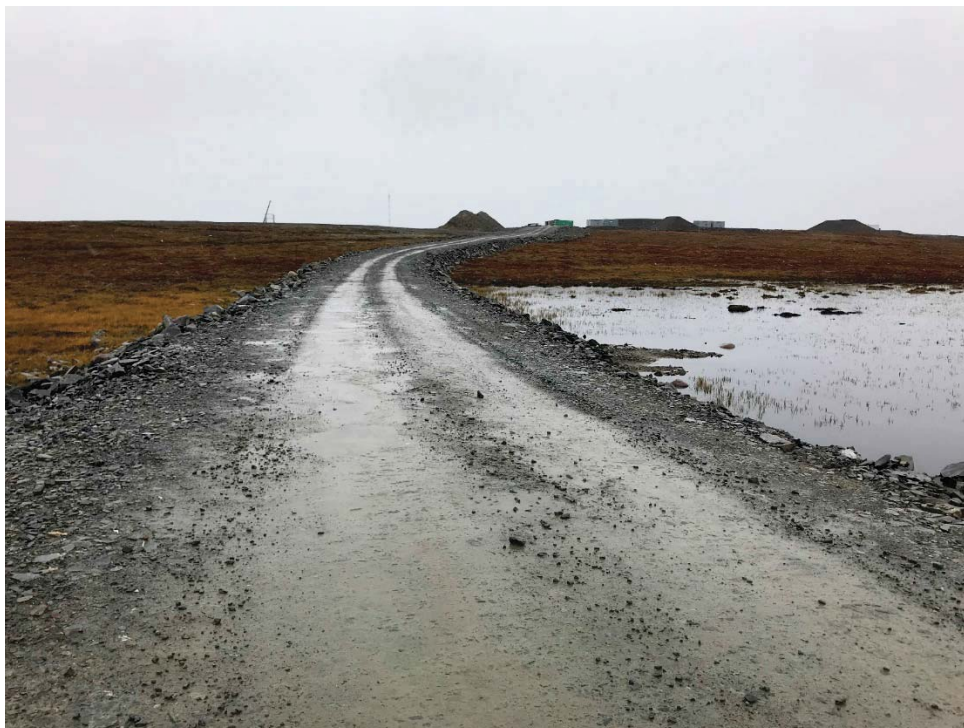
Photograph 28: Wesmeg Access Road, Water Ponded on South Side of Road (Lake B33A), Looking East (11 September 2018)

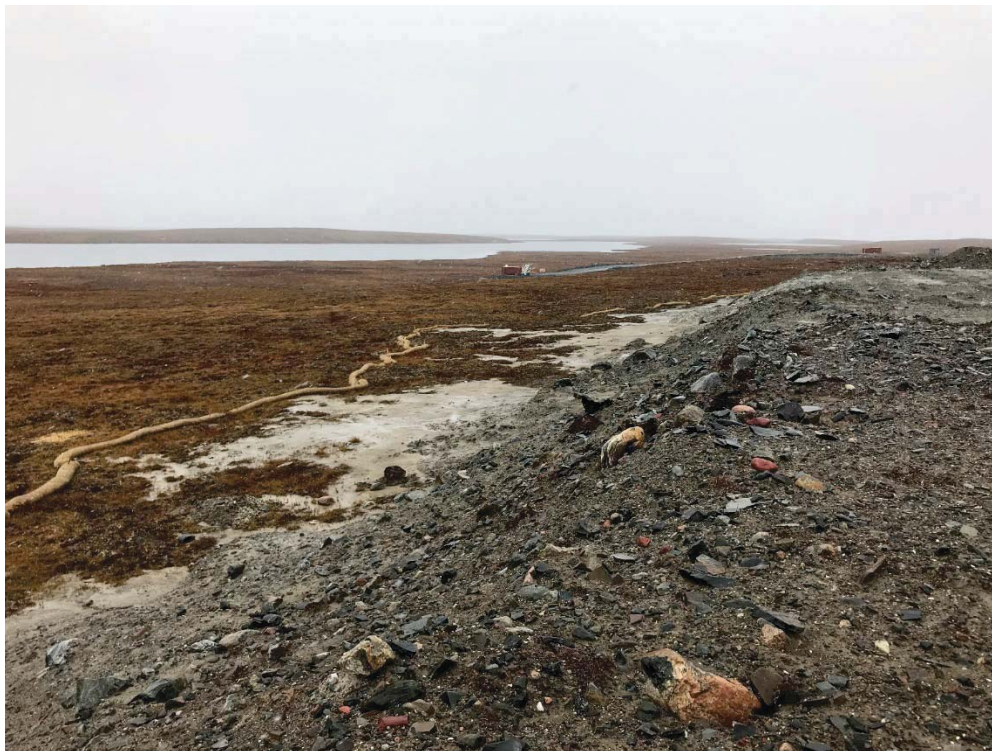
Photograph 29: Wesmeg Borrow, Erosion Along Western Toe, Looking North (11 September 2018)

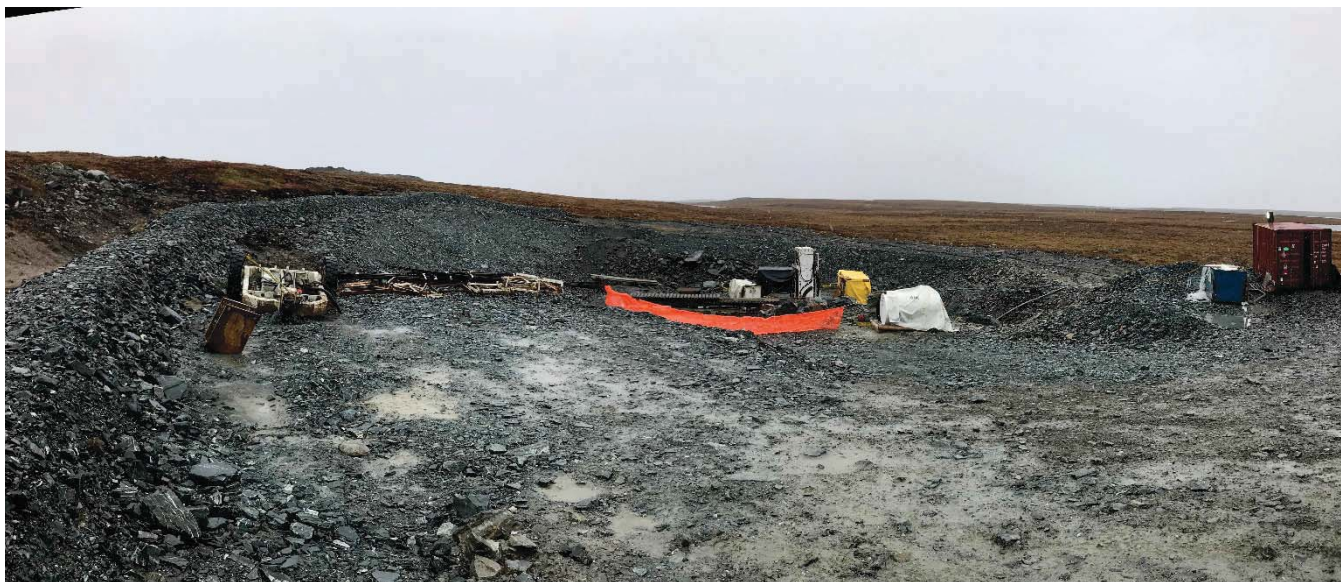
Photograph 30: Wesmeg Vent Raise Area (11 September 2018)

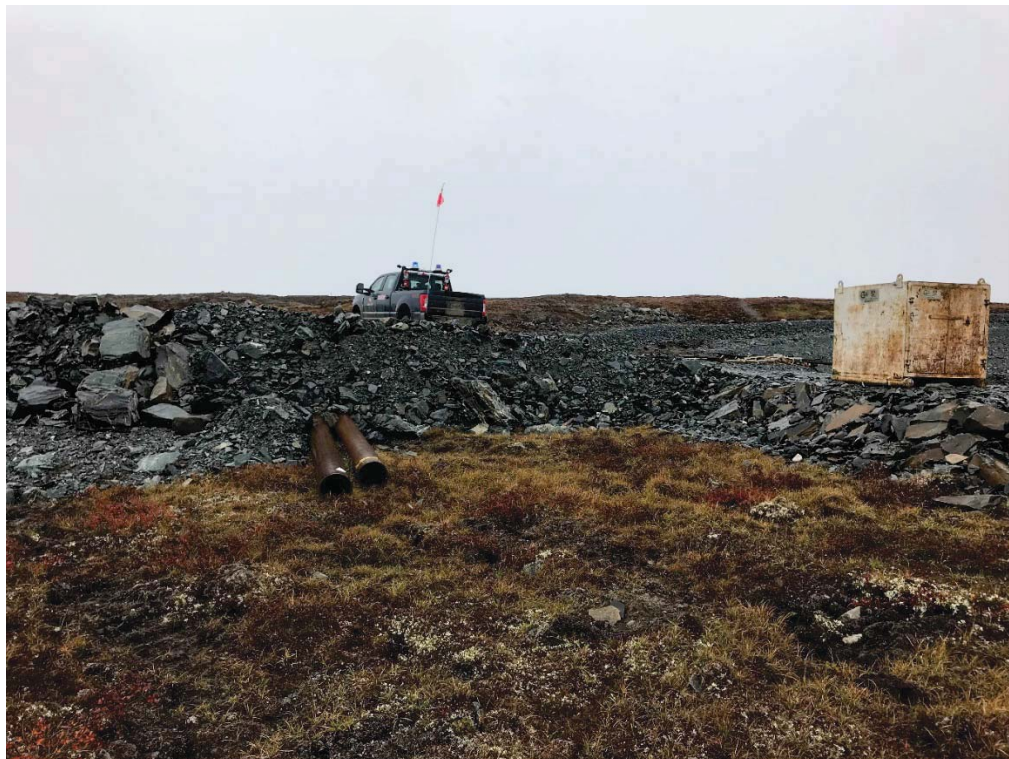
Photograph 31: Wesmeg Vent Raise, Steel Pipe Culverts Through Entrance to Vent Raise (11 September 2018)

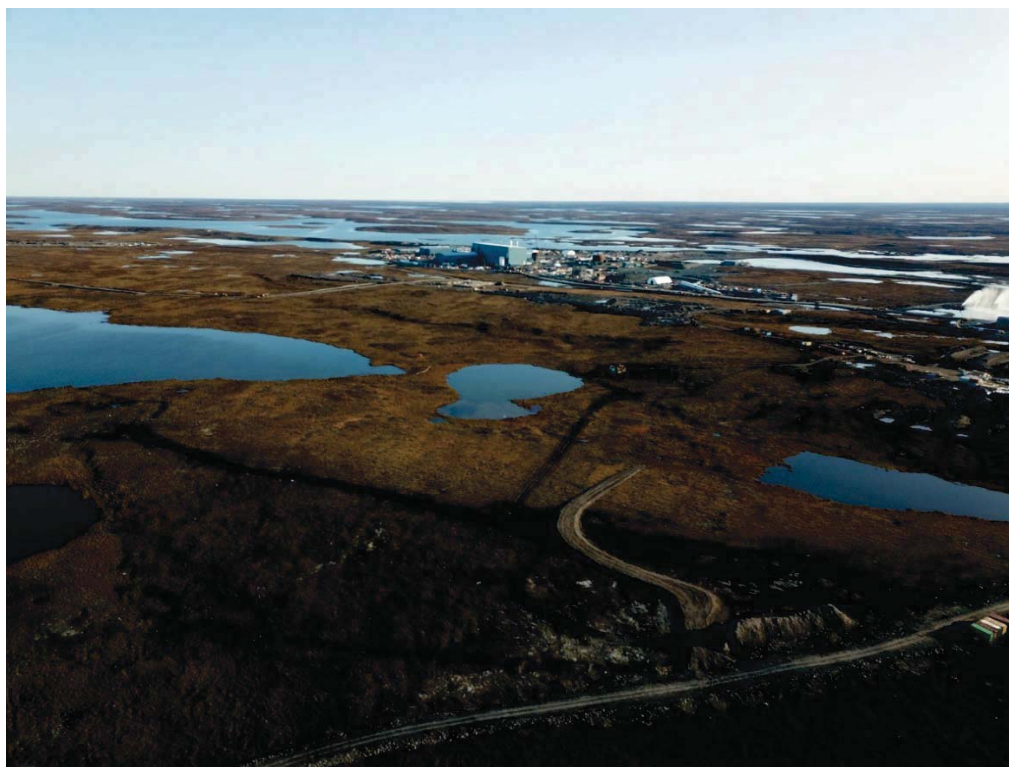
Photograph 32: Overview of Access Road to CP4 (AEM Drone Photo 1 September 2018)

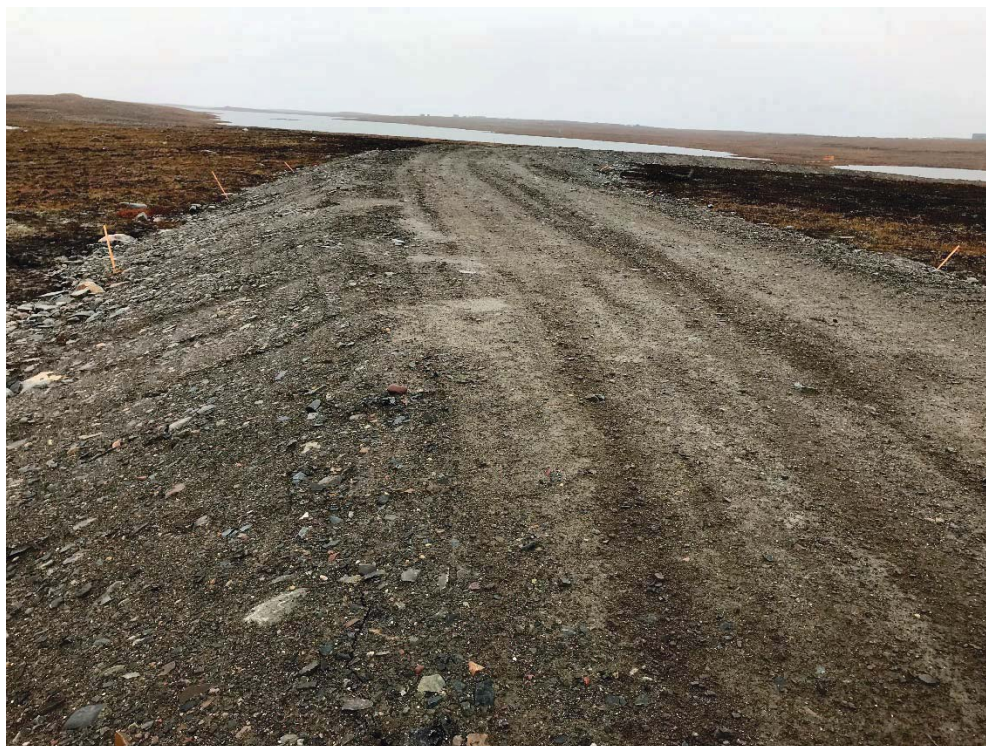
Photograph 33: Access Road to CP4 (11 September 2018)

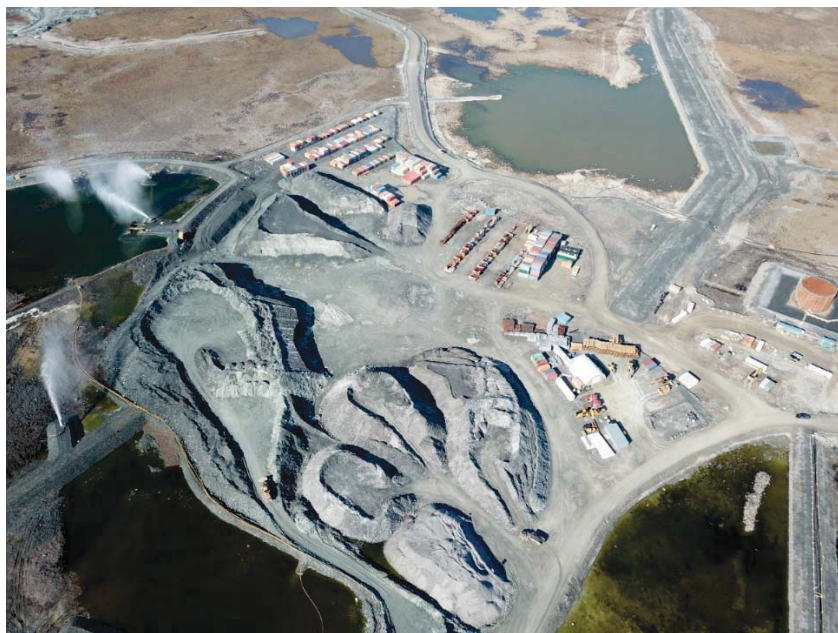
Photograph 1: Overview of Ore and Waste Rock Storage Area (AEM Drone Photo 1 September 2018)

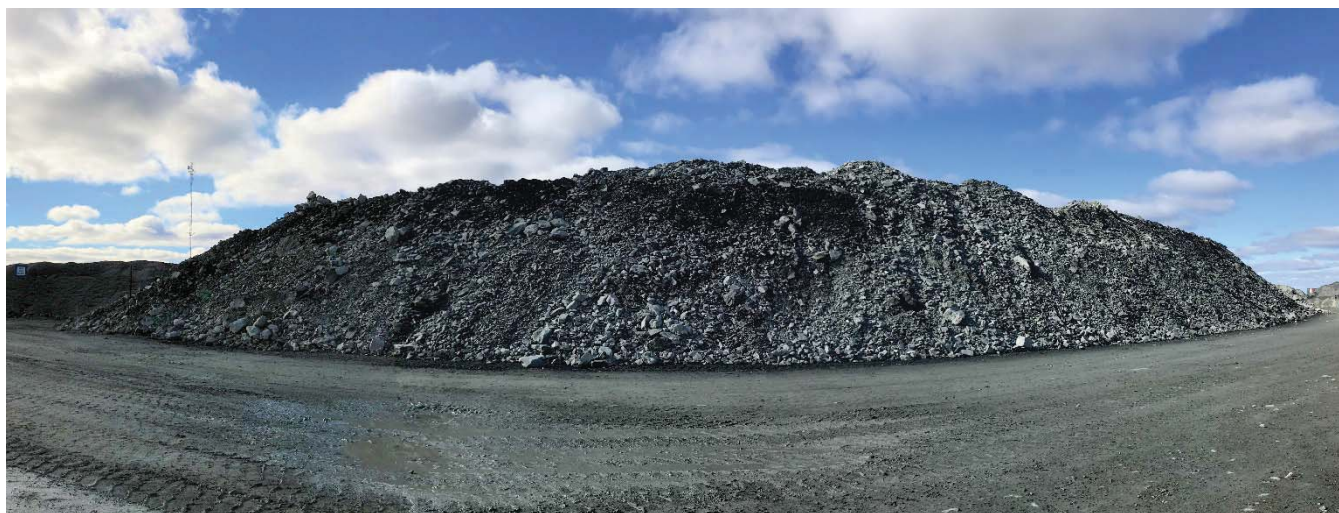
Photograph 2: South Slope of Low Grade Ore Stockpile, Looking North (14 September 2018)

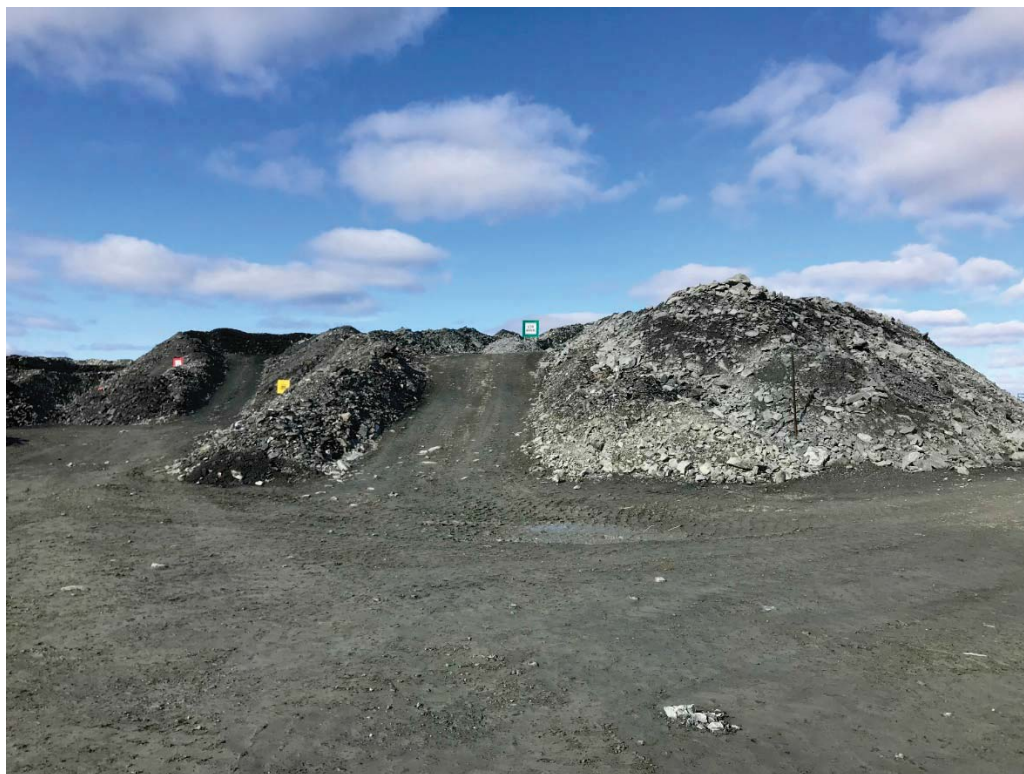
Photograph 3: View of Low and High Grade Ore Stockpiles, Looking North (14 September 2018)

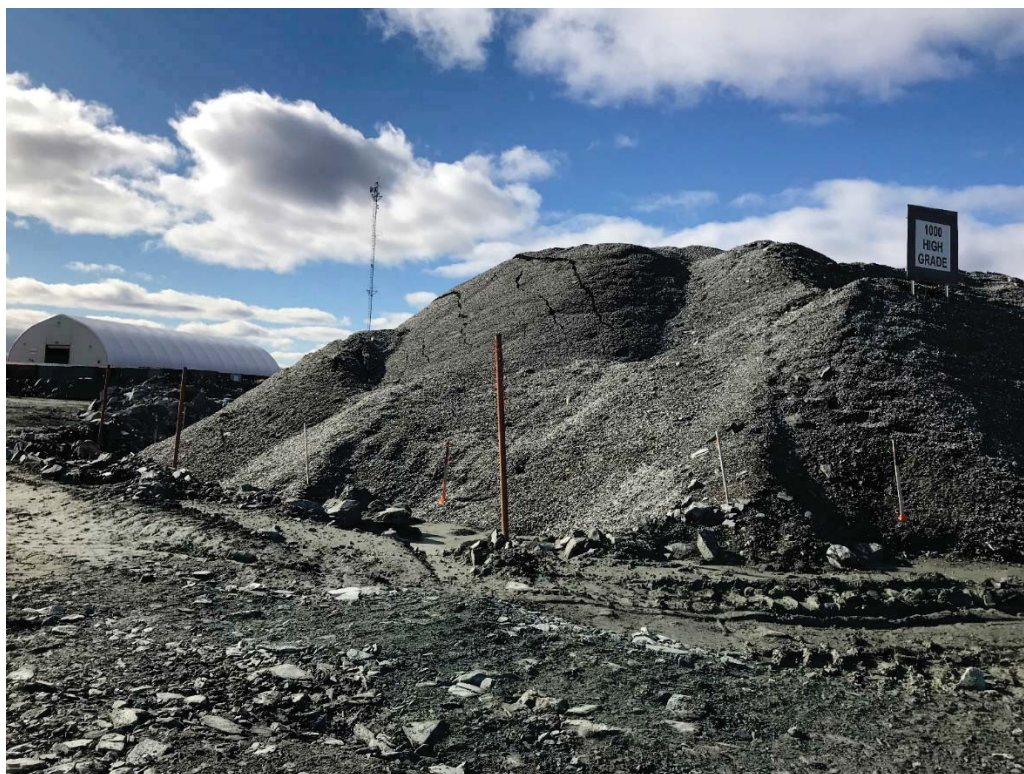
Photograph 4: Cracking in the High Grade Stockpile, Similar to 2017 (14 September 2018)
