APPENDIX A-3

Site Roads, Culverts, and
Tiriganiaq and Wesmeg Areas

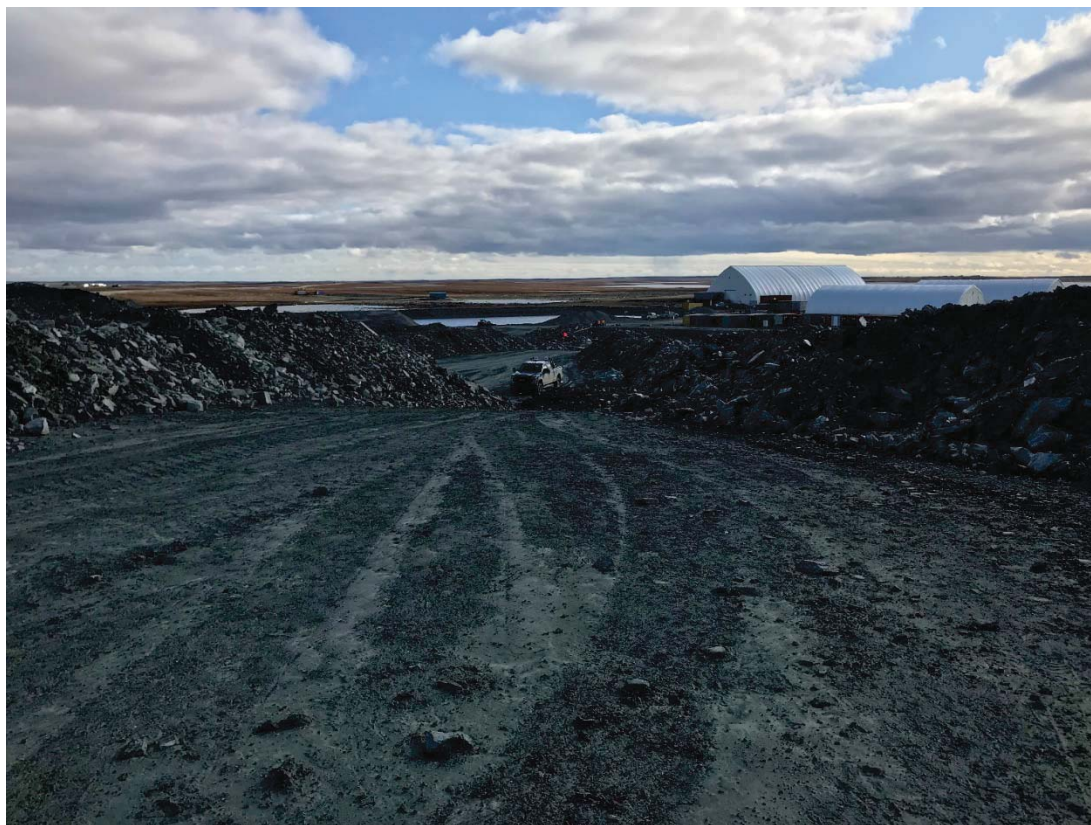
Photograph 6: View Down Ramp from Top of Waste Rock Pile (14 September 2018)

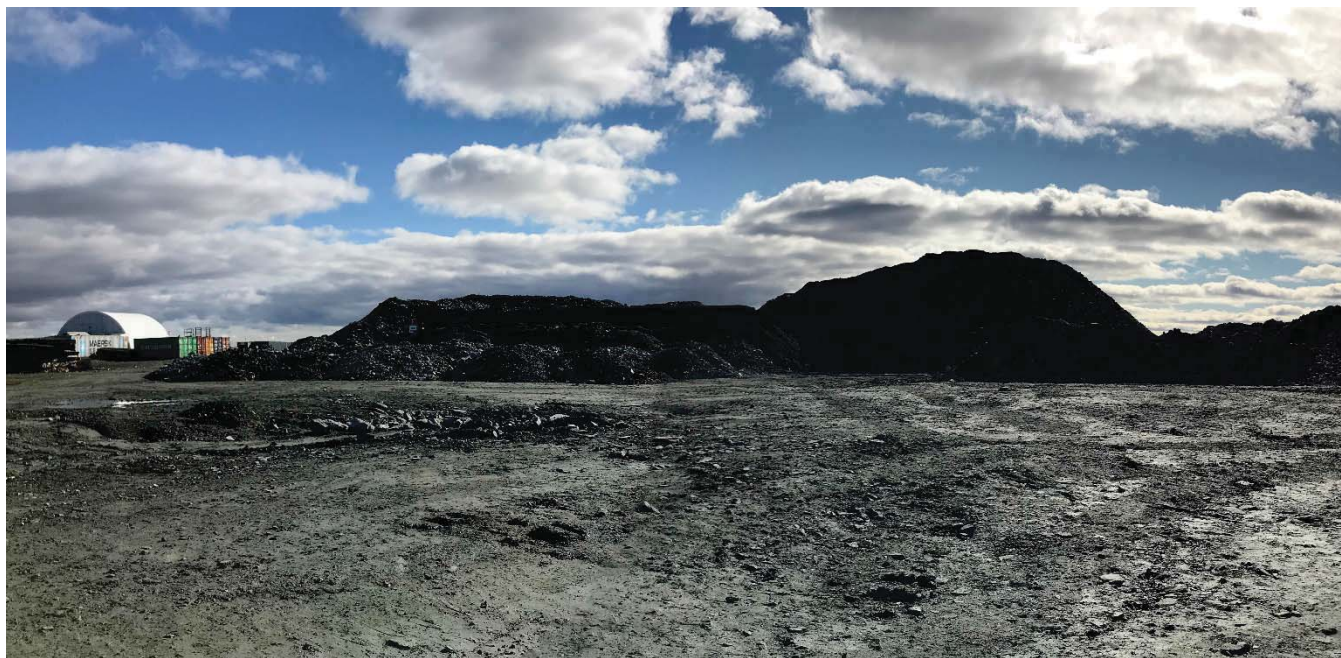
Photograph 7: View of Low and High Grade Ore Stockpiles, Looking Southeast (14 September 2018)

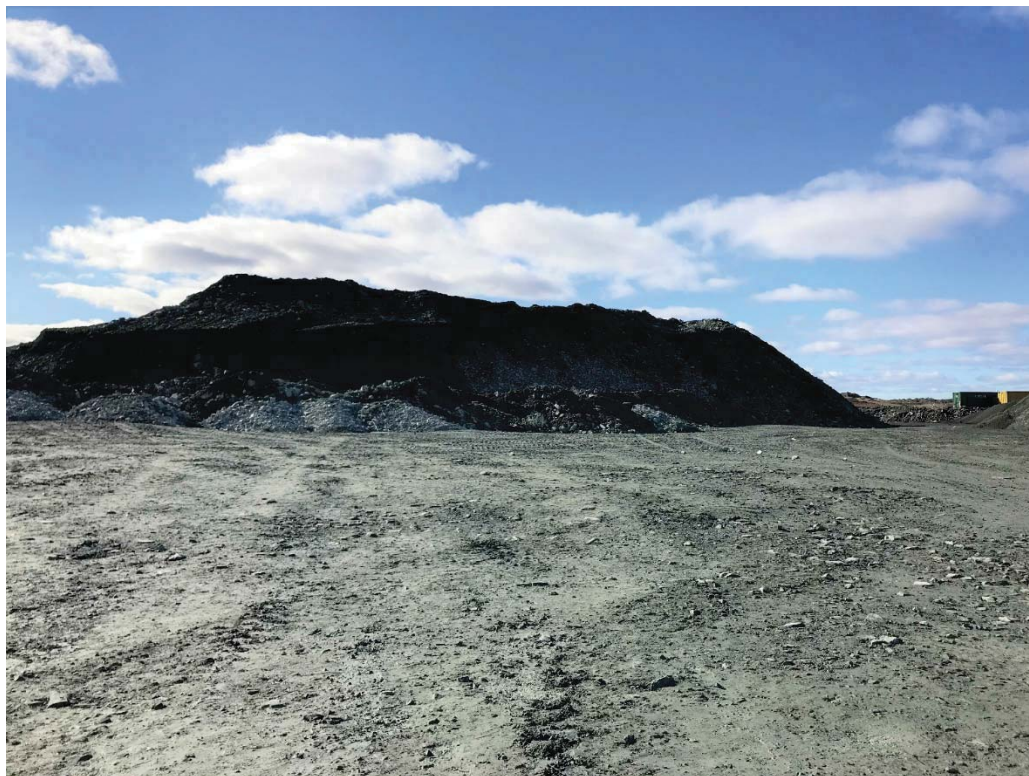
Photograph 8: View of Waste Rock Stockpile, Looking South (14 September 2018)

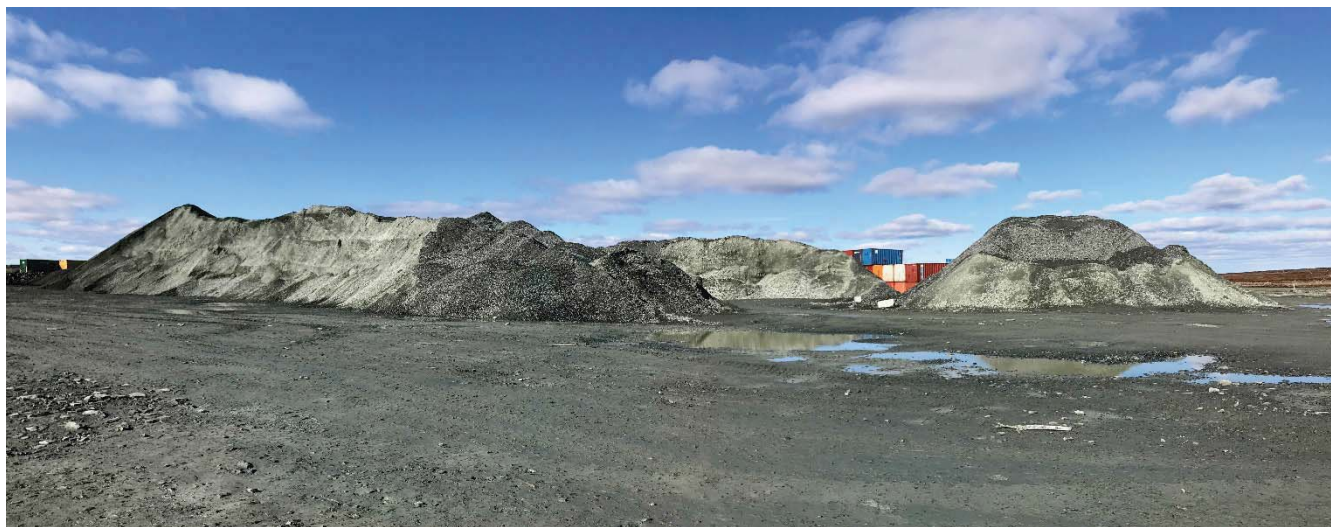
Photograph 9: View of Crushed Ore Stockpiles, Looking Southwest (14 September 2018)

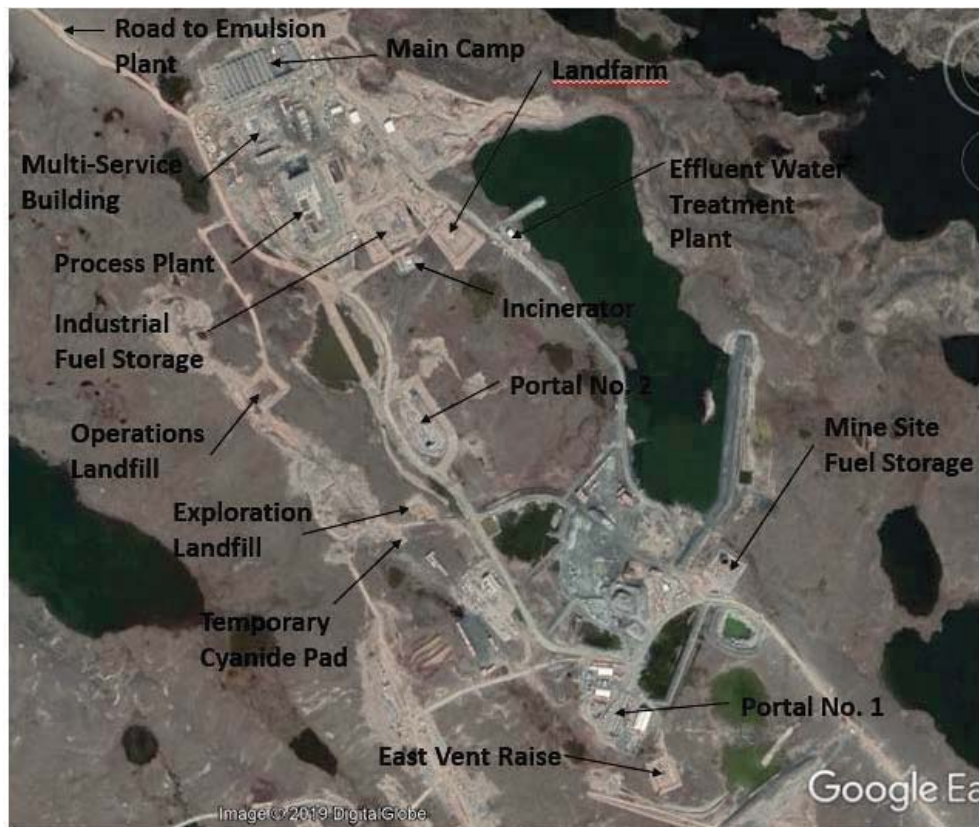
Photograph 1: Overview of Mine Facilities (Google Earth Image 2017)

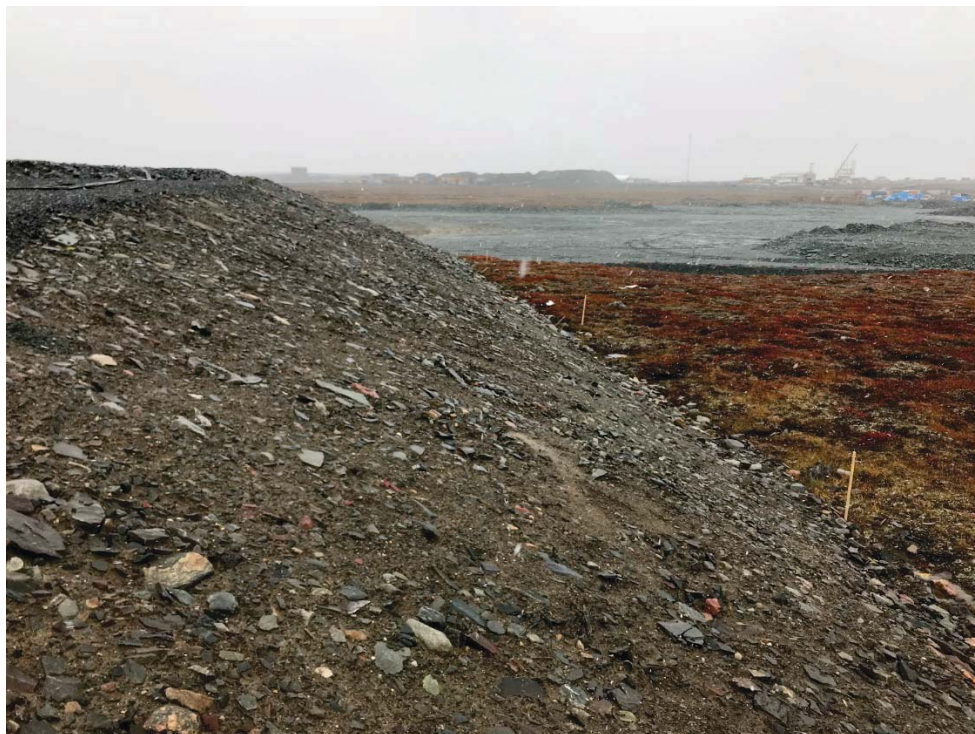
Photograph 2: Landfarm, West Slope, Looking South (11 September 2018)

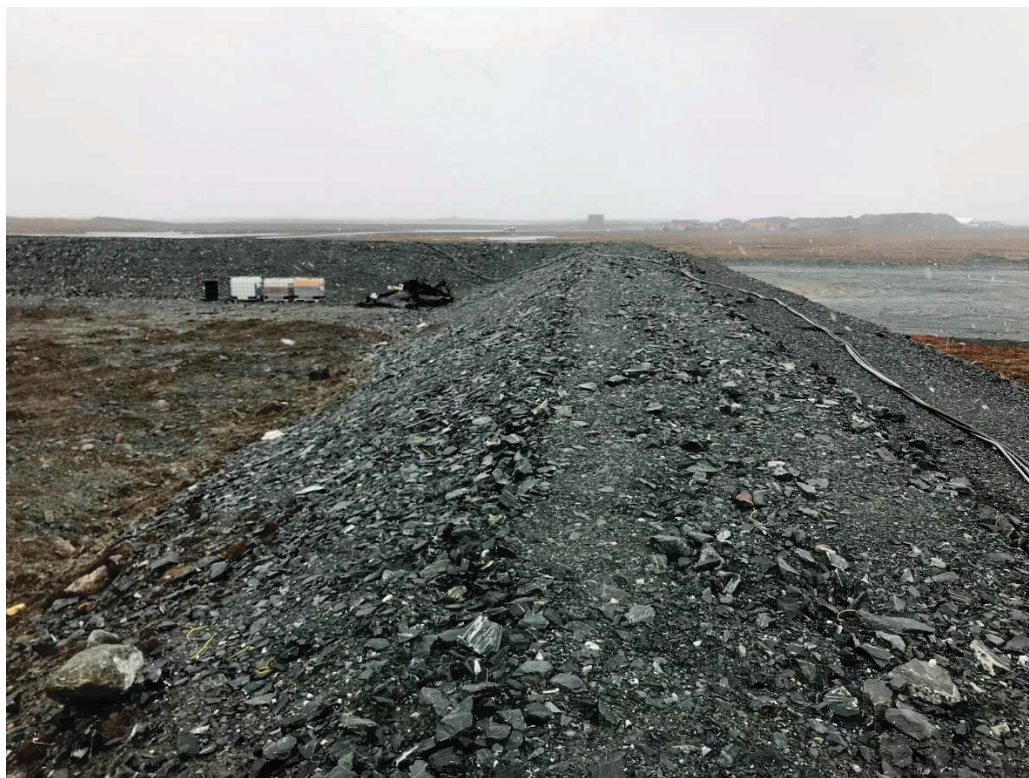
Photograph 3: Landfarm, Crest of West Side, Looking Southeast (11 September 2018)

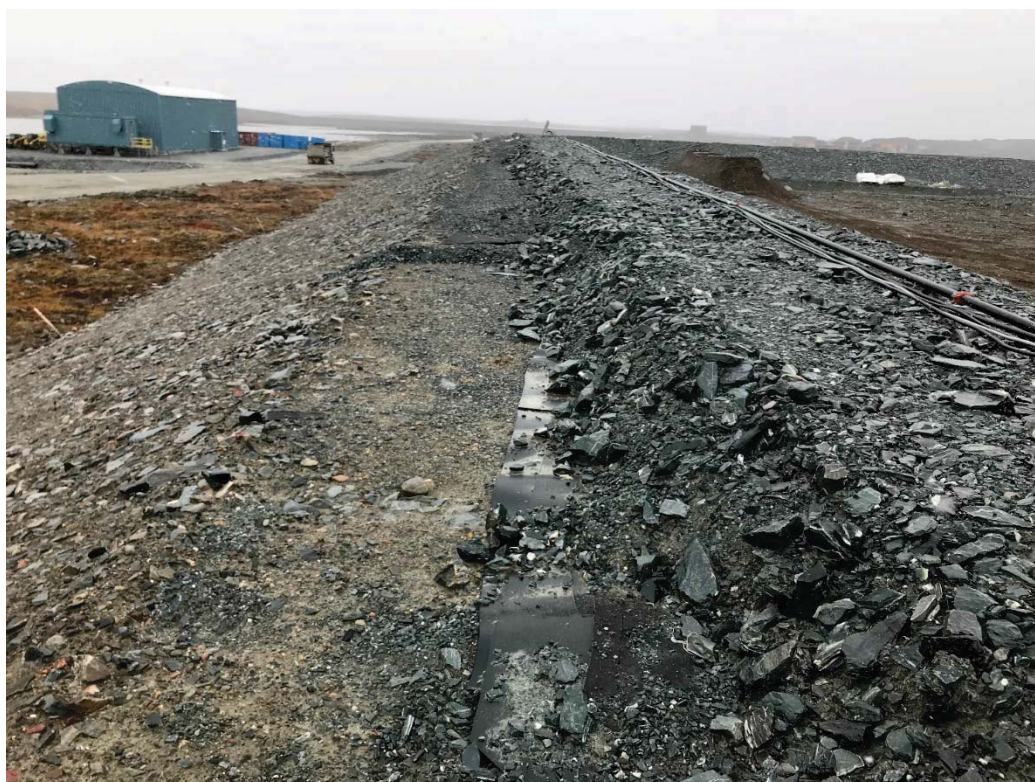
Photograph 4: Landfarm, Liner Exposed on East Side, Looking Southeast (11 September 2018)

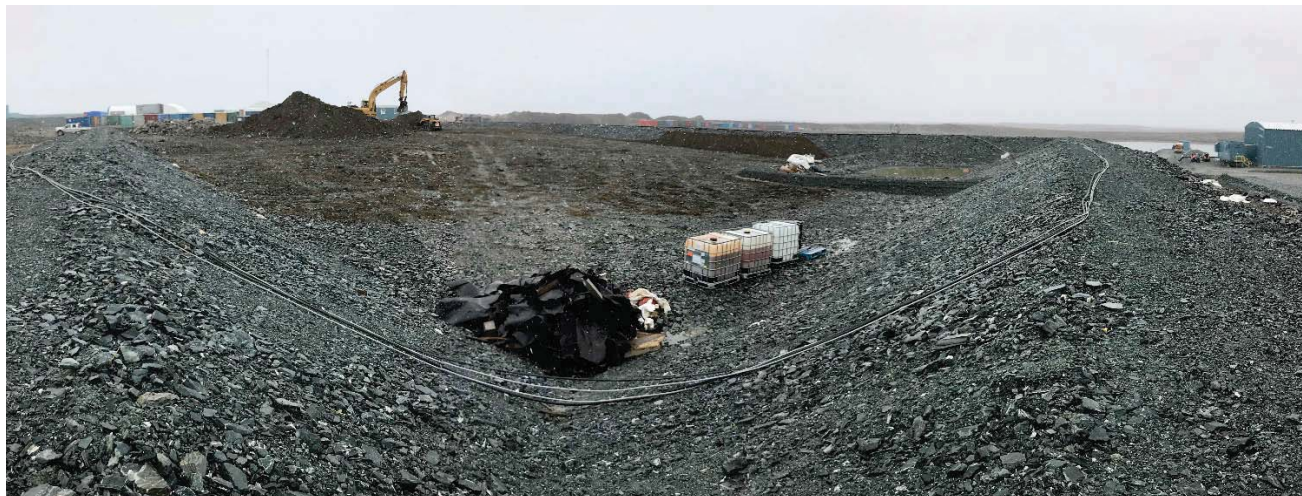
Photograph 5: Landfarm, View from Southwest corner Looking North. Material is being Excavated Hauled to Screener then Finer Material Returned to Landfarm (11 September 2018)

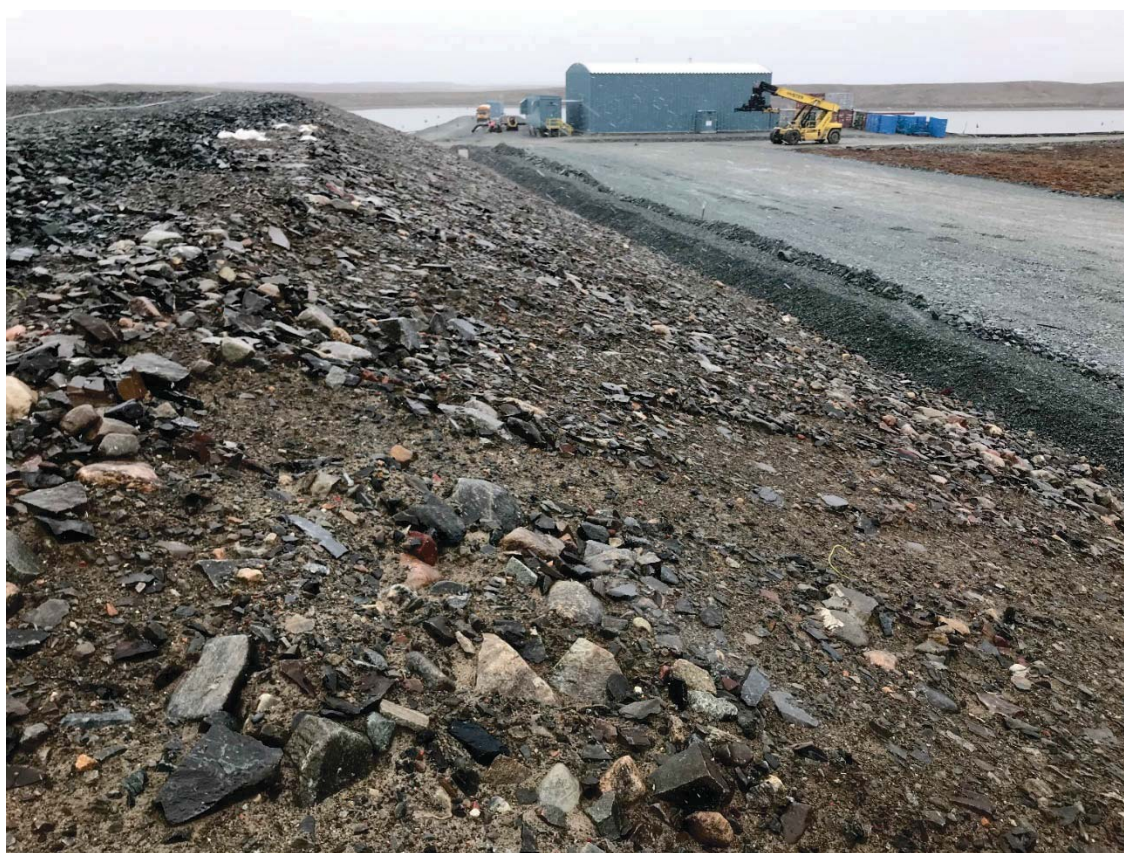
Photograph 6: Landfarm, South Slope, Looking East (11 September 2018)

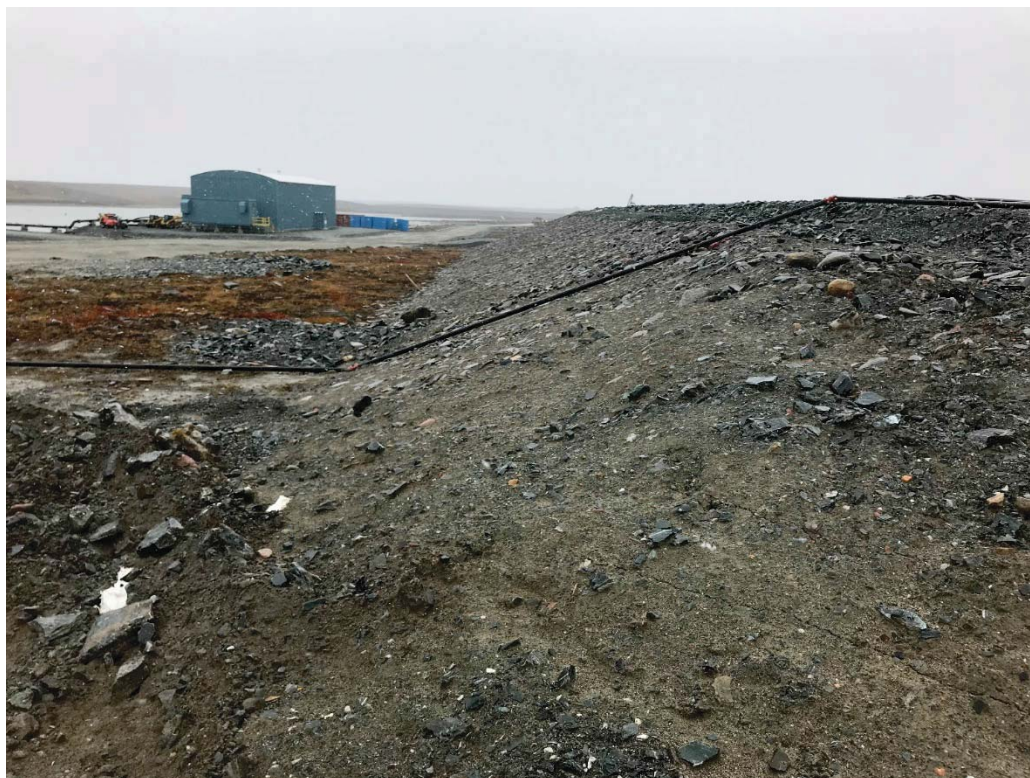
Photograph 7: Landfarm, East Slope, Looking South (11 September 2018)

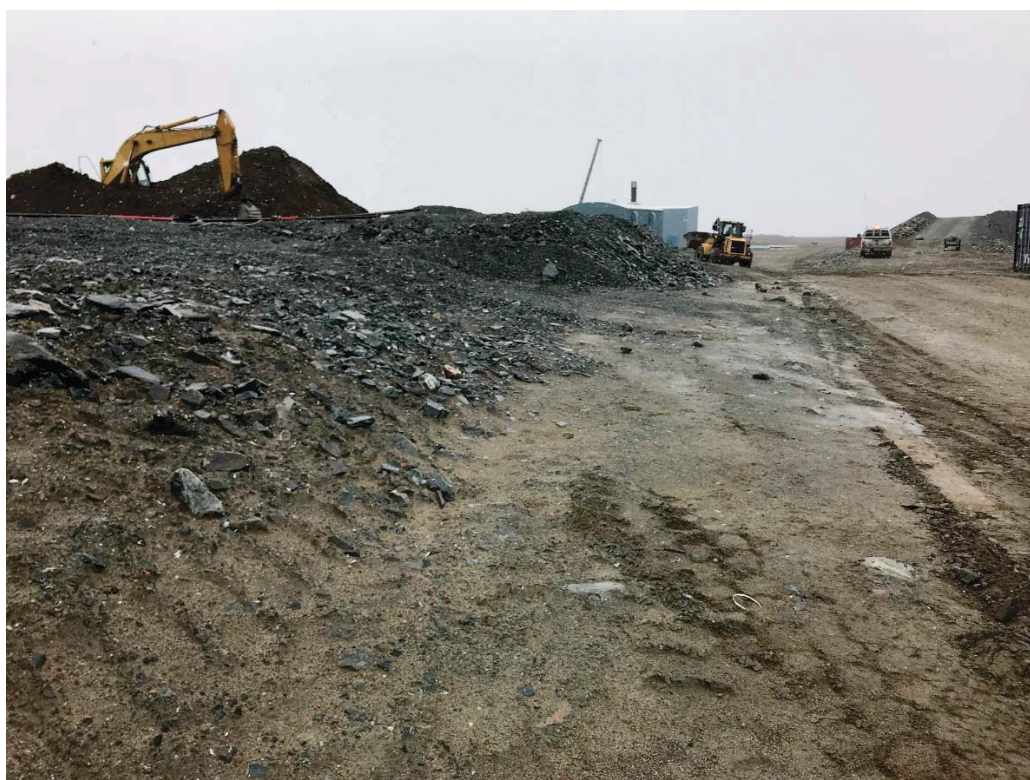
Photograph 8: Landfarm, North Slope, Looking West (11 September 2018)

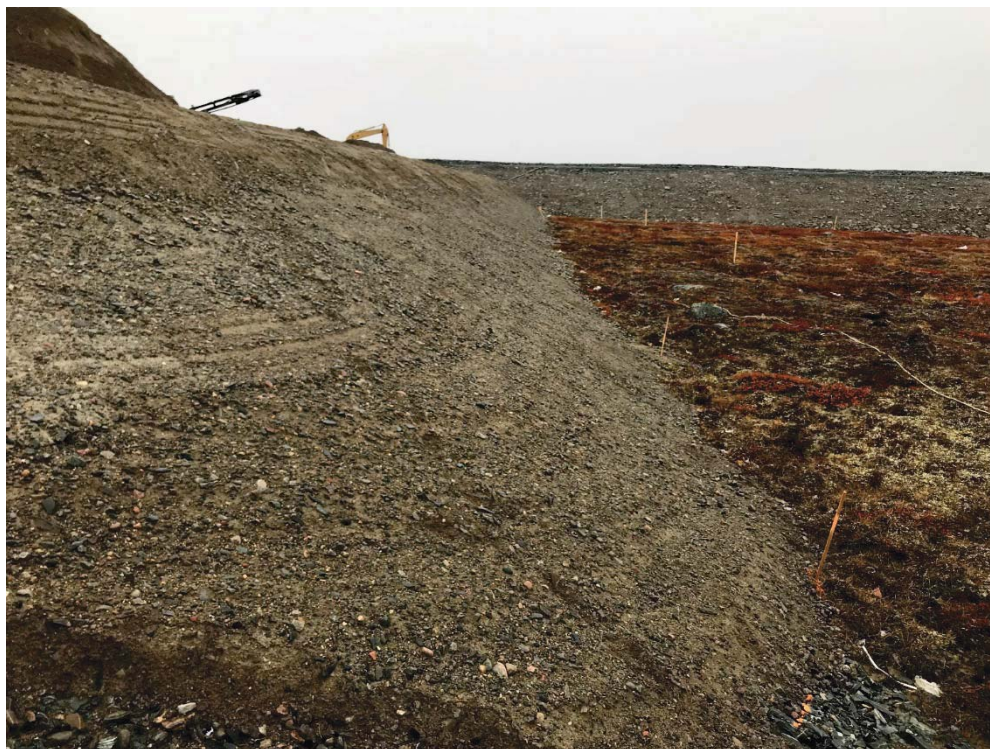
Photograph 9: Landfarm Screening Area, South Slope Looking East (11 September 2018)

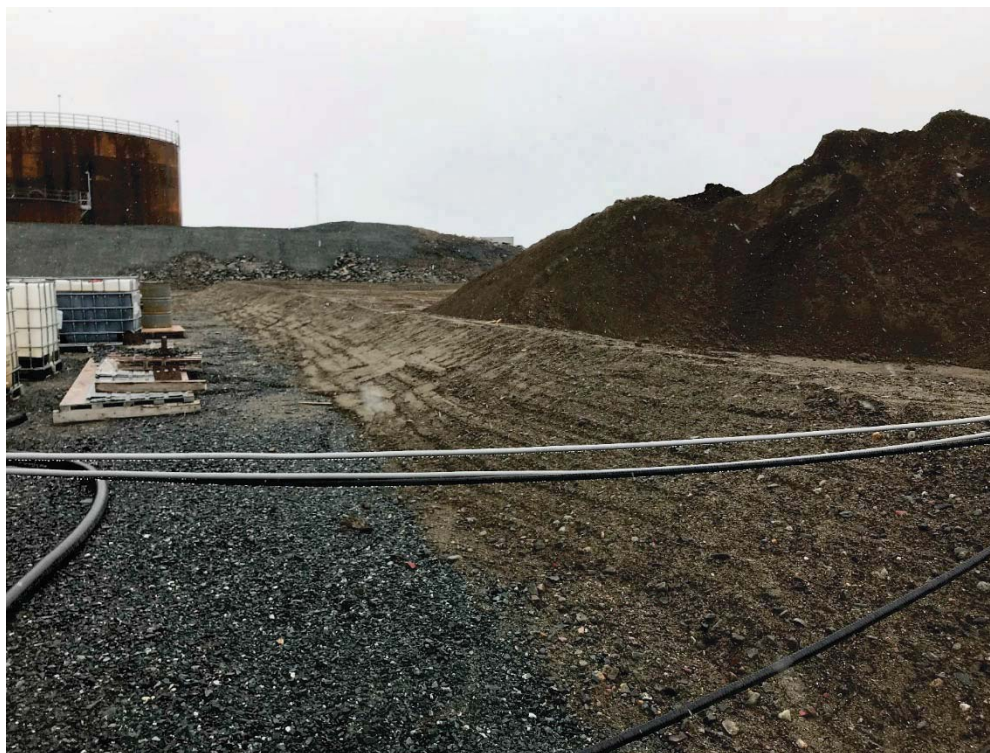
Photograph 10: Landfarm Screening Area, West Side, Looking North (11 September 2018)

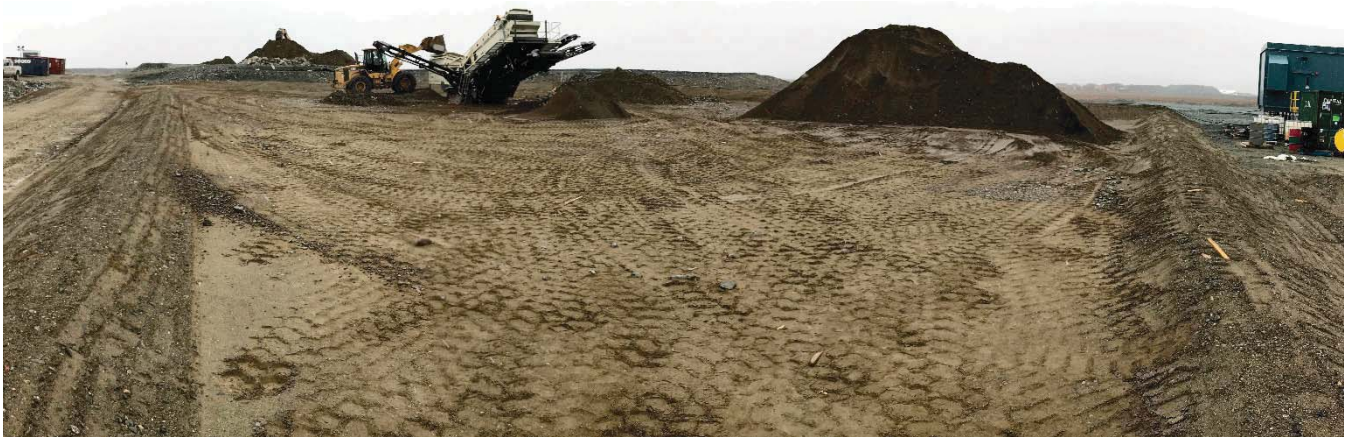
Photograph 11: View of Landfarm Screening Area from Northwest Corner (11 September 2018)

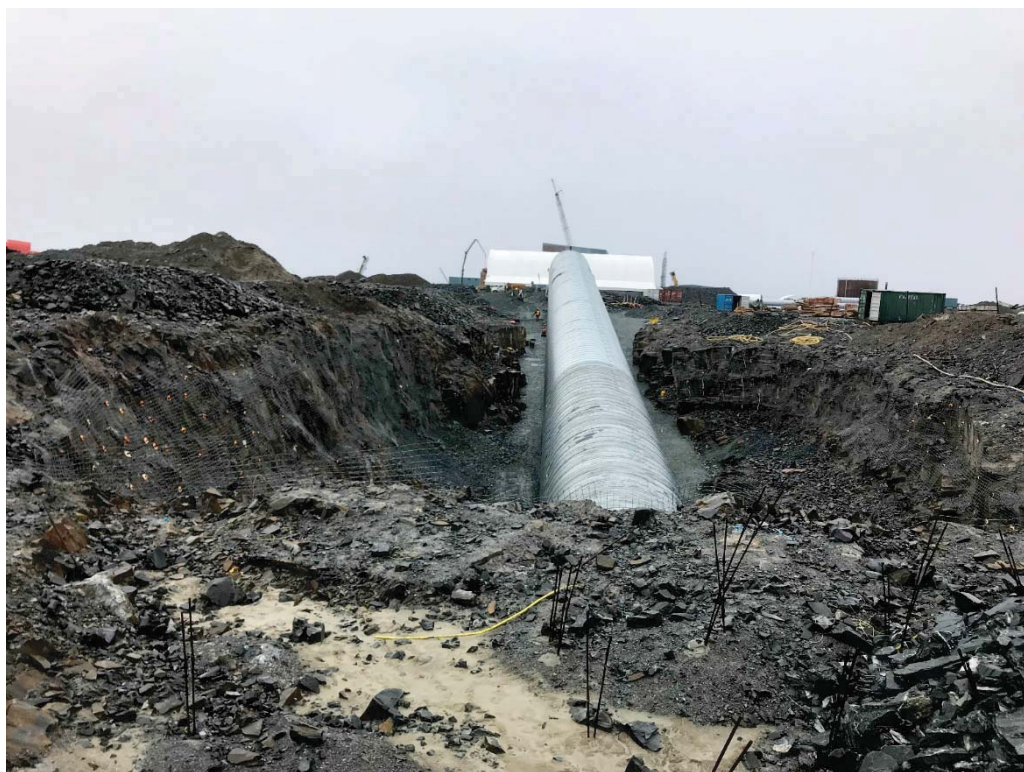
Photograph 18: Portal No. 2, Looking North (11 September 2018)

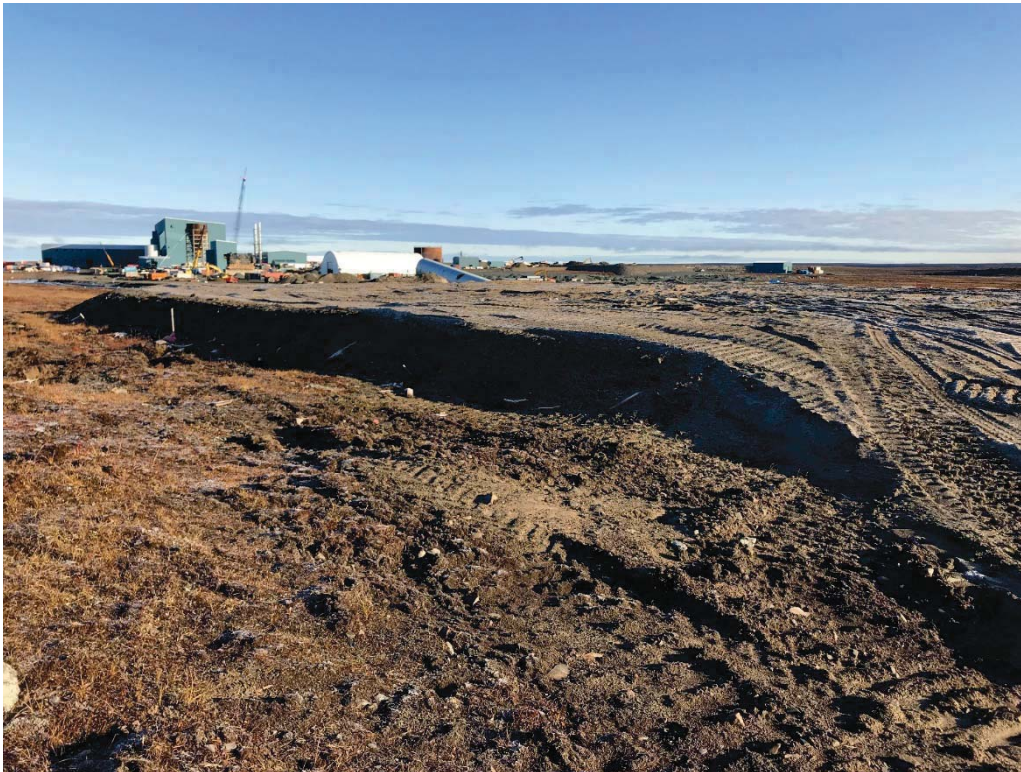
Photograph 21: Exploration Landfill, View from Southwest Corner, Looking North (13 September 2018)

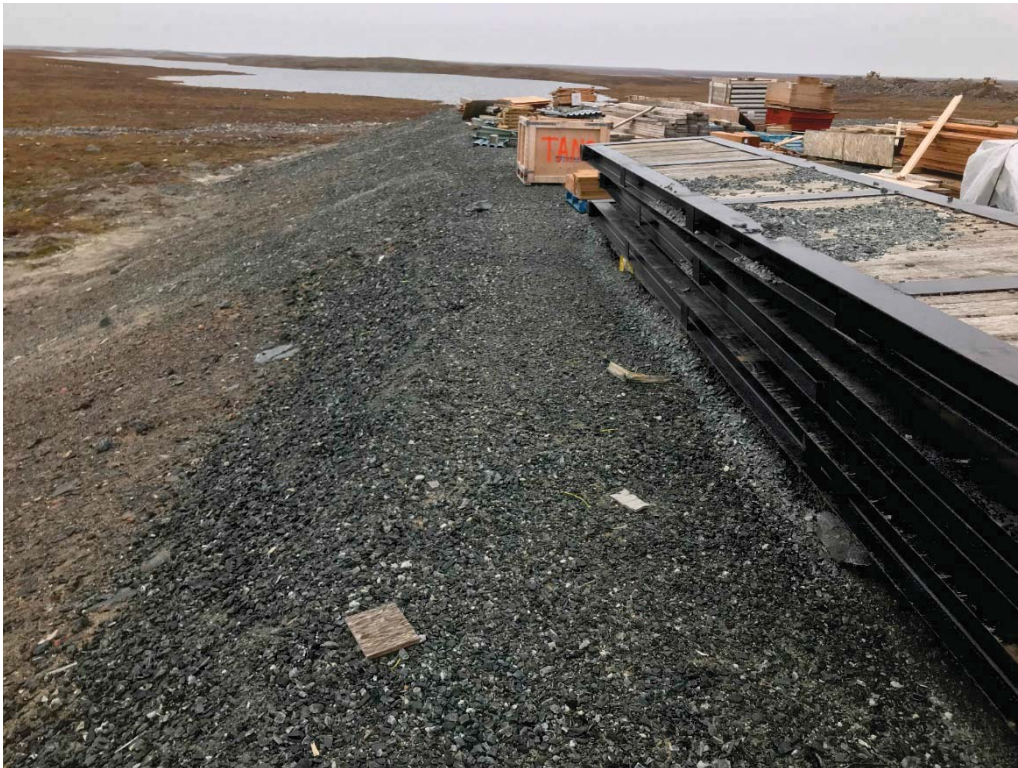
Photograph 43: Crest of Northwest Slope of Main Camp/Industrial Pad, Looking North. (11 September 2018)

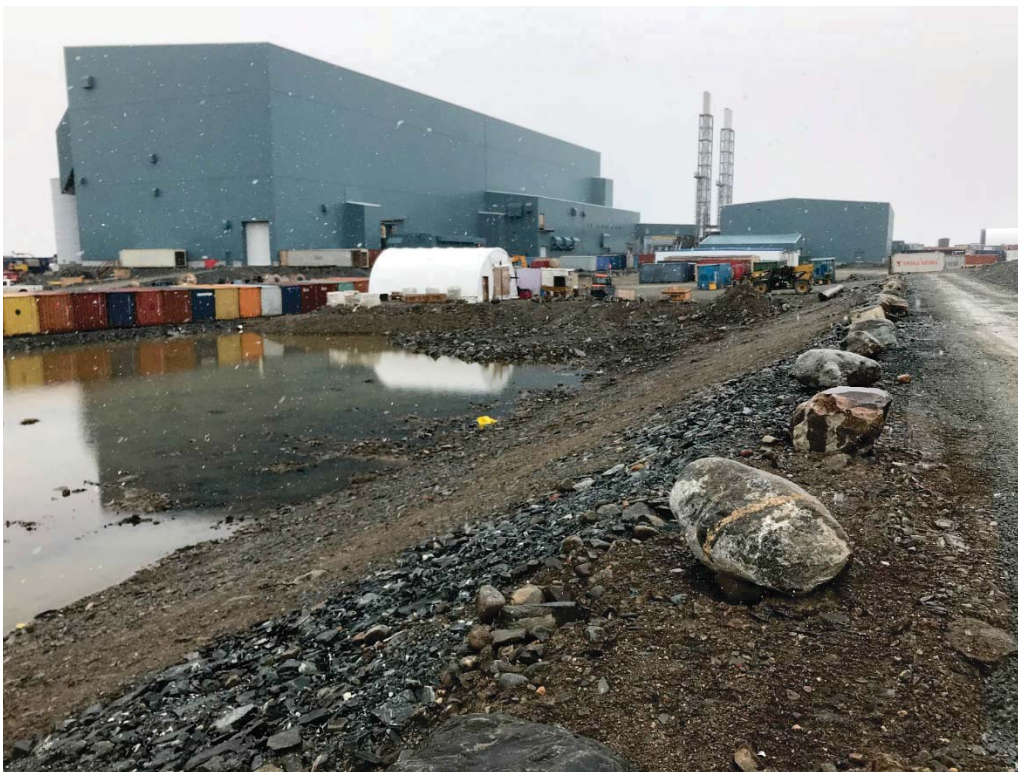
Photograph 46: Water Poned West of Industrial Fuel Storage and South of Process Plant, Looking North (11 September 2018)

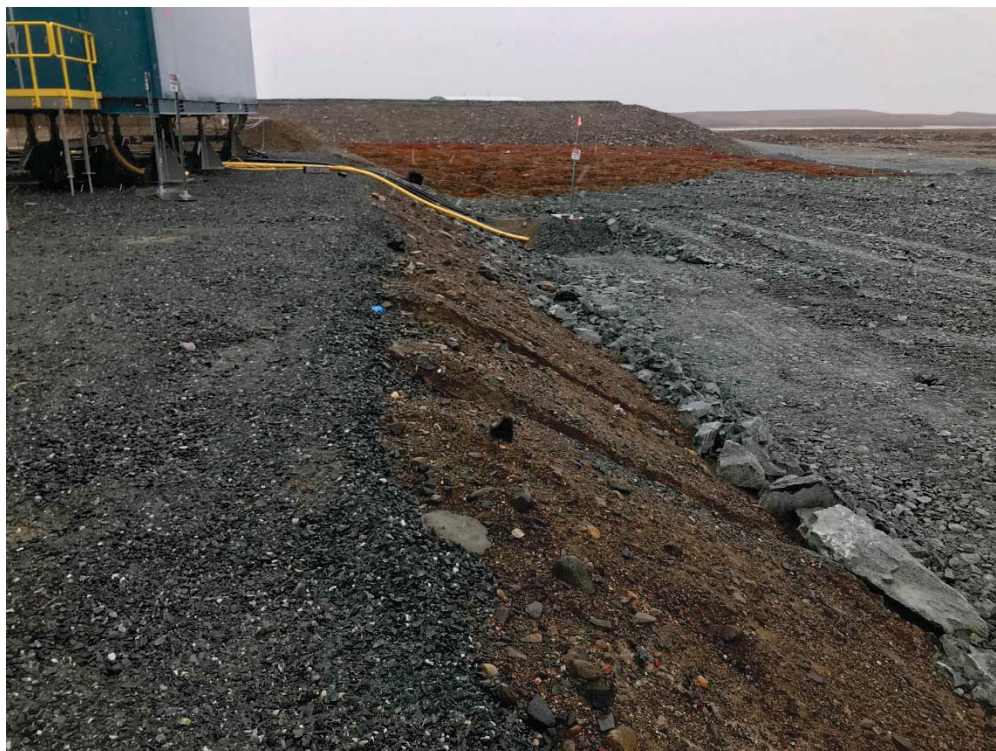
Photograph 47: South Slope of Incinerator Pad, Erosion of Esker Material on Slope, Crushed Material Placed as Pad Surface, Looking East. Placement of Rockfill for Construction of Ore Storage Pad 2 In Progress to South. (11 September 2018)

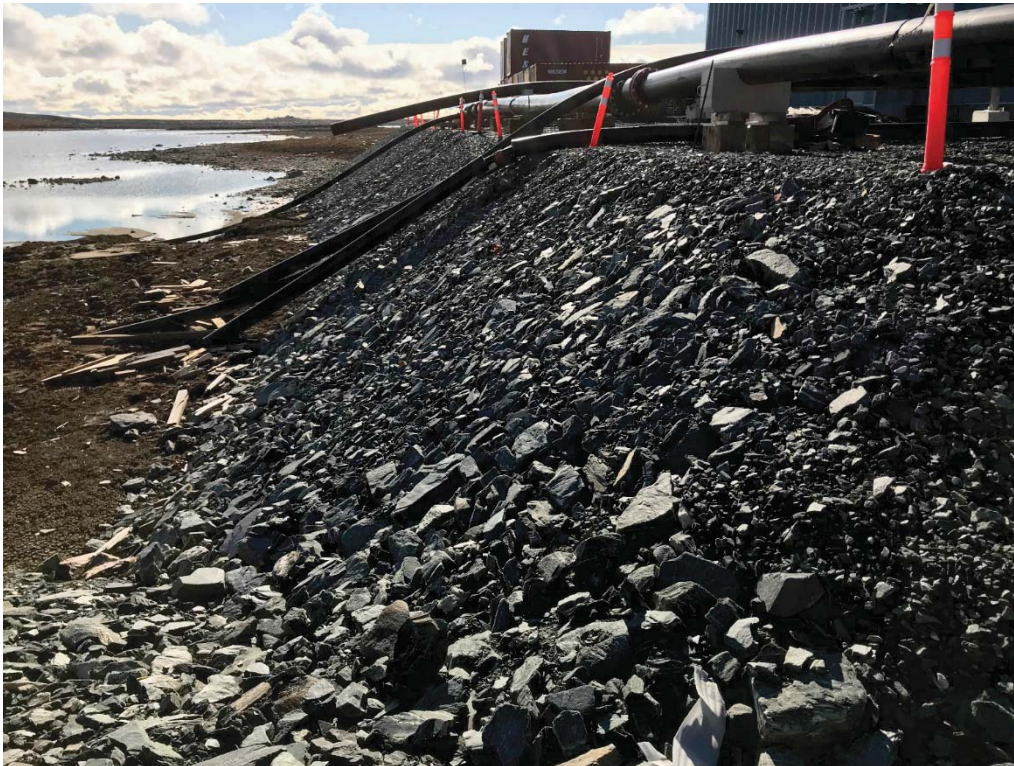
Photograph 51: Effluent Water Treatment Plant East Slope, Looking South. (13 September 2018)

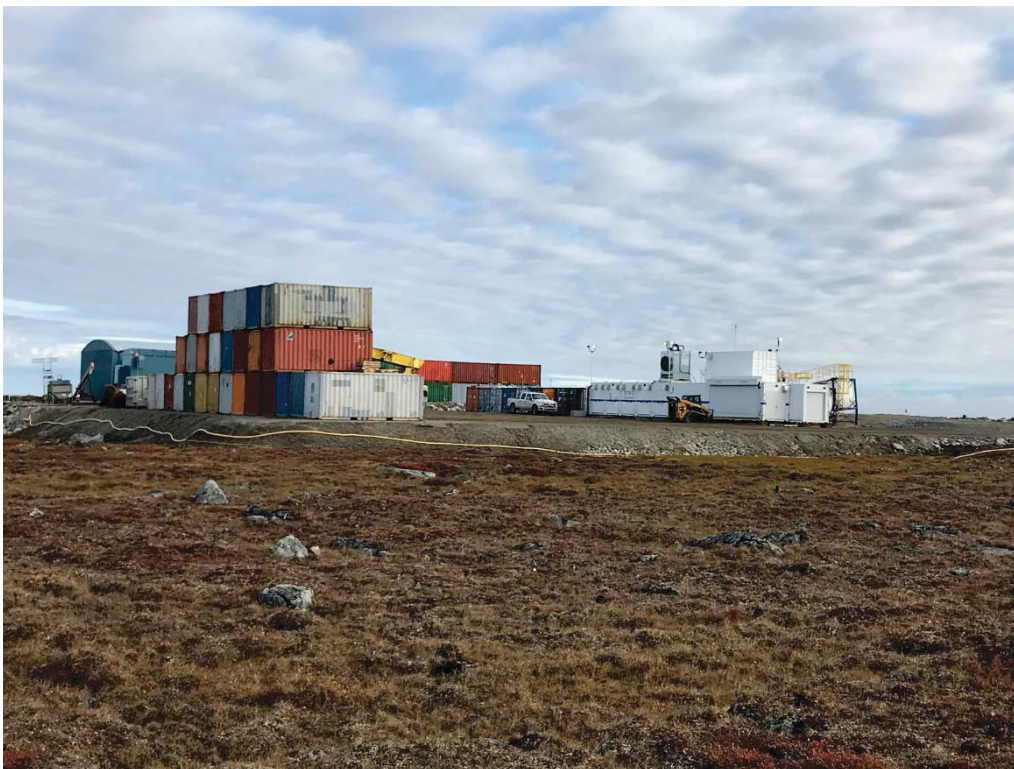
Photograph 52: Emulsion Plant Pad, Overview Looking Northeast from Emulsion Storage Pad (14 September 2018)

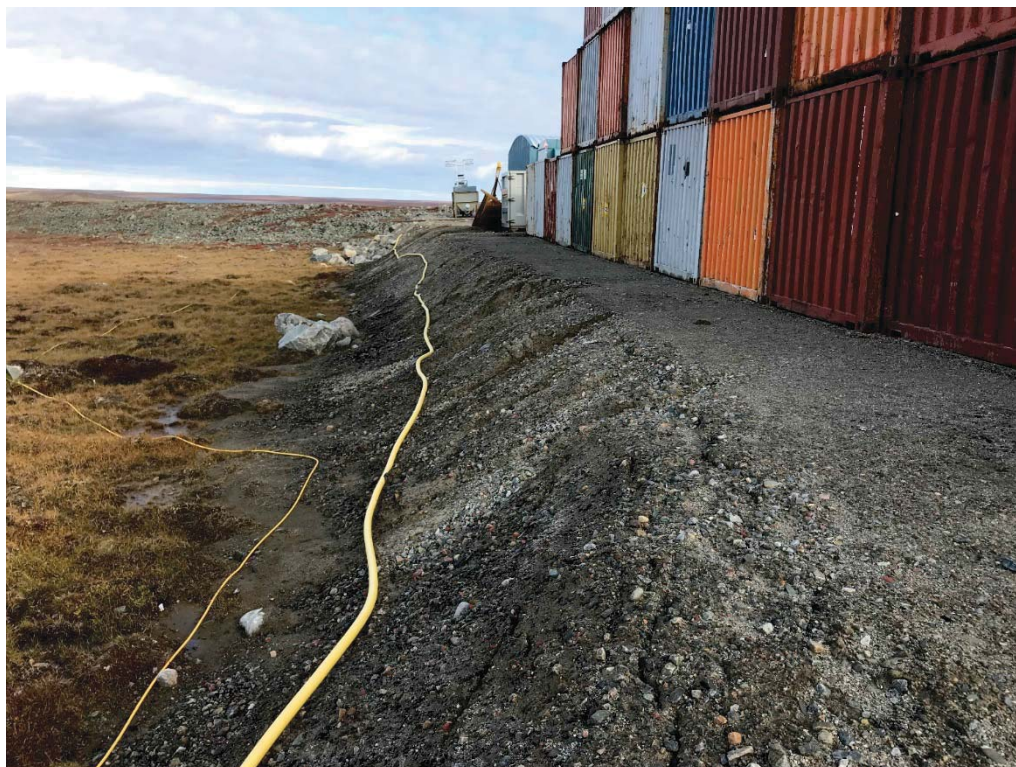
Photograph 53: Emulsion Plant Pad, Erosion and Cracking on East Slope, Looking North. (14 September 2018)

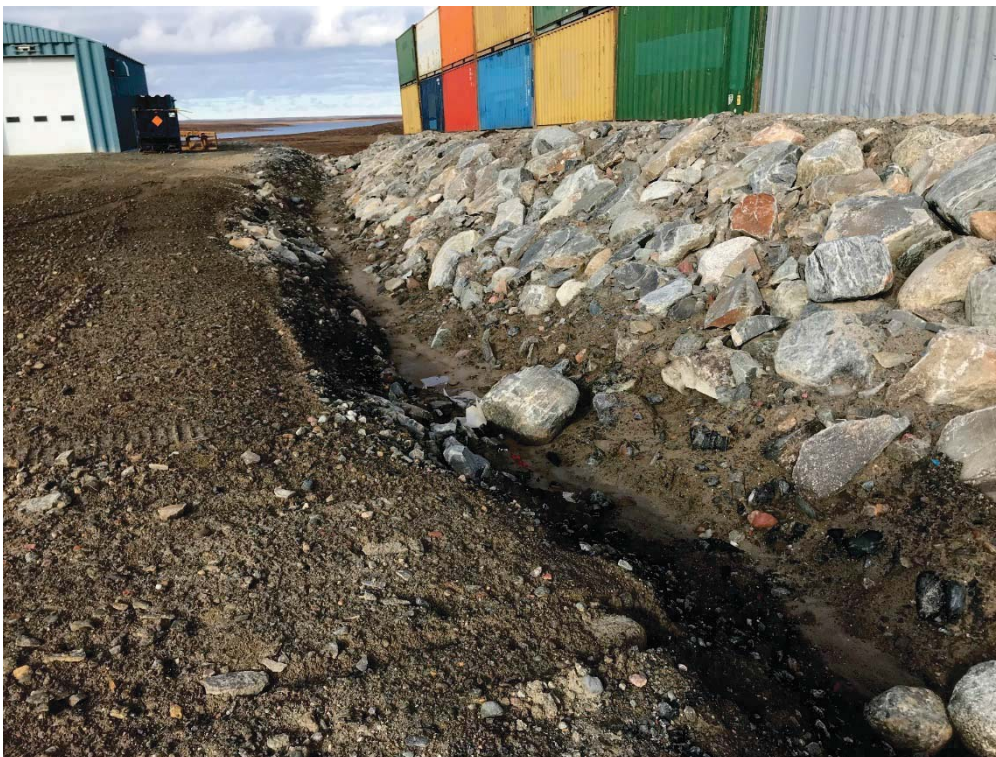
Photograph 56: Emulsion Plant Pad, Drainage Ditch Along North Side. (14 September 2018)

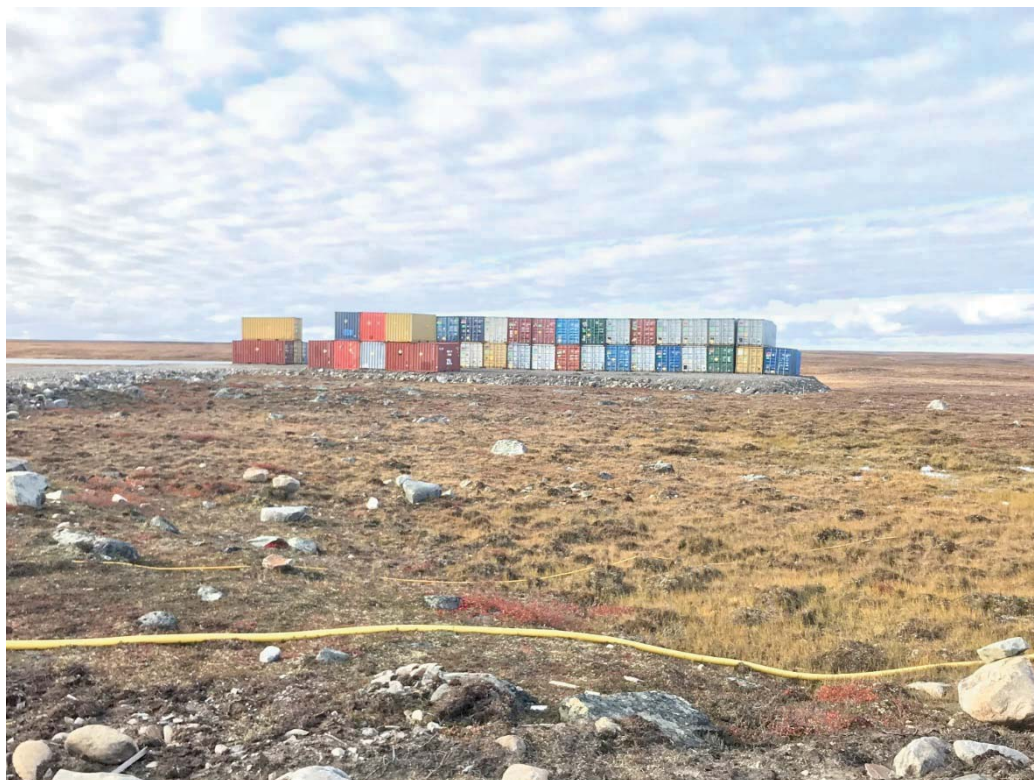
Photograph 57: Emulsion Plant Storage Pad, Overview Looking Southwest from Emulsion Plant Pad. (14 September 2018)

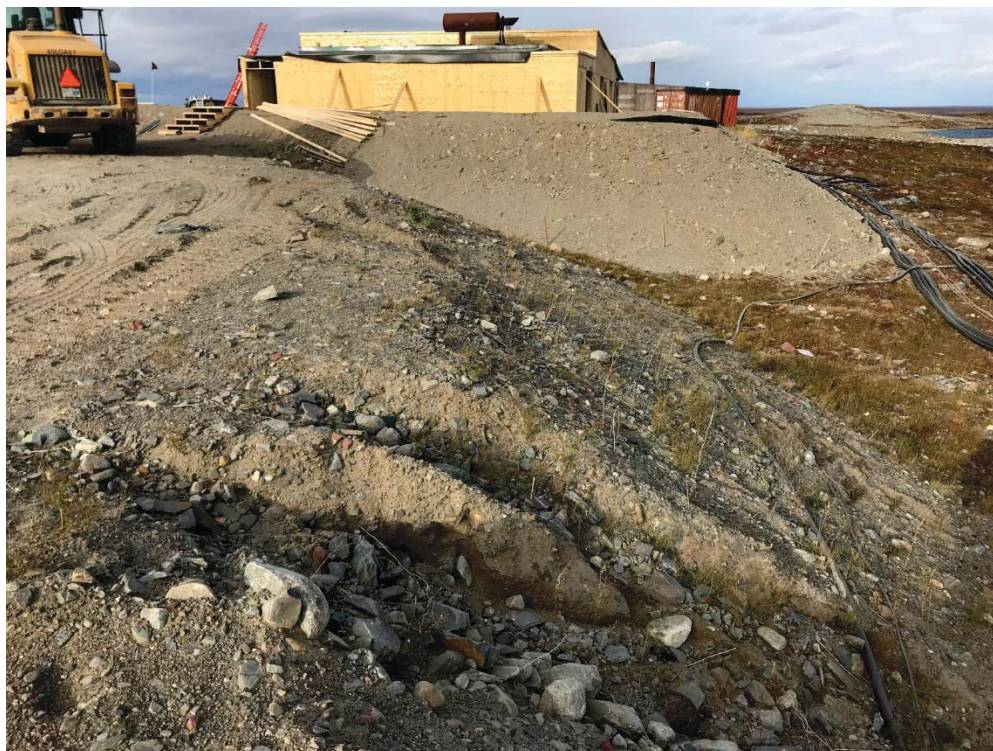
Photograph 3: Exploration Camp Pad, Erosion on Southeast Slope in Foreground of Photograph. New Genset Facility in Background (10 September 2018)

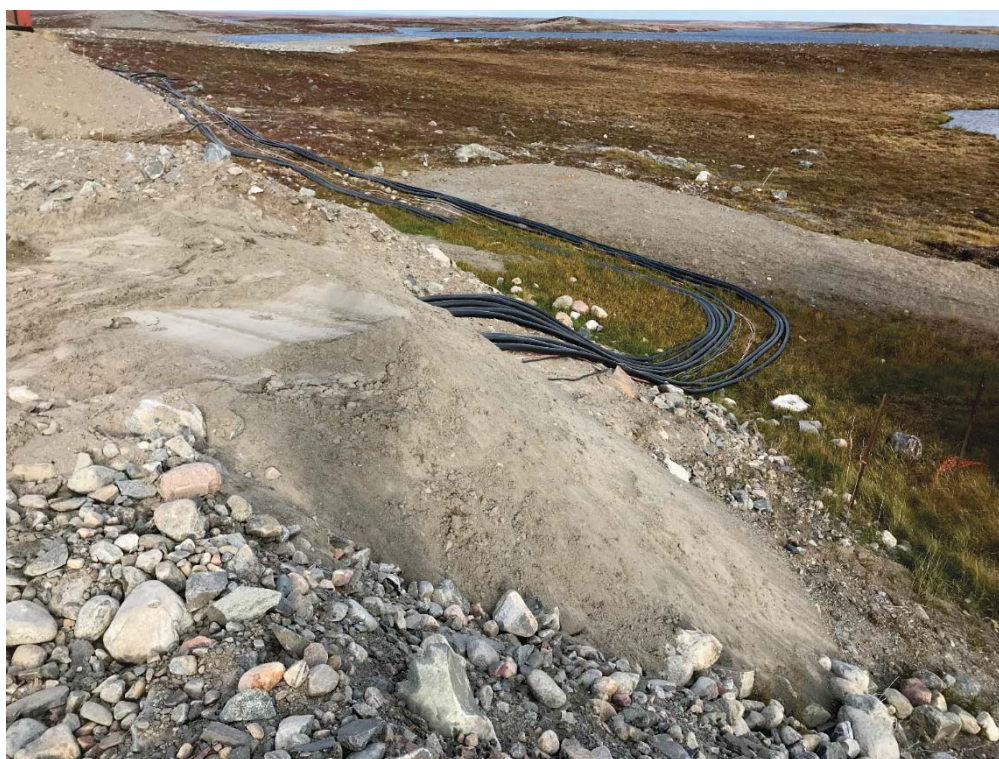
Photograph 4: Exploration Camp Pad, Sand Placed Over Cables (10 September 2018)

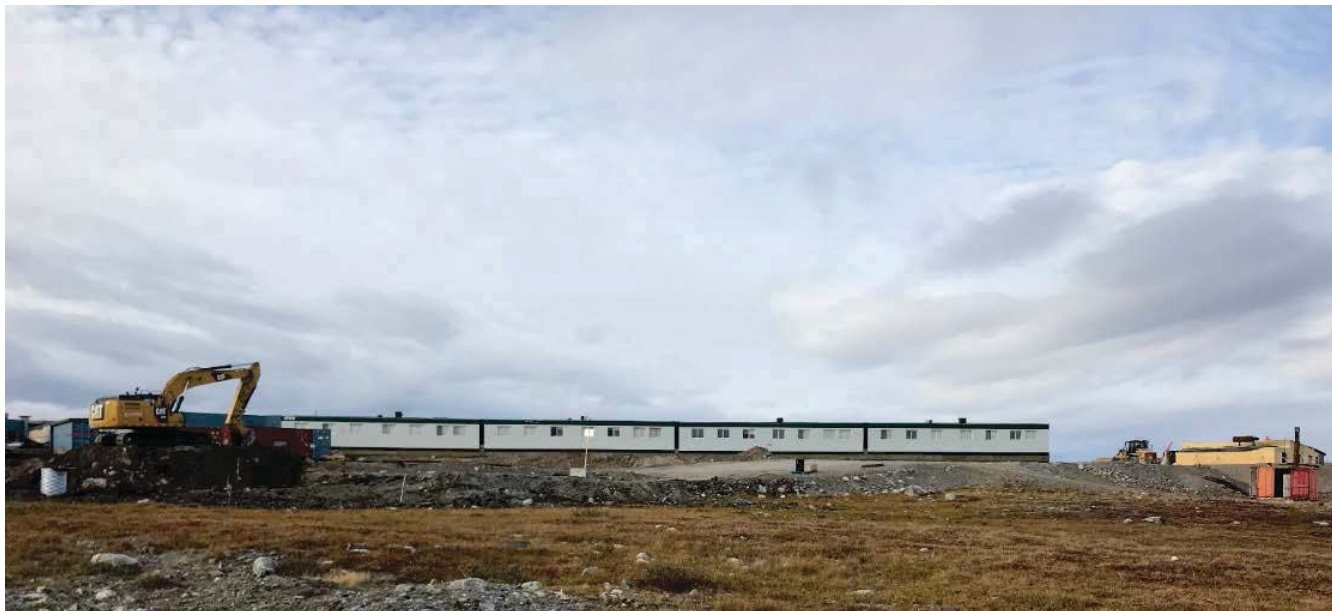
Photograph 5: Exploration Camp Pad, South Slope Looking Northeast, Excavator Removing Contaminated Soil from Fuel Spill (10 September 2018)
