APPENDIX A-3

Site Roads, Culverts, and
Tiriganiaq and Wesmeg Areas

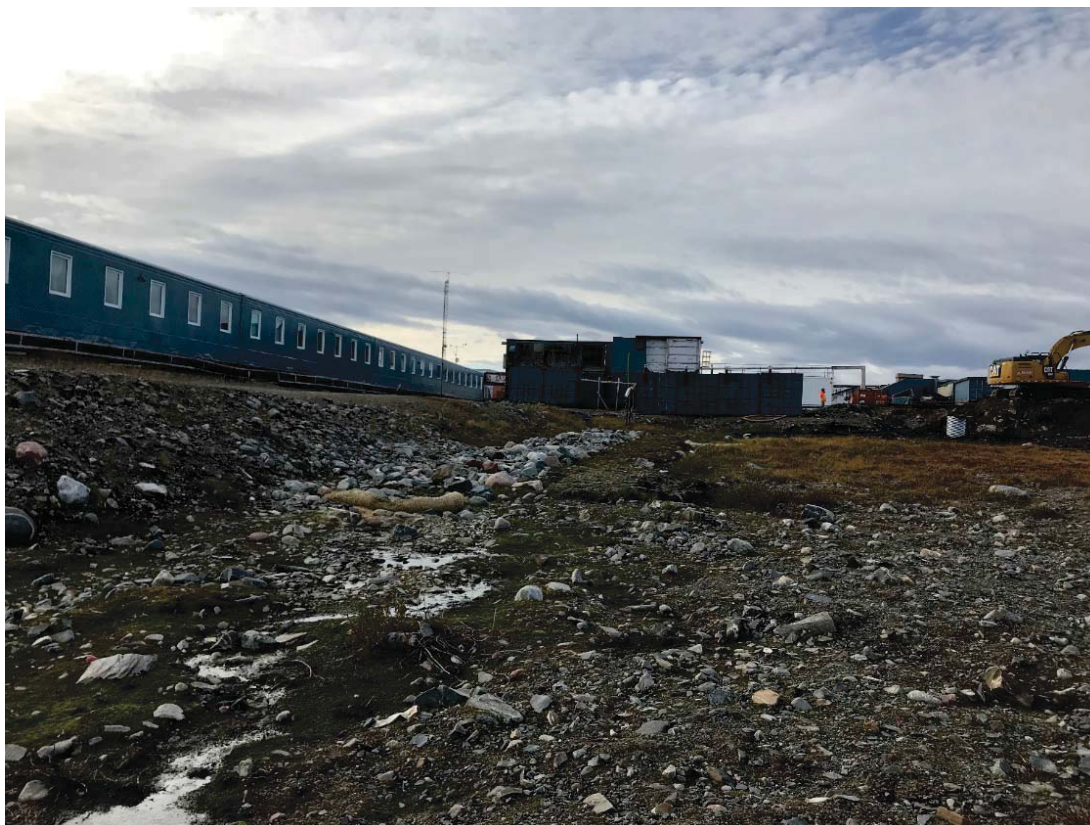
Photograph 6: Exploration Camp Pad, South Slope Looking North. Water Treatment Discharge (10 September 2018)

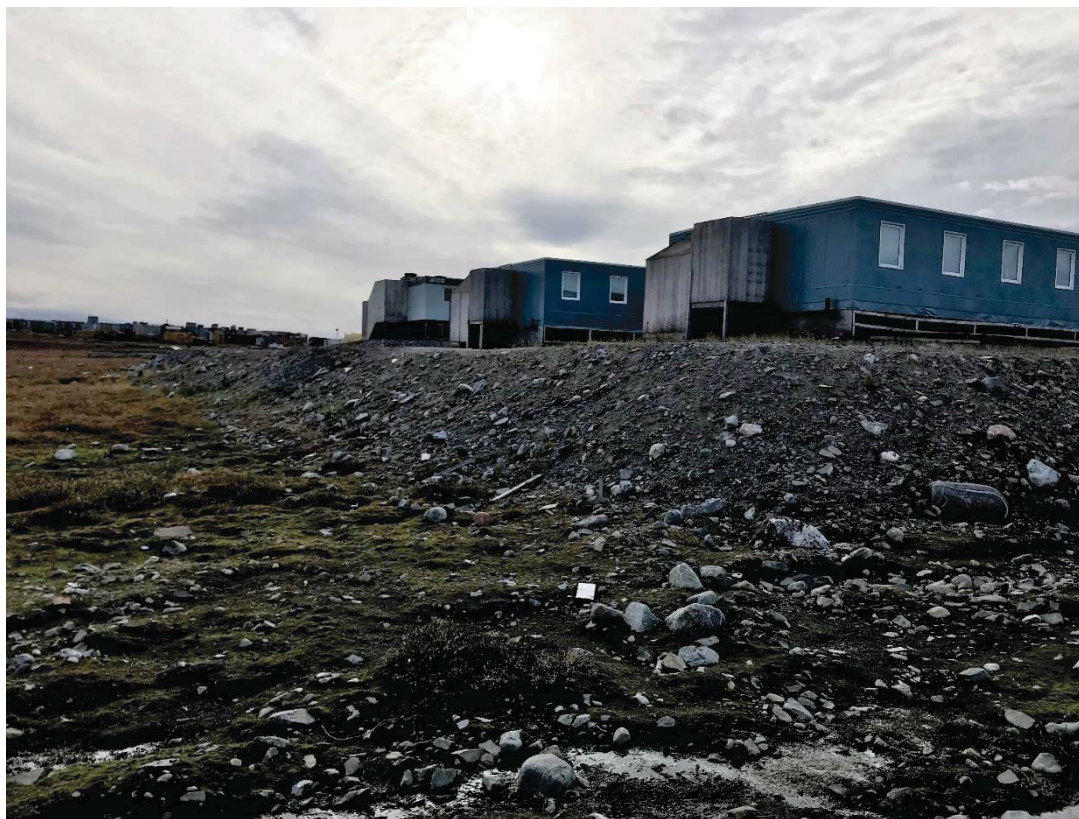
Photograph 7: Exploration Camp Pad, Looking West at Slope on South Side of Camp Trailers (10 September 2018)

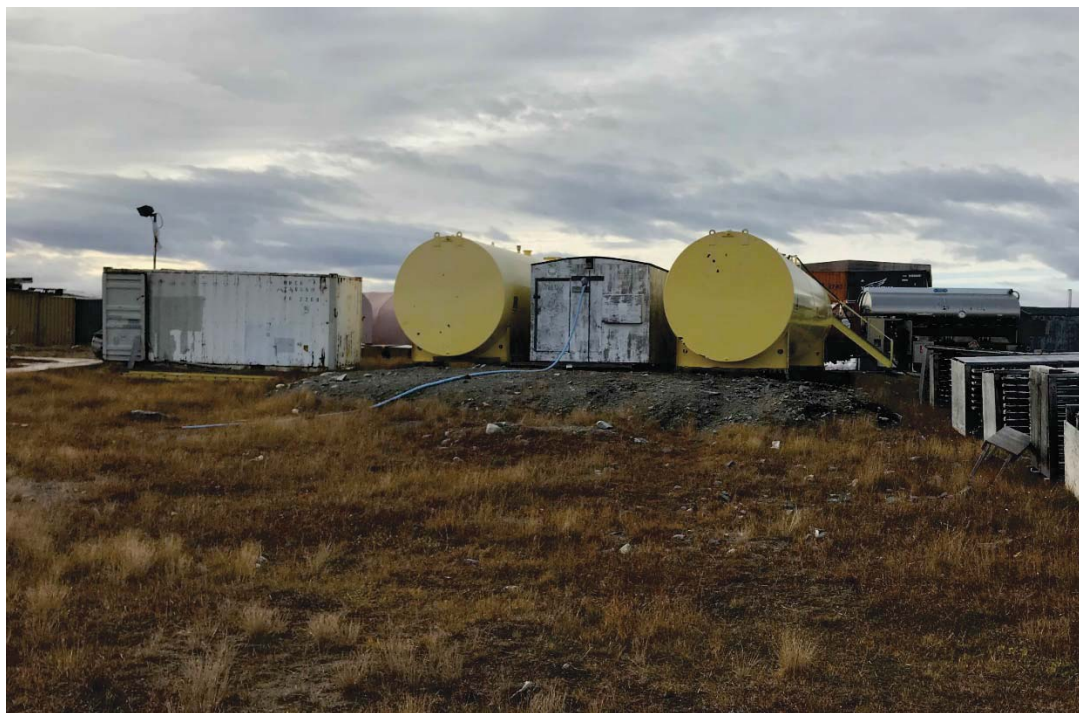
Photograph 8: Exploration Camp Pad, Looking North at Fuel Storage Near Helicopter Pad (10 September 2018)

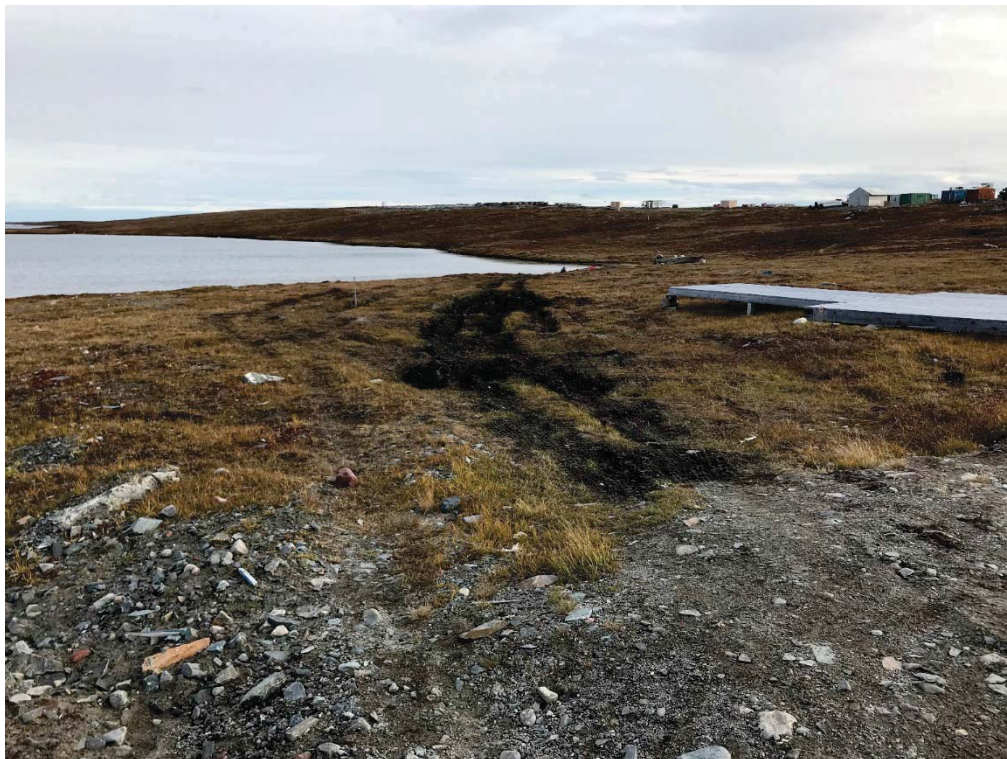
Photograph 9: Exploration Camp Pad, Looking Southwest, Disturbance of Tundra (10 September 2018)

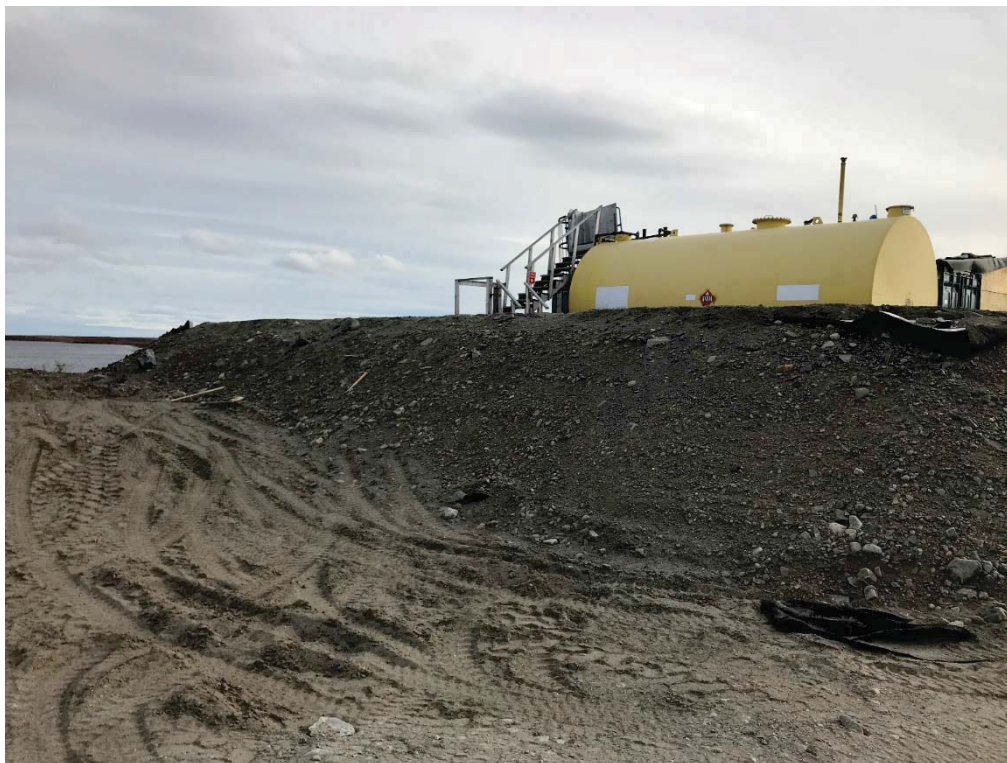
Photograph 10: Exploration Camp Pad, Genset Relocation, Looking Southwest at Berm Containment (10 September 2018)

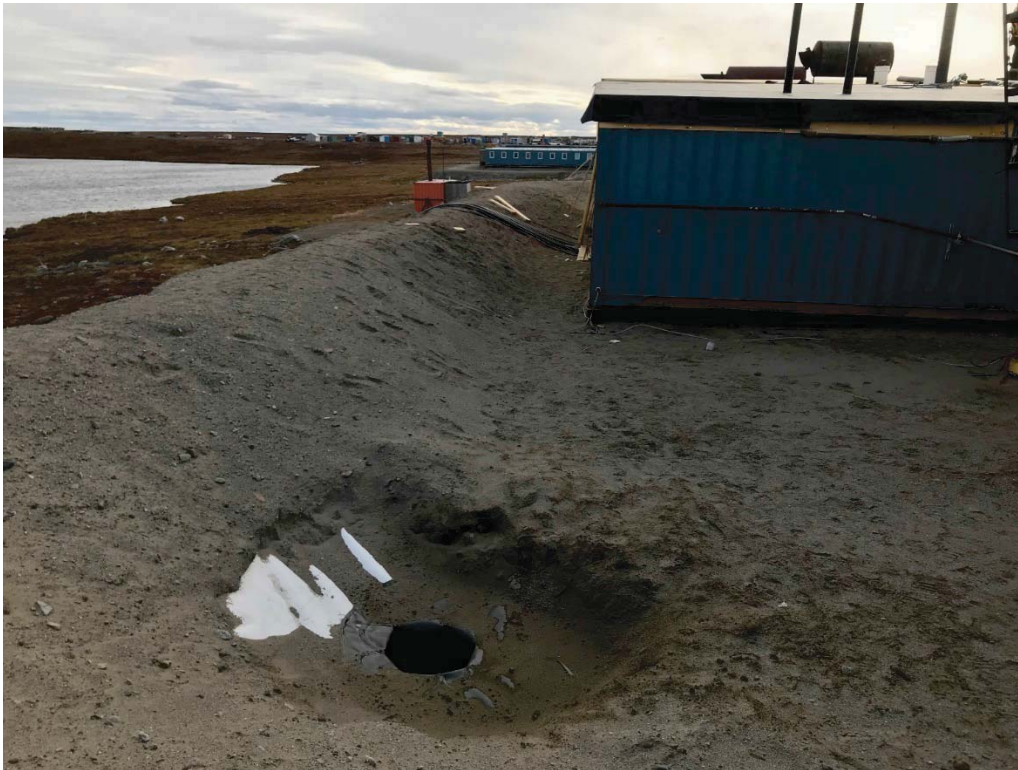
Photograph 11: Exploration Camp Pad, Genset Relocation, Interior Containment and Sump (10 September 2018)

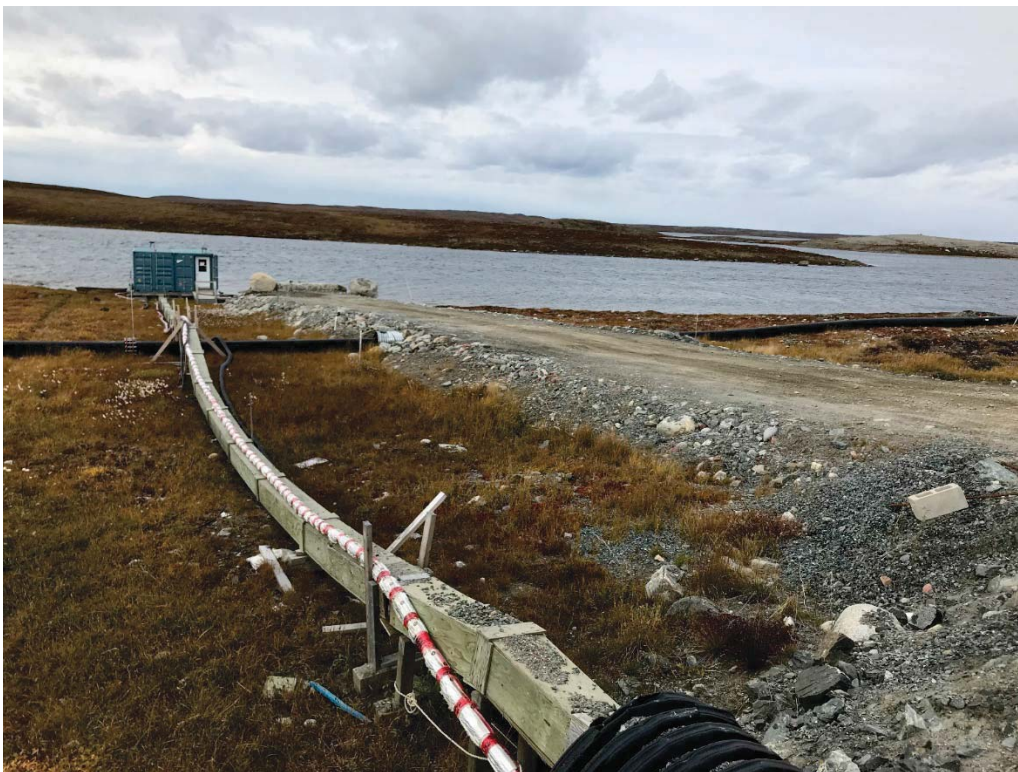
Photograph 12: Exploration Camp Fresh Water Intake, Looking North (10 September 2018)

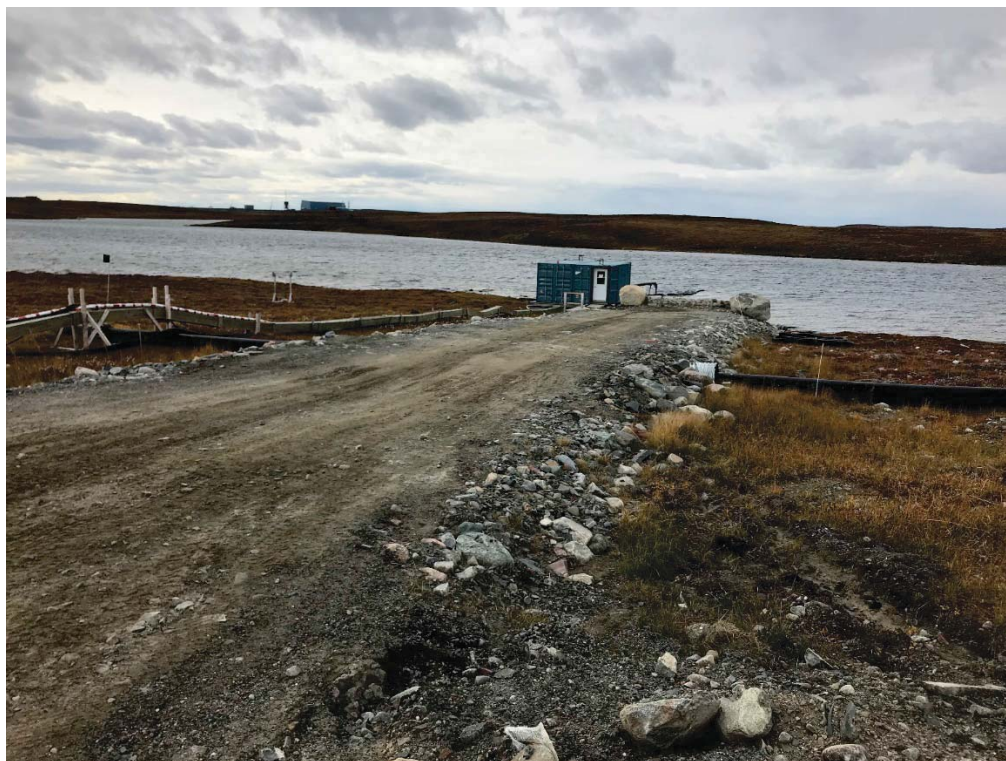
Photograph 13: Exploration Camp Fresh Water Intake, Looking Northeast (10 September 2018)

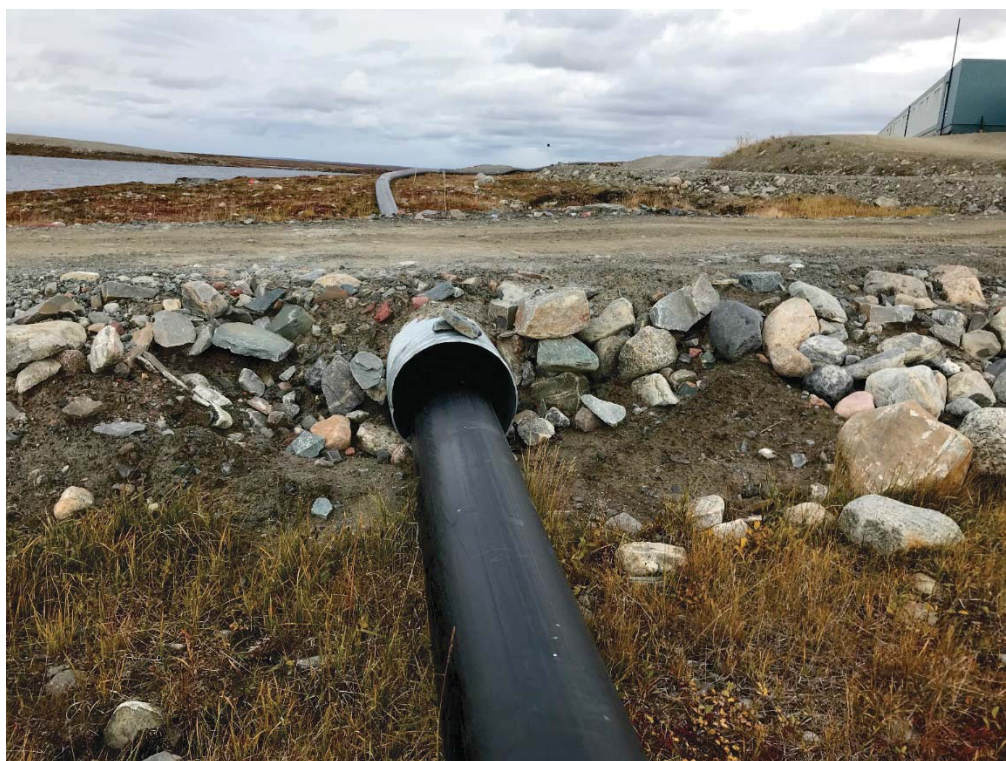
Photograph 14: Exploration Camp Fresh Water Intake Access Road, Pipeline Crossing, Looking Southwest (10 September 2018)

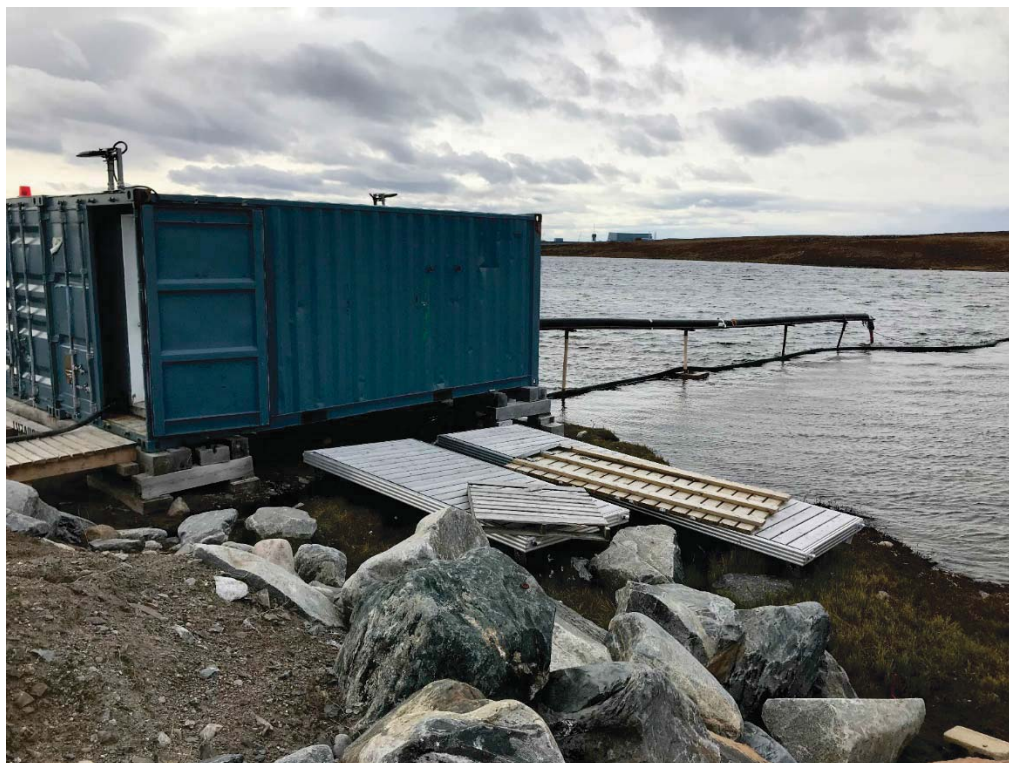
Photograph 15: Exploration Camp Fresh Water Intake, Looking West (10 September 2018)

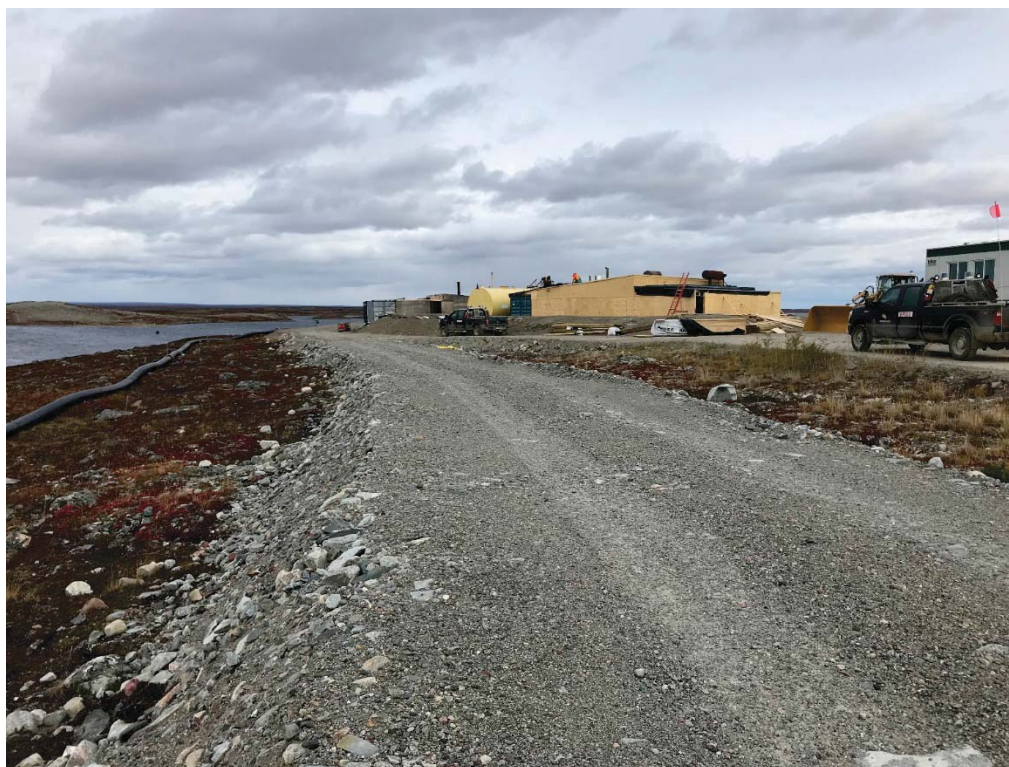
Photograph 16: Exploration Camp Diffuser Access Road Adjacent to Camp Trailers, Looking Northeast (10 September 2018)

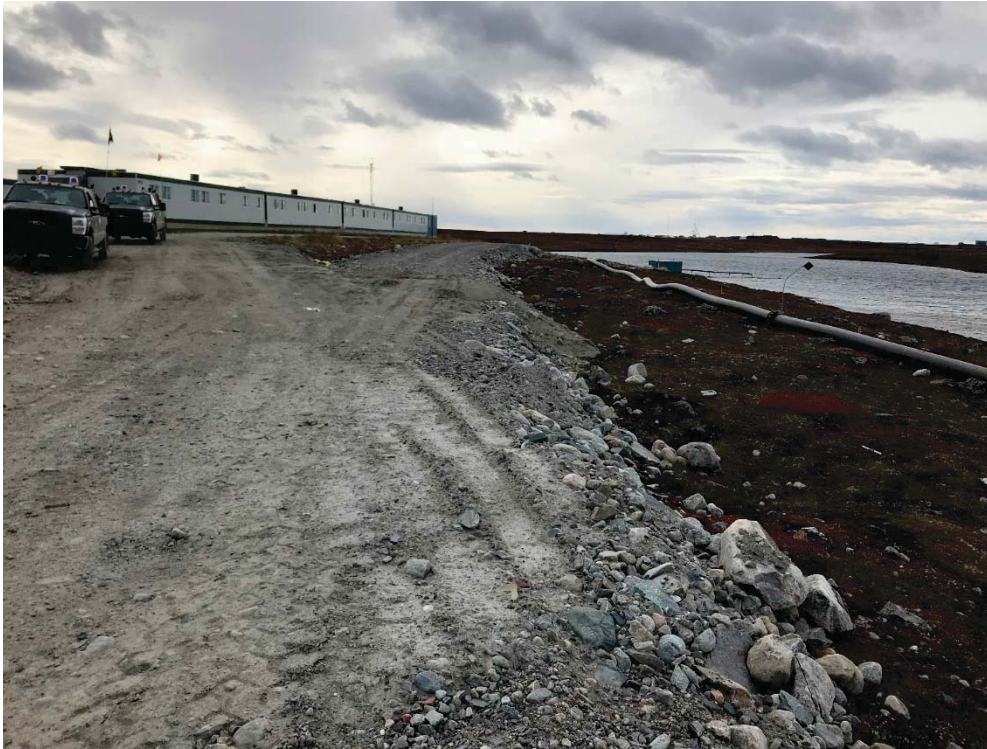
**Photograph 17: Exploration Camp Diffuser Access Road Adjacent to Camp Trailers, Looking West
(10 September 2018)**

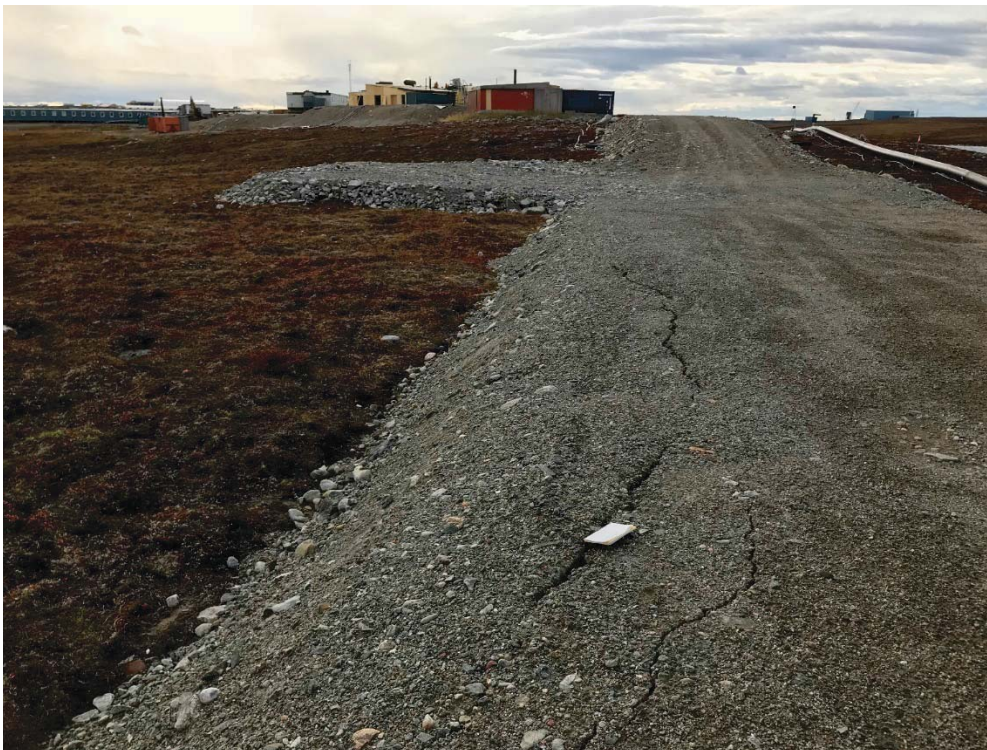
**Photograph 18: Exploration Camp Diffuser Access Road, Cracking on South Side of Road, Looking West
(10 September 2018)**

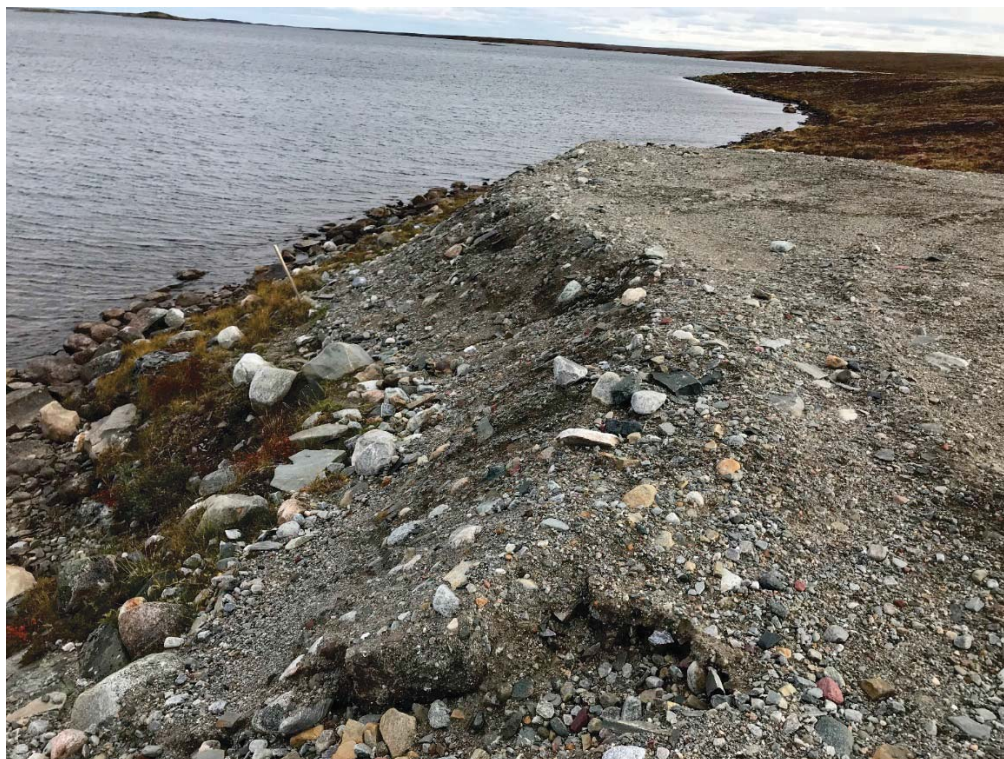
Photograph 21: Exploration Camp Diffuser Access Adjacent to Meliadine Lake, Looking South (10 September 2018)

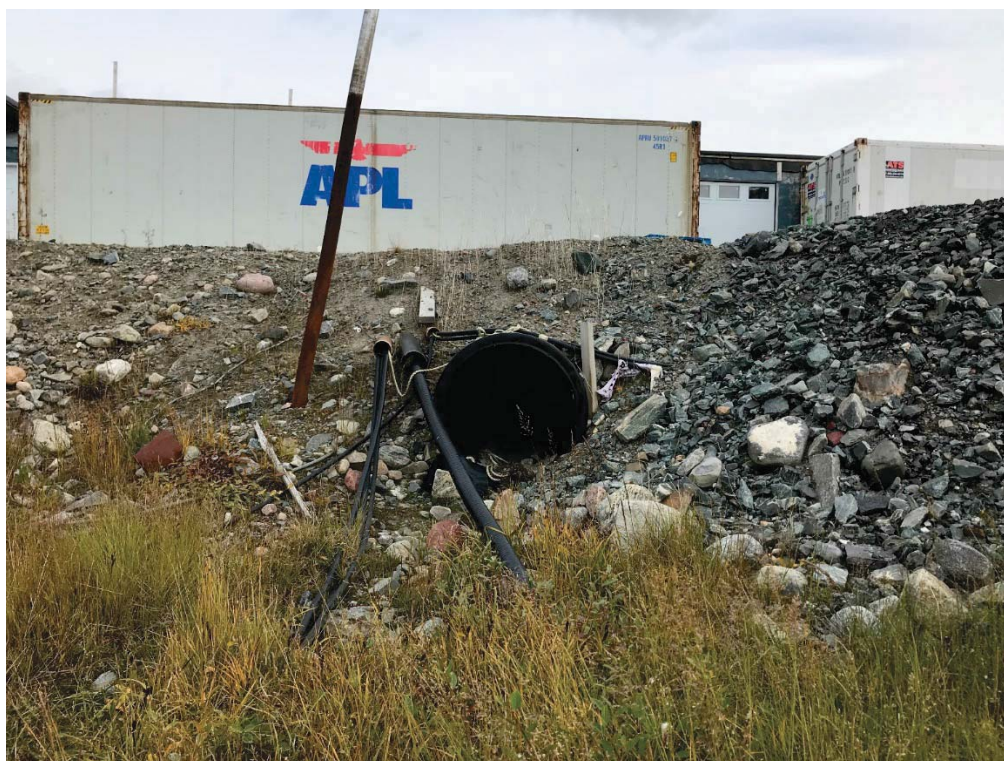
Photograph 22: Exploration Camp Access Road, Downstream End of Culvert on North Side of Camp, not exposed on upstream (10 September 2018)

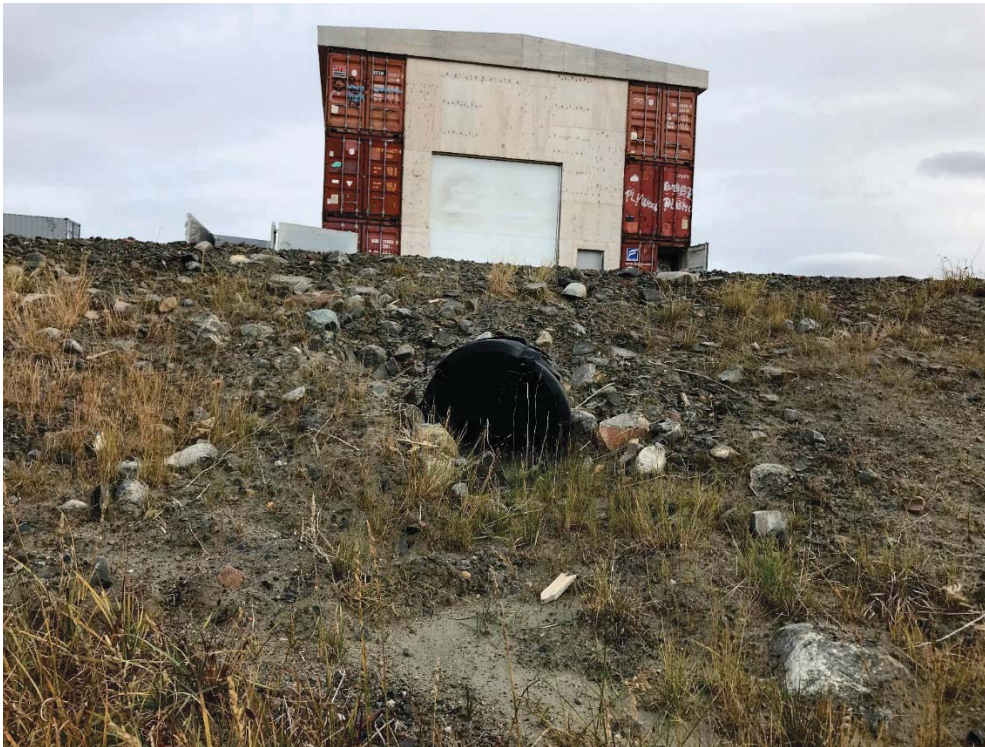
Photograph 23: Exploration Camp Access Road, Downstream End of Culvert on North Side of Camp, not exposed on upstream (10 September 2018)

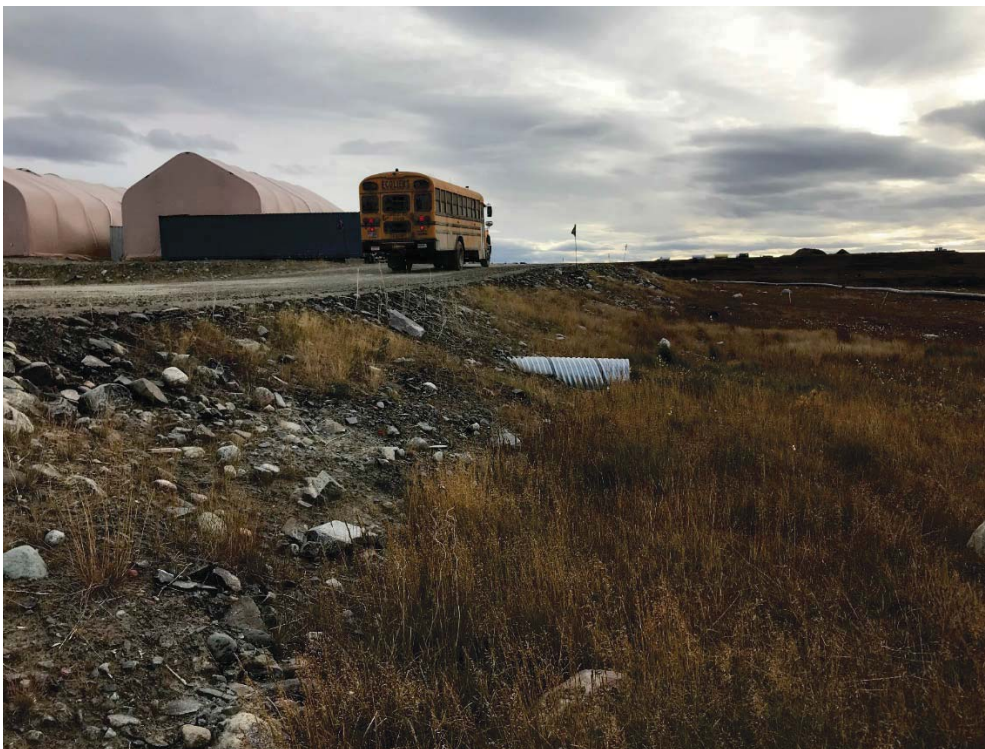
Photograph 24: Exploration Camp Access Road, Downstream End of Culvert on North Side of Camp (10 September 2018)

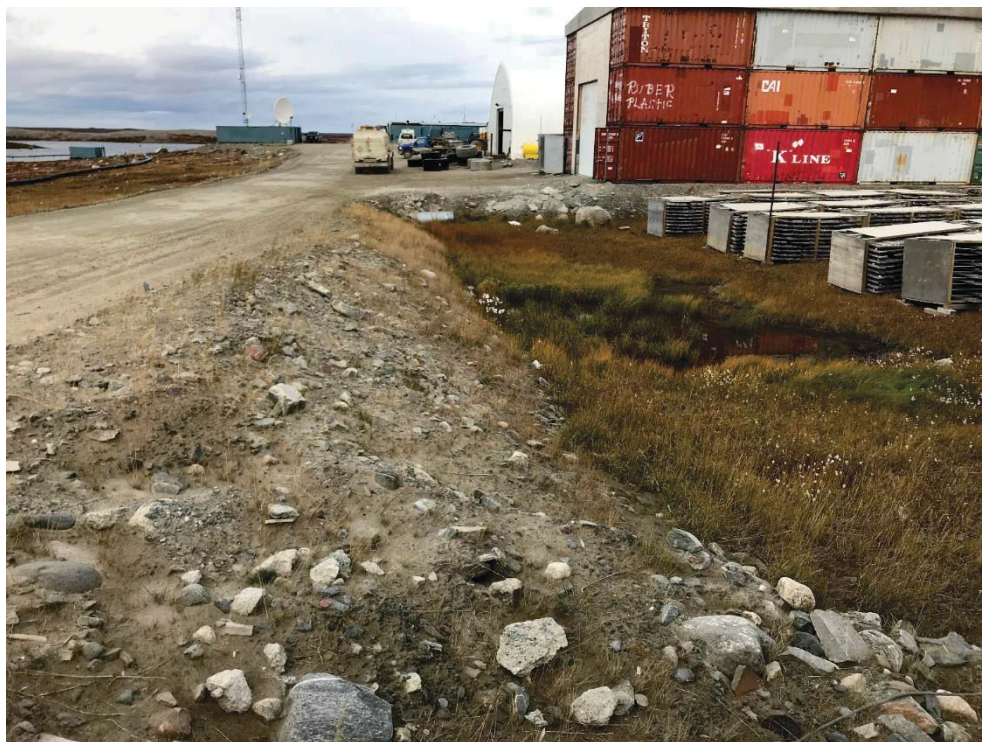
Photograph 25: Exploration Camp Access Road, Upstream End of Culvert on North Side of Camp (10 September 2018)

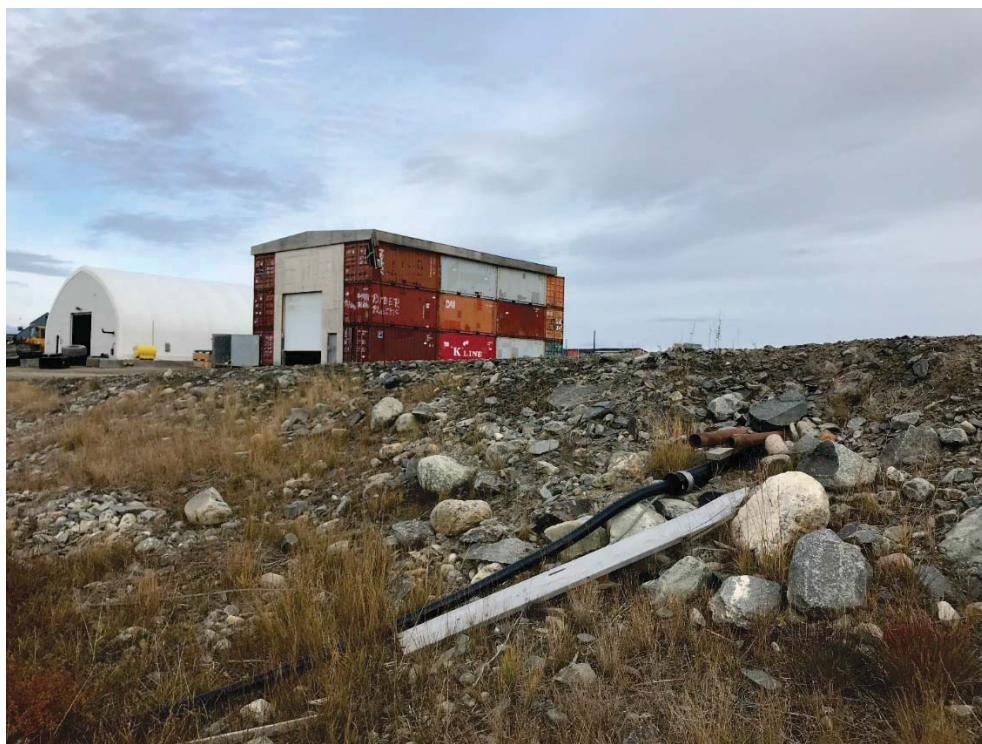
Photograph 26: Exploration Camp Access Road, Downstream Ends of Steel Pipes on Northwest Side of Camp, not exposed on upstream (10 September 2018)

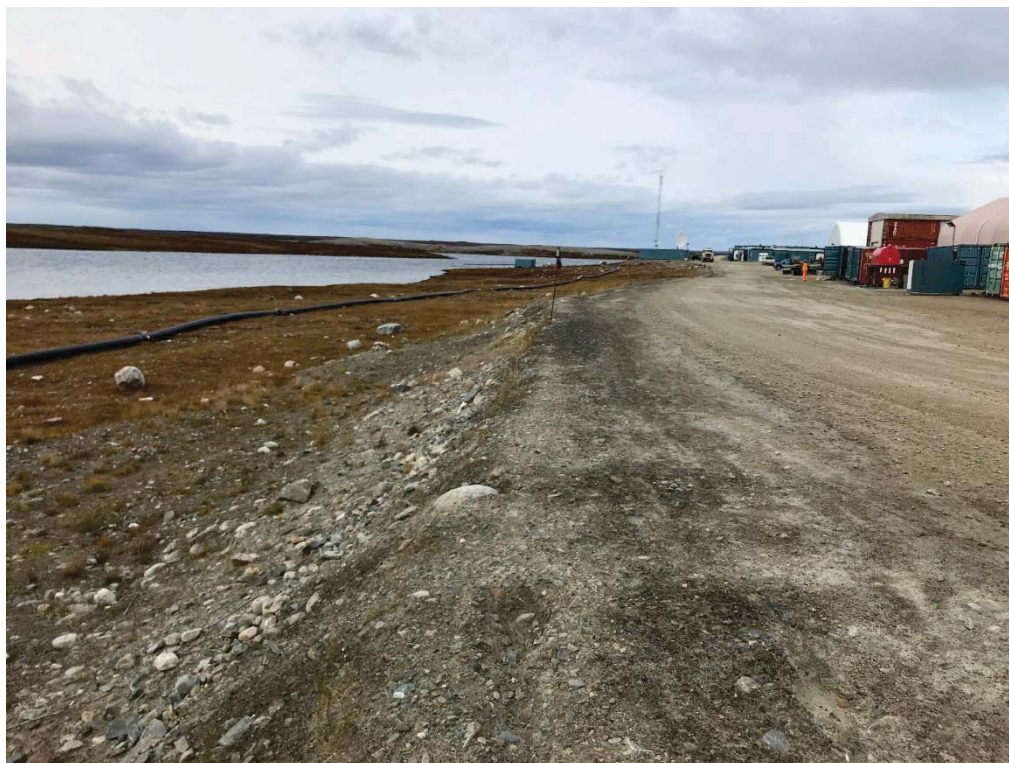
Photograph 27: Exploration Camp Access Road, North Side of Road near Camp, Looking East (10 September 2018)

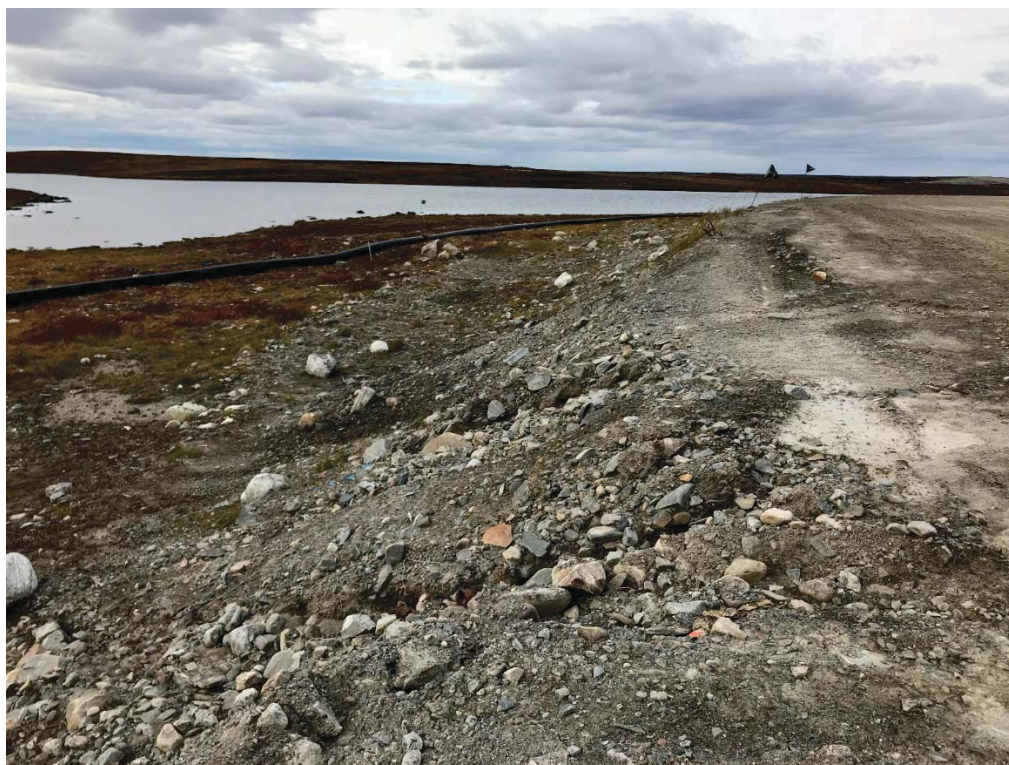
Photograph 28: Exploration Camp Access Road, approximately 250 m West of Camp, Erosion on Crest and Slope of Road, Looking North (10 September 2018)

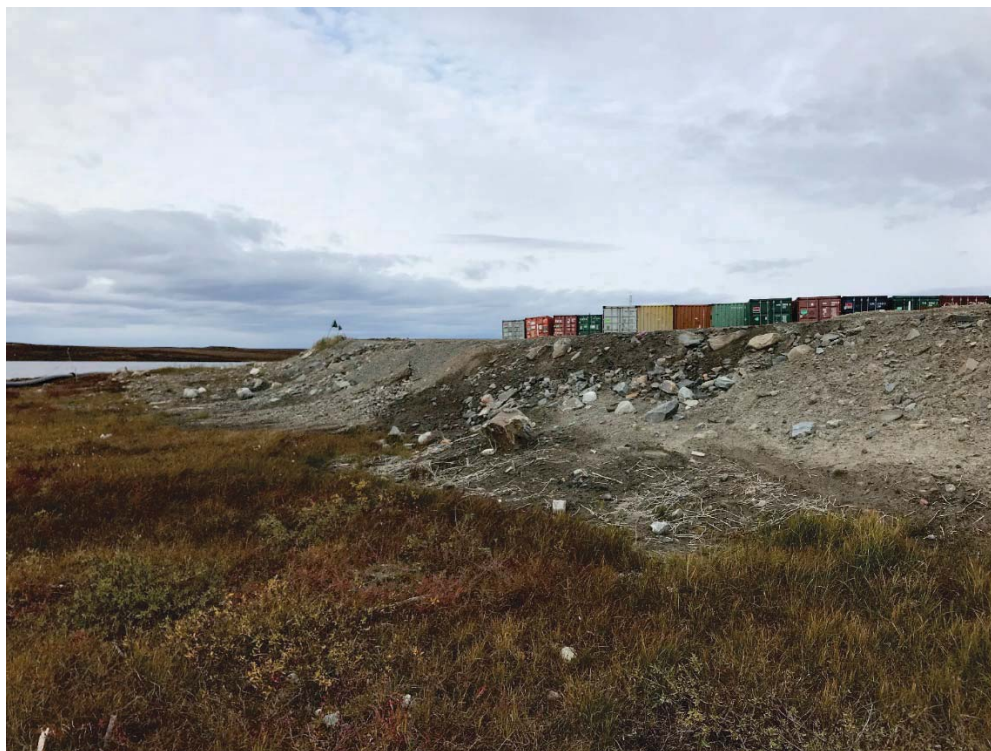
Photograph 29: Exploration Camp Access Road, approximately 250 m West of Camp, Erosion on Slope of Road, Looking North (10 September 2018)

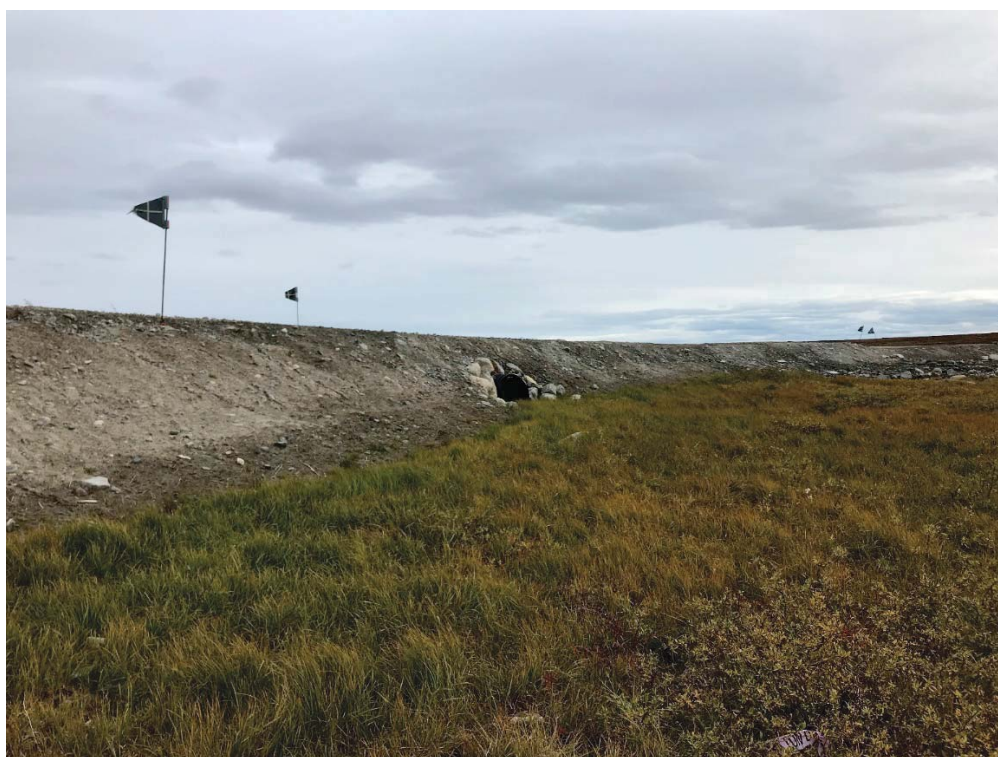
Photograph 30: Exploration Camp Access Road, Downstream End of Culvert through Road, Looking East (10 September 2018)

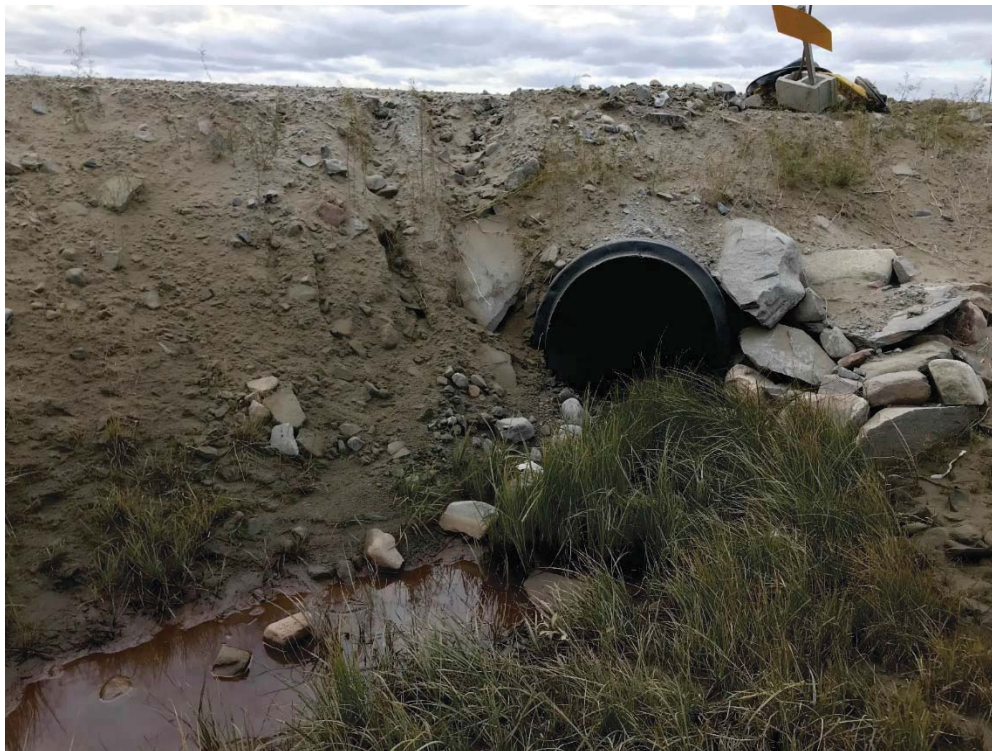
**Photograph 31: Exploration Camp Access Road, Upstream End of Culvert through Road, Looking East
(10 September 2018)**

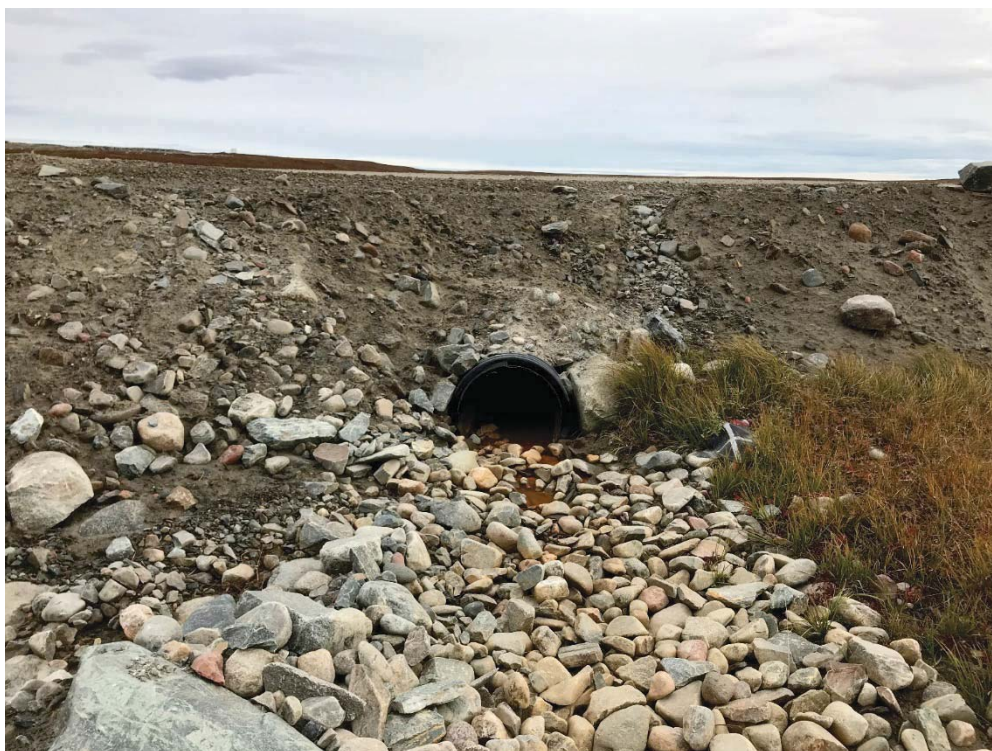
**Photograph 32: Exploration Camp Access Road, Downstream End of Culvert through Road, Looking North
(10 September 2018)**

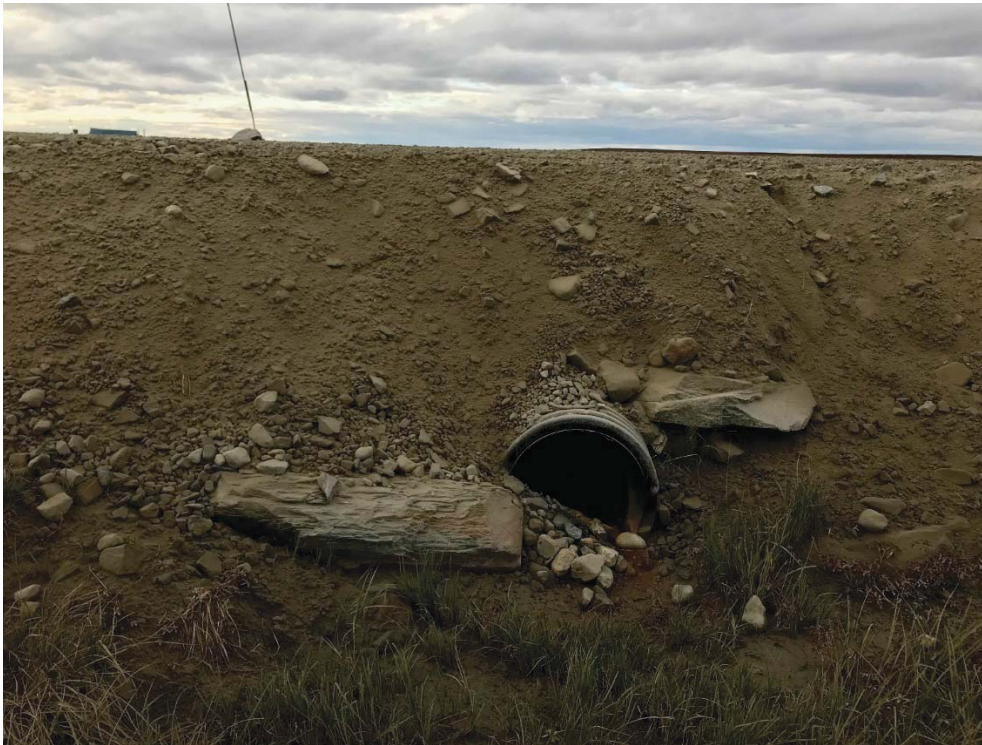
Photograph 33: Exploration Camp Access Road, Upstream End of Culvert through Road, Looking South (10 September 2018)

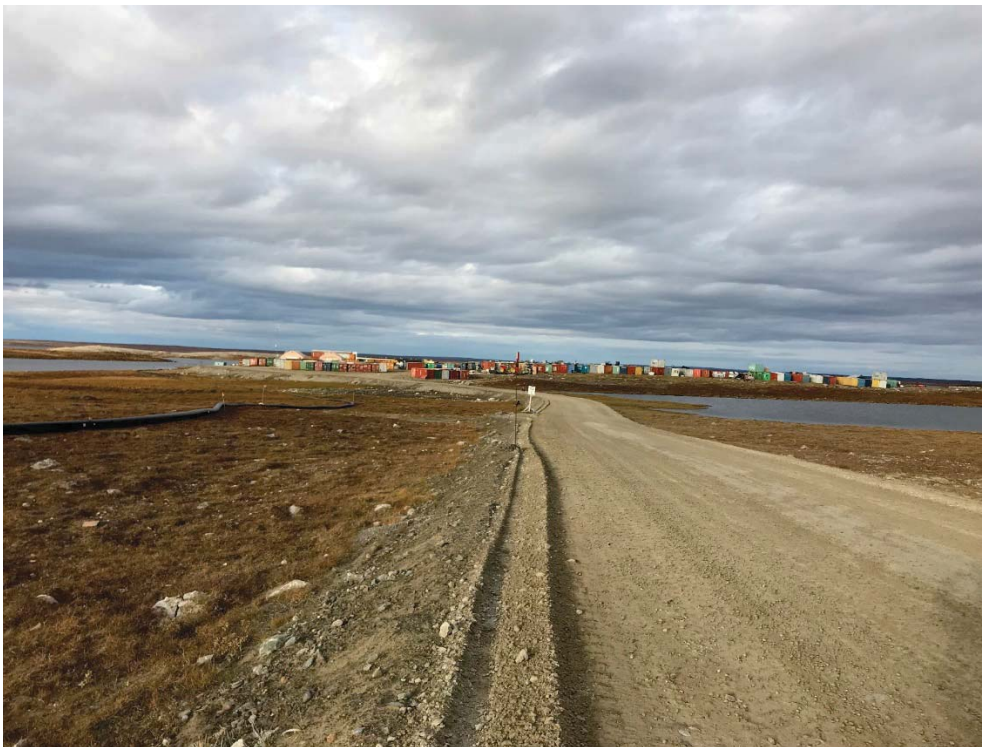
Photograph 34: Exploration Camp Access Road, North Side of Road Approximately 500 m West of Camp, Looking Northeast (10 September 2018)

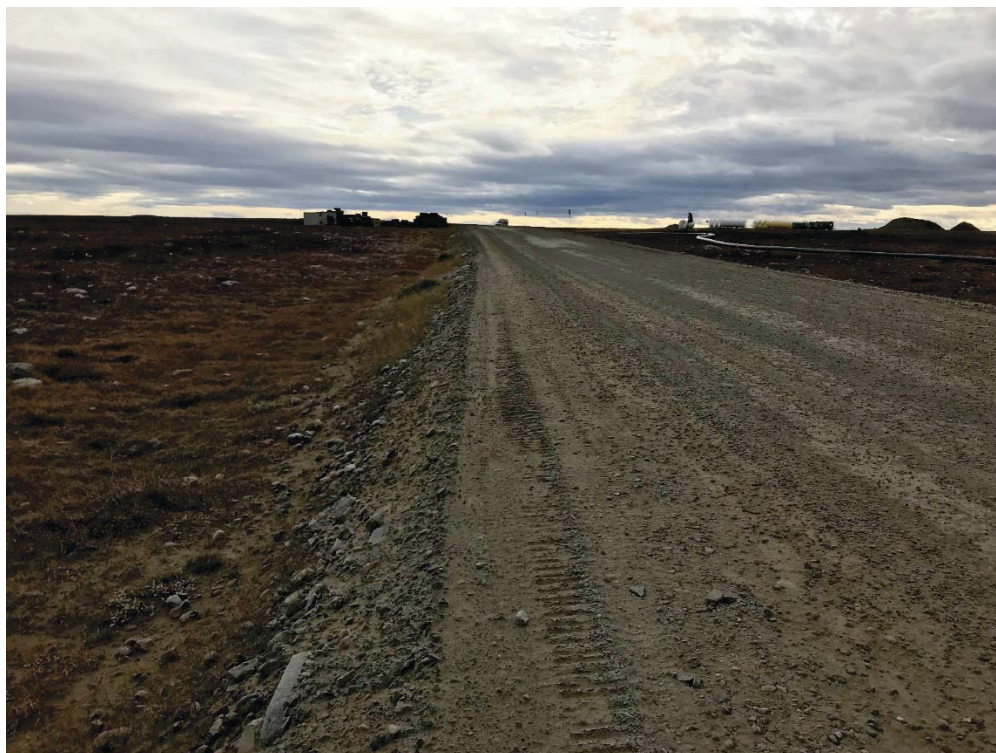
Photograph 35: Exploration Camp Access Road, South Side of Road Approximately 550 m West of Camp, Looking Southwest (10 September 2018)

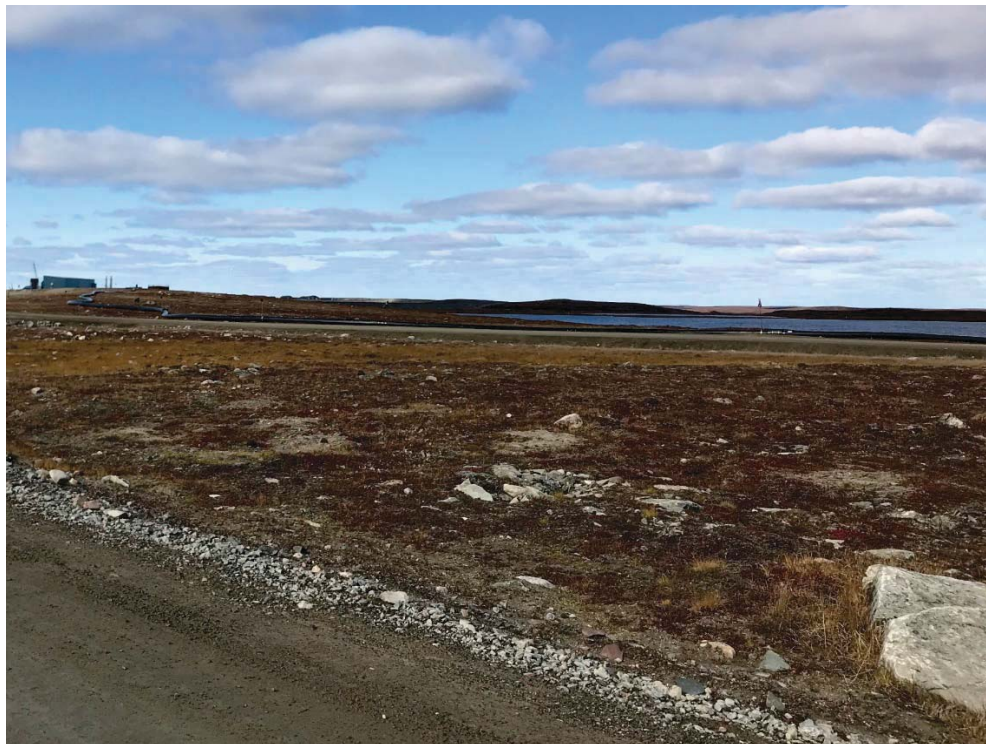
Photograph 36: Exploration Camp Access Road, North Side of Road Looking Southwest from the Fuel Storage Area (10 September 2018)
