APPENDIX A-3

Site Roads, Culverts, and
Tiriganiaq and Wesmeg Areas

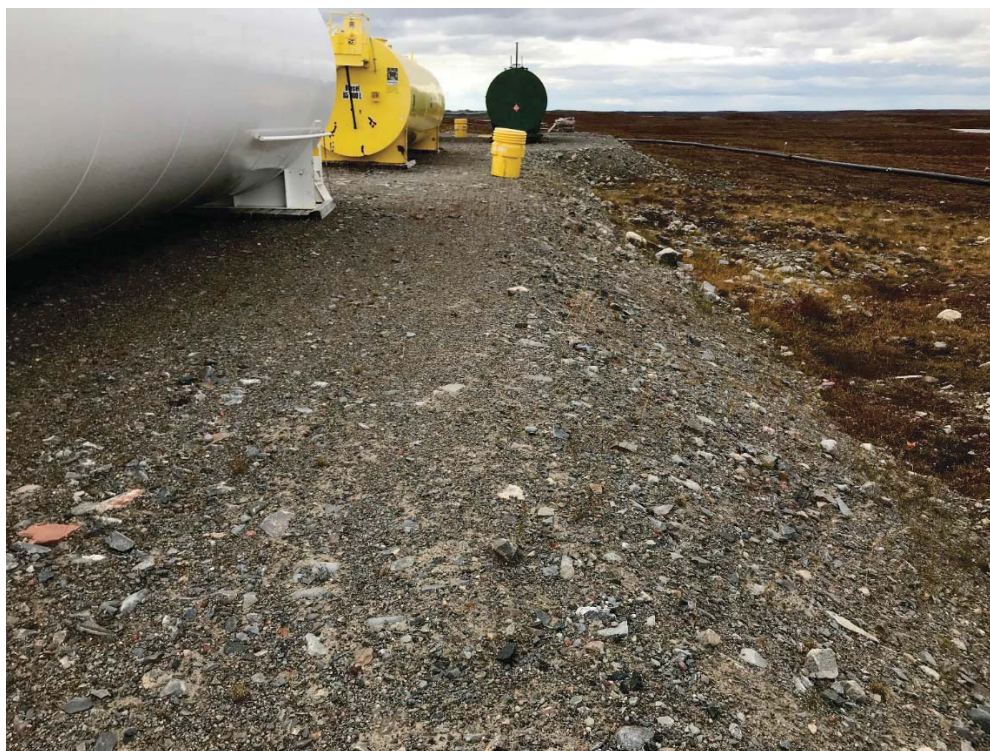
Photograph 37: Exploration Camp Access Road, South Side of Road near Intersection with AWAR Looking Northeast (10 September 2018)

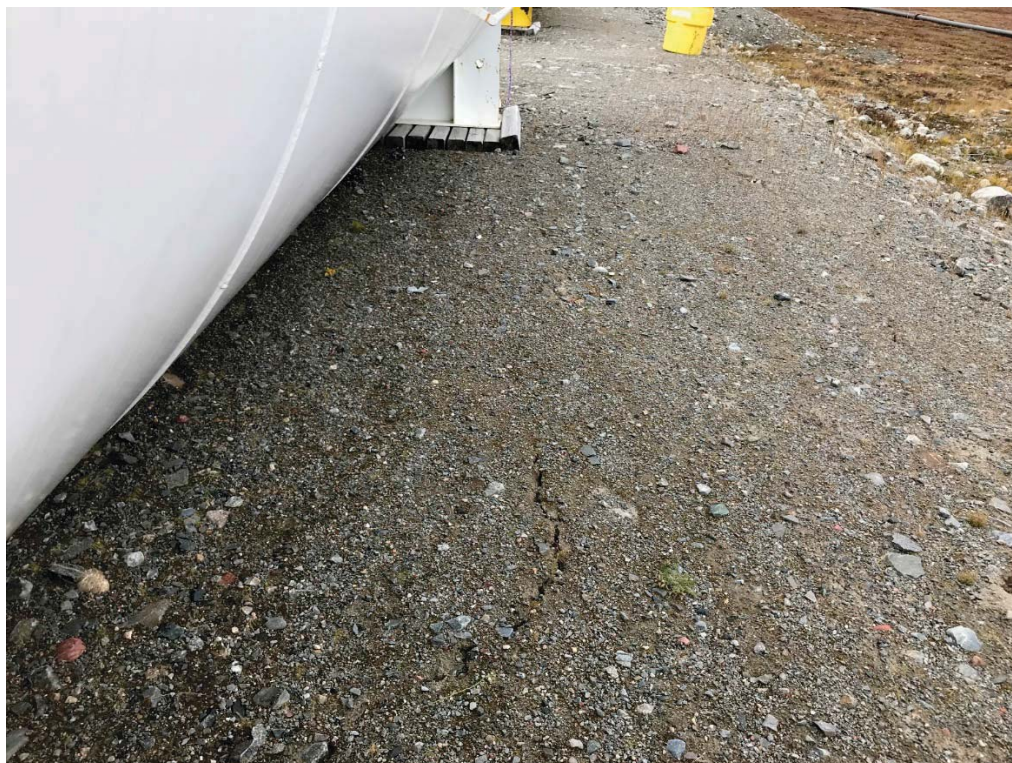
Photograph 38: Exploration Camp Fuel Storage, Looking Northwest along Northeast side of Fuel Storage Area (10 September 2018)

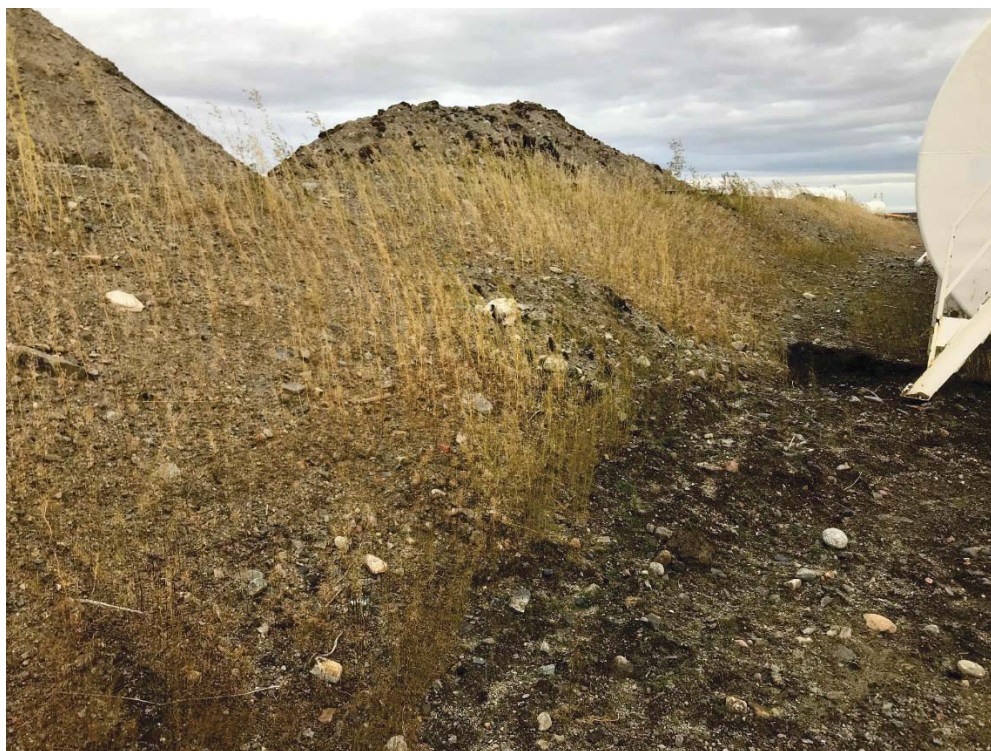
Photograph 41: Exploration Camp Fuel Storage, Looking North at South side of Fuel Storage Area (10 September 2018)

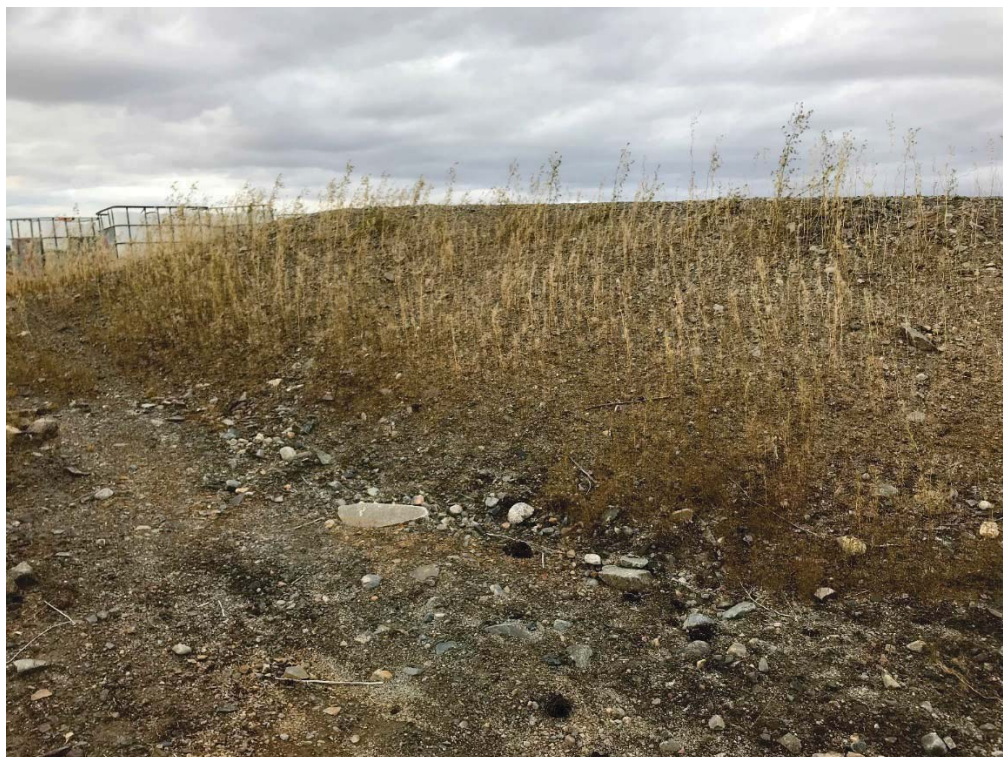
Photograph 42: Exploration Camp Landfarm, Downstream Face of West Slope, Looking Southeast (10 September 2018)

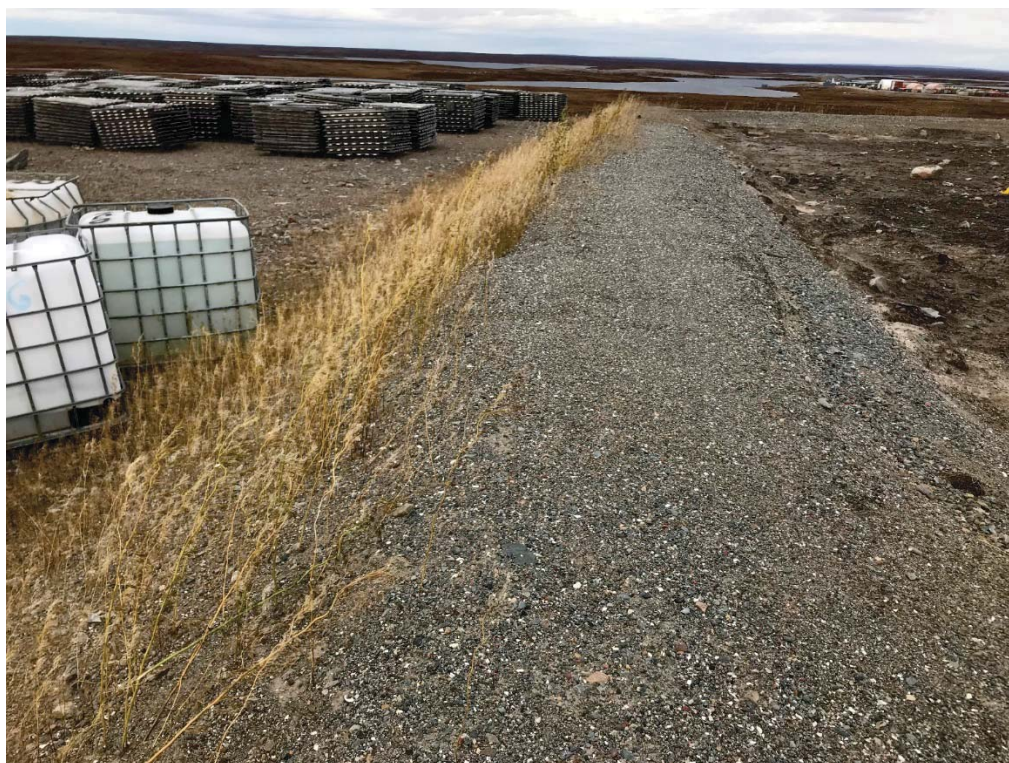
Photograph 43: Exploration Camp Landfarm, Downstream Face at Northwest Corner, Looking Southeast (10 September 2018)

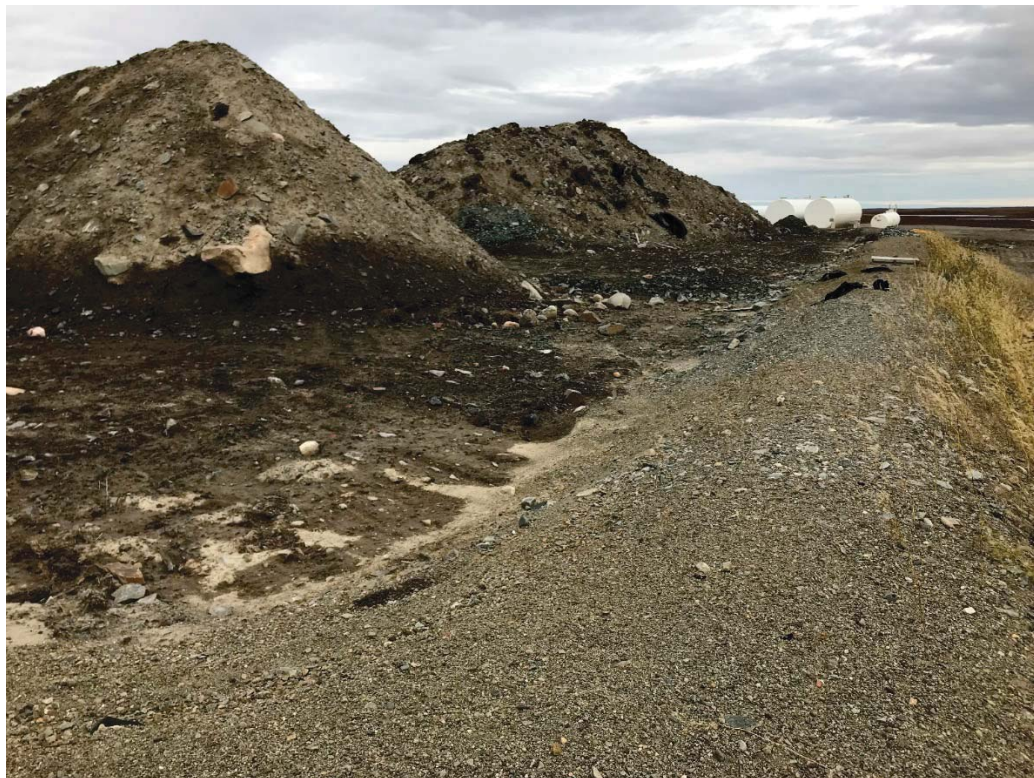
Photograph 44: Exploration Camp Landfarm, North Slope and Crest, Looking Northeast (10 September 2018)

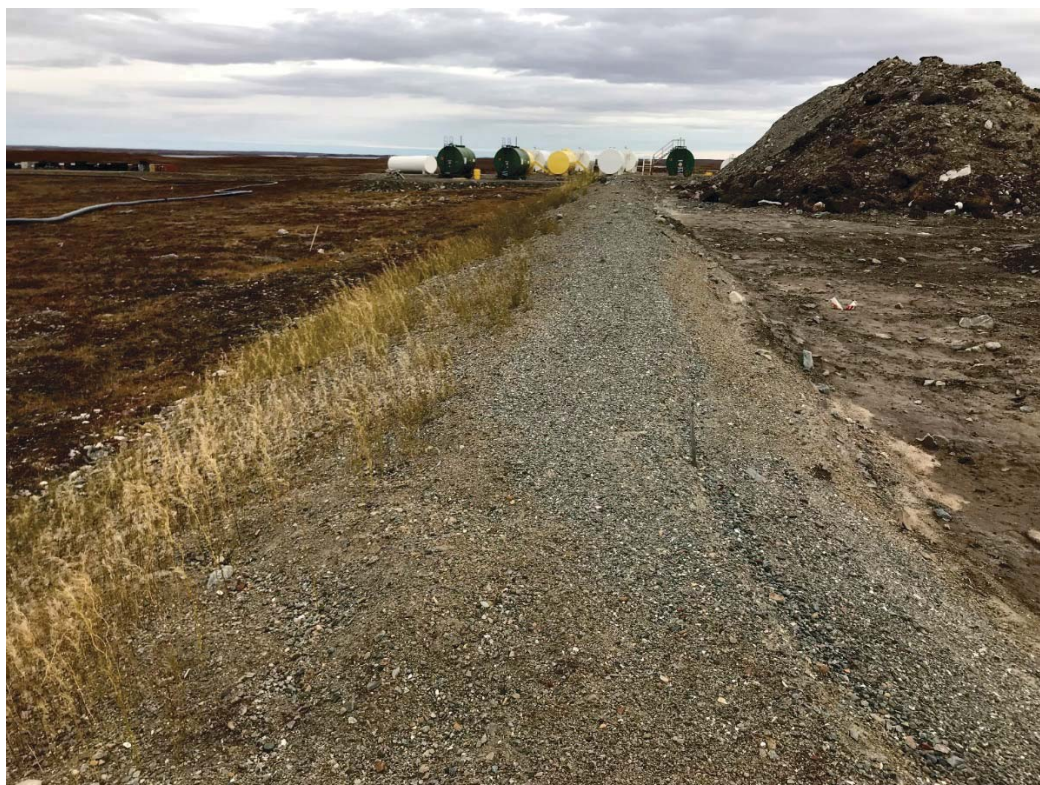
Photograph 45: Exploration Camp Landfarm, West Slope Crest, Looking Southeast (10 September 2018)

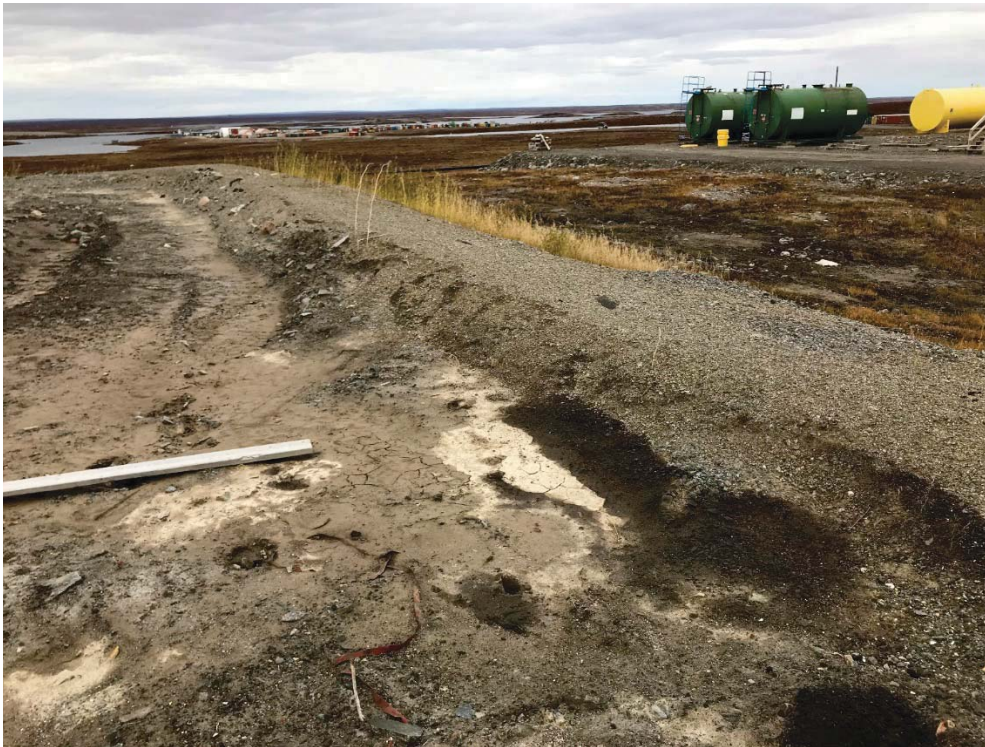
Photograph 46: Exploration Camp Landfarm, East Slope and Crest, Looking Southeast (10 September 2018)

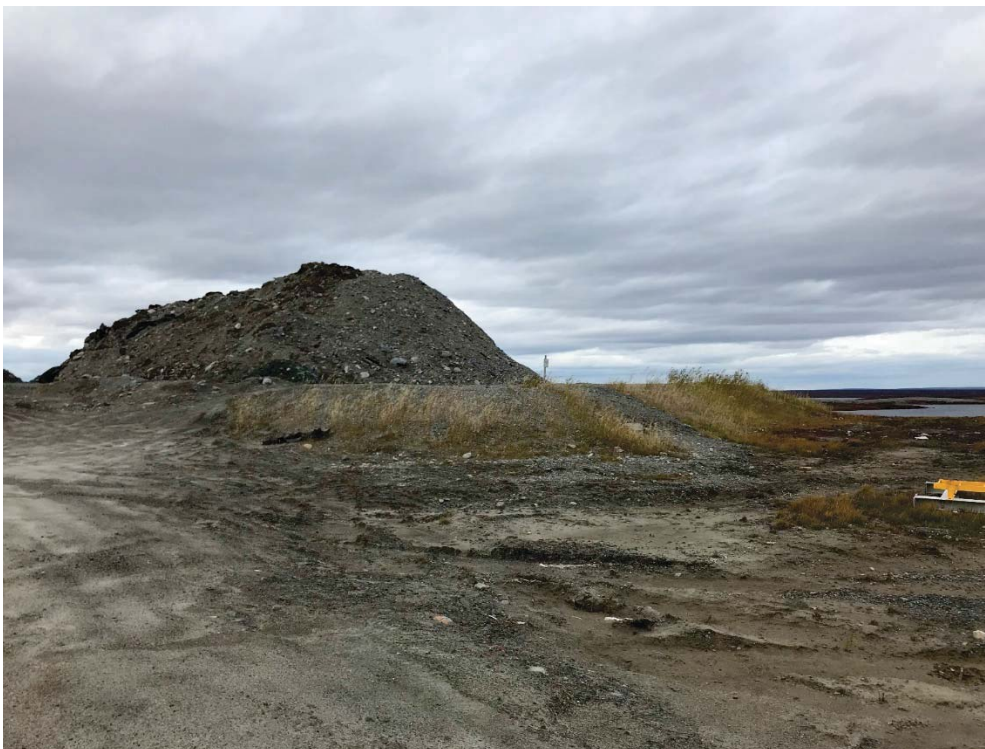
Photograph 47: Exploration Camp Landfarm, South Slope Crest, Looking Southeast. Fuel Storage in Background (10 September 2018)
