Appendix 6 : 2020 Annual Geotechnical Inspection Report

# **2020** Annual Geotechnical Inspection Meliadine Gold Project, Rankin Inlet, Nunavut

## **Agnico Eagle Mines Limited**

FEBRUARY 2021 ISSUED FOR USE

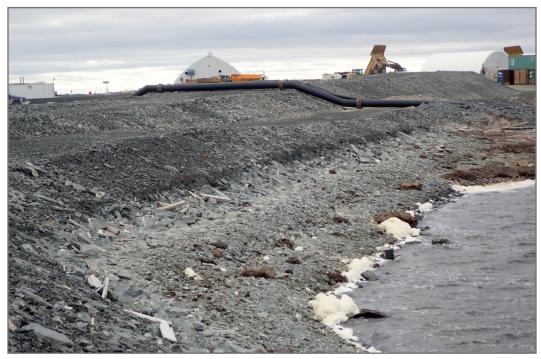
Photo 1: Dike D-CP1 - Upstream face—some wave and ice erosion evident

CP1, Dike D-CP1, and Jetty1 are performing well. Some erosion has occurred on the upstream shell of Dike D-CP1. The erosion should be surveyed to determine if remedial measures are required.

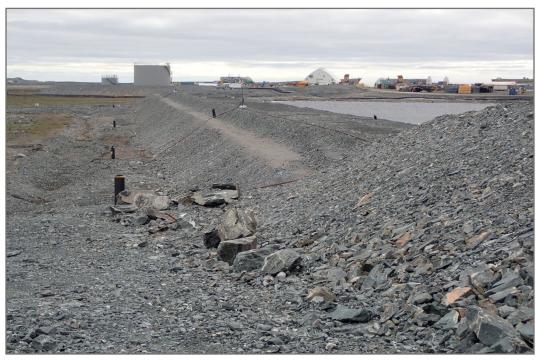
Photo 2: Dike D-CP1—Downstream face, looking south

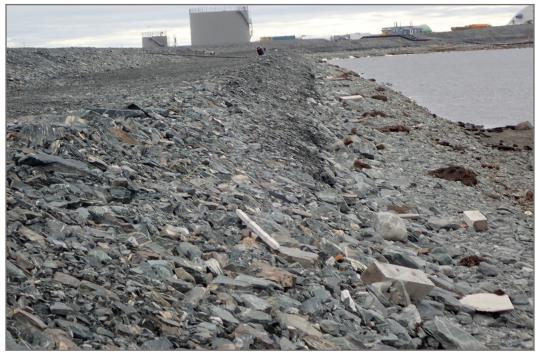
Photo 3: Dike D-CP1 - Upstream face—some wave erosion evident, scarp approximately 1 m high.

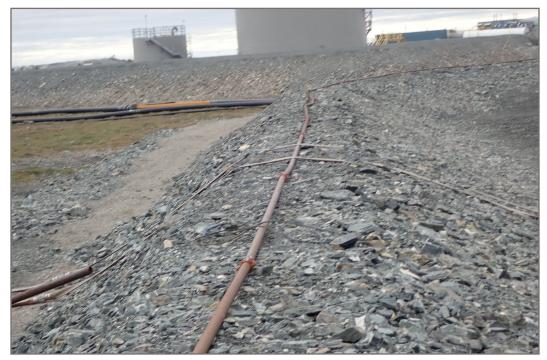
Photo 4: Dike D-CP1 - Upstream crest.

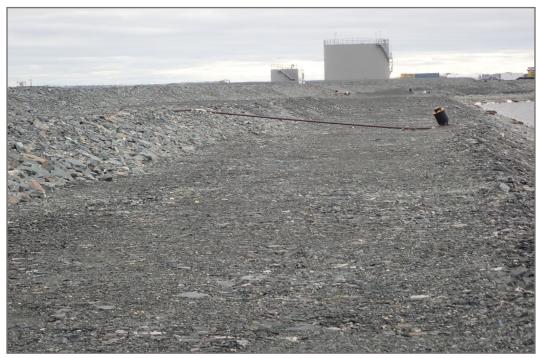
Photo 5: Dike D-CP1 - Upstream crest—some settlement is evident

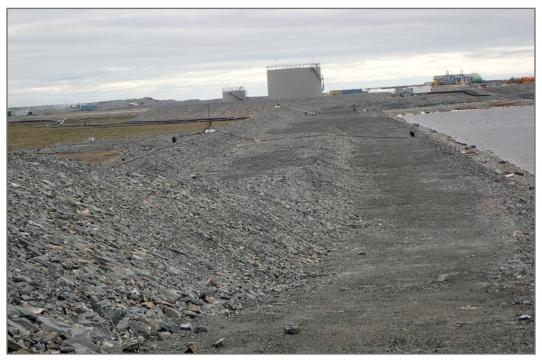
**Photo 6:** Dike D-CP1 - Upstream crest, looking south.

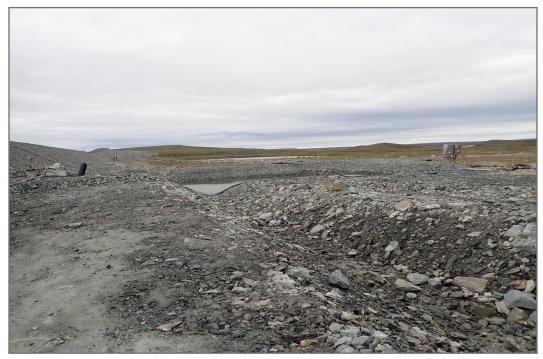
- No seepage was observed from the downstream toe.
- The water levels in the downstream collection channel pond and channels was relatively low (Photos 9, 11, and 14, Appendix B) at the time of the site visit. It is understood the sump was pumped out following freshet.

Photo 9: Dike D-CP1 - water collection channel at downstream toe of Dike (south end.)

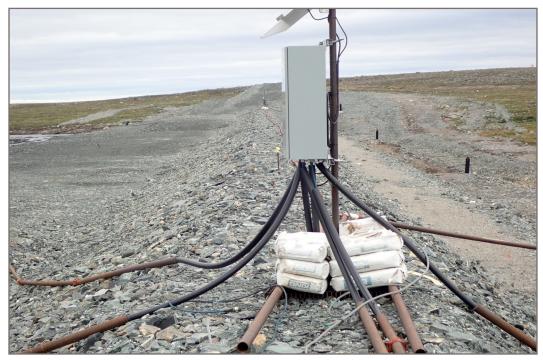
Photo 10: Dike D-CP1 - Dike crest, data acquisition terminal for GTCs

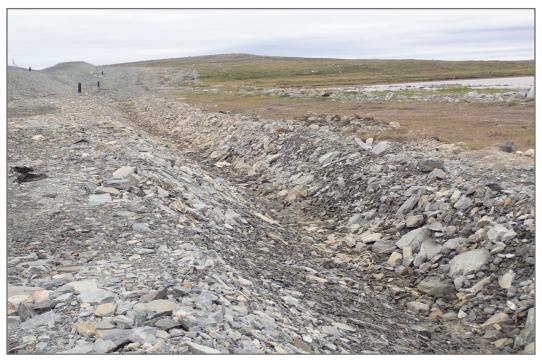
Photo 11: Dike D-CP1 - Water collection channel downstream of the Dike.

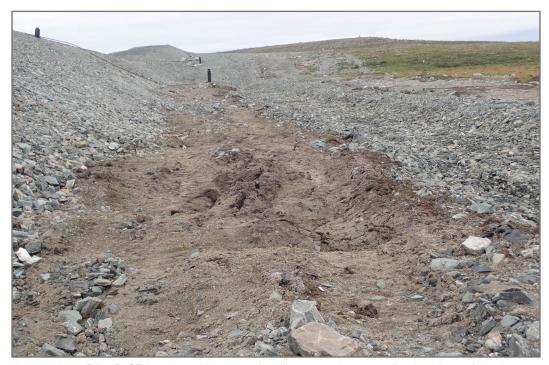
- Settlement and subsidence has occurred between the downstream dike toe and the water collection channel (as shown in Photos 12 and 14, Appendix B). Some of the settlement is in the disturbed original ground in the area, other settlement is in areas that were covered with fill for construction access. The settlement and subsidence does not appear to be impacting the dike's performance.

Photo 12: Dike D-CP1 - ground between the dike toe and water collection channel, settlement and subsidence

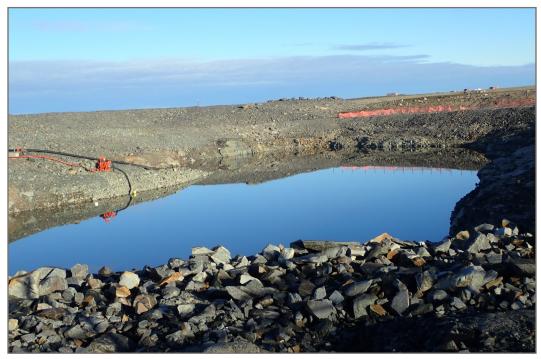
**Photo 1:** Pond CP3 - Looking northwest, bedrock overburden contact.

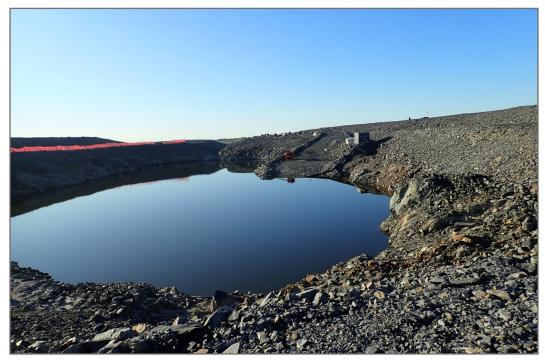
Photo 2: Pond CP3—Looking south, Berm CP3 on right, access ramp into pond.

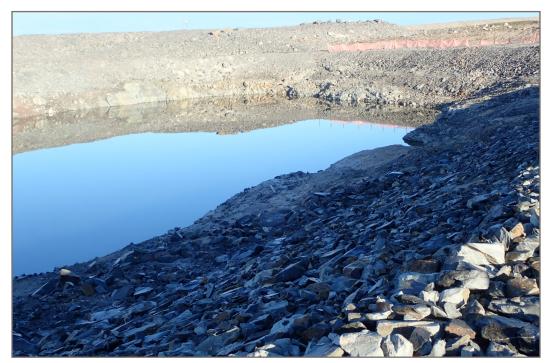
**Photo 3:** Pond CP3 - Looking north, rockfill covered overburden slope in foreground.

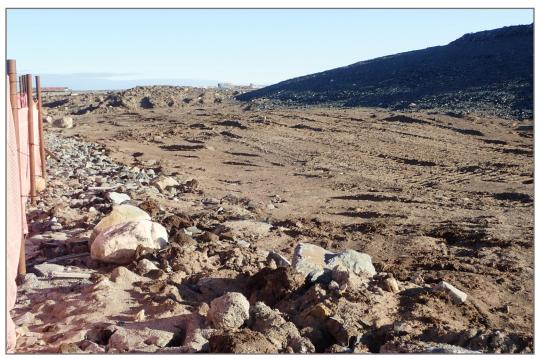
Photo 4: Pond CP3 - Regraded ground between TSF and Pond CP3

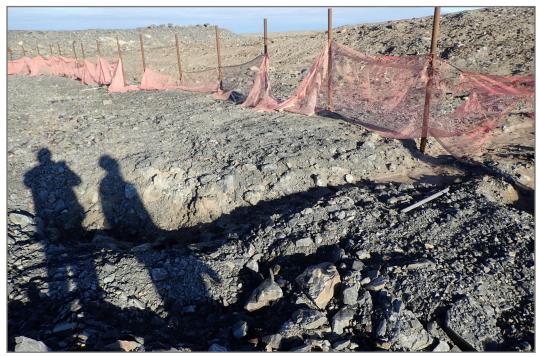
**Photo 5:** Pond CP3 - Runoff/erosion channel into pond from north end of TSF drainage, located on east side of pond.

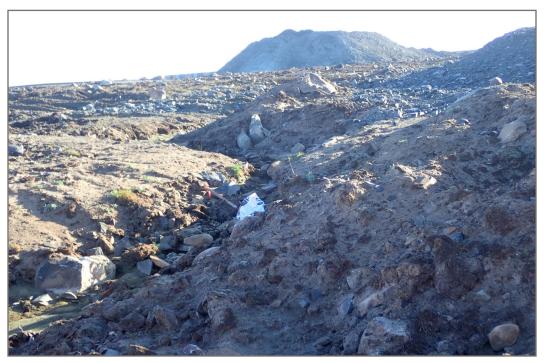
**Photo 6:** Pond CP3 - Runoff/erosion channel into pond from north end of TSF drainage, located on east side of pond.

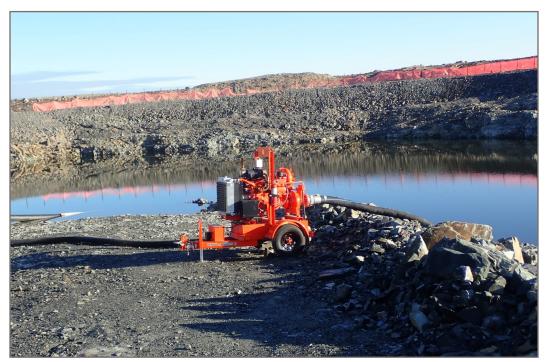
Photo 7: Pond CP3 - CDW 150 pump.

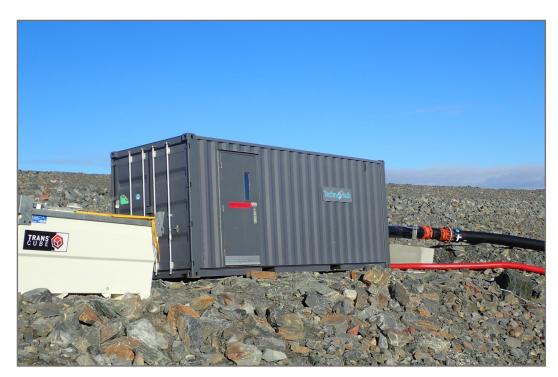
Photo 8: Pond CP3 - Pump on ramp.

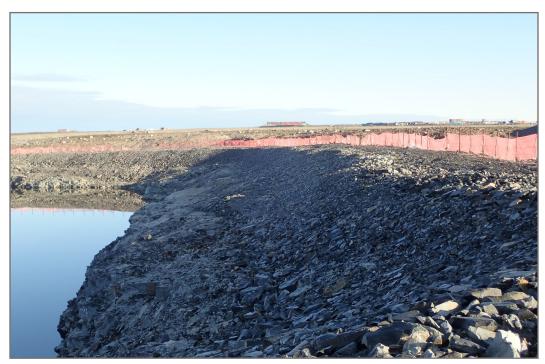
Photo 9: Pond CP3 - Rockfill covered overburden slope.

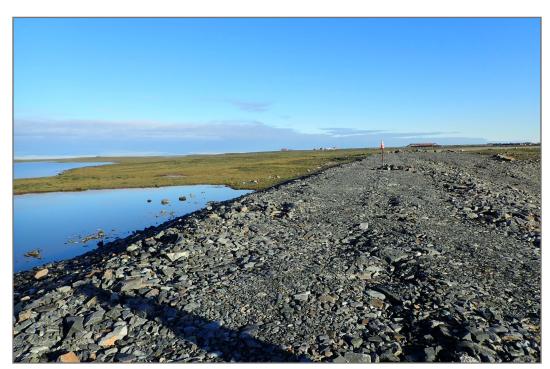
**Photo 10:** Berm CP3 - Berm crest, looking north. Undulations in crest 0.3 to 0.5 m.

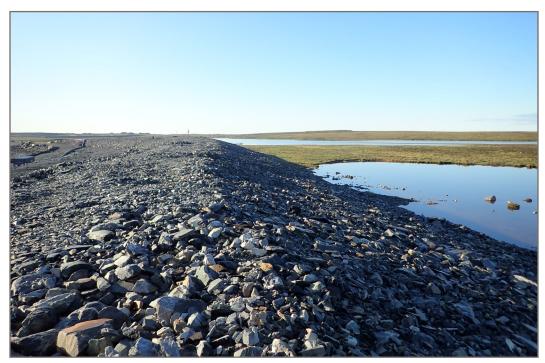
Photo 11: Berm CP3 - Downstream slope against lake B26.

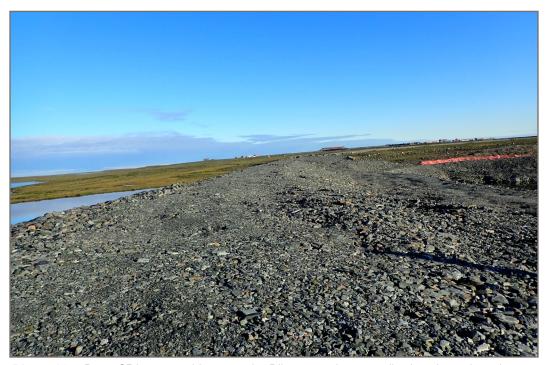
**Photo 12:** Berm CP3 - ground between the Dike toe and water collection channel, settlement and subsidence

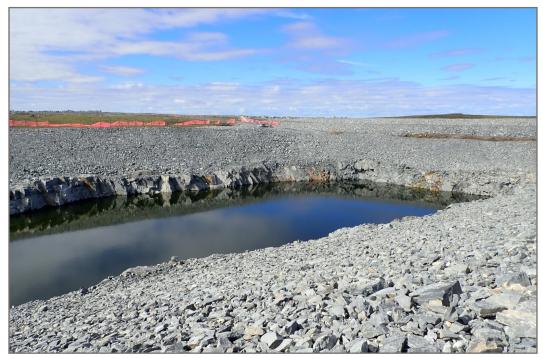
Photo 1: Pond CP4 - Looking west, Berm CP4 in the background.

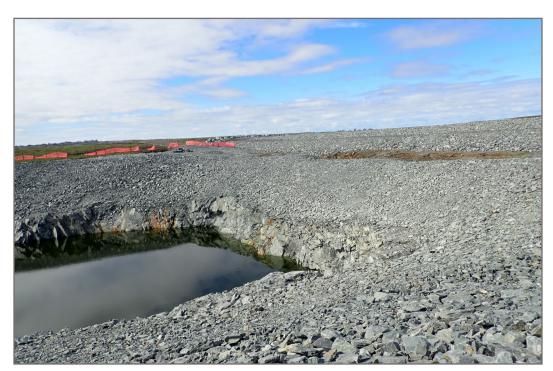
Photo 2: Pond CP4—West end of pond, Berm CP4 on right above pond. Original ground between the Berm CP4 and rockfill covered slope shown.

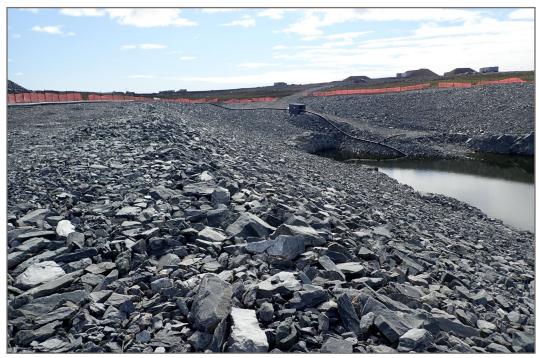
**Photo 3:** Pond CP4 - Looking southeast at the ramp into the pond.

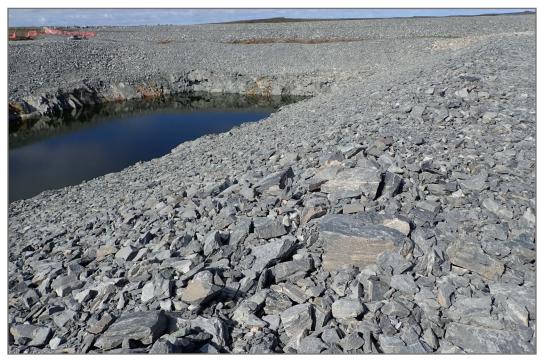
**Photo 4:** Pond CP4 - North slope—rockfill covered slope, no obvious signs of distress.

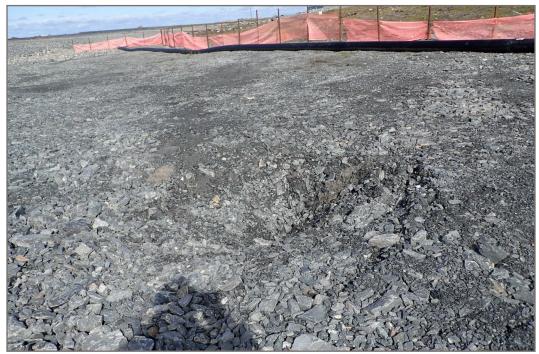
**Photo 7:** Pond CP4 - Ground above rockfill covered overburden slope. Settlement and subsidence in the area.

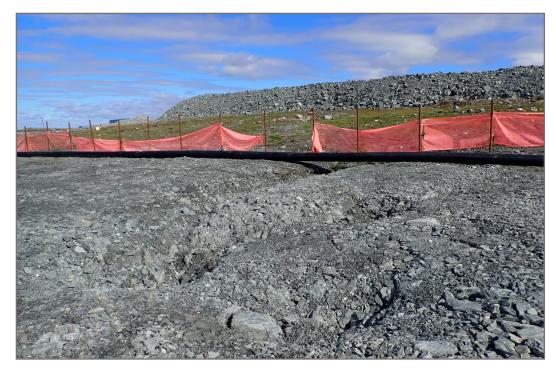
**Photo 8:** Pond CP4 - North slope, settlement in area between rockfill covered slope on original ground.

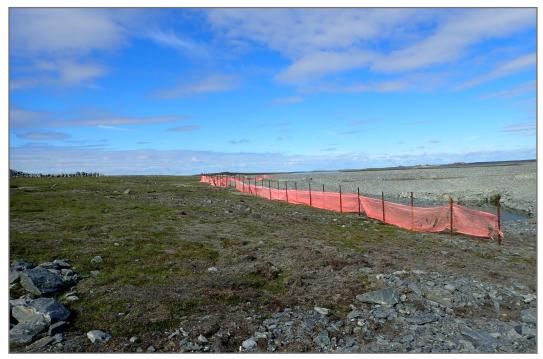
**Photo 9:** Pond CP4 - Original ground above north slope

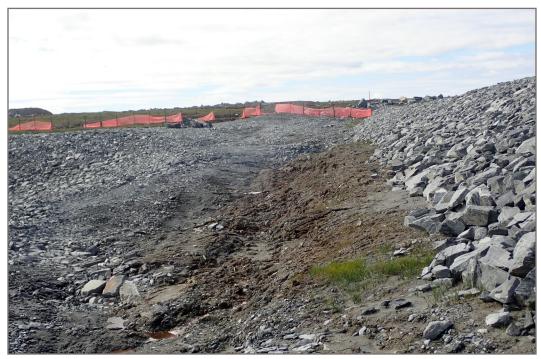
**Photo 10:** Pond CP4 - Settlement between Berm CP4 and west pond slope.

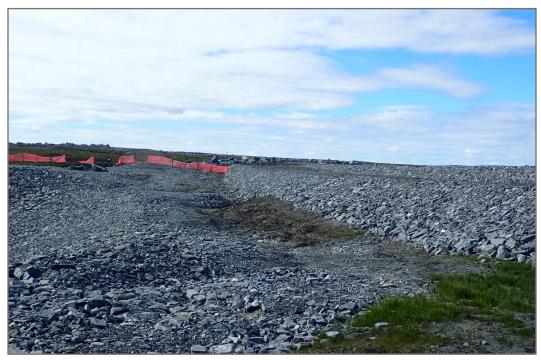
Photo 11: Pond CP4 - Settlement and between Berm CP4 and west pond slope.

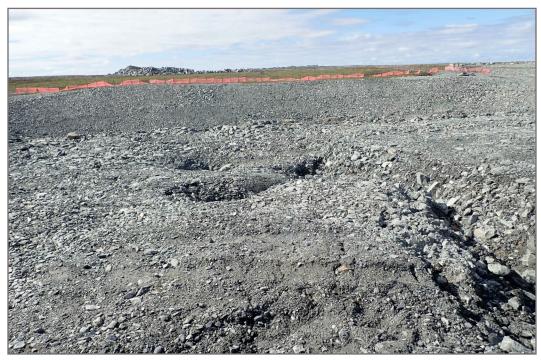
Photo 12: Pond CP4 - Settlement between original ground and north slope, looking south

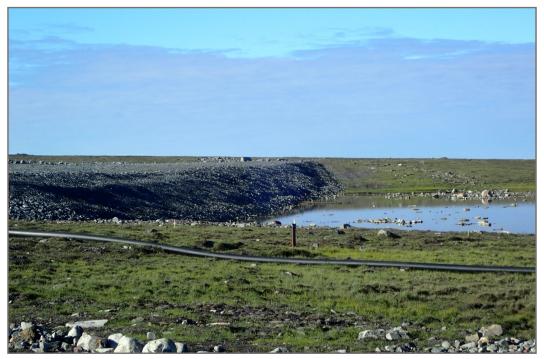
Photo 13: Berm CP4 - Downstream slope adjacent to Lake B8.

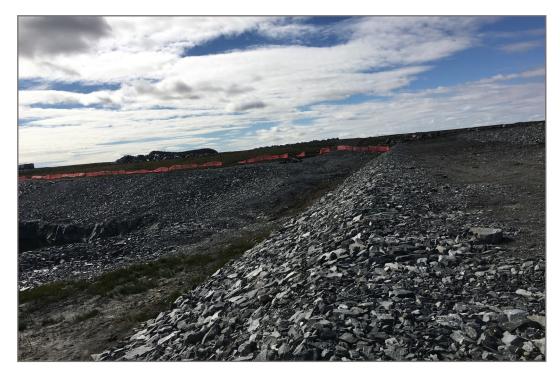
Photo 14: Berm CP4 - Upstream slope, thermal cover and original ground above Pond CP4

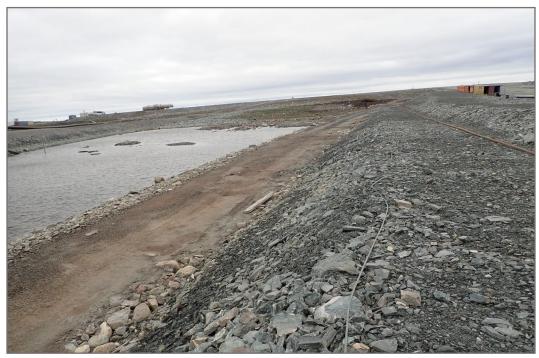
**Photo 1:** D-CP5 Dike - looking towards the north, upstream.

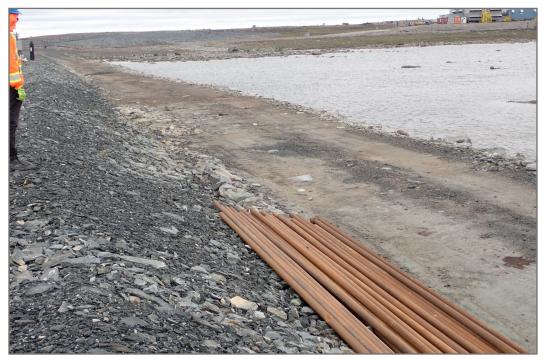
**Photo 2:** D-CP5 Dike - looking towards the south, upstream.

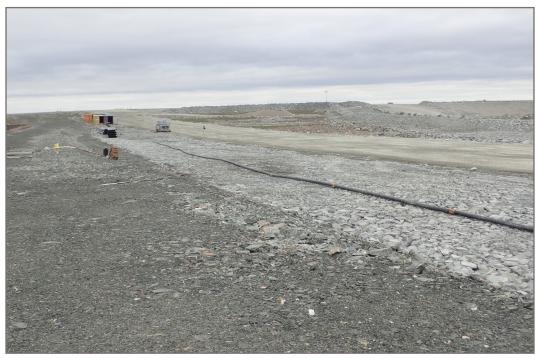
**Photo 3:** D-CP5 Dike - looking towards the south, downstream, new fill and haul road.

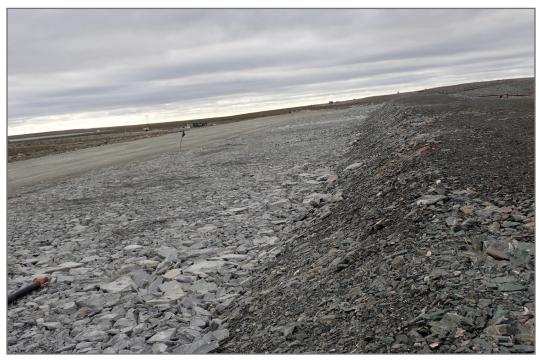
**Photo 4:** D-CP5 Dike - looking towards the north, downstream, new fill and haul road.

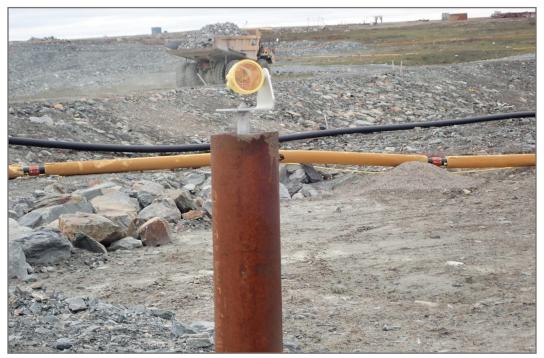
**Photo 5:** D-CP5 Dike—Survey monument.

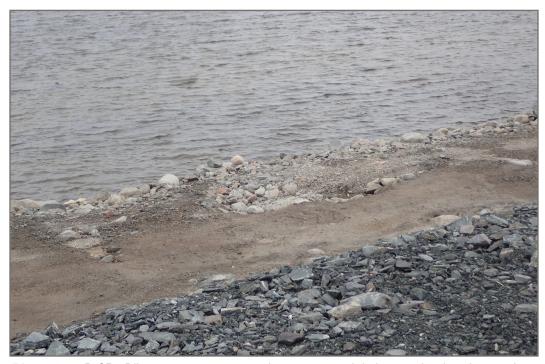
**Photo 6:** D-CP5 Dike - upstream, construction access road, below previously submerged area.

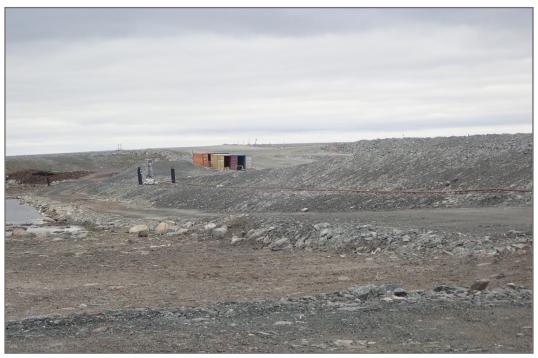
Photo 7: D-CP5 Dike - Upstream Shell

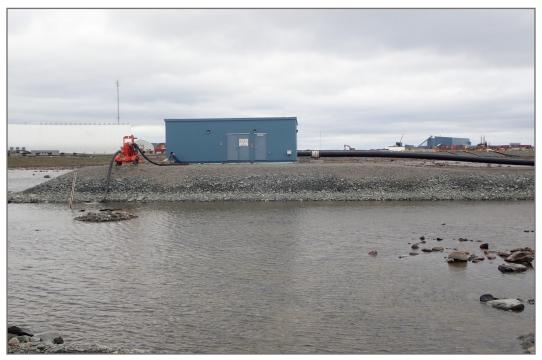
**Photo 10:** CP5 Jetty - looking towards the north.

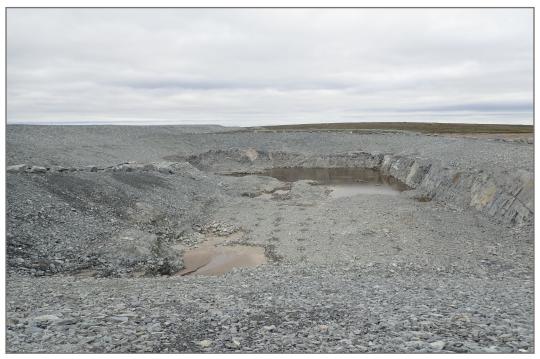
**Photo 1:** Pond CP6 - Looking north—contact between bedrock and overburden evident.

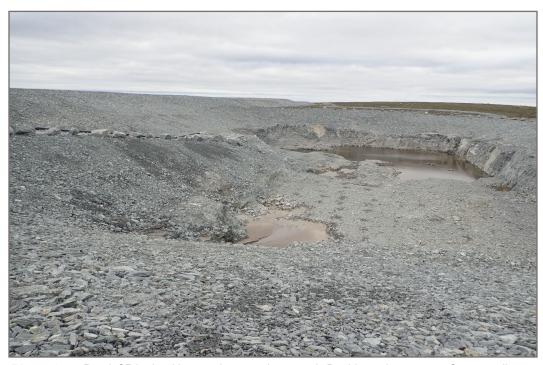
**Photo 2:** Pond CP6—Looking north, ramp into pond. Boulders along ramp. Some sediment washout in south west corner.

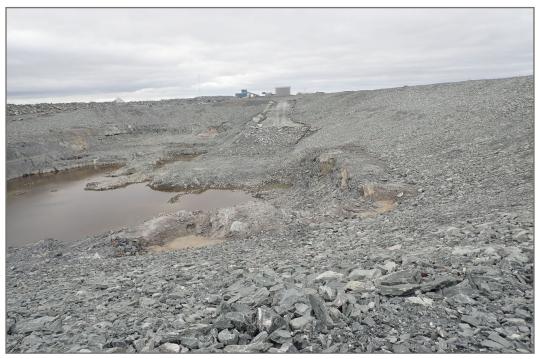
Photo 3: Pond CP6 - Looking south, exposed bedrock below Berm CP6

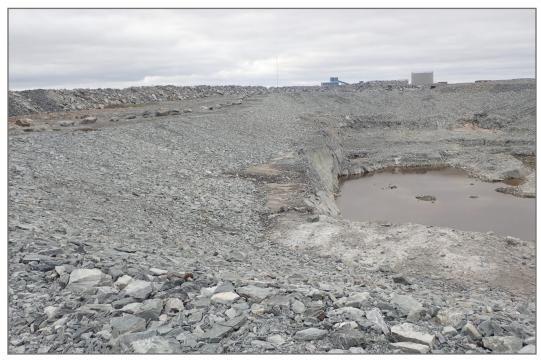
**Photo 4:** Pond CP6—South side of pond, WRSF3 to the left of the photo. Bedrock contact.

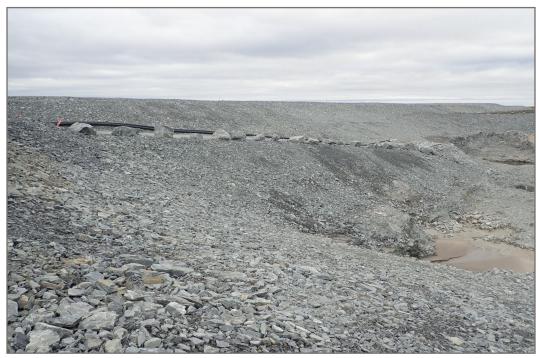
Photo 5: Pond CP6 - Upstream crest—some settlement is evident

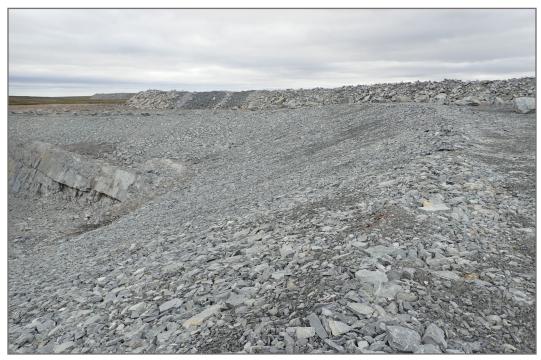
**Photo 6:** Pond CP6 - Southwest corner—Rockfill over the overburden slope.

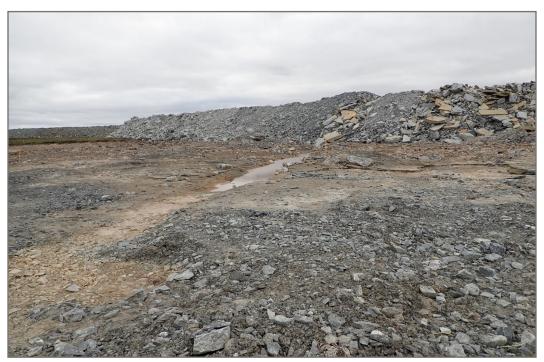
**Photo 7:** Pond CP6 - WRSF3 upstream of Pond CP6. Drainage coming off WRSF3.

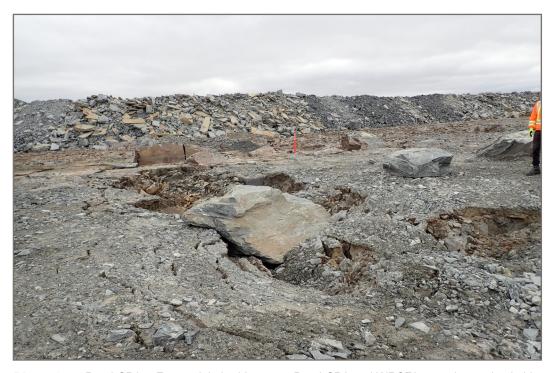
**Photo 8:** Pond CP6 - Former lakebed between Pond CP6 and WRSF3—erosion and subsidence channel.

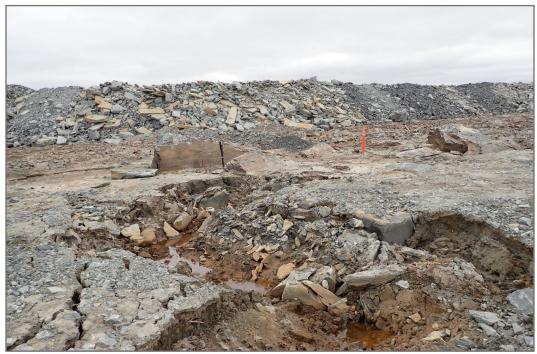
**Photo 9:** Pond CP6 - Former lakebed between Pond CP6 and WRSF3—erosion and subsidence channel.

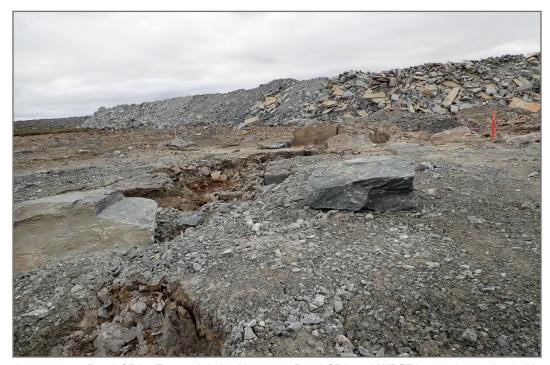
**Photo 10:** Pond CP6 - Former lakebed between Pond CP6 and WRSF3—erosion and subsidence channel.

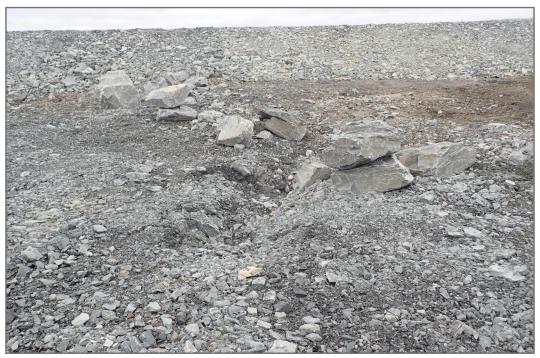
**Photo 11:** Pond CP6 - Subsidence and settlement in original ground adjacent to rockfill cover over overburden slope.

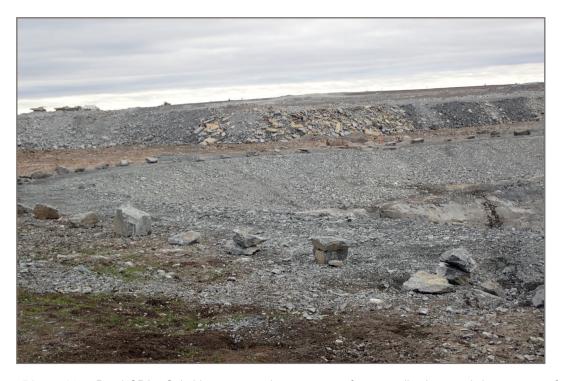
**Photo 12:** Pond CP6 - Subsidence at southeast corner of water collection pond downstream of the dike.

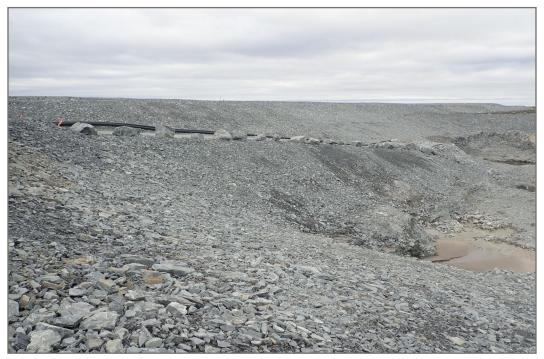
Photo 13: Berm CP6 - Looking northeast.

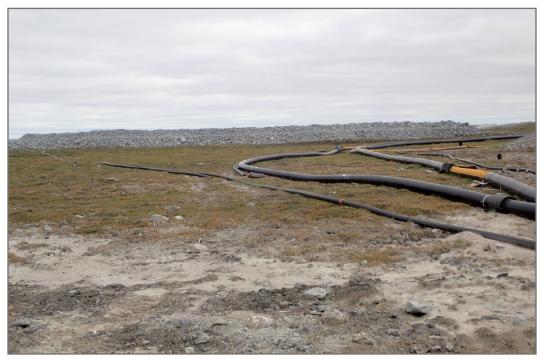
Photo 14: Berm CP6 - Viewed from Dike D-CP1.

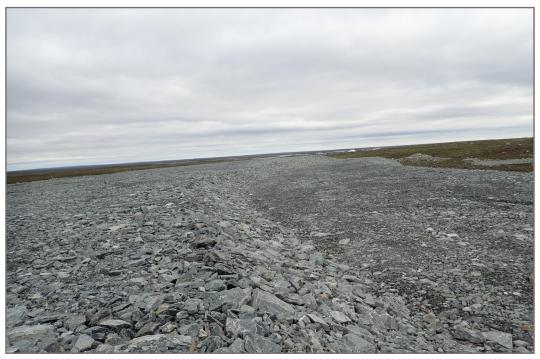
Photo 15: Berm CP6 - Crest and rockfill cover over upstream ground

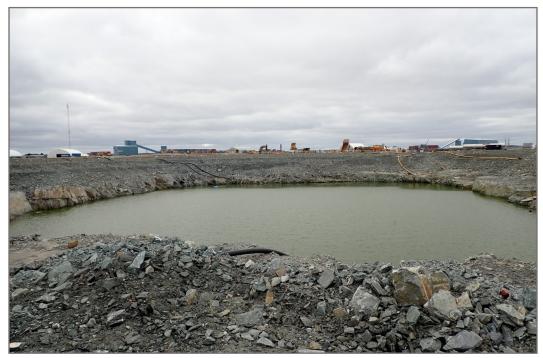
**Photo 1:** SP1 Saline Pond - looking towards the west, thermal berm at crest.

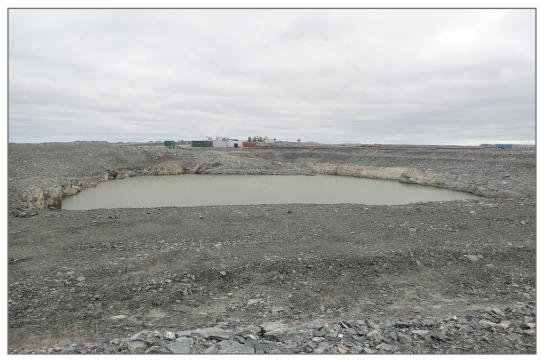
Photo 2: SP1 Saline Pond - Overburden bedrock contact.

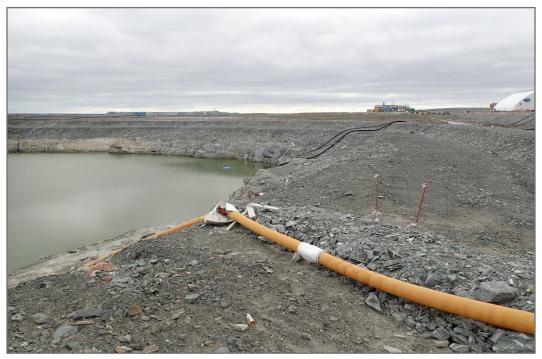
**Photo 3:** SP1 Saline Pond - discharge line into pond.

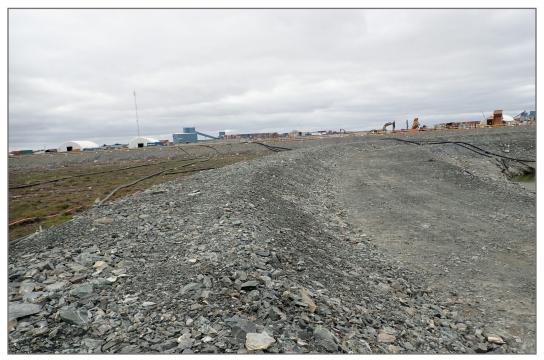
Photo 4: SP1 Saline Pond - thermal berm at crest.

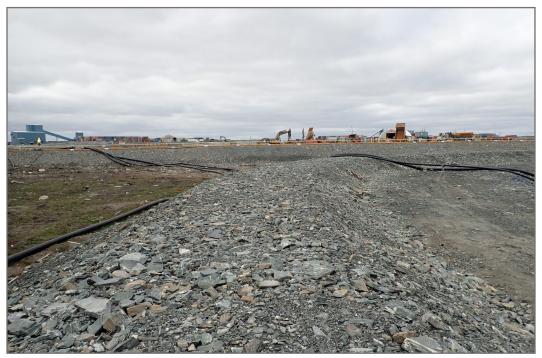
Photo 5: SP1 Saline Pond - looking north.

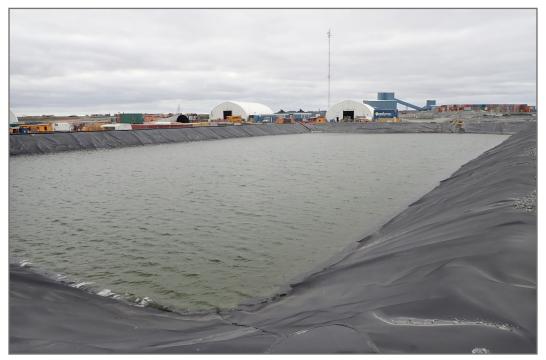
Photo 6: SP3 Saline Pond - looking west.

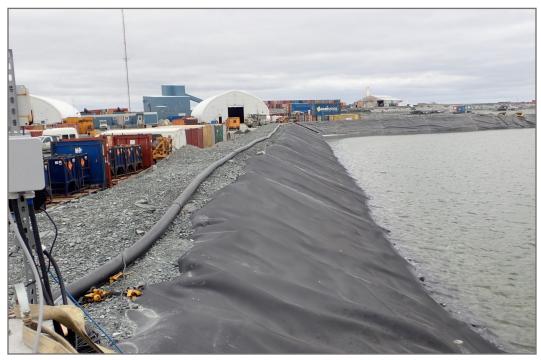
Photo 8: SP3 Saline Pond - west berm.

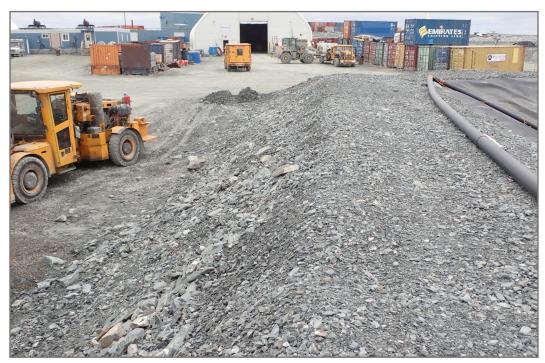
Photo 9: SP3 Saline Pond - looking west.

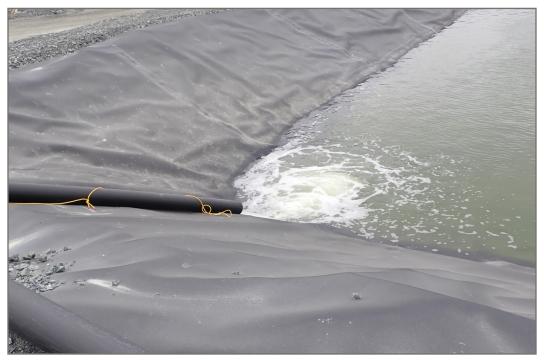
Photo 10: SP3 Saline Pond - Inflow discharge at northwest corner

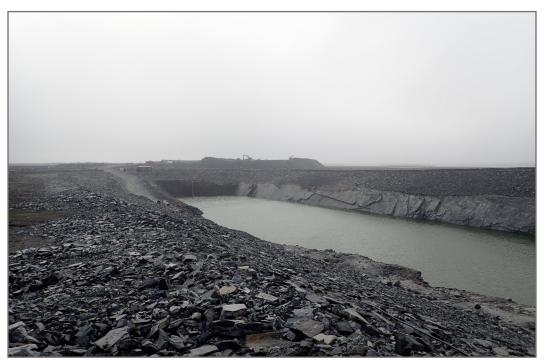
Photo 11: SP4 Saline Pond - looking east. Rockfill covered overburden slope over bedrock.

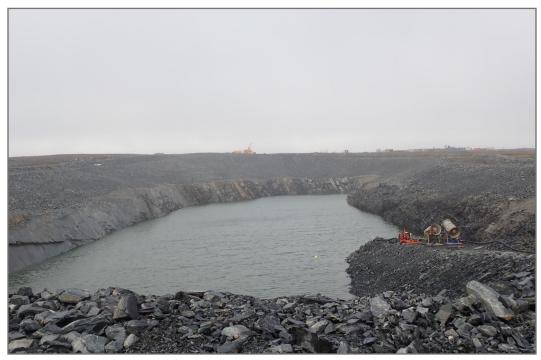
Photo 12: SP4 Saline Pond - looking west. Ramp into pond.

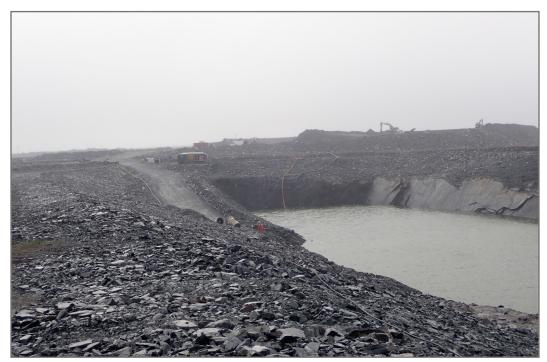
Photo 13: SP4 Saline Pond - looking southeast

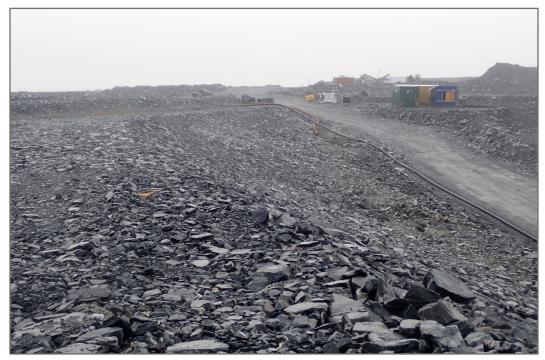
Photo 14: SP4—Rockfill covered overburden slope.

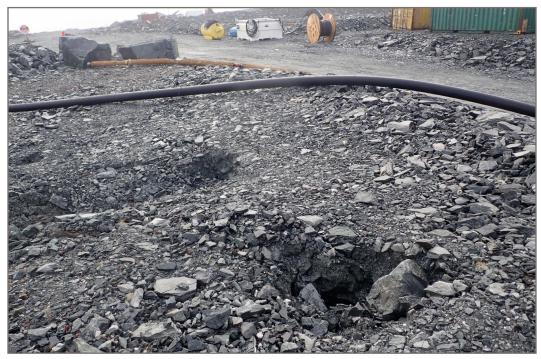
Photo 15: SP4 Saline Pond—Subsidence in rockfill at crest of slope.

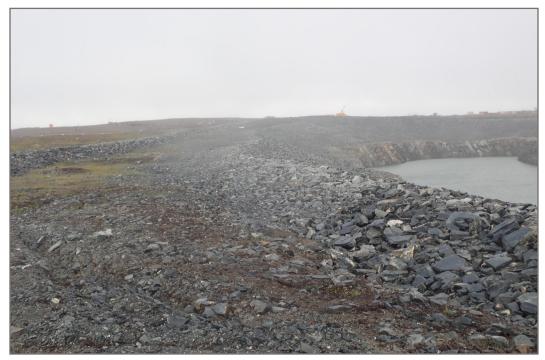
**Photo 16:** SP4 Saline Pond - Settlement of rockfill covering overburden slope.

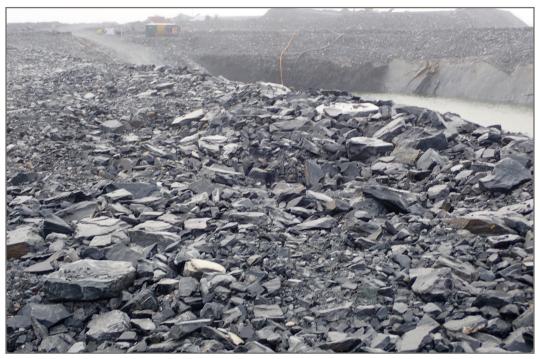
**Photo 17:** SP4 Saline Pond —Settlement in rockfill covering overburden slope.

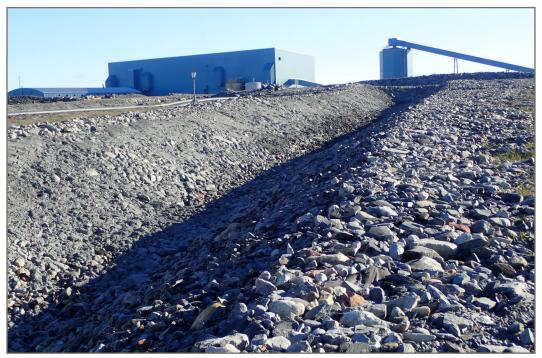
Photo 1: Channel 4 - Upper reach, below landfill

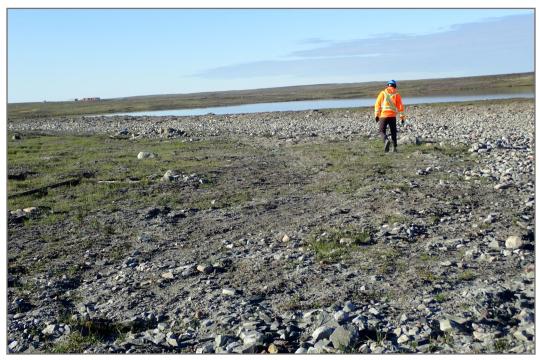
**Photo 2:** Channel 4—Original ground adjacent to upper reach. Ground covered with fines.

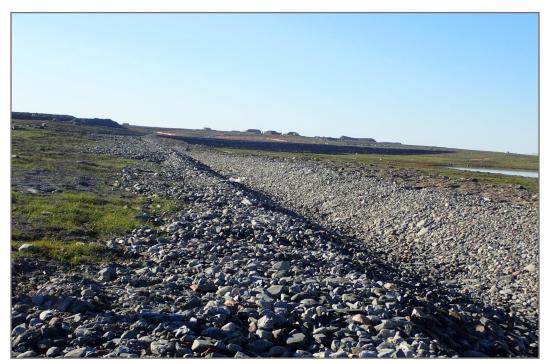
**Photo 3:** Channel 4 - Lower reach above Lake B7

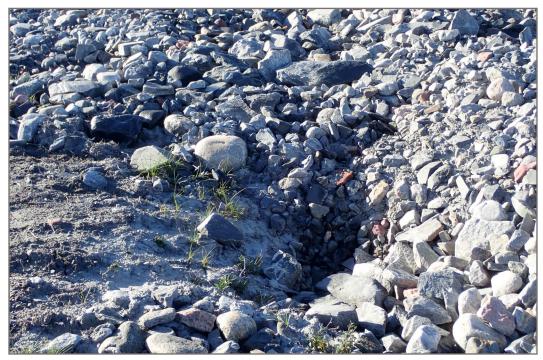
**Photo 4:** Channel 4 - Minor subsidence between original ground and channel rip rap.

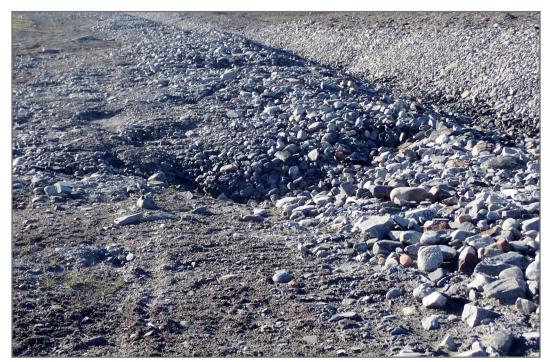
**Photo 5:** Channel 4 - Subsidence in rip rap—in upstream slope (east) slope of the channel.

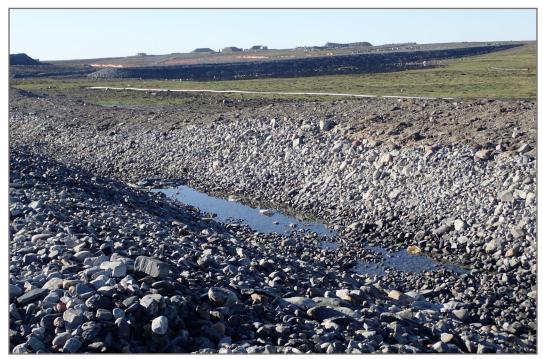
Photo 6: Channel 4 - Lower reach channel, minor ponding.

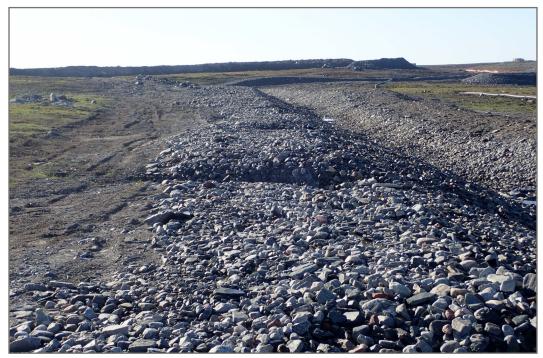
**Photo 7:** Channel 4 - Subsidence in rip rap—in upstream slope (east) slope of the channel.

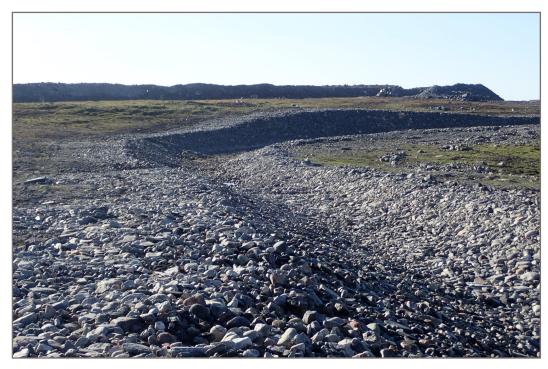
Photo 8: Channel 4 - Lower reach of channel prior to Berm CP4.

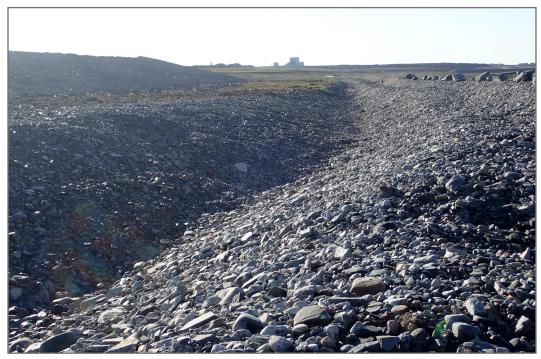
Photo 9: Channel 3 - Channel at CP3 Inlet.

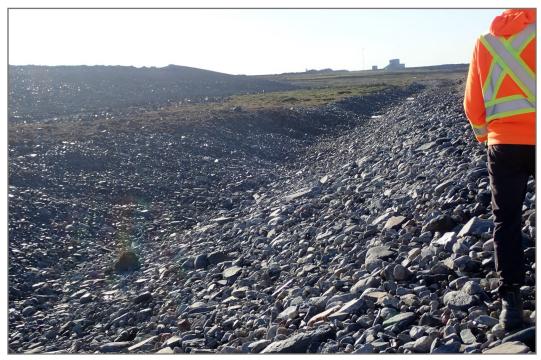
**Photo 10:** Channel 3 - Lower reach of Channel 3, good condition.

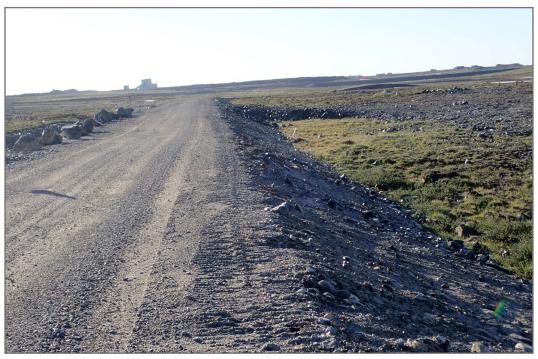
Photo 11: Channel 3 - Downstream slope of road adjacent to Channel 3.

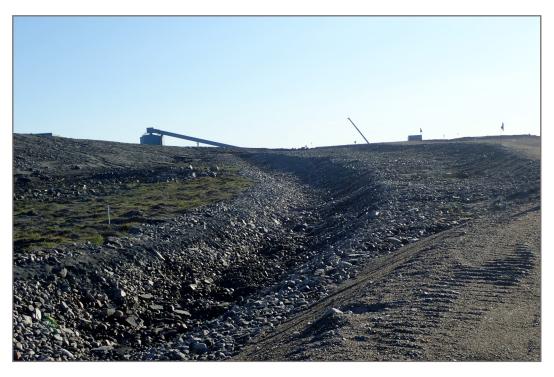
**Photo 16:** Channel 3 - Upper reach of channel.

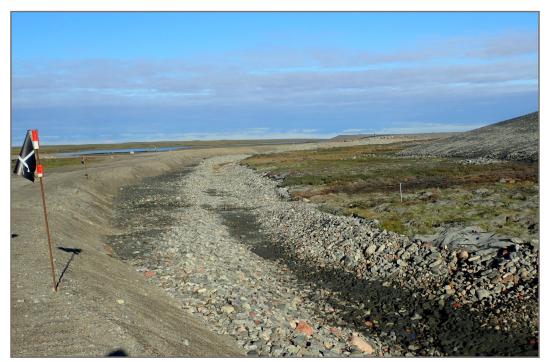
Photo 17: Channel 3 - Upper reach of channel

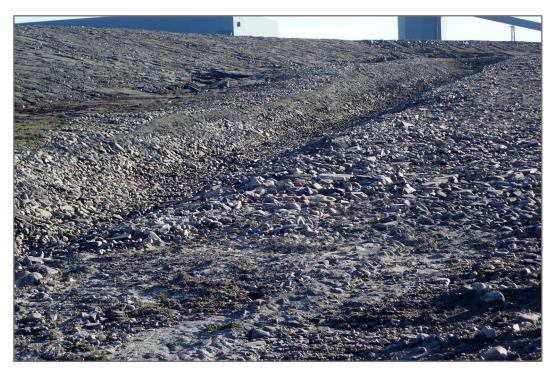
**Photo 18:** Channel 3 - Upper reach of channel, TSF on right of photo.

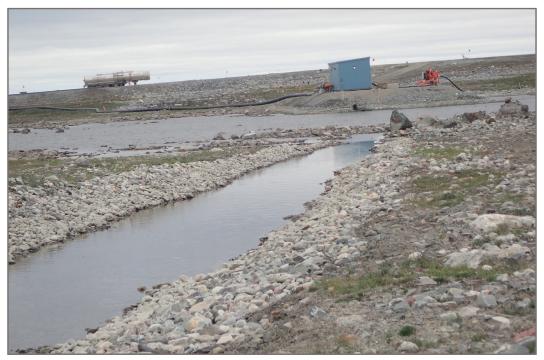
Photo 19: Channel 5 - Lower reach of channel

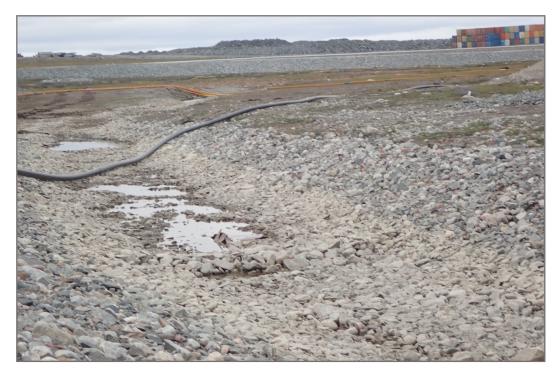
Photo 20: Channel 5—Settlement and ponding

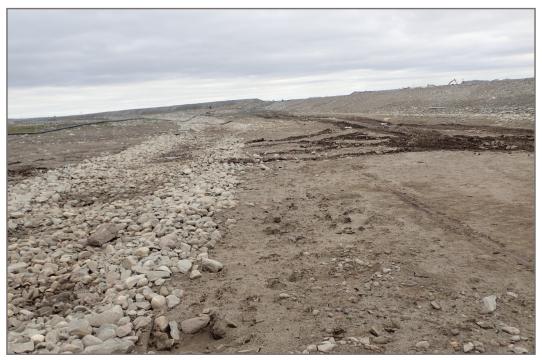
Photo 21: Channel 5 - Disturbance next to channel

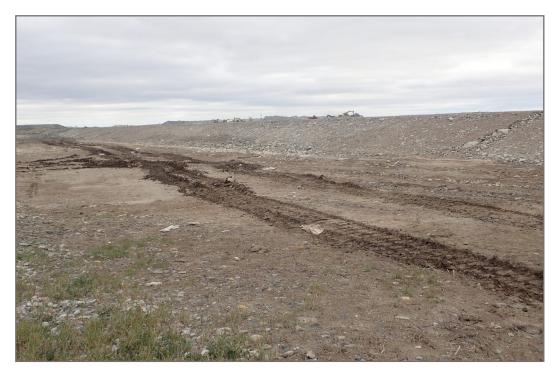
Photo 22: Channel 5—Disturbance next to Channel, Berm adjacent to channel.

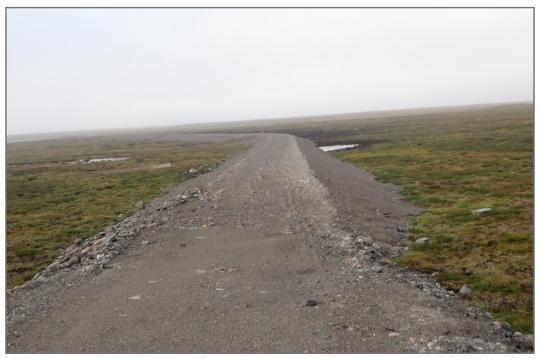
Photo 23: Berm 2 - Typical Profile

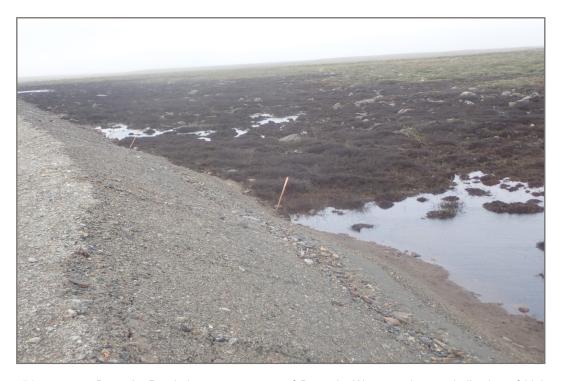
Photo 24: Berm 2—Ponded water upstream of Berm 2—Wave wash zone indication of higher water level.

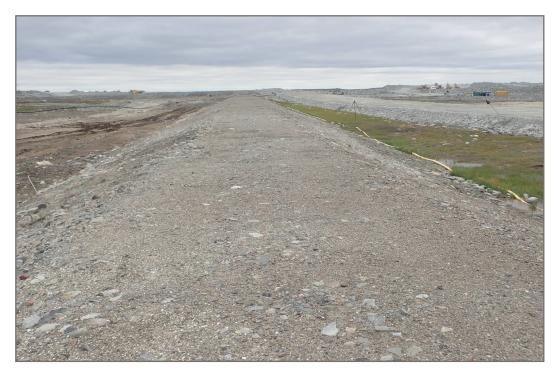
Photo 28: Berm 3—Typical Section, Channel 5 on left.

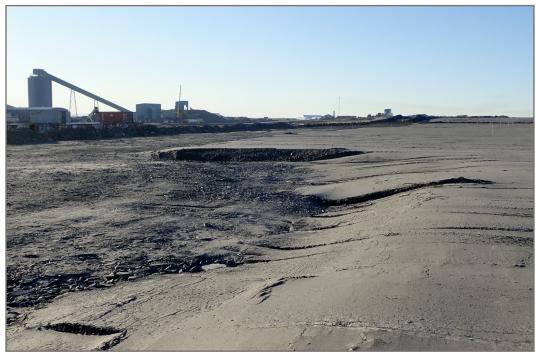
Photo 1: TSF - Tailing surface, northeast side, compacted, approximately 300 mm lift thickness

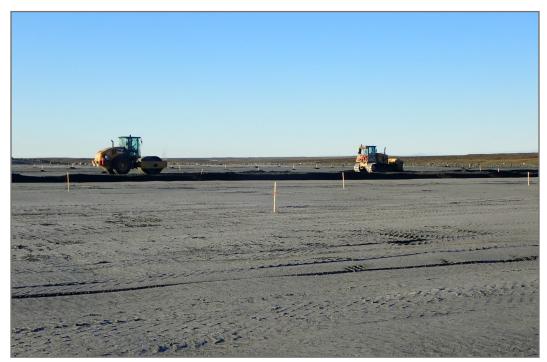
**Photo 3:** TSF - Placing and compacting tailings.

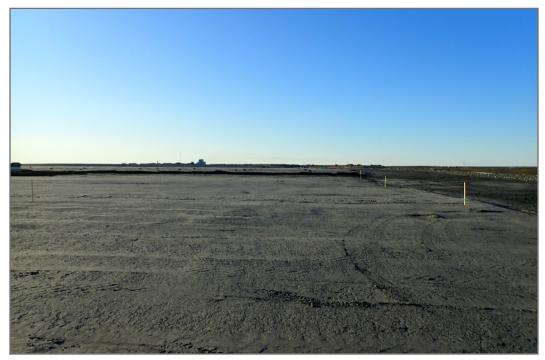
Photo 4: TSF - Placed tailings

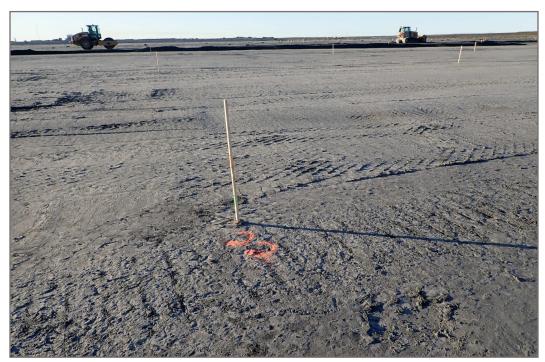
Photo 5: TSF - Placed tailings.

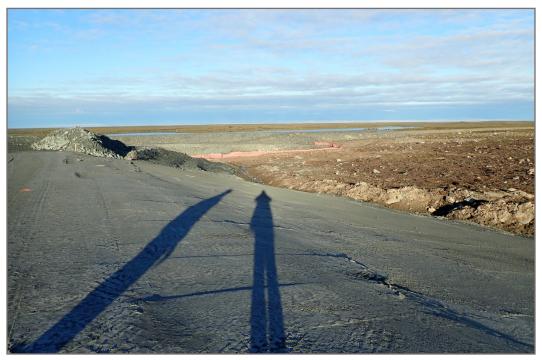
Photo 6: TSF - Slope between Cell 1 and future Cell 2.

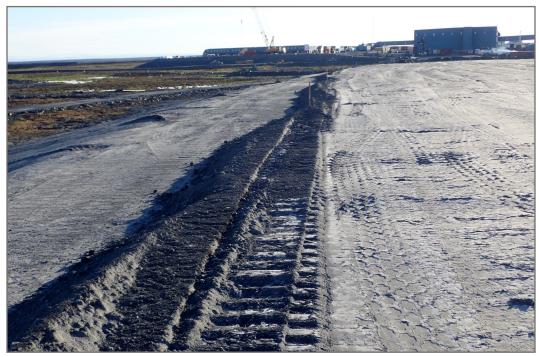
Photo 7: TSF - Slope between Cell 1 and future Cell 2. White precipitate on portions of the tailings surface.

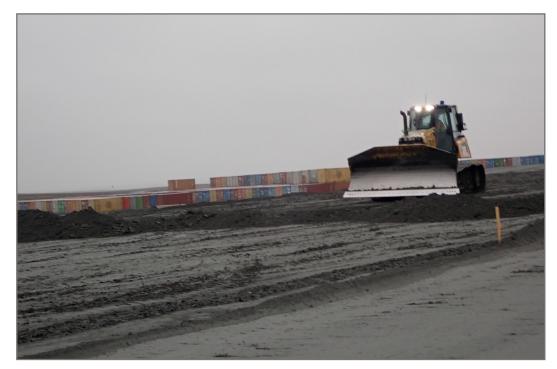
**Photo 8:** TSF - Spreading tailings, prior to compaction.

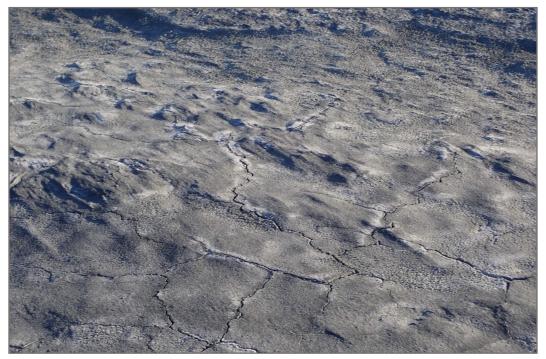
**Photo 9:** TSF - Desiccation of tailings, reported to be placed approximately three months prior.

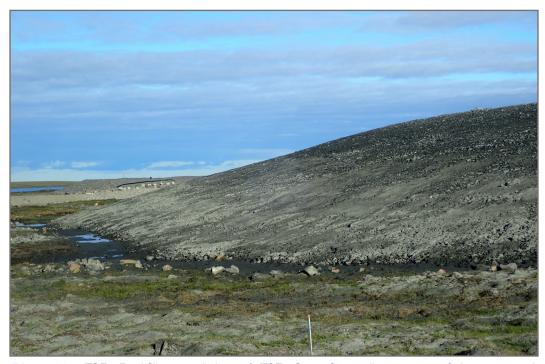
**Photo 10:** TSF - Rockfill covered slope of TSF. Some fine sediment at toe of slope, reported due to tailings contaminated snow placed in the area.

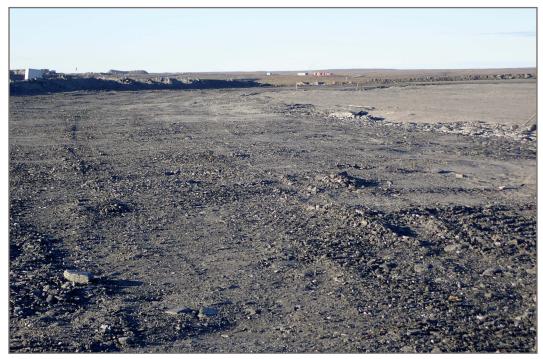
Photo 11: TSF - Crest of rockfill covered slope.

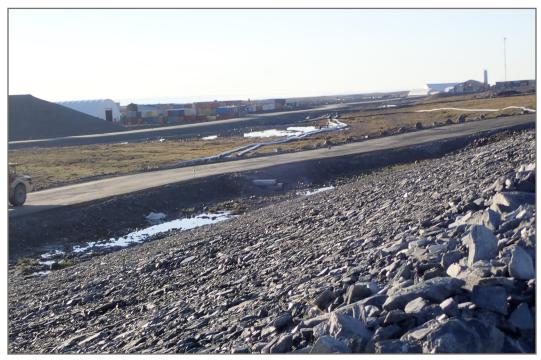
Photo 12: TSF - Rockfill covered TSF slope
