Appendix 6 : 2020 Annual Geotechnical Inspection Report

# **2020** Annual Geotechnical Inspection Meliadine Gold Project, Rankin Inlet, Nunavut

## **Agnico Eagle Mines Limited**

FEBRUARY 2021 ISSUED FOR USE

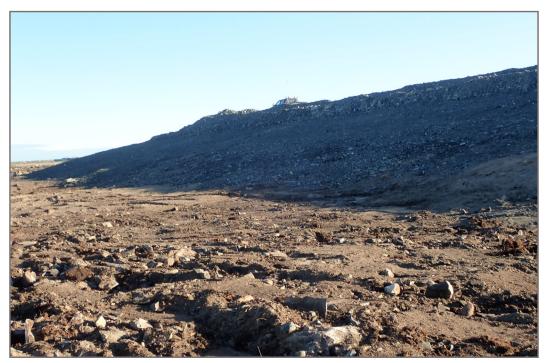
Photo 13: TSF - Rockfill covered TSF slope above CP3.

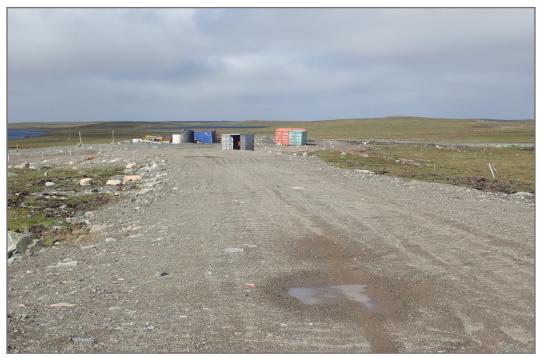
Photo 1: Site Roads—Road to Wes Mag Borrow

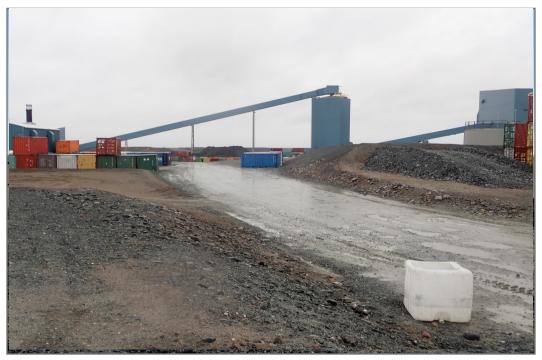
Photo 2: Site Roads—Industrial Pad

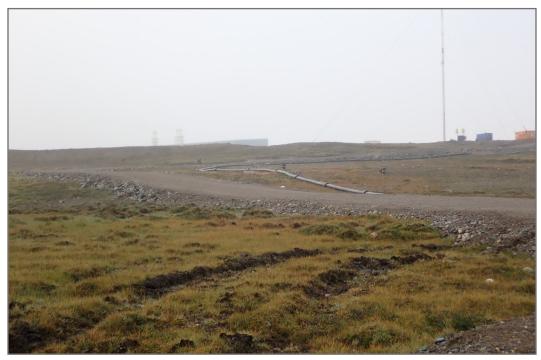
Photo 3: Water Intake Road.

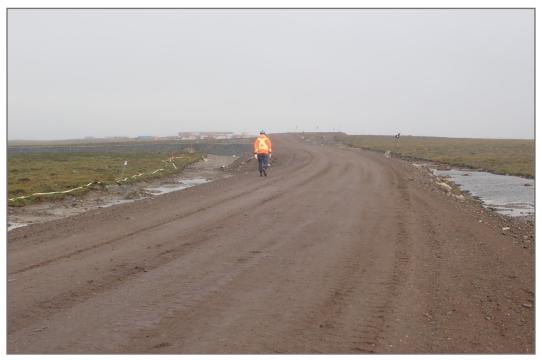
Photo 4: Site Roads—Road to Emulsion Plant

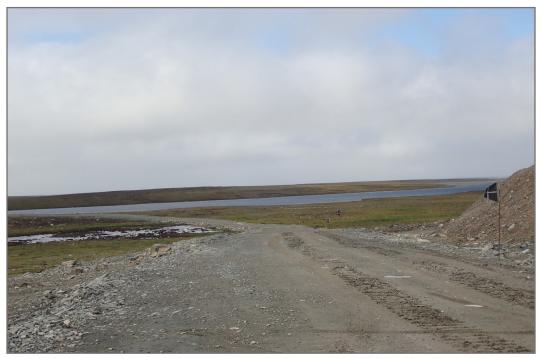
Photo 5: Site Roads—Magazine Access Road

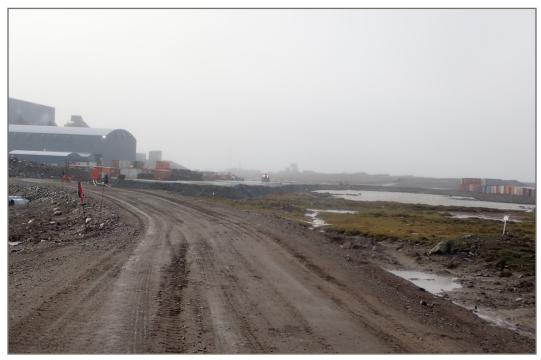
Photo 6: Site Roads—Road from Emulsion Plant to the Industrial Pad

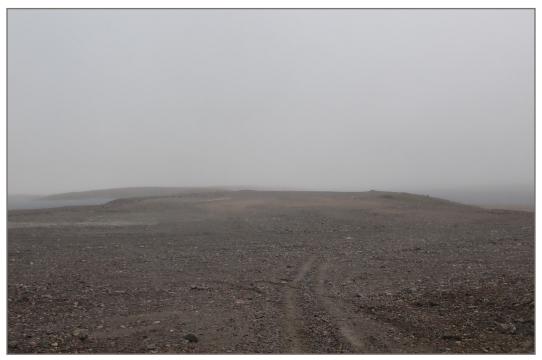
Photo 1: Meliadine North North Esker Borrow

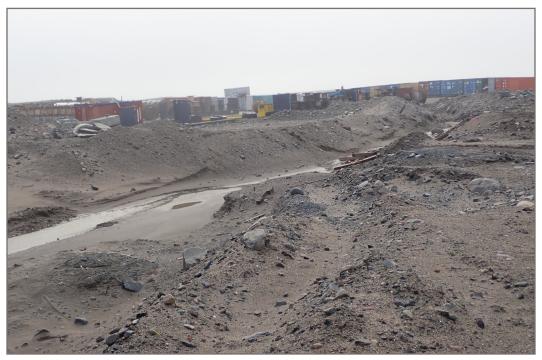
Photo 2: Meliadine Esker—drainage channel

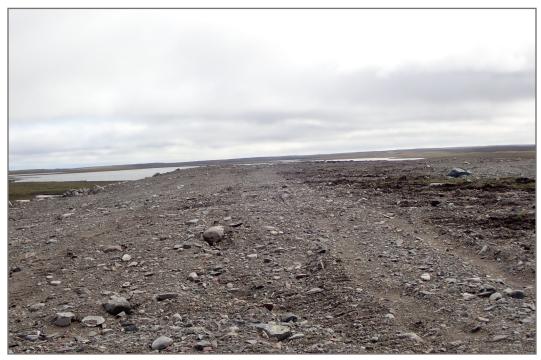
Photo 4: Wesmag Borrow

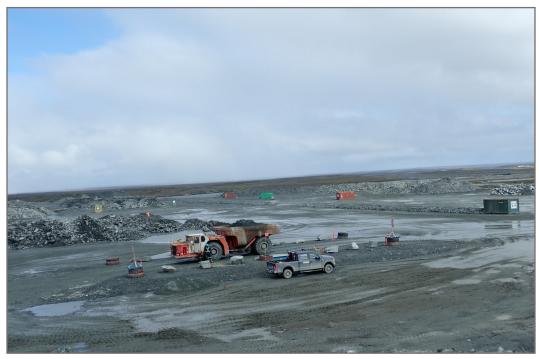
Photo 1: Ore Stockpile Area

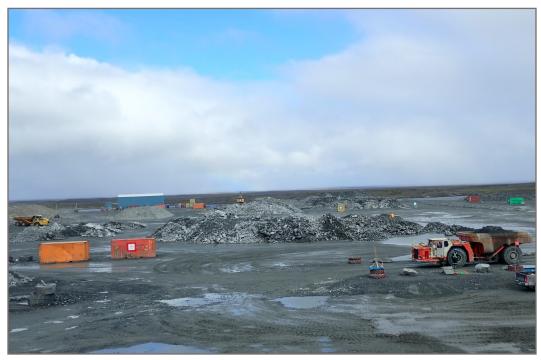
Photo 2: Ore Stockpile Area

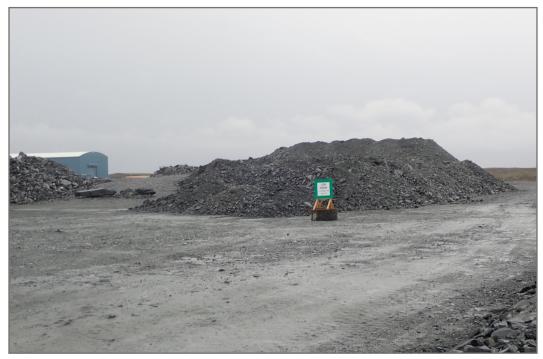
Photo 3: Ore Stockpile—Low Grade

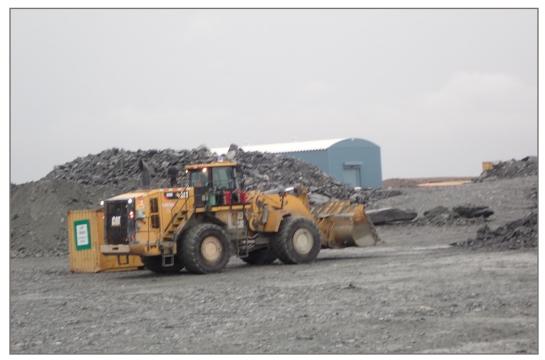
Photo 4: Ore Stockpile—Loader

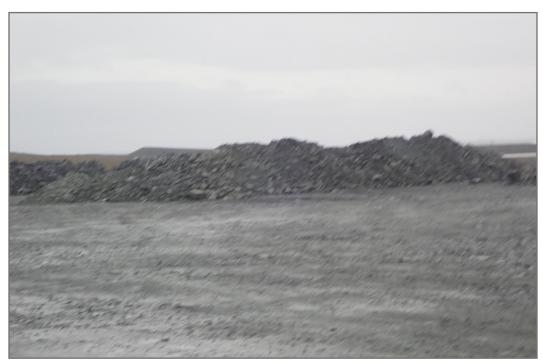
Photo 5: Ore Stockpile,

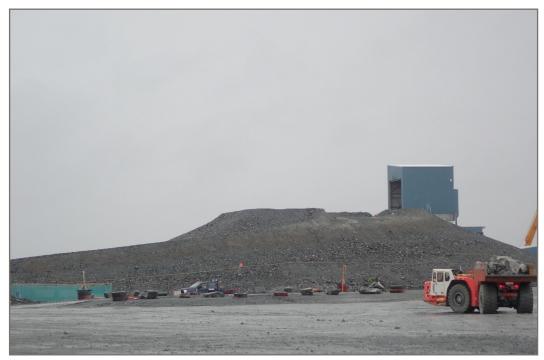
Photo 6: Ore Stock Pile

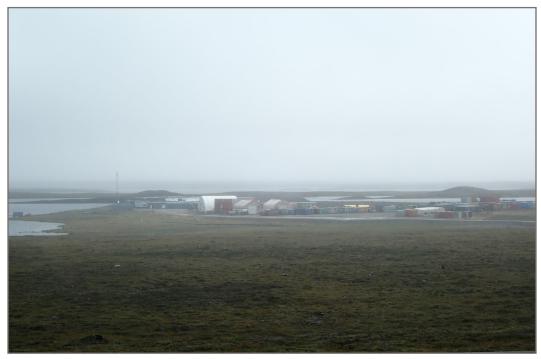
**Photo 1:** Exploration Camp

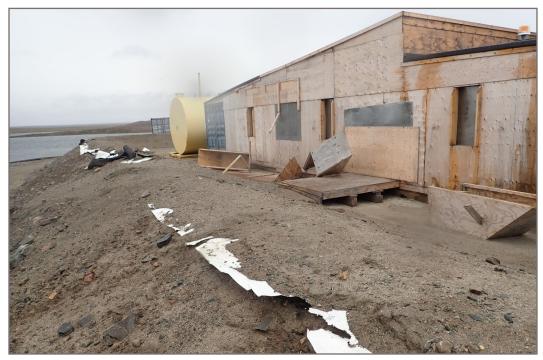
Photo 2: Exploration Camp Fuel Storage

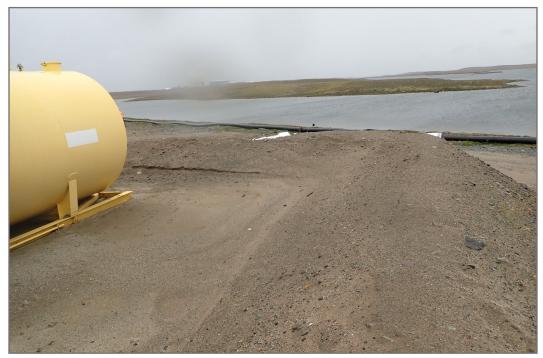
Photo 3: Exploration Camp Fuel Storage

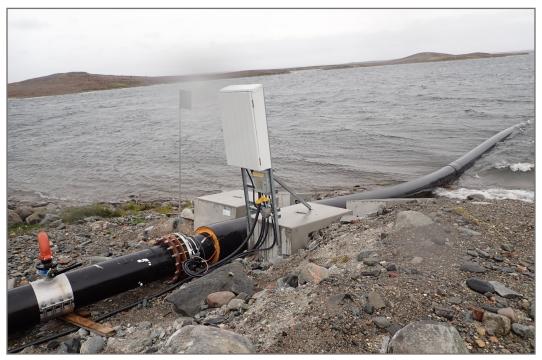
Photo 4: Exploration Camp—Diffuser line

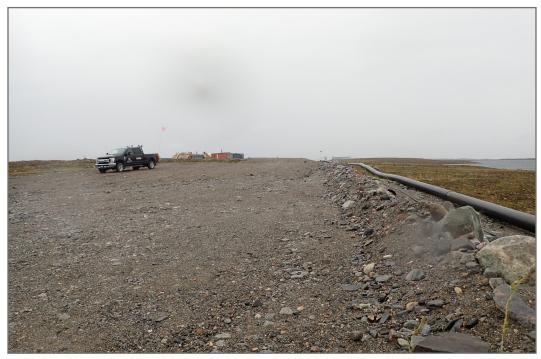
**Photo 5:** Exploration Camp—Road to diffuser line

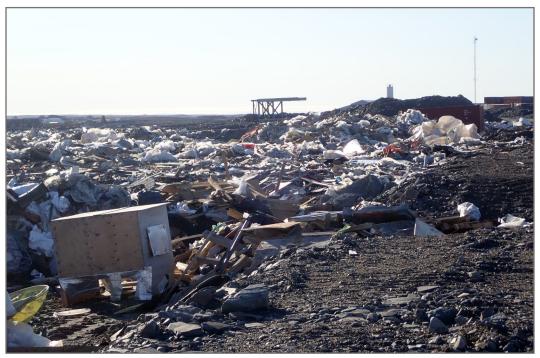
**Photo 1:** Landfill– Dry waste inclduing, wood, steel, plastic, and other.

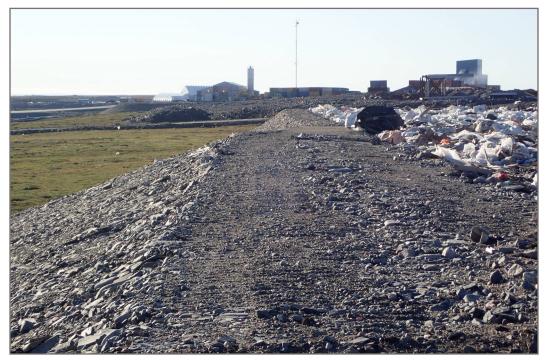
Photo 2: Landfill—East berm, waste close to crest.

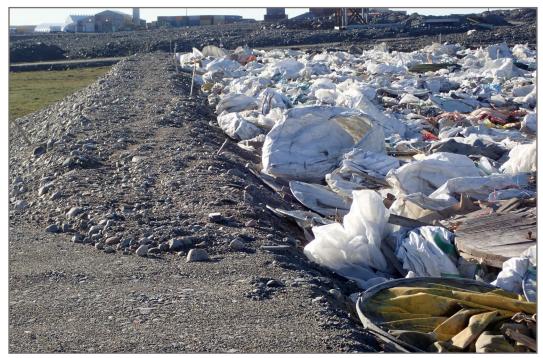
**Photo 3:** Landfill– Perimeter Berm, looking south.

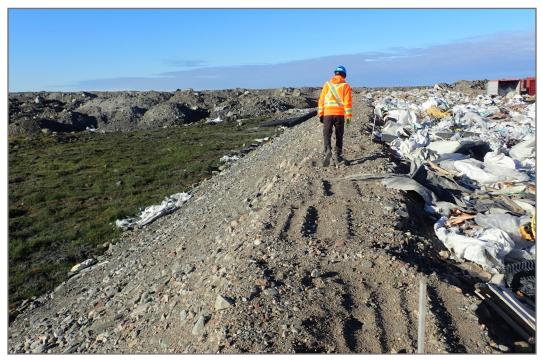
Photo 4: Landfill—South Berm.

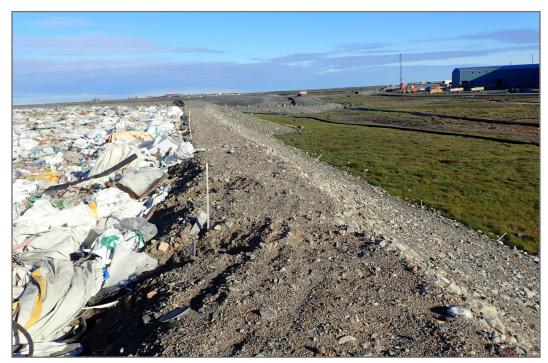
Photo 5: Landfill - West berm—esker fill.

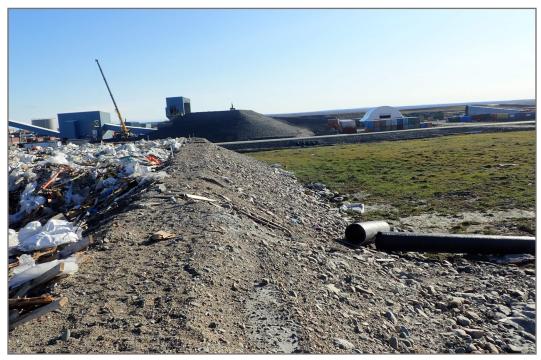
Photo 6: Landfill- South berm.

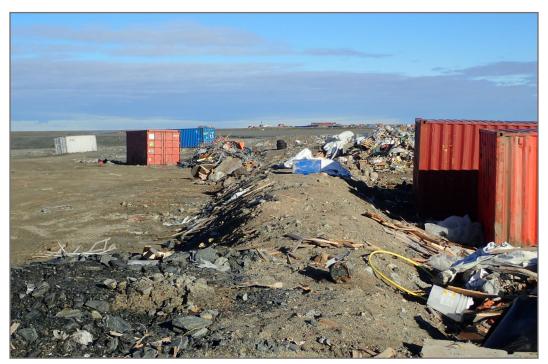
Photo 7: Landfill - west berm.

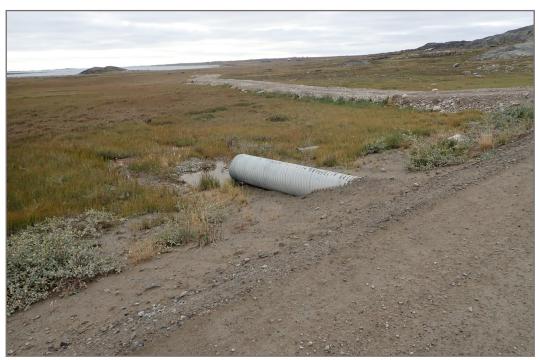
Photo 1: Culvert km 5.5

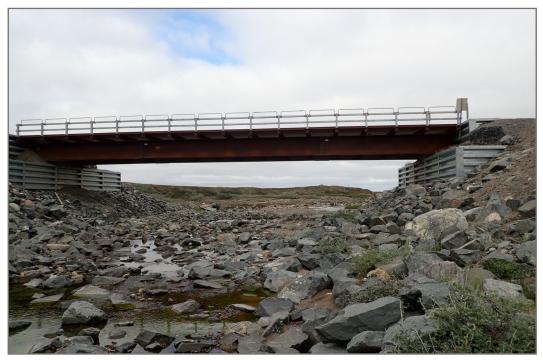
Photo 2: Char River Bridge

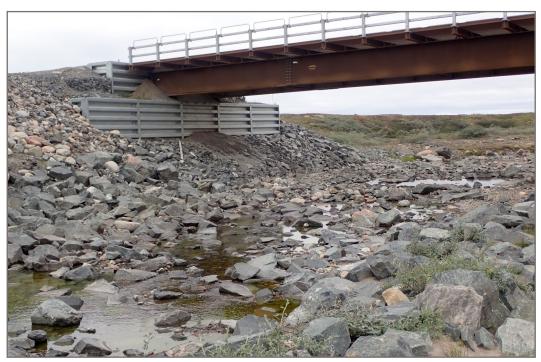
Photo 3: Char River Bridge—North abutment

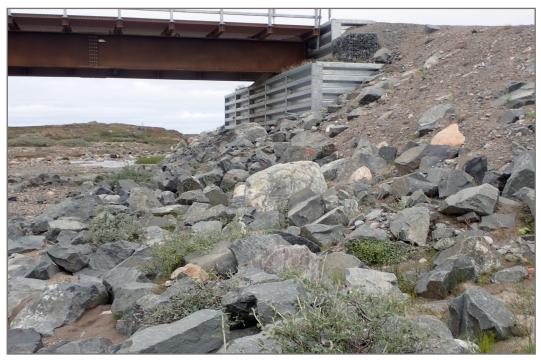
Photo 4: Char River Bridge—South Abutment

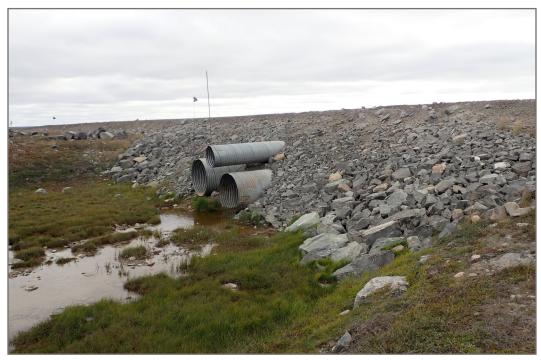
Photo 5: Culvert km 6.2

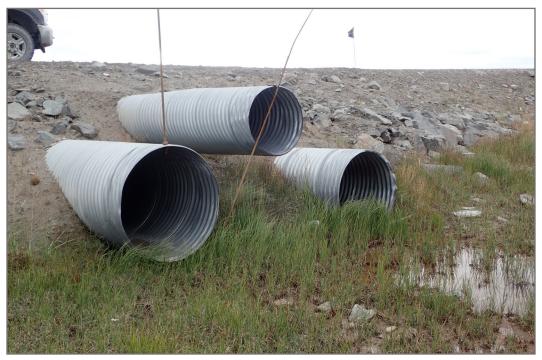
Photo 6: Culvert km 7.0

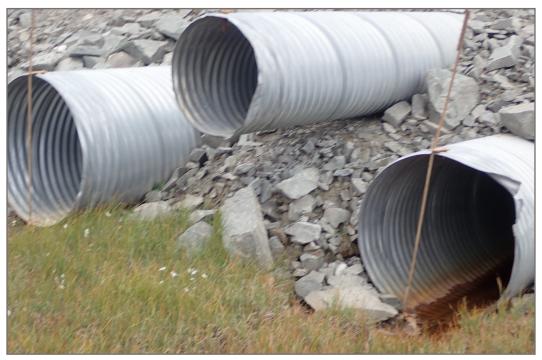
Photo 7: Culvert km 7.1

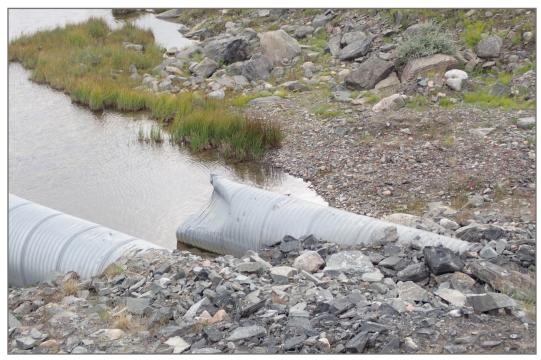
Photo 8: Culvert km 7.4—Damage to culvert inlet

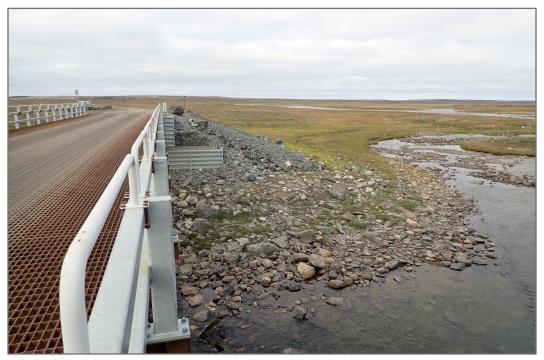
Photo 9: Meliadine River Bridge north abutment

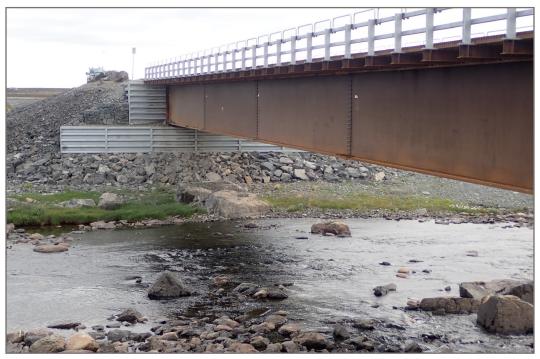
Photo 10: Meliadine River Bridge South Abutment

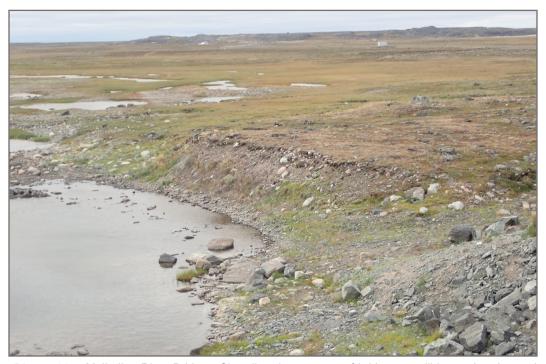
Photo 11: Meliadine River Bridge north abutment

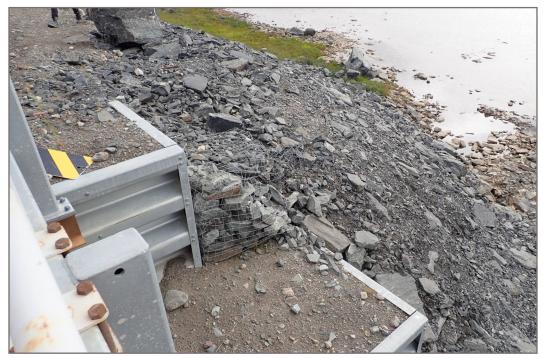
Photo 18: M-5 Bridge—North Abutment.

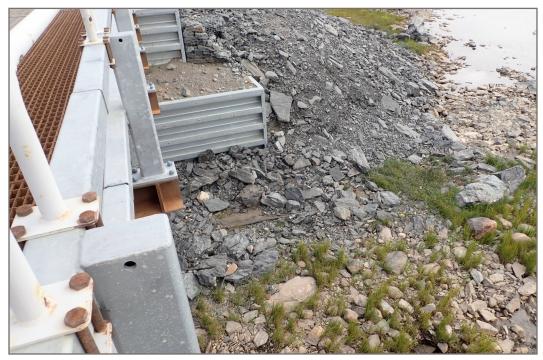
Photo 19: M-5 Bridge—Gabion North Abutment

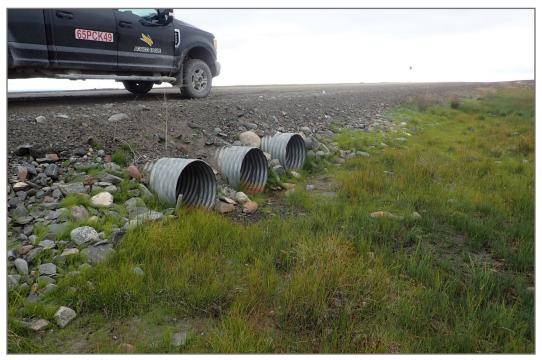
Photo 33: Culvert 26.2, Both inlets blocked with road fill.

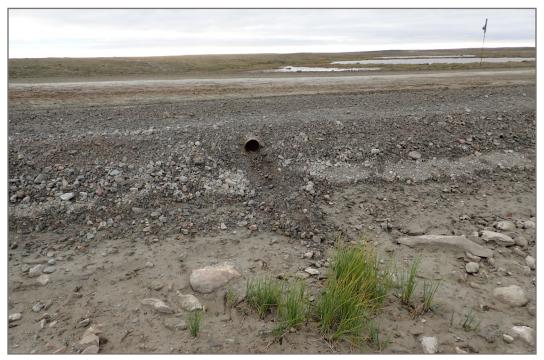
Photo 35: Culvert 26.8—Inlet completely blocked with road fill.

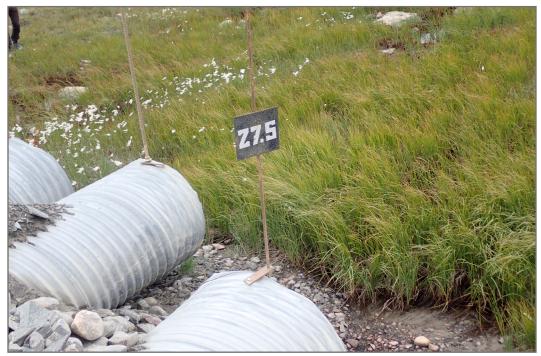
Photo 36: Culvert 26.8 - Lower culvert completely blocked with road fill.

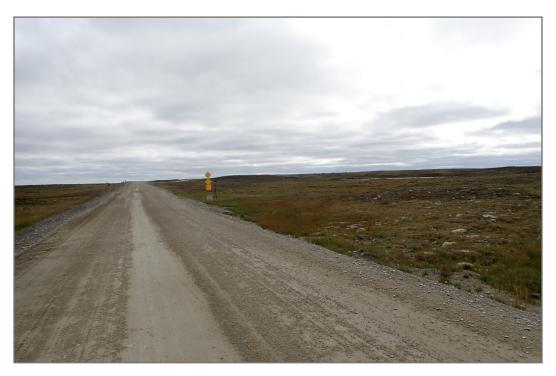
**Photo 38:** Culvert 29.6 - HDPE Culvert, inlet collapse approximately 25%.

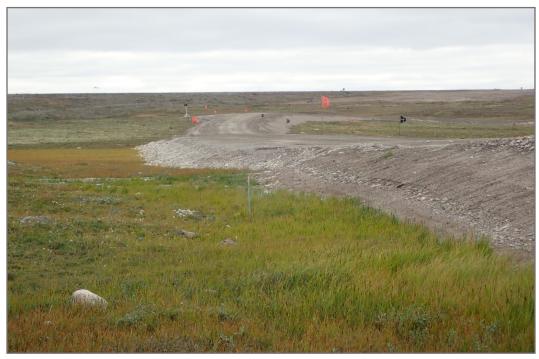
Photo 20: Low area in road northwest of C10, Filled in 2019.

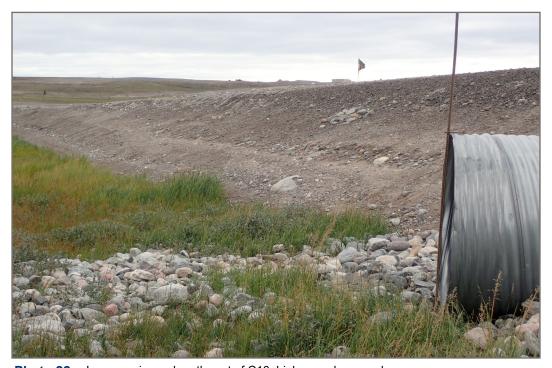
Photo 21: Low area in road northwest of C10, higher mark on road

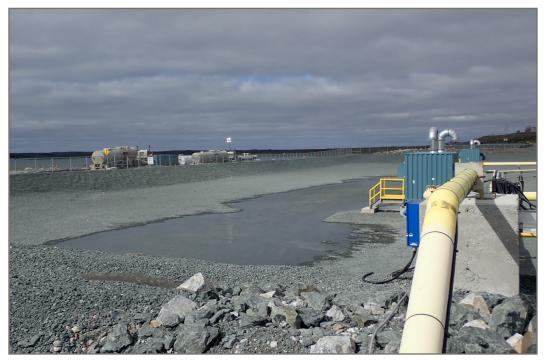
Photo 25: ITIVIA Tankfarm - east berm

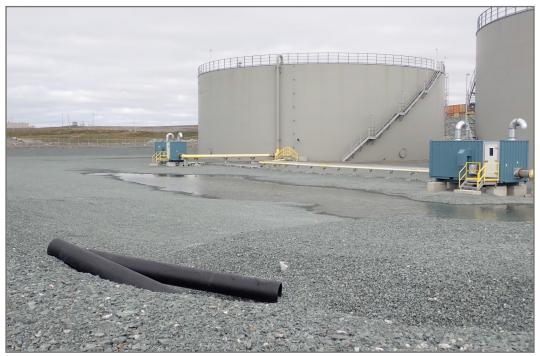
Photo 26: ITIVIA Tankfarm - ponded water in facility

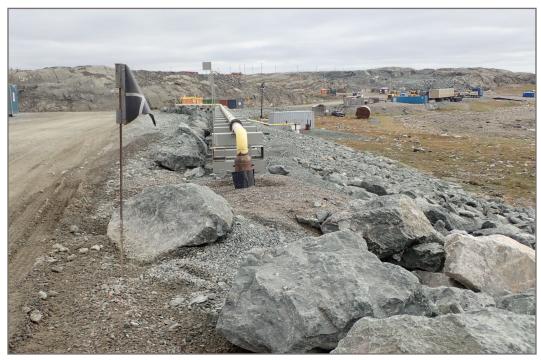
Photo 27: ITIVIA Tankfarm - south of tanks

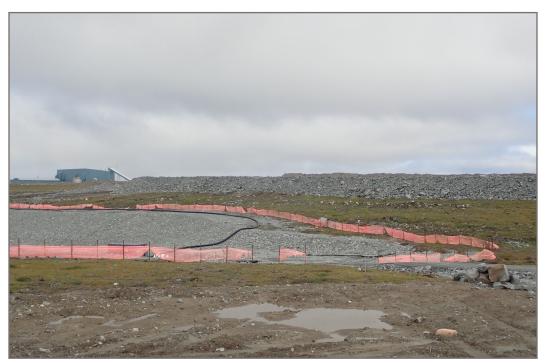
Photo 1: WRSF1 - Viewed from CP4—Waste Rock in WRSF in distance.

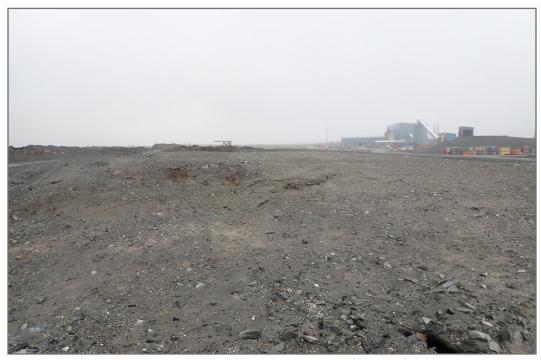
Photo 2: WRSF1 - Winter placed till—relatively wet, and settling.

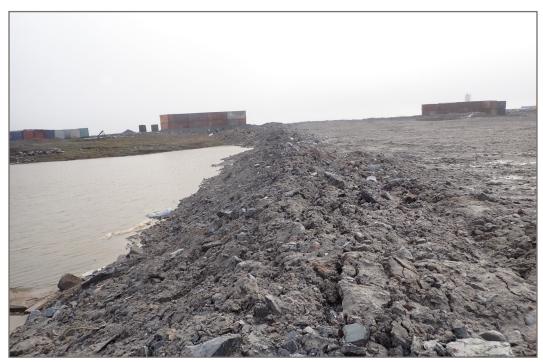
**Photo 3:** WRSF1—Winter placed till—wet and settling. Adjacent to small pond.

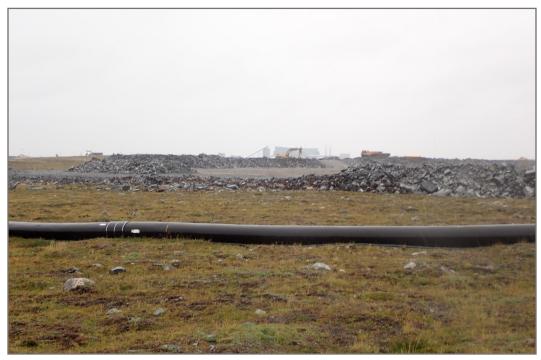
Photo 4: WRSF3—Initial lifts of waste rock in WRSF3

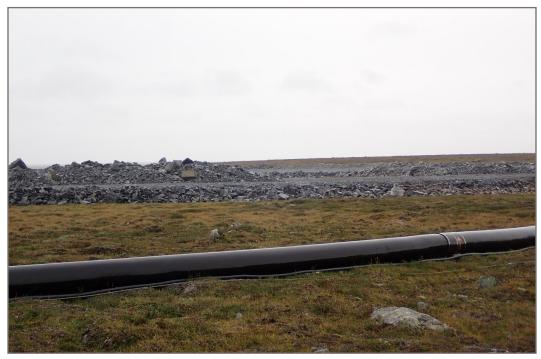
Photo 5: WRSF3—Initial lifts of waste rock in WRSF3

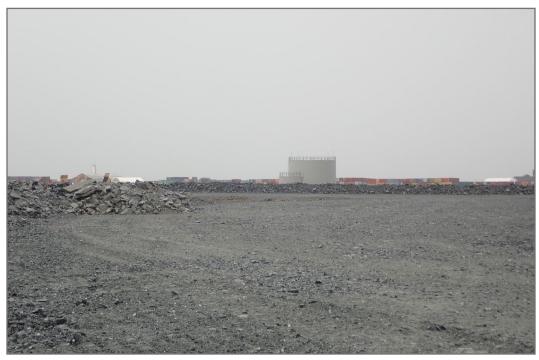
Photo 6: WRSF3—Initial lifts of waste rock in WRSF3—well spread, relatively tight structure

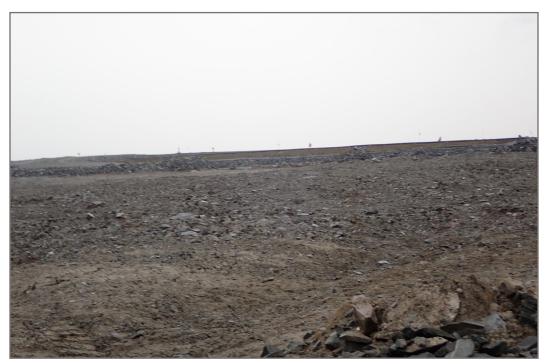
Photo 7: WRSF3—Initial lifts of till in WRSF3

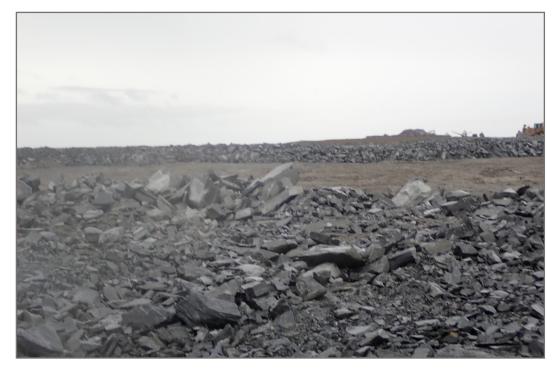
Photo 8: WRSF3—Waste rock in WRSF3
