Rail Alignment Watercourse Crossing Assessments

Crossing ID: 1

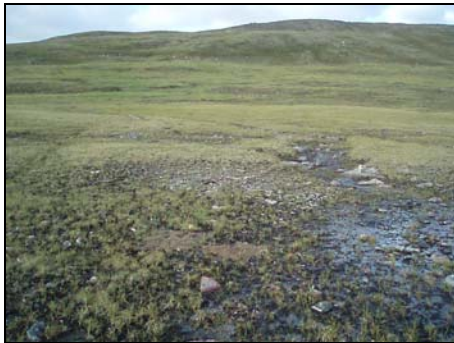
Figure 1: View upstream of crossing 1

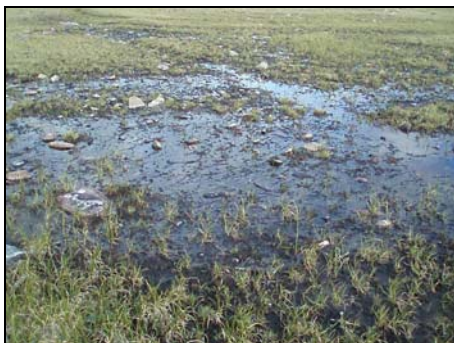
Figure 2: View across crossing 1 from left bank

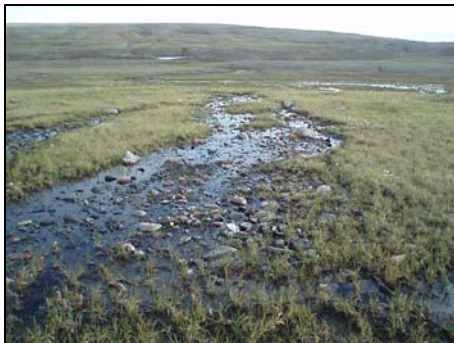
Figure 3: View downstream of crossing 1

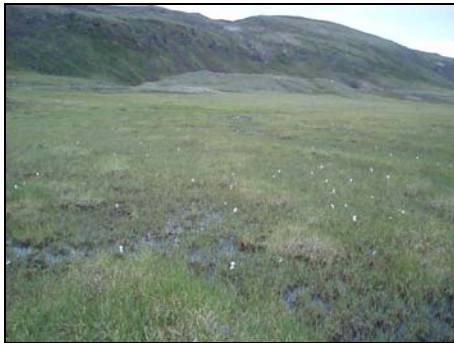
Figure 1: View upstream of crossing 4

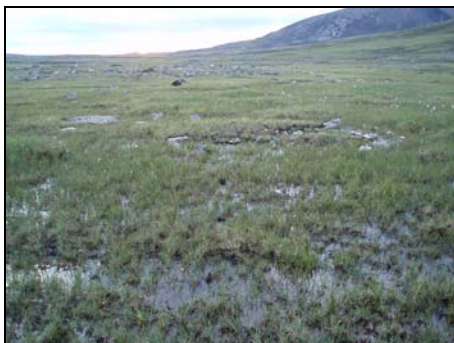
Figure 2: View across crossing 4 from right bank

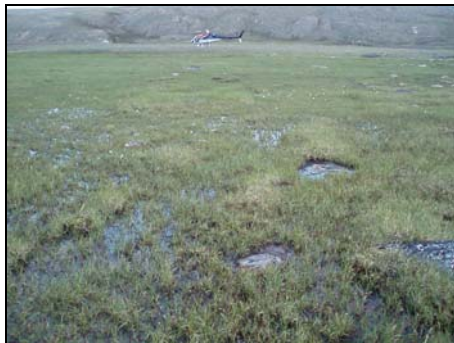
Figure 3: View downstream of crossing 4

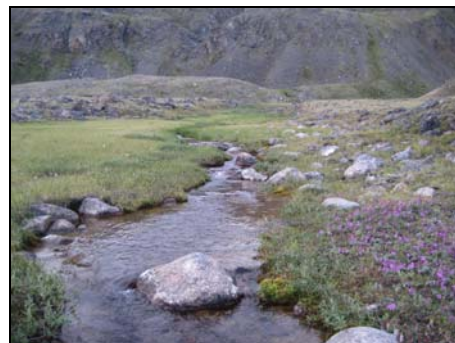
Figure 1: View upstream of crossing 6A

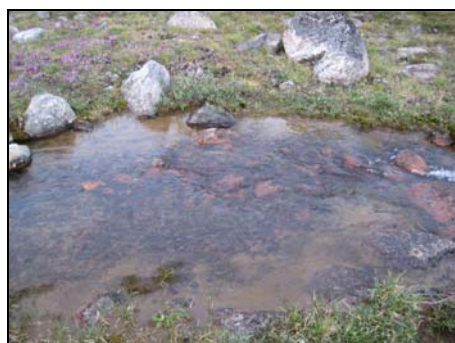
Figure 2: View across crossing 6A from left bank

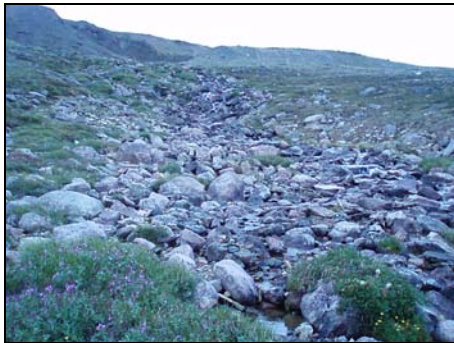
Figure 1: View upstream of crossing 9

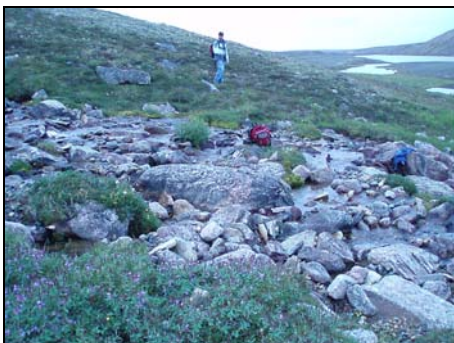
Figure 2: View across crossing 9 from left bank

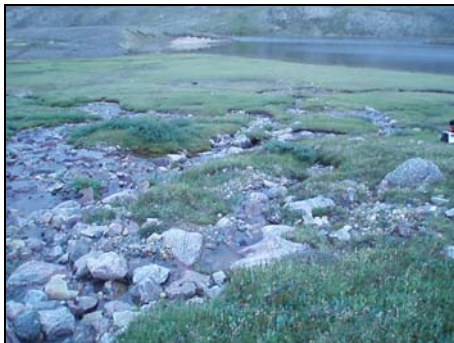
Figure 3: View downstream of crossing 9

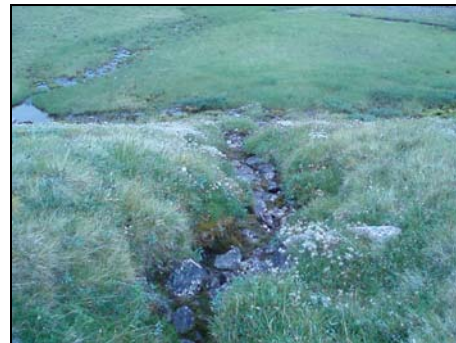
Figure 3: View downstream of crossing 10

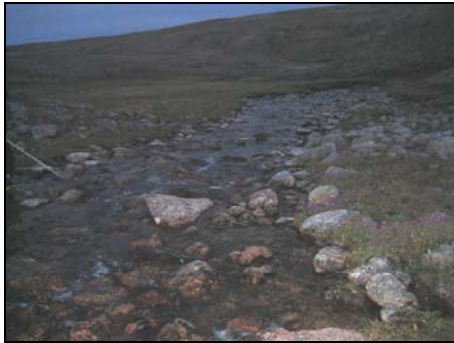
Figure 1: View upstream of crossing 11

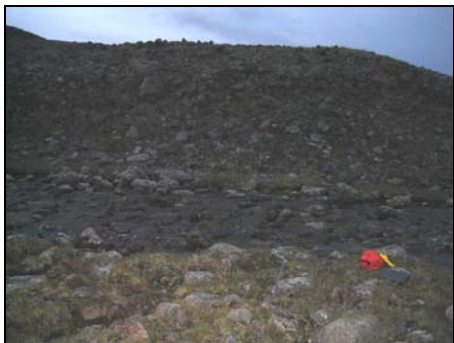
Figure 2: View across crossing 11 from left bank

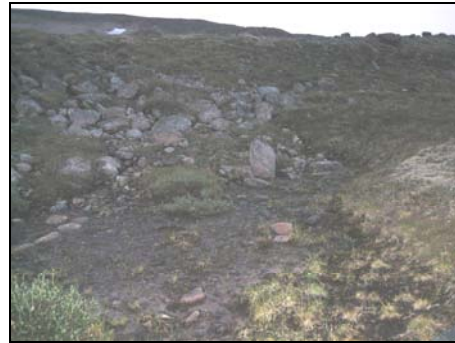
Figure 1: View upstream of crossing 12

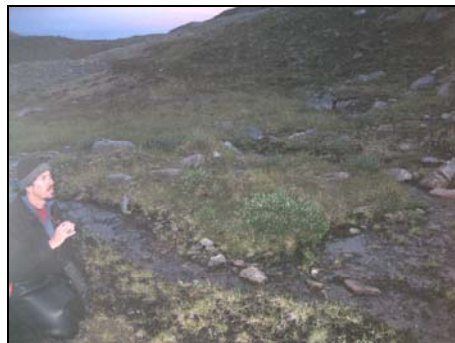
Figure 2: View across crossing 12 from right bank

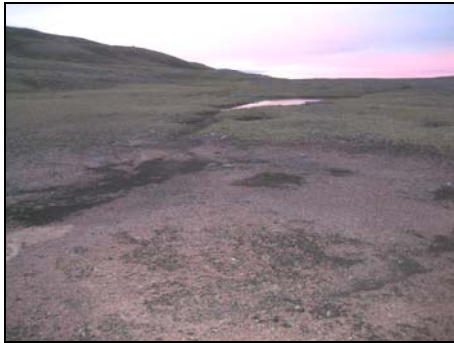
Figure 1: View upstream of crossing 13

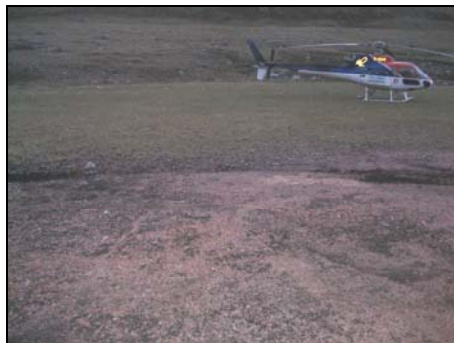
Figure 2: View across crossing 13 from right bank

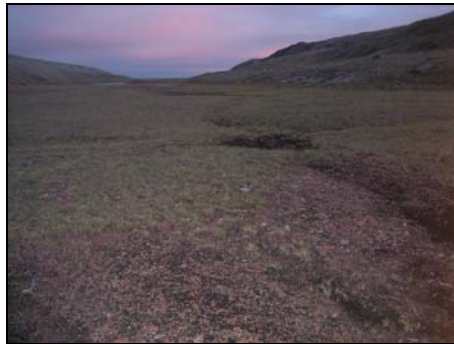
Figure 3: View downstream of crossing 13

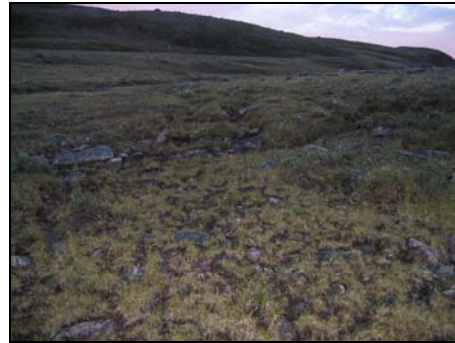
Figure 1: View upstream of crossing 14

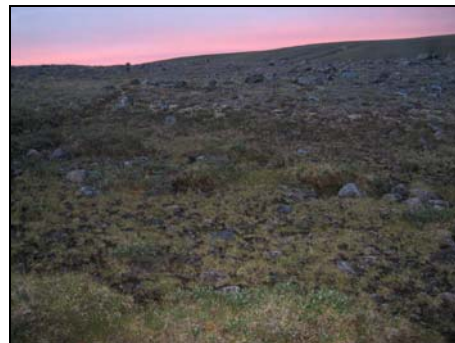
Figure 2: View across crossing 14 from left bank

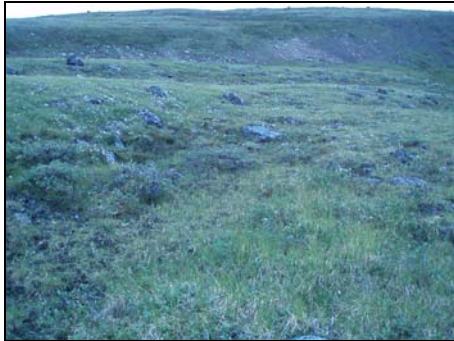
Figure 1: View upstream of crossing 15A

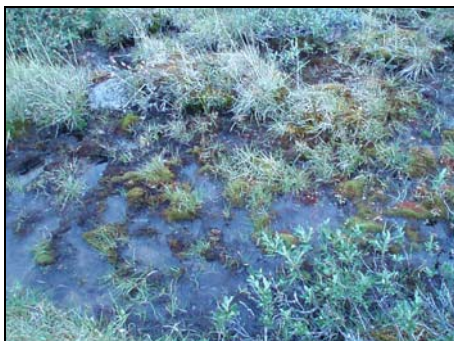
Figure 2: View across crossing 15A from right bank

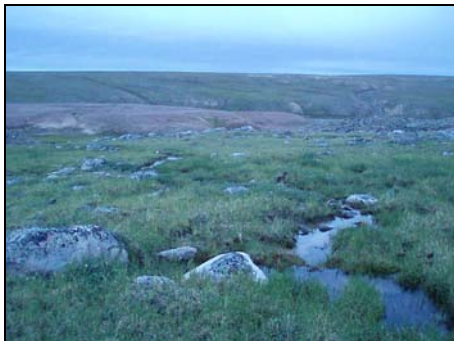
Figure 3: View downstream of crossing 15A

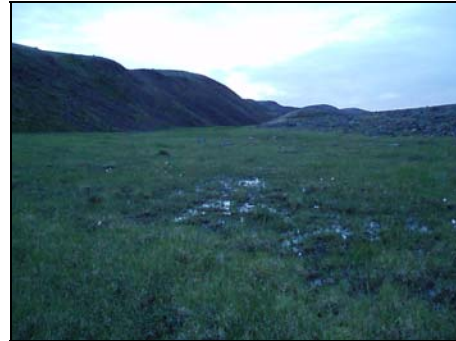
Figure 1: View upstream of crossing 15B

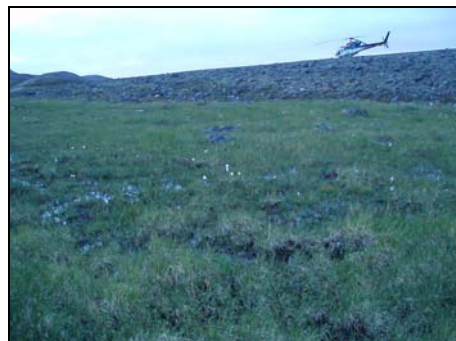
Figure 2: View across crossing 15B from left bank

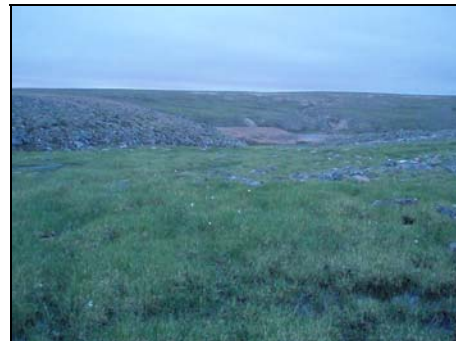
Figure 3: View downstream of crossing 15B

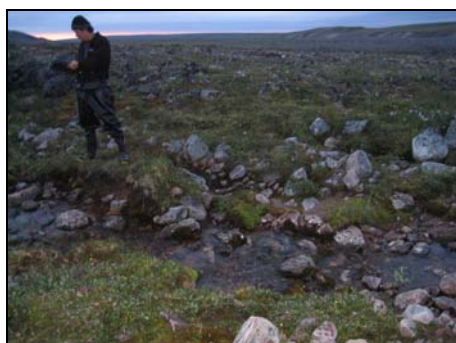
Figure 2: View across crossing 16 from left bank

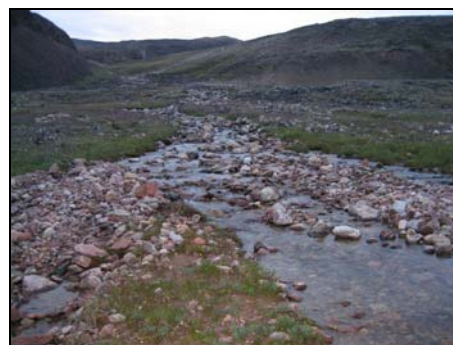
Figure 1: View upstream of crossing 16A

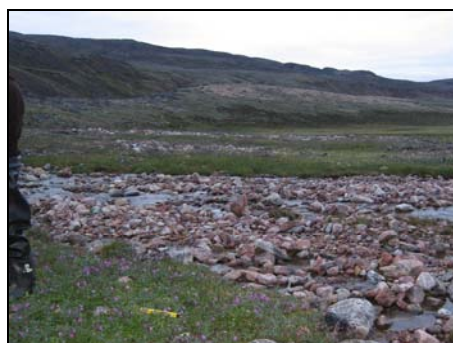
Figure 2: View across crossing 16A from left bank

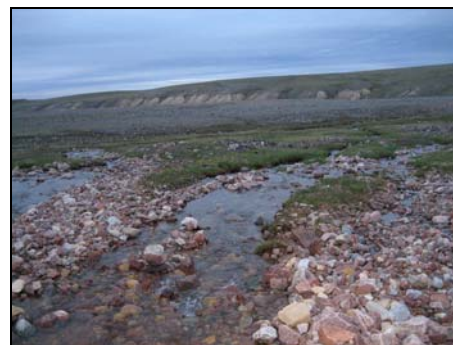
Figure 3: View downstream of crossing 16A

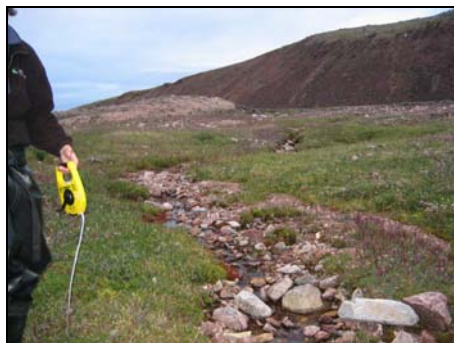
Figure 1: View upstream of crossing 16B

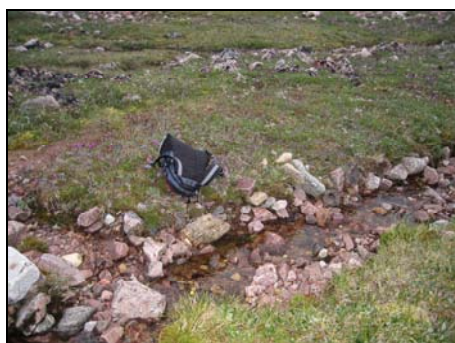
Figure 2: View across crossing 16B from left bank

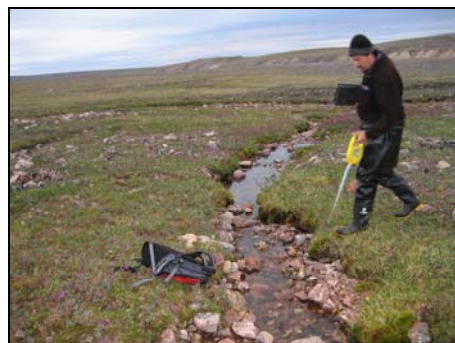
Figure 3: View downstream of crossing 16B

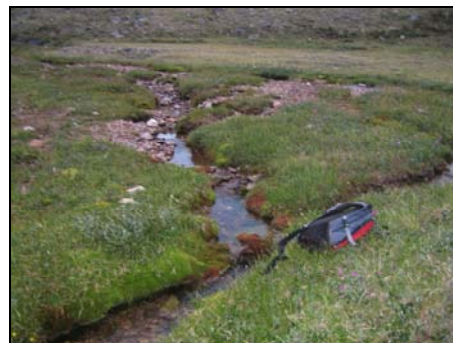
Figure 1: View upstream of crossing 17

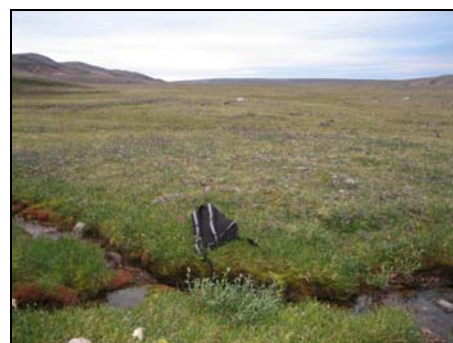
Figure 2: View across crossing 17 from left bank

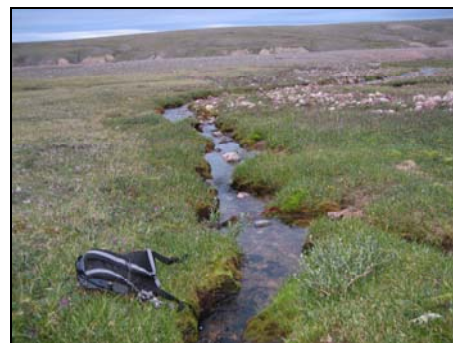
Figure 3: View downstream of crossing 17

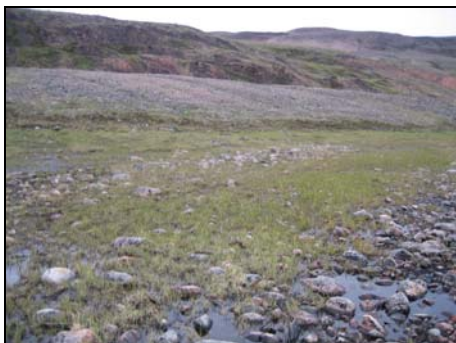
Figure 1: View upstream of crossing 18

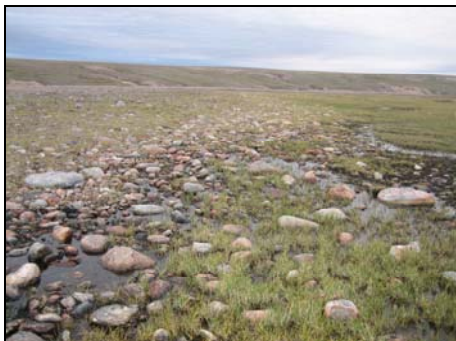
Figure 3: View downstream of crossing 18

The large, unnamed river is ~4.5 km downstream. A dry stretch acts as a barrier between the crossing and downstream reaches.

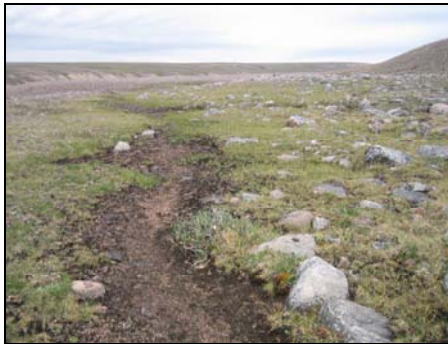
Figure 3: View downstream of crossing 22

The large, unnamed river is ~4 km downstream. There is a small lake ~0.5 km downstream of the crossing site. A dry stretch acts as a barrier between the lake and the crossing.

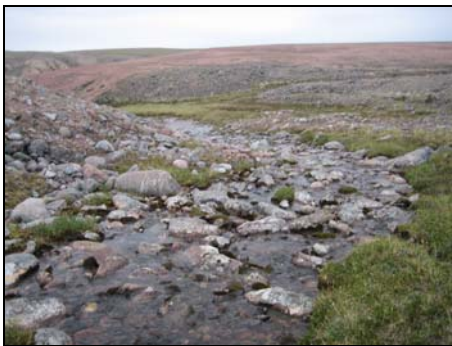
Figure 3: View downstream of crossing 23

There is a large, unnamed river ~3 km downstream of the crossing site. A lack of fish suggests that there may be an unidentified barrier between the large river and the crossing.

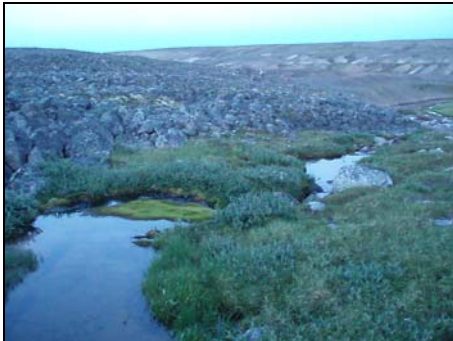
**Figure 3:** View downstream of crossing 32**Watercourse Characteristics**Tributary Status: 1st order trib of large river

The large, unnamed river is ~0.8 km downstream of the crossing. Cascades downstream of the crossing site act as a barrier.

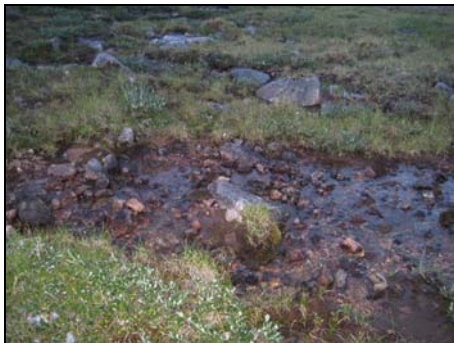
Figure 1: View across crossing 34A from left bank

The large, unnamed river is ~0.6 km downstream of the crossing. Barriers near the crossing include a steep drop ~50 m downstream, and no water upstream.

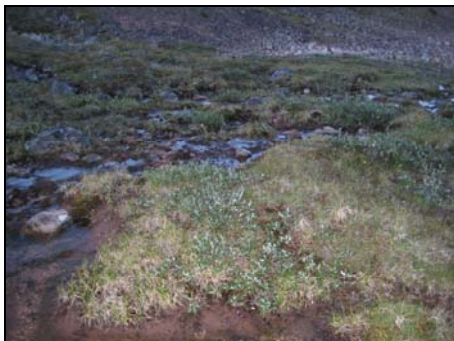
Figure 2: View across crossing 34B from left bank

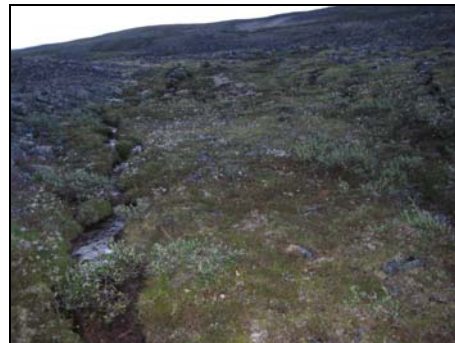
Figure 1: View upstream of crossing 34C

The large, unnamed river is ~0.6 km downstream of the crossing. A steep drop acts as a barrier between the river and the crossing.

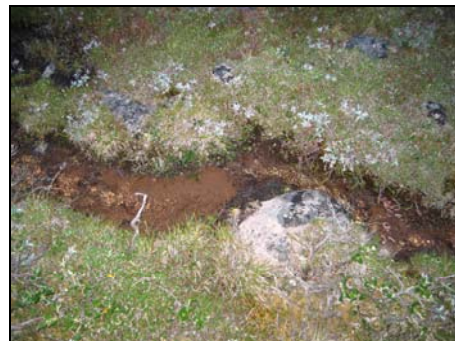
Figure 2: View across crossing 34C from left bank

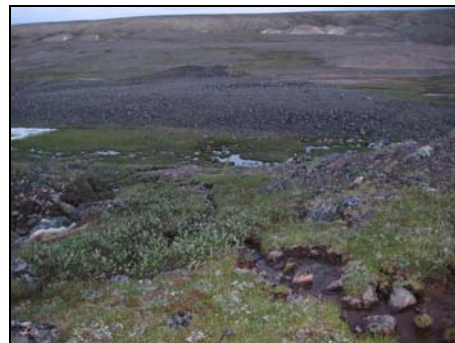
Figure 3: View downstream of crossing 34C

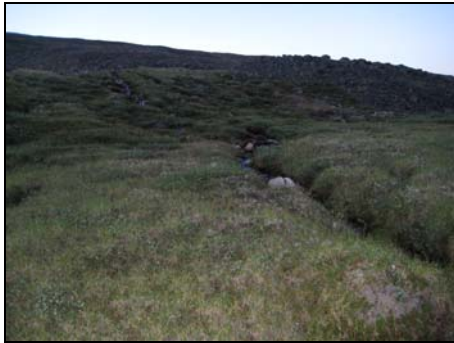
Figure 1: View upstream of crossing 35

The large, unnamed river is ~0.5 km downstream of the crossing. There is a small lake ~200 m downstream of the crossing. Cascades between the lake and the crossing act as a barrier.

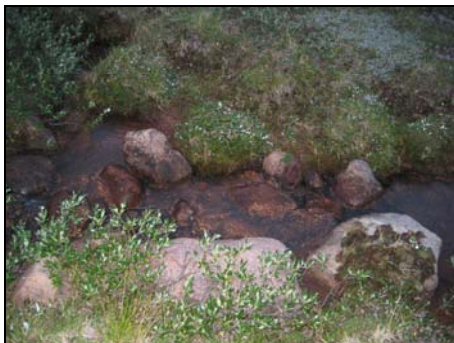
Figure 2: View across crossing 35 from left bank

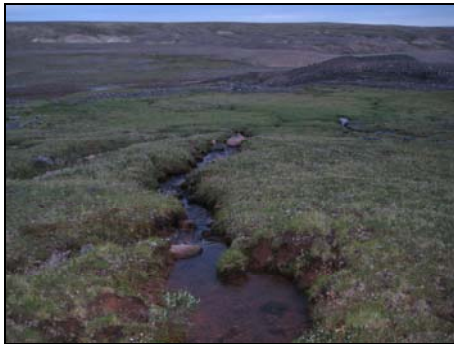
Figure 3: View downstream of crossing 35

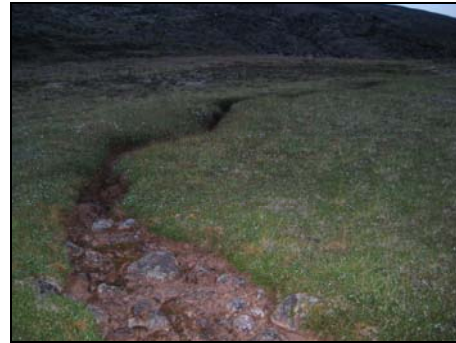
Figure 1: View upstream of crossing 36

The large, unnamed river is ~0.5 km downstream of the crossing. There is a small lake ~200 m downstream of the crossing site.

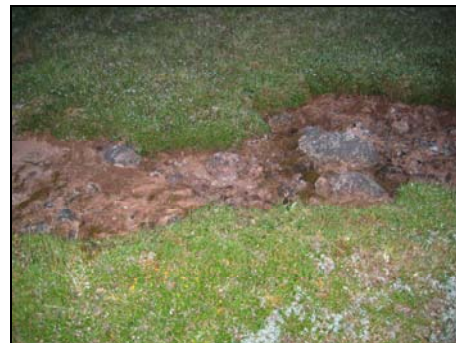
Figure 2: View across crossing 36 from left bank

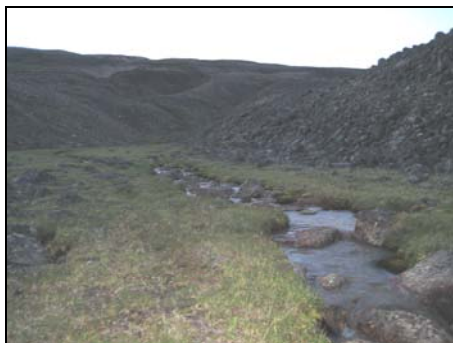
Figure 1: View upstream of crossing 37

There is a small lake ~300 m downstream of the crossing site. The large, unnamed river is ~0.6 km downstream of the crossing. A dry stretch between the lake and the crossing acts as a barrier.

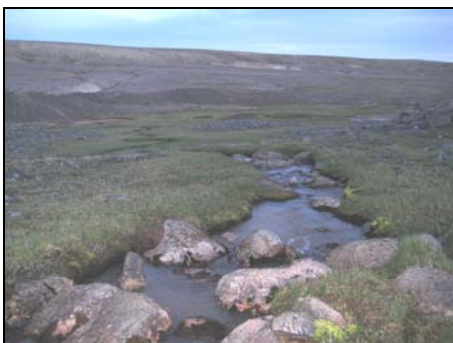
Figure 3: View downstream of crossing 37

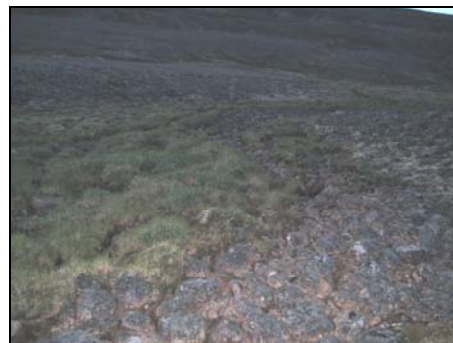
Figure 1: View upstream of crossing 37A

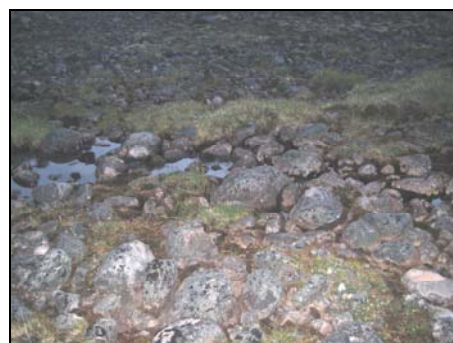
Figure 2: View across crossing 37A from right bank

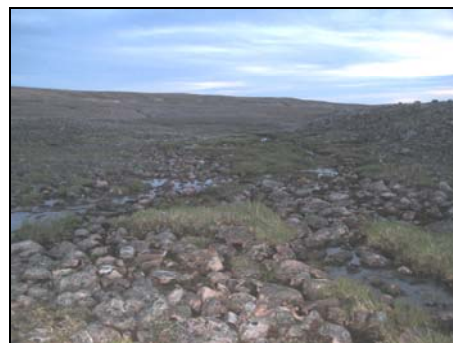
Figure 3: View downstream of crossing 37A

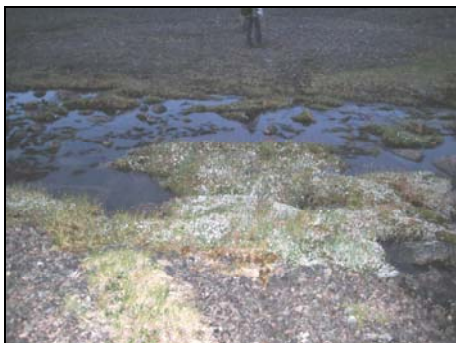
Figure 1: View across crossing 37B from left bank

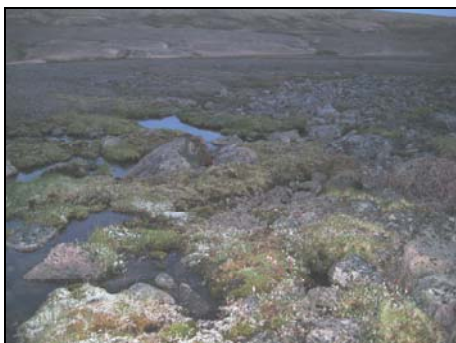
Figure 3: View downstream of crossing 37B

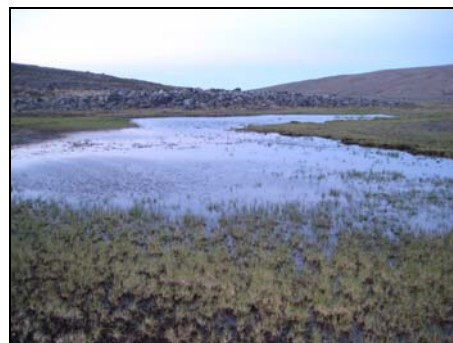
Figure 2: View across crossing 38 from left bank

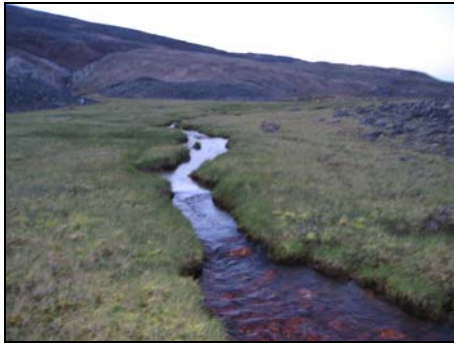
Figure 1: View upstream of crossing 39

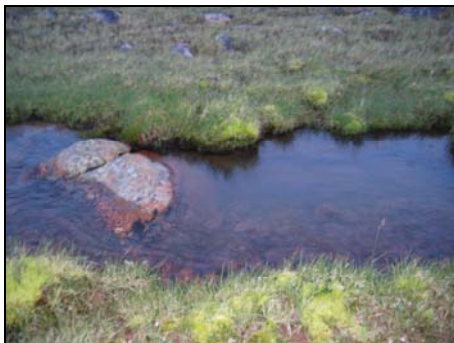
Figure 2: View across crossing 39 from left bank

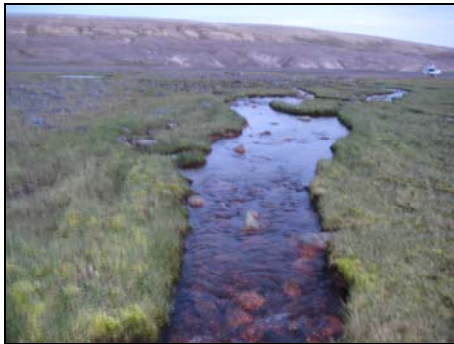
Figure 3: View downstream of crossing 39

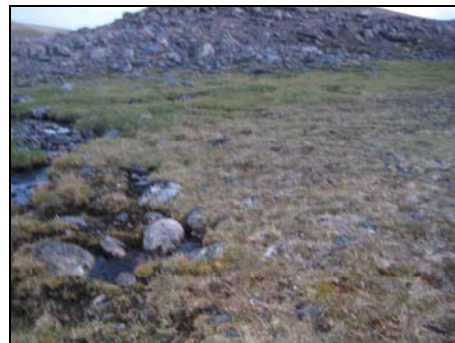
Figure 2: View across crossing 40 from left bank

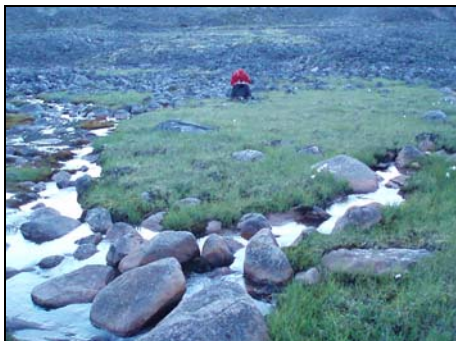
Figure 1: View upstream of crossing 41

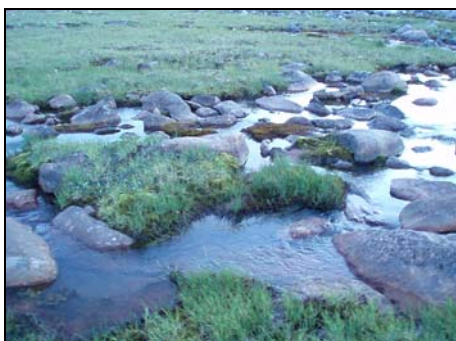
Figure 2: View across crossing 41 from right bank

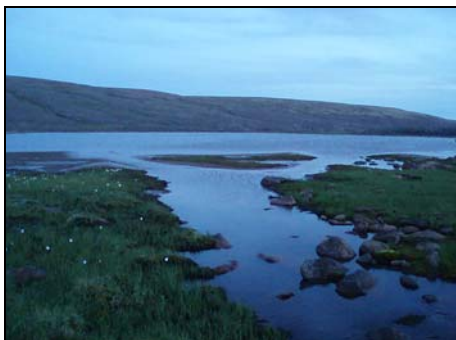
Figure 3: View downstream of crossing 41

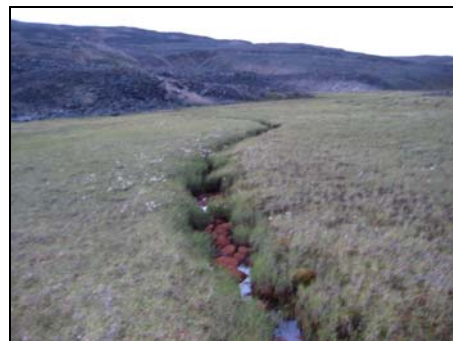
Figure 1: View upstream of crossing 42

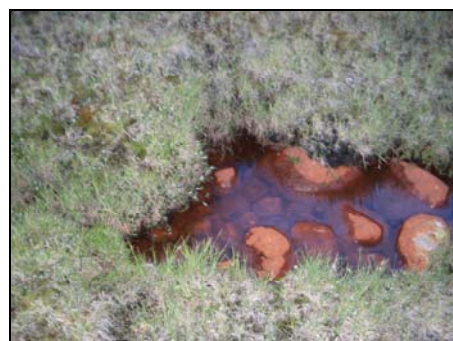
Figure 2: View across crossing 42 from left bank

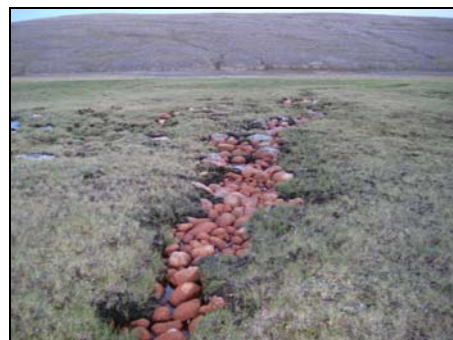
Figure 3: View downstream of crossing 42

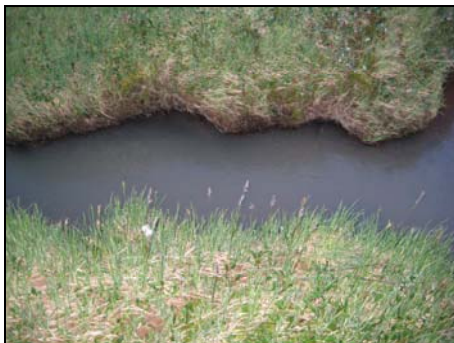
Figure 2: View across crossing 43 from left bank

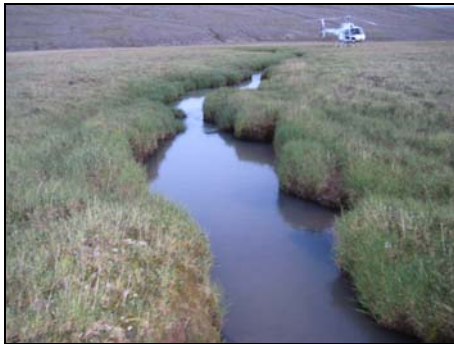
Figure 3: View downstream of crossing 43

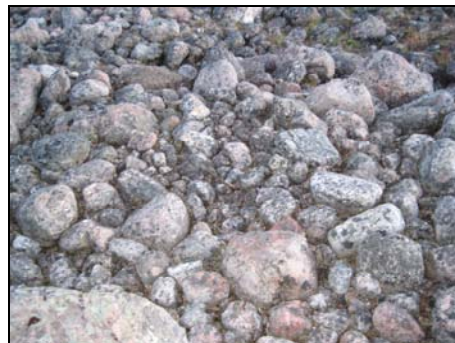
Figure 2: View across crossing 44 from right bank

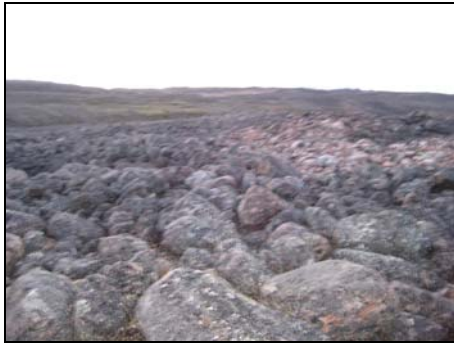
Figure 1: View upstream of crossing 45

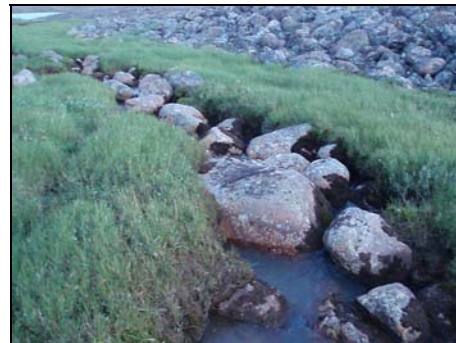
Figure 3: View downstream of crossing 46

There is a large lake (part of the large, downstream river) ~300 m downstream of the crossing site.

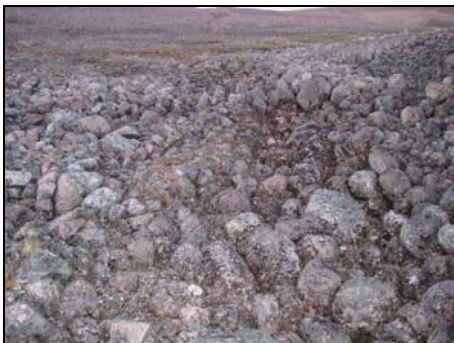
Figure 3: View downstream of crossing 49

There is a small lake ~300 m downstream and a large lake (part of the large, downstream river) ~900 m downstream of the crossing site.

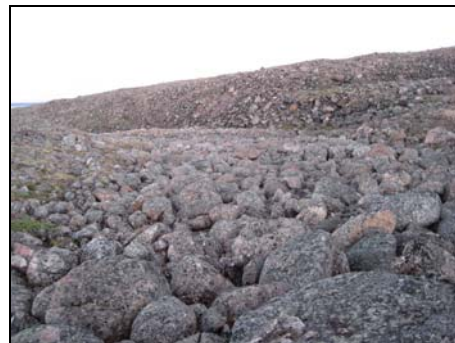
Figure 3: View downstream of crossing 50

There is a small lake (part of the large, downstream river) 1 km downstream of the crossing site. The stream flows under boulders between the lake and the crossing, creating a barrier.

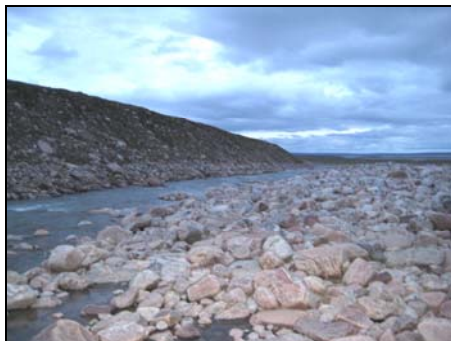
Figure 3: View downstream of crossing 61

Angajurjualuk Lake is ~8 km downstream of the crossing. Cascades downstream of the crossing act as a partial barrier.

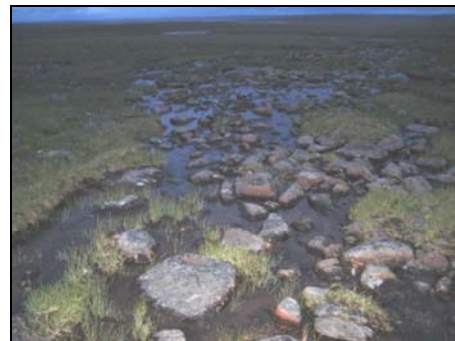
Figure 3: View downstream of crossing 62

Large, unnamed lake is ~4 km downstream of the crossing. Low water downstream of the crossing acts as a barrier.

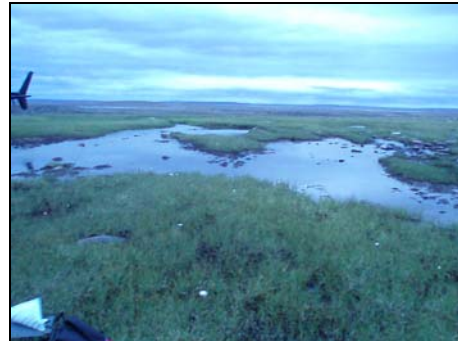
Figure 3: View downstream of crossing 64

There is a very small lake 0.5 km downstream of the crossing site and a large, unnamed lake ~3 km further downstream. Low water between the lake and the crossing acts as a barrier.

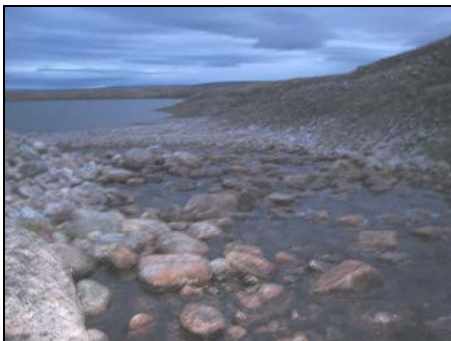
Figure 3: View downstream of crossing 67

There is a small lake ~100 m downstream of the crossing site and a large, unnamed lake ~3.5 km further downstream. Low water levels downstream of the crossing act as a barrier.

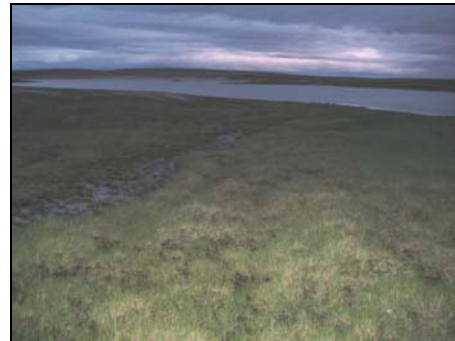
Figure 3: View downstream of crossing 74

The Ravn River is ~100 m downstream of the crossing site. There is a steep drop between the Ravn River and the crossing that acts as a barrier.

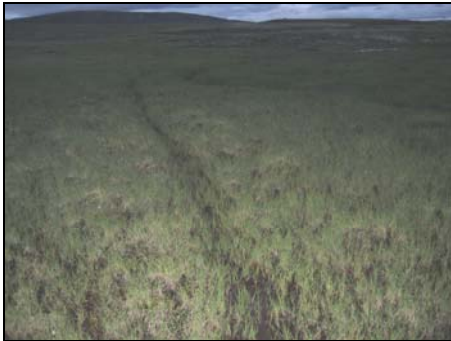
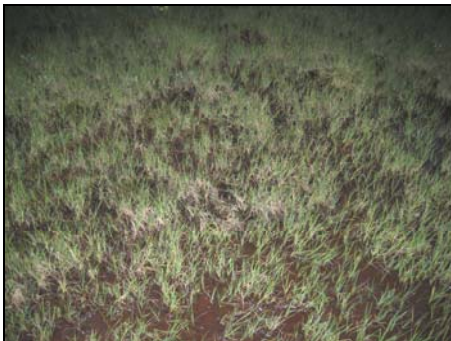
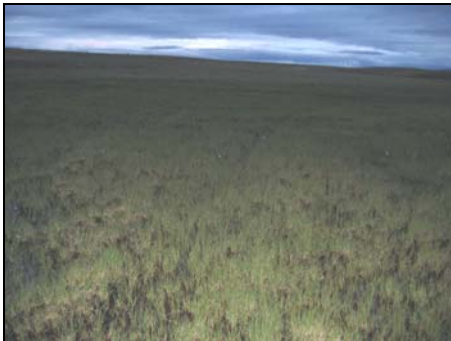
Figure 1: View upstream of crossings 75 & 76

Figure 2: View across crossings 75 & 76 from left bank

Figure 3: View downstream of crossings 75 & 76

Low water levels downstream of the crossing site act as a barrier between crossing and Ravn River, which is ~0.5 km downstream.

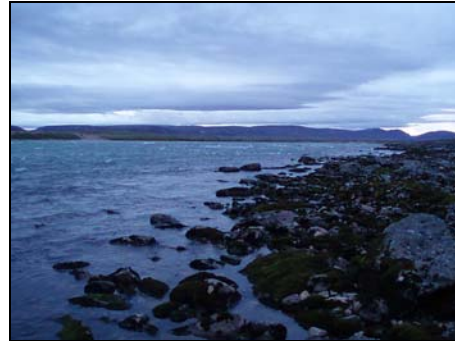
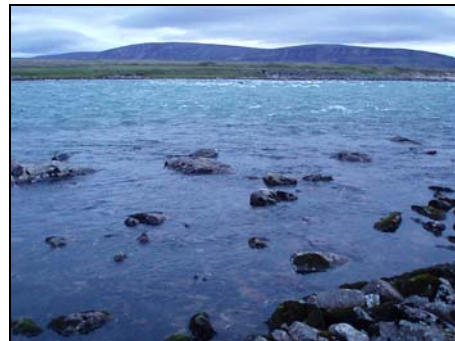
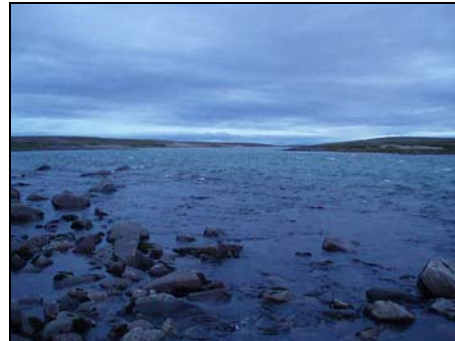
Figure 1: View upstream of crossings 77

Figure 2: View across crossing 77 from right bank

Figure 3: View downstream of crossings 77

This site is the Ravn River.

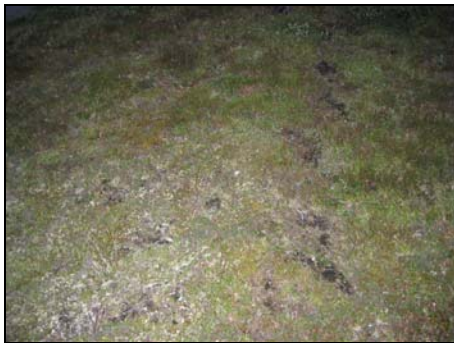
Figure 1: View across crossing 78 from right bank

There is a small lake immediately downstream of the crossing site, which is ~100 m upstream of the Ravn River.

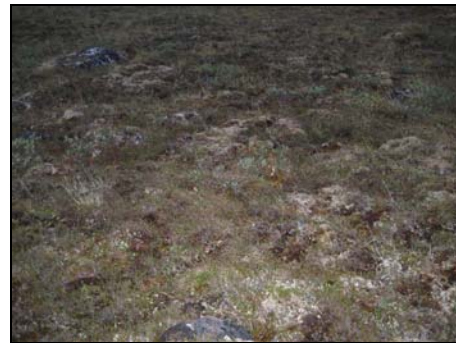
Figure 1: View downstream of crossing 79

This crossing is not likely wet at any point during the year, so this should not actually be considered a crossing.

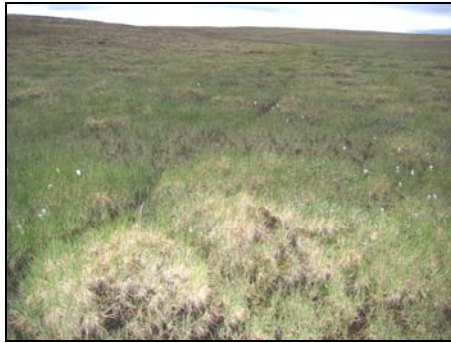
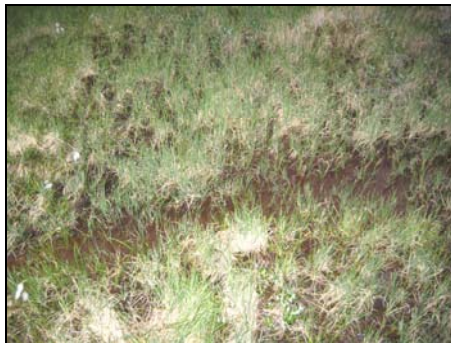
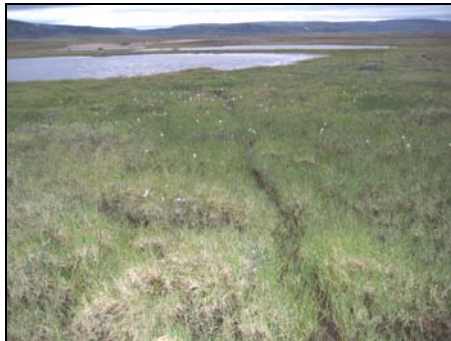
Figure 1: View upstream of crossing 80

Figure 2: View across crossing 80 from left bank

Figure 3: View downstream of crossing 80

The Ravn River is ~0.5 km downstream. There is a small lake ~100 m downstream of the crossing site. A dry stretch between the lake and the crossing acts as a barrier.

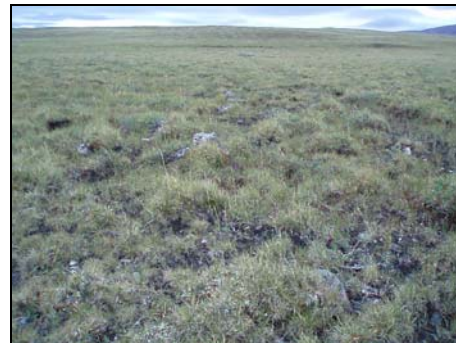
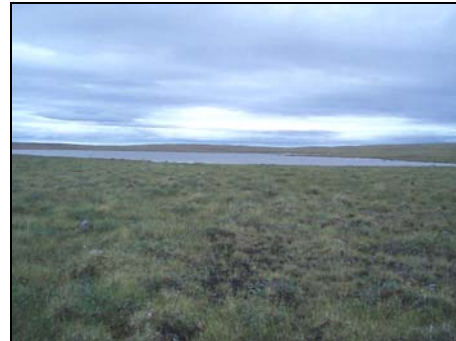
Figure 1: View upstream of crossing 81

Figure 2: View across crossing 81

Figure 3: View downstream of crossing 81

The Ravn River is ~3 km downstream of the crossing. There is a small lake ~100 m downstream of the crossing site. A dry stretch between the lake and the crossing acts as a barrier.

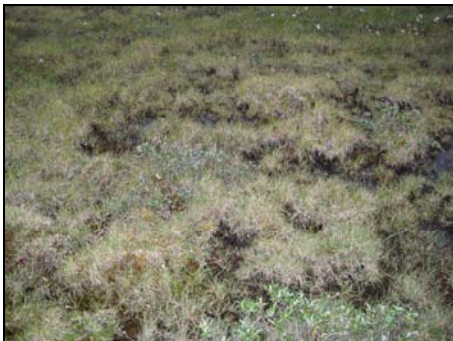
Figure 1: View upstream of crossing 82

Figure 2: View across crossing 82 from left bank

Figure 3: View downstream of crossing 82

Large, unnamed river is ~0.5 km downstream.

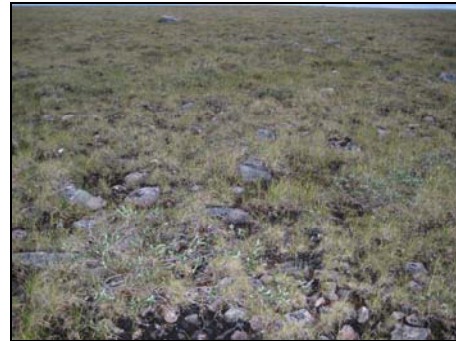
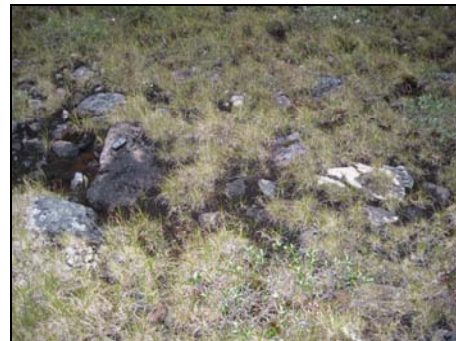
Figure 1: View upstream of crossing 83

Figure 2: View across crossing 83 from right bank

Figure 3: View downstream of crossing 83

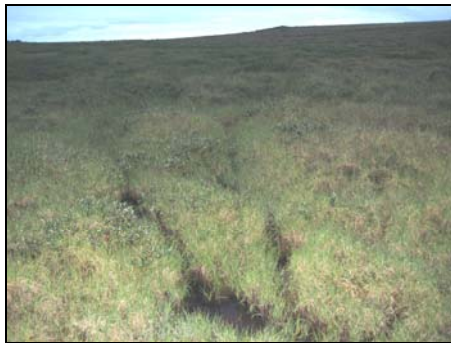
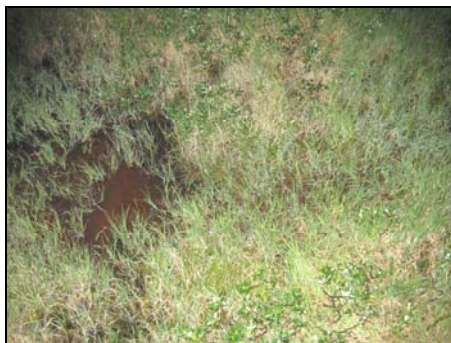
Figure 1: View upstream of crossing 84

Figure 2: View across crossing 84 from right bank

Figure 3: View downstream of crossing 84

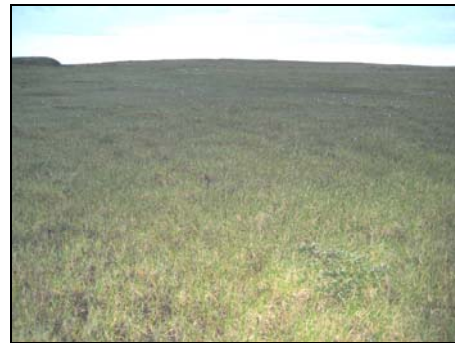
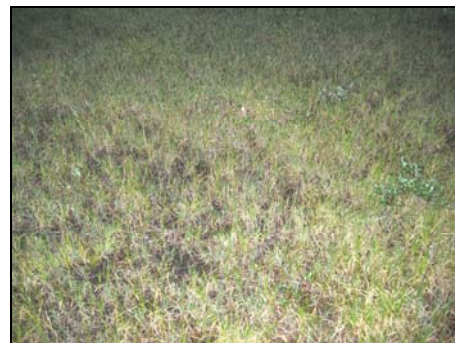
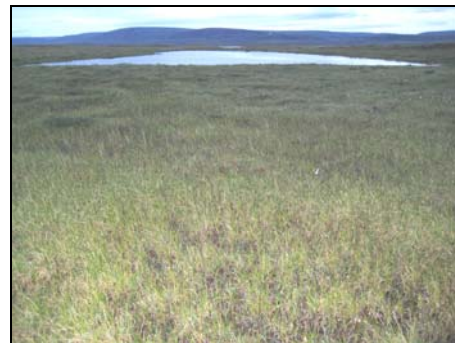
Figure 1: View upstream of crossing 85

Figure 2: View across crossing 85 from right bank

Figure 3: View downstream of crossing 85

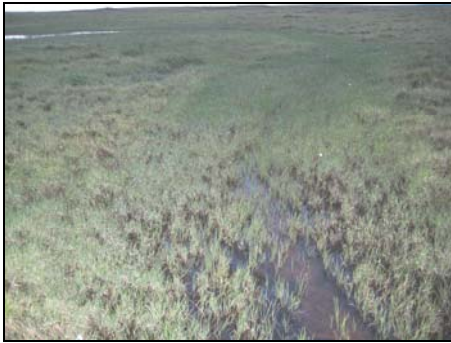
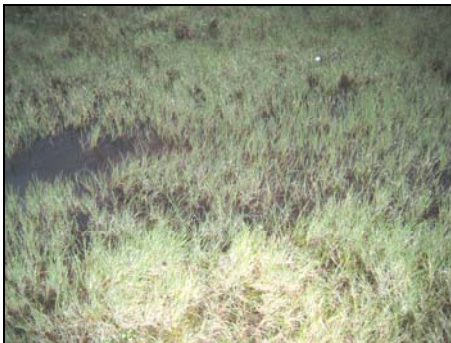
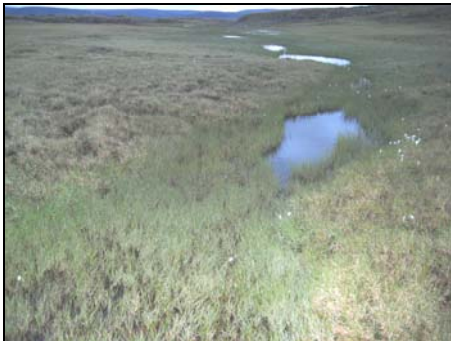
Figure 1: View upstream of crossing 86

Figure 2: View across crossing 86 from left bank

Figure 3: View downstream of crossing 86

The large, unnamed river is ~1 km downstream. Low water downstream of the crossing acts as a barrier.

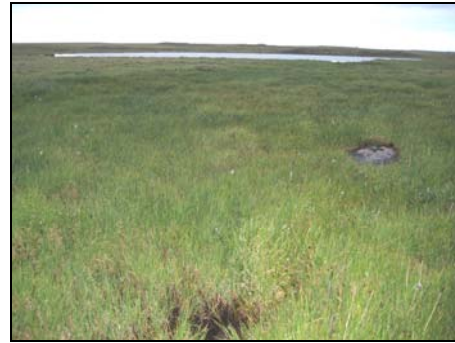
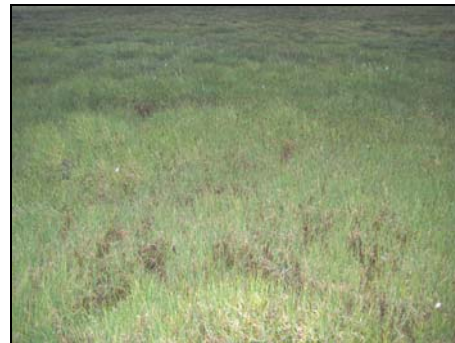
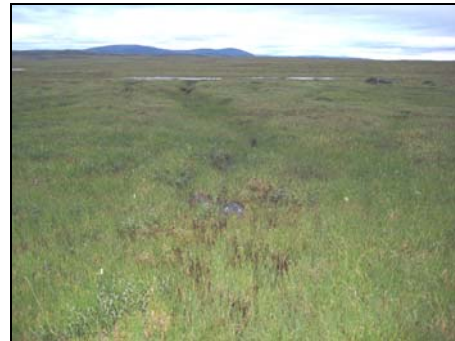
Figure 1: View upstream of crossing 87

Figure 2: View across crossing 87 from right bank

Figure 3: View downstream of crossing 87

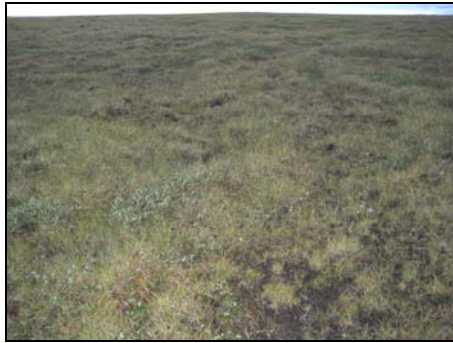
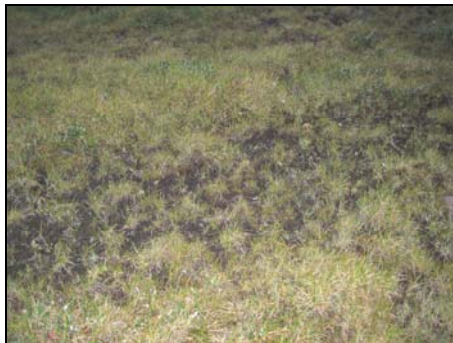
Figure 1: View upstream of crossing 88

Figure 2: View across crossing 88 from left bank

Figure 3: View downstream of crossing 88

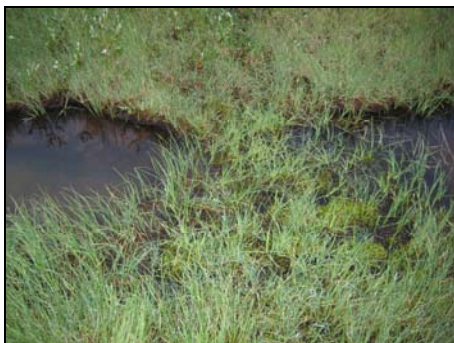
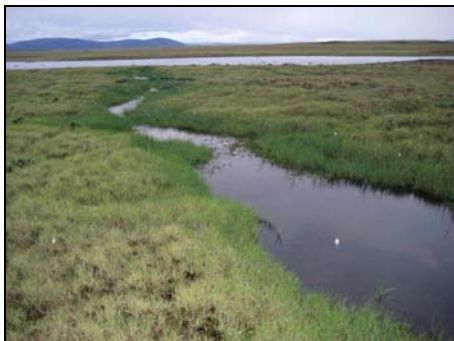
Figure 1: View upstream of crossing 90

Figure 2: View across crossing 90 from left bank

Figure 3: View downstream of crossing 90

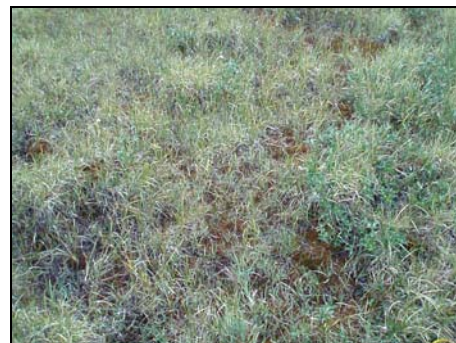
Figure 2: View across crossing 91 from left bank

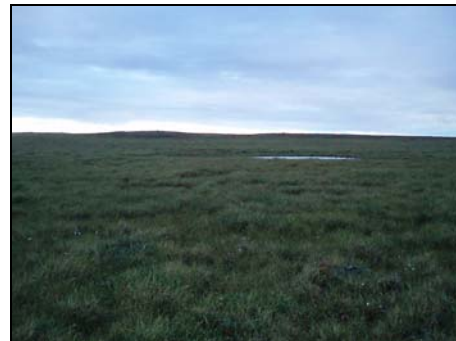
Figure 3: View downstream of crossing 91

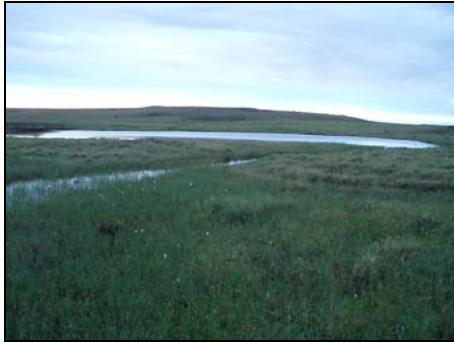
Figure 1: View upstream of crossing 92

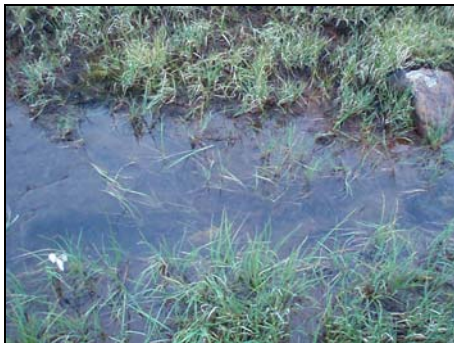
Figure 2: View across crossing 92 from left bank

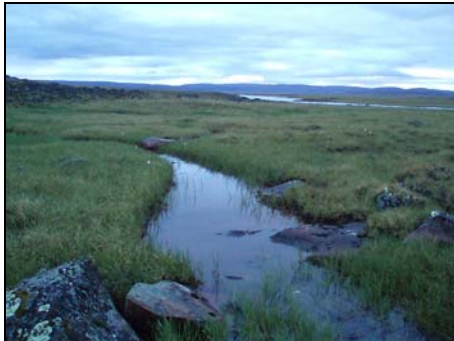
Figure 3: View downstream of crossing 92

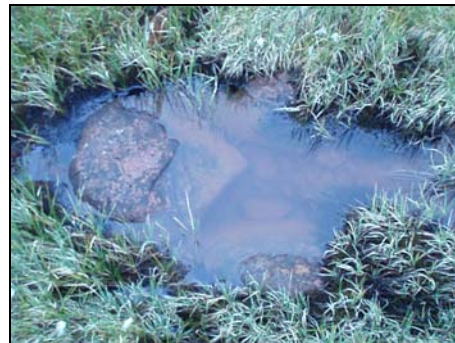
Figure 2: View across crossing 93

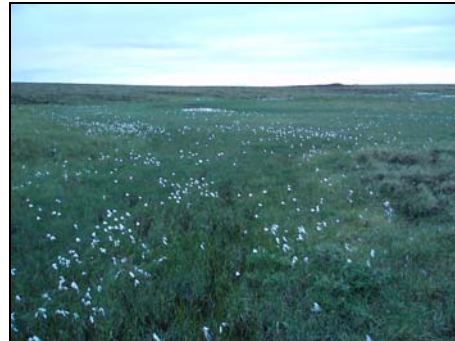
Figure 3: View downstream of crossing 93

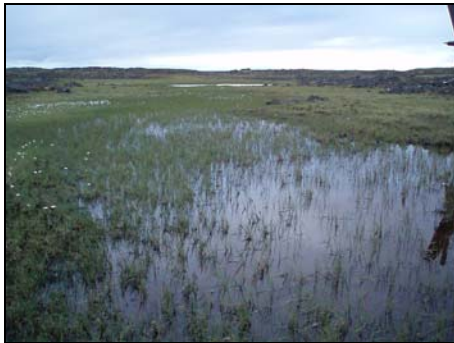
Figure 1: View upstream of crossing 95

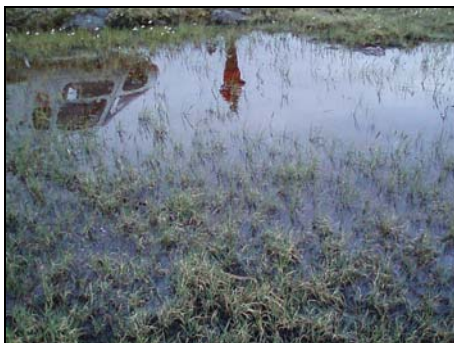
Figure 2: View across crossing 95 from left bank

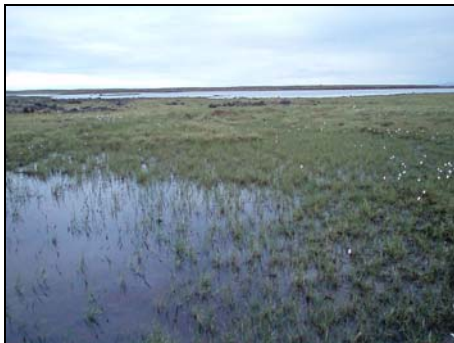
Figure 3: View downstream of crossing 95

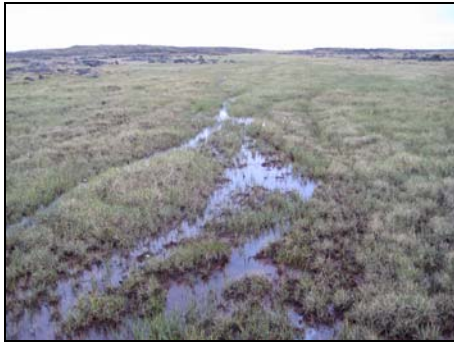
Figure 1: View upstream of crossing 97

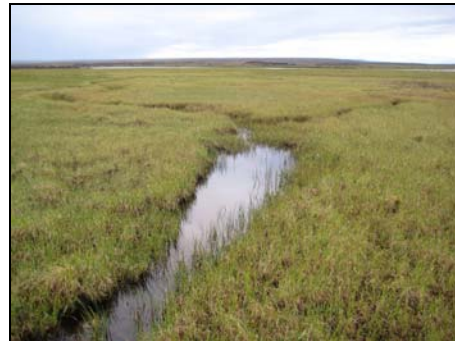
Figure 3: View downstream of crossing 98

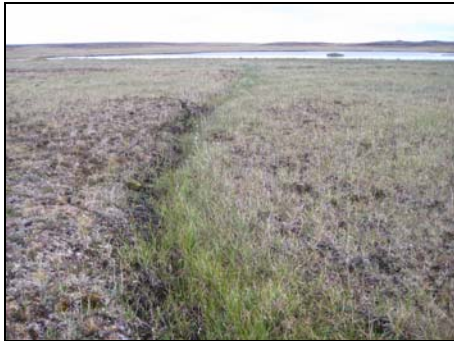
Figure 1: View upstream of crossing 99

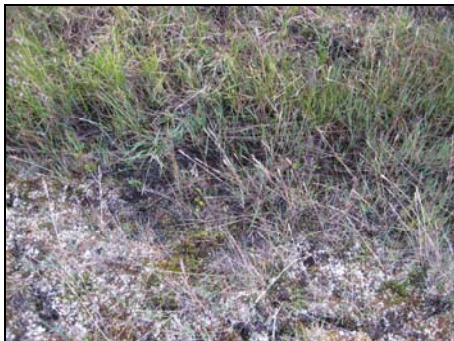
Figure 2: View across crossing 99 from left bank

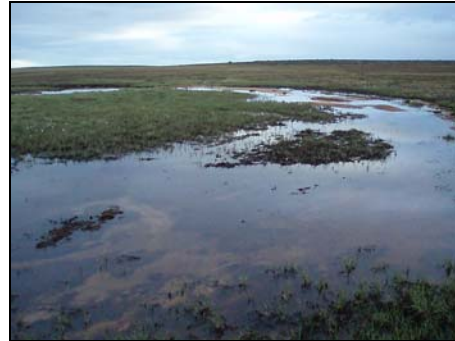
Figure 1: View upstream of crossing 100

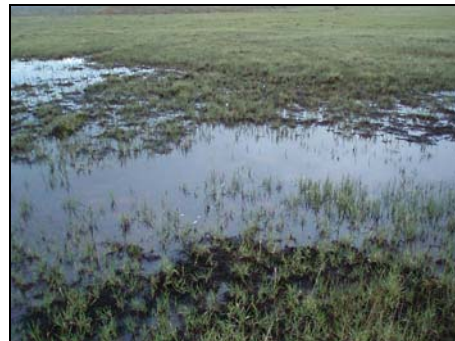
Figure 2: View across crossing 100 from left bank

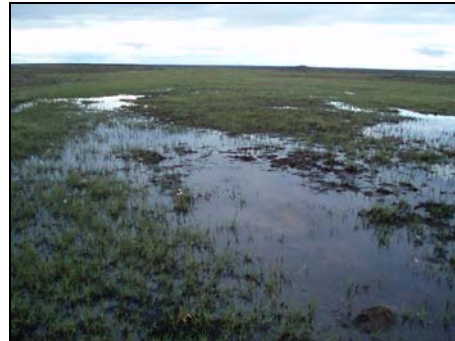
Figure 3: View downstream of crossing 100

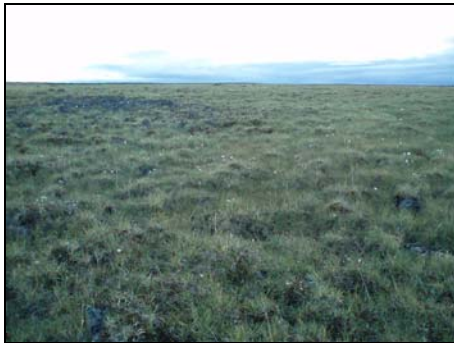
Figure 1: View upstream of crossing 101
