Rail Alignment Watercourse Crossing Assessments

Crossing ID: 1

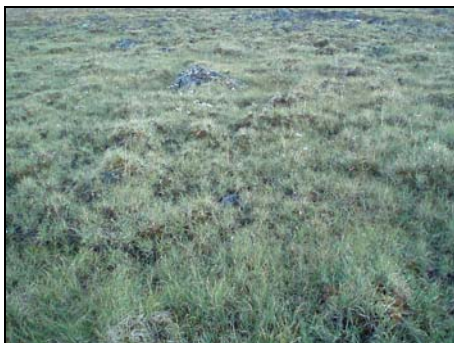
Figure 2: View across crossing 101 from left bank

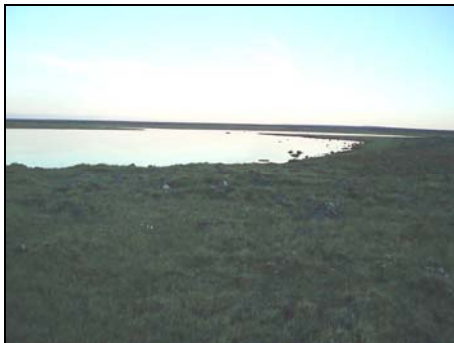
Figure 3: View downstream of crossing 101

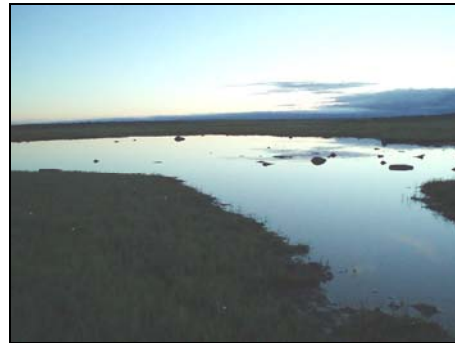
Figure 1: View upstream of crossing 102

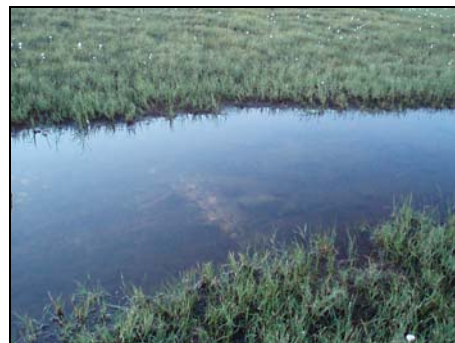
Figure 2: View across crossing 102 from left bank

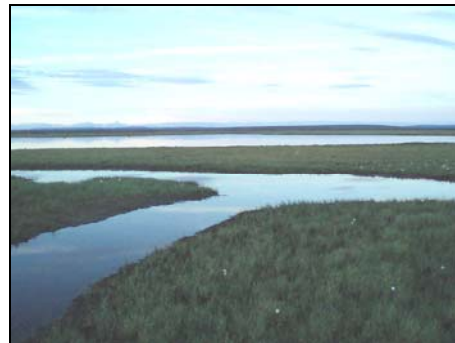
Figure 3: View downstream of crossing 102

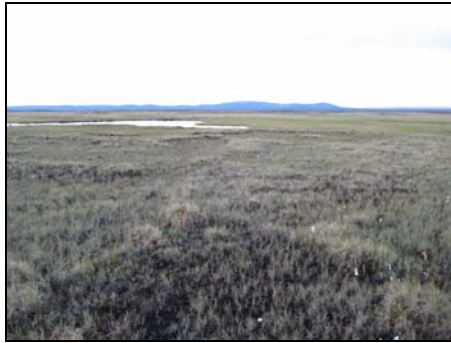
Figure 1: View upstream of crossing 103

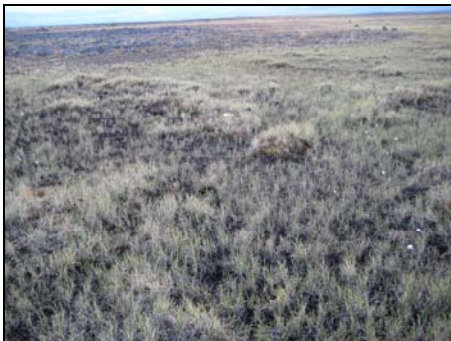
Figure 2: View across crossing 103 from right bank

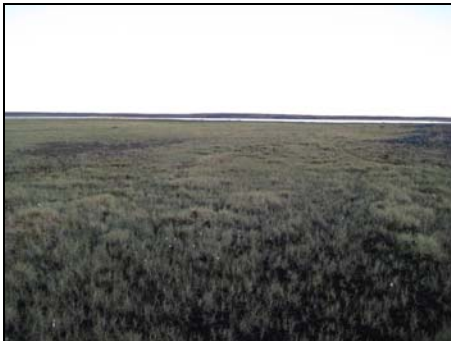
Figure 3: View downstream of crossing 103

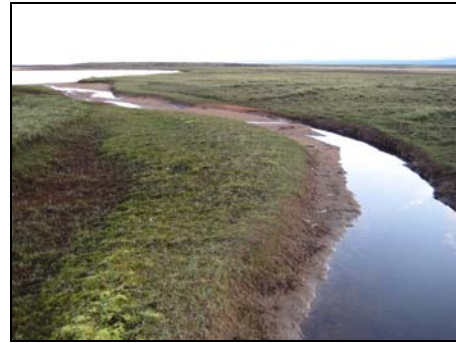
Figure 1: View upstream of crossing 104

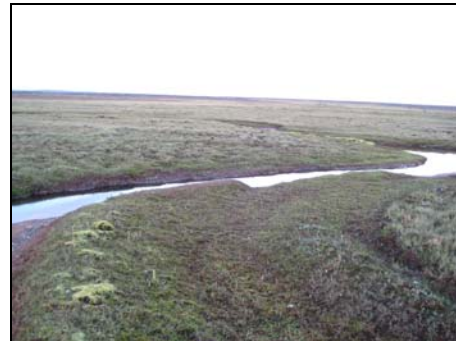
Figure 3: View downstream of crossing 104

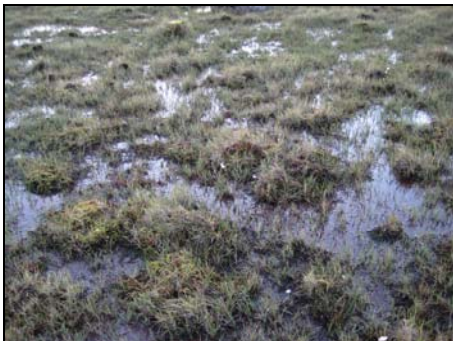
**Figure 2:** View across crossing 105 from right bank

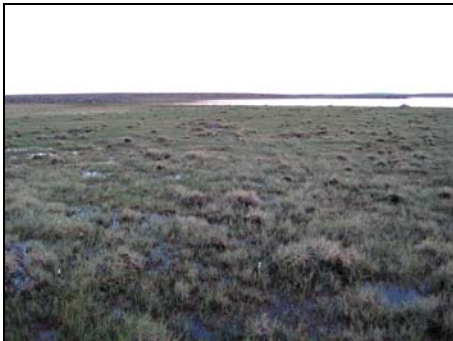
**Figure 3:** View downstream of crossing 105**Watercourse Characteristics**Tributary Status: 1st order trib of large lake
