Rail Alignment Watercourse Crossing Assessments

Crossing ID: 106**UTM:** 17W 599076 / 7875790**Latitude / Longitude:** 70°57'56.289" N / 78°16'38.296" W**Date / Time Surveyed:** 11-Aug-07 / 23:10

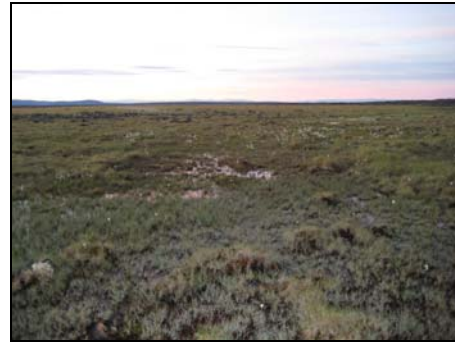
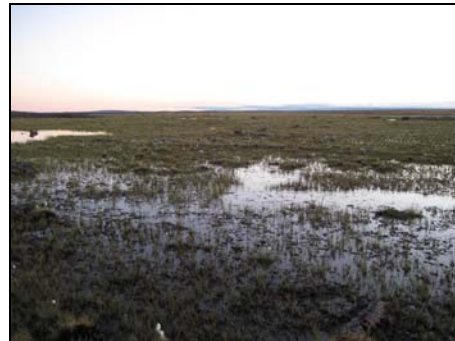
The large, unnamed lake is ~4 km downstream. Low water downstream of the crossing site acts as a barrier.

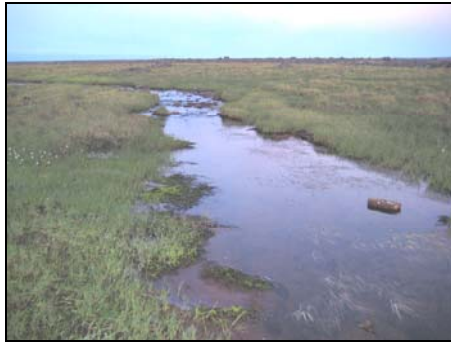
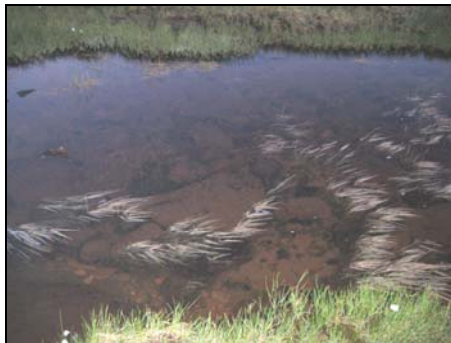
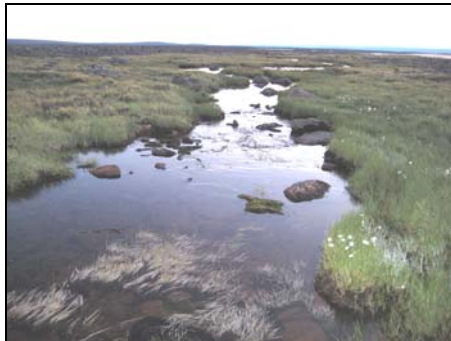
There is a small lake ~2 km downstream and a large, unnamed lake ~10 km downstream. Low water downstream of the crossing site acts as a barrier.

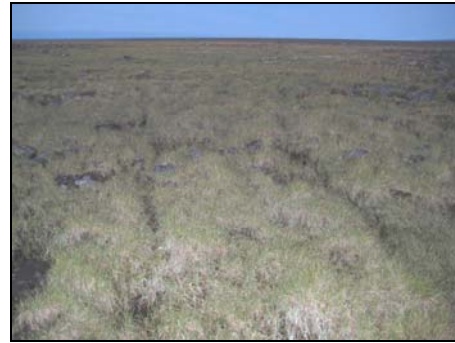
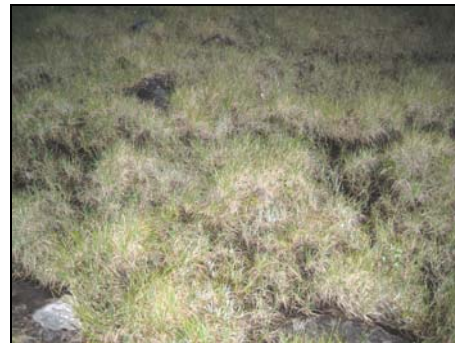
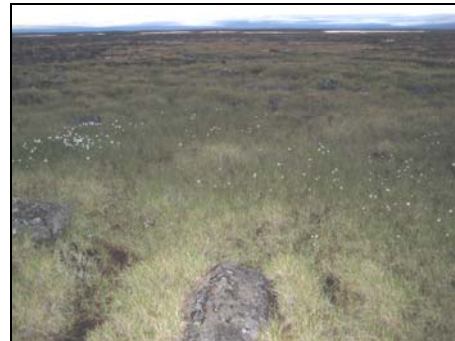
There is a small lake ~2 km downstream and a large, unnamed lake ~10 km downstream. Low water downstream of the crossing site acts as a barrier.

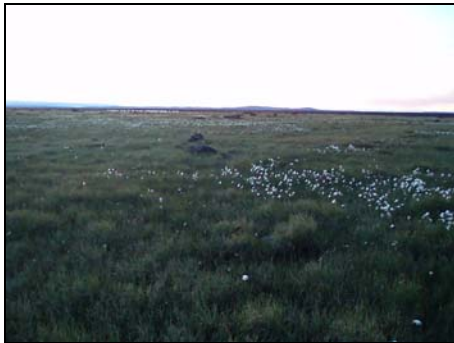
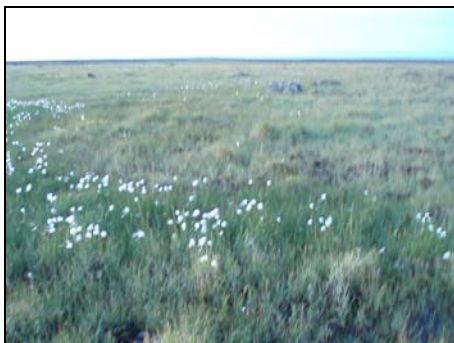
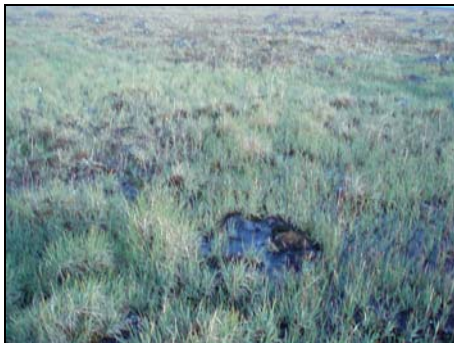
The large, unnamed river is ~2.5 km downstream. Low water downstream of the crossing site acts as a barrier.

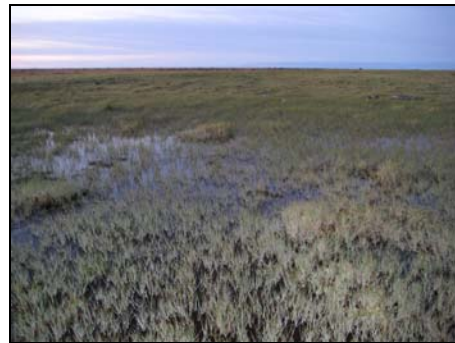
The large, unnamed river is ~3 km downstream. Low water downstream of the crossing site acts as a barrier.

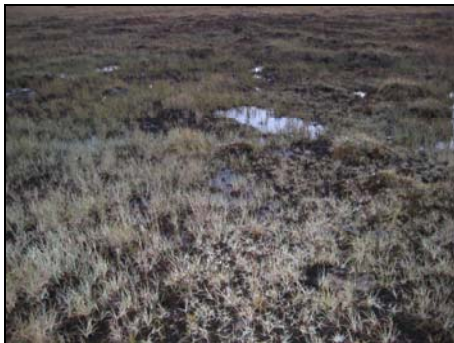
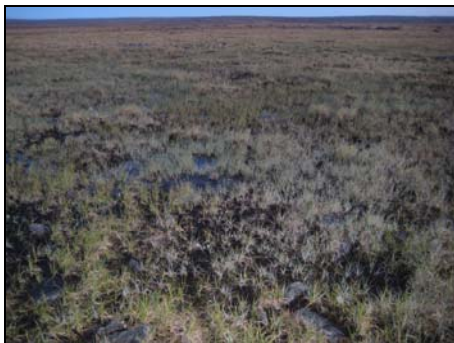
The large, unnamed river is ~3 km downstream. Low water downstream of the crossing site acts as a barrier.

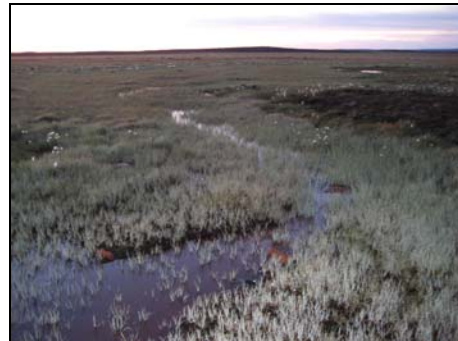
Figure 3: View downstream of crossing 120

The large, unnamed river is ~1.5 km downstream. Low water downstream of the crossing site acts as a barrier.

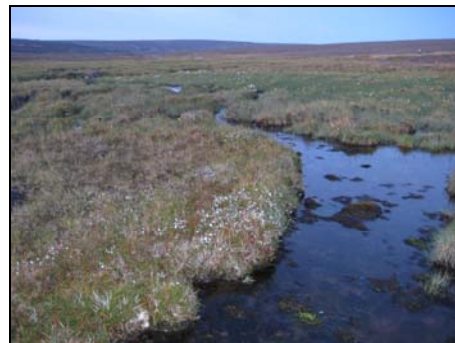
Figure 3: View downstream of crossing 124

The large, unnamed river is ~300 m downstream.

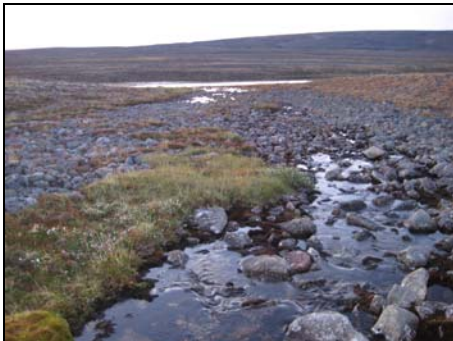
Figure 3: View downstream of crossing 125

The large, unnamed river is ~100 m downstream. The stream flows underground downstream of the crossing site, creating a barrier.

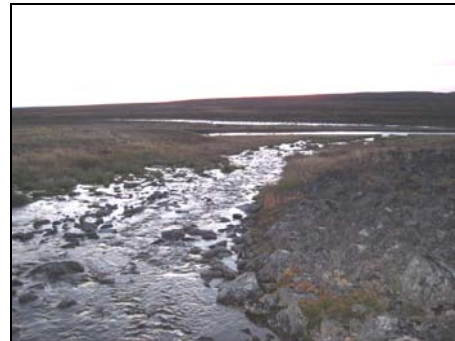
Figure 3: View downstream of crossing 126A

The large, unnamed river is ~100 m downstream.

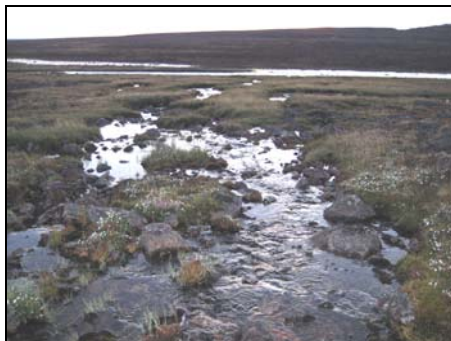
Figure 3: View downstream of crossing 126B

A small cascade downstream of the crossing site acts as a partial barrier.

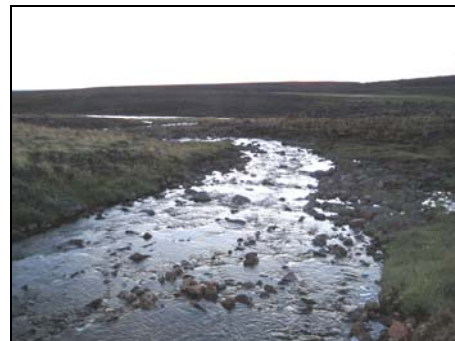
Figure 3: View downstream of crossing 126C

The large, unnamed river is ~100 m downstream.

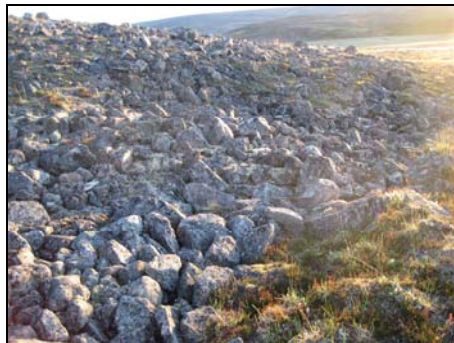
Figure 2: View across crossing 132 from left bank

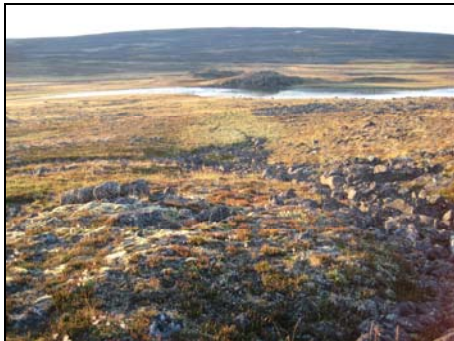
Figure 3: View downstream of crossing 132

There is a large, unnamed river ~300 m downstream.

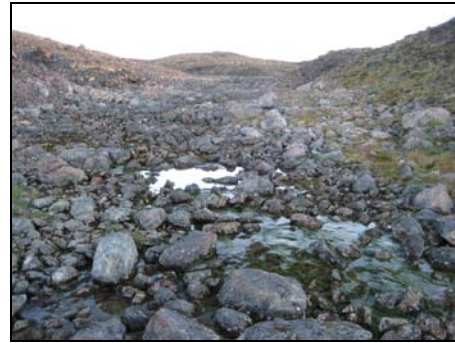
Figure 1: View upstream of crossing 133

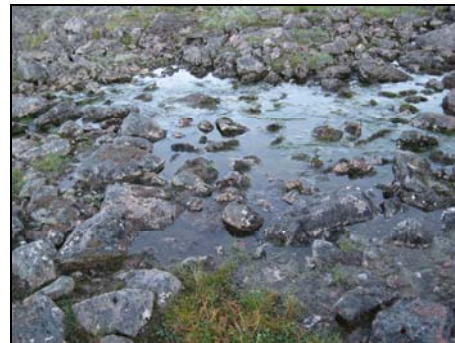
Figure 2: View across crossing 133 from right bank

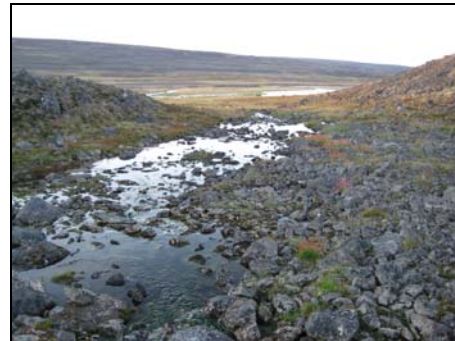
Figure 3: View downstream of crossing 133

There is a large, unnamed river ~300 m downstream. Cascades between the river and the crossing site act as a partial barrier.

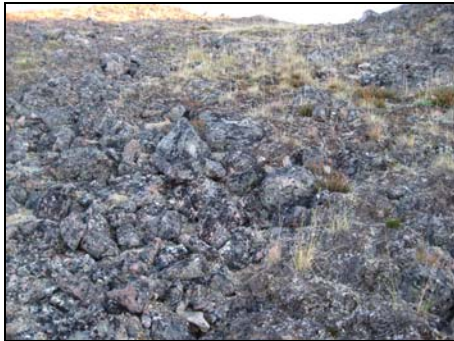
Figure 1: View upstream of crossing 133A

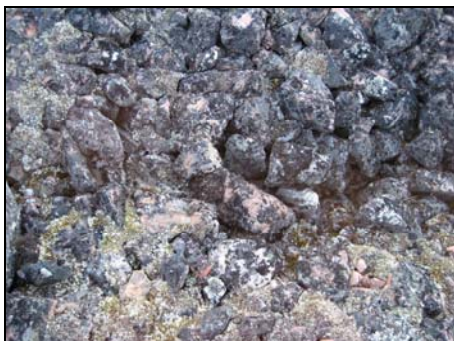
Figure 2: View across crossing 133A from left bank

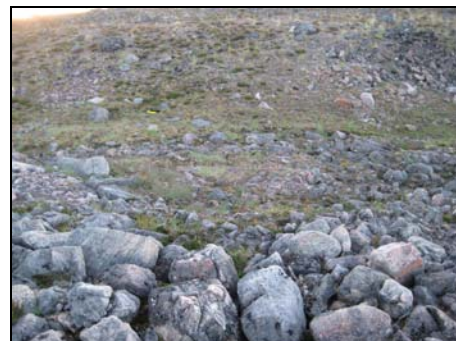
Figure 2: View across crossing 134 from left bank

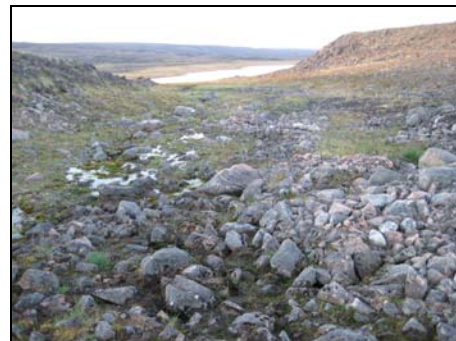
Figure 3: View downstream of crossing 134

There is a large, unnamed river ~500 m downstream. There is a steep set of cascades between the river and the crossing site that would act as a barrier even if water were present.

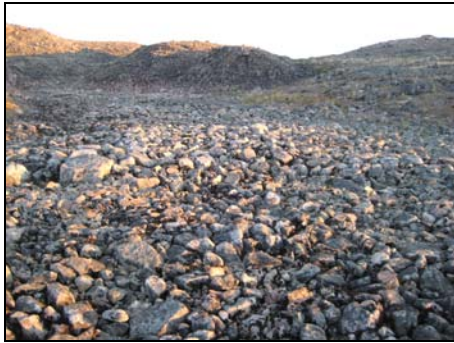
Figure 1: View upstream of crossing 135

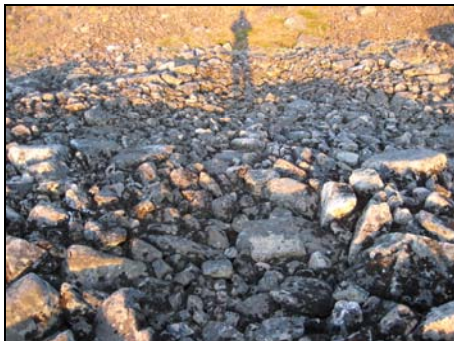
Figure 2: View across crossing 135 from right bank

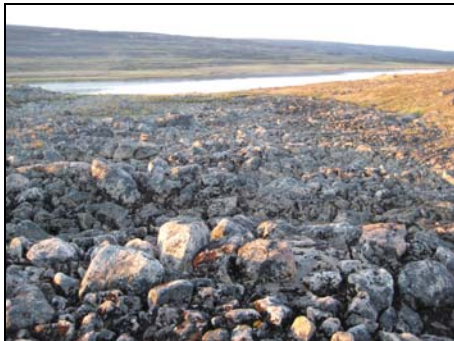
Figure 3: View downstream of crossing 135

The large, unnamed river is ~200 m downstream. Barriers near the crossing include a steep gradient both upstream and downstream of the crossing.

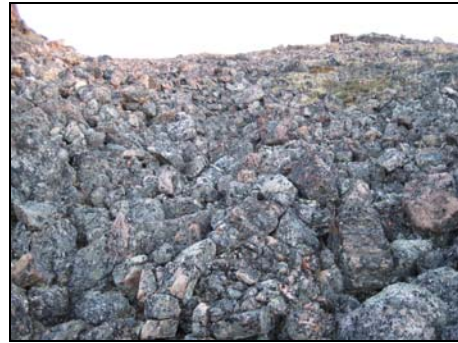
Figure 1: View upstream of crossing 136

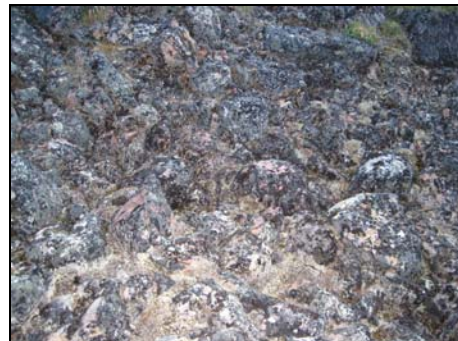
Figure 2: View across crossing 136 from left bank

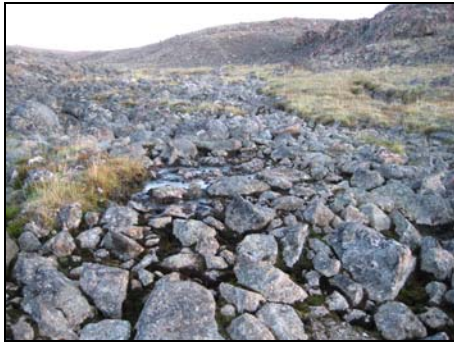
Figure 1: View upstream of crossing 137

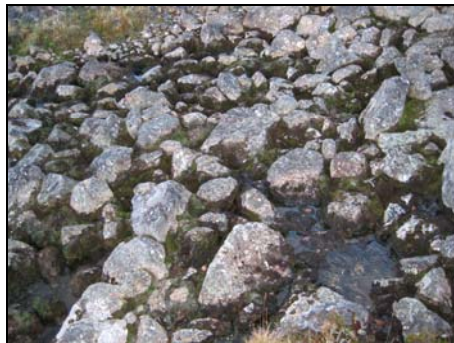
Figure 2: View across crossing 137 from right bank

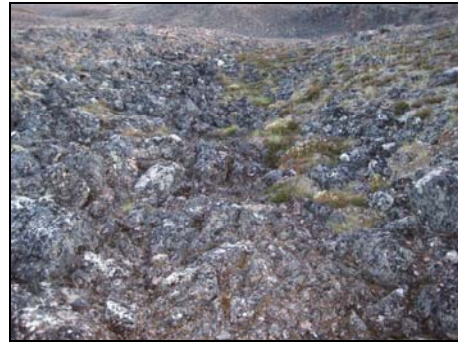
Figure 1: View upstream of crossing 138

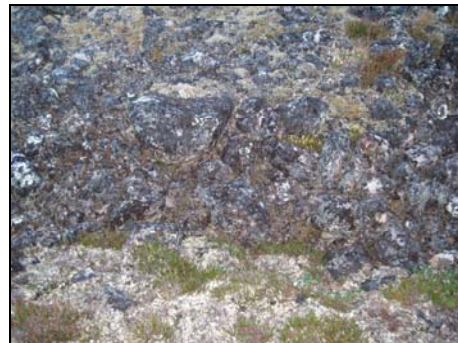
Figure 2: View across crossing 138 from right bank

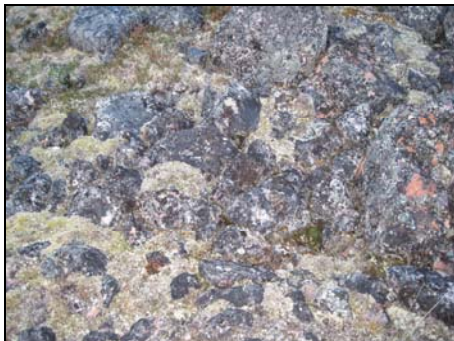
Figure 2: View across crossing 139 from right bank

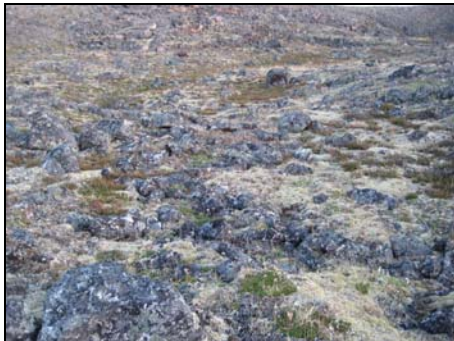
Figure 3: View downstream of crossing 139

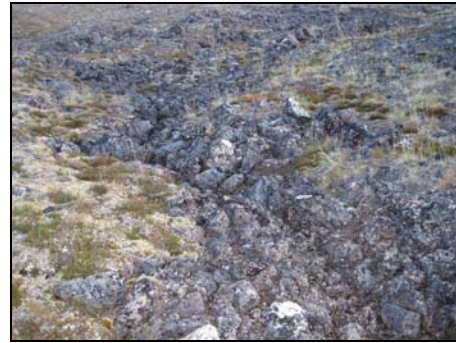
Figure 1: View upstream of crossing 140

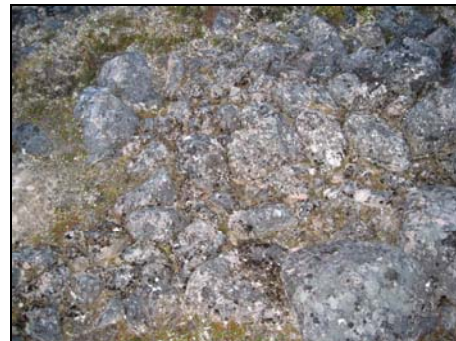
Figure 2: View across crossing 140 from right bank

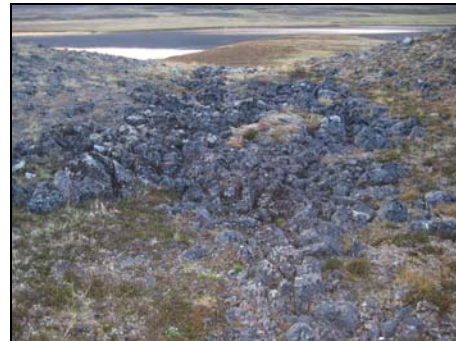
Figure 3: View downstream of crossing 140

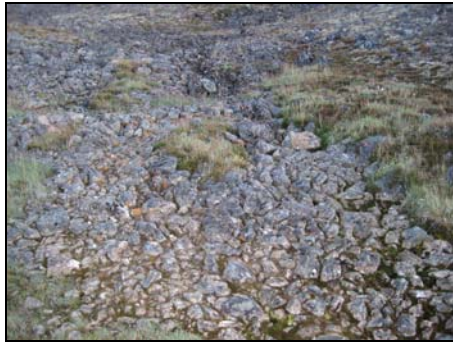
Figure 1: View upstream of crossing 141

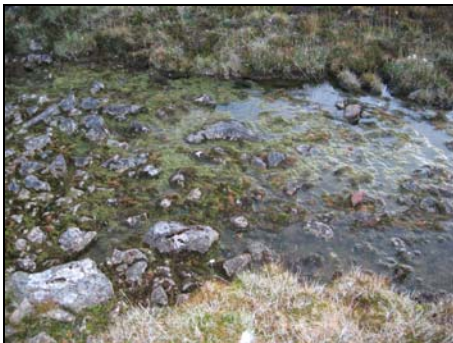
Figure 2: View across crossing 141 from left bank

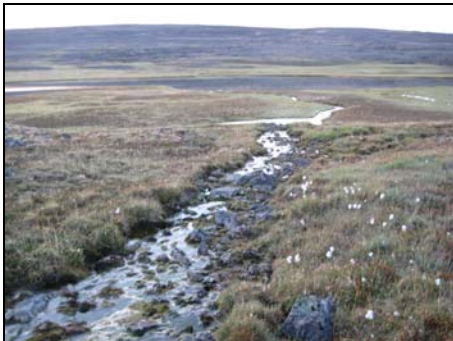
Figure 3: View downstream of crossing 141

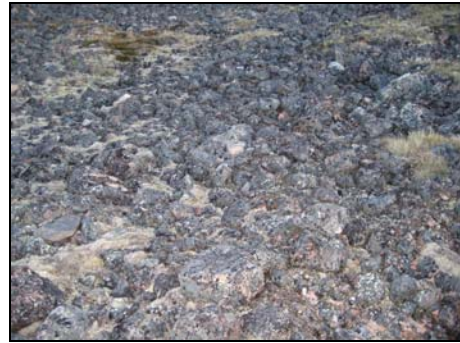
Figure 1: View upstream of crossing 142

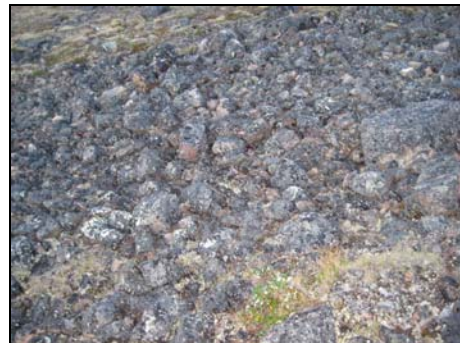
Figure 2: View across crossing 142 from right bank

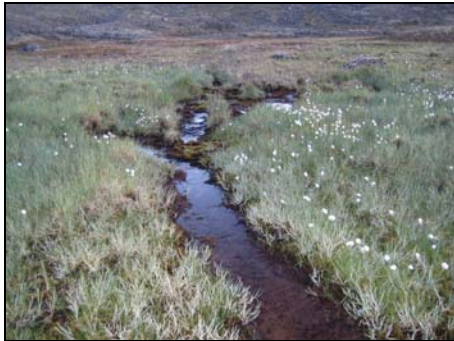
Figure 1: View upstream of crossing 143

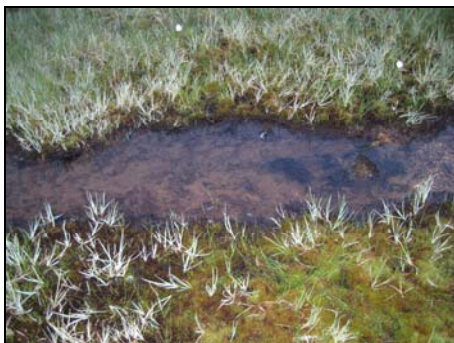
Figure 2: View across crossing 143 from right bank

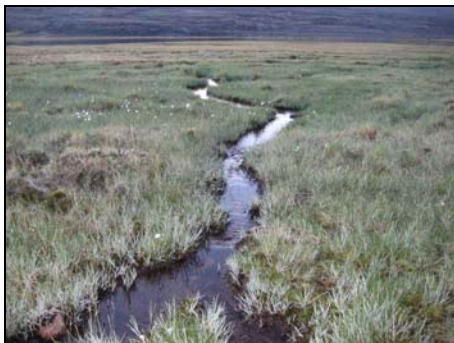
Figure 3: View downstream of crossing 143

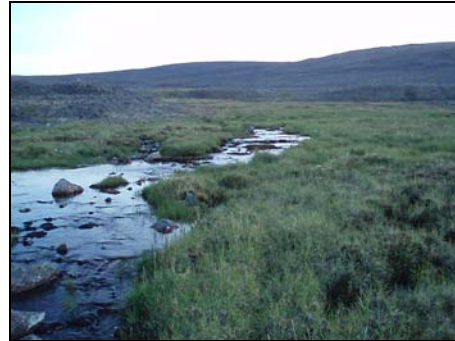
Figure 1: View upstream of crossing 144

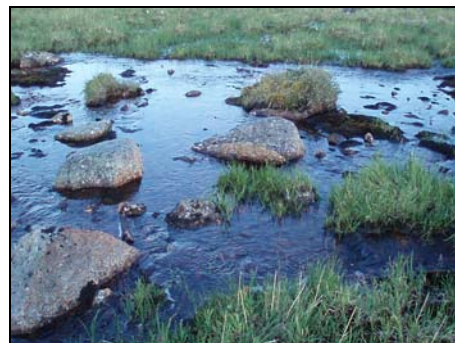
Figure 2: View across crossing 144 from left bank

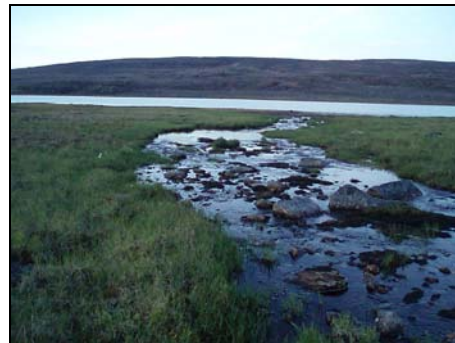
Figure 3: View downstream of crossing 144

The large, unnamed river is ~100 m downstream.

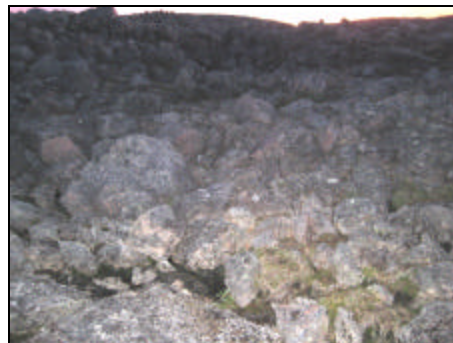
Figure 1: View upstream of crossing 151

The large, unnamed river is ~500 m downstream. Low water between the river and the crossing acts as a barrier.

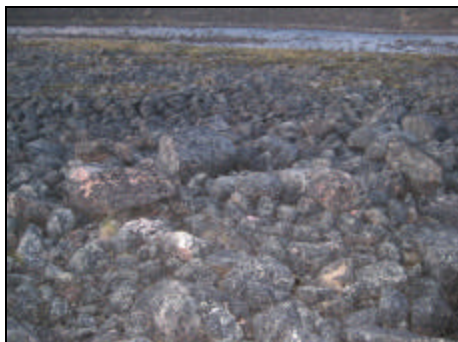
Figure 3: View downstream of crossing 158

The large, unnamed river is ~100 m downstream. The steep gradient between the river and the crossing acts as a barrier.

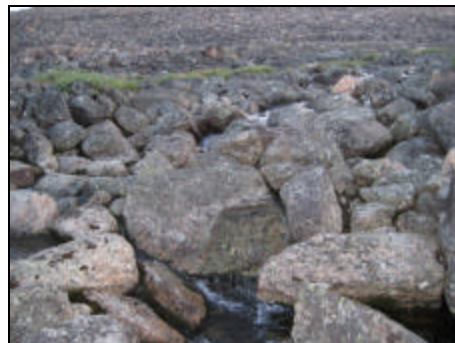
Figure 1: View upstream of crossing 159

The large, unnamed river is ~200 m downstream. Falls between the river and the crossing site act as barriers.

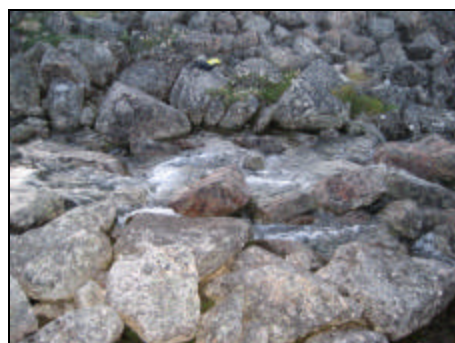
Figure 2: View across crossing 159 from left bank

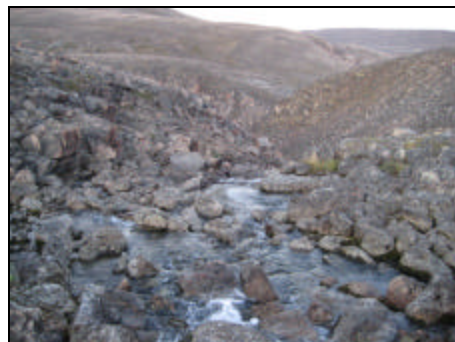
Figure 3: View downstream of crossing 159

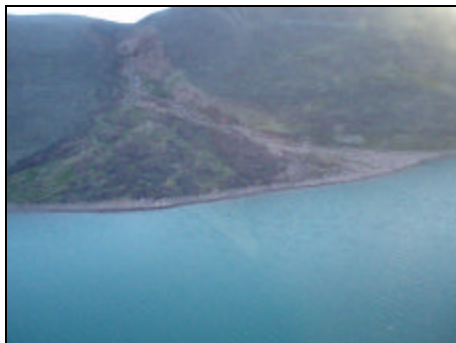
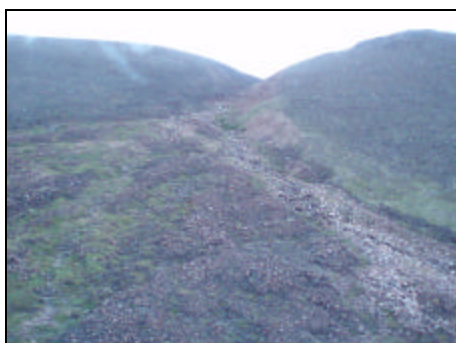
Figure 1: Aerial view of area near crossing 160

Figure 2: Another aerial view of area near crossing 160

Cockburn River/Lake is ~200 m downstream. Steep, shallow cascades between Cockburn Lake and the crossing act as barriers.

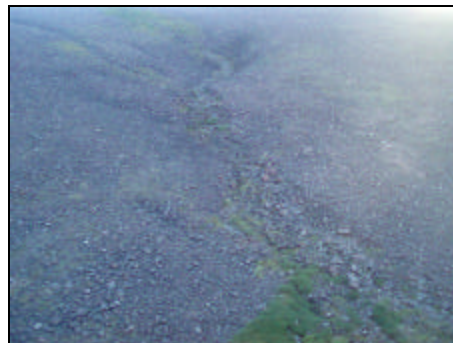
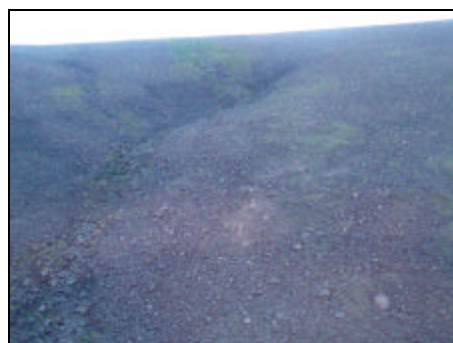
Figure 1: Aerial view of area near crossing 161

Figure 2: Another aerial view of area near crossing 161

Cockburn River/Lake is ~100 m downstream. Steep, shallow cascades between Cockburn Lake and the crossing act as barriers.

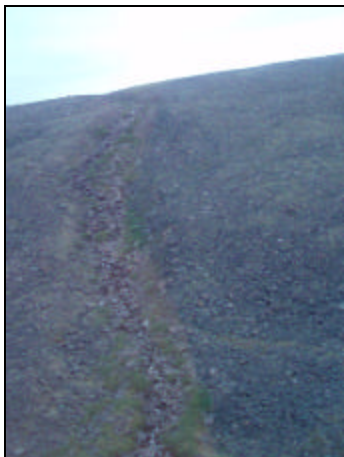
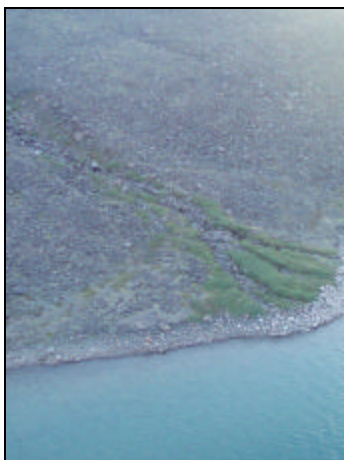
Figure 1: Aerial view of area near crossing 162

Figure 2: Another aerial view of area near crossing 162

Cockburn River/Lake is ~200 m downstream. Steep, shallow cascades between Cockburn Lake and the crossing act as barriers.

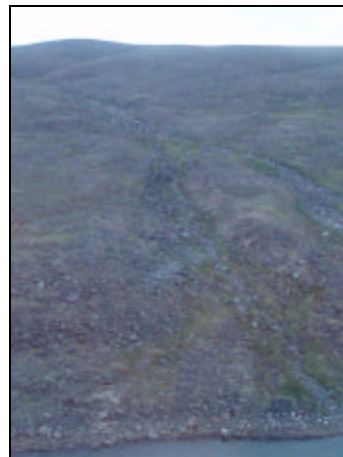
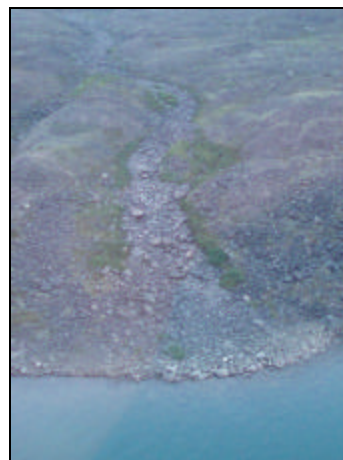
Figure 1: Aerial view of area near crossing 163

Figure 2: Another aerial view of area near crossing 163

Cockburn River/Lake is ~200 m downstream. Steep, shallow cascades between Cockburn Lake and the crossing act as barriers.

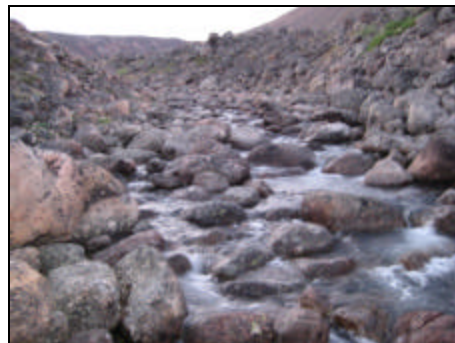
Figure 1: View upstream of crossing 165

Cockburn Lake is located ~100 m downstream of the crossing. Cascades upstream and downstream of the crossing act as partial barriers.

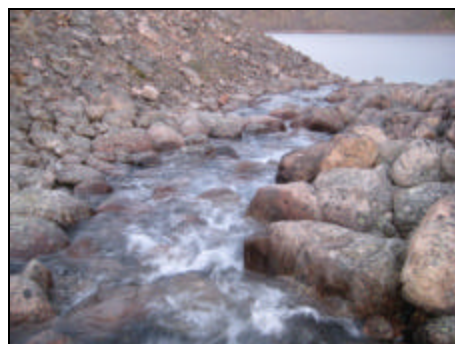
Figure 3: View downstream of crossing 165

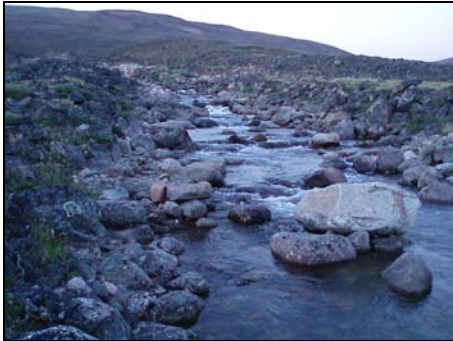
Figure 1: View upstream of crossing 166

Cockburn Lake is located ~100 m downstream of the crossing. Cascades upstream and downstream of the crossing act as partial barriers.

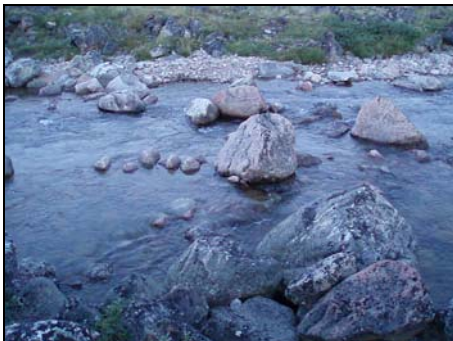
Figure 2: View across crossing 166 from left bank

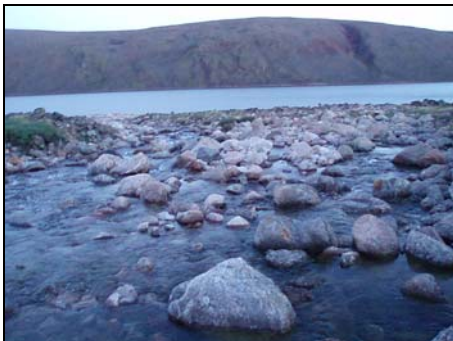
Figure 3: View downstream of crossing 166

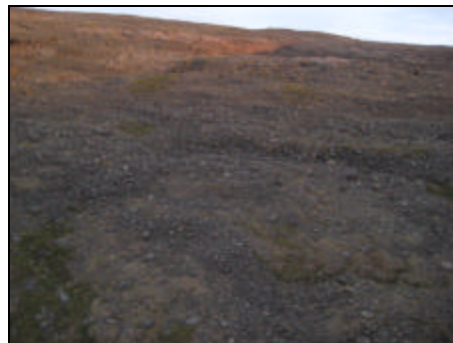
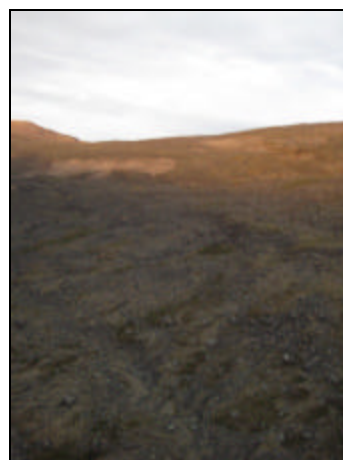
Figure 1: Aerial view of area near crossing 171

Figure 2: Another aerial view of area near crossing 171

Cockburn Lake is located ~100 m downstream of the crossing site. The steep gradient and low water upstream and downstream of the crossing act as barriers.

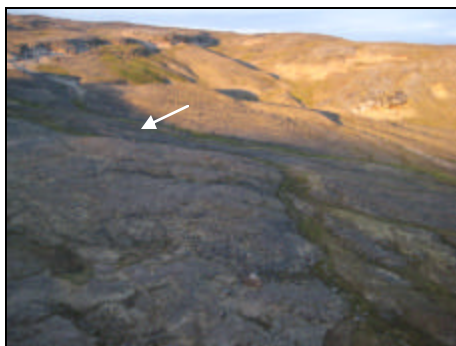
Figure 2: Another aerial view of area near crossing 177 (white arrow)

Cockburn Lake is located ~1 km downstream of the crossing site.

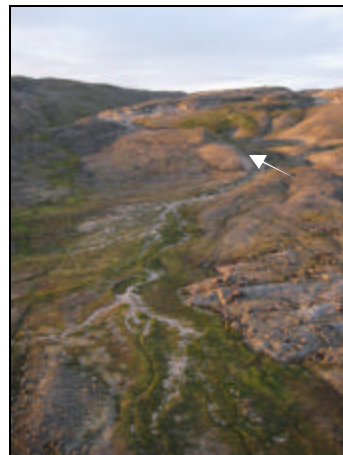
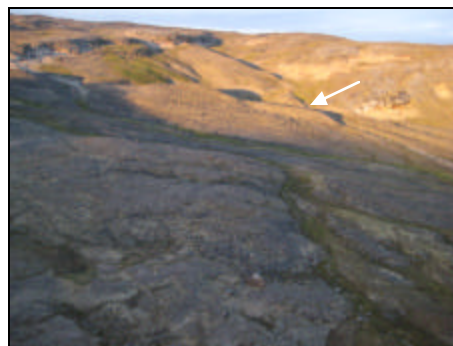
Figure 1: Aerial view of area near crossing 178 (white arrow)

Figure 2: Another aerial view of area near crossing 178 (white arrow)

Cockburn Lake is located ~1 km downstream of the crossing site.

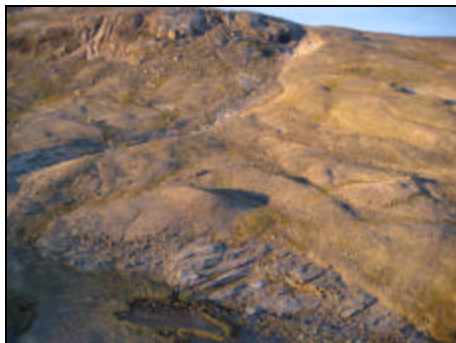
Figure 1: Aerial view of area near crossing 179

Cockburn Lake is located ~800 m downstream of the crossing site. Steep, shallow cascades between Cockburn Lake and the crossing act as barriers.

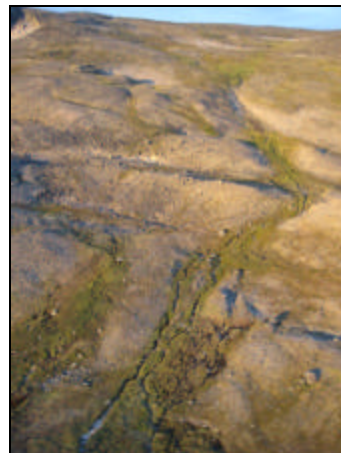
Figure 1: Aerial view of area near crossing 180

Cockburn Lake is located ~800 m downstream of the crossing site.

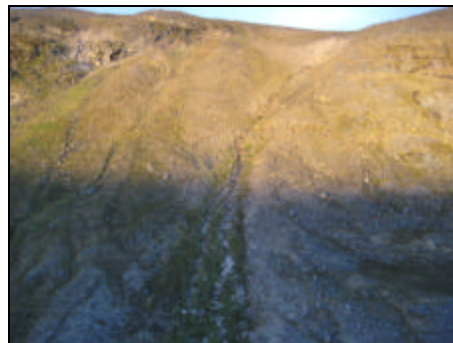
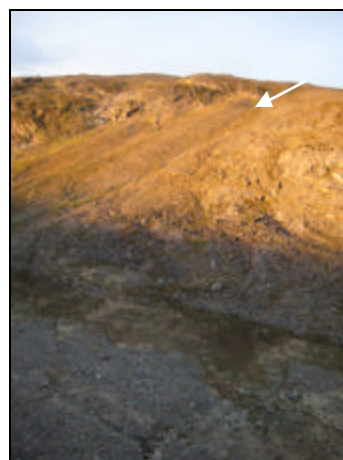
Figure 1: Aerial view of area near crossing 183

Figure 2: Another aerial view of area near crossing 183

Cockburn Lake is located ~300 m downstream of the crossing site. The steep gradient and low water upstream and downstream of the crossing act as barriers.

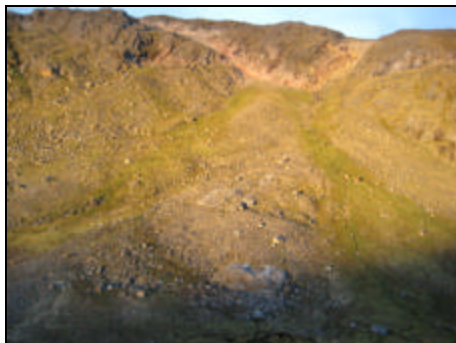
Figure 1: Aerial view of area near crossing 184

Figure 2: Another aerial view of area near crossing 184

Cockburn Lake is located ~400 m downstream of the crossing site. The steep gradient downstream of the crossing acts as a barrier.

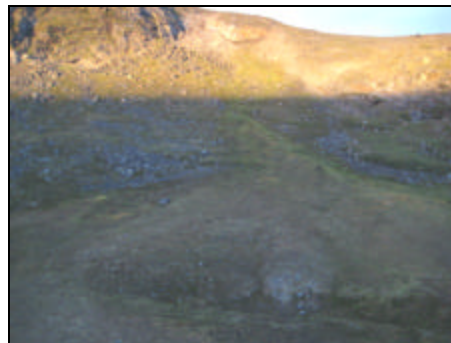
Figure 1: Aerial view of area near crossing 185

Cockburn Lake is located ~300 m downstream of the crossing site. The steep gradient and low water upstream and downstream of the crossing act as barriers.

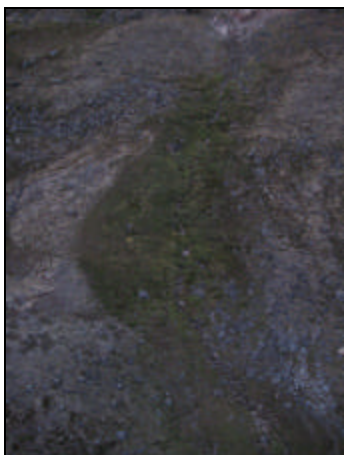
Figure 1: Aerial view of area near crossing 186

Figure 2: Another aerial view of area near crossing 186

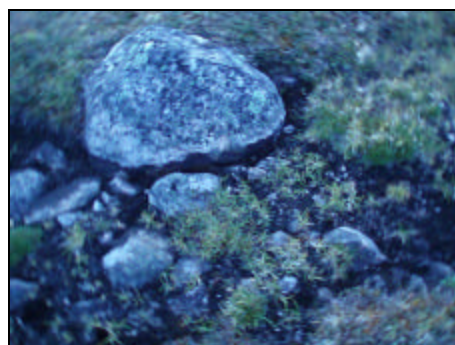
Figure 2: View across crossings 188 & 189 from right bank

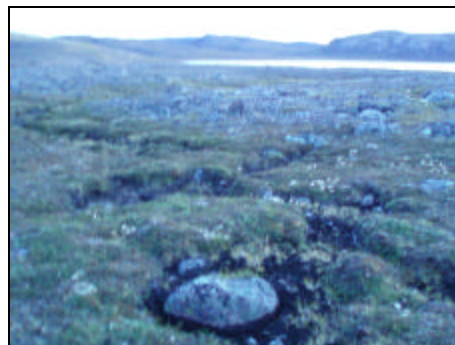
Figure 3: View downstream of crossing 188 & 189

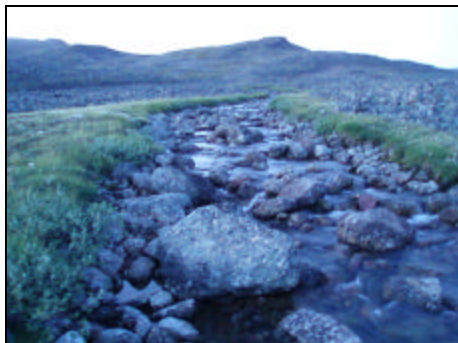
Figure 1: View upstream of crossing 190

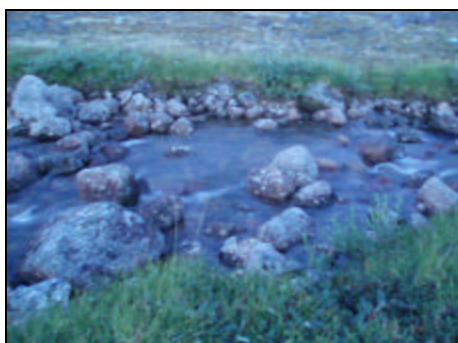
Figure 2: View across crossing 190 from left bank

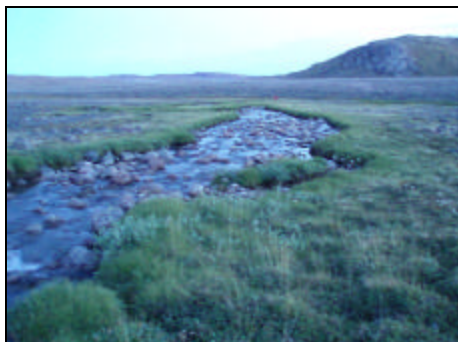
Figure 3: View downstream of crossing 190

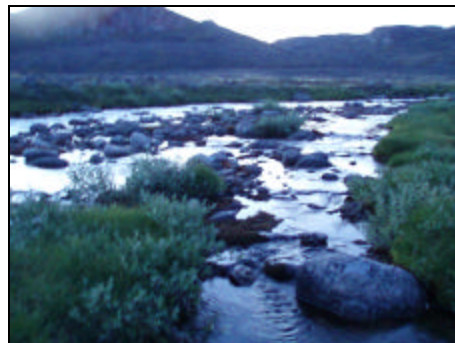
Figure 1: View upstream of crossing 191A

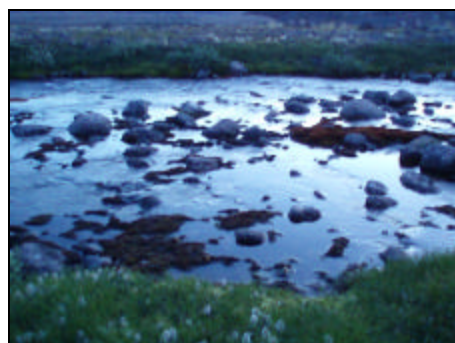
Figure 2: View across crossing 191A from right bank

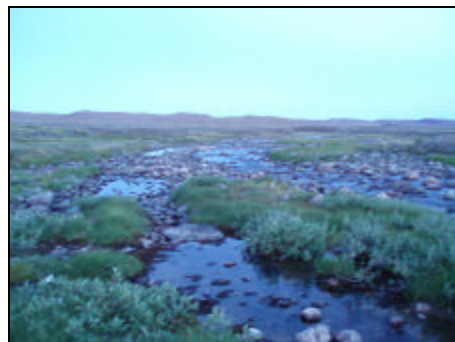
Figure 3: View downstream of crossing 191A

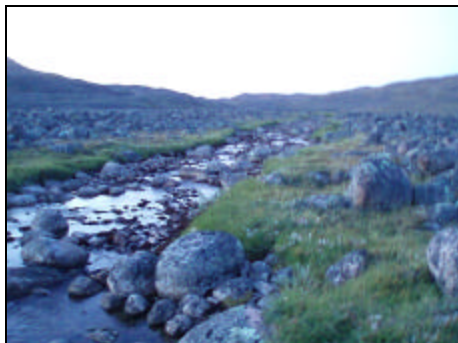
Figure 1: View upstream of crossing 191B

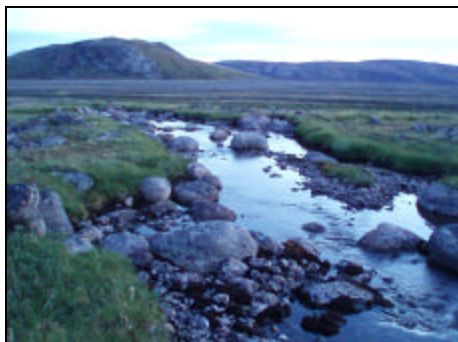
Figure 3: View downstream of crossing 191B

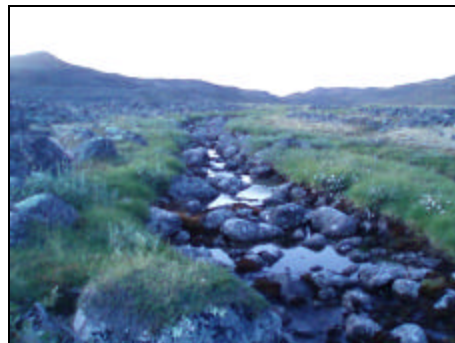
Figure 1: View upstream of crossing 191C

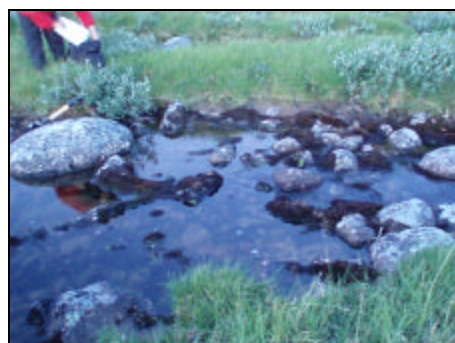
Figure 2: View across crossing 191C from left bank

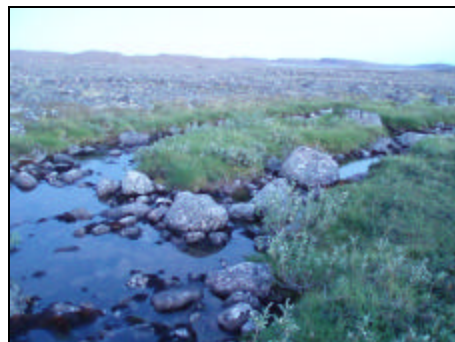
Figure 3: View downstream of crossing 191C

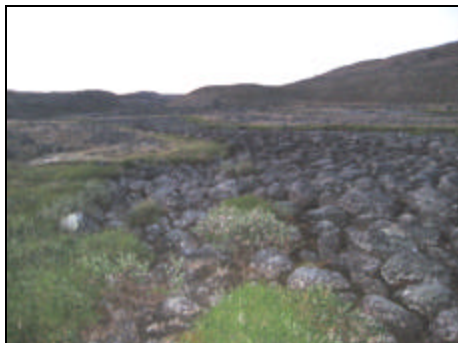
Figure 1: View upstream of crossing 192A

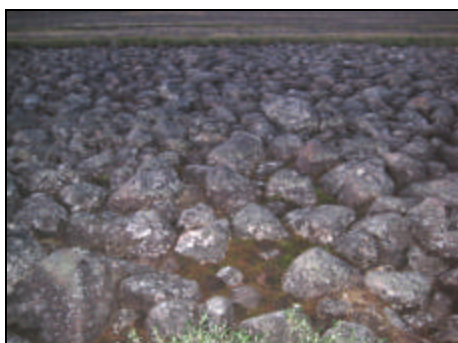
Figure 2: View across crossing 192A from left bank

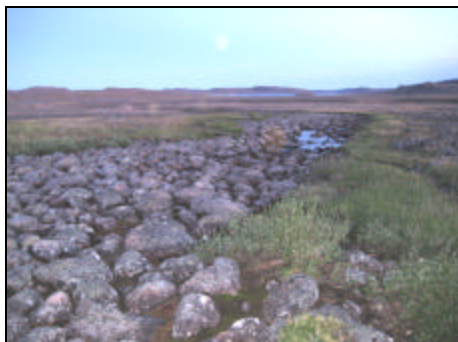
Figure 3: View downstream of crossing 192A

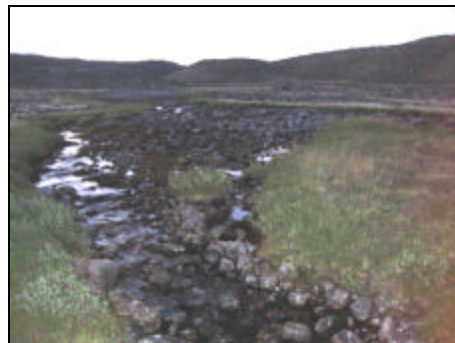
Figure 1: View upstream of crossing 192B

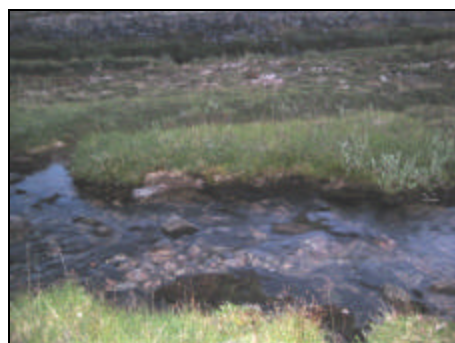
Figure 2: View across crossing 192B from left bank

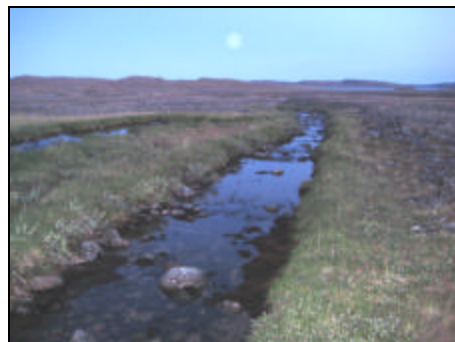
Figure 3: View downstream of crossing 192B

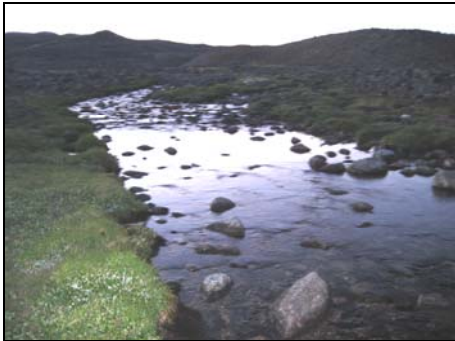
Figure 1: View upstream of crossing 193

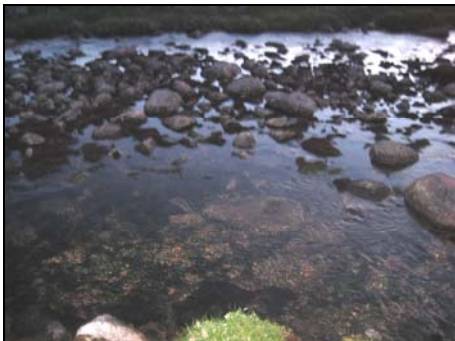
Figure 2: View across crossing 193 from right bank

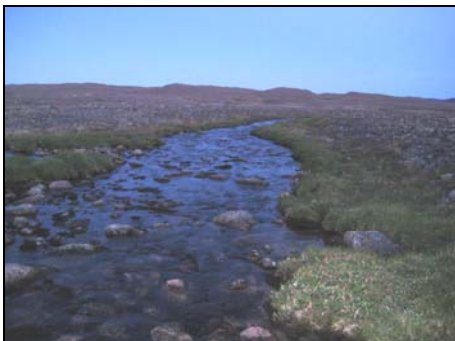
Figure 3: View downstream of crossing 193

Cockburn Lake is ~2 km downstream of the crossing site.

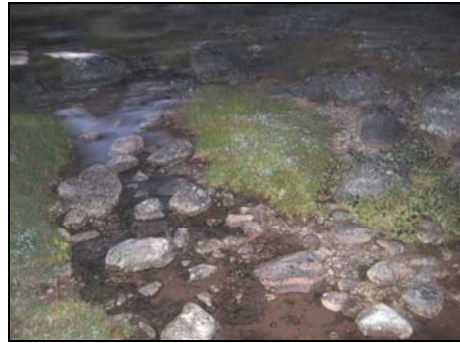
Figure 1: View upstream of crossing 194

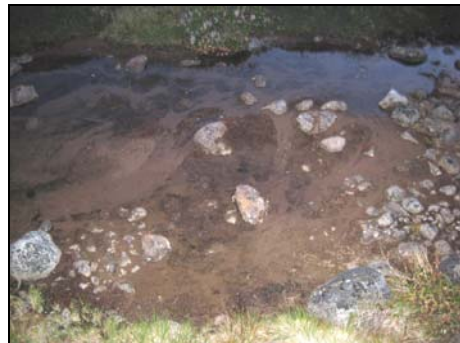
Figure 2: View across crossing 194 from right bank

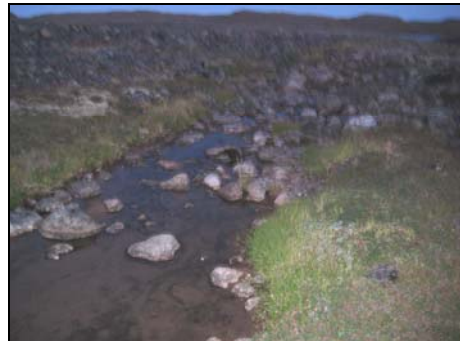
Figure 3: View downstream of crossing 194

Cockburn Lake is ~1.5 km downstream of the crossing site. Low water and steep stretch downstream of the crossing site acts as a barrier.

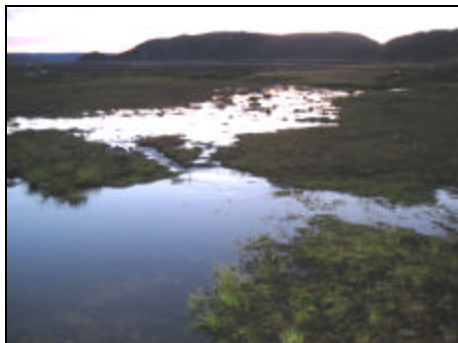
Figure 1: View upstream of crossing 195

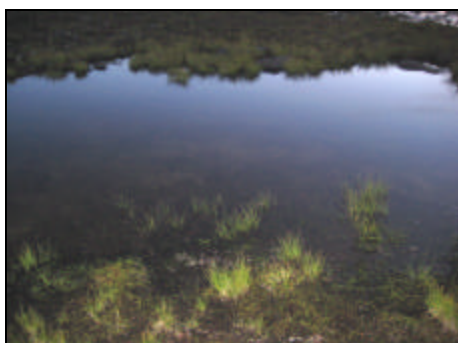
Figure 2: View across crossing 195 from right bank

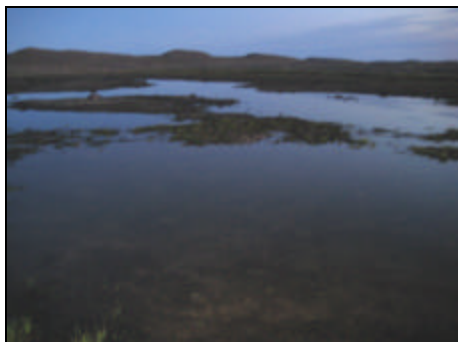
Figure 3: View downstream of crossing 195

Cockburn Lake is ~800 m downstream of the crossing site. Low water between the crossing site and the lake acts as a barrier.

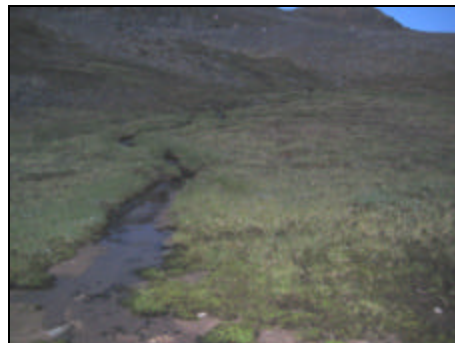
Figure 1: View upstream of crossings 196 & 197

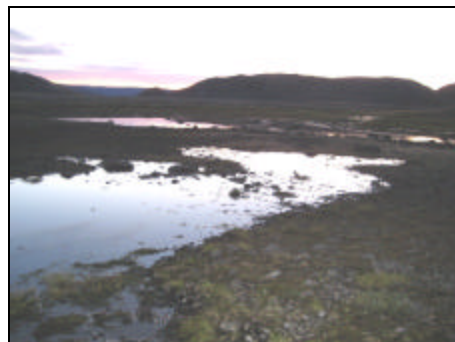
Figure 3: View downstream of crossing 196 & 197

Cockburn Lake is ~800 m downstream of the crossing site. A steep drop between the lake and the crossing site acts as a barrier.

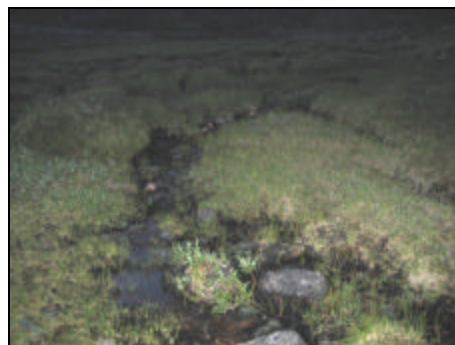
Figure 1: View upstream of crossing 199

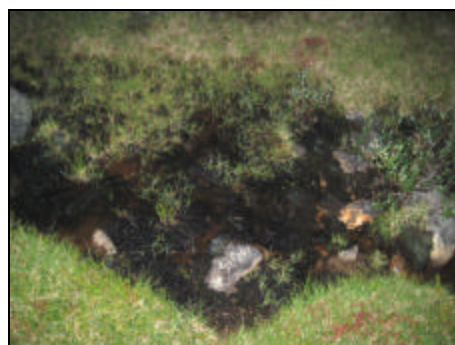
Figure 2: View across crossing 199 from left bank

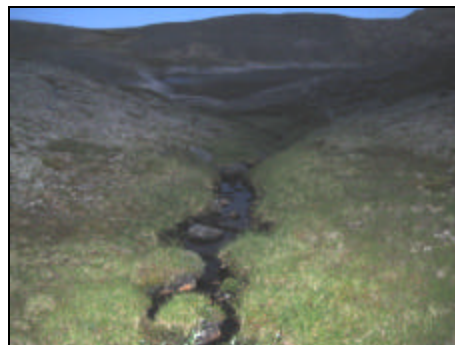
Figure 3: View downstream of crossing 199

A small, unnamed lake is ~100 m downstream and the Cockburn River is ~400 m downstream of the crossing site. Cascades between the lake and the crossing act as barriers.

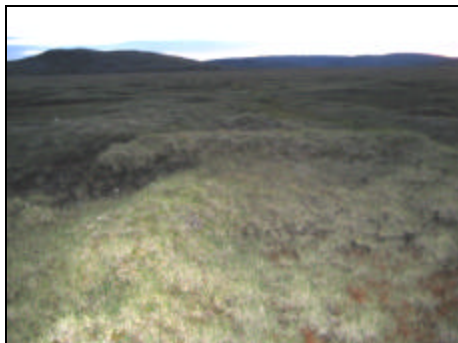
Figure 1: View upstream of crossing 200

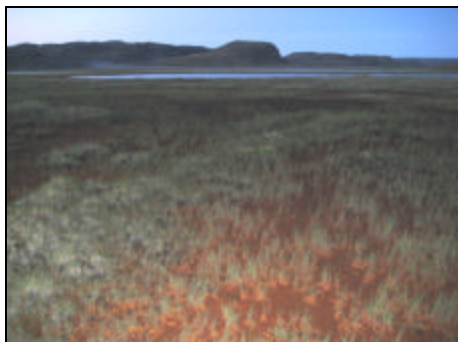
Figure 3: View downstream of crossing 200

The unnamed river is ~1 km downstream. There is a small lake immediately downstream of the crossing. A dry stretch between the lake and the crossing site acts as a barrier.

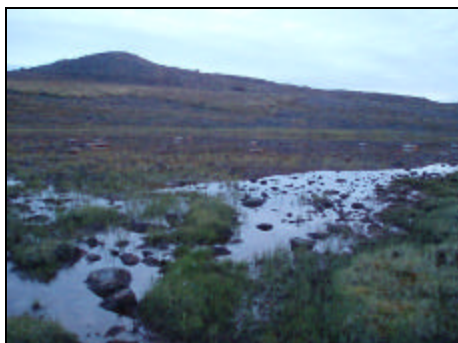
Figure 1: View upstream of crossing 202

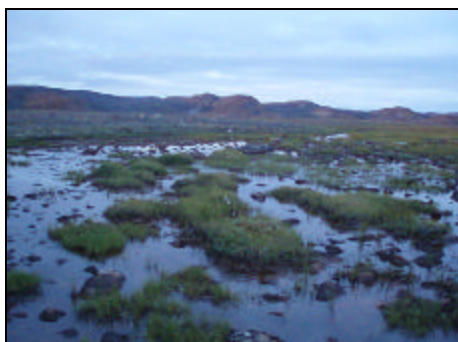
Figure 3: View downstream of crossing 202

The unnamed river is ~1 km downstream. There is a small lake immediately downstream of the crossing.

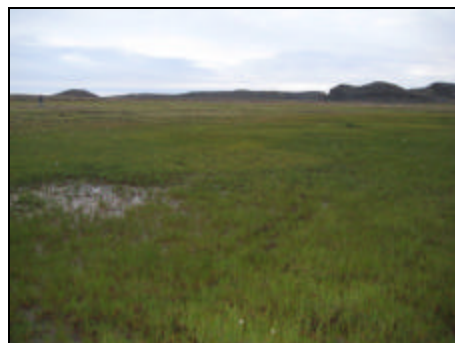
Figure 1: View upstream of crossing 203

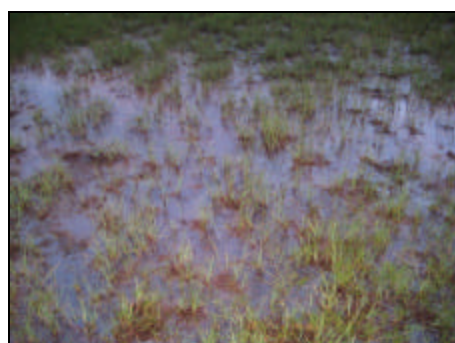
Figure 2: View across crossing 203 from right bank

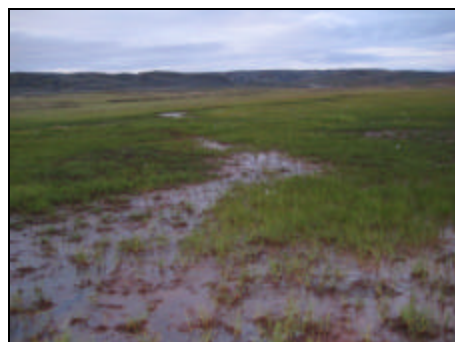
Figure 3: View downstream of crossing 203

The large, unnamed lake is ~1 km downstream. Low water downstream of the crossing site acts as a barrier.

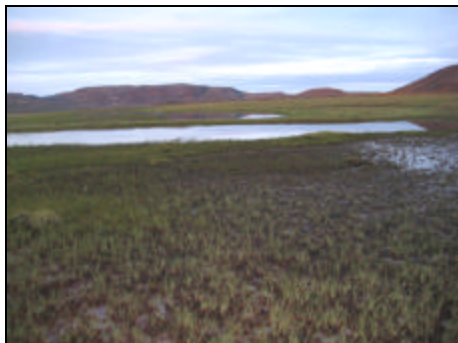
Figure 1: View upstream of crossing 204

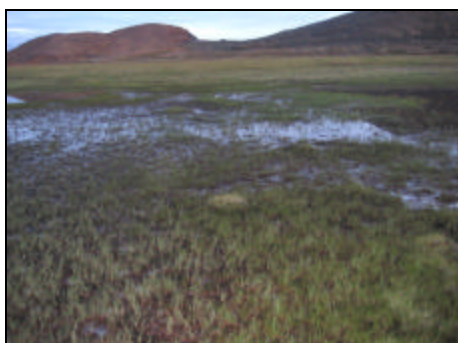
Figure 2: View across crossing 204 from left bank

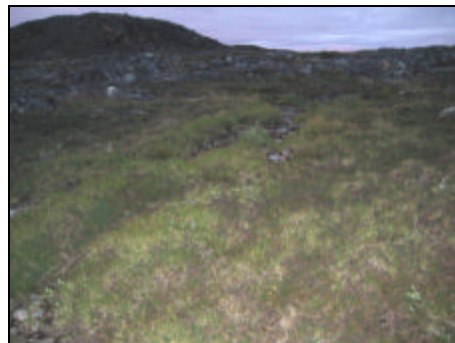
Figure 1: View upstream of crossing 205

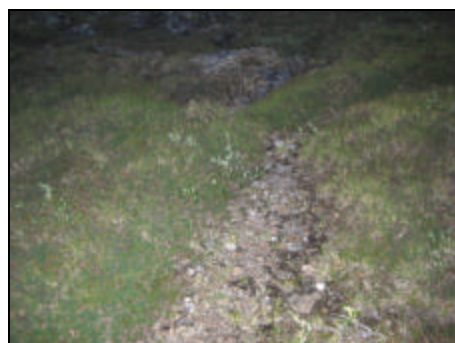
Figure 2: View across crossing 205 from right bank

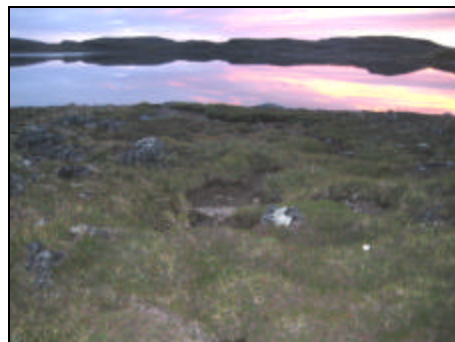
Figure 3: View downstream of crossing 205
