Rail Alignment Watercourse Crossing Assessments

Crossing ID: 106**UTM:** 17W 599076 / 7875790**Latitude / Longitude:** 70°57'56.289" N / 78°16'38.296" W**Date / Time Surveyed:** 11-Aug-07 / 23:10

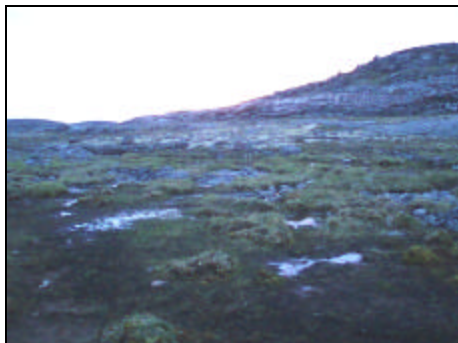
Figure 1: View upstream of crossing 206

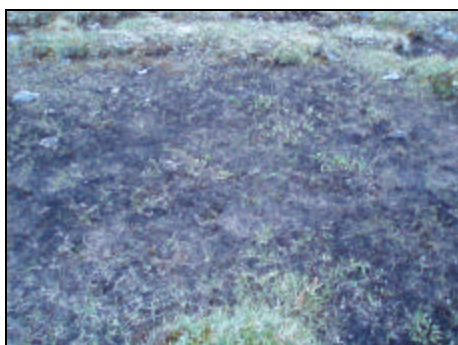
Figure 2: View across crossing 206 from left bank

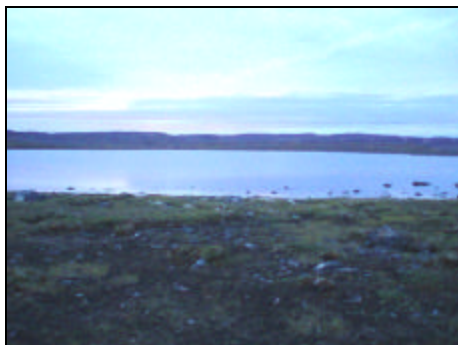
Figure 3: View downstream of crossing 206

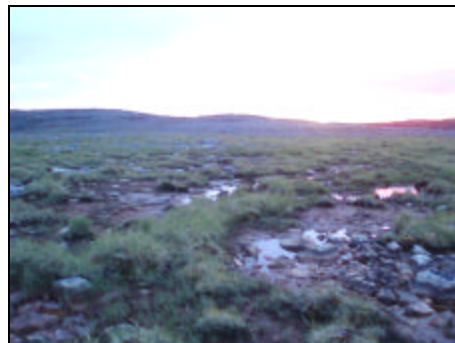
Figure 1: View upstream of crossing 207

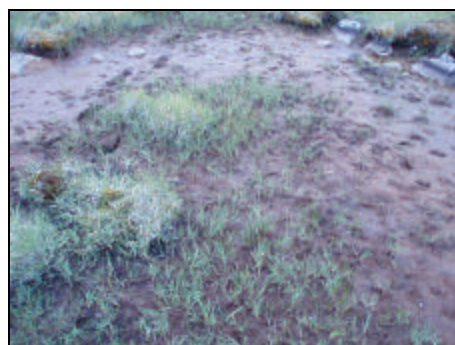
Figure 2: View across crossing 207 from left bank

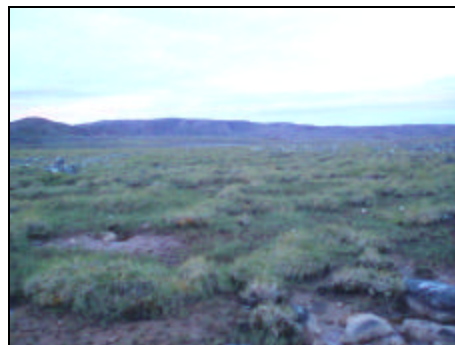
Figure 3: View downstream of crossing 207

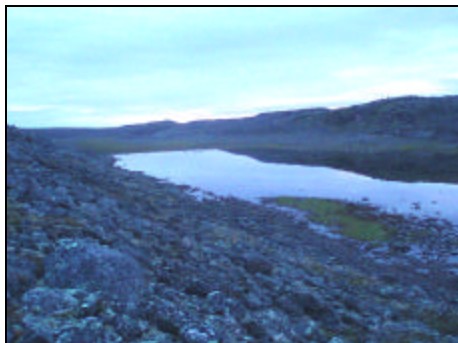
Figure 1: View upstream of crossing 208

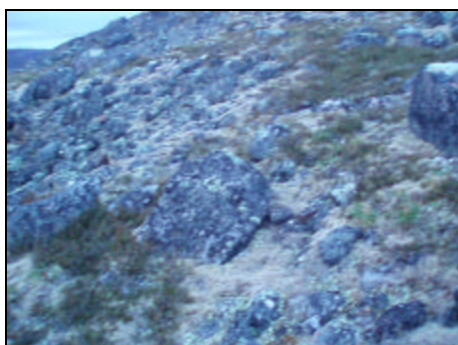
Figure 2: View across crossing 208

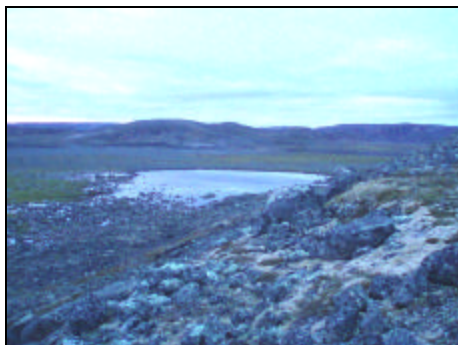
Figure 3: View downstream of crossing 208

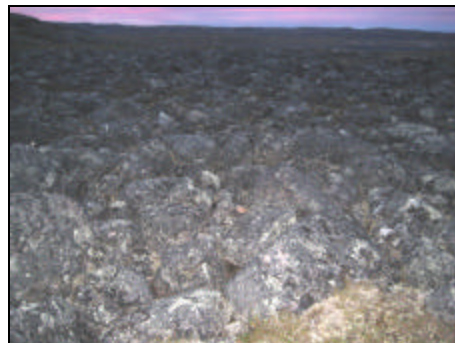
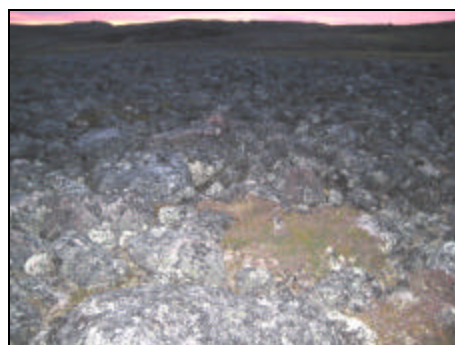
Figure 1: View upstream of crossing 209

Figure 2: View across crossing 209 from right bank

Figure 3: View downstream of crossing 209

The lake is ~600 m downstream. A dry stretch between the lake and the crossing acts as a barrier.

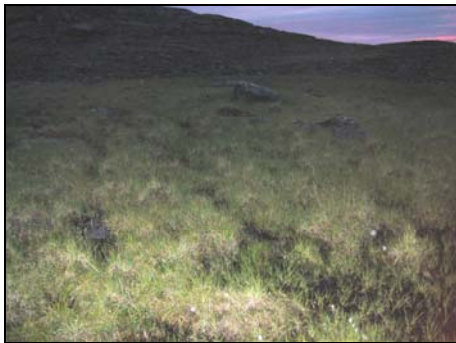
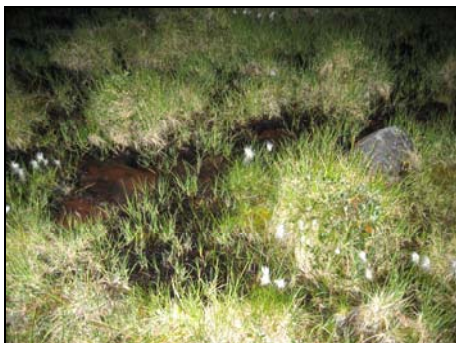
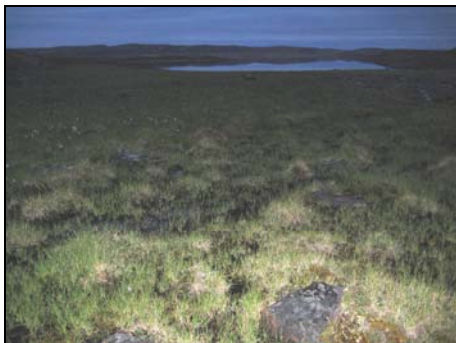
Figure 1: View upstream of crossing 210

Figure 2: View across crossing 210 from right bank

Figure 3: View downstream of crossing 210

The large, unnamed lake is ~300 m downstream. Low water downstream of the crossing site acts as a barrier.

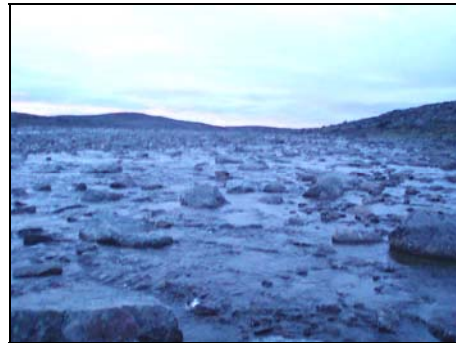
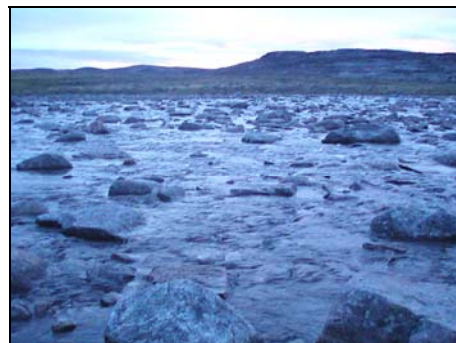
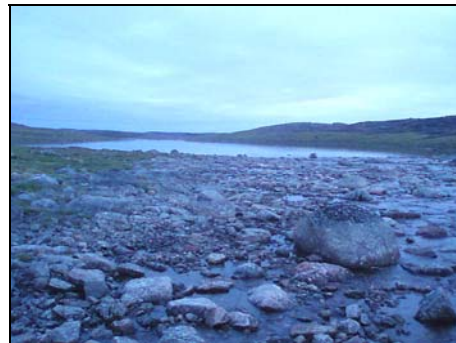
Figure 1: View upstream of crossing 211

Figure 2: View across crossing 211 from right bank

Figure 3: View downstream of crossing 211

Steensby Inlet is ~1 km downstream. A small, unnamed lake is between the crossing and Steensby Inlet.

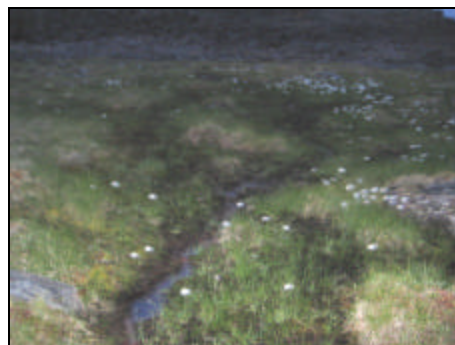
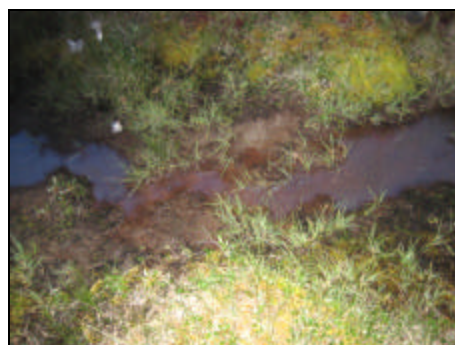
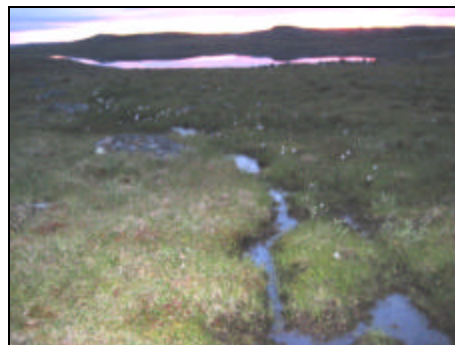
Figure 1: View upstream of crossing 213

Figure 2: View across crossing 213 from right bank

Figure 3: View downstream of crossing 213

Steensby Inlet is ~500 m downstream. Low water between the inlet and the crossing acts as a barrier.

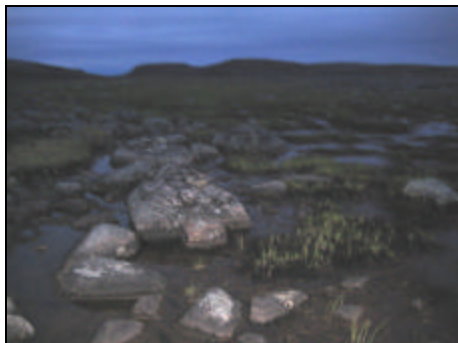
Figure 1: View upstream of crossing 214

Figure 2: View across crossing 214 from right bank

Figure 3: View downstream of crossing 214

Steensby Inlet is ~800 m downstream. There is a lake upstream of the crossing site.

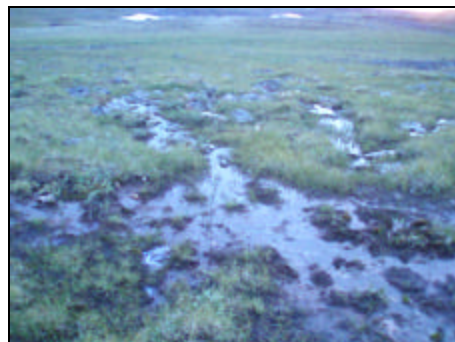
Figure 1: View upstream of crossing 215

Figure 2: View across crossing 215 from right bank

Figure 3: View downstream of crossing 215

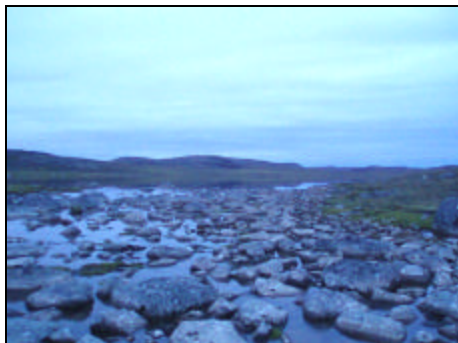
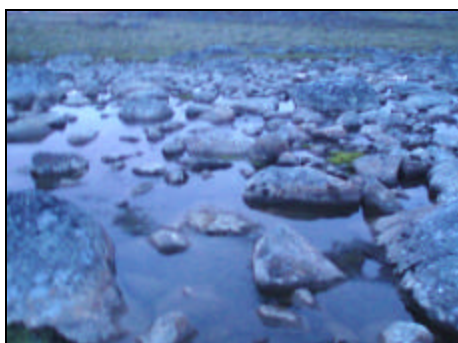
Figure 1: View upstream of crossing 216

Figure 2: View across crossing 216 from right bank

Figure 3: View downstream of crossing 216

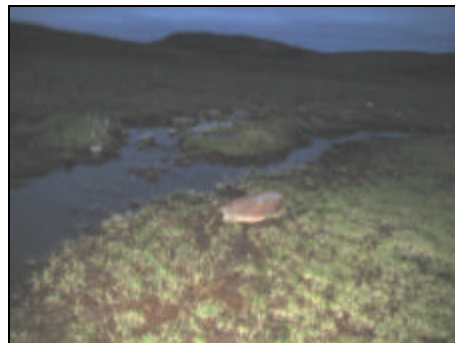
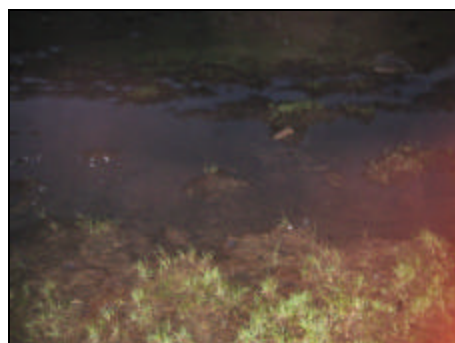
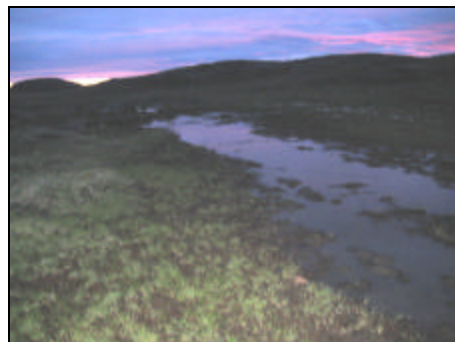
Figure 1: View upstream of crossing 217

Figure 2: View across crossing 217 from right bank

Figure 3: View downstream of crossing 217
